PUBLIC ROADS

MAY, 1928

REPORT ON CONNECTICUT AVENUE EXPERIMENTAL ROAD

A DISCUSSION OF CONSTRUCTION AND MAINTENANCE METHODS AND PRESENT CONDITION OF VARIOUS TYPES OF SURFACE LAID IN 1911, 1912, AND 1913

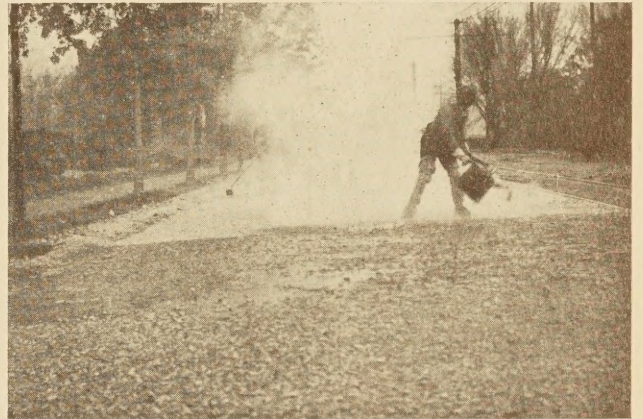
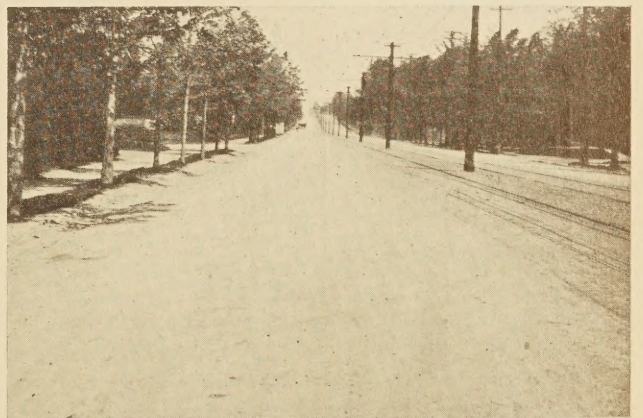
STEPS IN CONSTRUCTION AND FINISHED PAVEMENT OF PENETRATION MACADAM, EXPERIMENT 3

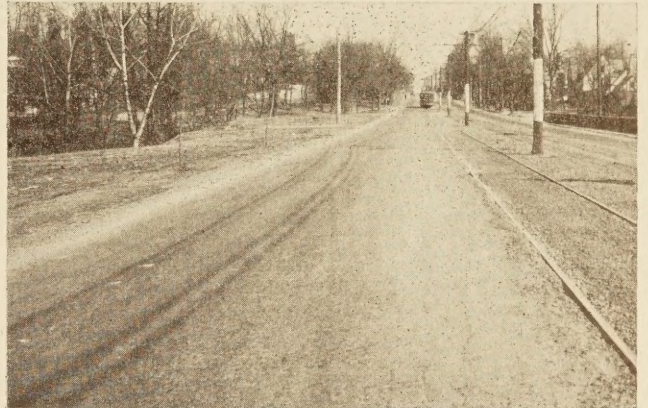
EXPERIMENT-4

CONDITION OF SURFACE-TREATED SECTIONS IN 1928

This surface gave early evidence of requiring repairs, but bleeding, which began with the advent of warm weather, caused the surface to seal itself. Some depressions occurred along the west edge and waviness and lack of stability in the surface were more apparent on that portion on which screenings containing dust were used in covering the original seal coat. In 1918 a surface treatment was applied consisting of 0.305 gallon per square yard of oil asphalt and a 1/2-inch stone cover. At the present time the section is in good condition, but in general the surface has worn more unevenly and has developed more waviness than that of experiment 3.

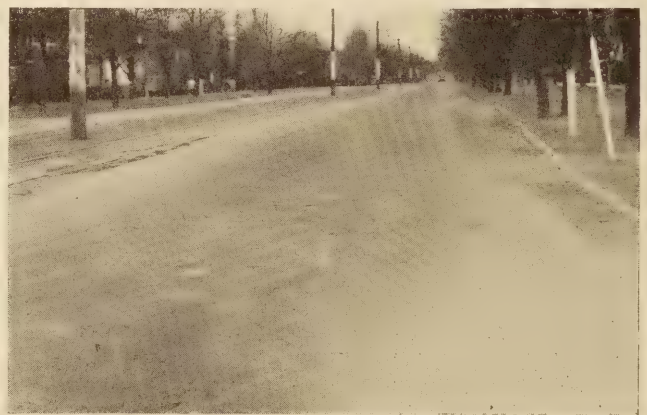
CONDITION OF EXPERIMENT 11 IN FEBRUARY, 1928. WATER-BOUND MACADAM SURFACE TREATED WITH ASPHALT EMULSION

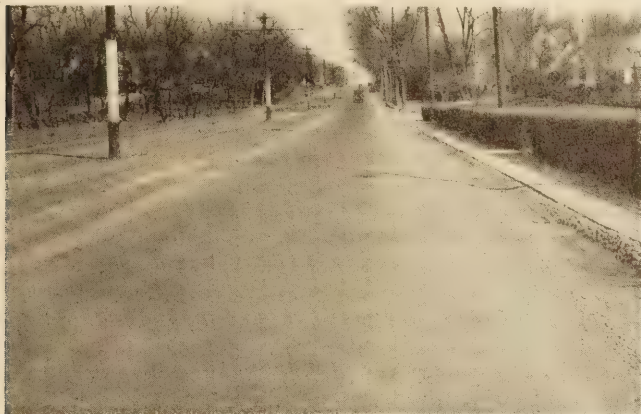
EXPERIMENT-7

Within a year after construction the binder appeared to be lifeless. It was considered also that the asphalt used was too hard and had a melting point too high for this type of construction. A number of worn depressions occurred in both sections A and B, although to a much greater extent in the single-application area. These defects were repaired and a surface treatment of 0.29 gallon of cold asphaltic oil and one-half inch stone was applied to the patches on section A and to the whole of section B. This treatment undoubtedly saved section B from total failure.

Subsequently section A required considerable patching and section B developed many short irregular waves. These waves have not, however, developed serious roughness although considerable cracking has occurred on a 3-foot strip adjacent to the car tracks. At the present time the appearance and condition of this section compares favorably with the other experiments of this group, although the maintenance costs for the past few years have been somewhat higher than the average.

CONDITION OF PENETRATION MACADAM (EXPERIMENT 7) AND THREE PENETRATION MACADAM SECTIONS IN 1928

From 1912 on, with the exception of the year 1915, this section required only light repairs up to 1918 at which time it received a surface treatment of 0.29 gallon of hot asphalt and ½-inch stone.

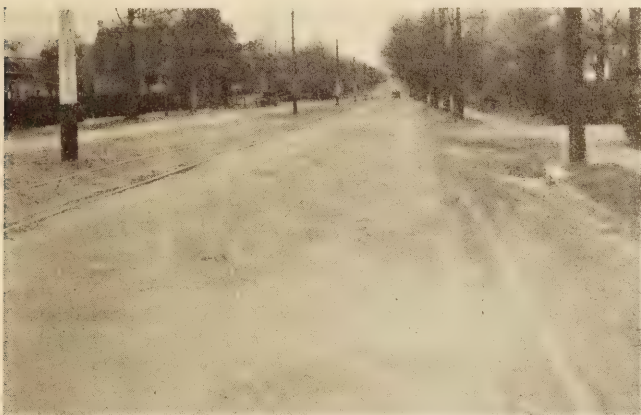
EXPERIMENT-9

The oil mat withstood the abrasion of traffic better than the preceding section treated with tar. However, a tendency to become muddy in wet weather was noticeable and deterioration developed in the more lightly traveled areas of the section.

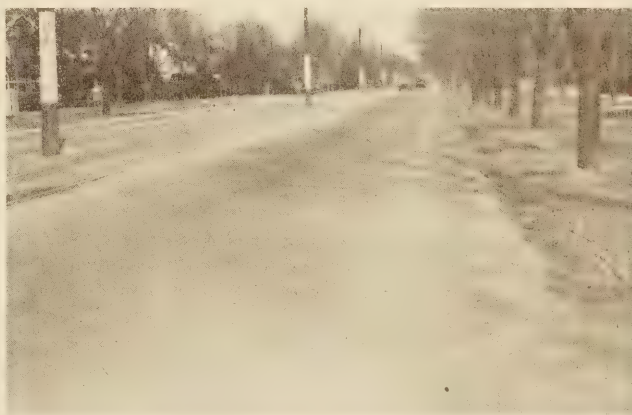
EXPERIMENT-10

This experiment gave promise of becoming troublesome from the beginning. The subgrade was soft and there was difficulty in bonding the macadam. With the advent of warm weather the thick mat began to bleed, necessitating the addition of more stone covering. It also proved unstable under traffic and developed a marked degree of waviness. Continued maintenance

failed to correct this condition and in 1914 it was scarified, brought to grade by the addition of new stone and refinished as water-bound macadam. After being opened to traffic for a few days a new bituminous treatment of asphaltic petroleum was applied. This material was the same as that applied to the adjacent experiment, No. 9, in fact, constituted an extension of the same treatment. Unfortunately, the work of reconstruction was done late in the fall and numerous small potholes soon formed. Persistent waviness and the tendency to become muddy in wet weather were characteristic of this section during its early life.

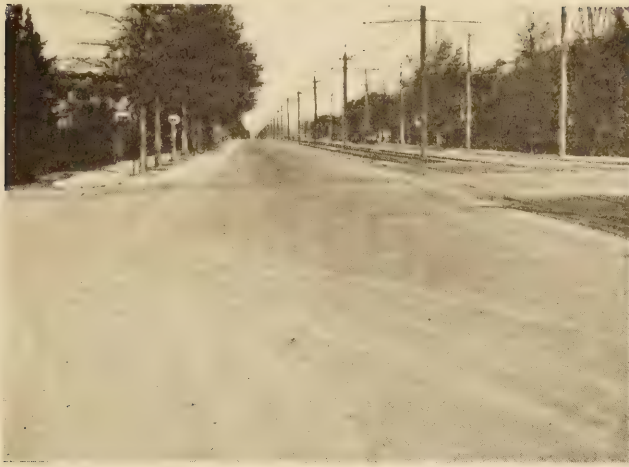
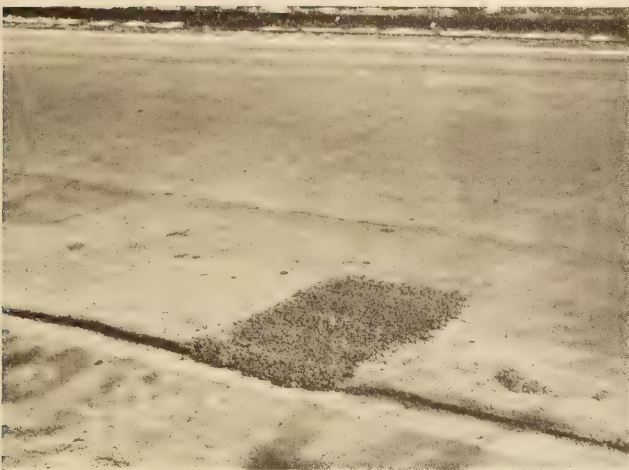
On a number of scattered areas in the limestone section, especially near the west edge, the surface has been broken by the formation of fine irregular cracks. These areas have remained firm and smooth and have required no additional maintenance up to this time. However, it may be reasonably expected that they will eventually affect the life of the pavement and will require more maintenance.

A BADLY CRACKED AREA OF BITUMINOUS CONCRETE IN EXPERIMENT 1, NORTH OF BRADLEY LANE. THE LOWER PICTURE SHOWS THE CONDITION OF THE CONCRETE BASE WHICH COULD BE REMOVED WITH A SHOVEL

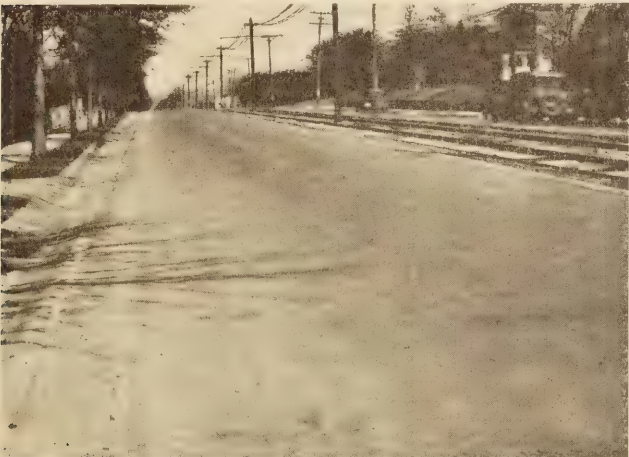
This pavement in general has remained in good condition throughout its 15 years of service and has required remarkably low expenditures for maintenance. Depressions have occurred from time to time along the west edge of section A and to some extent on the north end of section B, due, apparently, to the tendency of heavy trucks to follow the line of the gutter. Shortly after construction slight indications of waviness were observed, especially near the north end in the trap-rock section adjacent to the curb. This condition has not increased to a marked degree, although in a few places transverse cracks have developed in the base, resulting in a slight bulge in the wearing surface.

CONDITION OF BITUMINOUS CONCRETE SECTIONS IN 1928. THE THE UPPER PICTURES ARE OF EXPERIMENT 1 AND THE LOWER IS OF EXPERIMENT 2

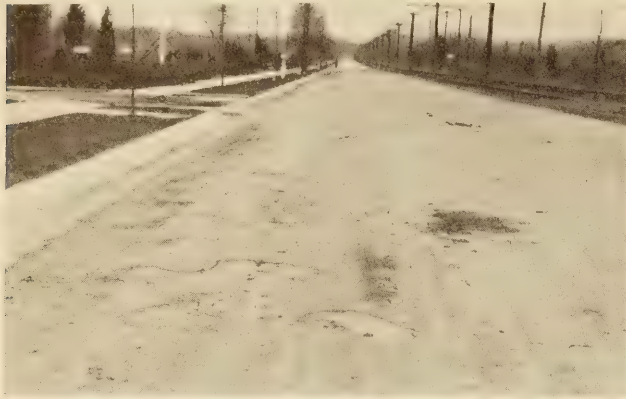
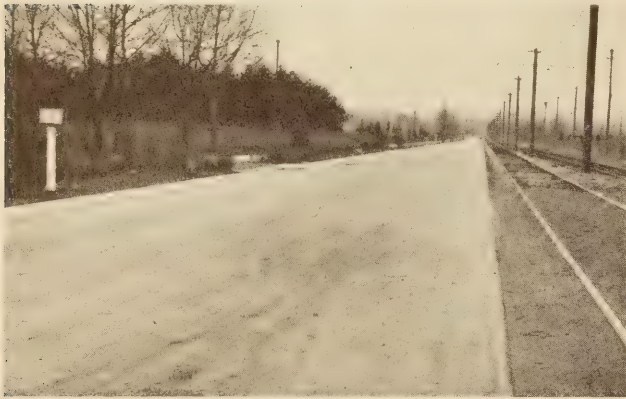
CONDITION OF 2 OF THE SURFACE-TREATED PORTLAND CEMENT CONCRETE SECTIONS IN 1914

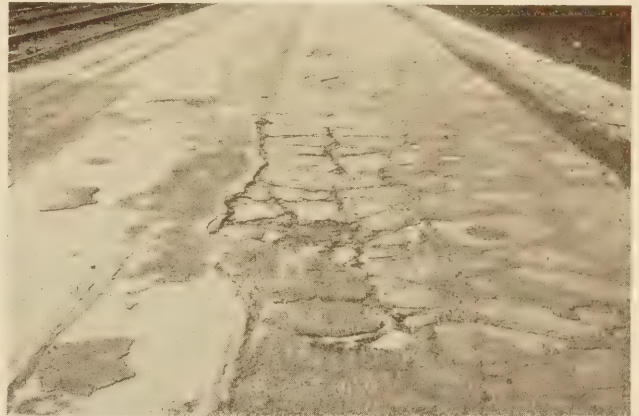
showed that the last treatment had for the most part worn off, although on the east side considerable areas remained intact, especially in the gravel oil-cement section, and small patches were scattered over the remainder of the surface.

All the sections in this experiment are in poor condition and will require heavy maintenance from now on. Very little difference in appearance is noted between the gravel and crushed-stone aggregate and between the cement and oil-cement sections.

CONDITION OF SURFACE-TREATED CONCRETE SECTIONS IN 1928, EXPERIMENT 3-B. THE UPPER PICTURE SHOWS CONCRETE NOT CONTAINING OIL AND THE LOWER PICTURE SHOWS OIL-CEMENT CONCRETE

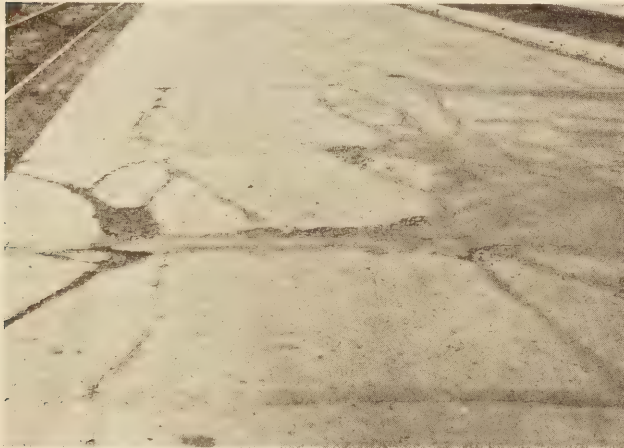
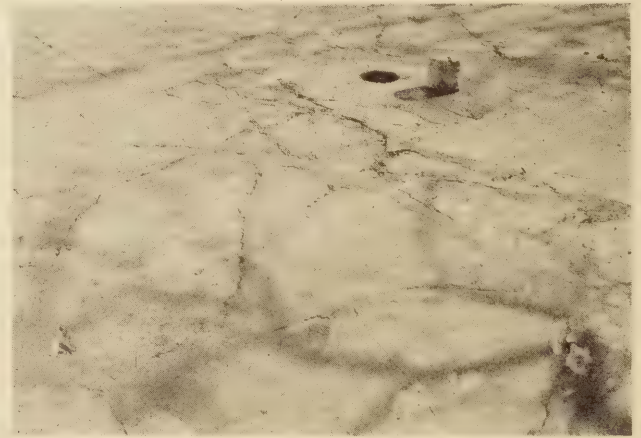
BADLY CRACKED CONCRETE PAVEMENT IN 1928 WHICH PRODUCED CORES OF FAIRLY HIGH STRENGTH

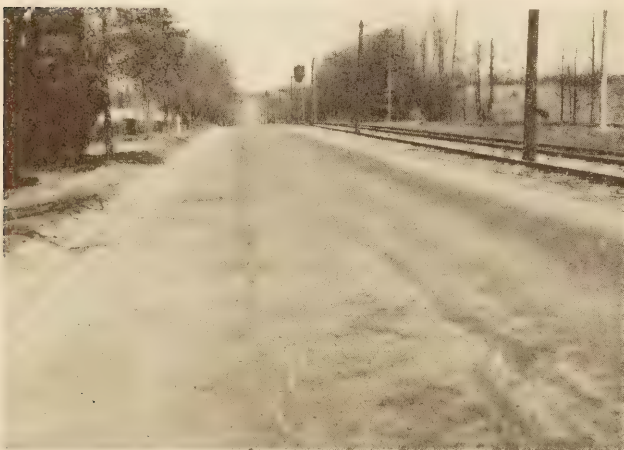
CONDITION OF CONCRETE SECTIONS IN 1928. THE UPPER PICTURE SHOWS EXPERIMENT 5-A AND THE LOWER PICTURE SHOWS EXPERIMENTS 4-E AND 5-D
