PUBLIC ROADS

VOL. 9, NO. 12

FEBRUARY, 1929

THE BRADLEY LANE EXPERIMENTAL ROAD

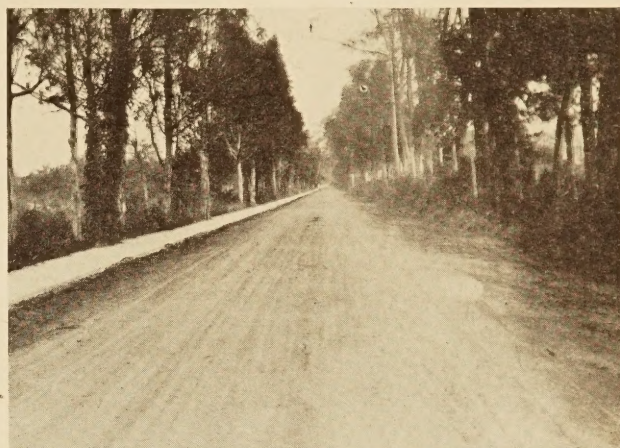
CONDITION OF SURFACE AFTER SURFACE TREATMENT IN 1911

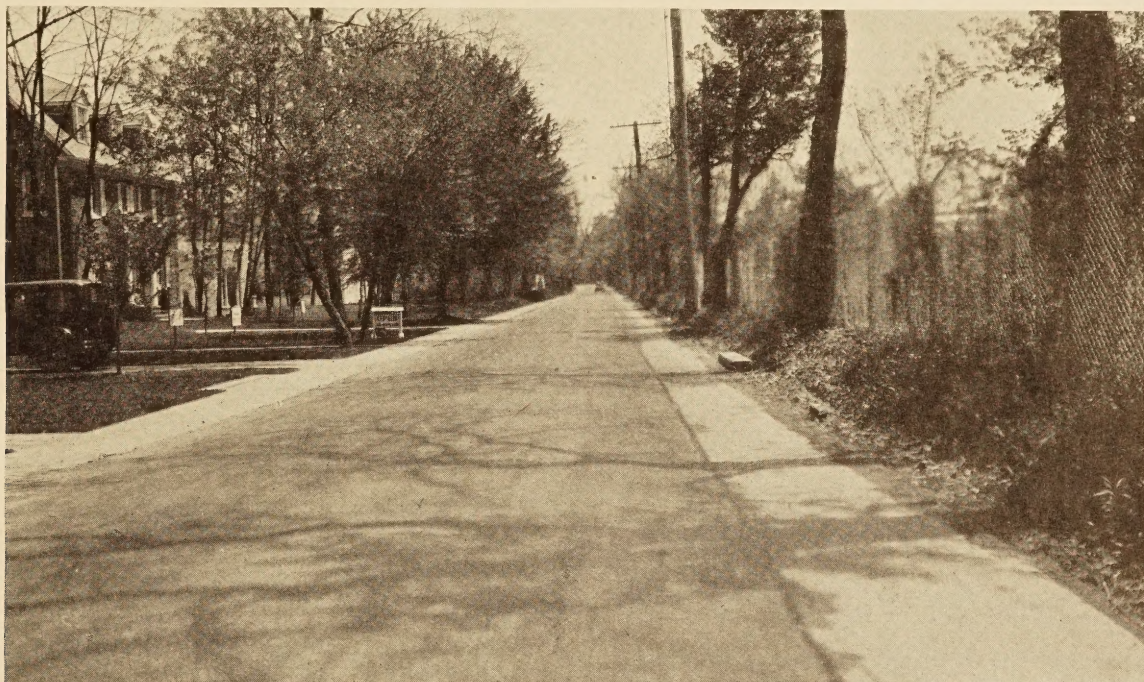
PRESENT CONDITION OF BRADLEY LANE. THE DRAINAGE ON THE LEFT IS TOWARD THE ROAD SURFACE

The traffic in 1927 was ten times that of 1915 and it will probably continue to increase in the future. The present condition of the macadam is generally good except for a few places where slight settlement has occurred. How long the macadam, which up to this time has proved sufficiently stable to overcome lack of drainage, will continue to support further increased traffic can not be estimated. However, in view of the present condition of the road it is reasonable to expect that under existing conditions it will continue indefinitely to give good service at a moderate maintenance cost. The present condition of the road is shown by the illustrations.

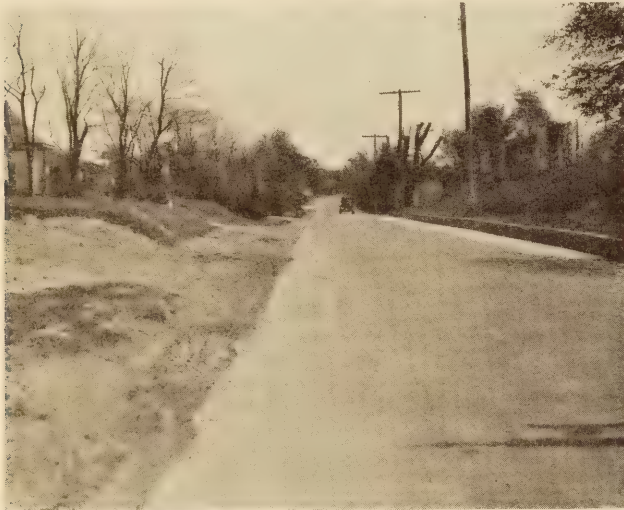
PRESENT CONDITION OF BRADLEY LANE AT A POINT WHERE DRAINAGE IS TOWARD THE ROAD FROM BOTH SIDES

sidewalk, which is a trifle higher than the surface, forms a curb with the macadam surface as a gutter. Due to the comparatively flat grade, water stands in this gutter for some time after a rain. Although a few depressions have occurred on this side, caused no doubt by the seepage of some of this water into the foundation, there is little evidence to indicate that the presence of free water is seriously jeopardizing the life of the pavement. A comparison of Table 7 and Figure 4 shows no relation between the slab thickness and the apparent maintenance and drainage conditions.

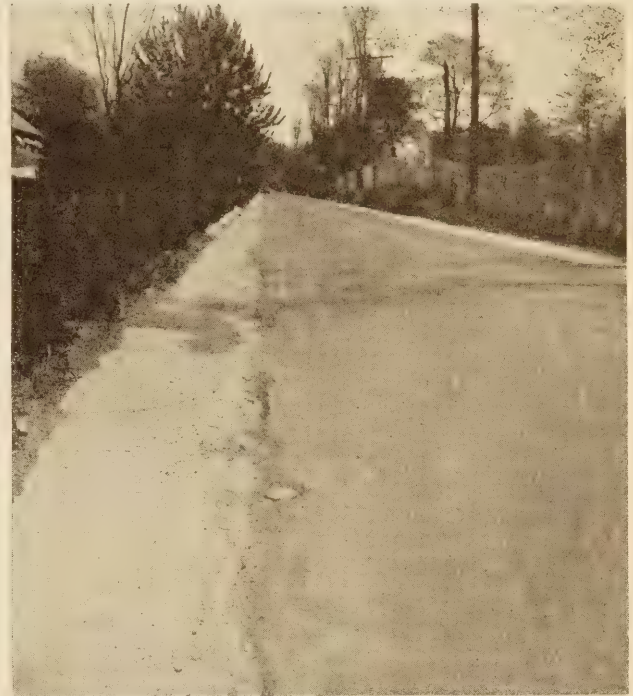
ONE OF THE WORST CONDITIONS OF SURFACE ON BRADLEY LANE AT THE PRESENT TIME

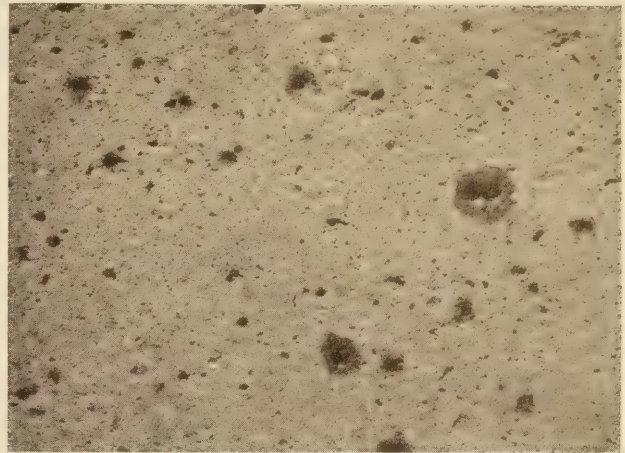
THE EFFECT OF SHALE IN GRAVEL

Such materials as shale and certain varieties of flint occurring either in the fine or coarse aggregate, must be avoided if sound concrete is to be obtained. It is surprising, however, what a wide variety of aggregate types may be used to produce durable, sound concrete, provided the latter is properly designed and fabricated. It seems safe to say that any aggregate which will pass the sodium sulphate soundness test⁵ will contribute to satisfactory durability in concrete which is otherwise of good quality. Conversely, failure in this test should subject the aggregate to suspicion until a thorough field investigation at the source has convinced the engineer that it is a safe material to use. Control of aggregates, however, will go for naught unless proper care is exercised in fabrication, and it is the failure of the field man to recognize one or more of the fundamental principles of good concrete construction that accounts, in the author's opinion, for most of the failures which we are apt to attribute to lack of durability.

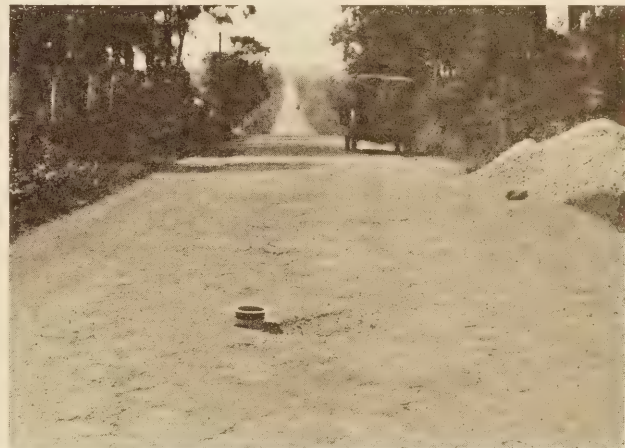
AN EXAMPLE OF SURFACE SCALING

Surface scaling is not well understood, although there is considerable evidence to indicate that it is almost entirely the result of frost action. That scaling is not observed in the South, but is confined entirely to the Northern States substantiates this view. It has been possible to simulate the surface scaling of concrete as observed in service by subjecting laboratory specimens to alternate freezing and thawing. Surface disintegration almost always begins on the top of the specimen, and is probably due to the inability of the relatively weak, porous mortar surface to resist disintegration to the same extent as the mass of the concrete.

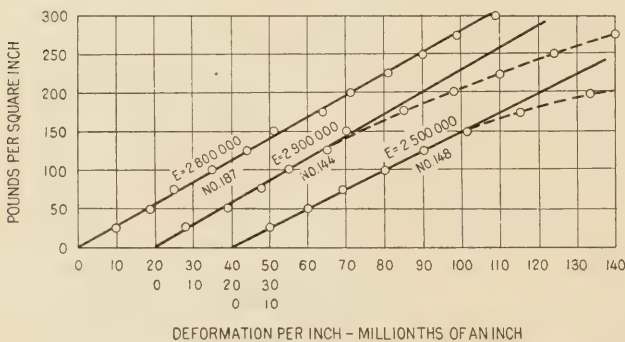
FIGURE 4.—TYPICAL STRESS-STRAIN CURVES FOR PORTLAND CEMENT MORTAR IN TENSION
