PUBLIC ROADS

A JOURNAL OF HIGHWAY RESEARCH

VOL. 12, NO. 10

Page
The Effect of Materials and Methods of Placing on the Strength and Other Properties of Concrete Bridge Floor Slabs	237
Highway Research Board Holds Annual Meeting	267

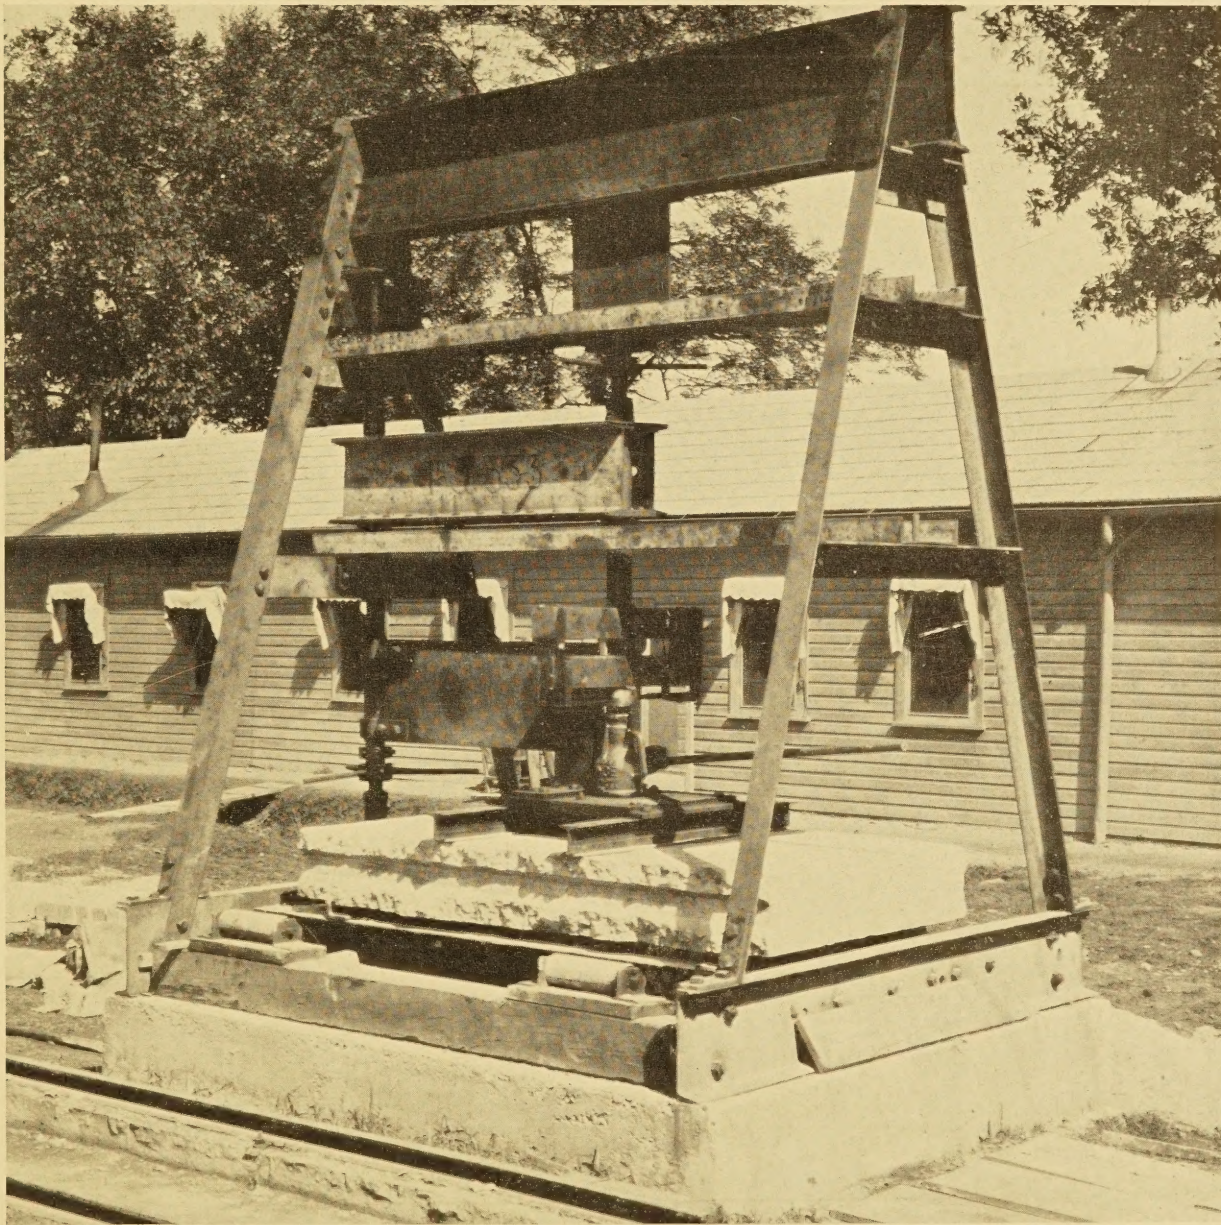
MACHINE FOR DETERMINING FLEXUAL STRENGTH OF CONCRETE SLABS

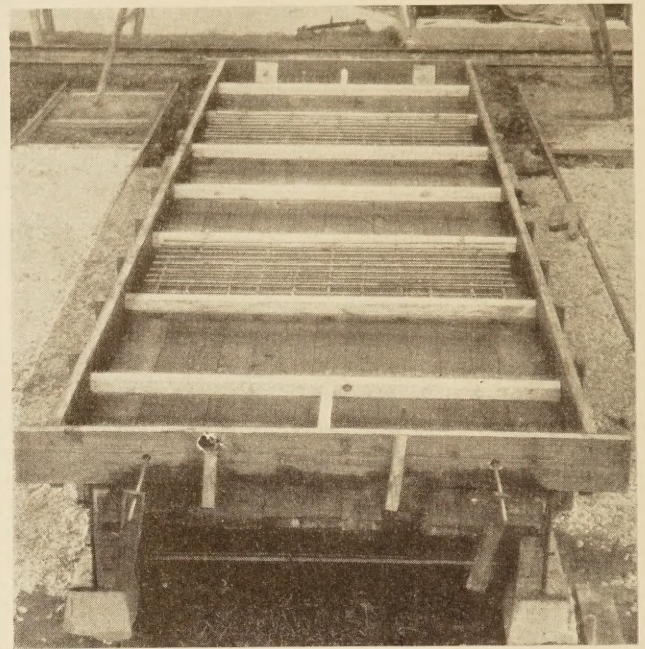
FIGURE 2.—FORM READY FOR CONSTRUCTION OF LARGE SLAB. NOTE SEPARATORS, STEEL MATS, AND BARS FOR BOND TESTS

Although each of the large slabs was constructed as a unit, it was divided in the forms into sections of a size suitable for testing by wooden dividing strips or partitions about half the depth of the forms, or 3/4 inches in width. These dividing strips, 2 inches thick with chamfered edges, were fastened in the forms in a very dry condition. On placing, the wet concrete caused these strips to swell sufficiently to crack the large slabs into smaller sections. Details of the method of dividing the large slab are shown in Figures 1 and 2.

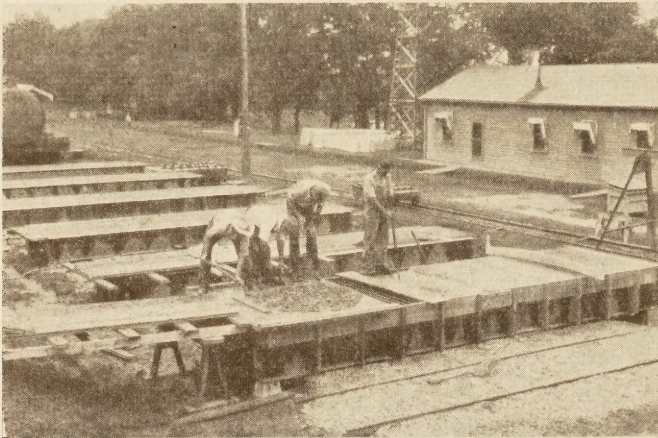
HAND PLACING

FIGURE 3.—THE FOUR METHODS USED FOR CONSOLIDATING THE CONCRETE

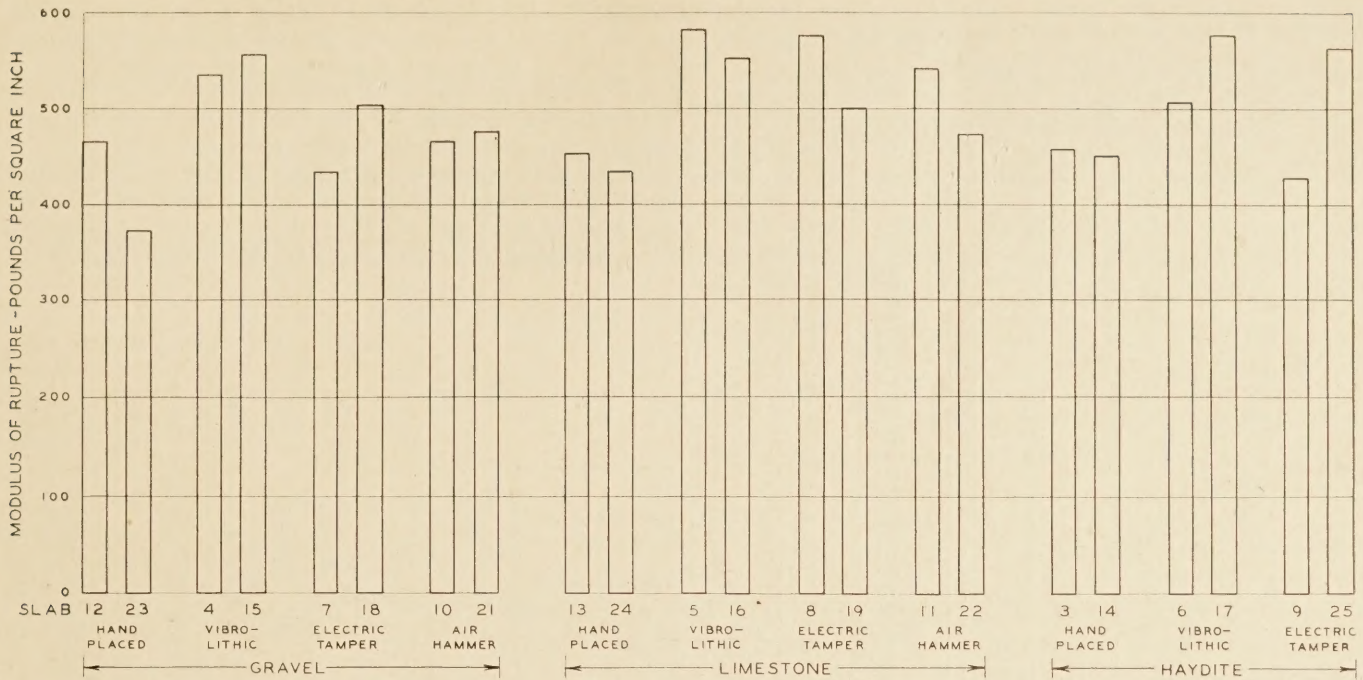
FIGURE 4.—VALUES OF MODULUS OF RUPTURE OF 36 BY 8 BY 72 INCH SLABS TESTED AT 22 DAYS. EACH VALUE IS THE AVERAGE OF FOUR TESTS

Comparative data from these flexure tests are shown in Table 3, and the average modulus of rupture for each test slab is shown in Figure 4. These data indicate that at the age of 22 days—

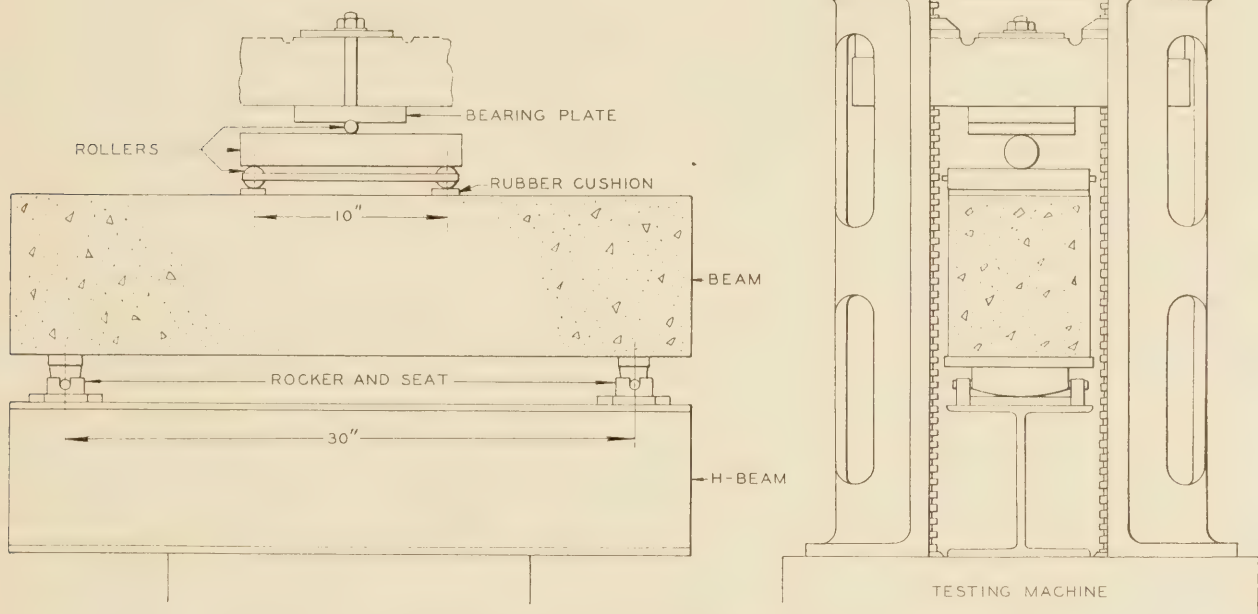
FIGURE 5.—APPARATUS USED IN MAKING FLEXURE TESTS ON SAWED BEAMS

The apparatus used for this test is shown in Figure 5. The load was applied at the third points of the span, which was 30 inches. Tension was produced in the bottom of the specimen as cast. The conventional testing machine in which the apparatus was set up was operated slowly with a handwheel. The modulus of rupture was calculated from the combined dead and

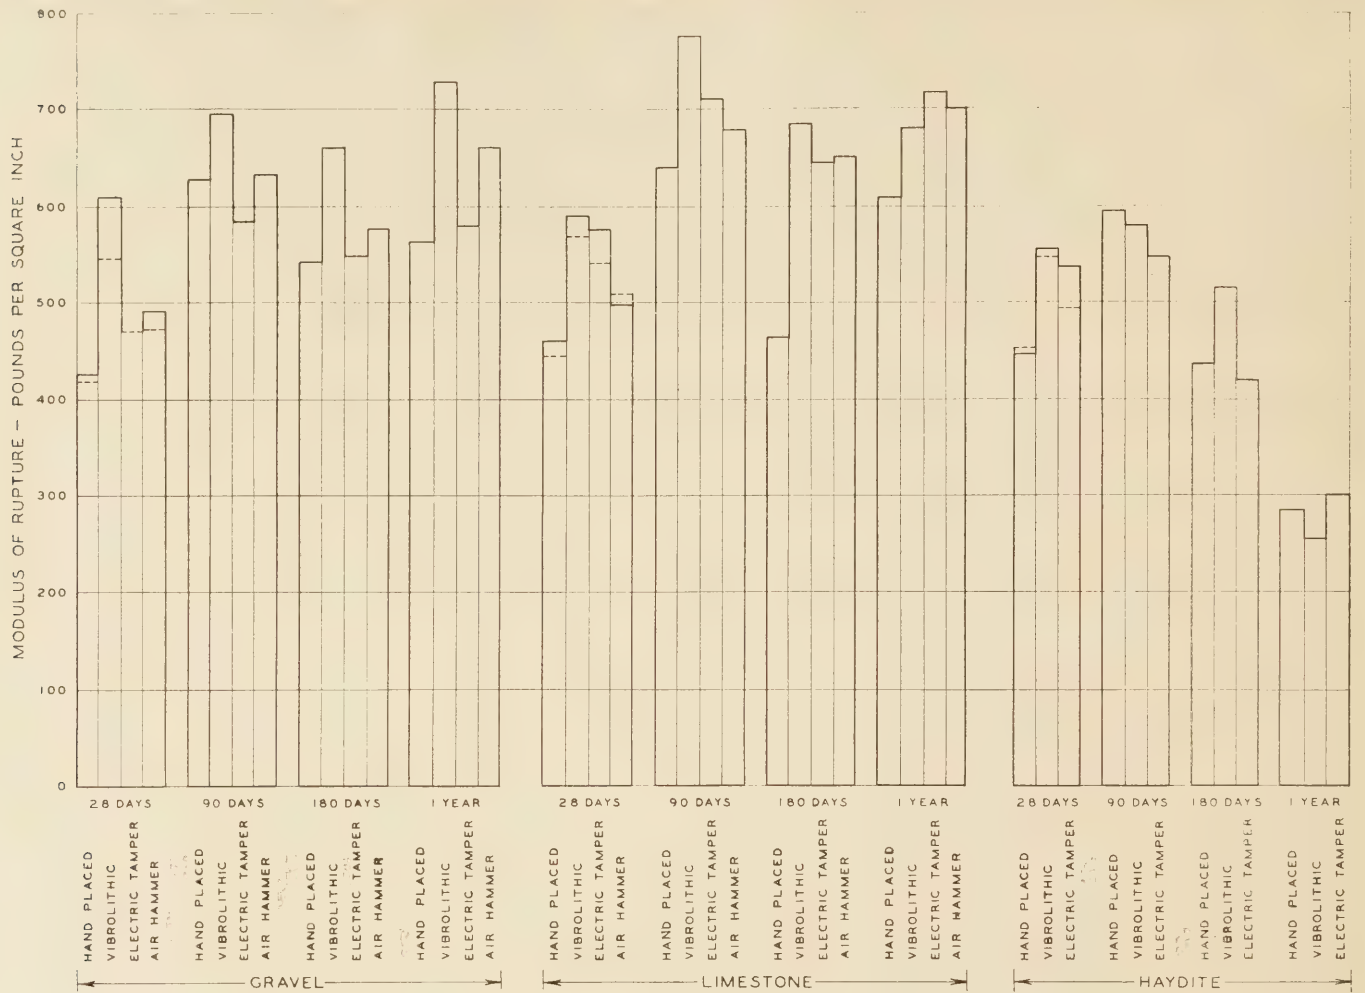
FIGURE 6.—EFFECTS OF AGE, METHOD OF PLACING, AND TYPE OF AGGREGATE ON FLEXURAL STRENGTH OF CONCRETE. VALUES SHOWN ARE MEAN VALUES OF MODULUS OF RUPTURE FOR SAWED BEAMS FROM TWO SLABS OF EACH TYPE AS GIVEN IN TABLE 4. DASH LINES INDICATE MEAN VALUES FOR LARGE SLABS BROKEN AT 22 DAYS

The indications of these figures are in rather striking agreement with those of the tests of the 3 by 6 foot slabs at 22 days. It will be noted that the vibrated concrete generally shows higher flexural strength than does the hand-placed concrete. This is most noticeable in the case of the specimens having the limestone aggregate, and is also clearly indicated by the specimens having gravel aggregate. In the case of the specimens in which Haydite was used, the majority of tests indicate a slight superiority on the part of the hand-placed concrete. It is also shown that of the three vibrating methods used, the Vibrolithic process yielded concrete of the greatest flexural strength.

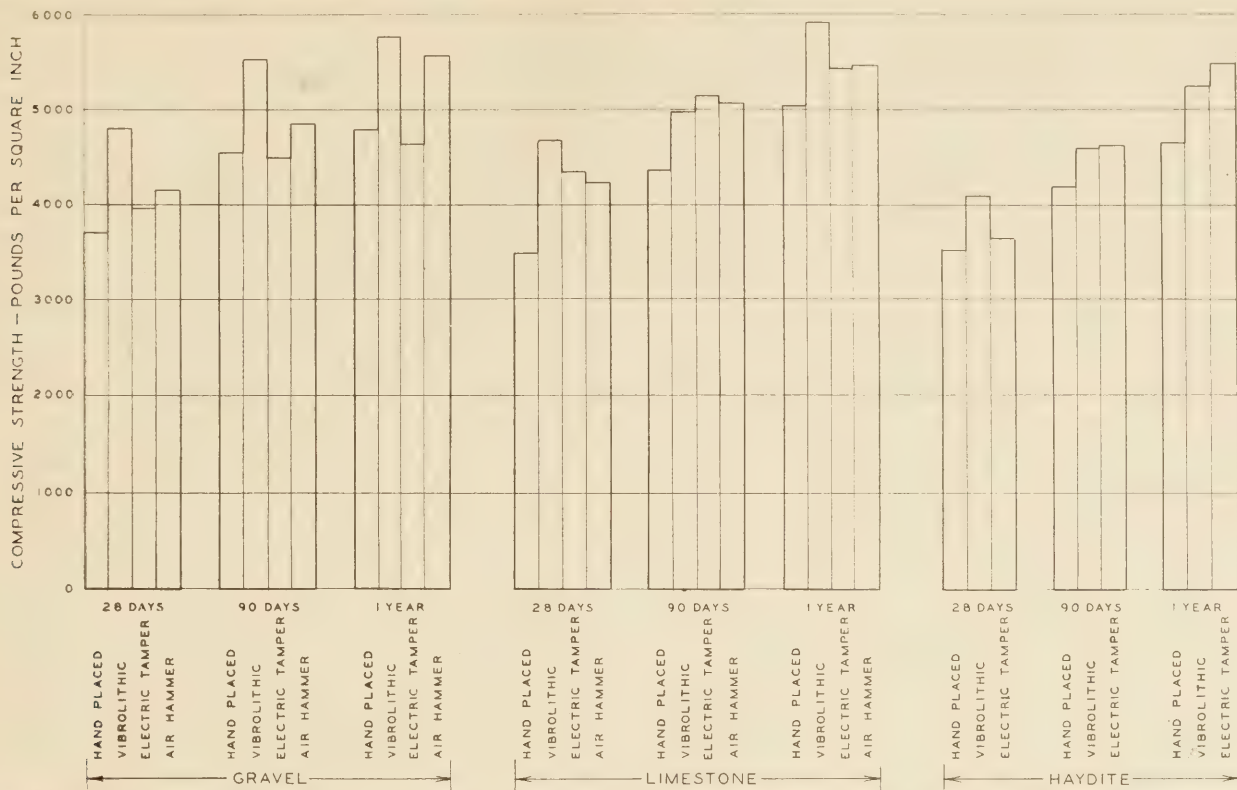
FIGURE 7.—EFFECTS OF AGE, METHOD OF PLACING, AND TYPE OF AGGREGATE ON COMPRESSIVE STRENGTH OF DRILLED CORES

The data from these tests are given in Table 6 and the average values are shown graphically in Figure 7.

It will be noted from these data that the concrete, for all methods of placing and for all three aggregates, shows a progressive increase in strength with age. It is also evident that the mechanical methods of placing, in general, result in higher compressive strength than is obtained by hand placing and also that of the three mechanical methods used the Vibrolithic process gave concrete of the highest compressive strength.

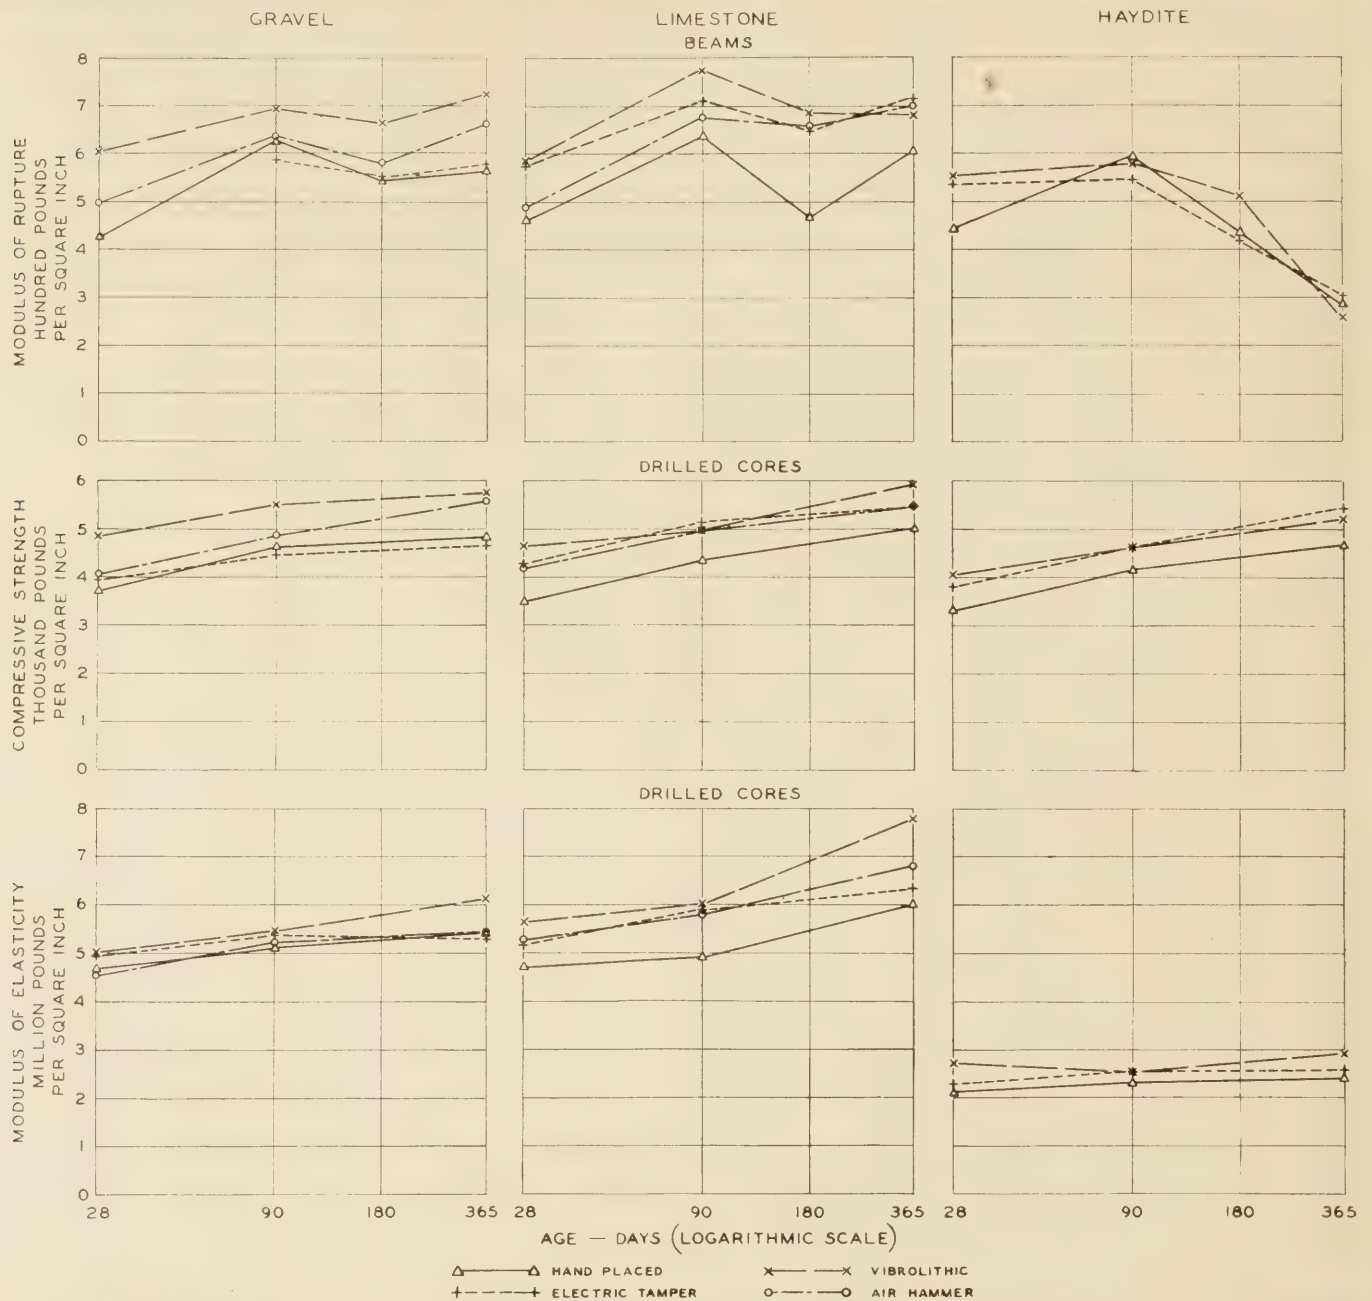
FIGURE 8.—RÉSUMÉ OF STRENGTH DATA, SHOWING VARIATION OF FLEXURAL STRENGTH OF SAWED BEAMS, COMPRESSIVE STRENGTH OF DRILLED CORES, AND MODULUS OF ELASTICITY OF DRILLED CORES, WITH INCREASING AGE OF SPECIMEN

These values show rather strikingly that the method of placing influences the flexural and the compressive strength to an equal degree. All of the data are in general accord as to the effect of the methods of placing on the strength of the concrete.

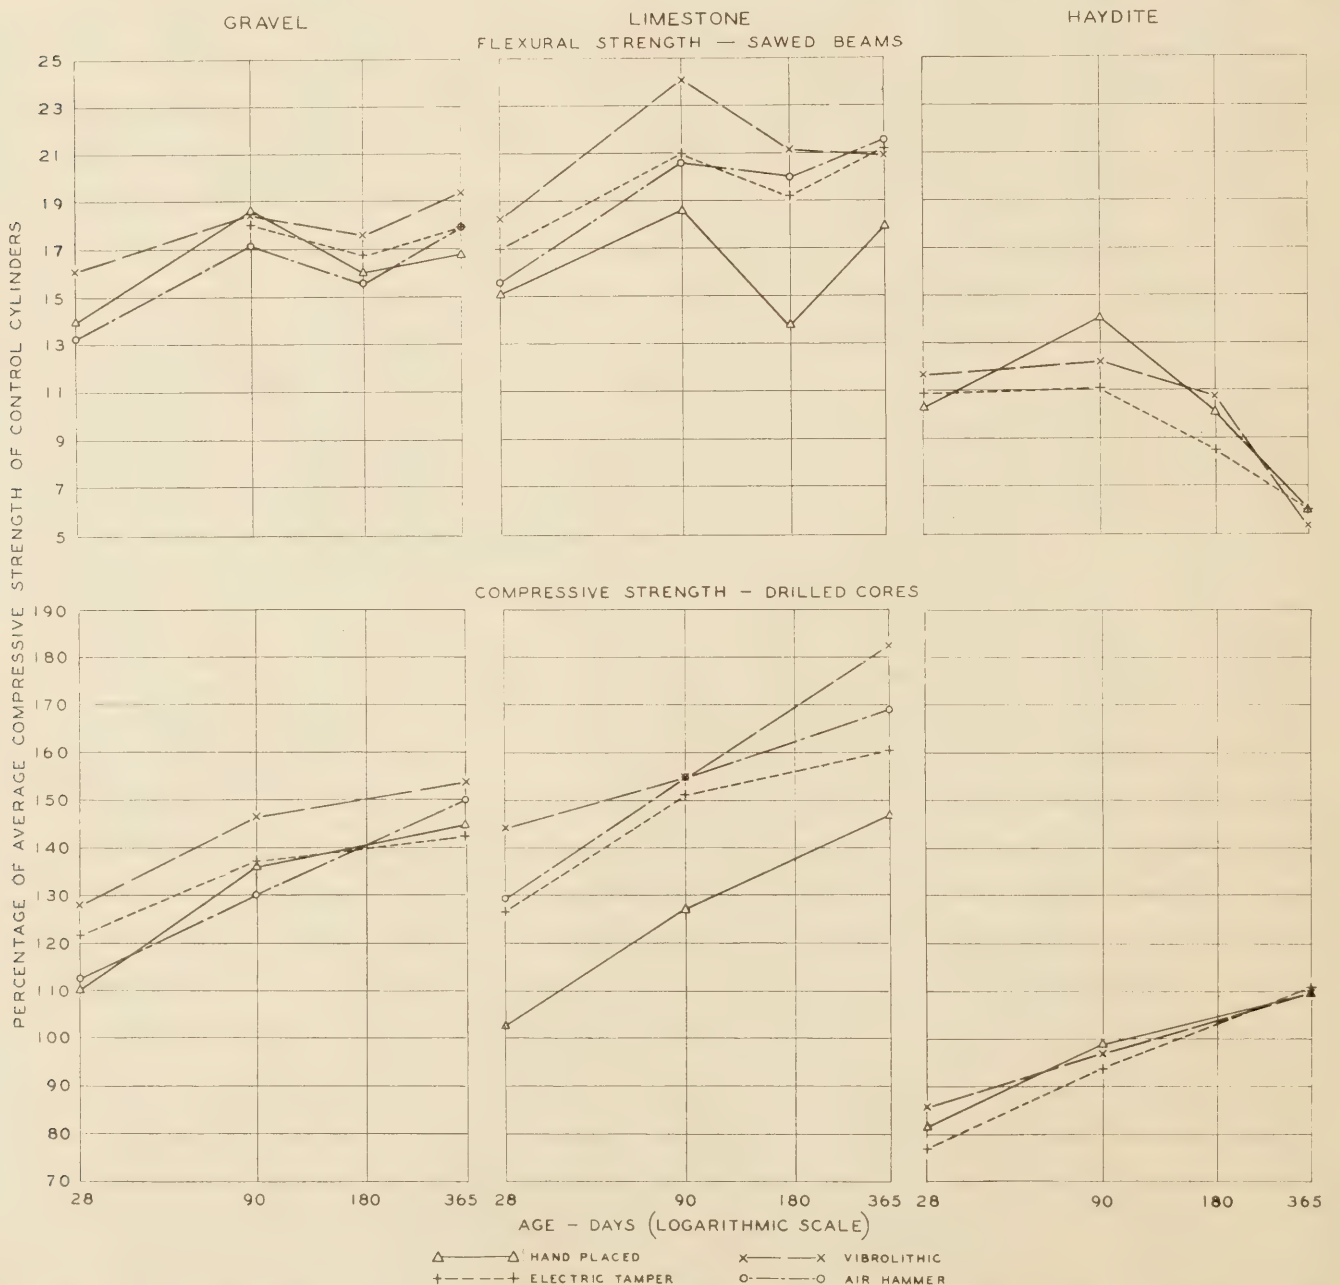
FIGURE 9.—FLEXURAL STRENGTHS OF SAWED BEAMS AND COMPRESSIVE STRENGTHS OF DRILLED CORES, EXPRESSED AS PERCENTAGES OF COMPRESSIVE STRENGTHS OF CORRESPONDING CONTROL CYLINDERS

In Table 10 and Figure 9 are shown the compressive and flexural strength data obtained from the various slabs at ages of 1, 3, 6, or 12 months. These data are expressed as percentages of the average compressive strength of the group of five cylinders tested for each of the particular slabs involved. In other words, the strength of this group at 28 days is taken as 100 per cent and all other test values related to it. It should be observed that Table 10 and Figure 9 do not afford a direct comparison of the strength of concretes made with different aggregates. They serve rather to indicate the extent to which the strength characteristics found in the control cylinders were realized in the finished concrete.

It will be noted that when the relative strengths of the concretes containing the three different aggregates are taken into account the trends and relationships shown by Figure 9 are practically the same as those expressed by the strength data before they were modified by the data regarding the control specimens given in Figure 8.

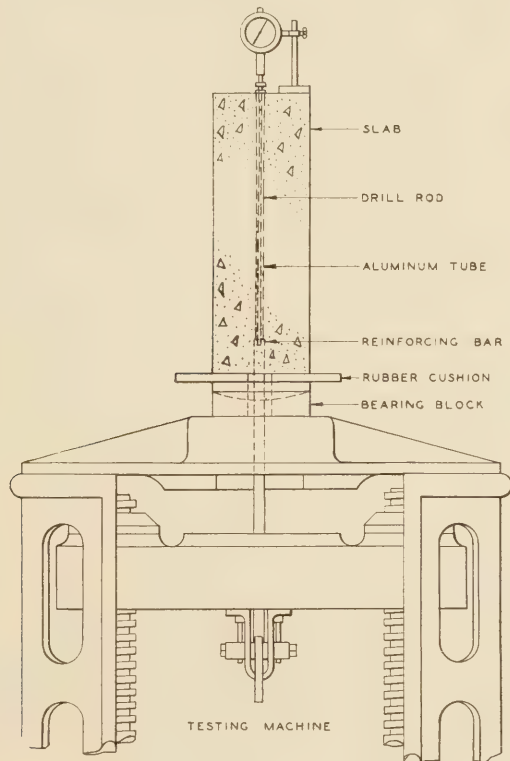
FIGURE 10.—APPARATUS USED IN BOND TESTS OF BARS EMBEDDED HORIZONTALLY

In the case of the bars placed horizontally a somewhat different scheme was adopted. The embedded end of each bar was drilled axially and tapped to receive a piece of ¼-inch drill rod 18 inches in length. This rod was sheathed with close-fitting tube of thin aluminum, which served to prevent any bond between the concrete and the drill-rod extension. The bars were inserted through horizontal holes in the ends of the slab forms at the mid-depth of the slab. The bar in bond extended into the concrete 6½ inches and the drill-rod extension continued entirely across the remainder of the slab section, the end being supported in a hole in the first transverse wooden separator. This served to hold the bar in position during the placing of the concrete and later, upon removal from the forms, to expose the extension to the embedded end of the reinforcing bar, permitting measurements of slip to be made.

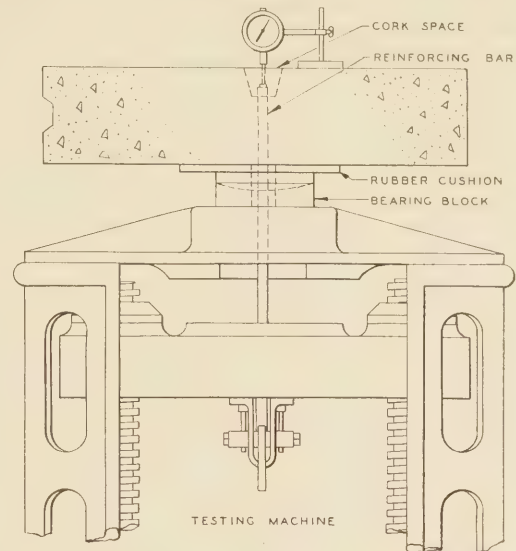
FIGURE 11.—APPARATUS USED IN BOND TESTS OF BARS EMBEDDED VERTICALLY

The vertical bars were passed through holes in the bottom of the slab form and were secured in such a position that the desired embedment was obtained. The upper end was capped with a large cork. After the finishing was completed and the concrete had hardened, the cork was removed and the end of the bar exposed. This permitted a measurement of slip to be made on these specimens.

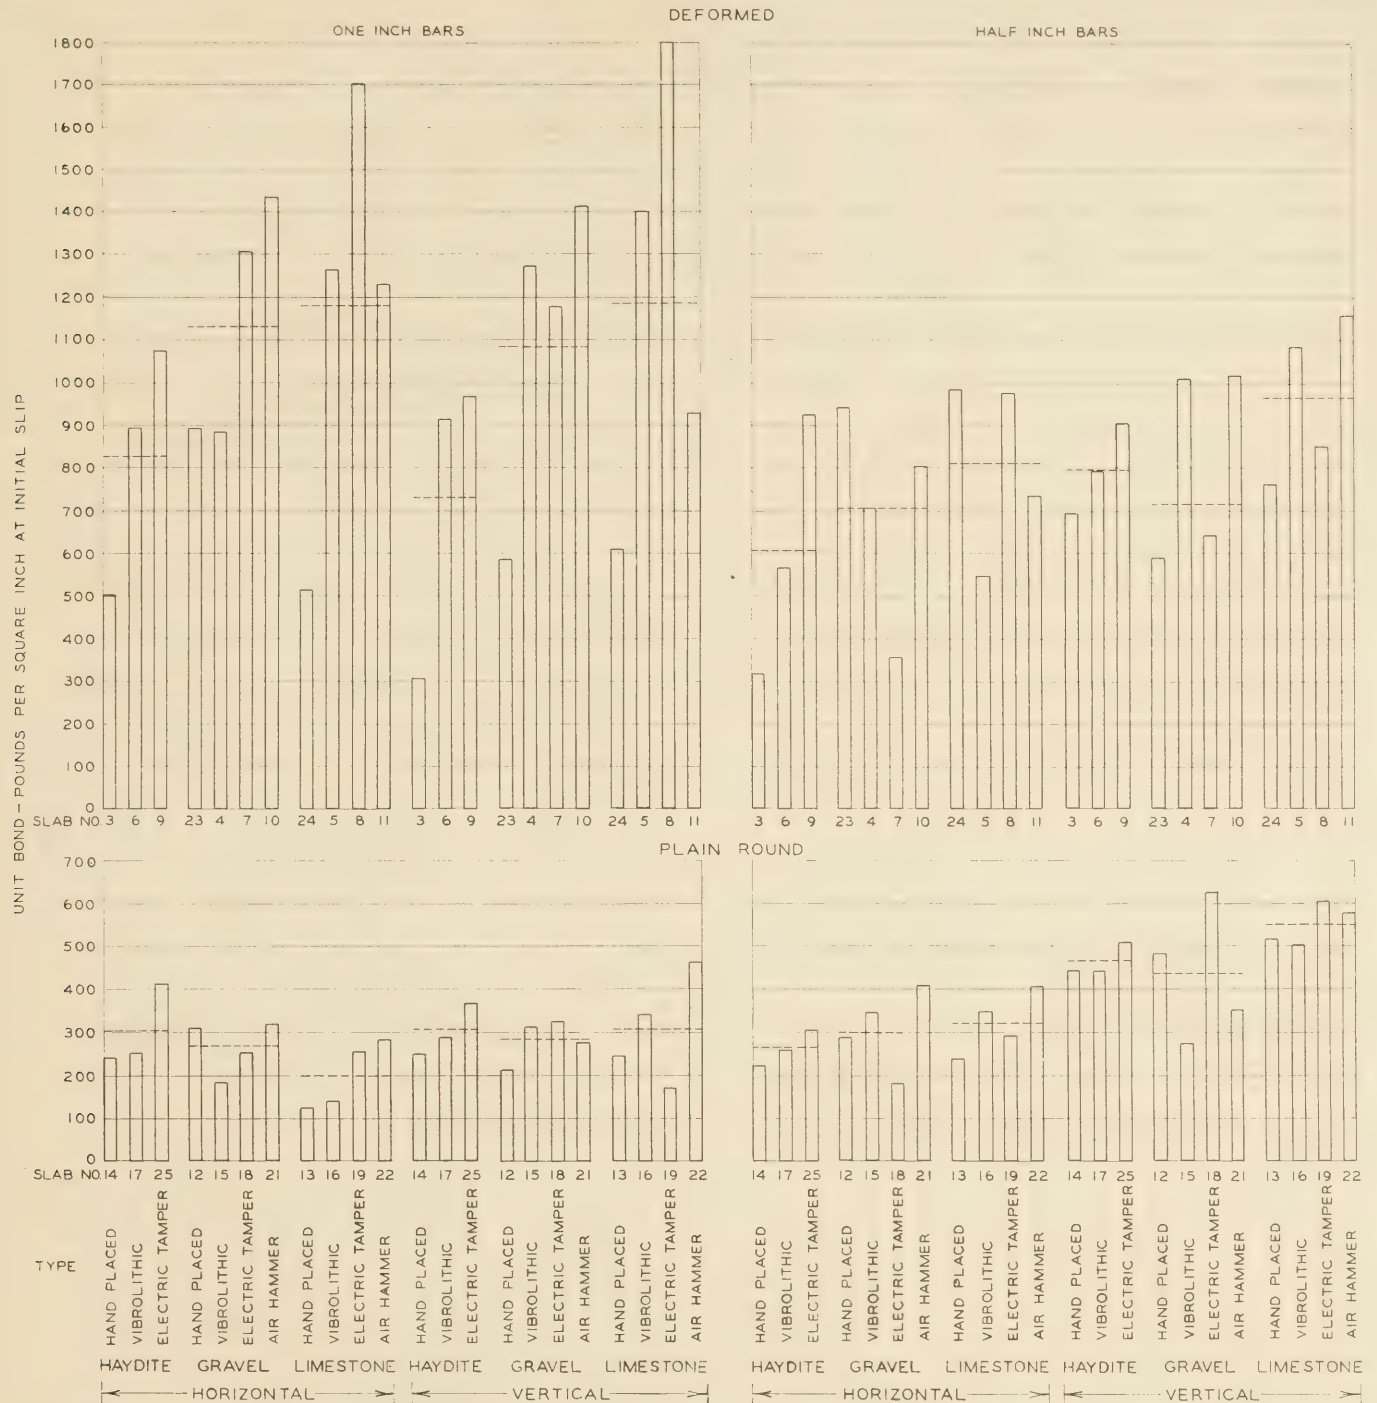
FIGURE 12.—MEAN UNIT BOND VALUES. DASH LINES REPRESENT AVERAGE VALUES FOR EACH GROUP

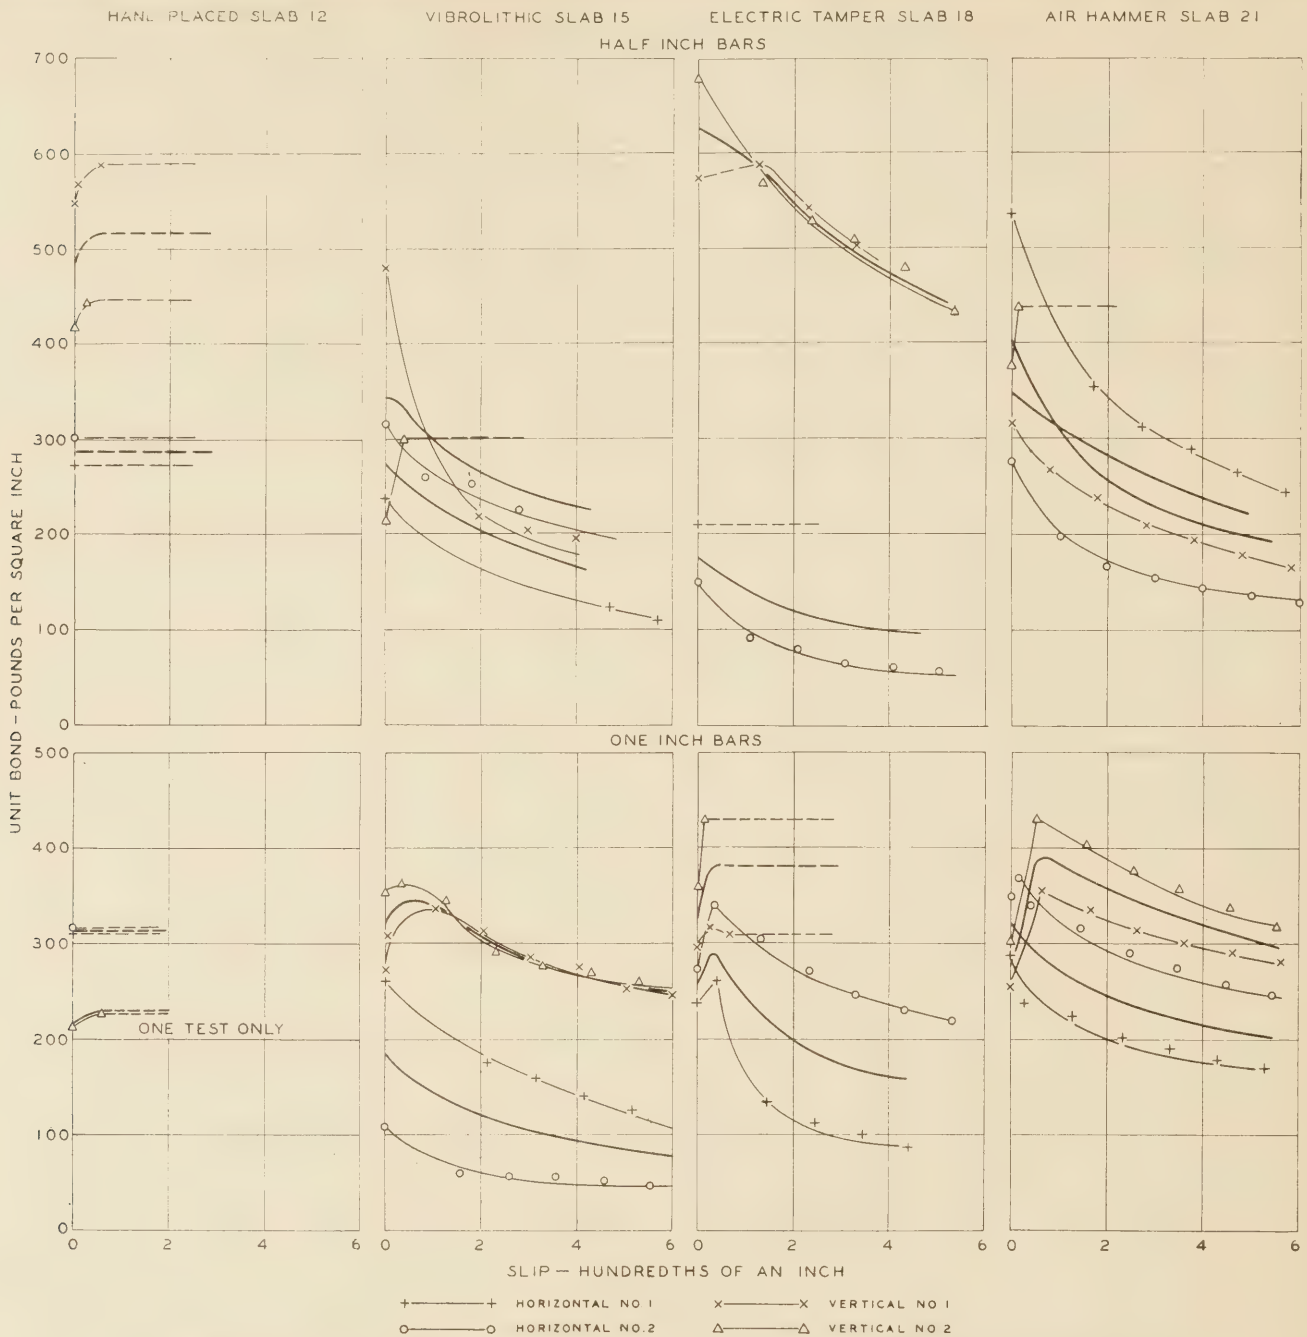
FIGURE 13.—LOAD-SLIP CURVES FOR BOND TESTS OF PLAIN ROUND BARS IN GRAVEL CONCRETE

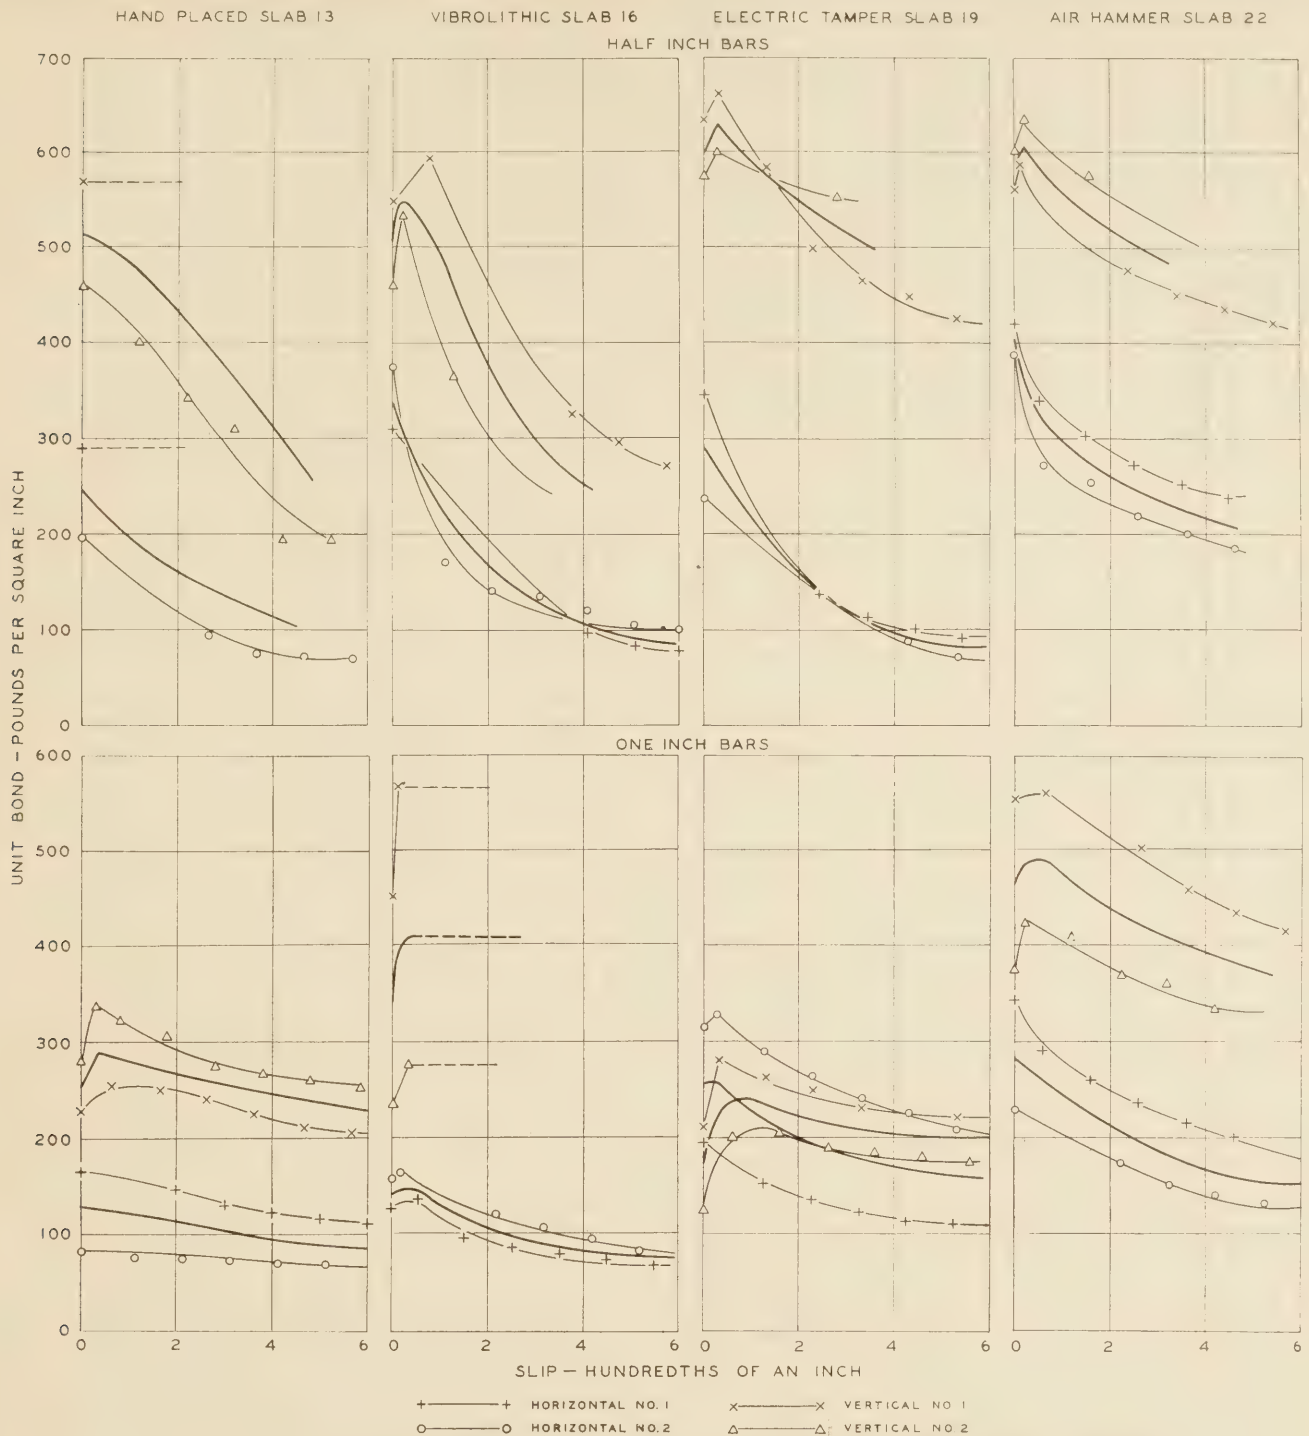
FIGURE 14.—LOAD-SLIP CURVES FOR BOND TESTS OF PLAIN ROUND BARS IN STONE CONCRETE

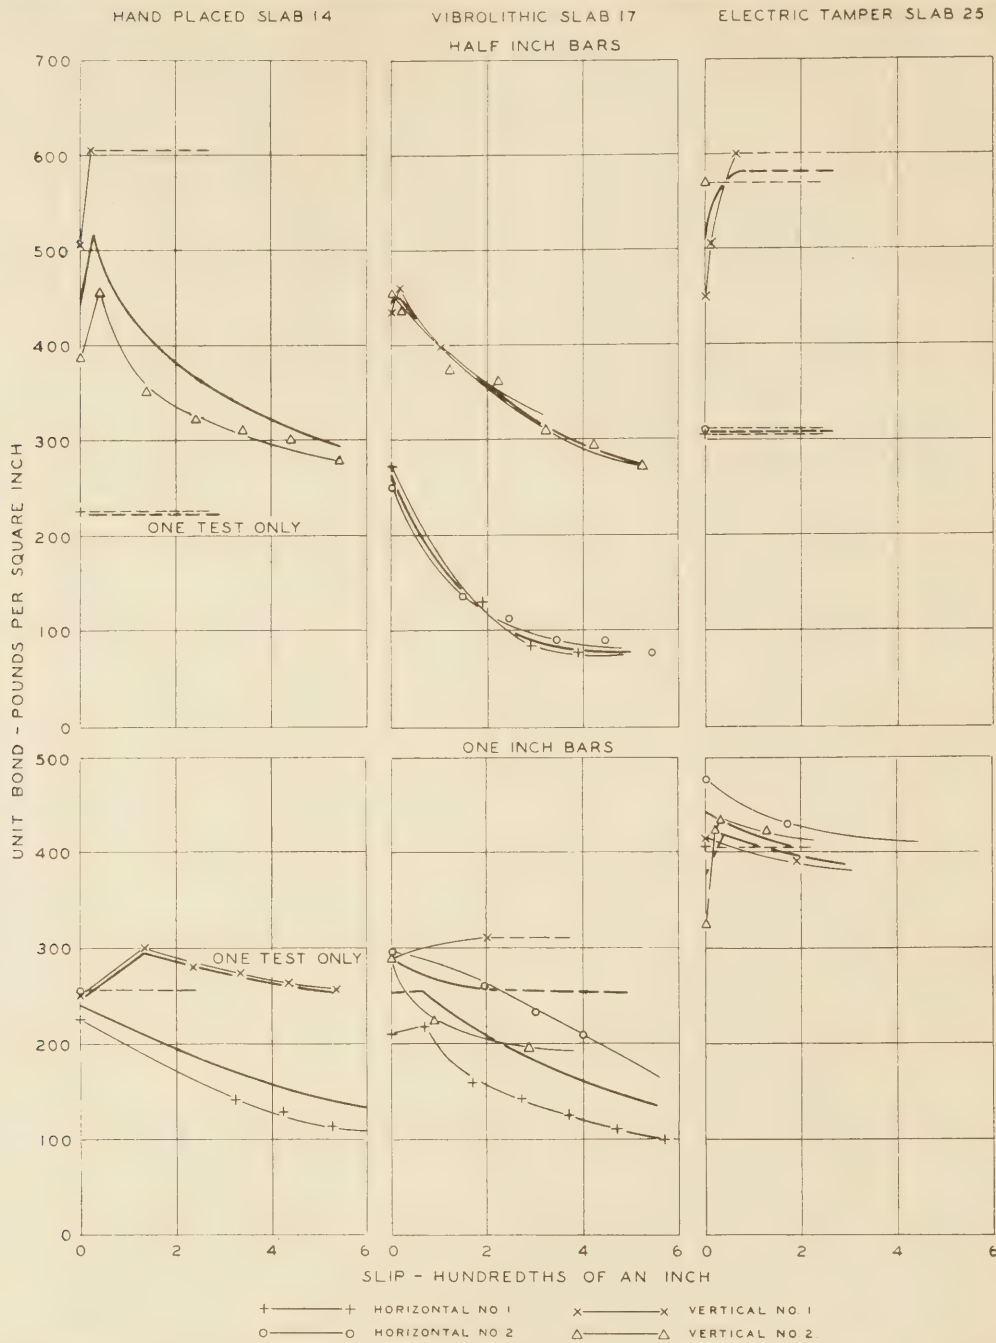
FIGURE 15.—Load-Slip Curves for Bond Tests of Plain Round Bars in Haydite Concrete

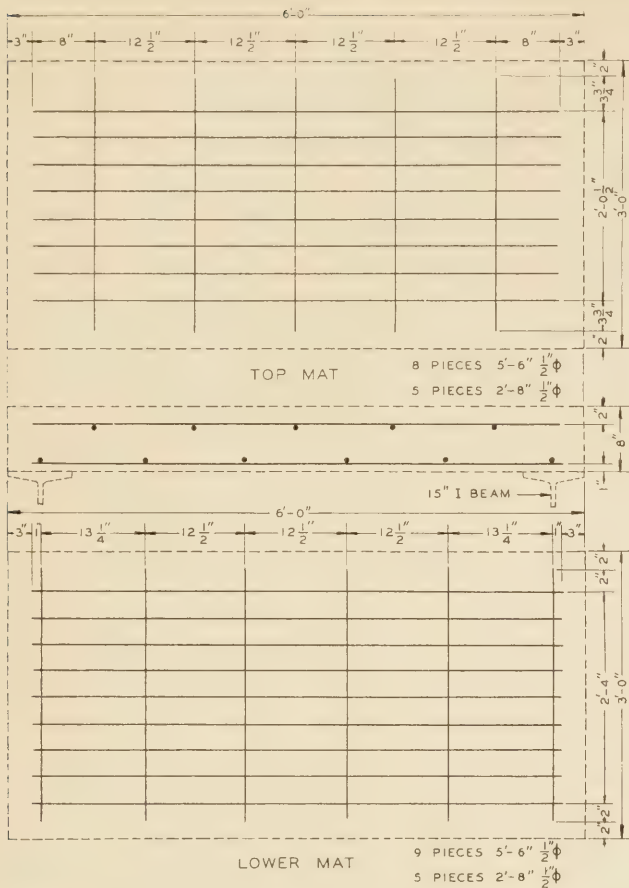
FIGURE 16.—PLACEMENT OF STEEL USED IN REINFORCED SLAB SECTIONS

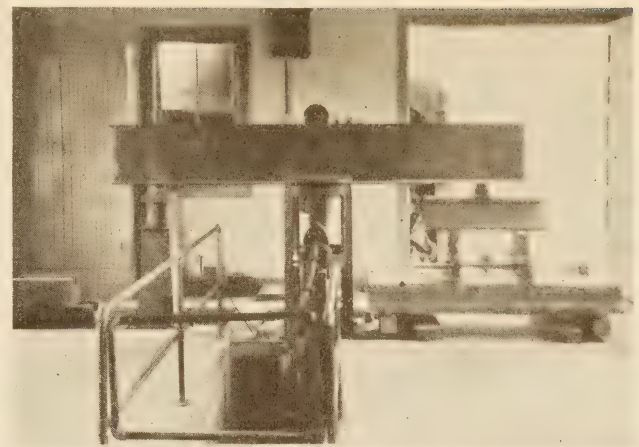
FIGURE 17.—GENERAL VIEW OF ARRANGEMENT FOR TESTS OF REINFORCED SLAB SECTIONS

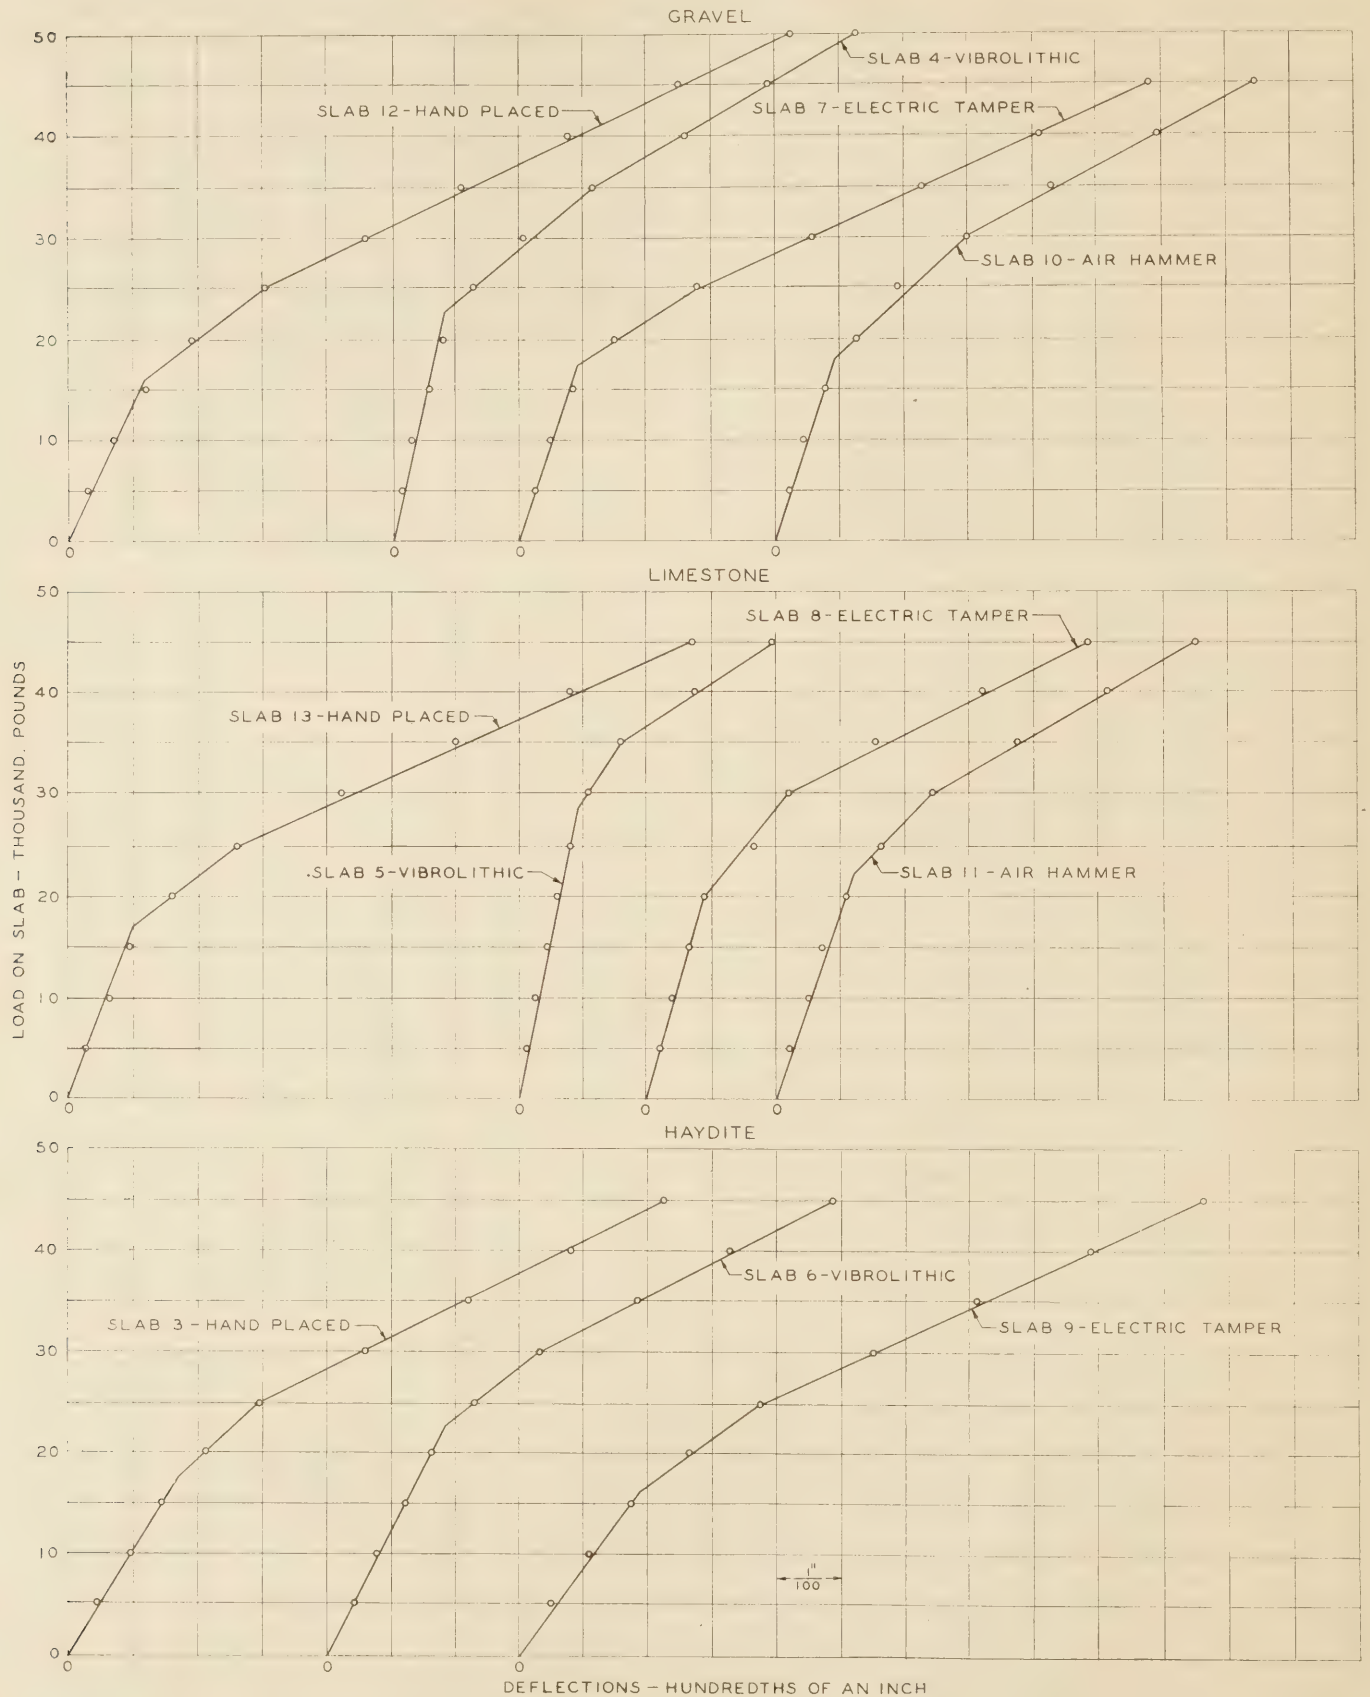
FIGURE 18.—LOAD-DEFLECTION CURVES FOR REINFORCED SLAB SECTIONS

The deflection data were obtained on both sections from each of the 11 large slabs of the first series and the observations were made after each 5,000-pound increment of load had been applied. These data are given in detail in Table 12, and the load-deflection curves are shown in Figure 18.

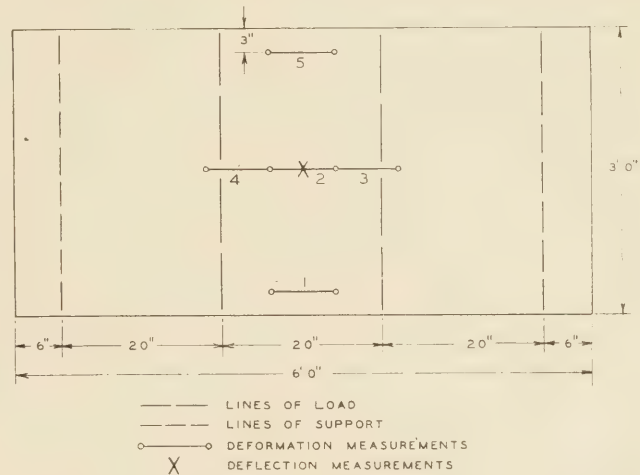
FIGURE 19.—GAGE LAYOUT ON REINFORCED SLAB SECTIONS

Strain measurements were made in one of the two reinforced sections from each of the 11 large slabs of the first series and the observations were made after each 10,000-pound increment of load had been applied. Strains in the concrete were measured at five points in the upper surface of the slab, the location of which is shown in Figure 19. These measurements were made with a hand strain gage between brass points set 8 inches apart. Corrections were made for temperature changes in the gage. The data obtained are given in detail in Table 12 and shown graphically in Figure 20 where the average stress across the transverse axis of the slab is plotted as a function of the total load. The observed strains at the other two gage lengths along the longitudinal axis of the slab were used as a check on the distribution of stress in the middle third of the slab.
