PUBLIC ROADS

A JOURNAL OF HIGHWAY RESEARCH

VOL. 12, NO. 10

Page
The Effect of Materials and Methods of Placing on the Strength and Other Properties of Concrete Bridge Floor Slabs	237
Highway Research Board Holds Annual Meeting	267

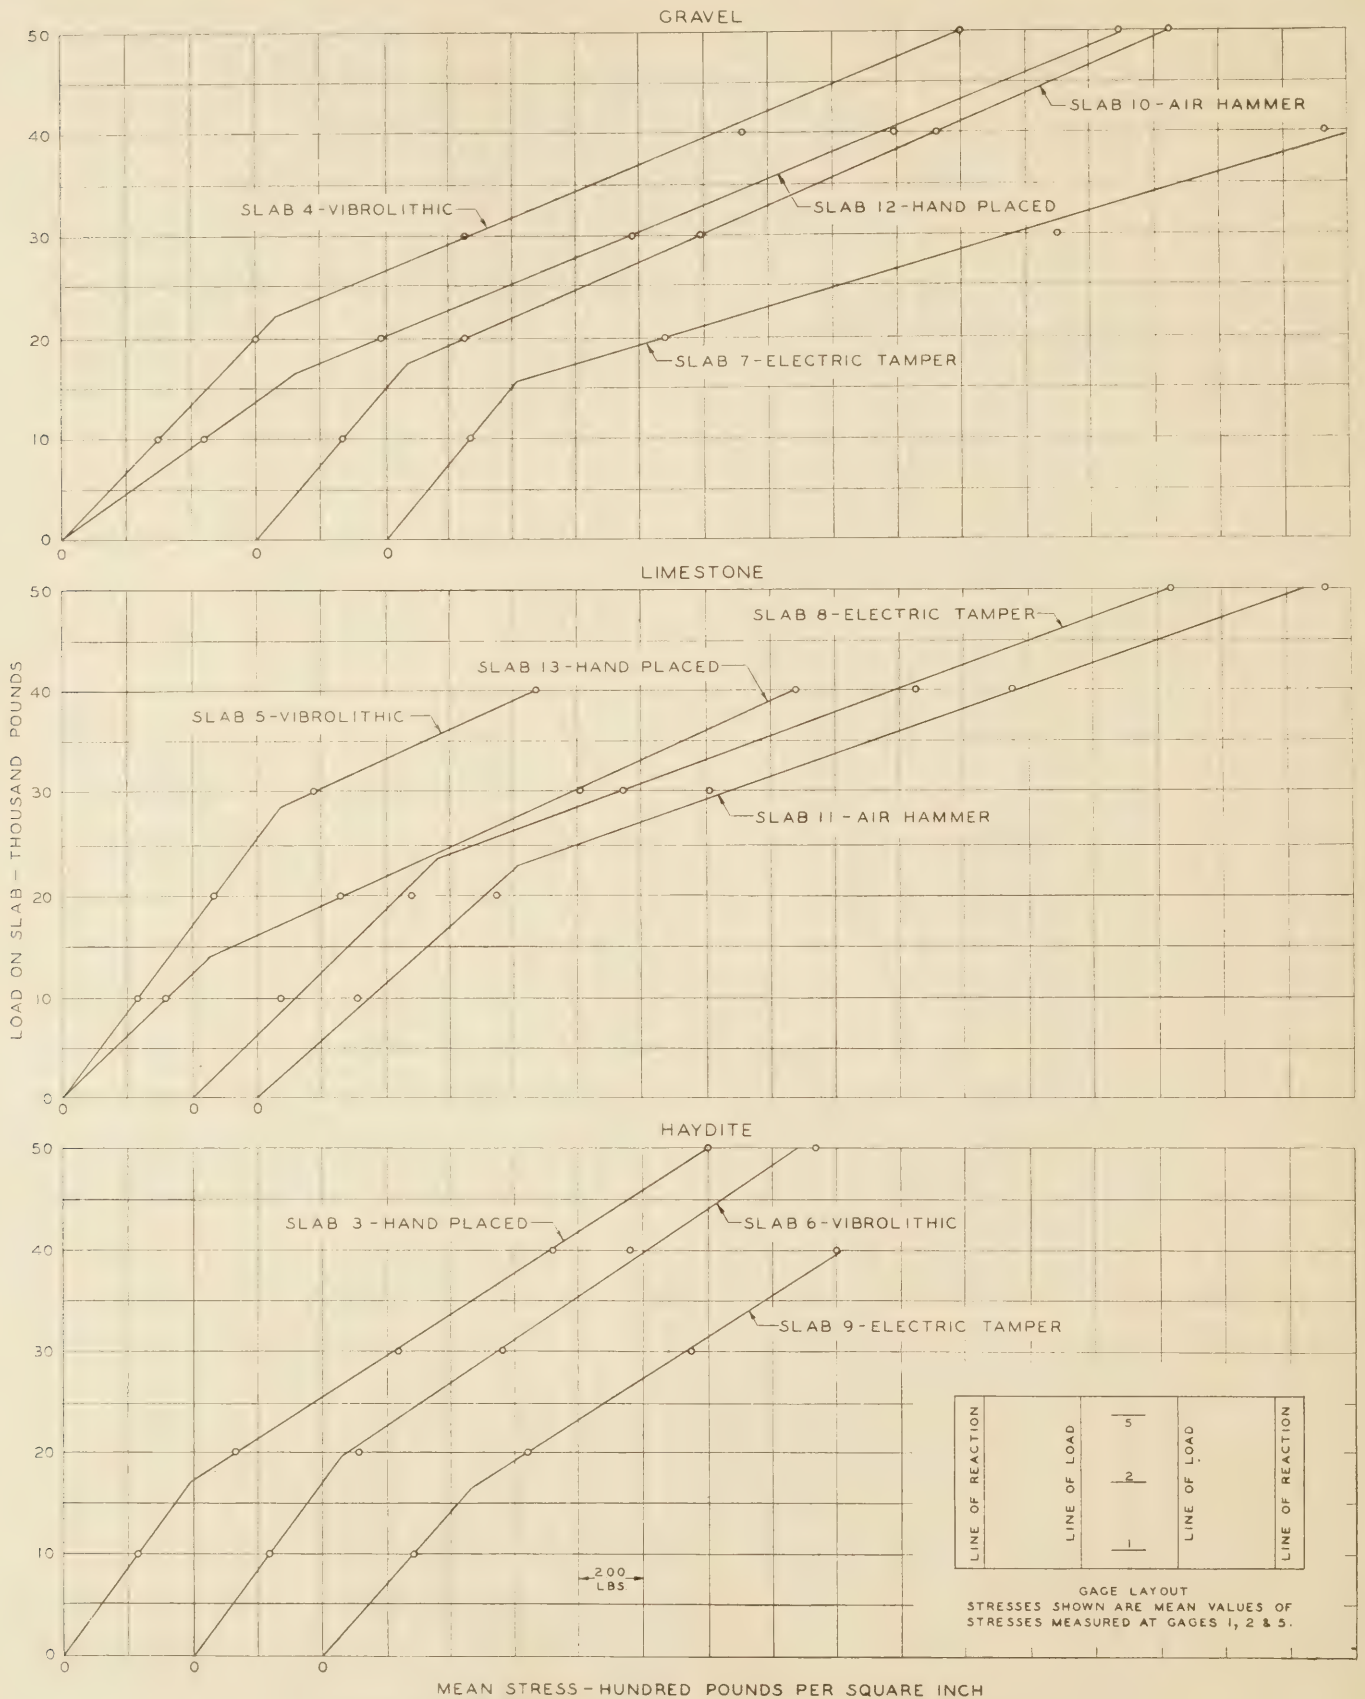
FIGURE 20.—LOAD-STRESS CURVES FOR REINFORCED SLAB SECTIONS

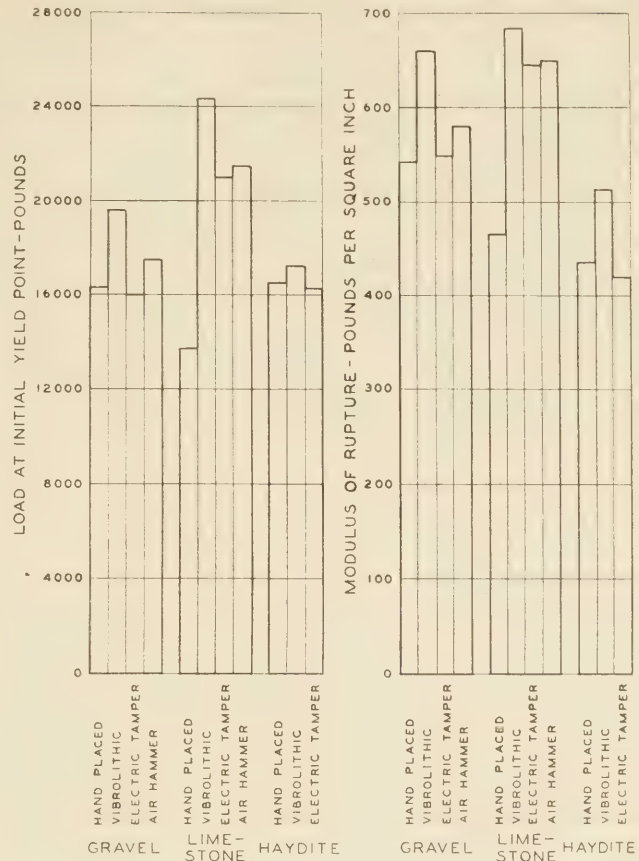
FIGURE 21.—COMPARISON OF VALUES OF MODULUS OF RUPTURE OF PLAIN CONCRETE BEAMS AND VALUES OF LOAD ON REINFORCED CONCRETE SLABS AT INITIAL YIELD POINT. IN LEFT-HAND PANEL ARE GIVEN VALUES OF LOAD ON REINFORCED SLABS AT CHANGE IN SLOPE OF LOAD-STRESS CURVES, CORRECTED TO 8-INCH THICKNESS. VALUES OF MODULUS OF RUPTURE OF SAWED BEAMS AT 180 DAYS, GIVEN IN RIGHT-HAND PANEL, ARE MEANS OF 4 TESTS ON GRAVEL CONCRETE, AND 8 TESTS ON LIMESTONE AND HAYDITE CONCRETE

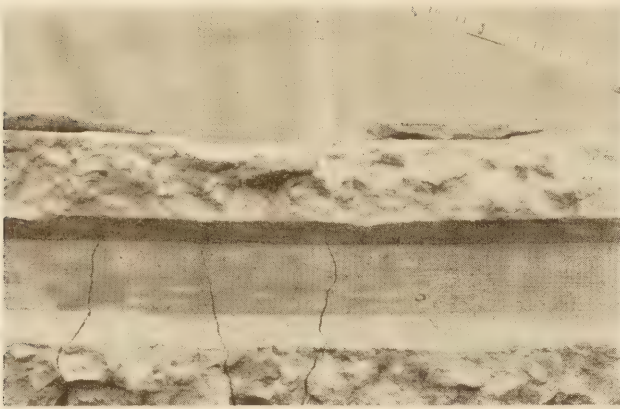
FIGURE 22.—FAILURE OF A REINFORCED SLAB. NOTE WIDE CRACKS REMAINING AFTER REMOVAL OF LOAD AND SPALLING OF CONCRETE ON COMPRESSION SURFACE OF SLAB

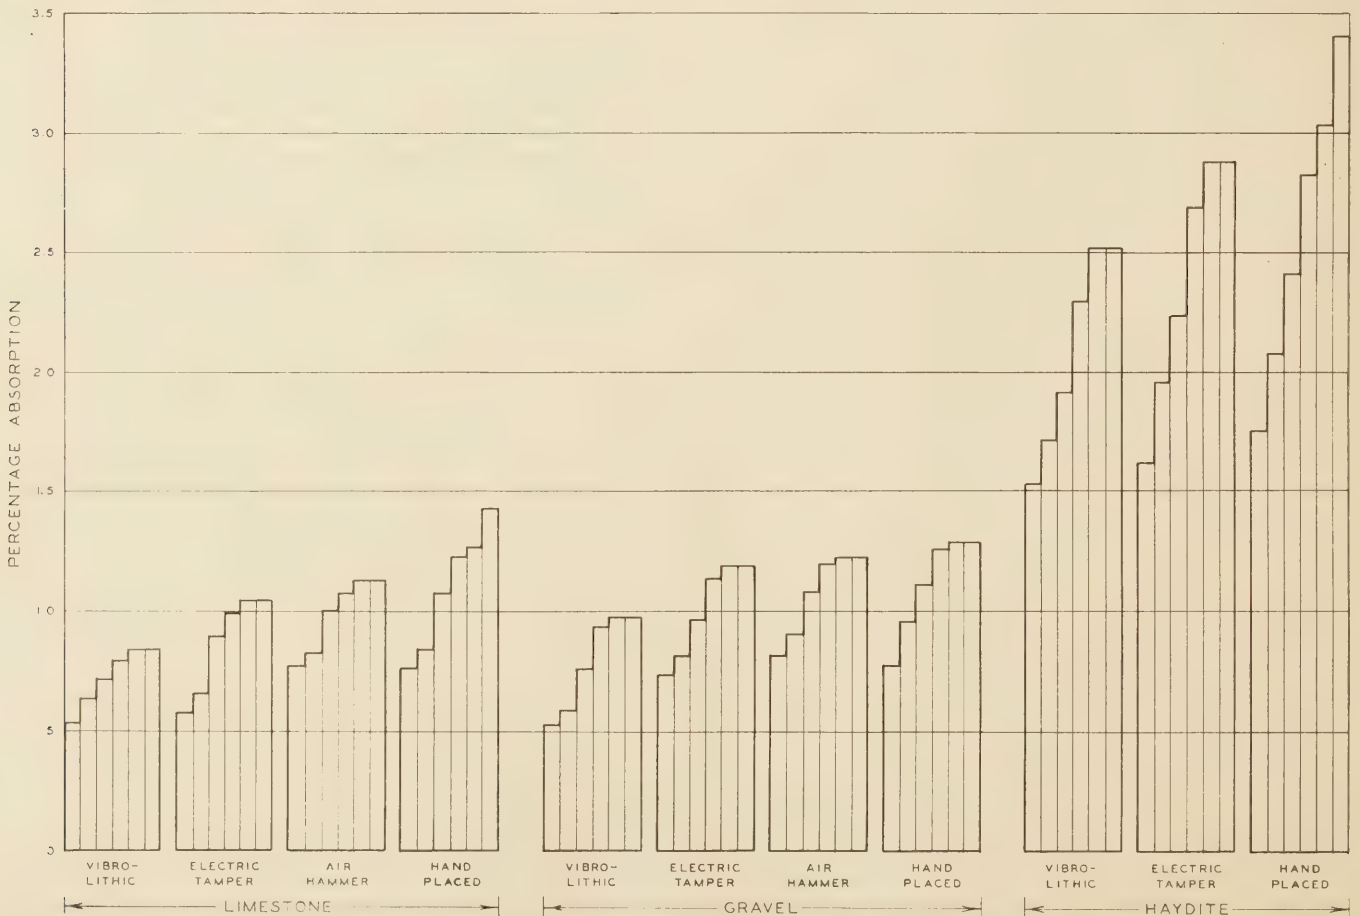
FIGURE 23.—EFFECTS OF METHOD OF PLACING AND TYPE OF AGGREGATE ON PROGRESSIVE ABSORPTION OF CONCRETE SPECIMENS AT 1, 2, 8, 28, 56, AND 140 DAYS' IMMERSION. EACH VALUE GIVEN IS THE MEAN OF FOUR TESTS

From these data it would appear that the vibratory methods of placing produced a perceptibly less absorptive concrete than was obtained by hand placing. This difference was most marked with the concrete containing the Haydite aggregate and least with the concrete containing the gravel aggregate. Of the three vibratory methods, the Vibrolithic method of placing appears to be the most effective from the standpoint of reducing absorption. These absorption values appear to be, in a general way, a measure of the density of the concrete as indicated by the unit weight values given in Table 3. For each aggregate the highest absorption and lowest weight per cubic foot are found to relate to hand-placed concrete, while the lowest absorption and highest unit weight are found to be for concrete

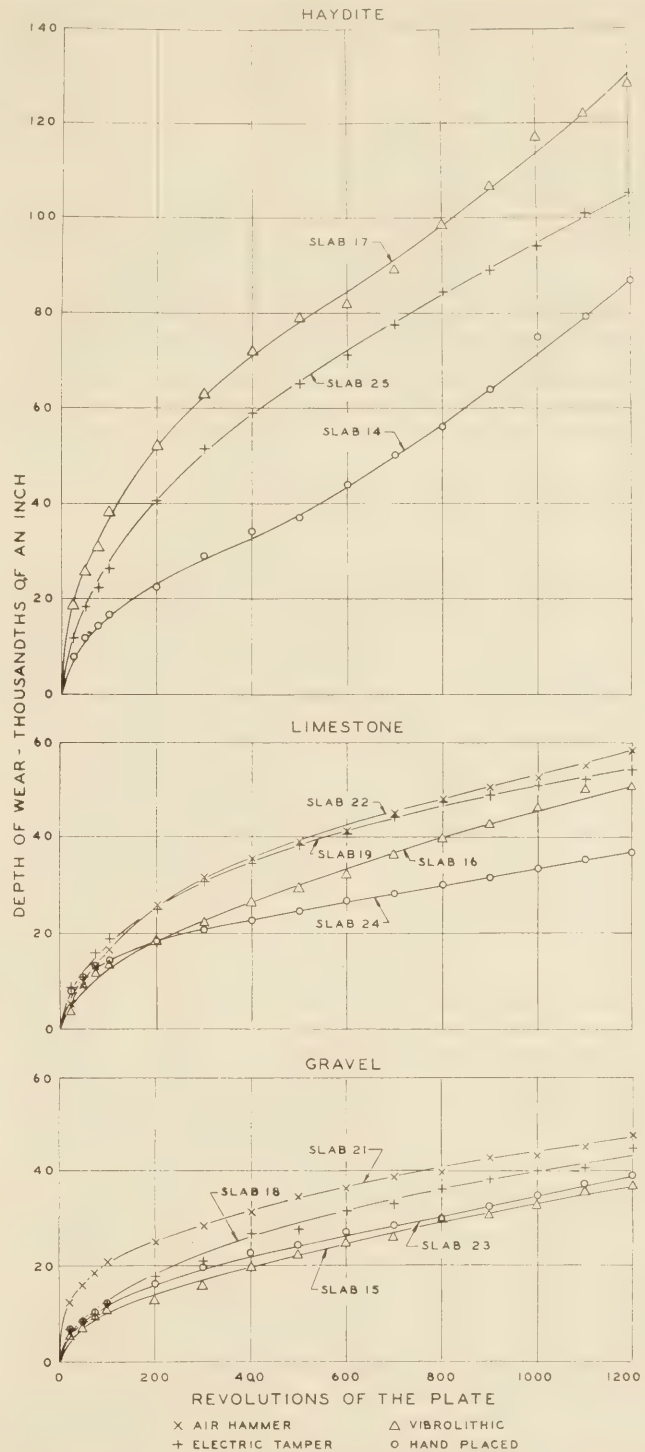
FIGURE 24.—RESULTS OF WEAR TESTS; AVERAGE CURVES DETERMINED BY TWO TESTS ON EACH SLAB

From these data it is evident that for all three aggregates the use of vibratory methods of placing tended to decrease the surface hardness of the concrete and that this effect was particularly pronounced in the case of the concrete containing the Haydite aggregate. The only exception is in the case of the concrete containing the gravel aggregate and placed by the Vibrolithic method. The concrete containing gravel aggregate which was placed by the two other vibrating methods consistently showed a softer surface than that which was

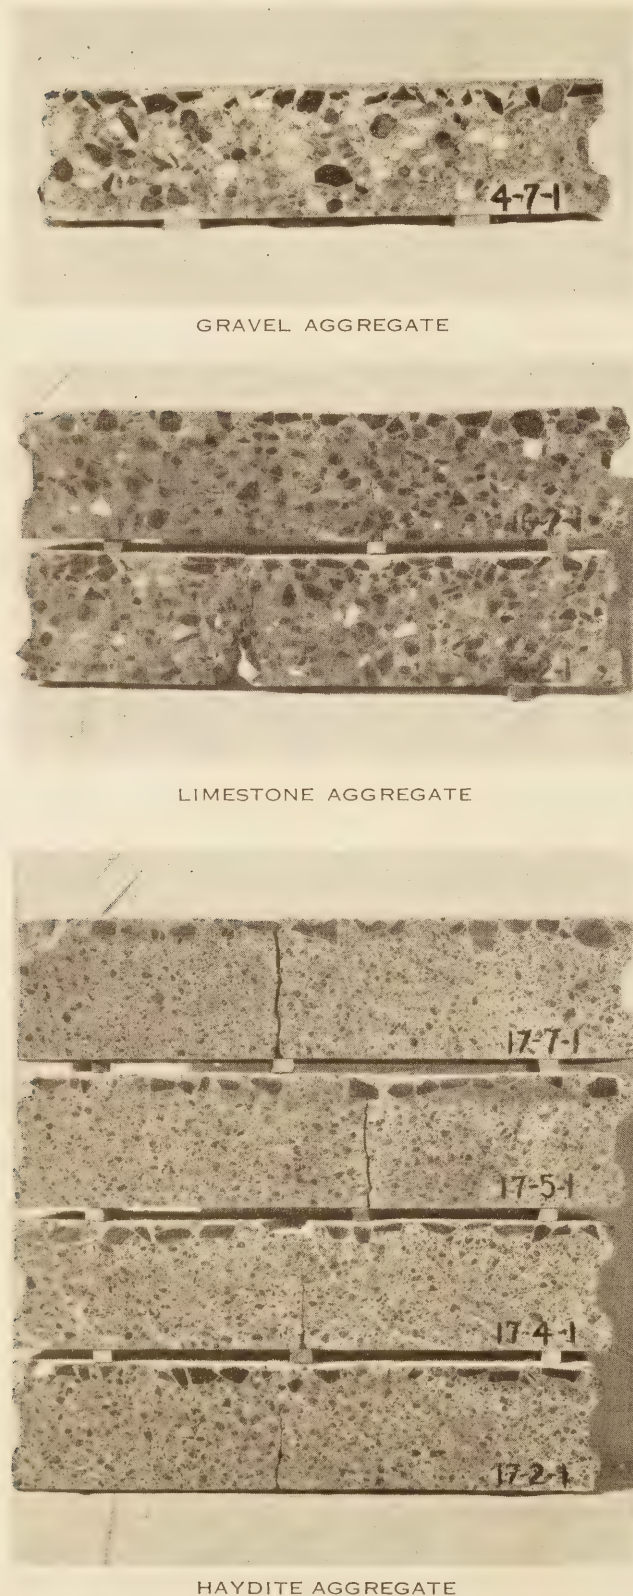
FIGURE 25.—SAWED SECTIONS OF CONCRETE PLACED BY VIBROLITHIC PROCESS, SHOWING FINAL POSITION OF TRAP ROCK ADDED DURING FINISHING

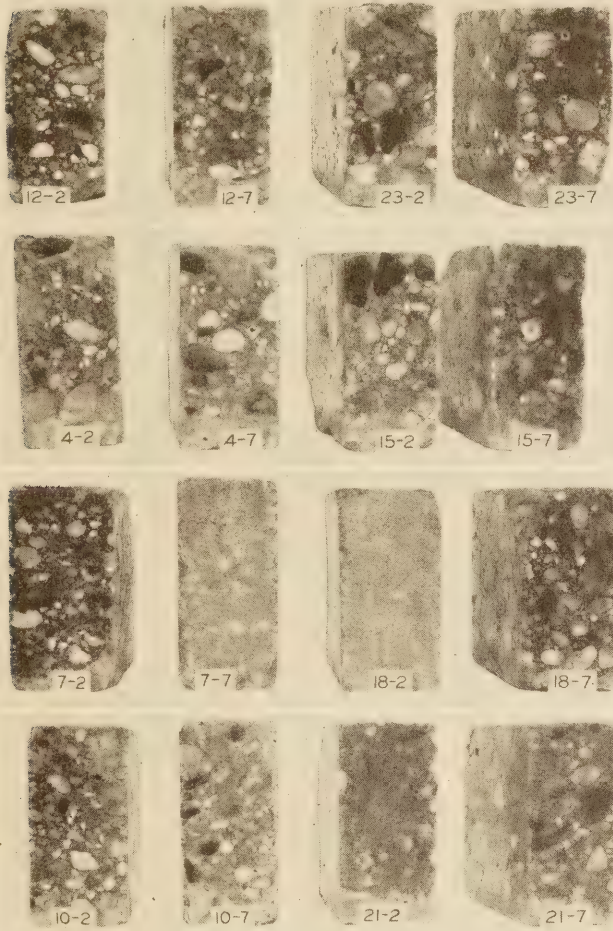
FIGURE 26.—RESISTANCE [OF GRAVEL CONCRETE SPECIMENS TO REPEATED FREEZING. SLAB AND SECTION NUMBERS ARE GIVEN ON THE PHOTOGRAPHS. SLABS 12 AND 23, HAND PLACED; 4 AND 15, VIBROLITHIC; 7 AND 18, ELECTRIC TAMPER; 10 AND 21, AIR HAMMER

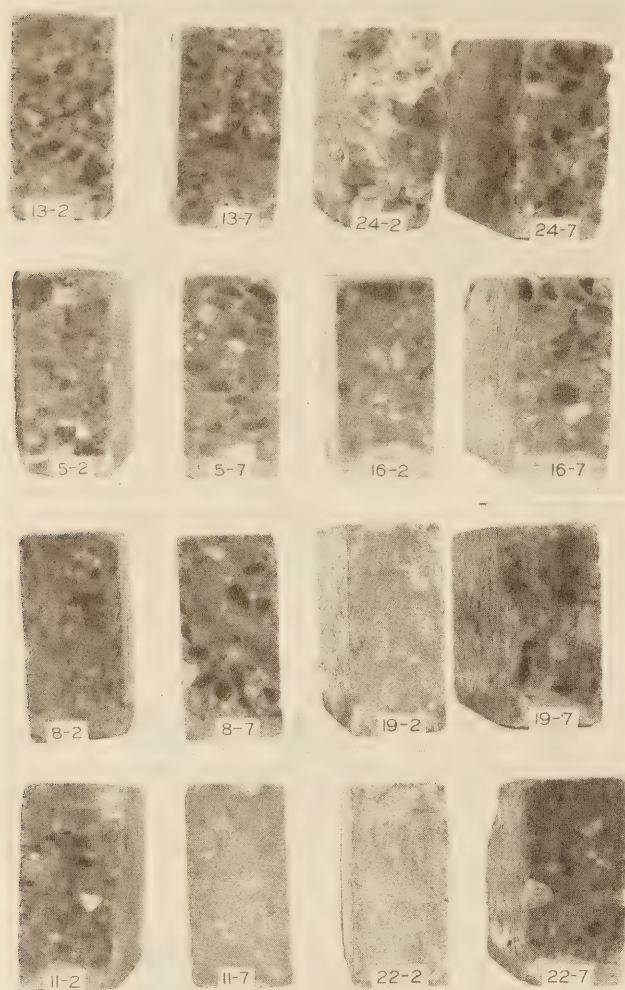
FIGURE 27.—RESISTANCE OF STONE CONCRETE SPECIMENS TO REPEATED FREEZING. SLAB AND SECTION NUMBERS ARE GIVEN ON THE PHOTOGRAPHS. SLABS 13 AND 24, HAND PLACED; 5 AND 16, VIBROLITHIC; 8 AND 19, ELECTRIC TAMPER; 11 AND 22, AIR HAMMER

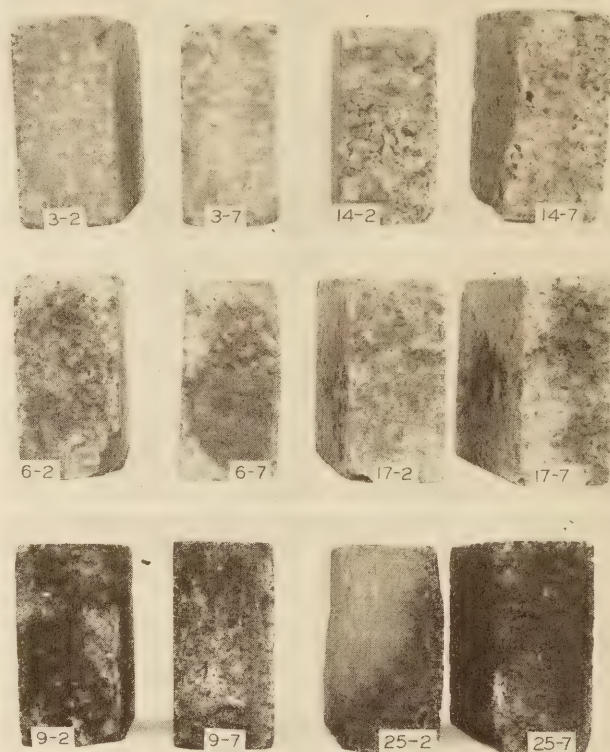
FIGURE 28.—RESISTANCE OF HAYDITE CONCRETE TO REPEATED FREEZING. SLAB AND SECTION NUMBERS ARE GIVEN ON THE PHOTOGRAPHS. SLABS 3 AND 14, HAND PLACED; 6 AND 17, VIBROLITHIC; 9 AND 25, ELECTRIC TAMPER
