PUBLIC ROADS

FULL-SIZE PAVEMENT SLABS TESTED AT ARLINGTON EXPERIMENT FARM

October 1935

Page
The Structural Design of Concrete Pavements	145
Part 1: A Description of the Investigation	
Road-Building Limerocks	159

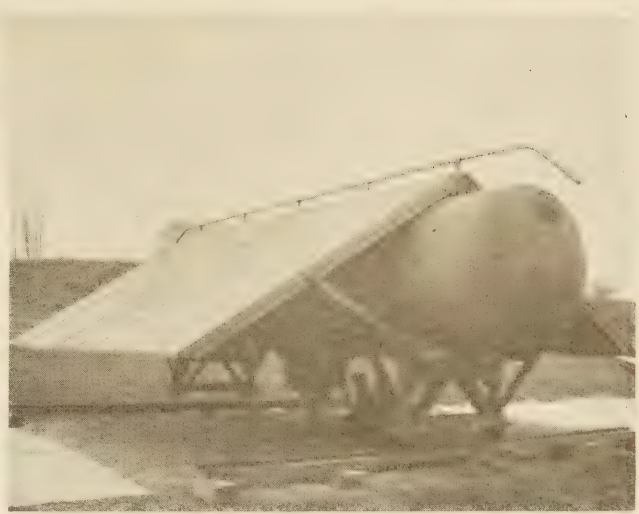
FIGURE 11.—LOADING EQUIPMENT IN PLACE OVER ONE OF THE TEST SECTIONS. THE SLAB IS COVERED WITH STRAW AND SHADED TO PREVENT WARPING.

magnitude were necessary to produce such stresses. It was also highly desirable that at the time the test load was being applied no other loads be on the slab, in order that the observed effects could be attributed definitely to a known reaction system. These two considerations and the availability of a large cylindrical steel tank led to the adoption of the loading equipment shown in figure 11. The tank, 30 feet long and 6 feet in diameter, was mounted in a structural steel frame or cradle, supported by two transverse end frames 22 feet apart. Each end frame was provided with a pair of heavy cast-iron wheels of small diameter and these rested upon a railway laid along the earth shoulders parallel to the pavement edge. The tank spanned the slab completely and could be moved longitudinally over the test sections at will.

A heavy wooden bolster or pad was fitted to the lower surface of the tank and so arranged that it could be shifted to any position from one end frame to the other, and thus be placed over any desired point on any of the sections.

By partially filling the tank with water a reaction in excess of any load required for the loading of the slabs became available. To develop the load on the slab the device shown in figure 12 was constructed. In this figure, A is the wooden bolster that bears against the bottom of the tank, B is a steel facing plate on the lower surface of the bolster, C is a hardened steel knife edge, D is a pair of heat-treated steel beams whose load-deflection rate being known through calibration enables the operator to determine the load on them at any instant by reading the micrometer dial that measures their deflection, E is a ball-bearing screw jack used for developing the thrust, F is a spherical bearing block that prevents eccentricity of loading on the bearing plate G, and H is a sponge-rubber pad to take up surface irregularities on the slab and assure a uniform intensity of load over the entire area of the bearing block.

In practically all of the load tests it was necessary to reduce the influence of slab warping to a minimum. It was found that if the slab was kept shaded from all direct sunlight and covered with several inches of dry straw, the temperature differential between the upper and lower surfaces became negligible and the warping of the slab was so small that its influence on stress was not important. Therefore, these precautions were taken in all tests as a matter of regular procedure. The shade and straw covering are shown in figure 11.

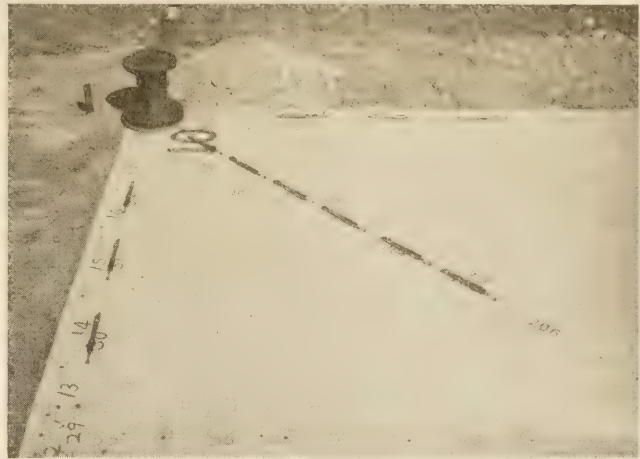
FIGURE 15.—ARRANGEMENT OF STRAIN GAGES FOR A LOAD TEST AT THE CORNER OF A SLAB OF UNIFORM THICKNESS.

As usually installed the axis of the strain gage was one-fourth of an inch from the surface of the concrete. This caused the recorded strain to be greater than the strain at the surface of the pavement by an amount that depended upon the relative distances of the gage and that surface from the neutral plane of the pavement slab. In most of the measurements, it was therefore necessary to apply a small correction to the observed strains in order to compensate for the gage position. Figure 15 shows an installation of the gages for a load test at the corner of a slab of constant thickness.

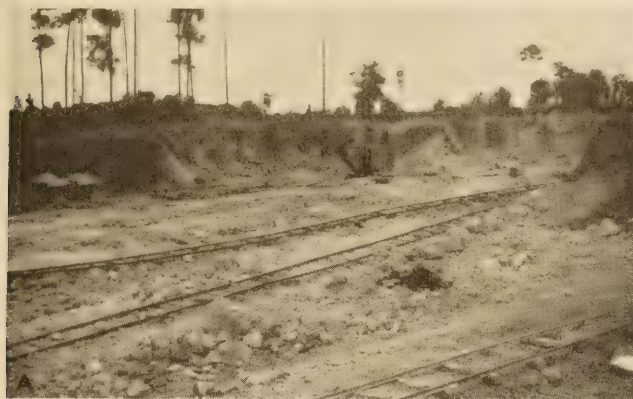
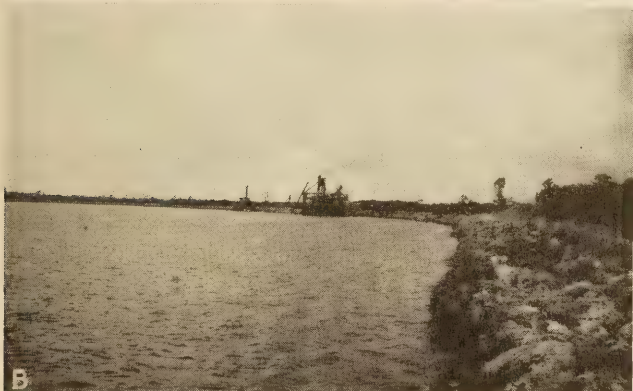
FIGURE 2.—METHODS OF MINING LIMEROCKS: A, OPEN-PIT MINING OF OCALA LIMEROCK; B, DREDGING OF MIAMI OOLITE.

shovels (see fig. 2). Although the rock is sometimes so soft that it can be scraped from the face of the pit by the shovels, it is usually fractured and loosened by blasting to facilitate handling. It is conveyed to crushers, crushed to the fineness required, and either loaded directly or stored. Although in most of the deposits the limerock is soft and powdery, crushing is usually necessitated by the occurrence of harder masses. Most pits are worked to the depth of the water table. However, Miami Oolite is mined by means of dredges to a depth of as much as 30 feet below the water table.
