PUBLIC ROADS

VOL. 20, NO. 11

CONSTRUCTING EXPERIMENTAL CONCRETE PAVEMENT IN INDIANA

Page
Experiments With Continuous Reinforcement in Concrete Pavements	205
The Cost of Curing Concrete Pavements With Cotton Mats	215
Cost of Operating Rural-Mail-Carrier Motor Vehicles	217

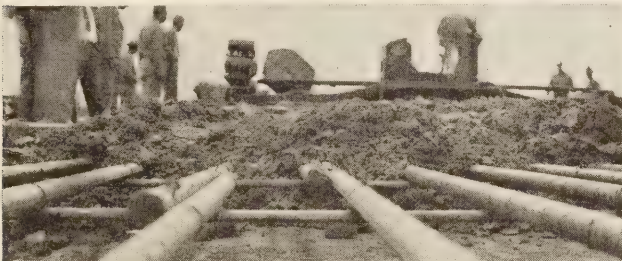
FIGURE 13.—CONCRETE BEING PLACED IN A HEAVILY REINFORCED SECTION.

The concrete mixer was kept to the side of the roadway during the placing of concrete. This allowed the bar mat reinforcement to be placed a short distance in advance of the mixer. The two views in figure 13 show the placing of the concrete in one of the heavily reinforced sections.

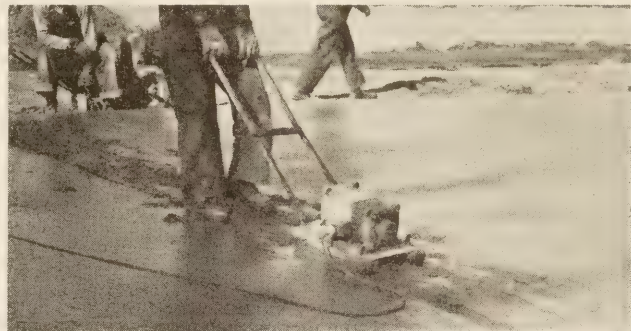
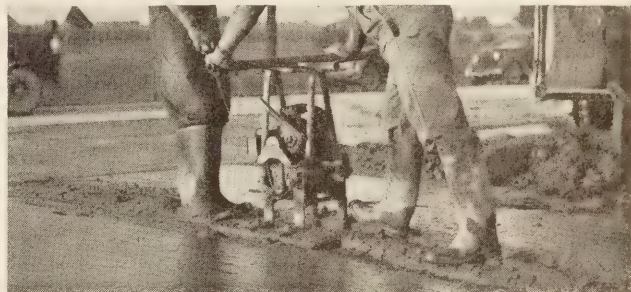
FIGURE 15.—VIBRATORS USED AROUND TYPE III JOINTS. UPPER, VIBRATOR USED ON EAST PROJECT; LOWER, VIBRATOR USED ON WEST PROJECT.

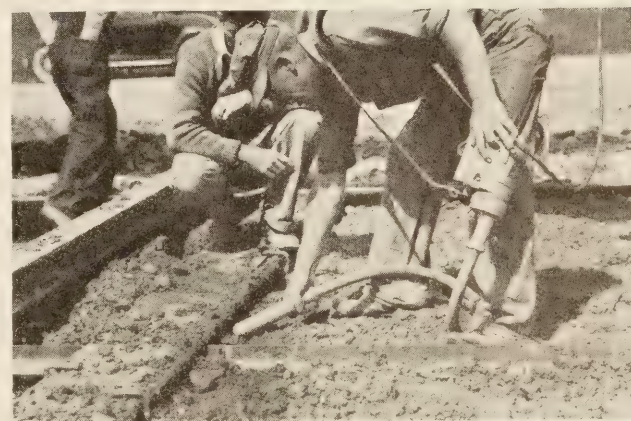
FIGURE 16.—INTERNAL VIBRATOR USED UNDER TYPES I AND II JOINTS.

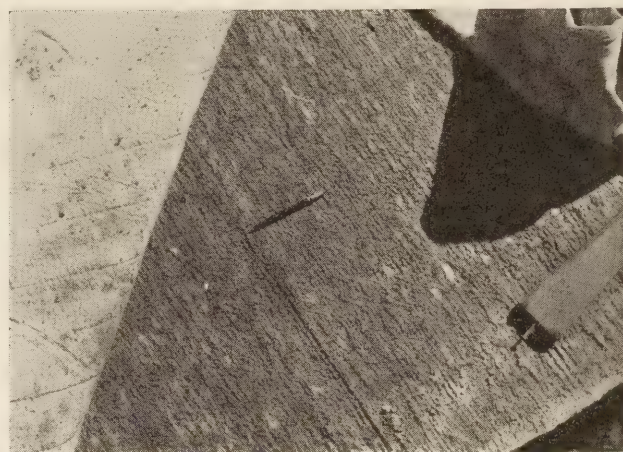
FIGURE 3.—PORTION OF CONCRETE PAVEMENT SLAB AND COTTON MATS USED IN CURING IT.

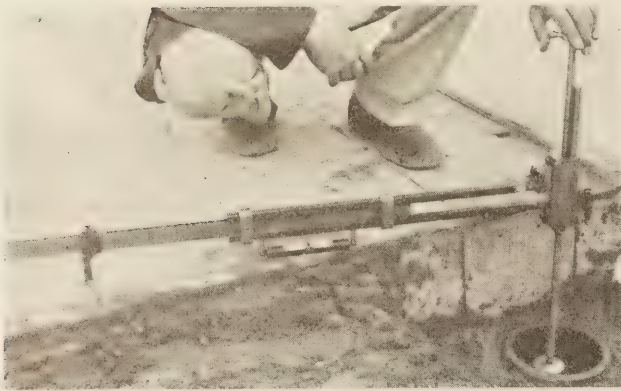
FIGURE 18.—DEVICE USED FOR MEASURING MOVEMENTS AT ENDS OF SLABS, AND BENCH MARK (LOWER RIGHT).

Since the combined movements of the ends of the two slabs at a joint should be equal to the total change in width of the joints, the changes in the widths of the joints are measured as a check on the measurements of the absolute movements of the ends of the slabs. These measurements are made with a micrometer between two metal points set in the concrete.

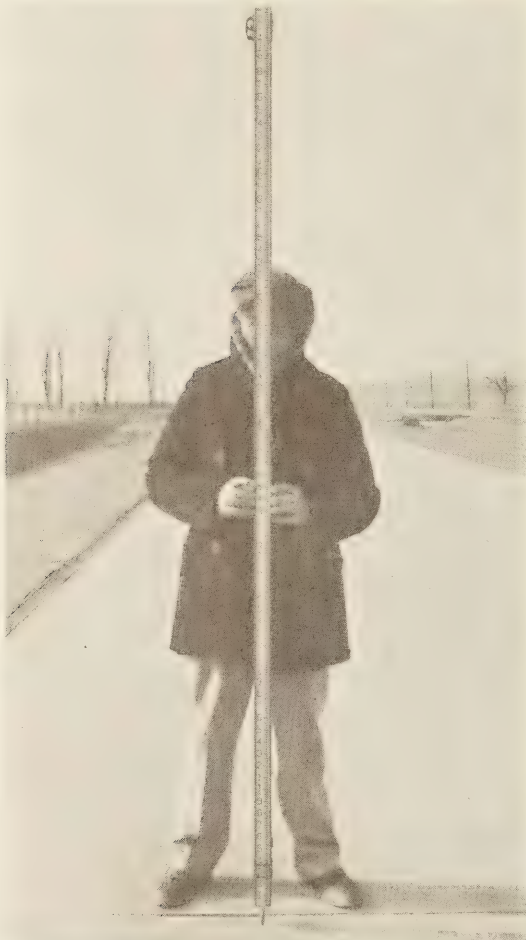
FIGURE 19.—LEVELING ROD WITH SPECIAL ATTACHMENT.

Metal points were set in the concrete at the points where the level measurements are taken. Figure 19 shows a leveling rod resting on one of these points.

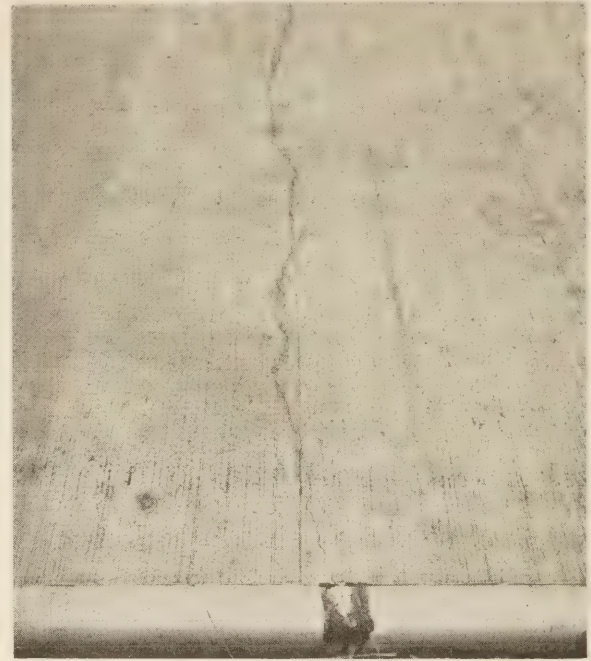
FIGURE 20.—TYPICAL CRACK IN A HEAVILY REINFORCED SECTION.

A typical crack in one of the heavily reinforced sections is shown in figure 20. These cracks are not apparent except on close examination and are very similar to those that occurred very early in the life of the heavily reinforced sections of the Columbia Pike experimental pavement. As stated earlier in this report, the cracks in the heavily reinforced sections on Columbia Pike have remained closed and no serious spalling or disintegration has occurred in their vicinity. It seems unlikely, therefore, that these fine cracks in the heavily reinforced sections of this pavement will ever cause serious damage.

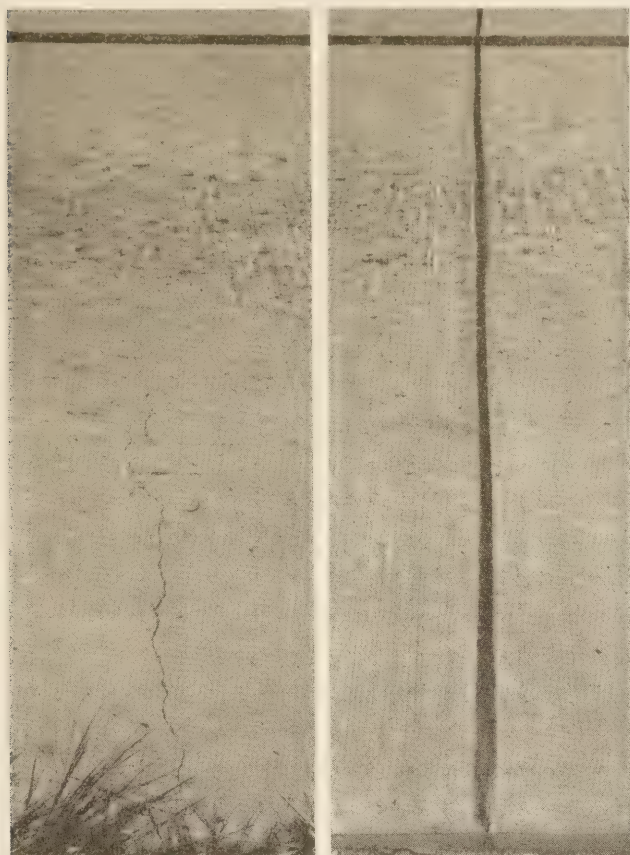
FIGURE 21.—LEFT, CRACK THAT HAS OCCURRED AT A SUBMERGED WEAKENED-PLANE JOINT; RIGHT, WEAKENED-PLANE JOINT WITH SURFACE GROOVE.

The sections in which the weakened-plane joints were placed at intervals of 10 feet are in excellent condition.
