# PUBLIC ROADS

A JOURNAL OF HIGHWAY RESEARCH

# EXPERIMENTAL SAND-CLAY BASE COURSE IN NORTH CAROLINA

# SPEED TRANSITION RAMPS ON A BRIDGED ROTARY

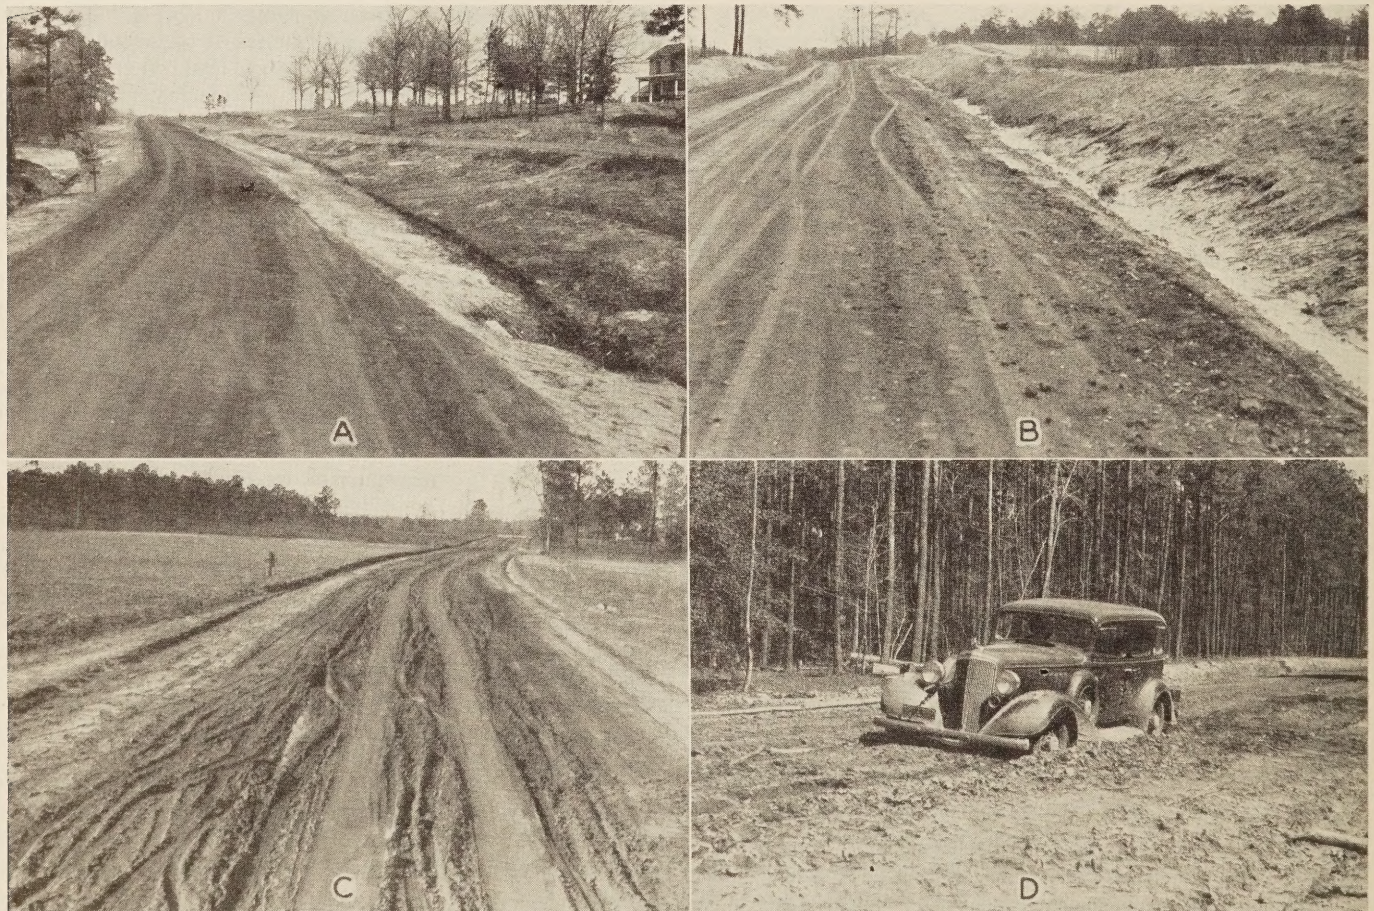
FIGURE 3.—POOR PERFORMANCE OF ORIGINAL SAND-CLAY SURFACING: (A) OUTLET OF POROUS STRATUM CAUSING UNSTABLE AREA; (B) WATER FLOWING FROM SANDY STRATUM IN SIDEHILL CUT; (C) POORLY DRAINED AREA IN PORTSMOUTH SOIL; (D) UNSTABLE ROADWAY IN HIGH WATER TABLE AREA.

Performance of the original sand-clay surfacing constructed in 1935 on sections 2, 3, and 4 is illustrated in figure 3. Where drainage was adequate, the road surface was maintained in satisfactory condition. However, the occurrence of springs in the roadbed, sidehill seepage, and high water table in low, poorly drained areas resulted in localized mudholes and longer sections of unstable roadway which became deeply rutted under traffic.

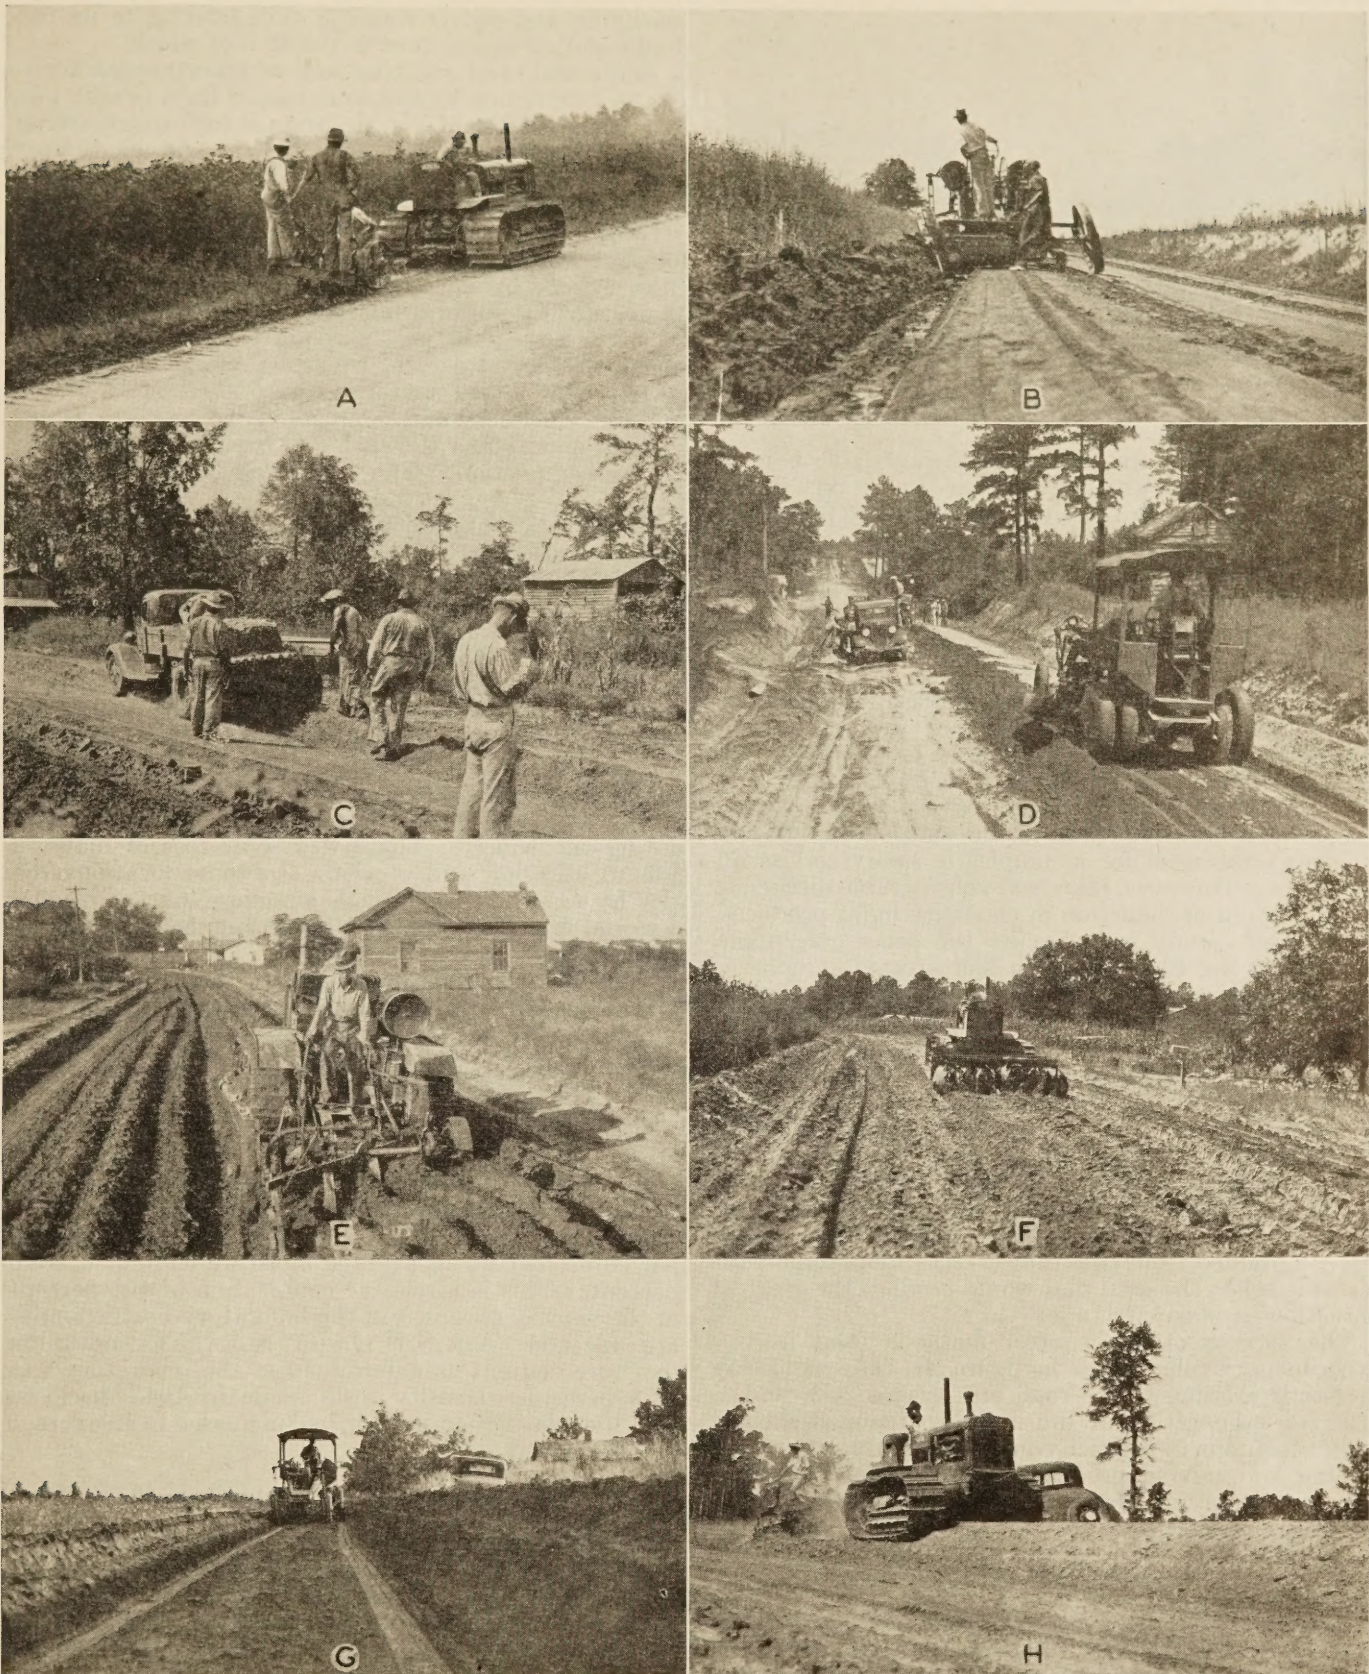
FIGURE 6.—CONSTRUCTION OF SAND-CLAY BASE COURSE: (A) SCARIFYING OLD ROADWAY AND (B) REMOVING MATERIAL TO WIDEN TRENCH SECTION; (C) DISTRIBUTING AND (D) SPREADING NEW MATERIAL FROM BORROW PITS; (E) PLOWING ORIGINAL SURFACE AND ADDED MATERIAL; (F) PULVERIZING WITH DISK HARROW; (G) MIXING ORIGINAL AND ADDED MATERIAL WITH MOTOR GRADER; (H) PULVERIZING WITH DISK HARROW DURING MIXING OPERATION.

Base construction on sections 2, 3, and 4 required the excavation of a trench 2 feet wide on each side of the existing sand-clay surfacing and the combination of the surfacing material with additional soil from selected pits to produce a base 7 inches in thickness and 22 feet wide, as shown in figure 1. This was accomplished by scarifying the shoulder material (fig. 6A) and removing it by means of a blade grader (fig. 6B), followed by

Additional sand and clay soils of known characteristics as determined by test were hauled from nearby pits and deposited (fig. 6C) on the original surfacing material in quantities calculated to give the specified cross section after compaction. Spreading was performed by motor grader (fig. 6D).

Gang plows, harrows, and motor graders were used for pulverizing and mixing the different materials (figs. 6E, F, G, and H). These operations were continued until a uniform mixture was obtained and until all materials would pass through a  $1\frac{1}{4}$ -inch sieve and not more than 14 percent would be retained on a No. 4 sieve. The mixed materials were then spread to a uniform thickness and compacted by traffic. Motor graders maintained the surface with the proper crown during compaction. The completed base is shown in figure 7.

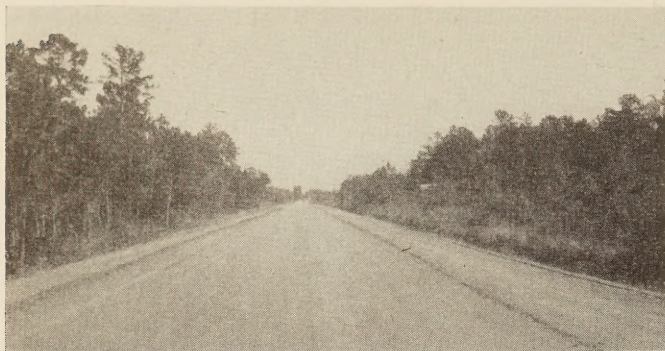
FIGURE 7.—THE COMPACTED STABILIZED BASE PRIOR TO APPLICATION OF BITUMINOUS SURFACING.

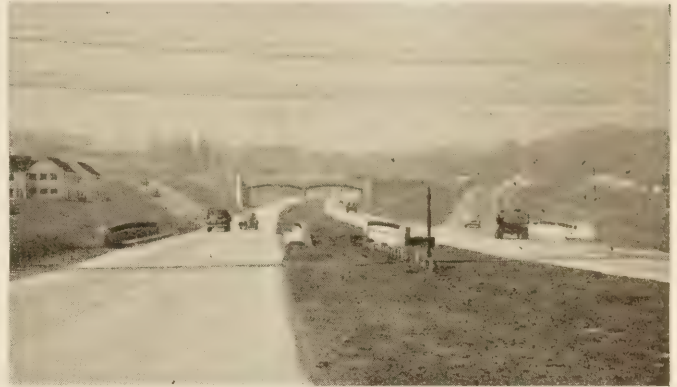
FIGURE 1.—THE ACCELERATION AND DECELERATION RAMPS STUDIED, SEEN FROM THE NORTH.

The bridged rotary on the Shirley Highway furnishes the interchange between the high-speed-designed expressway and the lower-speed streets that feed into a highly developed apartment-house community complete with a retail commercial area, as may be seen in the cover illustration. A view of the two ramps studied appears in figure 1, and their profiles are shown in figure 2.

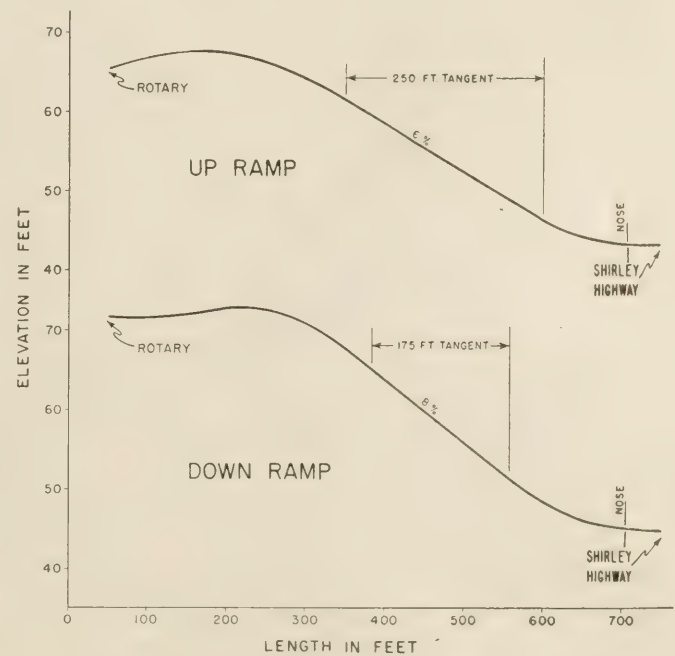
FIGURE 2.—PROFILES OF THE RAMPS STUDIED.
