Public Roads

A JOURNAL OF HIGHWAY RESEARCH

December 1971/Vol. 36, No. 11

Highway Lighting Maintenance, by <i>James A. Hogan</i>	229
Behavior of Curved Bridge Models, by <i>Conrad P. Heins, Jr.</i> , and <i>Bijan Bonakdarpour</i>	240
Determination of Motion and Deflection of Retain- ing Walls, by <i>S. A. Veress</i>	252

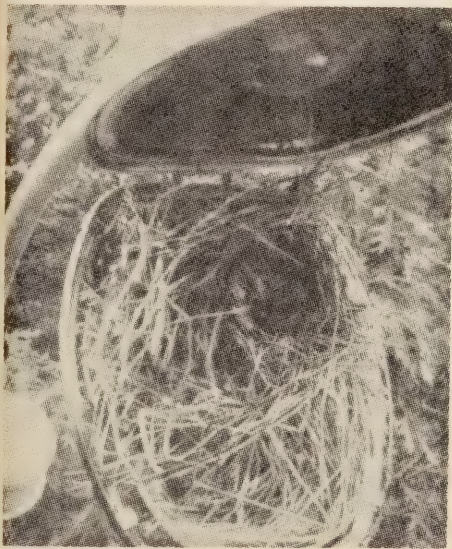
Glassware of this optical assembly has been broken through thermal shock (a condition directly resultant from accumulations of dirt). The fixture has become a haven for birds, rendering the street light totally useless.

Luminaire dirt depreciation can result from conditions other than ambient contaminants. Figure 10 shows several examples of broken or defective luminaires with excessive amount of light loss. While problems with squirrels or birds are no doubt more common to residential street lighting, highway lighting installations are by no means immune to such occurrences. Light loss resulting from insect accumulation inside the refractor is certainly not unique to residential street lights alone.

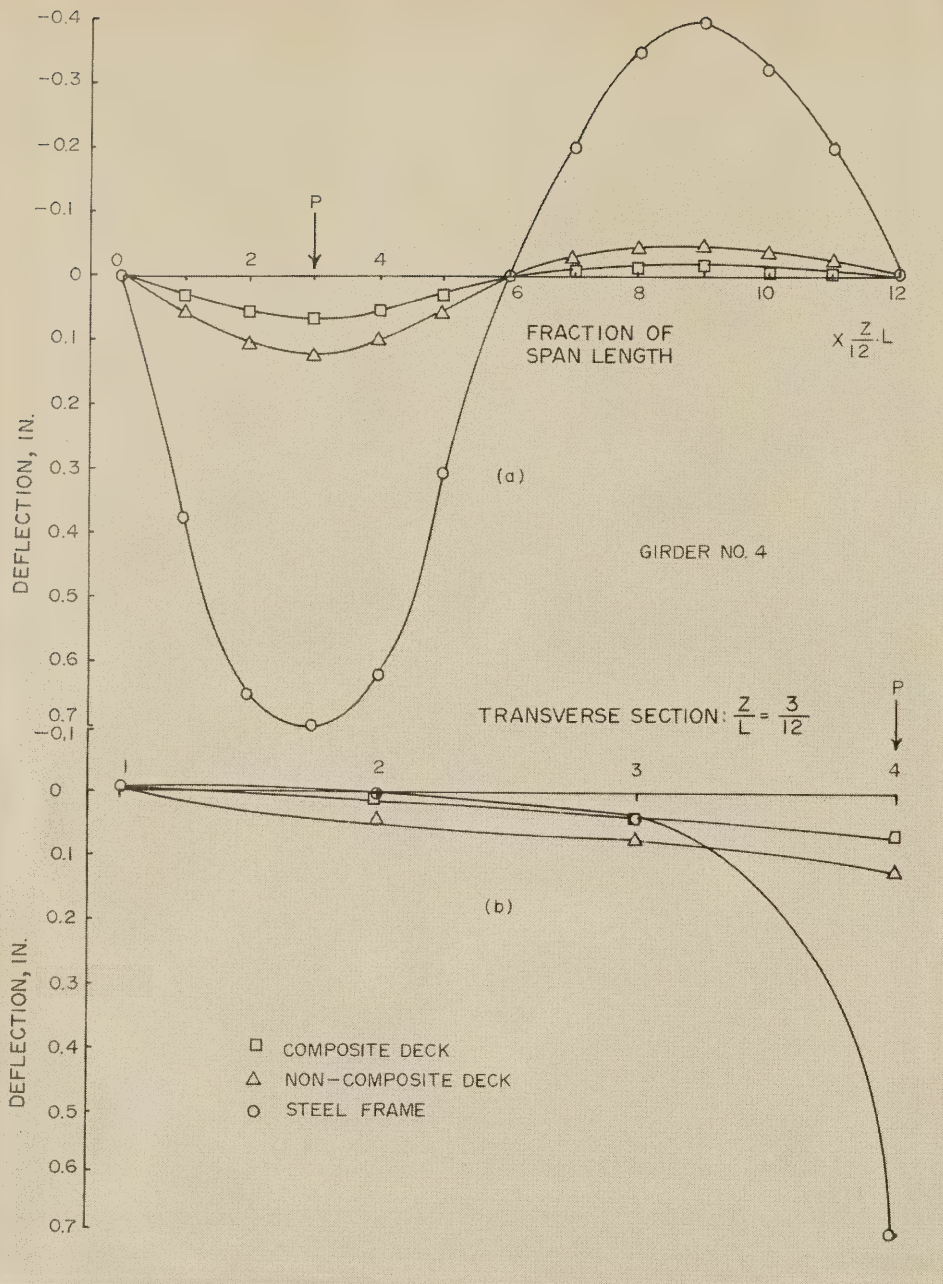
Figure 10.—Diaphragm series IV—all models.

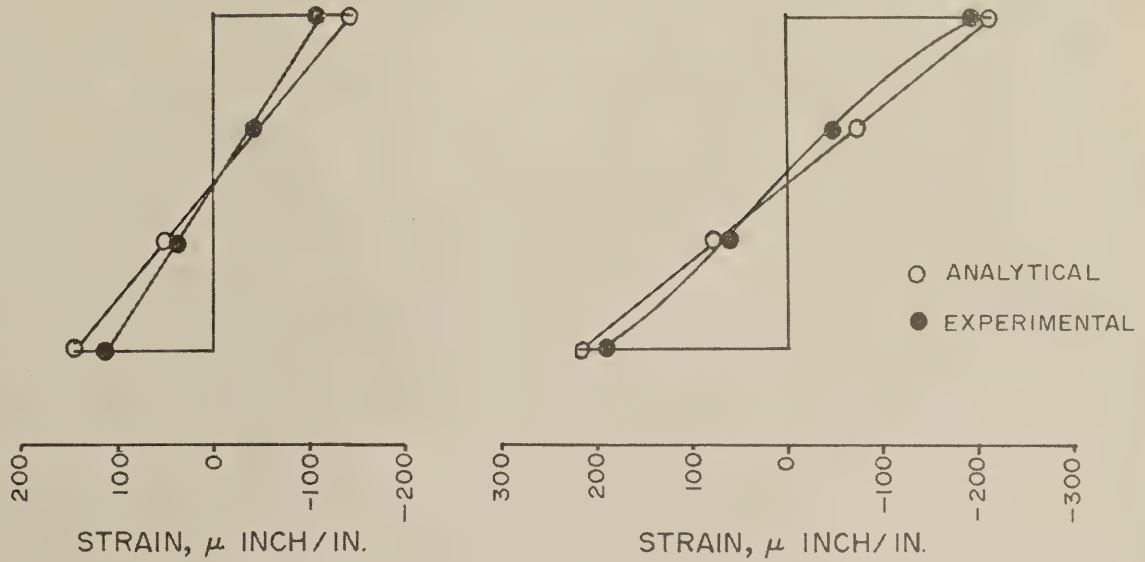
Figure 11.—Longitudinal strain distribution—bare steel frame model.

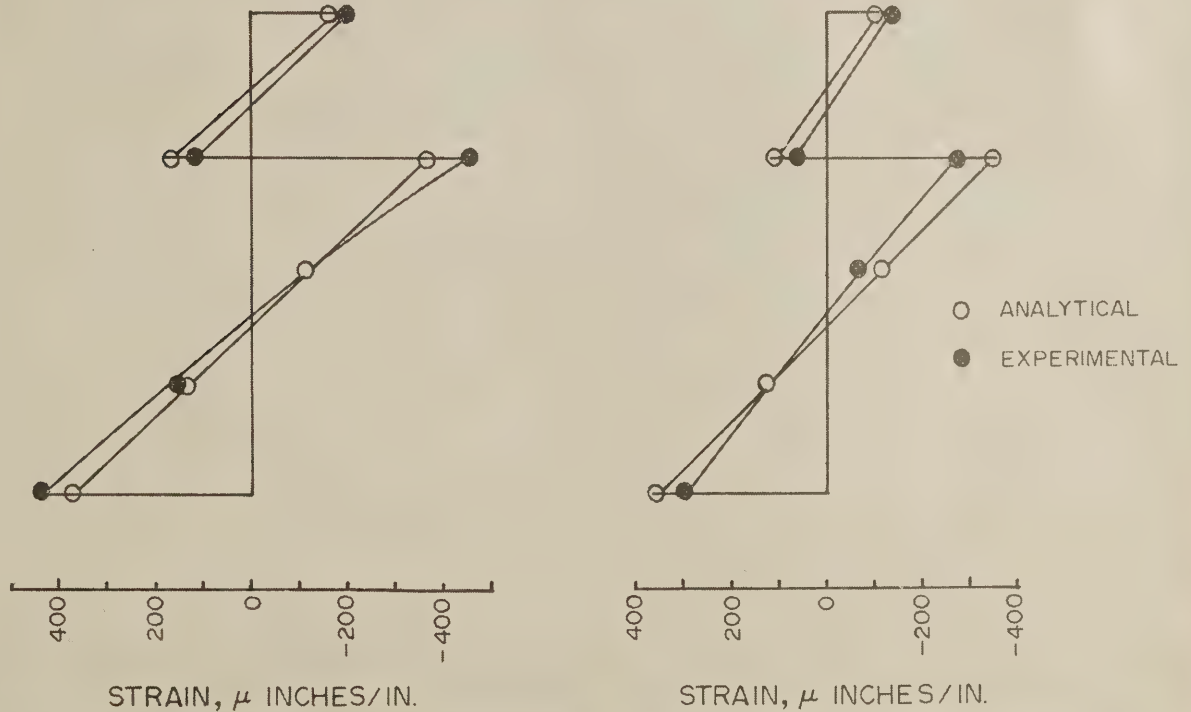
Figure 12.—Longitudinal strain distribution—noncomposite model.

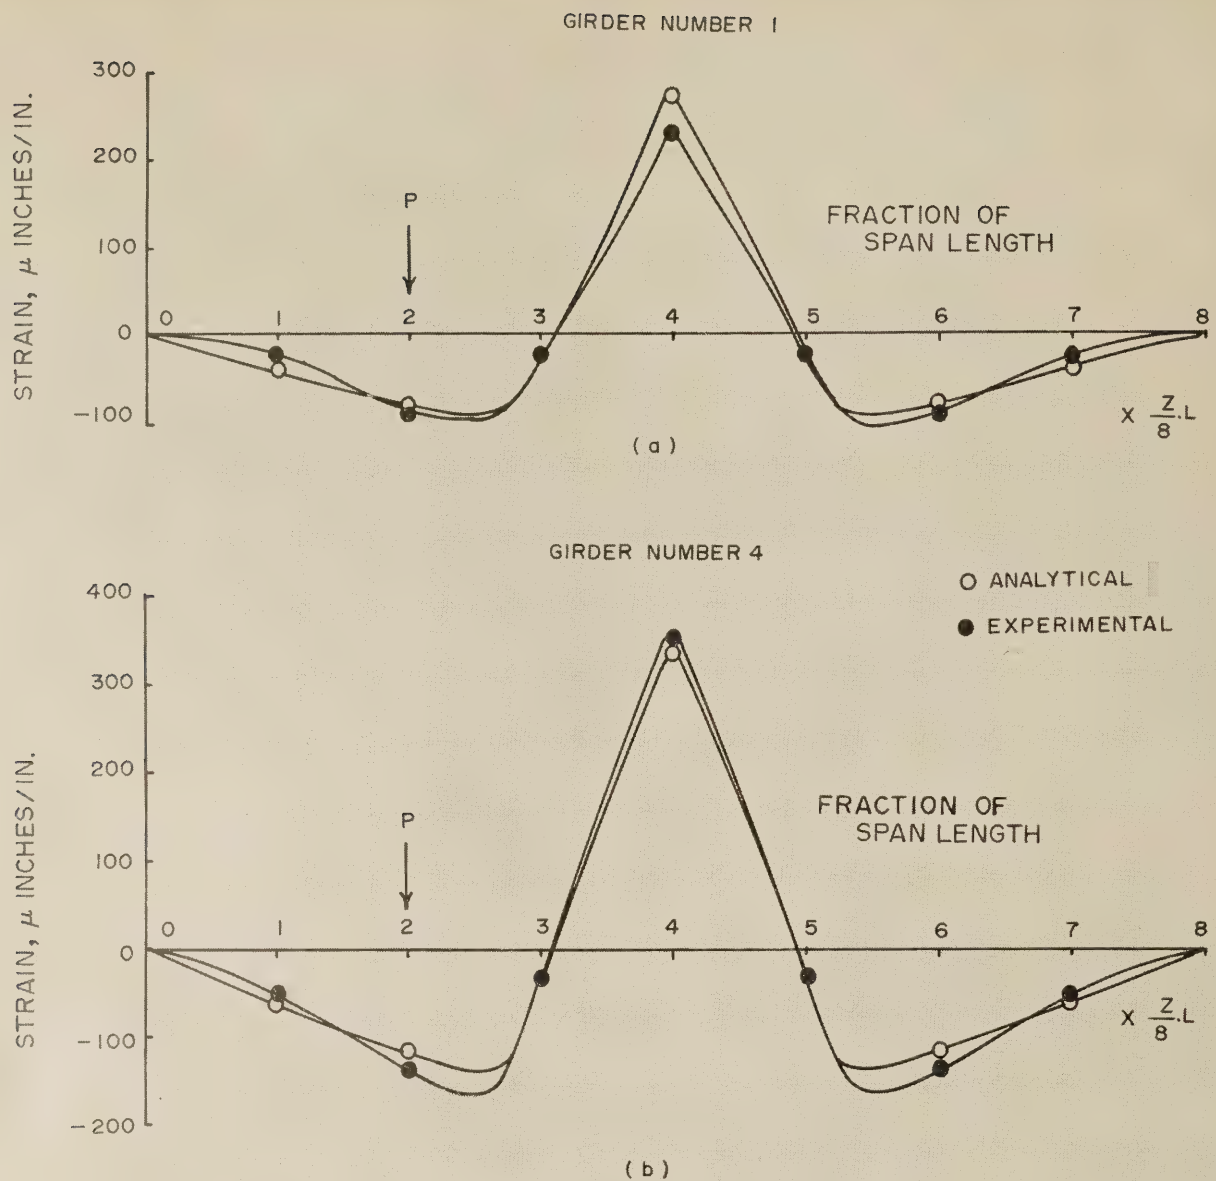
Figure 17.—Longitudinal strain distribution—bare steel frame model.

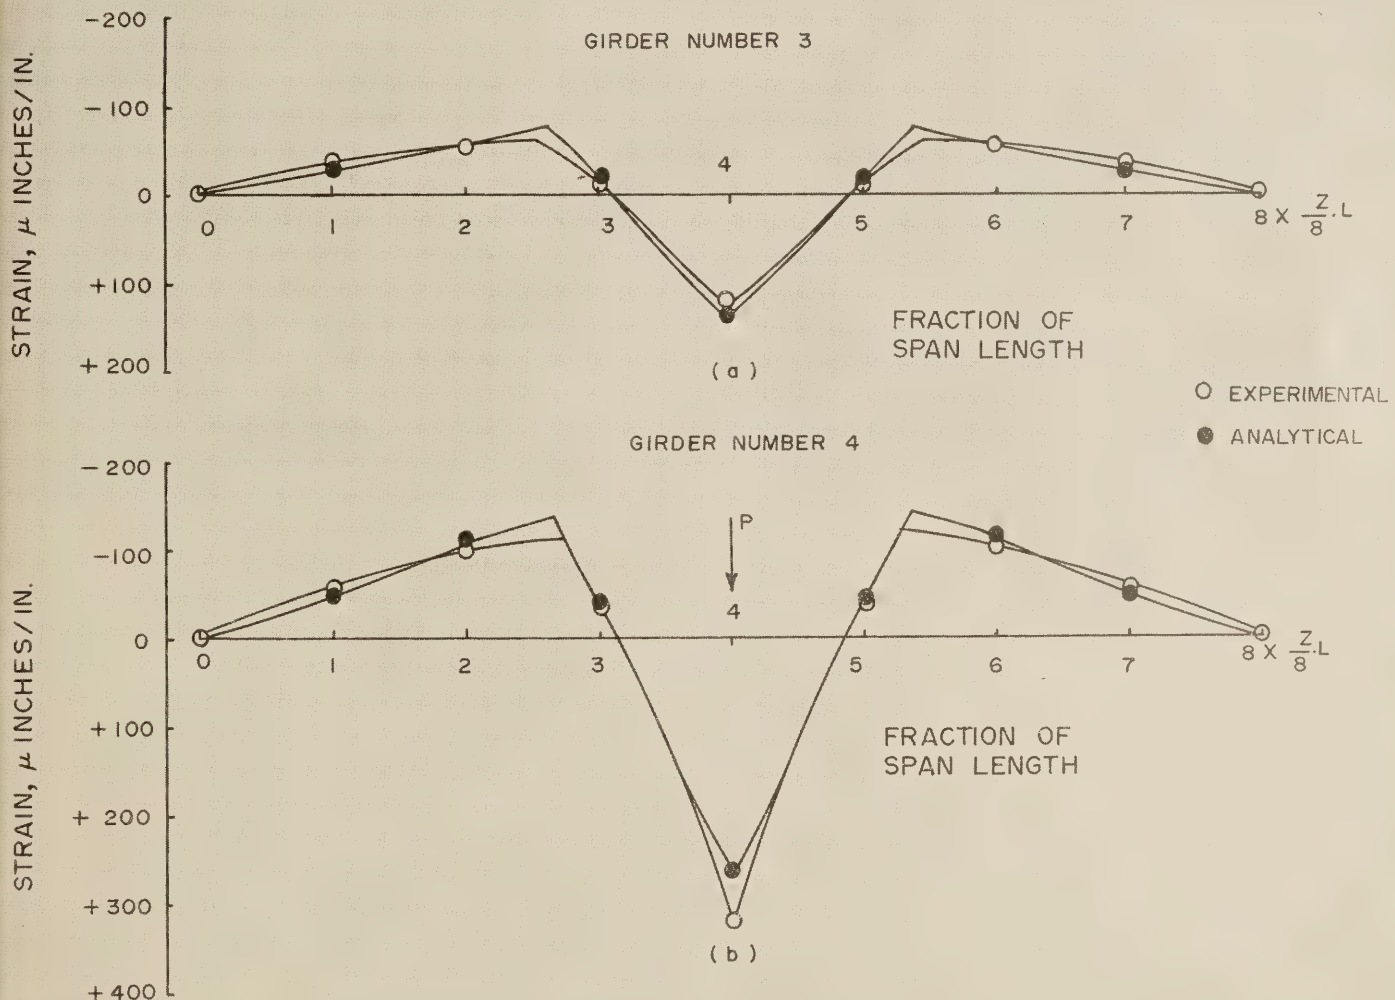
Figure 18.—Longitudinal strain distribution—noncomposite model.

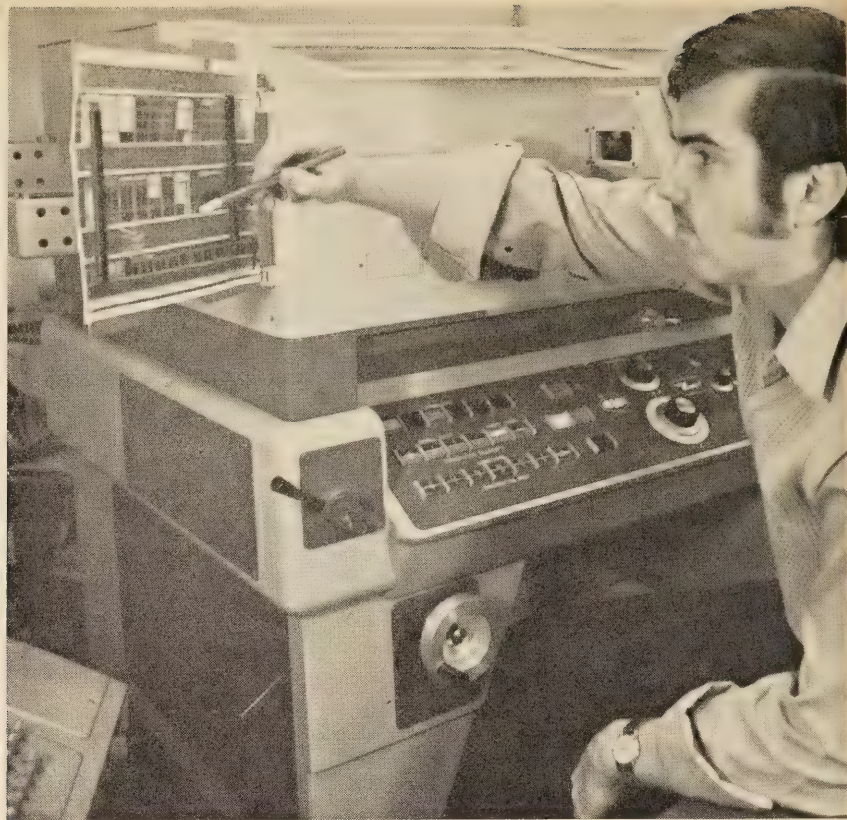
Analytical plotter with a photo of building wall that served as an imaginary retaining wall for the reported research.
