Public Roads

A JOURNAL OF HIGHWAY RESEARCH AND DEVELOPMENT

June 1973/Vol. 37, No. 5

NONMETALLIC COATINGS FOR CONCRETE REINFORCING BARS

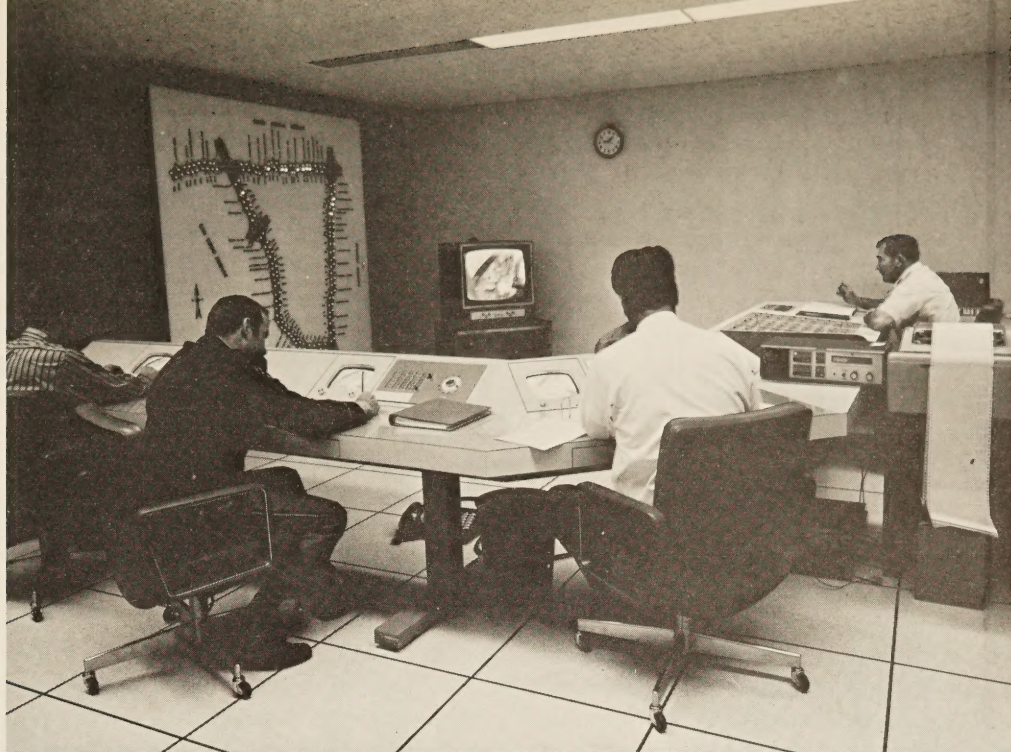
A modern control center.

The control center would contain the data reduction, decisionmaking, and control functions of the system and would, of course, heavily utilize a digital computer system. Data would be received from the various sources and analyzed; on the basis of this analysis, traffic conditions would be defined and predicted, disturbances and incidents located, and remedial measures enacted. Optimal routings would be computed for those specific decision points which require diversion. Ramp control (metering) would be exercised when demands have to be limited to maintain free flow. All of the control center operations would be automated as much as possible to improve system efficiency and keep operating costs reasonable, but control center personnel would have the capability to interrupt the system, if emergencies so require.

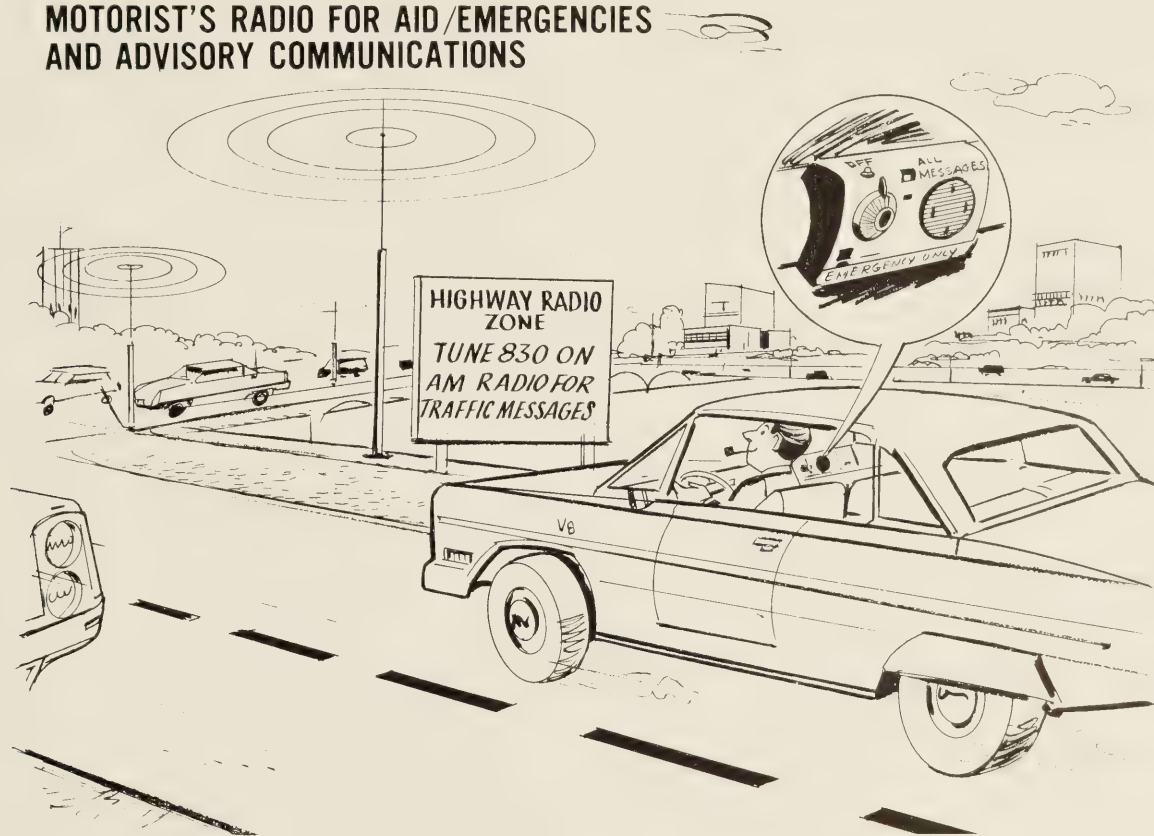
MOTORIST'S RADIO FOR AID/EMERGENCIES AND ADVISORY COMMUNICATIONS

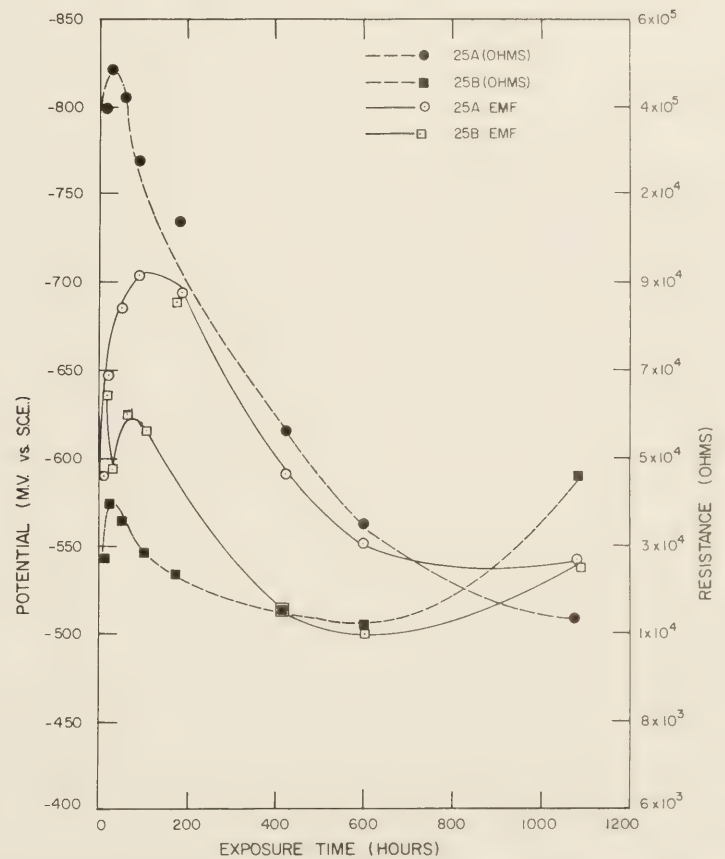
Figure 4.—Electrical potential and resistance measurements of coated reinforcing bars No. 25 immersed in 3½ percent NaCl.
