Public Roads

June 1983 Vol. 47, No. 1

Corrosion of Nonspecification Epoxy-Coated Rebars in Salty Concrete

by
Kenneth C. Clear and Yash Paul Virmani

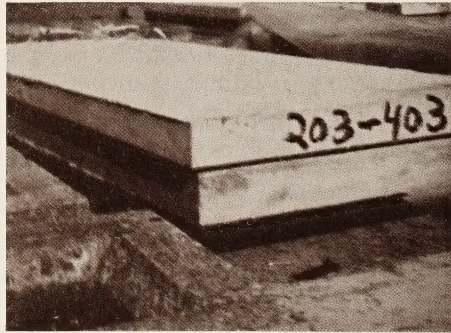
Figure 4.—Completed slabs.

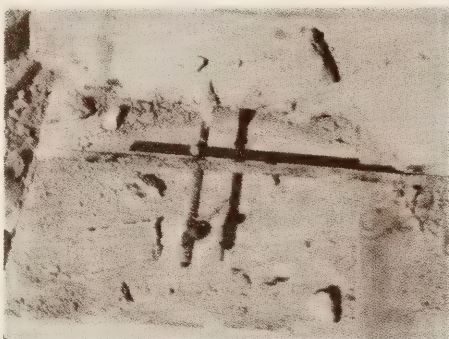
Figure 8.—Slab 201: Demolished, visible rust on iron rebar mat.

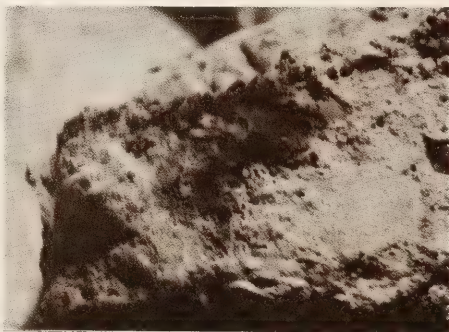
Figure 9.—Slab 201: Demolished, concrete with rebar rust imprint.

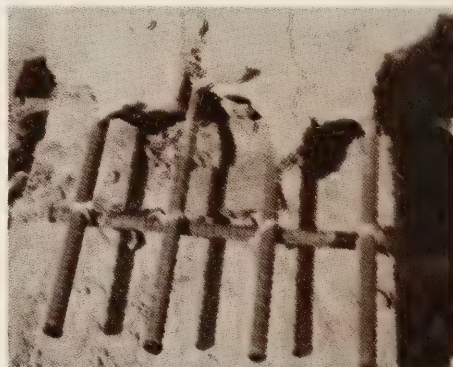
Figure 11.—Slab 204: Demolished, no visible rust on epoxy-coated rebars.

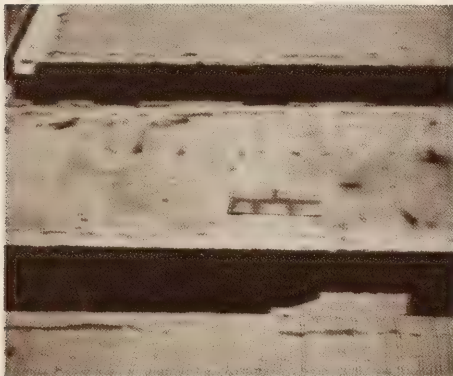
Figure 14.—Slab 234: Black steel, both mats, 11.3 kg CF/m³ (19 lb CF/yd³), April 1982.

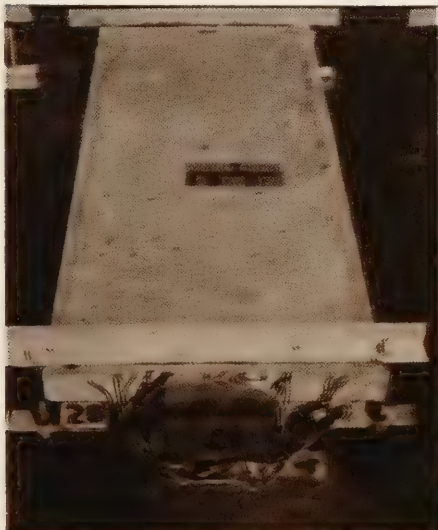
Figure 15.—Slab 206: Epoxy coated with holidays, both mats, 8.4 kg CF/m³ (14.2 lb CF/yd³), April 1982.

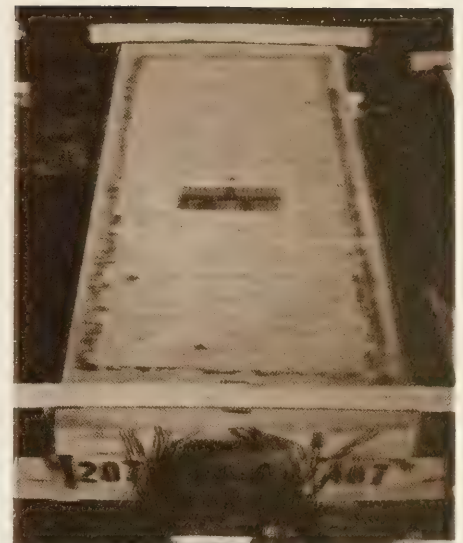
Figure 18.—Slab 203: Epoxy coated with holidays, top mat only, 8.6 kg CF/m³ (14.5 lb CF/yd³), April 1982.

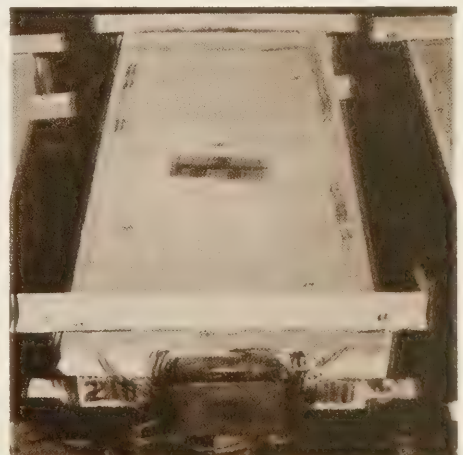
Figure 20.—Slab 210: Epoxy coated with holidays, 0.24 percent bare area, top mat only, 8.7 kg CF/m³ (14.7 lb CF/yd³), April 1982.

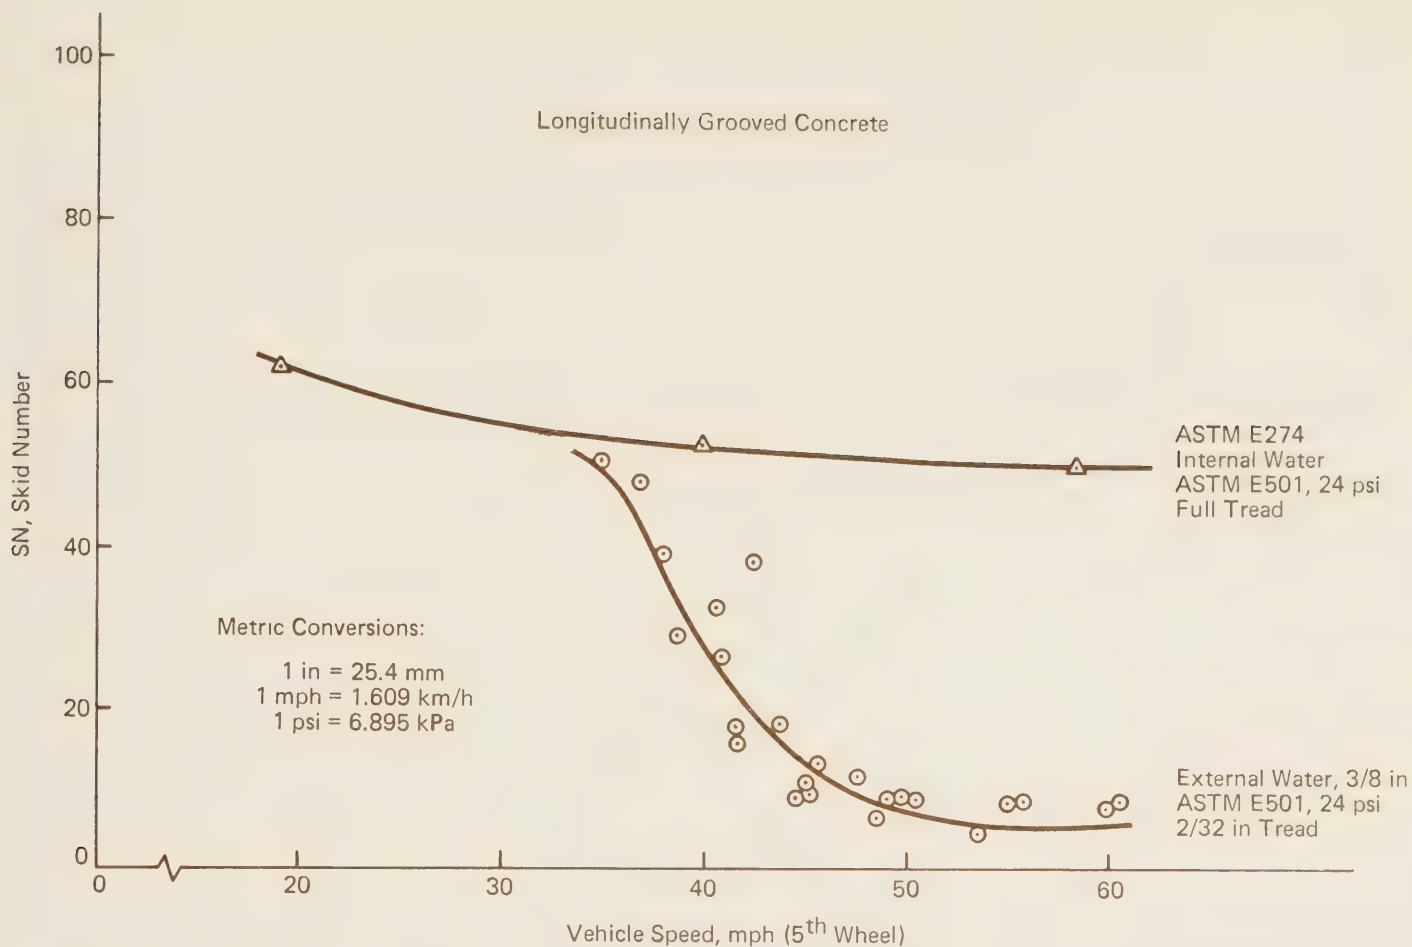
Figure 1.—Locked-wheel skid number versus speed.

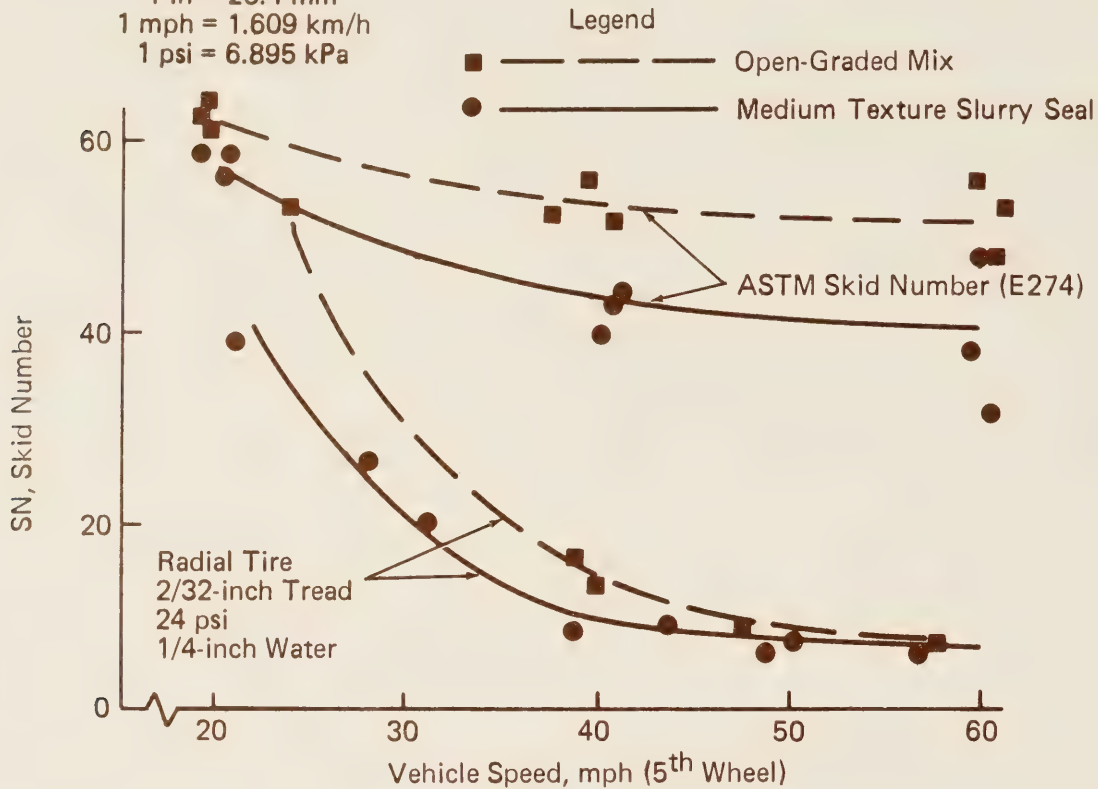
Figure 2.—Test results on coarse- and medium-texture surfaces.

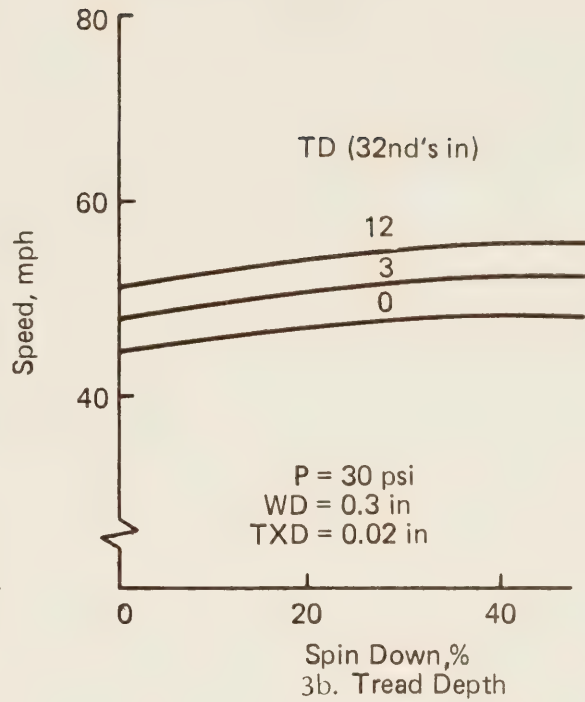
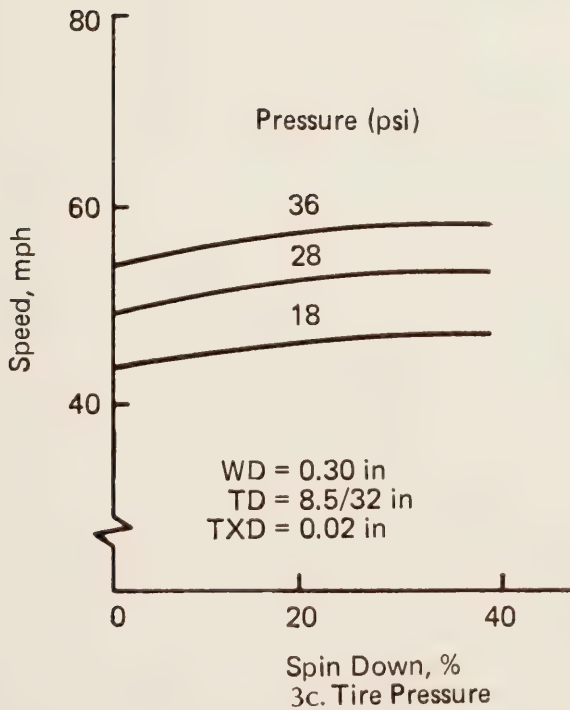
Figure 3.—Influence of four parameters on hydroplaning speed.

Hydroplaning increases as the tire tread pattern depth decreases (fig. 3b) because the water has less opportunity to escape through the tread pattern. Pattern depth usually has a greater influence on traction and initial hydroplaning speed than either tire inflation pressure or positive water depth. Many States require a minimum pattern depth of 1.5 mm (0.06 in) for wet-pavement travel.

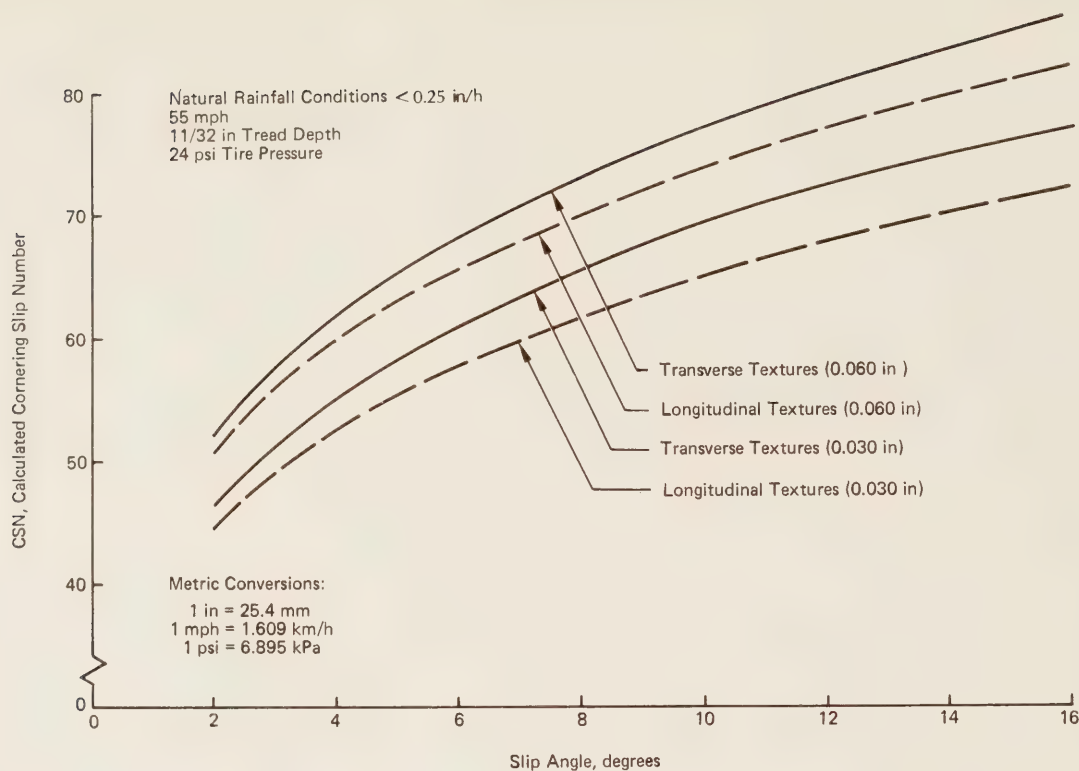
Figure 4.—Cornering slip number versus slip angle.

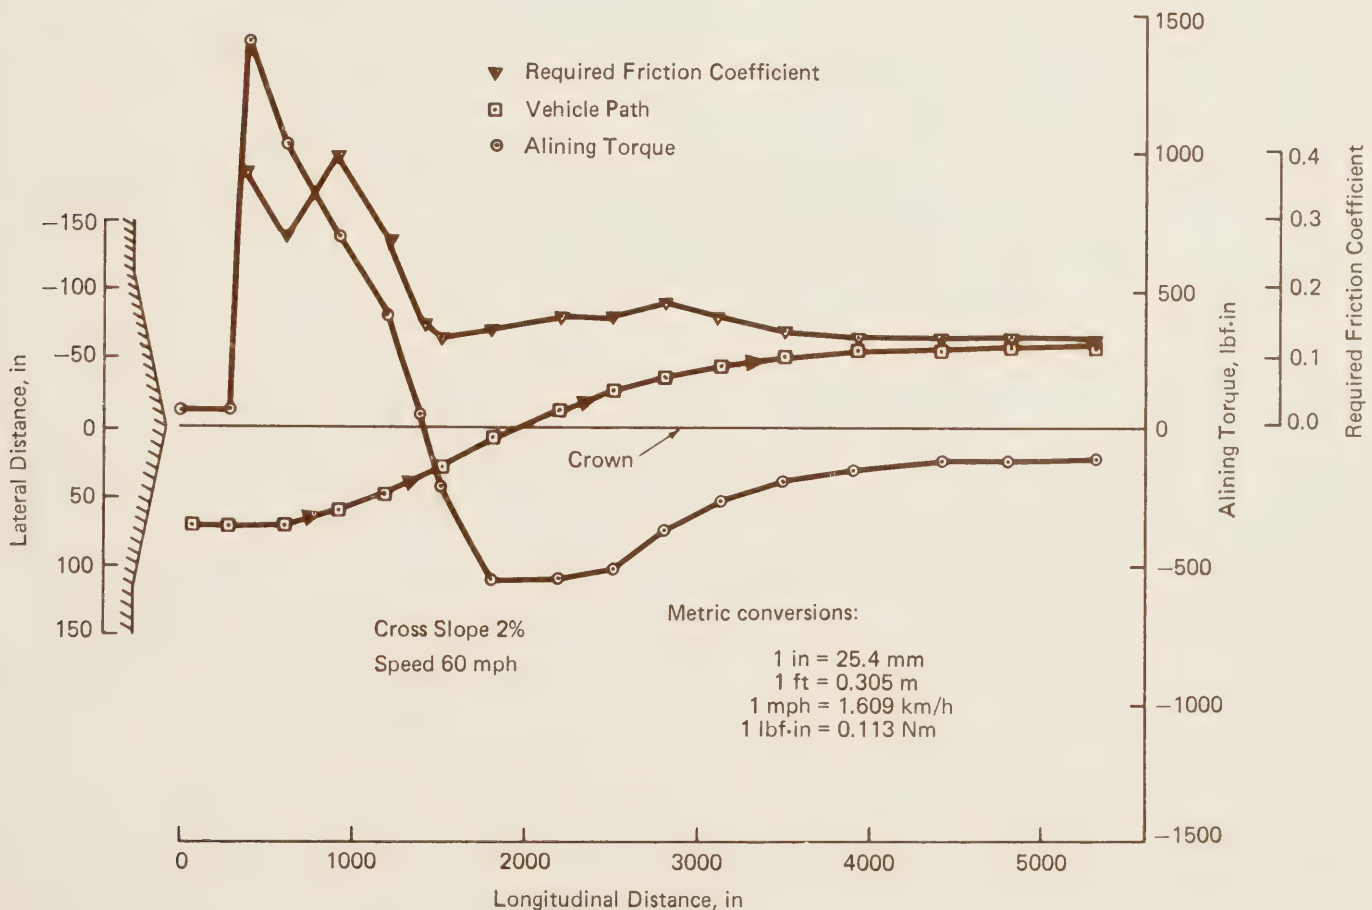
Figure 5.—Lane change, torque, and friction requirements. (1)

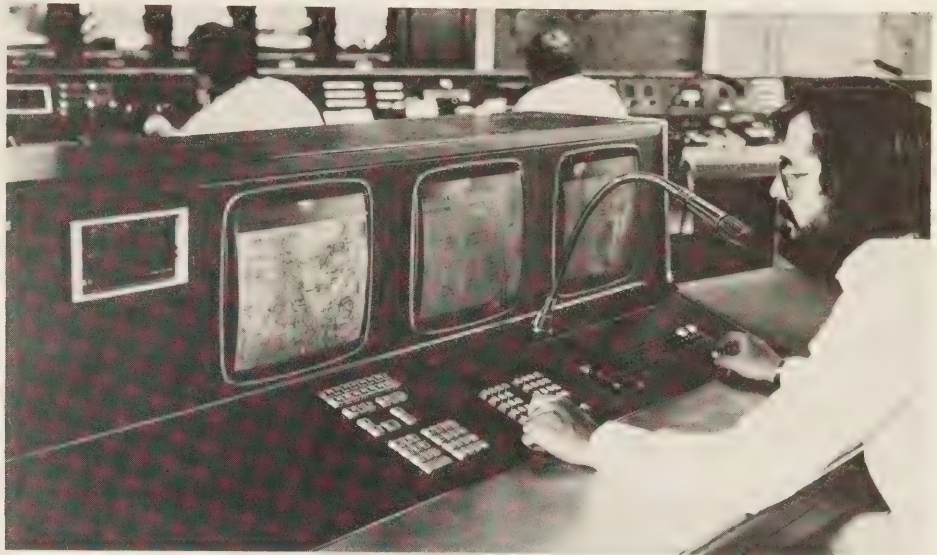
Figure 2.—ANF operating and control desk at EMS communications center.

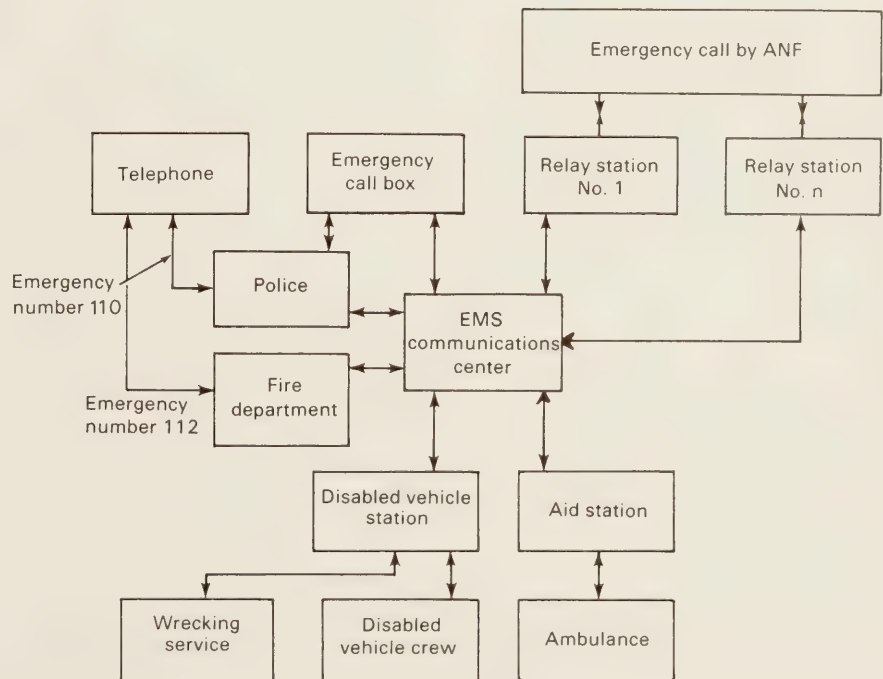
Figure 3.—ANF integrated into existing emergency call system.

Figure 3 shows the integration of the ANF into the existing emergency call system and figure 4 displays the ANF network.

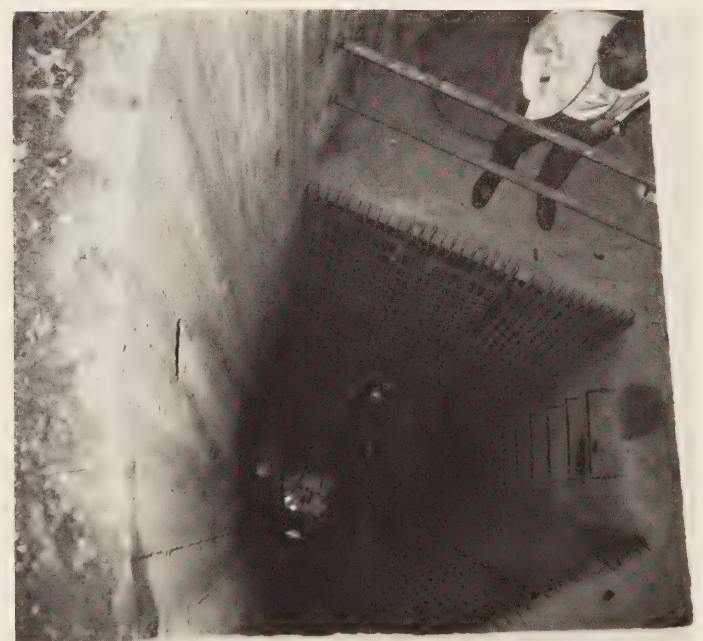
Figure 3.—Caisson-type wet-pit station.

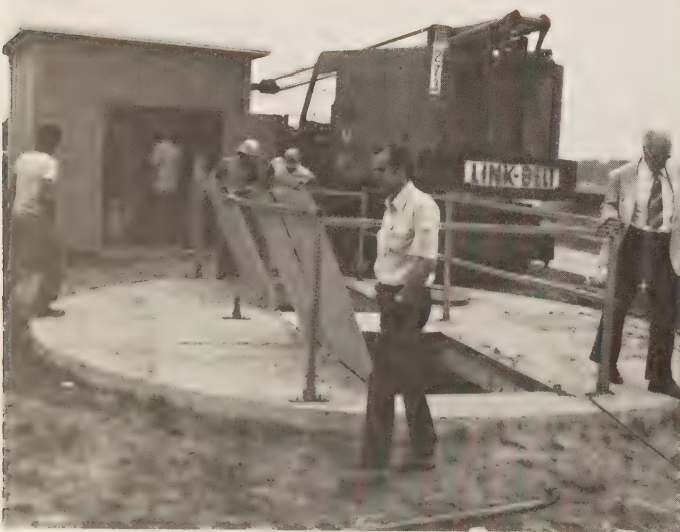
Figure 5.—Caisson for submersible pumps.

Five submersible pumps are housed about 9 m (30 ft) below the level shown in figure 5. Each submersible

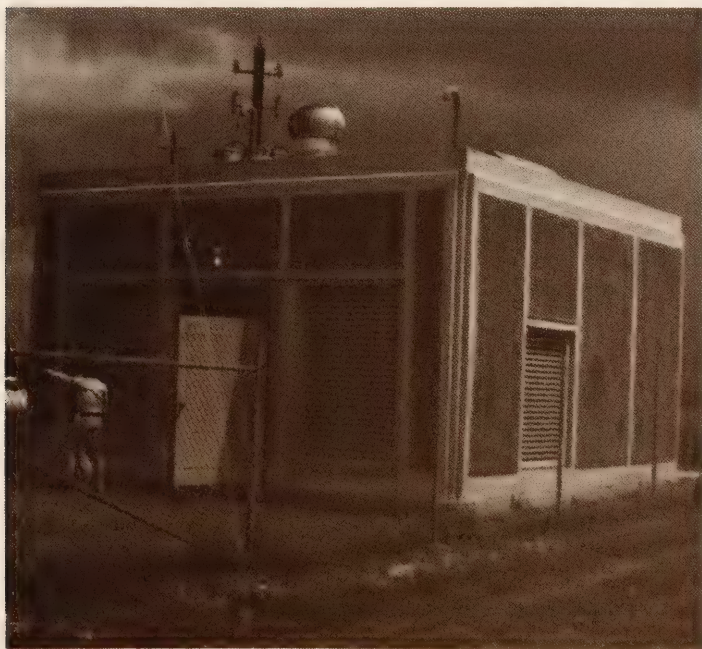
Figure 8.—Texas standard wet-pit station.

Heavy, stationary gas engines drive the pumps. Figure 6 shows a standard design developed by Texas in which a combination drive is used. The engine in figure 7 drives a vertical pump through a right-angle gear drive. An electric motor is mounted above the gear head so that either the engine or the motor can drive the pump, according to which is engaged. This increases reliability by eliminating problems caused by electrical power failure. Figure 8 shows the exterior of

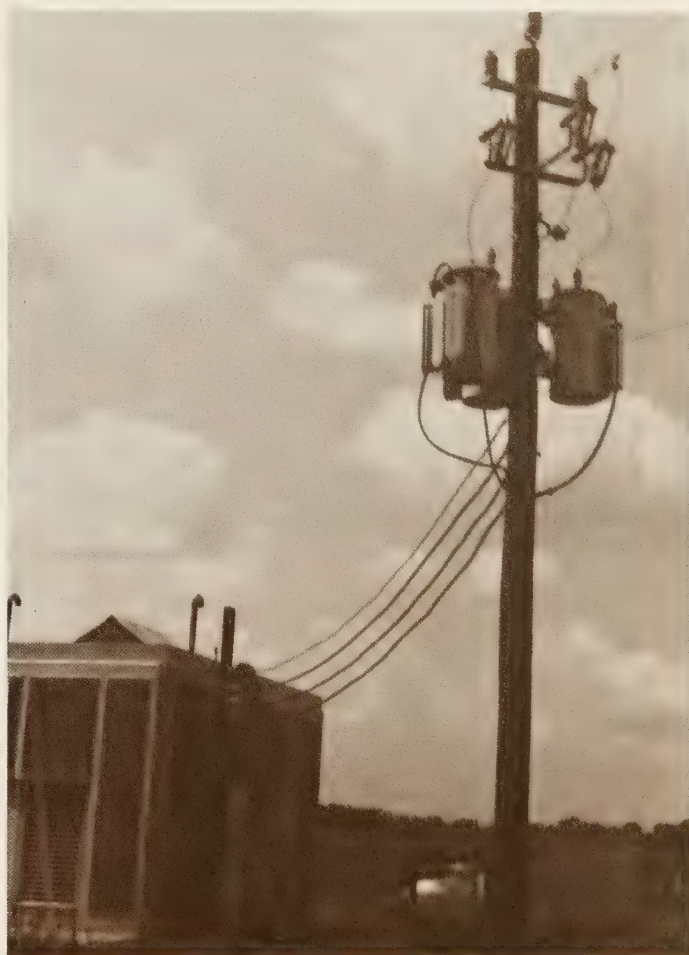
Figure 9.—Power supply to Texas station.

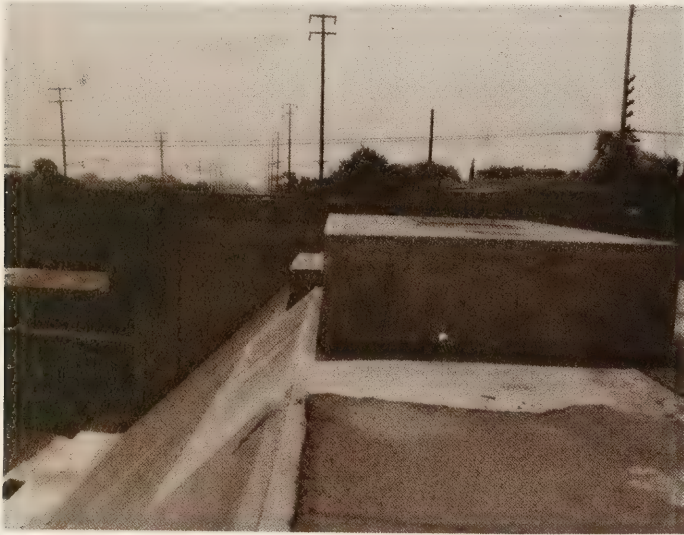
Figure 10.—Wet-pit station retrofitted to dry-pit.

Many agencies have one or more existing pump stations that perform inadequately or present a maintenance problem. Recognizing this situation, the manual gives some examples of how existing stations have been modified to upgrade performance. Water flow and hydraulic conditions may be improved by structural changes, particularly in rectangular wet-pits with vertical pumps. In other cases, replacing existing pumps with different kinds of pumps improves the station. Figure 10 shows a retrofitting where an existing wet-pit station serving a railroad underpass was converted to a dry-pit station with horizontal centrifugal pumps.
