Report No. KTRAN: KSU-02-3
FINAL REPORT

**EVALUATING FIBER REINFORCED POLYMER REPAIR
METHOD FOR CRACKED PRESTRESSED CONCRETE
BRIDGE MEMBERS SUBJECTED TO REPEATED
LOADINGS PHASE 2**

Kansas State University

May 2007

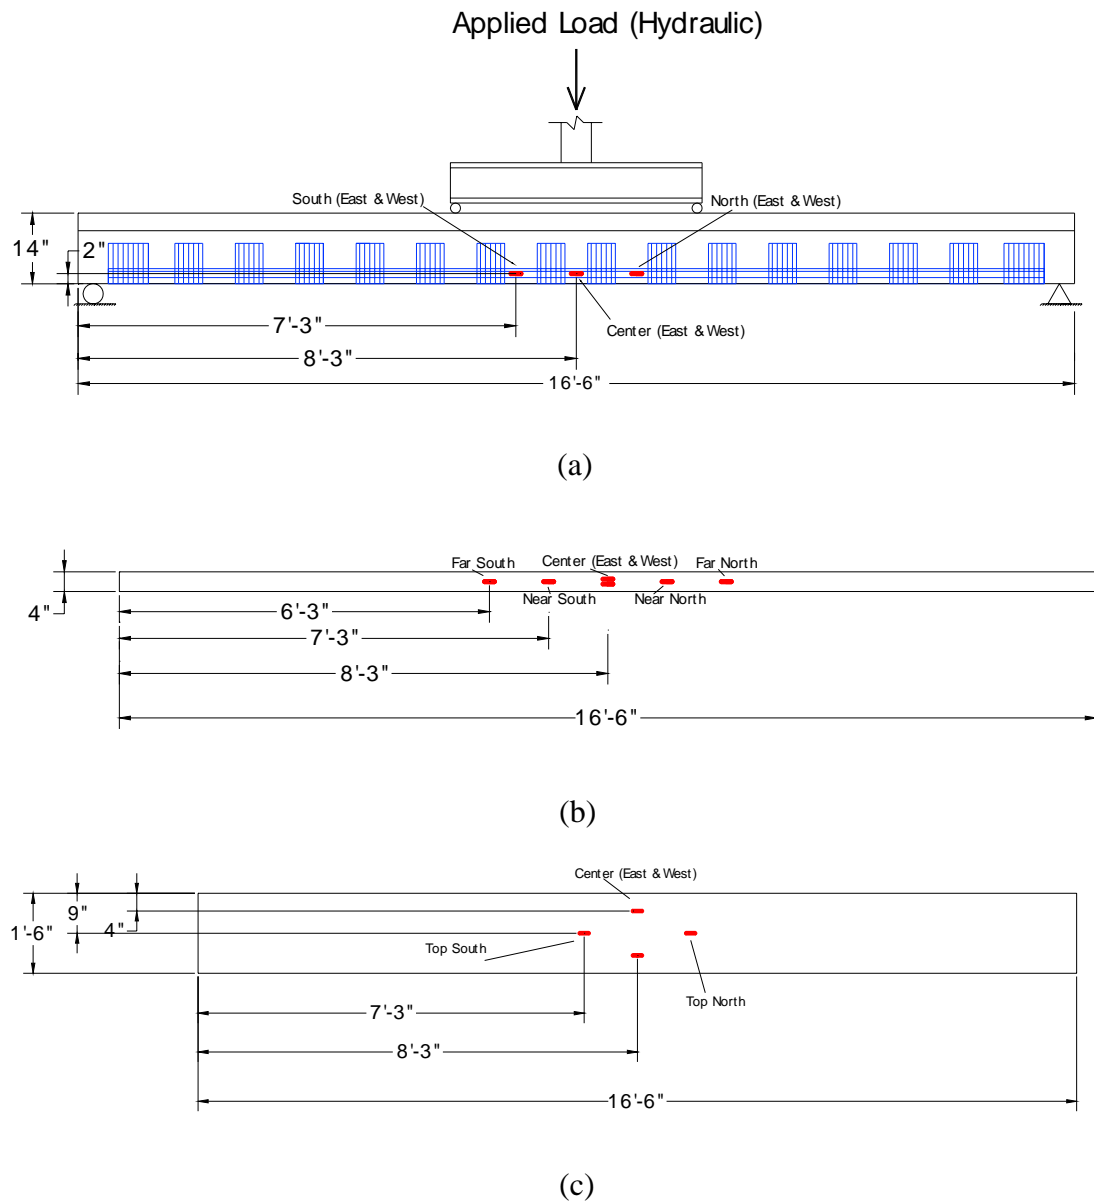
FIGURE 3.5. (a) Gage location for web side (b) Gage location for top flange (c) Gage location for web bottom, Note: Beam 2 had gages on stirrups while it did not have any gages on web side FRP (2" up) in longitudinal direction.

rate of 500 lb/min was used. When the specimens were loaded cyclically, a frequency of 3 Hz was used to vary the load between the upper and lower load limits. Mid-span deflection was measured using two Linear Variable Displacement Transducers (LVDTs) mounted on either side of the flange. The average reading was typically reported to exclude rigid body twisting, if any. During the precracking stage, the crack width opening at the bottom of the web and 5.75 inches up the web side was also measured with LVDT's, see Figure 3.4. Electrical resistance strain gages were placed on top of the flange in the constant moment region, on the bottom side of the web (applied directly to the CFRP, when applicable), at the level of the strand (applied to the CFRP), on the transverse CFRP, and directly on the prestressing strand for one specimen to record strain values during loading. The specific locations of strain gages are shown for all specimens on the strain gage map, Figure 3.5.

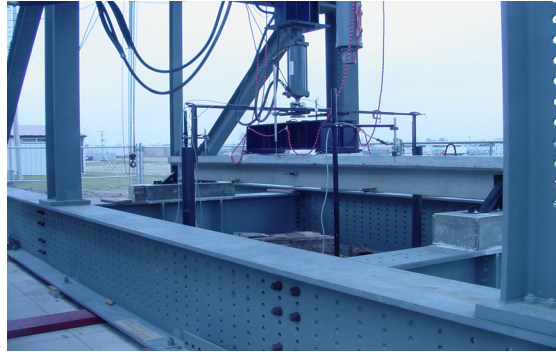
FIGURE 3.6. Beam in test frame.

mid-span crack to be clearly visible. Twenty-five additional loading cycles were then applied to identify the crack opening load and to back calculate the existing prestressing force. Beam 1 was loaded to failure at this point and was used as a control specimen for all the strengthened beams. The beams were loaded using the 500-kip capacity Havens Steel test frame and all remaining testing was done there, Figure 3.6.

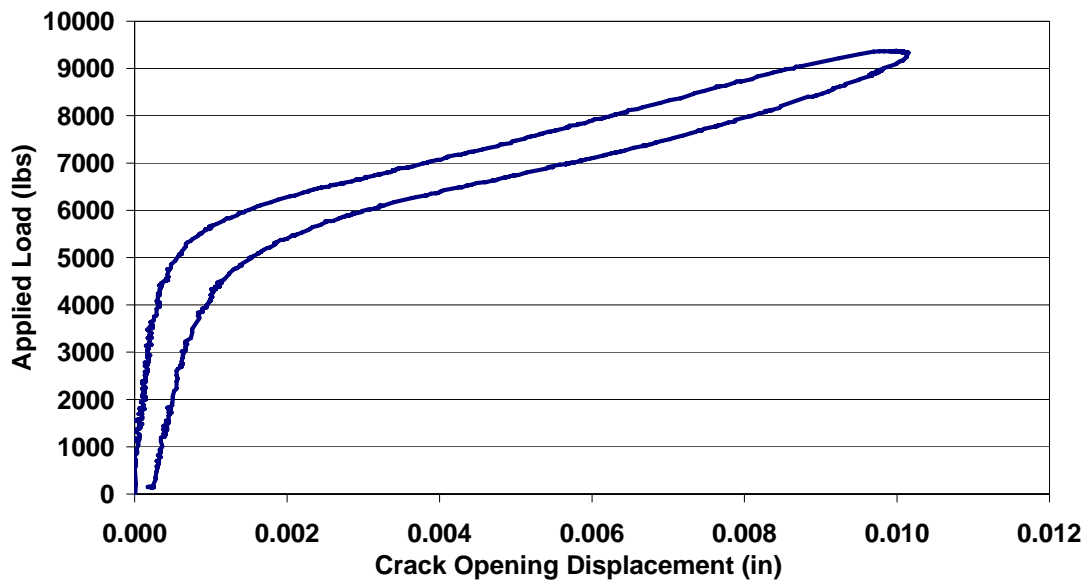
FIGURE 5.1. Crack opening response at web bottom mid-span for control beam.

The point at which the linearity ends is found to be 4.28 kips. This corresponds

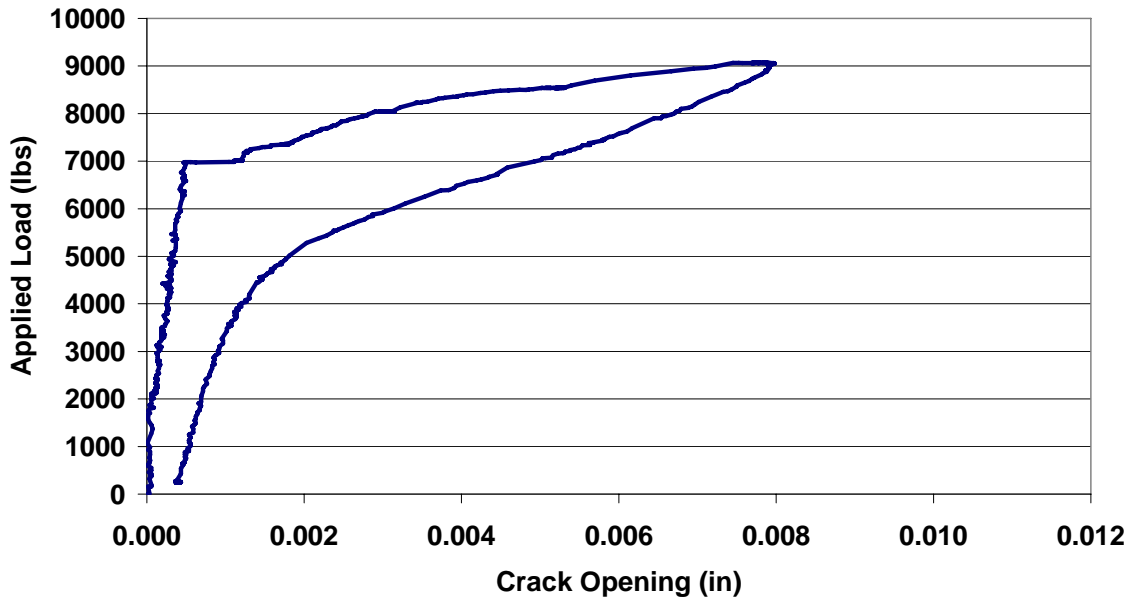
FIGURE 5.3. Load-crack opening for the 1st cycle used to determine f_r .

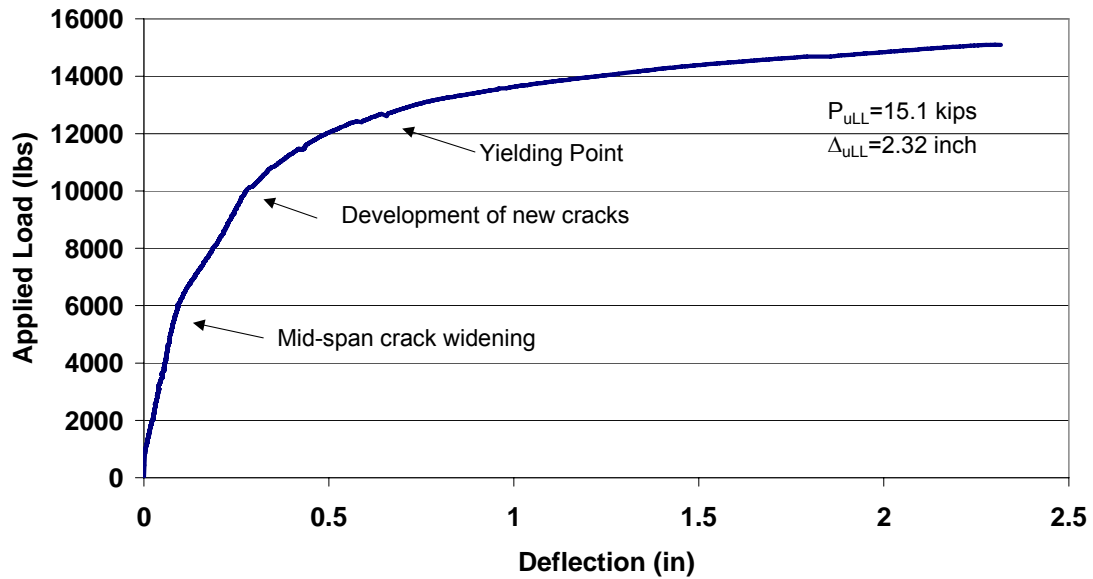
FIGURE 5.5. Load-deflection curve for control beam.

This beam was loaded just past its cracking moment at the mid-span crack former so that the cracking load can be used to determine the actual prestressing force, as described above in, sections 3.4 and 5.1. This pre-cracking was also important to establish a similarity in the specimen condition with the decommissioned girders tested under phase I of this project. The control beam will serve as a baseline for all the strengthened beams. Figure 5.5 shows the load-deflection plot of the control beam. This deflection data was recorded at mid-span and the plotted curve reflects the average deflection of the two top flange LVDT measurements.

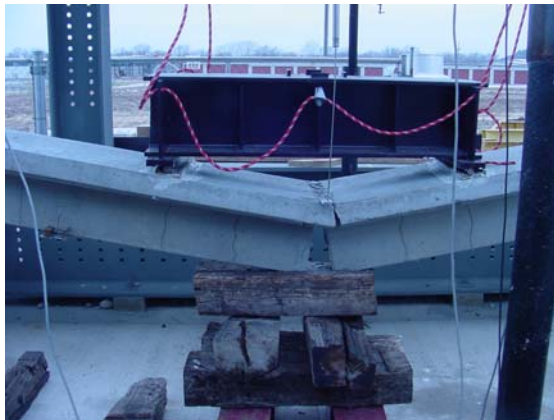
FIGURE 5.6. Failure configuration of control beam.

The ultimate failure load for the control beam was 15.1 kips with a maximum deflection of 2.32 inches including the effect of the spreader beam. The beam failed due to the rupture of the prestressing strand, Figure 5.6.

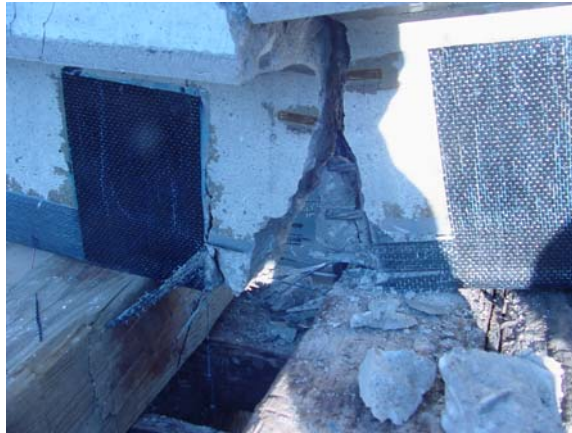
FIGURE 5.8. CFRP rupture of Beam 2.

The beam failed by CFRP rupture at a load of 25.7 kips with a deflection of 3.45 inches including the weight of the spreader beam. The FRP ruptured at a maximum average strain of 14,730 microstrain at mid-span, Figures 5.8 and 5.9. This is in excellent agreement with the coupon testing value found to be 14,000 microstrain.

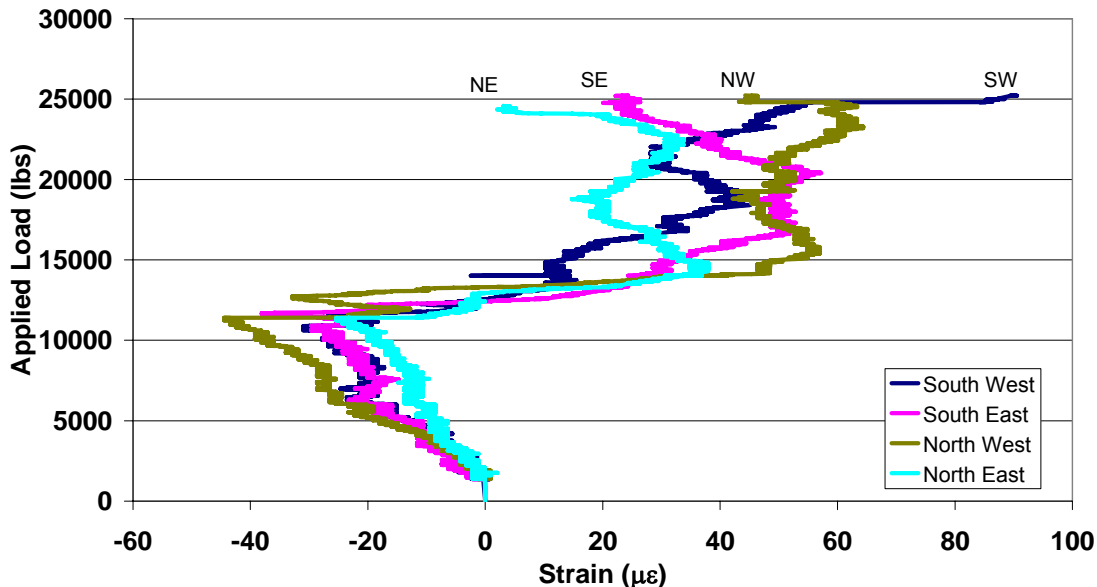
FIGURE 5.11. Load-transverse strain readings for stirrups of Beam 2.

verify that the CFRP allowable design strain for the stirrups ($3000 \mu\epsilon$) is conservative. The largest change in strain for any of the four stirrups was around 100 microstrain. Accordingly, the remaining beams did not have any gages placed on their stirrups.

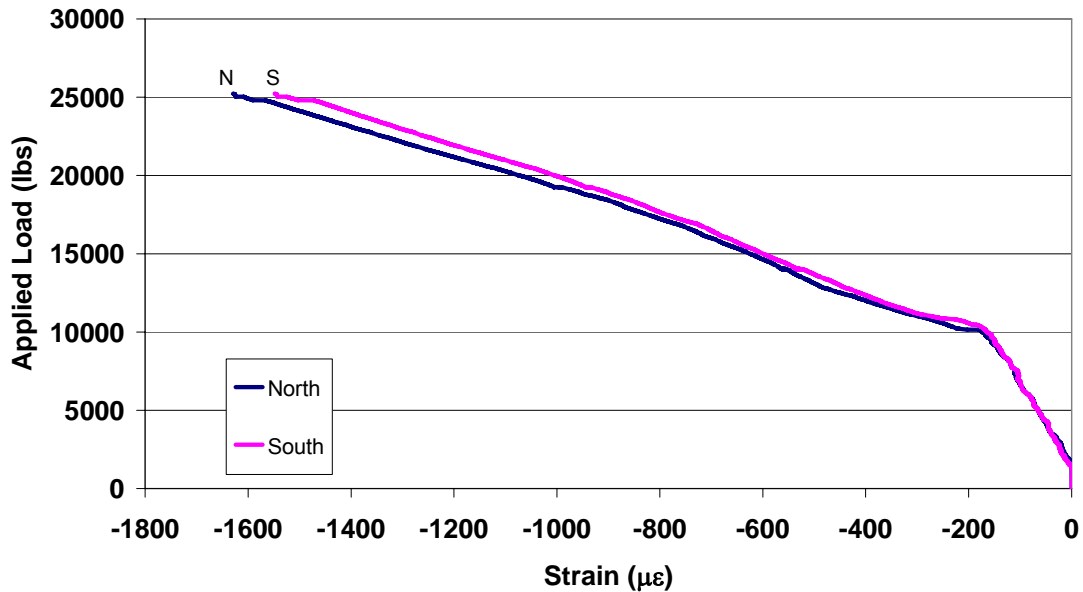
FIGURE 5.12. Load-strain response for top concrete in compression at mid-span.

Finally, gages were also put down on the top flange in the constant moment region to record the strains of the extreme compression concrete fiber during the loading process, Figure 5.12. The largest measured strain values for the concrete in compression were around 1600 microstrain upon CFRP rupture, which are noticeable lower than that corresponding to f'_c (0.002). It must be noted for both beams strengthened for the 18 ksi stress range (Beam 2 and 3) that a 2" wide piece of duct tape was placed over the crack at mid-span. This was done to create an unbonded region between the CFRP and the concrete at the strain gage location to avoid recording highly localized unsmoothed measurements. Accordingly, it is further evident that the prestressing strand slips beyond this region and it requires more than 1 inch on either side of the crack face to develop its' tensile force of the constant moment region.

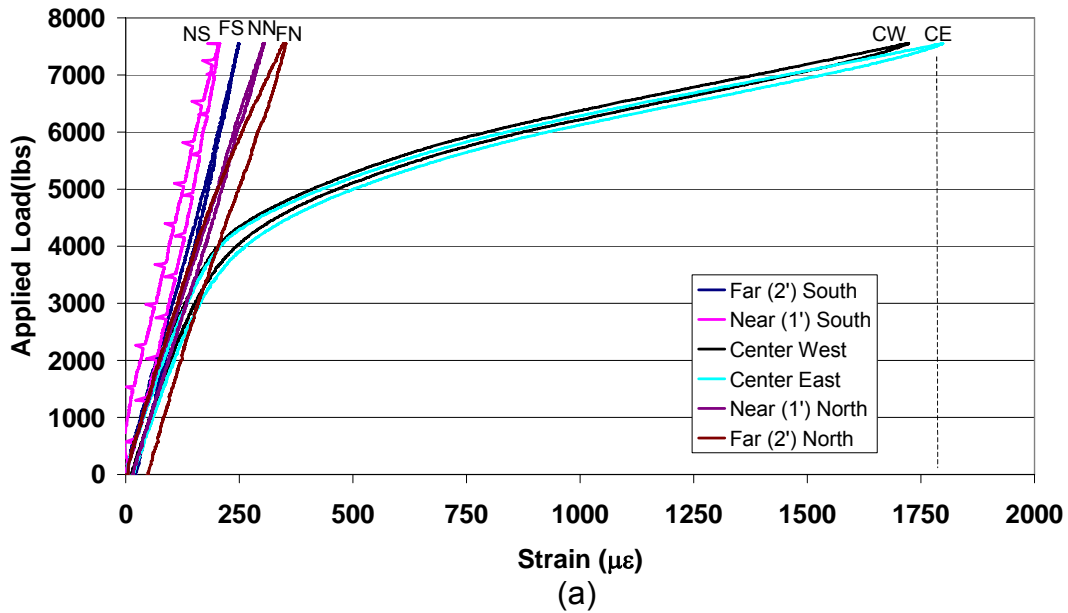
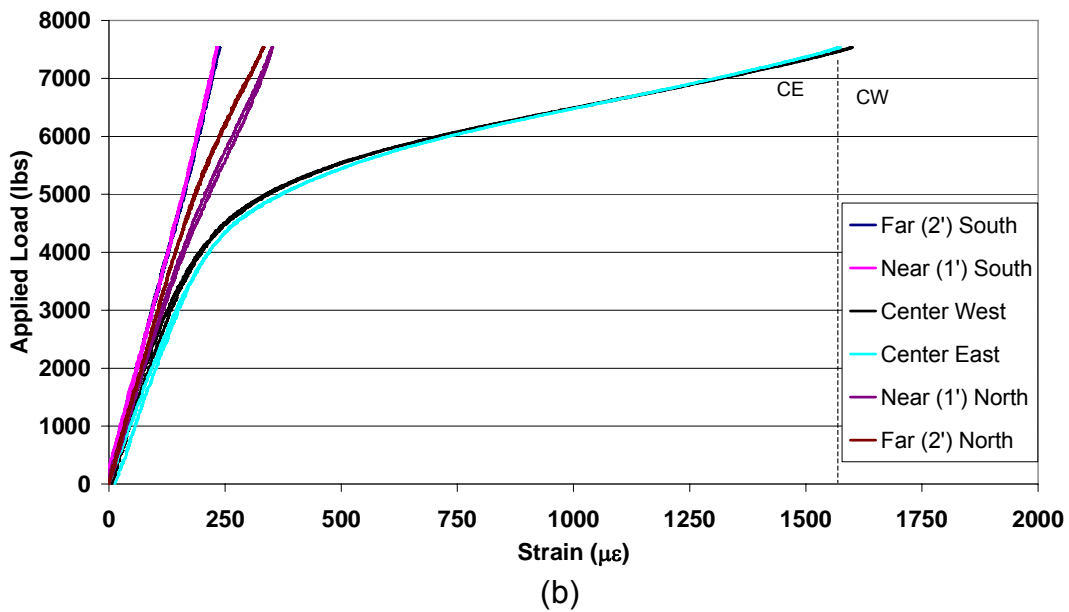
FIGURE 5.14. Load-CFRP strain response at bottom of web (a) At 0 cycles. (b) At 700,000 cycles.

recorded at mid-span since they were not in the same proximity to flexural cracks, Figure 5.14a-b.

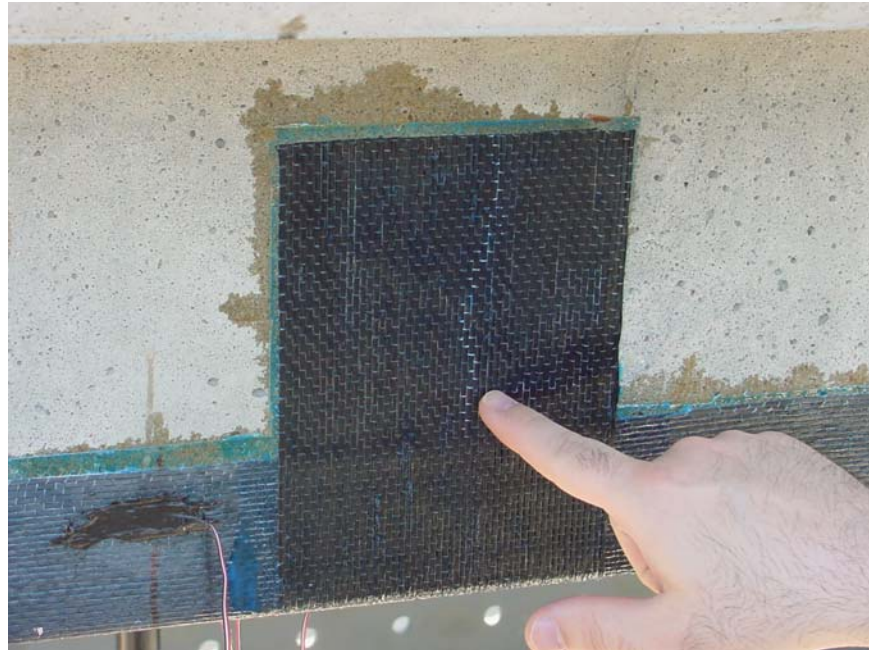
FIGURE 5.29. Existence of concrete flexural cracks in the constant moment region behind the external stirrups that developed during cycling.

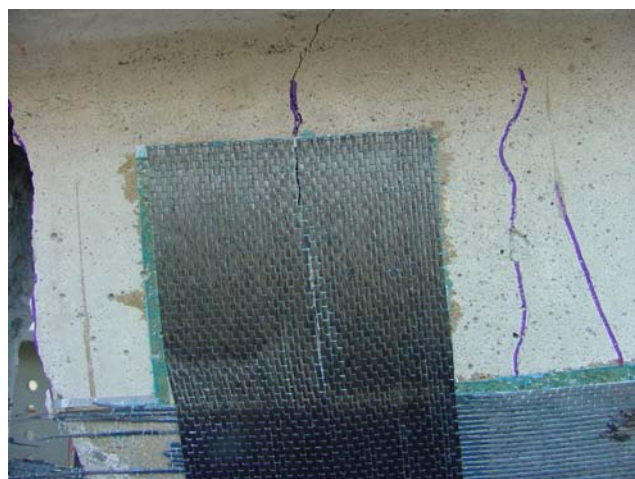
FIGURE 5.37. Flexural cracks held together by stirrups at failure

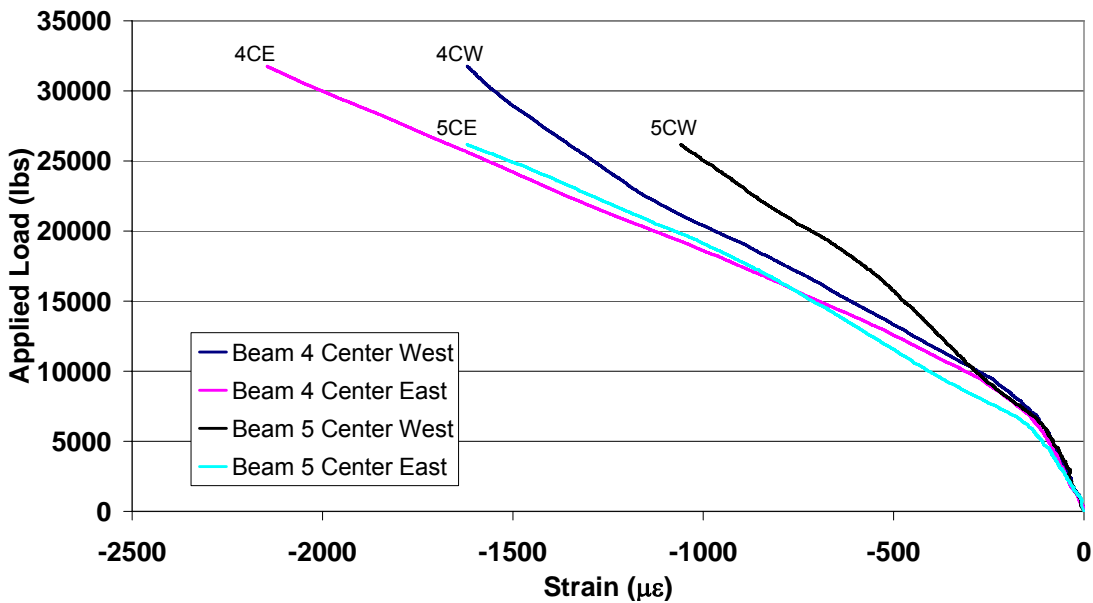
FIGURE 5.48. Top concrete load-strain for Beams 4 and 5.

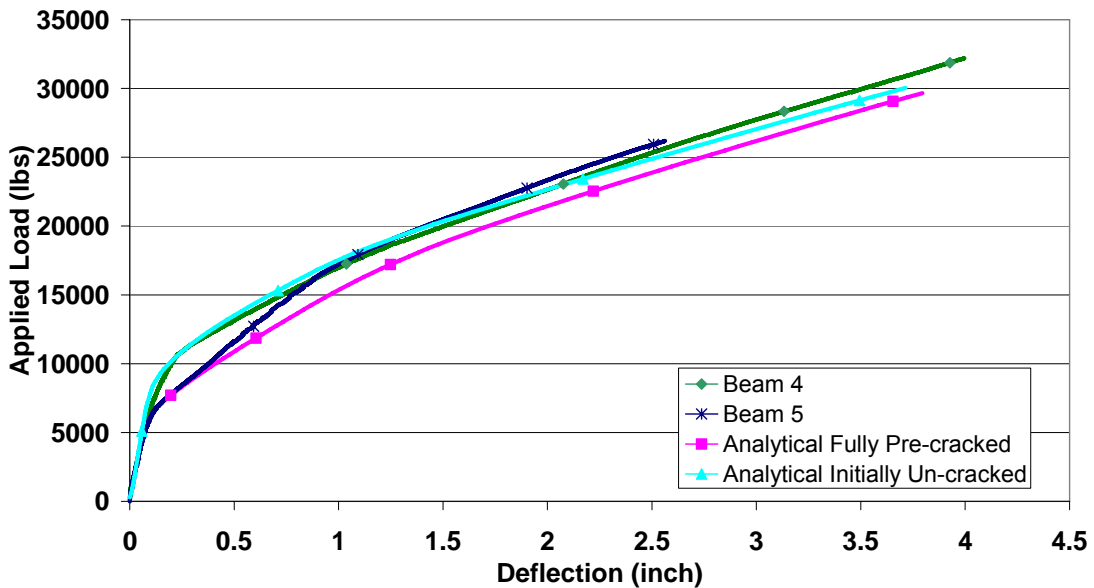
FIGURE 5.51. Analytical against experimental load-deflection results of Beams 4 and 5.

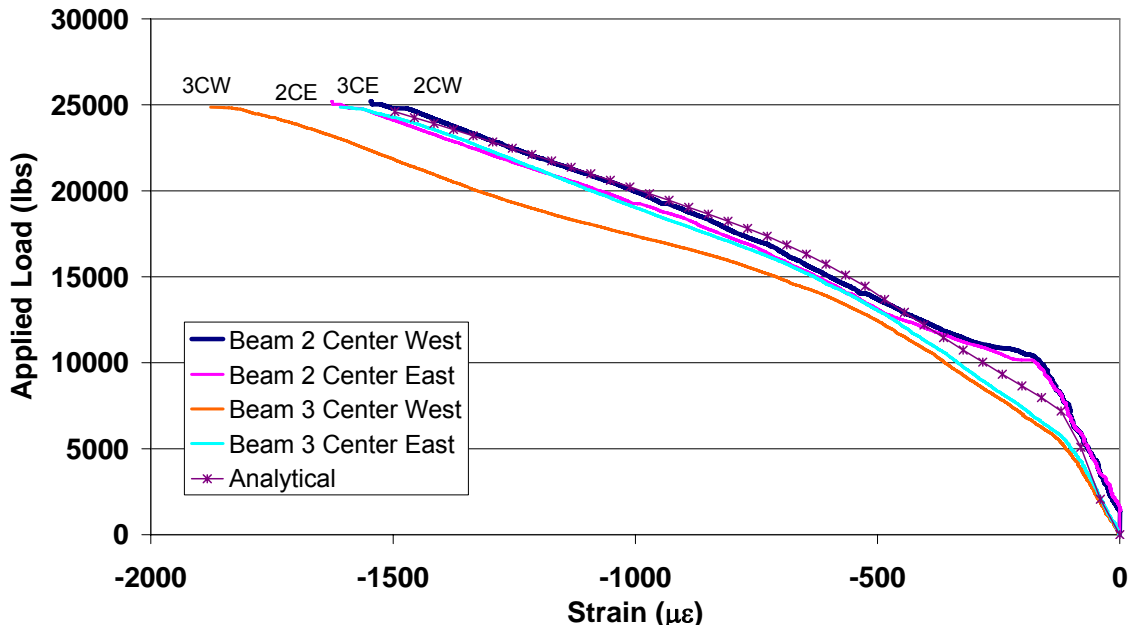
FIGURE 5.53. Analytical vs. experimental compression strains for Beams 2 and 3 (Top concrete).
