**National Highway
Traffic Safety
Administration**

DOT HS 813 212

January 2022

WorldSID 50th Percentile Male Durability Assessment

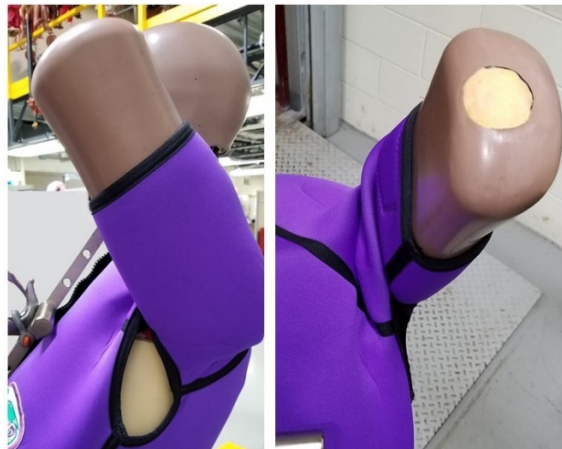
The original skinsuit included sleeves for the arms and contained a sizeable hole under the arm to facilitate arm motion (Figure 5.1). In this configuration, the sleeve fabric could bunch together during shoulder flexion and the hole provided a path for external light to enter the thoracic cavity, potentially interfering with the RibEye functionality. Therefore, a sleeveless skinsuit design was adopted (Figure 5.2). The sleeveless suit provides improved freedom of arm motion without bunching and eliminates the potential light path under the arm.

Figure 5.1. Suit With Sleeves

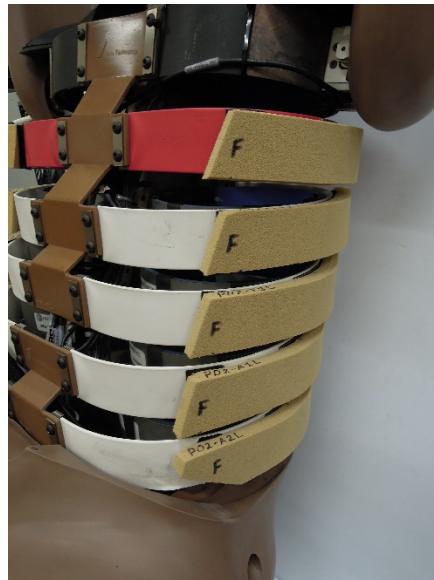
As discussed in Section 4.2, tears were observed in the one-piece thorax pad during the Phase 1 abdomen impacts. As a result of these observations, as well as similar observations made across the safety community, a split-pad system was implemented. The split-pad system eliminates foam padding in the areas between the ribs and also eliminates holes needed to secure the one-piece pad to the ribs. Figure 5.3 illustrates the split thorax pad system.

Figure 5.3. Split Thorax Pad System

As a result of Phase 1 tests and observations, several design revisions were implemented. The sleeveless suit, revised shoulder pad, and split thorax pad all proved to be durable and functioned as intended. With regard to rib delamination that was observed, process improvements have been identified and implemented at the dummy manufacturer to address rib damping material delamination and Phase 2 testing with updated ribs did not generate any observed rib delamination.

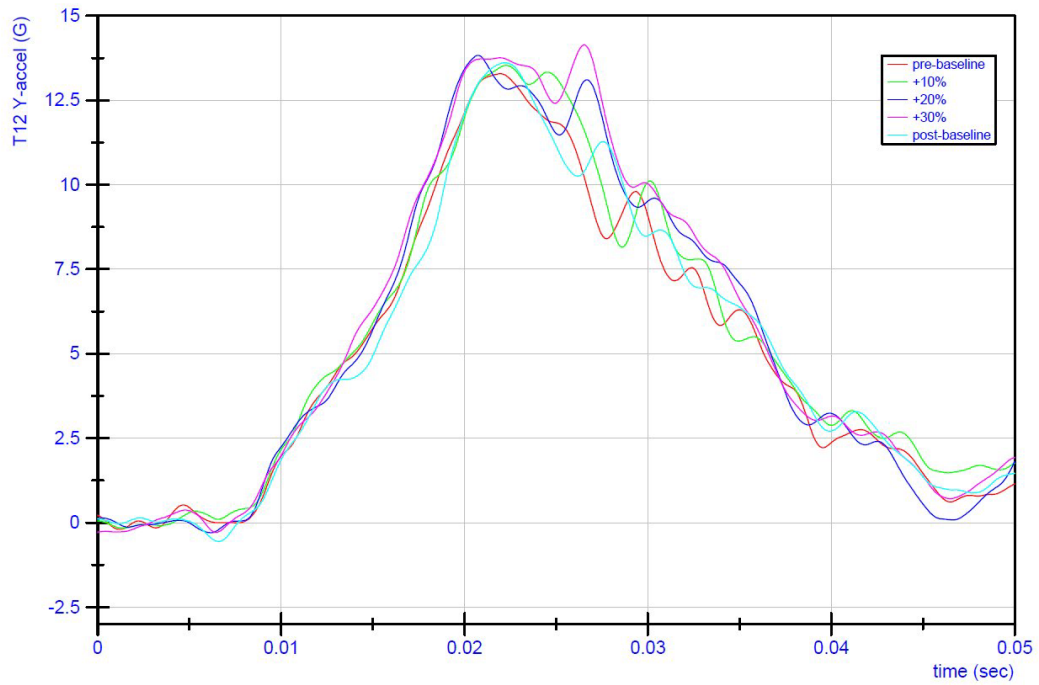
Figure A-1. Pelvis Impact - Probe Force

Figure A-2. Pelvis Impact - Lateral Pelvis Acceleration

Figure A-3. Pelvis Impact - T12 Lateral Acceleration

The 2016 qualification response corridors and durability test results for the pelvis impact tests are summarized in Table 4.2. Time-history plots of the criterion channels can be found in Appendix A.

Responses for the baseline tests conducted before and after the elevated energy impacts were within the 2016 specification requirements. Pre- and post-test inspections revealed no apparent damage to the pelvis assembly.

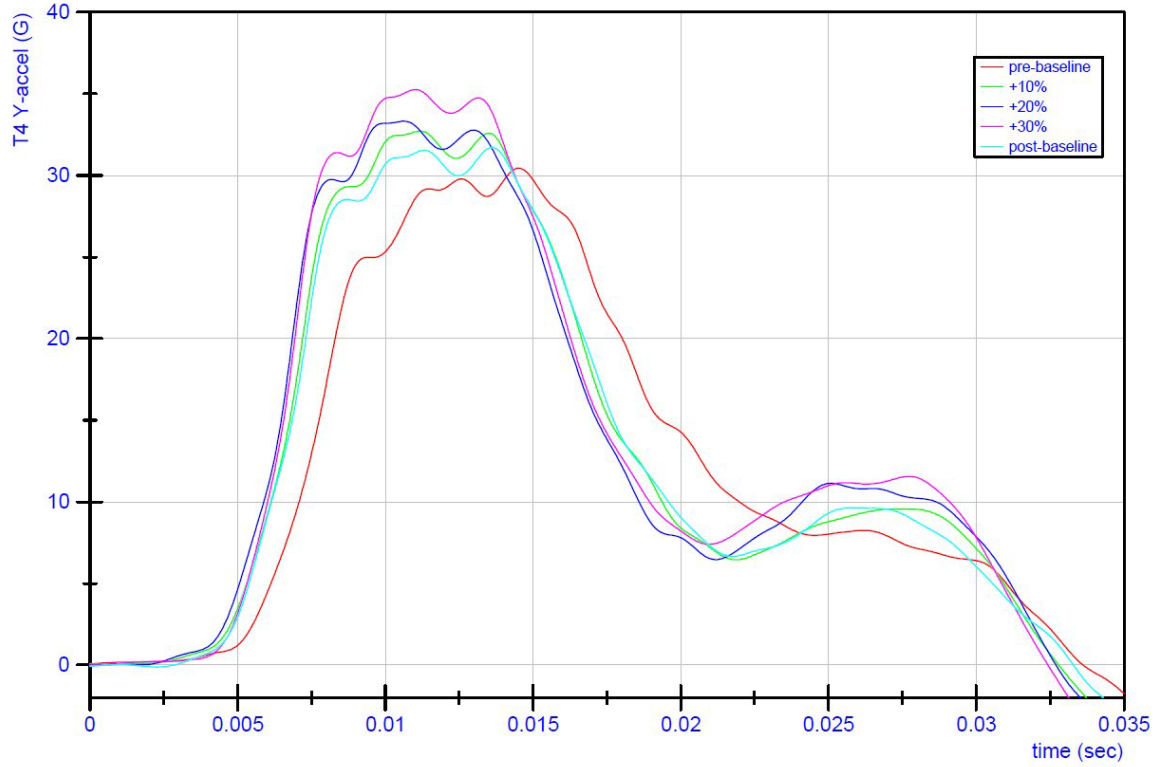
Figure D-1. Thorax With Arm Impact – Probe Force

Figure D-2. Thorax With Arm Impact – T4 Lateral Acceleration

Figure D-3. Thorax With Arm Impact – T12 Lateral Acceleration

Figure D-4. Thorax With Arm Impact – Thorax Rib 1 Length Change

Figure D-5. Thorax With Arm Impact – Thorax Rib 2 Length Change

Figure D-6. Thorax With Arm Impact – Thorax Rib 3 Length Change

The qualification response corridors and durability test results for the thorax with arm impact tests are summarized in Table 4.8. Time-history plots of the criterion channels can be found in Appendix D.

Responses for all of the criteria were within the specifications for the baseline test conducted prior to the elevated severity impacts, except for rib 3 deflection. In the baseline test conducted after the elevated severity tests, all criteria were met.

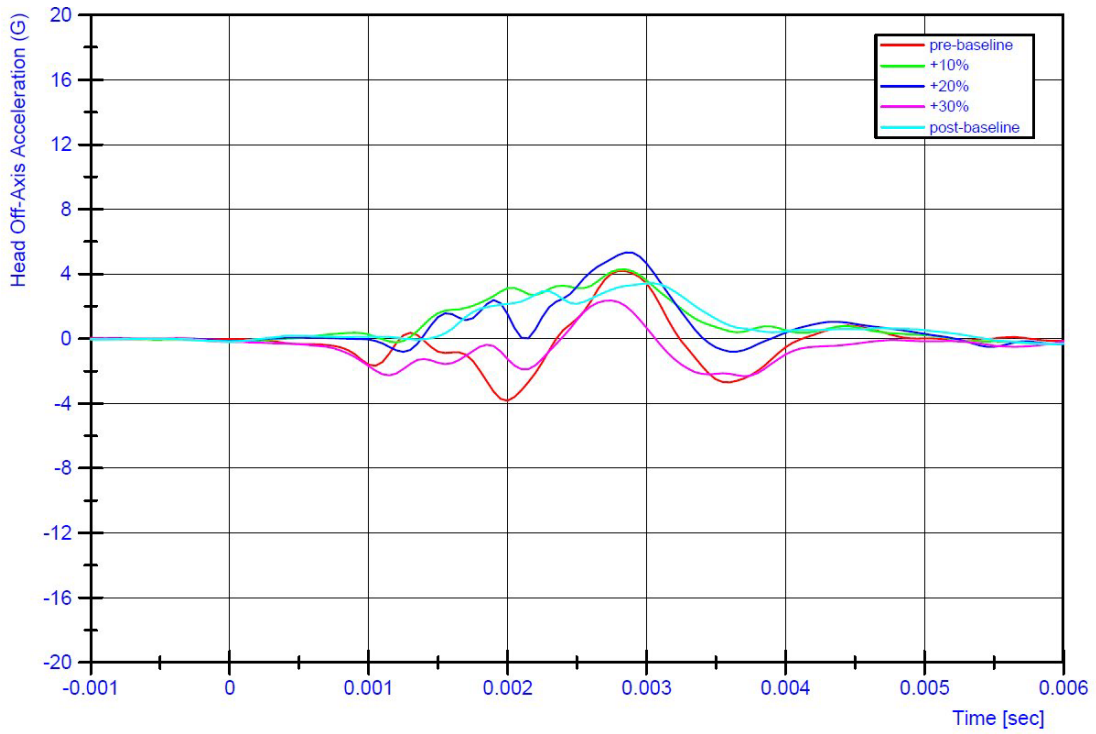
Figure H-1. Lateral Head Drop – Resultant Acceleration

Figure H-2. Lateral Head Drop – Off-axis Acceleration

The qualification response corridors and durability test results are summarized in Table 4.14. Time-history plots of the criterion channels can be found in Appendices G and H.

Responses for all pre- and post-elevated energy impacts were within the specification requirements. Pre- and post-test inspections revealed no obvious damage to the head assembly.

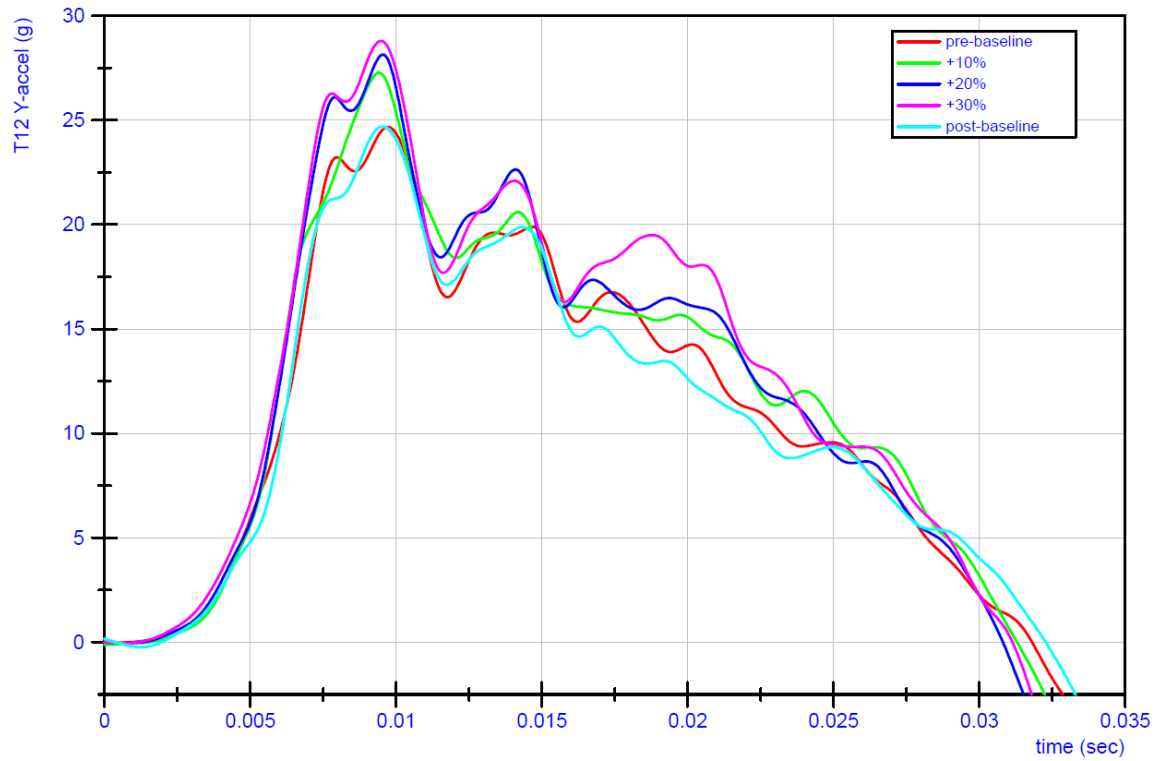
Figure J-1. Thorax With Arm Impact – Probe Force

Figure J-2. Thorax With Arm Impact – T4 Lateral Acceleration

Figure J-3. Thorax With Arm Impact – T12 Lateral Acceleration

Figure J-4. Thorax With Arm Impact – Thorax Rib 1 Length Change

Figure J-5. Thorax With Arm Impact - Thorax Rib 2 Length Change

Figure J-6. Thorax With Arm Impact - Thorax Rib 3 Length Change

The qualification response corridors and durability test results of the thorax with arm impact tests are summarized in Table 5.2. Time-history plots of the criterion channels can be found in Appendix J.

All responses for the pre- and post-elevated energy tests were all within the specification requirements. Post-test inspections revealed no additional damage.
