EVALUATION OF SELF CONSOLIDATING CONCRETE AND CLASS IV CONCRETE FLOW IN DRILLED SHAFTS

BDV25-977-25

FINAL REPORT

January 2020

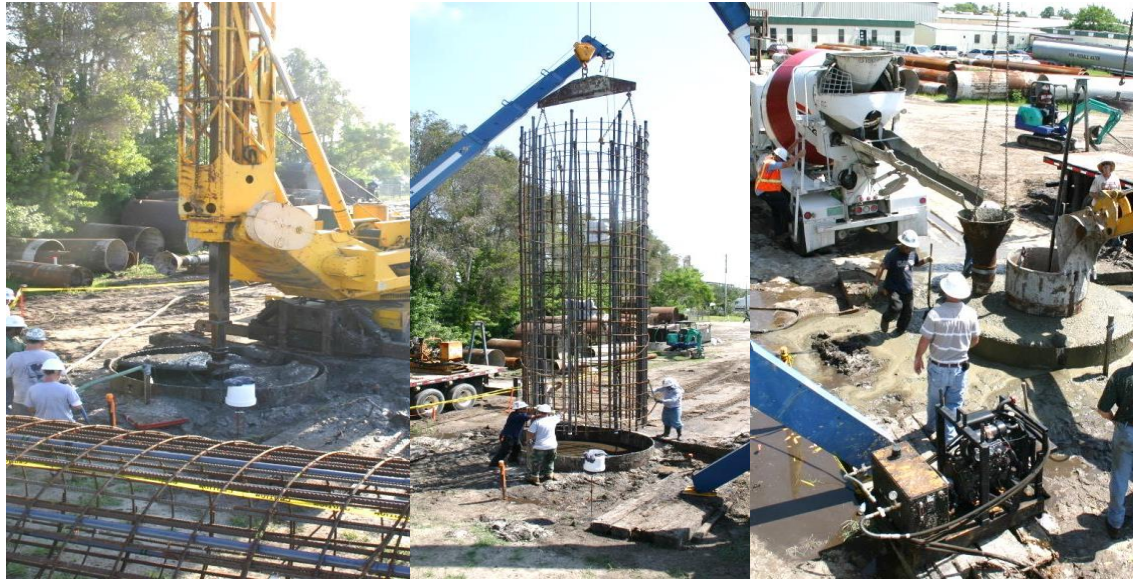
Figure 1.1 Shaft construction: excavation (left), cage placement (center) and concreting (right)

Drilled shafts are cylindrical, cast-in-place concrete, deep foundation elements that may be selected over driven piles on the basis of cost effectiveness, the soil strata encountered, or the need to control vibrations due to sensitive surroundings. In general, the process of constructing shafts involves the drilled excavation of soil or rock using large diameter augers to form a deep cylindrical void space. Within the excavation, placement of the necessary reinforcing steel is followed by concreting (Figure 1.1).

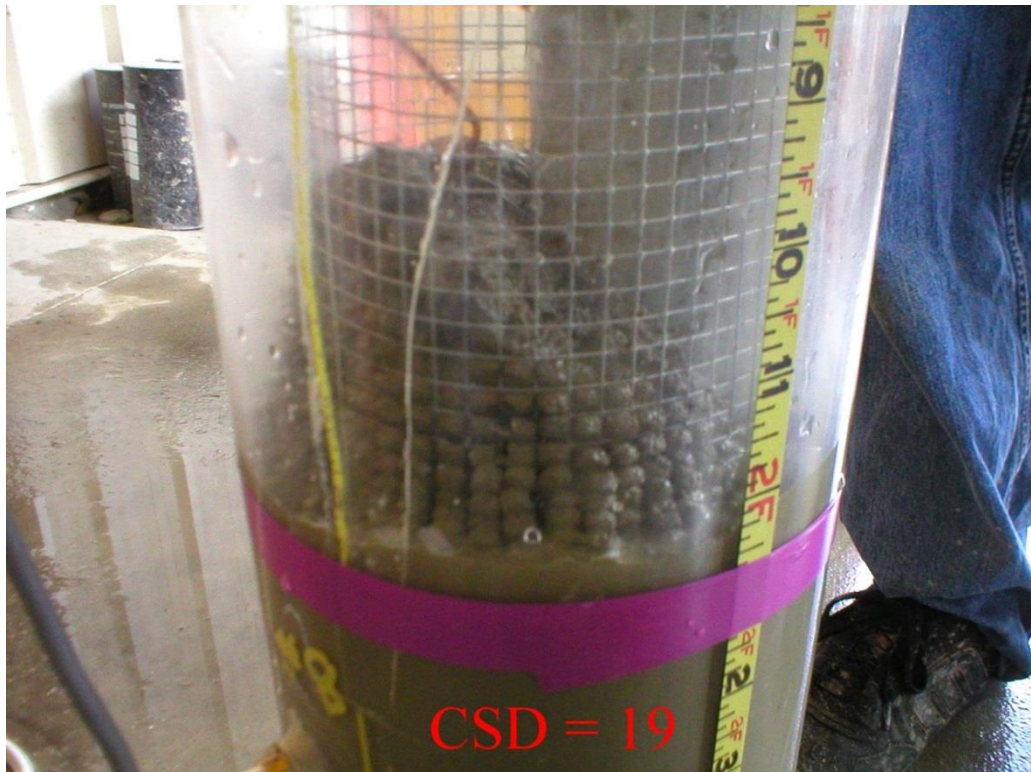
Figure 1.4 Laboratory tests with small-diameter aggregate and tight reinforcement (CSD = 19).

Small-scale lab specimens (Figure 1.4) showed concrete flows up beside the tremie in the remaining unobstructed portion of the cage. This was also observed in the field by weighted tape measurements taken from inside and outside the cage. For smaller-diameter shafts where the tremie diameter may occupy a large fraction of the interior cage region/volume, the differential may be even more drastic given a substantial increase in the upward concrete velocity from a standard concrete truck placement rate (e.g., 0.5 – 1 yd³/min); smaller diameter shafts are filled more quickly where the rising vertical flow rate of the concrete is significantly higher than larger shafts. Similar to head loss computations in water distribution systems, the concrete head increase was shown to be proportional to the square of velocity (Figure 1.5).

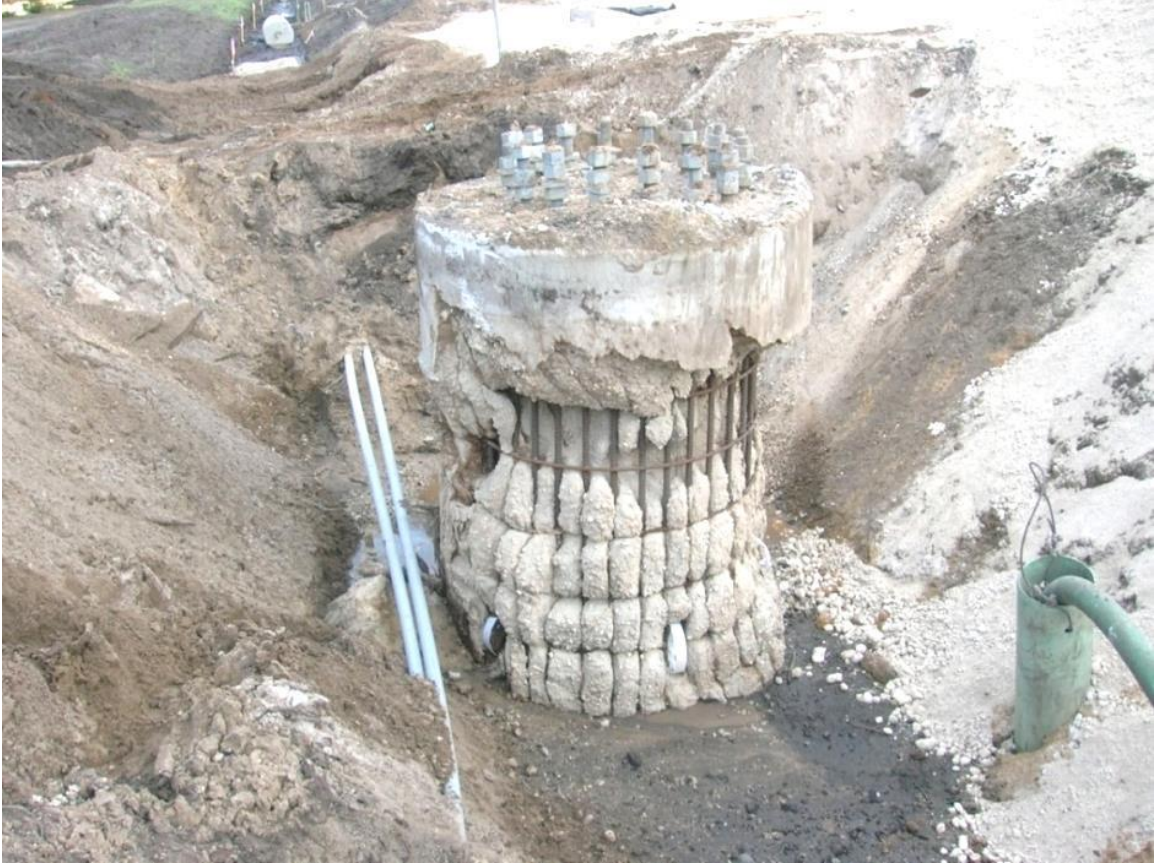
Figure 1.7 Shaft exhumed to show poor concrete flow performance from slurry properties or fresh concrete properties (courtesy of the FDOT State Materials Office).

State and federal specifications have been established to control fresh concrete and slurry properties with the aim of circumventing the potential for problematic shafts. However, despite these efforts (specifications), problems persist. Figure 1.7 shows an example of a shaft that exhibited concrete flow problems, either from fresh concrete or slurry properties. Recent conversations with engineers in the UK indicated that this type of concrete flow (termed there as “quilting” or “mattressing”) has been suspected but never confirmed. This image reinforced their fears. Since then and with this awareness, multiple occurrences have been documented.

The recurring finding of poor concrete flow through drilled shaft cages was the primary motivation for this study. The alarming condition of shafts found like that shown in Figure 1.7 raised the question, *how often does this occur?* This coupled with the findings of previous studies (Figures 1.3-1.6) further confirmed a general lack of understanding pertaining to concrete flow in tremie-placed, slurry displacing conditions. At the onset of this study, SMO/FDOT engineers along with USF researchers discussed the scope of the project and thereby narrowed the focus from *the development of a potentially viable SCC mix for shafts* to the present project, Part 1: an exploratory venture to identify the frequency/probability of poorly-cast underground structures and the effects of poor concrete flow on shaft performance and durability.

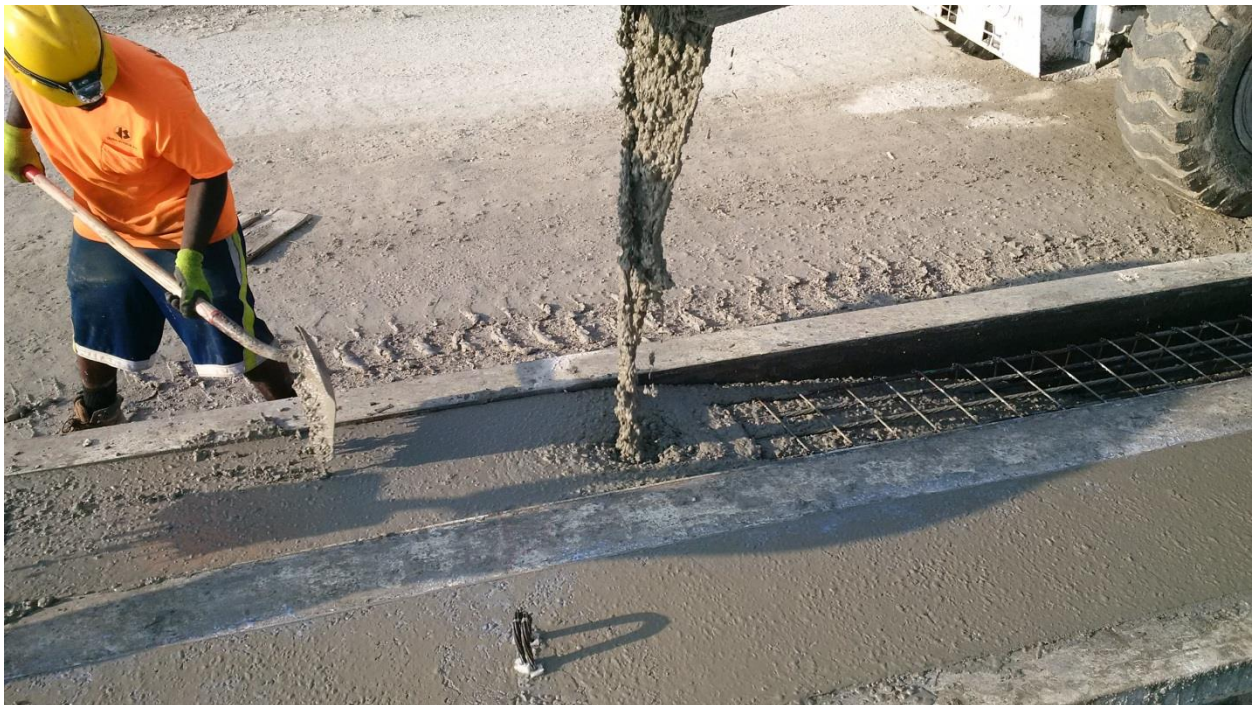
Figure 1.8 SCC used to cast prestressed piles requires almost no finishing as it pours out level.

Self-Consolidating Concrete. Self-consolidating concretes at first inspection seem to be natural candidates for drilled shaft applications as the poor flow that resulted in the Figure 1.7 observation might be alleviated. The first SCC prototypes were developed in the late 1980s (Osama et al, 1989) and hence are relatively new to construction as a whole. SCC is distinguished from conventional concrete by its water-like, free-flowing characteristics, which allow the mixes to flow into forms and around obstacles such as reinforcing steel under only the force of gravity (like shafts with no applied vibration). Recently, SCC concrete has become commonplace in precast yards (Figure 1.8) due to the reduced casting and finishing times.

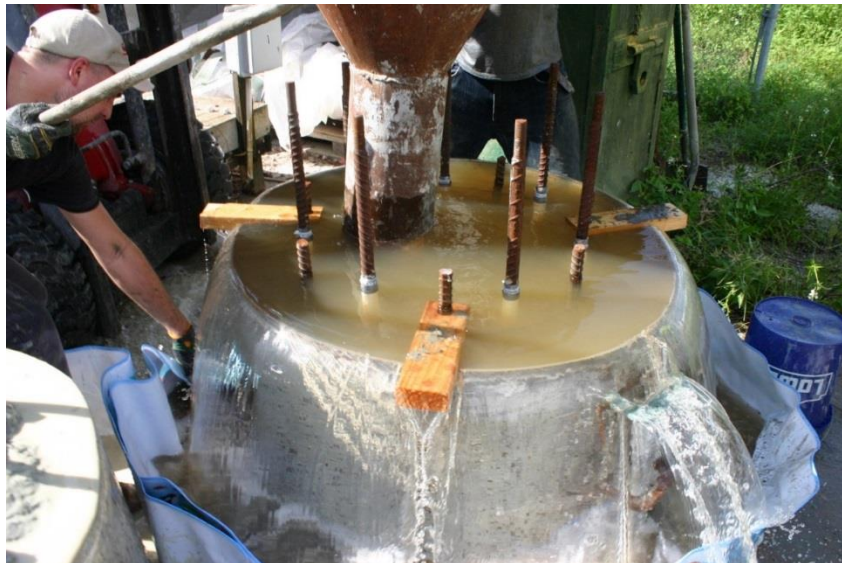
Figure 2.1 Natural slurry (water) exiting the form during concreting.

While not always possible, in some situations water can be used as a drilling fluid (Figure 2.1). The Federal Highway Administration (FHWA) drilled shaft manual recommends the use of water as a drilling fluid when the soil layers being penetrated are permeable, but unable to slough or erode when exposed to water in the borehole. For example a sandstone or cemented sand would work much better in comparison to a loose sand where water would rush in from the bottom faster than it could be pumped in, in turn also loosening the soil at the tip changing the SPT (standard penetration test) blow count. If water is chosen for use, the water level in the excavation must be kept above the piezometric surface so that seepage only occurs from excavation into the formation and not the opposite. (Brown, et al., 2010)

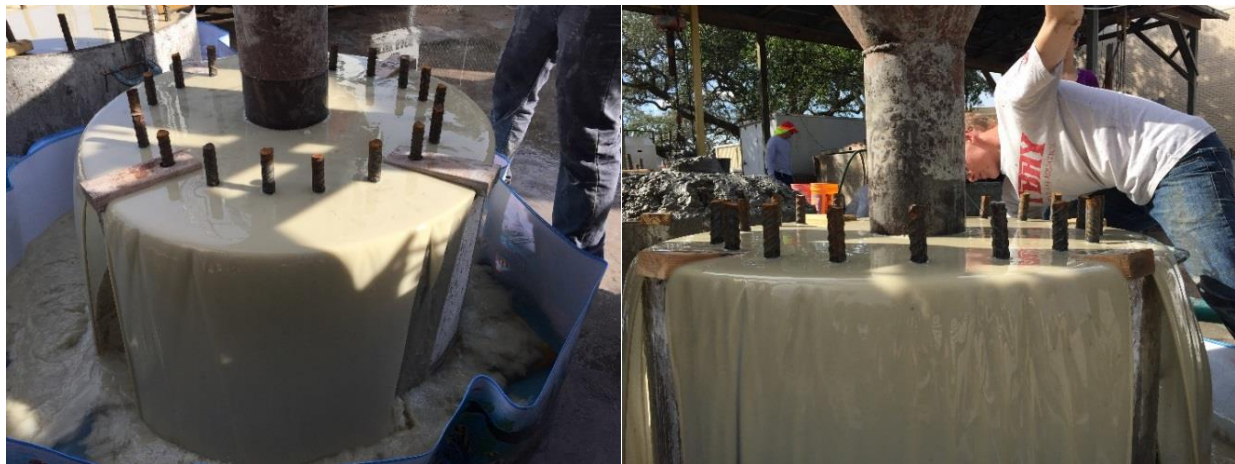
Figure 2.2 Bentonite slurry exiting the form during construction.

In the United States, the majority of bentonite comes from the state of Wyoming. Bentonite is classified as a sodium montmorillonite. When bentonite clay powder and water are mixed, the clay particles form a suspension (O'Neill and Reese, 1999). This suspension is caused when the bentonite powder is bound by water, causing it to scatter into microscopic plate-like particles. These particles then go on to constantly repel each other, similar to magnets when the same poles are trying to touch. This allows for an almost indefinite particle suspension. The hydration of bentonite can take up to several hours to complete, once finished the slurry is ready for final mixing and use (Brown, et al., 2010). Figure 2.2 shows bentonite slurry displacing out of a construction form.

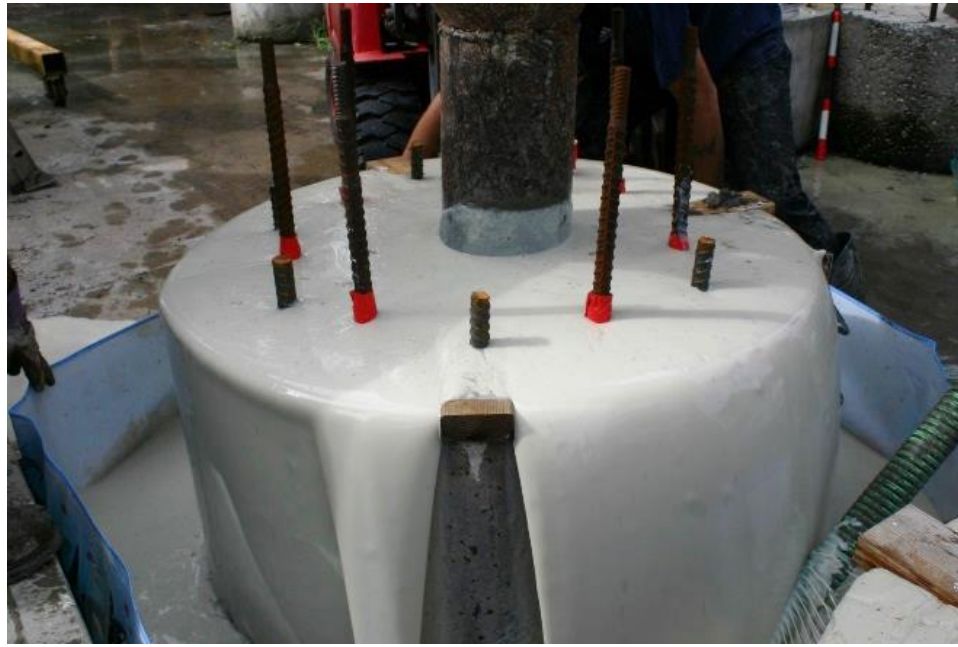
Figure 2.3 Attapulgite slurry exiting the form during concreting.

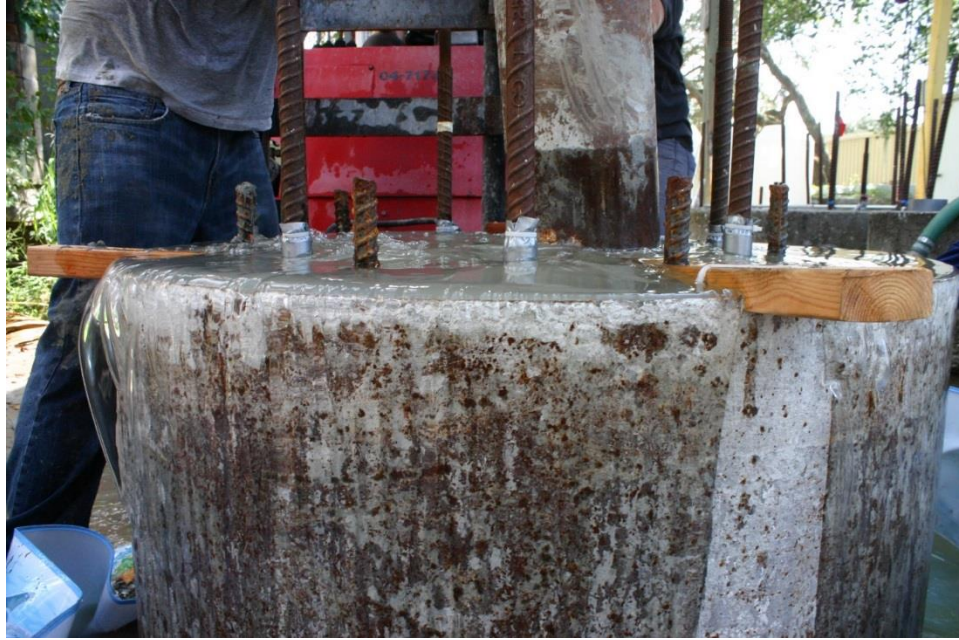
Figure 2.4 Polymer slurry exiting the form during concreting.

Polymer slurries, where approved, are a relatively new alternative to mineral slurry, (Figures 2.4 and 2.5). Polymer slurries were introduced to the market around the 1980's. “The term polymer refers to any of numerous natural and synthetic compounds, usually of high molecular weight, consisting of individual units (monomers) linked in a chain-like structure” (Brown, et al., 2010). Polymer slurry is formed through the mixture of polyacrylamides and water. This mixture forms long chain-like molecules. These molecules are negatively charged, promoting molecular repulsion (O'Neill and Reese, 1999).

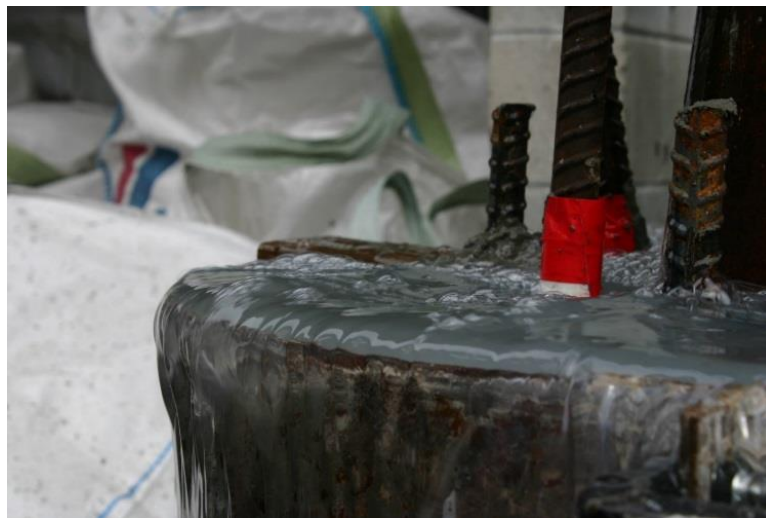
Figure 2.5 Close-up of a thicker viscosity polymer slurry exiting the form.

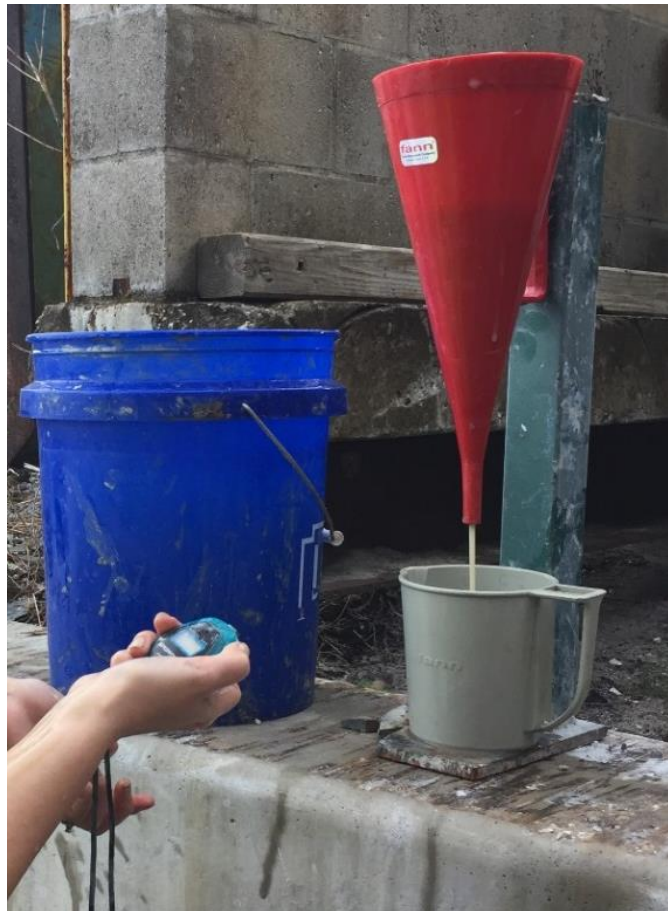
Figure 2.6 A Marsh funnel viscosity test in progress.

It has been established that slurry in general is used to provide excavation stability. This is generally executed by introducing the slurry to the excavation and maintaining it at an elevation of at least four feet above the groundwater table (FDOT, 2018). The slurry viscosity greatly affects the performance in maintaining stability. Slurry viscosity is tracked and measured through the Marsh funnel test method (API, 2009). This method works by timing how quickly a known volume of fluid discharges with falling head from a standardized funnel, Figure 2.6 (API, 2009). The unit of measurement for viscosity is seconds per quart. The thicker the slurry, the higher the Marsh funnel viscosity. For reference, the Marsh funnel viscosity of water is 26 sec/qt, this is the lower viscosity limit for drilling fluids. Typical workable ranges for mineral slurry are from 30 to 50 sec/qt (Brown, et al., 2010) and 50 to 90 sec/qt for polymer slurry (Mullins, et al., 2018).

The full-scale results showed less drastic differences over the exposure time frame (2 to 48 hr) where the 2-hr and 48-hr bentonite shafts showed the same average side shear resistance (Figure 2.13). However, a reduction in side shear (16-26% at 1-inch displacement) was noted for bentonite-cast shafts when compared to polymer-cast shafts. As much as 38% reduction was noted between a high-viscosity polymer shaft (100 sec/qt) and the bentonite 40 sec/qt shaft (B0-40). In Figure 2.13, P denotes polymer; B, bentonite; 40, 60 and 100 describe the Marsh funnel viscosity in seconds per quart (Figure 2.6).

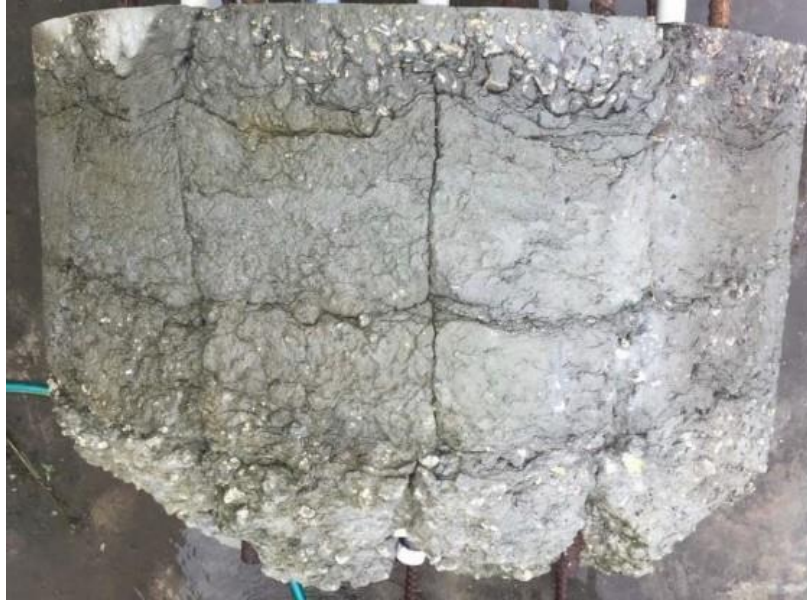
Figure 2.8 Mattressing on a drilled shaft test specimen.

The realities of concrete flow in a drilled shaft (Figure 2.7) creates a situation for possible concrete deficiencies. As the concrete flows through the reinforcement cage it is cleaved by the vertical and horizontal rebar and then rejoins on the outside of the cage. This provides an inherent opportunity for laterally forming laitance interfaces to become trapped, creating creases in the cover concrete (Figure 2.7). These creases often extend to the surface and reflect the reinforcement cage layout (Figure 2.8); this phenomenon is termed *mattressing* by the Deep Foundations Institute (Beckhaus, 2016).

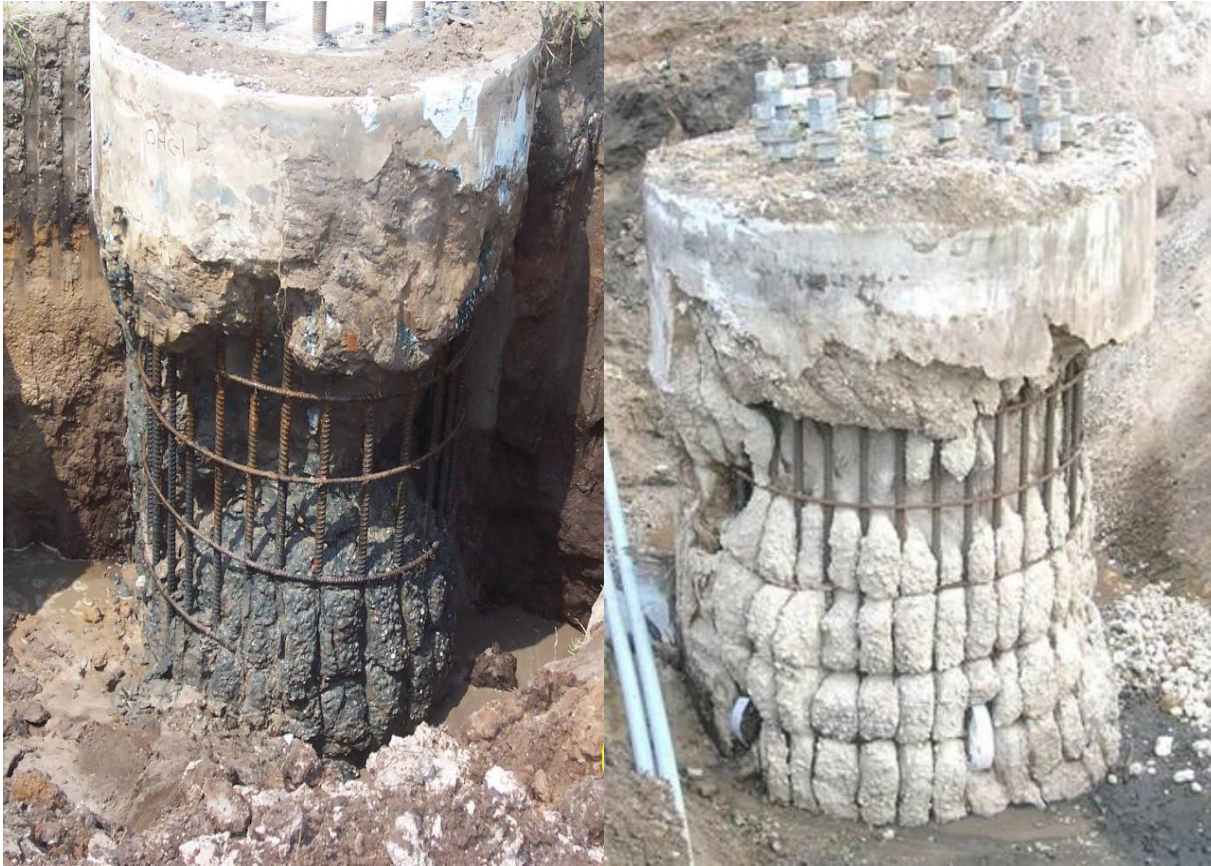
Figure 2.9 Concrete buildup inside the cage that provides lateral pressure to fill the cover.

Images of shafts have later shown the presence of this concrete buildup, but in cases where shafts were found to have been incompletely concreted. This further highlights that at the end of a concrete pour, when the concrete in the cage has reached the top of the cage, the cover concrete will still be lower and that only the toppling of concrete over the top edge of the cage will fill the final several feet of cover regions. This toppling action implies segregation of this concrete as it falls through the slurry in the cover. Figure 2.9 shows two shafts at different degrees of concrete completion when the tremie was extracted and where the buildup in the cage can be seen. In both cases, the tremie-placed portion of the concrete pour was assumed to be complete and a surface formwork was used to dry-pour the top of the shaft pedestal for a light mast fixture.

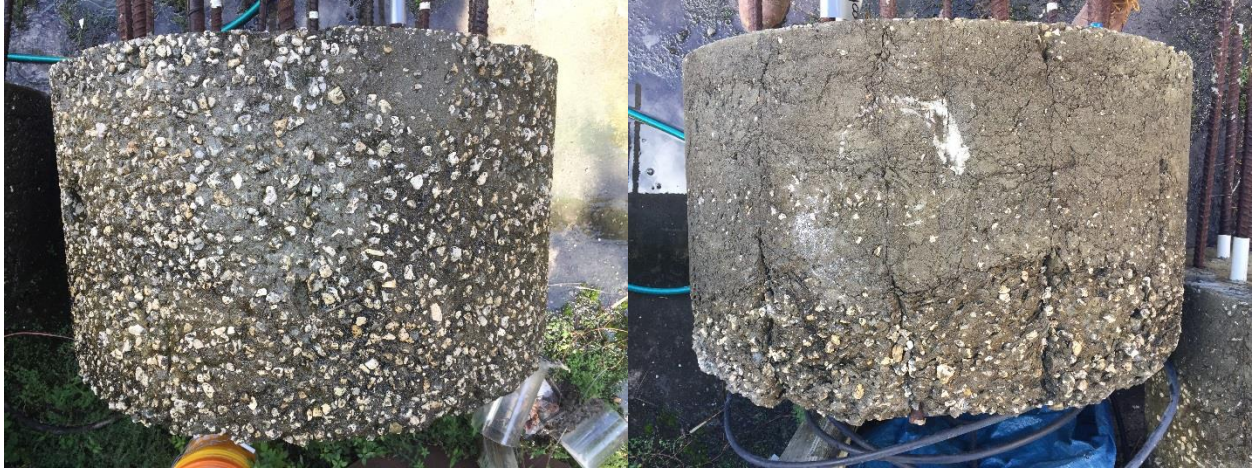
Figure 2.10 Shaft 7 30 sec/qt bentonite (left), shaft 8 40 sec/qt bentonite (right).

Bowen (2013) investigated the upper viscosity limit for bentonite slurry. However, during testing concrete flow issues were recognized. For this research, 18 small-scale shafts were cast that were 42-in. diameter and 24-in. tall using No.8 bars as reinforcement with 6-in. clear cover and spacing. A projection of the reinforcing cage could be seen on the concrete surface for almost all of the bentonite specimens (Figures 2.10 and 2.11). This was a result of laitance creases which form as radially flowing concrete fills the cover region, as depicted by Mullins and Deese.

While this research was focused on bentonite, several polymer shafts were cast as well. These shafts did not demonstrate the severity of mattressing noted with bentonite. Light crease lines were only noticed when closely examining the shafts. Bowen's work concluded by defining an upper viscosity limit for bentonite use in the state of Florida to be 40 sec/qt to prevent pronounced quilting/mattressing in bentonite cast shafts. (Bowen, 2013)

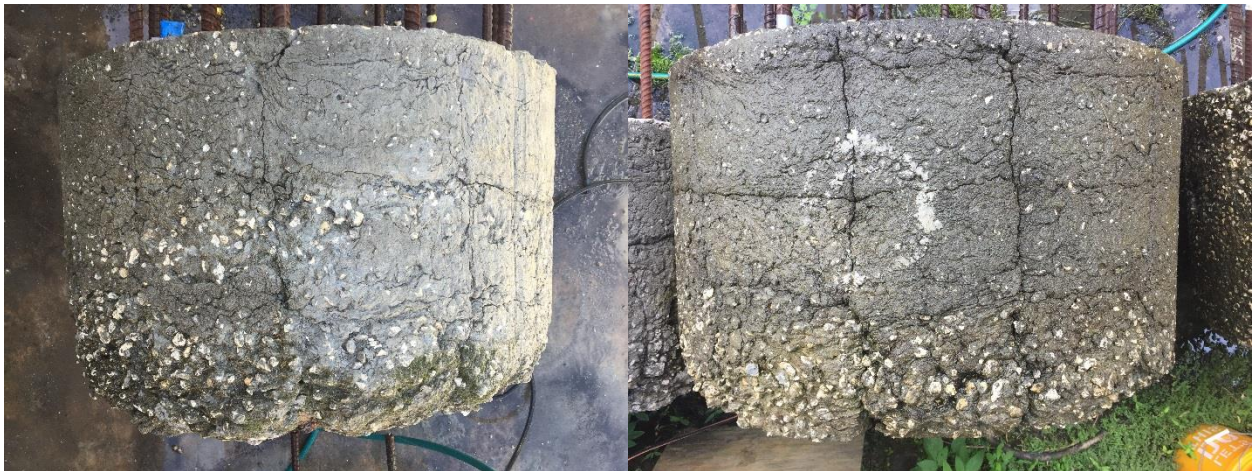
Figure 2.11 Shaft 4 55 sec/qt bentonite (left), shaft 5 90 sec/qt bentonite (right).

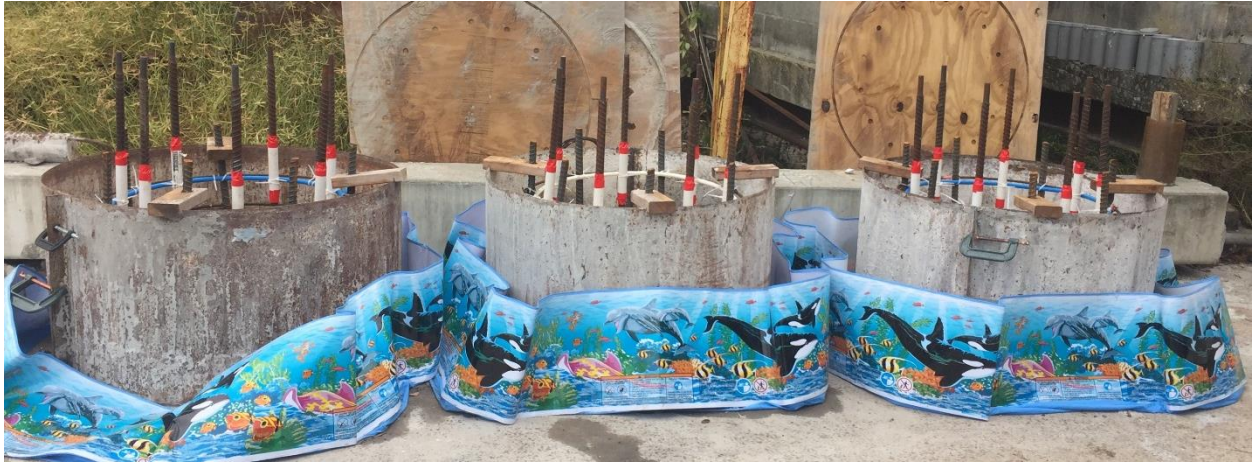
Figure 3.1 Forms set up prior to slurry and concrete placement.

To prevent fluid loss, silicone was used to seal the base of the steel forms to the plywood. Silicone was placed on both the inside and outside of the form, as well as along the seal where the angles

were clamped together. Once the silicone was dry each form was tested to ensure that it was water tight. Figures 3.1 and 3.2 depict the overall form set up.

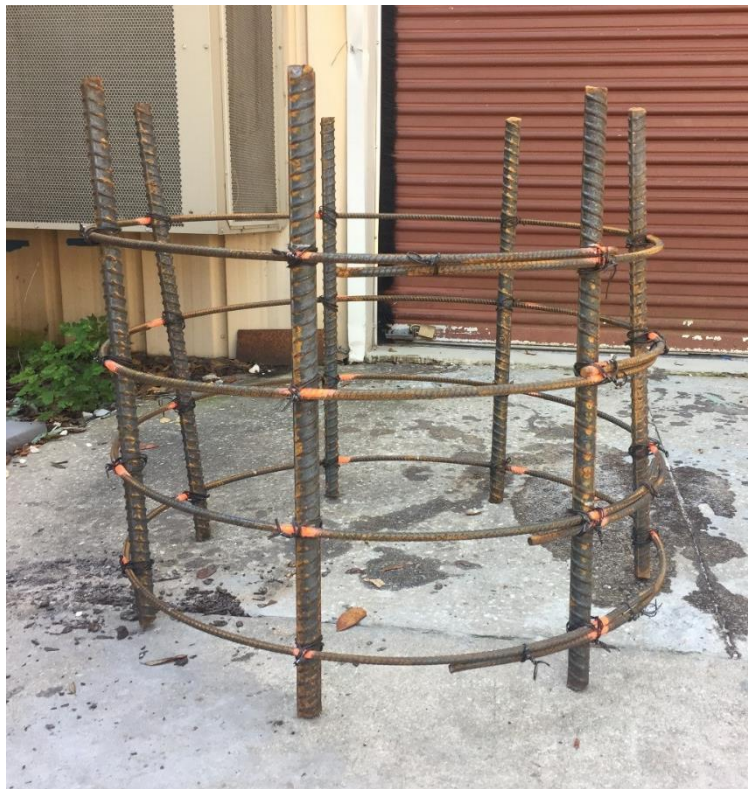
Figure 3.3 Outer seven longitudinal bars attached to the inside of the transverse reinforcement.

For cage construction the outer seven bars, which were used as structural reinforcement and not for pullout testing, were spaced and attached to the inside of the steel stirrups using steel tie-wire (Figure 3.3). The type of tie wire connection used was the quadruple-snap (Camilo Builes-Mejia, et al., 2014). Next, two rings of non-structural ½ in. polyethylene pipe (PEX pipe) were attached to the top and bottom hoops on the inside of the seven outer bars using plastic zip-ties. Finally, the debonded pullout bars were inserted and attached using zip-ties on the interior of the PEX pipe, this can also be seen in Figure 3.2. It should be noted that the steel stirrups did not come in contact with the longitudinal steel to be tested for pullout capacity.

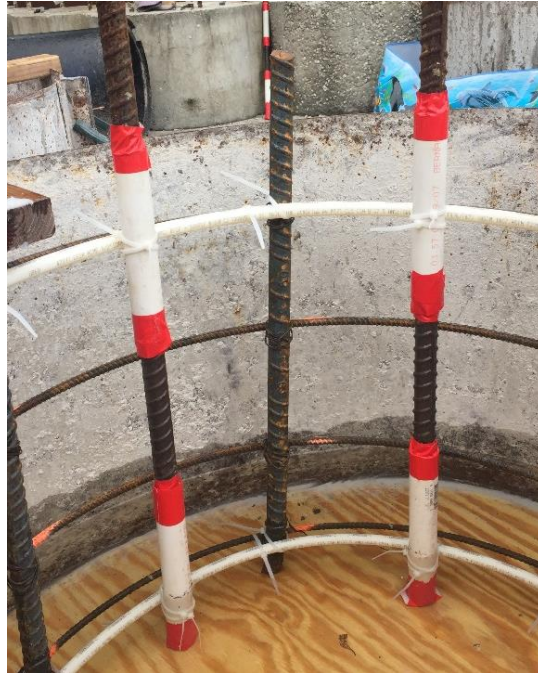
Figure 3.4 The ~~six~~-six-inch debonded section of bar through the use of PVC pipe sections.

The construction of the pullout specimens began by cutting to a length of 4 ft in order to accommodate the hydraulic ram and steel spacers used for testing. The bars were machined down to 7/8 in. diameter on the top and subsequently threaded to provide a point of resistance for the hydraulic ram during testing. Debonding on each bar was accomplished using 1-in. thin walled PVC pipe sealed with tape on the upper 8 inches and lower 10 inches of embedment length, resulting in a 6-in. bond length per bar (Figure 3.4).

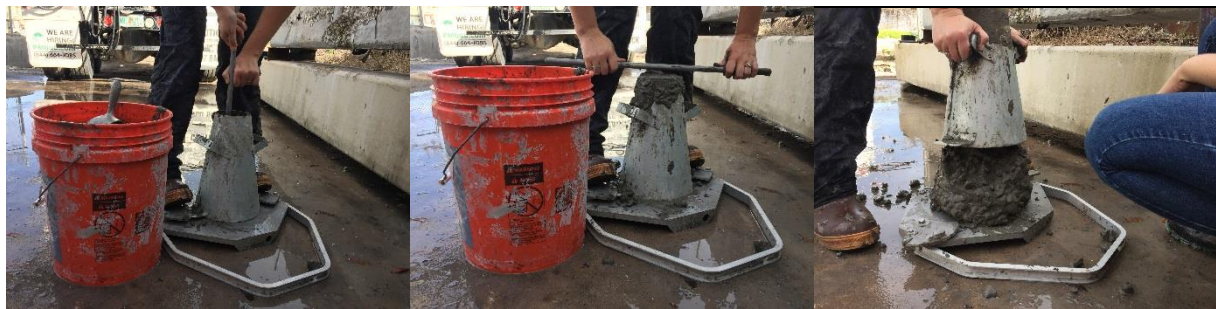
Figure 3.5 The phases of performing a standard slump test; from left to right: rodding 25 times per layer, leveling the top of the cone, removing the cone to measure the slump value.

The standard slump test (ASTM C143) is administered by first attaching the slump cone to a level base. The cone is then filled in three equal layers, with each layer being rodded 25 times. The top layer is then leveled off so that it is flush with the top of the cone. The cone is then lifted carefully off the base (within 3 to 5 seconds) to allow the concrete to spread or 'slump'. The removed cone is then flipped upside-down and placed on the base. The slump of the concrete is the measurement from the top of the 'slumped' concrete to the top of the cone. This process is shown in Figure 3.5.

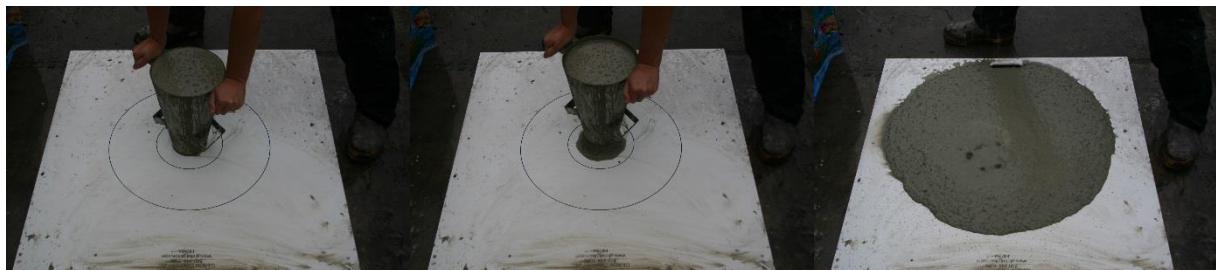
Figure 3.6 SCC slump/spread test where the standard slump cone is filled upside-down (left), the cone is lifted (center), and the diameter of the spread is measured (right).

The SCC slump is tested and measured in a different manner as SCC is highly fluid and does not hold the shape of the cone once removed. For this test, the same slump cone is used, however with a wider base plate (spread board). The slump cone is placed upside-down on the base plate and then completely filled with fresh concrete (Figure 3.6). The cone is once more carefully lifted allowing the concrete to spread (Figure 3.6). The diameter of the concrete is then measured at two perpendicular locations and the average is recorded as the concrete spread.

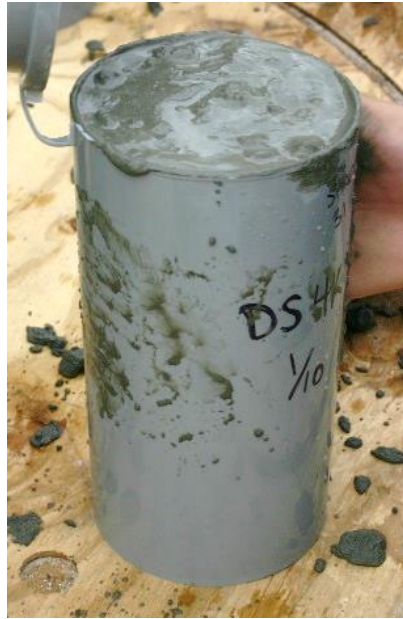
Figure 3.7 A Class IV concrete cylinder post leveling.

Following slump testing, 4-in. by 8-in. cylinders were prepared to evaluate the concrete compressive strength. Preparation methods varied for Class IV concrete and SCC. Class IV concrete cylinders were made in accordance with ASTM C192 by adding concrete in two layers, rodding each layer 25 times, then leveling the concrete at the top, (Figure 3.7). SCC cylinders were simply filled and leveled, (Figure 3.8).

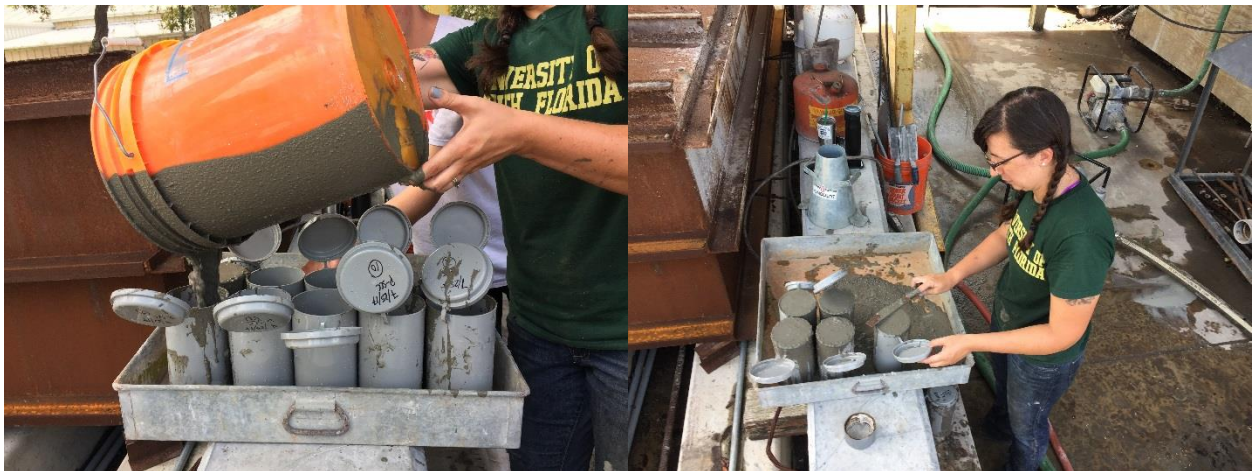
Figure 3.8 SCC cylinder preparation: pouring the concrete into cylinders (left) and leveling the tops (right).

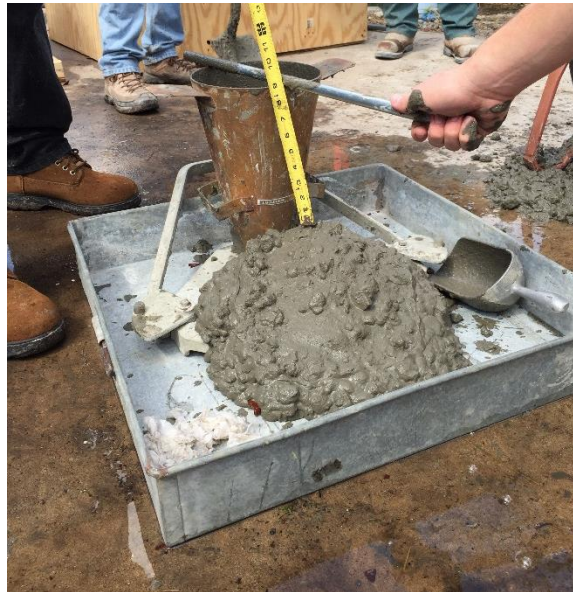
Figure 3.9 Measurement of 8.5-in. slump for shafts 19 to 22.

Shafts 19 to 22 were cast with Class IV concrete from Preferred Materials, Inc. The primary purpose of these samples was to test the pullout capacity of the second polymer manufacturer, thus the concrete properties had to be comparable. The slump of this concrete was measured to be 8.5 in. (Figure 3.9). Shaft properties can be found in Table 3.1.

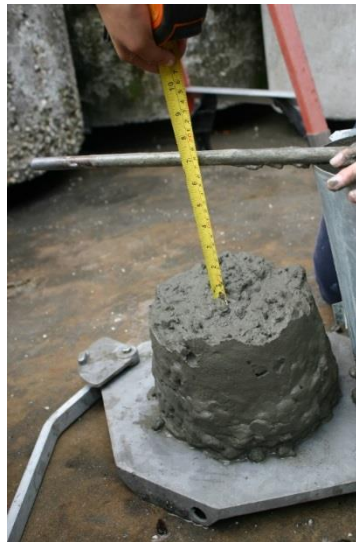
Figure 3.10 Measurement of 7-in. slump for shafts 31 to 36.

Shafts 31 to 36 were cast with the same Class IV concrete from Preferred Materials, Inc. that was used for shafts 1 to 22. The purpose of these specimens was to test the varying viscosities of attapulgate slurry in terms of concrete flow and pullout capacity so that this data could be compared to the other slurry types. This pour also tested two more shafts using polymer manufacturer 2. The slump of this concrete was determined to be 7 in. by the standard slump test; (Figure 3.10). Table 3.3 displays shaft details such as slurry type, viscosity, and bonded length.

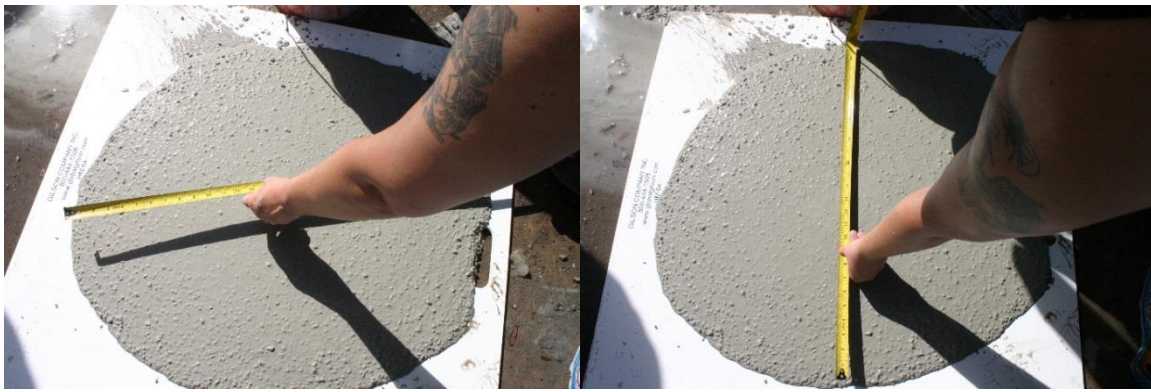
Figure 3.11 Measurement of spread for Argos SCC mix for shafts 47 to 52.

Test shafts 47 to 49 were cast with a different provider of SCC. The distributor selected was Argos USA. Slurry conditions were kept close to the SCC shafts already cast. The spread of this concrete was 28 in., Figure 3.11. Shaft details can be found in Table 3.4.

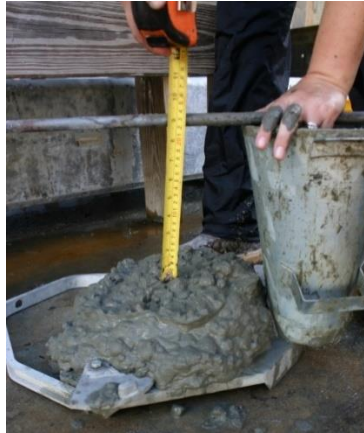
Figure 3.12 Measurement of 9-in. slump for shafts 53 to 58.

Test shafts 53 to 58 were cast to investigate a third polymer manufacturer. To be consistent, Class IV concrete from Preferred Materials was used. The slump of this concrete was measured to be 9 in. by the standard slump test; (Figure 3.12). Table 3.5 displays shaft details such as slurry type, viscosity, and bonded length.

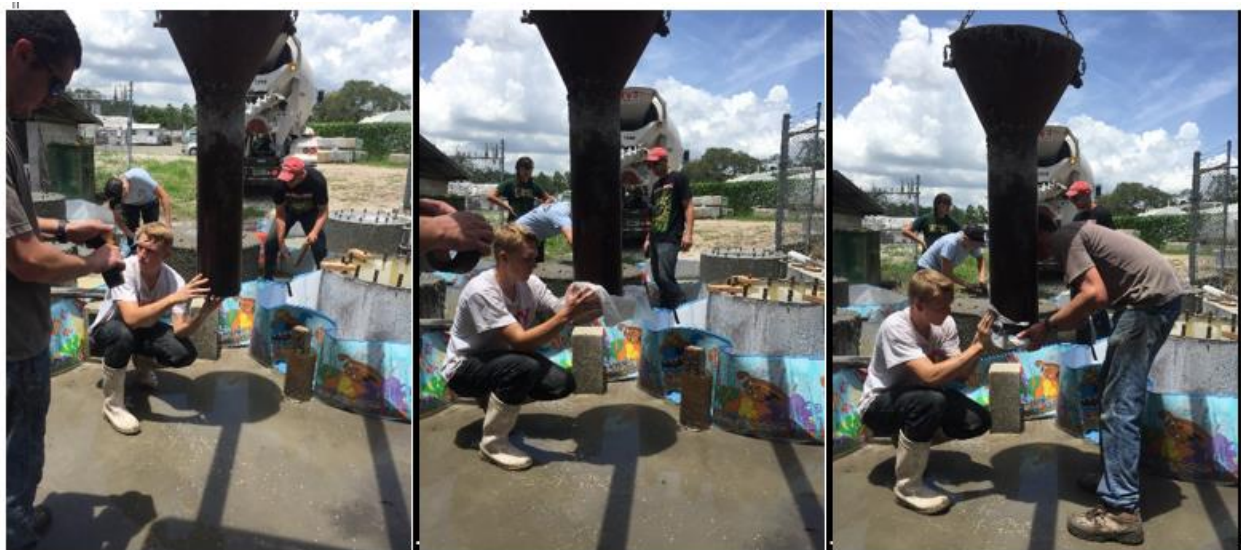
Figure 3.13 Tremie pipe preparation; placement of cap (left), covering of cap with plastic (center), taping of plastic around (not to) tremie pipe (right).

Once the concrete slump/spread was approved, the concreting process was initiated. For each shaft the tremie pipe was prepared by capping the base with a metal plate, placing a plastic bag over the plate/base of the tremie pipe, and taping to seal/hold the connection (Figure 3.13). The capped tremie pipe was then inserted into the center of the shaft and lowered to the bottom of the form. Next the tremie pipe was filled with concrete from the chute. Once full, the tremie pipe was slightly elevated allowing the concreting process to begin and displacing the slurry from the shaft form (Figure 3.14). Once placement was completed the tops of the shafts were levelled and labeled. Post concreting, the samples were allowed time to achieve at least three-quarters of their design compressive strength before the steel forms were removed.

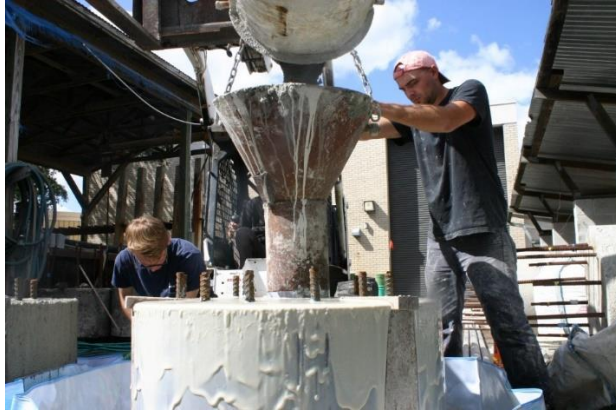
Figure 3.14 Displacement of slurry through the concreting process.

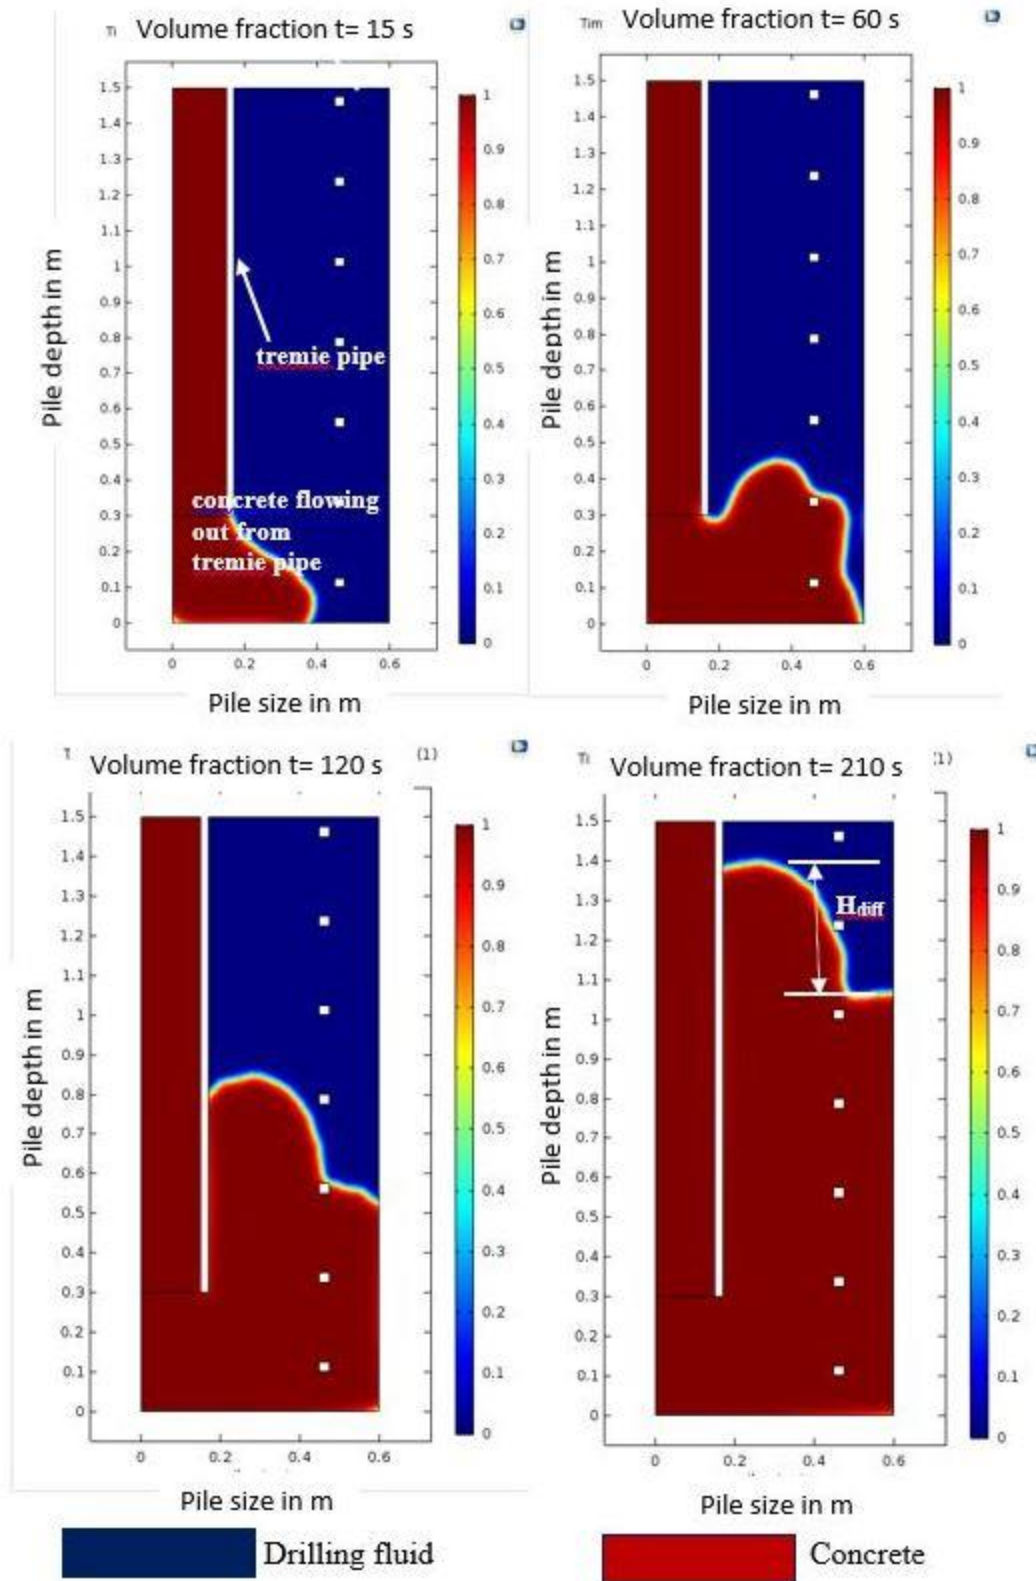
Figure 4.4.5 2-D Model in COMSOL: Concrete Flow Patterns at Different Flow Time Intervals.

As expected from field measurements, the head differential, H_{diff} , increases with increasing concrete inflow velocity (Deese, 2005; Mullins and Ashmawy, 2005). Figure 4.7 shows H_{diff} plots for different rebar spacing. The values are taken at 210 s. When studying the effect of rebars, there is an increase in the concrete head as the rebar spacing reduces or as the number of bar increases. Similar scenarios were observed during shaft construction in the field by others where the concrete flow was affected by the rebar blockage (Hodgson et al., 2005).

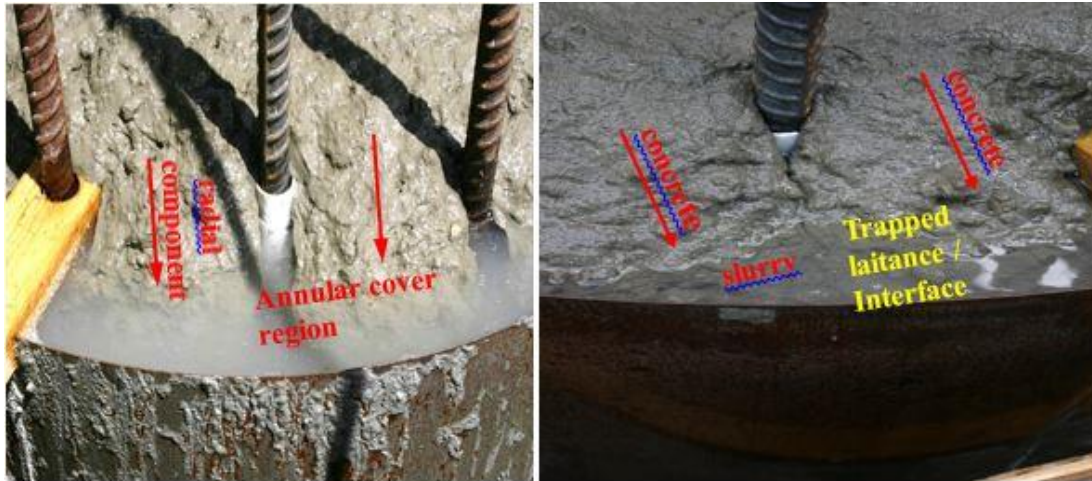
Figure 4.4.13 Experimental Study with Cast Shafts at USF, (Mullins, 2015): Flow Pattern Observed.

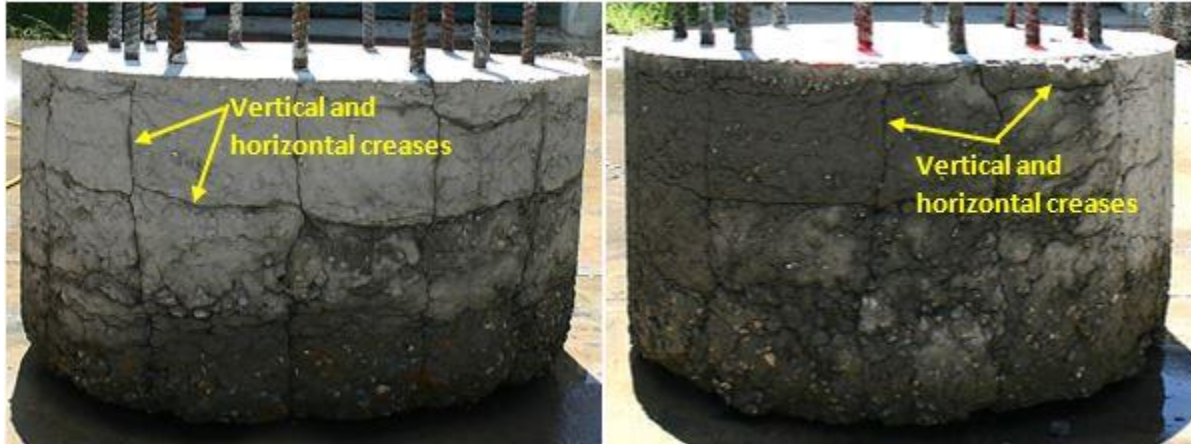
Figure 4.4.21 Experimental Study with Cast Shafts at USF: Vertical and Horizontal Creases Observed at the Edge of Cast Shaft, (Mullins, 2015).

In addition, the volume fraction patterns from the simulations were extracted from concentric vertical slices near the reinforcing cage and nearest the shaft/soil sidewall interface (Figure 4.20). Both vertical and horizontal creases are clearly seen nearest the cage; close to the shaft sides the horizontal creases are very faint. Similar patterns of vertical and the horizontal creases were observed during the experimental study with cast shafts and are shown in Figure 4.21.
