EVALUATION OF SELF CONSOLIDATING CONCRETE AND CLASS IV CONCRETE FLOW IN DRILLED SHAFTS

BDV25-977-25

FINAL REPORT

January 2020

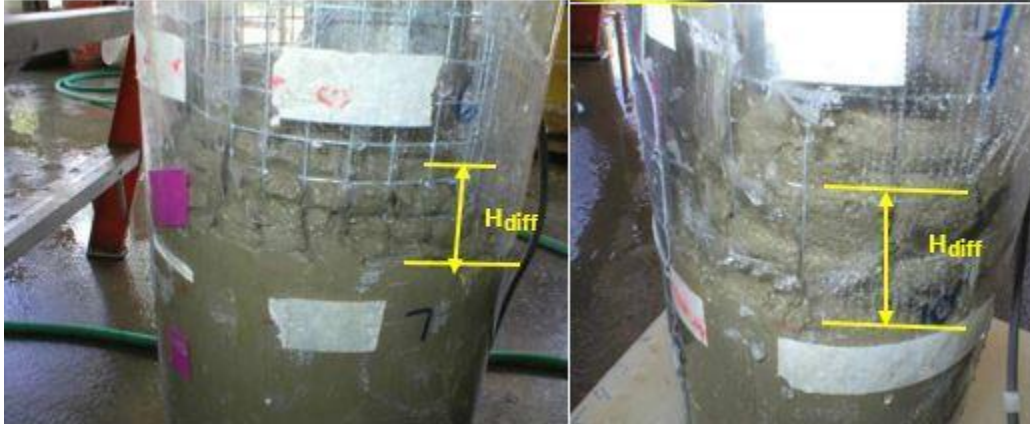
Figure 4.4.23 Laboratory LCP Test at USF: Flow Pattern of Rising Mortar with Head Differential, (Mullins and Ashmawy, 2005).

Moreover, the flow pattern extracted from a vertical plane shows the concrete head differential between inside and outside the rebar cage in Figure 4.22. This similar pattern of concrete flow was obtained, as shown in Figure 4.23, from the research study carried out at USF with the Lateral Pressure Cell (LCP) developed by Mullins and Ashmawy, (2005). The objective of Mullins and Ashmawy, (2005) was to study the rheology of concrete as it flows from the tremie bottom and rises inside the cage within an excavation.

Head differentials of rising mortar between inside and outside the reinforcement cage were measured by the LCP tests. Figure 4.23 shows the pattern of rising mortar observed in the LCP test. Field testing programs were also carried out and the concrete head differential was measured at Port of Tampa, Essex Cement Company Project, Crosstown Expressway Reversible Lanes Bridge site, and at Alagon Condominium project.

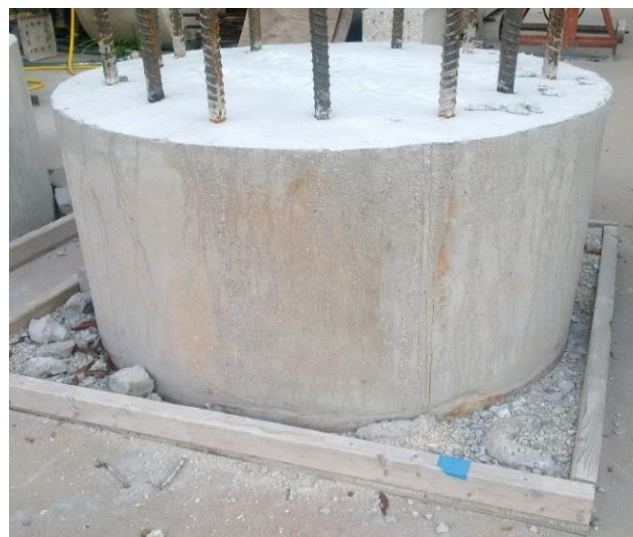
Figure 4.4.39 Experimental Study with Cast Shafts at USF, (Mullins, 2015): Flow Performance of SCC Shaft Cast under Water- Shaft Size 48-inch Diameter.

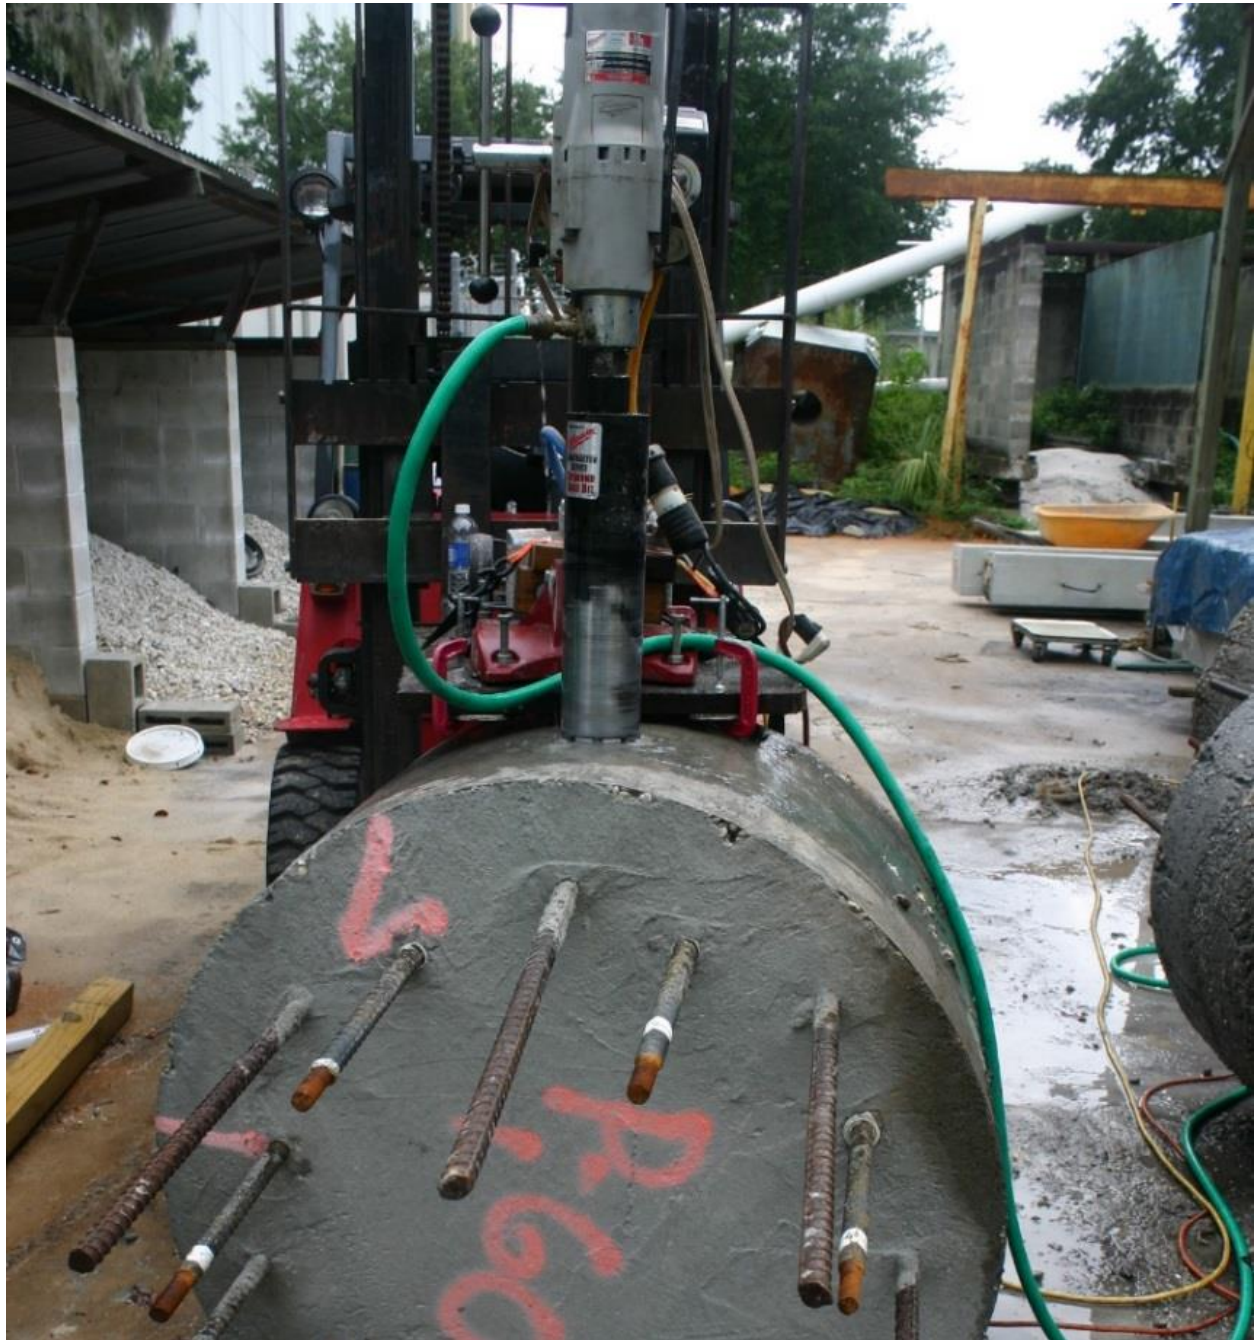
Figure 5.2 Radial coring set up.

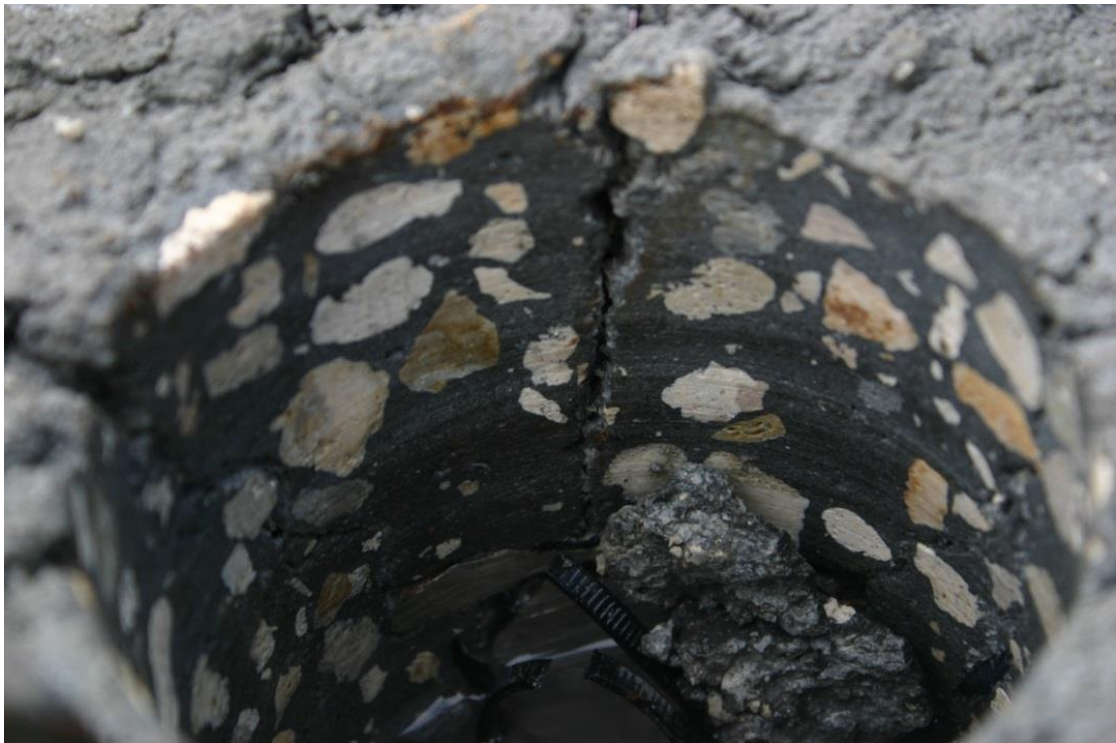
Figure 5.3 An empty core hole showing the surface crease extending to the reinforcing steel.

Another highlight of his findings was the examination of radial cores taken at the intersection of these creases that revealed the concrete was not contiguous at the creases. This was made exceedingly apparent when the high viscosity bentonite slurry sample was cored, it separated into four pieces defined by laitance crease locations. All four pieces were found to be coated with trapped bentonite slurry. Results from the coring can be seen in Figures 5.2 to 5.6, which show cores from a water-cast shaft, 60 sec/qt polymer-cast shaft, 30 sec/qt bentonite-cast shaft, 40 sec/qt bentonite-cast shaft, 50 sec/qt bentonite-cast shaft, and 90 sec/qt bentonite-cast shaft. On the water-

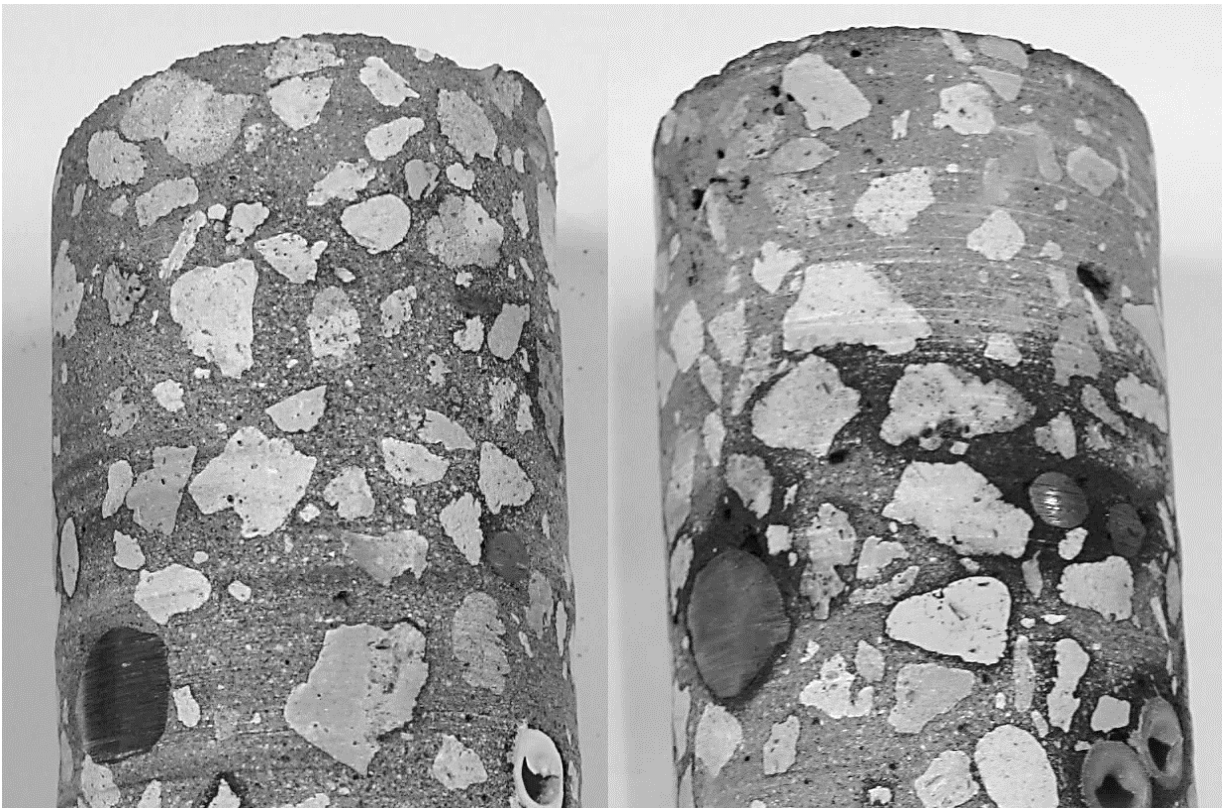
Figure 5.4 A water core (left) and 60 sec/qt polymer core (right).

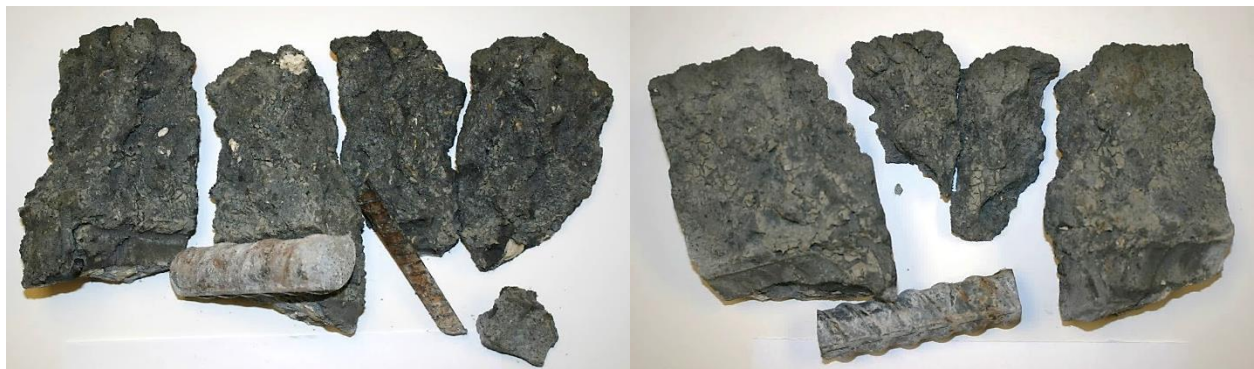
Figure 5.6 Pieces from a 50 sec/qt bentonite core (left) and a 90 sec/qt bentonite core (right).

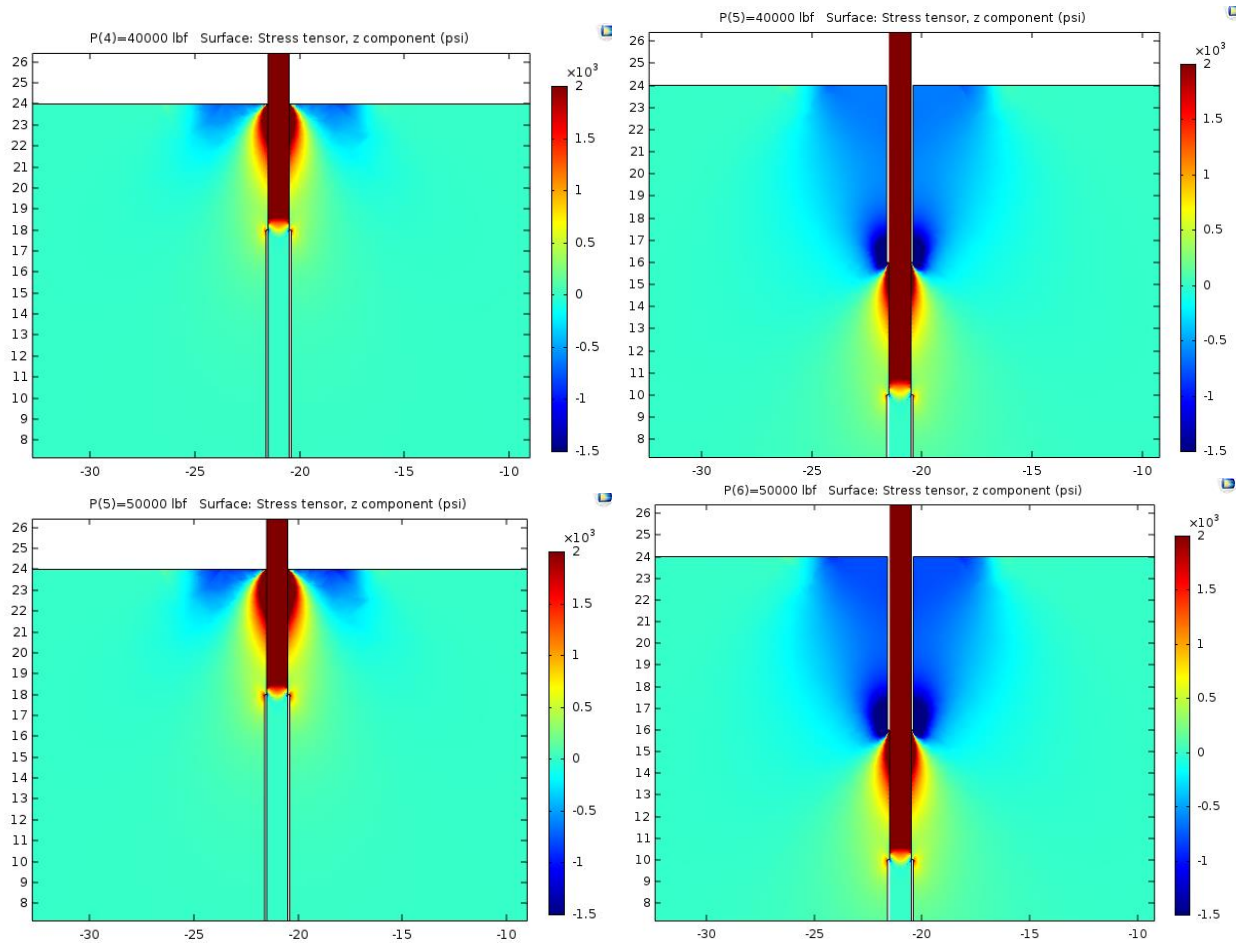
Figure 5.11 (Continued)

Figure 5.11 The loading of each model at 10, 20, 30, 40, and 50 kip; the top 6-in. bonded (left), the top 8-in. debonded (right).

For modeling purposes, 50 kip was assumed to be the greatest magnitude encountered. The scales seen on the right side of the images in Figure 5.11 are identical for all, representing positive 2000 psi to -1,500 psi, tension to compression, respectively, where zero is neutral. Thus, the darker royal blue colors noted are the extreme end of the modeled compression scale. Note that the compressive stress seen on the concrete from the loading jack is generated in the same region as the tensile stress generated from the loading of the pullout bar when the 6-in. bond is next to the concrete surface (case (a)) (Figure 5.12), versus an almost linear division of compressive and tensile stresses when the bonded region is 8-in. below the concrete surface (Figure 5.13). Note regions of tension and compression have been exaggerated to illustrate the stress fields.

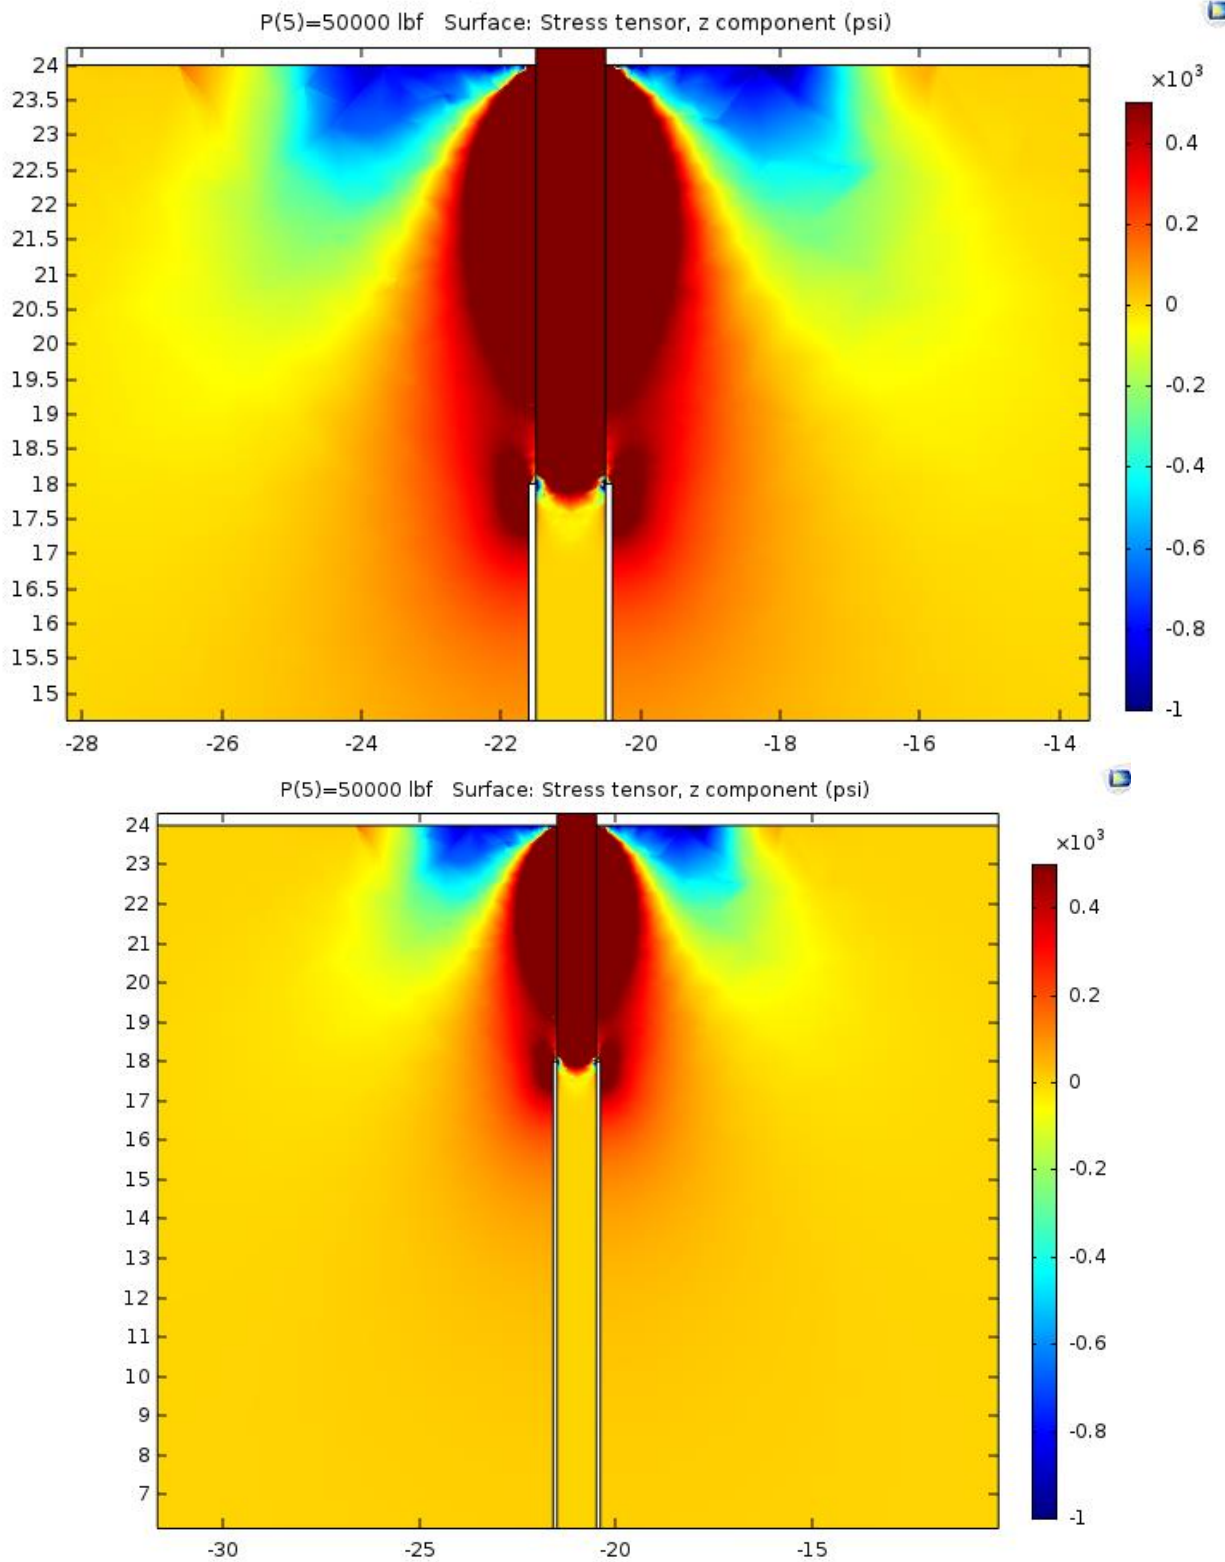
Figure 5.12 Zoomed in tension and compression fields for 6 in.-bond at the top.

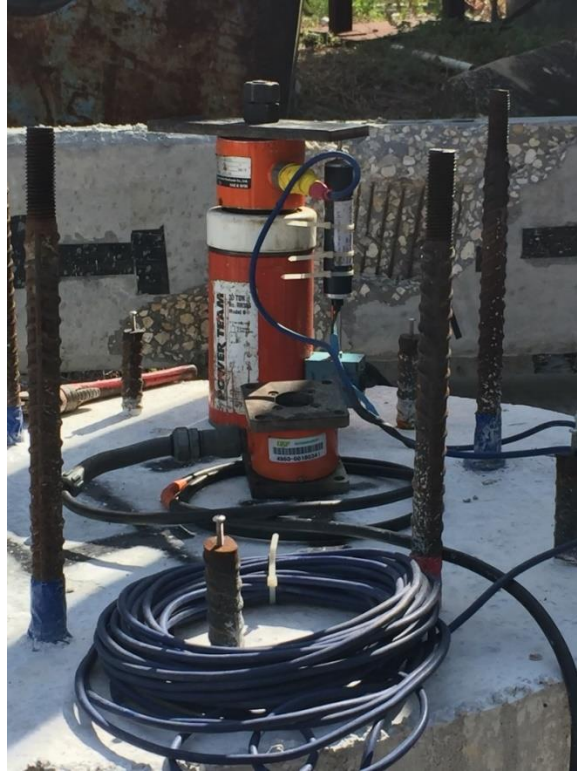
Figure 5.14 General assembly used for pullout testing: loading jack, load cell, steel plate, double nuts, and a displacement transducer.

A 60-ton capacity hollow-core hydraulic ram was placed over the bar to be tested and onto lead plates used to level the concrete surface. An 8-in. diameter load cell was then placed over the bar along with spacers and an upper steel plate. Double nuts at the top of the bar were used to secure the loading assembly and distribute the load along the entire threaded region. A displacement transducer was also attached to the side of the hydraulic ram to monitor movement. This assembly is displayed in Figure 5.14. A manually-operated hydraulic pump was used to conduct pullout testing, as it was able to apply a slow loading rate of approximately 100 lb/s.

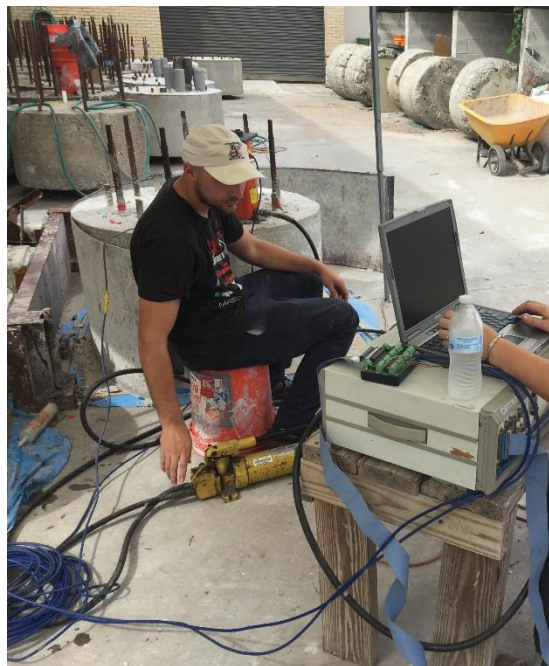
Figure 5.15 Testing of the pullout bars: as the bar is being loaded the computer is being monitored.

Using a computerized data acquisition system, the load cell and displacement transducer were monitored at a sampling rate of 10 Hz, ensuring peak force would be captured (Figure 5.15). Testing was only performed once the concrete reached a minimum compressive strength of 4 ksi. All testing was completed on the same day as cylinder compressive strength testing. In total, including pullout specimens from Bowen's testing, 268 tests were performed. This included 138 tests in mineral slurry, 82 in polymer slurry, and 47 in water.

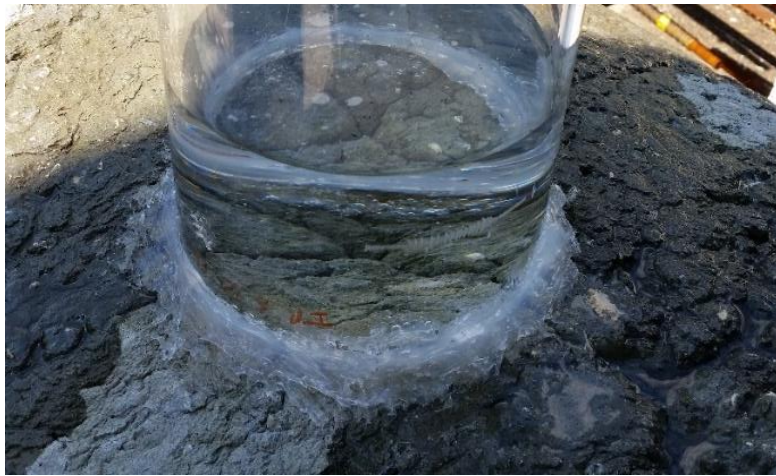
Figure 6.1 Water filled tank attached to concrete surface

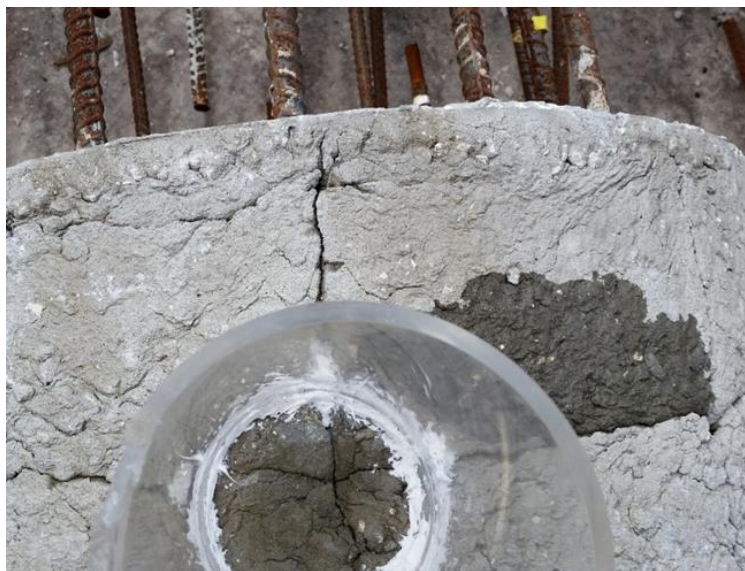
Figure 6.2 Water draining from the tank into the creases

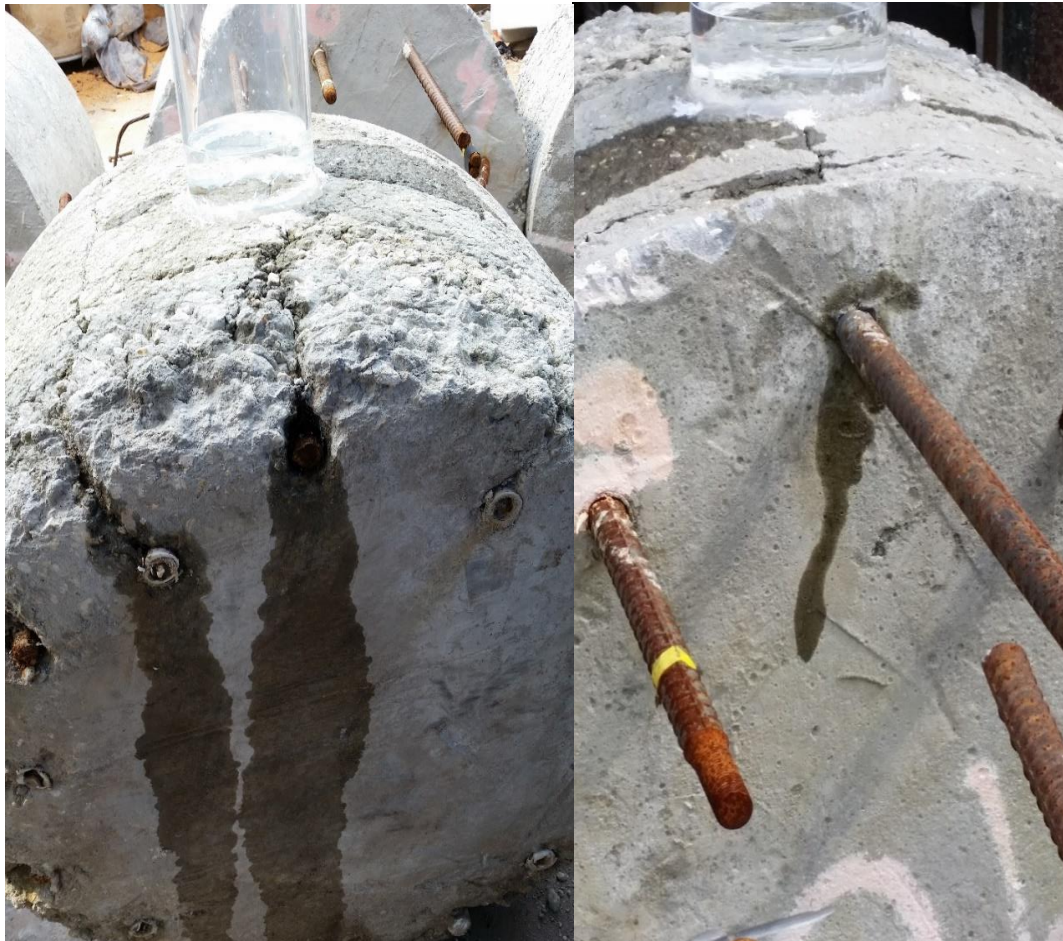
Figure 6.3 Water leaking below reinforcement in the bottom (left) and the top (right) of the shaft

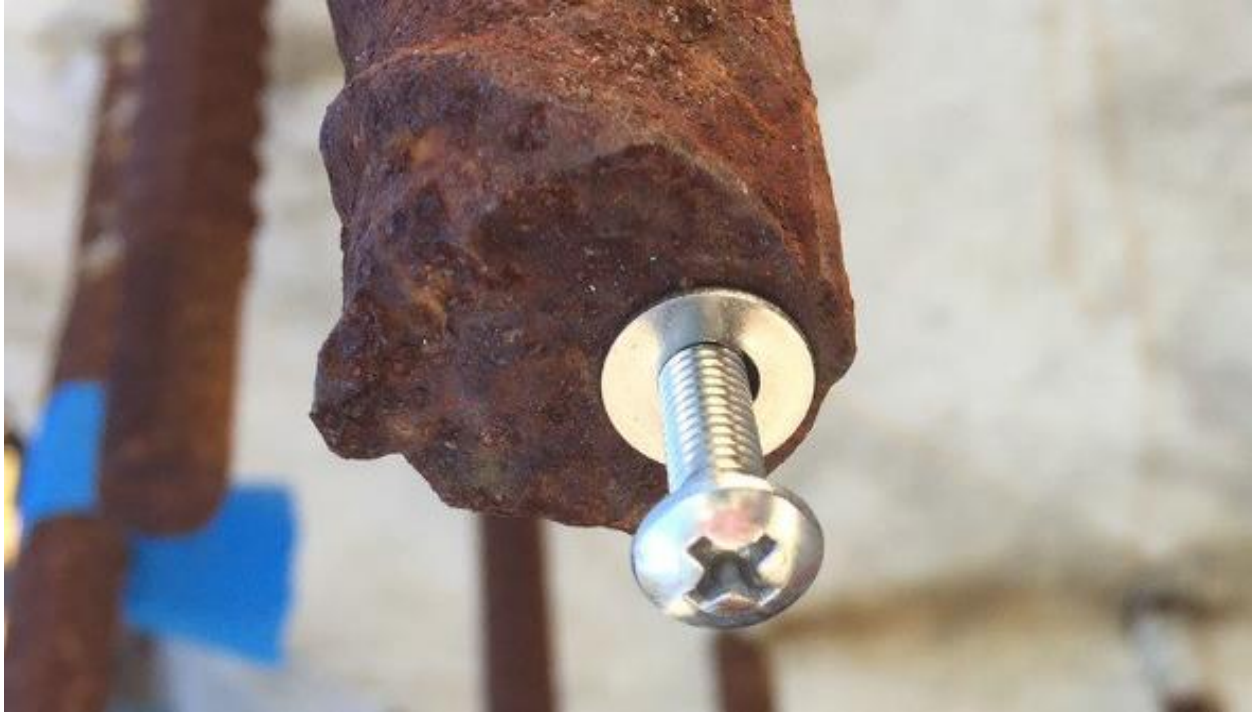
Figure 6.4 Stainless steel connection

The 2017 study conducted mutual potential and mutual resistance tests on all vertical reinforcement bars for each of twenty-three drilled shaft specimens. Prior to testing, the exposed end of each vertical rebar was drilled, tapped, and a stainless-steel screw was installed to establish a satisfactory electrical connection (Figure 6.4). The seven vertical rebar on each shaft were labeled, and testing was completed between all bar combinations (21 combinations per shaft).

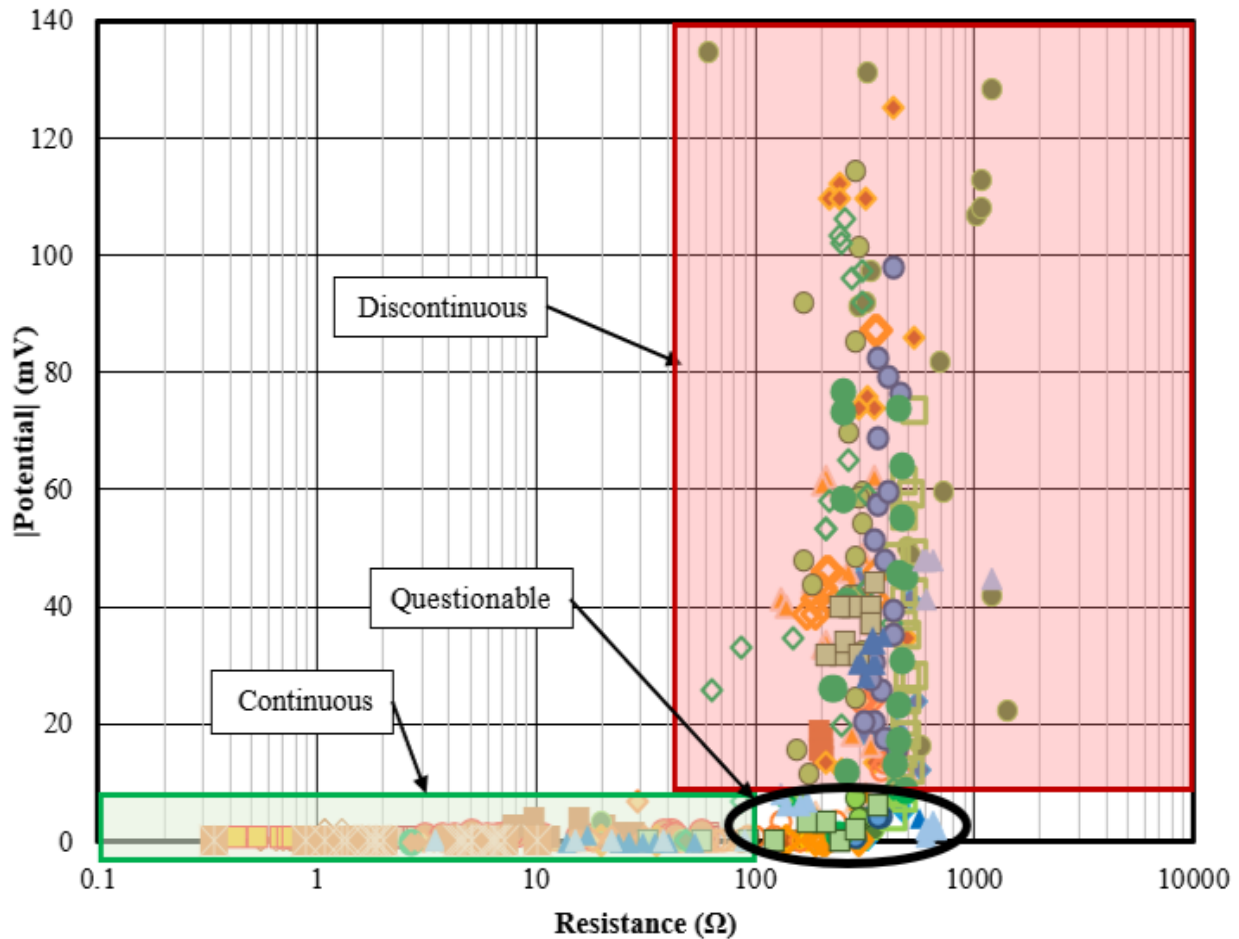
Figure 6.5 Mutual potential vs.. mutual resistance

When the mutual potential is graphed against the mutual resistance, the data is banded along the zero-millivolt potential line horizontally, and above 100- Ω the data is banded vertically. The data points scattered along the potential axis between zero and five are indicative of a well-connected system, as this reading reflects a negligible potential difference. The data points above five millivolts that are also above 100 Ω would generally indicate a poorly connected system as they exceed the inherent resistance between two pieces of reinforcing steel and exhibit a loss in potential across the system. The points of particular interest are the points positioned at the base of the vertical band in the data (Figure 6.5). These points have a resistance over 100- Ω but show negligible loss of potential.

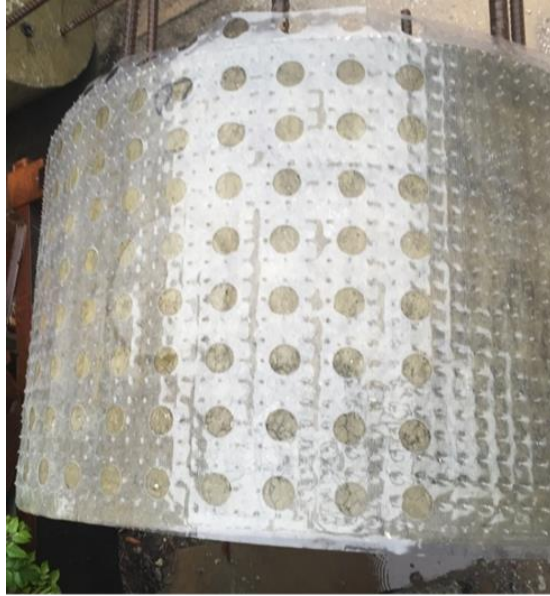
Figure 6.8 Completed template

The half-cell potential of each shaft specimen was mapped evenly over the surface using a prescribed grid. A grid template was made out of a single piece of 21-inch by 27-inch rubberized plastic sheeting. A sharpened 1.5-inch diameter pipe was used to punch holes through the plastic in rows with a 3-inch center-to-center spacing in both directions (Figure 6.8). This resulted in 80 measurement locations for each shaft. Half-cell potential testing was then conducted per ASTM C876-09: *Standard Test Method for Corrosion Potentials of Uncoated Reinforcing Steel in Concrete*, using a copper-copper sulfate reference electrode and a standard multi-meter.

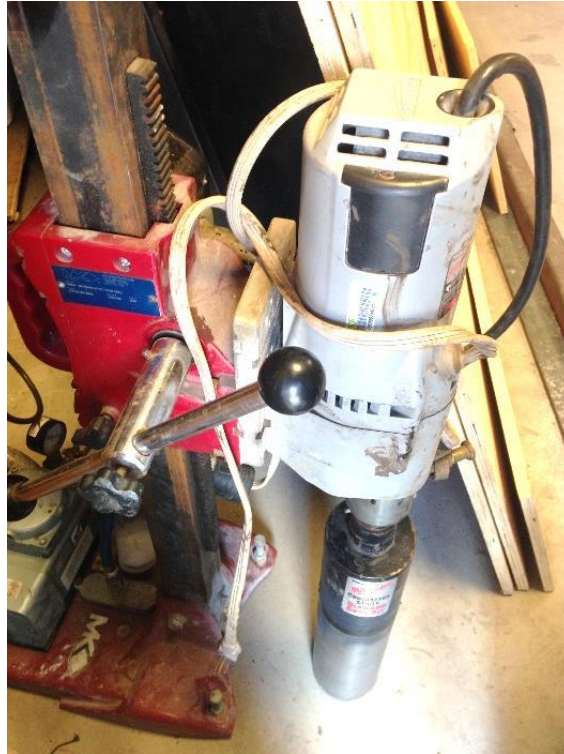
Figure 7.2 Standard manually operated core drill motor

The platform of the machine was a Milwaukee 4049, 20-amp manually-operated coring machine fitted with a 1-inch inner diameter, diamond tip, core barrel. This is a wet-core drill that lowers and lifts the core barrel with a linear gear / rack and pinion configuration, wherein turning the crank controls crowd and advances or retracts the drill with a manually-applied, variable force (Figure 7.2).

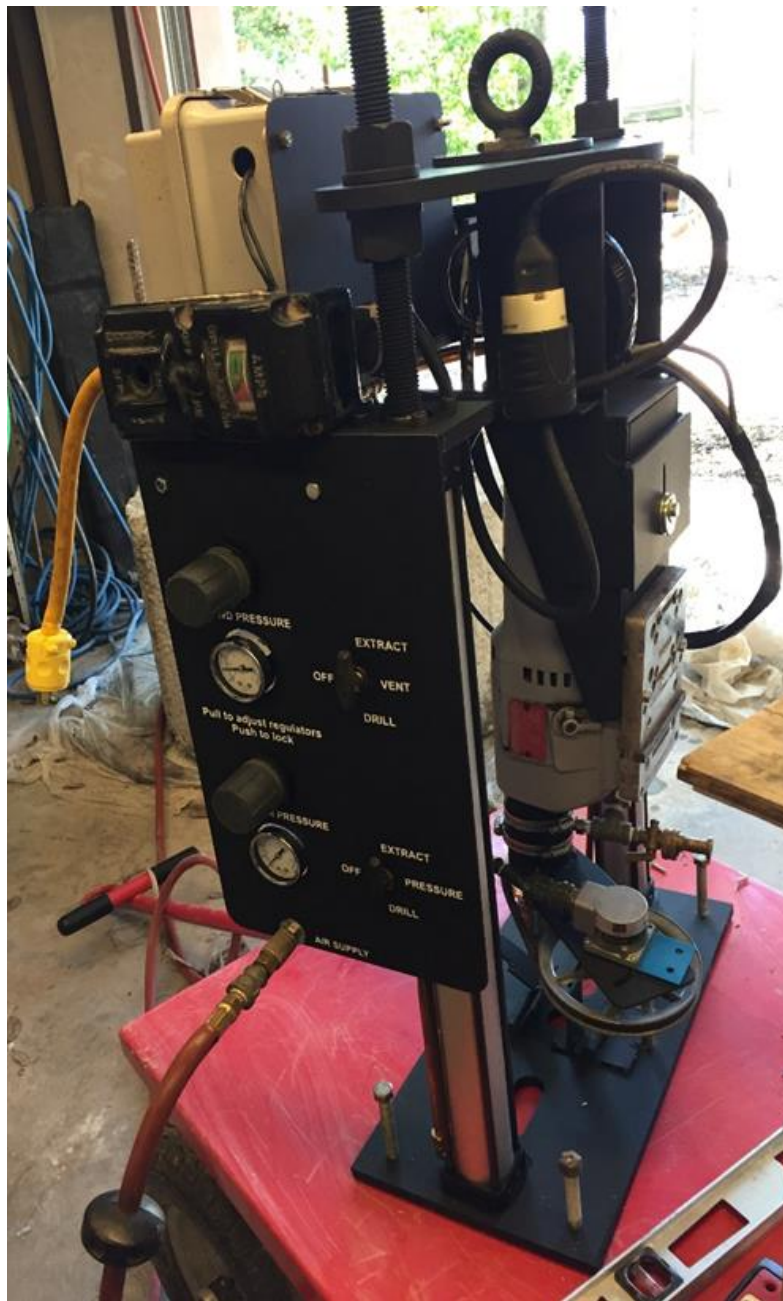
Figure 7.3 Control panel

The result of this instrumentation was a drilling machine with the ability to provide dynamic force, velocity, pressure, power, and rpm data (Figures 7.3-7.5). In post-processing, this data could then be used to determine the resistive force and strength of the concrete. This data analysis process is outlined in the results section.

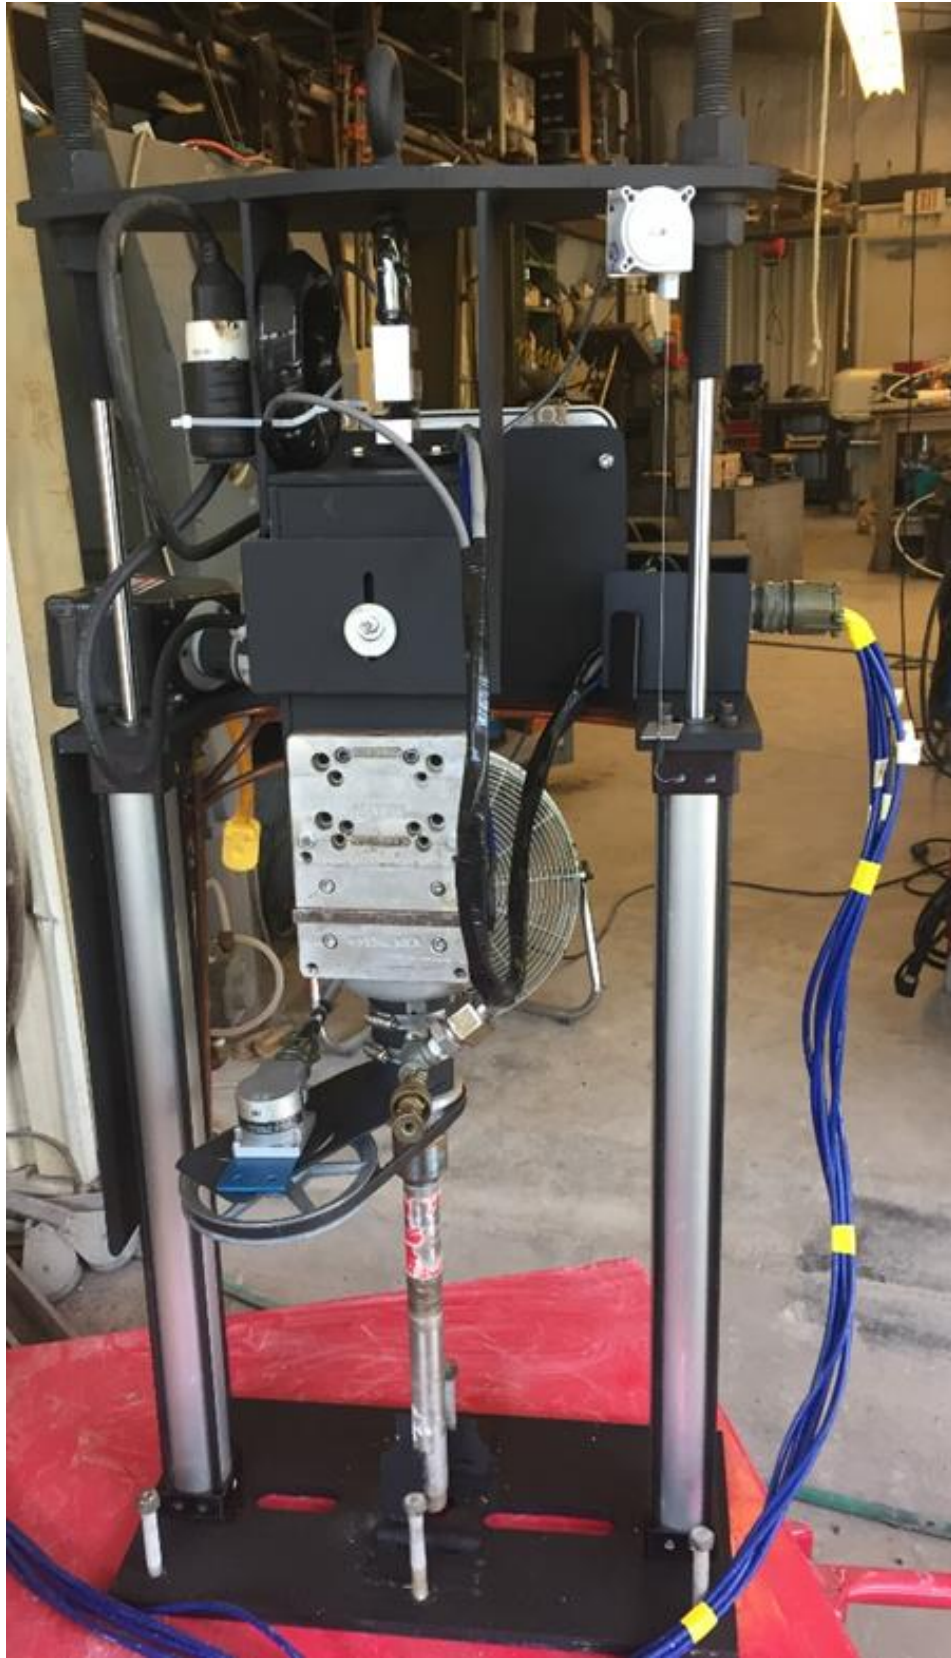
Figure 7.4 Back view

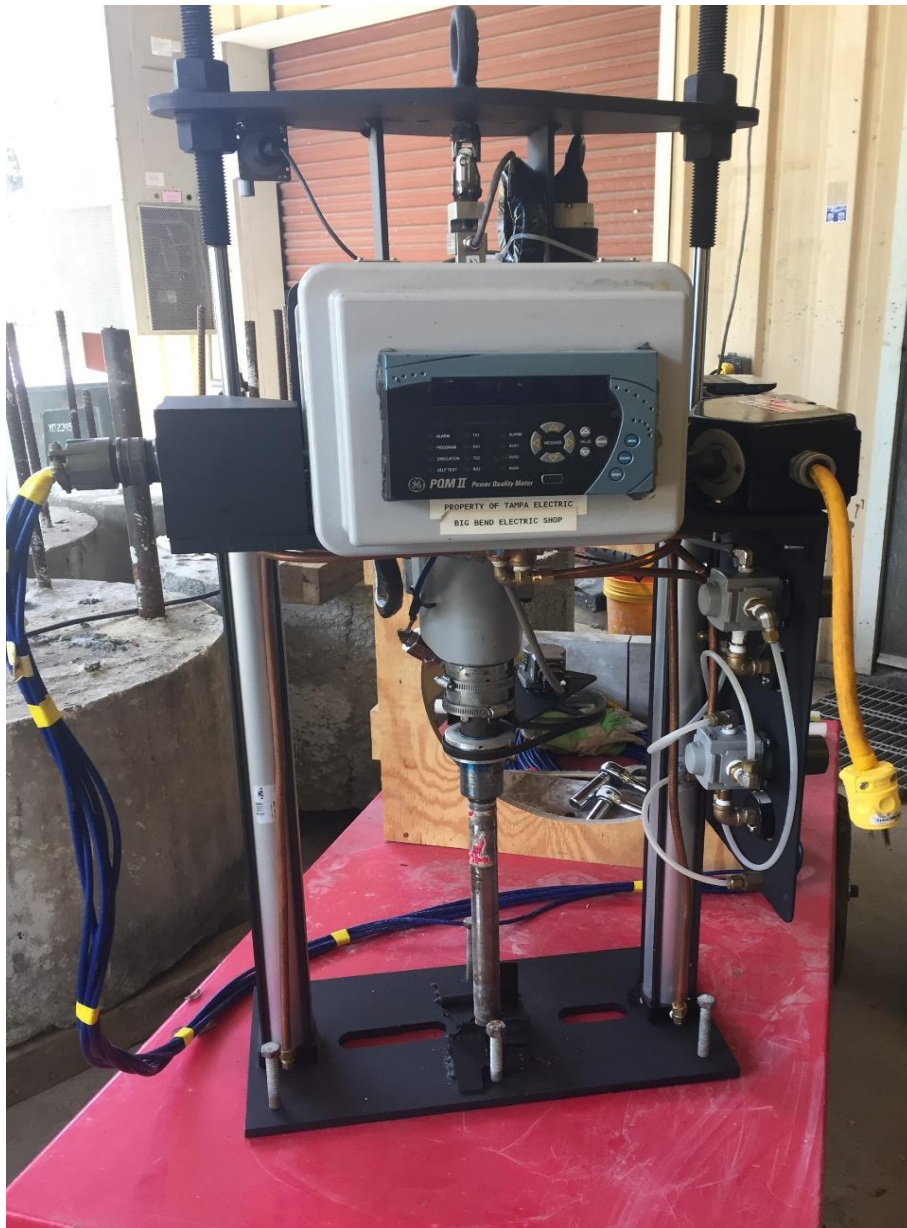
Figure 7.5 Front view

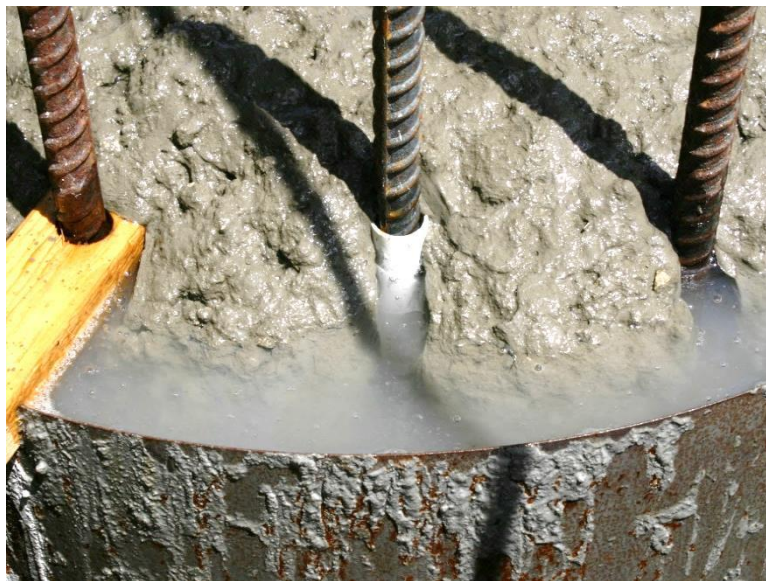
Figure 8.1 Radial concrete flow responsible for filling cover region.

As the timeframe for the formation of the radial / horizontal flow is relatively brief, it is likely that the degree of deterioration of concrete or slurry/concrete interface thickness of the laitance is minimal. Regardless, previous chapters have shown that the laitance does form. As vibratory consolidation of the concrete is rarely implemented in slurry-type drilled shaft construction, the region outside the cage is highly likely to contain veins of poorly cemented or diluted, high w/c ratio material. In the cases where bentonite is used, these veins contain trapped bentonite (Figure 8.1).

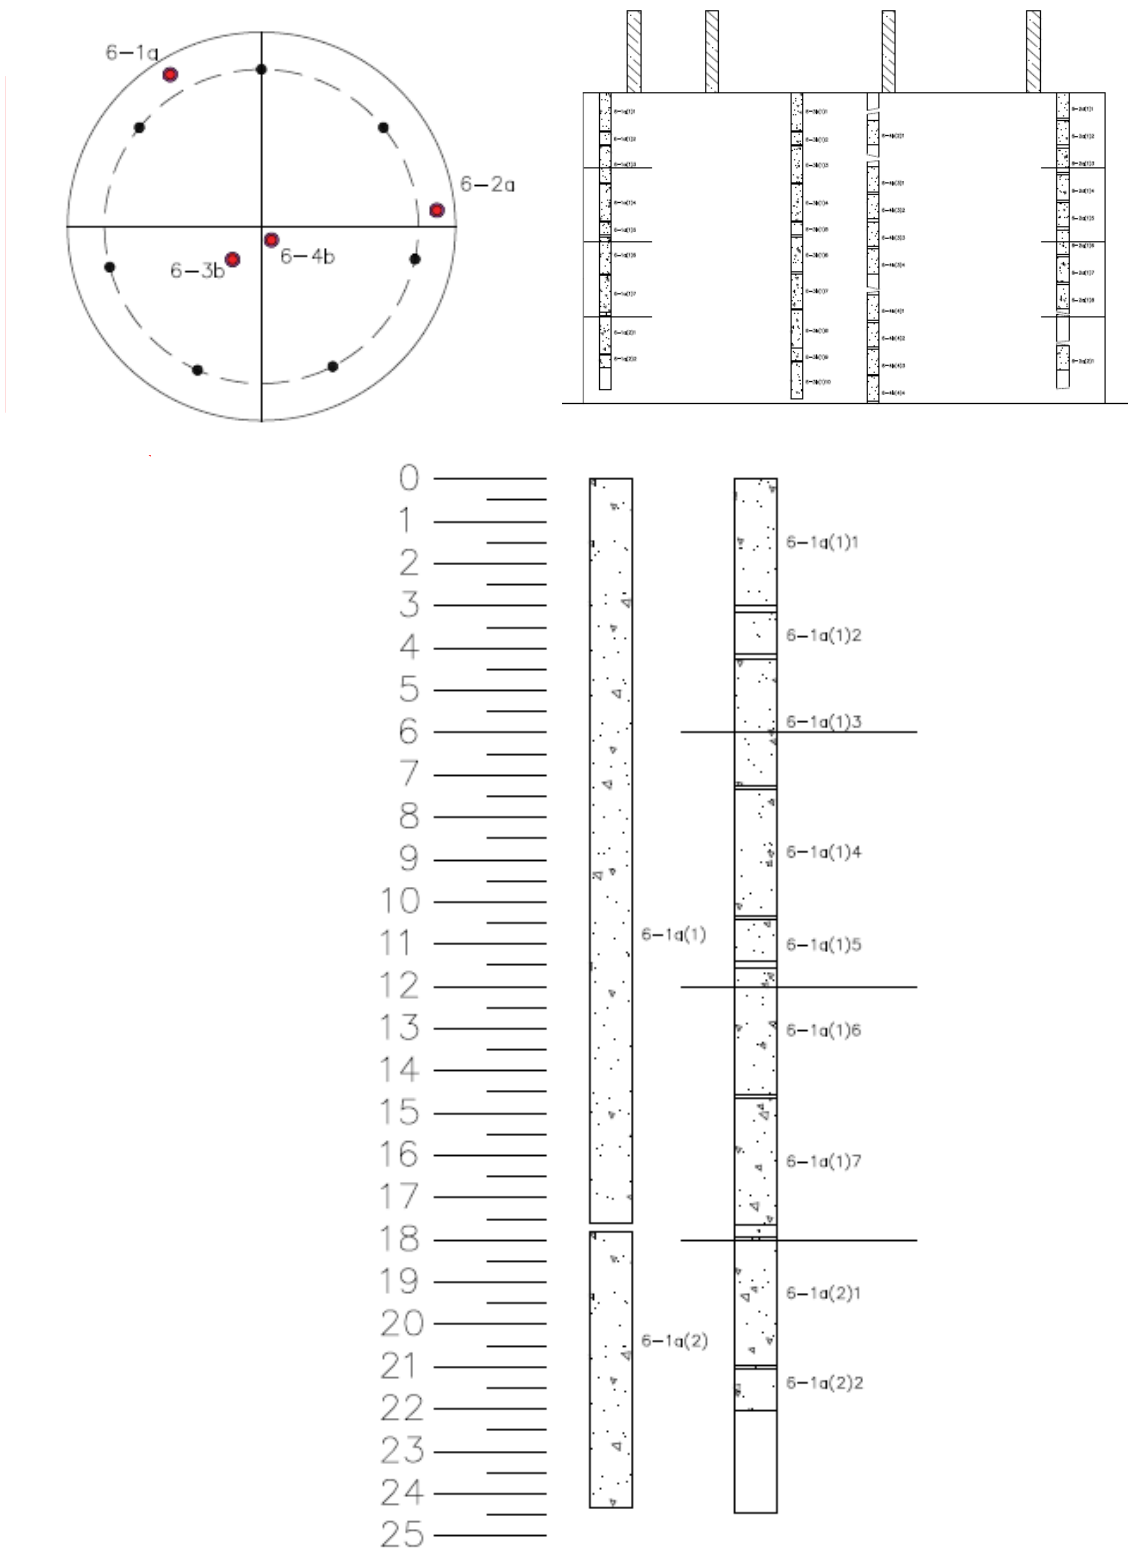
Figure 8.5 Core location and profile for 6-1a.

Cores were labeled using the following format: The first number was the shaft number. The second number denoted the region of the shaft from which the core was taken (the shafts were divided into four quadrants). The letter *a* or *b* indicated whether the core was outside or inside the reinforcement cage, respectively; *a* means the core was taken from outside the reinforcement cage in the cover region, and *b* denotes a core sample from within the reinforcement cage. The following number in parenthesis was the segment of the core. The last number was the section number cut from the noted core segment. For example 6-1a(2)1 denotes shaft 6, quadrant 1, outside of the reinforcing cage (*a*), second piece of the recovered core, and the first/uppermost sample from that core. Figure 8.5 shows the coring locations of Shaft 6 as well as the profile of the core.
