EVALUATION OF SELF CONSOLIDATING CONCRETE AND CLASS IV CONCRETE FLOW IN DRILLED SHAFTS

BDV25-977-25

FINAL REPORT

January 2020

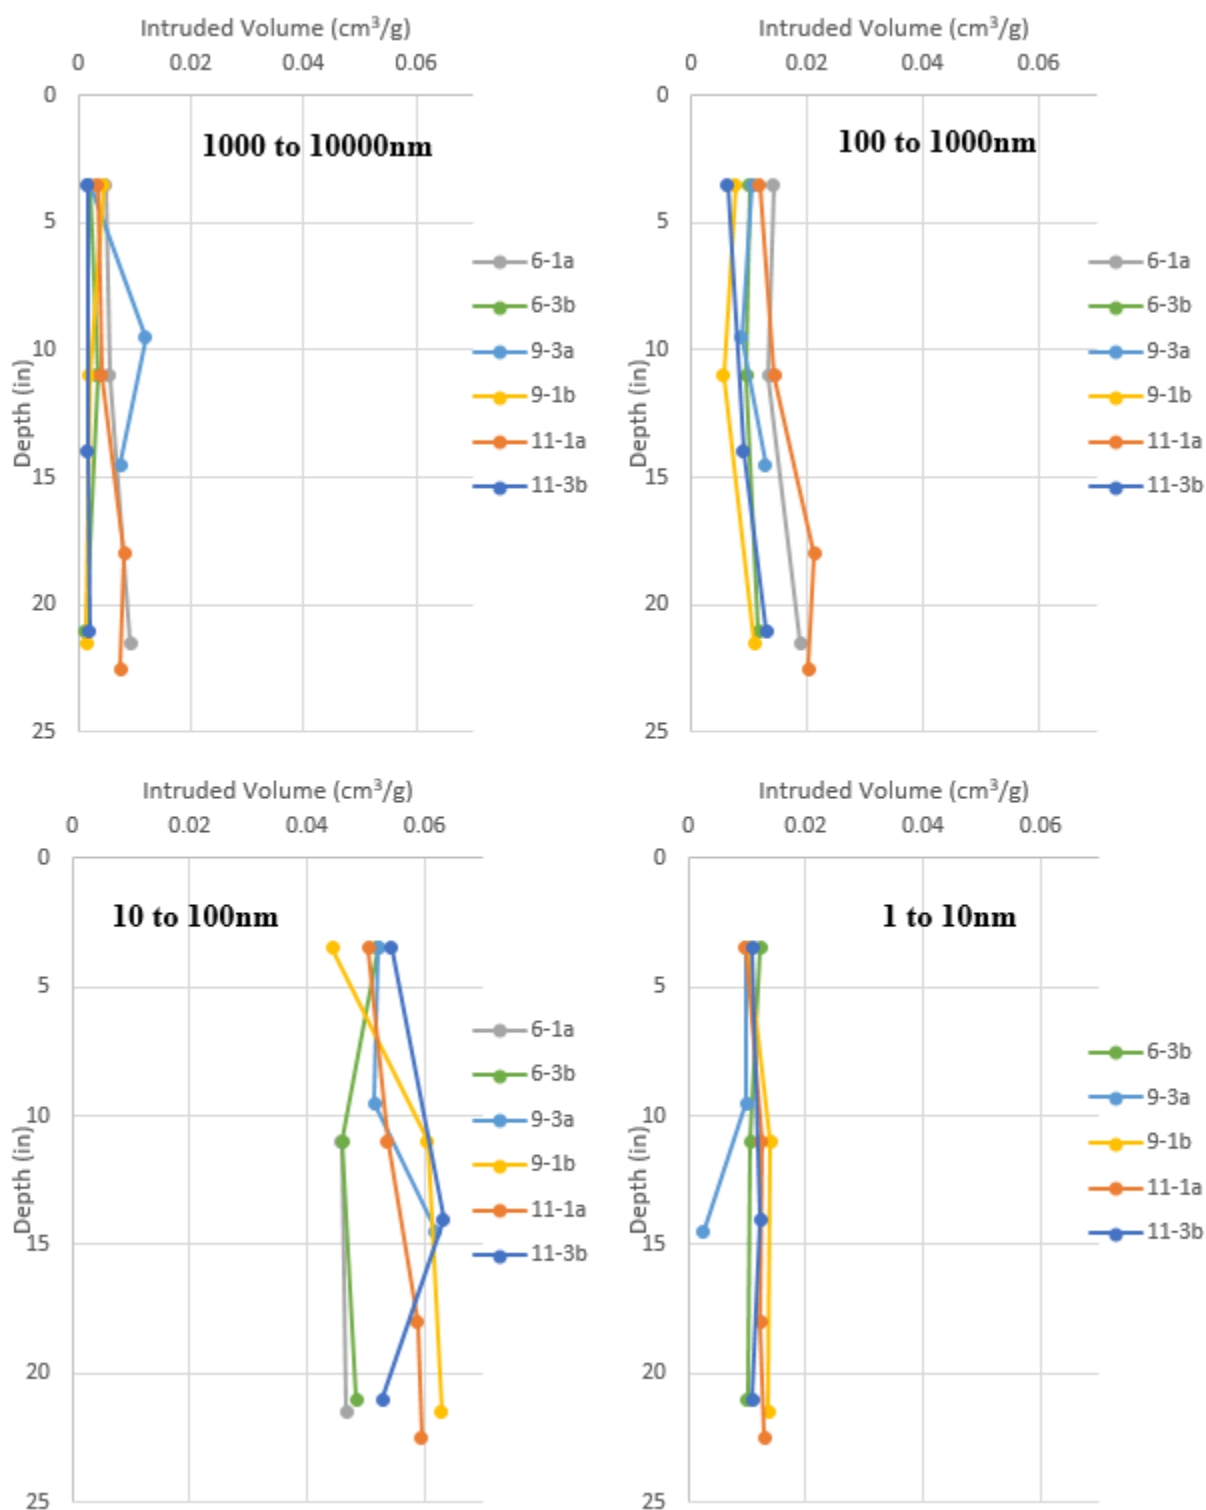
Figure 8.13 The four groupings of intruded volume.

Correlating with the pore size distribution, data was then broken into four groupings: 1,000 to 10,000 nm, 100 to 1,000 nm, 10 to 100 nm, 1 to 10 nm and plotted versus depth, Figure 8.13. Again, referring to Figures 8.6-8.8, this is the difference in volume from the 10,000, 1,000, 100, 10, and 1 locations. For example, 10 to 100 nm graphs show the value at 10 nm minus the value at 100 nm. Here again it can be noted that the 10 to 100 nm range has a higher intruded volume. This is also the trend seen in Figures 8.10-8.12. No significant variation is seen as a function of vertical position in the shaft.

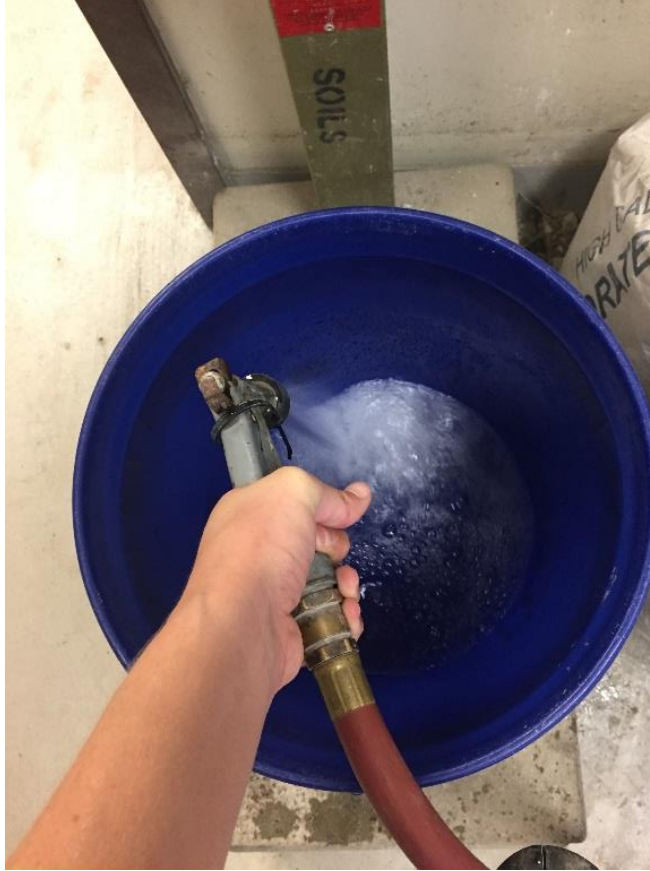
Figure 8.29 The water being measured out for the slurry.

- Measure out the needed amount of water (Figure 8.29)
- Add soda ash to water to raise pH to 9-10 pH per manufacturer recommendations (6.9 grams/3 gallons of water) and mix (Figures 8.30 and 8.31)
- Measure out needed amount of bentonite powder and slowly add to water mixture, mix until homogenous (Figure 8.32)
- Measure viscosity using Marsh funnel (Figure 8.33)

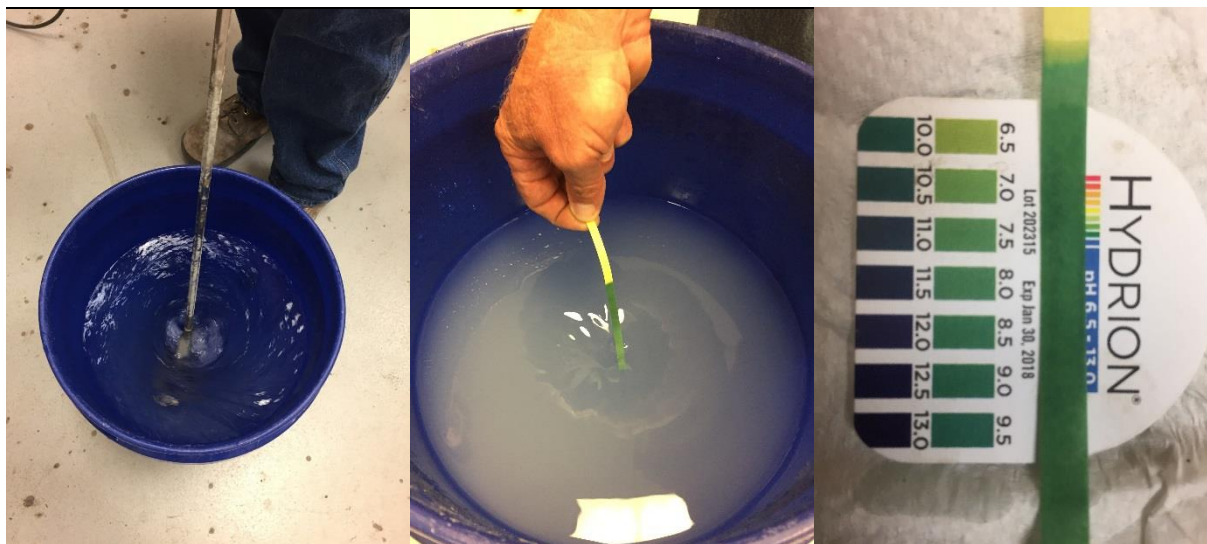
Figure 8.31 The pH being tested to ensure the water is at 9-10 pH.

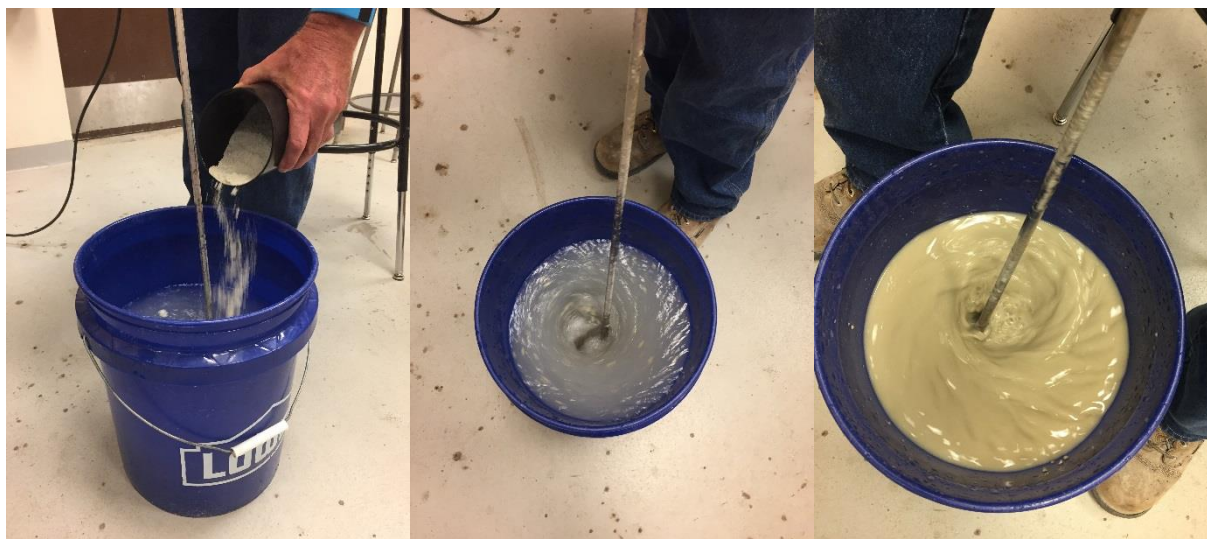
Figure 8.32 The bentonite powder slowly being added to the water (left) to form the slurry (middle and right).

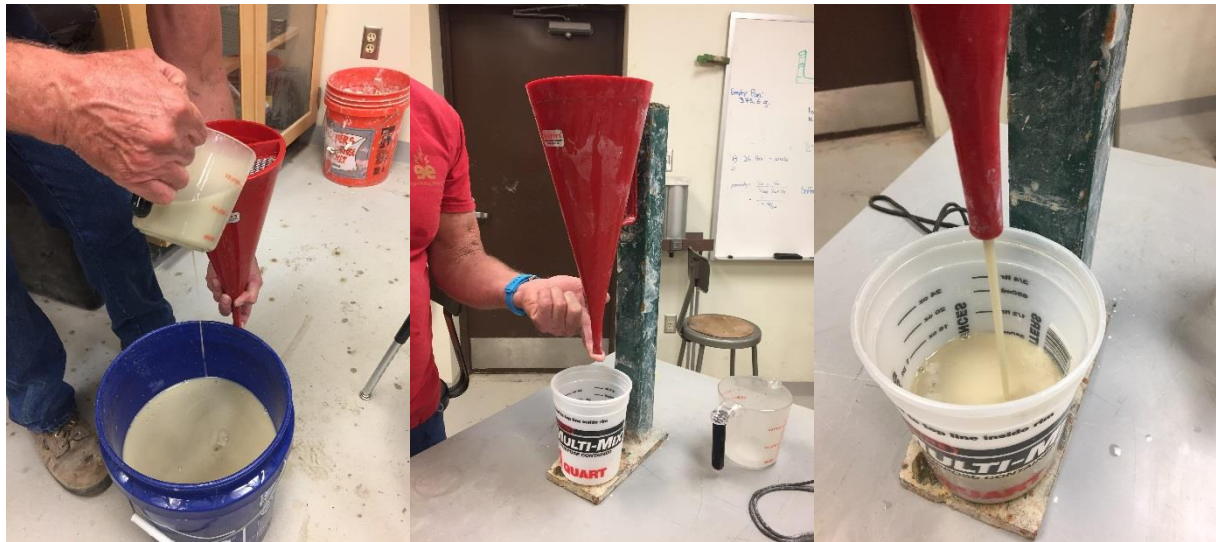
Figure 8.33 Testing of the bentonite slurry viscosity using the Marsh funnel.

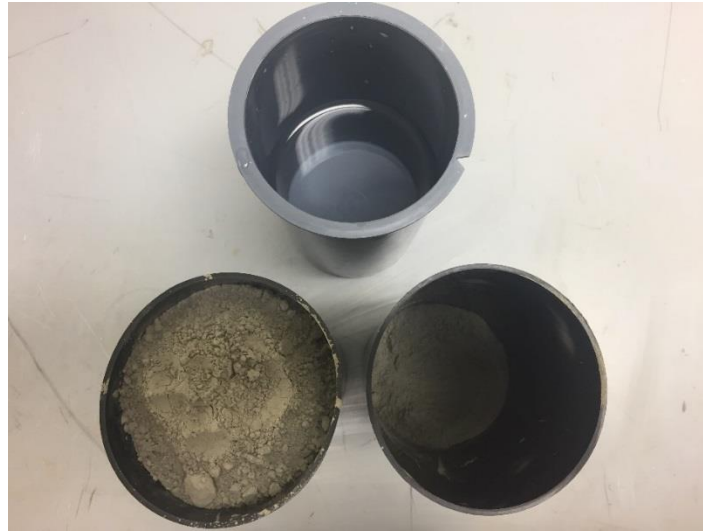
Figure 8.36 All measured out ingredients for mix 1.

The control mix consisted only of water and cement to form the paste (Figure 8.36). Mixing proportions were designed for a 0.4 w/c ratio and can be seen in Table 8.5. The mixing procedure for mix 1 follows ASTM C305-12 section 7 as there were no other variables to take into account for this mix design (Figure 8.37).

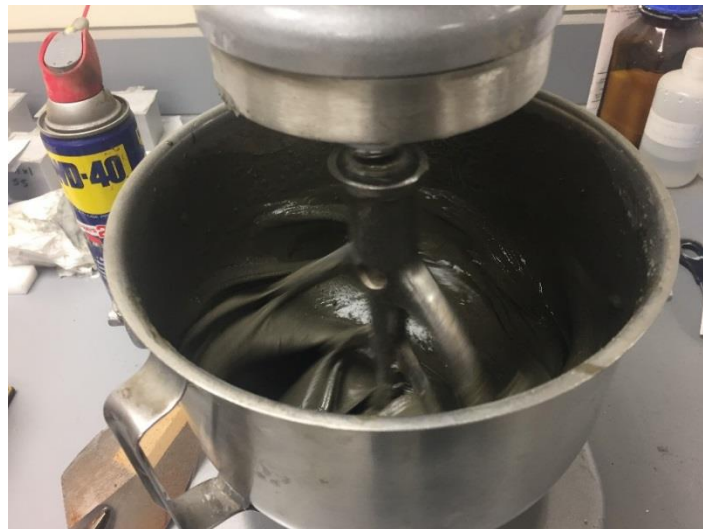
Figure 8.37 Mixing the paste.

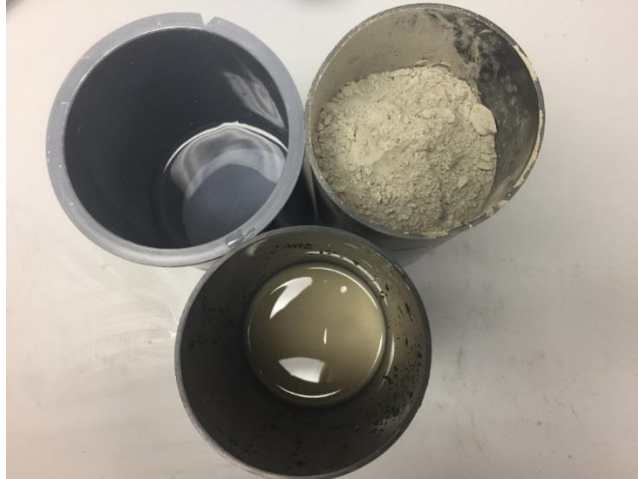
Figure 8.38 All measured out ingredients for mix 2.

- Measure out all ingredients (Figure 8.38)
- All water was placed into mixing bowl
- The cement was added to the water and allowed to sit for 30 seconds for the absorption of the water
- The mixer was turned on for 30 seconds at speed 1 (slow)
- The mixer was stopped and the bowl was scraped as needed for 15 seconds
- The mixer was turned on for 60 seconds at speed 2 (medium)
- Bentonite slurry was added to the cement paste and mixed at speed 1 (slow) for 30 seconds (Figure 8.39)

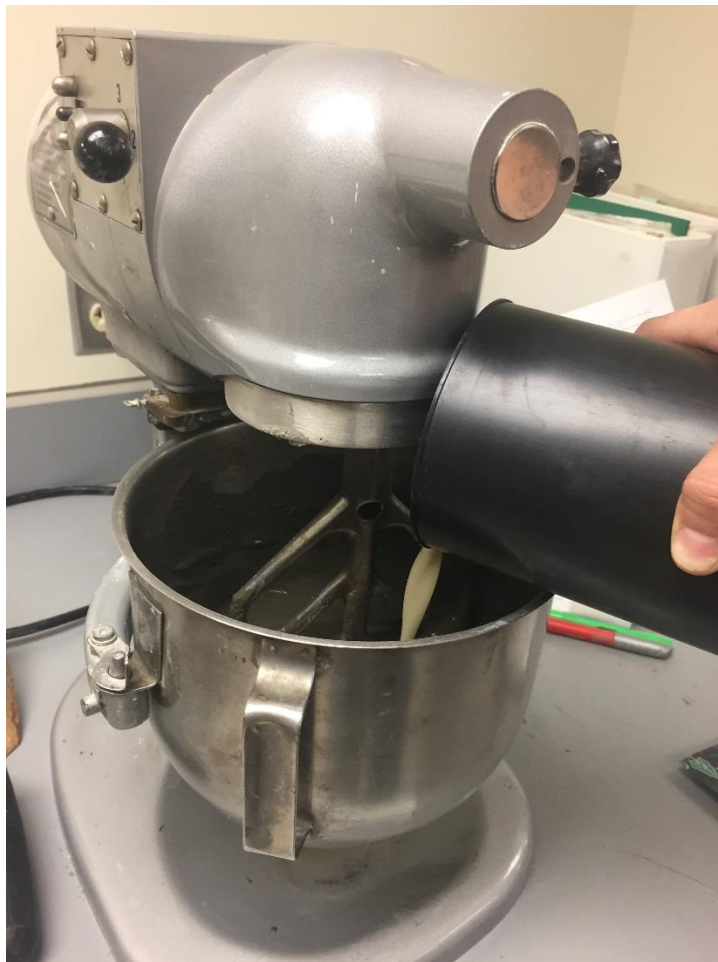
Figure 8.39 Bentonite slurry being added to mix 2.

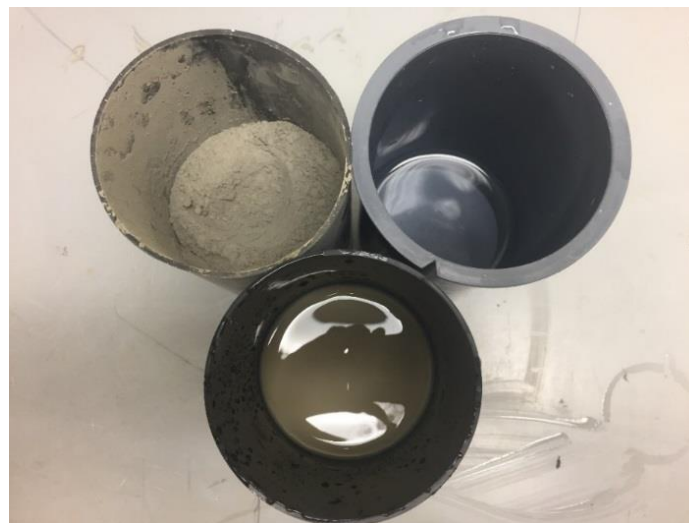
Figure 8.40 All measured out ingredients for mix 3.

- Measure out all ingredients (Figure 8.40)
- All water was placed into mixing bowl
- The cement was added to the water and allowed to sit for 30 seconds for the absorption of the water (Figure 8.41)
- The mixer was turned on for 30 seconds at speed 1 (slow)
- The mixer was stopped and the bowl was scraped as needed for 15 seconds
- The mixer was turned on for 60 seconds at speed 2 (medium)
- Bentonite slurry was added to the cement paste and mixed at speed 1 (slow) for 30 seconds (Figure 8.42)

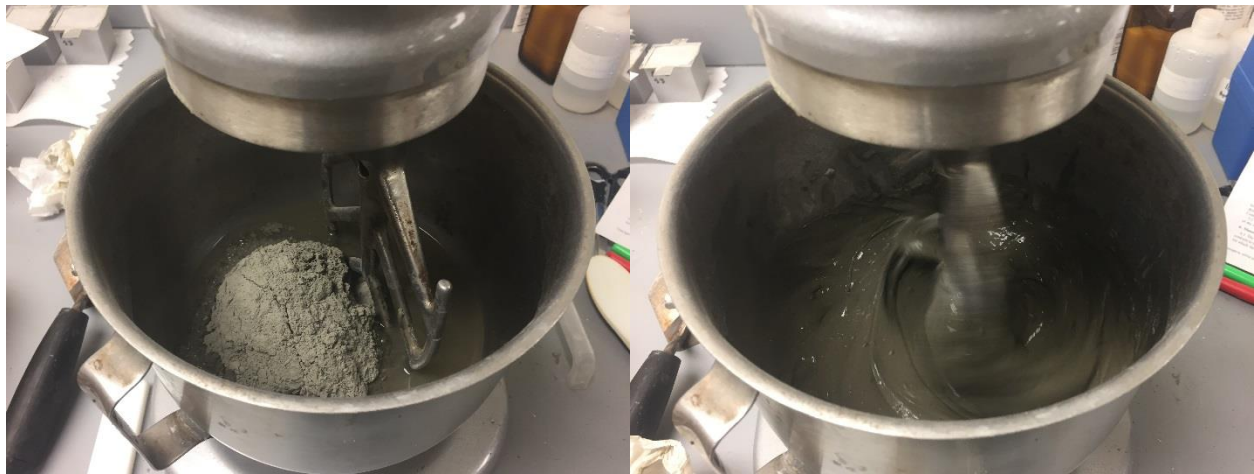
Figure 8.41 The addition of cement to water (left) and the mixing process (right).

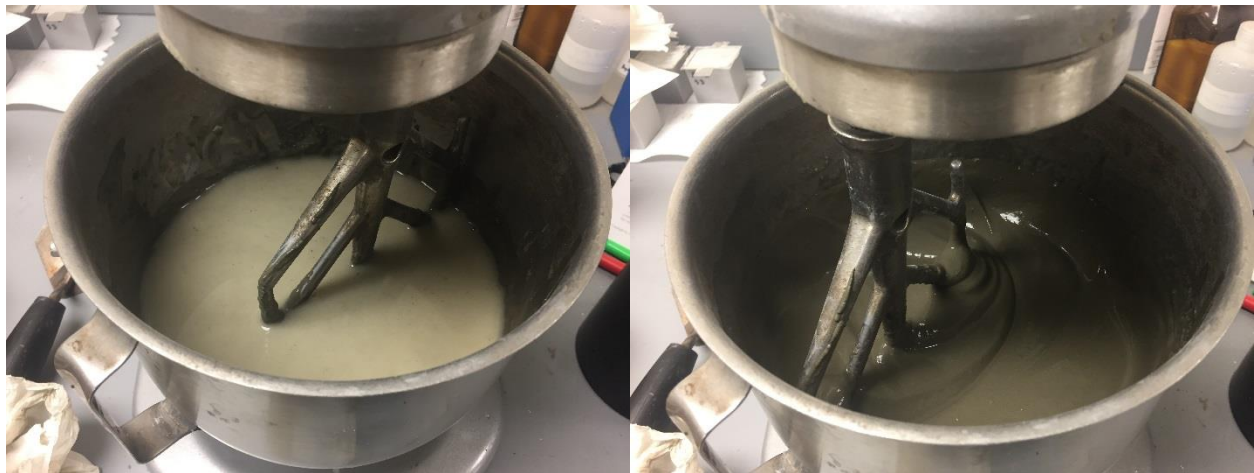
Figure 8.42 The addition of bentonite slurry to the mix (left) and the mixing process (right).

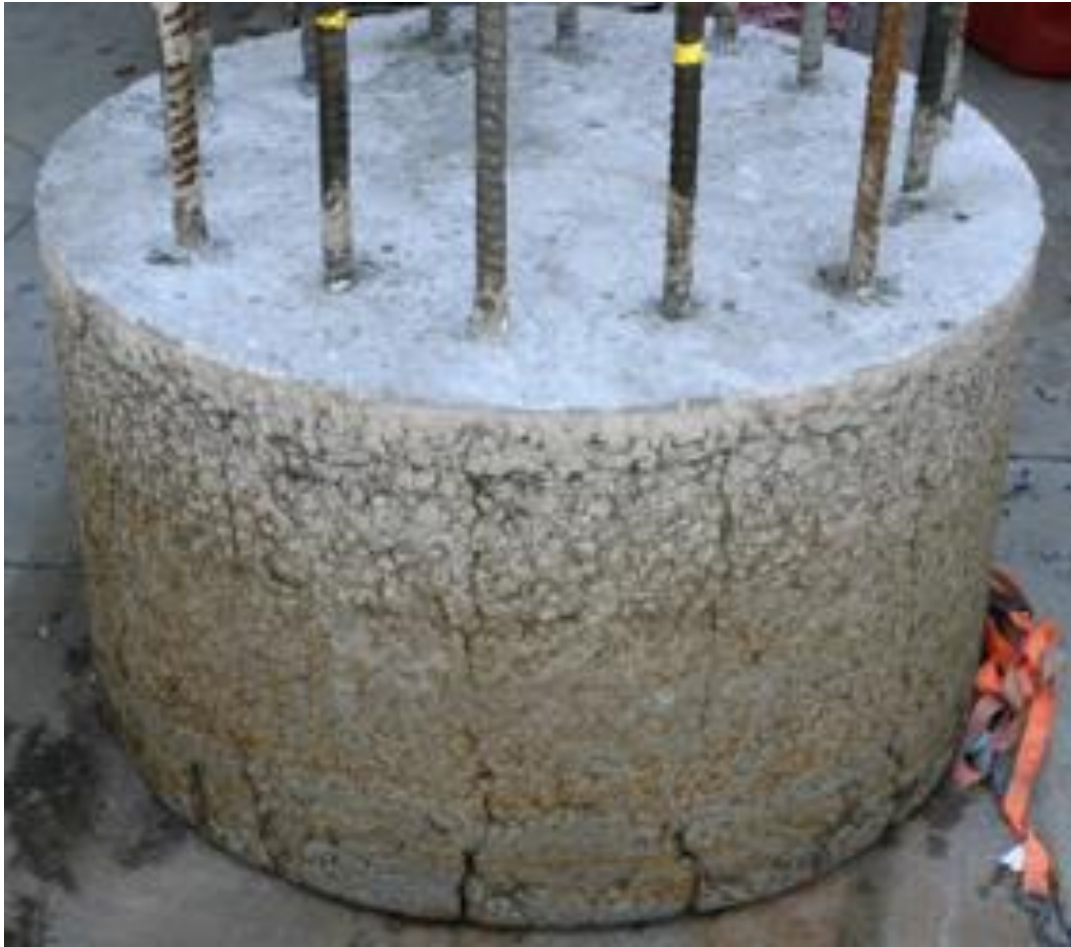
Figure 9.2 Visible mattressing upon form removal.

shaft immediately after form removal. Mattressing is visible on the surface and there is a thick layer of bentonite caked to the concrete (Figure 9.3). After pressure washing the surface of the test shafts, the mattressing become more apparent and the surface roughness was revealed. The state of deterioration on the shaft shown in Figure 9.4 was not uncommon in bentonite cast shafts.

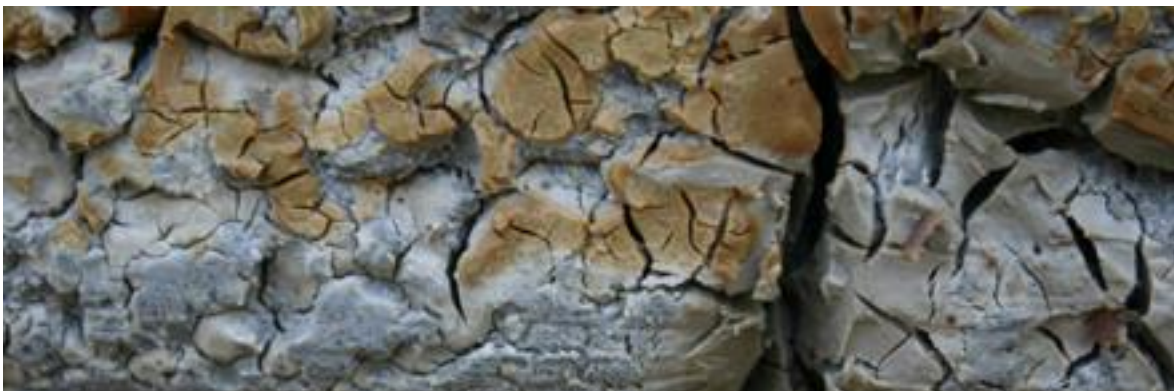
Figure 9.3 Bentonite caked to the concrete surface trapped between concrete and casing.

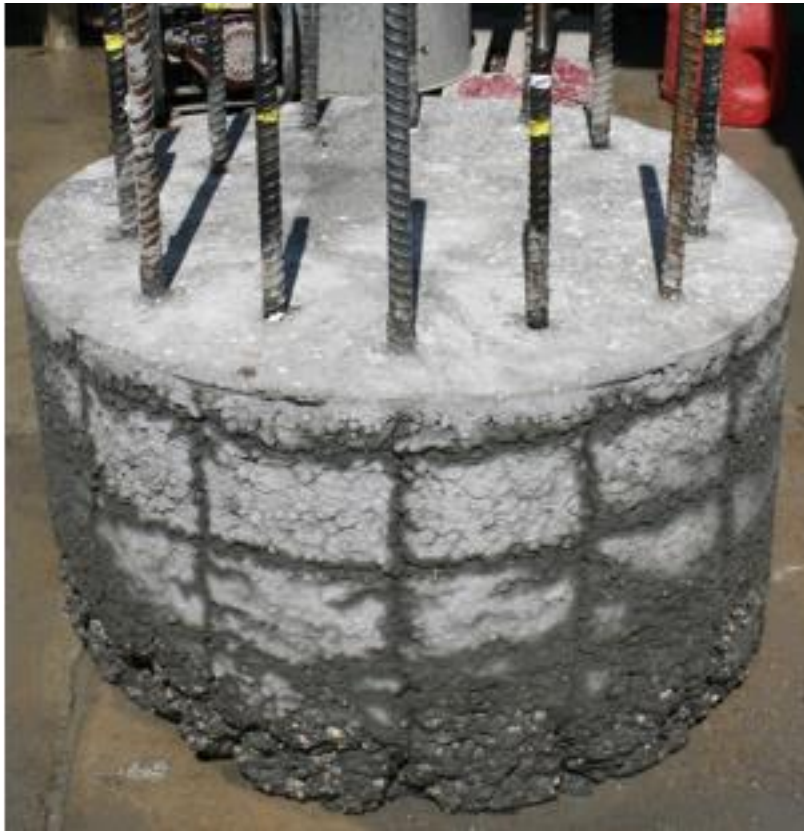
Figure 9.4 Visible mattressing after pressure washing

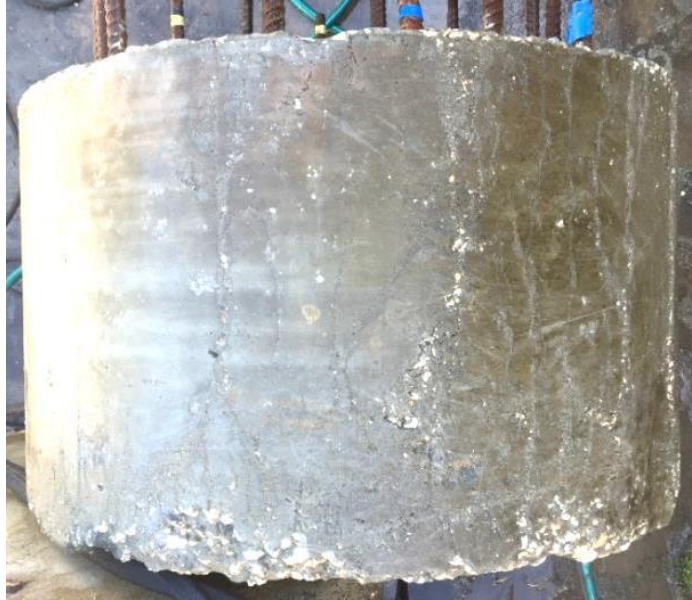
Figure 9.5 Shaft 6: f'_c 4358 psi; drilled shaft mix; water cast; smooth; faint channeling

Quantifying the surface roughness then became a primary focus of this work as surface roughness was suspected to be an indication of concrete quality (cover protection), which would then make external physical assessment a direct link to the internal health of the structural steel reinforcement and the structure as a whole. Visual inspection of the lab cast specimens immediately revealed variations in the surface texture that were in part a by-product of trapped support fluid between the outward flowing concrete and the simulated casing. Figures 9.5-9.7 demonstrate the differences seen between a water, bentonite, and polymer cast shafts.

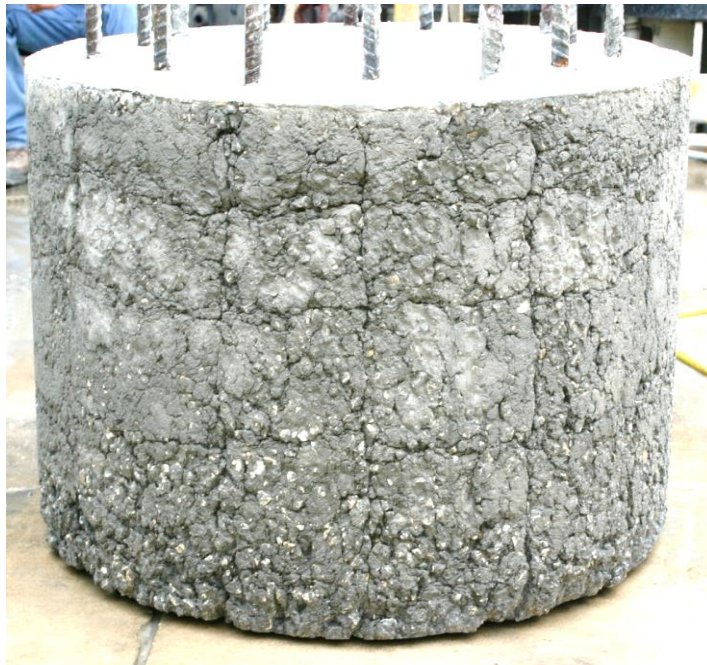
Figure 9.6 Shaft 9: f'_c 4530 psi; drilled shaft mix; 50 sec/qt bentonite; rough; with well-defined creases

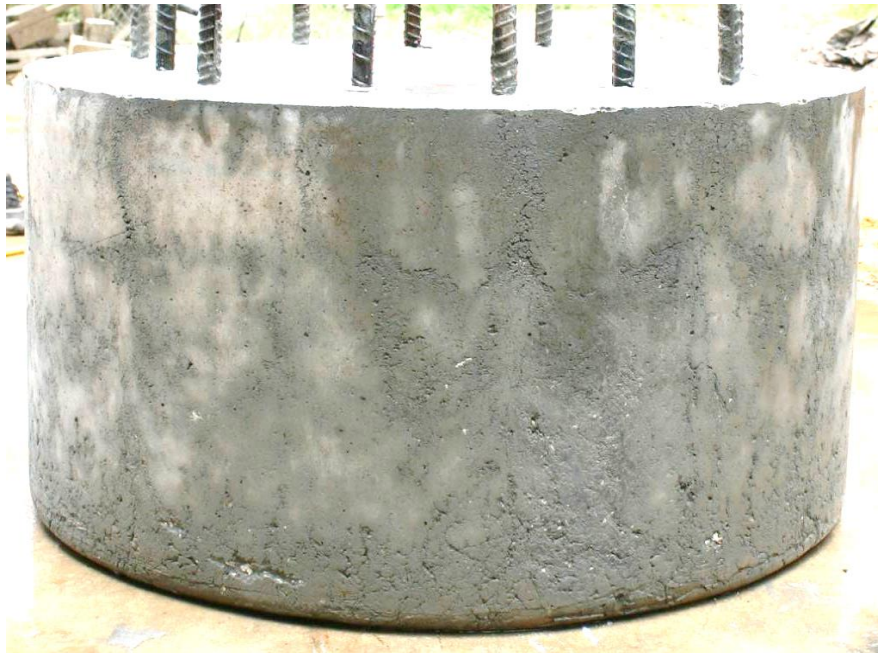
Figure 9.7 Shaft 11: f'_c 4530 psi; drilled shaft mix; 65 sec/qt polymer; smooth; no creases

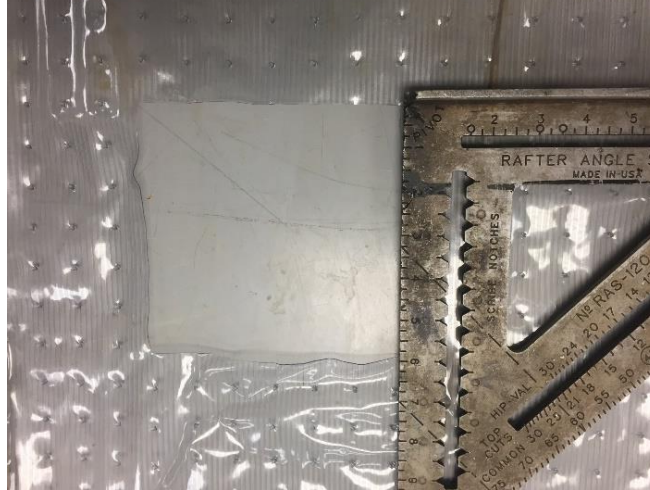
Figure 9.8 Template construction

Initially a testing area grid was created by cutting a 6-inch by 6-inch hole out of a sheet of thick plastic sheeting (Figure 9.8). This hole was used as a template for setting the limits of the testing area.

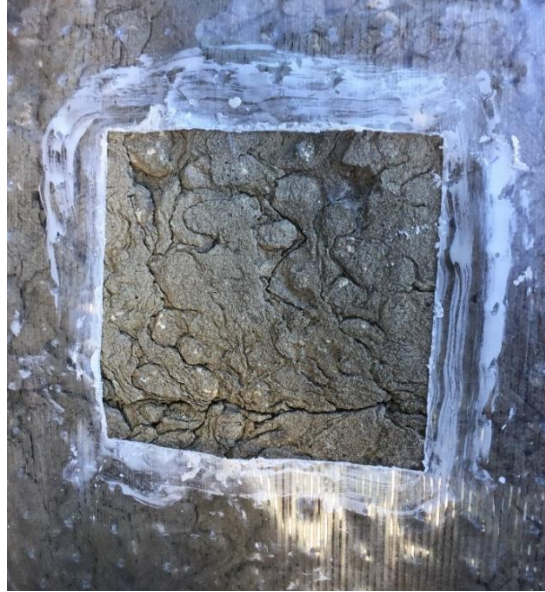
Figure 9.10 Testing template placed on shaft surface.

Next a beaker with a known volume was filled with drywall putty. Then all of the testing equipment was placed in a tray and the weight was recorded (Figure 9.9). The template was then placed on the surface of the shaft (Figure 9.10). This test was conducted two times on each shaft, care was taken to place the template on an area representative of the overall surface condition.

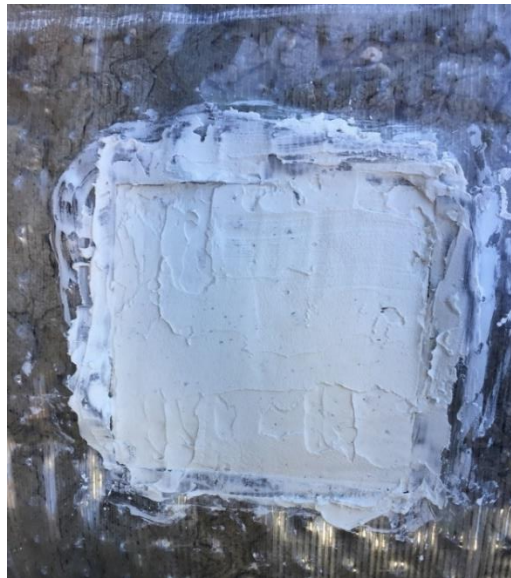
Figure 9.11 Testing template filled to approximate a void free surface

After putting on the rubber gloves, the putty knife was used to contour the concrete surface in the template area to approximate a smooth, void-free surface (Figures 9.11 and 9.12). Special care was taken to ensure all putty stayed on the tools, in the tray or on the concrete surface. The gloves, template, beaker with the remaining putty and all of the tools were then put back into the tray and reweighed (Figure 9.13). The difference in weight was then converted to a volume using the calculated density of the putty. Data tables can be found in Appendix H.

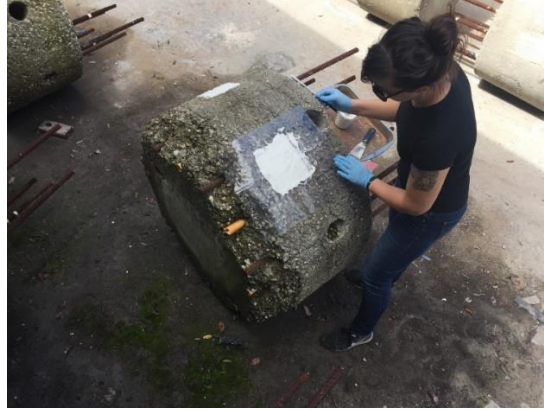
Figure 9.12 Testing the second location on shaft 10

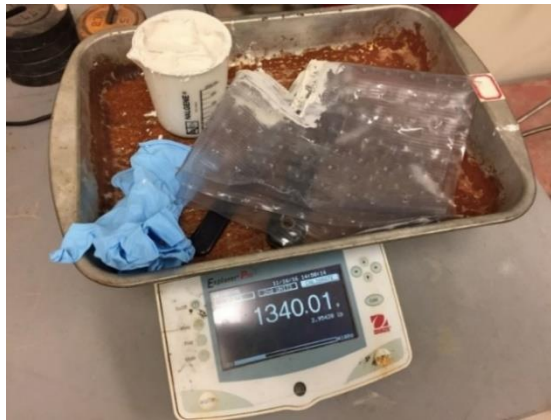
Figure 9.13 Weighing testing equipment after test is complete

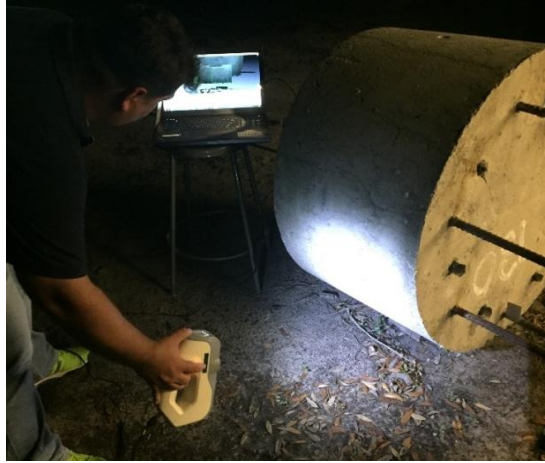
Figure 9.14 Scanning shaft 20

Shafts 1-24 were scanned on one side using an Artec Eva 3D scanner (Figure 9.14). An Artec Eva is a structured light device used to make texture and accurate 3D models of medium-sized objects such as the selected portions of the shafts. The handheld scanner captures precise measurements in high resolution, and can be used for multiple applications. Shafts 25-58 were scanned on one side using an Artec Leo 3D scanner (Figure 9.15). The chief difference in the two systems is that the Artec Leo offers onboard automatic processing.

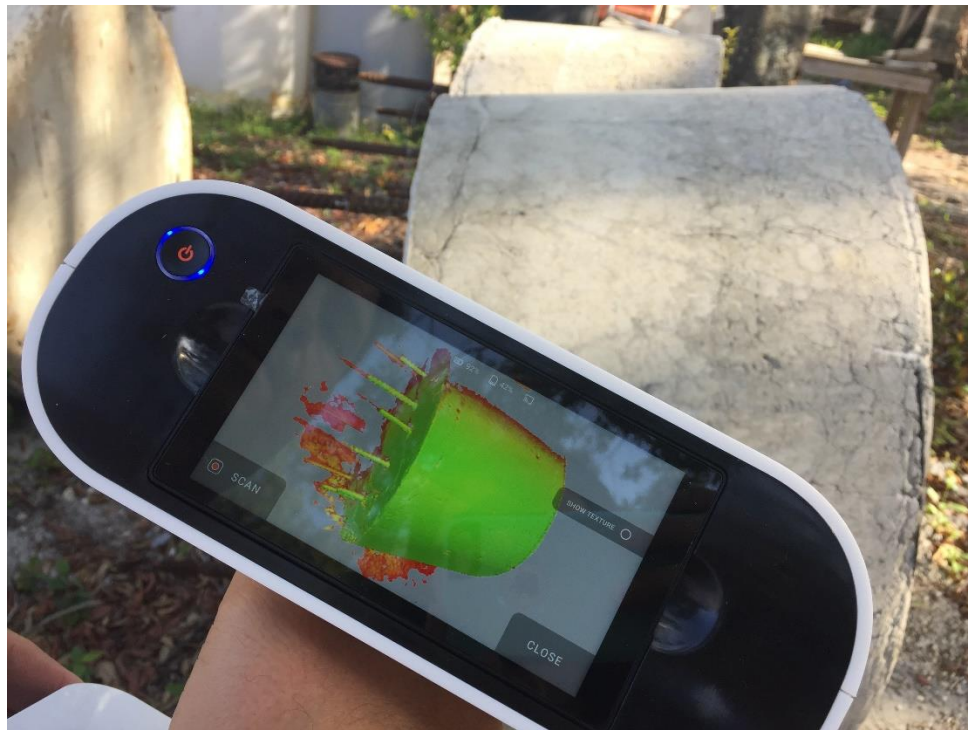
Figure 9.15 Scanning shaft 56

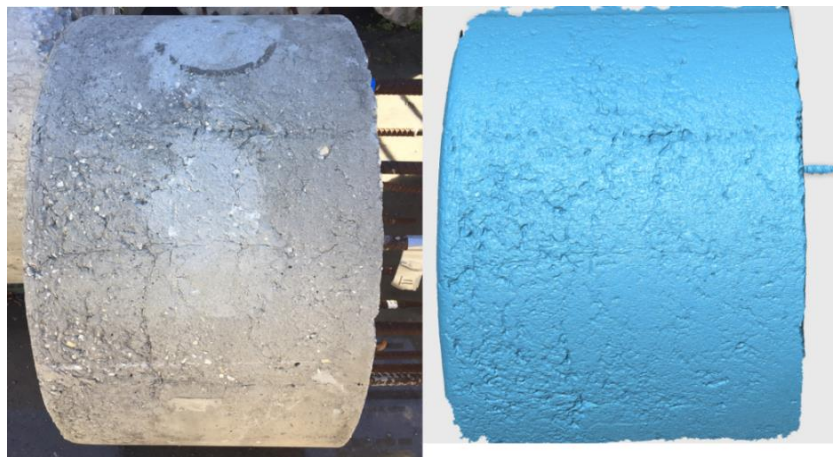
Figure 9.19 Shaft 11 photo and scan comparison

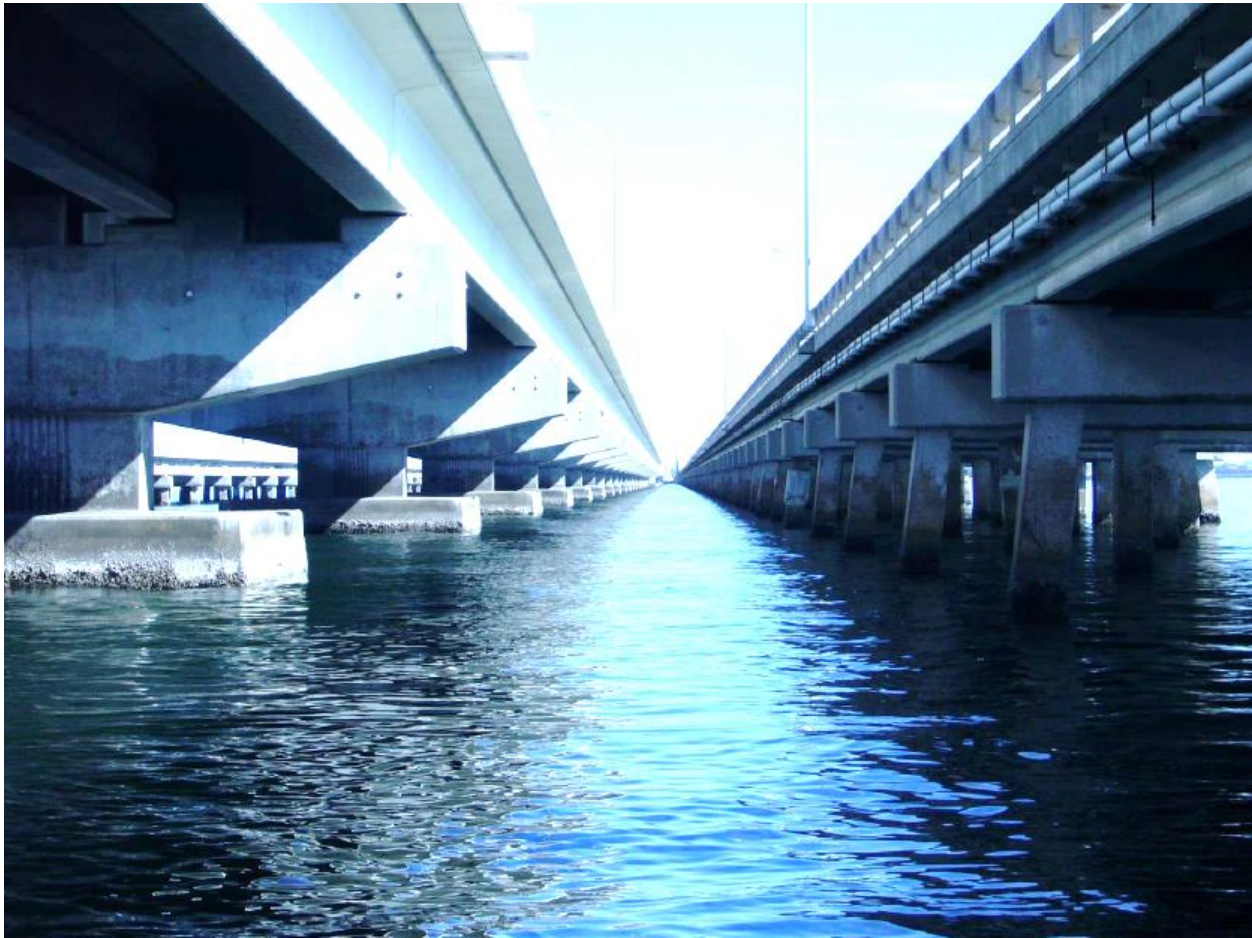
Figure 10.1 Newer cap and column pier design (left); older pile bent piers (right).

With extreme-event loading states often controlling pier/foundation designs for overwater bridges, there has been an almost complete change from bridge bents to cap and column footings. The net effect was to make all foundation elements (piles or shafts) work in concert to resist vessel impact loads. As a result, most new bridge piers have fully submerged foundation elements. Figure 10.1 shows the two variants comprising the east and west bound bridges in the Gandy Bridge corridor of Tampa Bay.

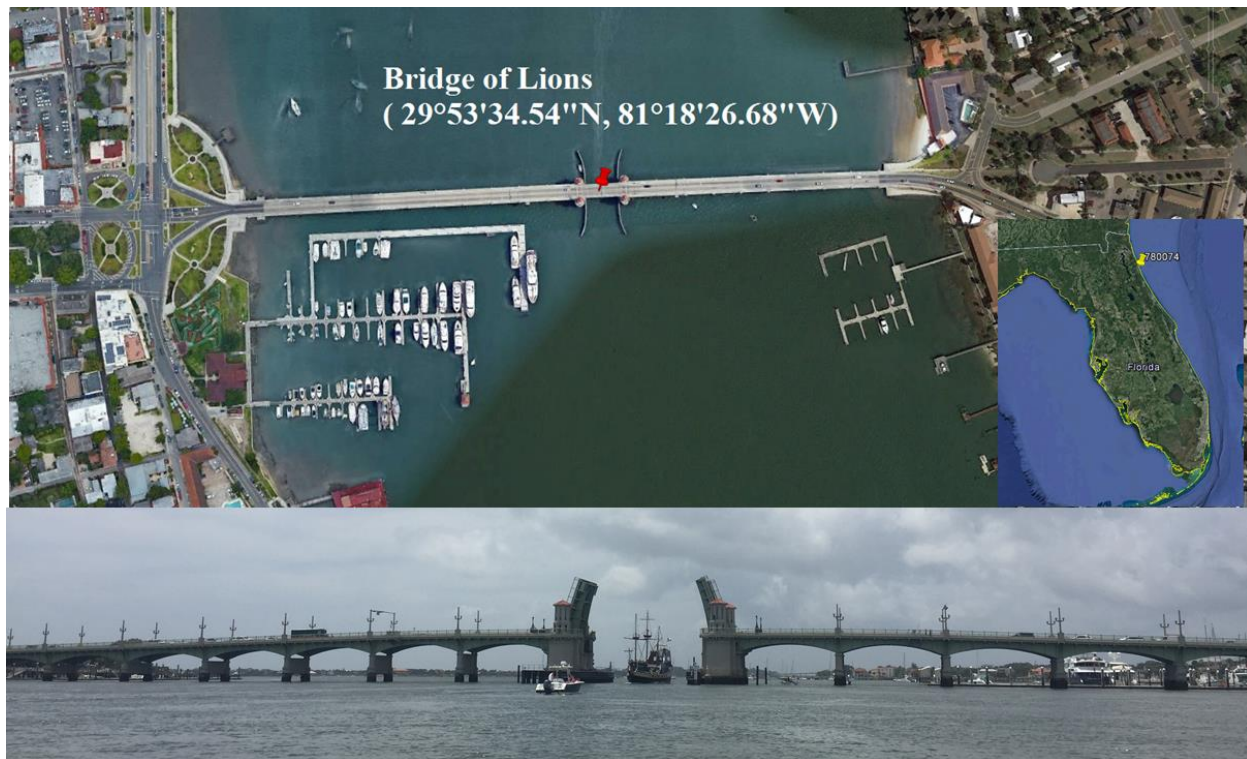
Figure 10.3 Bridge Number 780074 (Bridge of Lions) plan and elevation images.

Bridge of Lions is a double-leaf bascule bridge that stands on 25 piers (Figure 10.3). These piers are supported by drilled shafts ranging from 3 to 8 ft in diameter (Table 10.2). Inspection records show that the drilled shafts on piers 10 and 11 have steel casings extending up from the ground line to within 6 ft of the bottom of the footing. This is not a clear indicator that exposed concrete will be available for inspection. Inspection report photographs show delamination above the water line and minor damage to the fender system. The underwater photos do not indicate that any vegetation was removed for inspection and as such cannot be used to confirm or deny the presence of casing. Based on review of the information provided for this bridge, further on-site evaluation was warranted.

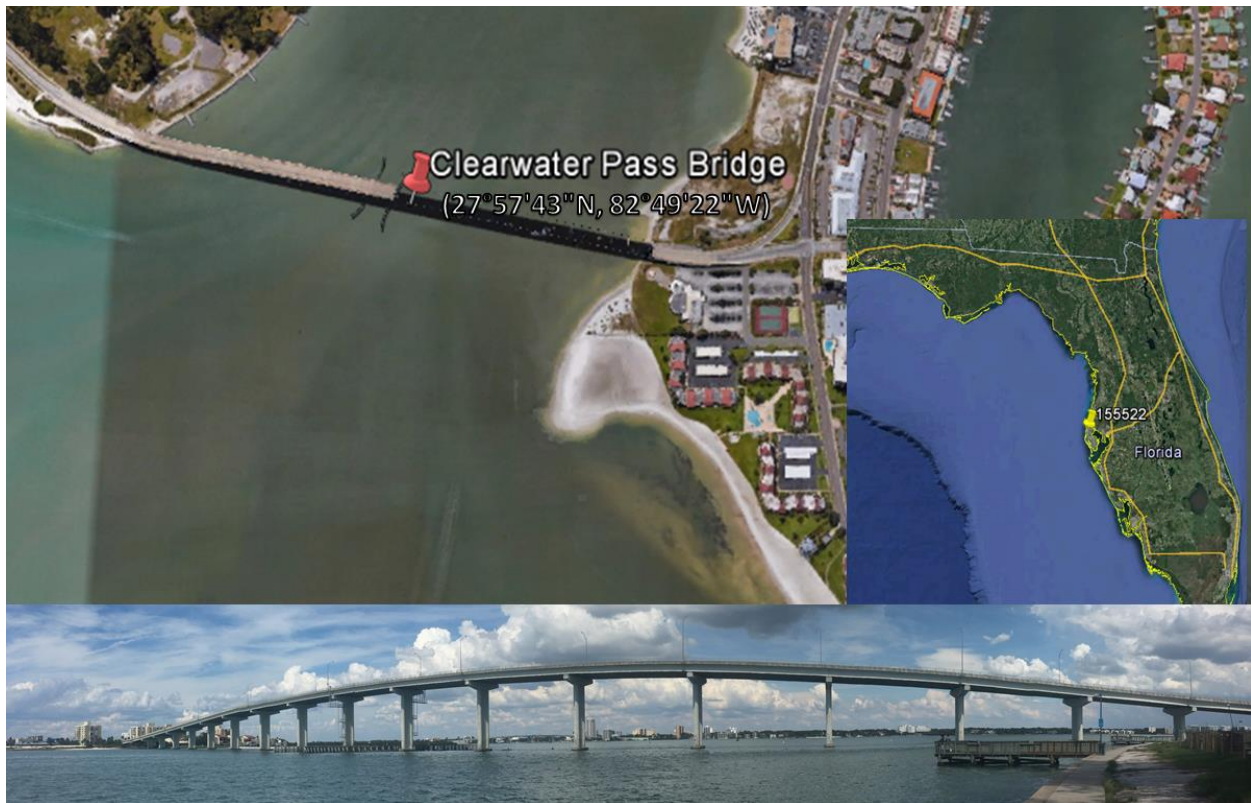
Figure 10.5 Bridge Number 155522 (Clearwater Pass Bridge) plan and elevation images

The underwater inspection report from 2017 indicates that the scour has exposed the concrete surface below the casing on 12 shafts. The depth of exposure varies from 7 to 42 inches. The concrete is noted as “irregular with no exposed steel.” This bridge was constructed using natural slurry, but the concrete irregularities may still warrant field verification. Based on review of the information provided for this bridge, further on-site evaluation was warranted.

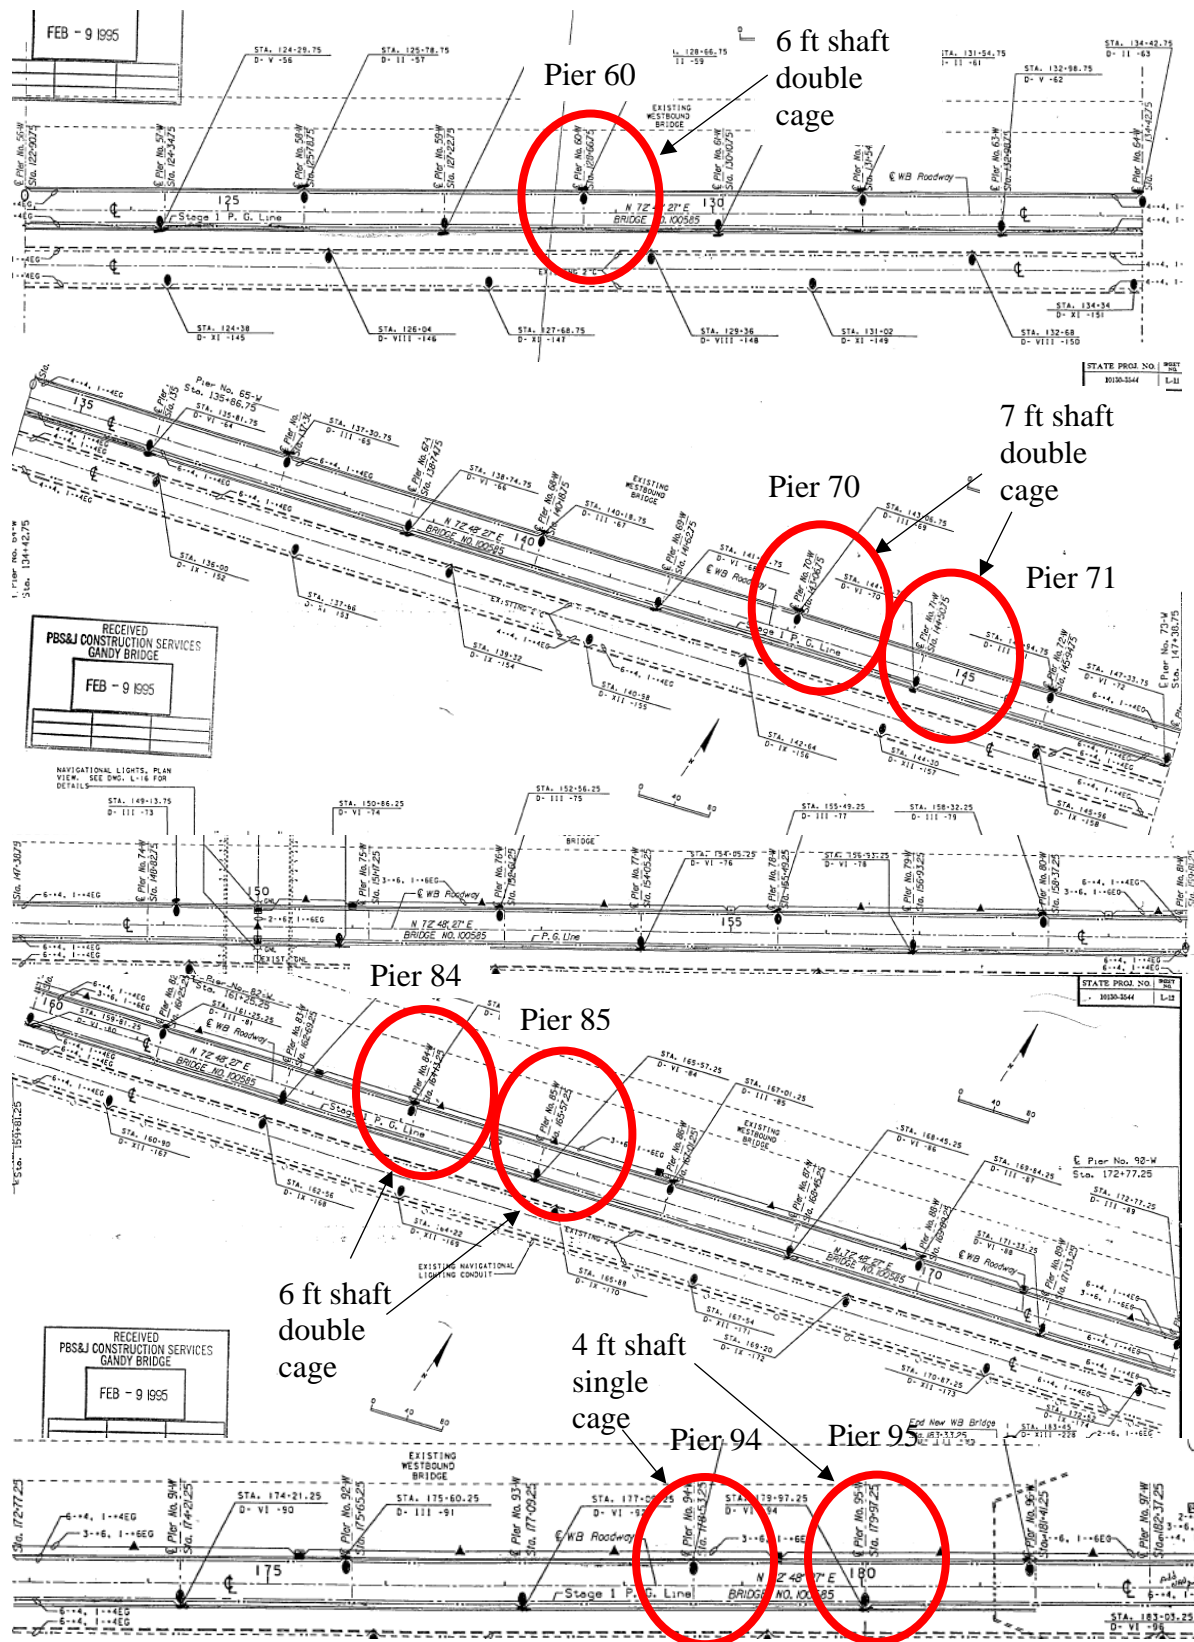
Figure 10.18 Plan view of eastern portion of Gandy Bridge. The piers that were inspected have been circled.

For dive inspections, shafts were selected based on the dive inspection reports provided by FDOT from Bolt Underwater Services. Uncased shaft locations were provided, as well as the presence of any voids or honeycombing. Piers with voids and honeycombing were selected in addition to piers without deficiencies. Later, to provide a means for observation of the encased concrete surfaces and for comparison with concrete surfaces that were not directly exposed to the surrounding environment, windows were cut in the casings of selected shafts. Figure 10.18 shows the plan view of the eastern portion of the bridge and has the inspected piers circled. Figure 10.19(a) shows the drilled shaft numbering protocol, where shafts are labeled 1-4, with 1 being NW, 2 SW, 3 NE, and 4 SE. Figures 10.19 (b) to (d) show the shaft sizes and layouts of reinforcement cages used. More detail can be found in Appendix K. A summary of piers inspected along with their shaft sizes, reinforcement cages, and comments made by the dive inspectors can be found in Table 10.17.

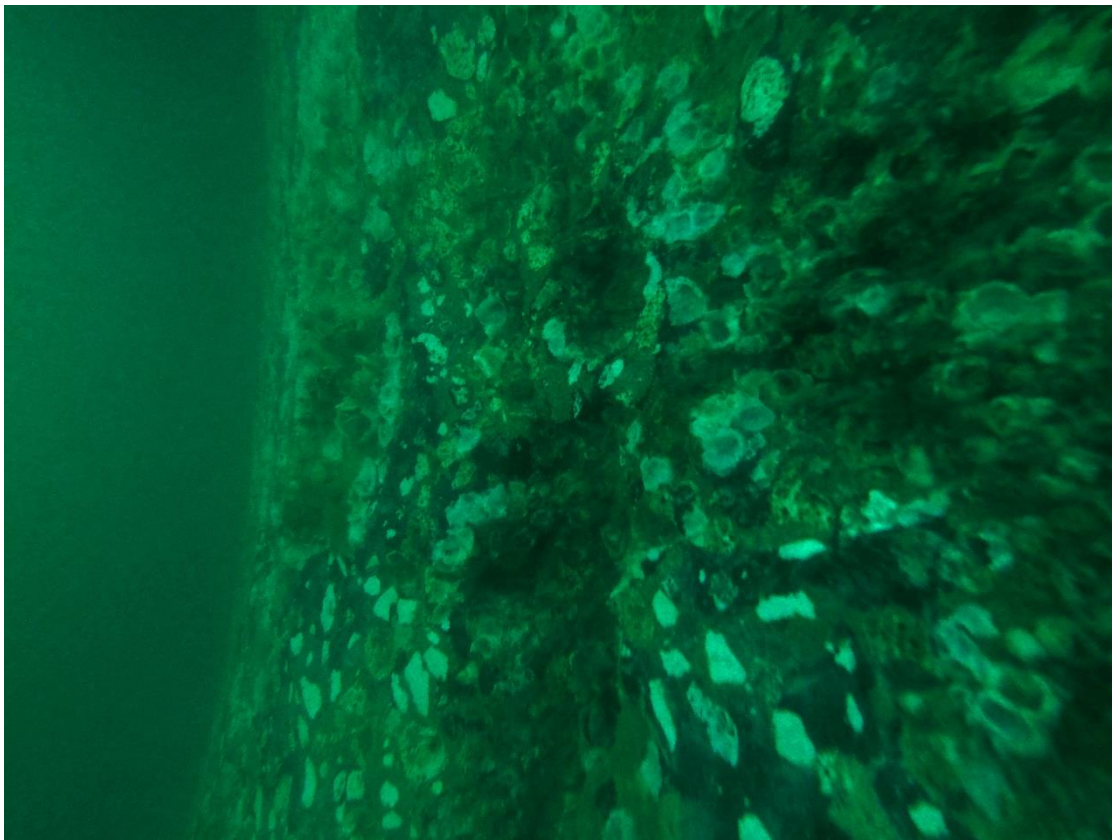
Figure 10.23 Large void found on the south side of 71-4.

Pier 71 contains 7-ft diameter Type 1 shafts (Figure 10.19(d)). Two shafts 71-1 and 71-4 were listed as having voids in the dive report, and shaft 71-4 was chosen for cleaning and inspection. Unfortunately, no images of the shaft were taken before cleaning; however, it looked similar to shaft 84-4 (Figure 10.24), covered in a layer of barnacles. Figure 10.20 shows each side of the cleaned portion of the shaft. The 7-ft shafts had small voids in the cleaned concrete surface (Figure 10.21). Sections of cleaned concrete can be seen up-close in Figure 10.22; note that this concrete was the roughest seen on this bridge. Figure 10.23 shows a long crevice in 71-4.
