EVALUATION OF SELF CONSOLIDATING CONCRETE AND CLASS IV CONCRETE FLOW IN DRILLED SHAFTS

BDV25-977-25

FINAL REPORT

January 2020

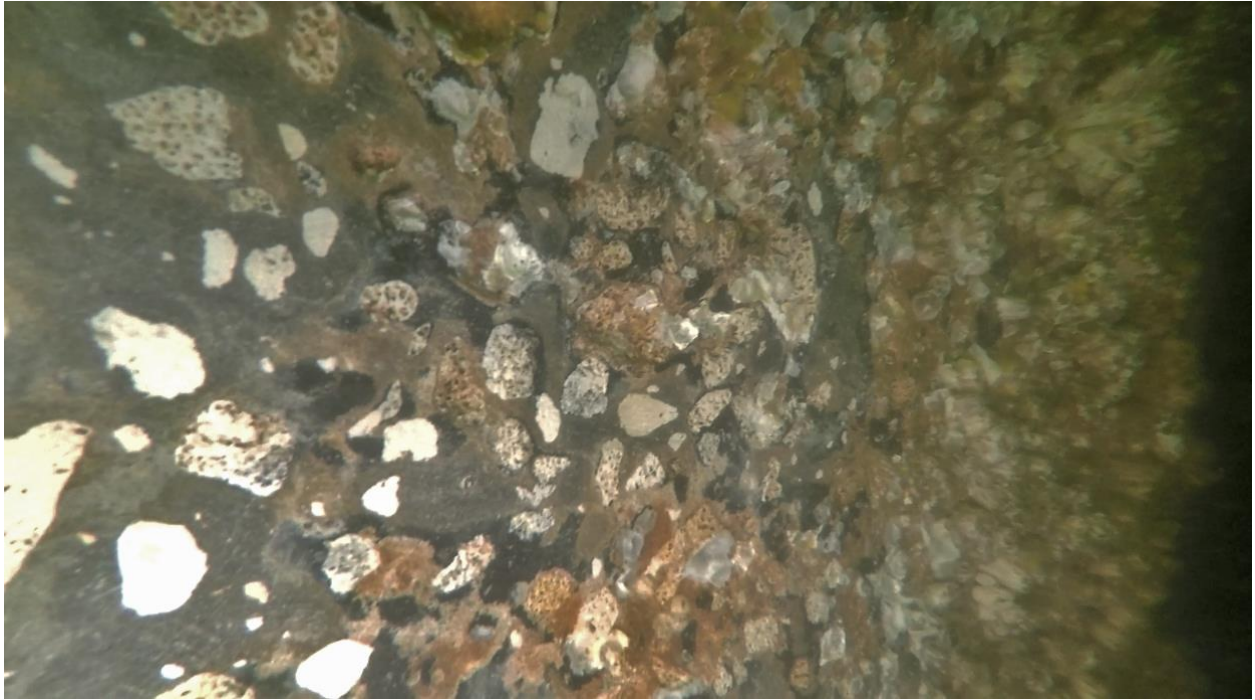
Figure 10.25 Shaft 84-4 partially cleaned, note clean concrete going into layer of barnacles.

layer is better viewed in Figure 10.25 where the cleaned concrete transitions into the barnacle layer. Figures 10.26 and 10.27 show the cleaned portions of the shaft from east and southeast sides. It can be seen in these figures that the concrete is not completely smooth. The circled red areas on Figure 10.26 represent areas of the cleaned concrete that are filled with barnacles. Therefore the 6-ft Type 1 shafts seem to experience at least small voids in the concrete. This is suspected to have been caused by the double reinforcement cage. Figure 10.28 shows the layers found when cleaning the concrete. Consistently throughout the examination of the Gandy shafts, encrustations were found consisting of barnacles and miscellaneous plant life/organisms. Upon initial cleaning, barnacles were knocked/scraped off and the remnants of the barnacle attachment were then removed. Below this layer, a thin black layer was encountered which was difficult to remove. In cases of smooth surfaces with no significant voiding, pristine concrete could clearly be seen. Rougher surfaces with voids retained the plant life, barnacles and black layer. Except for isolated instances, there was no attempt to dig into voids and determine the full depth.

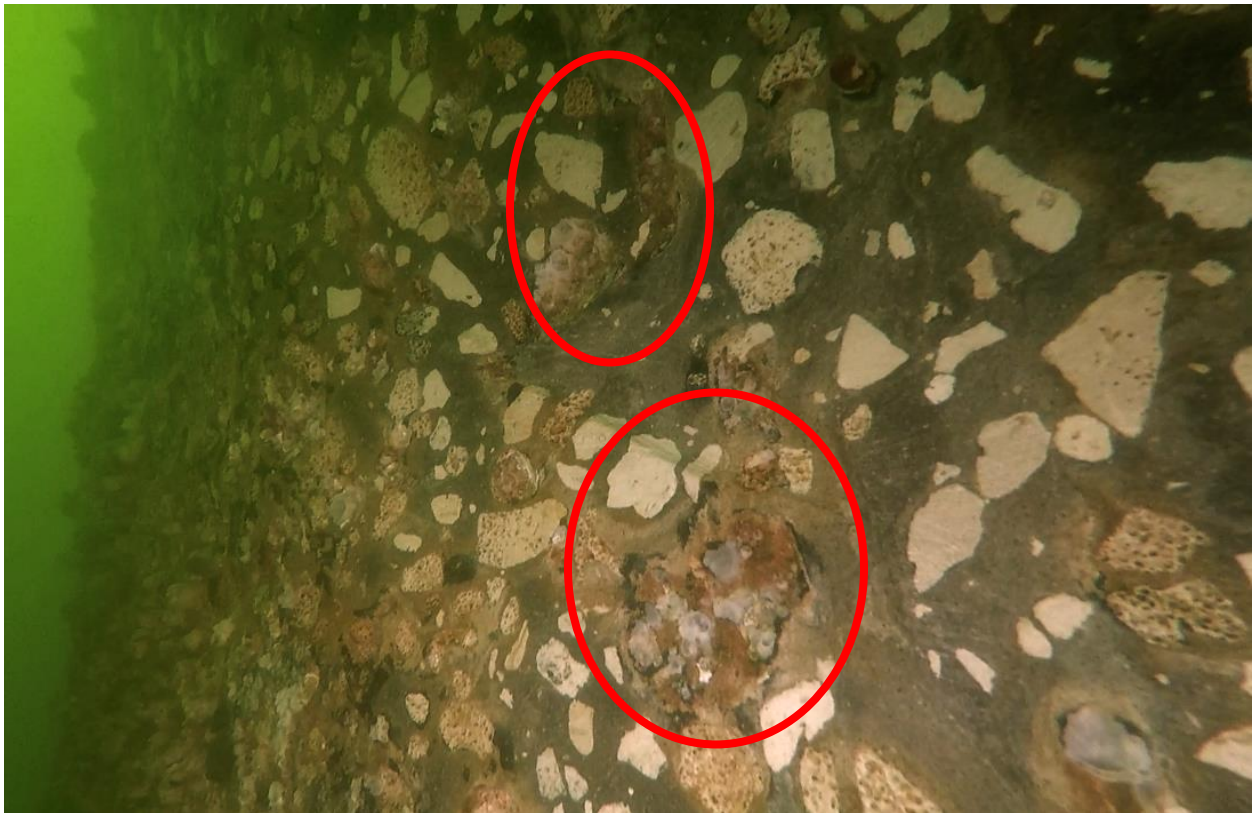
Figure 10.26 Cleaned portion of 84-4 on the southeast side of the shaft, circled sections indicate small voids in concrete filled by barnacles.

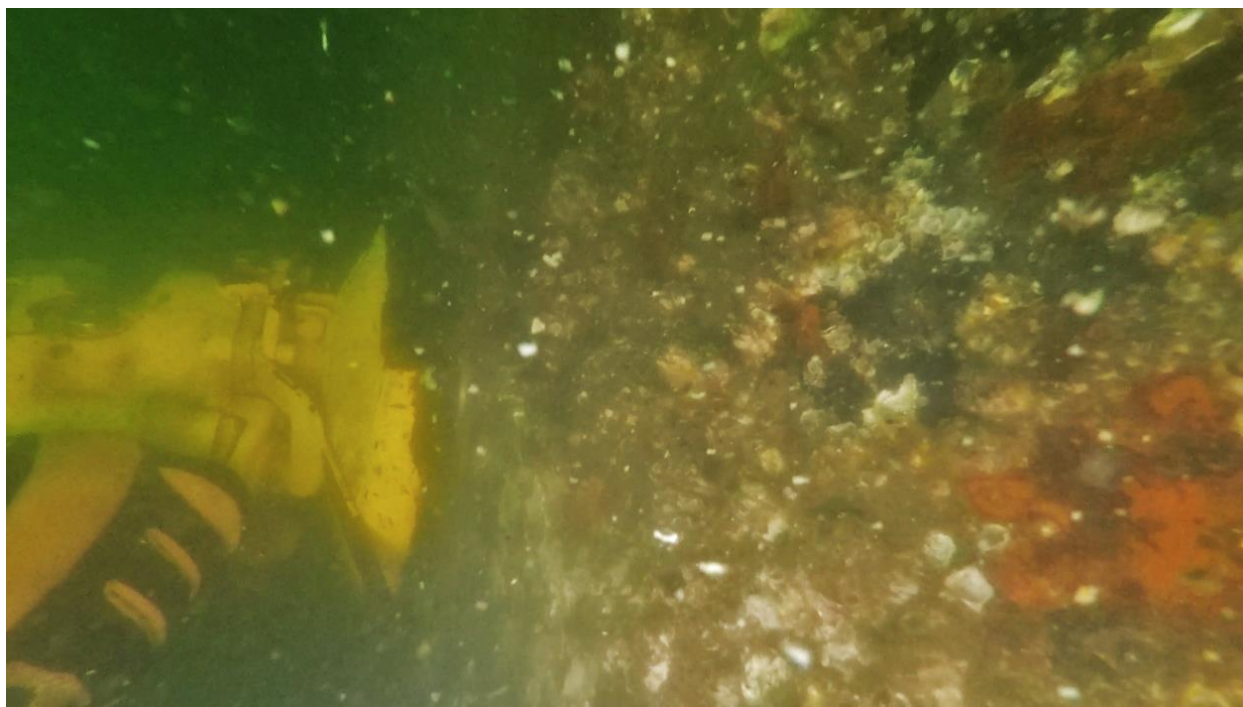
Figure 10.33 Shaft 94-4 during cleaning with the grinder.

Pier 94 was not mentioned in the diver report, and therefore it was thought to be a good candidate to have a casing. Upon initial inspection, it can be difficult to tell if the shaft has a casing or not because of the thick layer of barnacles attached to the shaft concrete or its casing. Therefore, shaft 4 from Pier 94 (94-4) was chosen for cleaning to demonstrate what steel casing looks like versus the concrete. Figure 10.32 shows 94-4 prior to cleaning and Figure 10.33 shows 94-4 during cleaning. In Figure 10.34 the steel from the casing is visible. As seen from Figure 10.34, there is a black layer underneath the encrustation and on top of the steel casing.

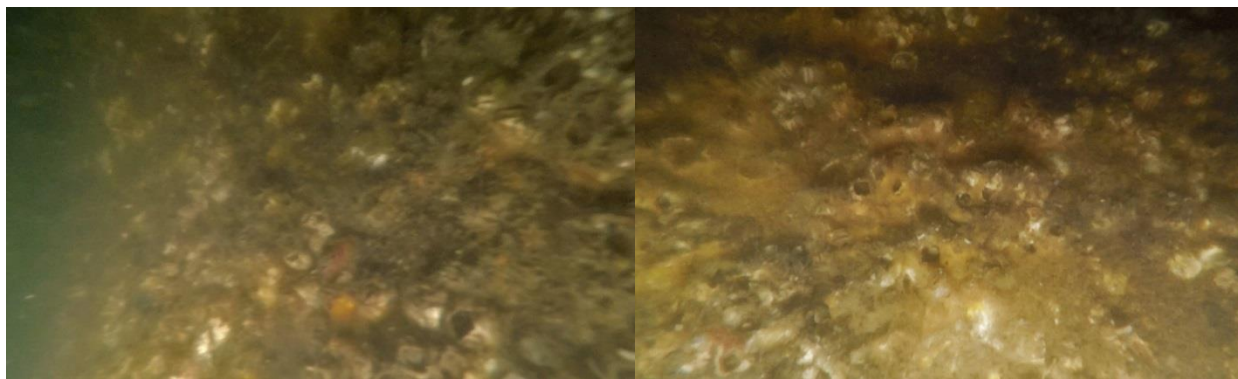
Figure 10.40 Shaft 95-3 pre-cleaning.

Shaft 95-3 was cleaned for comparison as a shaft with no observed problems. Figure 10.40 shows 95-3 prior to cleaning. Due to the lack of water clarity on the day of inspection it was difficult to take a picture of the entire shaft, so sections are presented instead of an overall image. Figure 10.41 demonstrates a cleaned portion of the shaft. This shaft did not have any noticeable voids like 95-1. As seen from the cleaned portions the concrete surface was smooth.

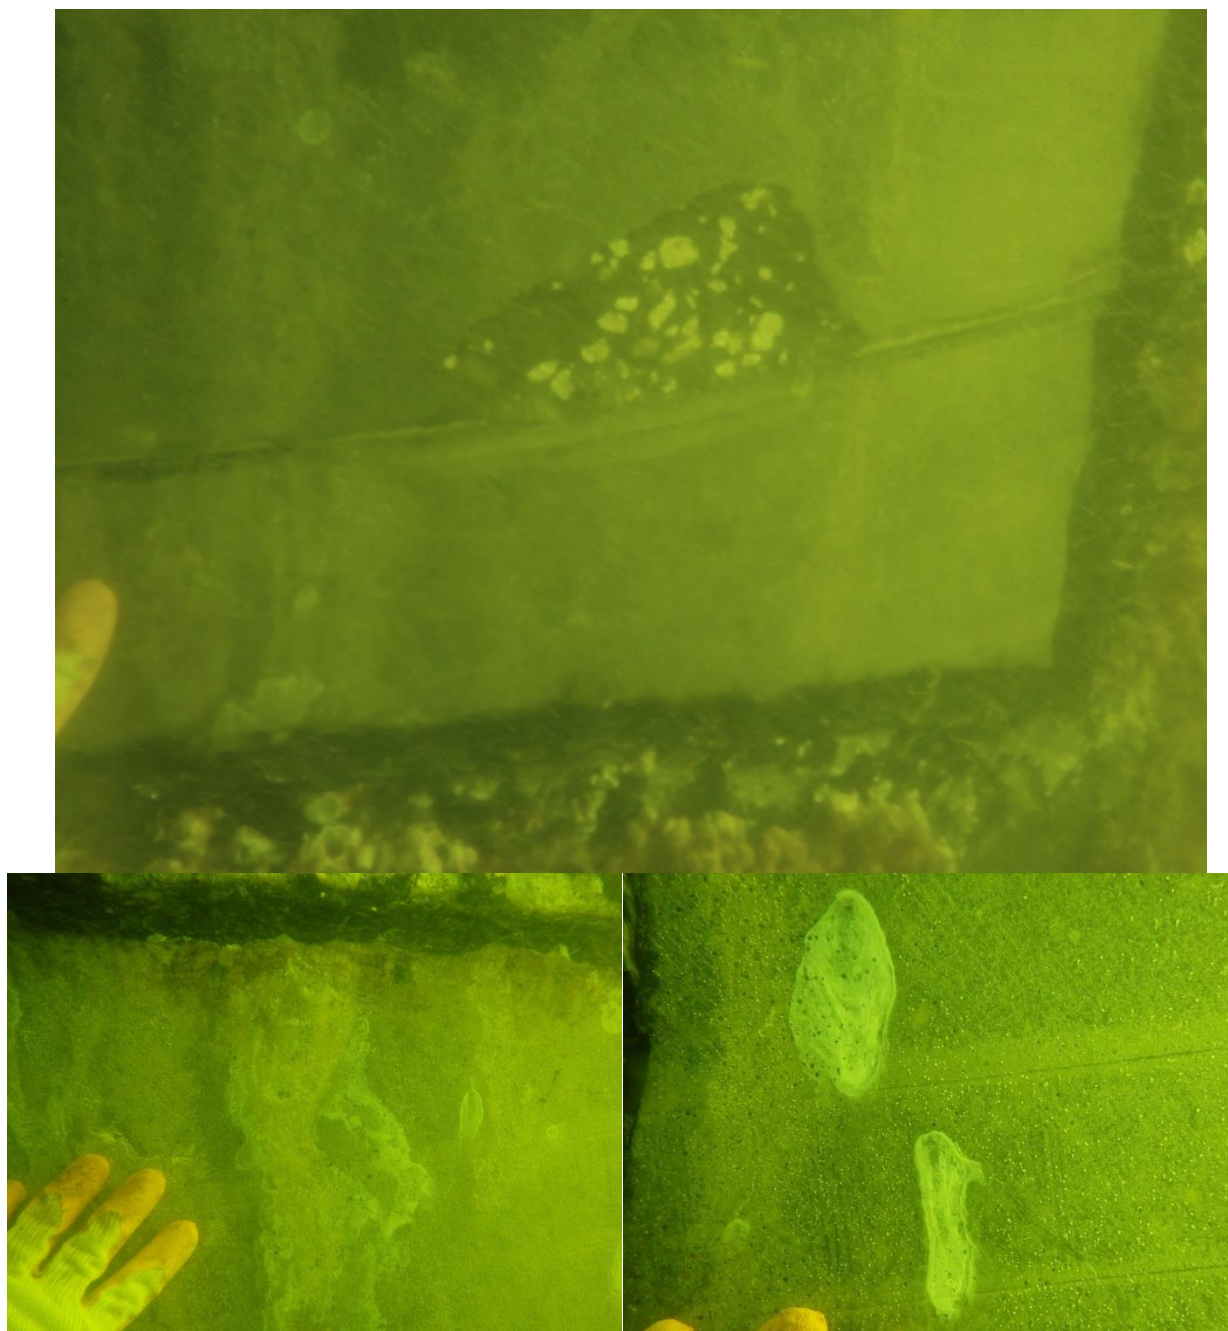
Figure 10.46 Shaft 70-1.

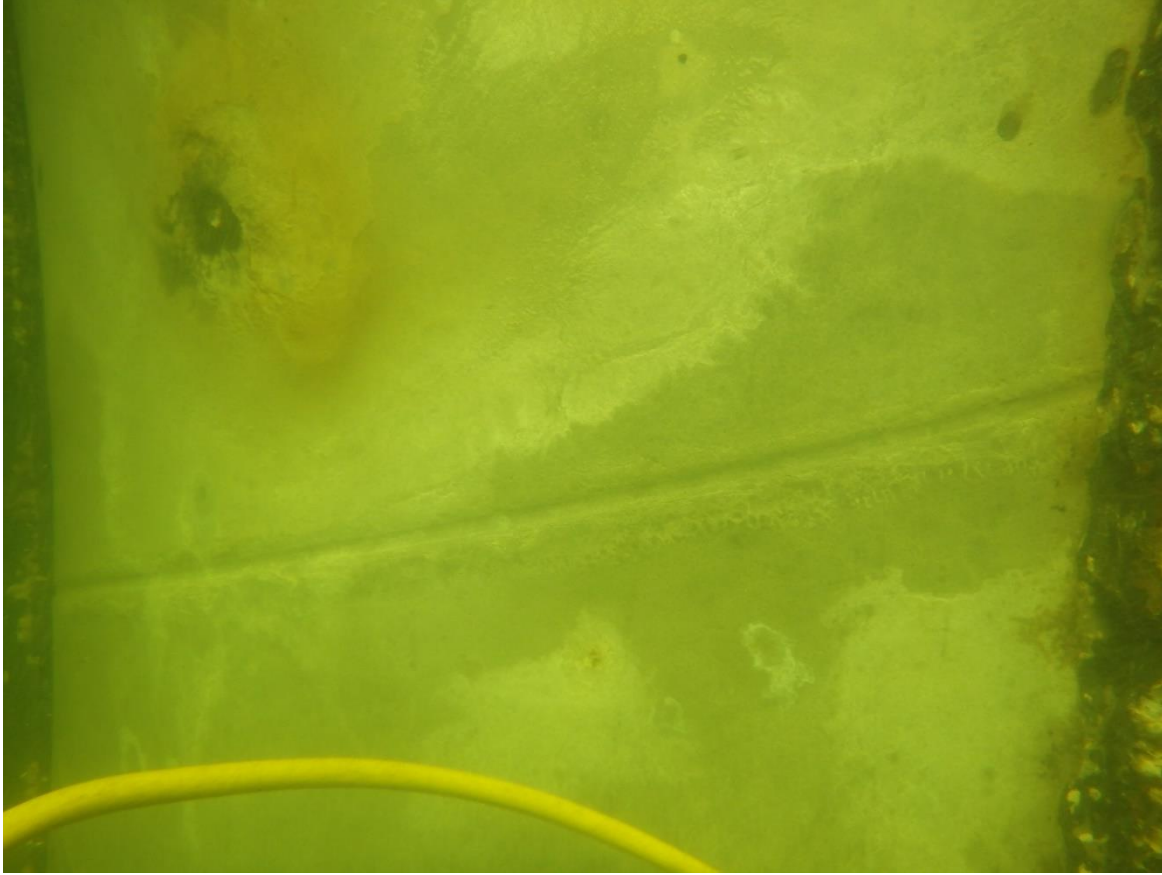
Figure 10.49 Shaft 91-2 (SW) immediately after casing window removal.

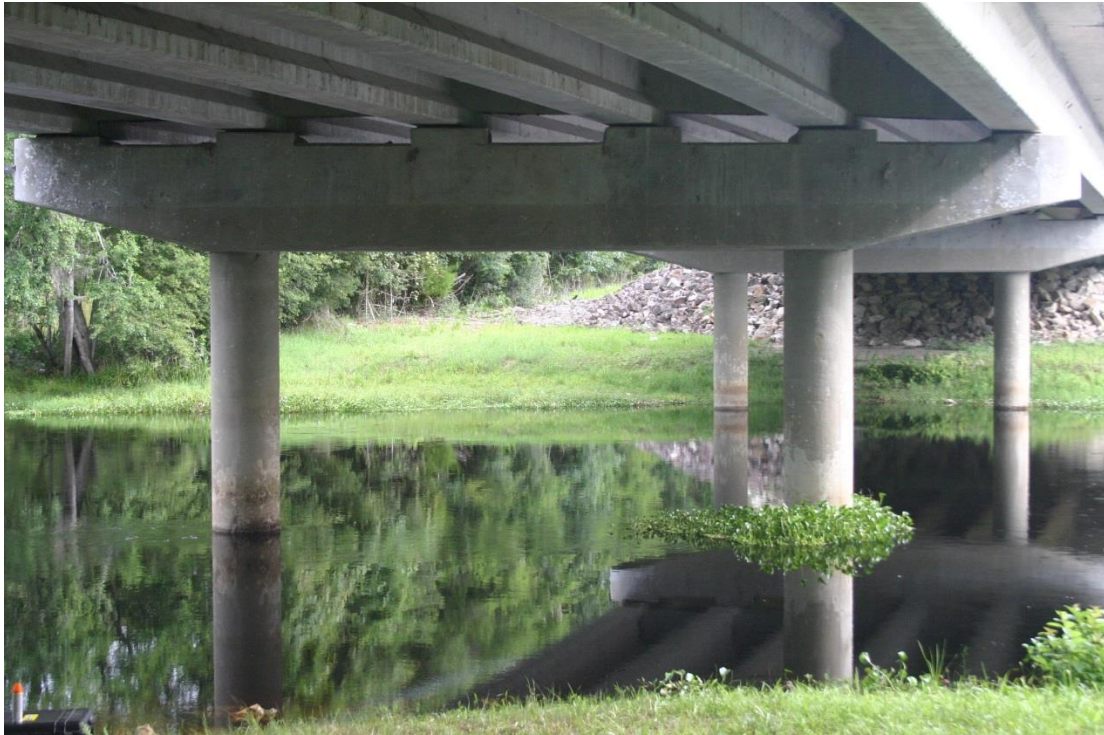
Figure 10.52 Four water column-to-shaft structures.

The Santa Fe River Bridge has three intermediate piers (Figure 10.51), each on two 5-ft shafts (Figure 10.50). Two piers were in the river at the time of the on-site review (Figure 10.52). The shafts for this bridge were cast using bentonite slurry, making this bridge a good candidate for the study. According to the plans, shafts for this bridge terminate very close to the mudline and are mono-shaft column structures. However, considering river bottom depth changes after looking at the inspection report, it was decided that this bridge yielded potential for investigation. The piers were investigated first using a remote-operated vehicle (ROV) (Figure 10.53), then by divers (Figure 10.54). While it was expected that only the very top of the shaft would potentially be available, on-site inspection revealed depth changes due to scouring were not enough to expose the shafts. All four shaft/columns were investigated and only the smaller diameter 3-ft columns could be seen (Figure 10.55).

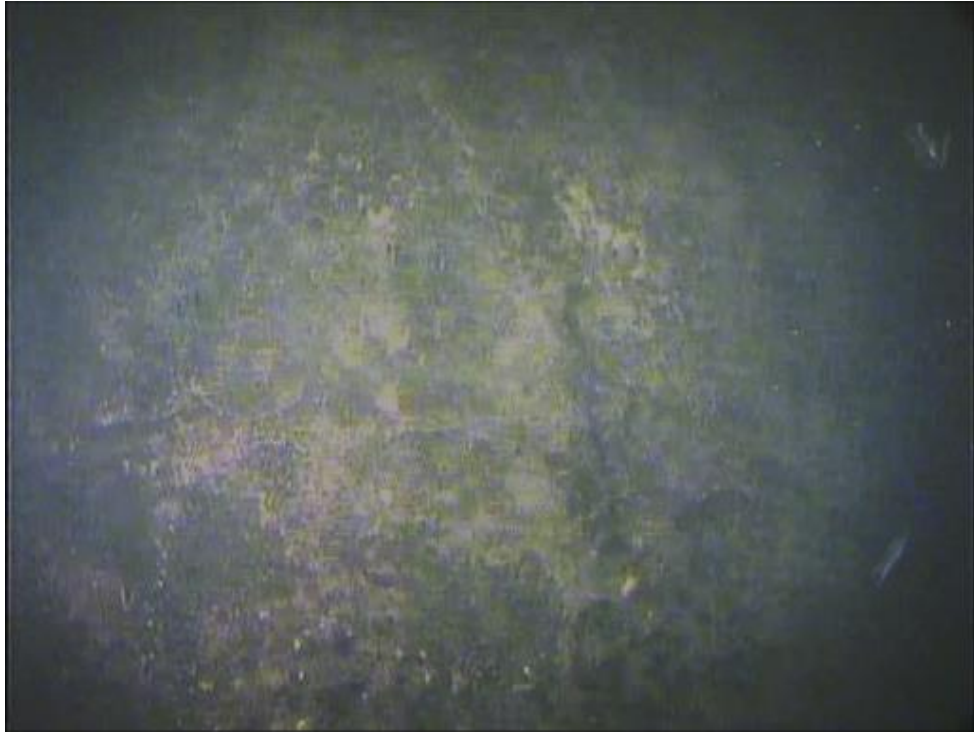
Figure 10.62 Shaft 58-1 prior to cleaning

Pier 58 was selected initially for cleaning and inspection. While it was expected that there would be exposed shaft, after inspection it was realized that the only portion exposed was from what looked like a missing seal slab support collar (Figure 10.61). Rubble on the bottom of river was likely to be remnants of the seal slab, and a steel collar was seen around shaft 2. Nevertheless, approximately 16-18 inches of uncased shaft was visible. Figure 10.62 is a picture of what the exposed portion of shaft looked like prior to cleaning shaft 58-1 (note shafts were labeled 1 and 2 based on river flow seen in Figure 10.58). Figure 10.63 shows the 58-1 shaft after cleaning. Figure 10.63 also shows four positions labeled 1-4 corresponding to close-up images taken at those locations. The water clarity was poor and made overview images unhelpful. In all four images of

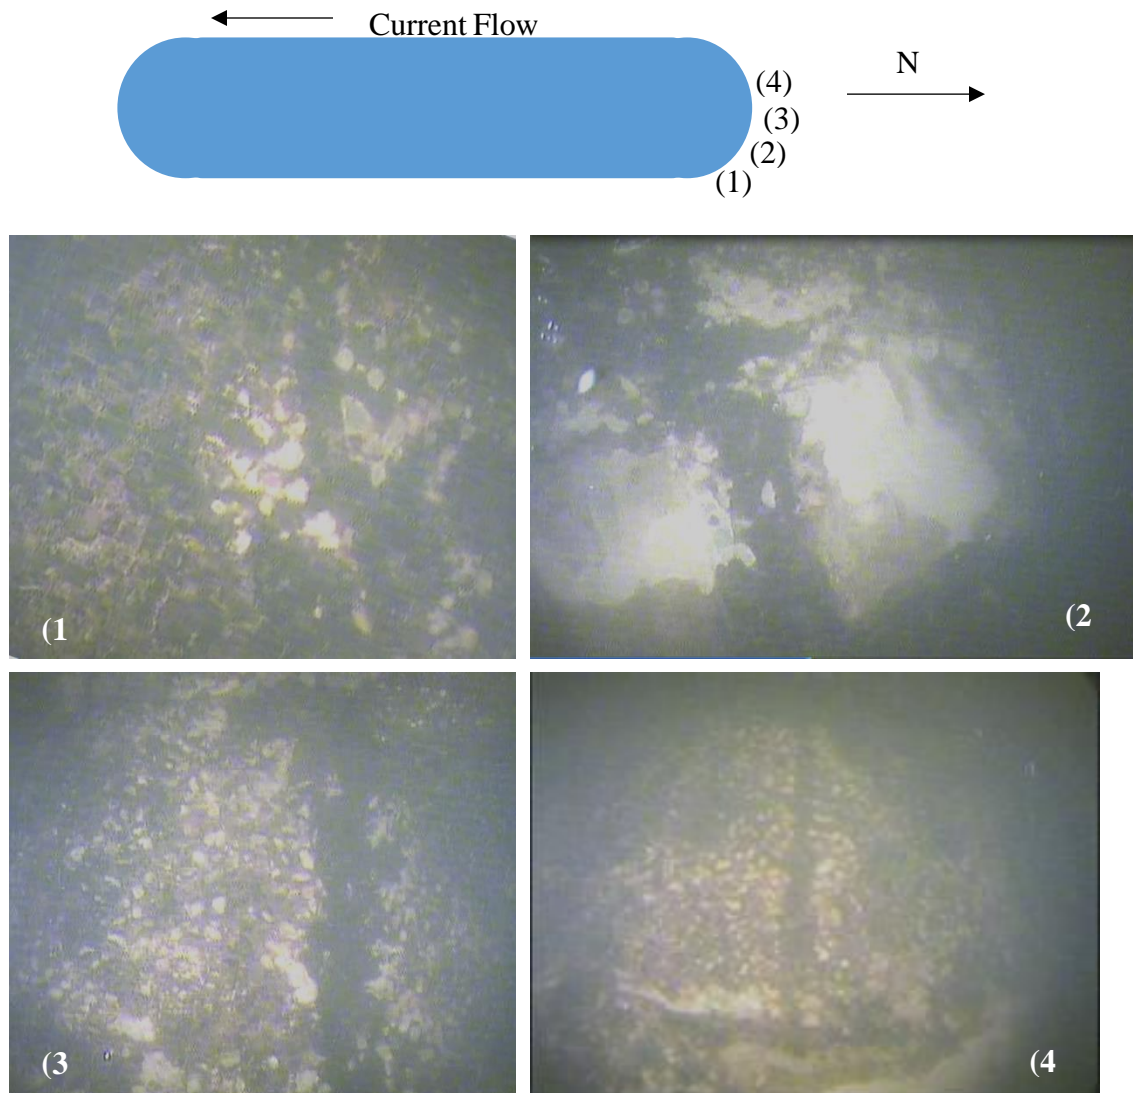
Figure 10.63 Images demonstrating quilting on Shaft 58-1. Images 1-4 correlate to positions 1-4 noted at the top of the figure.

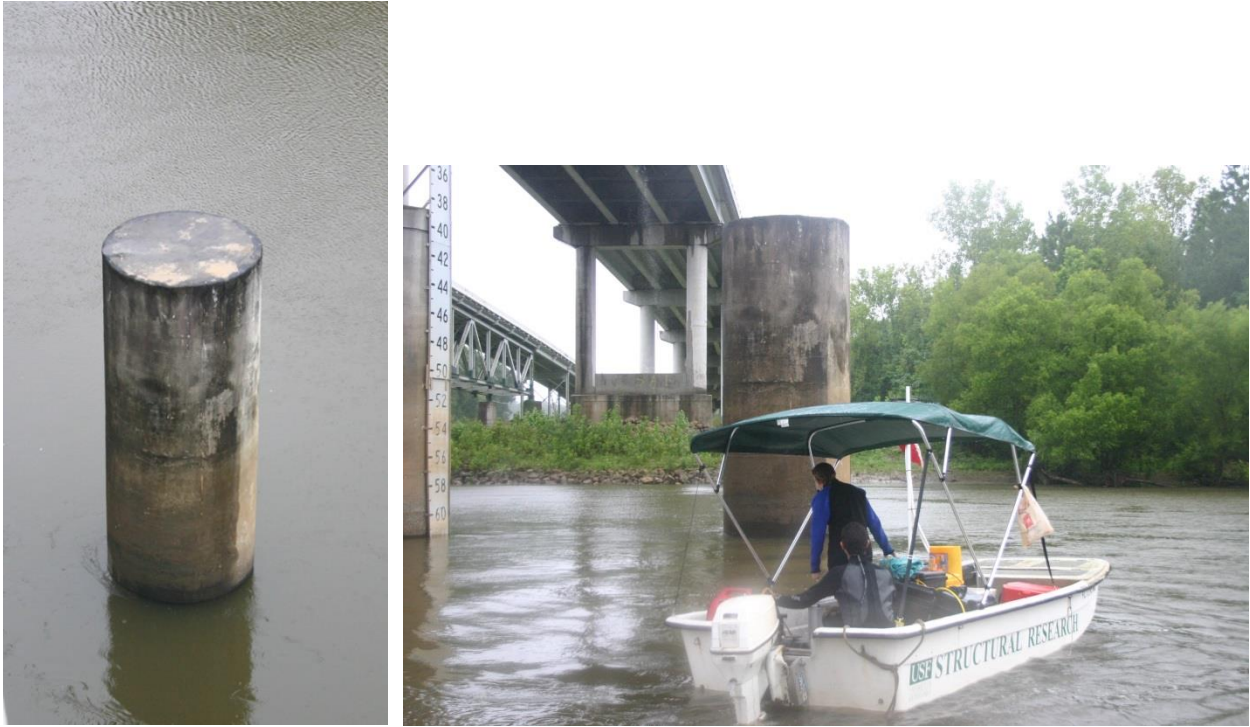
Figure 10.64 Test Pile adjacent (west) of Pier 59.

Adjacent Pier 59, test shaft 8 (Figure 10.64) was also inspected. This is a 9-ft diameter out-of-position shaft south of pier 59 near the main channel. By visual inspection there was some light creasing along the vertical reinforcement (Figure 10.65). Figure 10.66 shows test shaft 8 before cleaning; Figure 10.67 shows after cleaning. Again, the creasing is light but it can be seen. Being a test shaft, construction sequencing is often not exactly the same as production shafts. This shaft had additional longitudinal instrumentation, which compounds concrete flow problems.

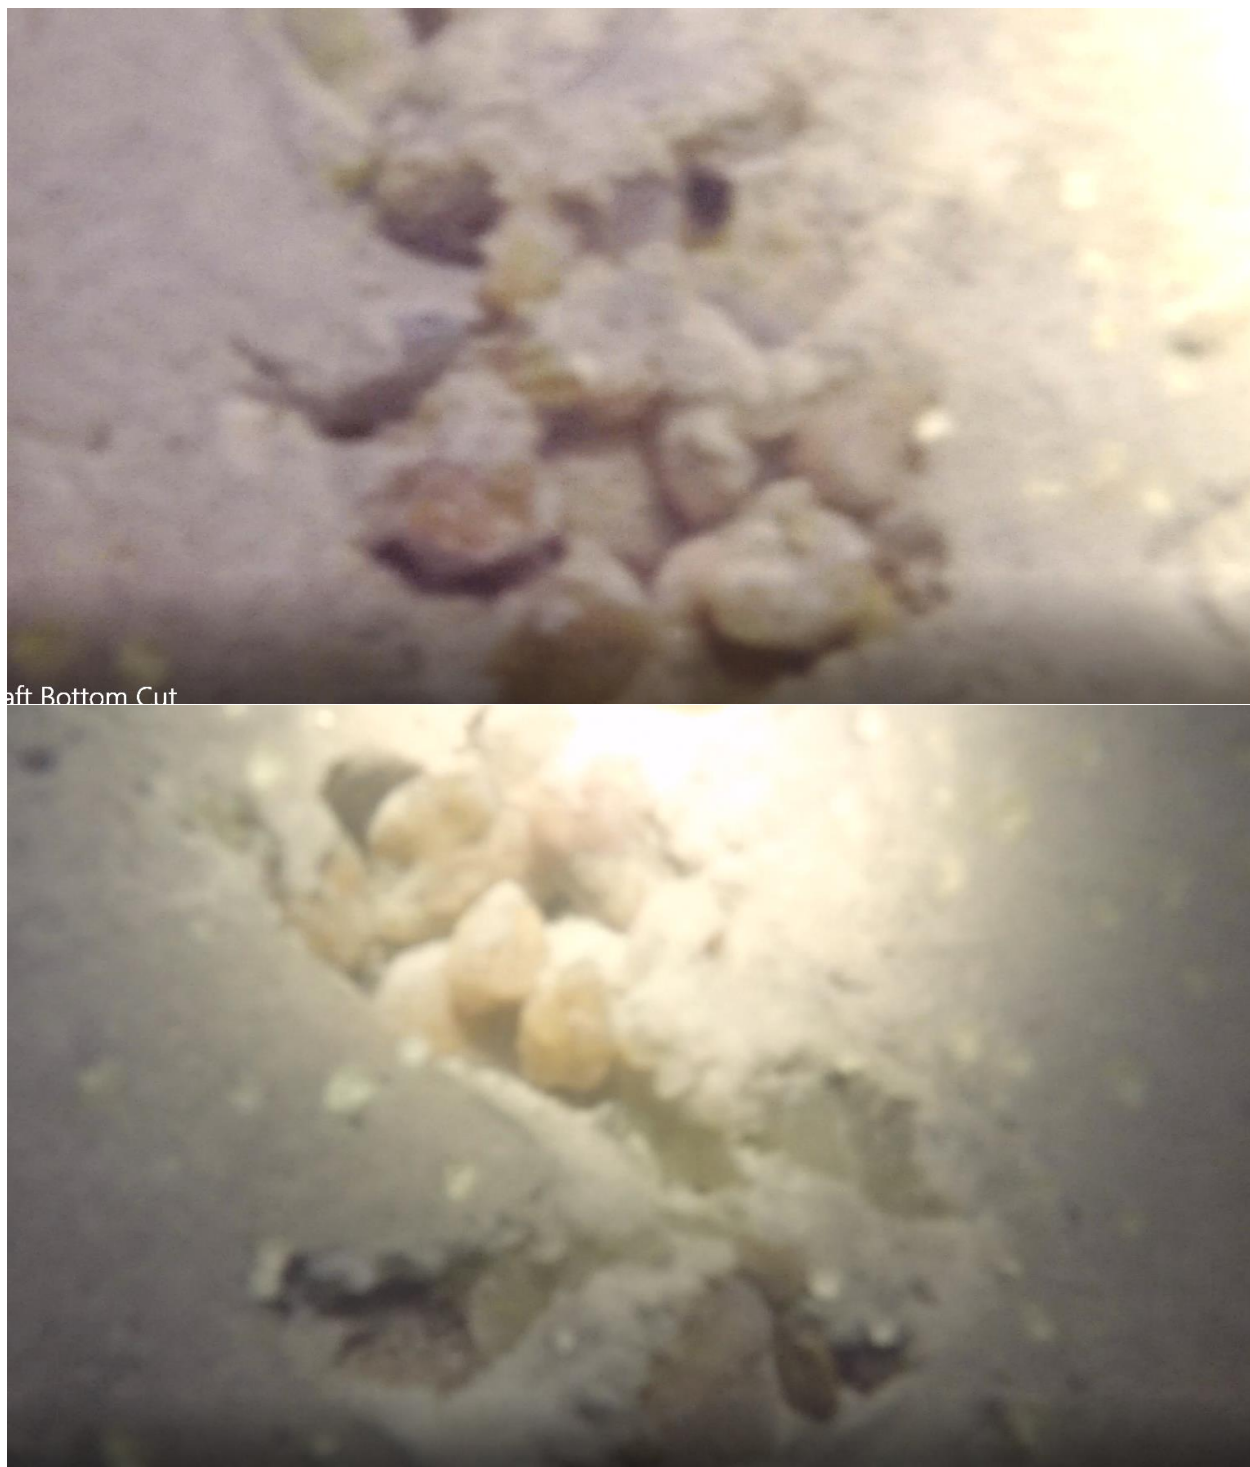
Figure 10.70 Shaft 58-1 casing removed from the lower portion of the shaft.

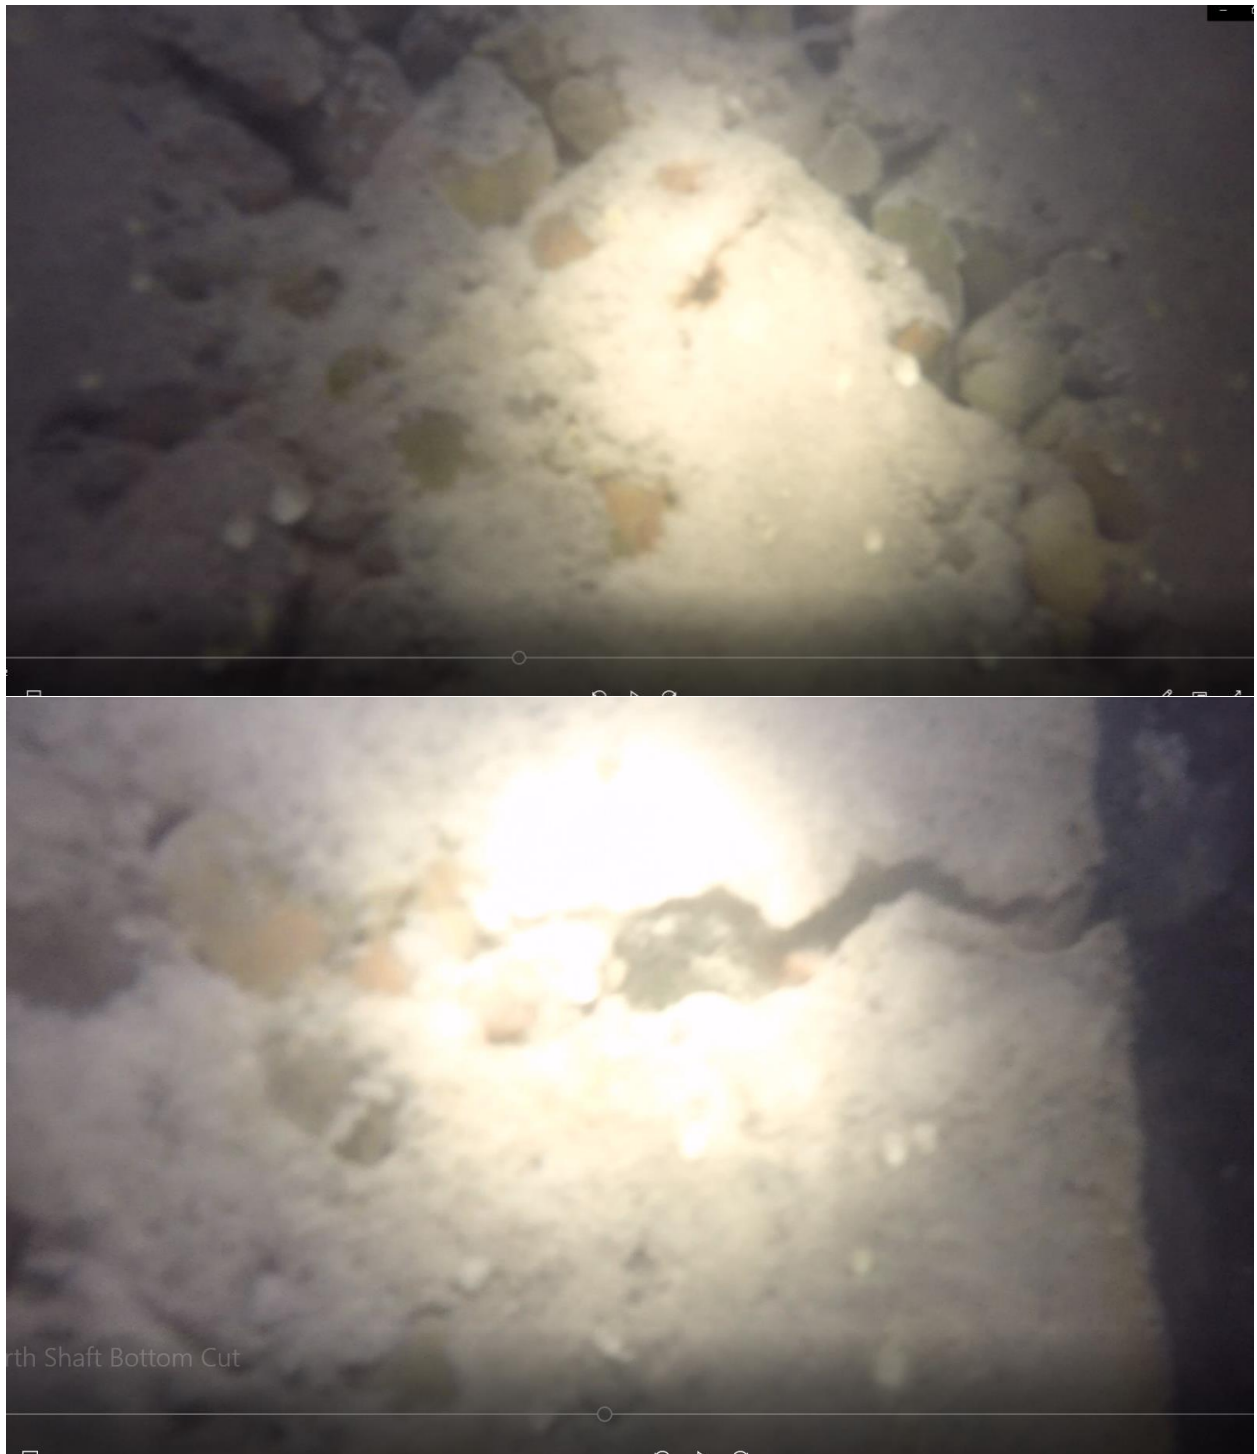
Figure 10.70 Shaft 58-1 casing removed from the lower portion of the shaft (continued).

Once the river level decreased to a workable level, the dive team returned for casing removal. Casing windows were removed from each shaft from an upper and a lower portion of the shaft. The previous window cut from shaft 58-2 was counted as a top window. Figures 69 to 76 display the concrete conditions observed from each cutout window in the casings for shafts 58-1, 58-2, 59-1, and 59-2, top and bottom, respectively. Every shaft showed a highly degraded concrete surface. In most cases the images were taken from video that swept across the shaft at a very close distance due to water quality conditions. Figure 10.69 shows a compilation of many images in their approximate position estimated from the video speed and closeness.

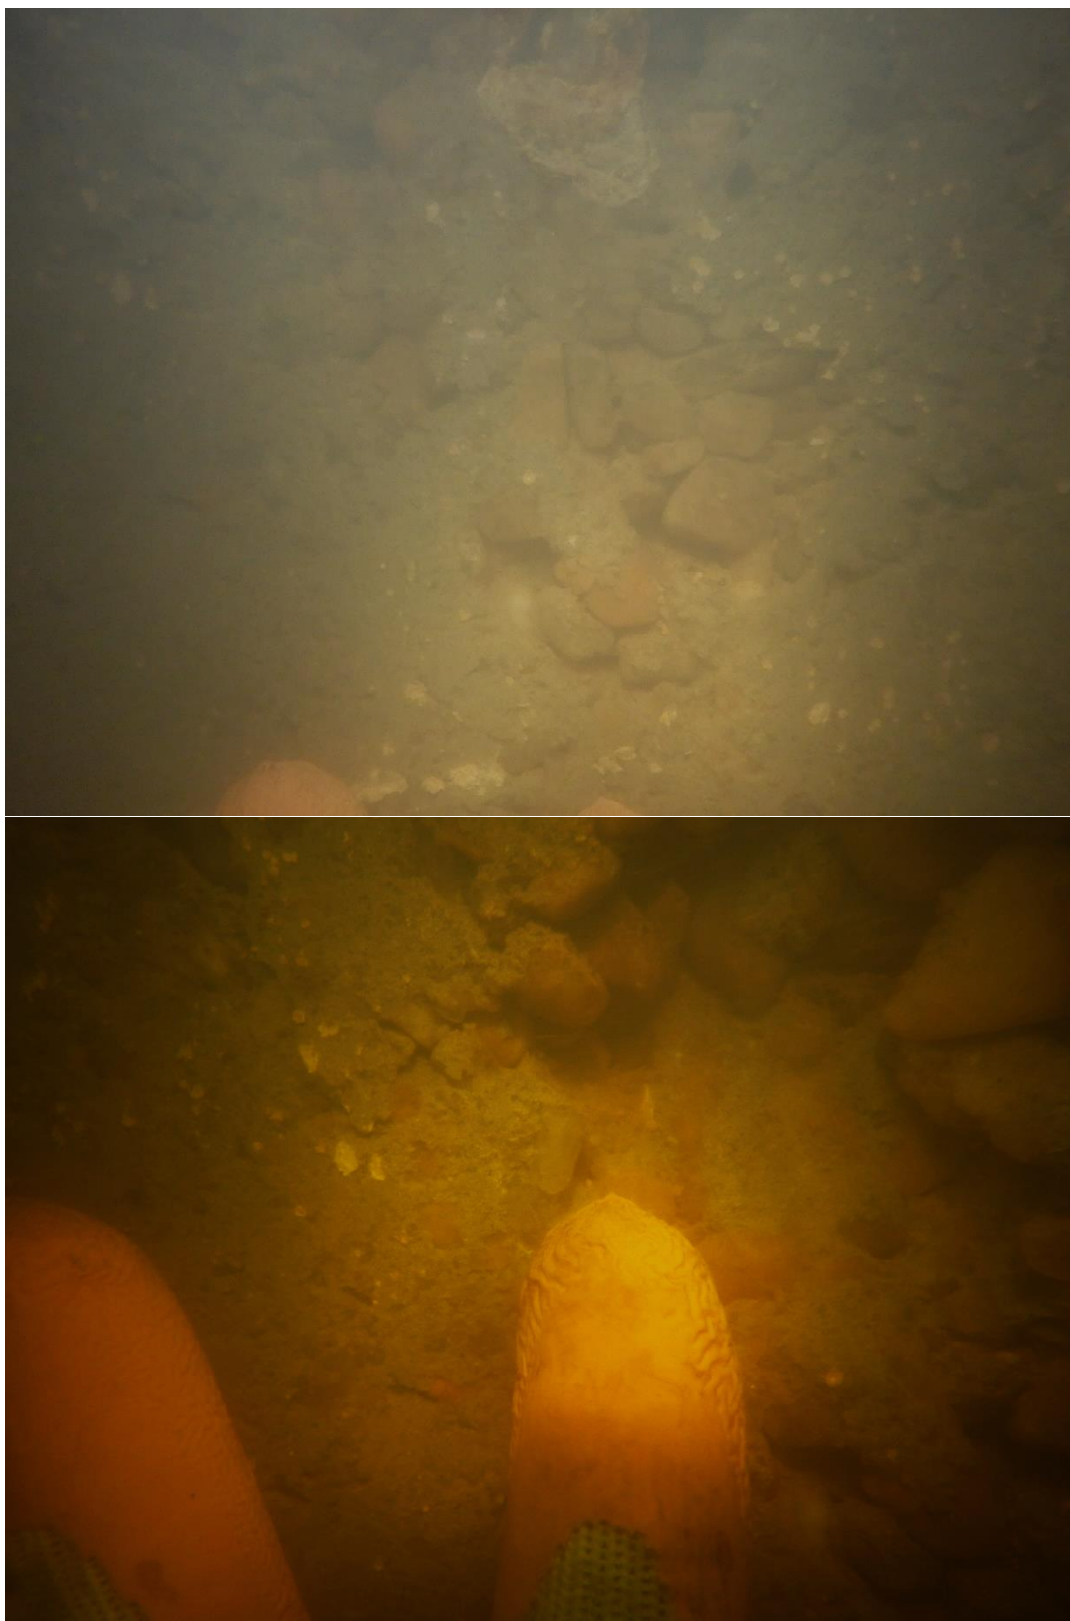
Figure 10.71 Images of Shaft 58-2 with the casing removed from the upper portion of the shaft demonstrating quilting and poor surface quality .

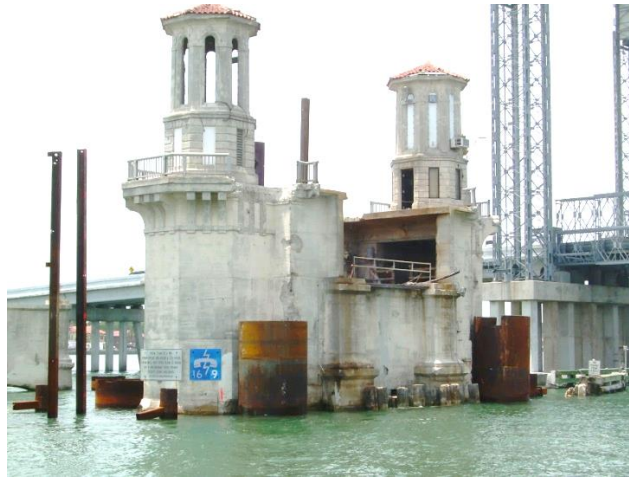
Figure 10.79 West Bascule (Pier 15 implied via plans / Pier 11 via inspection report) during rehabilitation; image taken from SE side looking NW.

When Bridge of Lions was rehabilitated, shafts were constructed using attapulgitite slurry around the existing piers and a below-water footing was cast to tie the existing caissons to the new sister shafts (Figure 10.79 and 10.80). Figure 10.79 shows the 8-ft diameter casing at the corners of the west bascule pier. These shafts were those indicated as possible locations for investigation. Figure 10.80 shows four 8-ft casings around each of the neighboring piers 13 and 14.

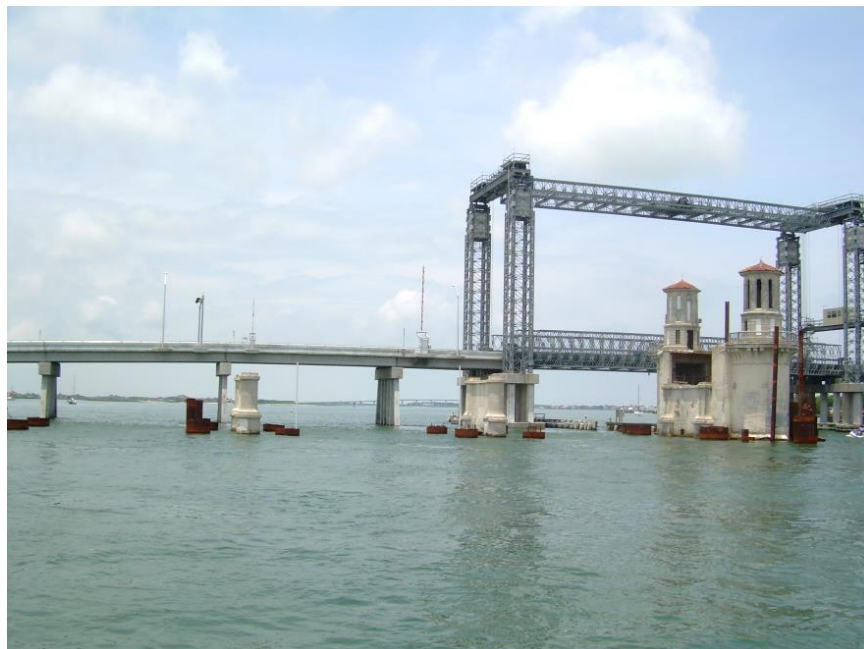
Figure 10.80 West Bascule (Pier 15; right), Piers 14 and 13 moving to the left with four 8-ft shaft casings shown from south looking north during rehabilitation.

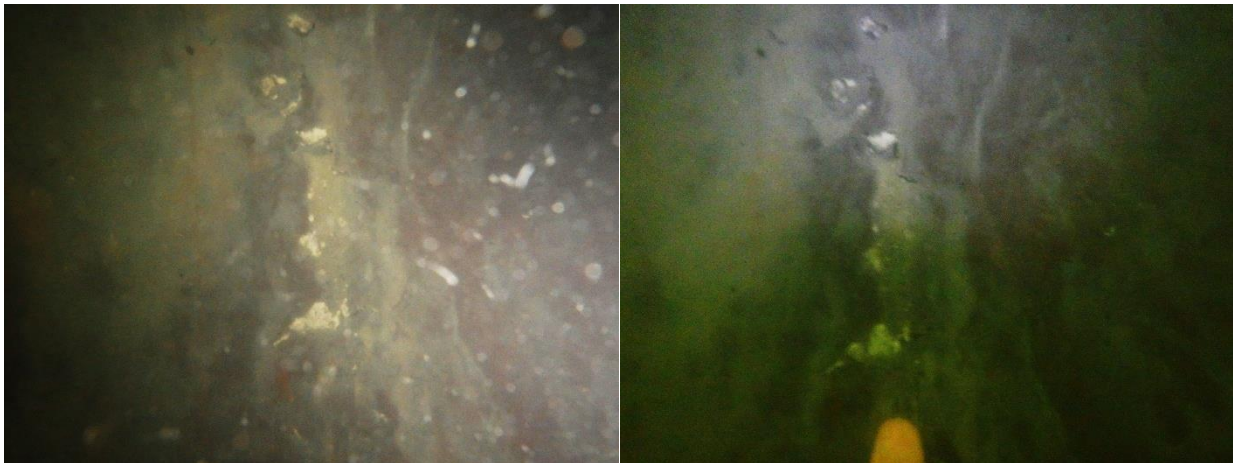
Figure 10.85 Pier 17 NW shaft concrete quality.

For Pier 17, all four shafts had a window of casing removed. On this pier, initial inspection showed two shafts with clean concrete, and two with issues. A summary of this and the corresponding visual inspection notes are seen in Figure 10.84. Figures 10.85 and 10.86 display photographs taken of the NW and SW shafts, respectively, showing images of the poor concrete quality.

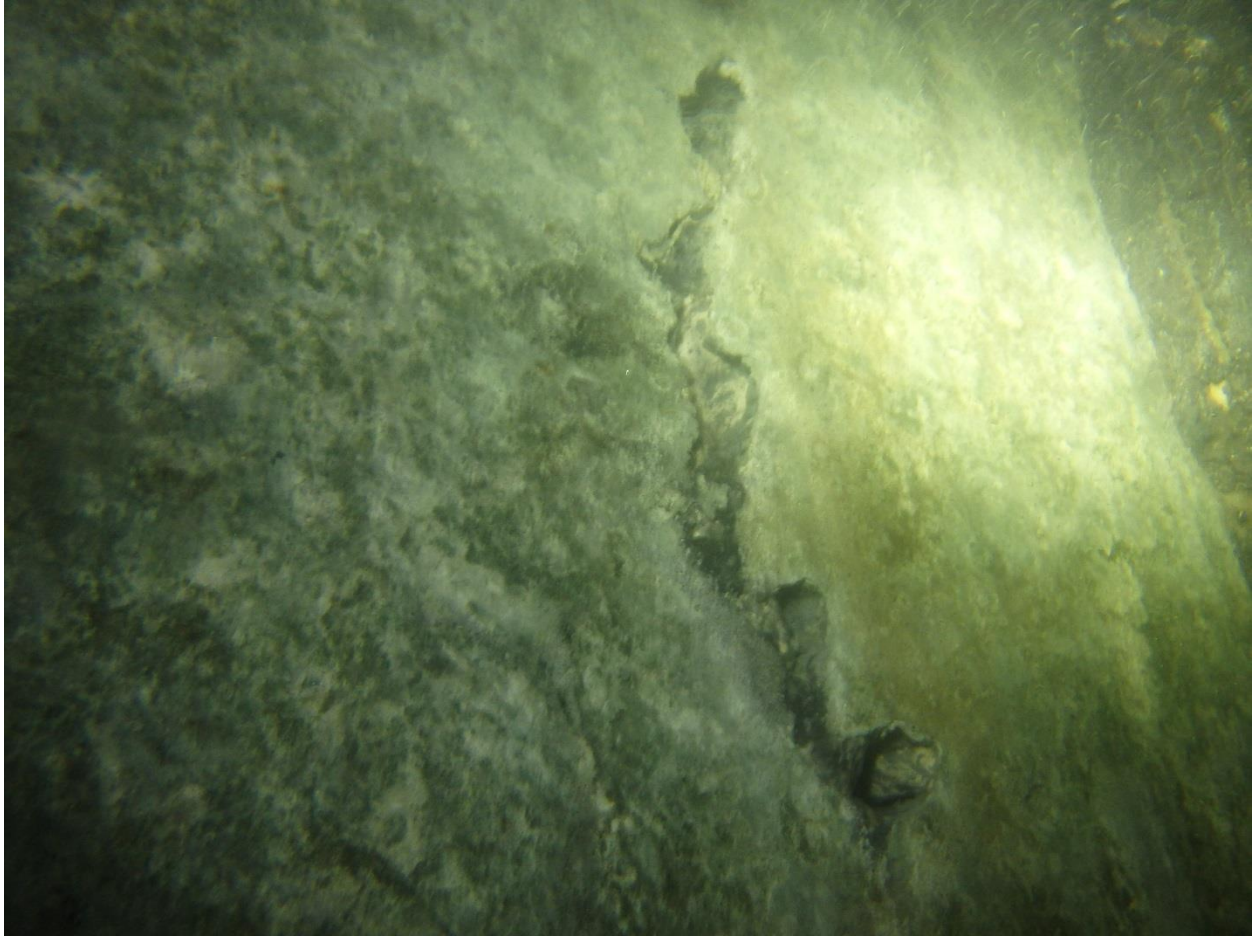
Figure 10.91 Pier 19 SE shaft concrete quality.

On Pier 19, only the NW, NE, and SE shafts had a window of casing removed. While the NW shaft showed smooth concrete, the NE and SE shafts showed poor concrete surface quality. A summary of this and the corresponding visual inspection notes is seen in Figure 10.89. Figures 10.90 and 10.91 display photographs taken of the NE and SE shafts, respectively.

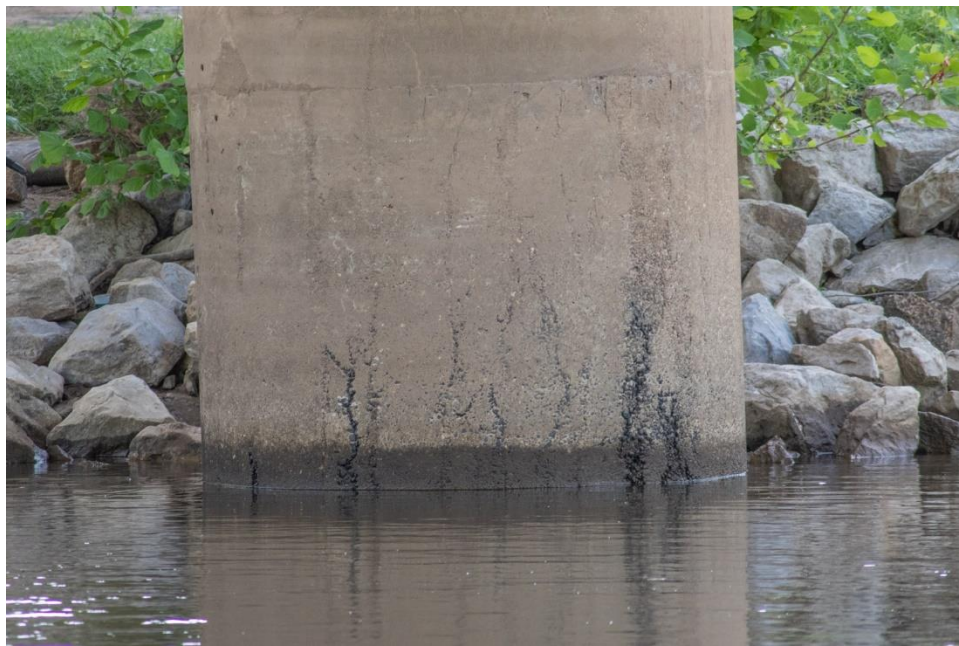
Figure 10.95 Drilled shafts displaying mattressing creases.

Upon initial inspection, matting could be seen prior to casing removal as some casing had previously been removed above water, Figures 10.94 and 10.95. Additionally, Pier 12 was on the river bank, so it was possible to do an above-ground inspection of shafts 12-1 and 12-2 of Pier 12. Both shafts 12-1 and 12-2 displayed creases and concrete deficiencies, Figures 10.96 and 10.97 respectively.

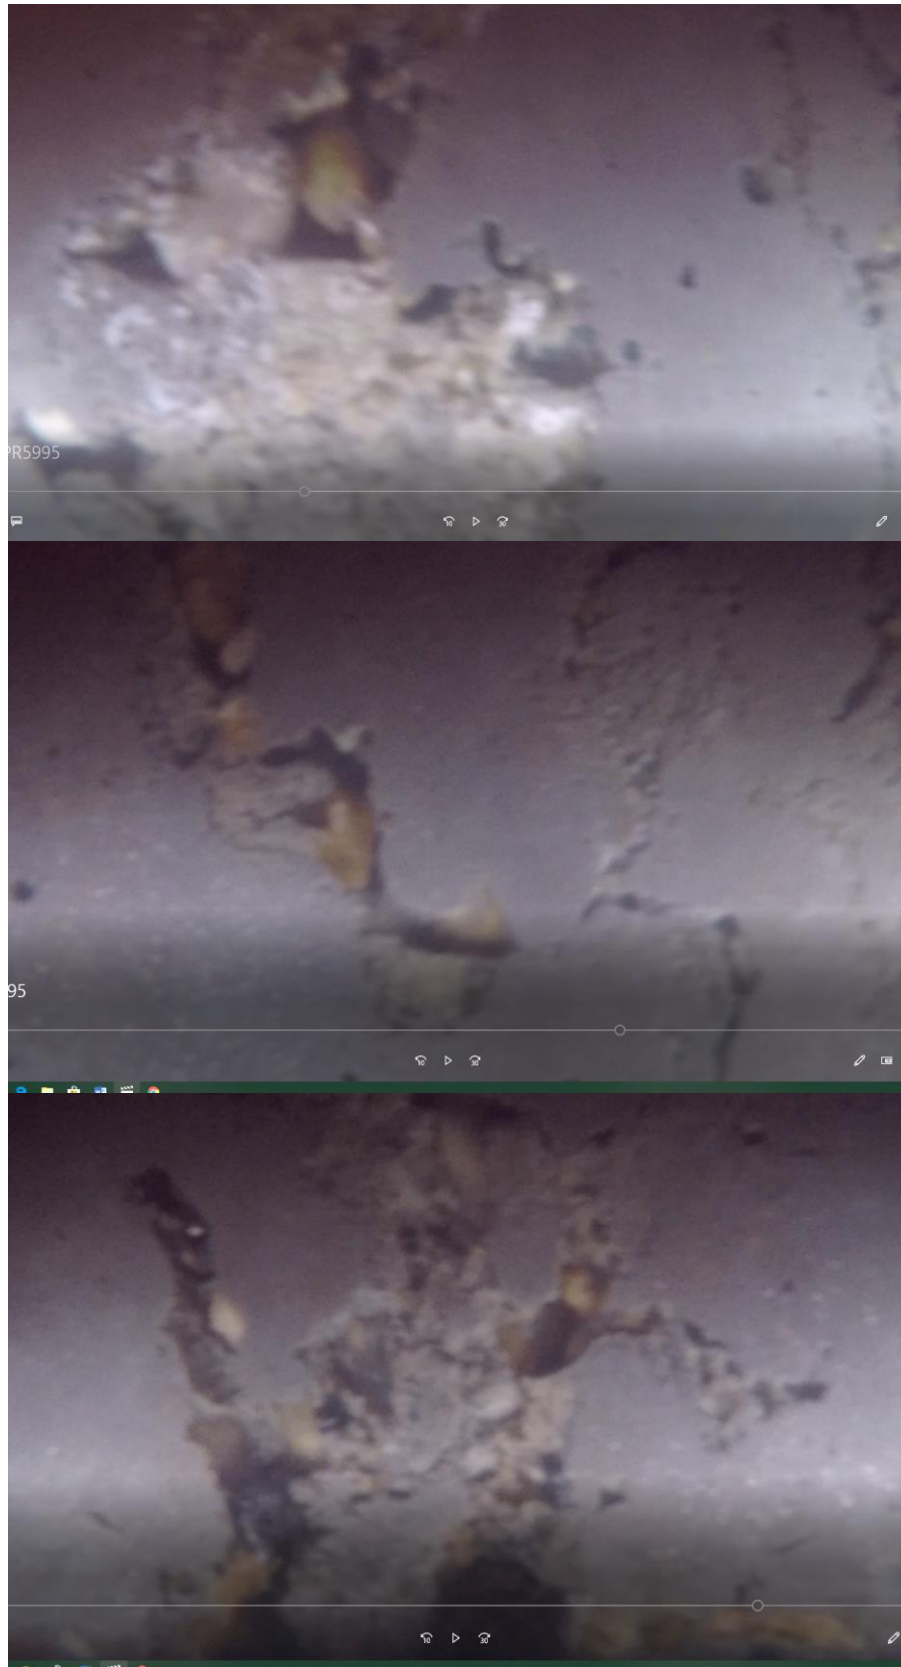
Figure 10.98 Shaft 13-1 upper casing removed.

Table 10.19 displays the locations of casing removal along with the initial concrete quality observed. Only one shaft (13-2) displayed clean concrete; however, on the opposing side, matting was seen, suggesting the possibility of poor construction. On the creased side of 13-2, the crease was noted to start above water and continue the entire length of the shaft. Figures 10.98 to 10.103 display images from the casing removal inspections of Piers 13, 14, and 15, for shafts 13-1, 13-2, 14-1, 14-2, 15-1, and 15-2, top and bottom, respectively.

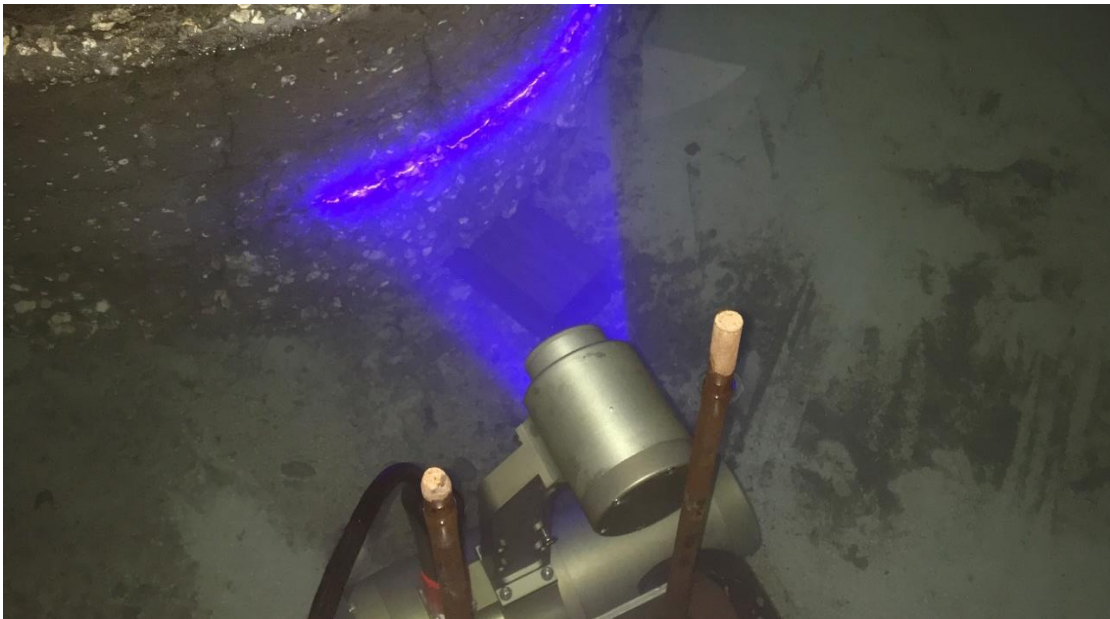
Figure 11.2 Newton M3200UW Laser Line

The underwater scanner uses optical triangulation to construct 3D models. The laser creates a beam across the shaft surface, this beam is then reflected to a high-resolution digital camera. As the beam sweeps across the concrete shaft surface, the camera detects the location of the beam. Algorithms are then used to correlate this deformation to depth changes on the concrete surface. The scanner has a sub-millimeter accuracy, which is needed to accurately conduct void volume determination. Figure 11.2 shows the scanner line while in use.
