EVALUATION OF SELF CONSOLIDATING CONCRETE AND CLASS IV CONCRETE FLOW IN DRILLED SHAFTS

BDV25-977-25

FINAL REPORT

January 2020

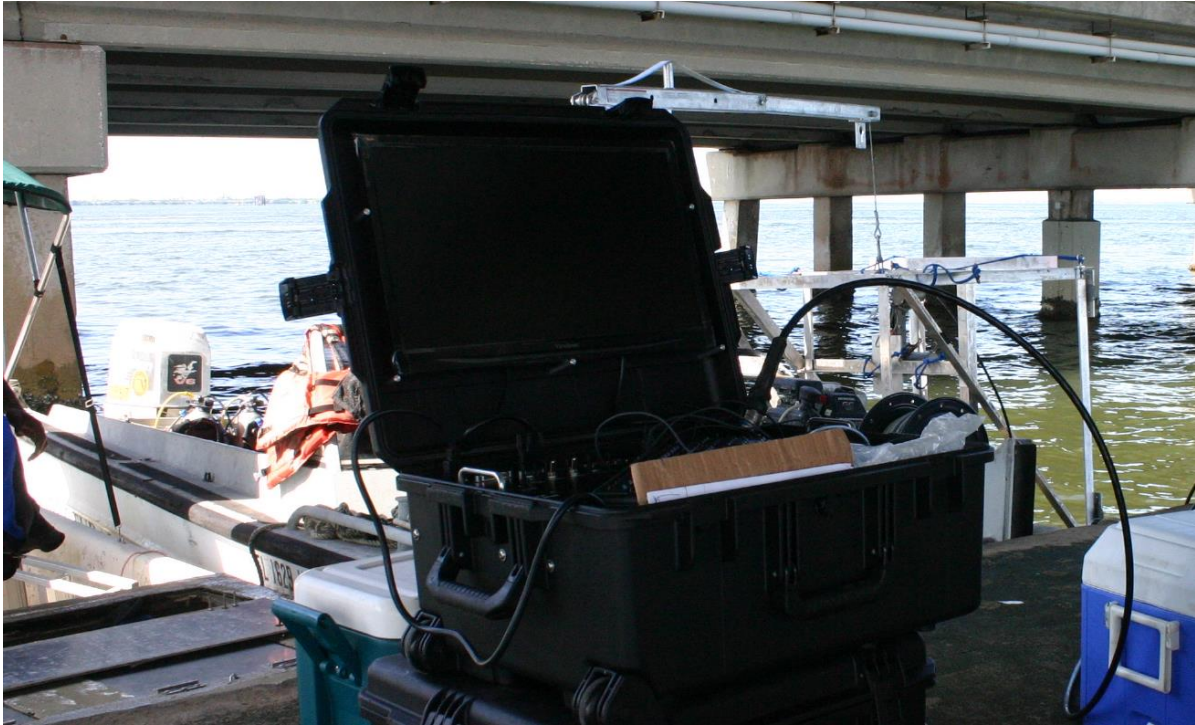
Figure 11.3 Newton Underwater Scanner Surface Computer

The surface computer, seen in Figure 11.3, is a standard desktop computer in a protective case with a Linux operating system. The computer has specialized software to receive and interpret the data being sent from the underwater scanner. This software is provided by Newton Labs. The two components, the underwater scanner and surface computer, are connected by a 300-foot cable.

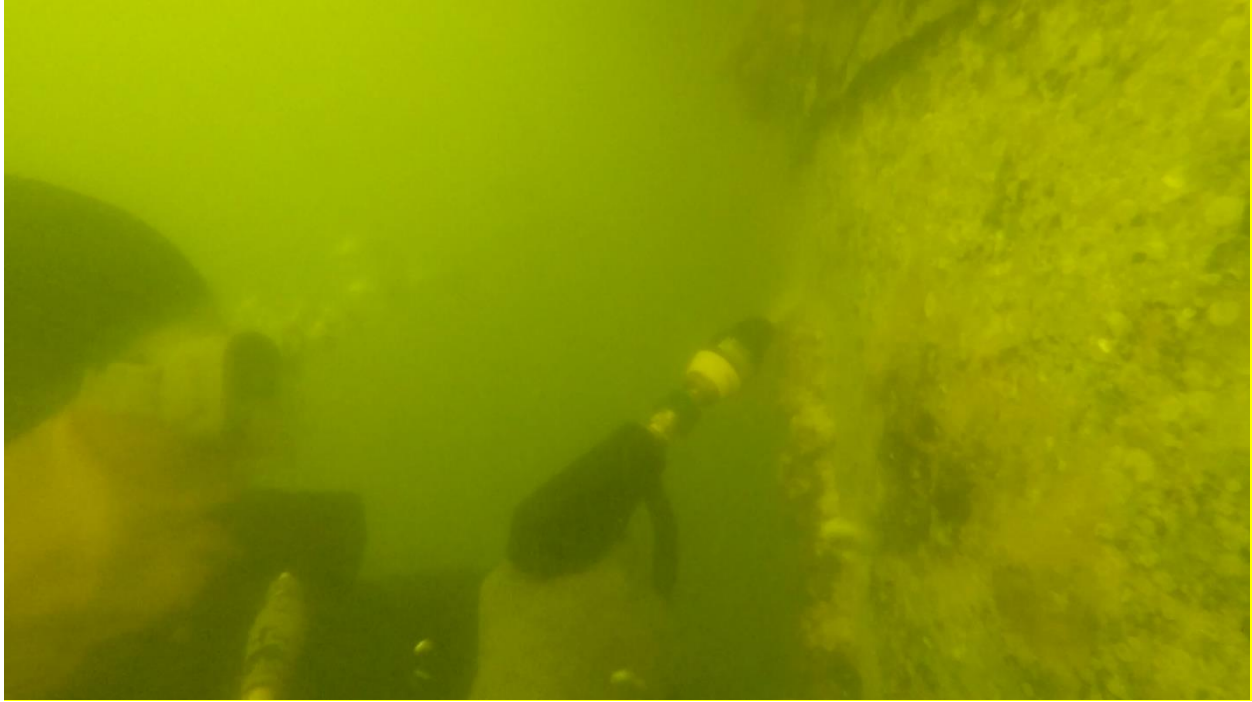
Figure 11.5 Pressure Washing Shaft Surface

The first component of successful underwater scanning is proper concrete surface preparation. Since most of the concrete shafts being scanned are in saltwater environments, barnacles are prone to cover the target concrete surface. Before every scan, the surface needs to be thoroughly cleaned to remove all barnacles and expose the concrete. A scraper was used to remove the bulk of growth followed by a 3000 psi power washer, seen in Figure 11.5. This removed any loose particles, sediment, or other build up that might have filled the voids present in the concrete surface. Since void volume is being used to quantify concrete cover quality, all non-concrete material needs to be removed.

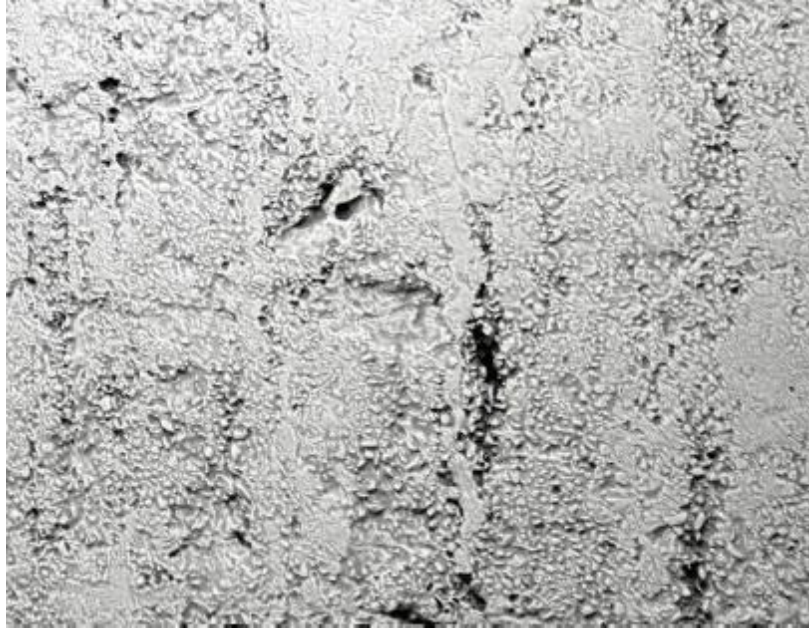
Figure 11.28 Digital scan of Pier 59N, Blountstown Bridge.

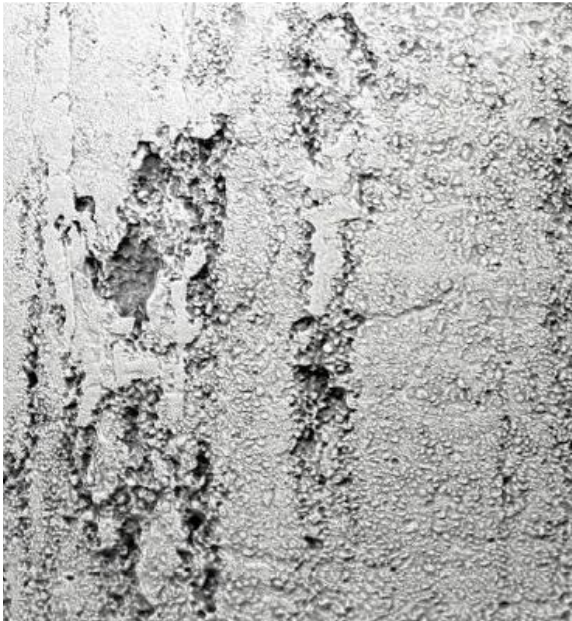
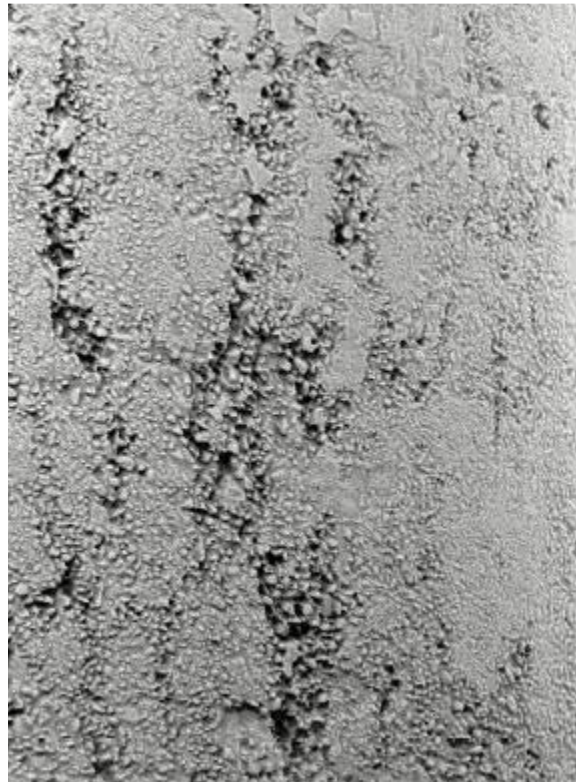
Figure 11.29 Digital scans of Pier 59S, Blountstown Bridge.

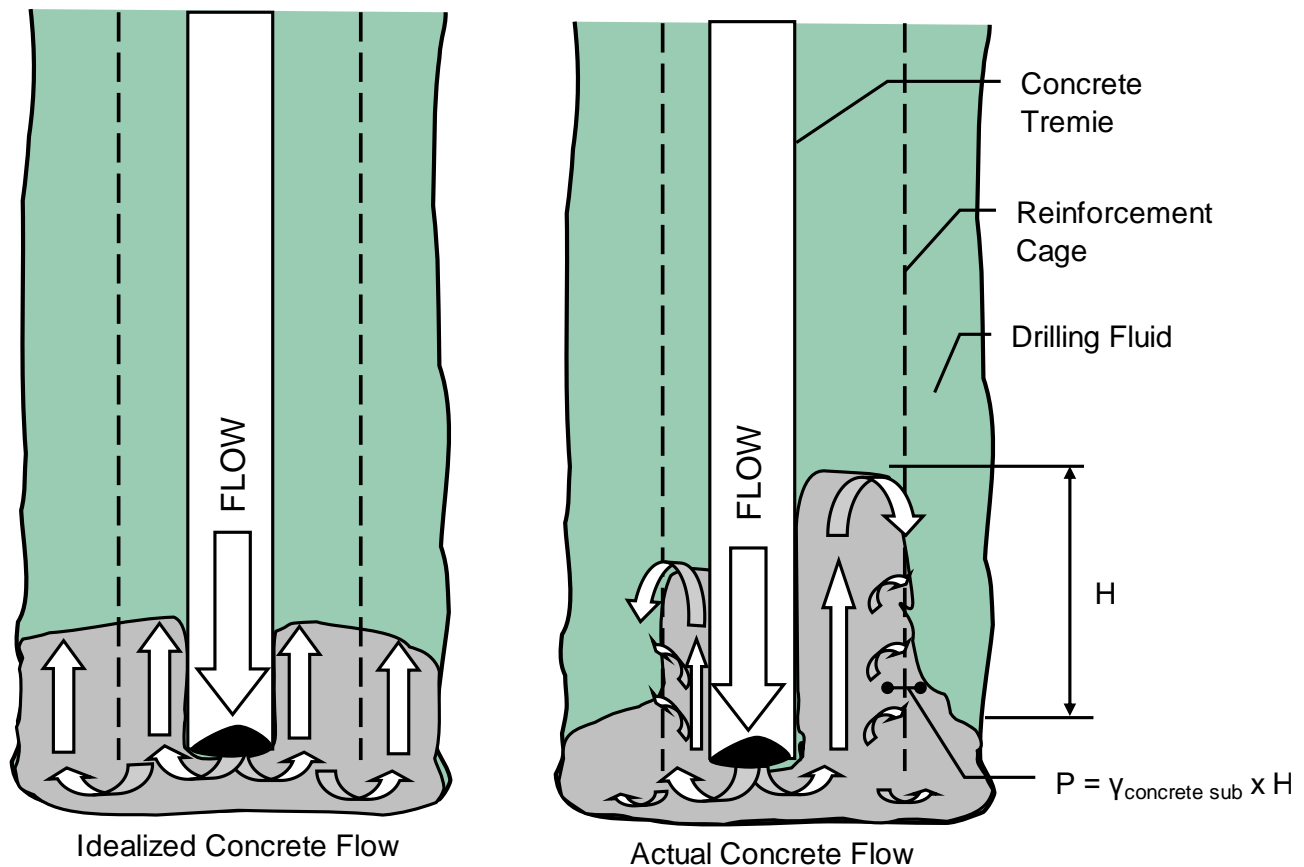
Figure 12.1 Comparison of idealized flow with observed (Mullins, 2005)

At the root of this issue, is a misconception as to how concrete flows in a tremie-placed, slurry displacing excavation. Recalling from Chapter one, Figure 12.1 demonstrates the comparison between the idealized concrete flow, rising in a single laminar lift and actual concrete flow that builds up inside the reinforcement cage before pushing horizontally into the cover region. As the

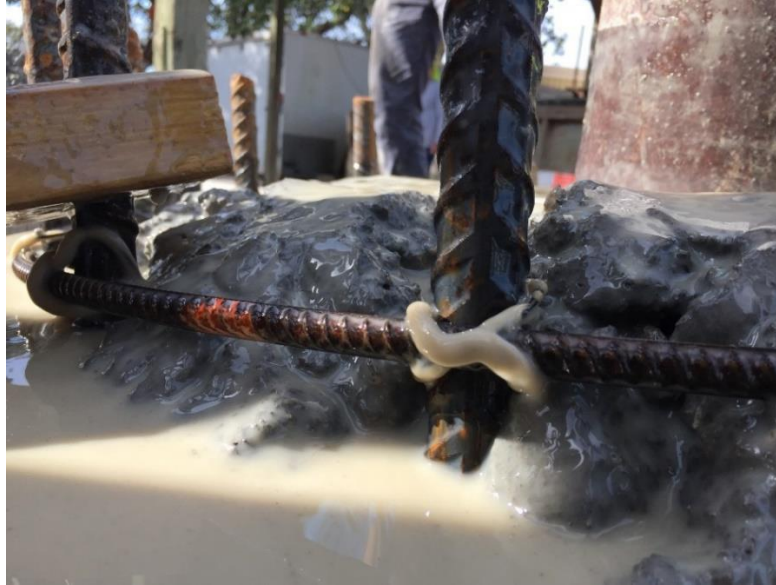
Figure 12.3 Bentonite coating on reinforcement and trapped around tie-wire.

As the concrete leaves the tremie and pushes horizontally through the reinforcement, a layer of support fluid becomes trapped, coating the surface of the steel. The surface condition of the reinforcement bars is known to have an impact on pullout capacities as ACI 318-14, ACI 408R-03, and AASHTO equations for development length all provide modification factors for epoxy coated bars, ranging from 1.2 to 1.5, depending on the cage spacing and the cover dimensions. ACI 408R-03 explicitly discusses reinforcement surface condition, specifically bar cleanliness and epoxy coatings. Under bar cleanliness ACI 408R-03 states, “*To prevent a reduction in the bond strength, ACI 318 requires that reinforcement must be free of mud, oil, and other nonmetallic coatings that decrease bond strength*” (ACI Committee 408, 2003). However while this is stated, the only modification factors noted are for epoxy coating, with none stated for drilling fluid, which can leave a coating or residue on the reinforcement (Figure 12.3).

Even under ideal concrete flow conditions, slurry becomes trapped along the topside of deformed rebar (Jones and Holt, 2004). However, in tremie-placed conditions the concrete flow is far from ideal as the concrete flows radially around the reinforcement, further encapsulating a layer of slurry on the bars and forming laitance creases. Ignoring the already accepted issues associated with concrete flow and cover, these laitance creases also cause a reduction in pullout capacity.

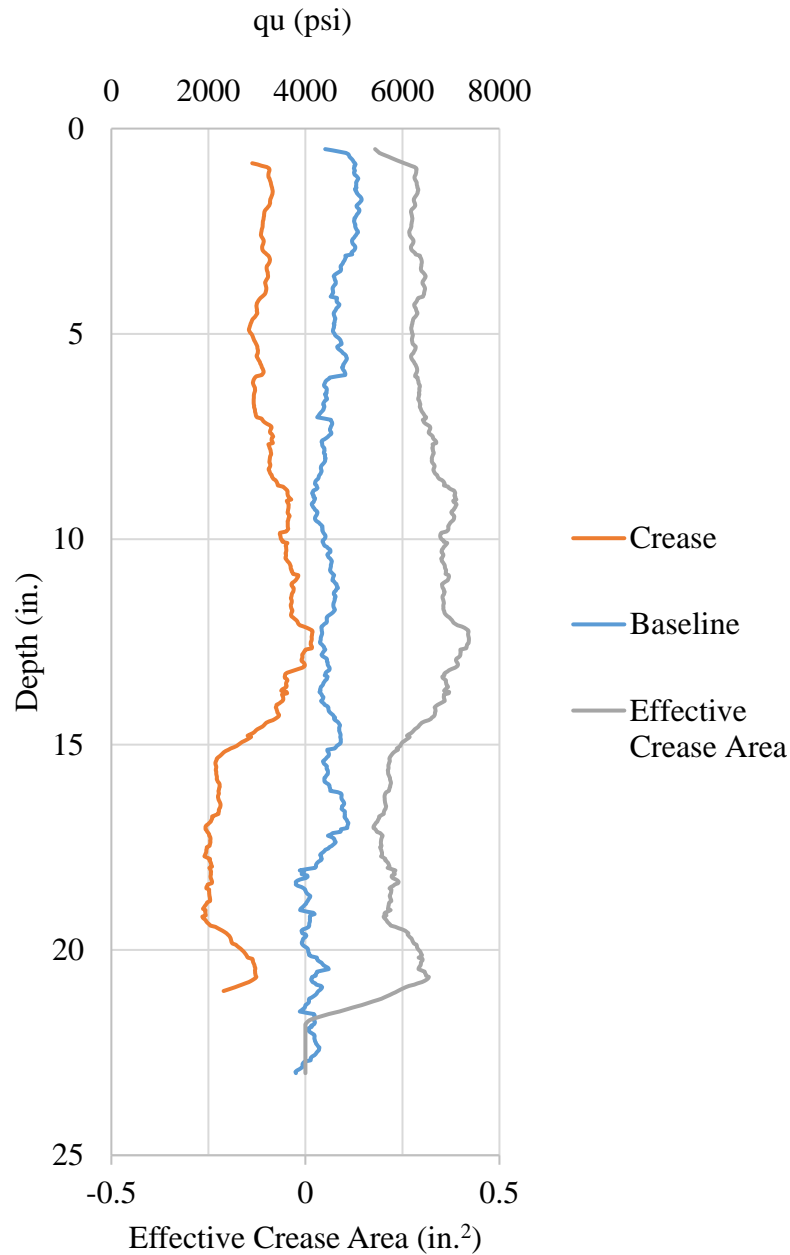
Figure 12.13 Effective crease area profile.

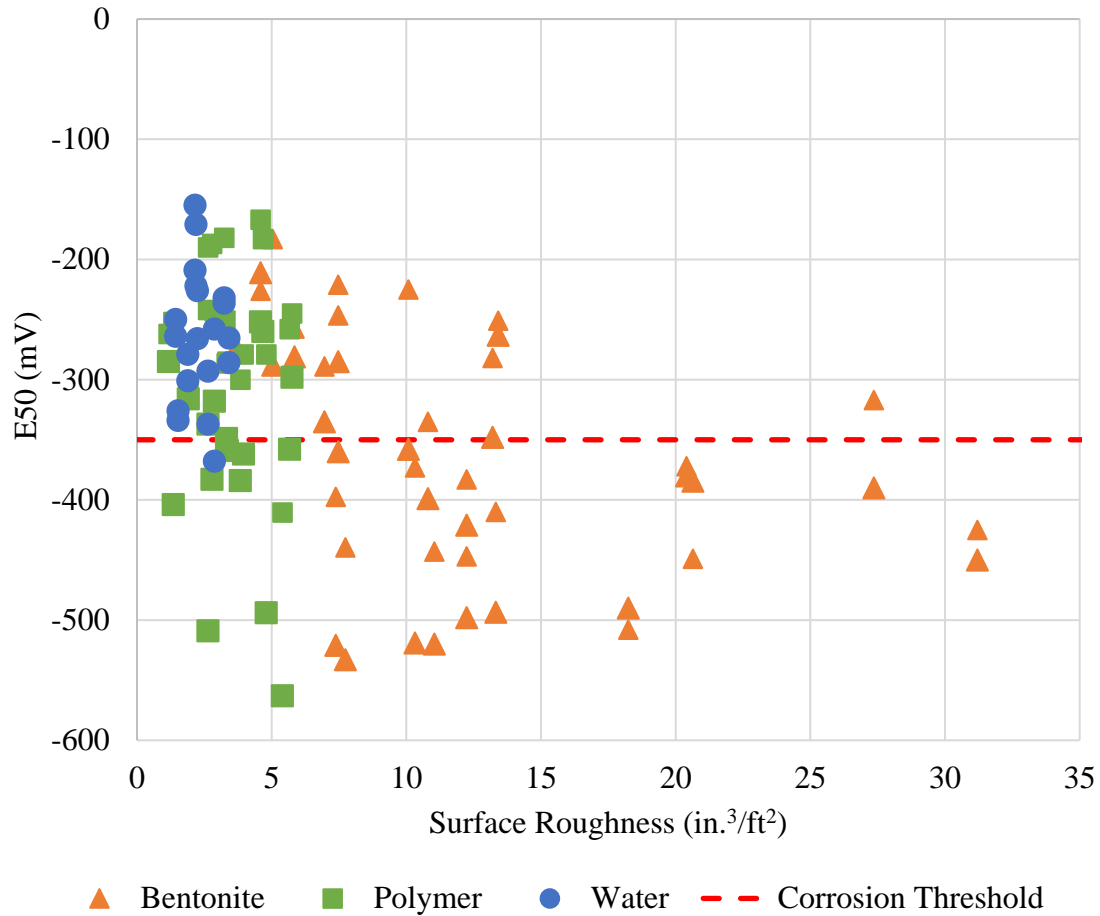
Figure 12.15 E₅₀ versus surface roughness

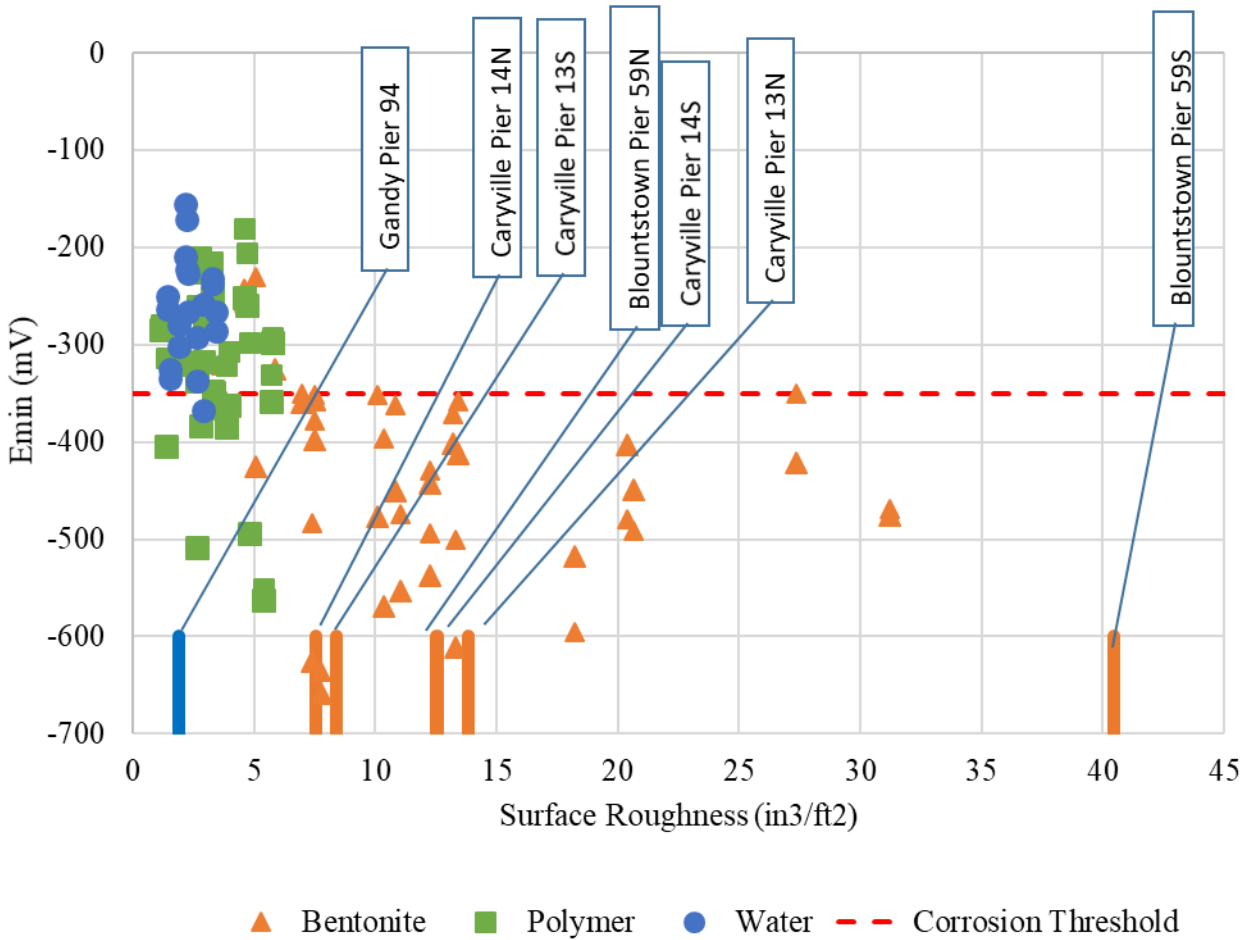
Figure 12.17 All field data showed bentonite surface roughness to exceed surface roughness criterion; water cast shafts were well below and again similar to lab cast specimens.

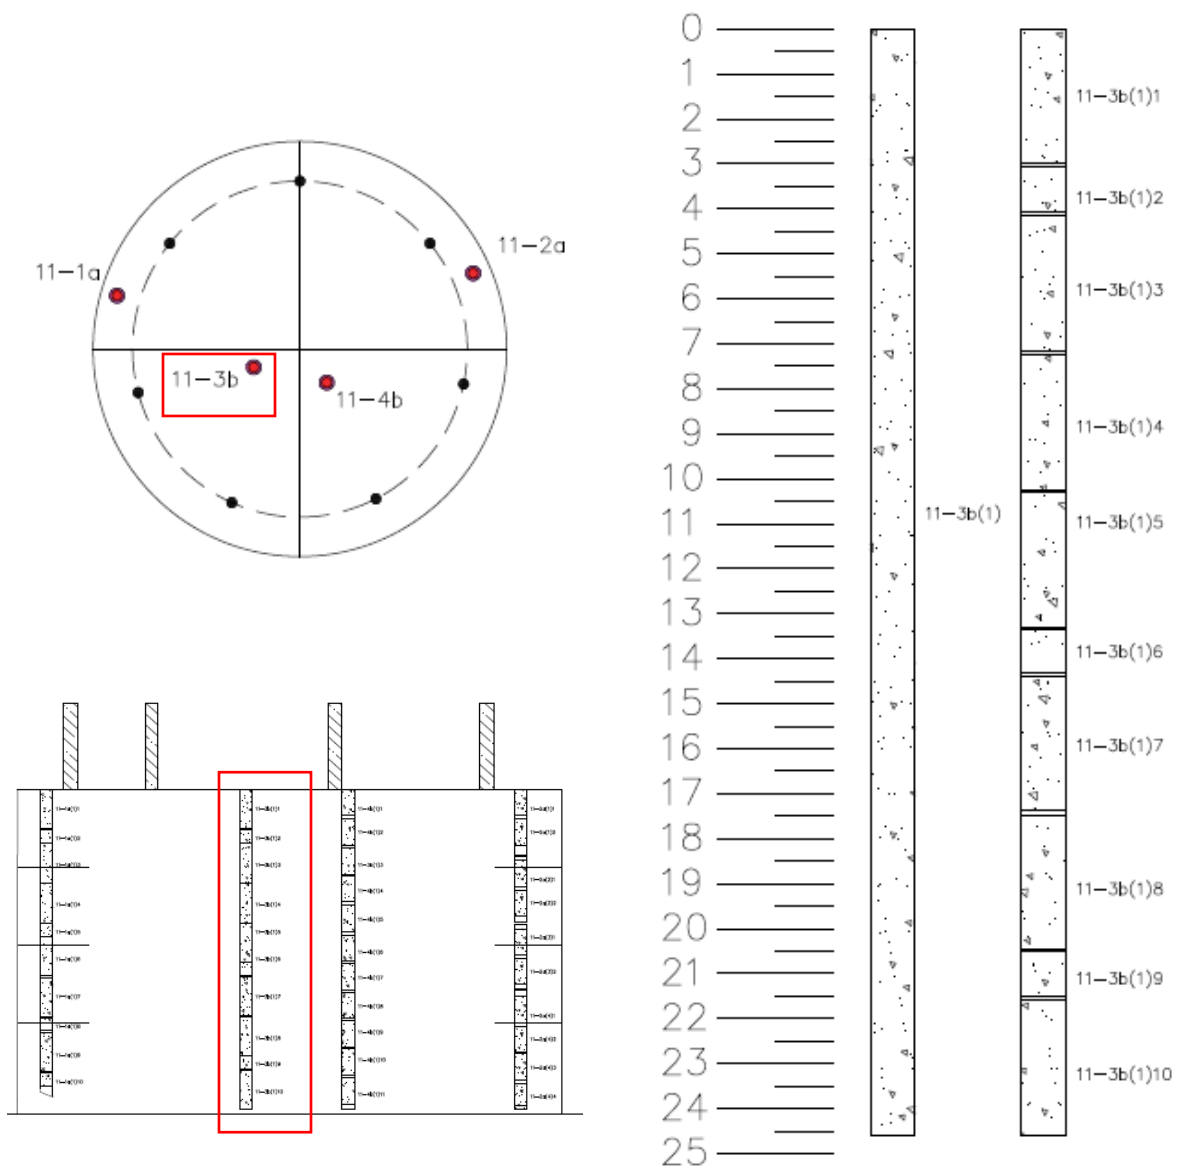
Figure G.6 Core location and profile for 11-3b.

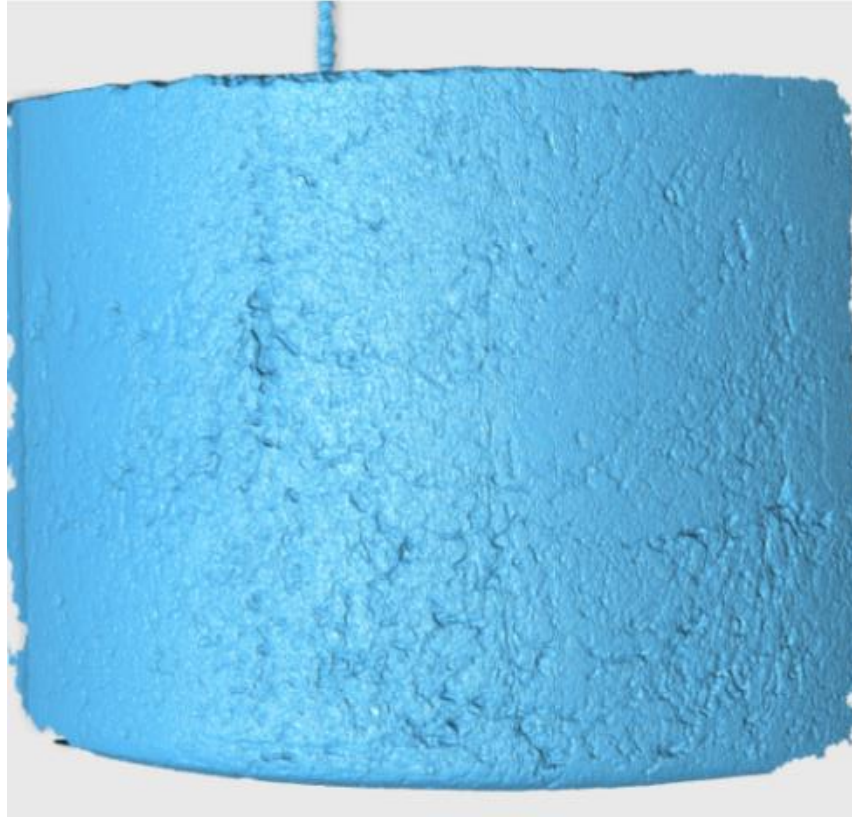
Figure I.11 Shaft 10 digital rendering

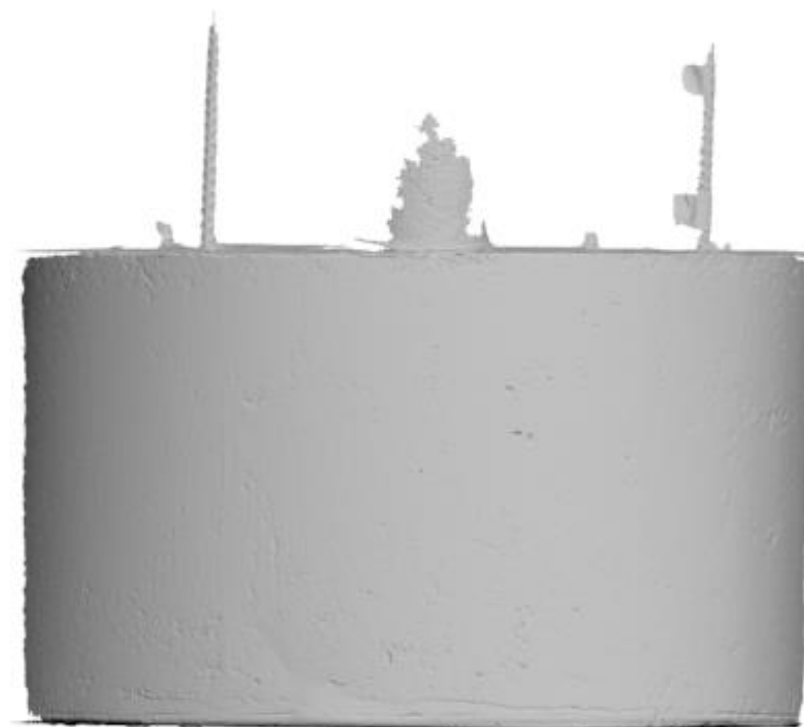
Figure I.19 Shaft 19 digital rendering

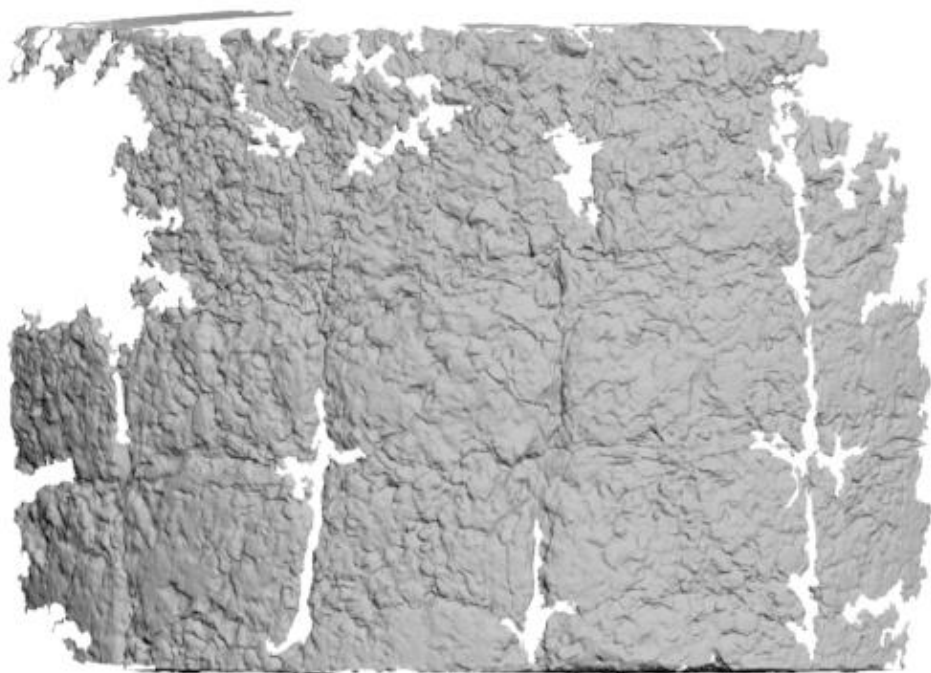
Figure I.21 Shaft 21 digital rendering

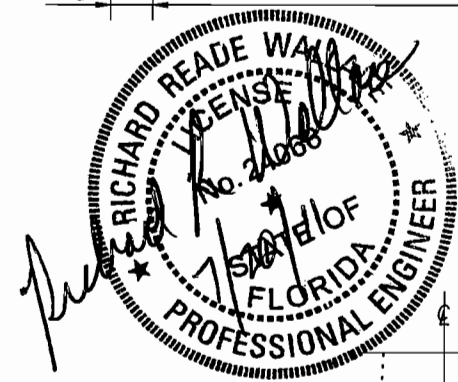
PLAN - PIER 21

1. THE INFORMATION PRESENTED ON THIS SHEET DEPICTS THE MODIFIED SUBMERGED TWO SHAFT PIER FOOTING USED TO SUPPORT THE PIER COLUMNS AT PIER 21.
2. 5P05, IIP04, AND 6P06 BARS MAY BE SHIFTED SLIGHTLY IN VICINITY OF DRILLED SHAFTS AND PIER COLUMNS TO AVOID CONFLICTS WITH REINFORCEMENT IN THOSE ELEMENTS.
3. PROVISIONS FOR MASS CONCRETE SHALL APPLY TO CONCRETE COLUMNS AND FOOTINGS FOR PIERS 6-10 AND 20-24.
4. NON-REINFORCED, CLASS III (SEAL) CONCRETE SEALS SHALL BE 3'-6" THICK FOR PIERS 6-11 AND 20-24. CONTRACTOR MAY PROVIDE ALTERNATE DESIGN FOR SEALS, SIGNED AND SEALED BY A PROFESSIONAL ENGINEER REGISTERED IN THE STATE OF FLORIDA.

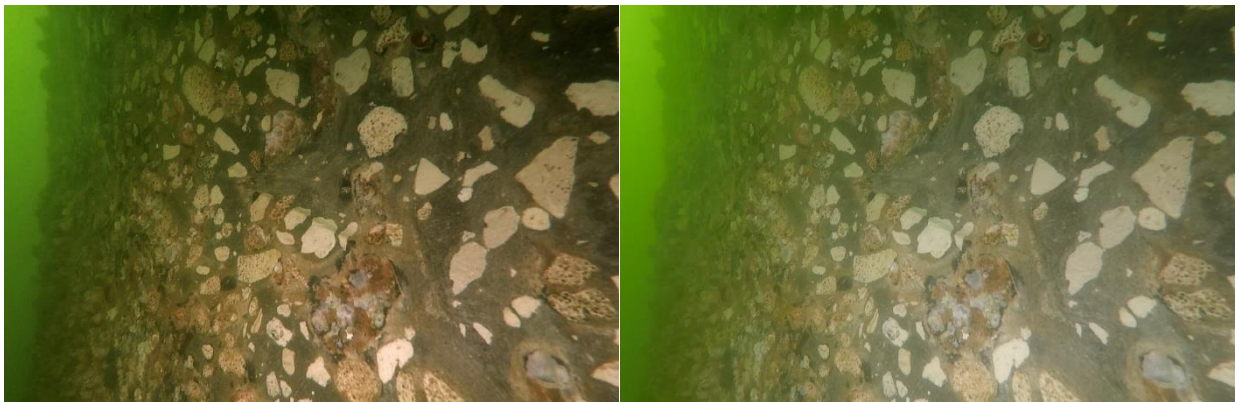
Figure M.17. Figure 10.35, photoshopped (left) and original (right)

Figure 10.35 95-1 prior to cleaning.

Shaft 95-1 did have a void as noted, and it was noticeable even prior to cleaning (Figure 10.35). This void was substantial; Figure 10.36 shows the void before cleaning, which involved scraping barnacles, grinding and/or wire-brushing. A screwdriver was used for reference of void depth, which was about 2-3 in. (Figure 10.37). However, on the south (interior) side of the same shaft,
