**Final Report 645**

## **Evaluation of Counting Device for Pedestrians and Bicyclists**

Yasser Ismail

***Southern University***

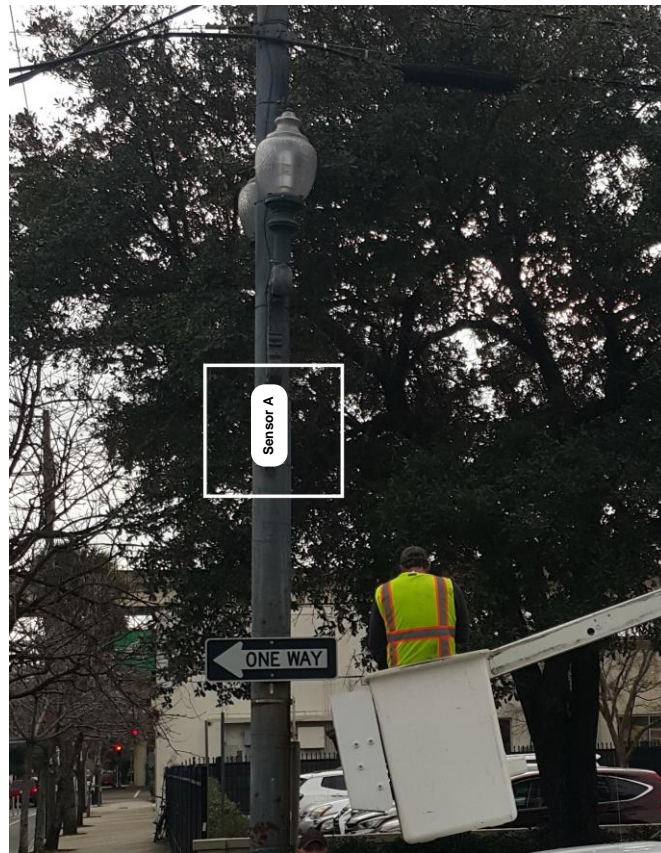
**Figure 1. The mounting process of sensor A on a light pole**

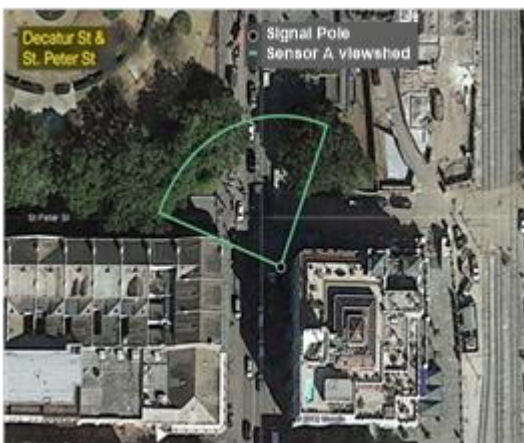
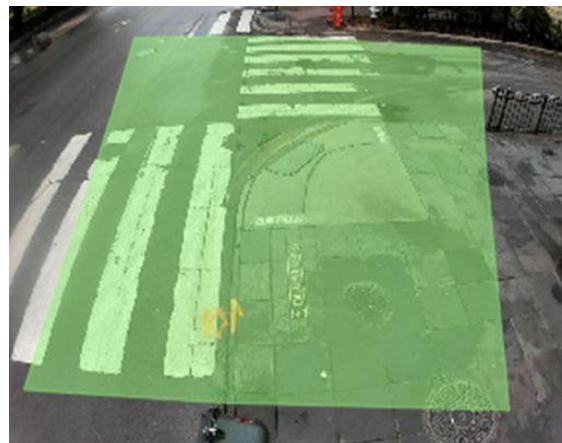
Figure 2. Selected poles to mount sensor A and the corresponding coverage areas

Decatur St. & St. Peter St. (LTRC1)

The video cameras that are seen in Figure 3, Figure 4, and Figure 5, are mounted on the same poles of sensors A. The cameras' lenses were adjusted to cover the same coverage areas of sensors A as seen on the right side of Figure 2. The recorded videos during certain periods were used by a graduate student to manually count the number of pedestrians and bicyclists. It is worth mentioning that the manual counting process is only performed within the green areas seen on the right side of Figure 2 to get a fair comparison with sensor A counts.

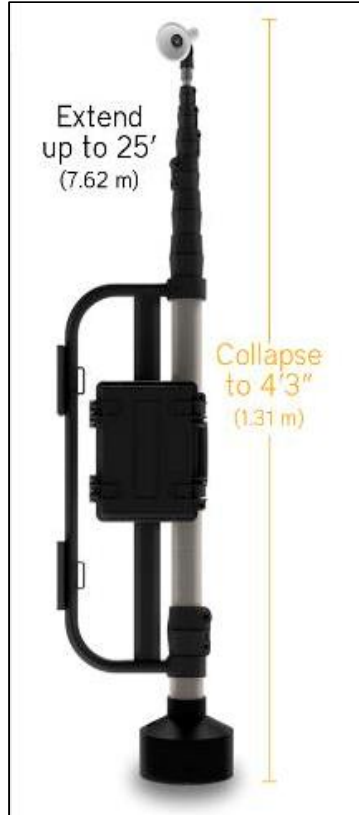
**Figure 4. Miovision Camera System**

Miovision is a well-known Canadian company in transportation engineering that focuses on traffic operations, traffic data, and smart city solutions. The installation of the system is easy and does not require professional installation or special software to review the footage. Minimal space is necessary to store the equipment shown in Figure 4.

The following is an itemized list of the components for the camera system in Figure 4.

1. Scout Control Unit
2. Lock with Key
3. Miovision Ultra SD Card
4. USB SD Card Reader (1)
5. Universal Charger & Regional Power Cord
6. Scout Pole Mount
7. Scout Camera
8. Ratchet Straps
9. TR30 Screw Driver
10. Lock with Key
11. Power Pack

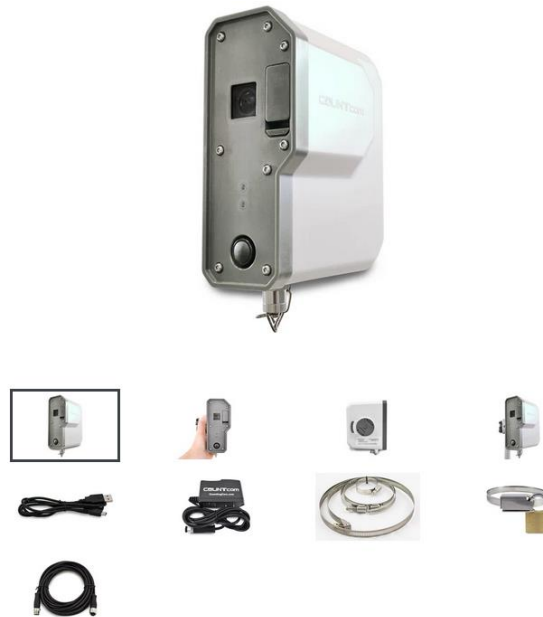
**Figure 5. COUNTCAM2 Camera System**

COUNTCAM2 is (Serial Number: E0B94D672598) an American manufacturer and online store that develops and sells durable, cost-effective transportation data collection equipment. The installation of the system is easy and does not require professional installation or special software to review the footage. Minimal space is necessary to store the equipment shown in Figure 5. The video recording operation can be started by a phone application.

The following is an itemized list of the components for the camera system including images as seen in Figure 5.

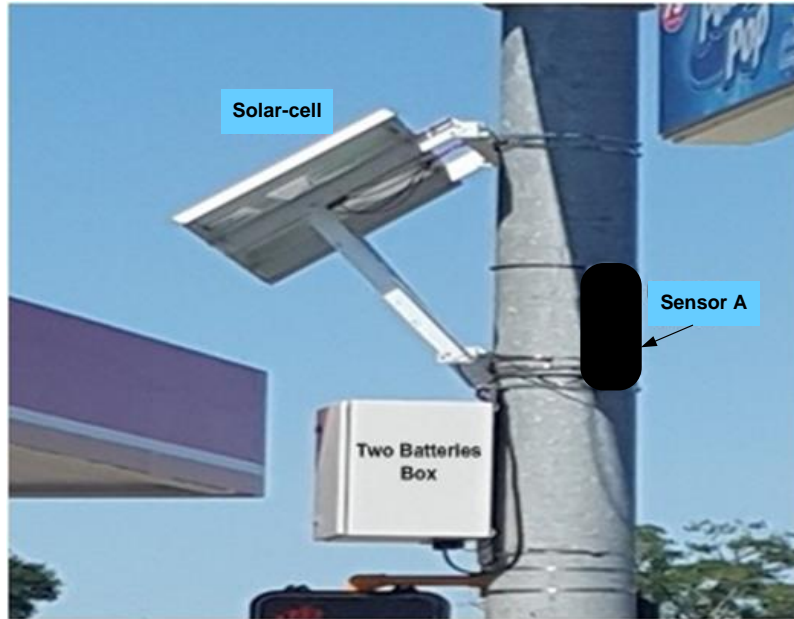
**Figure 6. Solar-cell system**

Three kits of sensor A were mounted at three different locations in Baton Rouge. Along with the solar cells, all sensors at Baton Rouge locations were connected to either a signal or a light pole. The City of Baton Rouge did not allow wired connection; this is why solar-cells were used.

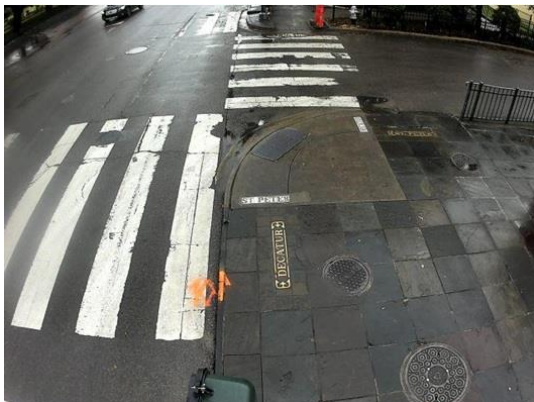
(a) The original snapshot

Figure 7 (a) illustrates an example of the original snapshot that was taken by sensor A and the selected coverage area is shown in Figure 7 (b). The counting algorithm of sensor A excludes the outer edges of the original snapshot to get the maximum counting accuracy.

**Figure 7. An example of a coverage area by sensor A**

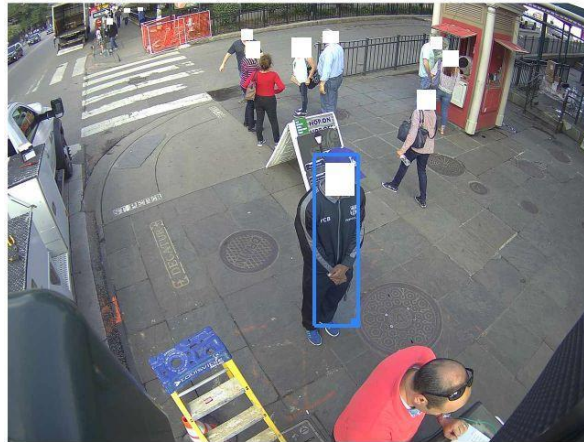
**Figure 8. The object window decision process by sensor B**

Sensor B is capable of automatically counting objects in addition to capturing videos that were used for our manual validation purpose. Sensor B has a static IP address that can be used to set-up the device. It is important to select the correct setup parameters to successfully calibrate the camera. The calibration process of sensor B includes the object window decision as seen in Figure 8. The object window size depends on the angle and the height of sensor B's lens. The second calibration step is to determine the location of the passing lines as seen in Figure 9. Sensor B can provide up to eight lines. Any object that passes the line/s as shown in Figure 9 will be automatically counted by sensor B.

Sensor B is used for both automatic counting and recoding video footage that we used for manual counting purposes. The calibration and the setup of the sensor B are done as mentioned before in the methodology section. Sensor B is only capable of counting objects that fit the calibrated window-size. It means that sensor B cannot classify the type of objects as sensor A does. Sensor B was mounted at the LTRC1 location that had a high-traffic volume of pedestrians. Figure 41 represents the daily count of the sensor B and the manual counts for the period from February 24 to March 3. It is worth mentioning that the manual counting process considered two calibration lines as seen in Figure 9. The Absolute Percentage of Error (APE) for sensor B is seen in Figure 42. It is clear from Figure 42 that sensor B failed to match the manual counts in the outdoor environment. During the evaluation period shown in Figure 41 and Figure 42, the median APE is 89.9%; the average APE is 86.1%; and the maximum and the minimum APE are 116.99% and 50.87%, respectively.

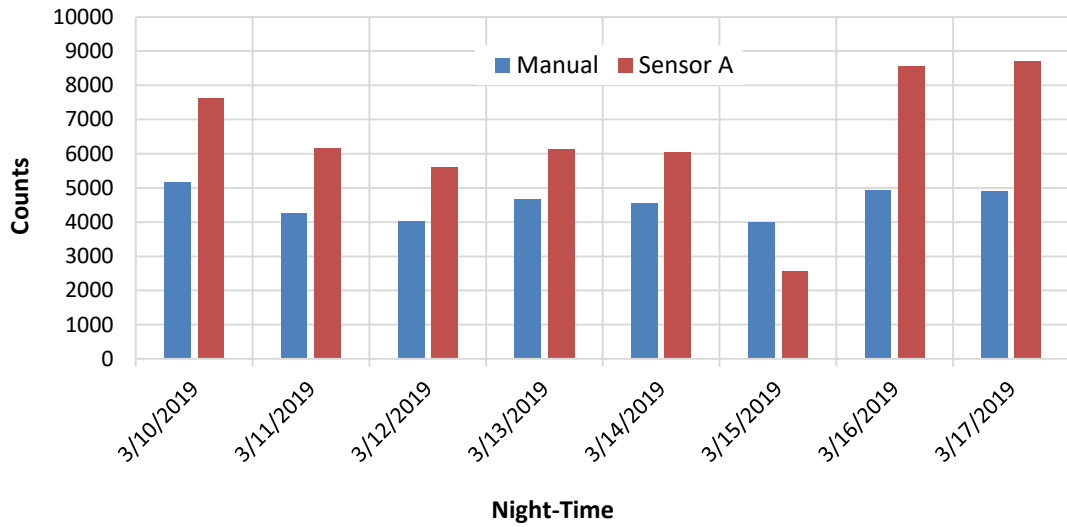
**Figure 10. The daily pedestrians' count of LTRC1**

Night-Time	3/10/2019	3/11/2019	3/12/2019	3/13/2019	3/14/2019	3/15/2019	3/16/2019	3/17/2019
Manual	5163	4269	4033	4658	4560	3996	4936	4885
Sensor A	7624	6165	5600	6133	6040	2561	8546	8698

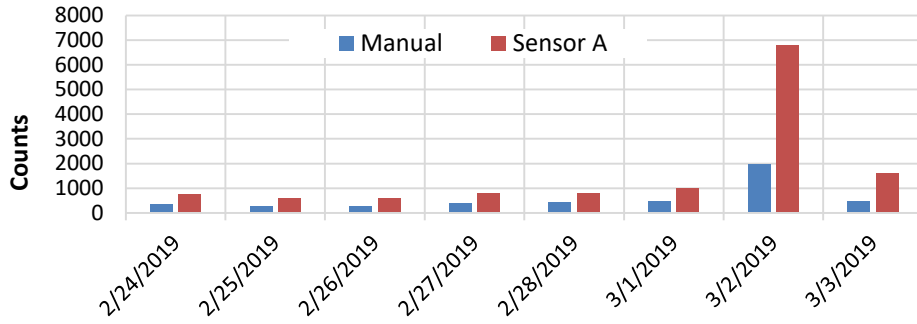
**Figure 16. The daily pedestrians' count of LTRC3 from February 24 to March 3**

Day-Time	2/24/2019	2/25/2019	2/26/2019	2/27/2019	2/28/2019	3/1/2019	3/2/2019	3/3/2019
Manual	329	263	249	367	416	446	1979	451
Sensor A	759	584	573	781	794	1002	6804	1604

LTRC3 location has a high-traffic pedestrians and bicyclists volume. A video recording camera was mounted with sensor A to record real-time video footage at LTRC3. Three different continuous video data were recorded by the video recording camera. A comparison between the manual and sensor A's counts of the pedestrians and the bicyclists, during the day-time and the night-time of LTRC3 from February 24 to April 13, is seen through Figure 16 to Figure 21. It is noted from the results that sensor A at LTRC3 failed to accurately count both the pedestrians and the bicyclists during the day-time and the night-time period compared to the manual counts.

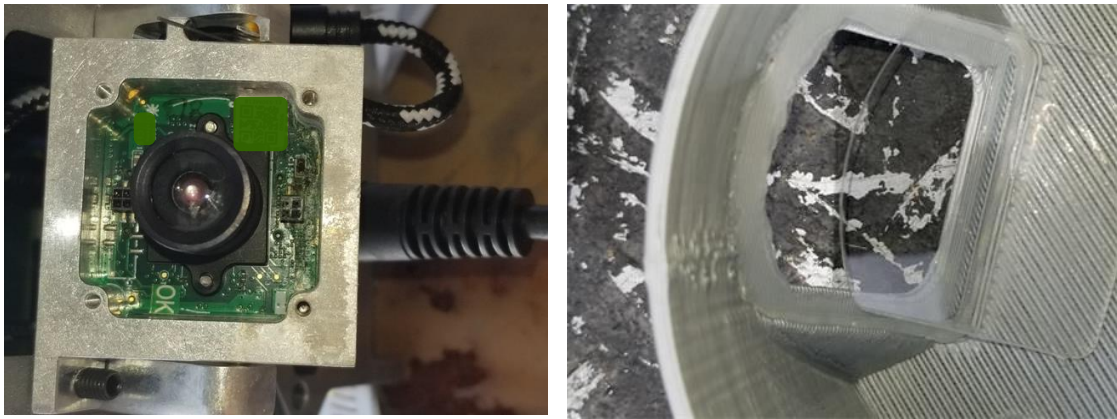
The sensor at Esplanade Ave & N Peters St. (LTRC2) was installed on January 15, 2019. It stopped working after two weeks from the installation time due to a technical problem with its lens. There was a leak and rainwater affected the sensor as seen in Figure 22. A replacement sensor was reinstalled on February 20, 2019.

**Figure 22. Defective parts of the sensor at LTRC2 location**

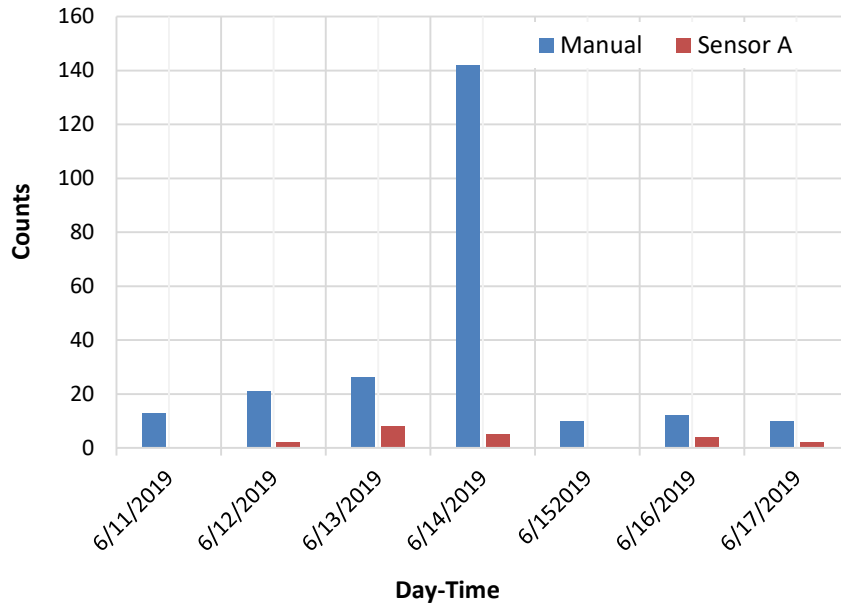
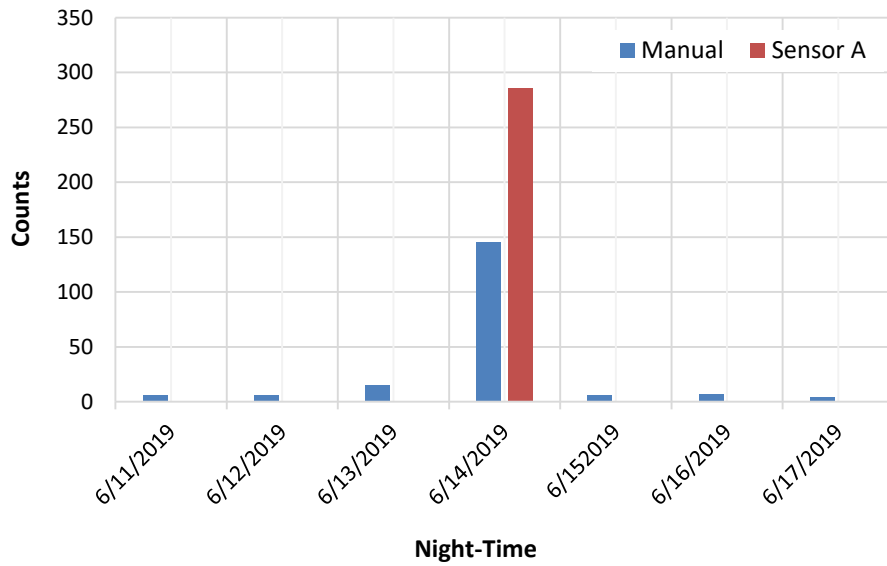
**Figure 32. The daily bicyclists' count of LTRC5 from June 11 to June 17**

Day-Time	6/11/2019	6/12/2019	6/13/2019	6/14/2019	6/15/2019	6/16/2019	6/17/2019
Manual	13	21	26	142	10	12	10
Sensor A	0	2	8	5	0	4	2

Night-Time	6/11/2019	6/12/2019	6/13/2019	6/14/2019	6/15/2019	6/16/2019	6/17/2019
Manual	6	6	15	145	6	7	4
Sensor A	1	0	0	286	0	0	0
