JRC2020-8030

**LOCOMOTIVE CRASH ENERGY MANAGEMENT
VEHICLE-TO-VEHICLE IMPACT TEST RESULTS**

This paper describes the results of the most recent test in the research program: the first vehicle-to-vehicle impact test. In this test, a CEM-equipped locomotive impacted a stationary conventional locomotive. The primary objective of the test was to demonstrate the effectiveness of the components of the CEM system in working together to absorb impact energy and to prevent override in a vehicle-to-vehicle collision scenario. The target impact speed was 21 mph. The actual speed of the test was 19.3 mph. Despite the lower test speed, the CEM system worked exactly as designed, successfully absorbing energy and keeping the vehicles in-line, with no derailment and no signs of override. The damage sustained during the collision is described. Prior to the tests, a finite element model was developed to predict the behavior of the CEM components and test vehicles during the impact. The test results are compared to pre-test model predictions. The model was updated with the conditions from the test, resulting in good agreement between the updated model and the test results. Plans for future full-scal

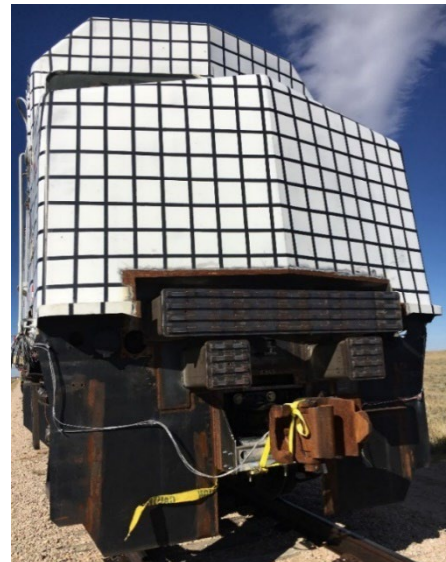
Figure 2. CEM Locomotive: F40 #234 retrofit with a PBC and DAC

The equipment that was used in the CEM vehicle-to-vehicle test is an F40 locomotive retrofit with the two CEM components, and a conventional F40 locomotive. Locomotive #234 is shown in Figure 2, with the retrofit CEM components: the PBC and DAC.

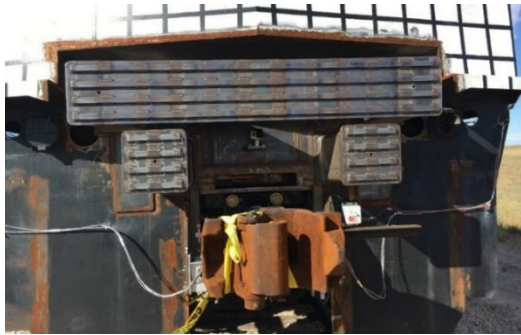
Figure 3. The DAC (top) and the PBC (bottom) comprise the locomotive CEM system

Figure 3 shows a close-up of the DAC and PBC retrofit to the F40 locomotive. These two components comprise the CEM system. Figure 4 shows the PBC installed within the sliding lug, and Figure 5 is an exterior view of the shear bolts, which hold the sliding lug to the draft pocket. During an impact that occurs at greater than typical coupling speeds, the goal is for the following sequence of events to occur. The deformation tube of the PBC begins to deform permanently at a trigger force of approximately 670 kips. It then pushes back at that load level, absorbing a substantial amount of energy. When the PBC stroke is exhausted, the back of the coupler head impacts the limit stop

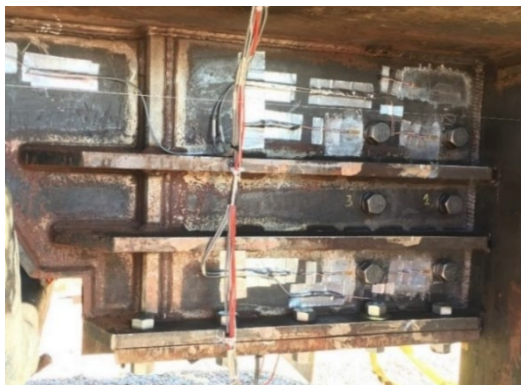
Figure 5. Exterior view of the shear bolts installed through the side plates of the draft pocket and into the side plates of the sliding lug

(a feature at the front of the sliding lug), causing a sudden increase in load to approximately 1,100 kips, which activates the failure of the 12 shear bolts. This causes the sliding lug to push back into a 10" long pocket behind it. Prior to exhaustion of the PBC stroke, the DAC impacts the anti-climbing structure of the conventional locomotive. Once the shear bolts break, the load path transfers completely from the PBC to the DAC, which then crushes in a controlled manner, absorbing additional collision energy. The entire CEM system is designed to have the colliding vehicle ends engage while absorbing the energy of the collision. This minimizes lateral buckling and ramp formation due to uncontrolled crush, both of which promote override. The design development and requirements of the CEM components are detailed in [5], [6], [7]. The details of the retrofit of F40 #234 can be found in [11], [12].

The shear bolts connecting the sliding lug to the draft pocket did not trigger, therefore the sliding lug did not slide back into the draft pocket.

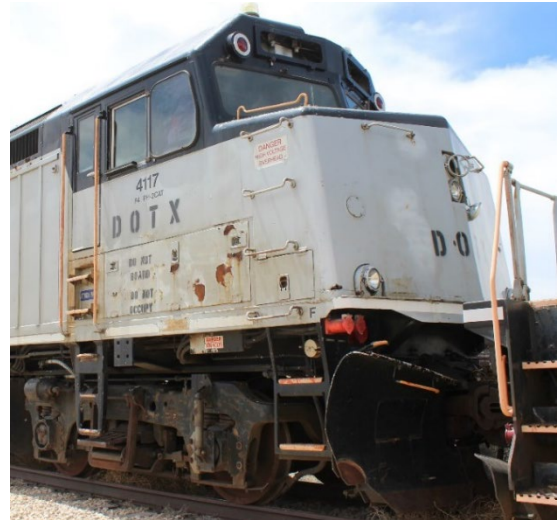
Figure 6. Conventional locomotive: F40 #4117

Locomotive #4117 was used as the conventional locomotive for the test and can be seen in Figure 6. This is an F40PG-2CAT. It was rebuilt by Conrail in 1997 and has never been previously used in testing.

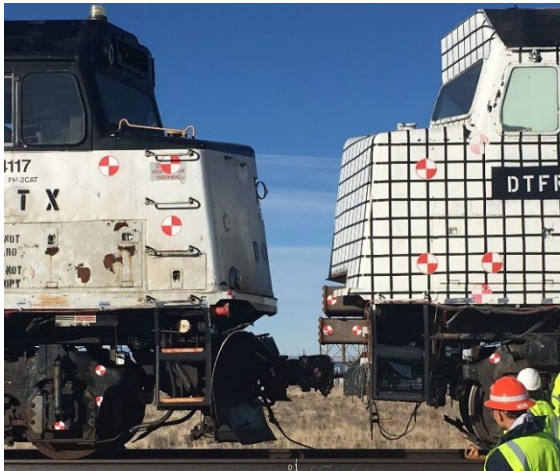
Figure 8. Pre-test photo of conventional locomotive (left) and CEM locomotive (right)

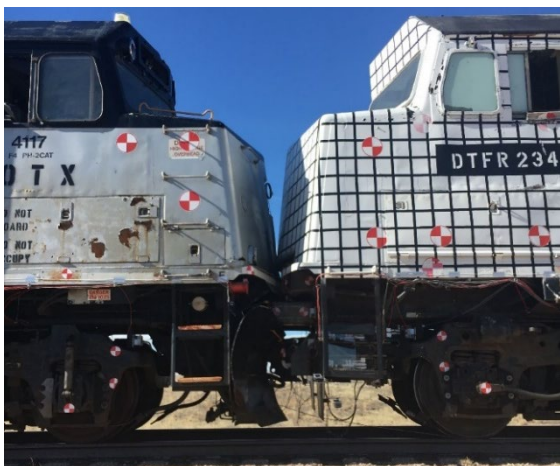
Figure 9. Post-test photo of the locomotives

On the day of the test, the weather conditions were clear with low winds. It was decided that both couplers would be left open in order to increase the chance of coupling, and the couplers were aligned within 1 inch vertically. The target impact speed was 21 mph, and the actual impact speed was 19.3 mph. Figure 9 shows the vehicles after the test. The vehicles were kept in-line. There was no derailment of the vehicles and no sign of override.

Figure 28 shows the predicted deformation. Comparing it to Figure 9 and Figure 17 shows very good agreement between prediction and test result. In both the prediction and the test, the end structures of the two vehicles are well engaged and in-line.

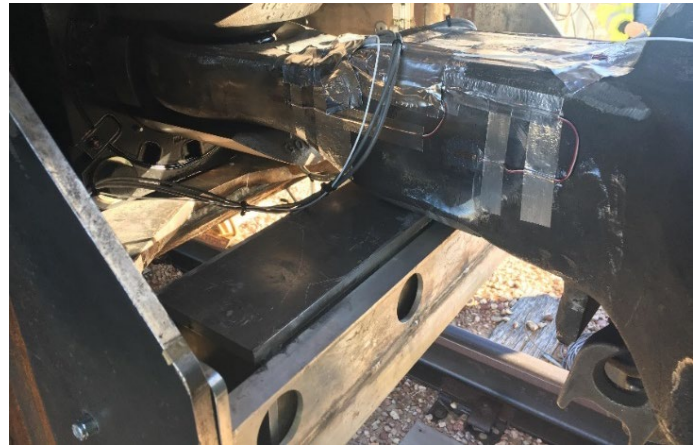
Figure 10. Pre-test photograph of the coupler carrier

During the test, the couplers engaged at impact, but did not lock together. The PBC triggered properly and moved back into the draft pocket. As the PBC moved back, the coupler carrier broke away, as designed. The intact coupler carrier before the test is shown in Figure 10. Figure 11 shows the failed coupler carrier where it fell after the PBC moved through it.

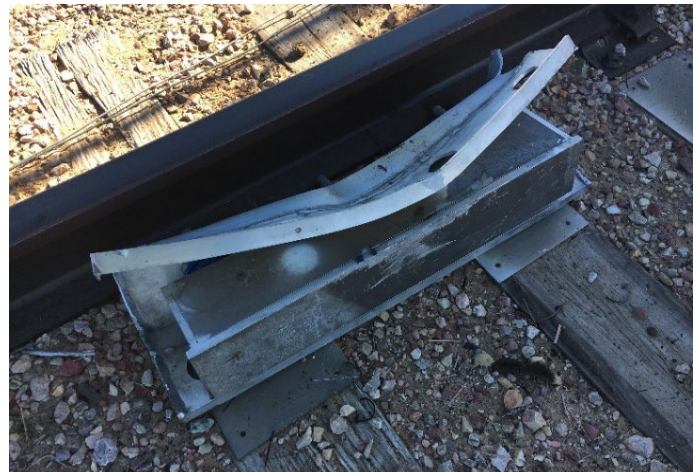
Figure 11. Post-test photograph showing the coupler carrier lying on the track

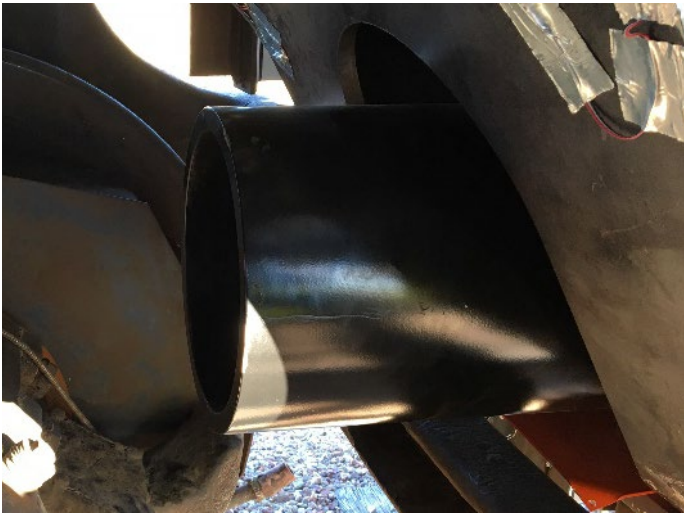
Figure 12. Pre-test photograph of the PBC

After pushing through the coupler carrier, the PBC continued to move back, deforming the crush tube. Figure 12 and Figure 13 show the back of the deformation tube of the PBC before and after the impact. The deformation tube is covered in paint that is designed to peel off in strips as the exterior tube deforms. Figure 13 indicates that the stroke of the deformation tube was almost exhausted. Figure 14 shows the deformation tube after it was removed from the draft pocket. Measurements taken confirmed that the 21" design stroke of the deformation tube was indeed nearly exhausted. This was confirmed by evidence of contact between the limit stop mounted on the sliding lug and the rear of the PBC head, as shown in Figure 15 and Figure 16. This contact is designed to occur at the full stroke of the PBC.

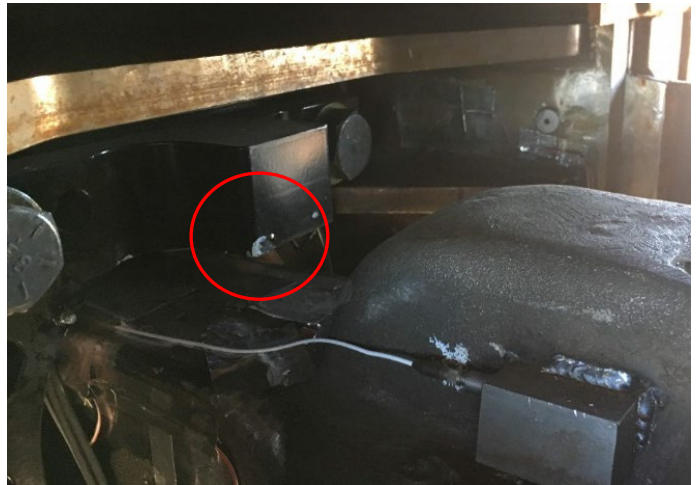
Figure 15. Damage to the limit stop mounted to the front of the sliding lug due to contact by the back of the PBC coupler head

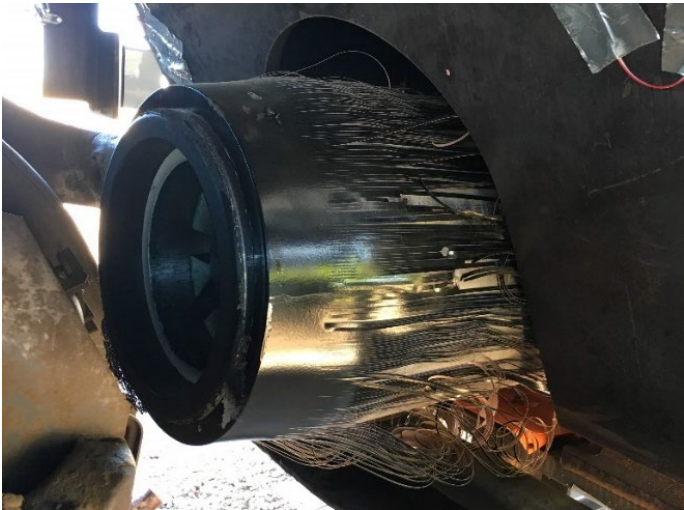
Figure 13. Post-test photograph showing the back of the deformation tube

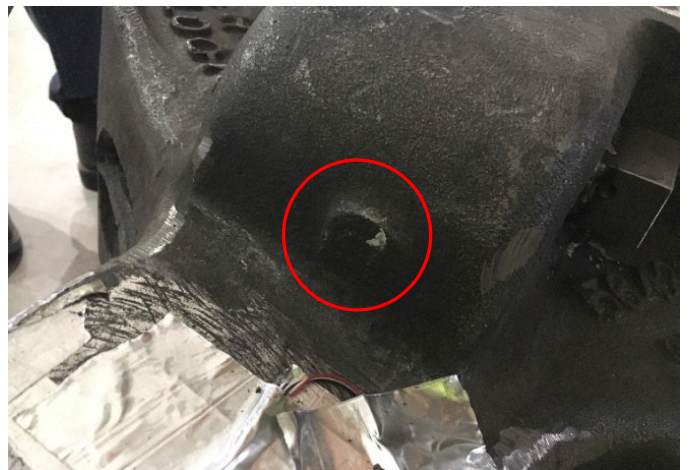
Figure 16. Damage to rear of the PBC coupler head from limit stop contact

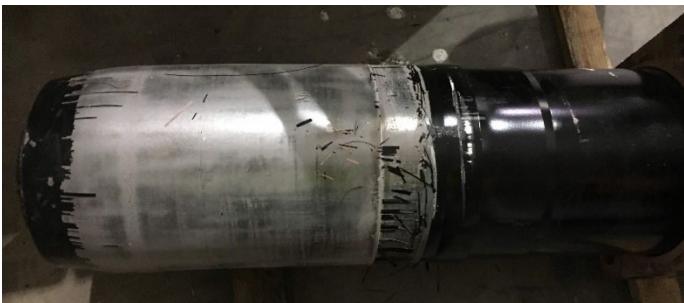
Figure 14. Deformed PBC deformation tube removed from the draft pocket

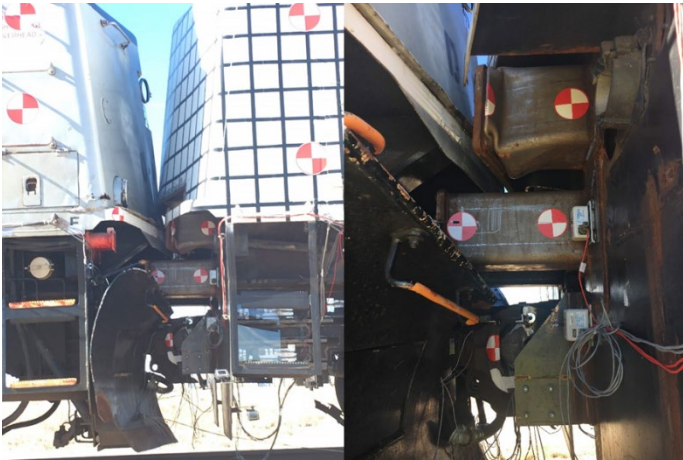
Figure 17. Post-test photo of CEM system; close-up on the right

As the PBC was pushed back, the top DAC tubes impacted the front of the conventional locomotive and began to crush. Figure 17 shows the two locomotives engaged after the impact. The photo on the right shows that only the upper DAC tubes crushed, the lower DAC tubes did not deform, as expected.

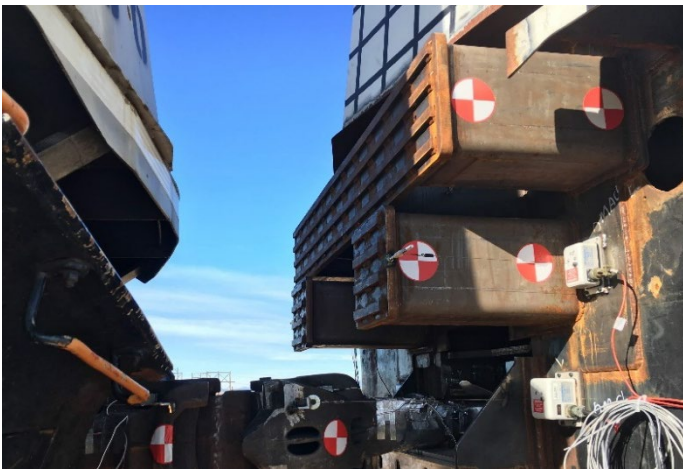
Figure 18. Pre-test photograph of DAC

For comparison, Figure 18 shows the undeformed DAC before the test, and Figure 19 shows the deformed DAC after the test, and after the vehicles had been separated. Figure 20 shows side views of both the right and left upper DAC tubes. The crush was greater on the right side than on the left. This was due to an approximately 2-inch lateral offset between the locomotives at the moment of impact.

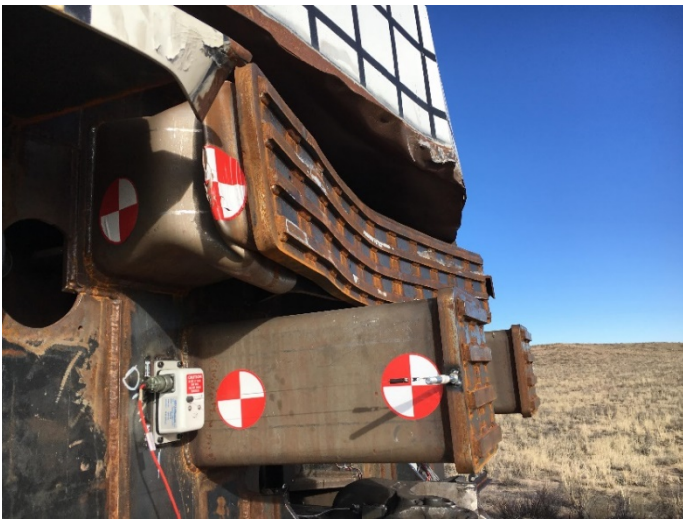
Figure 19. Post-test photograph of DAC showing that only the upper DAC tubes deformed

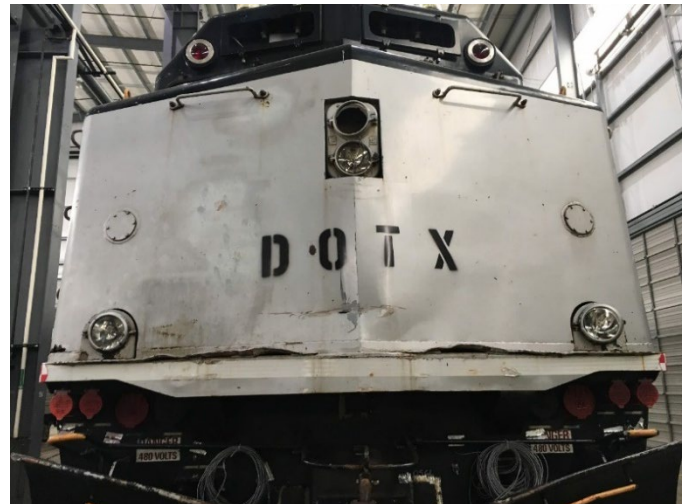
Figure 22. Conventional locomotive damage

There was also minimal damage to the conventional locomotive. Figure 22 and Figure 23 show the dent caused by interaction with the short hood of the CEM locomotive. This is also minor and easy to repair.

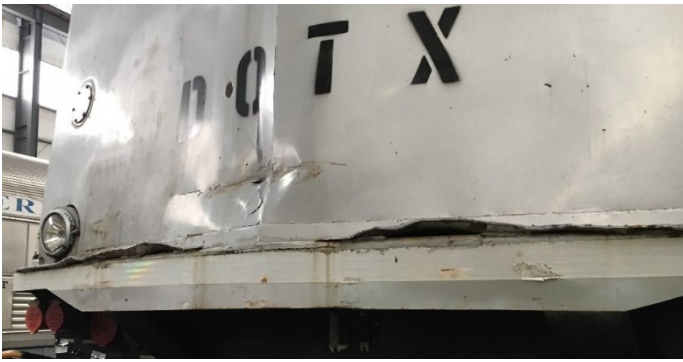
Figure 23. Close-up of conventional locomotive damage

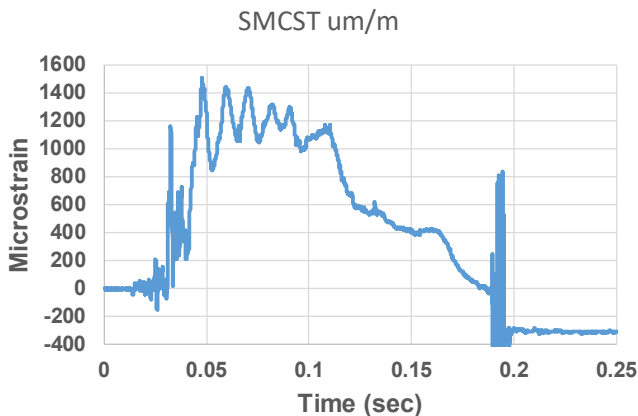
Figure 25. Strain at top of CEM coupler shank

Accelerometer and strain gage data, shown in Figure 24 and Figure 25, suggest that complete impact of couplers did not occur until approximately 0.031 seconds after initial impact. At a speed of 19.3 mph, this suggests additional travel of approximately 10.5” prior to impact. String pot data indicate that the upper DAC assembly impacts the skirt of the conventional locomotive after approximately 0.075 seconds. This is corroborated by the significant jump in acceleration of the car bodies accompanying the impact of the anti-climbers at 0.075 seconds. The acceleration pulse drops to near zero after about 0.175 seconds.

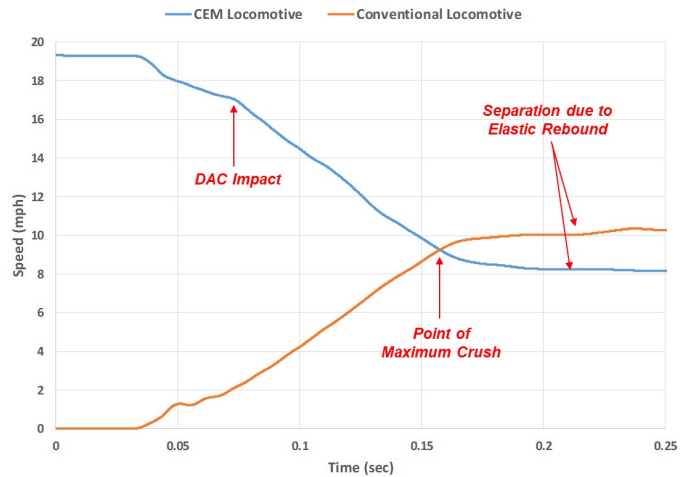
Figure 26. CEM and conventional locomotive speeds

Plotting the vehicle speed curves together, as shown in Figure 26, indicates that the maximum crush of the vehicles occurs after about 0.157 seconds. There is an abrupt change in the rate of decrease in CEM locomotive speed at 0.075 seconds due to impact of the DAC.

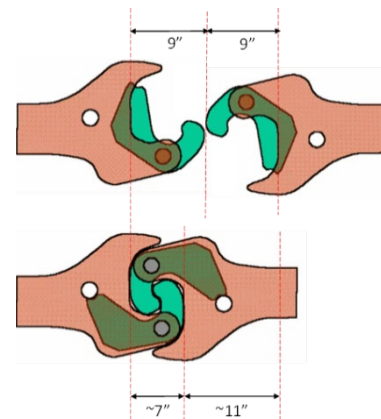
Figure 27. Coupler engagement dimensions

It was determined that the relative displacement of the locomotives peaks after 0.157 secs at 34.1 inches. Subtracting the displacement prior to full coupler impact yields a peak crush distance of 23.6 inches. This 10.5” difference is consistent with the travel (11”) that occurs when the couplers are open and the knuckles move past one another and rotate before the respective vehicles fully engage, as illustrated in Figure 27. These distances have been verified by TTCL. (The 0.5” difference may be due to the thickness of the impact tape). The 23.6” inch maximum crush is consistent with full exhaustion of PBC stroke (21”) plus 2–3 inches of draft gear compression in the conventional locomotive.

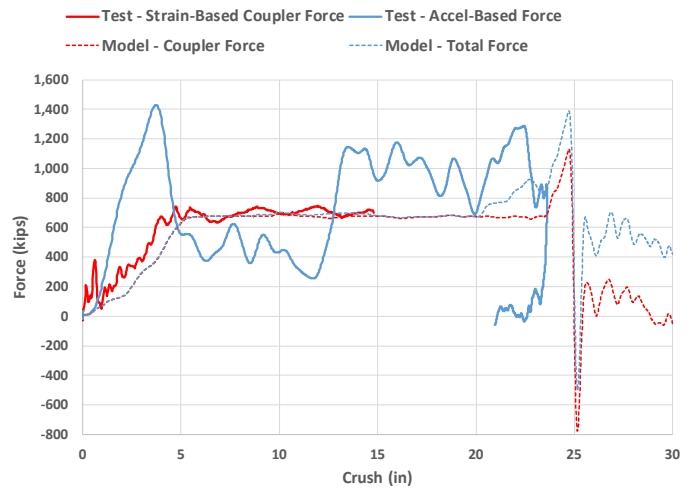
Figure 29. Force versus crush comparison of pre-test predictions with test results

The longitudinal acceleration can be multiplied by the mass of the CEM locomotive (232,600 lb.) to estimate the longitudinal force. Figure 29 shows the force versus crush through the car body and through the coupler, from both the pre-test prediction and the test data. The solid blue line is the accelerometer-based force from the CG of the carbody. The solid red line is the strain-based force from the coupler shank, which gives a better estimate of the force through the push-back coupler. As seen in the figure, the average force through the CEM locomotive carbody (solid blue line) increases considerably — from an average of about 450 kips (when the PBC deformation tube alone is absorbing energy) to an average of about 1,000 kips (when the DAC assembly is impacted). While the estimated carbody force is about 450 kips during the PBC deformation, the coupler force (solid red line) is approximately 670 kips, which is the designed force level of the PBC push back.

A comparison of the force-crush behavior from the test and the pre-test model indicates clearly that, in the test, the DAC tubes begin to absorb collision energy much earlier than they are predicted to in the model. This is primarily due to the 10.5” or so of travel prior to loading the PBC, which causes the DAC assembly to engage earlier relative to PBC crush.
