**April 2021**  
**Report No. 21-017**

# Post-Fire Damage Inspection of Concrete Structures

**Principal Investigator (s)**  
**Dr. Simos Gerasimidis**  
**Dr. Scott Civjan**  
**University of Massachusetts Amherst**

Final Report

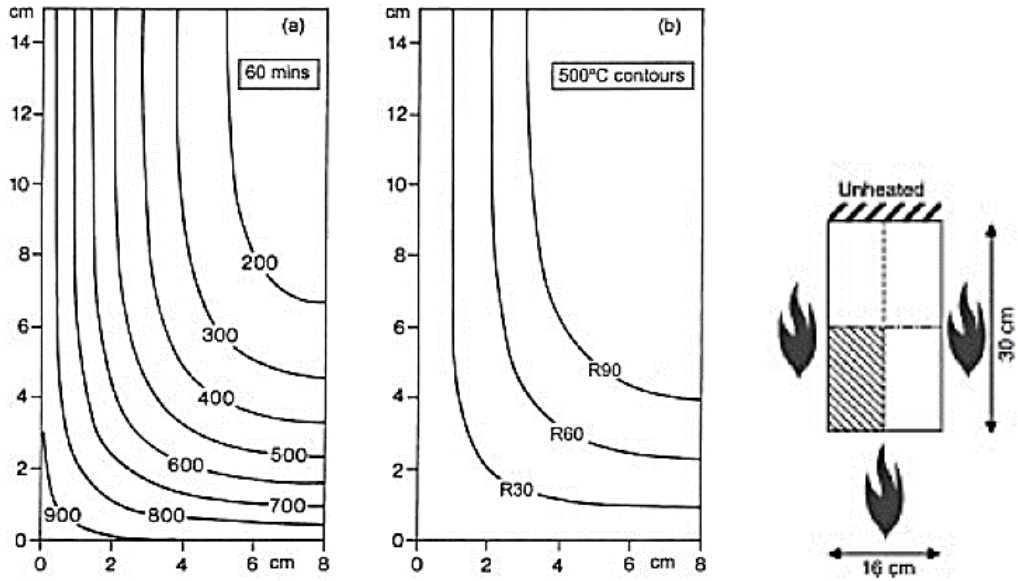
**Figure 2.16: Isothermal lines (Celsius) after 60 minutes of exposure to ISO 834 design fire (L); 500°C isotherms after 30, 60, and 90 minutes of exposure to ISO 834 design fire (C); heating conditions of beam (R)**

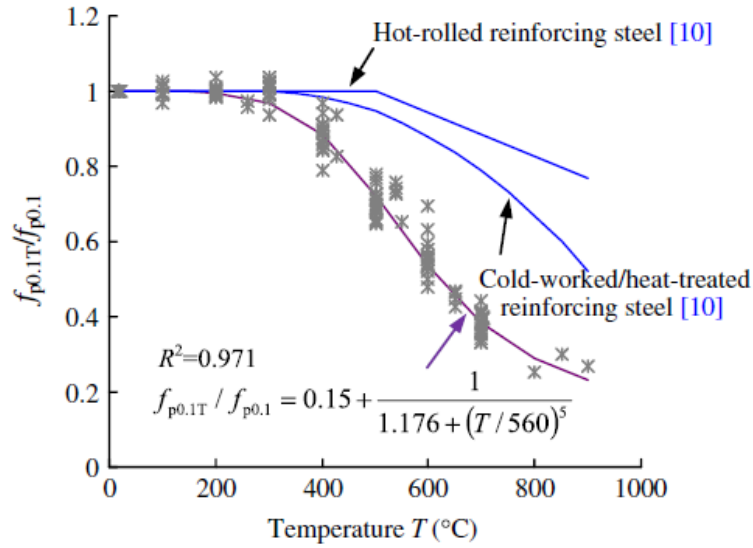
**Figure 2.36: Residual 0.1% proof stress of prestressing steel and yield strengths of reinforcing and heat-treated/cold-worked steel**

The properties of prestressing steel after cooling from elevated temperatures are discussed as follows. As noted previously, the post-fire condition of prestressing steel is of particular concern, as the residual strength losses for given temperatures are much greater than those for other types of steel. A 2014 study performed a meta-analysis on studies of the residual mechanical properties of prestressing steel after thermal exposure [32]. The types of steel used in the studies included a variety of as-drawn, stress-relieved, and low-relaxation strands and wires. Figure 2.36 shows the residual 0.1% proof stress of prestressing steel reported in the studies, along with the yield strengths of hot-rolled reinforcing steel and heat-treated /cold-worked reinforcing steel from the meta-analysis discussed in previous sections [5] for comparison. Proof stresses are often used as an arbitrary definition for the yield point of high-strength steel, and this particular study adopts a 0.1% proof stress definition as required by *Australian Standard AS 3600*.

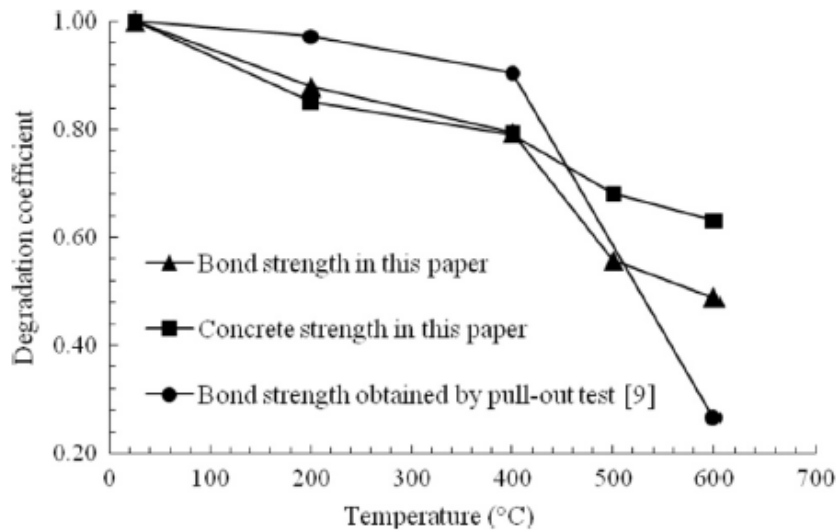
**Figure 2.45: Degradation coefficients for bond strength measured by beam test, concrete compressive strength, and bond strength measured by pullout test on similar concrete**

Beam specimens were heated to various temperatures up to 600°C and allowed to cool to room temperature in air. Afterwards, they were subjected to a three-point beam test. Figure 2.45 shows the degradation of the bond strengths as measured by the beam test and the degradation of the concrete strength measured by compression tests on separate specimens made of the same concrete mixture as the beams [45]. At and below 400°C, the compressive strength and bond strength degradation are nearly identical, but above 400°C, the bond strength decreases more than the concrete compressive strength. The results are also compared to bond strength obtained in a similar experiment previously performed by the researchers (labelled “Bond strength obtained by pullout test [9]”) that used the pullout test rather than the beam test.

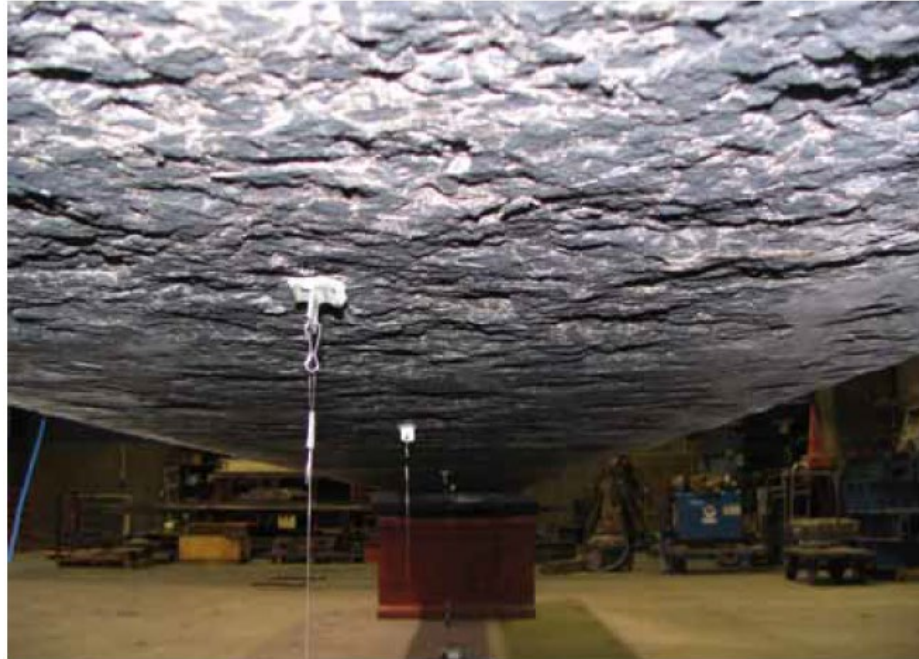
**Figure 3.9: Visual condition of bottom of Beam 4, Ridgefield bridge**

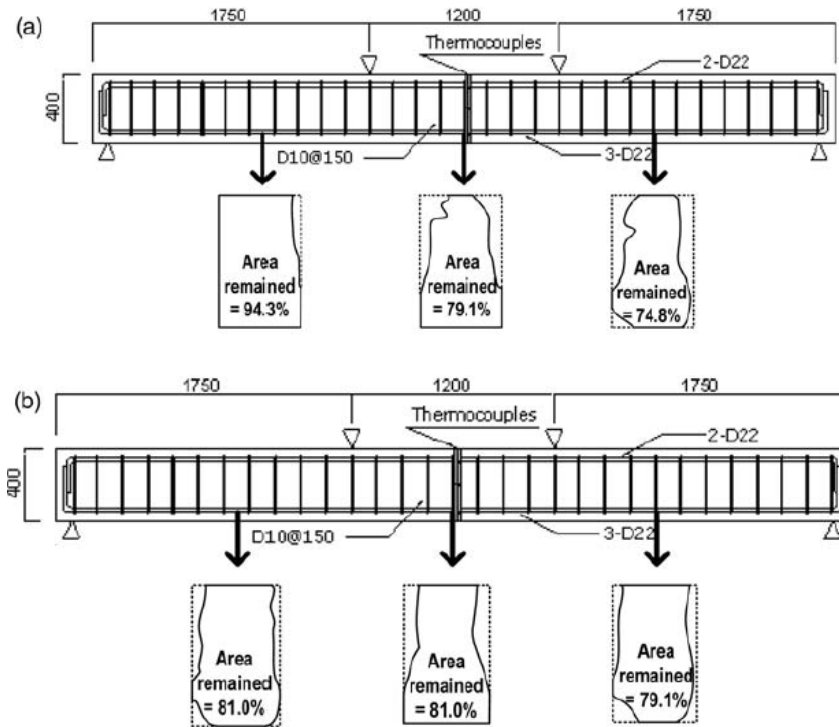
**Figure 3.15: Spalling in HSC beams with 40 mm cover (top); with 50 mm cover (bottom)**

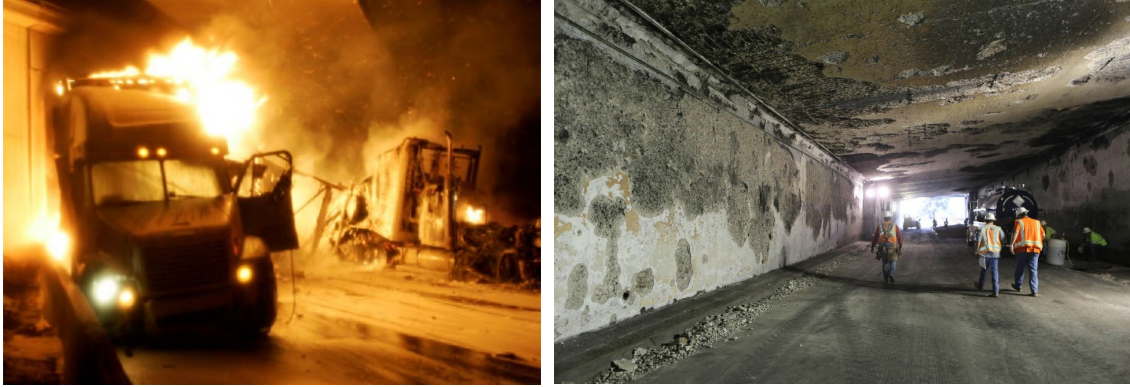
**Figure 4.1: Picture taken during Newhall Pass fire event (L); post-fire condition of tunnel (R)**

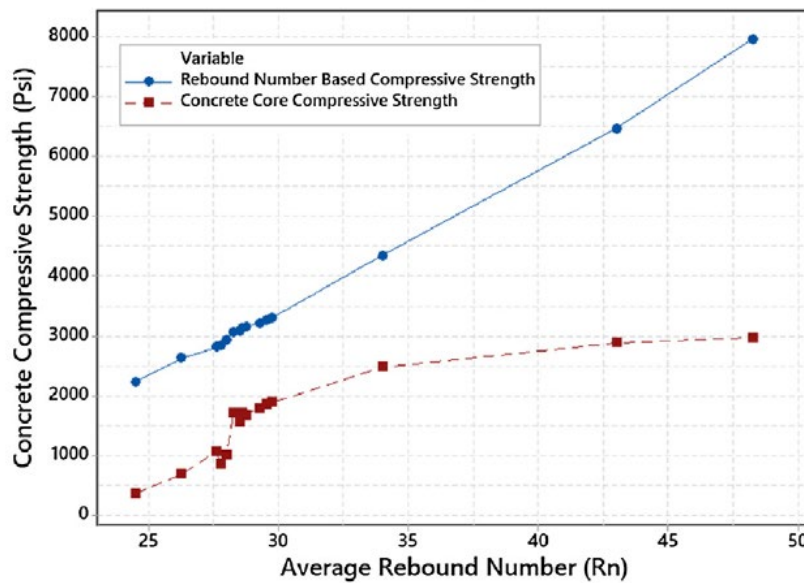
**Figure 4.13: Measured core strength of concrete vs. rebound number and compressive strength estimated by rebound number**

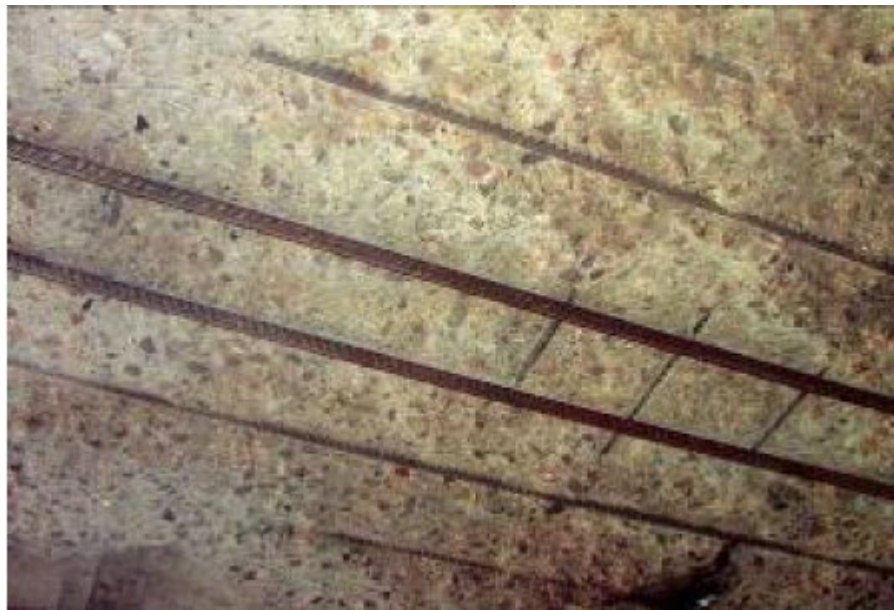
**Figure 5.1: Buckled reinforcing bars in underside of slab**

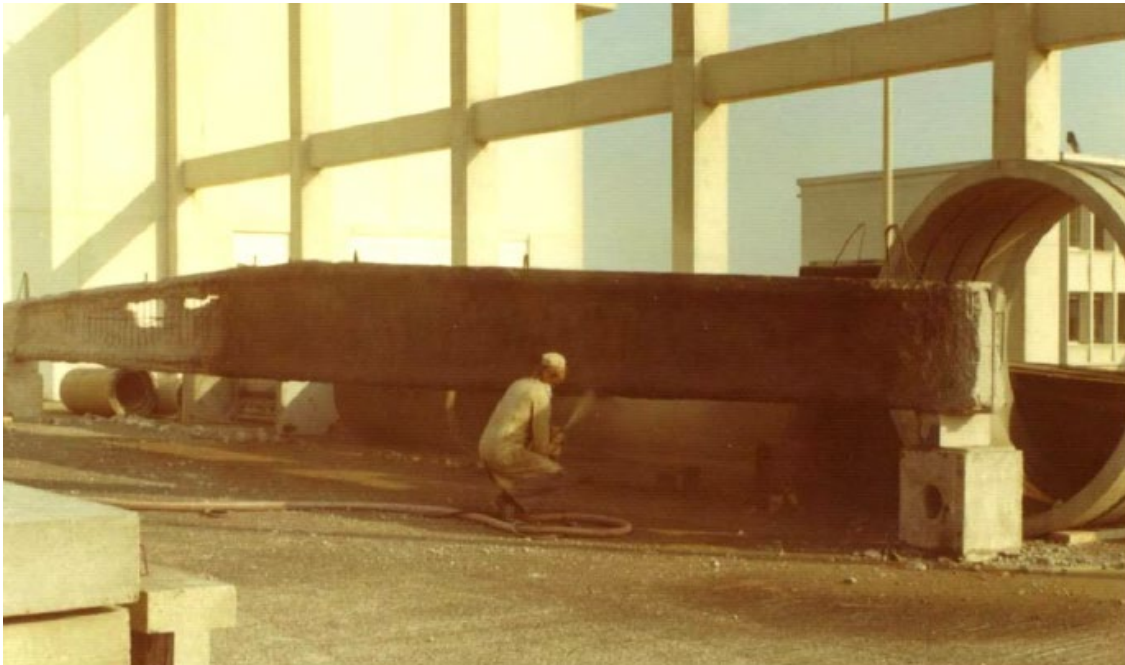
**Figure 5.11: Application of shotcrete to damaged girder**

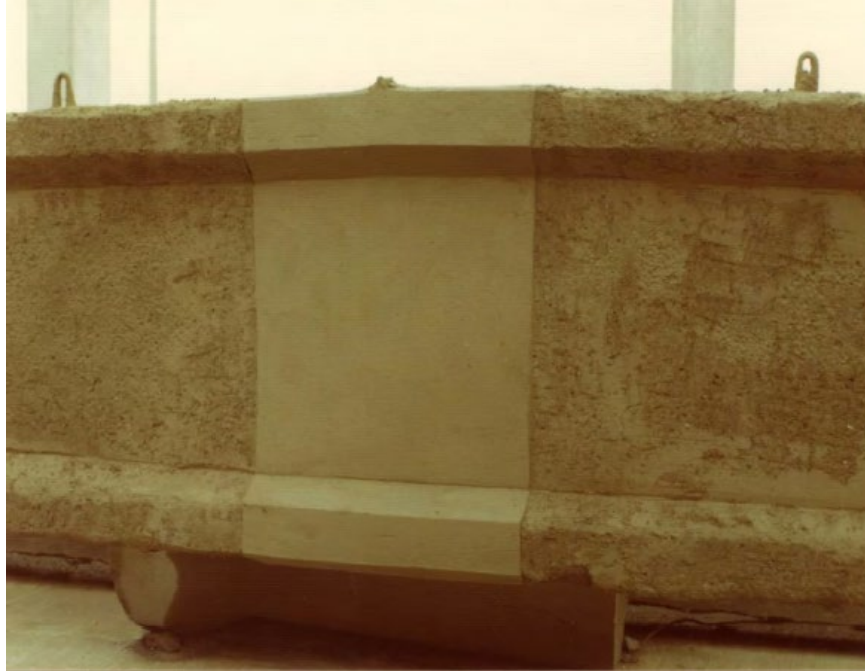
**Figure 5.12: Midspan of girder after repair**

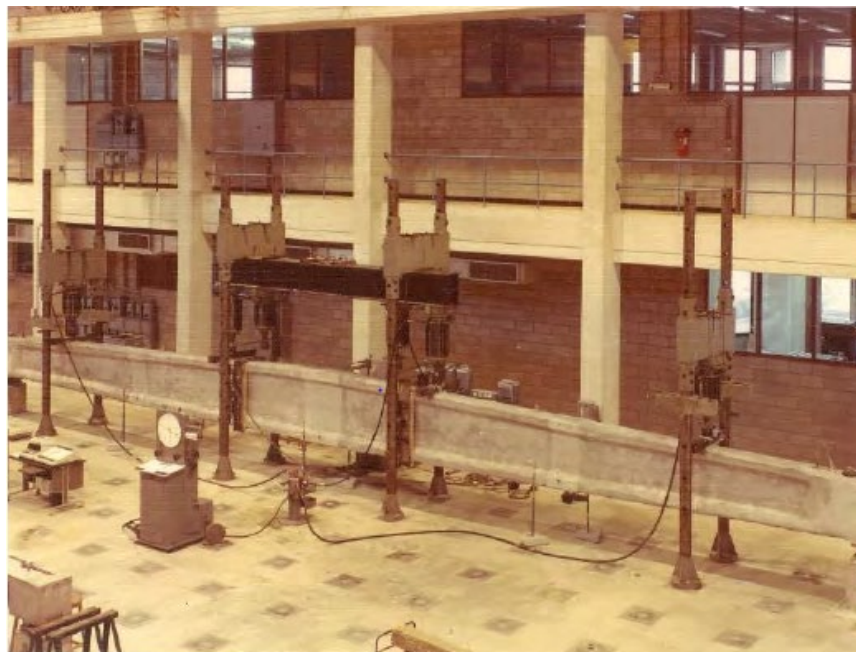
**Figure 5.13: Load testing setup for girder**

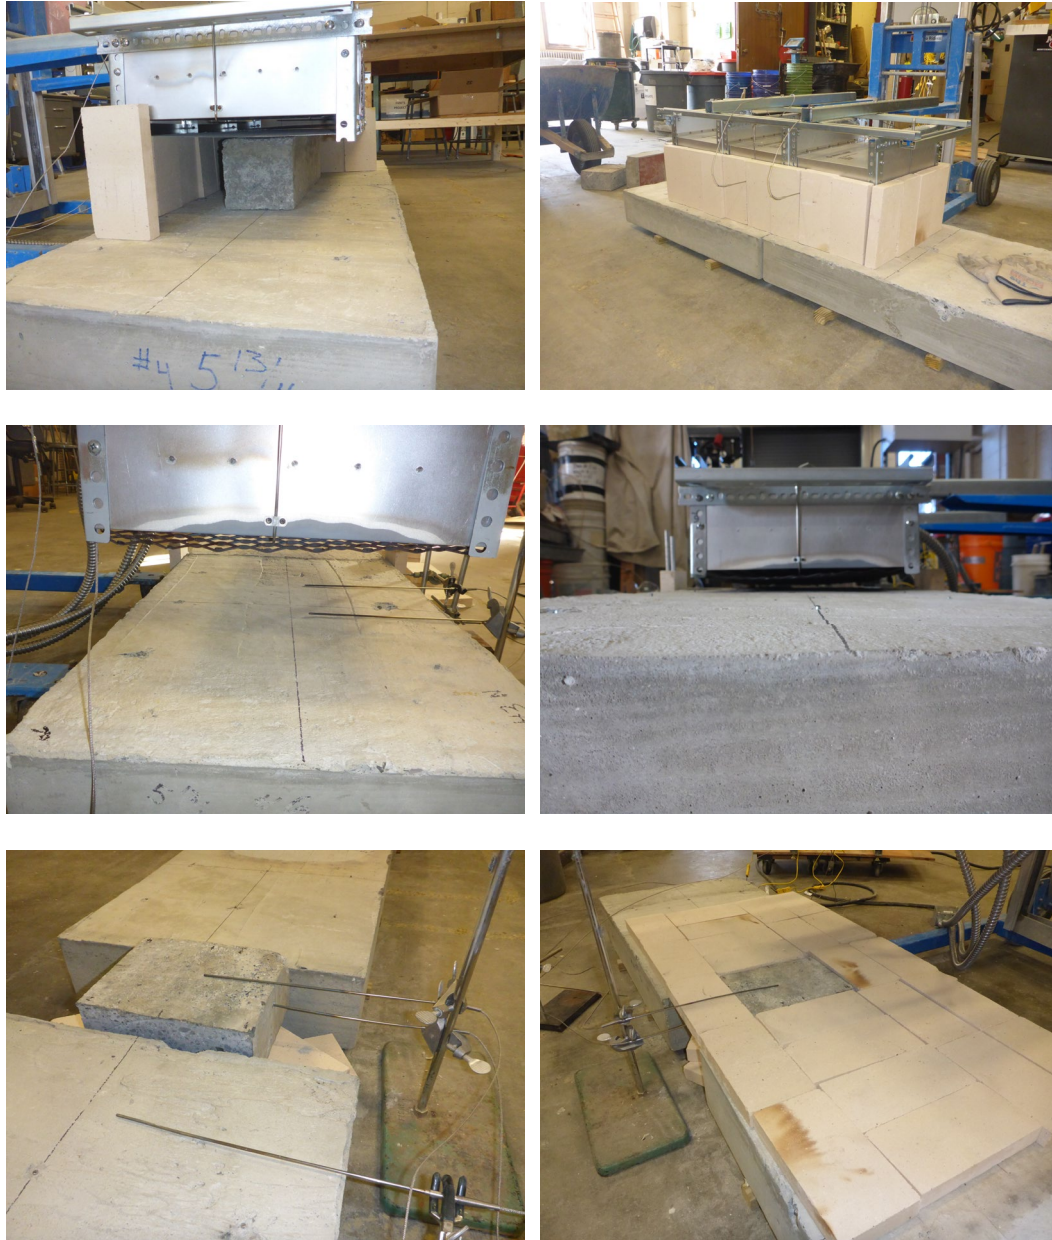
**Figure 7.2: Heating chamber configuration (top L and R); direct heating of specimen (center L and R); heating of smaller specimen between two throwaway slabs (bottom L and R)**

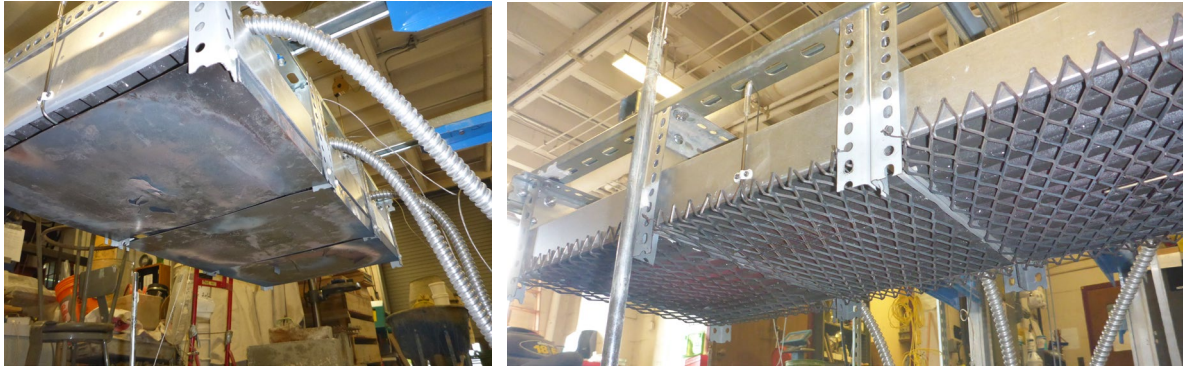
**Figure 7.3: Sheet metal shield (L); flat expanded metal shield (R)**

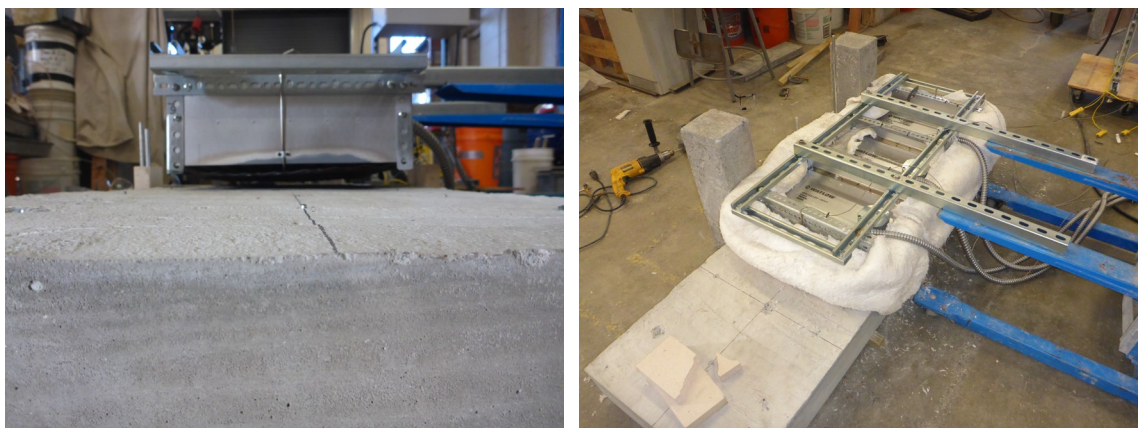
**Figure 7.13: Concrete slab heating setup**

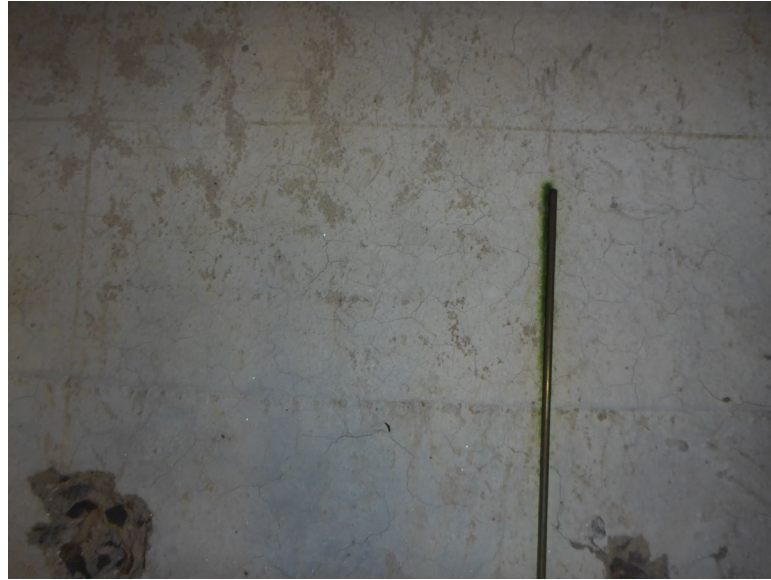
**Figure 7.14: Typical map cracking pattern for slabs after heating up to 930°C**

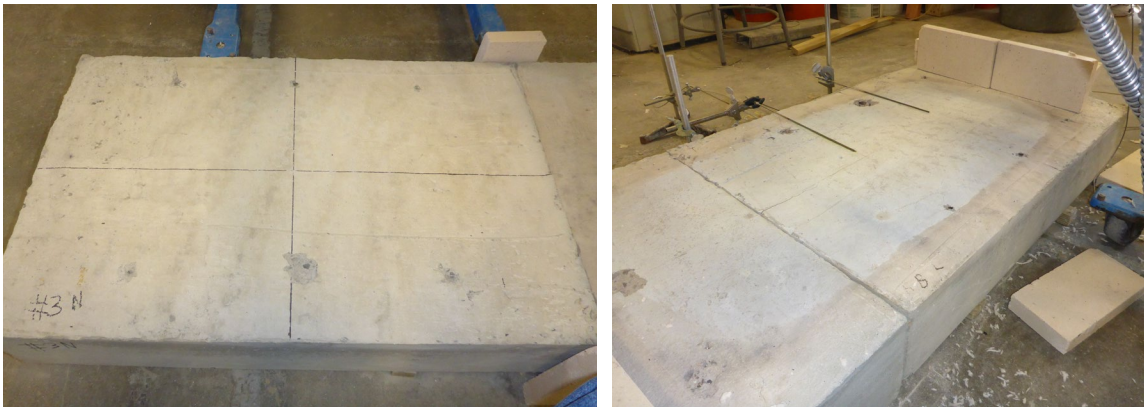
**Figure 7.15: Slab before heating (L); whitening after heating to surface temperatures up to 930°C (R)**

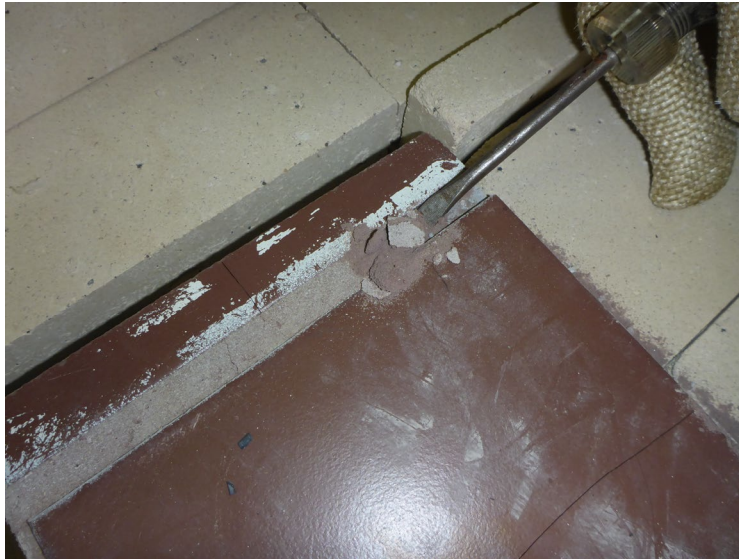
**Figure 7.22: Removal of grout with a screwdriver after heating**

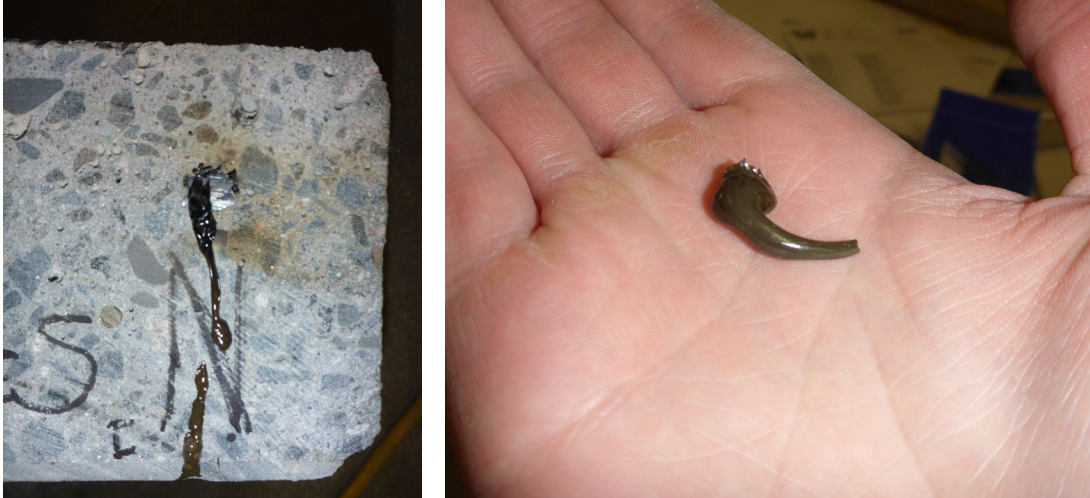
**Figure 7.23: Melting of epoxy reinforcement coating**

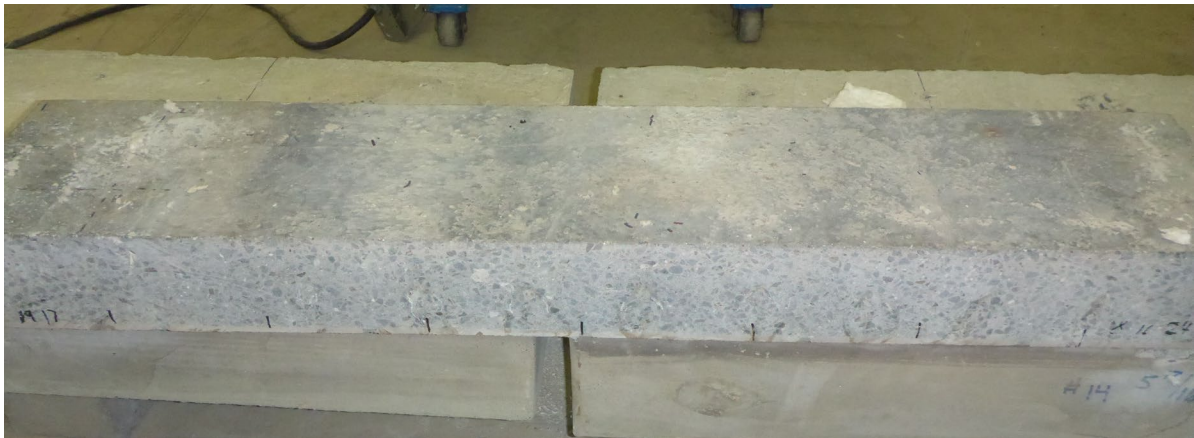
**Figure 7.25: Intact minimally reinforced beam specimen after heating**

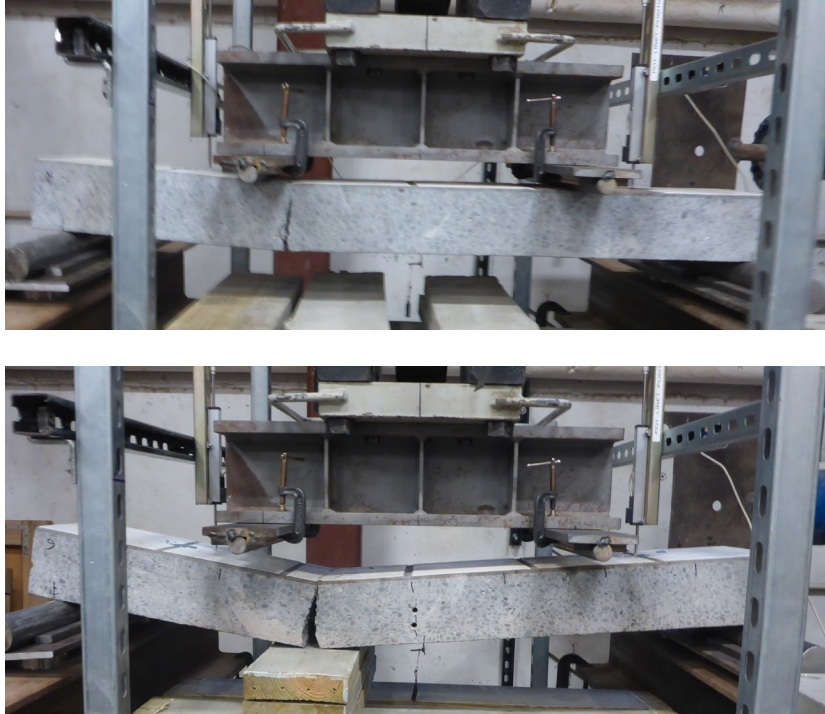
**Figure 7.28: Photo of minimally reinforced beam specimens during load testing. Propagation of crack in control specimen during load application (top); after failure of heated specimen (bottom)**

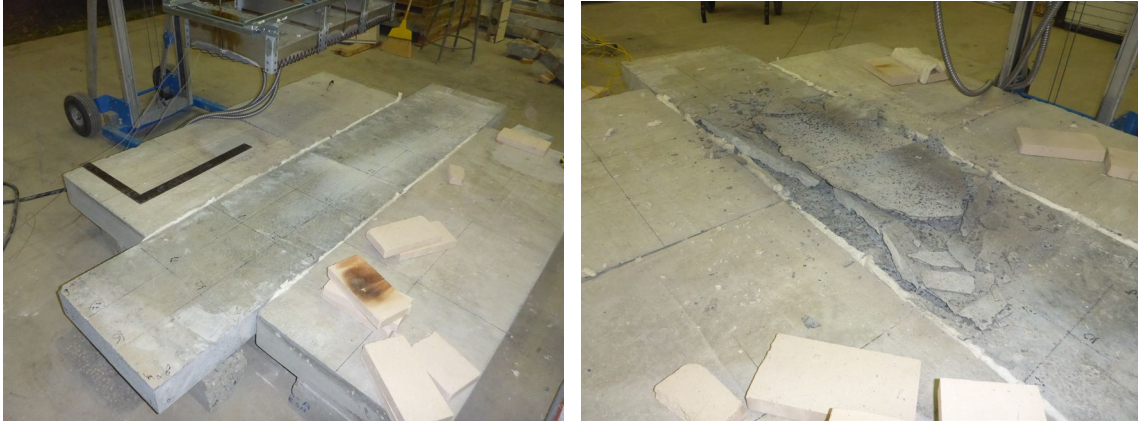
**Figure 7.32: Spalling of 600°C beam specimen prior to heating (L), post heating (R)**

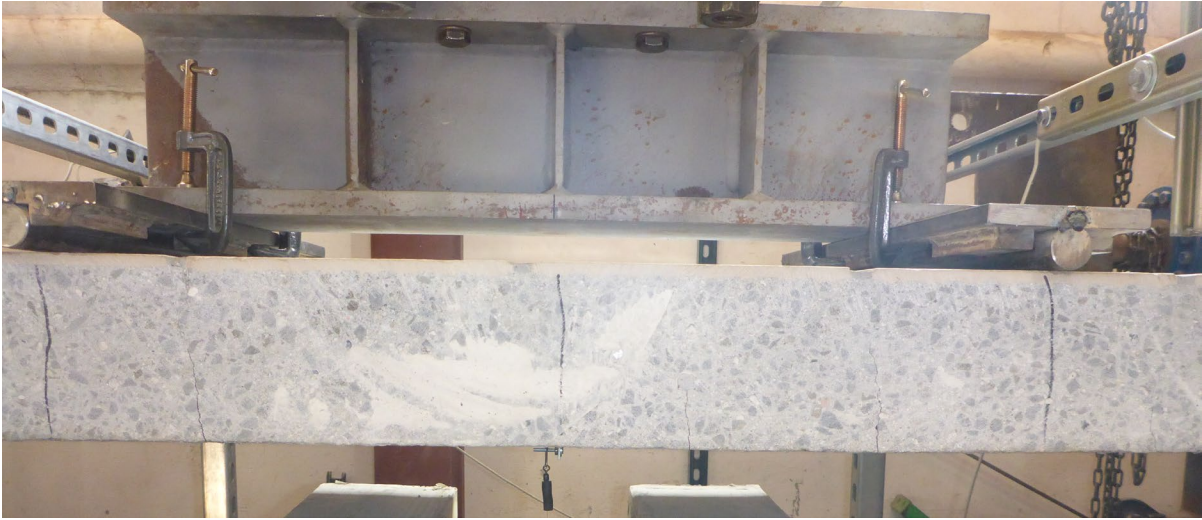
**Figure 7.37: Photos of 300°C intact specimen load testing. Multiple flexural cracks in constant moment region during load application (top and middle); after failure (bottom)**

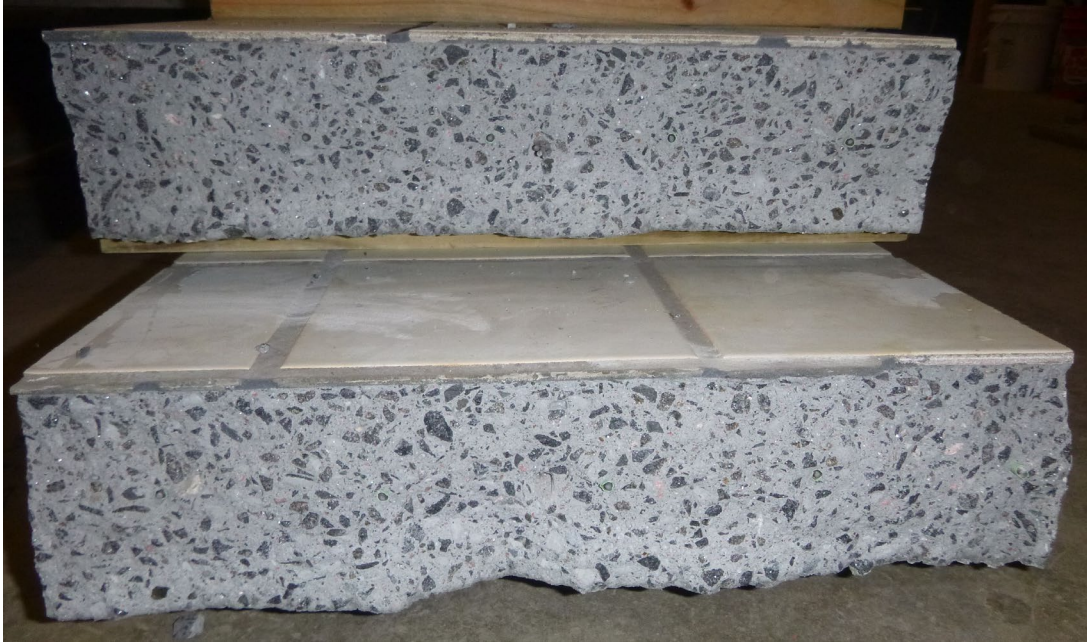
**Figure 7.40: Ruptured surface of 300°C heated specimen**
