Implementation of a 3-D Sensing Technology  
for Automated Pavement Data Collection in Connecticut

**Report Number:** CT-2297-F-18-2

**Final Report**

**SPR-2297**

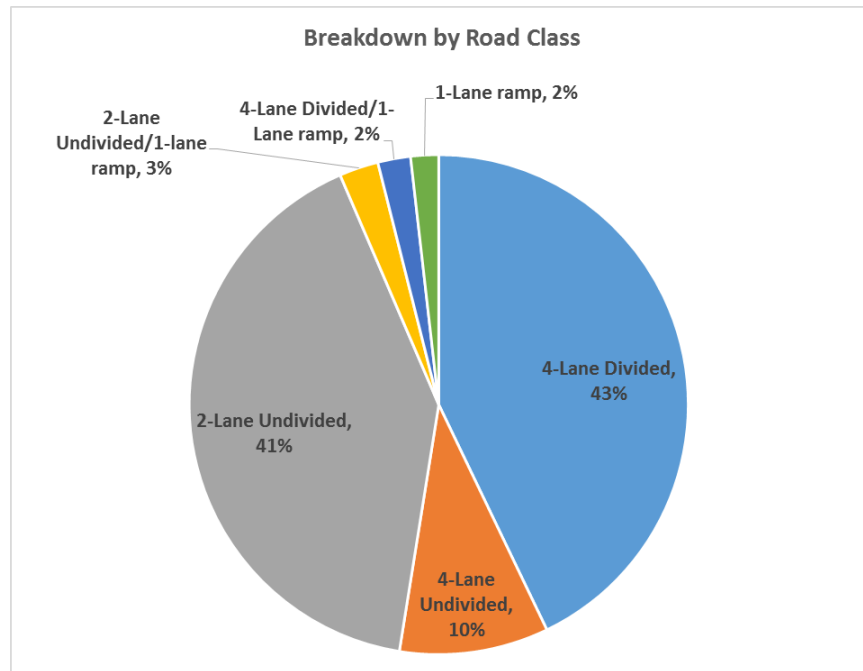
**Figure 3.1 Breakdown of “Big Loop” by road classification.**

As shown in Figure 3.1, a 4-lane divided Interstate and a 4-lane divided Connecticut State Route comprised 43% of the surveyed lengths, whereas 51% of surveyed sections were undivided local arterials and collectors. The rest of the loop consisted of access ramps for which no PMIS information was available. Figure 3.2 indicates that before the project started (2014), new, intermediate, and old surfaces comprised 10, 49, and 28 percent of the surveyed loop length, respectively, with no age information available for 12 percent of the loop. In 2015, about 25 percent of the loop was overlaid, resulting in a relatively balanced distribution of ages (37, 35, and 28 % for new, intermediate, and old surfaces, respectively).

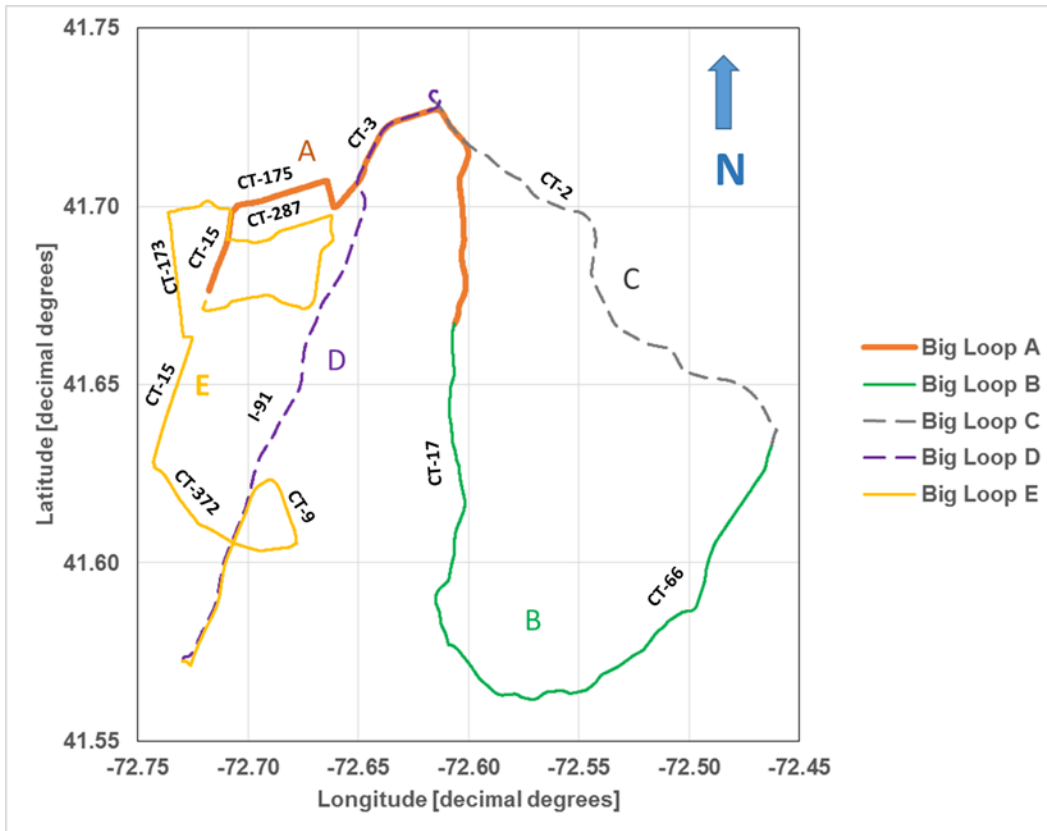
**Figure 3.4 Spatial location of Big Loop segments.**

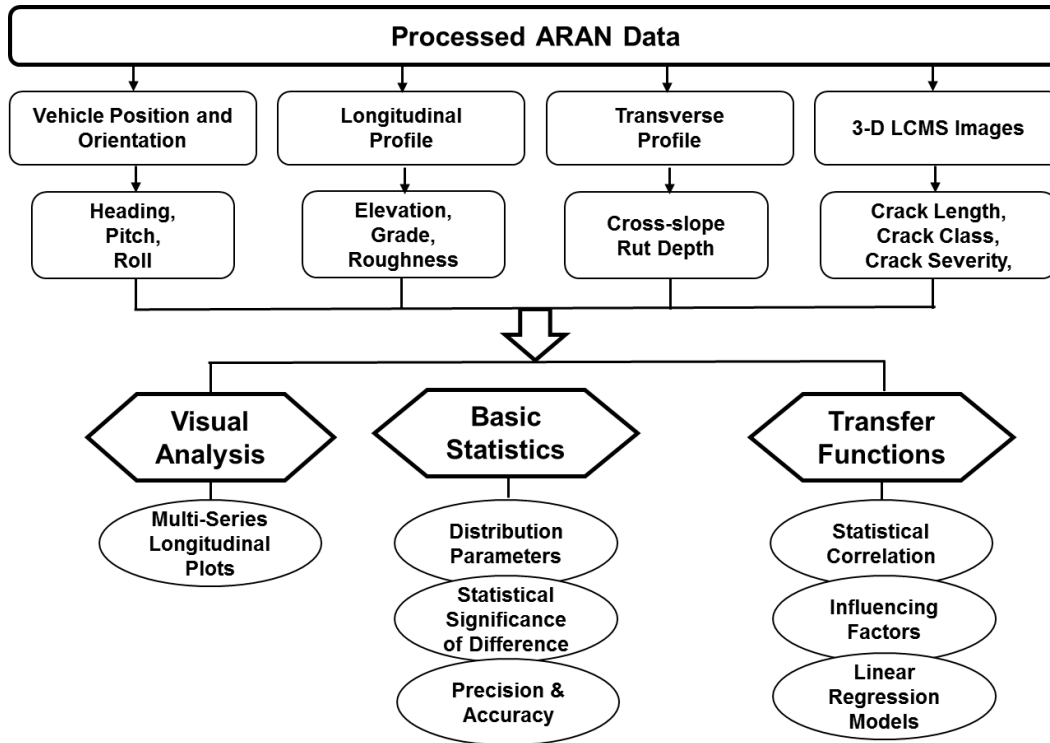
**Figure 3.5 Flow chart of ARAN data processing and analysis.**

The new 3-D laser survey system produces a great deal of data with very fine resolution that differs by an order of magnitude from the 2-D system. To ensure comparability of the 3-D and 2-D datasets, the UConn team used the 5-m and 0.1-mi average values to create IRI, rutting, grade, and cross-slope datasets for each ARAN vehicle involved in the experiment (Van 7, 8, and 9). With respect to cracking data, sum of cracks by type class, severity, and location (lane zone) per 5 m and 0.1 mile were computed separately to create cracking datasets for each ARAN vehicle. The steps and routines of the survey data analysis are illustrated in Figure 3.5.

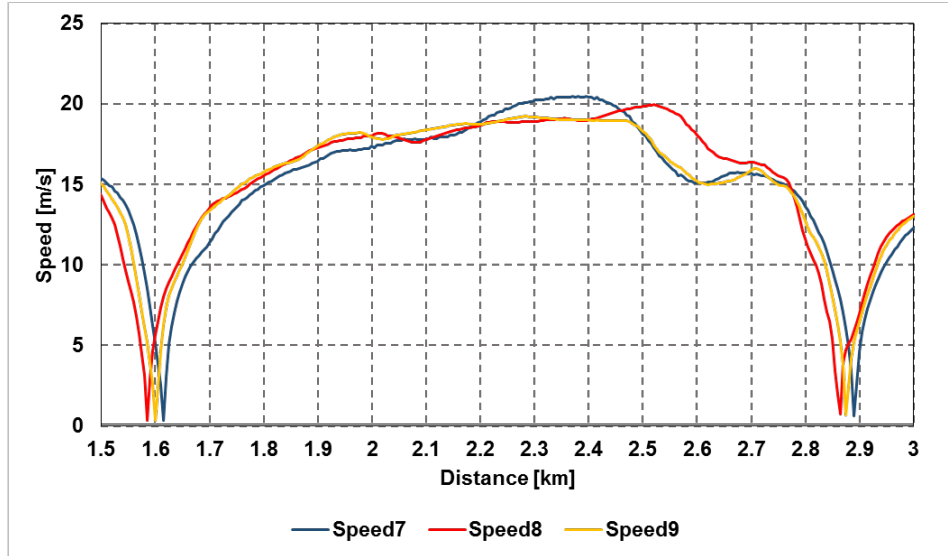
**Figure 3.6 Longitudinal plot of average 5-m speed (a) and IRI (b) for Big Loop segment A with two stops at around km 1.6 and km 2.875.**

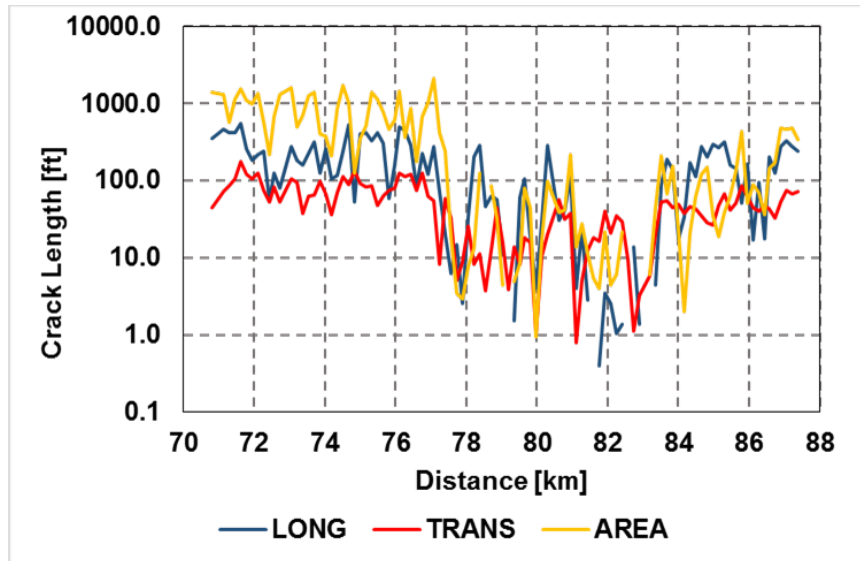
**Figure 3.7 Crack length trends along Big Loop segment D.**

In another example, Figure 3.7 superimposes longitudinal, transverse, and area cracking for Big Loop segment D. One observation is that crack lengths vary by at least three orders of magnitude, which suggests that cracking data has a logarithmic distribution. Secondly, the patterns of the three classes of cracking are similar, which suggests strong correlation between longitudinal, transverse, and area crack lengths reported by the LCMS. However, such a trend may not necessarily reflect the ground truth because the LCMS may misclassify a longitudinal or transverse crack as an area crack, for instance.

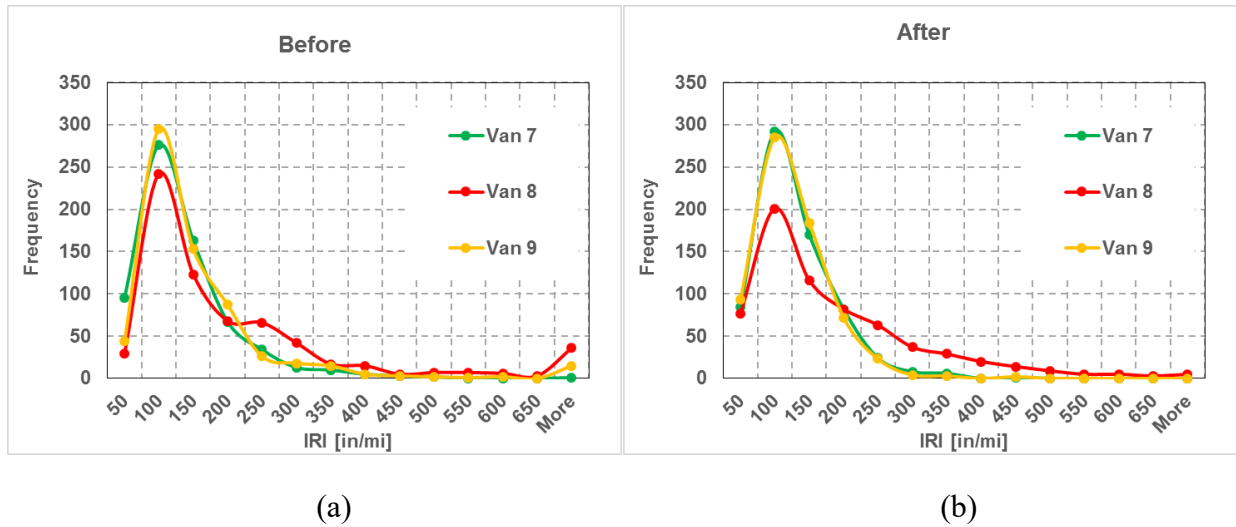
**Figure 3.8 Distributions of 0.1-mi average IRI values from ARAN datasets (a) before and (b) after post-processing.**

An example of the distribution of IRI values before and after running a post-processing algorithm is shown in Figure 3.7, whereas Table 3.5 compares basic statistics for the 160-m average IRI between Vans 7, 8, and 9. Figure 3.8 (a) shows that Vans 8 and 9 recorded a significant amount of illogical, higher than 600 in/mi, IRI values. Furthermore, Van 8 stood apart from Vans 7 and 9, while reporting more IRI measurements within a "poor" range of 250 to 400 in/mile. Removing IRI values obtained during low speeds, by a post-processing routine, helped eliminate most illogical values for both Vans 8 and 9. However, the distribution of Van 8 remained dispersed for reasons unknown at the time of analysis (see Figure 3.8 (b)), however, postulated to be likely due to problems with hardware. The data in Table 3.5 indicate that on average, IRI values reported by Van7 changed very little, as compared with Vans 8 and 9, which indicates that Van 7 motion sensors are much less sensitive to acceleration/deceleration than those installed on the newer ARAN vehicles.

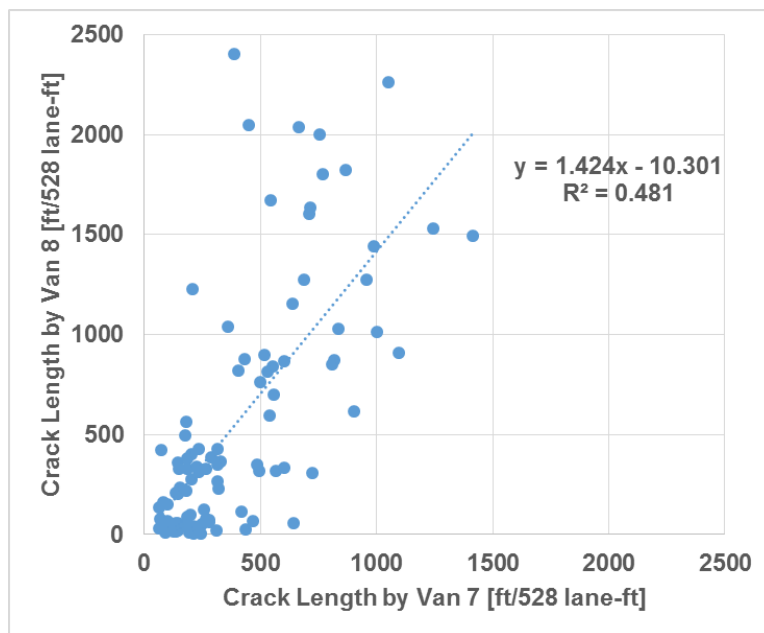
**Figure 3.10 Bivariate plot of cracking lengths per 0.1mile reported by Vans 7 and 8.**

In this project, a simple linear correlation between older and newer system's outputs was first evaluated by fitting a straight line. Ideally, a slope within 0.95 to 1.05 with no intercept and coefficient of determination, or R-squared, of greater than 95%, would be considered a good fit. If no good fit could be achieved by simple regression, the influencing factors of the difference between ARAN systems, such as road classification, surface condition rating, and survey speed were introduced into the relationship as categorical variables in an attempt to improve the correlation. An example of a bivariate plot of total crack lengths per 0.1 mi as reported by Van 7 and Van8 for a 16-km long segment of the Big Loop is shown in Figure 3.10. One can notice that, while the intercept of the trend line to predict Van 8 cracking from Van 7 is very small, its slope (1.424) indicates that, on average, Van 8 reports 40 percent more cracking per 0.1 mile than Van 7.

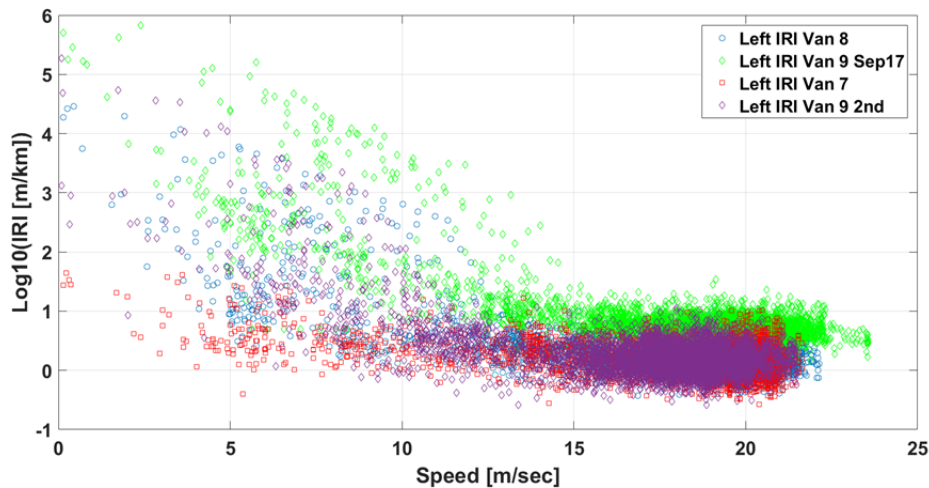
**Figure 4.2 Effect of speed on reported IRI on Big Loop Segment B.**

Another finding showed that the RoLine sensors on Vans 8 and 9 were extremely sensitive to change in speed gradient (acceleration and deceleration) as opposed to the Selcom sensors installed on Van 7. One can observe on Figure 4.2 that at speeds lower than 13.4 m/s (30 mi/hr) the IRI reported by Vans 8 and 9 increased three to four orders of magnitude, with Van 9 showing even greater sensitivity than Van 8.

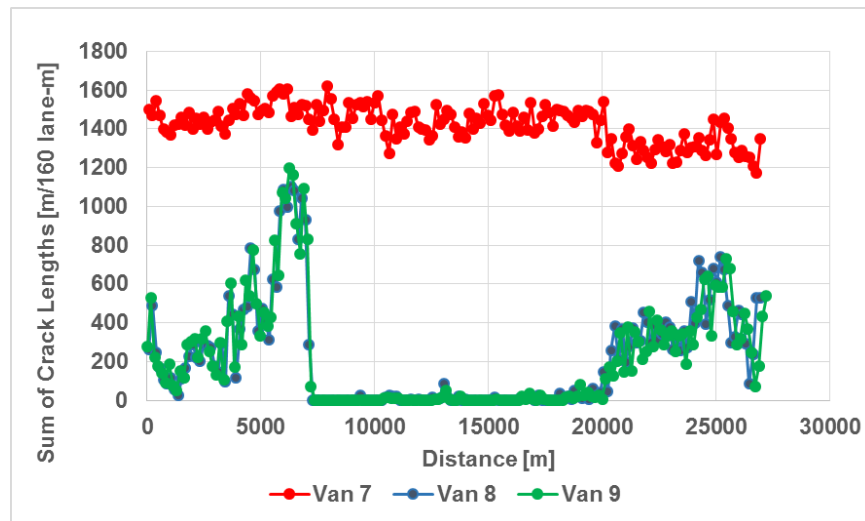
**Figure 4.5 Plot of total crack lengths per 0.1 mile on Big Loop Segment B.**

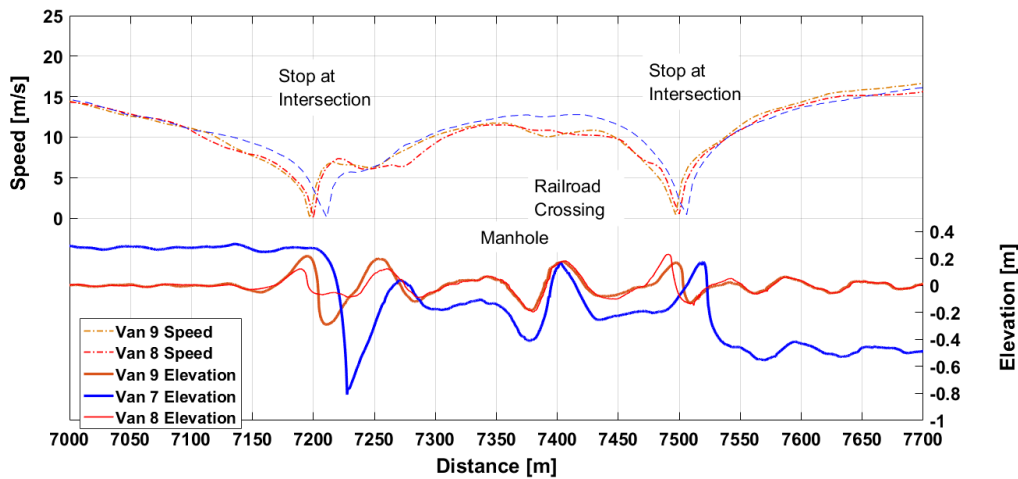
**Figure 5.3 Sample of longitudinal LWP profile including slowdowns, obstacles, and accelerations after post-processing.**

After processing the raw roughness data for all three vans through the "Roughness Processor," the Vision software produces "improved" longitudinal profiles. The result is reasonable comparability for data from all three vans (Figure 5.3). The exact algorithm behind the "Roughness Processor" is proprietary to Fugro Roadware and it cannot be controlled by the user. Interestingly, this post-processing does not noticeably change the Van 7 original values of elevation, but mostly affects Vans 8 and 9 unreasonably high accelerometer readings.

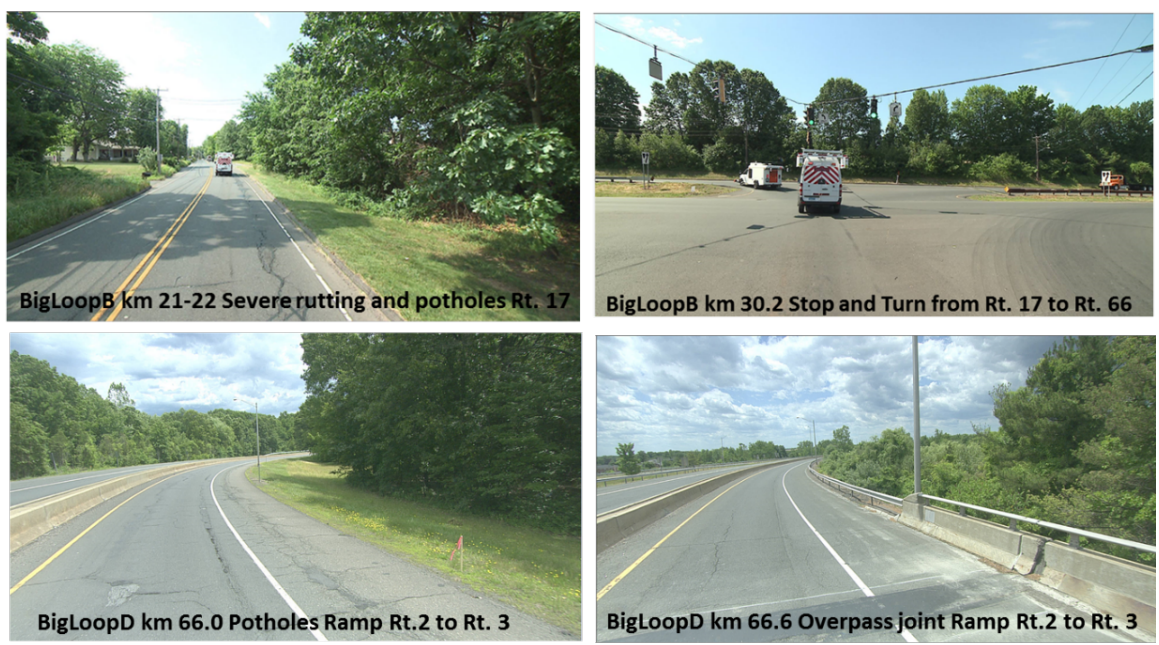
**Figure 5.8 Roadware Vision ROW images of sections with extreme IRI values.**

Before the exploration into the development of transfer functions could be undertaken, the relationships between left and right wheelpath IRI were compared. The basic assumption was that, besides the extreme situations as shown in Figure 5.8, there should not be much difference in IRI between the wheelpaths, except right IRI has been traditionally found to be slightly higher than left IRI due to the inherent roadway structure. If this assumption proved true for this studies' dataset, it would allow for elimination of multiple transfer functions, while focusing on mean IRI (MRI) measure, which is usually used by the CTDOT for quality control and acceptance of newly paved roads. The bivariate plots of RWP vs. LWP IRI in Figure 5.9 indicate a relatively small bias of 5 to 10 in/mi toward higher RWP IRI exists, which translates to 9 to 12 percent of relative difference between the two wheelpaths. It can also be seen that the RWP and LWP IRI have a rather nonlinear relationship as indicated by the increased goodness of fit as compared with the linear trend (0.81 vs. 0.6, respectively) (see equations in Figure 5.9).

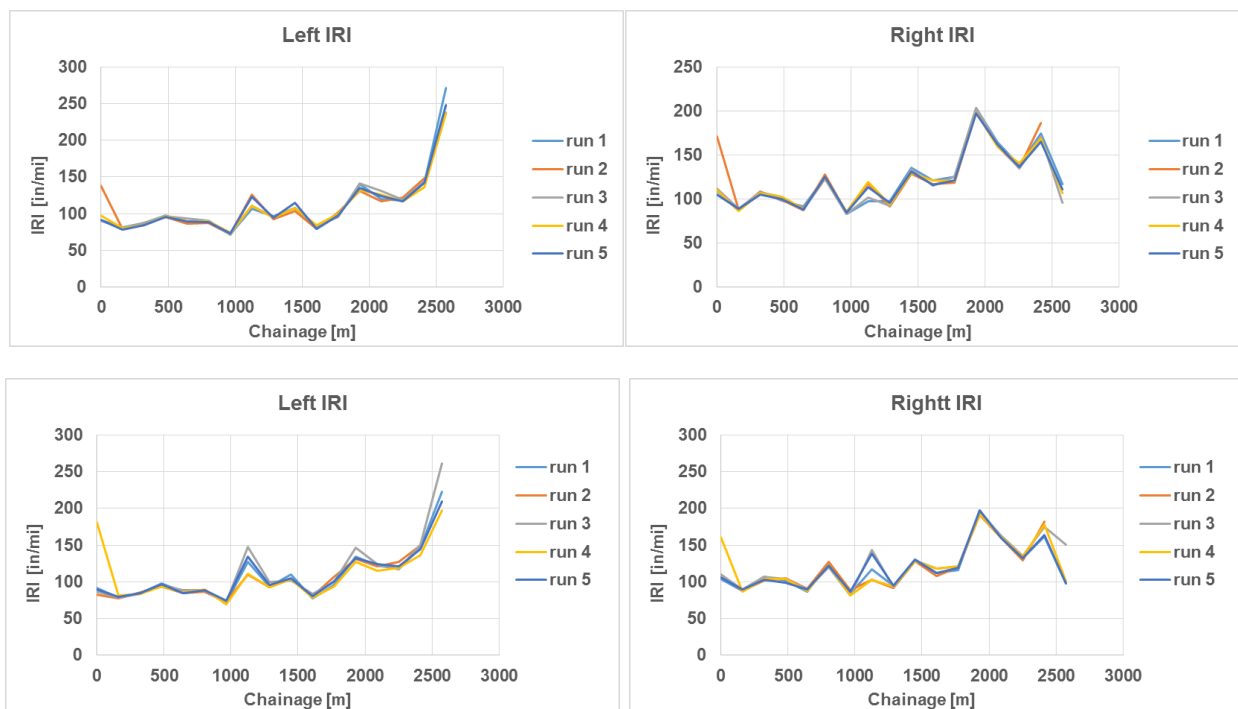
**Figure 5.10 Longitudinal profiles of repeatability runs on Brook Street Eastbound by Van 8(top) and Van 9 (bottom).**

Figures 5.10 through 5.12 show left and right wheelpath 0.1-mile average IRI profiles for each run on Brook St. EB, WB, and Thornbush Rd. respectively. Note that on average, those three segments yielded 115, 105, and 175 in/mi, respectively, indicating relatively good ride quality on Brook St. and fair to poor ride quality on Thornbush Rd. While the corresponding wheelpath profiles for each ARAN dataset follow similar patterns (Figures 5.10 and 5.11), differences between runs can be seen, especially in the beginning and toward the end of the Brook St. sections as well as around station 1120 m on Eastbound, most likely due to slowdowns and accelerations. Figure 5.12 shows much larger differences between runs on Thornbush Road as compared with Brook Street, most likely due to variable fair to poor pavement conditions along this section.

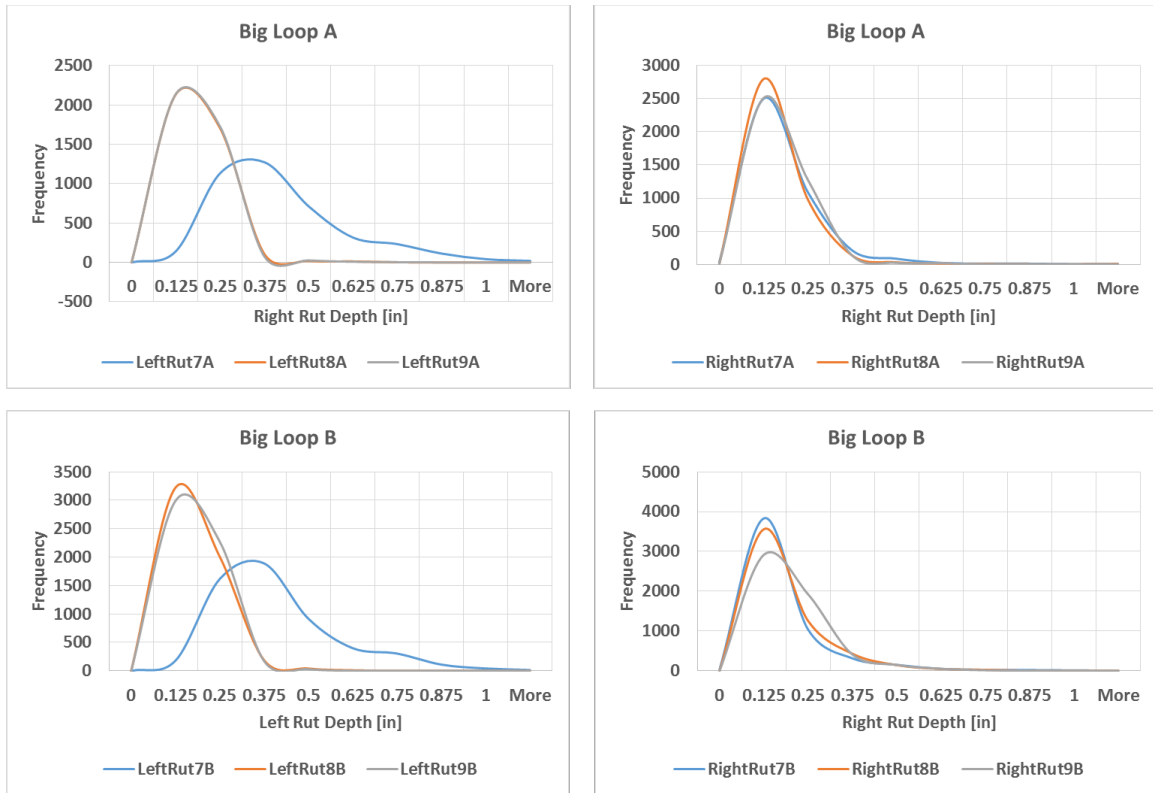
**Figure 6.7 Sample histograms of 5-m average rut depth values reported by CTDOT ARAN systems.**

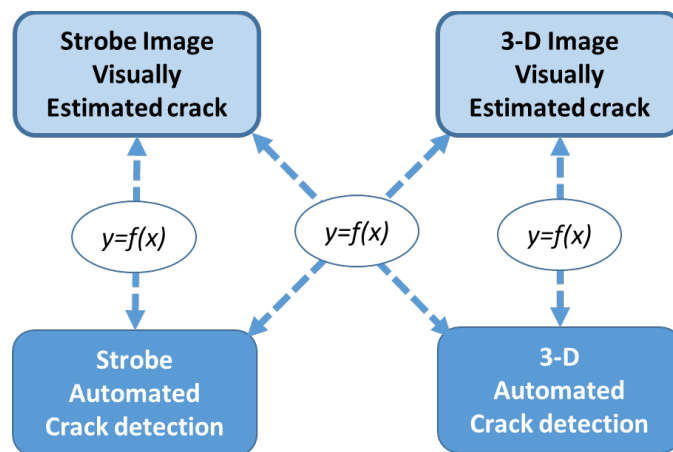
**Figure 7.3 Flowchart for evaluation of transfer functions for cracking data**

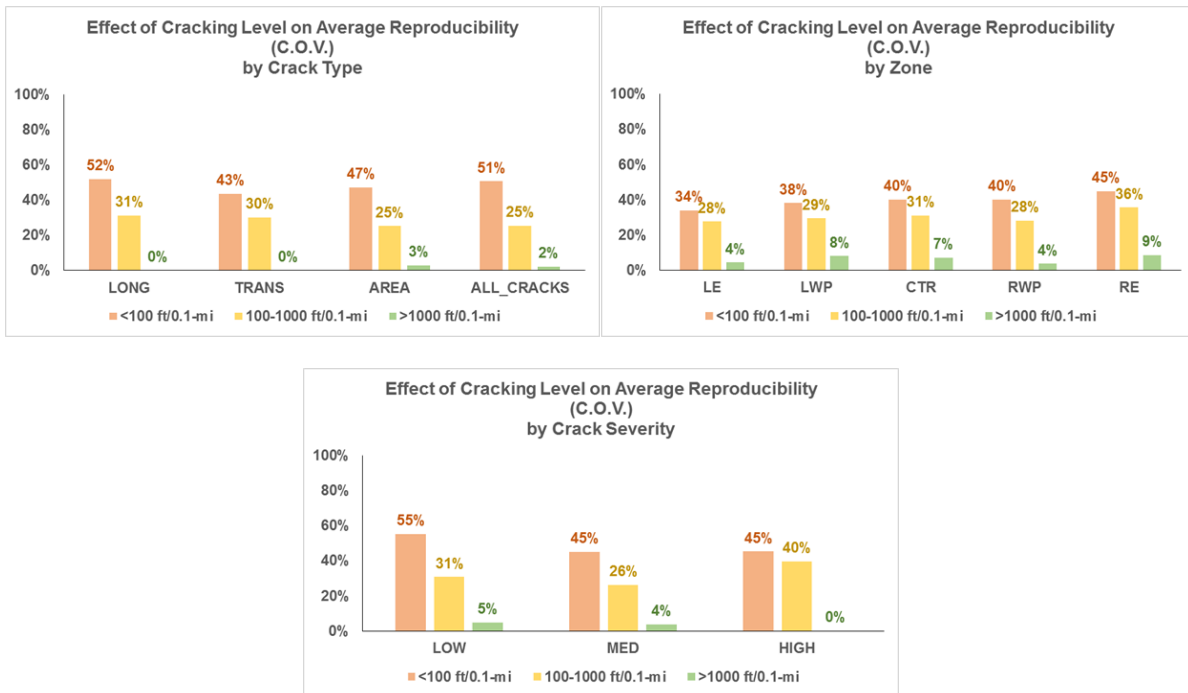
**Figure 7.13 Effect of cracking extent on variability in crack survey on the Big Loop.**

As stated before, the analysis of crack length data from all surveys under this project produced crack length values (in ft/0.1 lane-mile) over a range of at least three orders of magnitude, and having *lognormal* statistical distributions. Furthermore, a detailed analysis of the ranges of relative accuracy for all categories showed variability that was highly dependent on the magnitude of crack length. In formal statistics, such a trend is called heteroscedasticity or unequal variance over the population. To illustrate this trend, Figure 7.13 compares average values of relative accuracy between Van 8 and Van 9 on the Big Loop for three cracking conditions: less than 100, 100 to 1000, and more than 1000 ft per lane-mile of cracking. One can easily notice a significant decrease in variability with an increase in cracking extent for all categories of cracks.

To investigate possible reasons for the variability trends shown in Figure 7.13, sample pavement images with detected, classified, and rated cracks were pooled for equivalent locations. An example is shown in Figure 7.14, where it can be seen that Van 9 fails to detect some cracks reported by Van 8 (note presence of cracks on the left image and their absence on the right image as highlighted by ellipses). In addition, different lengths and amount of cracking is assigned to the same distress (note differences within lower right corner of both images, for instance). Lastly, the same crack may be rated differently (note green, yellow, and red lines for low, medium, and high severity, respectively). Although the reasons are unknown, such an outcome is believed to be caused by differences in brightness/contrast of the image and/or algorithms used in the Roadware Vision statistical routines for detecting, classifying, and rating the cracks.
