FINAL REPORT

**Evaluation of Corrosion Inhibiting Materials Applied by Impregnation
(Pressure Injection) Methods to Prevent Corrosion of Post-Tensioned
Tendons**

FDOT Contract Number: BDV25-977-35

July 2020

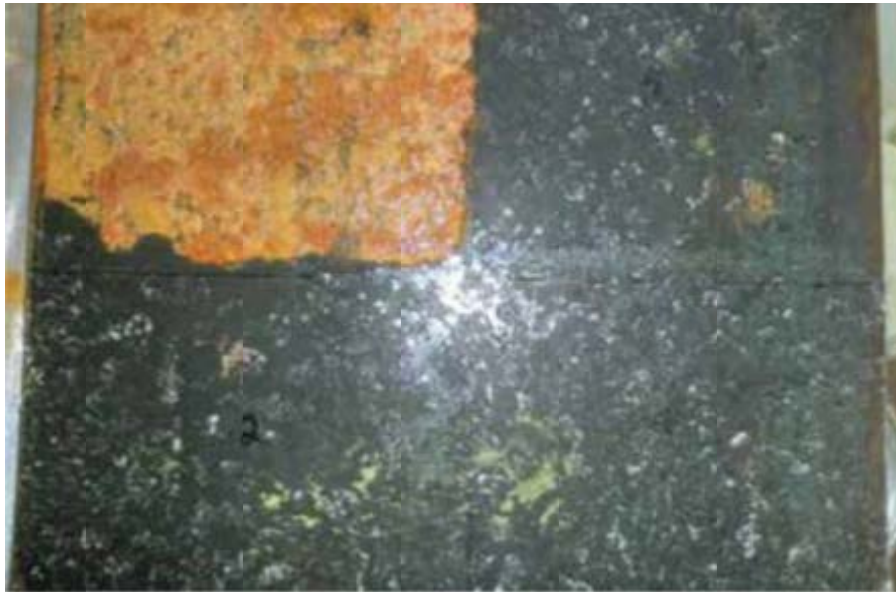
Figure 2-2: Corrosion protection effect of impregnation fluid applied on a steel plate exposed to salt spray test. Compare with untreated upper left portion.⁴⁷

It was reported that steel plates and PTT treated with the impregnation liquid did not show visual evidence of corrosion (Figure 2-2) when exposed to periodic salt, seawater and sulfate spray tests for up to 30 days^{43,46-47}. Potentiostatic polarization tests^{26,44,46,48} showed that chloride free impregnated samples containing 4.5% grout voids exhibited ~ 95% reduction in the corrosion current as indication of corrosion rate reduction. Void-free samples containing 2% chloride showed ~93% reduction in corrosion current, whereas void- and chloride-free samples showed ~ 81% reduction in corrosion current after treatment (It should be mentioned here that these tests were conducted over test periods of only up to one hour, and data reproducibility was not indicated).

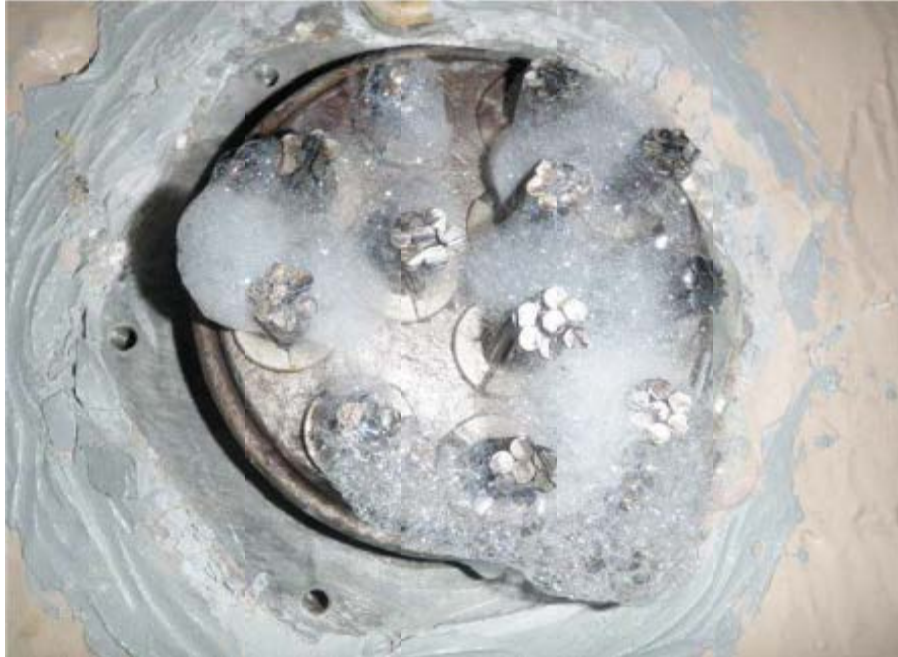
Figure 2-3: Impregnation fluid reported to successfully displace moisture from a tendon end opposite to the injection end.⁴⁷

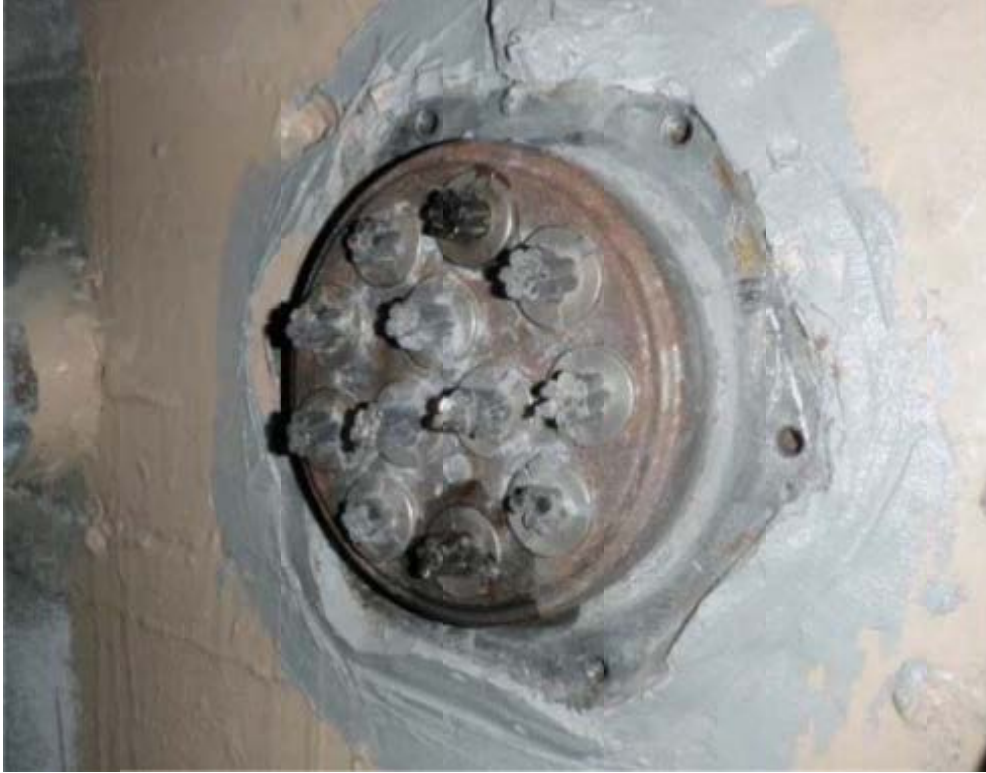
Figure 2-4: Impregnation material seep out of the far end of a >250-ft-long tendon.⁴⁷

In tests performed on a Florida bridge⁴⁷ drying of the strand and surrounding grout was reported not to be required prior to impregnation and the free water/moisture was reported to be pushed out of the tendons during the pressurized impregnation process. Moreover, the fluid was found to successfully flow through the interstitial spaces for up to about 250 and 100 ft when injected from end and intermediate locations, respectively (Figure 2-3). After impregnation was terminated, tendon autopsy was carried out at different locations along the entire length of the tendon which confirmed the successful performance of the impregnation system (Figure 2-4).

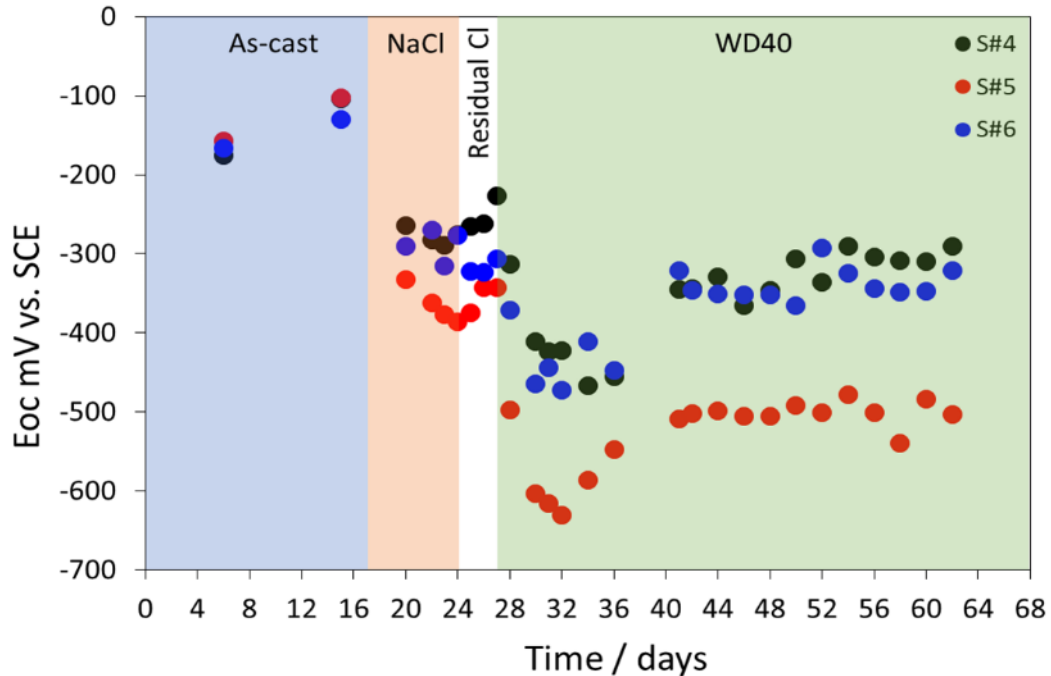
Figure 3-4: Evolution of EOC. Results from three replicate specimens.

The time evolution of E_{OC} of three replicate samples is shown in Figure 3-4. In the as-cast period, the E_{OC} stayed more positive than $\sim -180 \text{ mV vs. SCE}$. After exposure to the 3%-NaCl, there was a sudden drop in E_{OC} that might be caused by the active corrosion behavior of the strands when exposed to the corrosive medium. When the latter was removed (here grout is still contaminated with Cl⁻) the E_{OC} showed a slight increase, which was followed by another drop as TIM (WD-40) was introduced. Beyond day 36, values of E_{OC} showed another increase and then reached steady state values.

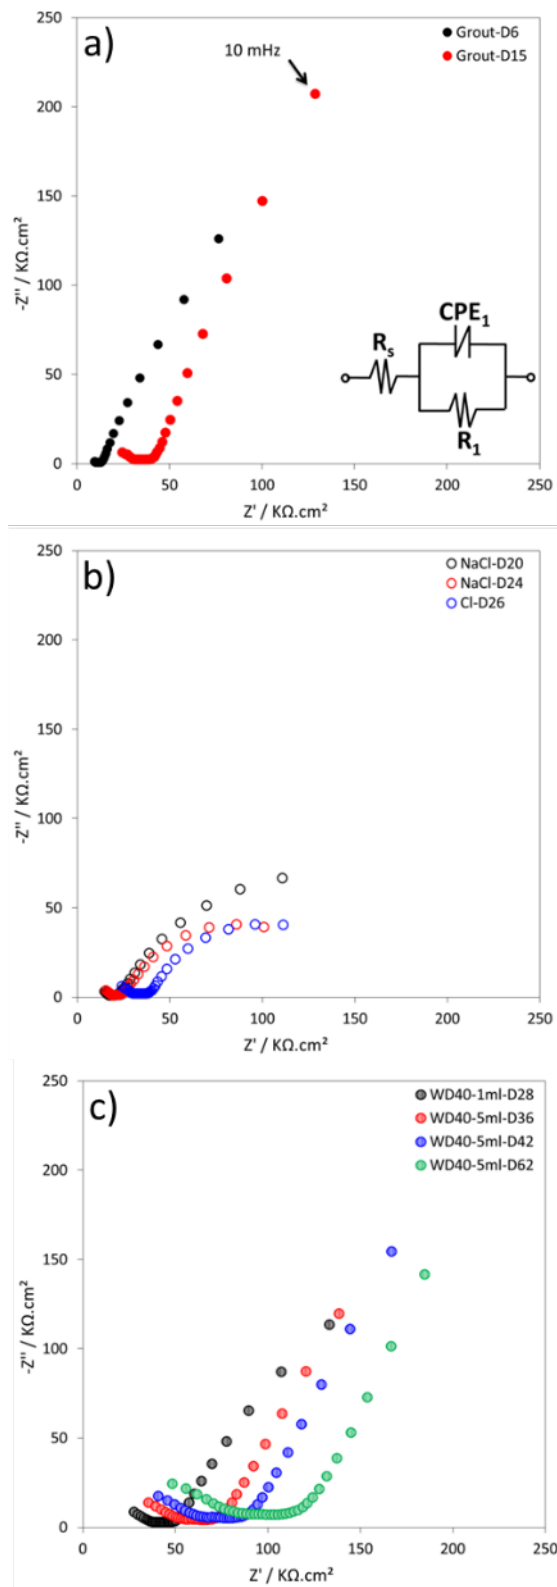
Figure 3-5: Typical evolution of EIS behavior for (a) as-cast, (b) during corrosion, and (c) following impregnation. The last figures in the legends indicate days since casting.

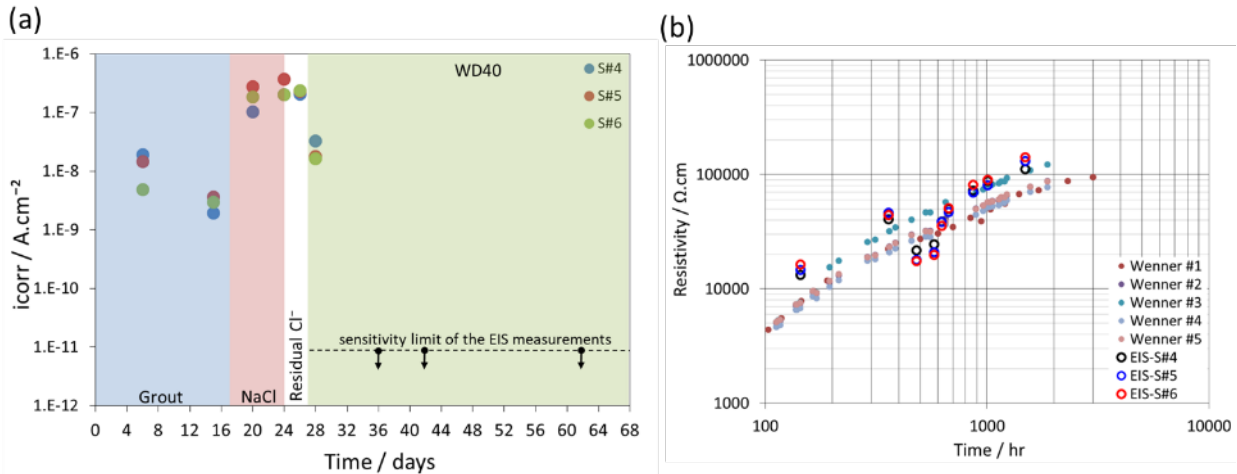
Figure 3-7: Evolution of (a) i_{corr} from EIS and (b) grout resistivity measured by EIS and FWAP

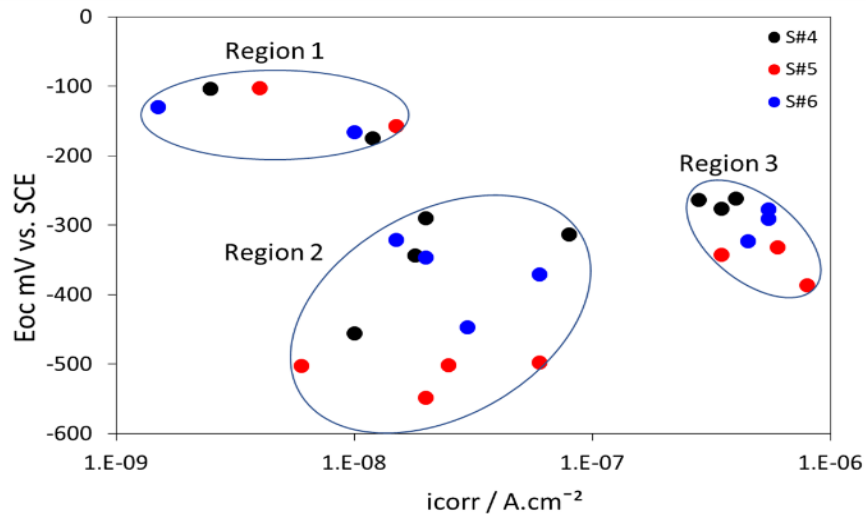
Figure 3-10: Relationship between E_{oc} and i_{corr}

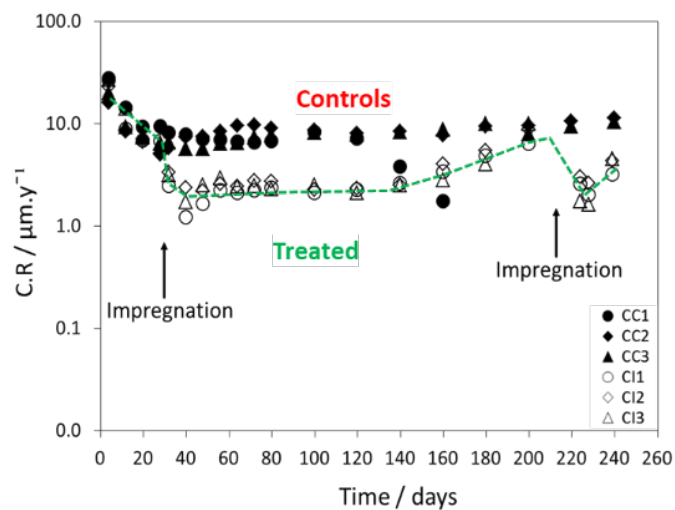
Figure 3-11: Long-term evolution of corrosion rate in control and impregnated tendons.

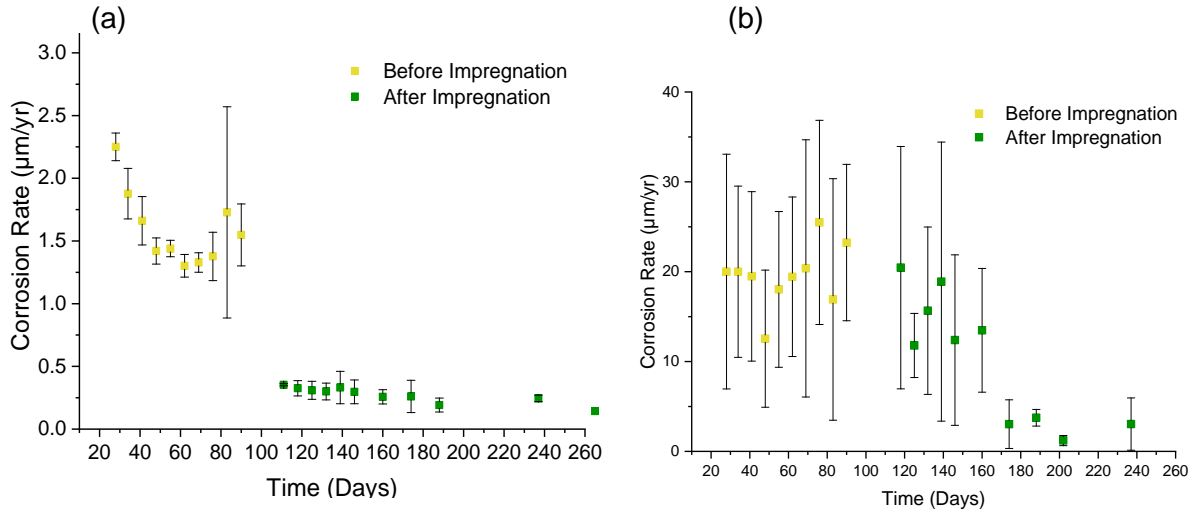
Figure 3-17: Corrosion rate as a function of time prior to and following impregnation of 3-ft tendons: (a) Chloride-free; (b) Chloride-contaminated

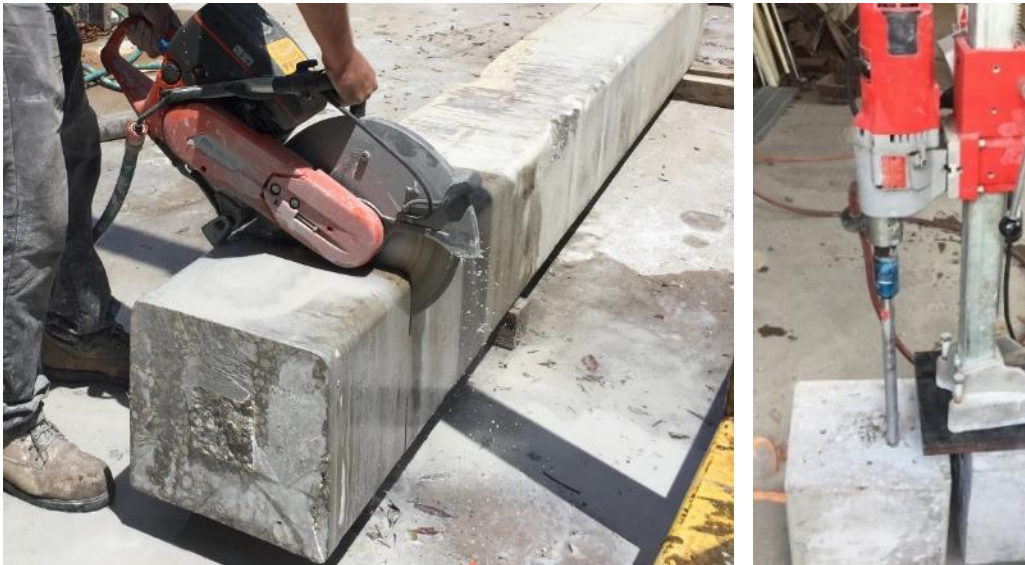
Figure 4-1: Cutting 14-inch square pile for concrete specimens and coring simulate duct corridors into 1ft concrete segments

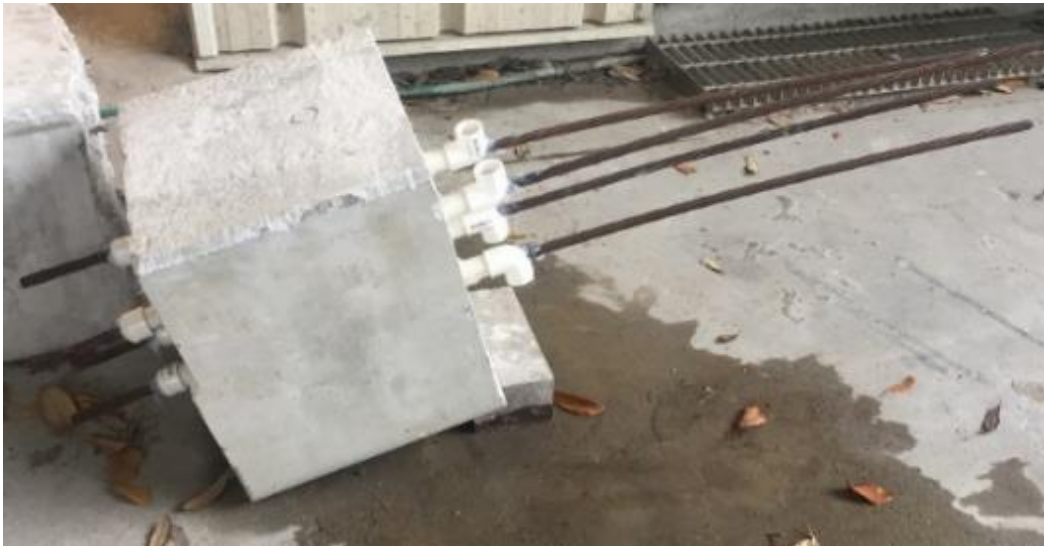
Figure 4-2: Concrete specimen 1 completely set up before grout installation

four 48-in long ½-in prestressing strands were cut and set aside. ¾-in I.D. SCH 40 PVC (1-in O.D.) pipe was cut into eight 3-in long length sections as extension to snugly fit into the 1-in core holes. PVC elbows and end caps were drilled with a 9/16-in diameter hole in the center for strand installation. The elbows and end caps were slid onto each of the 3-in-long PVC pipe sections, and the completed half sections were wrapped in duct tape 1 in of the free end creating a de-bonded surface. The taped ends were placed into the concrete and the strands were fed through the 9/16-in holes in the PVC sections. Silicon was used around the 9/16-in holes and strands as well as the concrete faces and PVC duct extensions, which sealed any grout from leaking out. Before grout was installed, the front face of the concrete specimen was raised on a 2-in thick steel brick as shown in Figure 4-2. The syringe with flexible hose was filled with water and the hose was installed through the opening of the elbow until it reached near the back of the specimen. Table 4-1 shows the amount of grout, water, and water injected into each tendon for concrete specimen 1. Once tendons 1 and 2 were grouted and cured for one day, the specimen was flipped upside down for tendons 3 and 4 to be grouted. Figure 4-3 shows the entire grouting and water injection process.

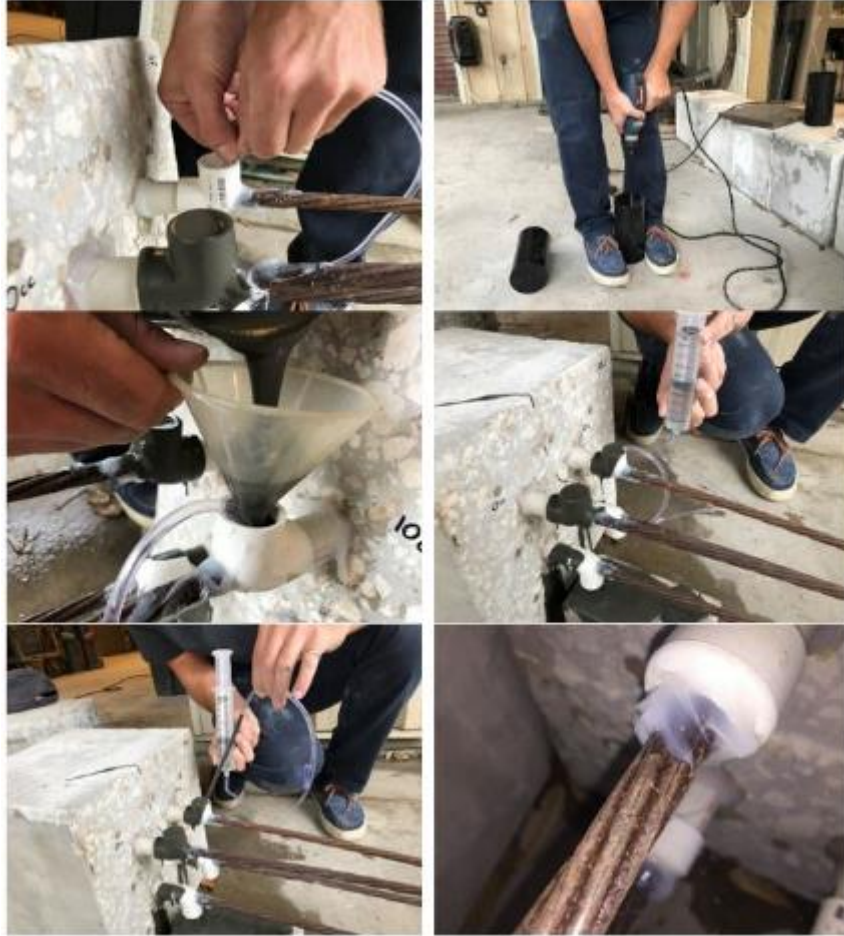
Figure 4-3: Feeding flexible hose into tendon for water injection (top left); Mixing grout in 4x8 concrete cylinder (top right); Pouring grout into funnel to prevent grout spillage (middle left); Removing steel brick to place concrete specimen horizontal and injecting water into tendon (middle right); Extracting flexible hose from tendon (bottom left); Water wicking out of the strand from water injection (bottom right).

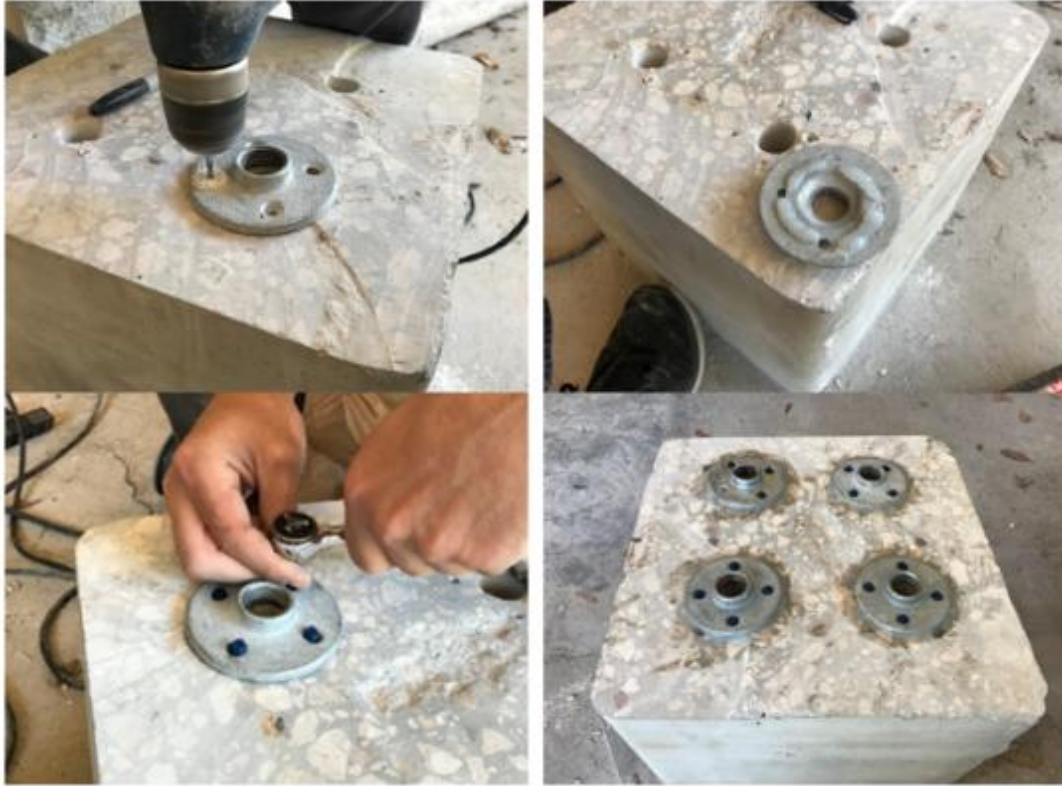
Figure 4-6: Predrilling holes into the concrete face (top left); Silicon applied to the bottom of the metal flanges (top right); Anchoring the metal flanges to the concrete face (bottom left); All flanges anchored and silicon placed around the flanges (right).

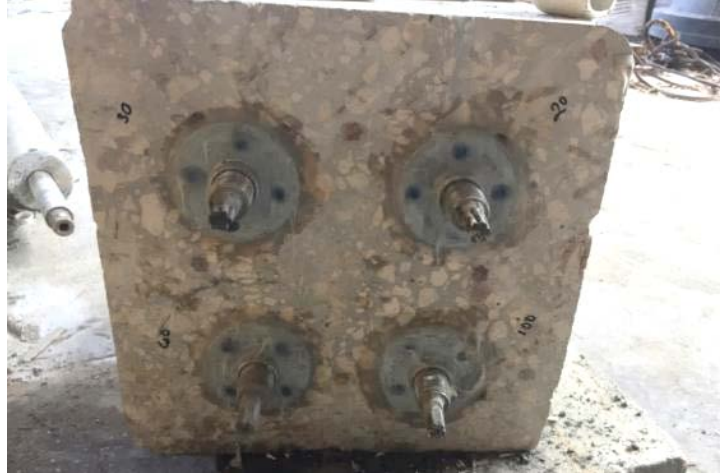
Figure 4-9: Removal of PVC fittings leaving grouted strands exposed.

After the grout cured for 7-days the back PVC pipe extensions and elbows were removed for inspection and the concrete specimen was repositioned vertically on the concrete blocks for pullout tests. The front duct standpipes were removed and the 90° elbows were cut for clearance for the hydraulic 60-ton jack.

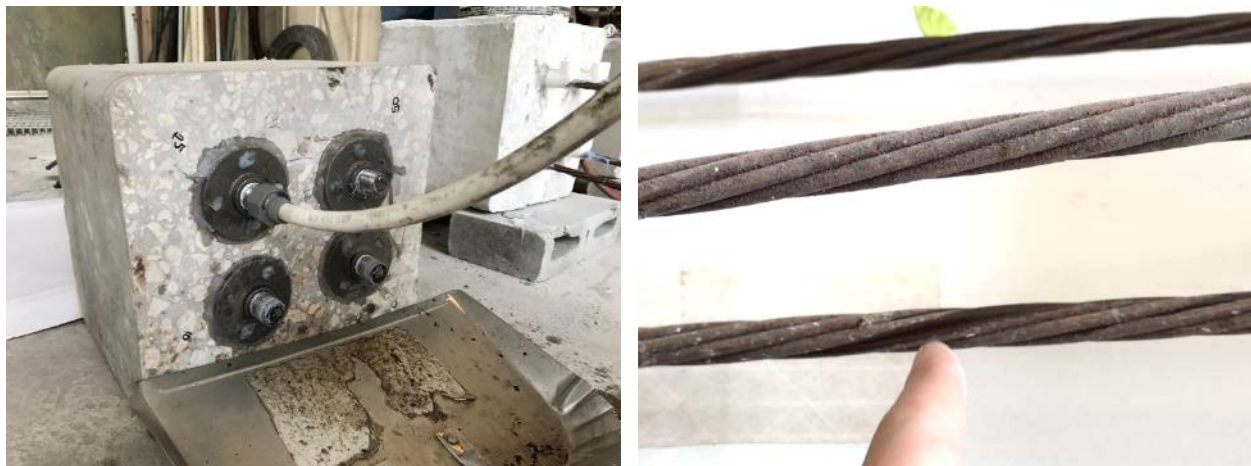
Figure 4-10: Specimen pressurized with WD-40 (left); WD-40 traveling along strand (right).

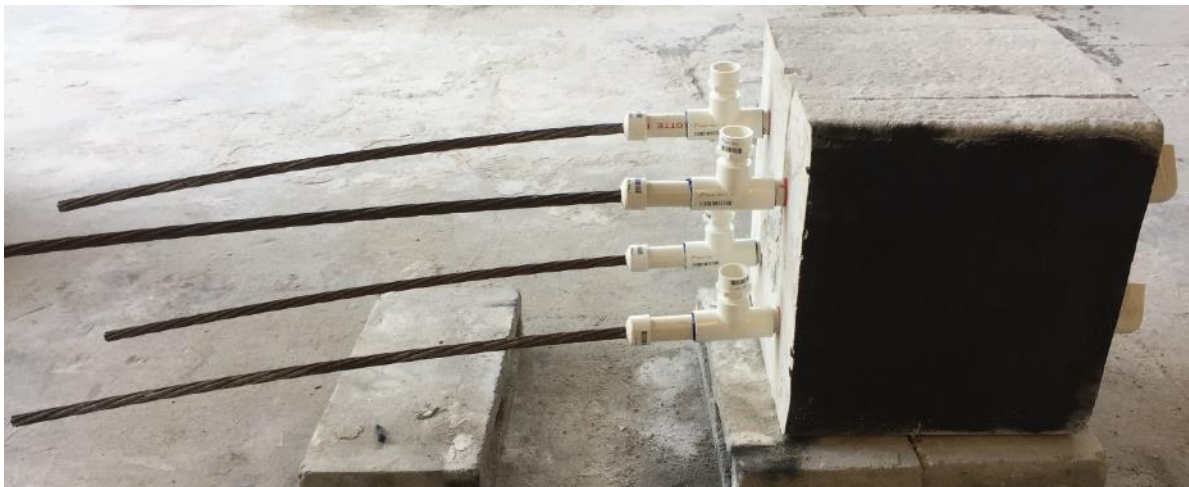
Figure 4-11: Concrete specimen 9 before grout installation.

Further investigation from the literature⁹⁰, the corrosion inhibiting oil needed to be pressurized for 24-hrs so the oil would travel around the strand and into the grout. Concrete specimen 9 was installed with ¾-in PVC tees instead of the 90° elbows. 3-in long PVC pipe were installed on both sides of the tee and duct taped one end to create a de-bonded surface like all specimens previously casted. ¾-in end caps were drilled with 9/16-in holes and installed to free end of the tee as shown in Figure 4-11. The strands were fed through the openings of the end caps and silicon was placed around the strand-to-PVC and PVC-to-concrete interface.

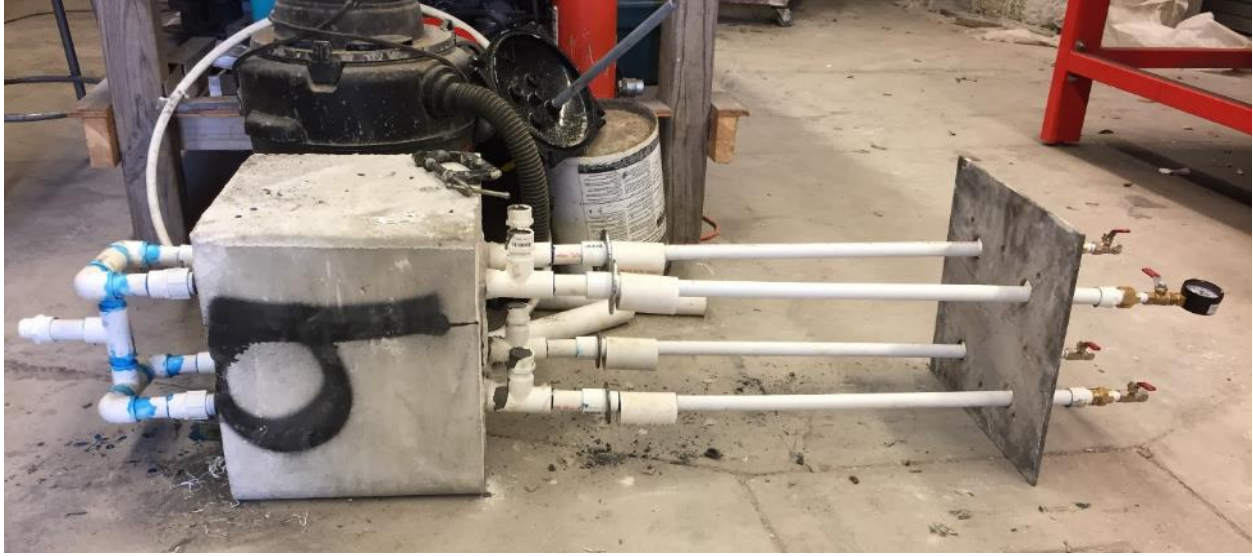
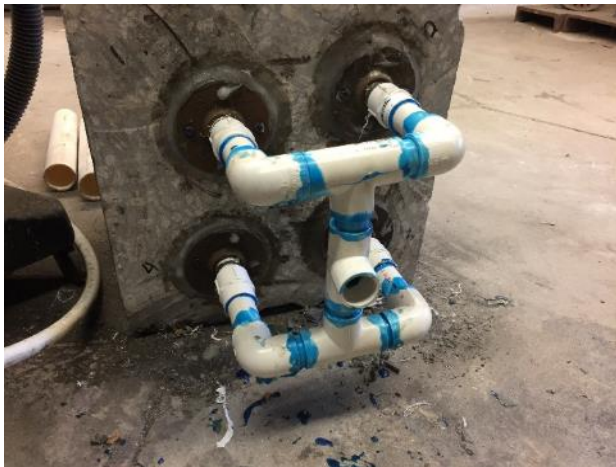
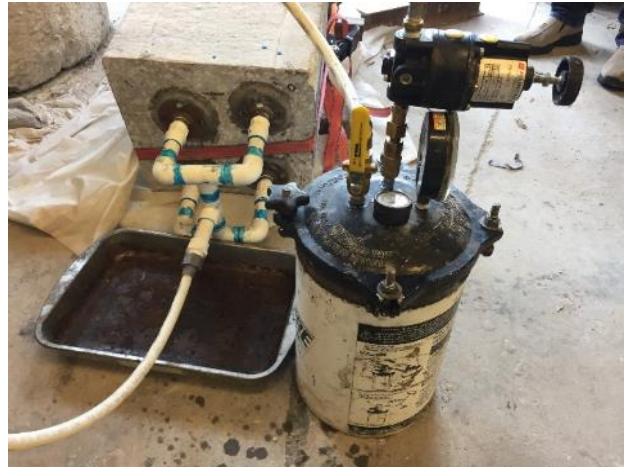
Figure 4-12: Concrete specimen 9 prepared for WD-40 injection for 24-hrs. Concrete specimen 9 with PVC manifold (lower left); specimen 9 WD-40 injection (lower right).

The manifold was created out of ¾-in PVC pipe, tees, elbows, and couplers. The couplers were attached to the ¾-in metal nipples first, since the entire manifold would be glued together and once installed could not be removed until oil had been pressurized for 24-hrs. Once the manifold was prepared and attached to the back of the tendons, the pressure pot filled with WD-40 and was pressurized to 10-psi as shown in Figure 4-12. Expecting oil to travel through the strands and fill the ½-in PVC pipes quickly the specimen was monitored for 4-hrs. Oil never came out of the ends of the PVC pipes while being monitored. After 24-hrs the PVC pipes and adapters were removed for inspection of oil. As shown in Figure 4-13 oil traveled through all of the strands and began to collect near the adapter where the grouted section ended and exposed strand began.

After concrete specimen 9 cured for 7-days the ends caps were removed and ¾-in to ½-in reducers were installed with ½-in PVC pipe which covered the exposed free end of the strands. The free ends of the PVC pipe were sealed with ½-in PVC and brass adapters which led to brass valves where the flow of oil could be stopped and monitored with a removable pressure gauge. In order to pressurize all the tendons at once a PVC manifold was made to split the oil to each tendon. Table 4-11 shows the finished prepared concrete specimen for 24-hr pressurized oil.

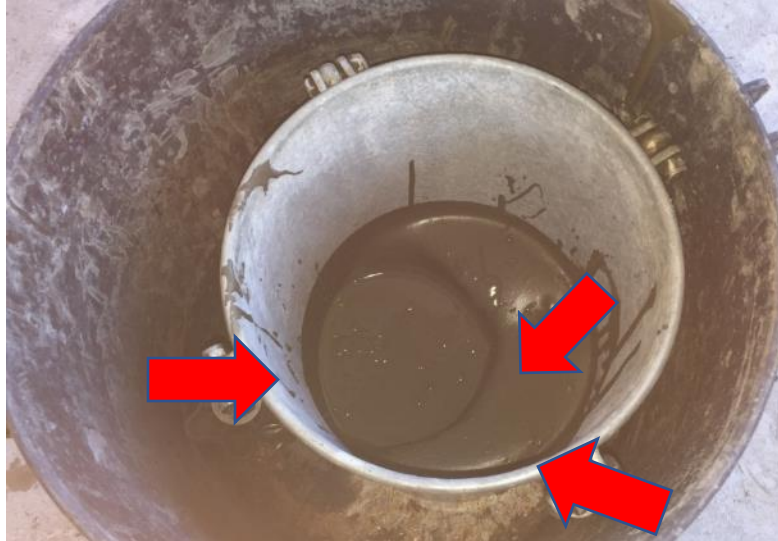
Figure 4-15: The property of thixotropic grout.

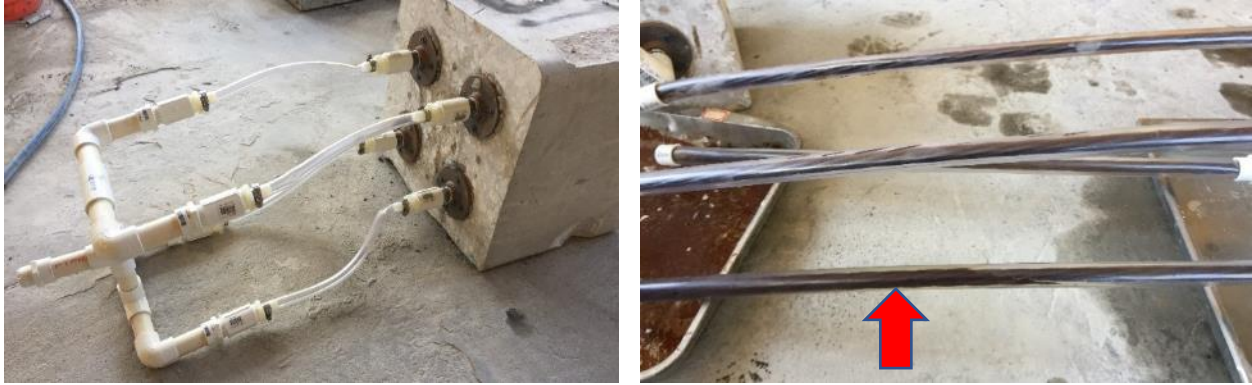
Figure 4-17: Manifold attached to the back of the specimen (left); Clear tubing filled with WD-40 (right).

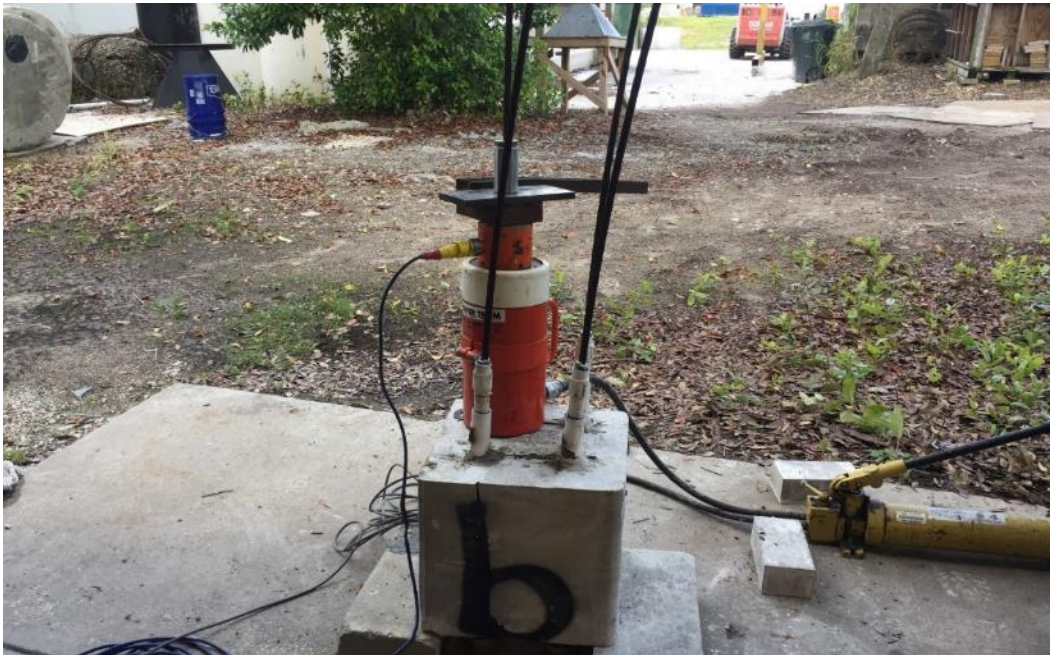
Figure 4-19: Pullout test setup for concrete specimen 9.

Once the grout had cured, the general procedure was to remove the PVC fittings on the back metal flanges and the PVC elbows on the front duct extensions were cut to fit the 60-ton hydraulic jack. Pressure was applied to the hydraulic jack by a 10,000-psi manually operated hydraulic pump. A 50-ton load cell was placed onto the hydraulic jack. Two metal plates were placed on top of the load cell, the first was a 2-in steel plate followed by a ¼-in steel plate as shown in Figure 4-19. A spring loaded ½-in strand wedge set (chuck) was installed on the strand and slid down in soft contact with the steel plates. A displacement transducer (LVDT) was secured to a magnetic stand and the stand was attached to the side of the hydraulic jack.

The initial phase of each load test was to determine the peak bond force. Once all four samples were tested an electric hydraulic pump was connected to the jack to fully extract the strands from the ducts allowing inspection of the internal bonding surface.

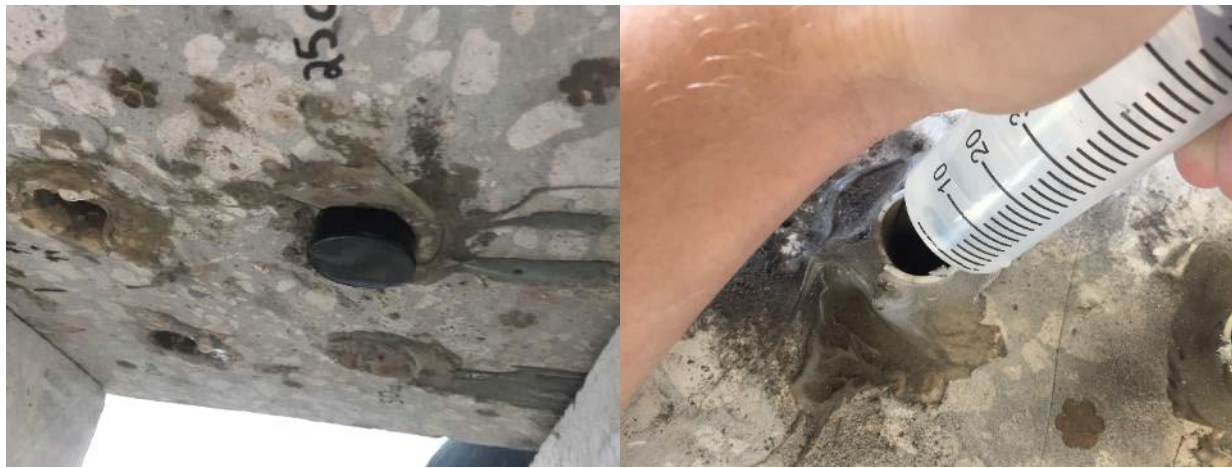
Figure 4-44: Rubber plug installed into the front face of concrete specimen 1 (left); water injection into vacated duct (right).

After the strands were extracted from the grouted ducts, a rubber plug was squeezed into each tendon on the front face of concrete specimen 1. A 100-cc syringe was with water and weighed (filled beyond the marked scale). The water was injected into the tendon on the back face of specimen 1 until it reached the concrete surface as shown in Figure 4-19. The syringe was weighed again and the difference between the water weighed before the injection and after was used to compute the true volume of the duct which contained the bonded grout but without the volume of the strand. In all cases, the strand pulled from the grout leaving an imprint of the strand/spiraled wires.

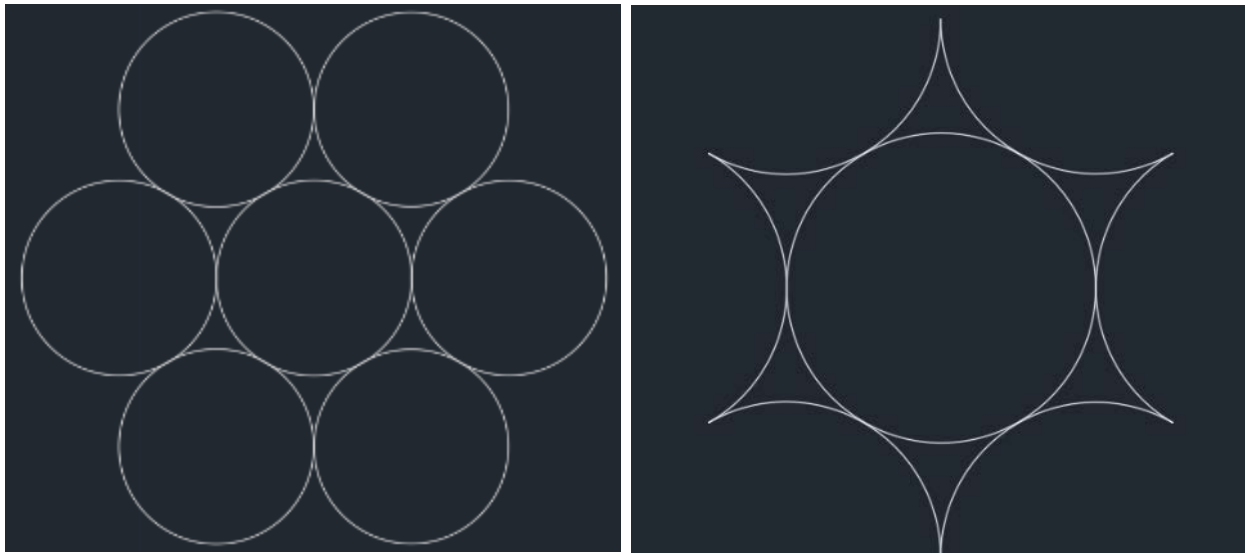
Figure 4-45: Full 1/2-in strand (left); trimmed version of the 1/2-in strand to calculate the interstitial spaces (right).

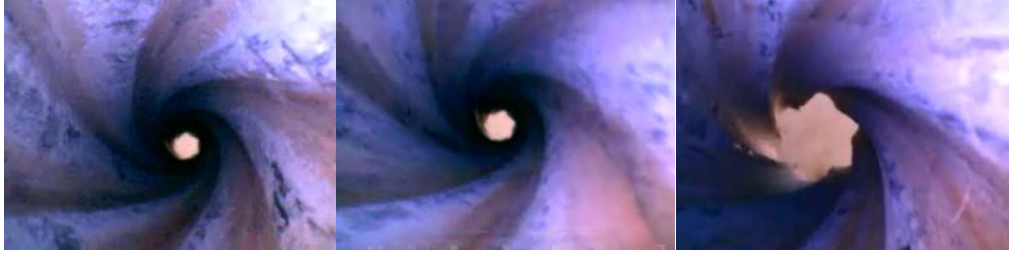
Figure 4-48: Sample 1-1 (none) lowest void perfect grout distribution.

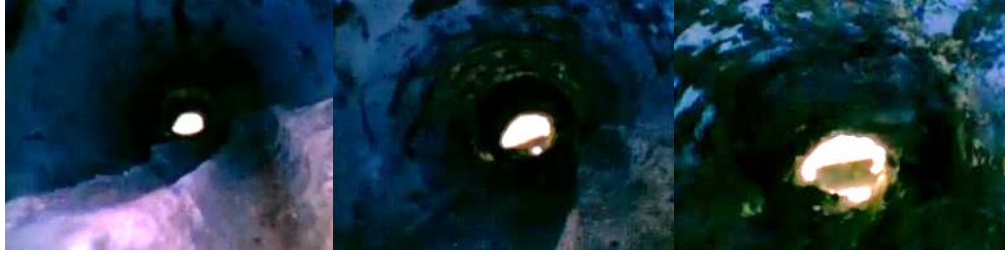
Figure 4-53: Sample 15-4 (WD-40) lowest bond 73-cc void volume, partial bond near bottom.

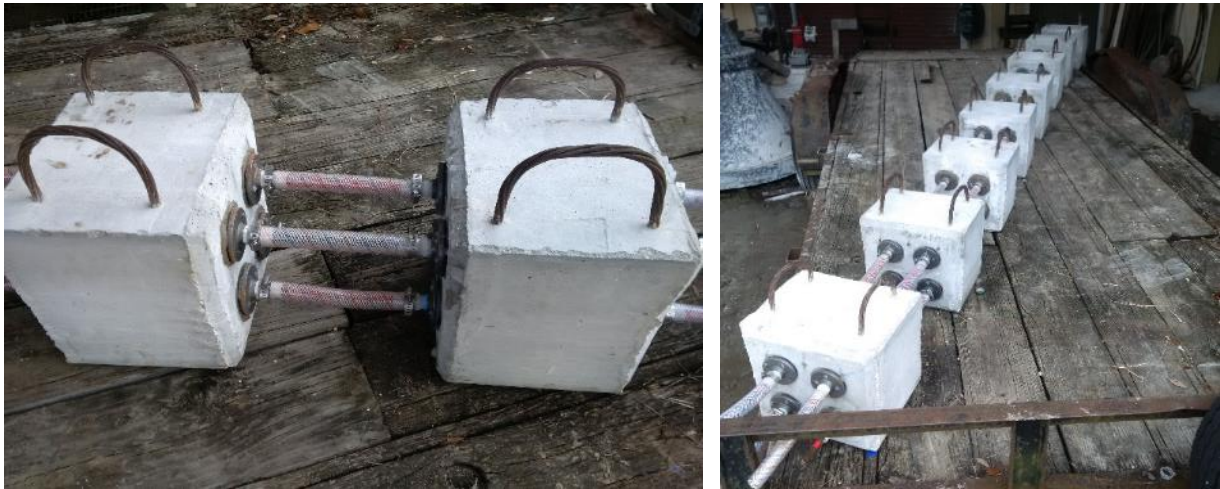
Figure 4-55: Pile segments complete with pipe flanges, barbed hose fittings, and high-pressure hoses to simulate a longer length duct.

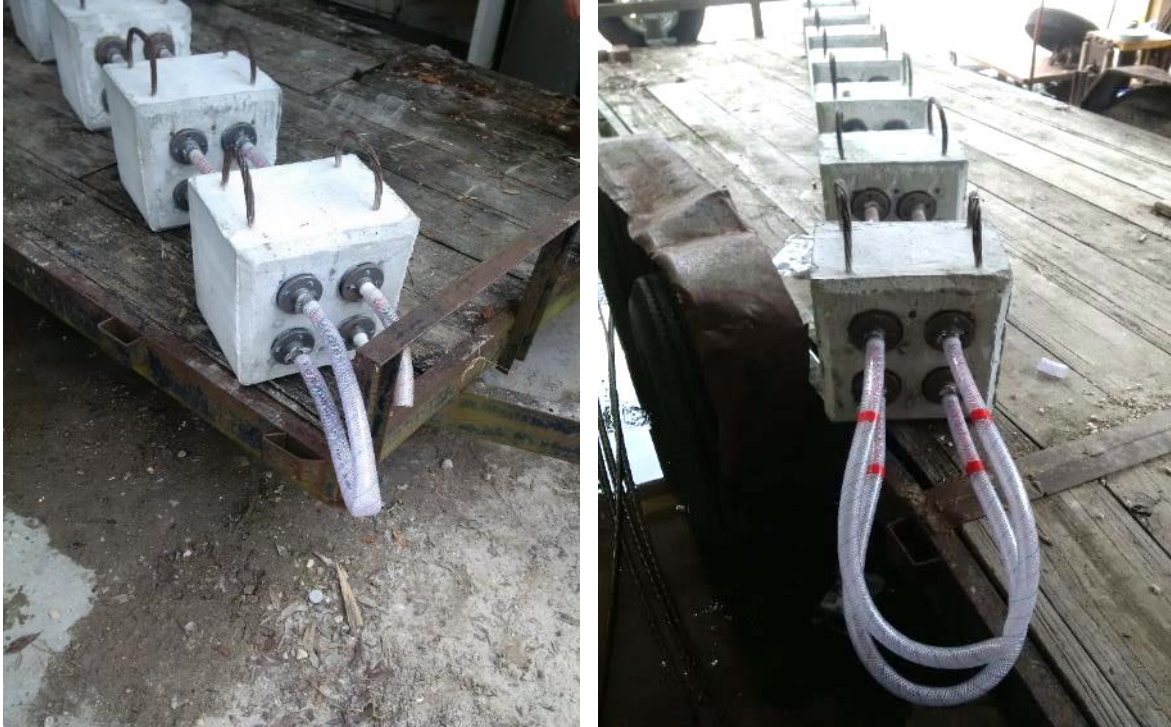
Figure 4-56: Grouting to be performed on all four duct assemblies at once via looped grout hoses on each end.

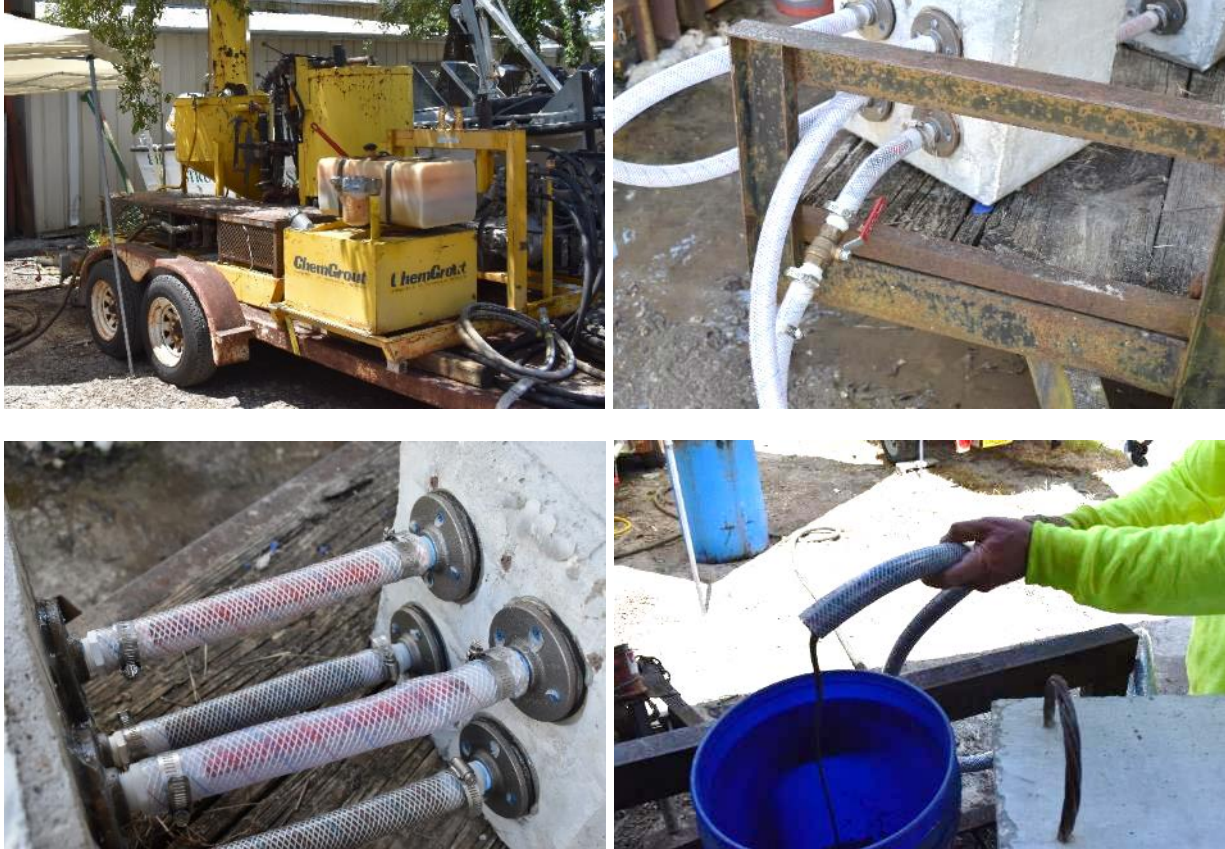
Figure 4-57: Grouting: grout plant (top left); grout hose connected to bottom duct, strand 3 (top right); grout in bottom two ducts but not yet in top two (bottom left); grout exiting four-duct system (bottom right).

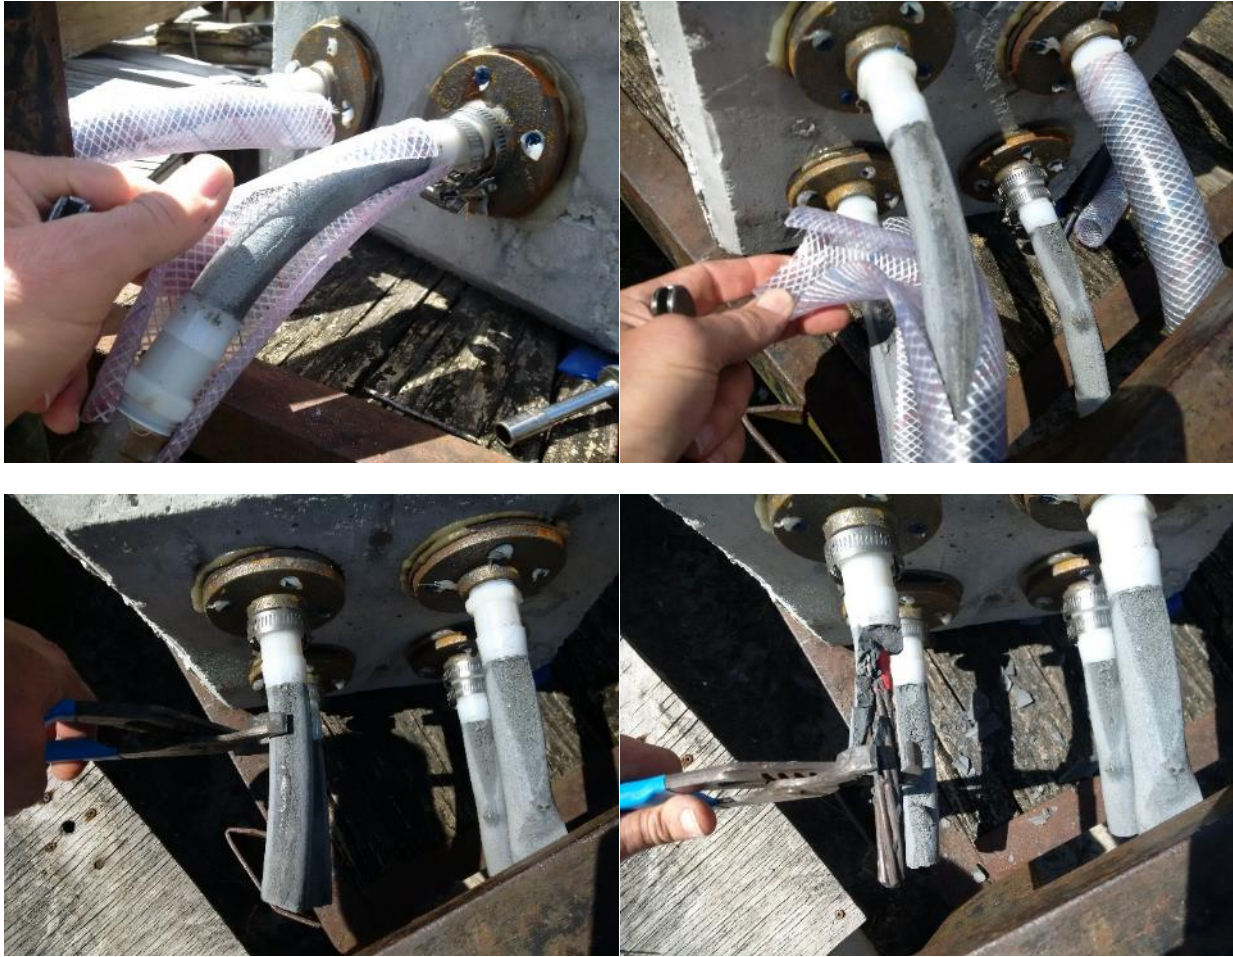
Figure 4-58: Removal of hoses (top); breaking grout off the strands (bottom) before installing new hoses and valves on both ends of the entire 8 specimen assembly.

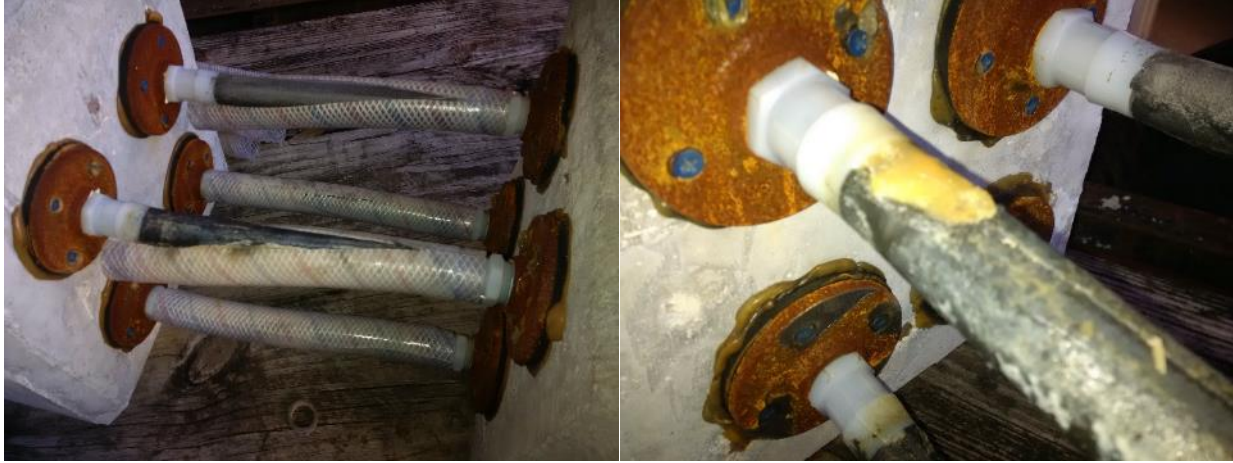
Figure 4-59: Connecting hoses removed showing residual impregnation product.

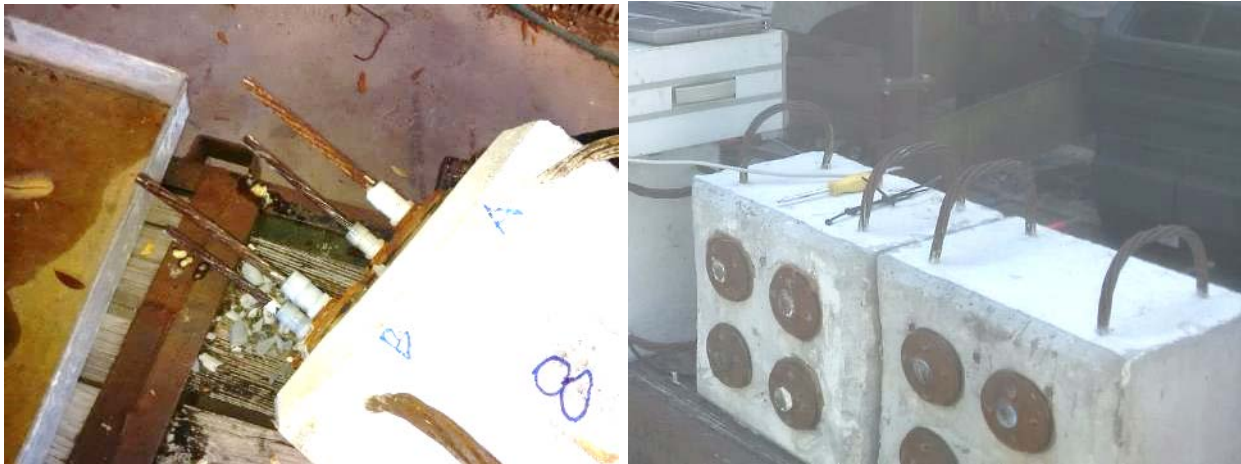
Figure 4-60: Strands extending from specimens (left); flush cut on backside (right).

The strands on the last specimen on the trailer had been extended 12in to provide a connection for pullout testing (Figure 4-60). At the backside of the specimen, the connecting strands between specimens were flush cut with the flange leaving 12in of strand at one side of each specimen.
