FINAL REPORT

**Evaluation of Corrosion Inhibiting Materials Applied by Impregnation
(Pressure Injection) Methods to Prevent Corrosion of Post-Tensioned
Tendons**

FDOT Contract Number: BDV25-977-35

July 2020

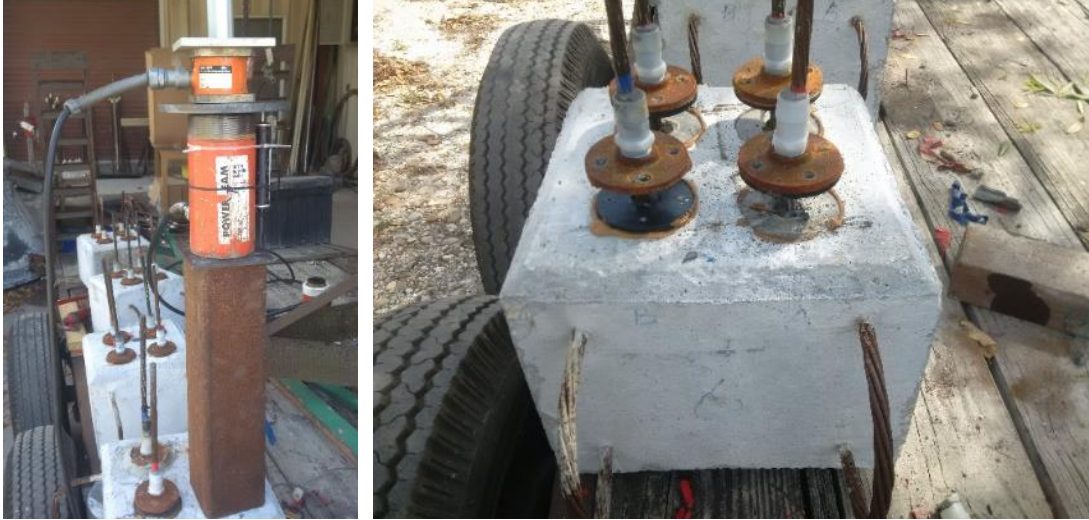
Figure 4-61: Pullout testing (left); flange displaced upward 2 in (right)

Using a 1/2in strand coupler, the pullout strands were extended to pass through a thick-walled square tube section (housing the strand coupler), a hollow-core hydraulic jack, load cell, bearing plate, and a prestressing chuck with spring loaded wedges. Pullout tests were continued until a minimum of two inches of pullout displacement was achieved (Figure 4-61). Note: the fasteners holding the flanges to the concrete were removed before testing. The inner dimensions of the square tube section were sufficiently large to allow the flange clearance from binding or adding to the pullout resistance.

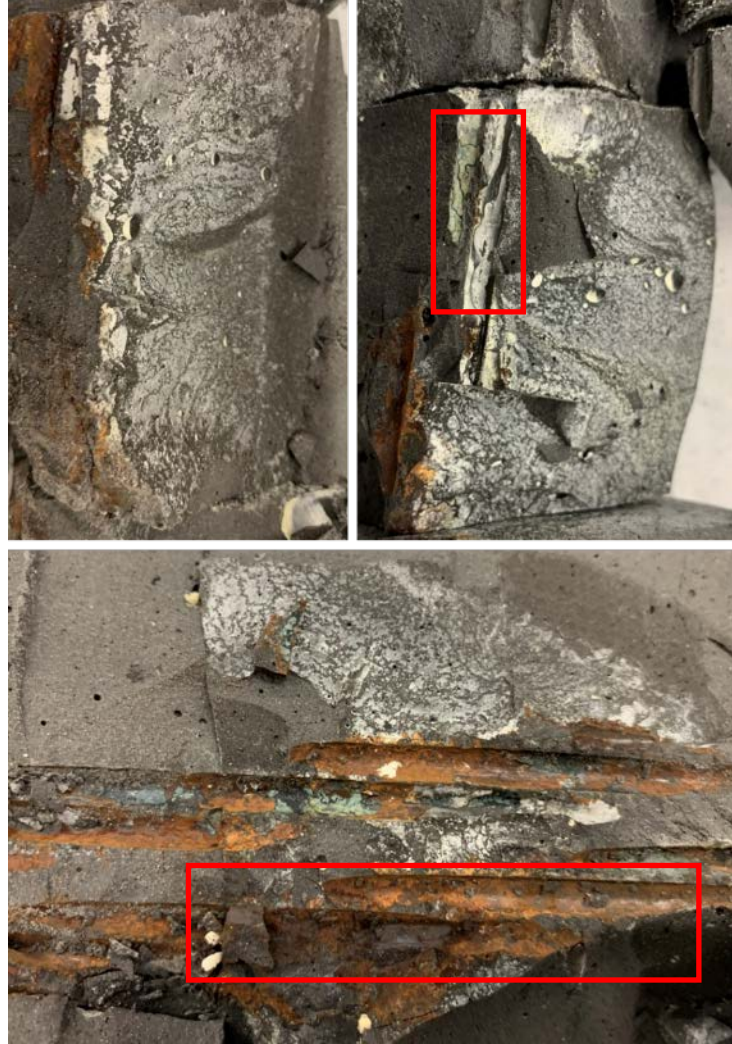
Figure 5-8: Images of the interior pores and voids contained in the 3-ft chloride-contaminated grout with impregnation material.

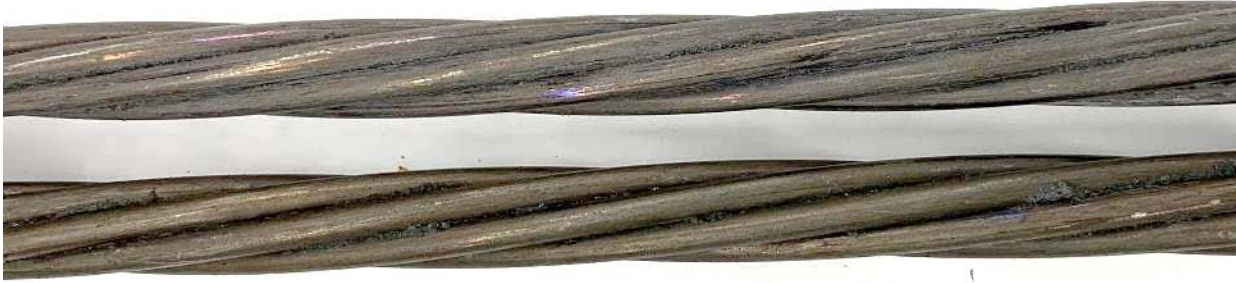
Figure 5-9: The reinforcement extracted from the 1-ft normal tendons. The reinforcement on the top is from the control group and the reinforcement on the bottom is from the impregnated group.

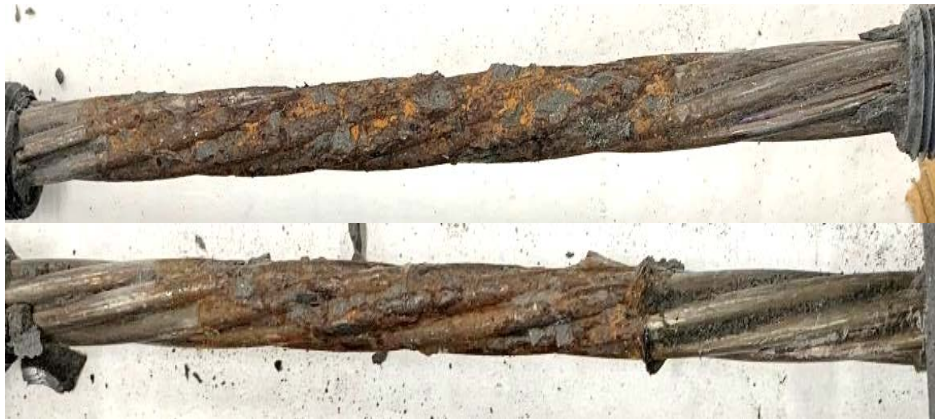
Figure 5-10: An image of the reinforcement extracted for the 1-ft chloride-contaminated tendons. The top image is the control tendon and the bottom image is the impregnated tendon.

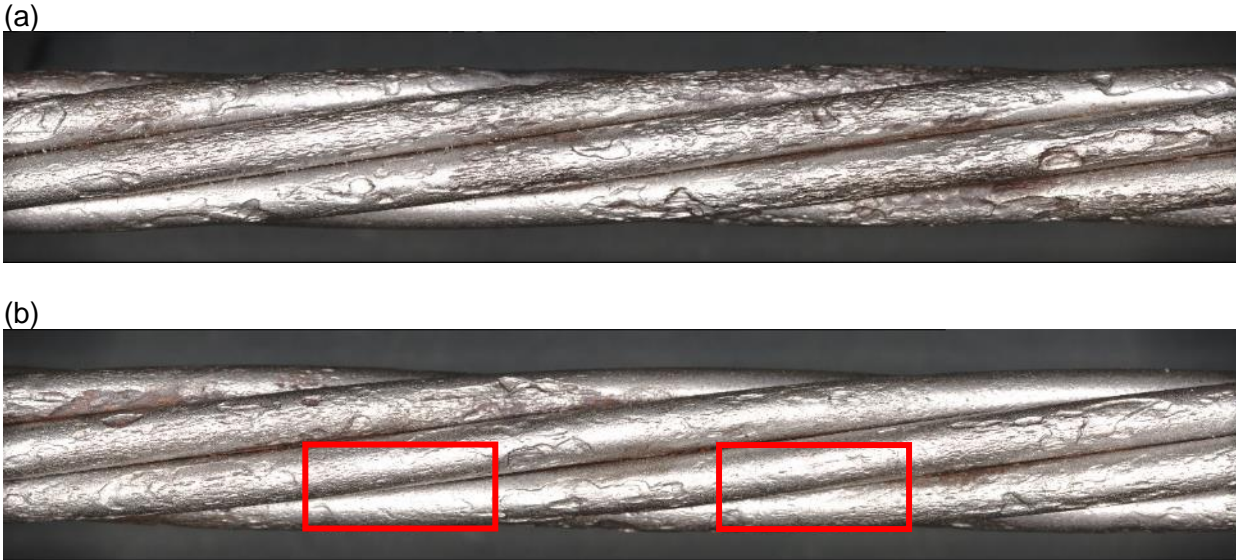
Figure 5-11: Steel strands after corrosion product removal extracted from 1-ft tendons: (a) not impregnated; (b) impregnated.

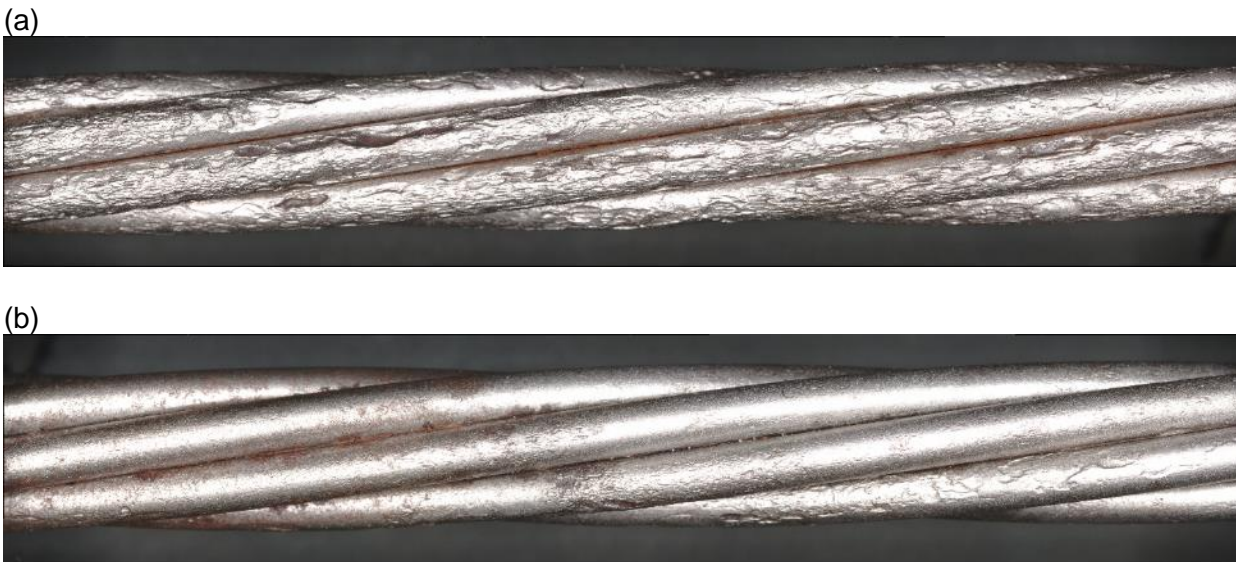
Figure 5-12: Steel strands after corrosion product removal extracted from 3-ft tendons: (a) not impregnated; (b) impregnated.

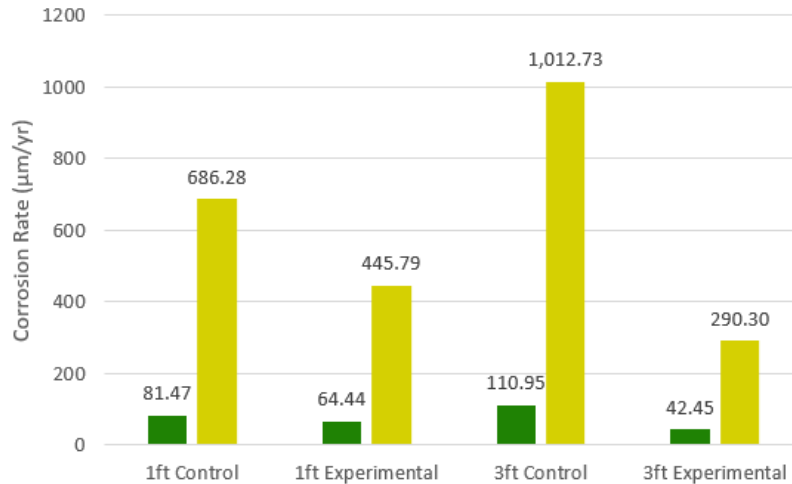
Figure 5-14: Average and maximum corrosion rates of strands extracted from 1-ft and 3-ft chloride-contaminated tendons with and without impregnation.

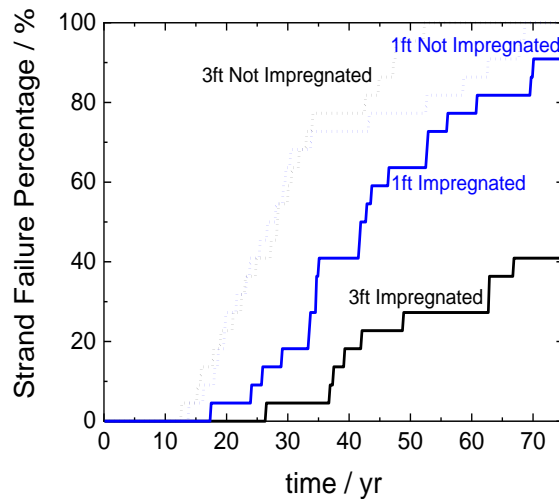
Figure 5-18: Strand failure percentage as a function of time obtained from corrosion data presented in Figure 5-14.

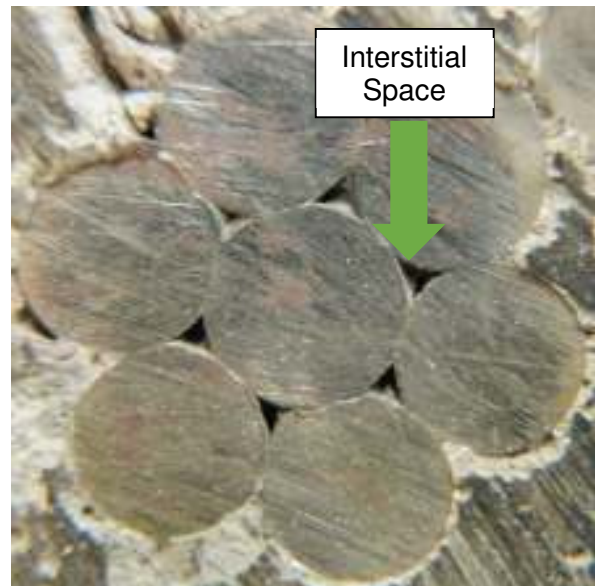
A single strand from a tendon showing the interstitial spaces between the wires

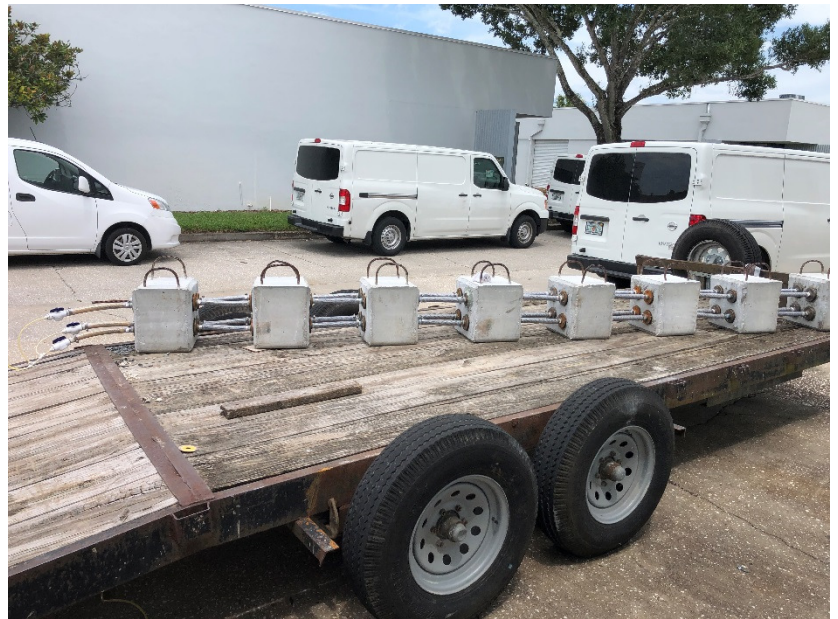
Interconnected concrete blocks

In preparation, valves were installed at either end of the hoses that encapsulated the tendon ends that were exposed at the start and end of the line of 8 blocks. At the one end, the valves were fitted with pumping ports to which the impregnation pump could be connected.

The tendons were then tested with compressed air to determine the location of any leaks. Locations where air was leaking were identified and then sealed with a two-part epoxy paste. Confirmation testing with compressed air was then re-performed prior to the impregnation.

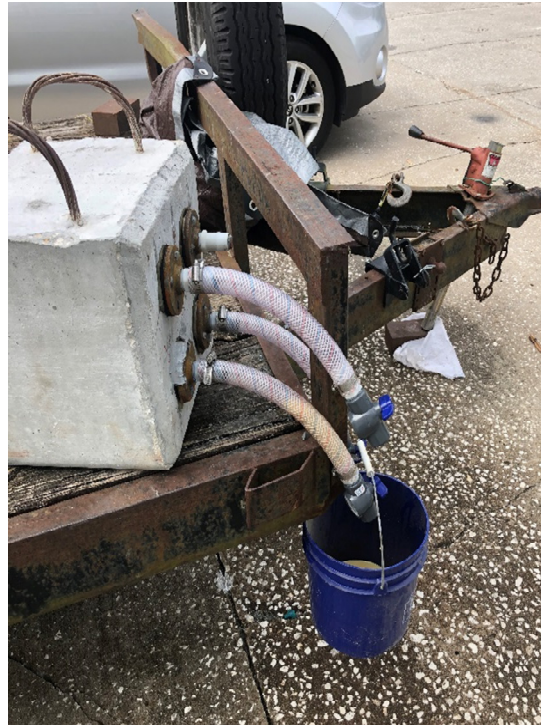
Down-stream end of tendons – photo shows two right tendons' valves closed after appearance of impregnation material. Bottom joint also shows a location of a sealed leak.

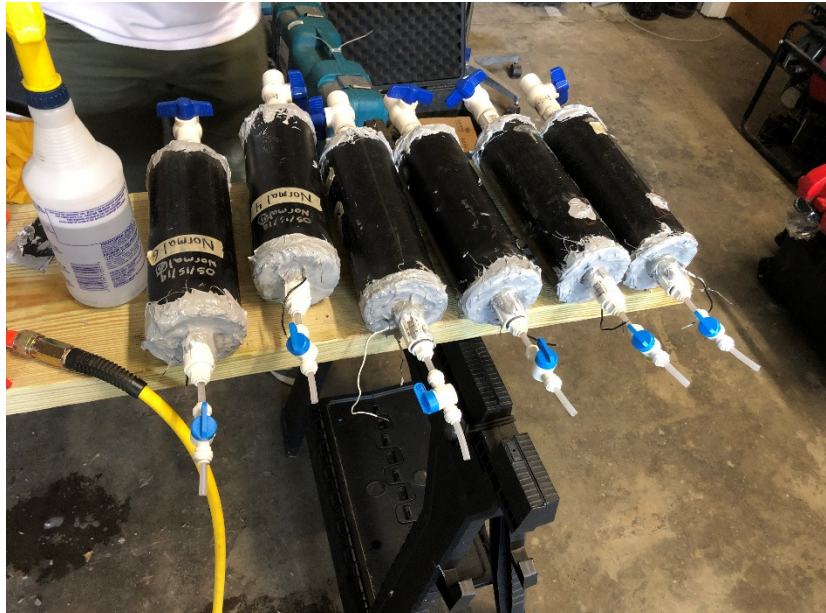
Preparation of 1ft Specimens

In preparation, the caps and collars that were on the samples were removed and the exposed ends were cleaned and prepared for sealing. Valves were installed at either end of the specimens on the grouted nipples that surrounded the tendon at either exposed end. At the one end, the valves were fitted with pumping ports to which the impregnation pump could be connected.

The ends of the ducts were capped and sealed with two-part epoxy then tested with compressed air to determine the location of any leaks. Locations where air was leaking were identified and then sealed. This procedure repeated until no leaks were evident.

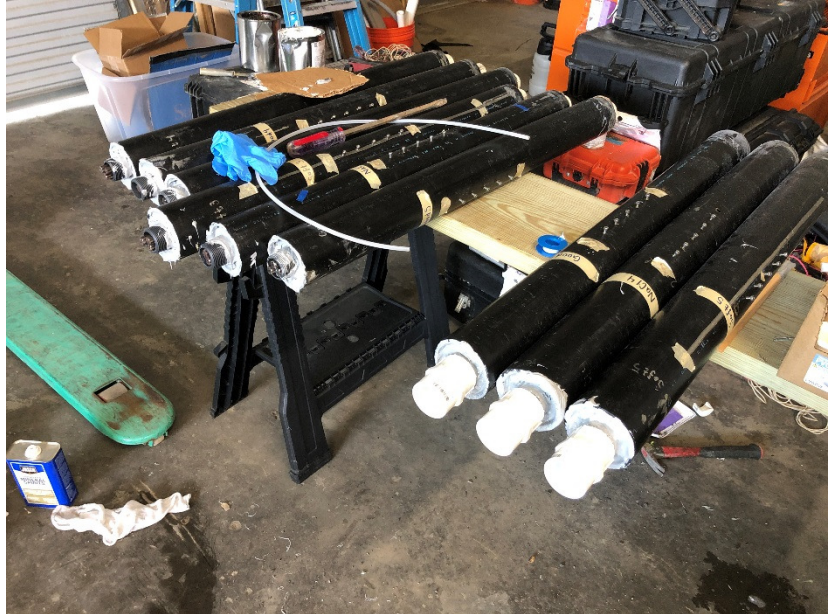
Preparation of 3ft Specimens

The impregnation of these specimens commenced between the afternoon of August 29th and the afternoon of August 30th. Impregnation material was observed exiting the down-stream valves anywhere between several minutes and several hours after initiating treatment on all samples. Once material was observed at the down-stream valve, the valves were subsequently closed.

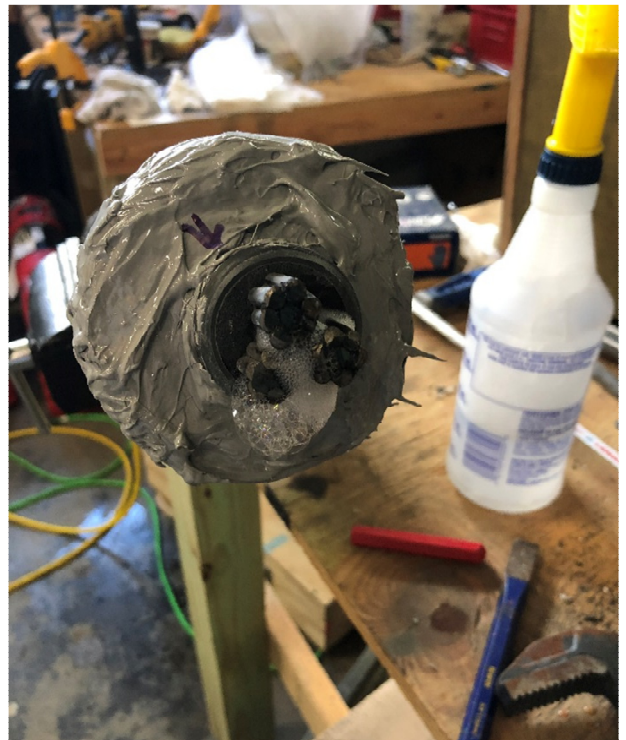
Air testing 3ft Specimen – photo shows bubbles formed by air exiting the interstitial spaces in the tendons.
