1. Report No. FHWA/TX-11/9-1526-1		2. Government Accession No.		3. Recipient's Catalog No.	
4. Title and Subtitle  Fatigue Life of Steel Base Plate to Pole Connections for Traffic Structures				5. Report Date January 2011; Revised July 2011

16. Abstract This is a final report of an extensive experimental and analytical examination of the fatigue behavior of the welded end connection used on high-mast light structures and traffic signal masts. The weld details commonly used for these connections produce very poor fatigue performance. Their performance is a function of base plate stiffness, weld type and geometry, and number of anchor bolts. Older connection designs produced very poor fatigue performance far below the lowest AASHTO fatigue category. These connections can be improved by increasing the base or end plate thickness, improving weld details, and other geometric considerations. Due to the interaction of the overall connection geometry upon fatigue performance, the fatigue performance of the connection cannot be classified by simply the type of connection. The fatigue life can be improved to fatigue performance comparable to Category B but a similar connection with a thinne

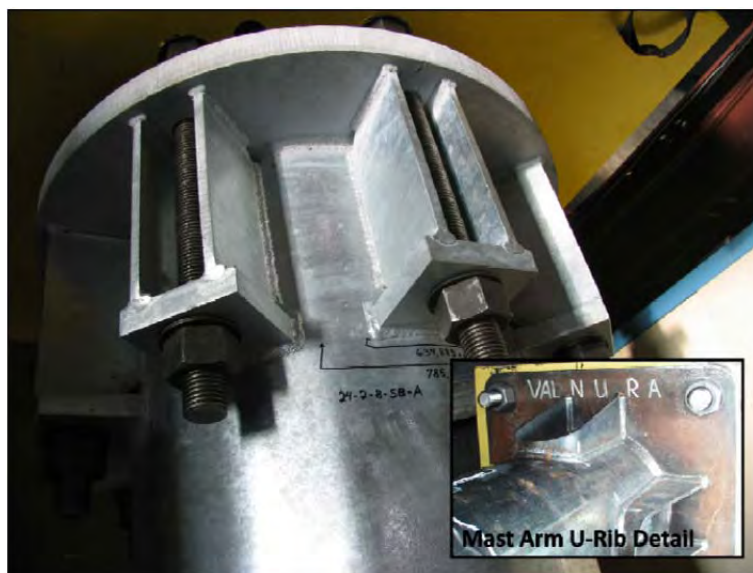
*Figure 1.2: U Rib Stiffener and Stool Base Details*

Variations on the socket connection are shown below. External stiffeners have been used to stiffen the connection. Both plain tapered stiffeners and U-shaped stiffeners have been employed. The U-shaped stiffener, shown in the inset of Figure 1.2, provides improved fatigue performance. The stool base connection in Figure 1.2 stiffens the connection similar to the U-shaped stiffener and reduces the concentration of forces at the anchor bolt locations. External collars or ground sleeves are used to provide a uniform increase in stiffness around the shaft.

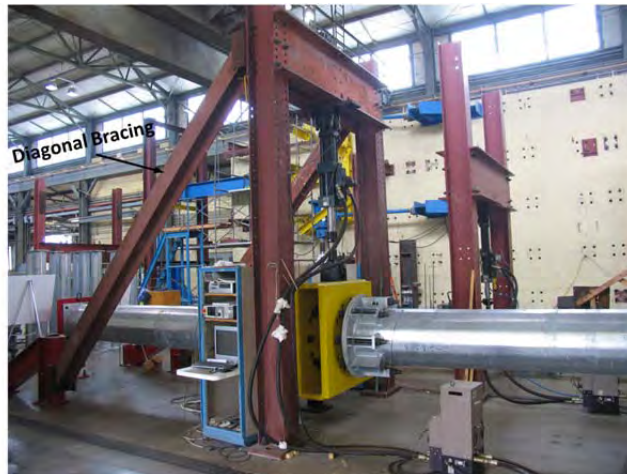
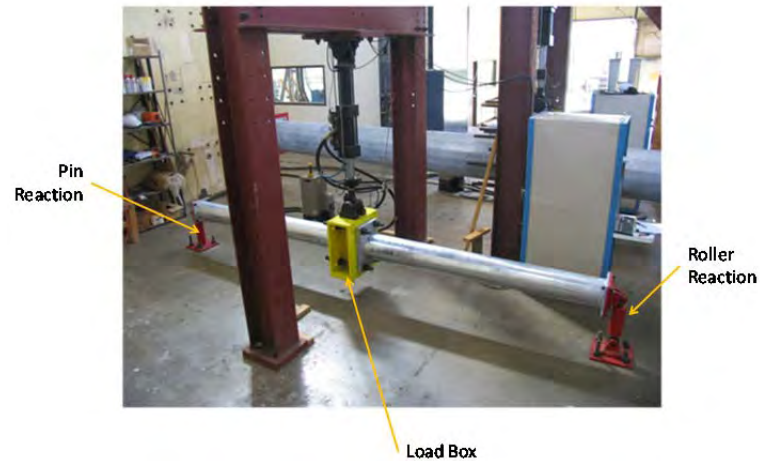
*Figure 2.3: Portal Loading Frame High-mast and Mast Arm Tests*

When the ram applied a compressive (downward) force into the coupled masts, the rotational and translational freedoms permitted by these joints would cause the masts to rotate about their long axis rather than forcing them into the desired positive curvature. As the masts rotated, the inclination of the ram created a lateral force, only worsening the instability. As a result, the ram was used only to apply tensile forces, and all fatigue stresses at the top fibers of the masts were tensile.

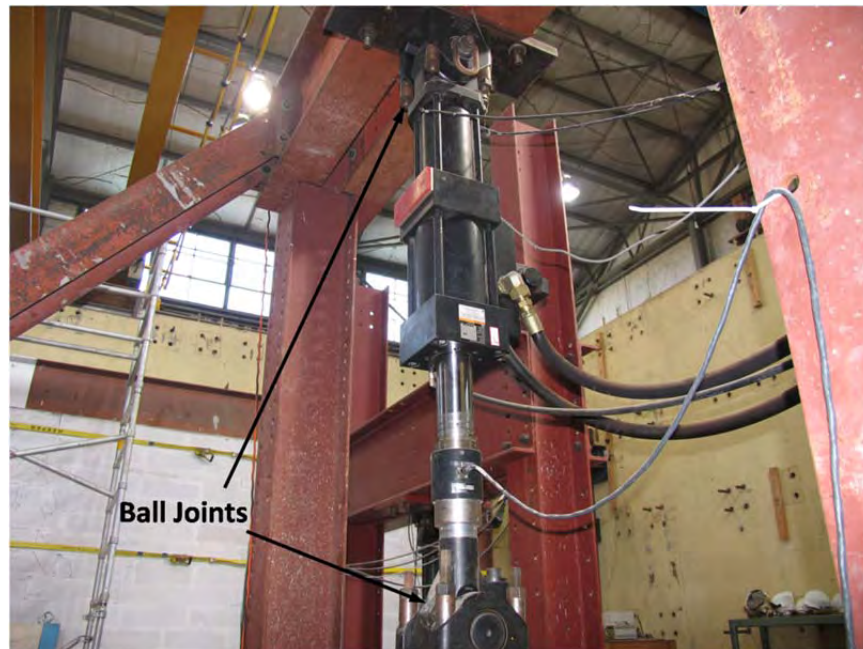
*Figure 2.4: MTS 55-kip Hydraulic Actuator*

The horizontal testing configuration did have one drawback due to instability inherent in the setup design. The MTS hydraulic rams used for testing had ball-and-socket type joints at both top and bottom (see Figure 2.4).

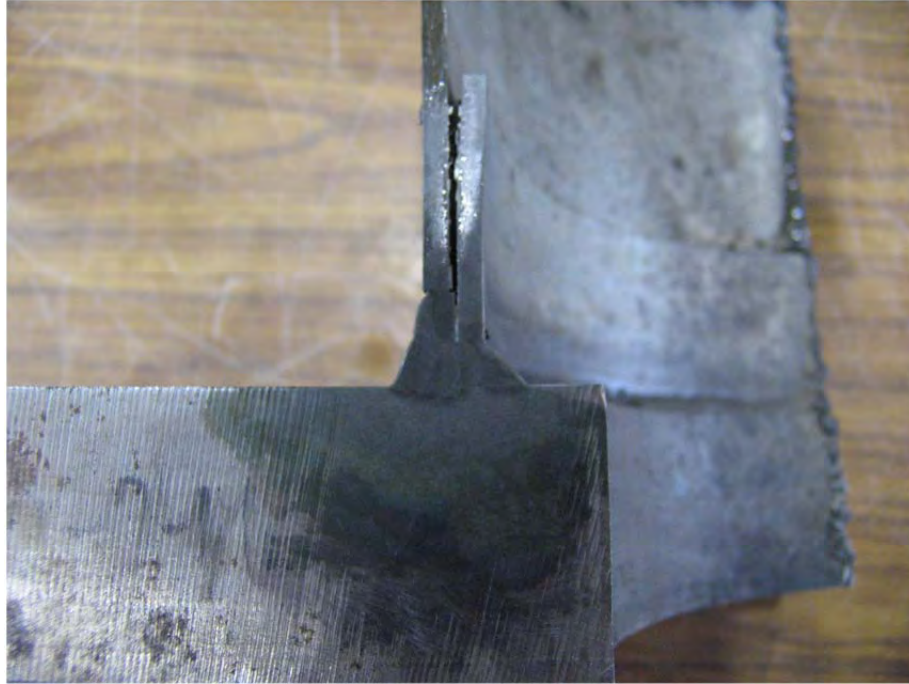
*Figure 3.2: Cross Section of a Typical Full Penetration Connection*

An etched cross section of a typical full penetration detail is given in Figure 3.2.

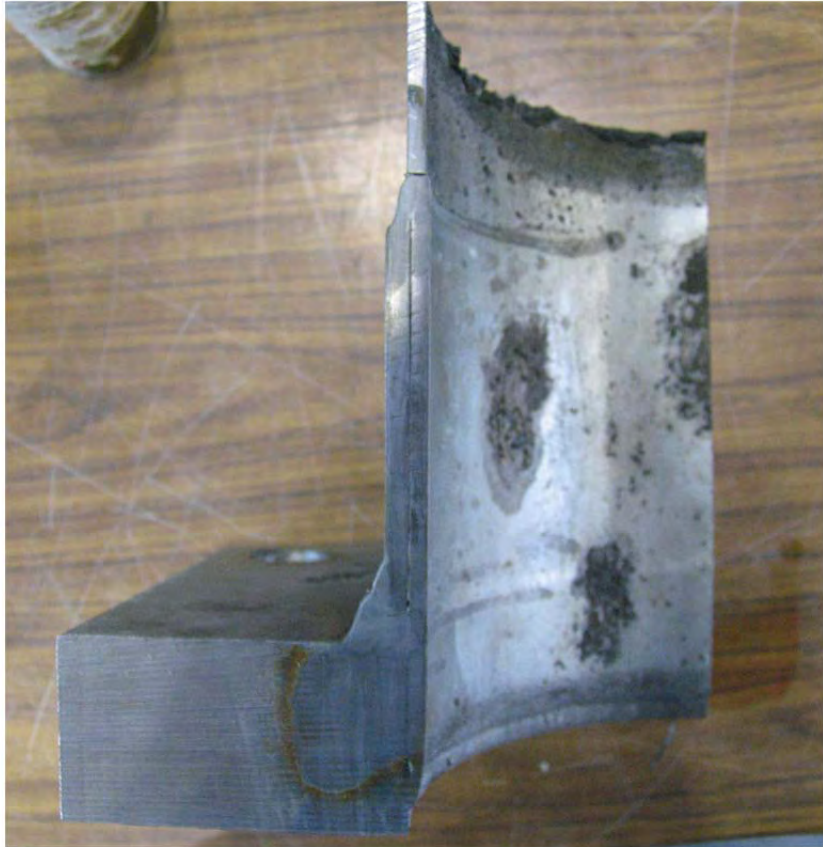
*Figure 3.8: A Cross Section of a Typical External Collar Detail*

Etched cross sections of a typical external collar detail are given in Figures 3.8 and 3.9.

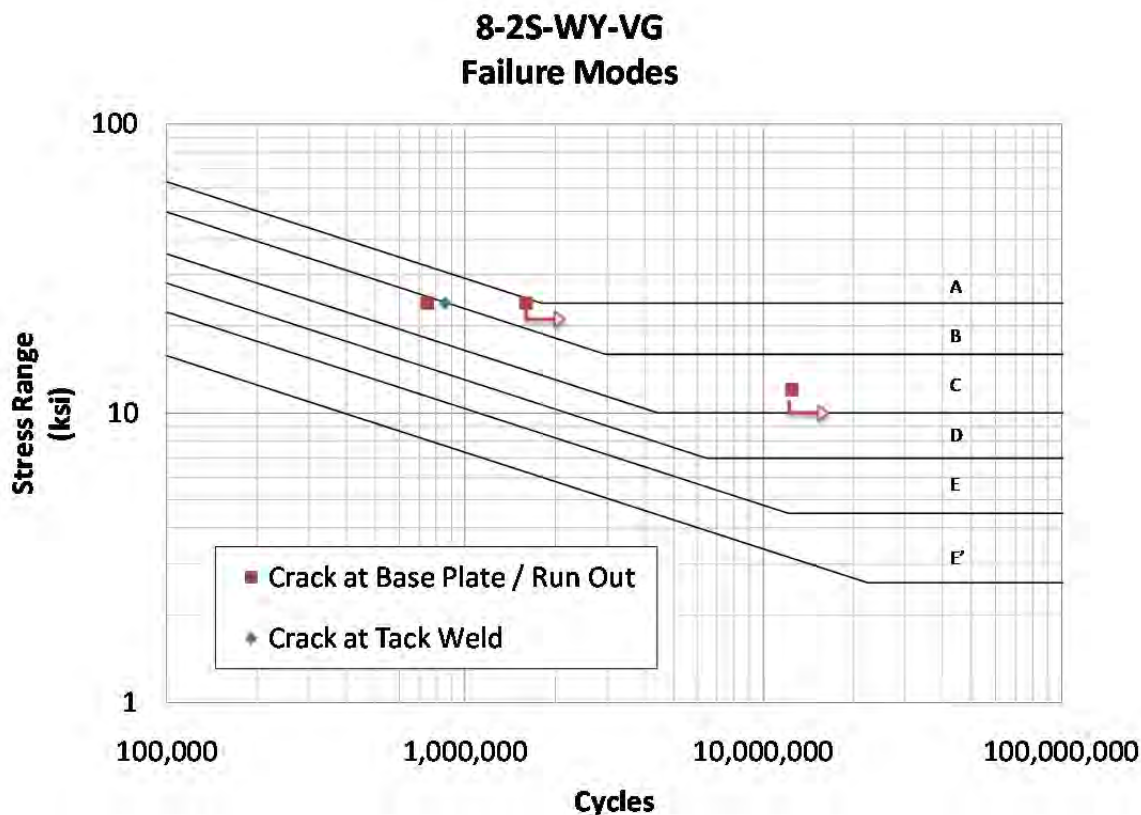
*Figure 3.19: Variation of Backing Ring Welds, 8-2S-WY*

The data from the tests of specimens with a backing ring weld with 2-in. base plate, 8-in. diameter full penetration detail is plotted in Figure 3.19.

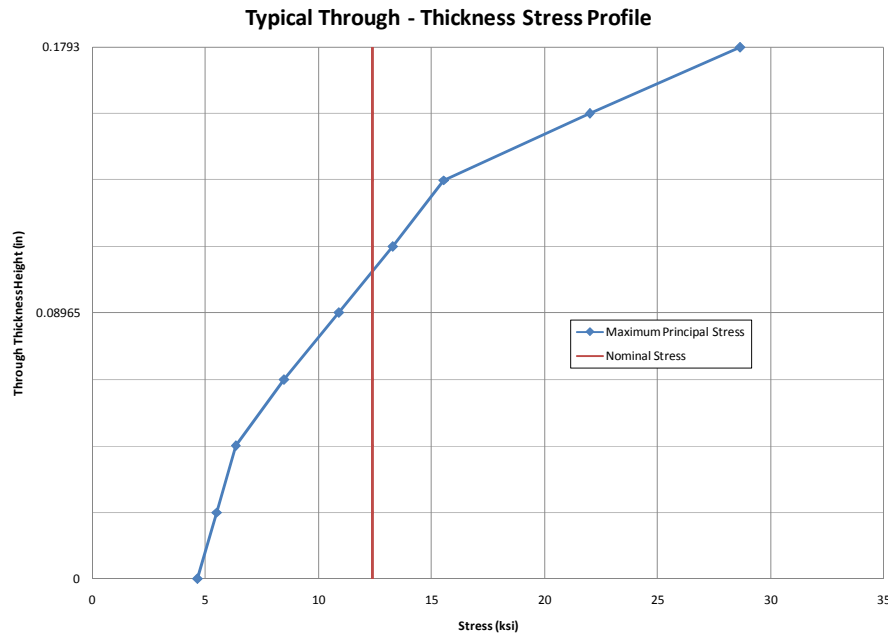
*Figure 4.1: Typical Through Thickness Stress Profile*

stresses at any given point will be approximately constant through the thickness. Localized curvature in the mast arm wall will induce local bending stresses in the wall, increasing the tension stresses at one edge of the mast arm wall and decreasing the tension stresses (making them more compressive) on the other side, as shown in Figure 4.1.

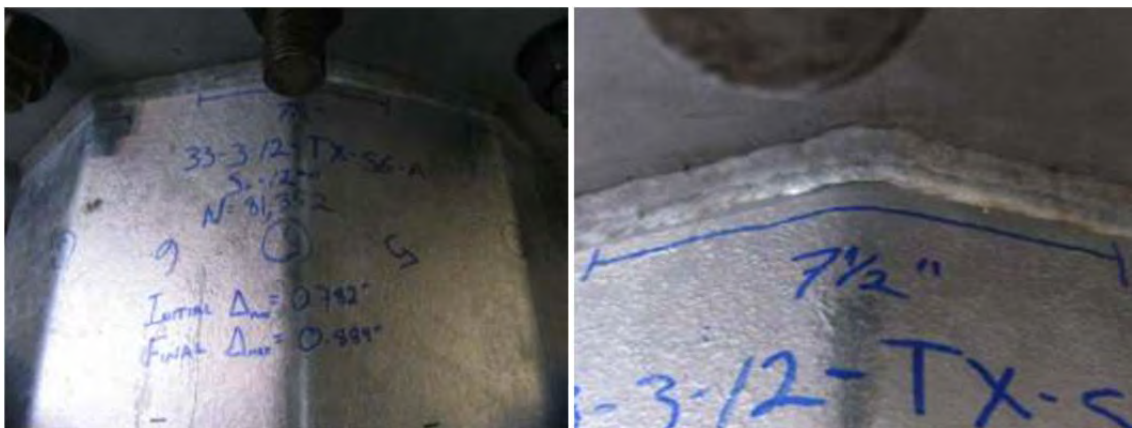
The test was first stopped at 4,464 cycles due to loss of stiffness. There were no visible cracks visible. A second inspection after 5,144 cycles also revealed no visible cracks. A third inspection occurred at 27,322 cycles; a very small visible crack at bend 5 was found. Testing was continued on the sample by adjusting the displacements to produce the desired fatigue loads. Testing on bend 5 was stopped at 81,326 cycles. A large, visible crack had formed in bend 5, as well as smaller cracks in bends 4 and 6. No cracks had formed in the black specimen. The crack at bend 5 can be seen in Figure 7.4. The sample was rotated 90°, placing the bend 5 at the neutral axis so that testing could continue.

*Figure 7.4: Crack Length at Bend 5 on the Galvanized Specimen after 81,326 Cycles*

As mentioned above, bend 5 had a 1.625 in. crack indication found during ultrasonic testing and a 7.5-in. fatigue crack found after fatigue testing. After testing, bend 5 was cut open to view the cracks. Figure 7.6 is a picture of the opened bend. A close-up of the crack is shown in Figures 7.7 and 7.8.

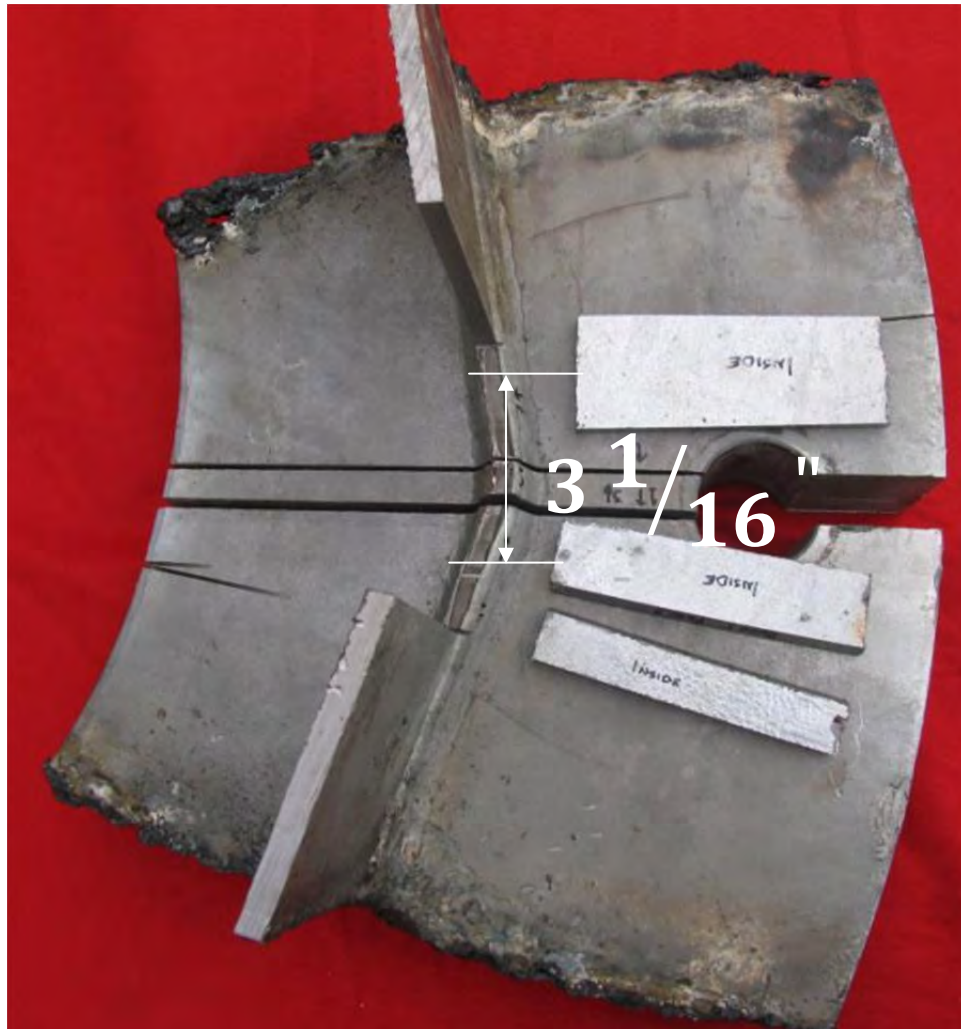
A distinct difference in the crack is visible between the outer and inner edge of the shaft. The interior edge is a classic example of a fatigue crack with a smooth fracture surface. The exterior edge of the crack is darker and rougher, which does not appear to be the result of fatigue. This is believed to be an initial crack. The initial crack was approximately 3 in. long. The crack depth was approximately 0.094 in. deep.

*Figure 7.6: View of Bend 5 after Sectioning. Length of Observed Initial Crack is Labeled*

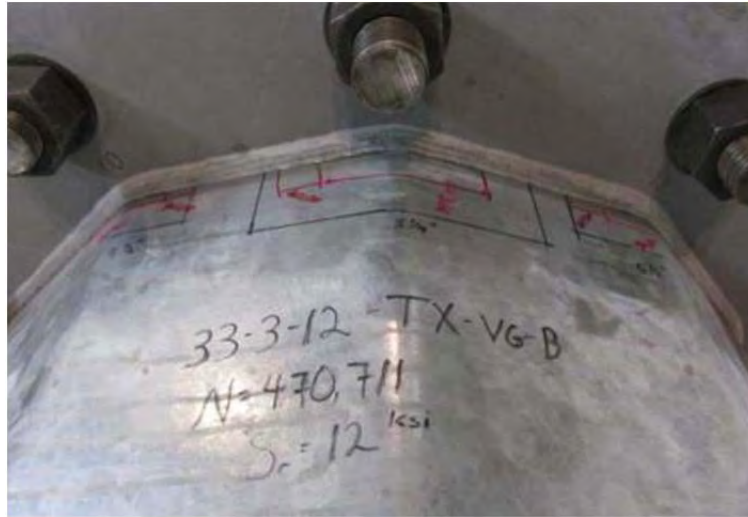
Figure 7.15 is a photograph of specimen B after failure. The specimen had a 4.5-in. crack at bend 10, an 8.25-in. crack at bend 11, and a 5.5-in. crack at bend 12. All cracks were located at the toe of the weld connecting the shaft to the base plate. Again, there were no initial cracks found by ultrasonic test at these bends prior to testing.

*Figure 7.15: Specimen 33-3-12-TX-VG-B after Fatigue Testing*
