Quantifying Gully Erosion and Potential for Sediment and Phosphorus Pollution Reductions Achieved by Erosion Remediation Projects on Vermont's Roads

July 2021

Research Project

Reporting on VTRC019-002

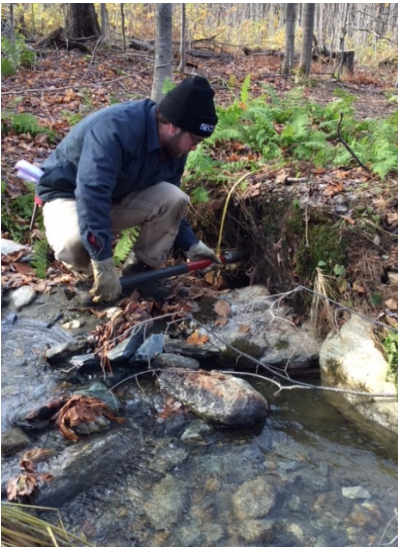
Figure 3: Soil sampling. Left panel displays technician collecting a soil sample with AMS soil coring device. Right panel displays sample collection approach, with samples collected along the gully wall, at 30 cm depths.

To characterize phosphorus content of gullied soils, samples were collected in summer and fall 2019 from the walls of gullies at 30-centimeter depth intervals using a 2-inch diameter AMS soil core sampler (Figure 3). Samples were transported to the Agricultural and Environmental Testing Lab (AETL) at the University of Vermont for analysis. The bulk core sample (fine soil and pebbles) were oven dried at 105°C overnight and weighed to determine dry bulk density. Samples were subsequently sieved through a #10 (2mm) mesh to remove coarse grains and ground with mortar and pestle before passing through a #35 (0.5 mm) sieve. Approximately 0.5 g of this ground fraction was weighed to 0.001 g and digested using a microwave-assisted nitric acid digest (EPA method 3051). Digests were analyzed for total phosphorus (TP) by ICP-OES (Avio 300, Perkin Elmer Corp., Norwalk, CT, USA). Site #1 on I-89 North in Colchester was added to the study in late Spring 2020, following the shut down of laboratory facilities at the University of Vermont during the Covid-19 pandemic, and not included in soil samples collected.

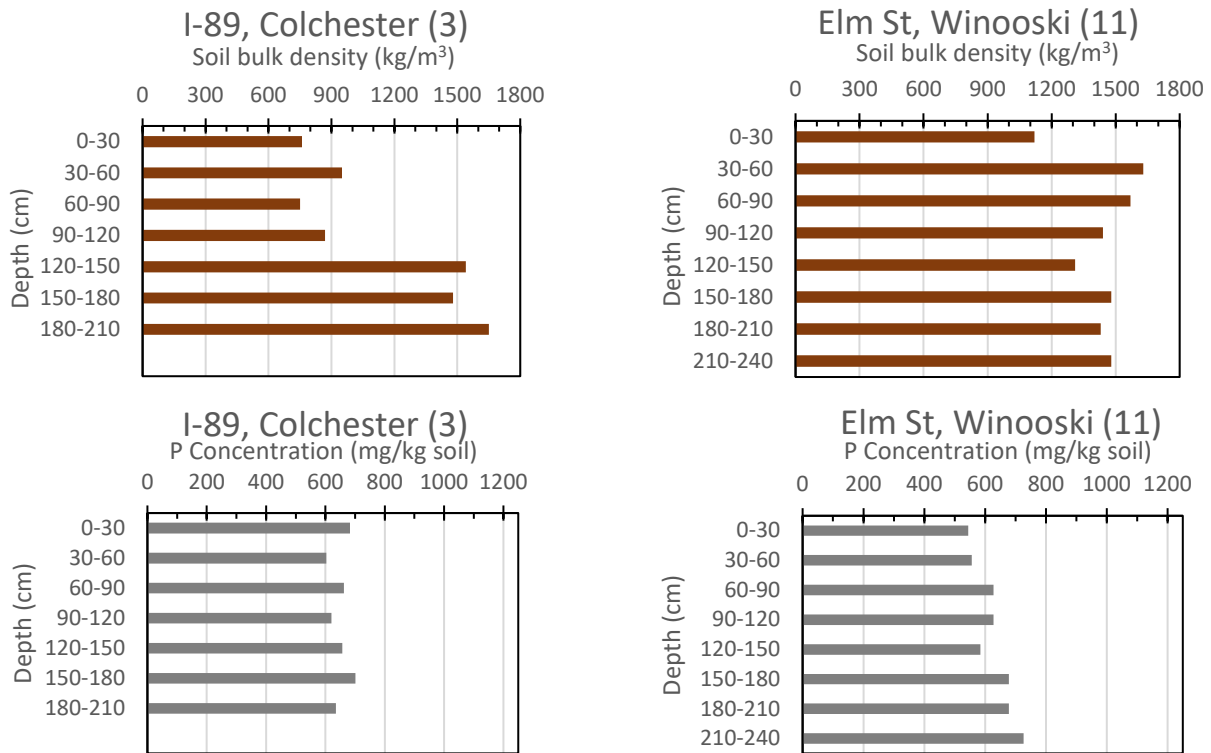
Figure 7: Soil bulk density (top panel) and soil phosphorus concentrations (bottom panel) for two sampled sites. Full dataset presented in Appendix 2.

Properties of the soils sampled from gully walls varied both within and across sites (Figure 7, Appendix 2). In general, soil bulk density tended to increase with depth but P concentration showed no clear pattern with depth. The range in depth-sampled bulk density was greatest at I-89 Colchester (site 3), varying between 750 kg/m³ in the 60-90 cm depth to 1,650 kg/m³ in the 180-210 cm depth. Depth-averaged bulk density across all sites ranged from 950 to 1,458 kg/m³ and averaged 1,239 kg/m³. Soil phosphorus (P) concentrations ranged from 450 mg per kg (mg/kg) of soil at the 30-60 cm depth at Young St, Colchester (site 10) to just over 1,200 mg/kg in the 0-30 cm depth at I-89 Colchester (site 3). Depth-averaged P concentrations across all sites ranged from 486 mg/kg to 1,207 mg/kg with an average of 694 mg/kg (Appendix 2).

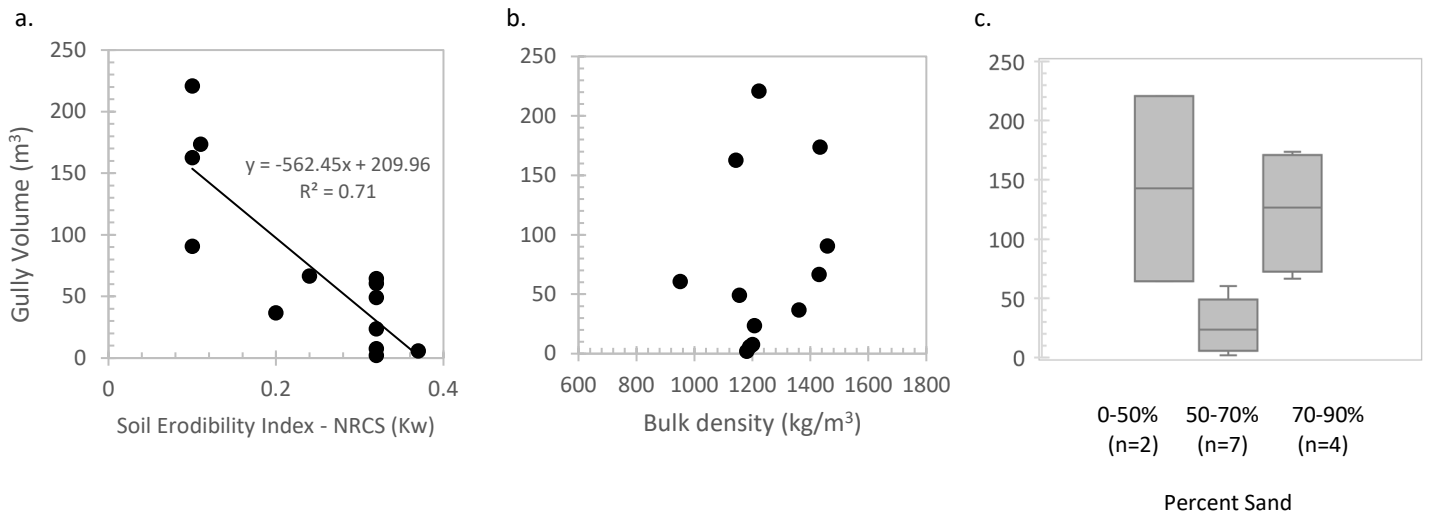
Figure 9: May 2020 gully volume at study sites vs. soil erodibility index (a), mean site soil bulk density (b), and percent sand (c). Sample size values (n) on panel c are the number of gullies represented in each group.

Soil properties appear to exert a lesser influence on gully volume compared to road length and area. Soil erodibility index, taken from NRCS soils data for each site, is statistically related to gully volume, though the form of the relationship is counter intuitive, with higher values of the index (more erodible soils) associated with smaller gully volumes (Figure 9a). Mean soil bulk density (Figure 9b) measured from field samples and soil texture (Figure 9c) taken from NRCS soils descriptions also appear less important than contributing water volumes (as indicated by road length, road area, and contributing area) in explaining gully volume.

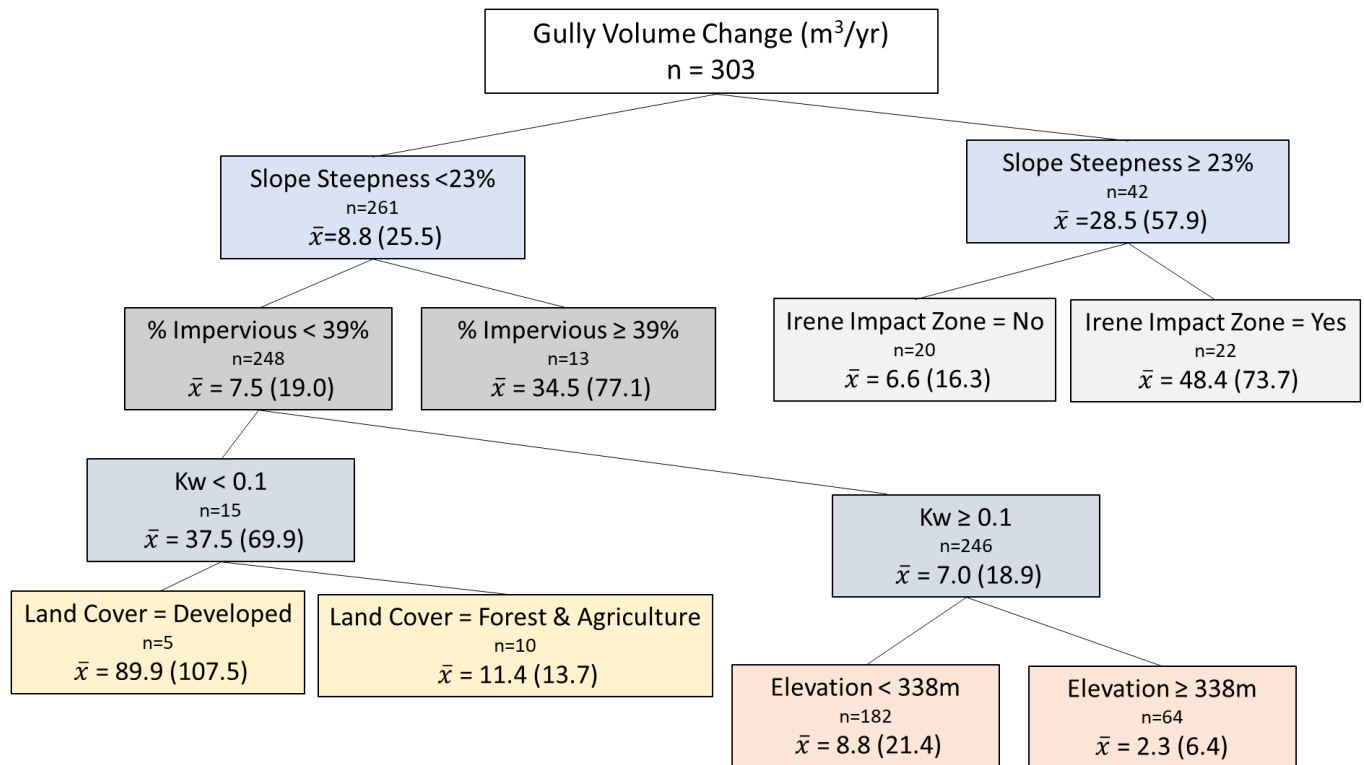
Figure 13: Regression tree analysis of gully volume change in time using 303 features identified on multi-date lidar datasets. Number of gullies (n), mean (\bar{x}), and standard deviation (in parenthesis) given for each group discriminated in the tree.

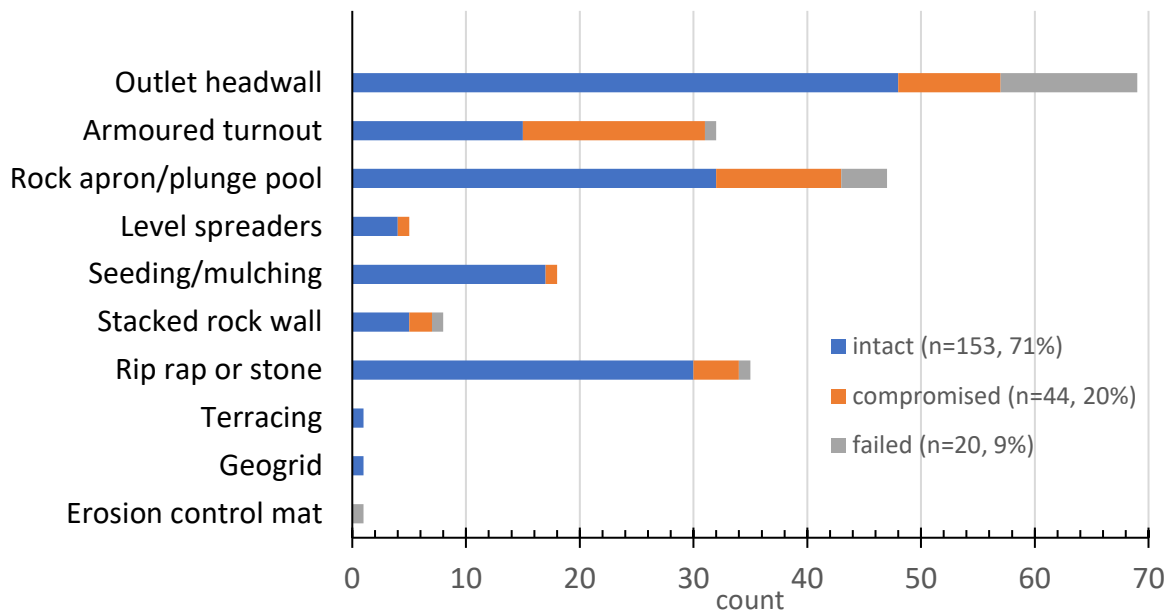
Figure 15: Results of retrospective assessments of erosion control projects conducted in summer 2020 in collaboration with Lamoille County Planning Commission. Appendix 5 provides additional details on the retrospective assessment dataset.

Results of our retrospective assessments of erosion control projects provide additional insights into the efficacy of erosion control measures (Figure 15). Among the 217 outlet structure or slope stabilization measures, 71% were assessed as intact and functioning to provide water quality benefits as designed. Only 20 of the 217 practices were assessed as failed, with evidence of washouts or slope failure. Installations of armored turnouts and rock aprons or plunge pools were the most common practices assessed as compromised. In these cases, accumulation of sediment is the design intent, mitigating discharges into downstream receiving waters, and the “compromised” assessment score can be interpreted as a measure of the need for ongoing maintenance of these practices.

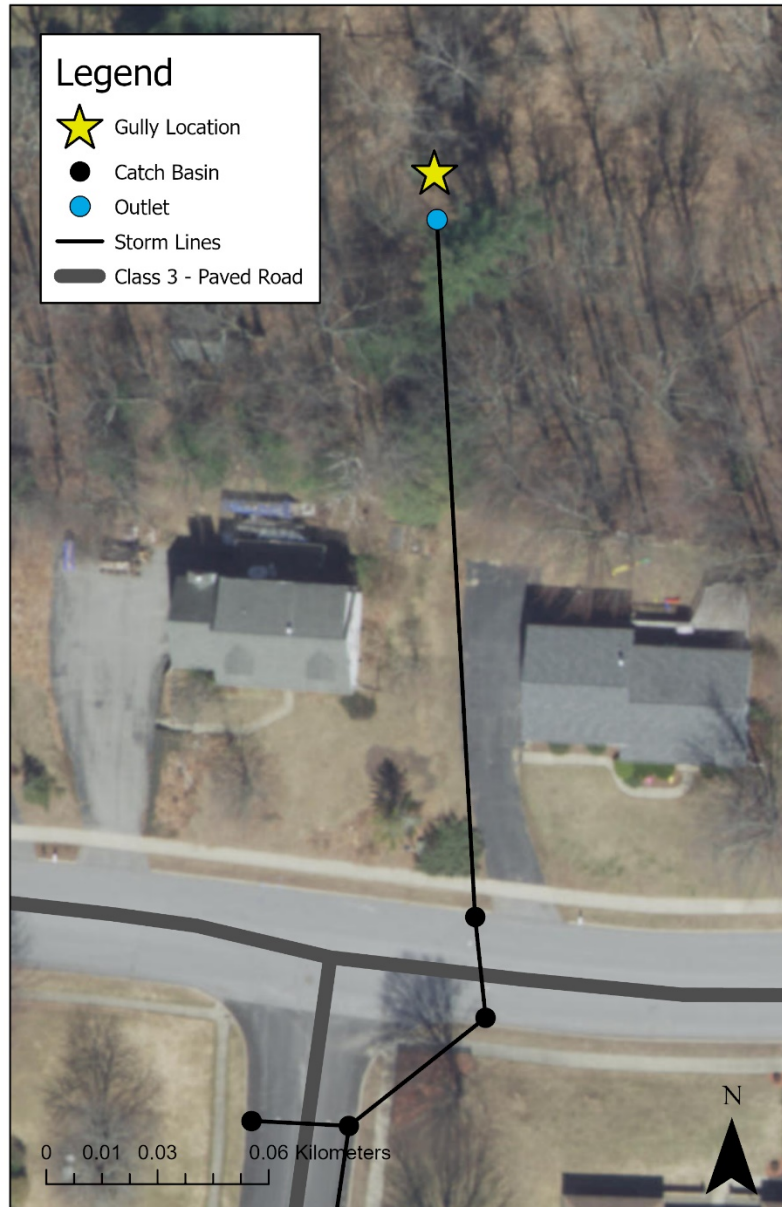
VALE DRIVE (15)

This gully is located between Vale Drive and Corduroy Road in the town of Essex, Vermont. The access to this gully was specifically on Vale Drive where field technicians had landowner permission to access gully behind their house. This road is a class 3 paved road that is residential. The culvert monitored is part of the town of Essex culvert database. The culvert diameter is 15 inches and is a closed drainage system. The drainage area for this culvert was estimated to be 7,910 meters². The road length draining to this culvert was estimated at 212.9 meters and an average width of 9.2 meters. The slope steepness at outlet was estimated as 35.2% (derived from 10-meter DEM). The soil type at the culvert outlet is Agawam with a soil texture of fine sandy loam. Repeated surveys on this site took place from September 27th, 2019 to September 9th, 2020 with a total of 4 surveys. Due to landowner restrictions, surveying at this was terminated after September 9th, 2020. Erosion mitigation was not installed at this site.

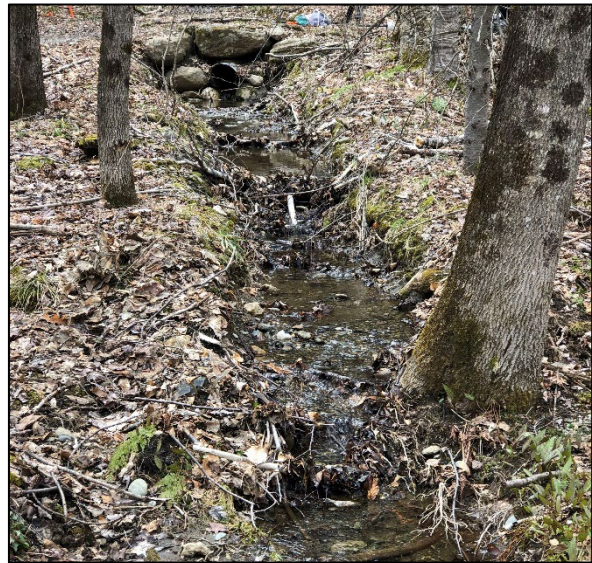
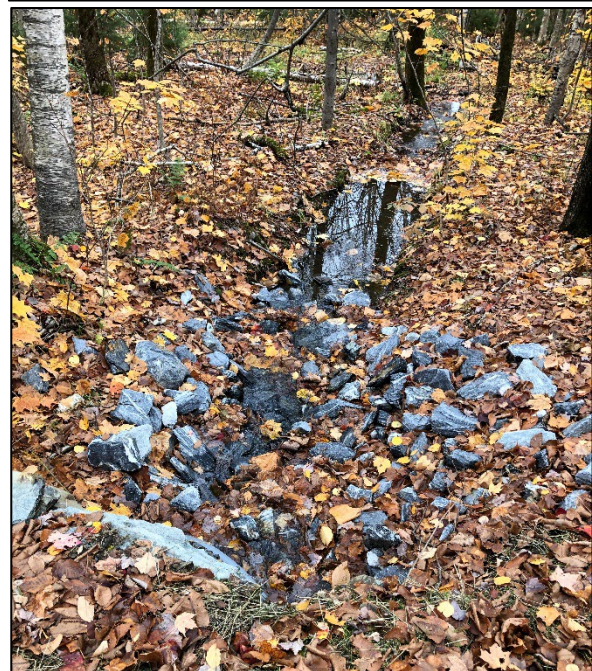
MAPLE RUN LANE (30)

This gully is located off Maple Run Lane in the town of Stowe, Vermont. This road is a class 4 unpaved road and located 0.18 kilometers from a pull off on Maple Run Lane (access to site is on foot). The culvert monitored is not part of any database. This culvert is a single pipe part of an open drainage network. The drainage area for this culvert was estimated to be 2,294 meters². The road length draining to this culvert was estimated at 145.3 meters and an average width of 4.5 meters. The slope steepness at outlet was estimated as 7.7% (derived from 10-meter DEM). The soil type at the culvert outlet is Berkshire with a soil texture of fine sandy loam. Repeated surveys on this site took place from November 2nd, 2019 to May 17, 2021 with a total of 6 surveys. Erosion mitigation was installed at this site in October 2020.

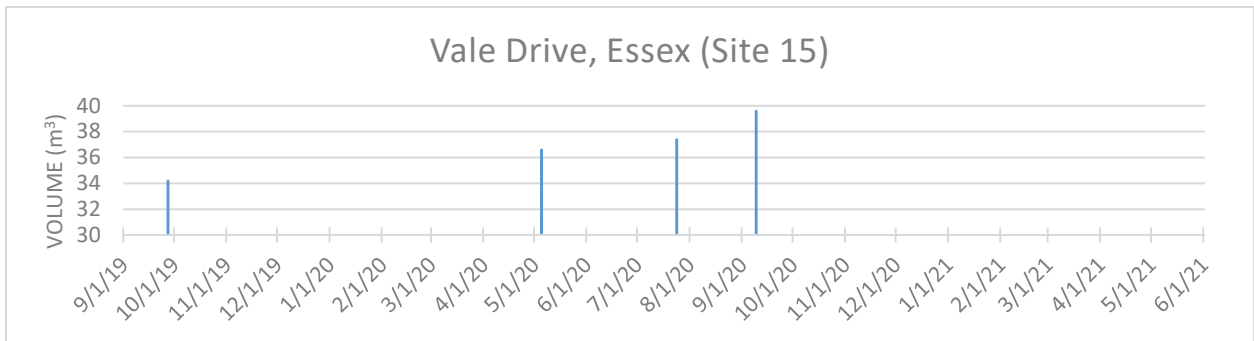
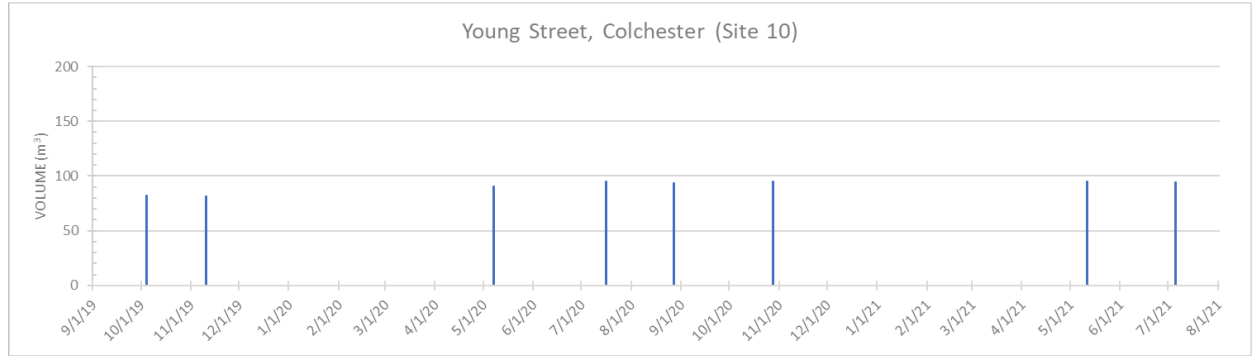
Note: Plots presented in this Appendix are for data collected over the term of this project. Precipitation data are daily totals for Burlington International Airport (BTV) and Morrisville Airport (MVL). Y-axis scales for precipitation and gully volume differ among plots displayed. Site pairs are plotted on common y-axis scale to aid in visual comparison of gully volumes.
