Striping Materials Performance Curves – Life Cycle Analysis

1. Report No. CDOT-2021-04	2. Government Accession No.	3. Recipient's Catalog No.	
4. Title and Subtitle Striping Materials Performance Curves – Life Cycle Analysis		5. Report Date May 2021

Final Report

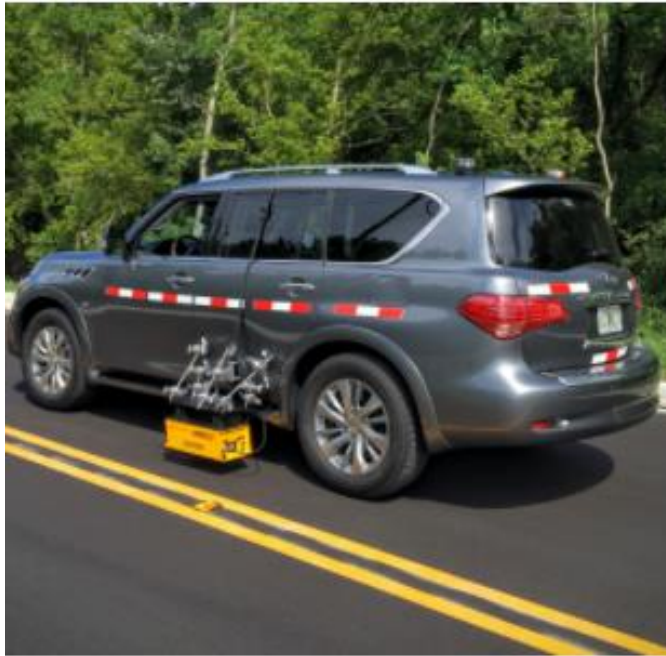
Figure 1. Mobile retroreflectometer system.

Accurate and safe data collection is critical to overall project success. The project approach included gathering field reflectivity information using mobile retroreflectometers (see Figure 1.) for all CDOT Engineering Regions in the state (Figure 2.) The mobile retroreflectometer units (MRU) used in this research were subcontracted from Beck Enterprises of Woodbury, LLC meeting all the minimum specification noted in the project's Scope of Work and following CDOT safety standards, and regulations during all field work activities. The MRUs used in this investigation are compliant with ASTM E1710 (ASTM, E1710, 2018) where this test method covers measurement of the retroreflective properties of horizontal pavement marking materials containing retroreflecting beads, such as traffic stripes and surface symbols, using a portable retroreflectometer that can be placed on the road delineation to measure the retroreflection at a prescribed geometry. Gathering data with mobile retroreflectometry units is accurate and inherently safer than using other data collection methods. Mobile units gathered data in July and October of 2017, January, April, August, and October of 2018, June/July of 2019, and June/July of 2020. The overall project covered during the three-year period 120 sections of test material in 66 different road, totaling 27,288 line miles of existing striping.

Data was taken every 4 feet or less, and then rolled up into 1/10th mile or 528 feet intervals. Measurements were taken on mainline through lanes only excluding ramps, turn lanes, climbing lanes, and auxiliary lanes. Measurements were taken on all edge, center, and lane line pavement markings. Based on these criteria and using shapefile information of the routes provided by CDOT, we have estimated a total of 3,411-line miles measured per measurement during this project (see Table A.)

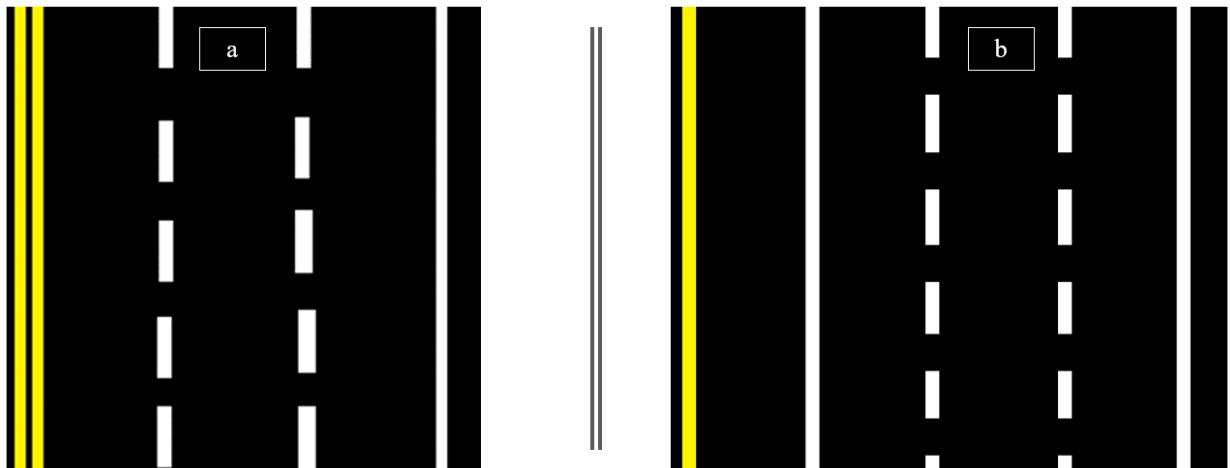
Figure 3 A display of different types of road lines. From left to right, the lines displayed are: (a) a centerline, two lane lines, and a right edge line, and (b) a left edge line, an HOV line, two lane lines, and a right edge line.

In general, for highway striping operations, there are a variety of lines that can be seen in Figure 3. From left to right, according to the perspective of the driver proceeding down a road in the intended direction, the first line is either referred to as a center line (CL) or left edge line (LEL), depending on whether the road is a two-way or one-way road, respectively. These lines are either a continuous double line with a yellow pigmentation for CL, or a continuous single line with also a yellow pigmentation for LEL. These lines represent the edge of the permitted driving area.

To the right of the CL or the LEL can be a range of zero to four lane lines (LL) (from the roads observed in this investigation). These lines are dashed lines with a white pigmentation, and are used to delineate different paths that a vehicle may take while travelling in a determined direction. This helps avoid vehicle collision and to increase physical space optimization for

vehicles in high traffic conditions. On the far right hand side of the road is a line referred to as a right edge line (REL). This is a continuous single line with a white pigmentation. This line, like the LEL, is used to delineate drivable and non-drivable areas.

A final type of line is used in unique circumstances, and is known as a high occupancy vehicle (HOV) line. These lines are continuous lines with a white pigmentation, typically one line to the right of the LEL or CL. These lines are used to denote HOV lanes in which vehicles are legally required to have at least two occupants.

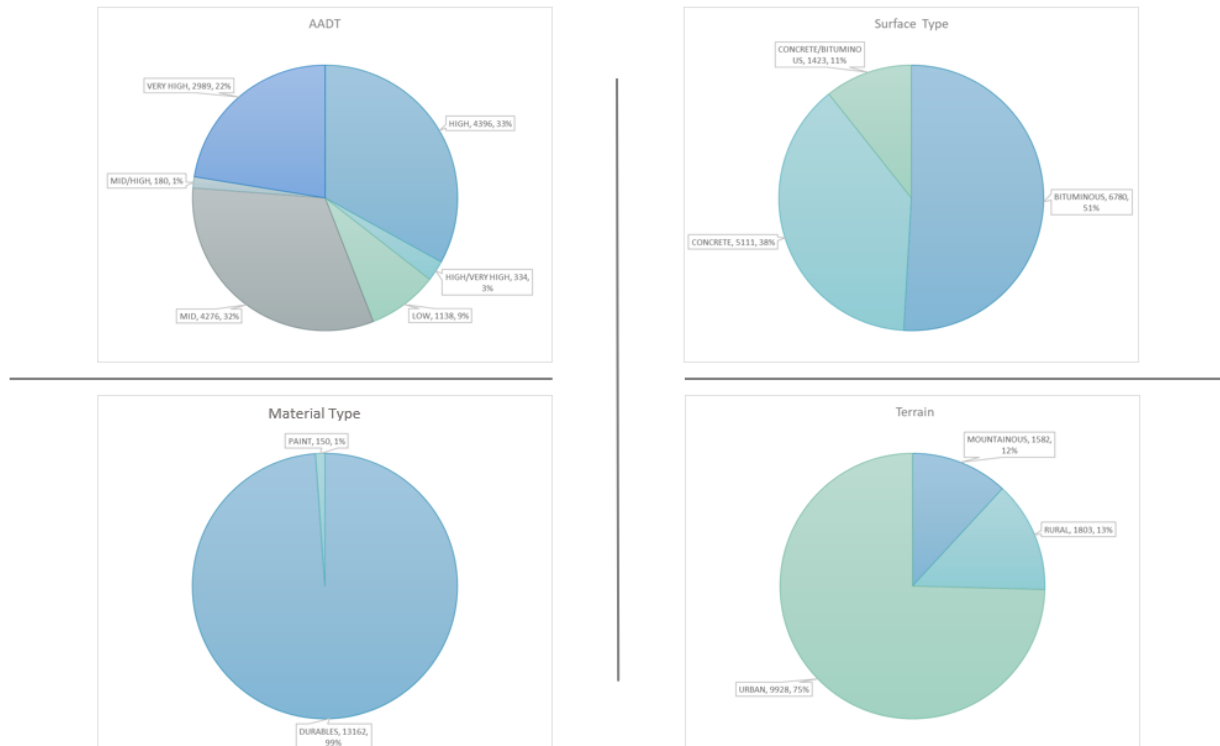
Figure 11. Road feature surveyed in Region 1 for AADT, Surface Type, Material Type and Terrain. In each inserted figure, the callout indicates feature, total mileage, and percentage.

In Region 1, 13,313 miles were surveyed in about 23 roads and 55 sections. The roads attributes such as AADT, Surface, Materials and Terrain type surveyed for this region is presented in Figure 11. In this Region, the relative percentages of roads with MID/HIGH and HIGH/VERY HIGH AADT as well PAINT as a material type are too small to make statistical significant conclusion. Therefore, these sections will be omitted in this discussion.

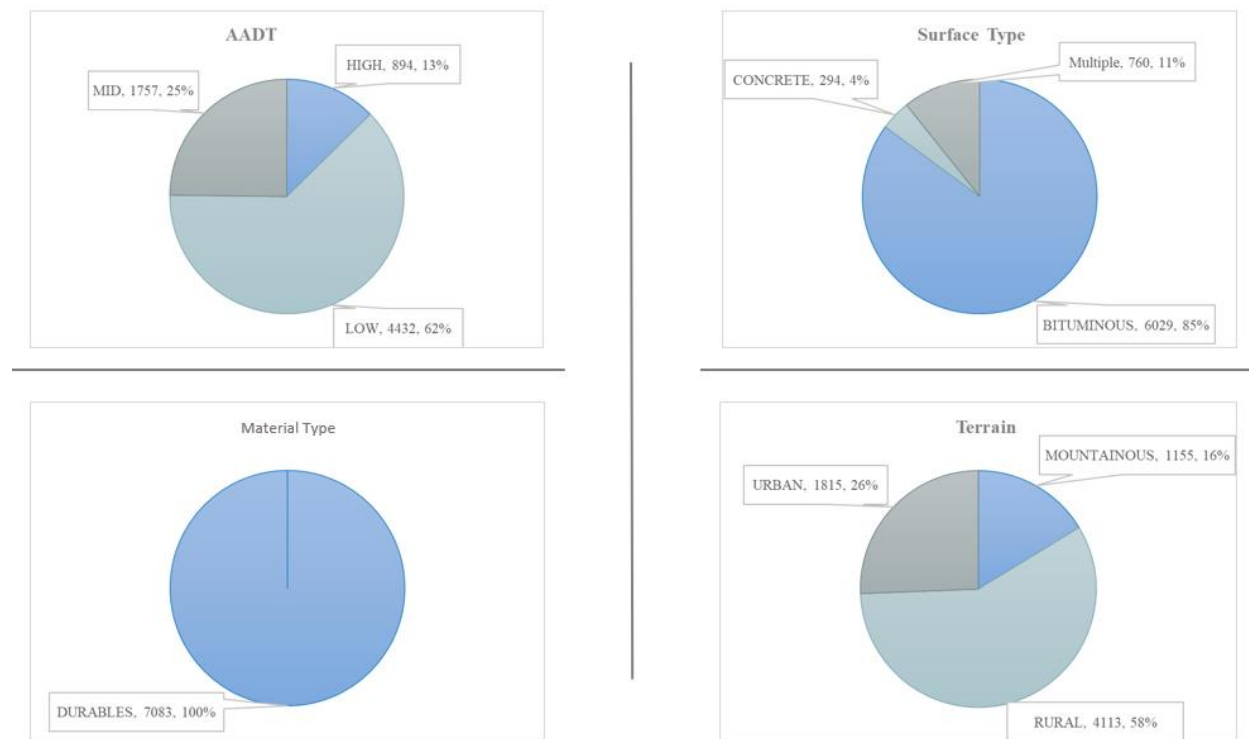
Figure 19. Road feature surveyed in Region 1 for AADT, Surface Type, Material Type and Terrain. In each inserted figure, the callout indicates feature, total mileage, and percentage.

In Region 2, a total of 7,083 miles were measured. These miles were distributed among 12 roads and 18 road sections. The road attributes, as well as, their distribution in the data collected are presented in Figure 19 below. In this Region only 4% of the data collected was in concrete surfaces and all (100%) material types surveyed were on DURABLE materials.
