# Concrete Bridge Deck Deterioration Assessment Using Ground Penetrating Radar

Research Final Report from the University of Tennessee, Knoxville | Da Hu, Shuai Li, Z. John Ma,  
Baoshan Huang | May 31, 2021

Sponsored by Tennessee Department of Transportation Long Range Planning  
Research Office & Federal Highway Administration

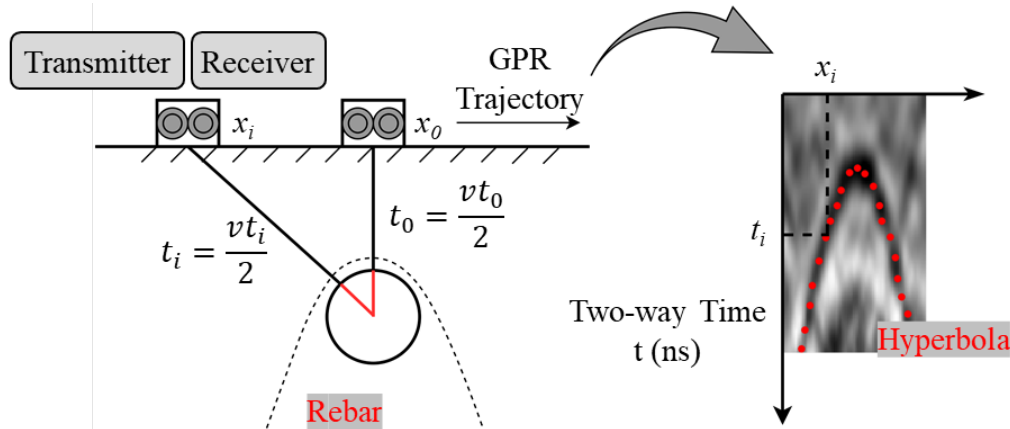
**Figure 2-1. Mathematical Formulation of GPR reflection Generated by a Rebar**

Rebars are reflected as hyperbolic features in a GPR scan as shown in Figure 2-2. The hyperbolic feature is generated as the GPR antenna sends energy in a conical shape to the subsurface. Therefore, two-way travel time of received rebar reflection decreases as the antenna approaches the rebar and increases after passing the rebar peak location. The rebar radius is defined as  $R$ . In Figure 2-1, the X-axis and Y-axis represent GPR moving distance and two-way travel time from electromagnetic (EM) wave emission to wave reception, respectively. The position relationship between  $x_i$ ,  $x_0$  and rebar center meets the Pythagorean theorem shown in Eq. (3), where  $r_i$  represents the distance from starting position  $x_i$  of the antenna to surface of the rebar  $r_0$  is the perpendicular distance from rebar to the surface point  $x_0$ , which is also the shortest distance.

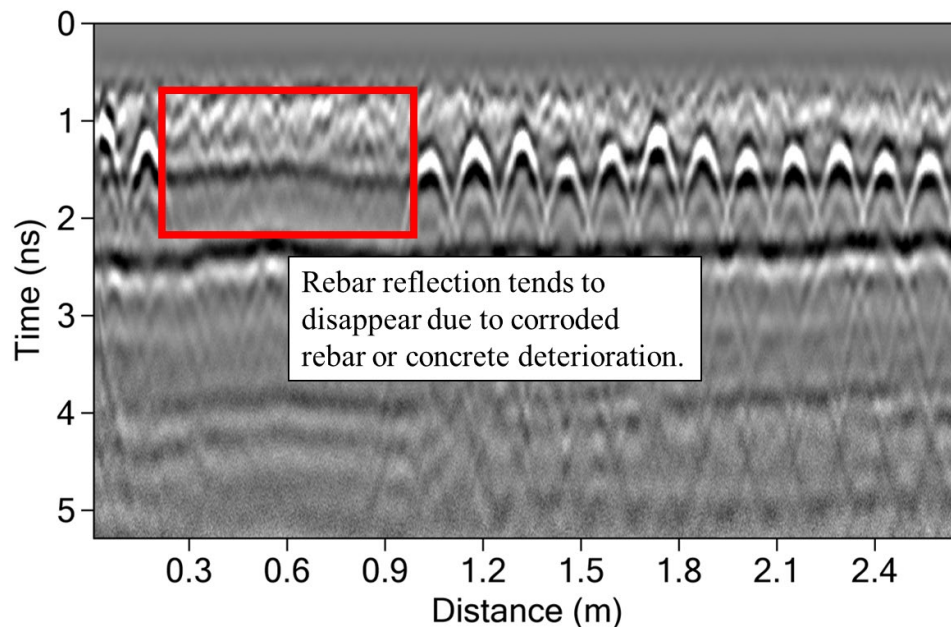
data. The hyperbola peak represents the location of rebar, and its amplitude is an indicator of the bridge deck condition when rebar depth is constant throughout the bridge. The deteriorated concrete has a higher electrical conductivity compared to healthy concrete due to the presence of moisture and chloride ions [10]. A higher electrical conductivity leads to greater signal attenuation in the areas, which is shown as weaker rebar reflection amplitude in GPR scans [11]. Furthermore, cracks are common defects of concrete, which may be filled with air or water. The scattering of GPR signal energy will cause energy loss, and eventually lead to weak rebar reflection or blurry hyperbolic signatures. Therefore, weak rebar reflection and blurry hyperbola features can be used as indicators of bridge deck deterioration, such as concrete deterioration and/or corrosion of rebar. Figure 2-3 shows a GPR scan collected from a concrete bridge deck. As shown in the box, the hyperbolic signatures are not obvious in the GPR scan. Considering that rebars are typically equally spaced in the bridge deck and comparing with the regions with obvious hyperbolic signatures, the deterioration regions can be identified due to weak or blurry rebar signatures in the GPR scan.

**Figure 2-2. Example of GPR B-scan**

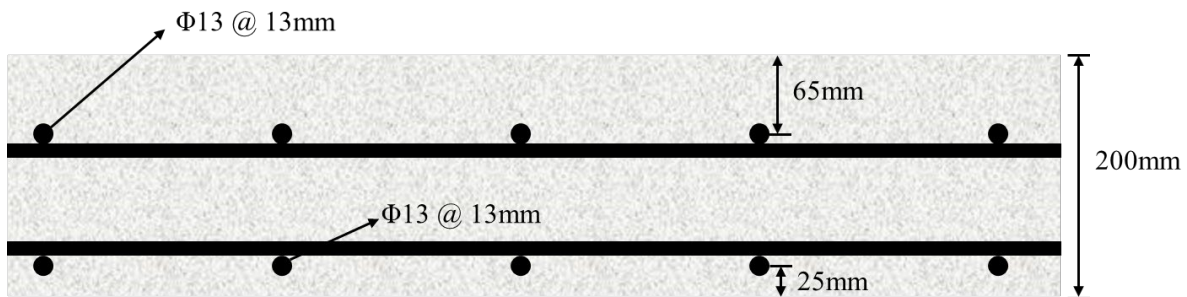
Figure 3-1 shows the cross-section of an exemplary bridge deck design. The thickness of the bridge deck is 200mm. The rebar size is 13mm with 200mm spacing. The top rebar mat depth is 65mm and the bottom layer of reinforcement is 25mm from the bottom. This bridge deck design will serve as a reference for GPR simulation.

**Figure 3-1. An Example of Bridge Deck Specification**

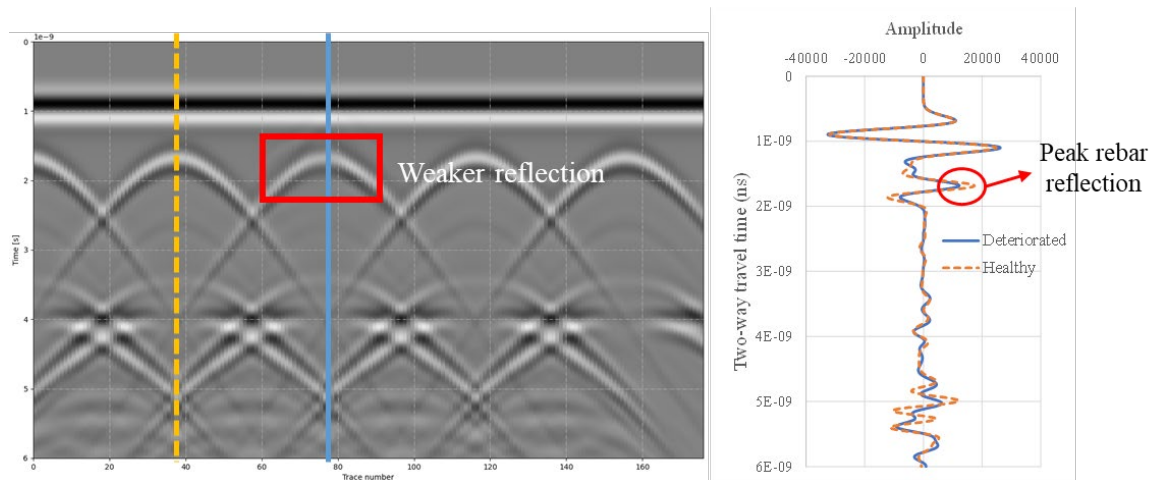
Figure 3-2 shows the GPR signatures for reinforcement concrete deterioration with cracks filled with air in the bridge deck. The simulated result indicates that rebar amplitude of deteriorated areas is smaller than that of healthy concrete. This is because the presence of cracks causes the scattering of GPR signals which leads to signal attenuation.

**Figure 3-2. GPR Signatures of Reinforcement Concrete Deterioration with Cracks Filled with Air**

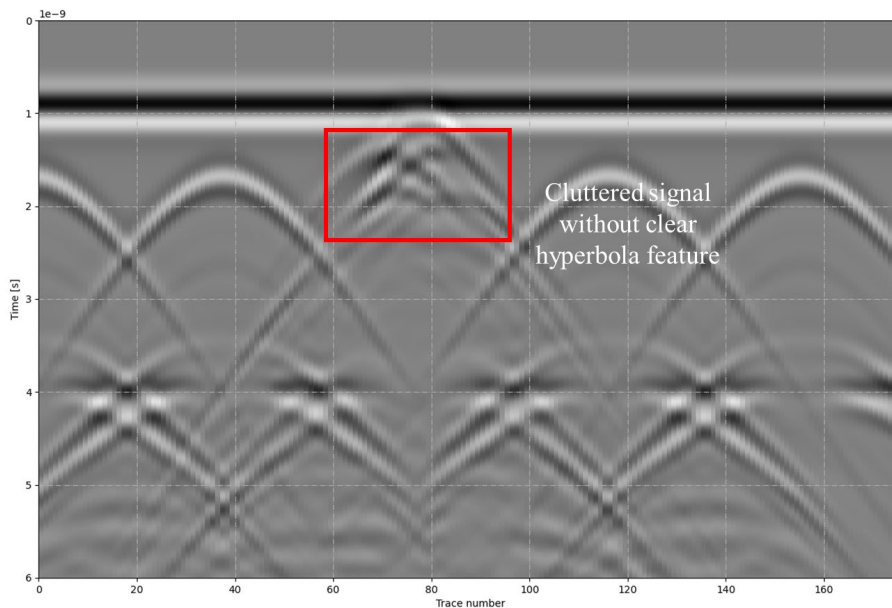
Figure 3-3 presents GPR scans for reinforcement concrete deterioration with cracks filled with water in the bridge deck. The deterioration with water-filled cracks displays a clutter signal pattern at the rebar position. In addition, the hyperbola reflection of rebar is barely recognized in this area, which indicates that concrete has deteriorated. This is because that if the bridge deck is in good condition, there will be significant rebar reflection due to a large dielectric contrast between steel and concrete.

**Figure 3-3. GPR Signatures of Reinforcement Concrete Deterioration with Cracks Filled with Water**

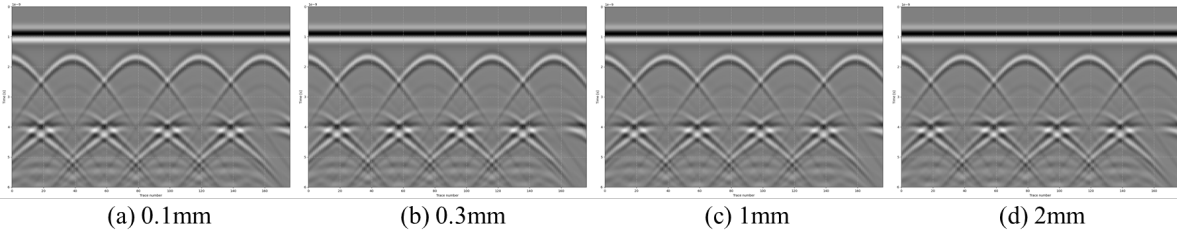
Figure 3-6 presents synthetic GPR scans for deep delamination defects. The width of simulated delamination varies from 0.1mm to 2mm. The simulated results do not show evident signatures of deep delaminations in GPR scans. This can be explained in two aspects. First, GPR B-scan is very complicated to analyze for the area close to the bottom of the slab because reflections are coming from the two layers of reinforcement and the bottom of the slab. Second, the reflection from deep delamination is inherently weak due to signal attenuation caused by geometric and conductive losses. As a result, deep delamination is hard to detect solely based on the GPR B-scan.

**Figure 3-6. Synthetic GPR B-scans for Deep Delamination**

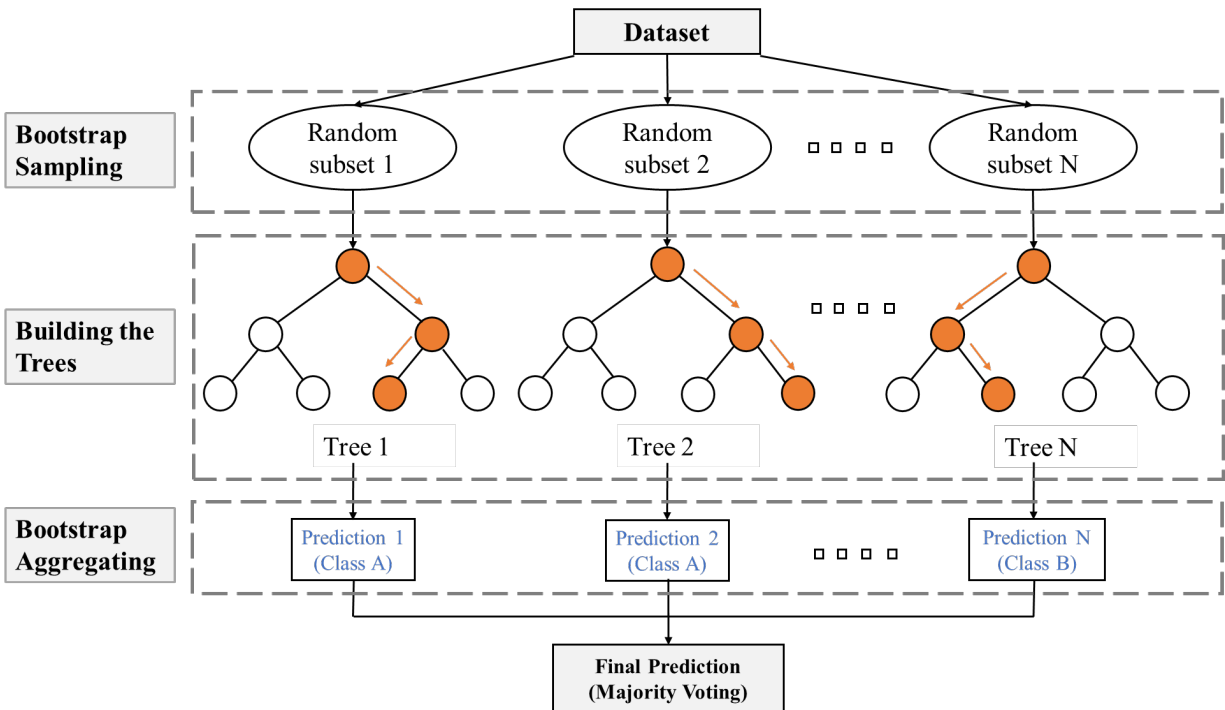
The Random Forest (RF) approach [41] was adopted to detect hyperbolic features in GPR scans that represent rebars in a bridge deck. The RF approach is a supervised classification algorithm that uses bootstrap aggregating (bagging) with random feature selection (Figure 4-2). The RF method fits a number of decision tree classifiers on sub-training datasets of the entire dataset, and averages these trees to improve model performance and avoid over-fitting issues. The bootstrap method, a resampling technique [42], is used to de-correlate the trees with different resampled training sets. The bootstrap method can decrease the variance of the model without introducing bias and improve the performance of the classification model.

**Figure 4-2. Schematic of Random Forest Approach**

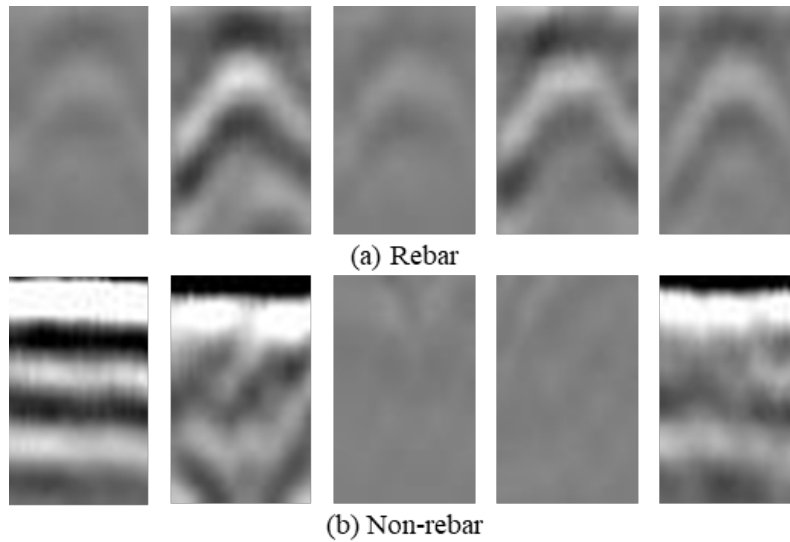
To train an RF classifier, both positive and negative classes were prepared. Specifically, the positive class is the sample with rebar regions, and the negative class is the sample without rebar regions. The training image dataset has a fixed 32×52 pixel size. Figure 4-3 presents examples of the training dataset. A total number of 1500 positive samples and 3000 negative samples were collected and prepared.

**Figure 4-3. Examples of Training Samples (32×52)**

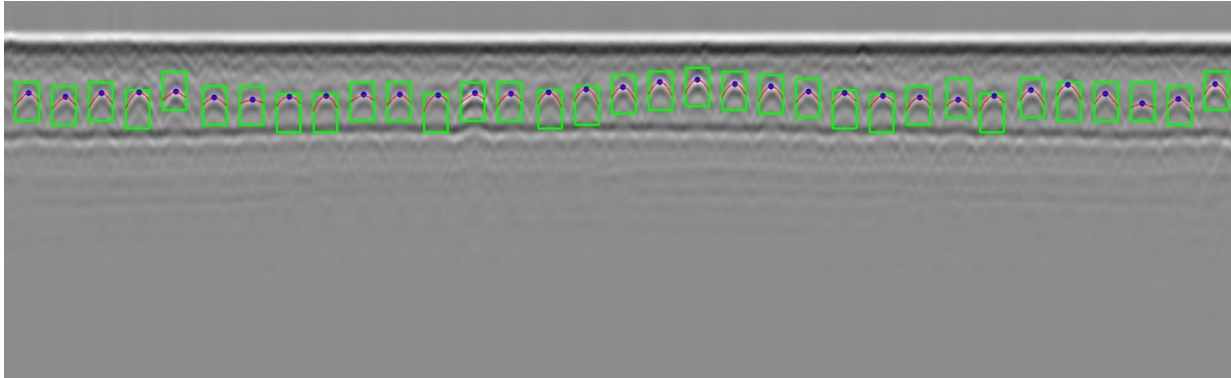
Figure 4-7 presents the results of robust hyperbola fitting for GPR scans of a bridge deck. The hyperbola peak is correctly estimated, which represents the potential rebar location. The corresponding amplitude, location, and two-way travel time (TWTT) of each rebar were extracted for further normalization and depth correction analysis.

**Figure 4-7. Exemplary Results of Rebar Localization**

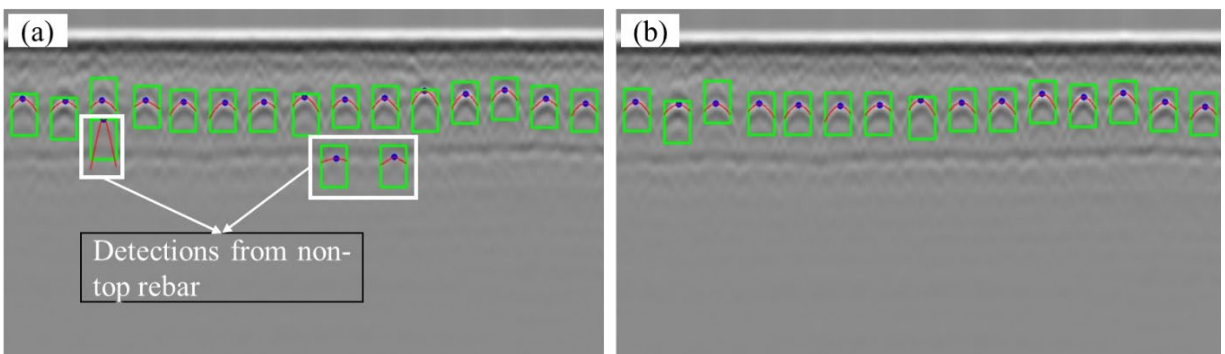
Figure 4-9 presents examples of rebar detection without redundant detection.

**Figure 4-9. Examples without Redundant Detection**

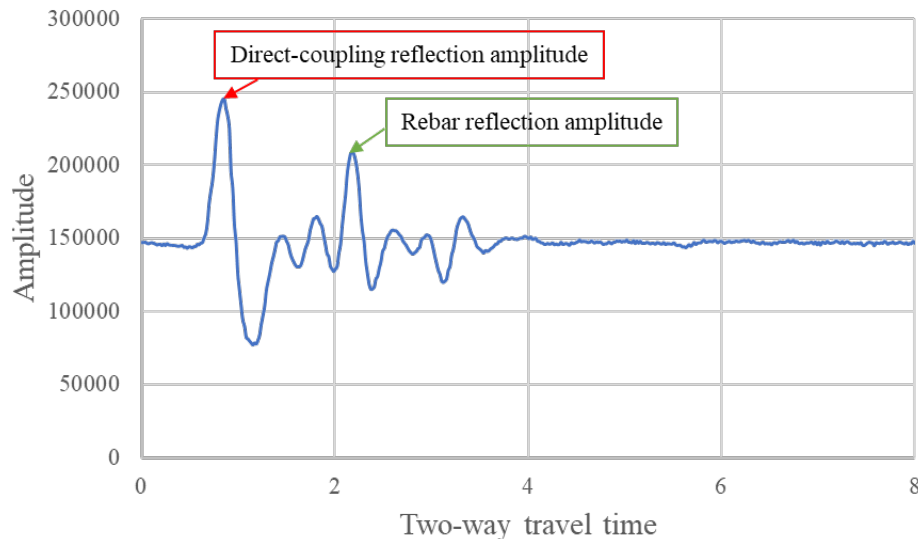
value, which is 32,767 for 16-bit data and 4,294,967,296 for 32-bit unsigned long int data. The GPR data is converted to decibel scale through normalization. However, this method does not consider surface conditions. Surface defects such as patch and crack can affect direct-coupling reflection and rebar reflection amplitude. Figure 4-10 shows the raw GPR A-scan at the hyperbola peak of rebar. The direct-coupling reflection amplitude has the highest reflection amplitude as shown in the figure.

**Figure 4-10. Raw GPR A-scan Over a Rebar**

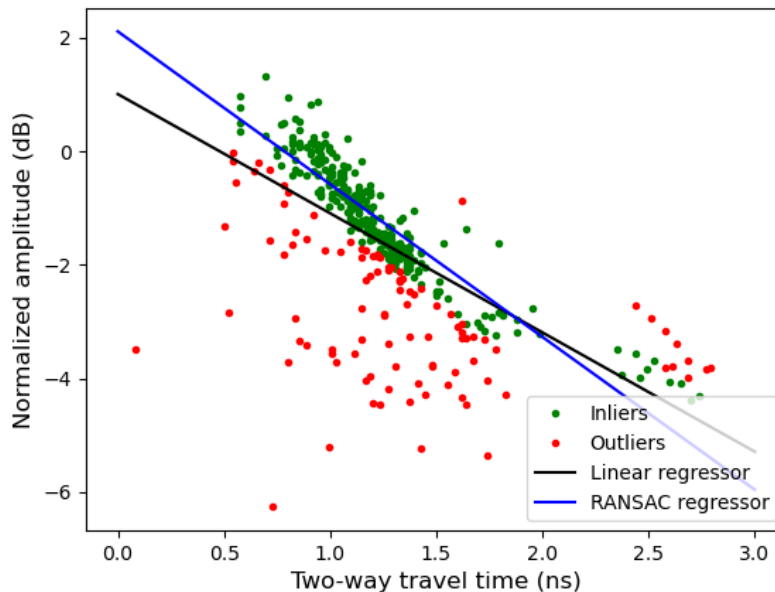
In this study, RANSAC linear regression [48] is used to model the relationship between TWTTs and rebar reflection amplitudes. RANSAC is more appropriate than linear regression in this case since many outliers are present in the data. The residual threshold for a data sample to be classified as an inlier or outlier is set as 1. The maximum number of iterations for random sample selection is 2000. Figure 4-13 shows the comparison of linear fitting and RANSAC robust fitting. The results indicate that the RANSAC fitting method can exclude the outliers and fit the model using inlier samples. The depth effect is corrected by adjusting the slope angle of the fit line to zero. The RANSAC fitted line has a slope of  $-4.16\text{dB/ns}$ . The negative slope could be attributed to depth variation of rebars and signal attenuation due to corrosion of rebars and/or concrete deterioration. If the bridge deck is in good condition, the amplitude decreasing with TWTTs can be considered as the effect of depth variation of rebars. Therefore, the amplitude must be corrected to represent the condition of the bridge deck. If the amplitude is low after correction, it is an indicator of concrete deterioration and/or corrosion of rebars.

**Figure 4-13. Scatter Plot of Amplitude Versus TTWT and RANSAC Line Fit (Each Point Corresponds to a Rebar)**

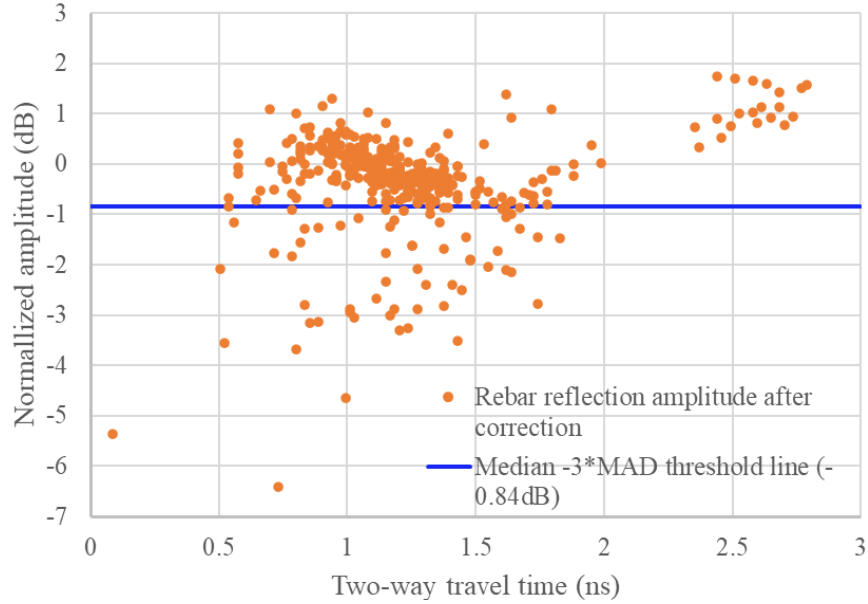
The amplitude threshold value needs to be determined to identify potential deteriorated areas. If the bridge deck is in sound condition, rebar reflection amplitudes should follow a normal distribution [49]. The deterioration of the bridge deck will slightly shift the amplitude distribution to the negative side [49]. Median Absolute Deviation (MAD) around the median [50] is adopted to detect outliers in the distribution. Specifically, the amplitude that is 3-fold-scaled MAD below the median is considered as deteriorated areas [49]. Based on this condition,  $-0.84\text{ dB}$  is selected as the threshold value to determine whether the area has deteriorated or not. Figure 4-14 shows the threshold value for potential deterioration areas after depth correction.

**Figure 4-14. Threshold Value for Deterioration After Depth Correction**

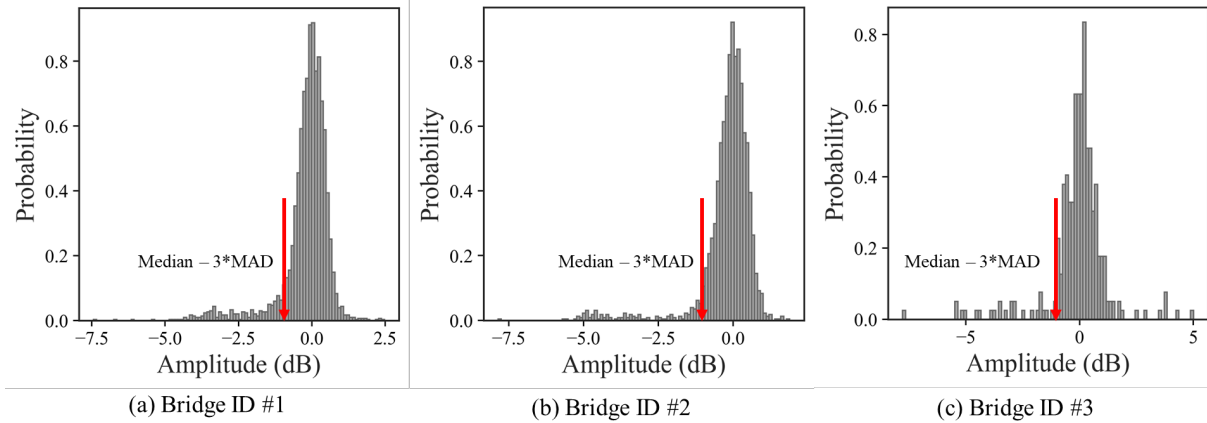
Histograms of the depth-corrected rebar reflection amplitudes from the three bridge decks are shown in Figure 4-17. The areas are considered to have deteriorated if amplitudes are 3-fold-scaled MAD below the median. As a result, -1.01 dB, -0.99 dB, and -1.10 dB are calculated as threshold values (i.e., determine whether the area has deteriorated or not) for Bridge ID #1, #2, and #3, respectively.

**Figure 4-17. Histogram of the Rebar Reflection Amplitude of the Three Bridges**

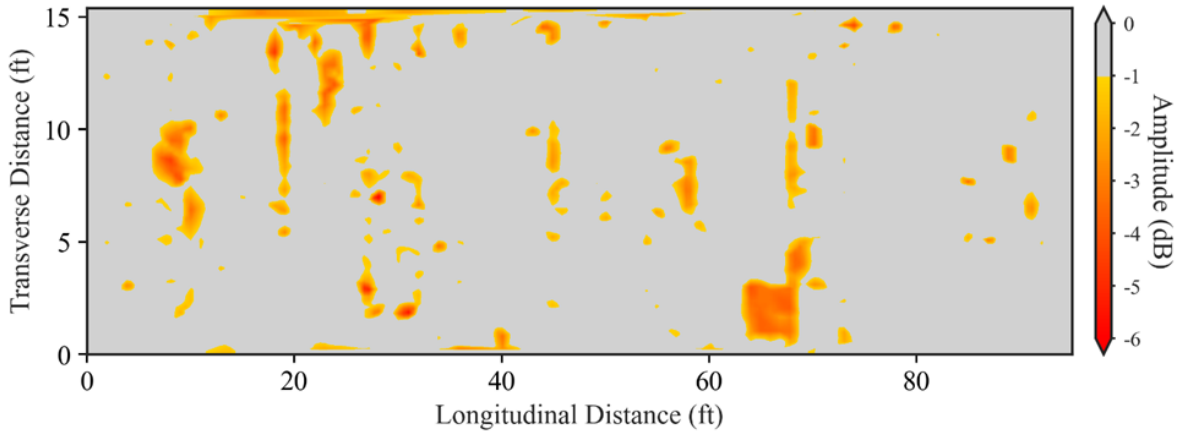
(a) Bridge ID #1

Bridge ID	Deteriorated areas (m <sup>2</sup> )	Percentage of total deck areas
1	12.4	9%
2	8.1	8%
3	6.4	8%
