**RESILIENT AND RAPID REPAIR  
MEASURES FOR SEISMICALLY  
VULNERABLE BRIDGES FOLLOWING  
MAJOR EARTHQUAKES**

**Final Report**

**PROJECT SPR 816**

**September 2021**

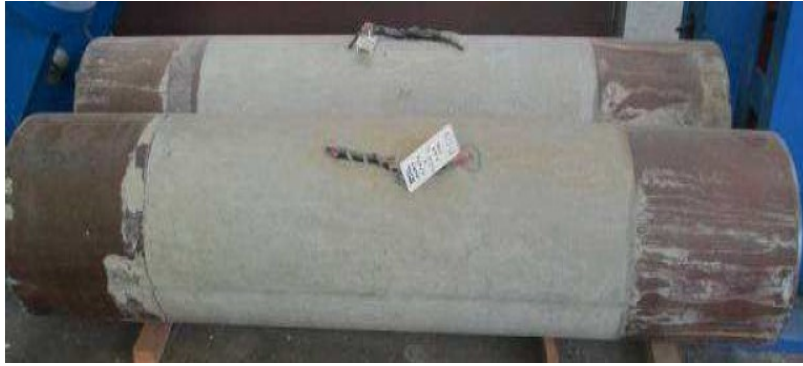
**Figure 2.5: Precast Bridge Columns with 10mm steel jackets (Mashal et al. 2014)**

The ABC Low-Damage specimen was identical to the High-Damage specimen construction, but the connection was replaced with a hybrid connection. The hybrid connection consisted of a combination of post-tensioning with external replaceable dissipaters. The system provides self-centering with minimal permanent deformation and damping through the hysteretic devices. The expected ABC Low-Damage bent hysteresis curve is flag shaped with no permanent structure drift. The ABC Low-Damage bent was designed using the outline procedures in PRESSS Design Handbook (Pampanin et al. 2001). To prevent concrete spalling at the ends of the precast columns, 10mm steel jackets were installed as shown in Figure 2.5. The steel shells connected to the concrete column core through welded studs. For the low-damage system, the steel shell length was determined based on the MSC column plastic hinge length and a length of 500 mm was used.

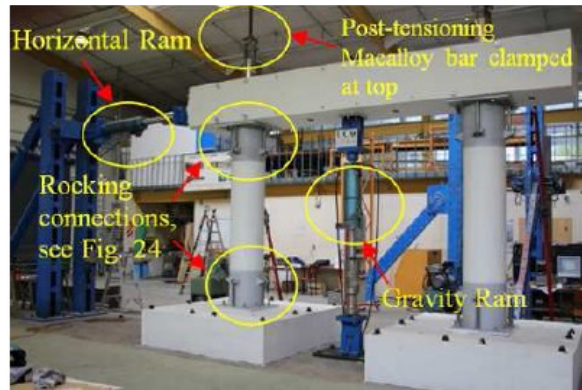
**Figure 2.7: Test configuration (Mashal et al. 2014)**

The assembled bridge bent is shown in Figure 2.7 where the footing, column and bent cap are post-tensioned using Macalloy bars running through the center of the precast columns. Two hydraulic actuators were used to control lateral and gravity forces during the experiment. The foundation base plate, steel column shell, device brackets, and hysteretic energy dissipaters are shown for the bottom and top column interface in Figure 2.8.

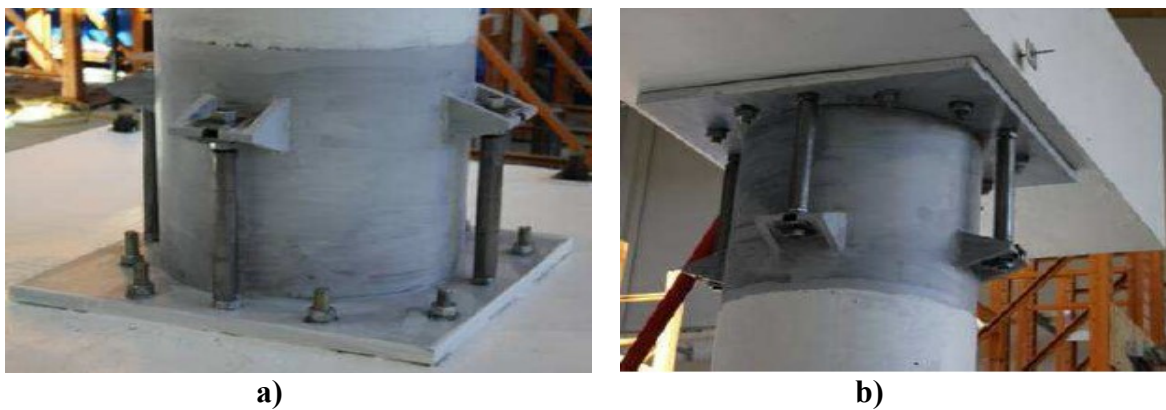
**Figure 2.8: (a) Lower rocking interface, (b) Upper rocking face (Mashal et al. 2014)**

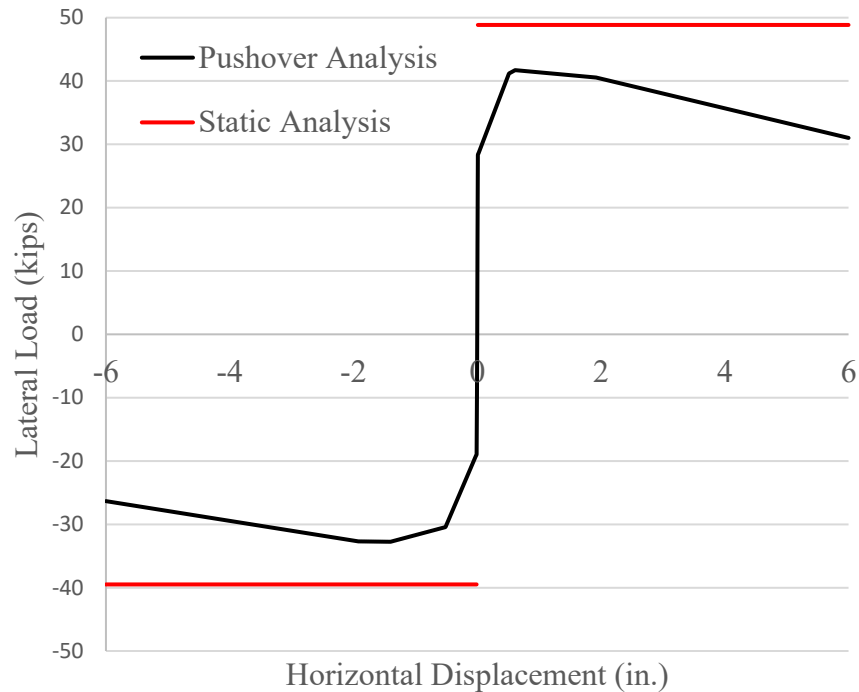
**Figure 3.7: Pushover analysis vs. static analysis**

Figure 3.7 shows a comparison of the static analysis and the pushover analysis. This figure is for a column that was repaired with hold-downs in the face orientation and with UFPs that have a plastic moment force of 5.4 kips.

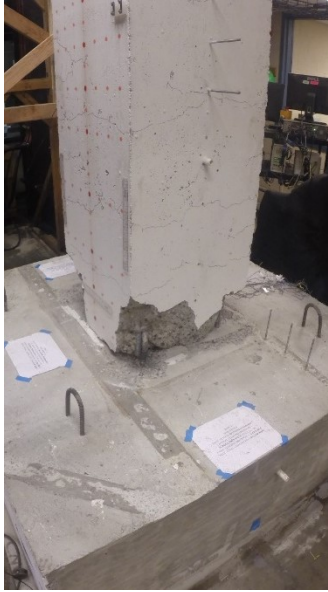
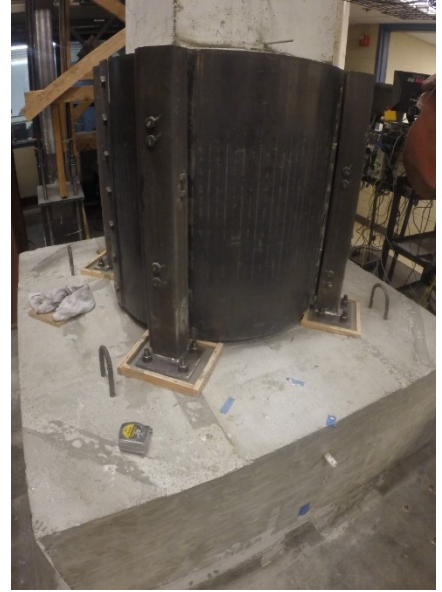
**Figure 4.3: Prototype Repair Sequence**

The final step of the repair is to attach the ductile fuse hold-downs. Inside of the hold-down, there are four UFPs that act as ductile fuses. One side of the hold down is welded to the steel jacket while the other side is anchored to the foundation via conventional threaded rods with Hilti epoxy. Figure 4.4 shows the ductile fuse hold-down before the outer leg is installed. The UFPs are bolted with two  $\frac{5}{8}$ -inch diameter slip-critical A325 bolts on each leg. Nuts are welded to the inside of the UFP such that the bolts can be secured without access to the inside of the UFP. Upon installation of the hold-downs, there is a gap between the hold-down base plate and the foundation. This gap is to be filled with self-leveling grout before the anchor rod nuts are tightened. Figure 4.3(c) shows a picture of temporary forms that were installed for the base plate grout. Figure 4.5 shows the base plate with anchor rods after the forms have been removed.

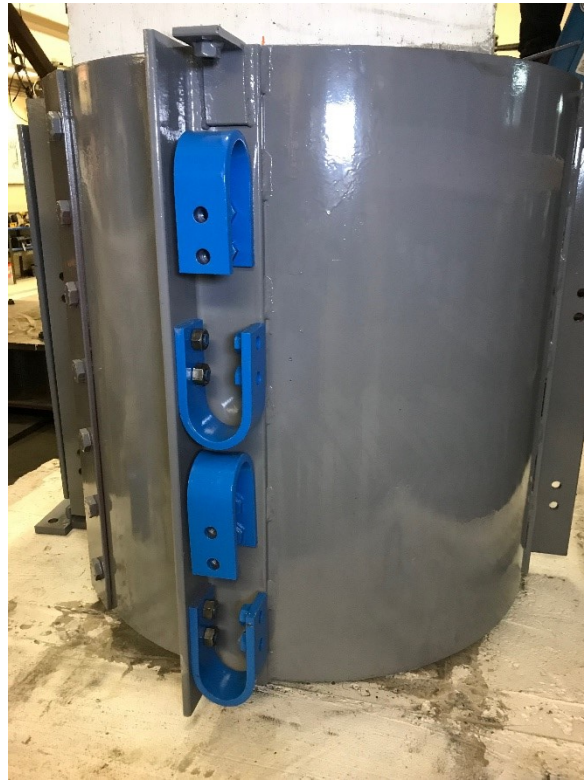
**Figure 4.4: UFPs inside hold-down**

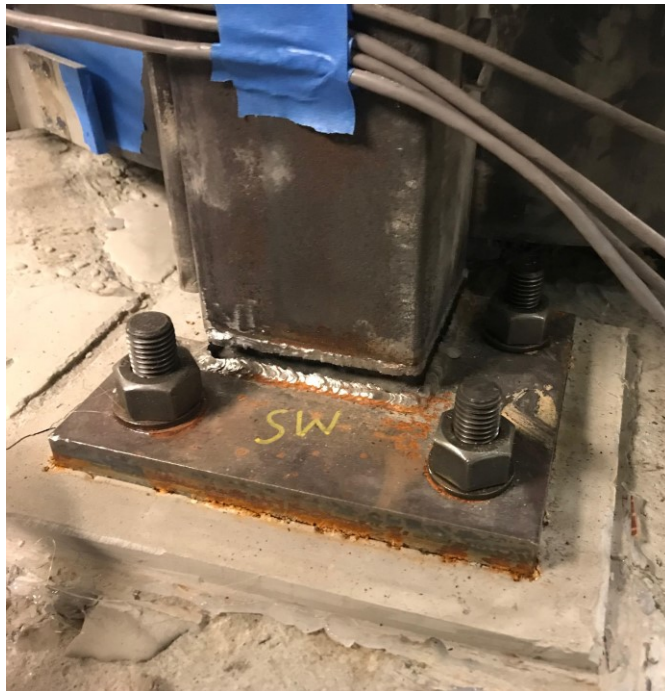
**Figure 5.4: Hold-down weld failure**

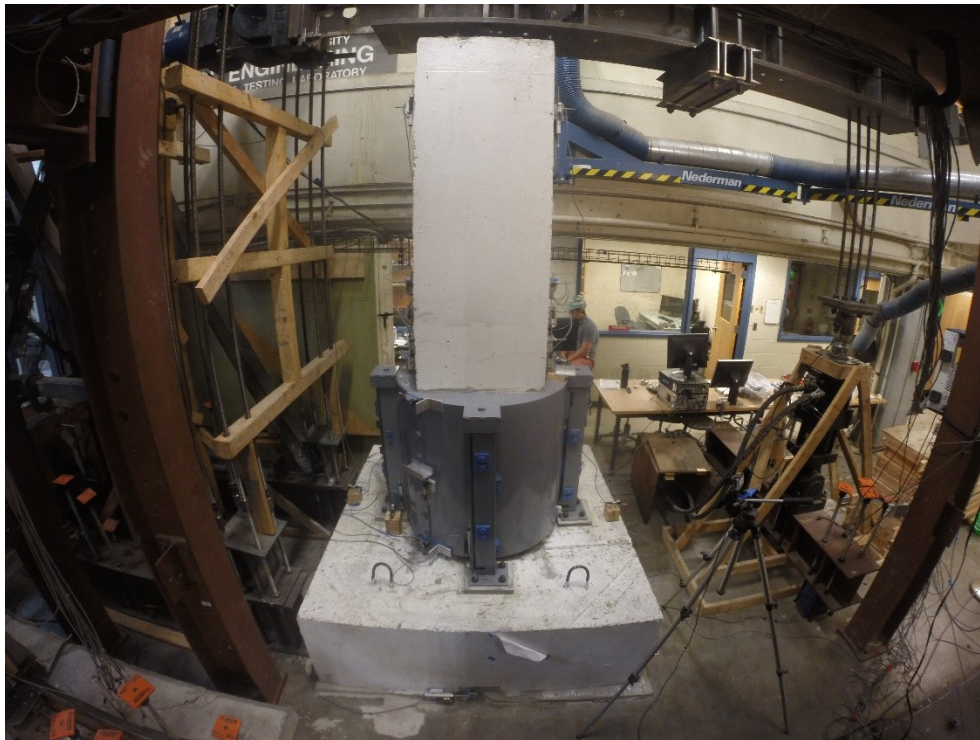
**Figure 5.6: Test 2 @ initial state**

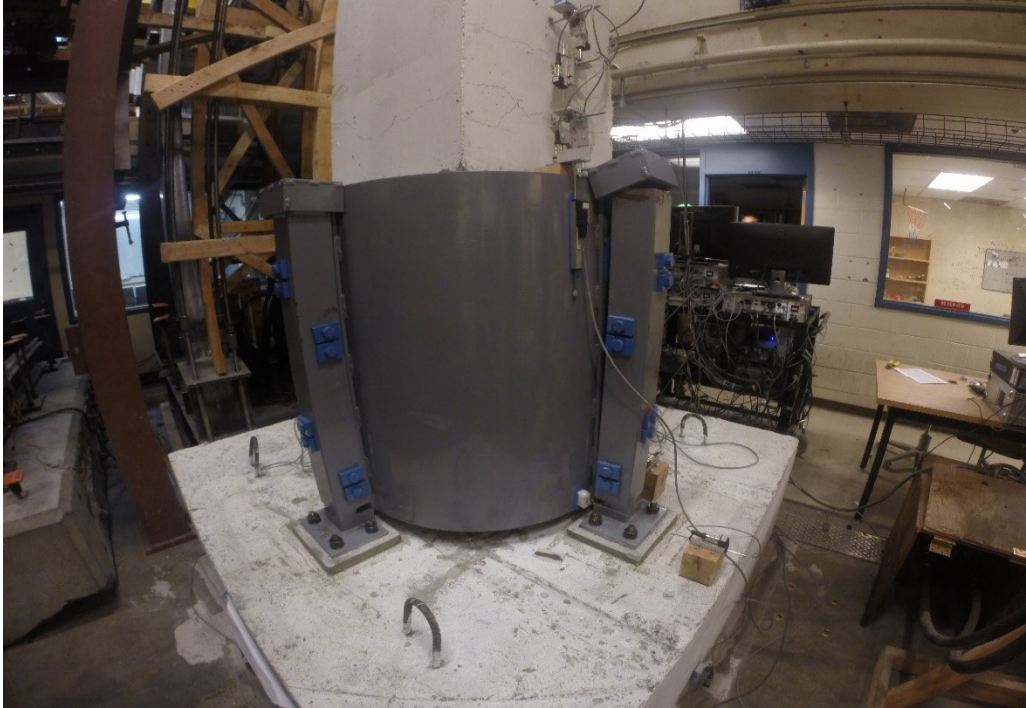
**Figure 5.7: Test 2 @ final state**

The hold-down caps did not function as intended. With each cycle, the cap was slowly pushed up as the angle bracket yielded. Figure 5.7 show the final state of the test specimen. The cap bracket has yielded and no longer engages the exterior leg of the hold-down. Following this test, the hold-down cap was abandoned and replaced by hold-down rollers that are discussed in the following section.

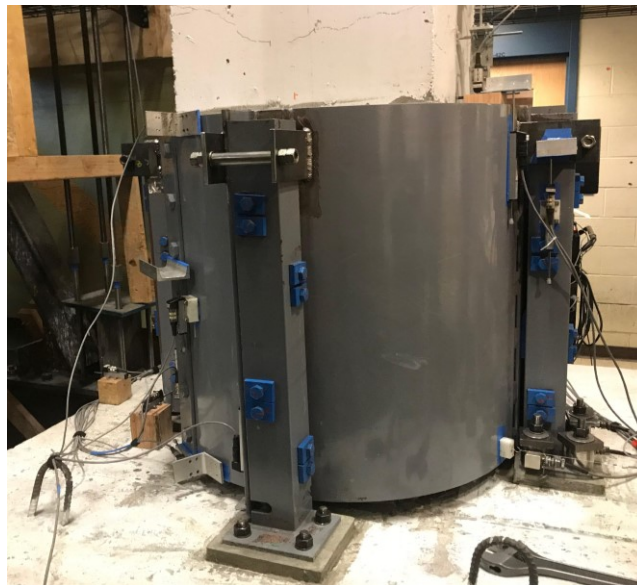
**Figure 5.8: Test 3 modification - hold-down roller**

For the third test, the hold-down caps were removed, and new hold-down rollers were installed. The hold down roller is shown in Figure 5.8. The roller was made from a  $\frac{1}{2}$ -inch threaded rod and a hollow pipe that were mounted using  $\frac{1}{4}$ -inch plate welded to the shell. The rollers prevent hold-down separation while allowing vertical displacement.

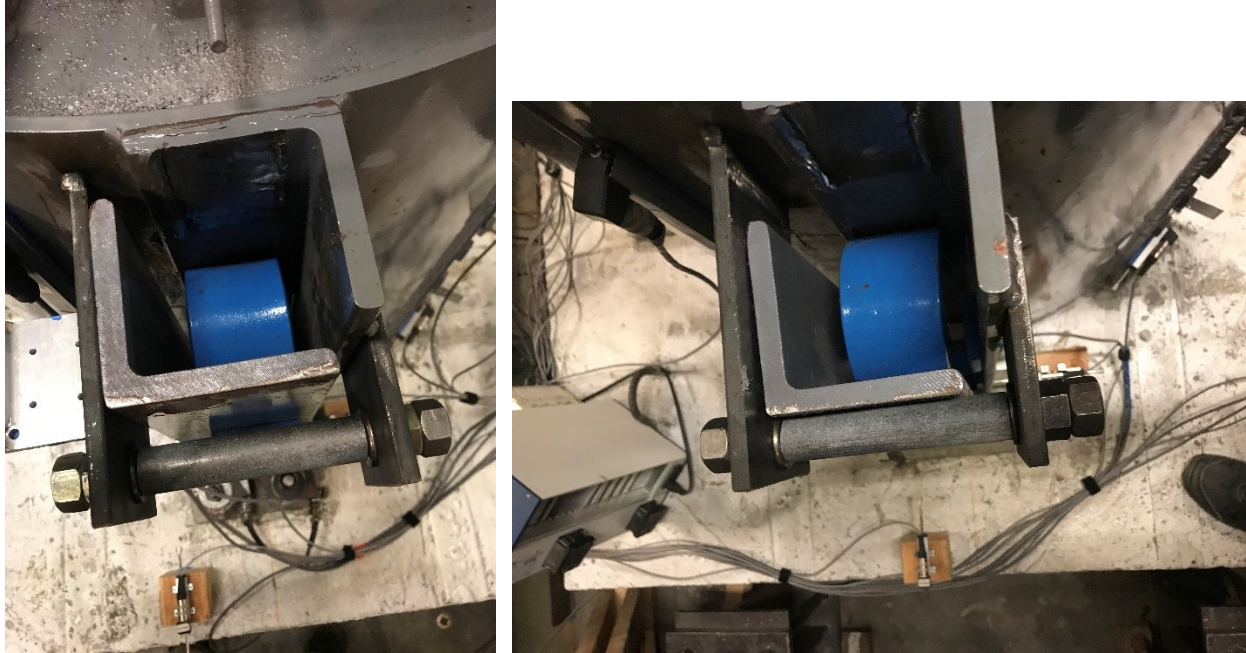
**Figure 5.10: Hold-down rollers (a) before and (b) after test**

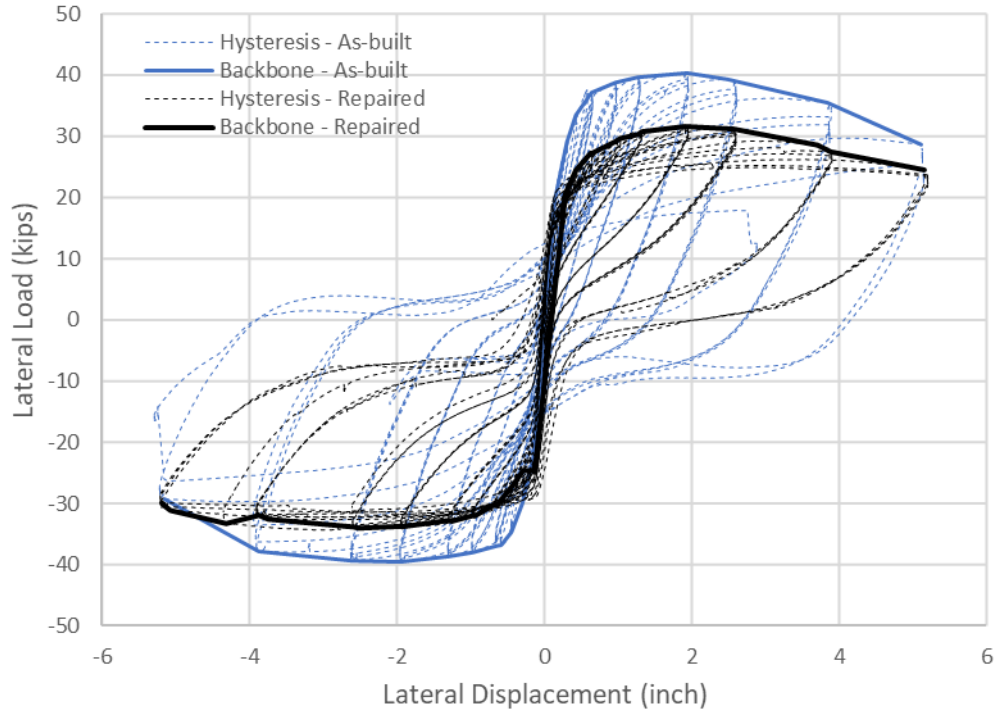
**Figure 5.13: Test 2 Hysteresis**

The second specimen was repaired for Test 2 and the conventional ACI lateral loading protocol was used for the as-built column test and the repaired column test. The repair was oriented with the hold-downs at each face of the column and the hold-down caps were installed. The lateral load-displacement response for Test 2 is shown in Figure 5.13. The as-built column had a peak horizontal load of 40.3 kips, and the expected lateral load based on the static analysis is 48.9 kips. The measured peak lateral load for the repaired column was 31.6 kips, 35% less than expected and 21% less than as-built. Test 2 showed greater strength degradation than Test 1. At the final cycle displacement of 5.4 inches, the strength degradation was 25% compared to 15% in Test 1.

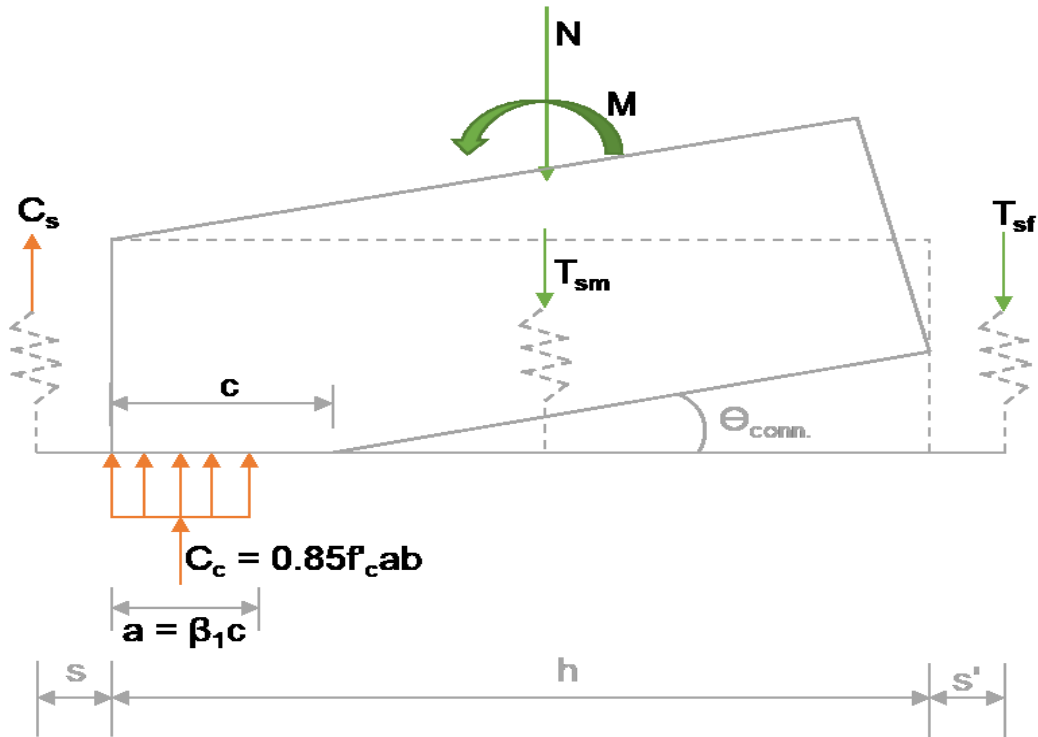
Figure 6.3: Section equilibrium at column-footing interface.
