Implementation of Unmanned Aerial System-Based (UAS) Digital Photogrammetry for Design, Risk Analysis, and Hazard Mitigation of Rock Slopes

CHESTER F. WATTS, Ph.D., P.G., M.ASCE
Professor and Director
Geohazards and Unmanned Systems Research Center
Geology Department, Radford University

Final Report VTRC 22-R16

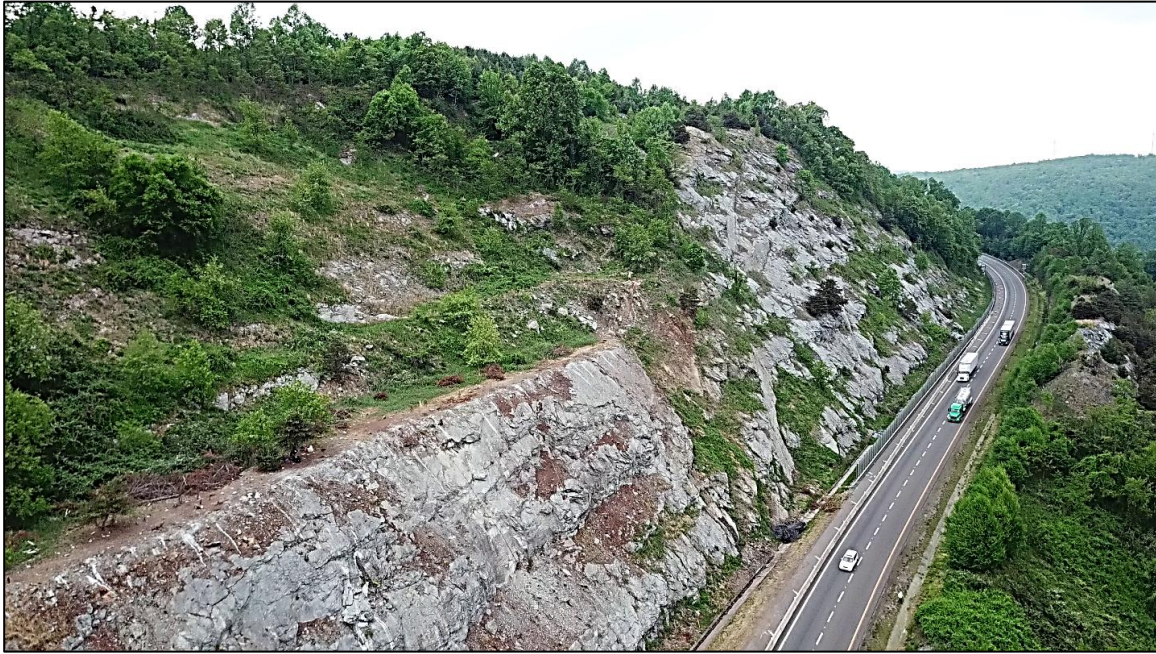
Figure 2. UAS photograph of Site #1 work area on I-77 at MP 5.4 southbound, looking north. Foreground shows slope after rock scaling in preparation for treatment with rockfall protection mesh. Distant slope is awaiting treatment.

Site #1 (Figure 2) consists of three rock slope work zones close to each other, south of Fancy Gap on I-77. The specific locations are MP 5.4 SB, MP 3.8 SB and MP 3.7 NB. In 1989, Dr. Watts documented rockfalls that blocked lanes and caused detours for over a week at MP 5.4 SB.

The dominant rock type at the Site #1 locations is garnet-muscovite-biotite gneiss of the Alligator Back Formation. The rock is characterized by a fine “pin-striped” appearance, due to transposed thin compositional layers or laminations (Rankin et al., 1973). Multiple episodes of ductile deformation produced refolded tight to isoclinal folds and a penetrative metamorphic foliation. The contact with the underlying Ashe Formation was originally considered stratigraphic (Rankin et al., 1973), but more recently has been recognized as a zone of high strain (Carter et al., 2017). The ages of the Ashe and Alligator Back Formations are uncertain, but commonly presumed to be Neoproterozoic (Z) to Lower Paleozoic (Carter et al., 2017). The rocks are strongly jointed, and steeply southeast-dipping joint sets or foliation planes dominate stability at the site locations.

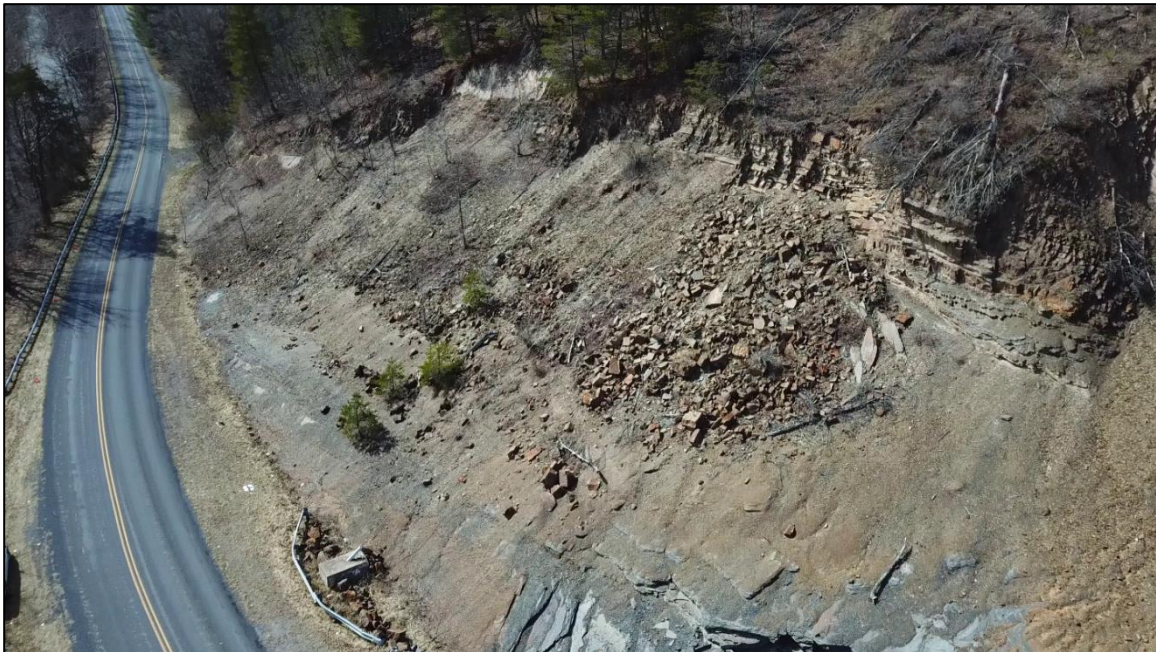
Figure 3. UAS photograph of Site #2 Route 629, Deerfield. Center right shows recent slope failure threatening anchor block for guy wires (hard to see) supporting transmission line tower out of sight.

Site #2 (Figure 3) is located on Route 629 in the Valley and Ridge province, in Augusta County near Deerfield, Virginia. It has a history of both major and minor rock slope failures. The most serious occurred in May 2009 when a large rock mass slid along bedding planes and blocked both of the travel lanes.

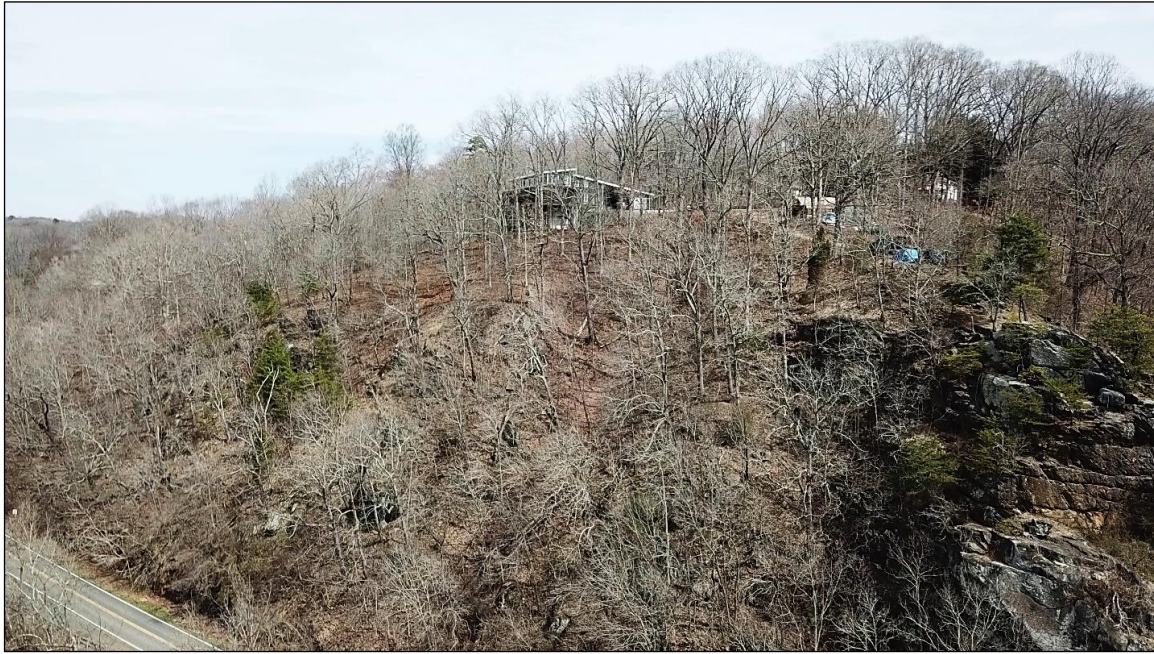
Figure 4. UAS photograph of Site #3, Route 685 River Road Lynchburg. Right side shows large rocky slope face with potential block failures controlled by the structural geology.

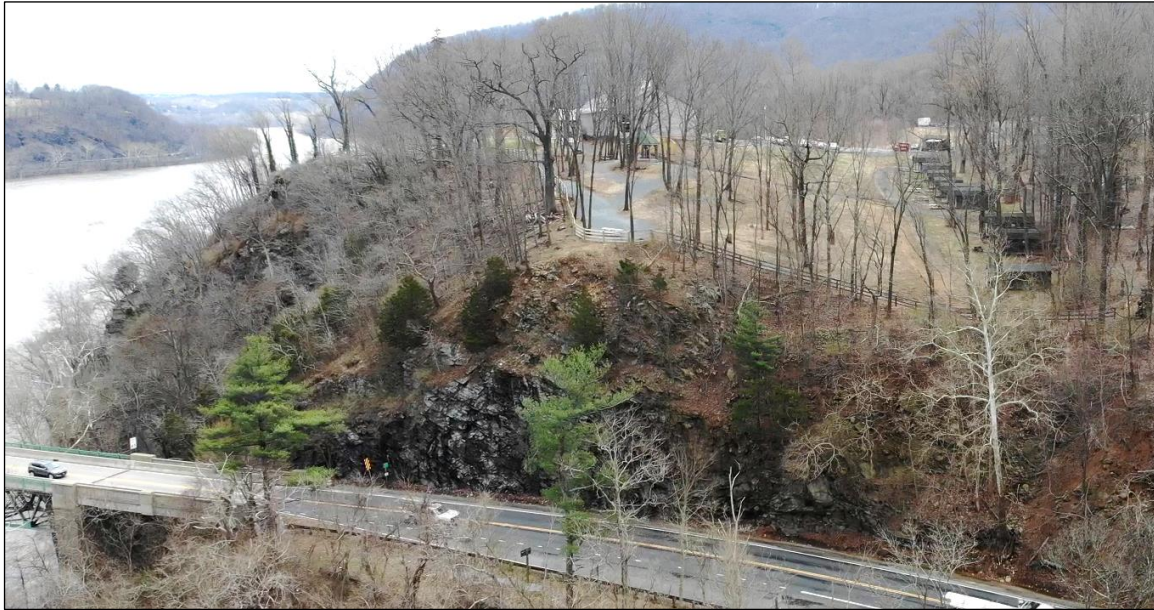
Figure 5. UAS photograph of the east end of Site #4, Route 340 at Harpers Ferry. Center left shows a pod of competent rock where stability is controlled by joint sets. The rock mass changes to softer weathered rock and soil moving to the right (west) causing stability to be controlled by the strength of soil and soft rock.

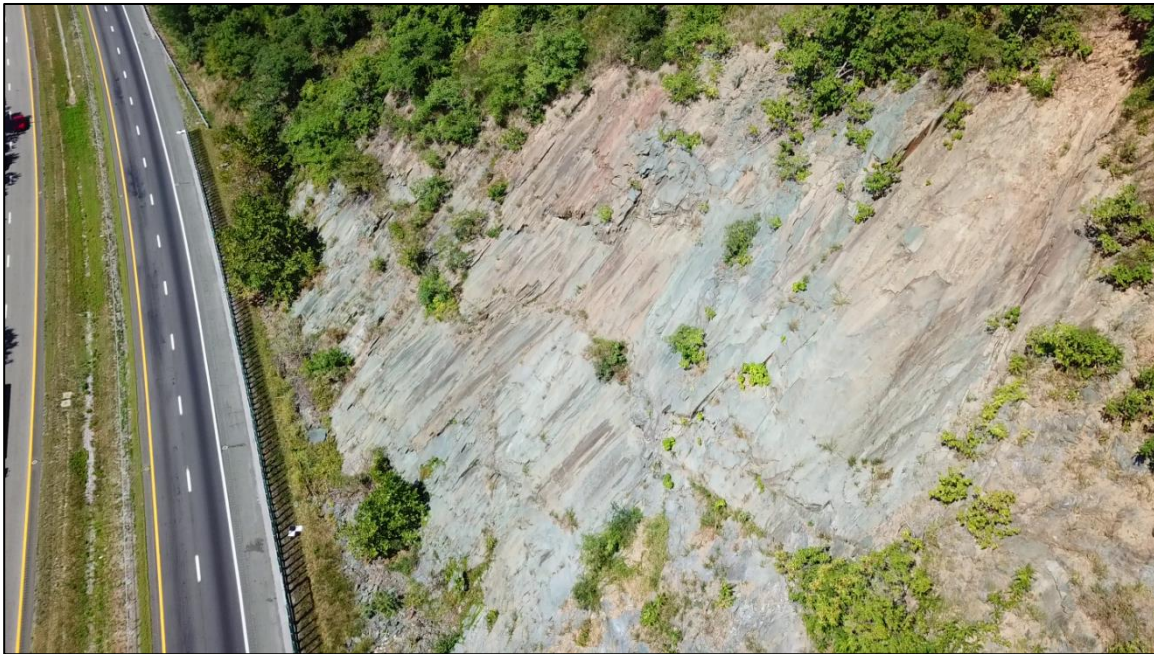
Figure 6. UAS photograph of Site #5, I-64 at MP 101 near Afton Mountain looking westbound. This is the site of previous rockslides; one of the worst occurred in 1989 and blocked the westbound lanes.

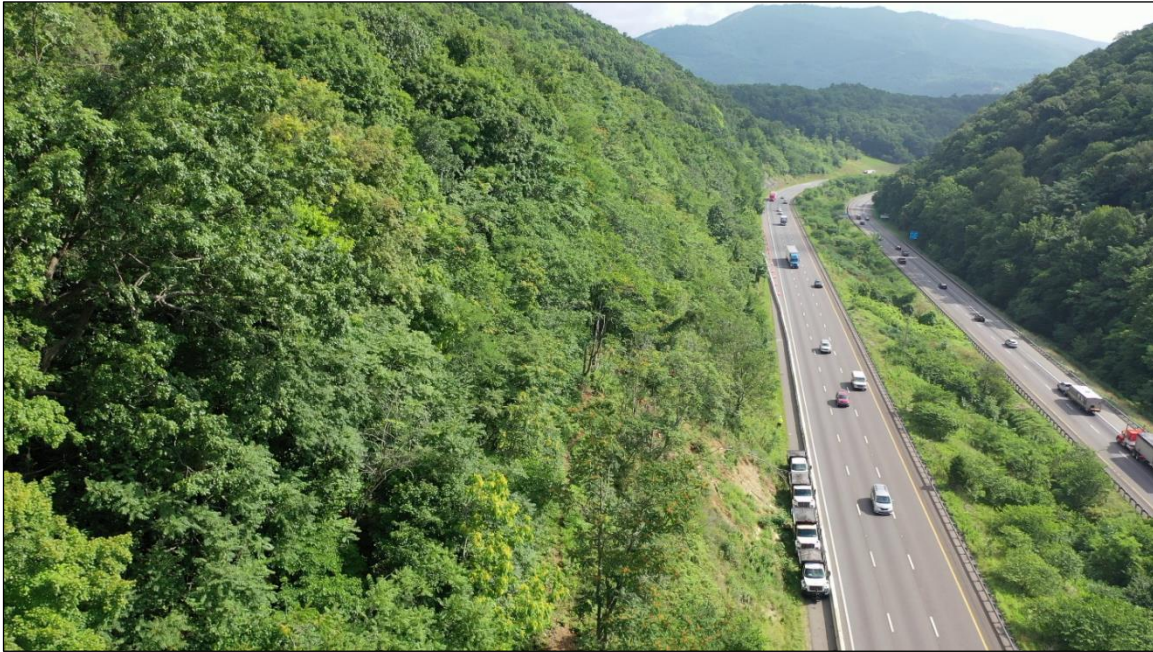
Figure 7. UAS photograph of Site #6, I-81 at MP 126.5 southbound, looking northbound. The current landslide is adjacent to the trucks placed as temporary rockfall barriers. The site of a massive 1969-70 landslide is at, and rising to the left above, the grassy area just beyond the curve in the distance at about MP 127.0. This picture illustrates the challenging nature of the site for UAS flights: dense leaf-on vegetation, narrow valley, rugged median sloping down toward the northbound lanes.

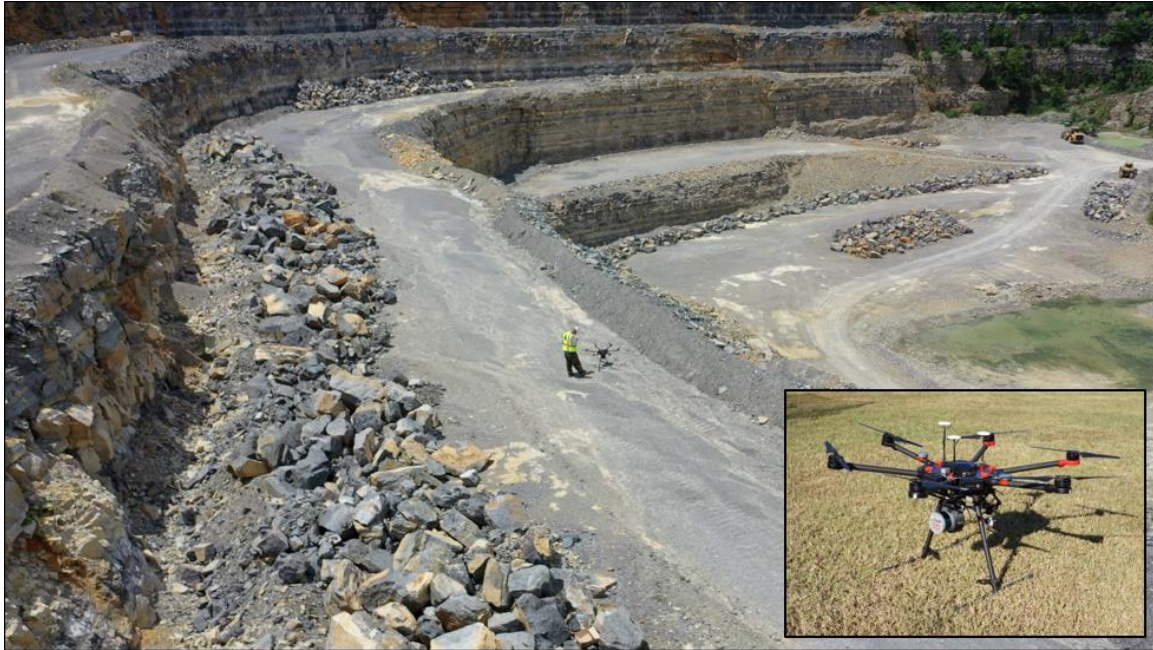
Figure 8. UAS Mavic Pro photograph of Site #7b, the Salem Stone, Holston Quarry, near Dublin. This was used as a flight-testing area and was the location of the crash that took the LiDAR unit out of service for the remainder of the research study. Graduate student James Young (center) is preparing to launch the DJI Matrice 600 (inset) with LiDAR mounted.

Site #7b (Figure 8) was a test range for evaluating different drones, mission planning software, and the use of drone-borne LiDAR in a quarry setting. Referred to as the Salem Stone Holston Quarry, it is adjacent to I-81 at Exit 101. It was also the crash site for the heavy-lift UAV carrying Radford University's LiDAR unit. The incident caused irreparable damage to the unit.

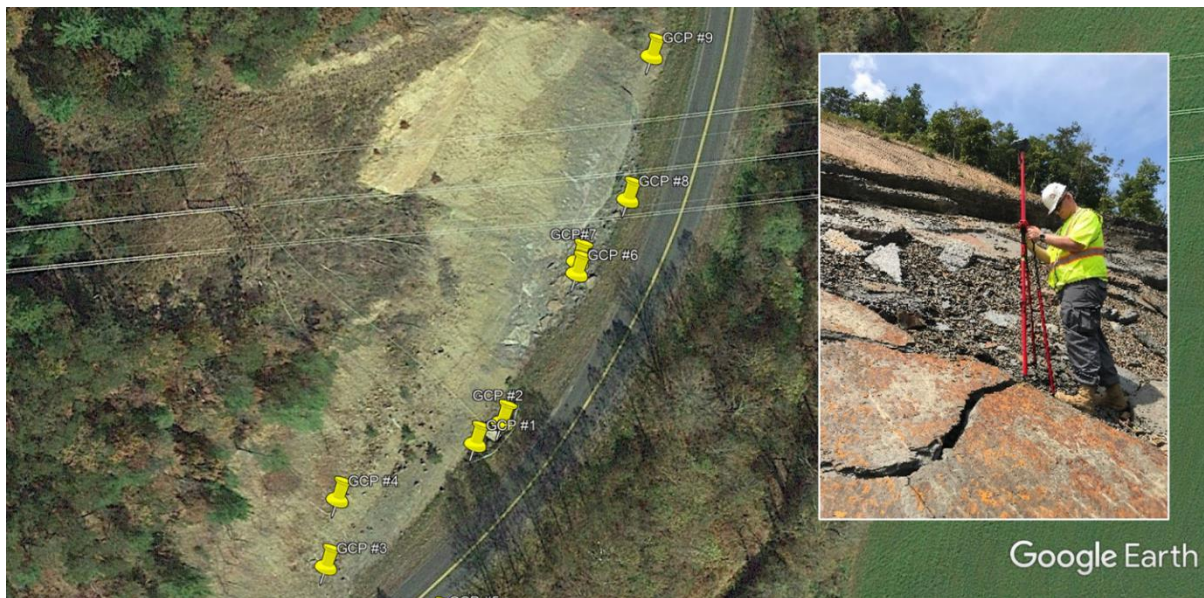
Figure 9. Satellite image of surveyed ground control points (GCPs) at Site #2 Deerfield. The inset shows graduate student James Young obtaining coordinates for GCP #7 using a roving, Emlid RTK GPS receiver, synchronized to a nearby base station in 2019. Base map from Google Earth.

For the Deerfield site, geospatial sciences graduate student, James Young performed a test of UAS point cloud positional accuracy using root mean square analysis (Figure 9). Table 1 shows the results when compared to surveyed RTK checkpoints. The mean RMS error, with respect to georeferencing, was found to be 0.176m (0.575ft) during image processing using *Pix4D Mapper* software. Resolving that offset vector into its three X, Y, and Z components (east-west, north-south, and vertical), the root mean square (RMS) errors were found to be 0.179256m, 0.3366262m, and 0.099307m (0.5881ft, 1.1044ft, and 0.3258ft) respectively (Table 2). Similar values are anticipated for flights at Site #4 Harpers Ferry and Site #5 Afton Mountain. While not considered accurate enough for highway design, these results are superior to traditional transit compass and tape measurements currently used for ground-based collection of geologic structure data.

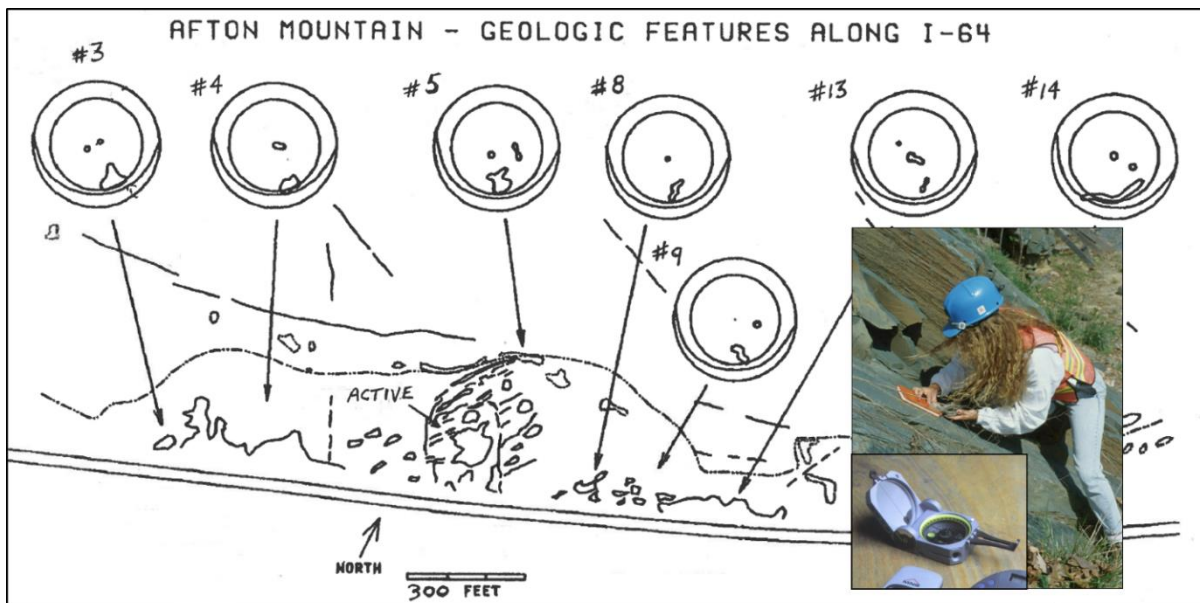
Figure 10. 1988 map of geological features and structural data presented as dip vector stereonet for Site #5, Afton Mountain. The inset shows former graduate student Robin Reed using a transit compass to measure discontinuity orientations at Afton Mountain. This map of *Geologic Features* is from Watts and Whisonant, 1988.

The irregular closed shapes within the stereonet in Figure 10 represent clusters of discontinuities plotted in the dip vector format. In stereonet #4 (Figure 10), only two clusters are present, one large and one small. If one imagines the circular stereonet as a compass, a larger cluster can be seen in the southeast quadrant and a smaller cluster near the center of the stereonet. When plotted as dip vectors, the closer to the center that a cluster appears, the more steeply dipping the discontinuities represented by it are.

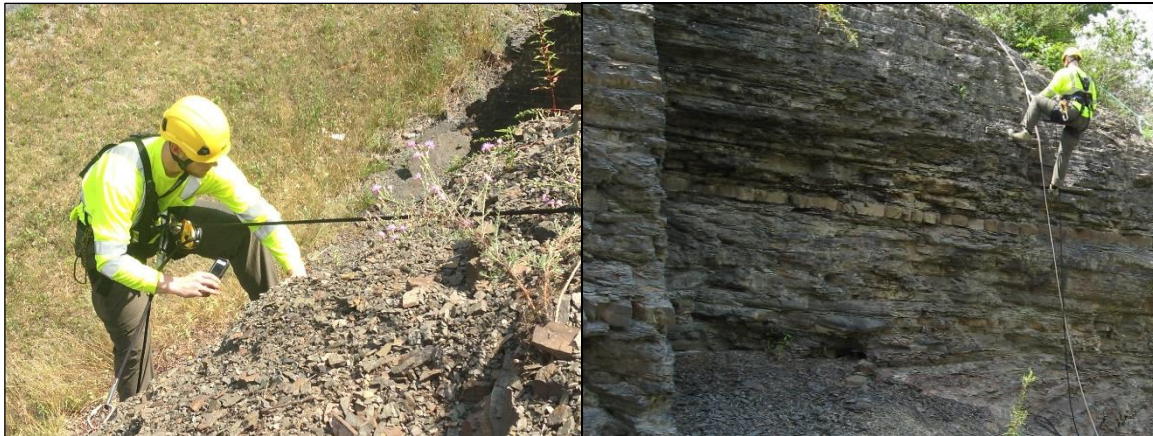
Figure 11. Graduate student Robert Huber using rope access to safely collect geologic structure data at the Deerfield site in the traditional manner. This method is less efficient than newer UAS techniques and can place personnel in hazardous situations.

Figure 11 shows graduate student Robert Huber collecting geologic structure in the traditional fashion, using rope access techniques for rappelling and climbing the slope face at the Deerfield site. This method requires more time to complete than UAS flights, does not cover all parts of a slope face, and might place personnel in hazardous situations. In addition to the Deerfield site, rope access techniques were also used at the Afton Mountain site for collecting structure data.

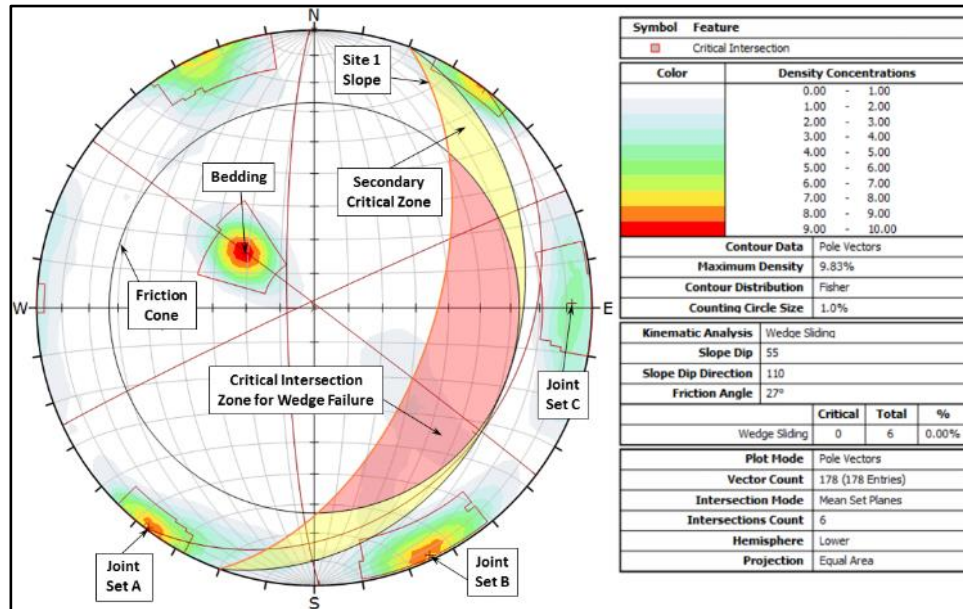
Figure 14. Transit compass data for Deerfield, plotted as poles, rather than dip vectors, and contoured for kinematic stability analysis on a standard stereonet using *DIPS* software (from Delaney, et al., 2020). Bedding plane discontinuities and three joint discontinuity clusters are revealed and labeled as Joint Set A, B, and C. This can be compared with dip vector plots of the same data in Figure 13b.

stability, plotted using RocScience *DIPS* software. Discontinuity orientations have been contoured in Figure 14 to highlight clusters (population centers), of discontinuities. Figures 13b and 14 both reveal the potential for plane and wedge failures within the rock mass.

the Deerfield site has the potential for both plane and wedge type failures. Possible plane failures are shown most clearly in Figure 13b by the cluster of blue points in the southeast quadrant on the edge of the crescent-shaped and shaded Markland critical zone. Potential wedge failures are revealed in Figure 13b and in Figure 14, by the intersecting great circles (arcs) shown in red, within or close to the “Critical Intersection Zone for Wedge Failure” labeled in Figure 14.

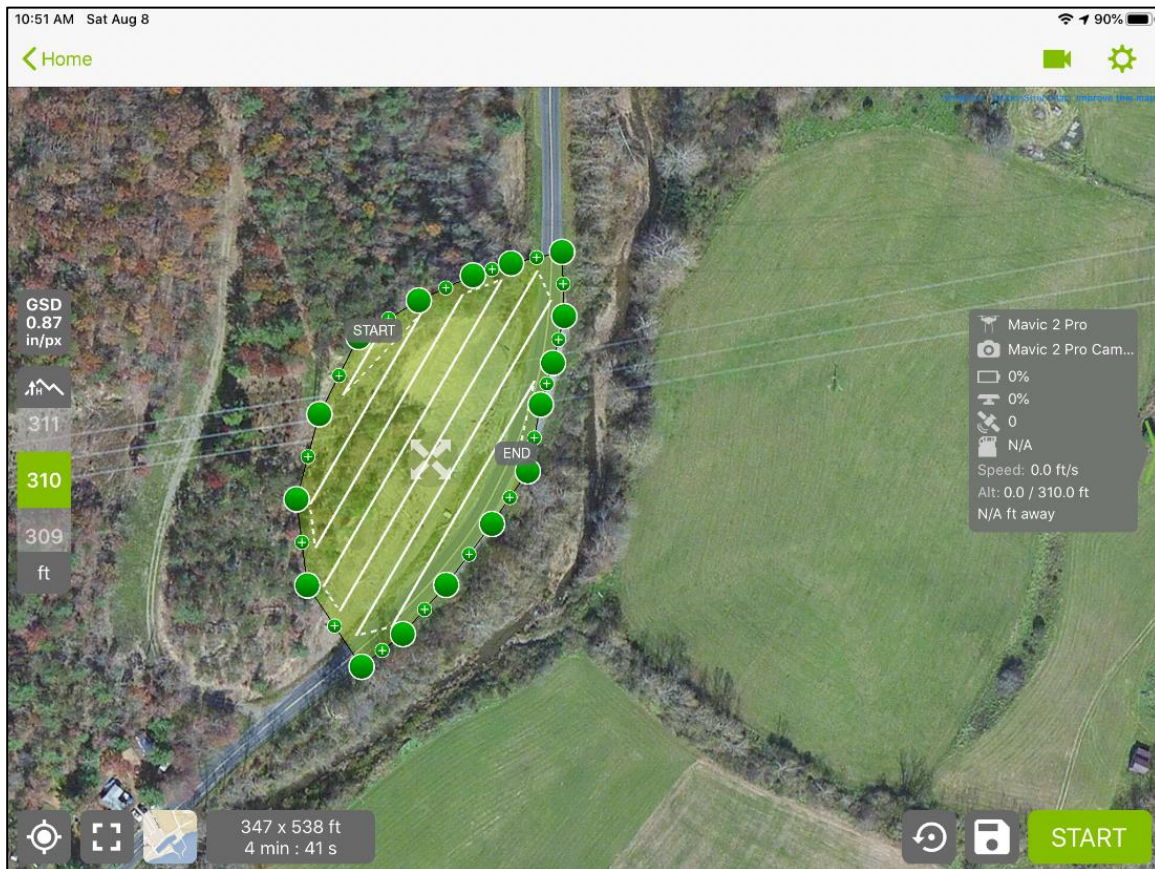
Figure 16. Site #2, Deerfield. Dots outline the imaged portion of the rock slope face. White lines represent the flight path of the aircraft as it flew directly over rock slope. The UAV camera was looking vertically downward for standard photogrammetric mapping. The flight control software was Pix4D Capture.

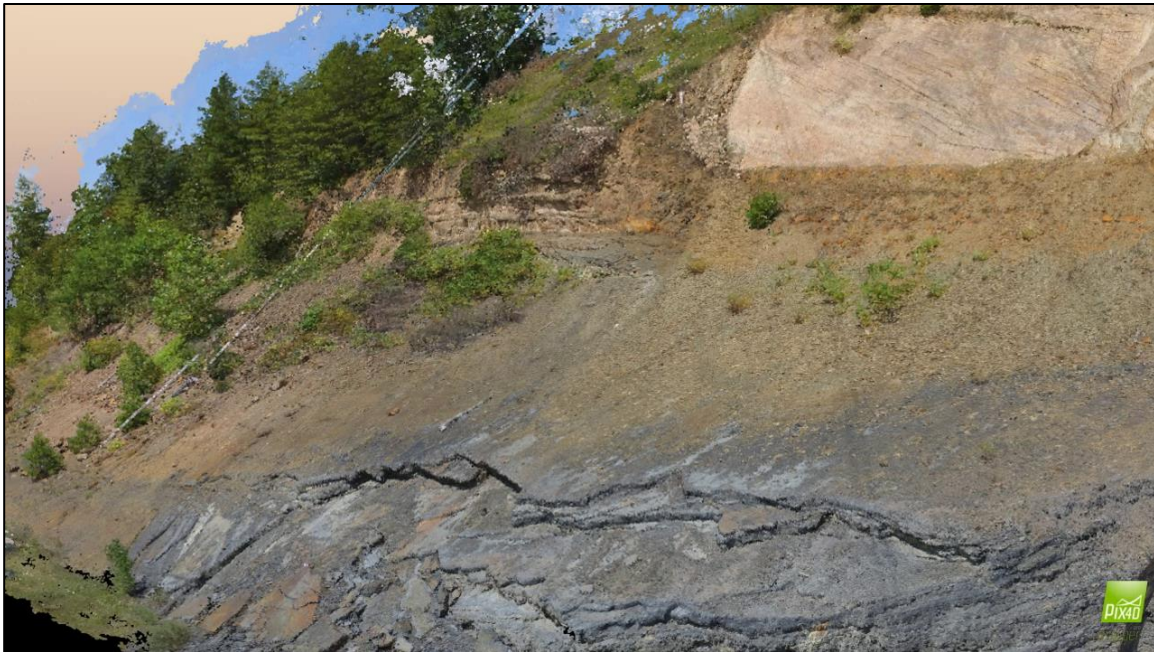
Figure 24. Site #2, Deerfield. UAS point cloud, scaled and georeferenced for obtaining measurements including the extraction of geologic structure data for stability analyses. This model represents conditions in 2016, prior to rock block failures from the rock projection feature in the top center of the image. This is a portion of one of the two point clouds used to test change detection techniques to fulfill of Task #11.

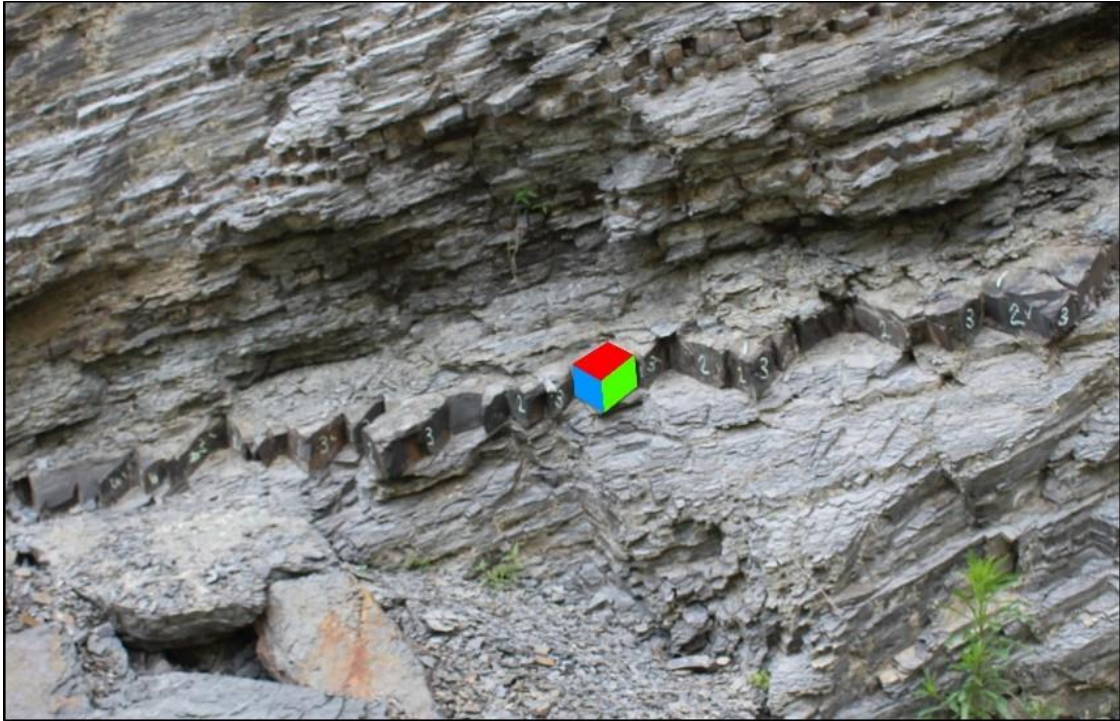
Figure 25. Site #2, Deerfield. Example of extraction of structure data from UAS-based point cloud for plotting on stereonets (Delaney, et al., 2020).

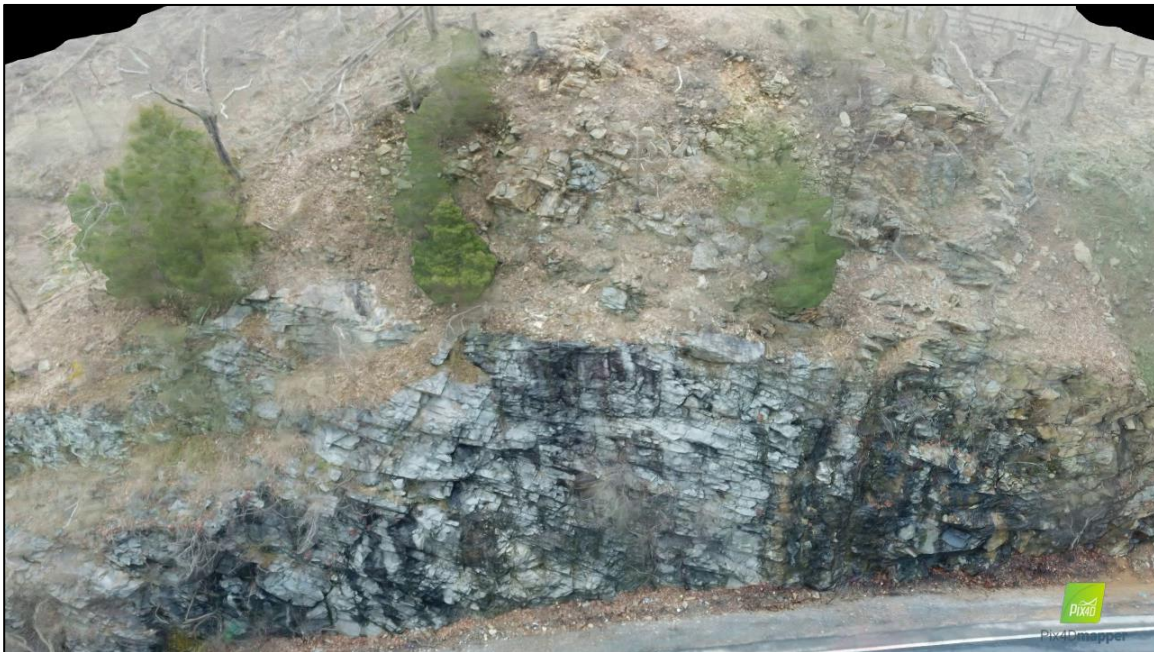
Figure 28. Site #4, Route 340, Harpers Ferry, Virginia. This is not a photograph, rather a portion of the georeferenced densified point cloud from which topographic maps and sections (below) were generated by *Pix4D Mapper*. Results were then transferred to *ArcMap* for distribution to HDR for constructability review purposes. This image is a screen capture from a video animation of the dense point cloud.

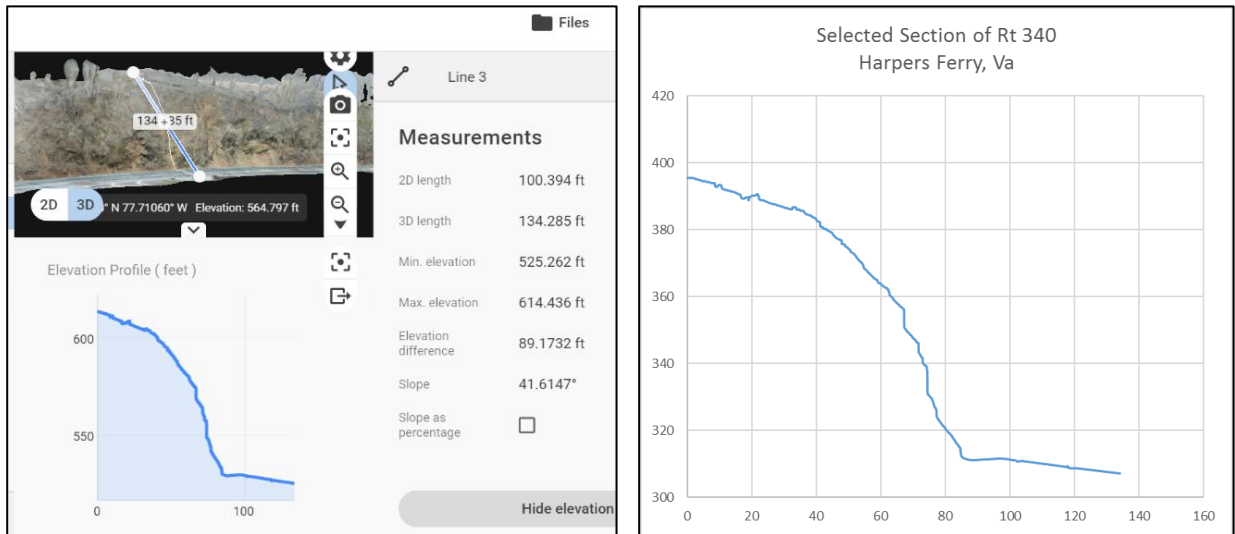
Figure 29. Site #4, Route 340, Harpers Ferry, Virginia. Examples of measurements and station sections that can be created from UAS data using *Pix4D Mapper*, *Pix4D Cloud*, and *ArcMAP*. Results shown are from *Pix4D Cloud*.

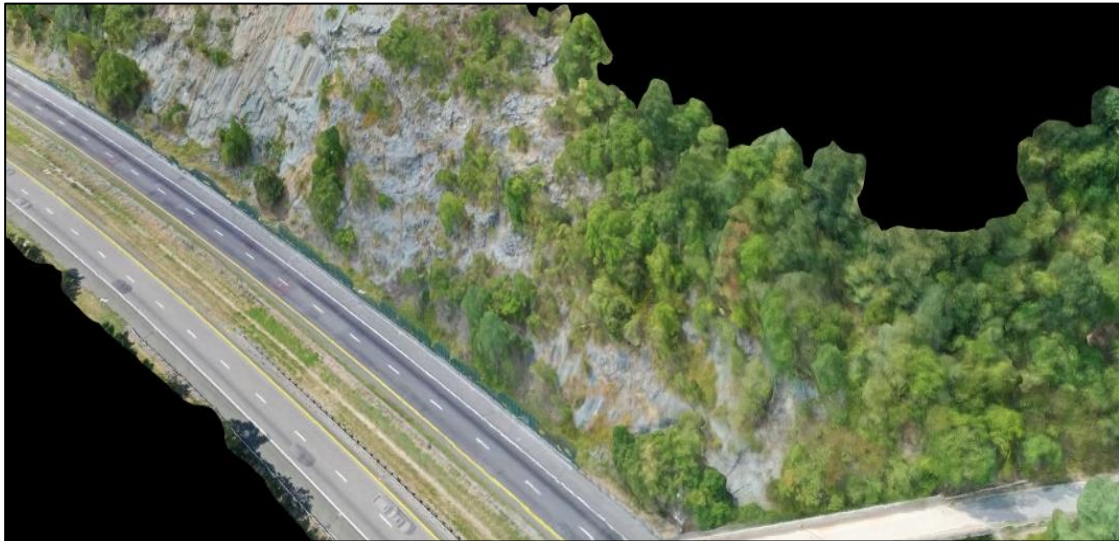
Figure 30. Site #5, Afton Mountain, I-64 Milepost 101. Farthest lanes are westbound. Densified point cloud with overlain triangle mesh, generated from UAS imagery using *Pix4D Mapper*.

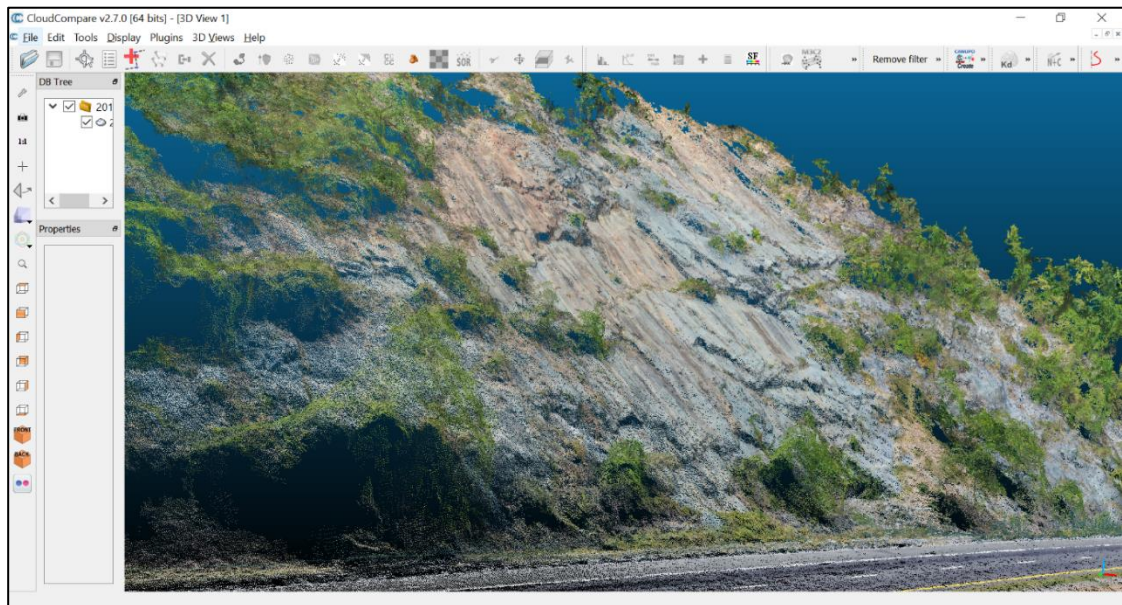
Figure 31. Site #5, Afton Mountain, I-64 Milepost 101. Dense point cloud presented as a simulated LiDAR image in the .las format. Generated from UAS imagery and exported using *Pix4D Mapper*. Displayed in *CloudCompare*.

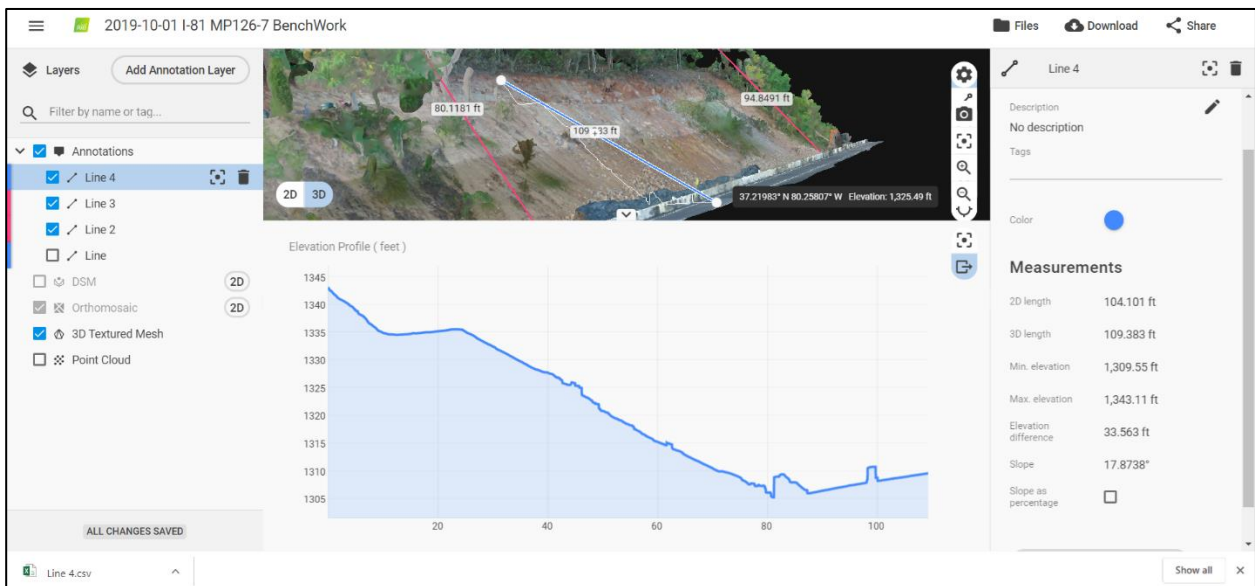
Figure 32. Site #6, Ironto, I-81 Milepost 126.7 Southbound; UAS demo project for GeoStabilization International. Measurements and profile section made on the dense point cloud generated in *Pix4D Cloud*. Note how the UAS 3D model picked up the Jersey barrier on the right side of the profile, the bundled rockfall mesh in the ditch, and some rock slabs resting on the slope face.

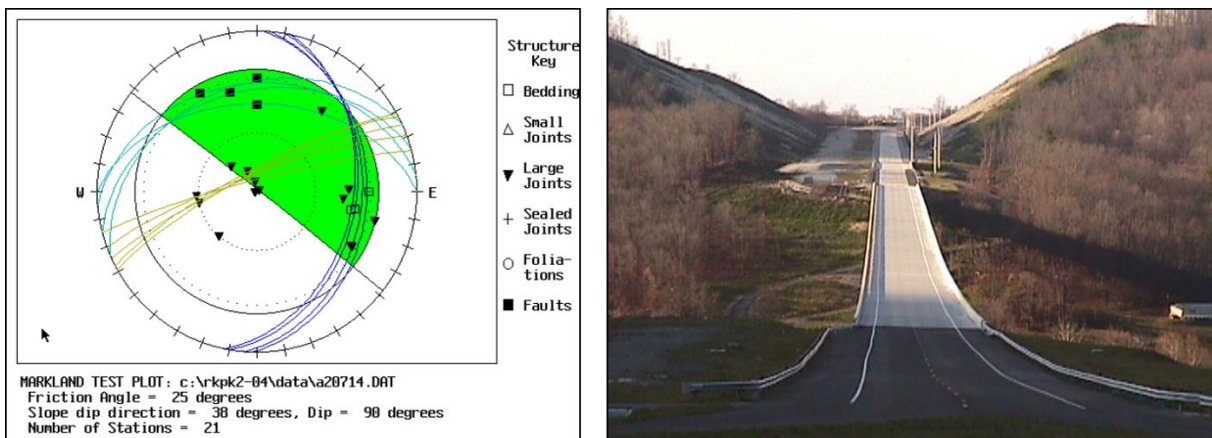
Figure 35. Stereonet derived from data collected manually in 1998 (left), comparable to 2019 UAS stereonet from the adjacent quarry. This plot reveals the cause of the unstable slopes (Figure 34a) during Smart Road construction, until laid back to 30 degrees as shown (right) at considerable cost overrun.
