MPC 21-437 | A. Kode, J. van de Lindt, and M.O. Amini

Investigation of Cross
Timber Bridge Decks as
a Sustainable Solution for
Repair of Deficient Rural
Wood Bridges

May 2021

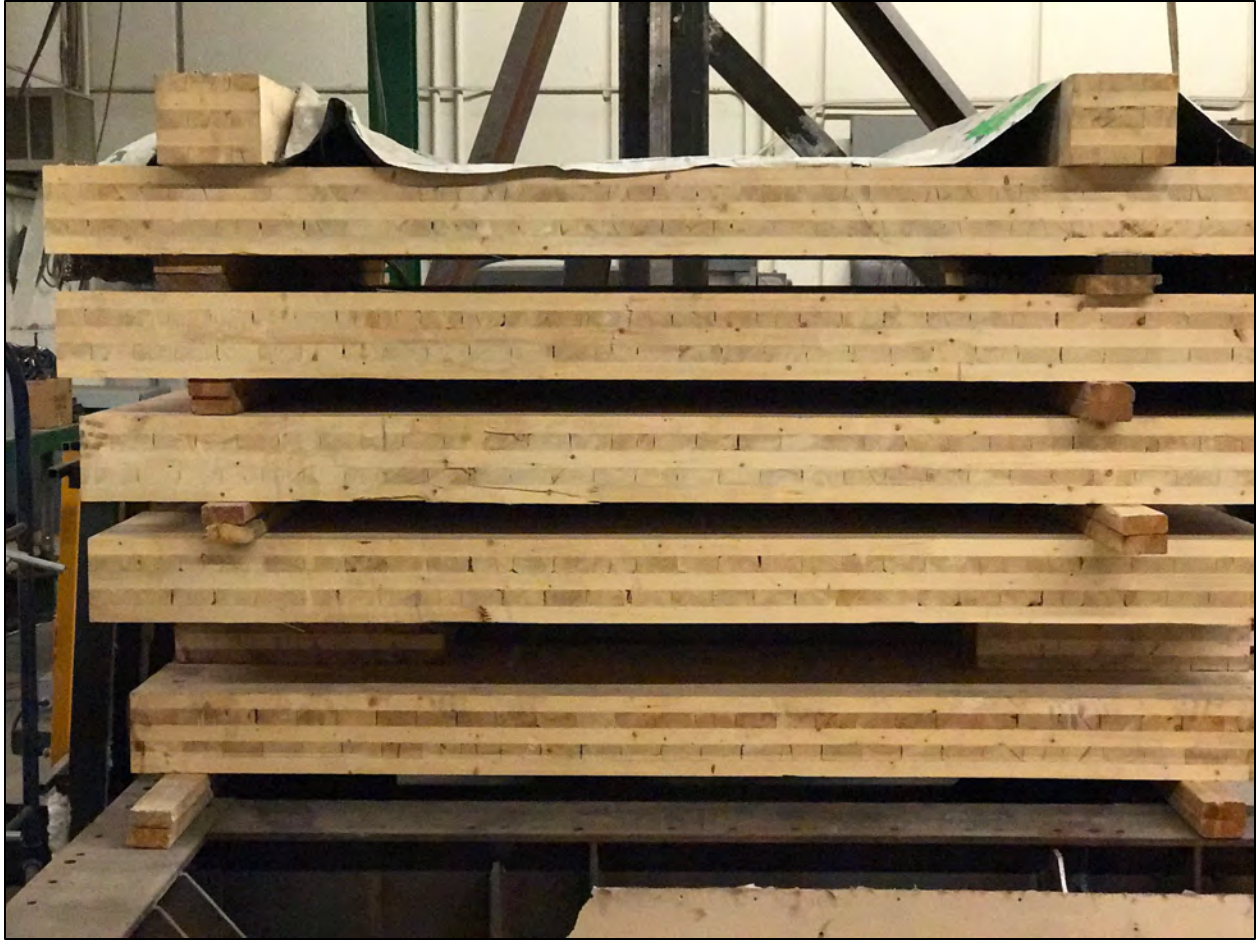
Figure 1.4 CLT Panels in the Laboratory at Colorado State University

A CLT panel has at least three layers of lumber boards. The most commonly used CLT panels have three, five, or seven layers. The lumber boards are typically 0.625-inches to 2-inches thick and from 2.4-inches to 9.5-inches wide. The size of a CLT panel depends on the manufacturer and is typically restricted by transportation constraints or the size of the press used to make the CLT. They are available in widths of 2 ft., 4 ft., 8 ft. and 10 ft. and can be 60-ft. long in the United States, but less than 40 ft. in length is more typical for transportation. The thickness can be up to 20 inches (FPIinnovations, 2013). Figure 1.4 shows a side view of CLT panels.

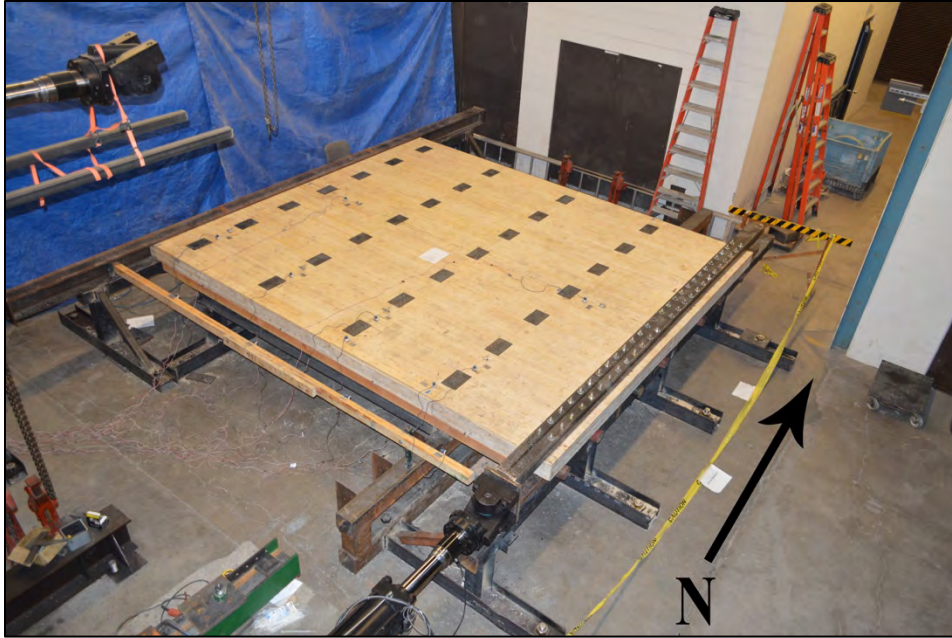
Figure 2.3 CLT Diaphragm Test Setup (View from a Top Angle)

Figure 2.3 shows a photo of the test setup from the top. The fixed end of the cantilever is on the west side of the test setup. A steel W-beam is connected to CLT panels 5 and 10 to form the fixed end. Holes are drilled through the web of the steel I-beam to make a fixed connection. The connection is made with lag screws that are drilled into the side grain of CLT panels. The SDS screw connection to the CLT panels from the top is shown in Figure 2.4. Figure 2.5 shows the rows of SDS screws drilled through the CLT panels. These SDS are 2.5-inches deep into the chord members underneath. This was done to ensure sufficient penetration for maximum strength.

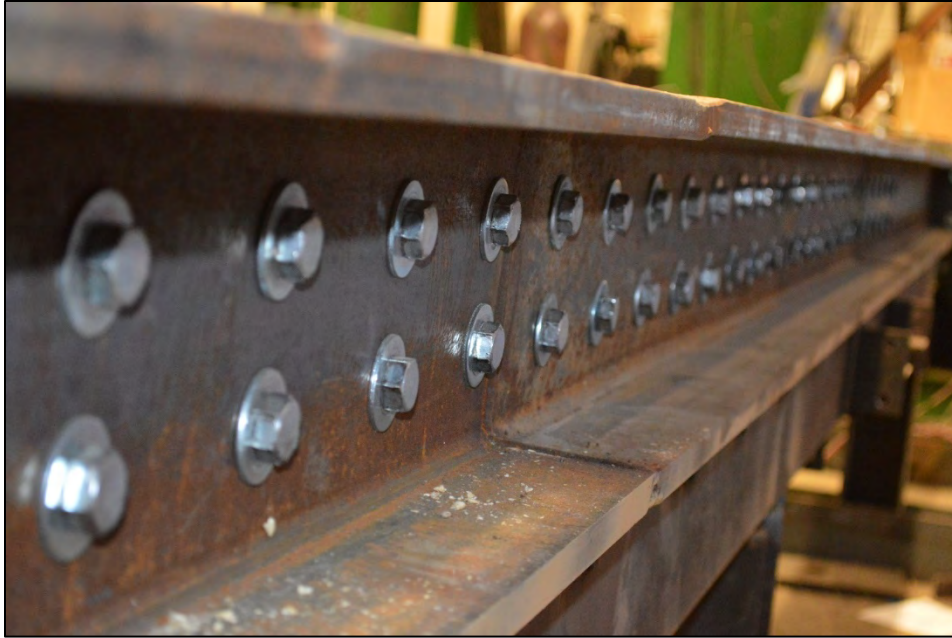
Figure 2.7 West End Steel I-Beam

Figure 2.7 shows the heads of lag screws going through the web of the steel I-beam on the west side (fixed end of the cantilever) of the diaphragm. These lag screws are drilled into the side grain of the CLT panels. The steel beam and CLT panels are supported by tube steel that runs in the north-south direction under the steel I-beam. A frame supports this tube steel. The steel frame starts on the west side. The first components are set underneath the tube steel on the fixed end. These act as legs to connect the fixed end to the concrete strong floor. The steel frame is fixed into the concrete strong floor with the use of 2-inch threaded rods that have pre-drilled holes into the floor. The steel frame has kickbacks into the concrete floor. From this end, there are three long pieces of tube steel that span the length of diaphragm. These members are used to support the three chord members that support the diaphragm. The chord members are connected to the diaphragm with SDS screws.

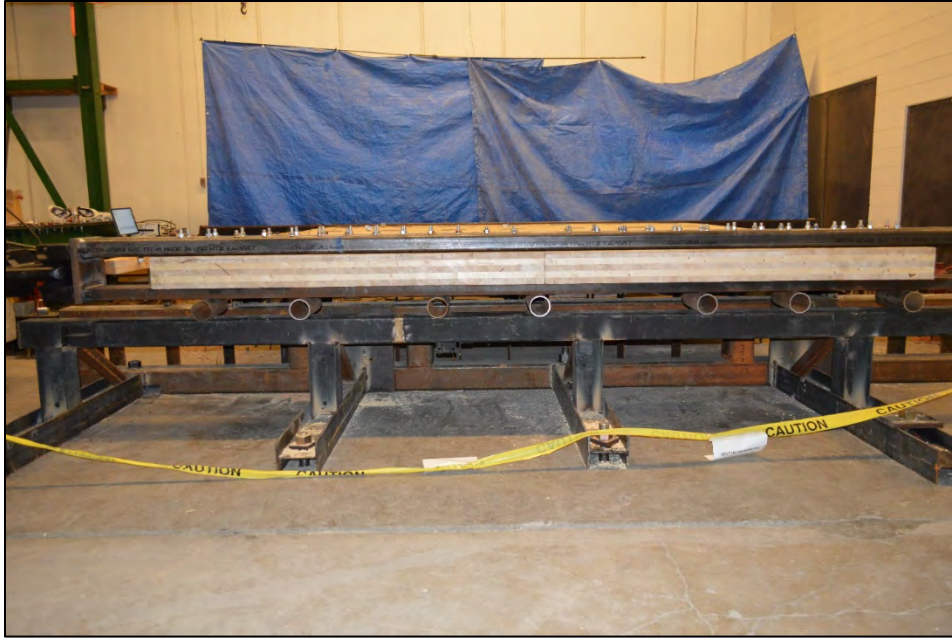
Figure 2.8 East End of the Test Setup

On the east end underneath the chords and the supporting steel tubes, there is another set of legs that connect the diaphragm to the concrete strong floor. On the easternmost end of the test setup, these members connect to another steel frame. This steel frame has steel rollers on the top. These rollers are kept underneath the loader bar setup to reduce or eliminate any friction that would occur if it were sliding and allows the loader bar to move during testing. This is illustrated in Figure 2.8.

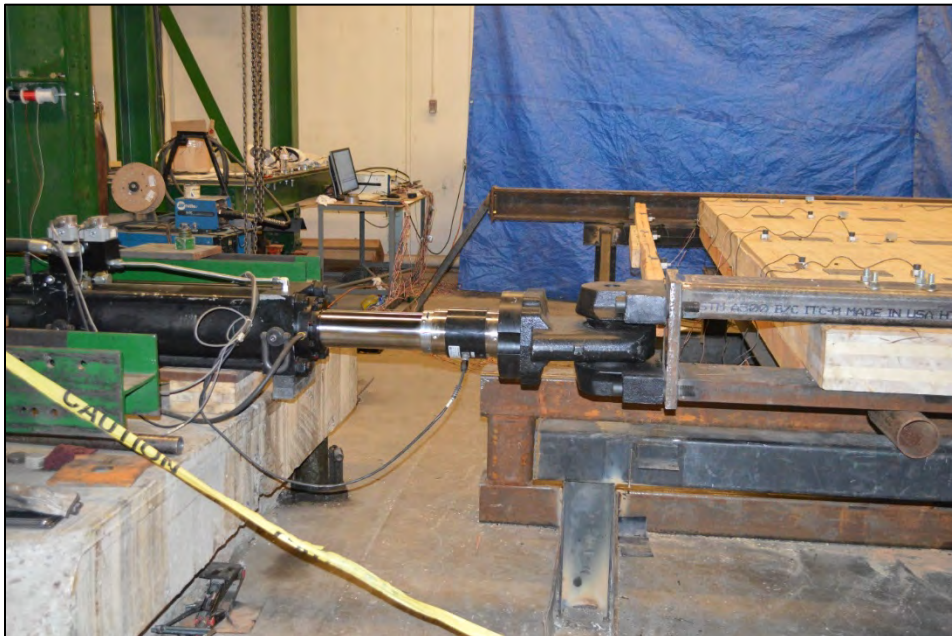
Figure 2.9 Southeast End of the Test Setup

At the south end of the loader bar the actuator is connected to the loader bar. The actuator sits on a block of concrete. The actuator is mounted on a steel plate, which is connected to a steel beam that distributes the load into two steel beams that are placed into the strong concrete floor. At the end is another steel tube.

Figure 2.9 shows the actuator connection to the loader bar. The concrete block underneath the actuator is also visible. This provides support and acts as a kickback to control the resistance from loading when testing the diaphragm. All the other necessary drawings and photos have been included in the Appendix of this report.

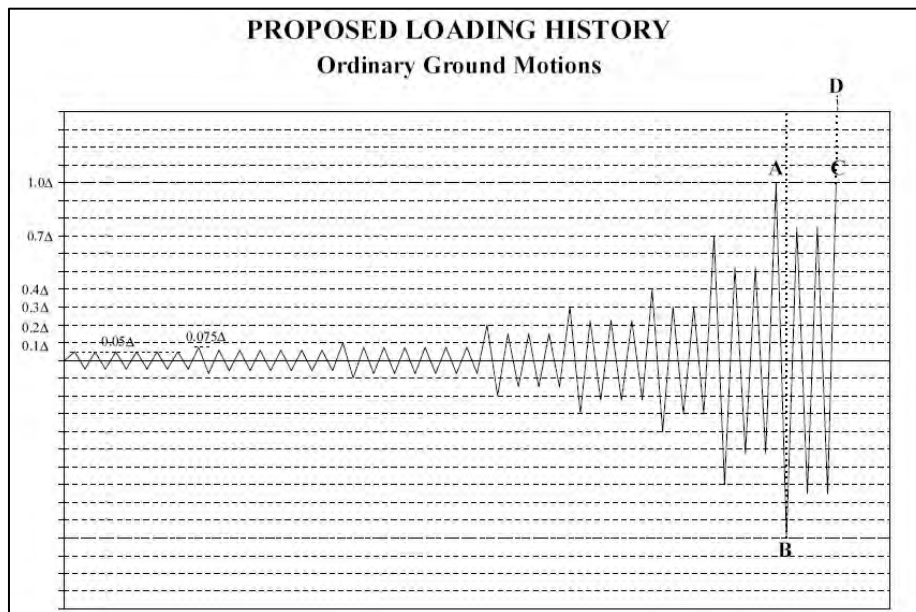
Figure 3.1 Loading History for Basic Cyclic Load Test
(Excerpted from Krawinkler et al., 2001)

The Consortium of Universities for Research in Earthquake Engineering (CUREE) developed a loading protocol for testing of wood shear walls and other wood components and subassemblies as part of the CUREE-Caltech Woodframe Project (Krawinkler et al., 2001). Deformation controlled quasi-static cyclic testing was done. The cyclic load test typically follows the protocol shown in Figure 3.1.

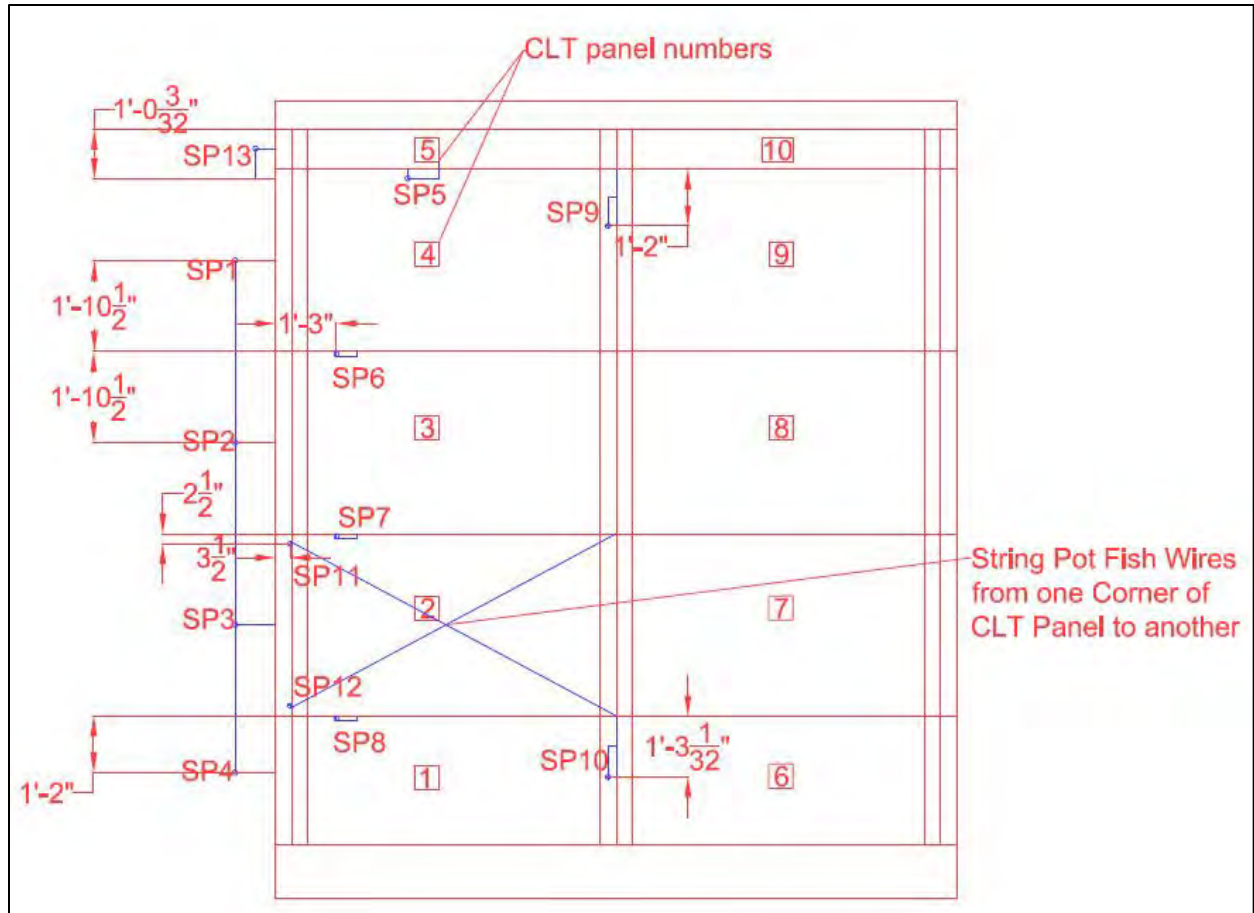
Figure 3.4 String Pot Locations on the CLT Diaphragm (Plan View)

Four of the string pots are used to measure linear deflection in the CLT panels with respect to actuator displacement. They are placed on the south side of the diaphragm into the panels. These are labeled 1, 2, 3, and 4. Figure 3.4 shows the locations of all the string pots in a plan view.

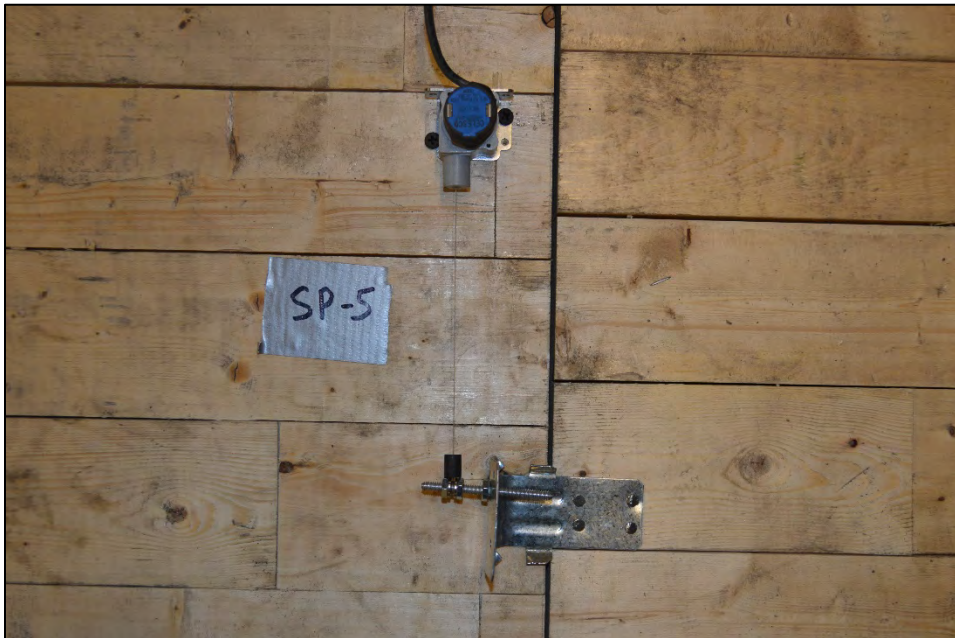
String pots 5, 6, 7, and 8 were used to measure the twist between CLT panels in the north-south direction by placing them at the edge between panels. Similarly, string pots 9 and 10 measure twist in the east-west direction. Figures 3.5 and 3.6 show string pots 1 and 5 after installation.

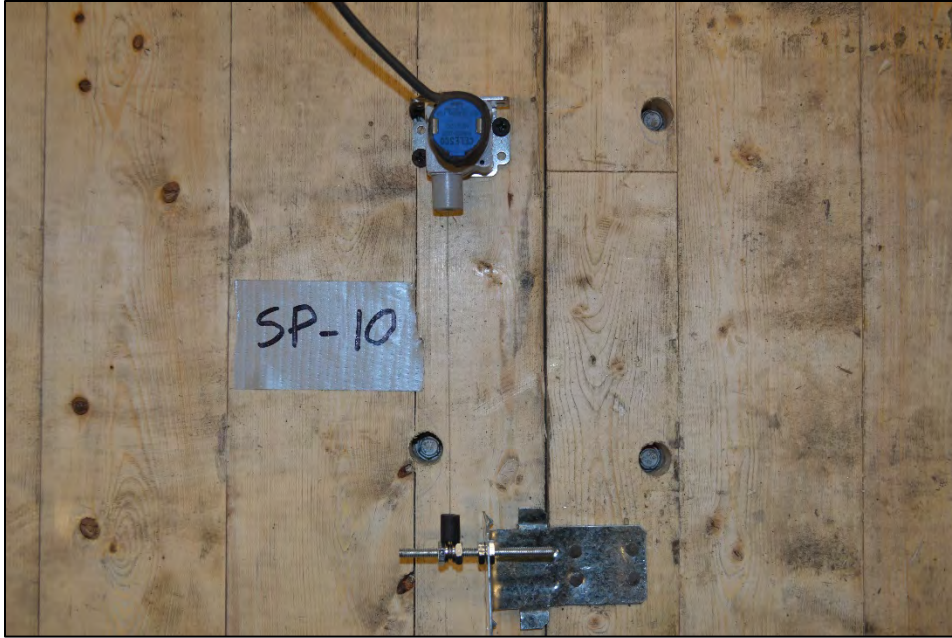
Photos of string pots 10 and 12 after installation are shown in Figures 3.7 and 3.8.

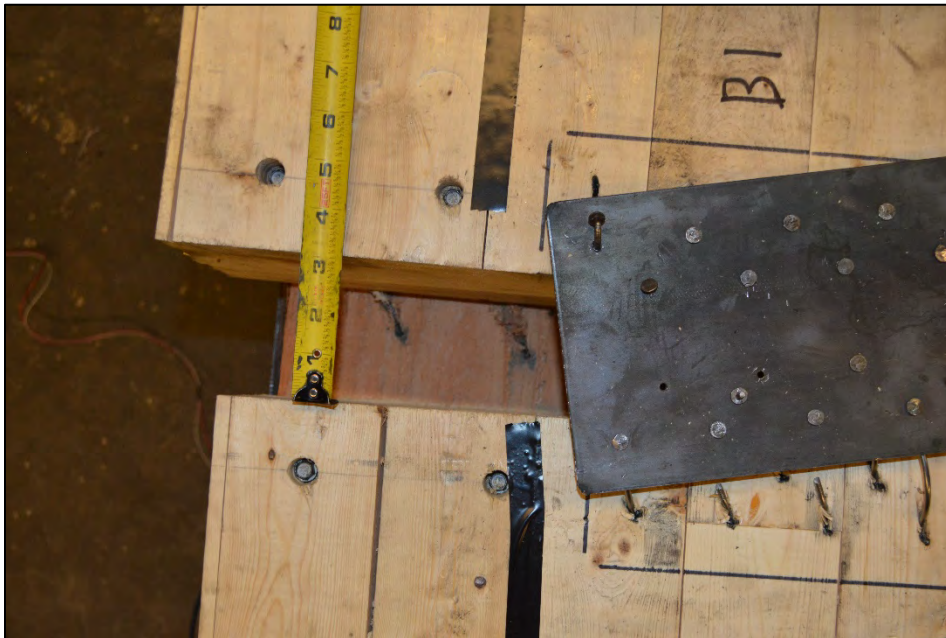
Due to cyclic loading, the separation between panels kept gradually increasing with the increase in actuator displacement as expected. This resulted in shear failure of SDS screws in the chord underneath the diaphragm and subsequent failure of the steel connectors. As one can see in Figures 4.3 and 4.4, the panels separated and the gap between the panels increased from less than 0.25 inches to more than 3 inches prior to stopping the protocol.

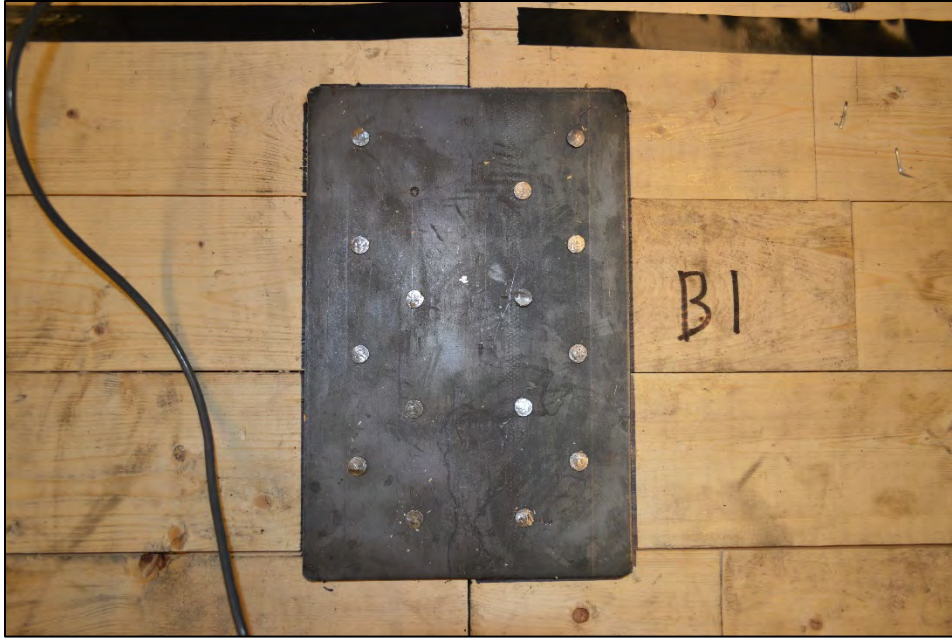
Figure 4.5 Connector B1 before the Test (Top View)

The steel splices started to fail gradually when in cyclic loading. First, the nails started to pull out slowly because of the in-plane movement of the CLT panels. Several nail heads sheared off because of the in-plane movement. As you can see from the following photos, there was total failure of the connectors along line B. Figure 4.5 shows connector B1 before the test.

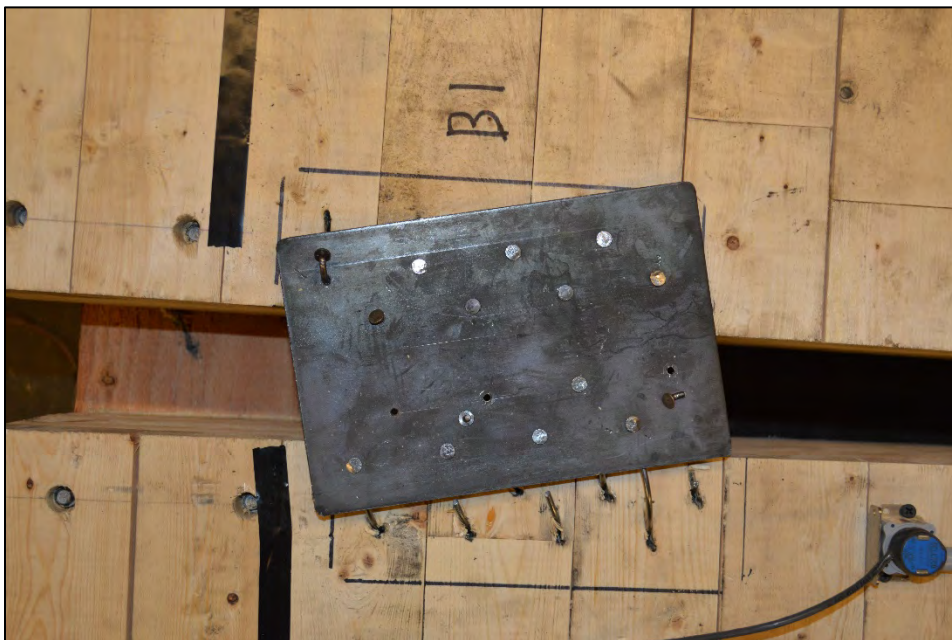
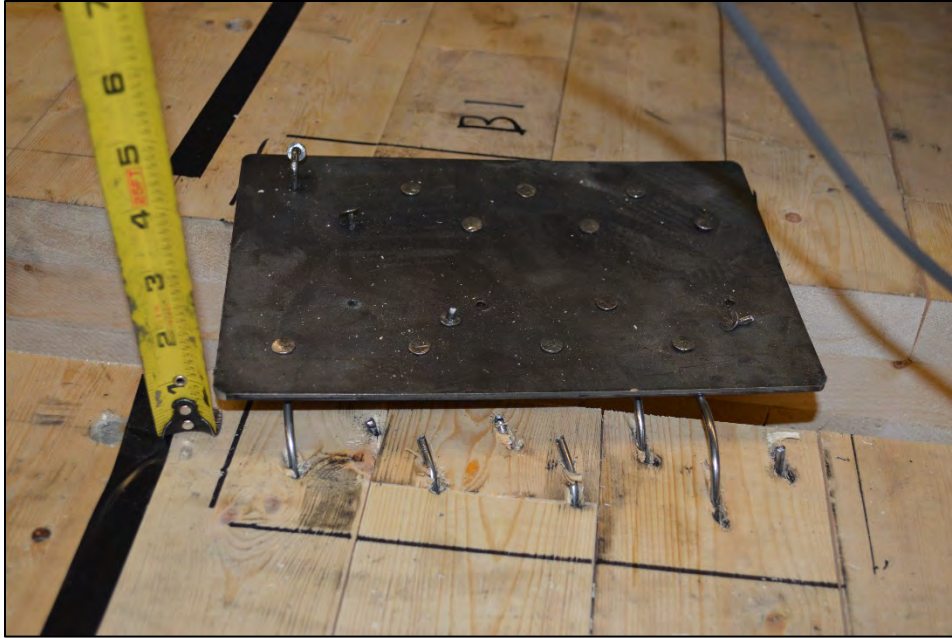
After the test, connector B1 had moved in all three directions. In Figure 4.6, one can see the black outline of a marker around connector B1, which was the original location of the B1 connector. It was twisted and turned due to cyclic loading. In Figure 4.7, we can see B1 did move out-of-plane because of the cyclic movement of the CLT panels. This type of failure occurred in all connectors on line B. More photos are included in the Appendix.

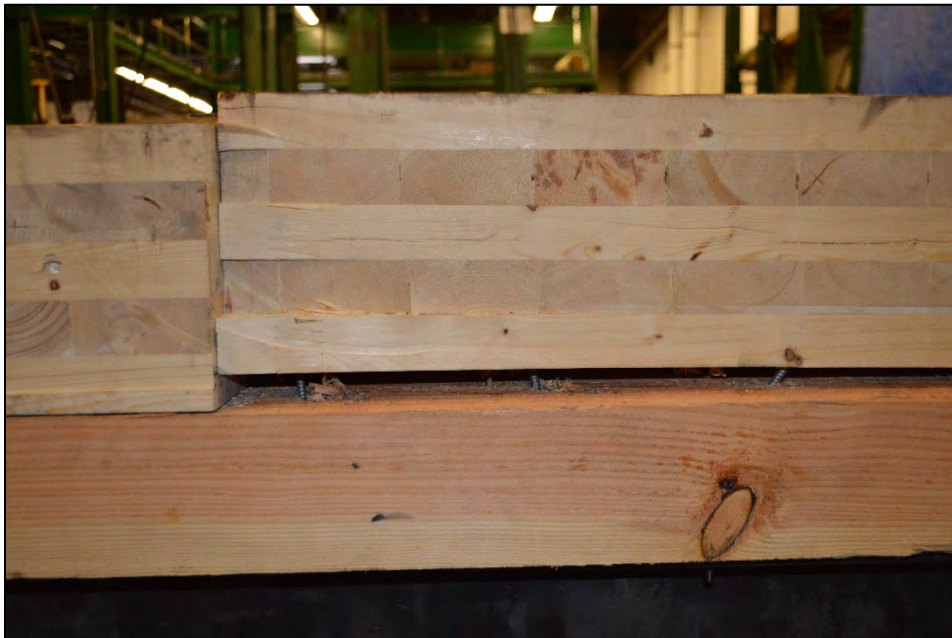
Figure 4.8 SDS Screw Shear Failure

In Figure 4.8, one can see the side view of CLT panels 8 and 9 and the chord member underneath. Failure of the SDS screws in shear can also be seen in Figure 4.8. CLT panel 9 has some slight wood crushing. This is due to panels pushing at each other because of the cyclic movement of the panels. This can be seen in Figure 4.9.

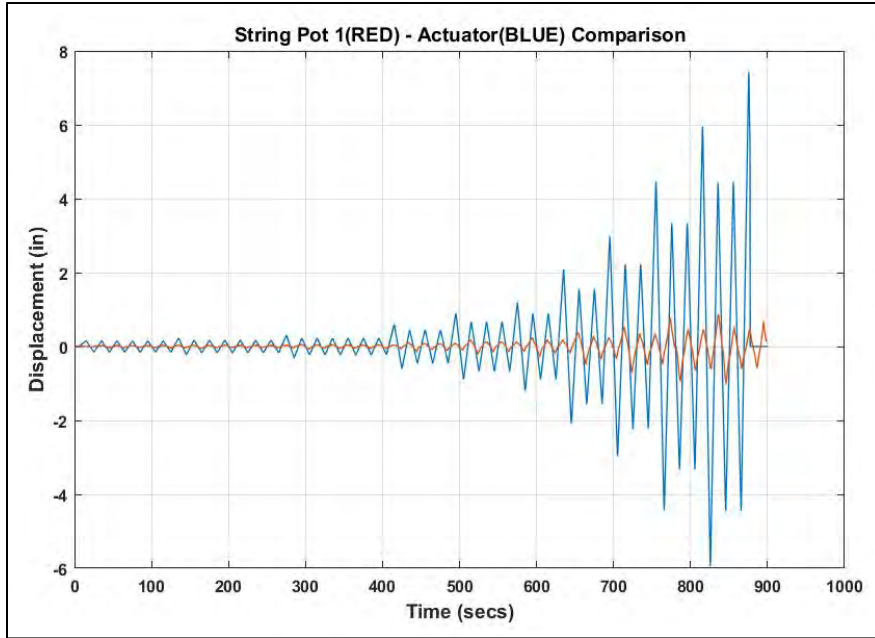
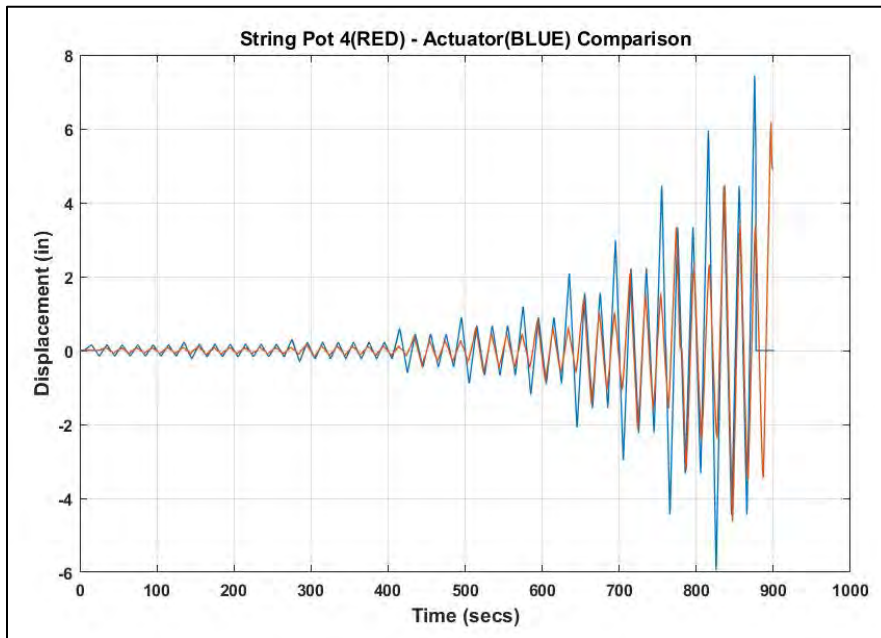
As one would expect from basic beam theory, there is an increase in displacement as we move from the fixed end of the cantilever to the free end. SP4 was closest to the free end of the cantilever beam and SP1 closest to the fixed end. Figures 4.11 and 4.12 show the comparison between actuator and string pot displacements. In Figure 4.10, the difference in values between actuator and SP1 is approximately 6.5 inches at maximum actuator displacement. One can see there was very little deflection as one moves closer to the fixed end of the diaphragm. However, in Figure 4.12, one can notice the very similar plotlines of actuator and SP4. The difference in values was minimal. The slight lag was noted and was not intentional.

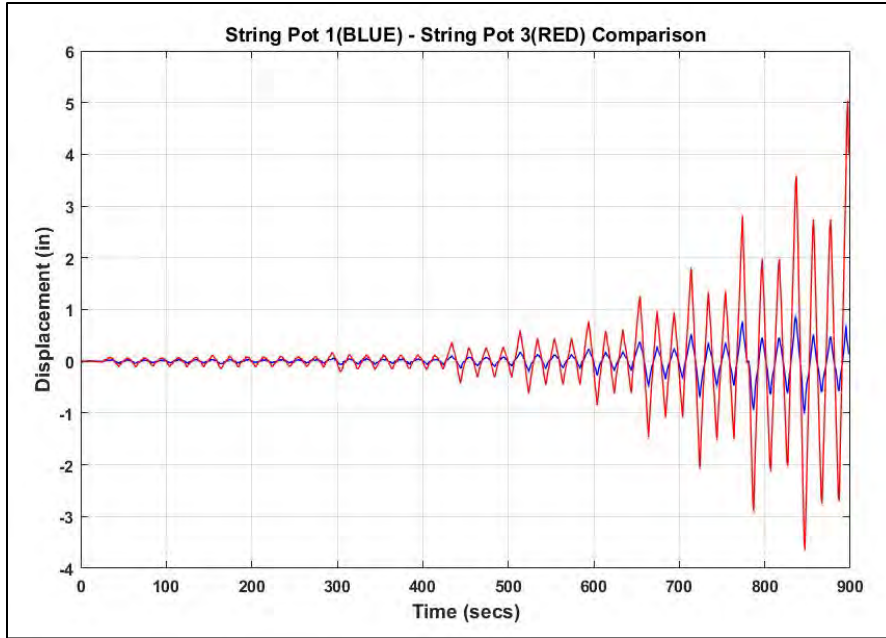
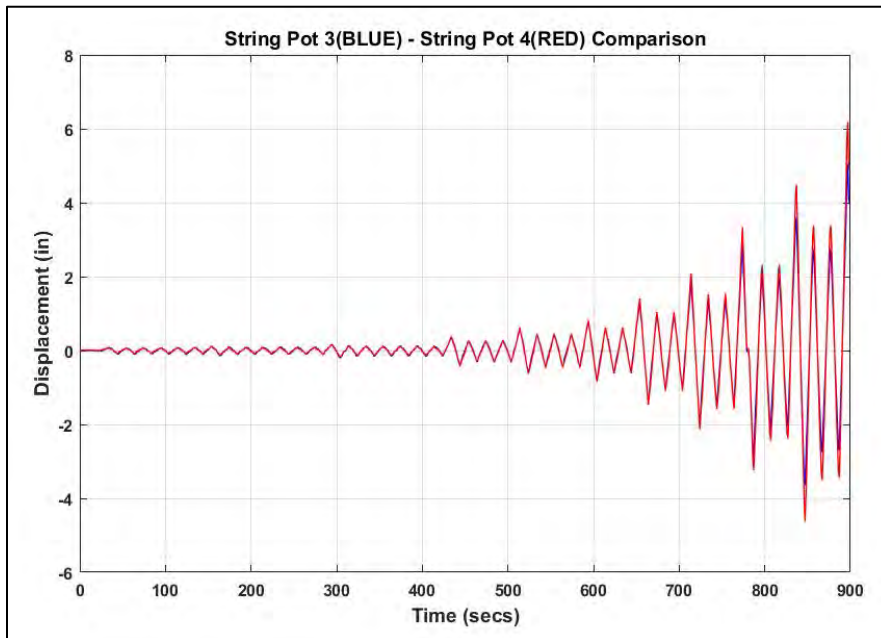
Figures 4.13 and 4.14 compare data among SP1, SP3, SP3, and SP4. From the graphs, we can see that SP1 and SP3 have a large difference in values. However, SP3 and SP4 have almost indistinguishable values. This is because SP3 and SP4 are located very close to each other. SP1 is closer to the fixed end and far from SP3 and SP4.

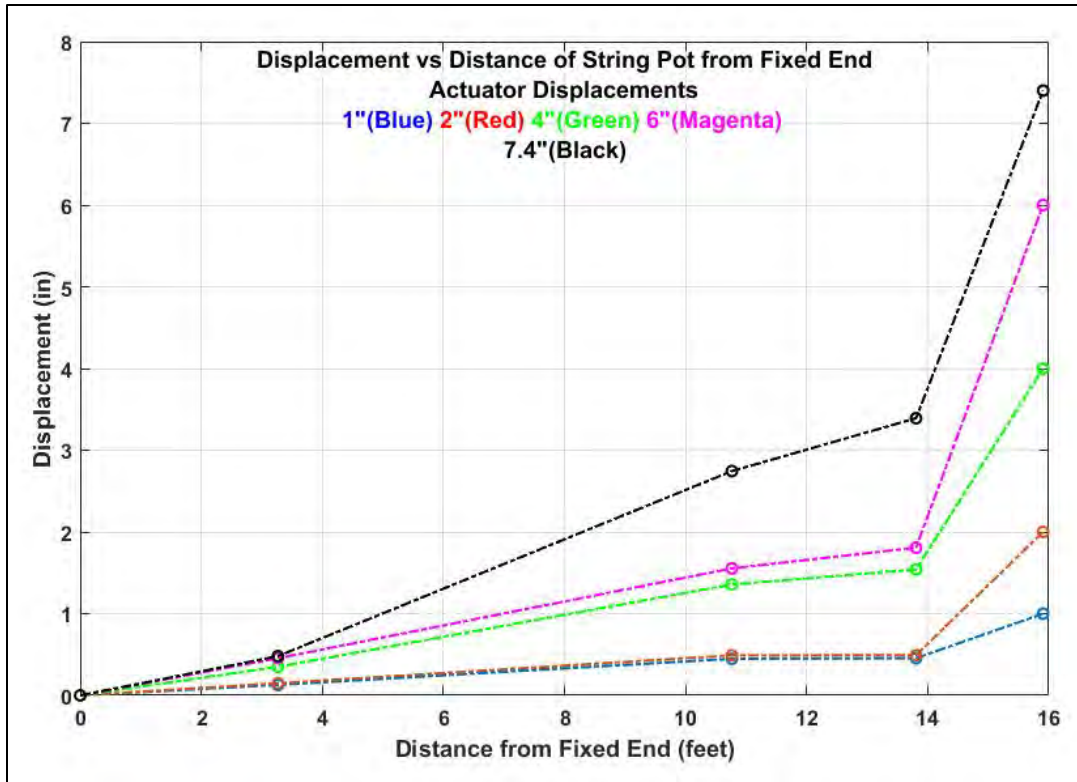
Figure 4.23 Displacement of String Pots vs Distance of String Pots from Fixed End

Figure 4.23 is a plot of displacement values of string pots versus distance of string pots from the fixed end of the cantilever. As one can see, the plots are linear for lower displacements. For higher values of actuator displacement, SP4 values are closer to the maximum displacement. As the diaphragm started to fail, the steep increase in values of displacement from SP1 to SP3 to SP4 is very noticeable. This occurred because the chord member connection failed.
