Identification of Practices, Design, Construction, and Repair Using Trenchless Technology

Final Report
October 2010

IOWA STATE UNIVERSITY
Institute for Transportation

Sponsored by
Iowa Highway Research Board
(IHRB Project TR-570)
Iowa Department of Transportation
(InTrans Project 07-288)

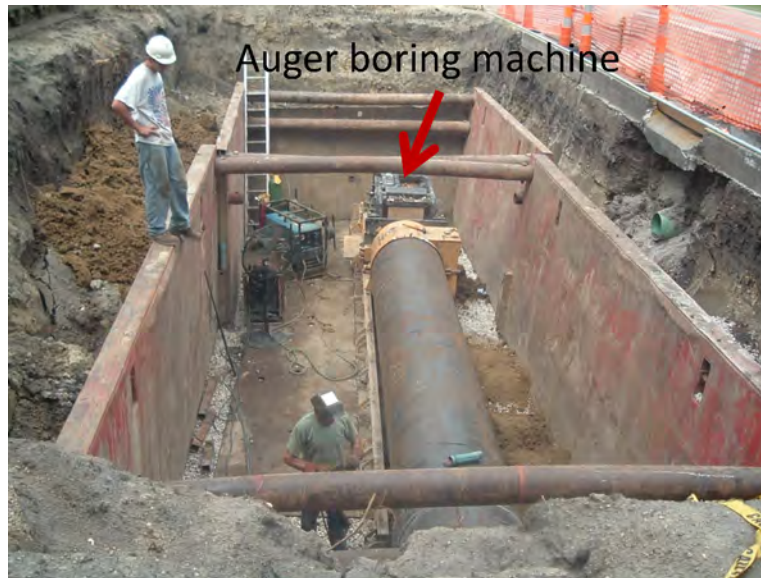
Figure 2.2. Launching pit with auger boring machine installing pipe

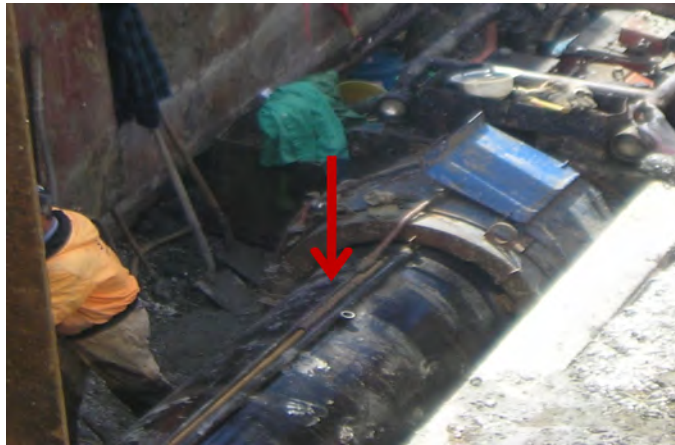
The machinery may possess varying degrees of steering capability. The most basic types of auger boring operations have limited line and grade control and rely heavily on the initial setup of the track to launch the bore in the proper direction. This operation requires constructing a stable thrust block and foundation for the track. Generally, three small-diameter metal pipes are attached to the top of the casing as it is augered into the soil (see Figure 2.4). The first small pipe is used for a basic waterline system to measure grade. The second small pipe is a fluid supply line that can be used in case it becomes necessary to deliver grout or water to the cutting face. Water may be needed if sticky clay is encountered, and grout may be necessary to fill voids outside of the casing caused by the excessive inflow of water and sand into the pipe. The third small pipe is a steering rod that allows the cutting head to pivot up and down. The steering rod is the most common method used to steer during installation (ASCE 2004), although it allows little horizontal maneuvering. Some horizontal steering can be achieved by attaching a piece of metal

called a “wing” to the side of the casing to induce the pipe to veer in the desired direction as it is jacked.

Figure 2.4. Waterline grade measurement pipe, steering rod, and fluid supply pipe attached to top of casing

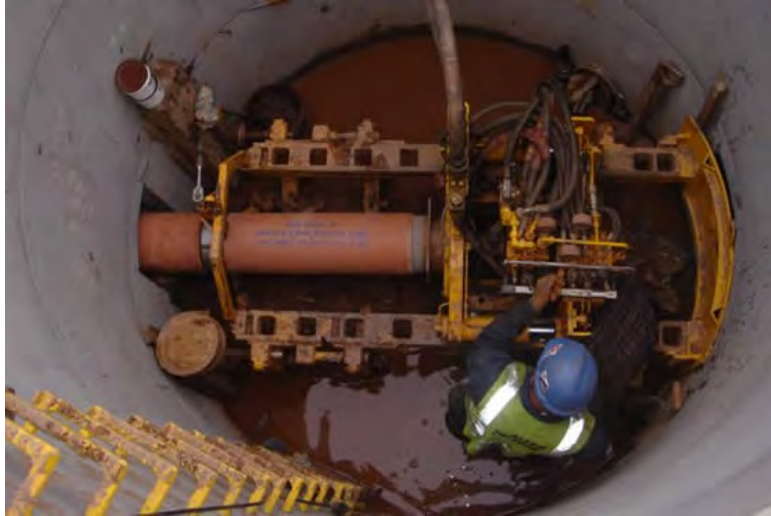
Once the cutting head has emerged in the retrieval pit, a larger diameter auger boring system is connected to the last section of drill rod and jacked into the soil. Attaching the auger boring cutting head to the pilot bore drill string ensures that the path followed by the pilot bore will also be followed by the auger bore. As with conventional auger boring, no drilling fluid is necessary. Additional sections of casing and auger are connected in the launching pit as the bore progresses. The auger bore enlarges the hole to a diameter slightly larger than that of the pipe to be installed. Once the cutting head emerges in the retrieval pit, a section of product pipe is connected one by one to the casing and jacked into place, while the auger and casing sections are simultaneously removed at the retrieval pit (see Figure 2.5).

Figure 2.5. Vitrified clay pipe being installed using guided auger boring (from Allen Watson, Ltd.)

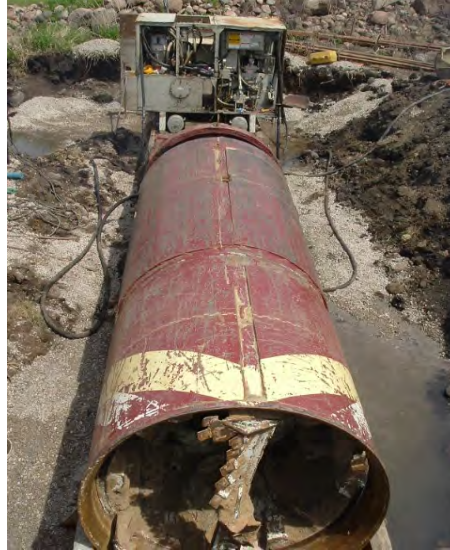
Figure 2.6. Rotating cutter head TBM

TBMs can be classified as either stationary shield excavator machines or rotating cutter head wheel machines. A stationary shield TBM requires personnel at the excavation face to remove the soil with hand tools while the machine is steadily advanced into the borehole by a hydraulic jack positioned behind the borehole in the launching pit. A rotating cutter head TBM (see Figure 2.6) excavates the soil using cutter heads rather than hand tools. The TBM's functions, including cutter head rotation, jacking rate, steering, and spoil removal, are controlled by an operator seated inside the machine. A laser is generally used to monitor line and grade. Steering is accomplished by adjusting the angle of the cutter head. A variety of cutter heads are available, such as fully open, sand shelves, open-face, and closed-face cutter heads. Spoil is removed by

either a conveyor or a cart on which the cuttings are deposited at the cutting face before they are transported out of the machine for disposal (Mathy and Kahl 2003). The most common diameters for TBMs are 48 to 72 inches, although TBMs can be as large as 12 feet in diameter. A cross-section of a TBM is shown in Figure 2.7.

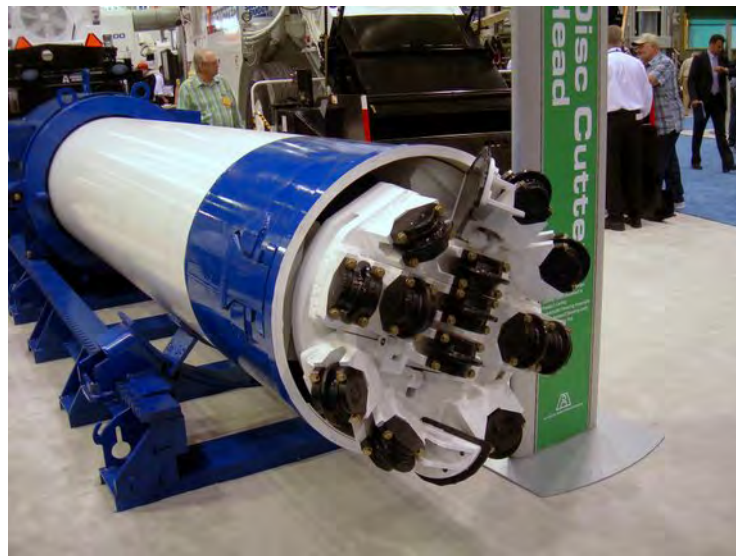
Figure 2.8. MTMB with disc cutter head on display (photo by Charles T. Jahren)

MTBMs are mostly used for installing gravity pipelines, such as for a sanitary or storm sewer. ASCE's *Standard Construction Guidelines for Microtunneling* (2001) defines the procedure as "a remotely controlled, guided pipe jacking technique that provides continuous support to the excavation face and does not require personnel entry into the tunnel." Drilling slurry is typically used to transport spoil. MTBMs (see Figure 2.8) are available with inside diameters ranging from

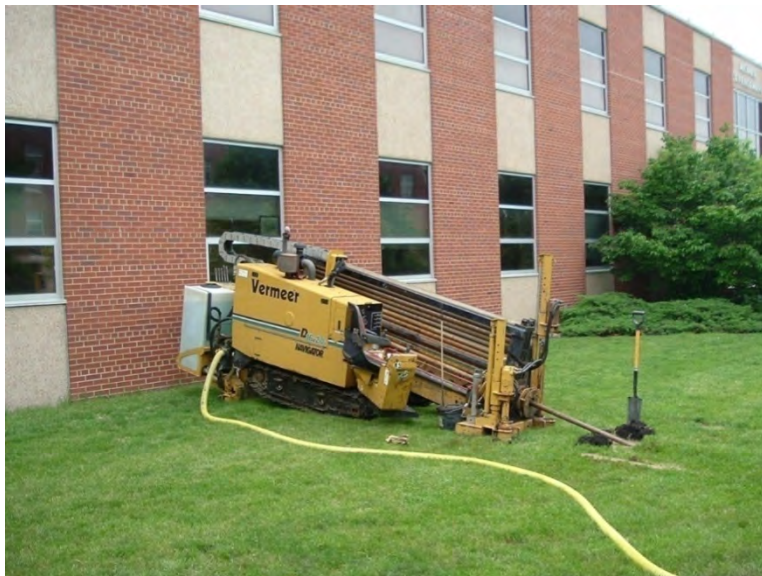
Figure 2.10. Directional drilling machine

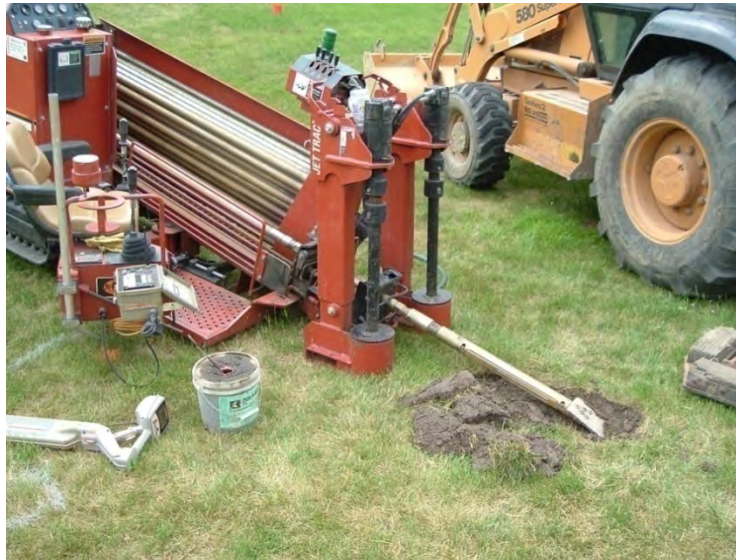
Figure 2.11. Pilot bore being started by pushing drill bit into soil

A small-diameter pilot bore, usually between 1 and 5 inches in diameter, is then drilled into the soil from the boring machine to the receiving pit (see Figure 2.11). The bore begins at the ground surface and proceeds downward at an angle of 8° to 15° until the target depth is reached (Treadway 1997). The drill bit is advanced by pushing and spinning the drill rod using the hydraulic machinery of the drill rig. A sonde (transmitter) attached to the drill bit allows a handheld locator at the surface to monitor the position of the drill bit in the ground. When course correction is not required, the drill rod is spun, which spins the attached bit and cuts the soil. The soil in the path of the drill hole is partially removed to the launching area and partially displaced and compacted into the sides of the borehole. Information was not available about the amount of soil displaced and the amount compacted into the sides of the borehole. When a course correction is required, the bit is rotated to a specific angle measured by clock position. Then, the bit is pushed into the soil without rotation. The slant-head bit is shaped in such a way that it will deflect the drill rod in the desired direction (see Figure 2.12). Additional sections of drill rod are added as the bore progresses. These drill rods are made of a special alloy steel and are designed to handle the stresses caused by the sag bends and directional changes. The rods are hollow, permitting drilling fluid to be pumped through them to the bit (Woodroffe and Ariaratnam 2008).

A slant-head drill bit, such as the one shown in Figure 2.11, is used for drilling operations in soft soils. A mud motor drill head fitted with a roller cone drill bit is used for consolidated or tightly compacted formations. Various reamer types exist, such as the barrel, blade, delta, fluted, fly cutter, and spiral reamer. Each reamer type is designed to be appropriate for particular soil conditions. A barrel reamer is used in soft conditions because it helps create stable borehole walls. A blade reamer, such as the one shown in Figure 2.13, is used in normal sands and clays and come in sizes up to 26 inches in diameter. A delta reamer is a type of blade reamer that is optimal for harder soil conditions, such as stiff clays. A fly cutter reamer is used for even harder soil conditions, such as sandstone and siltstone. A fluted reamer is suitable for most ground conditions, although it has a risk of “balling up” in clay if improper drilling fluid is used. A spiral reamer is used for loose and stony soil. Each type of drill bit and reamer contains small nozzles

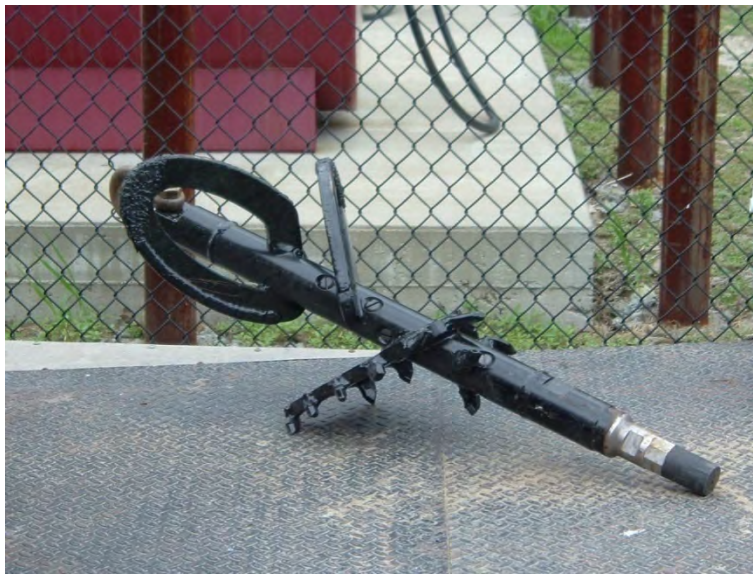
Once the initial pilot hole has been completed and the drill bit has emerged into the exit pit, it will be replaced with a reamer (also called a “back reamer”) (see Figure 2.13) that will be rotated and pulled back toward the drilling machine. This process will both enlarge the hole and smooth any sharp bends that may have occurred while drilling the pilot hole. The back reaming may be completed in one pass or in several passes with reamers of progressively larger diameters. The product pipe will be attached to the reamer before the final pullback to complete the installation of the pipe (see Figure 2.14). Typically, product pipe pullback is the operation that causes the highest pullback stresses, due to the friction between the product pipe and the wall of the borehole. (Najafi, 2005)

Figure 2.13. Reamer with 14-inch-diameter

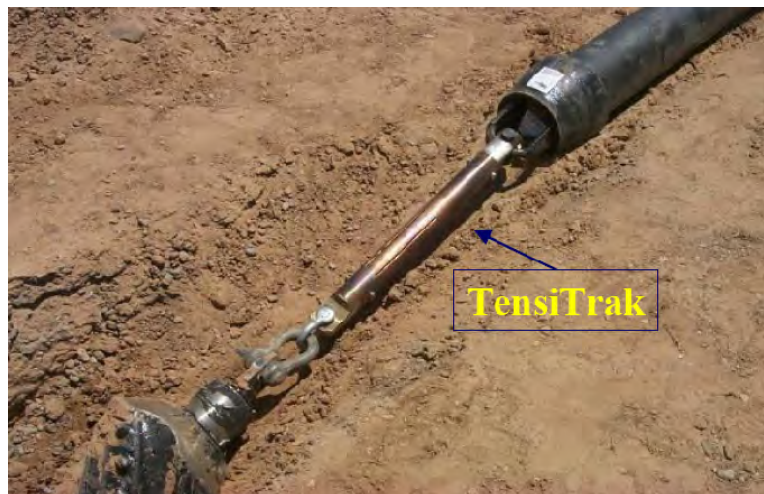
Project specifications require a weak-link device to be attached between the reamer and product pipe during installation. A weak-link protects the pipe from excessive tensile stresses. Newer equipment is also available, such as the “TensiTrak” device, that measures the pullback forces and reports the results to the operator (see Figure 2.15). American Society for Testing and Materials (ASTM) pipe standards are used to determine the allowable tensile load for setting weak-link devices.

Figure 2.15. Weak-link device (trade name “TensiTrak”) (NASTT 2005)

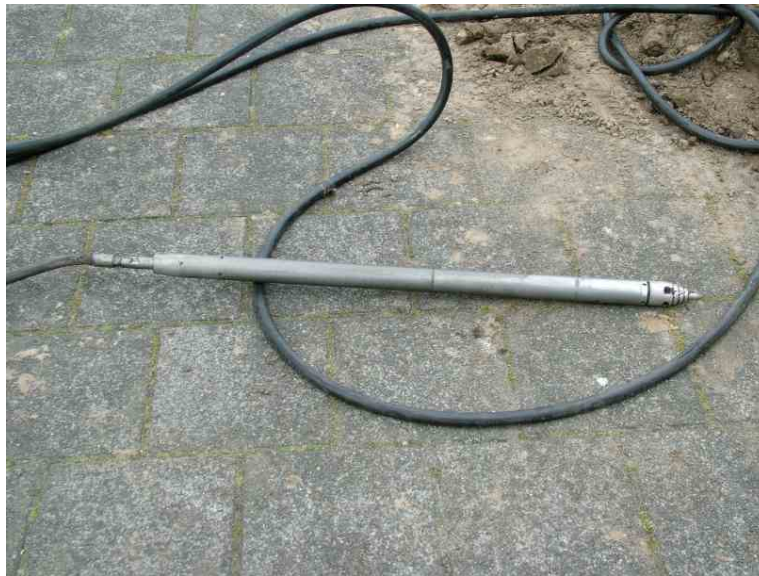
No soil is removed during impact moling. Instead the mole compresses the soil in front of the device, resulting in lateral soil deformation as the bore is advanced (see Figure 2.18). This makes impact moling suitable for compressible soils. Similarly, impact moling can be inappropriate in stiff soils that resist deformation and unsuitable for loose sands and gravels because of the

Figure 2.18. Impact mole

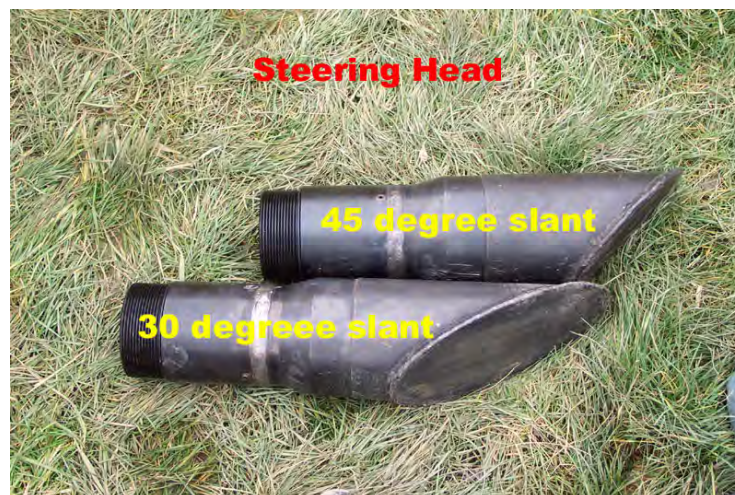
PTMT was first introduced in the United States in 1995 and has been becoming increasingly popular as an alternative to microtunneling. PTMT is used for installing small diameter pipes that require high accuracy. This method can be considered a hybrid of three existing trenchless boring methods. Similar to HDD, a pilot bore head with a slanted face is used (see Figure 2.20). The guidance system is identical to that used in conventional microtunneling, and the auger spoil removal system is similar to that used in auger boring (Boschert 2007).

Figure 2.20. PTMT steering heads (Purdue University)

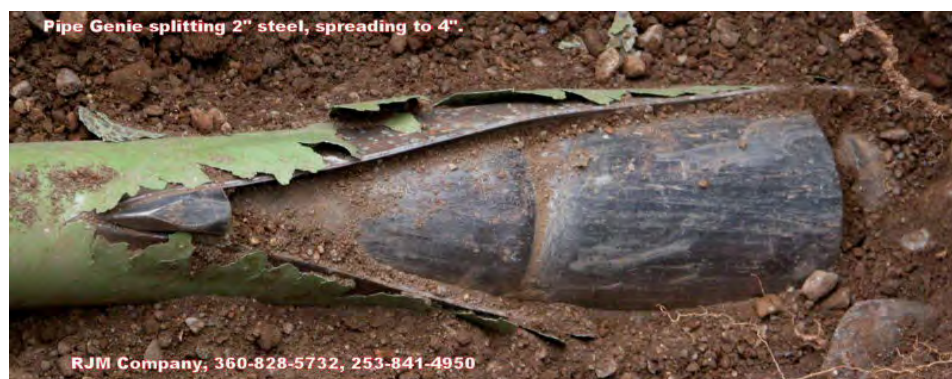
Pipe splitting is a variation of pipe bursting used for ductile pipes, such as steel and ductile iron. Instead of using a bursting head that fractures the pipe radially, pipe splitting uses a splitter, which cuts the existing pipe along one line on the bottom side, slicing it open rather than fracturing it (see Figure 2.25). The pipe is then expanded outward as the tapered splitter is pulled through (Chapman et al. 2005).

Figure 2.25. Pipe splitting (RJM Company)

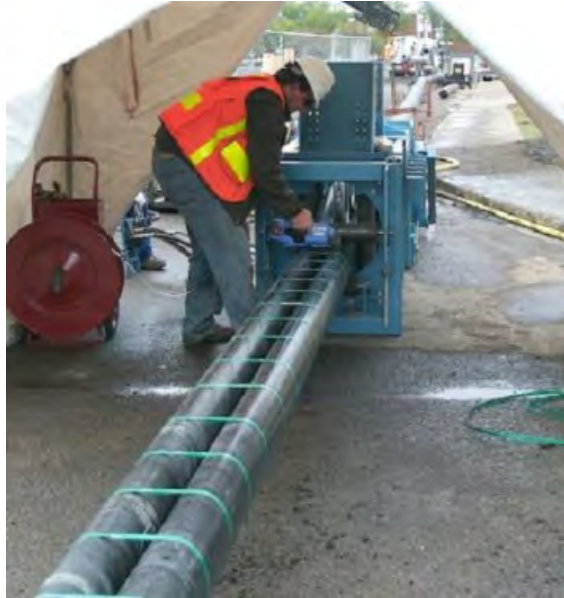
This method reduces the size of the new pipe before it is installed inside the damaged pipe (see Figure 2.26). After installation, the new pipe is expanded back to its original size and shape to provide a close fit with the original pipe. The new pipe can be designed to serve either structural or nonstructural purposes. (Barber et al. 2005)

Figure 2.26. Close-fit pipe (Insituform Technologies Inc.)

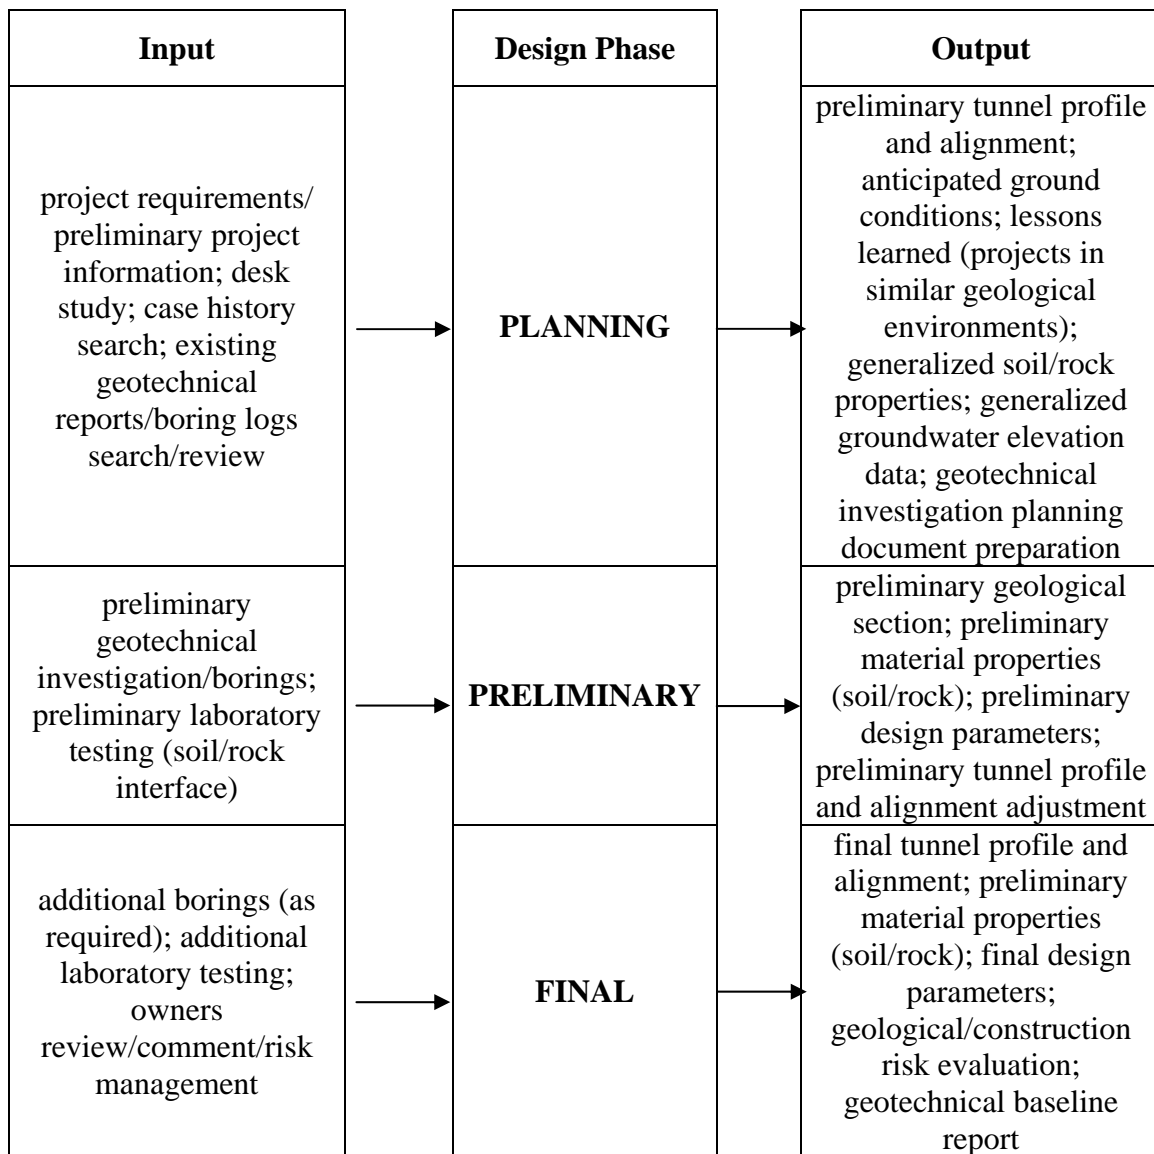
Geotechnical investigations for trenchless projects should typically have three general phases. These phases, which are closely coordinated, progress from planning to investigating to reporting. Figure 2.27 shows a proposed iterative approach of the three phases with possible inputs and outputs (Richardson et al. 2003).

Figure 2.27. Suggested iterative approach for trenchless projects (from Richardson et al. 2003)

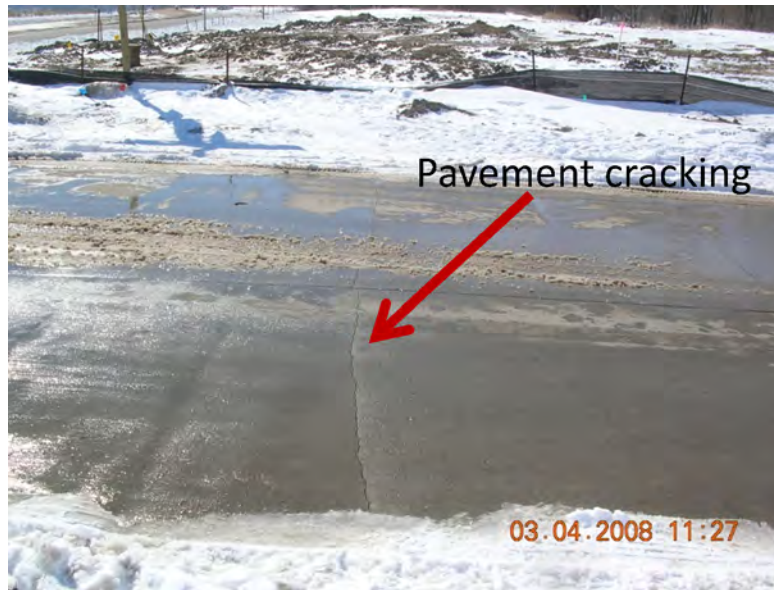
On another HDD project, a problem was encountered when a reamer was lost 15 feet underground. An example of pavement cracking resulting from a shallow HDD bore is shown in Figure 3.15.

Figure 3.15. Pavement cracking caused by HDD installation

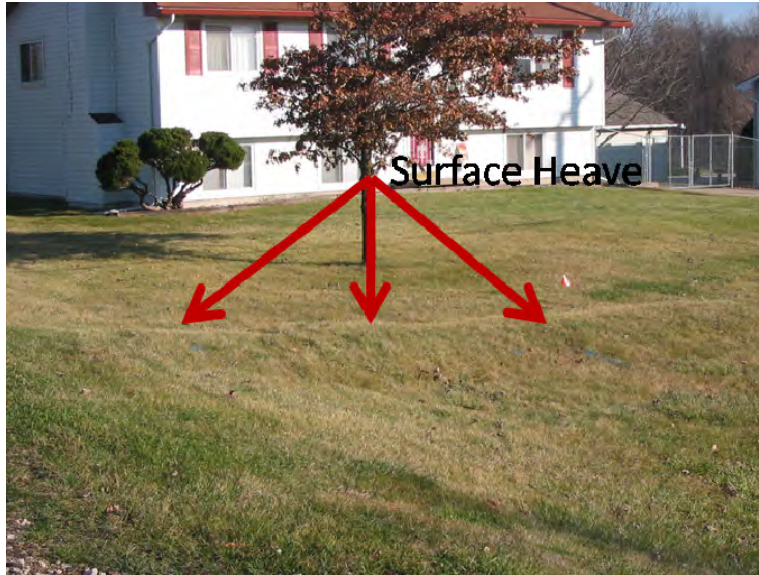
HDD installations that are not back-reamed to a sufficiently large diameter have been observed to cause heave. When the product pipe is pulled into the hole, some of the drilling fluid is displaced and must flow out of the hole. The drilling fluid is expected to pass in the opposite direction that the pipe is being pulled and therefore must travel through the annular space between the outside of the pipe and the edge of the hole. The rule of thumb for HDD is that the diameter of the hole should be 1.5 times the outside diameter of the pipe. However, sometimes contractors do not include the thickness of the pipe and bells or other protrusions on the outside of the pipe when they calculate pipe diameter. If the machine generates high enough pulling force, drilling fluid pressure can become high enough to heave the soil. The designer recalled an instance in which this occurred along an entire installation, heaving soil up to 1.5 feet and disrupting lawns and driveway pavements during the installation of a 12-inch-diameter conduit at a depth of 5 feet (see Figure 3.16).

Figure 3.16. Surface heave on HDD project

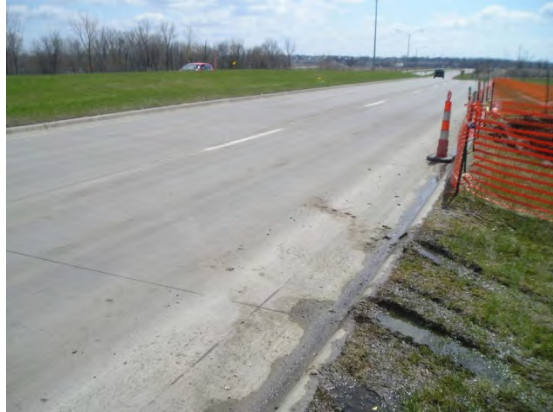
Figure 4.3. North section of State Street above boring; insertion pit visible at right

Trenchless construction was selected to avoid closing the separated four-lane State Street (see Figure 4.3). Auger boring was used by the contractor on this project. Although the contractor had experience with HDD, the contractor chose to use the auger boring procedure because the steel casing was 36 inches in diameter, which was larger than the normal sizes that the contractor had worked with for HDD. Also, the large depth of 20 to 30 feet would require that a direction drilling rig be set up at a considerable distance away from the road in order to have room for the bore to descend from the surface to the prescribed depth.

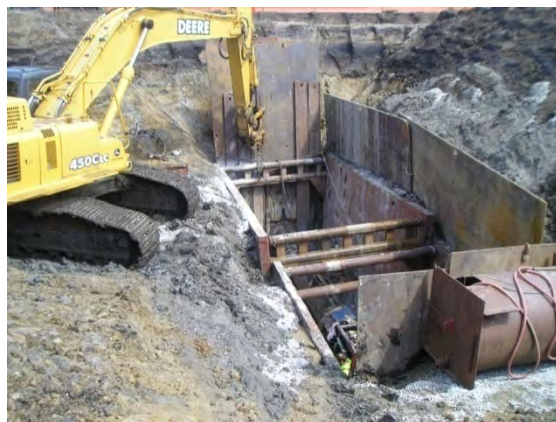
Figure 4.4. Launching pit

After nearby existing utilities were located, the launching pit at point A was dug and steel shoring was installed. Track for the boring machine was laid on a crushed rock base at the proper line and grade in the launching pit. The auger boring machine was then lowered into the launching pit and placed on the tracks, as shown in Figure 4.4.

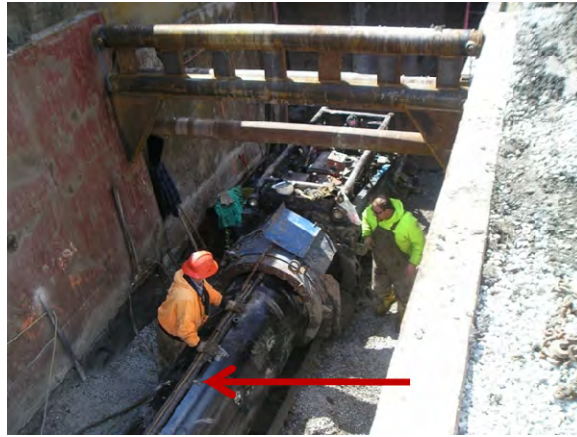
Figure 4.5. Pipe and auger boring machine operation, with fluid supply line, water line, and steering rod running along top of pipe

The auger boring machine had a waterline system to measure the grade of the steel casing and a fluid supply line in case it was needed to deliver drilling fluid or water to the cutting face. A steering rod was also attached to the top of the casing so that slight adjustments could be made to the grade of the steel casing.

The first 20-foot section of casing pipe was lowered into the launching pit with the 20-foot length of auger inside the pipe. The pipe and auger were connected to the machine, and boring began (see Figure 4.5). Soil cuttings were transported back through the casing pipe to the launching pit. A backhoe was used to remove the cuttings to the ground surface. For each new 20-foot-long pipe section, the crew checked the line and grade before welding each pipe section to the pipeline.

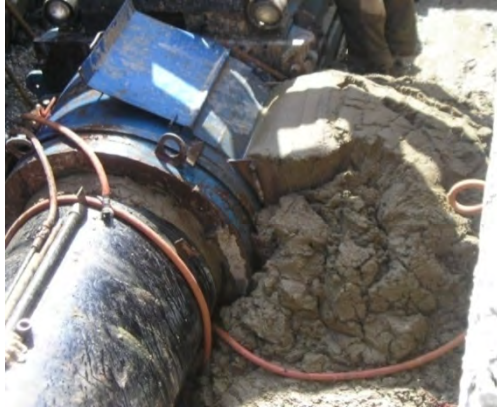
Figure 4.6. Sandy soil deposited out of auger boring machine

After about 100 feet of boring, a sand seam (with no boulders) was encountered (see Figure 4.6). The sand was accompanied by a large quantity of water, which flooded the borehole and left 6 inches of standing water in the launching pit, slowing the installation process. This water flow was due to the high permeability of the sand and the depth of the bore beneath the water table. The loss of volume due to water flow was expected to result in a void forming under the pavement. To avoid future settlement problems and to be able to continue the installation process, the contractor pumped 5 cubic feet of grout to the cutting face through one of the small pipes located immediately above the casing pipe. Pumping grout continued until the pumping pressure started to build up and reached an acceptable level, at which point the void was considered to be filled. No subsidence or other pavement damage was observed, which was a result of the contractor's actions.

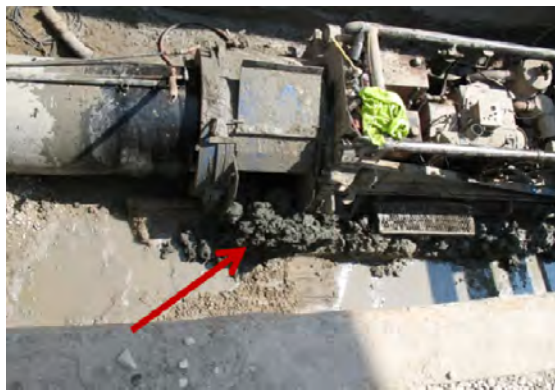
Figure 4.7. Clayey weathered shale deposited out of auger boring machine

Boring through the sand continued for about 30 feet, at which point the soil transitioned back to weathered shale until the completion of the installation (see Figures 4.7 and 4.8). Boring through sand took about one and a half days. The transition to weathered shale greatly increased the rate of construction progress. It was observed that while boring, 10 feet of pipe was installed in 10 minutes.

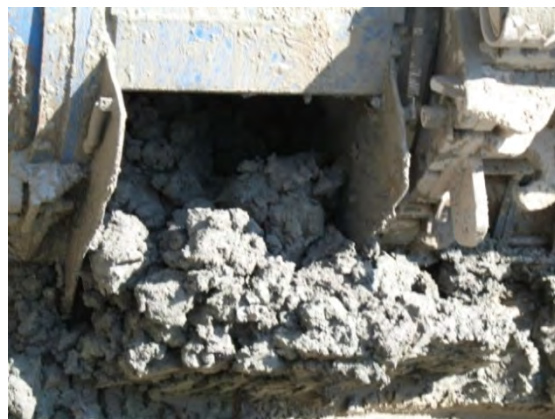
Figure 4.8. Weathered shale deposited out of auger boring machine

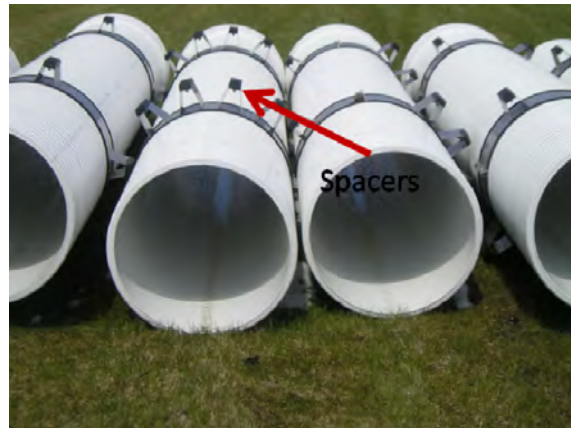
Figure 4.9. Spacers on 18-inch PVC carrier pipe to allow pipe to “float” in casing

After the last section of steel casing pipe was placed, the PVC carrier pipe was installed. Casing spacers (guides) were fastened to the PVC pipe to allow the carrier pipe to “float” in the casing to protect the pipe’s joints and to allow proper positioning (see Figure 4.9). The PVC pipe was then placed in the casing using a backhoe. This process completed the pipeline installation. No additional problems were encountered on this project, and no surface heave or settlement was observed.

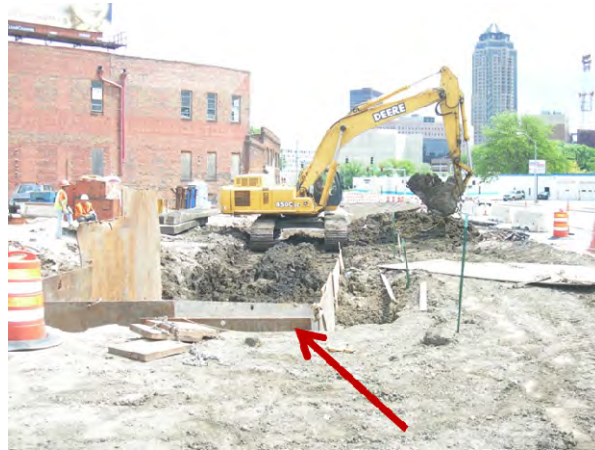
Figure 4.12. Launching pit with trench box and steel plates

After several nearby existing utilities were located, the launching pit at point A was dug and a trench box and steel plates were installed to prevent the walls of the pit from caving in (see Figures 4.12 and 4.13). The area around the overlying telephone vault was stabilized with grout to prevent the development of voids that could undermine the vault. The launching pit took approximately two to three days to build, which was considered typical for a project of this size. The hydraulic jacking equipment was then lowered into the launch pit and assembled. Four separate jacks were set up, with the purpose of each one delivering thrust to a corner of the box

pipe to provide a balanced distribution of jacking force. The jacks used the back wall of the trench box as a thrust block.

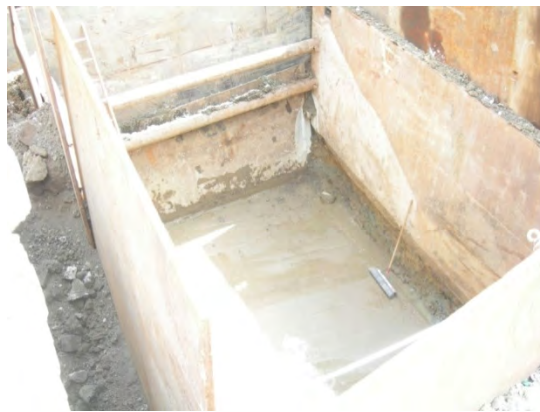
Figure 4.13. Trench box before installation began

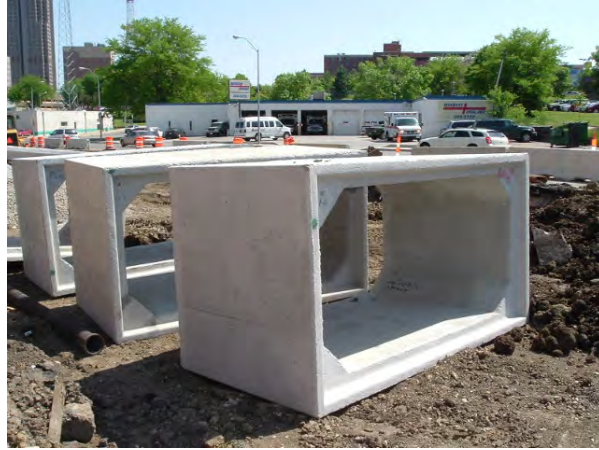
Figure 4.14. Segments of 10-foot by 5-foot RCBCs

The first 6-foot-long box pipe section (see Figure 4.14) was placed into the pit using a backhoe. Connections were made to the jacking equipment and the jacking began. However, progress was halted immediately because of problems with the connection between the hydraulic jacks and the back of the trench box, which the jacks push against. The contractor fixed the connection by welding additional steel plates between the jacks and the trench box to stabilize the connection. The jacking then resumed. It was important to launch the tunnel correctly because it is difficult to correct an initial misalignment.

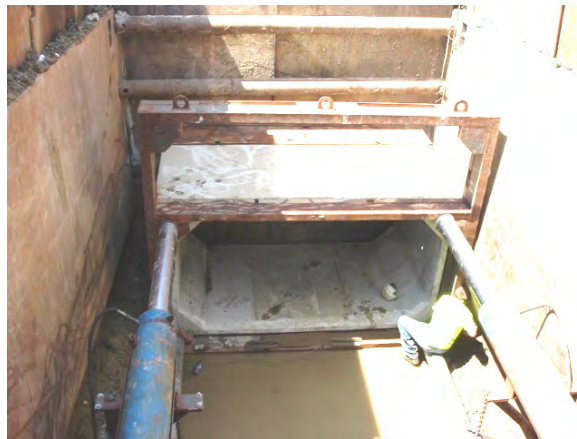
Figure 4.15. Jacking begins on the first box pipe section

The first box pipe was then jacked into the soil, using a mini road header to excavate the soil (see Figures 4.15 and 4.16). The spoil was then moved out of the pipe using a skid loader (see Figure 4.17) back to the trench box where the backhoe removed it. The contractor was hoping to install the pipe at a rate of about 4 feet per day.

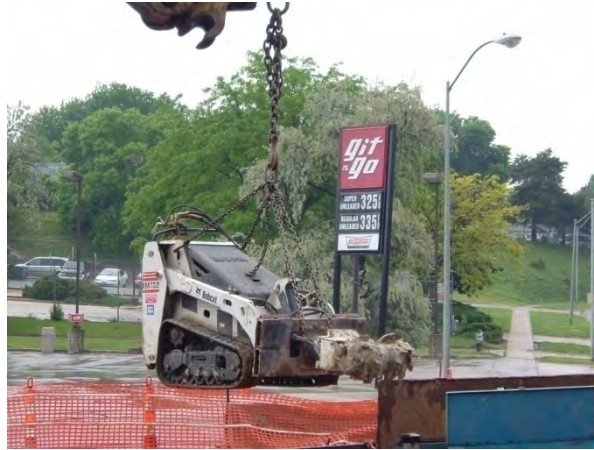
Figure 4.16. Mini road header used to excavate soil as pipe was jacked in

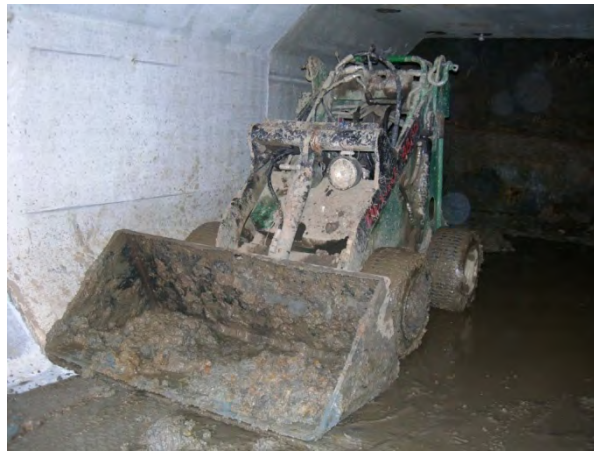
Figure 4.17. Skid loader used to move spoil from pipe to trench box to be removed by backhoe

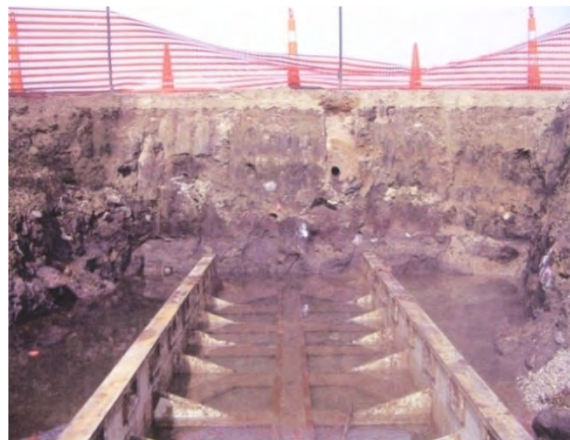
Figure 4.20. Partially flooded launching pit at point A, with track installed prior to tunneling

After nearby existing utilities were located, the launching pit at point A was dug, and a bed of 0.75-inch maximum size gravel, 6 inches thick, was laid in the launching pit. The track for the TBM was then placed on the gravel bed at the correct line and grade. The distance from the top of the pipe to the pavement was approximately 2.6 feet at the closest point, which occurred at the beginning of the installation on the east side (see Figure 4.20).

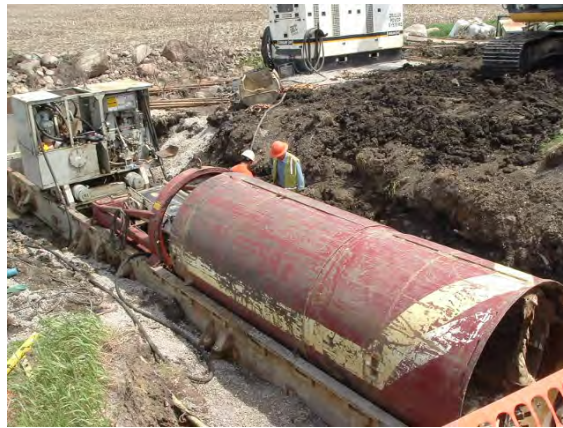
Figure 4.21. TBM before starting the bore

The TBM had limited steering capability, so it heavily relied on the accuracy of the initial track placement (see Figure 4.21). A laser sight was used to determine if the TBM was on target. A

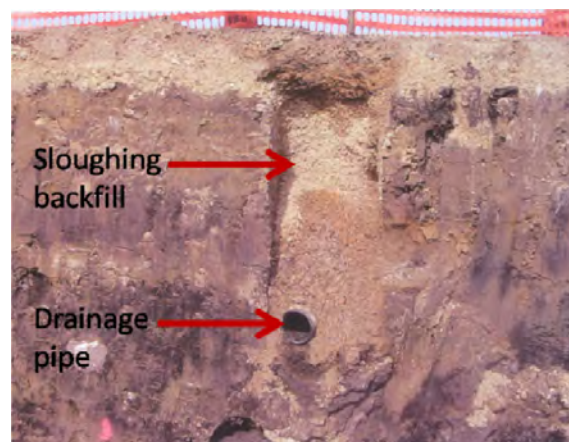
Figure 4.22. Existing granular backfill over a drainage pipe begins to slough away

The TBM was jacked to the start of the bore and the cutter blades were spun, excavating the soil. As progress began, sloughing off the pea gravel fill above an existing perforated HDPE drainage pipe caused some concern (see Figure 4.22). However, it was thought that the loss of material would not propagate as far as the pavement surface, so the bore proceeded. As predicted, this did not develop into a serious problem, and the lost pea gravel was replaced.

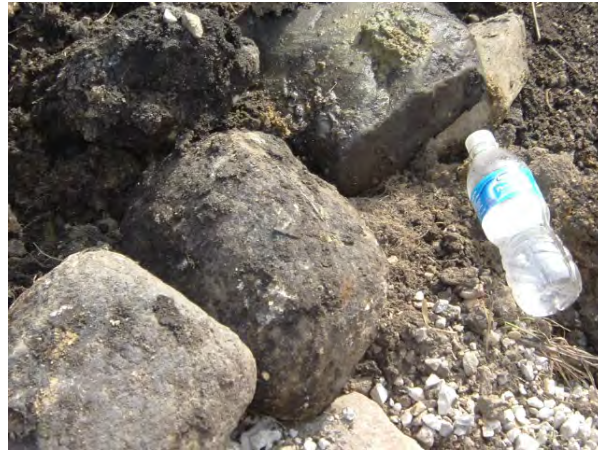
TBM was jacked into the bore to advance the excavation. A large number of glacial boulders between 12 and 18 inches in diameter that were encountered significantly slowed progress (see Figure 4.23). A much larger quantity of these boulders was found than had been expected. The reason they were found at such a high concentration and close to the surface is likely because past highway construction practices allowed boulders to be included in the fill.

Figure 4.23. Boulders removed from the borehole (12 to 18 inches in diameter)

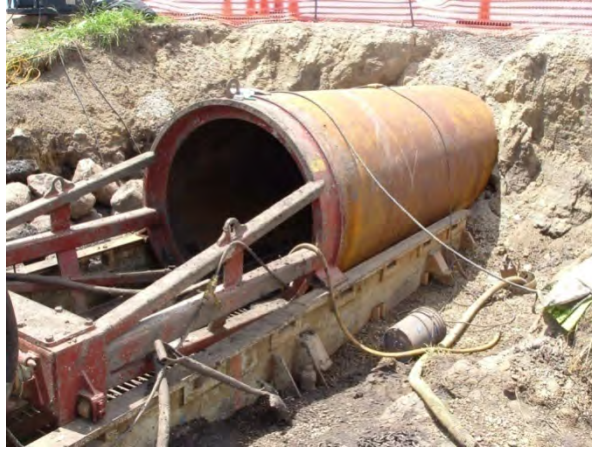
The pipe sections were attached behind the TBM and jacked into the borehole as the TBM was advanced (see Figure 4.24). The pipe sections were each 20 feet in length and were welded together. The drill head was 14 feet long.

Figure 4.24. Pipe being jacked into the soil behind the TBM

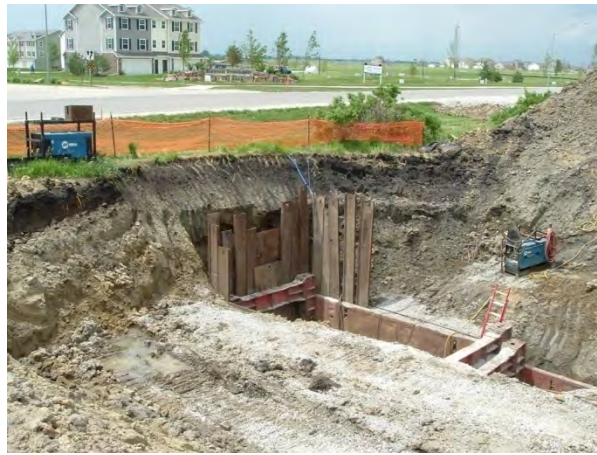
Figure 4.28. Launching pit with Delaware Avenue in background

After nearby existing utilities were located, the launching pit at point A was dug (see Figure 4.28). Next, steel shoring was installed (see Figure 4.29), and track for the boring machine was laid on a crushed rock base at the proper grade in the launching pit. The auger boring machine was then lowered into the launching pit and placed on the tracks.

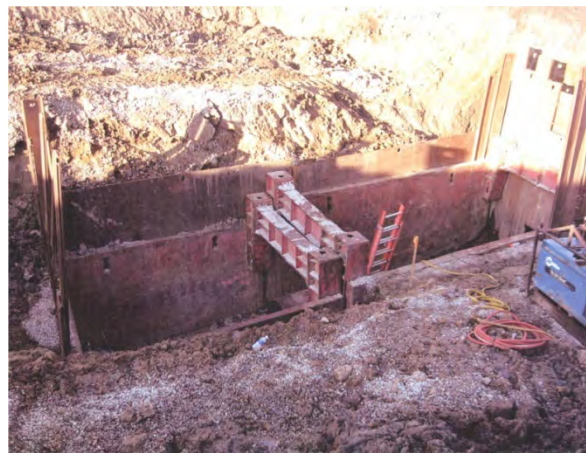
Figure 4.29. Launching pit with shoring and gravel base

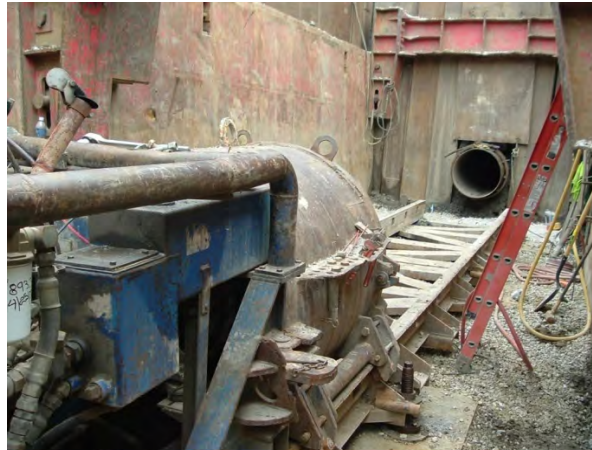
time a new 20-foot pipe section was welded to the pipeline. A flashlight was placed inside the pipe, and a transit was aimed at the light to measure the bore's position relative to the planned centerline. The crew discovered that the bore was drifting left; a correction was required. A wing was installed on one side of the pipe. This wing deflected the pipe back on course and was removed after the installation was complete.

Figure 4.30. Launching pit before a new 20-foot pipe section is lowered into place

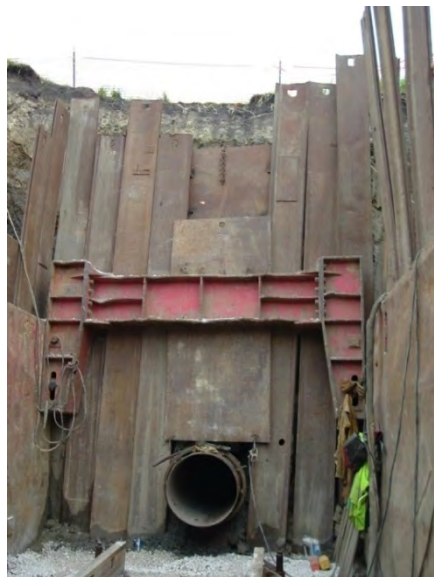
Figure 4.31. Protruding casing after boring is finished

The course of the pipe was corrected, and the installation was successfully completed (see Figure 4.31). The carrier pipe emerged at the manhole vault at point B within accuracy tolerance.

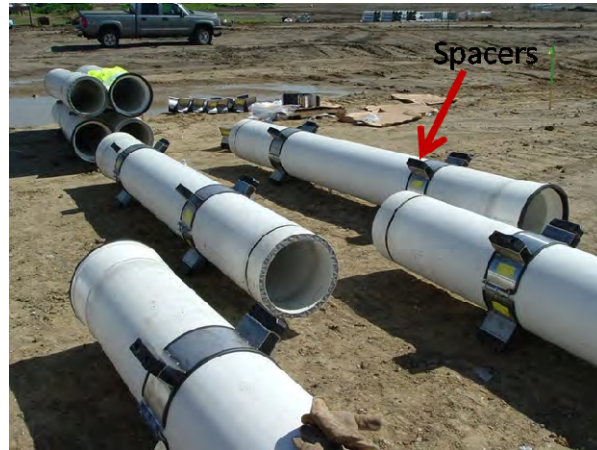
After the last section of steel casing pipe was placed, the PVC carrier pipe was installed. Casing spacers were fastened to the PVC pipe to allow it to “float” in the casing and correctly position the carrier pipe (see Figure 4.32). The PVC pipe was then placed in the casing using a backhoe. This completed the pipeline. No additional problems were encountered on this project, and no surface heave or settlement was observed.

Figure 4.32. PVC carrier pipe with visible spacers

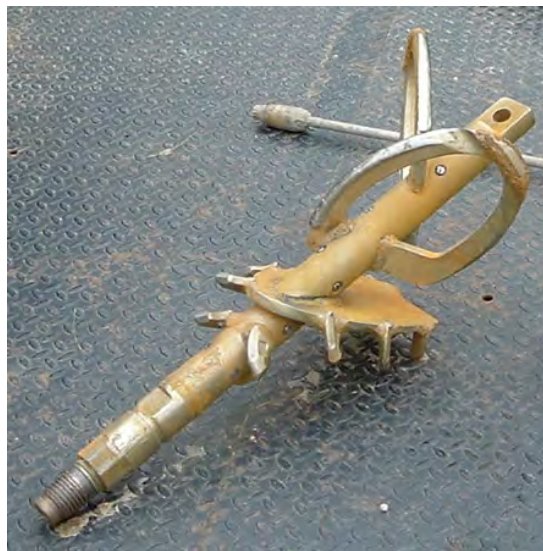
Figure 4.37. Twelve-inch-diameter reamer

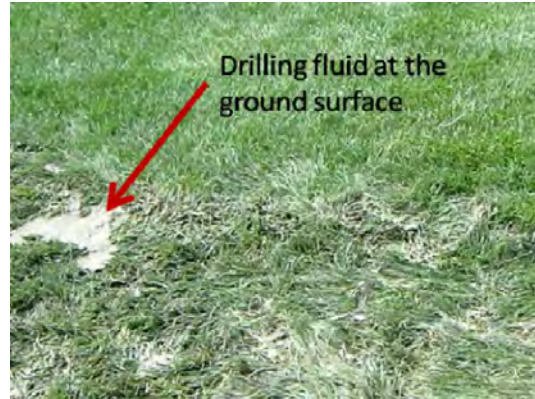
Figure 4.39. Edge of frac-out region with drilling fluid at the ground surface

A possible initial cause of the frac-out is that the gravel may have caved in behind the reamer. In addition, stiff clayey soil cuttings may have clogged the previously enlarged hole and prevented the evacuation of drilling fluid to the exit pit. The reamer itself may have also become clogged with clay solids, preventing the drilling fluid from flowing through the reamer and out through the smaller pilot borehole toward the entry pit. This clogging may have led to rising fluid pressures and the eventual soil fracturing along planes of greatest weakness. Another possibility is that the drilling fluid flowed out of the borehole in a direction roughly perpendicular to the bore path and finally reached the surface 20 feet away as a visible frac-out. The appearance of these inadvertent returns can be seen in Figure 4.39, which shows the edge of the frac-out. This hypothesis is supported by the later subsurface soil investigation in the area where the frac-out occurred; sandy soil was observed in that area. Additional damage was done to subsurface sprinkler water main pipes at a depth of 10 feet.

The surface heave that followed the frac-out several hours later is thought to have resulted from a similar mechanism. At the location of the surface heave, the subsurface investigation showed that stiff clay existed between the ground surface and the location of the HDD construction work. Although the reamer had, by this time, passed the subsurface gravel, stiff clays continued to slow the progress so that fluid pressures in the borehole may have reached sufficiently high levels to rupture the sides of the borehole. If the drilling fluid could not escape, it may have displaced the soil upward. The heave mechanism may have released enough pressure so that a frac-out did not occur.

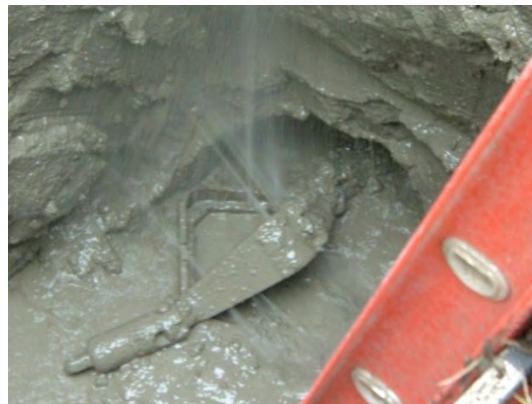
Figure 4.41. Reamer shown jetting drilling fluid in point D exit pit just before pullback

After the contractor finished pulling the 12-inch-diameter reamer back from the exit pit to the entry pit, the reamer was removed. A more powerful drill rig had been rented to increase the speed of the bore and to accomplish the pullback of an 18-inch-diameter reamer with the product pipe attached during the same pull. The 2-inch-diameter drill string was easily pushed back through the borehole to the exit pit. There, an 18-inch-diameter reamer was attached to the drill string so that it could be pulled back through the borehole to increase the diameter (see Figure 4.41). Two 4-inch HDPE conduits were also connected to the back of the 18-inch reamer. The two conduits simultaneously pulled side by side created an effective conduit outside diameter of 10 inches in an 18-inch borehole, which falls within the HDD rule of thumb for a borehole-to-pipe diameter ratio between 1.5 and 2 to 1.

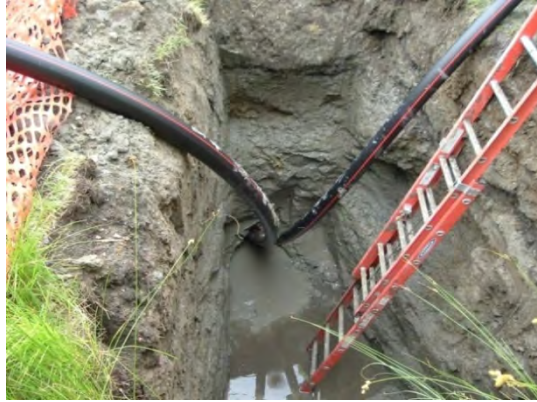
Figure 4.42. Installation of two conduits connected behind 18-inch reamer at point D

The 18-inch reamer was then reattached to the drill string with the product pipe. Although the borehole had already been pre-reamed once with the 18 inch reamer, it was necessary to reattach the reamer for a second pullback to ensure that the borehole would be clear of debris that may have caved in after the last reamer pass. This pullback and installation was completed smoothly because the already enlarged borehole required only a reasonable amount of pullback force (see Figure 4.42).

The new drill rig had a gauge for monitoring pullback forces, and it was observed that the successful pullback of the pipe and reamer through the already enlarged borehole required a nominal pullback force (3,000 pounds), while the previous pullback of the 18-inch reamer through the 12-inch hole required much less pullback force (500 pounds). This force difference indicates that the pullback friction of the pipe against the edges of the borehole caused a large increase in the required pullback force. The 18-inch reamer pullback and the following 18-inch reamer with product pipe pullback took a combined three days to complete.

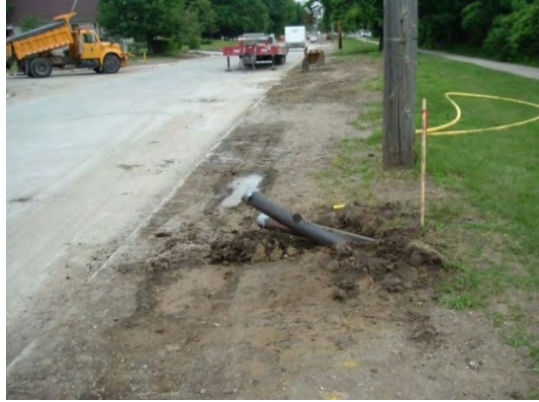
Figure 4.43. Capped 4-inch HDPE pipes after installation at point E next to Beach Avenue

In light of the difficulties encountered during the practice field drilling, a different drilling fluid mix was used for the second bore. This time, a polymer-based drilling fluid with a clay inhibitor additive and less bentonite was used. The pilot bore was quickly finished, and the effectiveness of the drilling fluid mix encouraged the contractor to back ream a 12-inch-diameter reamer attached to the two 4-inch HDPE conduits. Although this procedure created a 12-inch hole for the 10-inch-diameter product, which violated the 1.5 to 1 rule of thumb, the contractor considered it adequate given the ease with which the pilot bore had been accomplished and the relatively short distance. This operation was completed successfully and without incident in one day (see Figure 4.43).

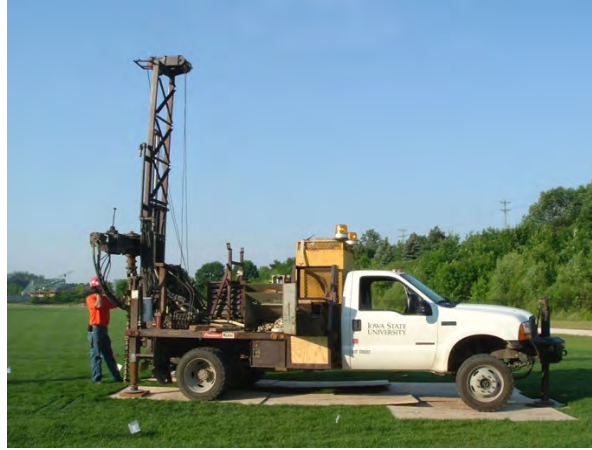
Figure 4.44. Drill rig used by research team to recover soil samples

The research team drilled five test boreholes near the areas of frac-out and surface heave to better understand the soil types in these areas and to formulate theories for the reasons behind these occurrences (Figure 4.44). Samples of the disturbed soil were taken at various depths, and 2- and 3-inch-diameter thin-walled Shelby tubes were recovered. The soil samples from the Shelby tubes and the bagged samples of disturbed soil were tested in the laboratory.
