Identification of Practices, Design, Construction, and Repair Using Trenchless Technology

Final Report
October 2010

IOWA STATE UNIVERSITY
Institute for Transportation

Sponsored by
Iowa Highway Research Board
(IHRB Project TR-570)
Iowa Department of Transportation
(InTrans Project 07-288)

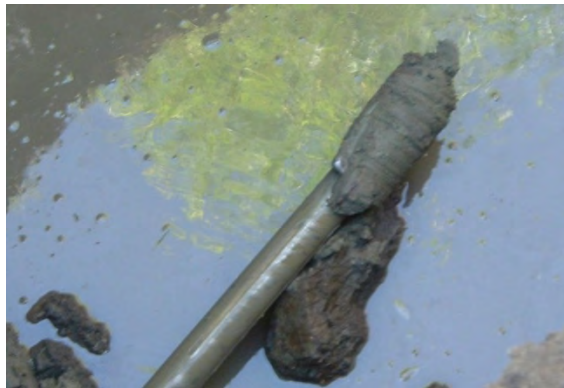
Figure 4.53. Clay-caked drill bit shown after emerging into the exit pit at point D

These problems may not have occurred if a polymer drilling fluid that emulsifies clay been used instead of the sodium bentonite slurry that was selected because sodium bentonite is more effective for granular material. Instead, the clay remained sticky and coated the pilot bore drill bit and, later, the reamer. The clay-caked pilot bore drill bit can be seen in Figure 4.53. However, the contractor used bentonite because of the concern of possibly encountering sand. A polymer slurry would not have been as effective as bentonite in stabilizing the borehole if sand were

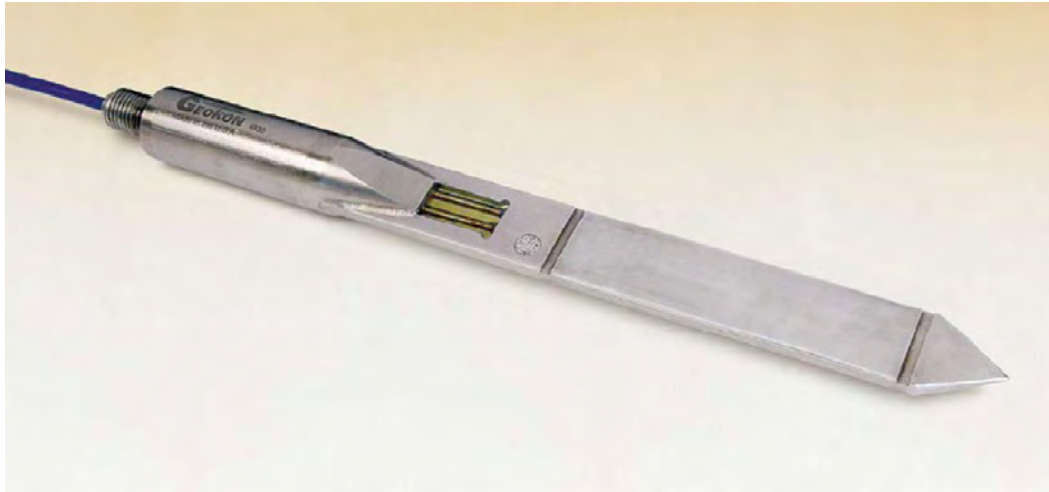
Figure 4.54. Geokon model 4830 push-in pressure cell (from Geokon)

To measure the soil pressure changes during construction, a push-in pressure cell was installed near the bore path. The instrument selected was the Geokon model 4830 push-in pressure cell, which uses vibrating wire technology to measure total stress, pore water pressure, and temperature (see Figure 4.54). Two of these instruments, each with a range of 25 psi, were purchased. This range was exceeded on several occasions; however, the manufacturer informed the research team that the effect would be a shift in baseline readings, which could be corrected by taking new zero readings after the pressure cells were removed. One note is that the pressure cells were designed to be installed by a conventional drill rig.

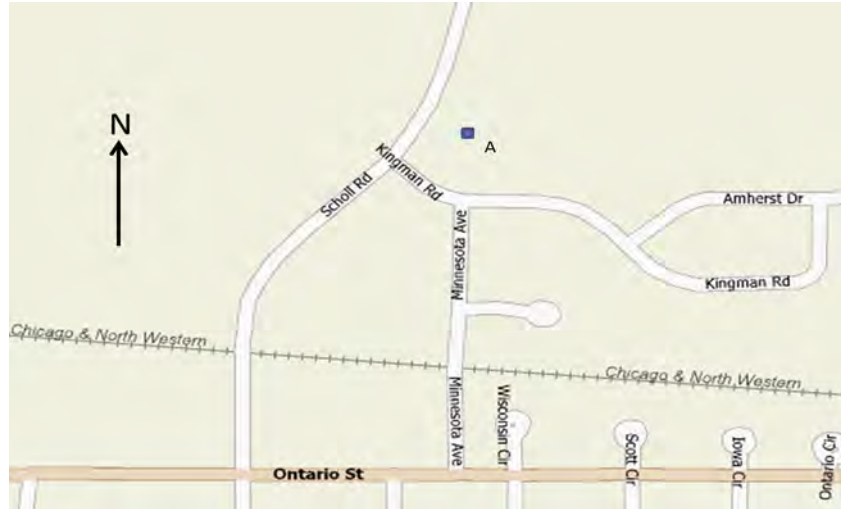
Figure 4.55. Location of pressure cell testing at Spangler Geotechnical Laboratory in Ames, IA

Because most planned projects were in close geographic proximity to the experimentation site and the soils at these sites were stiff clay glacial till, the pressure cells were tested at the Spangler Geotechnical Laboratory experimentation site in Ames, Iowa (a site with similar soil properties), in April 2008 to collect sample data (see Figure 4.55). An open area was selected where soil data were available from previous research (see Table 4.6). A conventional drill rig was brought on-site to install the instruments. The drill rig first drilled an instrumentation hole through the clayey soil to a depth of 5 feet, at which point the drill bit and auger were removed from the drill rig and push-in pressure cell A was attached to a drill rod. The drill rig then vertically pushed the pressure cell into the ground to a depth of 5 to 7 feet. Due to the instrument configuration, the sensors in the pressure cell were centered at a depth of 6.5 feet, which is a common depth for water main installations. A similar process was used to install pressure cell B. The pressure cells took readings for 27 days, which are shown in Figure 4.56.

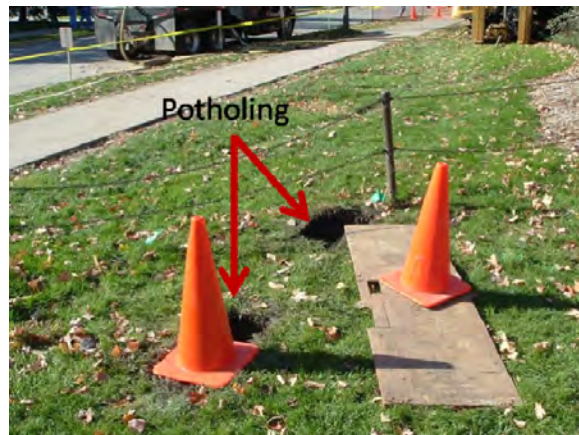
Figure 4.59. Potholing to verify position of nearby utilities

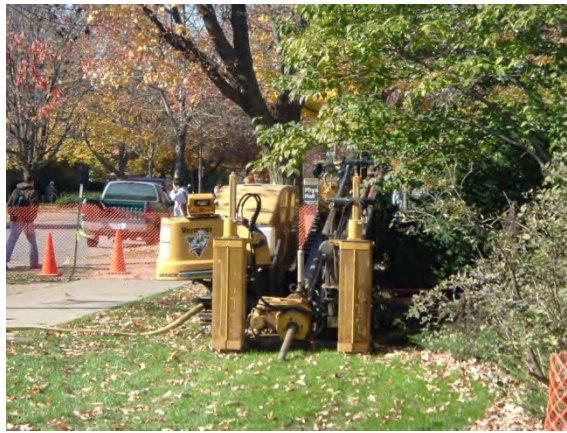
Figure 4.60. Directional drilling machine

The pilot bore began by attaching a 4-inch drill bit to the directional drilling machine and pushing the bit into the ground. As the pilot bore proceeded, periodic adjustments were made to the depth and direction to keep the bore online and to avoid nearby utilities. The borehole was drilled to a depth of about 6 feet to the expected top of pipe, except where vertical steering was necessary to avoid existing pipe. Figure 4.60 shows the position of the drill rig at point B while

pilot boring from point B to point C. The pilot bore was successfully conducted, and the drill bit emerged in the exit pit after about two hours.

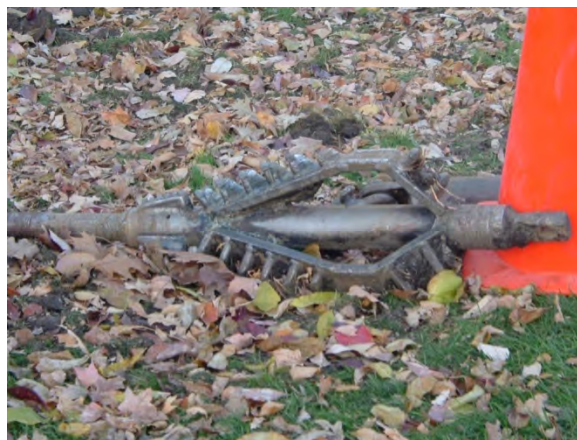
Figure 4.61. Fourteen-inch reamer

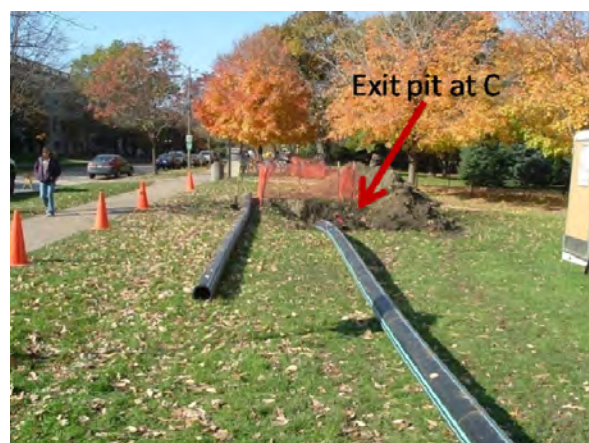
Figure 4.63. HDPE pipe being pulled from exit pit at point C to launching pit at point A

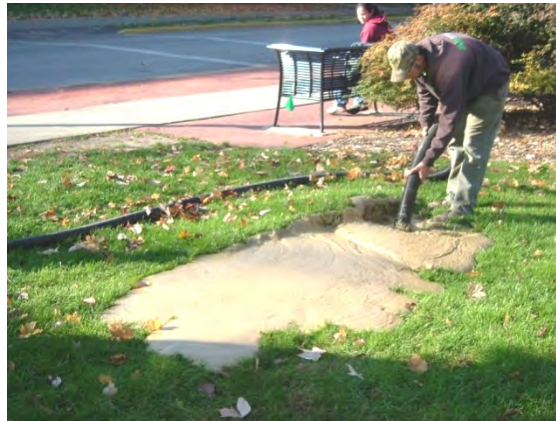
Figure 4.64. Drilling fluid at ground surface resulting from frac-out

The pipe installation continued as expected until another frac-out occurred at point G, approximately 30 feet east of the pressure cell at point E. This point was about 100 feet west of the drilling machine at point B. Fluid pressures in the borehole had again built up and created a fissure in the borehole wall that propagated to the ground surface. The installation was again halted, and a vacuum was used to remove the drilling fluid from the ground surface (see Figure 4.64).

The contractor tamped down the ground surface at the location of the frac-out in order to close the fissure and then restarted the boring. More drilling fluid seeped through the crack, however, so the rate of machine pullback was decreased to keep drilling fluid pressure low enough to prevent further frac-outs. The contractor was then able to successfully finish the 495-foot installation.

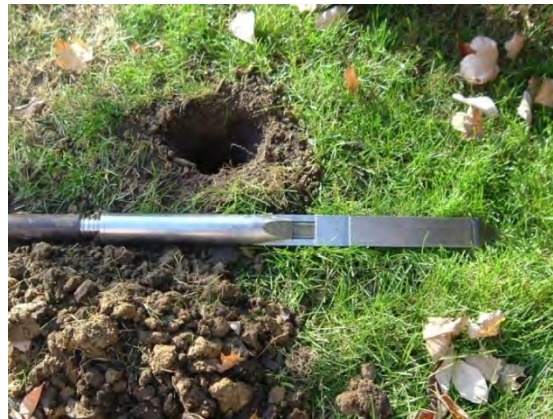
Figure 4.65. Push-in pressure cell before installation

Additionally, a third vertical instrumentation hole was drilled at point E at a distance of 1 foot from the centerline of the planned bore path to a depth of 5 feet. Once this depth was reached, the drill bit and auger were removed from the drill rig and the push-in pressure cell was attached to a hollow rod (see Figure 4.65). This pressure cell was then vertically pushed into the ground by the drill rig to a depth of 5 to 7 feet (see Figure 4.66). The flat side of the pressure cell was parallel to the planned horizontal borehole. The sensors in the pressure cell were centered at a depth of 6.5 feet, matching the intended HDD installation depth. The lateral distance between the face of the pressure cell and the center of the bore path was measured to be 1.3 feet (see Figure 4.67). The contractor's pilot bore commenced one hour after the research team finished installing the pressure cell.

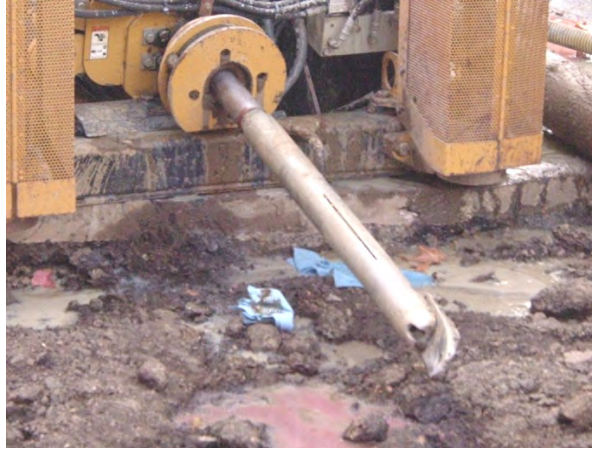
Figure 4.76. Pilot bore drill bit attached to drill rig

The pilot bore began by attaching a 4-inch drill bit to the directional drilling machine (see Figure 4.76) and using the machine to push the drill bit into the ground. The pilot bore proceeded with periodic adjustments to the depth and direction to keep the bore online (see Figure 4.77). The borehole was drilled to a depth of about 6 feet to the expected top of the pipe. The pilot bore was successfully conducted, and the drill bit emerged in the exit pit at point C.

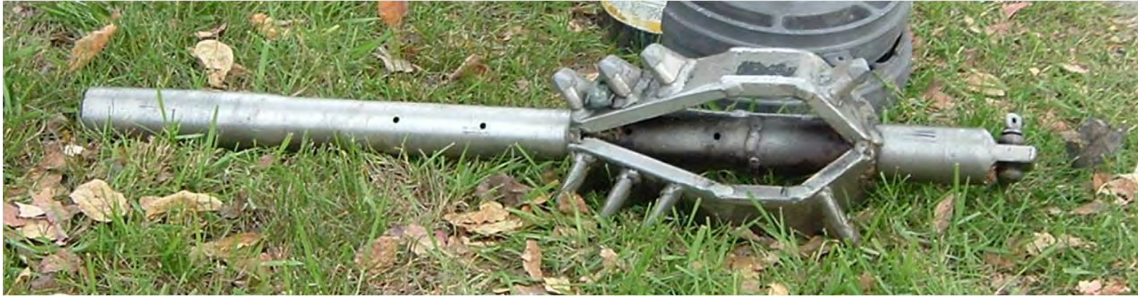
Figure 4.78. Ten-inch reamer

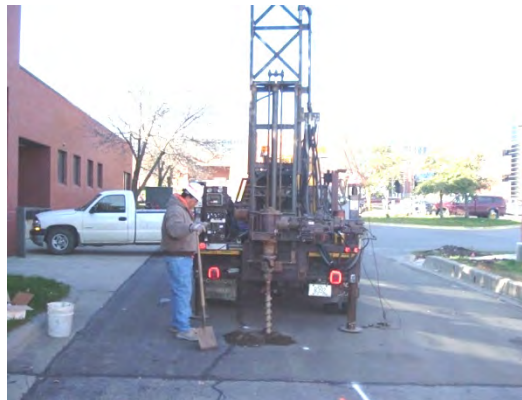
Figure 4.80. Drilling a borehole through asphalt

Two vibrating wire push-in pressure cells were installed at point B. To install them, a hole was first drilled at a lateral distance of 3 feet from the planned bore path (see Figure 4.80). This instrumentation hole was drilled to a depth of 5 feet, at which point the drill bit and auger were removed from the drill rig and the push-in pressure cell denoted “B” was attached to a drill rod. The drill rig then vertically pushed the pressure cell into the ground to a depth of 5 to 7 feet. This procedure placed the flat pressure-sensing side of the pressure cell parallel to the planned horizontal borehole. Due to the configuration of the instrument, the sensors in the pressure cell were therefore centered at a depth of 6.5 feet, matching the intended depth of the HDD installation. A similar process was then used to install the second pressure cell, denoted “A,” at a depth of 6.5 feet but at a lateral distance of 4.6 feet away from the planned bore path. Pressure cell B was located 3 feet away from pressure cell A so that they were located as close as possible while still leaving a buffer (see Figure 4.81). This buffer was to ensure that the soil deformations induced by the installation process for one pressure cell would not affect the other pressure cell’s readings.

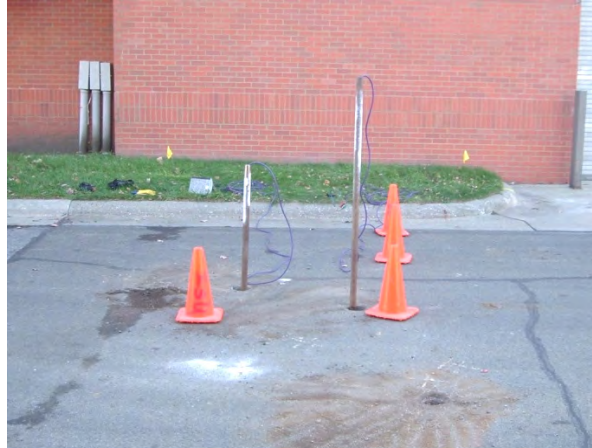
Figure 4.82. Push-in pressure cells in place at point B (looking south)

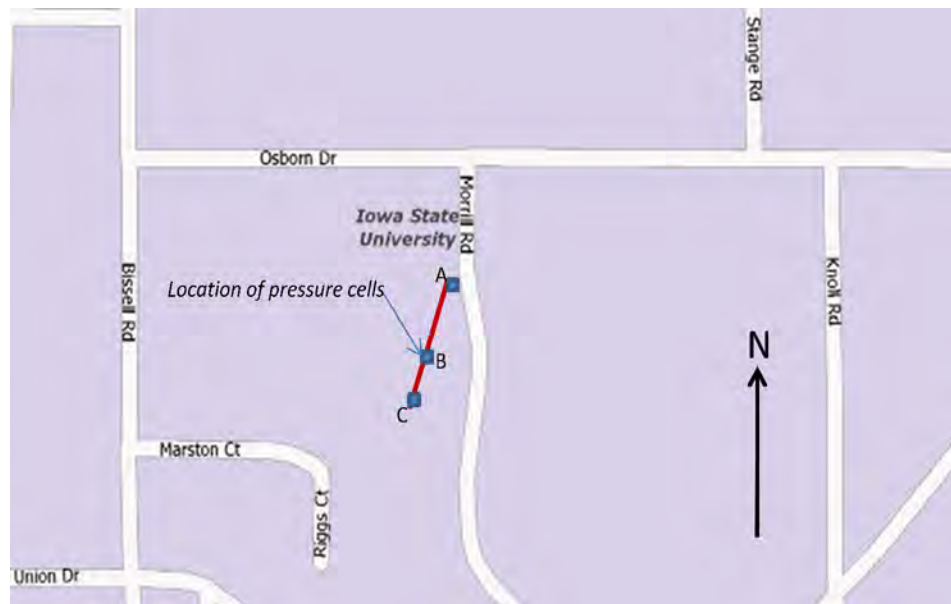
Figure 4.85. Location of HDD project (bore path in red) at the Hub in Ames, IA

The pipes were installed by completing two parallel bores (see Figure 4.85): one for each pipeline. The bores ran northeast of the Hub, which is a building that houses vending machines in the middle of the ISU campus, as shown in Figure 4.86. The research team installed two vibrating wire push-in pressure cells at point B in Figure 4.85 to observe changes in lateral earth pressure during installation.

The contractor made preparations for boring by setting up the HDD machine on the north side of the site (point A in Figure 4.85) for the first bore going 200 feet northwest to southeast (from point A to point C). An exit pit was excavated using a backhoe at the planned termination of the run to allow the pipe to emerge at the proper 6-foot depth. All existing utilities near the bore path

The pilot bore began by attaching a 4-inch drill bit to the directional drilling machine and pushing it into the ground. The pilot bore proceeded with periodic adjustments to the depth and direction to keep the bore online and to avoid nearby utilities. The borehole was drilled to a depth of about 6 feet to the expected top of the pipe, except where vertical steering was necessary to avoid existing pipe. It was necessary to steer the bore down to a depth of 8 feet for at least two locations. The position of the drill rig at point A is shown in Figures 4.85 and 4.87. The pilot bore was completed successfully.

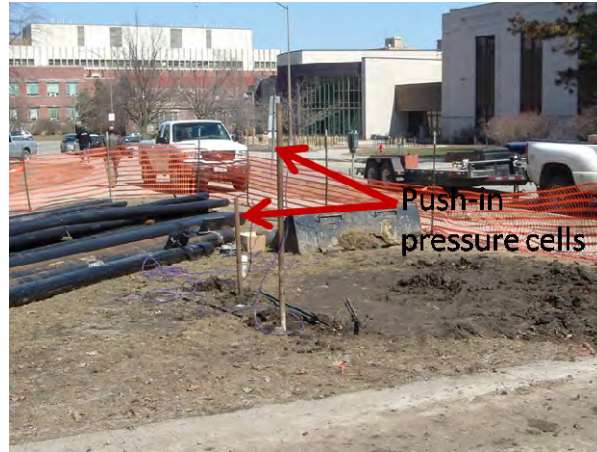
Figure 4.88. Push-in pressure cell after installation

The two vibrating wire push-in pressure cells were installed at point B. To do this, an instrumentation hole was drilled at a lateral distance of 2 feet from the planned bore path and to a depth of 5 feet, at which point the drill bit and auger were removed from the drill rig and the push-in pressure cell denoted “A” was attached to a drill rod. The drill rig then vertically pushed the pressure cell into the ground to a depth of 5 to 7 feet. The cells were oriented so that the flat pressure-sensing side of the pressure cell was parallel to the planned horizontal borehole. Due to the configuration of the instrument, the sensors in the pressure cell were centered at a depth of 6.5 feet, matching the intended depth of the HDD installation. A similar process was used to install the second pressure cell, denoted “B.” Pressure cell B was installed in a new instrumentation hole to take readings at a depth of 6.5 feet but at a lateral distance of 3 feet from the planned bore path (see Figure 4.88). Pressure cell B was located 3 feet away from pressure cell A so that they were located as close as possible while still leaving a buffer. This buffer ensured that the soil deformations induced by the installation processes would not affect the other pressure cell’s readings (see Figure 4.89).

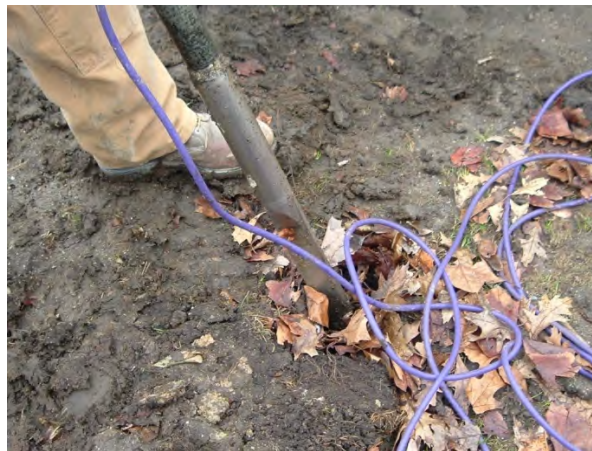
Figure 4.91. Push-in pressure cells being removed

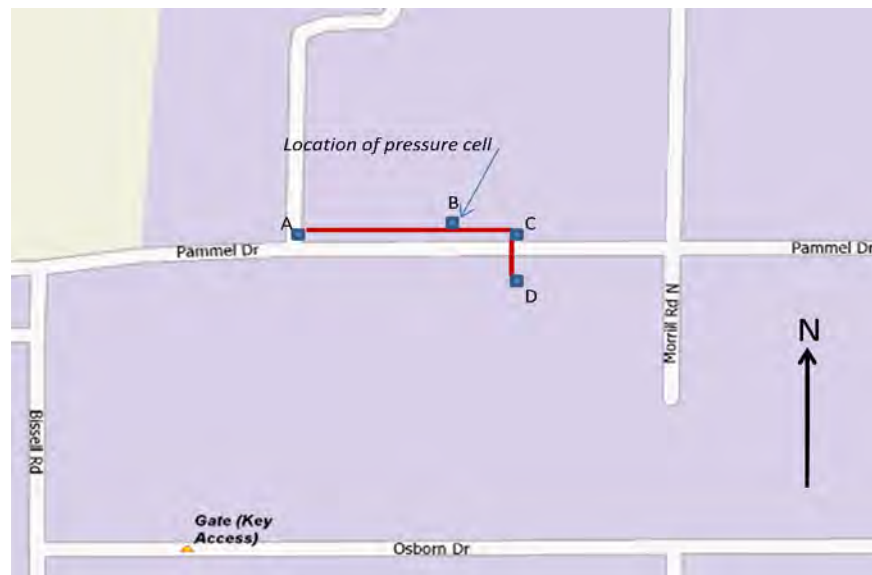
Figure 4.94. Location of HDD project (bore path in red) on Pammel Drive in Ames, IA

The pipe was installed by drilling and enlarging two straight bores: a north-south bore between points C and D and an east-west bore between points A and C (see Figure 4.94). The research team installed two vibrating wire push-in pressure cells at point B (shown in Figure 4.94) to detect changes in lateral earth pressure during installation.

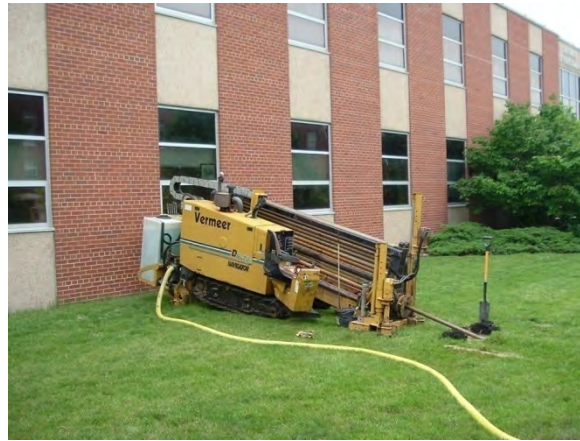
Figure 4.96. Directional drilling machine drilling from point C to D

The pilot bore began by attaching a 4-inch drill bit to the directional drilling machine (see Figure 4.96) and using the machine to push the drill bit into the ground. The drill bit was advanced by pushing and spinning the rod using the hydraulic machinery of the drill rig. A sonde attached to the drill bit allowed a handheld locator at the surface to monitor the position of the drill bit in the ground (see Figure 4.97). The pilot bore proceeded with periodic adjustments to the depth and

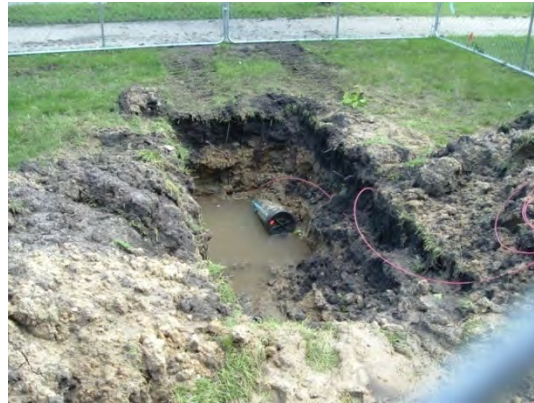
Figure 4.98. HDPE pipe (8-inch diameter) capped at point C after installation from points C to D; locate wire visible

Next, the 12-inch reamer was reattached to the drill string and the 8-inch-diameter HDPE pipe was attached behind the reamer. The 20-foot pipe sections were butt-fused together to reach the total length of 80 feet. The pipe and reamer were then pulled into the borehole at point D. The reamer in front of the pipe cleaned out the borehole and ensured that the diameter was a full 12 inches. The pipe was successfully installed without any problems. A pit was dug at point C to allow better access to the end of the pipe. The pipe was then capped until it could be connected to the rest of the pipeline (see Figure 4.98).

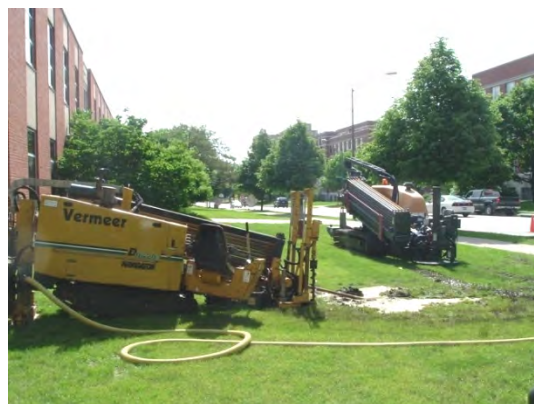
Figure 4.99. HDD rigs set up for 80-foot bore from points C to D (left machine) and 400-foot-bore from points C to A (right machine)

The contractor followed a similar procedure for the 400-foot bore path from point C to A. A larger, more powerful drill rig was brought in to handle the increased pullback resistance of the longer bore (see Figure 4.99). For this bore, a 5-inch pilot drill bit was used instead of the 4-inch drill bit used for the bore from points C to D. The larger drill bit was used because the contractor intended to create a larger borehole for this longer installation and to decrease pullback pressures when the product pipe was pulled through.

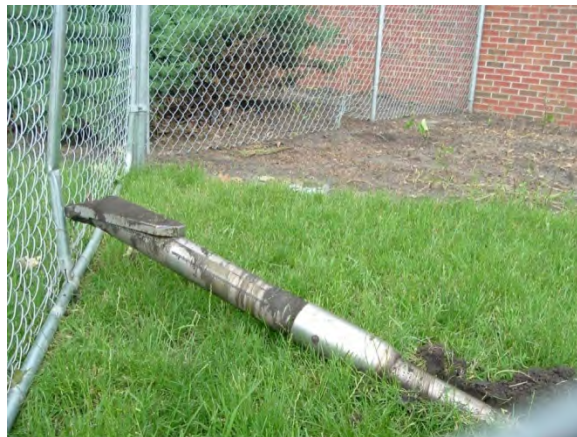
Figure 4.100. Drill bit (5-inch diameter) emerging at point A

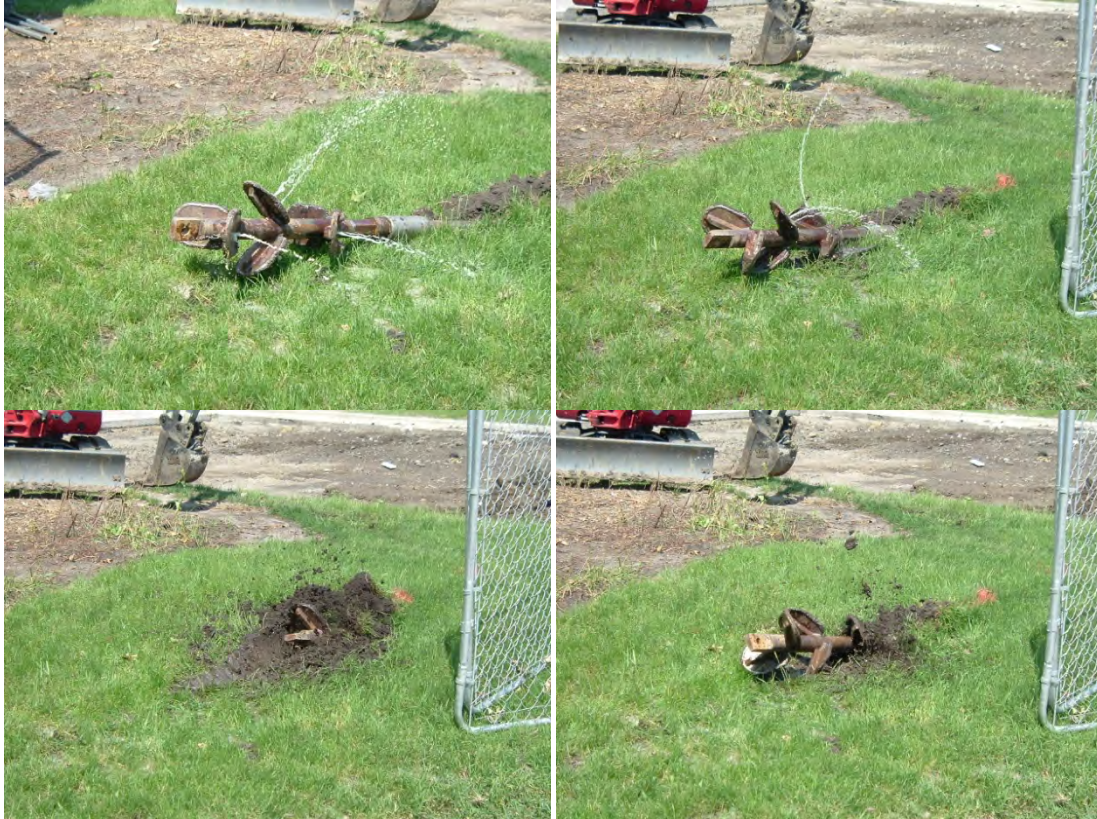
Figure 4.101. Reamer (14-inch diameter) pulled into borehole at point A (clockwise from upper left)

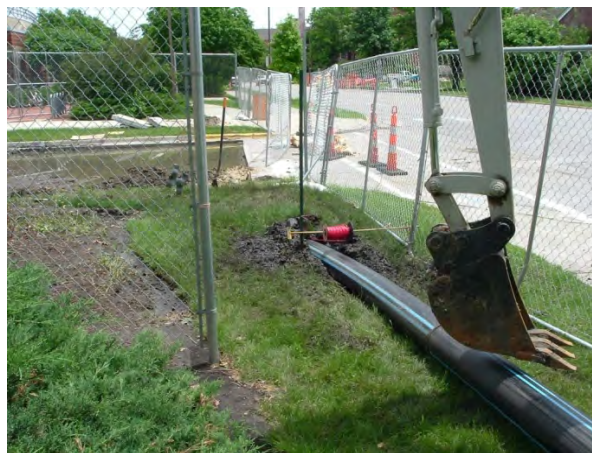
Figure 4.102. HDPE pipe (8-inch diameter) pulled into borehole at point A

The 14-inch reamer was reattached to the drill string, and the 8-inch-diameter HDPE pipe was attached behind the reamer. The reamer and pipe were then pulled into the borehole at point A (see Figure 4.102). The pipe was successfully installed following the same procedure used for the bore from C to D, and no new problems were encountered. The pipe was capped, and the trenchless installation was completed.

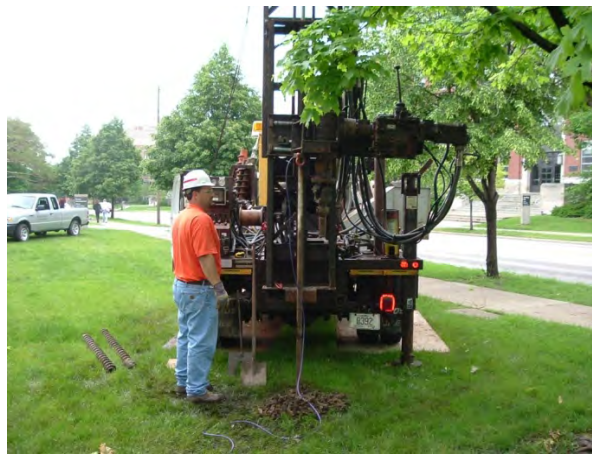
Figure 4.103. Installing push-in pressure cell

Two vibrating wire push-in pressure cells were installed at point B. To install them, an instrumentation hole was first drilled at a lateral distance of 3 feet from the planned bore path. This instrumentation hole was drilled to a depth of 5 feet, at which point the drill bit and auger were removed from the drill rig and the push-in pressure cell, denoted “A,” was attached to a drill rod. The drill rig vertically pushed the pressure cell into the ground to a depth of 5 to 7 feet (see Figure 4.103). The cells were oriented with the flat pressure-sensing side of the pressure cell parallel to the planned horizontal borehole. Due to the configuration of the instrument, the sensors in the pressure cell were centered at a depth of 6.5 feet, matching the intended HDD installation depth. A similar process was used to install the second pressure cell, denoted “B.” Pressure cell B was installed in a new instrumentation hole to take readings at a depth of 6.5 feet but at a lateral distance of 3.8 feet from the planned bore path. Pressure cell B was located 4.7 feet away from pressure cell A so that they were located as close as possible while still leaving a buffer. This buffer was to ensure that the soil deformations induced by the installation process for one pressure cell would not affect the other pressure cell’s readings.

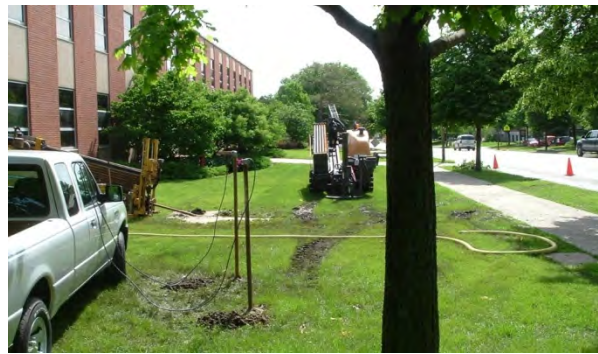
Figure 4.104. Bore seen approaching the two pressure cells (left)

After the pilot bore had passed the pressure cells, it was possible to measure the actual lateral distance between the pressure cells and the actual center of the bore path. The walkover locator marked the position of the pilot bore as it passed, which was measured to be 3.0 feet laterally from the face of pressure cell A and 3.8 feet from pressure cell B (see Figure 4.104). These measured distances matched the target distances. The depth of the pilot bore also followed expectations; it was measured to be about 6.5 feet deep when it passed the pressure cells (see Figure 4.105).

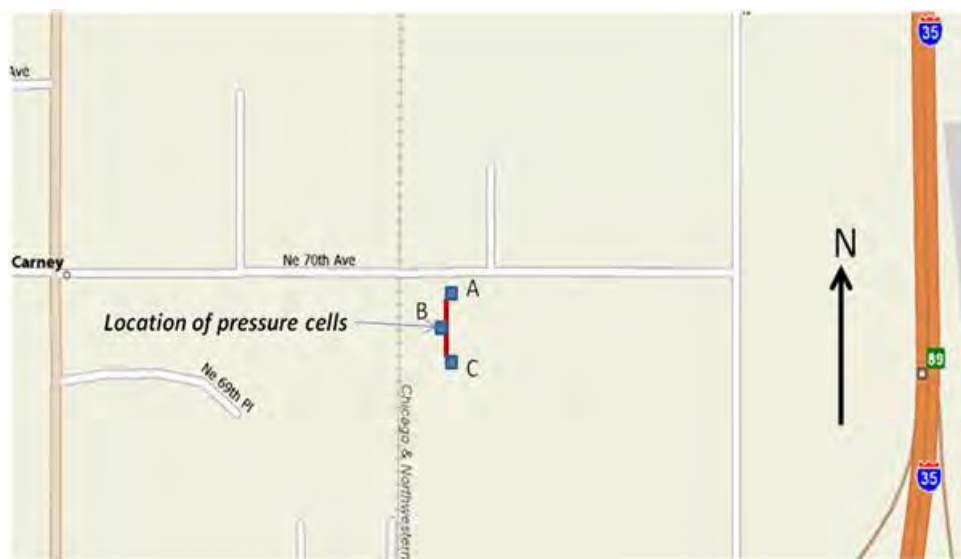
Figure 4.107. Location of IAMU's Safety and Training Field on NE 70th Avenue in Ankeny, IA; bore path shown in red

The pipe was installed by first using a pneumatic piercing tool, often called a “mole,” to create a 2.5-inch-diameter borehole. The copper pipe was then pulled through the hole and into position. The borehole was drilled between points A and C shown in Figure 4.107. The research team installed two vibrating wire push-in pressure cells at point B to observe changes in lateral earth pressure during installation.

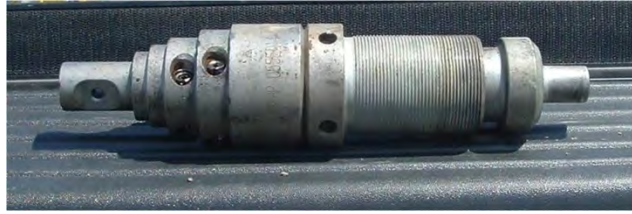
Figure 4.109. Grundomat reciprocating stepped-cone chisel head

This demonstration used a 2.5-inch-diameter Grundomat impact mole, the head of which is shown in Figure 4.109. This mole head differs from models following an older, conventional design in that the Grundomat mole contains a stepped head and concave tip rather than a smooth conical head. This design alteration is intended to help the mole remain on course if it encounters an underground obstruction, such as a rock. No drilling fluid is necessary for impact moling, and the equipment is not designed to deliver drilling fluid.

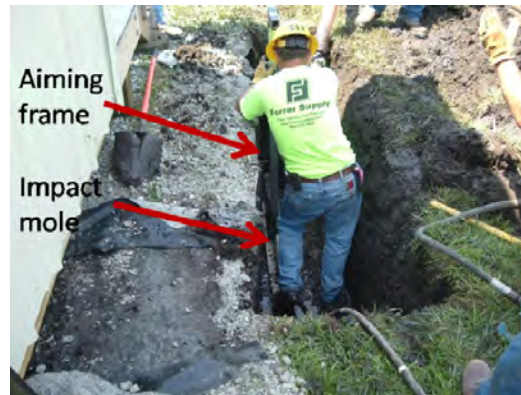
Figure 4.110. Launching the mole and adjusting line and grade using telescopic aiming frame

The next step was to position the 2.5-inch-diameter mole at the bottom of the entry pit. The mole was laid in a starting cradle 1 to 2 inches above the bottom of the pit and slowly eased into the ground while using a telescopic aiming frame to monitor line and grade (see Figure 4.110). Compressed air from the trailer was turned on, and the mole began piercing the soil. Line and grade were continuously monitored and adjusted until the mole had fully entered the soil, at which point further steering was impossible. The mole continued its progress into the soil without the need for further adjustments.

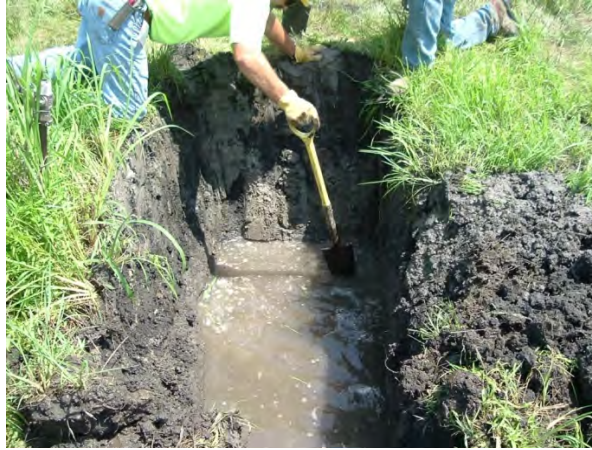
Figure 4.111. Locating mole after it emerged at point C into exit pit, which was flooded

The mole continued to advance without pausing until it successfully reached the exit pit at point C (see Figure 4.111). The pit had become flooded with 8 inches of water when the mole arrived at the pit. Dewatering was necessary so that the mole did not “swim”; swimming could occur if the soil was sufficiently saturated and soft so that the mole could no longer advance. The vacuum tank was emptied of its contents from dewatering the entry pit, and the exit pit was dewatered, allowing the mole to be retrieved (see Figure 4.112).

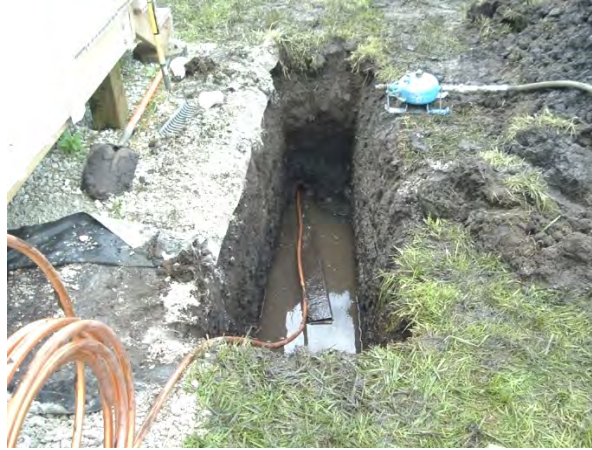
Figure 4.113. Entry pit at point A as 0.75-inch copper pipe was pulled into 2.5-inch-diameter hole

Next, the 0.75-inch copper pipe was installed. This installation was done by disconnecting the pneumatic hose from the air compressor at point A and reconnecting it to the end of the copper pipe. The pneumatic hose was used like a rope and pulled out of the borehole at point C by hand while the copper pipe was pulled in at point A (see Figure 4.113). This process completed the installation.

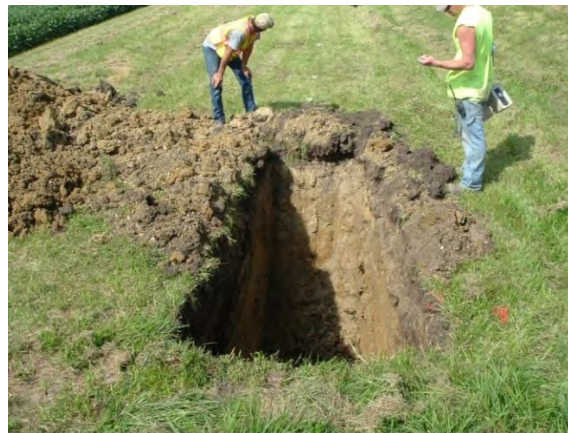
Figure 4.119. Pit at point B

The contractor made preparations for installation by using a backhoe to dig pits on both sides of the field entrance at points B and D. These were the points where the 30-foot-long pipe installed with trenchless construction would eventually be connected to the rest of the pipeline, which would be installed later with open-cut methods. The pit dug at point B is shown in Figure 4.119. The pit at point D served as the exit pit where the bore would emerge to the surface. The contractor then set up the HDD machine on the north side of the site at point A. No utilities were located in the vicinity of the bore, so potholing was not necessary to confirm existing utility locations.

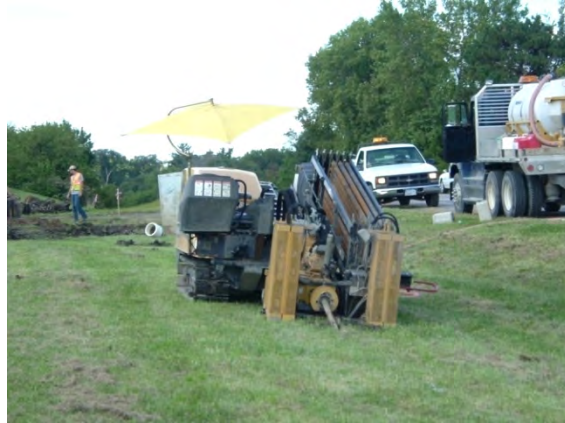
Figure 4.120. Directional drilling machine

The pilot bore began by attaching a 5.5-inch drill bit to the directional drilling machine (see Figure 4.120) and using the machine to push the drill bit into the ground. The drill bit was advanced by pushing and spinning the drill rod using the drill rig's hydraulic machinery. A sonde attached to the drill bit allowed a handheld locator at the surface to monitor the position of the drill bit in the ground (see Figure 4.121).

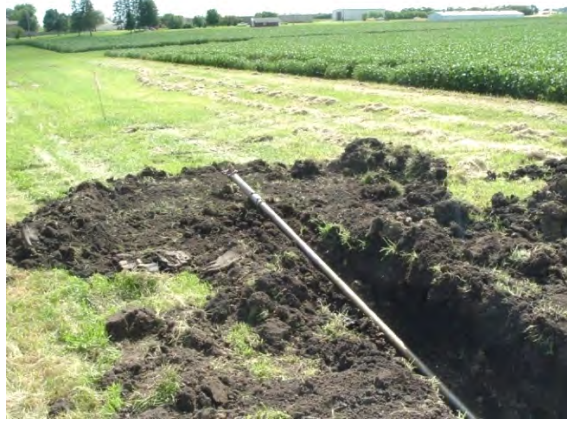
Figure 4.122. Pilot bore emerging from exit pit at point D

The pilot bore proceeded with periodic adjustments being made to the depth and direction to keep the bore online. The borehole was drilled to a depth of about 8 feet to the expected top of pipe, measured from the field entrance. This depth was used to accommodate minimum depth requirements at low points in the ground surface, as stated in the specifications. The pilot bore was conducted successfully, and the drill bit emerged in the exit pit at point D after around 30 minutes of boring (see Figure 4.122).

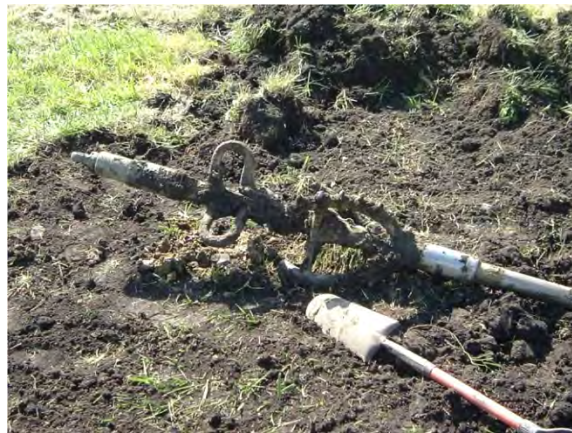
Figure 4.123. Reamer (16-inch diameter) attached to drill string

The 5.5-inch drill bit used for the pilot bore was removed from the drill string and replaced by a 16-inch reamer for the pre-reaming stage (see Figure 4.123). The directional drilling machine was switched from push mode to pull mode, and the drill string with the reamer attached was then pulled back through the pilot bore toward the directional drilling machine. The reamer was pulled back using the existing pilot bore for guidance, enlarging the hole from 5.5 inches to 16 inches in diameter. This pre-reaming process was executed without problems, and the pullback was finished when the reamer emerged in the pit that was dug at point B. The machine was then switched to pushing mode, and the reamer was pushed back into the borehole it had just carved until it reemerged at point D.

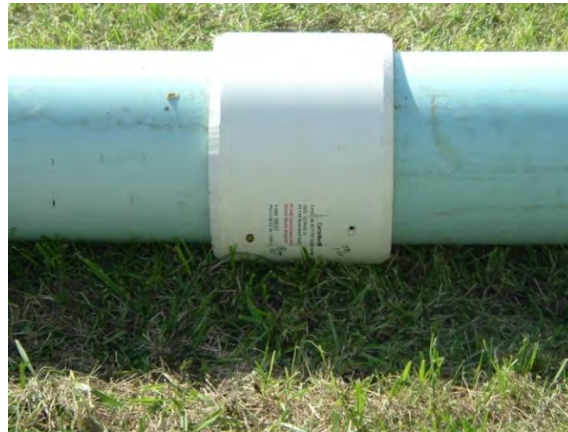
Figure 4.124. Certa-Lok[®] bell (16-inch diameter) connecting pipe sections (12-inch diameter)

Next, the 12-inch-diameter PVC pipe was attached behind the reamer. A skid loader was used to move the pipe into place. The pipe was a combination of two 15-foot sections connected by a 16-inch-diameter Certa-Lok® bell (see Figure 4.124). The pipe and reamer are shown being pulled into the borehole at point D in Figure 4.125. The reamer in front of the pipe cleaned out the borehole and ensured that the diameter was a full 16 inches. The pullback was subject to additional resistance because both the borehole and the bell had 16-inch diameters, but the pullback was only 30 feet, so it was deemed acceptable. The pipe was successfully installed

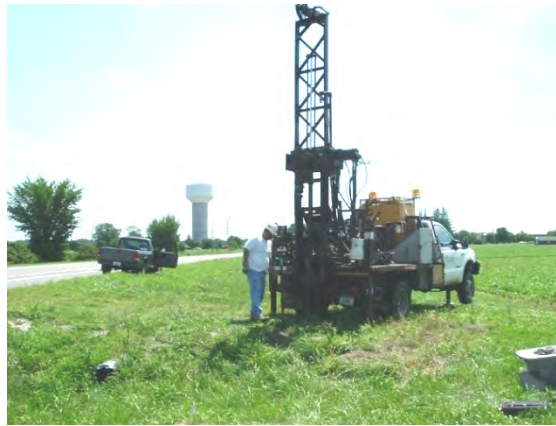
Two vibrating wire push-in pressure cells were installed at point C. To do this installation, an instrumentation hole was drilled a lateral distance of 2 feet away from the planned bore path. This borehole was drilled to a depth of 6 feet, at which point the drill bit and auger were removed from the drill rig and the push-in pressure cell denoted “A” was attached to a drill rod. The drill rig vertically pushed the pressure cell into the ground to a depth of 6 to 8 feet (see Figure 4.126). The cells were oriented so that the flat pressure-sensing side of the pressure cell was parallel to the planned horizontal borehole. Due to the configuration of the instrument, the sensors in the

pressure cell were centered at a depth of 7.5 feet, matching the expected depth of the HDD installation. A similar process was used to install the second pressure cell, denoted “B.” Pressure cell B was installed in a new instrumentation hole to also take readings at a depth of 7.5 feet but at a lateral distance of 3.5 feet from the planned bore path. Pressure cell B was located 3 feet away from pressure cell A so that they were located as close as possible while still leaving a 3-foot buffer (see Figure 4.127). This buffer was ensured that the soil deformations induced by the installation process for one pressure cell would not affect the other pressure cell’s readings.

Figure 4.126. Push-in pressure cells being installed

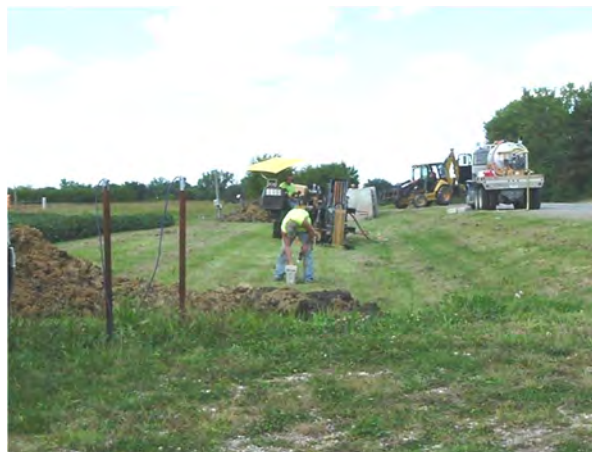
Figure 4.128. Bore approaching two pressure cells

The pressure readings reached a fairly stable, constant value in the time between their installation and the start of the HDD project. The approach of the pilot bore to the pressure cells' location is shown in Figure 4.128. After the pilot bore had passed the pressure cells, it was possible to measure the true lateral distance between the pressure cells and the actual center of the bore path. The walkover locator marked the position of the pilot bore as it passed, which was measured to be a lateral distance of 2.1 feet from the face of pressure cell A and 3.4 feet from pressure cell B. These actual distances were considered to be very close to the expected distances. The depth of the pilot bore was slightly deeper than expected, however, as it was measured to be 8 feet instead of the expected 7.5 feet. This difference in expected depth was expected to lower the pressure readings.

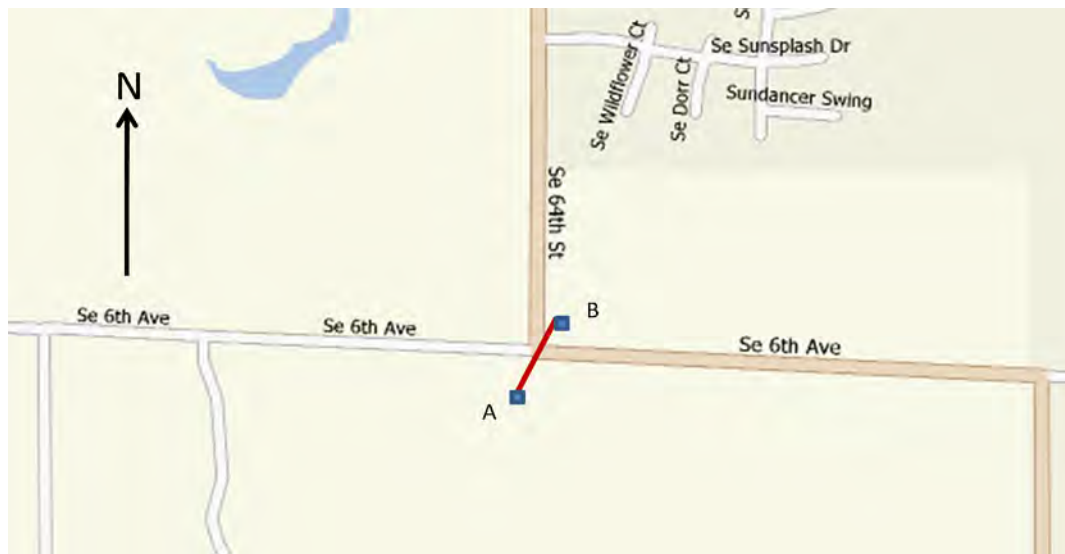
Figure D.1. Location of auger boring project on SE 6th Avenue and SE 64th Street in Des Moines, IA; bore path in red

This project was located at the T-intersection of Southeast 6th Avenue and Southeast 64th Street in Des Moines, Iowa, during June 2007. The auger boring technique was used to install a 32 inch diameter concrete casing pipe for a 24 inch storm water drainage pipe. The casing was bored for a length of 85 feet at a depth of 17 feet to the top of the casing pipe. The auger bore was set up at point A and bored northeast to point B in Figure D.1. No plan view from the bid documents was available.

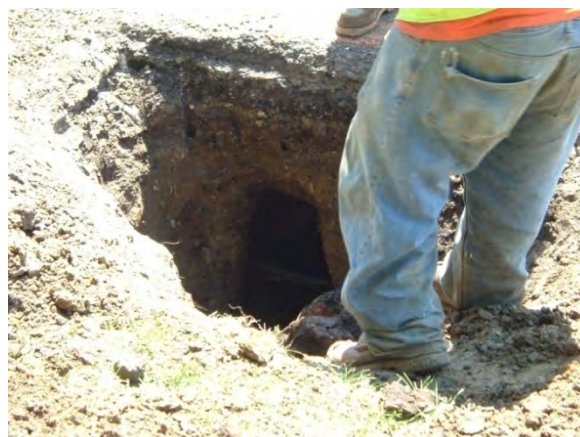
Figure D.2. Potholing by edge of pavement

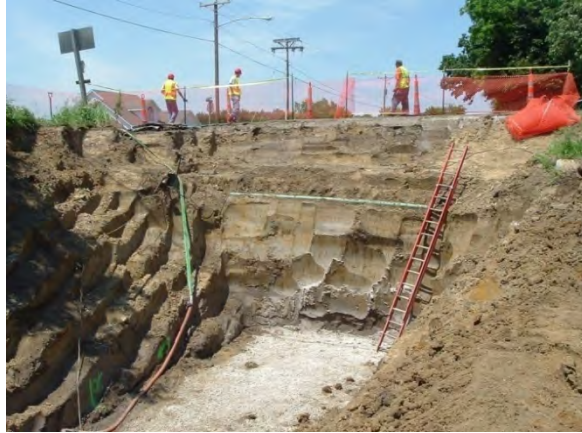
Figure D.3. Launching pit with terraced sides and a gravel base

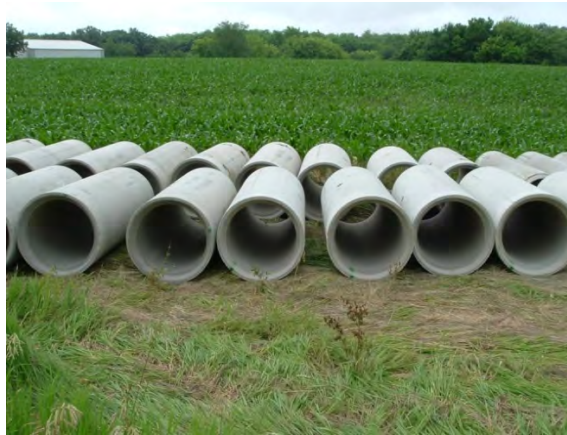
Figure D.4. Twenty four inch concrete pipe

- The first section of pipe (see Figure D.4) was lowered into the launching pit and connected to the machine. The boring then began. Soil cuttings were transported by the auger back through the pipe to the launching pit. A backhoe was used to remove the cuttings to the surface. The crew checked the line and grade each time a new pipe section was welded to the pipeline. The sandy clay soil that had been at first encountered transitioned into clay with less sand. This did not negatively affect the boring procedure. Water was also encountered near the middle of the bore. A possible reason for this water was the presence of voids in the soil surrounding an old pipe.

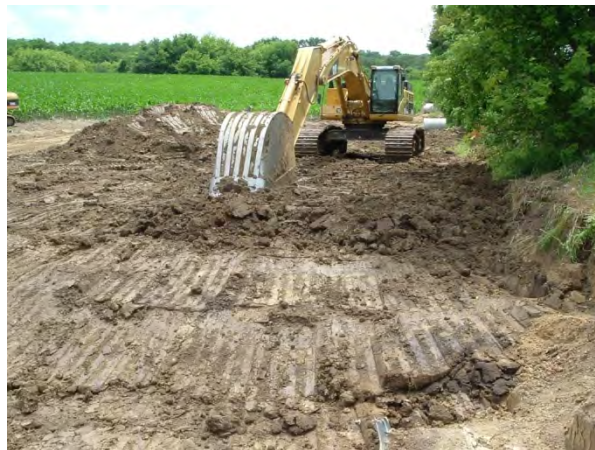
Figure D.5. Launching pit at point A being filled in as the installation is completed

- The bore was kept on course and the installation was completed successfully in two days (see Figure D.5). The carrier pipe emerged at the manhole vault at point B within the accuracy tolerance. No unusual problems were encountered, and no damage to the overlying pavement was observed.

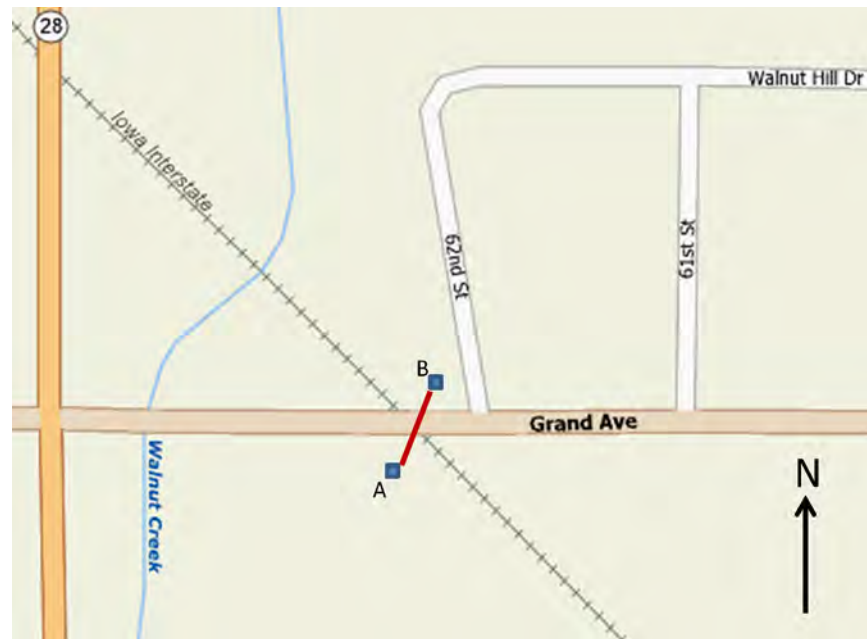
Figure D.7. The location of the auger boring project at Grand Avenue in Des Moines, IA; bore path in red

The purpose of the project was to connect a newly constructed retail store to the city's water distribution network. The auger bore was set up at point A and bored northeast to point B in Figure D.7. Drawings for the project were not made available to the researchers.

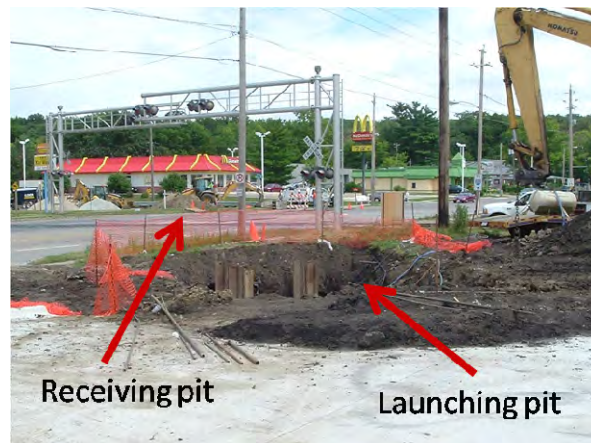
Figure D.8. View of the project looking from the launching pit at point A across Grand Avenue and the railroad tracks to the receiving pit at point B

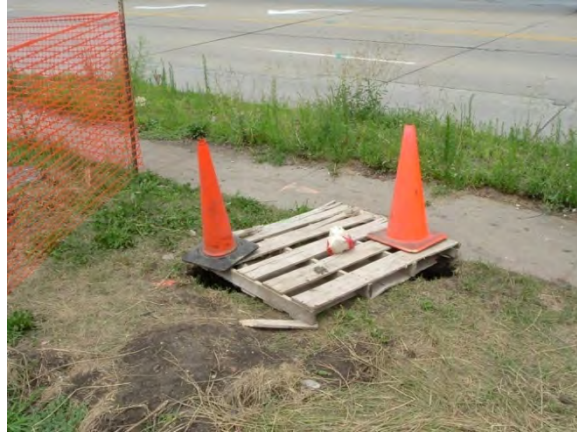
Figure D.9. A potholing pit covered and marked

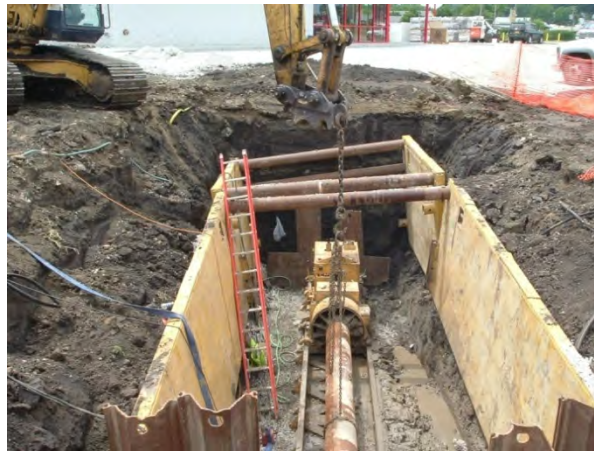
Figure D.10. A backhoe lowers a new 20 foot section of steel pipe into the launching pit

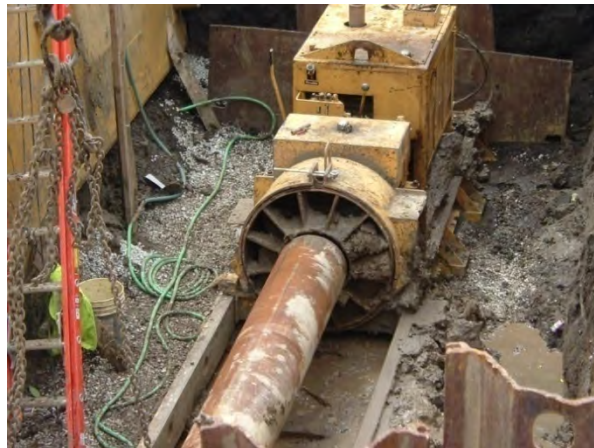
Figure D.11. Pipe and auger boring machine as a new pipe segment is being fitted to the machine and welded to the pipeline

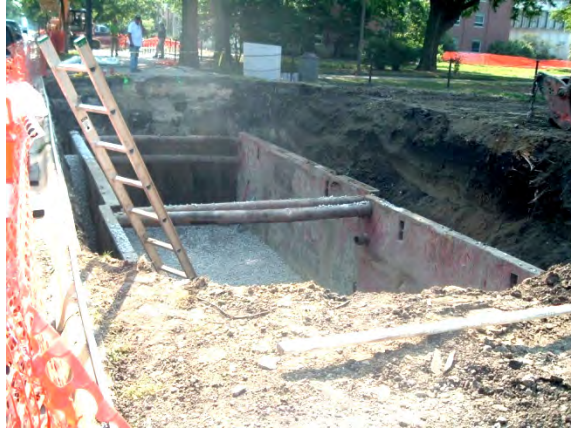
Figure D.13. Launching pit with shoring and a gravel base

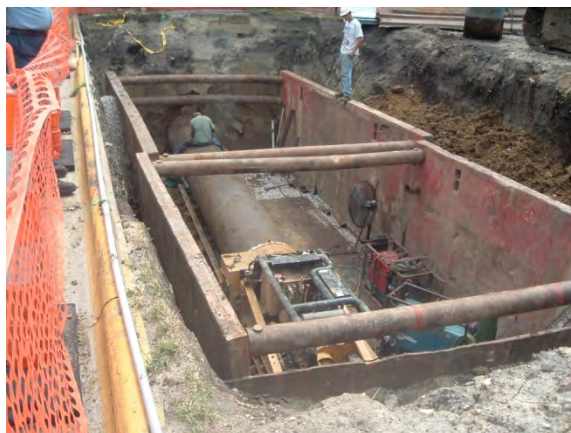
Figure D.15. First casing being bored from the launching pit
