Identification of Practices, Design, Construction, and Repair Using Trenchless Technology

Final Report
October 2010

IOWA STATE UNIVERSITY
Institute for Transportation

Sponsored by
Iowa Highway Research Board
(IHRB Project TR-570)
Iowa Department of Transportation
(InTrans Project 07-288)

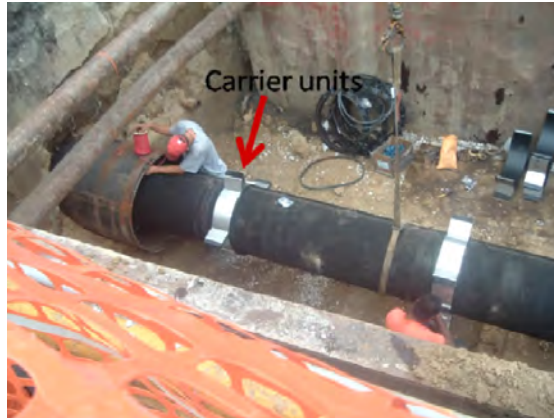
Figure D.16. The first ductile iron water pipe with casing spacers attached is placed by backhoe into the steel casing

- After the last section of steel casing pipe was placed, the ductile iron carrier pipe was installed. Casing spacers were fastened to the ductile iron pipe to allow it to “float” in the casing to protect the joints in the ductile iron pipe. The ductile iron pipe was then placed in the casing using a backhoe, as shown in Figure D.16. The two installed casings with the first ductile iron pipe installed is shown in Figure D.17. A link seal was attached to the open end. The final pipe section was then lowered into the driving pit and welded to the augered pipe sections.

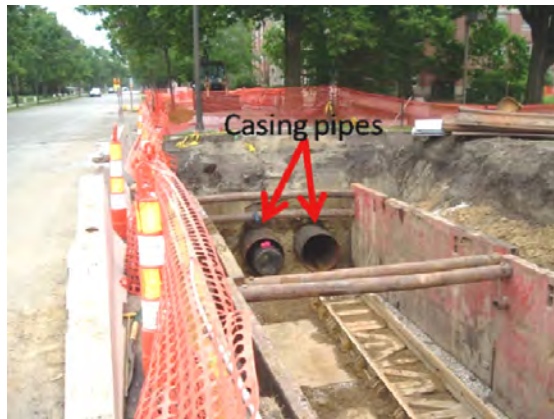
Figure D.17. Both casing pipes after boring are seen from the launching pit, and the carrier pipe can be seen in the casing pipe on the left

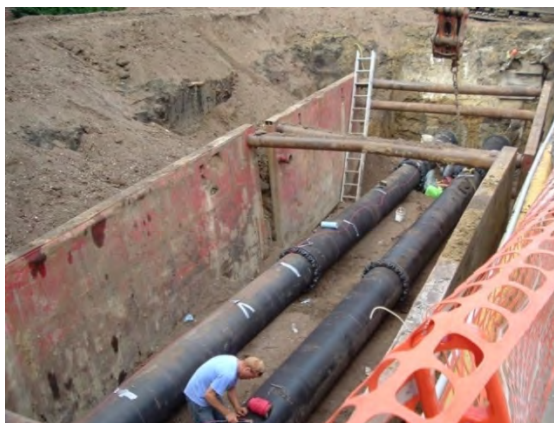
Figure D.18. The final connection of pipe sections in the launching pit

- The project was then completed by connecting the new pipes to two existing capped pipes that had been installed one year earlier. The final connections are shown in Figure D.18. This completed the pipeline. No additional problems were encountered on this project and no surface heave or settlement was observed.

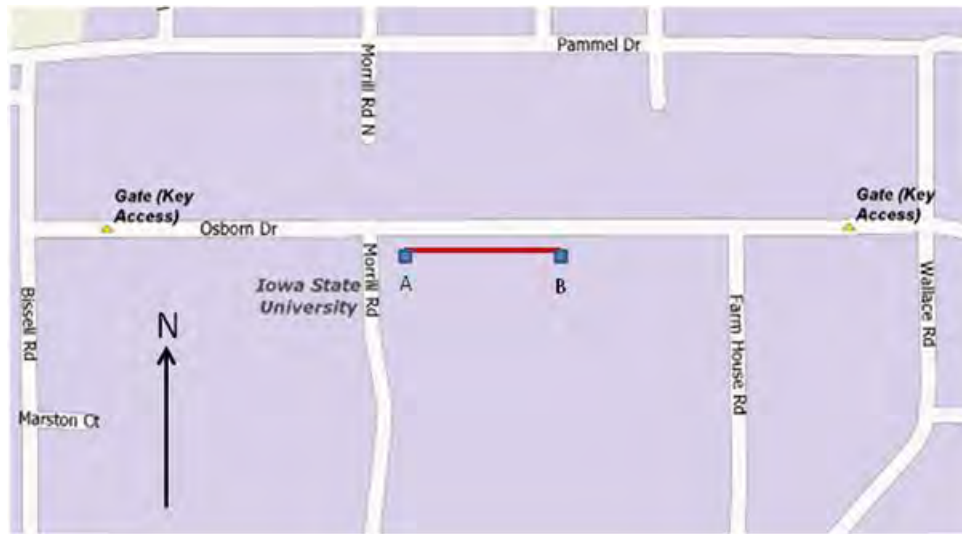
Figure D.20. The location of the HDD along Osborn Drive in Ames, IA; bore path in red

The pipe was installed by completing a single bore, as shown in Figure D.20. The boring ran east to west, parallel to Osborn Drive. The research team observed the installation and interviewed crew members. The plan view of the project is shown in Figure D.21.

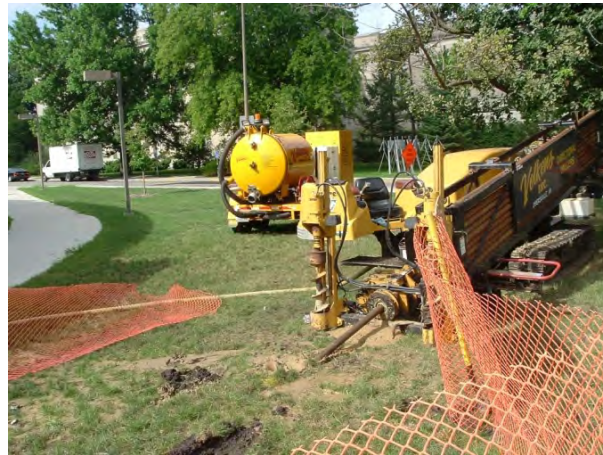
Figure D.22. Directional drilling machine

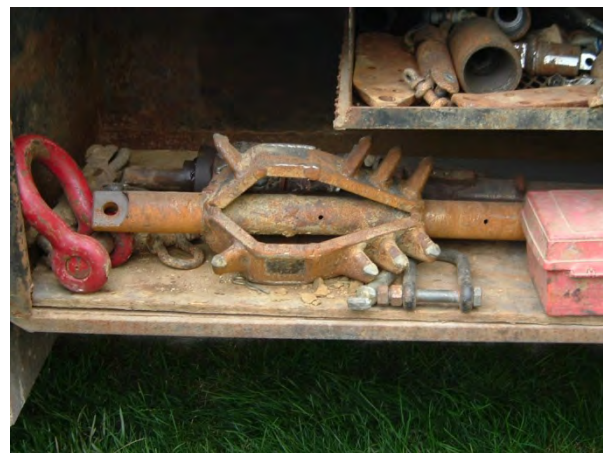
Figure D.23. Fourteen inch diameter reamer

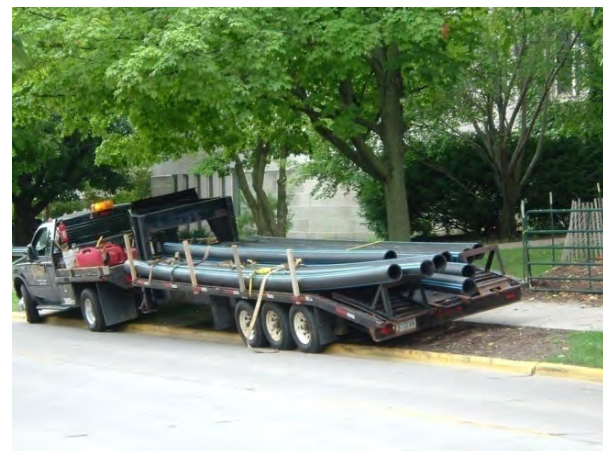
Figure D.24. Eight inch HDPE pipe

- The drill string was then pushed back to the exit pit at point B with the 14 inch reamer still attached. The 8 inch HDPE pipe (see Figure D.24) was then attached to the reamer, and the reamer and pipe were pulled back from point B to point A. The reamer in front of the pipe served to clean out the borehole and ensure that the diameter was a full 14 inches. The pipe was installed successfully and without any problems. A pit was then dug at point A to allow better access to the end of the pipe. The pipe was capped until it was

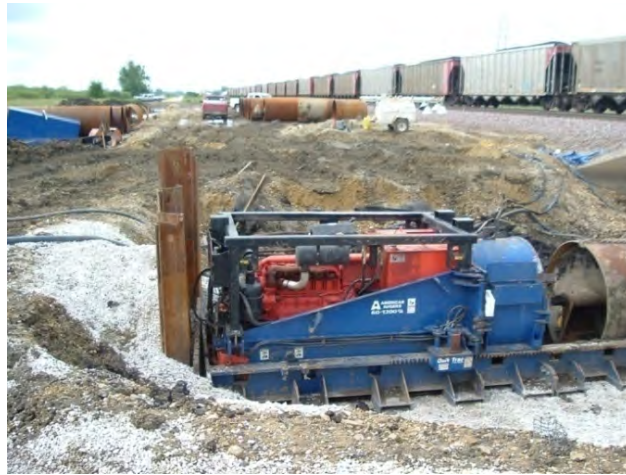
Figure D.27. Auger boring machine on its track against the sheet pile thrust block

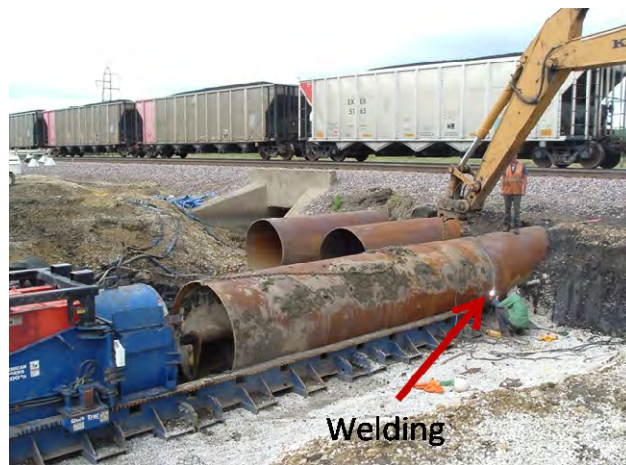
Figure D.28. A new 20 foot long pipe section being welded to the pipeline

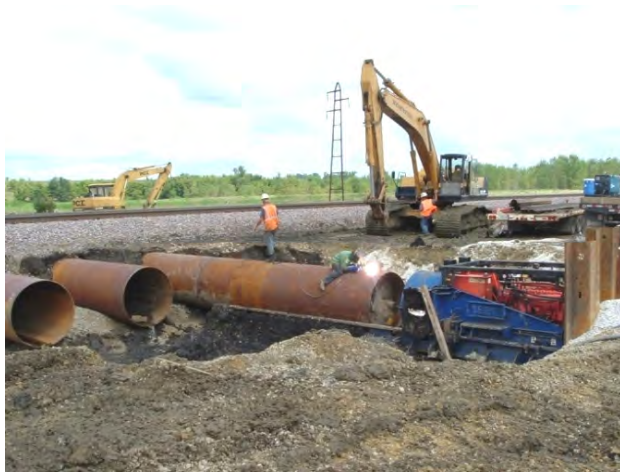
Figure D.29. The third pipe being installed

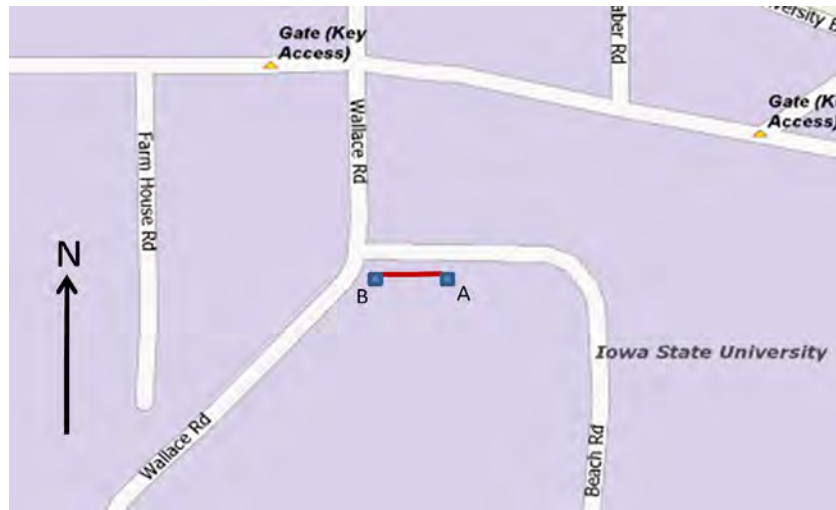
Figure D.30. The location of the HDD along Beach Road in Ames, IA; bore path in red

The pipe was installed by completing a single bore, as shown in Figure D.30. The bore path runs east and west, parallel to Beach Road on the Iowa State University campus (see Figure D.31 and Figure D.32). The research team observed the installation and interviewed crew members.

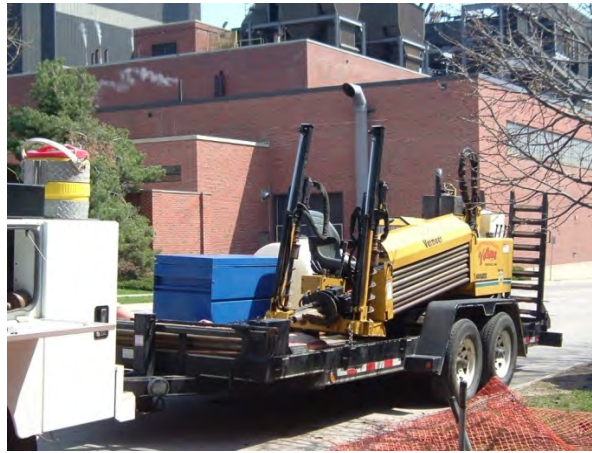
Figure D.32. Directional drilling machine

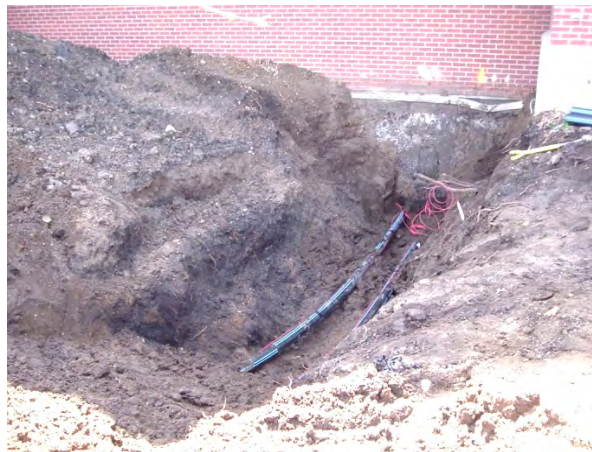
Figure D.33. The 4 inch diameter HDPE pipes connected to the building near point B

- The drill rig was then shifted 3 feet to bore the second hole. This bore was conducted using the same procedure was used for the first. The second installation was also completed successfully and without unusual difficulty. The installed parallel pipes are shown at point B in Figure D.33.

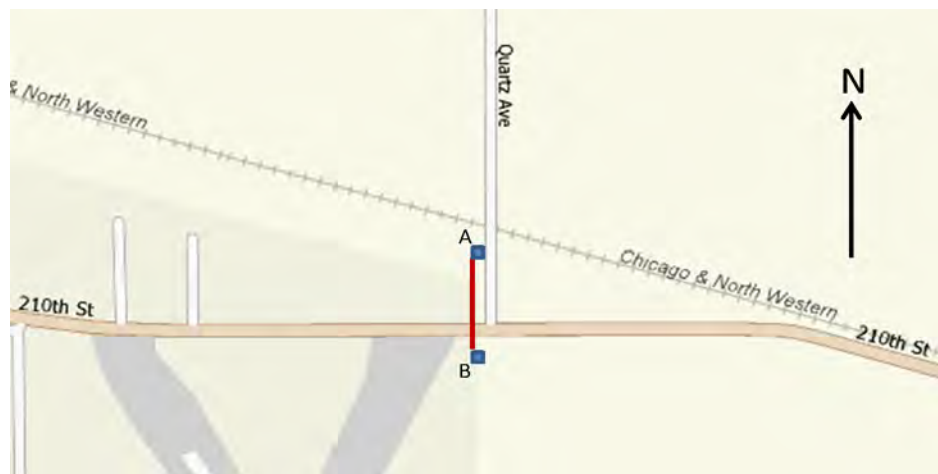
Figure D.35. The location of the HDD project across 210th Street in Boone, IA; bore path in red

The pipe was installed by completing a single bore, as shown in Figure D.35. The bore path runs north and south, parallel to Quartz Avenue (see Figure D.36). The research team observed the installation and interviewed crew members.

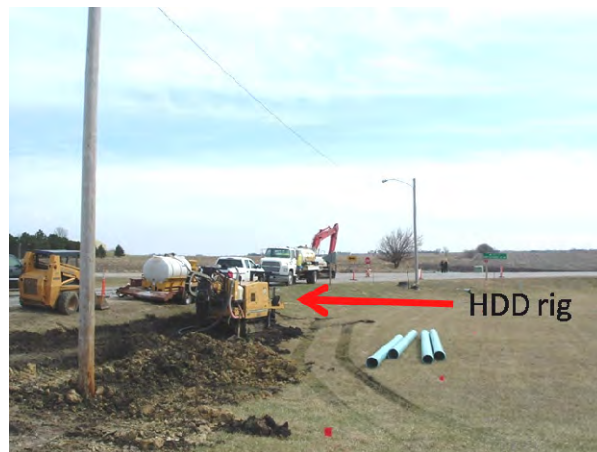
Figure D.37. The directional drilling machine

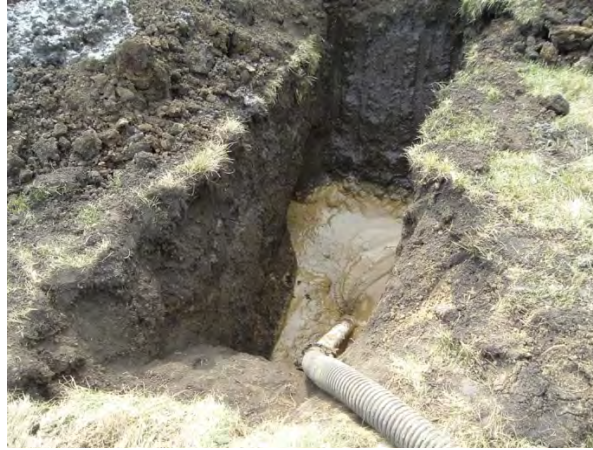
Figure D.38. Drilling fluid being vacuumed from the bottom of the exit pit at B

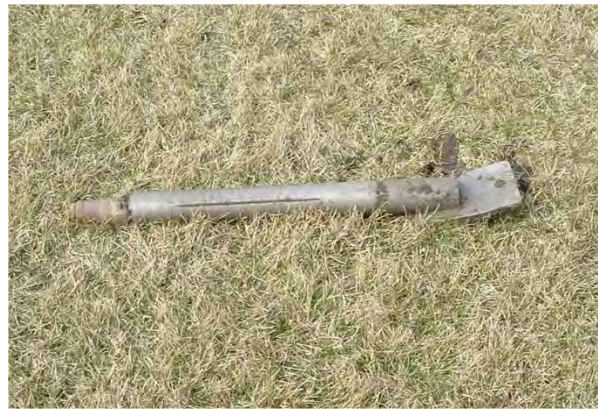
Figure D.39. Five inch diameter pilot bore drill bit

- The 5 inch drill bit from the pilot bore was then removed from the drill string and replaced by an 18 inch reamer for the pre-reaming stage. The directional drilling machine was switched from push mode to pull mode and the drill string with the reamer attached was then pulled back through the pilot bore, toward the directional drilling machine. The reamer was pulled back using the existing pilot bore for guidance, and enlarged the hole from 5 inches to 18 inches in diameter. The contractor's decision to substantially increase the borehole diameter without using incrementally larger reamers was due to the relatively short length of run (100 feet) and the fact that the contractor was using a relatively large drill rig. The reaming step was completed successfully, and the reamer emerged by the drill rig at point A on Figure D.35. The reamer was removed, and the drill string was capped and pushed back through the borehole to the exit pit at point B.

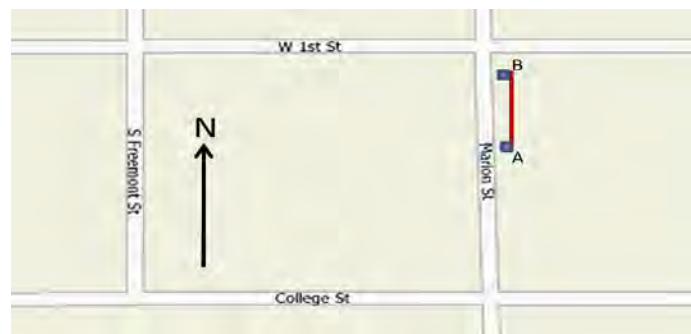
Figure D.41. The location of the HDD installation along Marion Street in Boone, IA; bore path in red

The pipe was installed by completing a single bore, as shown in Figure D.41. The boring runs north-south, parallel to Marion Street (see Figure D.42). The research team observed the installation and interviewed crew members.

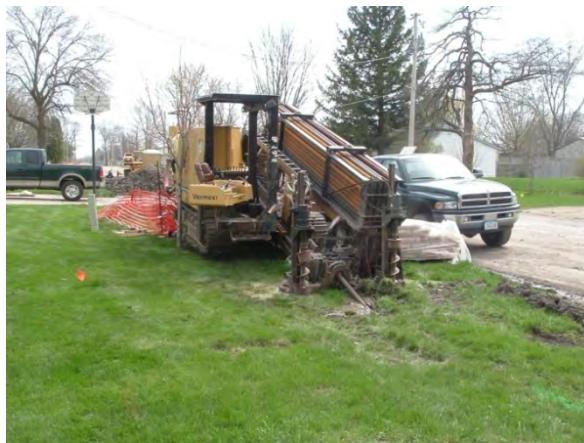
Figure D.43. The directional drilling machine

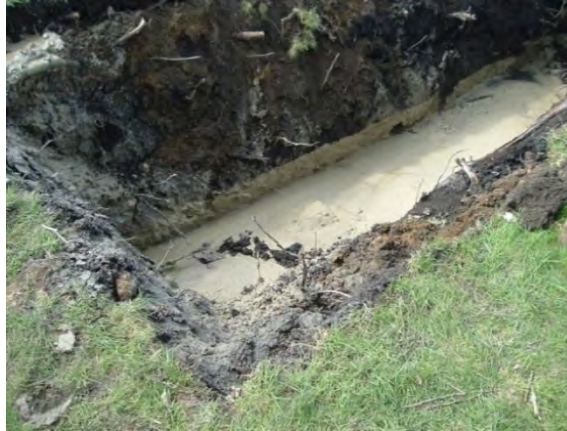
Figure D.44. Drilling fluid at the bottom of the exit pit at B

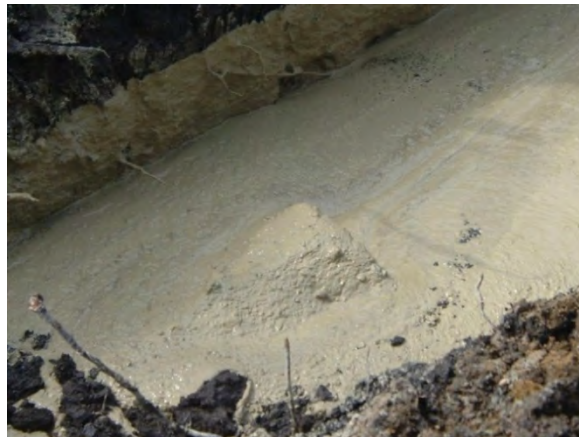
Figure D.45. Drilling fluid close-up showing texture

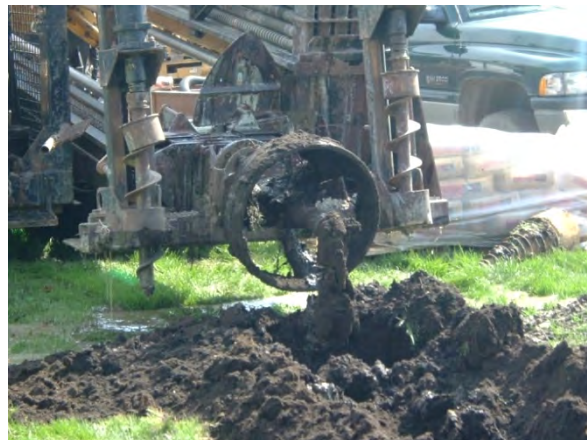
Figure D.46. Twenty-four inch wagon wheel reamer

- The 5 inch drill bit from the pilot bore was then removed from the drill string and replaced by a 24 inch wagon wheel reamer for the pre-reaming stage (see Figure D.46). The directional drilling machine was switched from push mode to pull mode and the drill string with the reamer attached was then pulled back through the pilot bore, toward the directional drilling machine. The reamer was pulled back using the existing pilot bore for guidance, and enlarged the hole from 5 inches to 24 inches in diameter. This substantial increase in borehole diameter was possible due to the relatively short length of run (75 feet) and because the drill rig had sufficiently high pull back force. The reamer successfully emerged by the drill rig at point A on Figure D.41. The reamer was removed, and the drill string was capped and pushed back through the borehole to the exit pit at point B.

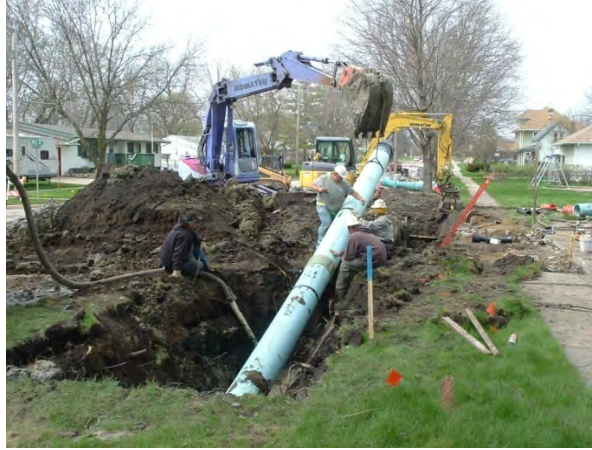
Figure D.47. Sixteen inch pipe being lowered into the exit pit at point B, before it is pulled into place by the drill rig

- Next, the 24 inch reamer was reattached to the drill string and the 16 inch diameter PVC pipe was attached behind the reamer (see Figure D.47). The pipe and reamer were then pulled into the borehole at point B. The reamer in front of the pipe served to clean out the borehole and ensure that the diameter was a full 24 inches. The pipe was installed successfully and without any problems. The pipe was then capped until it was later connected to the rest of the pipeline. The installation was completed in less than a day.
