Report FY21(012)

Field Demonstration of GPR and UAV Technologies for Evaluation of Two US 75/77 Bridges

Department of Civil Engineering, University of Nebraska-Lincoln

July 2021

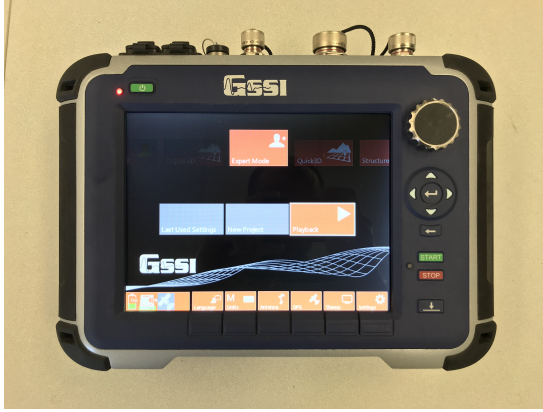
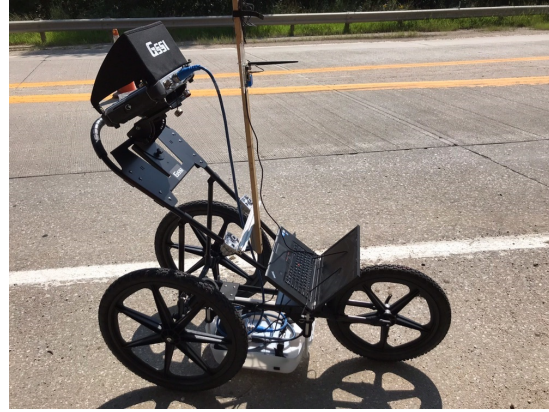
Fig. 2.1. GSSI-4000 GPR system.

A survey cart, shown in the **Figure 2.1**, was used in ground-coupled GPR survey. Since ground-coupled GPR survey can only be conducted at a walking speed, traffic control is needed. The center frequency of the antenna determines the maximum penetration depth of EM wave and the vertical resolution of the B-scan image. Increasing the frequency will improve the image resolution at the cost of decreasing the penetration depth. In most bridge deck surveys, ground-coupled antennas with a center frequency of 1.5 GHz provides sufficient penetration depth and adequate resolution. The time range determines the total time that GPR records for the reflections from the subsurface. The proper time range can be determined by the expected penetration depth and velocity information.

(a) GSSI SIR-4000 computer

(b) GPR system on a survey cart

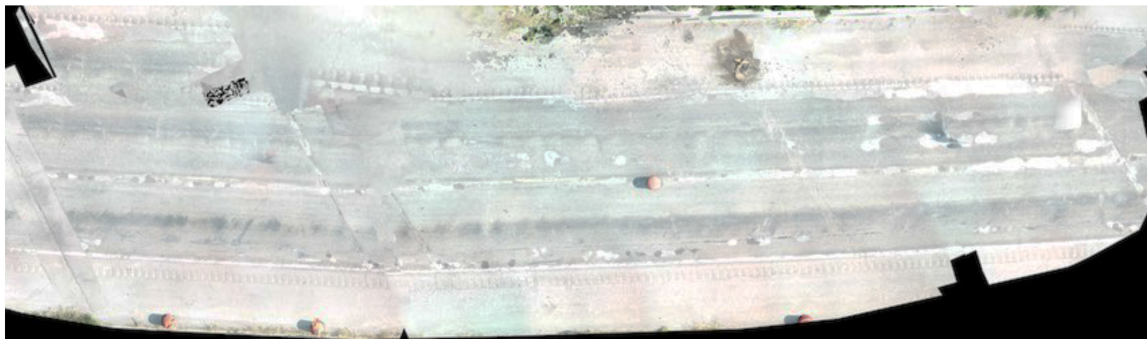
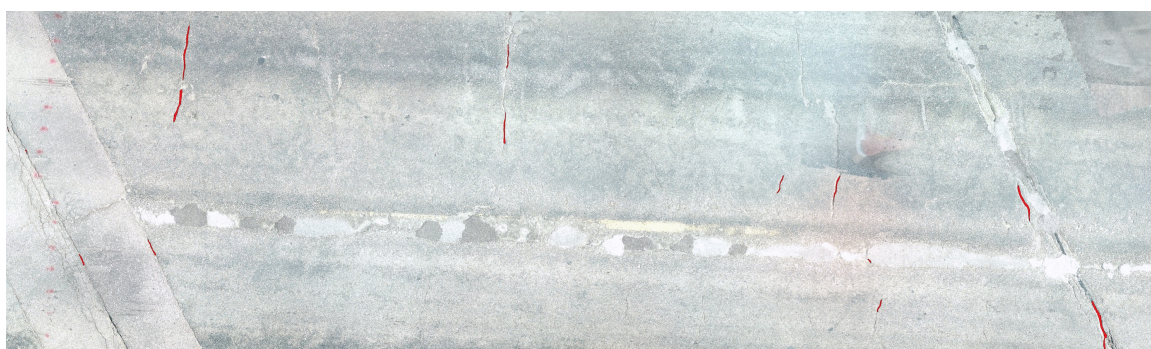
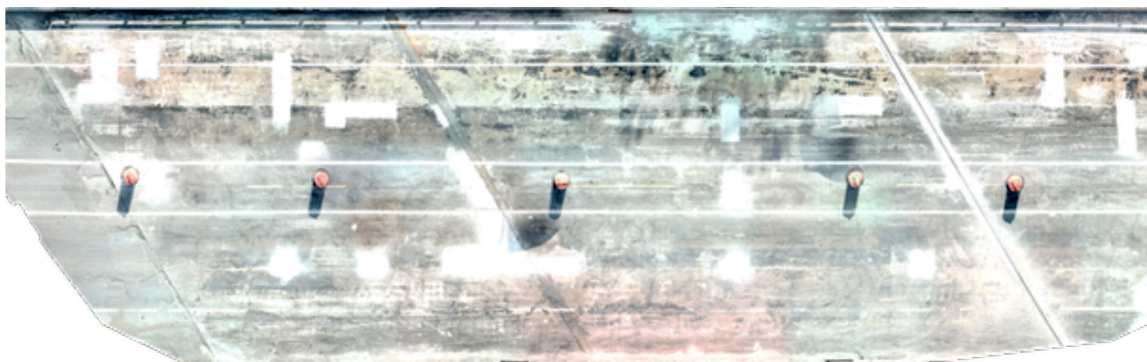
Fig. 3.5. Stitched UAV images of bridge S075 17596 before and after repair

only on one side of the bridge and the flight had to be paused and resumed multiple times while semi-trailers were passing by. As a result, the stitched image map is warped and missing some important information within the area of interest (Figure 3.5a). In this study, delamination, patched area, and cracks were the type of defects that was inspected with our data analytics tools.

The images collected from the UAV for this bridge had some limitations as discussed above. Traffic control was conducted only on one side of the bridge and data collection was interrupted multiple times. In addition, the image capture from the UAV had to be conducted from a height 16 ft above the bridge deck. This can be improved by having manual control of the UAV for future data collection to improve the resolution of the images being collected. The predictions made from the deep learning model did not show much crack information. In the zoomed image of the top left corner between the expansion joints, some of the transverse cracks were detected from the prediction as shown in Figure 3.5b. These are also the locations in proximity where delamination was identified by NDOT chain drag operation after asphalt removal and later repaired with concrete patches (patches identified in Figure 3.5c).

In the second data collection conducted on the repaired bridge on September 18, most of the images (230 images; 99%) had an overlapping feature which allowed a better stitching result as shown in Figure 3.5c. The stitching results are improved than the image collected on 8/24. Since the images were still collected from 16 ft above the bridge deck, there were not many cracks detected on the bare deck. Yet, the photos do allow to compute the area of patches.

(a) Stitched UAV image collected on asphalt overlaid concrete deck

(b) Closeup view of the left top corner with cracks detected on Bridge S075 17596 (asphalt overlaid concrete deck)

(c) Stitched UAV image of bridge S075 17596 collected on repaired concrete deck

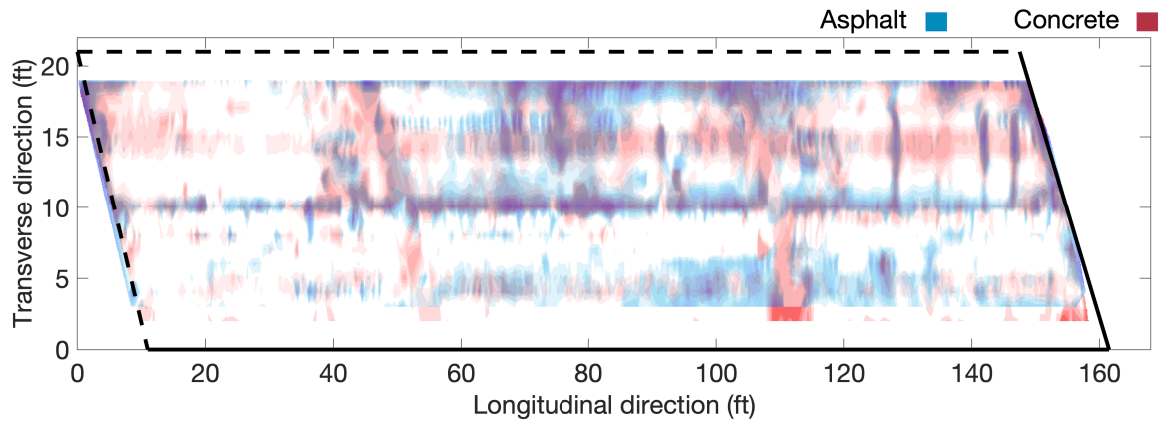
Fig. 3.6. Comparison of GPR maps collected on Bridge S075 17596 on asphalt overlay and on concrete deck

GPR data collected on the same bridge on asphalt overlay and bare concrete will allow us to analyze the correlation between two sets of data, and evaluate the effect of asphalt overlay on GPR. GPR amplitude maps on asphalt overlay (Figure 3.3a) and on bare concrete (Figure 3.3b) are in general agreement. For qualitative comparison of these two GPR results, we overlapped the deteriorated areas detected by two GPR scans and showed the overlapped comparison in Figure 3.6.

In Figure 3.6, the red color represents deterioration detected by GPR scans on bare concrete, and the blue color indicates deterioration detected by GPR scans on asphalt overlay. Purple color indicates deterioration detected by both GPR scans. In general, both maps agree with each other in deterioration regions, especially along the cold joint at 10 ft (transverse direction) and a horizontal line at 5 ft. Both maps also detect deterioration at the end joints and in the driving lane between 70 ft and 120 ft. However, the GPR data collected on concrete (red) detected more deteriorated areas in the driving lane along a horizontal line at 15 ft in the transverse direction. These areas might have less severe deterioration (light blue color in Figure 3.3b) which was not clearly shown in GPR data collected on asphalt overlay.

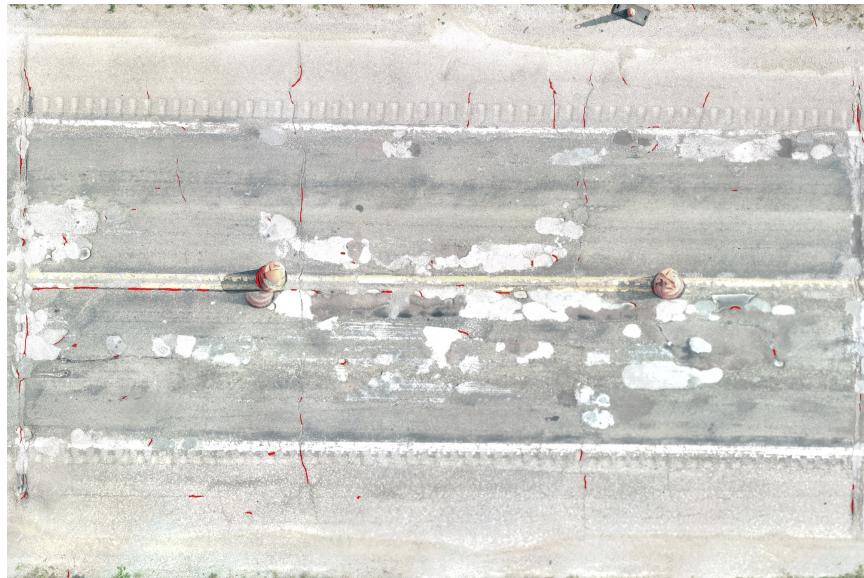
Fig. 3.15. Stitched image of asphalt overlaid concrete deck for bridge S075 17062

A total number of 200 images were collected on August 24 from the Bridge S075 17062 for a 13-minute data collection time and 126 images were collected on September 18 from the identical bridge for a 16-minute data collection time after the deck was repaired. Approximately 6,100 square feet of area was covered from each data collection. In the first data collection conducted on the asphalt overlay bridge on August 24, 98% of the images had sufficient features to allow stitching for the calibrated images. The results are demonstrated on a stitched image map shown in Figure 3.15. Figure 3.15 also shows the crack detection conducted by the deep learning model. It is clearly shown that several transverse cracks are identified within the traffic lane and shoulder of the bridge. The cracks are formed between and in proximity to where the expansion joints are located in this bridge.

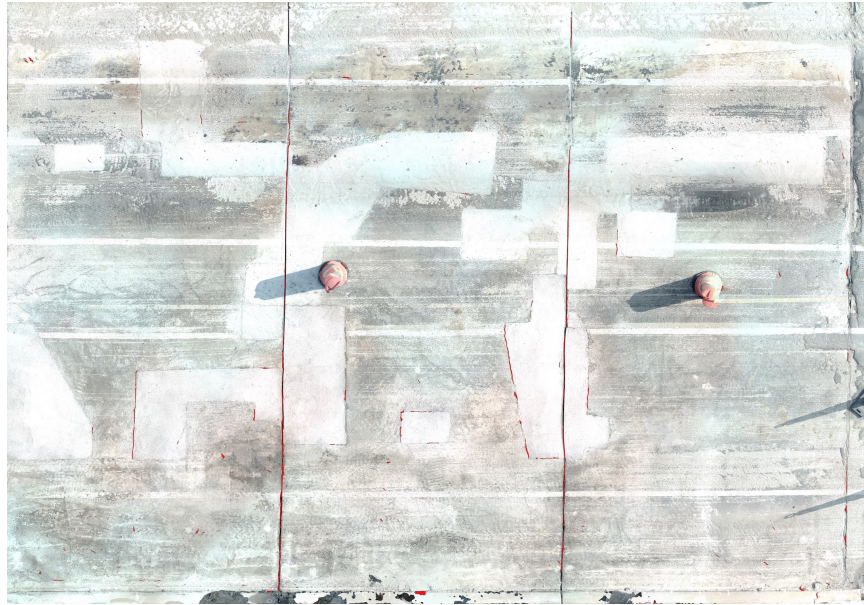
Fig. 3.16. Stitched image for Bridge S075 17062 collected on repaired concrete deck

99% of the images collected had an overlapping feature which allowed creating a stitch map as shown in Figure 3.16. The stitched image clearly shows the expansion joints and concrete repair patches. Most patches are along these joints between different spans. The deep learning model predictions identified in Figure 3.16 detects the edges of these patches which helped calculate the area of repair patches. This calculation can help quantify the amount of repair conducted for these bridges with UAV images.
