Data Analyses from Seismic Instrumentation Installed on the I-40 Bridge

Determination of When Crack Occurred on the Hernando
de Soto I-40 Bridge

Research Final Report from the University of Memphis | Shahram Pezeshk, Charles Camp, Ali
Kashani, and Mohsen Akhani | October 31, 2021

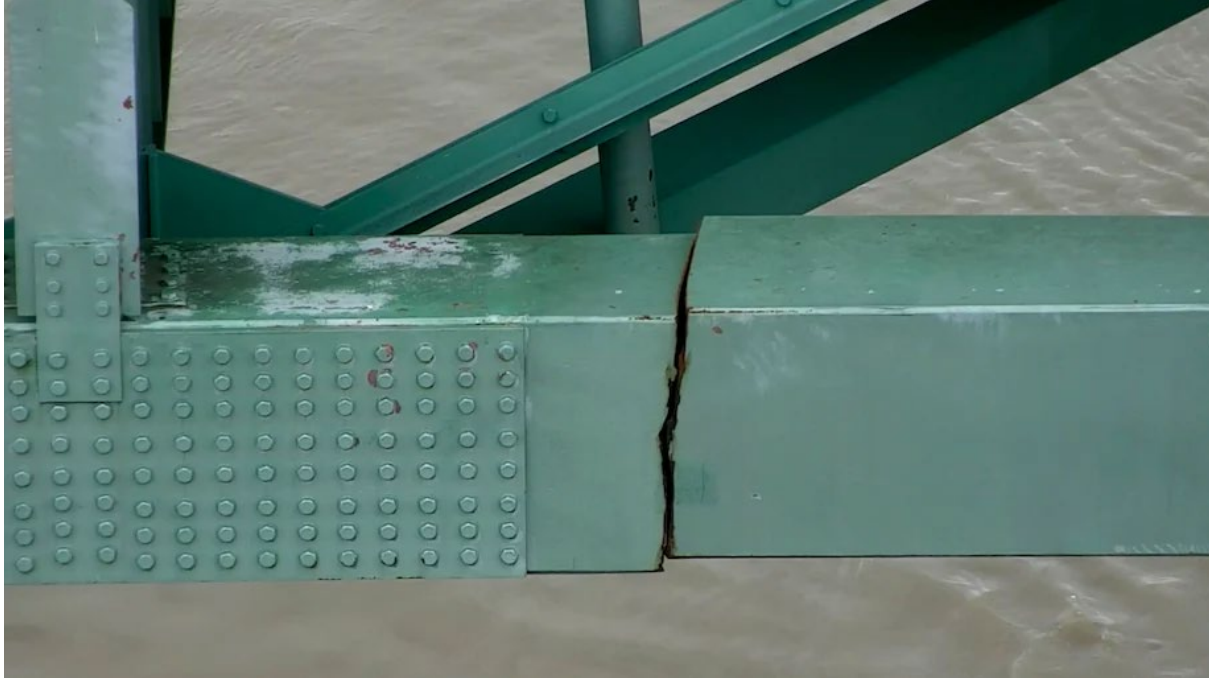
Figure 1-1. A detected crack in a critical steel support beam of the I-40 Bridge.

A crack in one of two 900-foot horizontal steel tension tie girders critical for the bridge's structural integrity was discovered on May 11, 2021 (see Figure 1-1). Figure 1-2 is a photo from 2019, confirmed by transportation officials to be authentic, that shows the crack was visible in 2019. Another photo appears to show a crack as far back as 2016, but the authenticity of that image remains under investigation. The main span of the I-40 Bridge was shut down abruptly on May 11, 2021, after inspectors called 911 to report the crack. According to ARDOT, the six-lane Hernando de Soto Bridge connecting Tennessee and Arkansas was reopened to eastbound I-40 traffic first and was reopened in both directions on Saturday, July 31, 2021, at 10 PM. The I-40 Bridge reopened following almost three months of emergency repair work. The bridge became a national example of the risks posed by the nation's infrastructure. The emergency repairs on the closed span created major traffic disruptions in the Memphis area while traffic was diverted to the nearby Interstate-55 bridge. Along with the reason behind this fracture, estimating the occurrence time is still an important mystery.

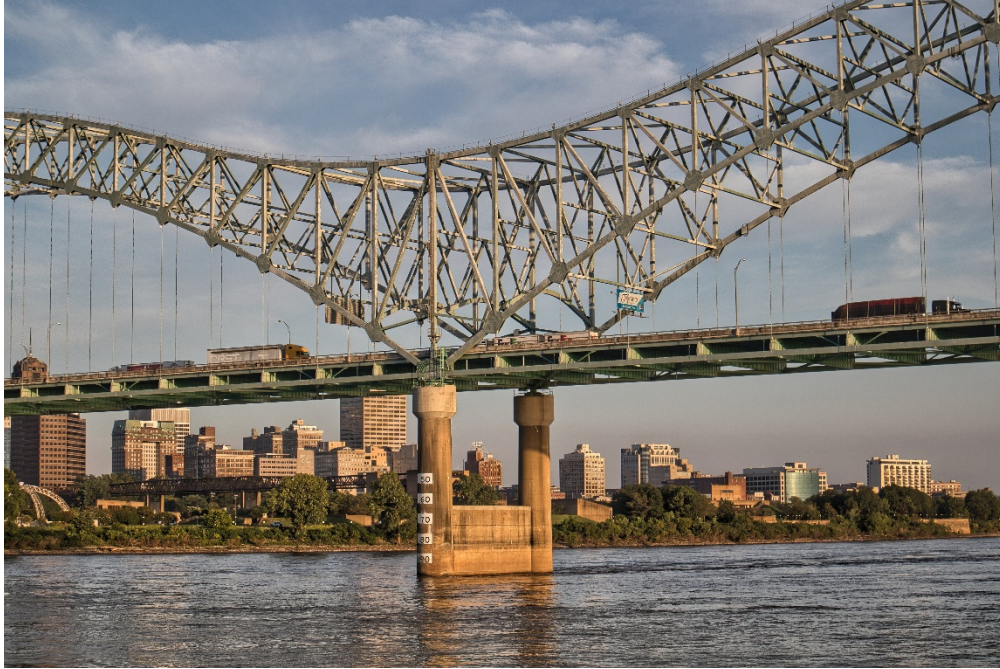
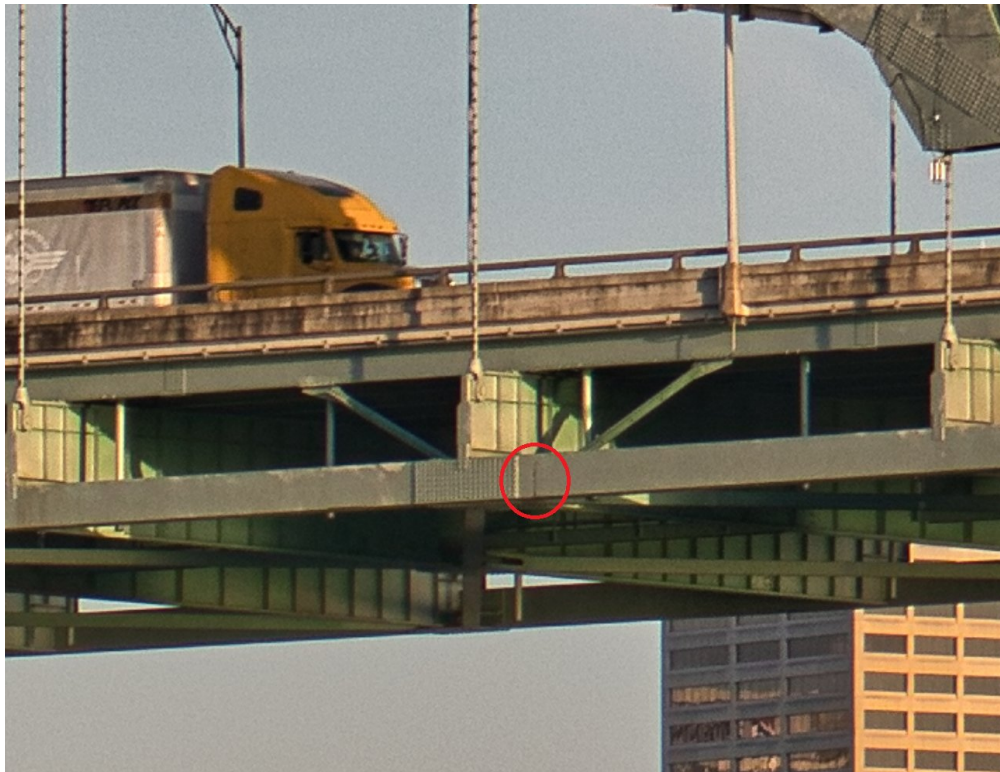
Figure 1-2. Photos of the I-40 Bridge in 2019 identifying the crack.

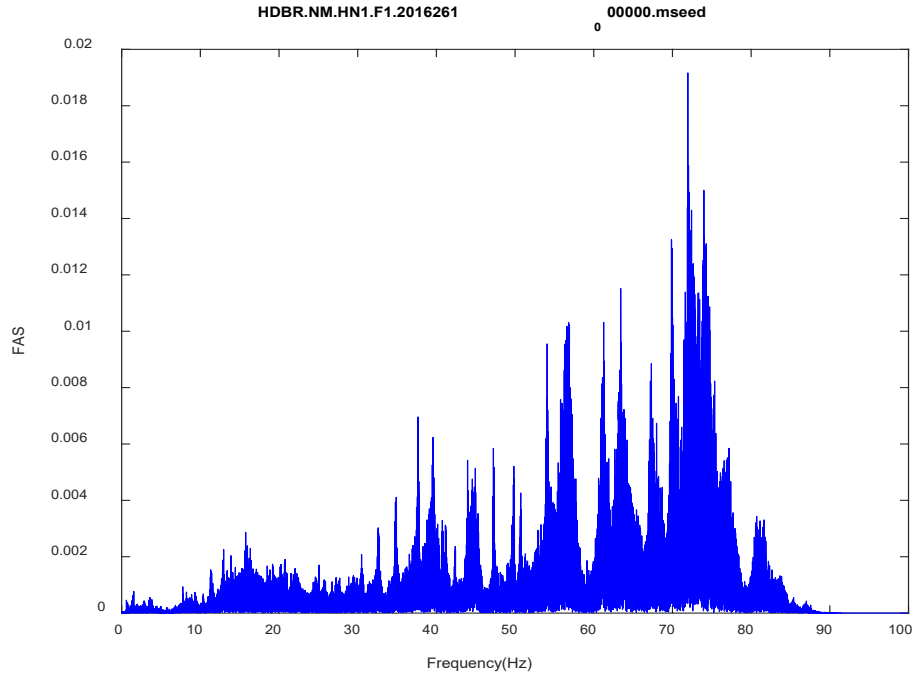
Figure 4-3. Fourier Amplitude Spectrum (FAS) for channel HN1 of sensor F1 for 12:00 AM to 00:15 AM, September 17, 2016.

After signal correction, the data's discrete Fourier transform (DFT) was computed using a fast Fourier transform (FFT) algorithm. Fourier Amplitude Spectrum (FAS) contains the absolute value of the Fourier transform of the time series. The frequency range is defined by n , which determines the number of data points in the time series for the n -point DFT. The timestep of the time series is 0.005 seconds for all the signals. Each data set was recorded for 15 minutes or 900 seconds. Therefore, for a time step of 0.005 sec, there are 180,000 data points in each recorded signal. The FAS was computed for each 15 minute signal for all the data sets listed in Table 3-4. For example, Figure 4-3 shows the FAS between 12:00 AM and 00:15 AM, September 17, 2016, for sensor F1, channel HN1.
