Developing an Implementation Strategy for Virginia Department of Transportation Pavement Rehabilitation Design Using Mechanistic-Empirical Concepts

Final Report VTRC 22-R13

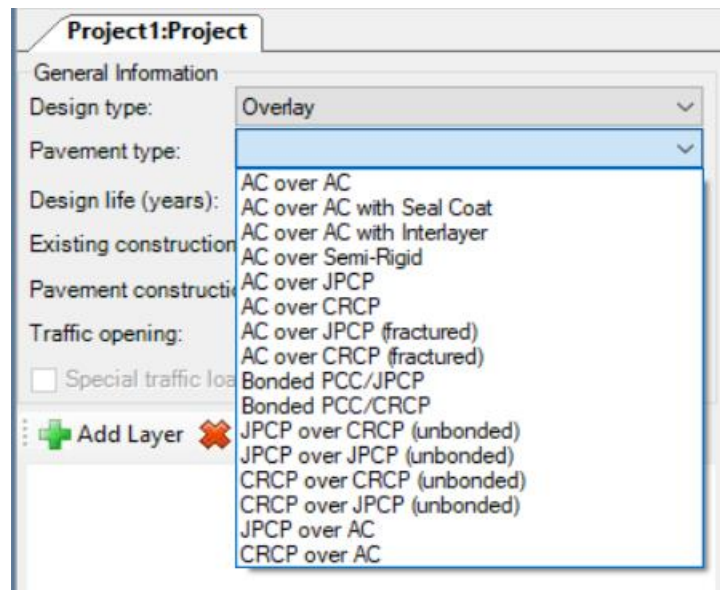
Figure 1. Overlay Options Available for Rehabilitation Design in Pavement ME Design

Several different rehabilitation options using hot mix asphalt (HMA) and concrete overlays can be applied to existing pavements to extend their useful life. Currently, VDOT does not plan to use all of the rehabilitation options available in the MEPDG, as shown in Figure 1. This study identified the most widely used VDOT rehabilitation strategies.

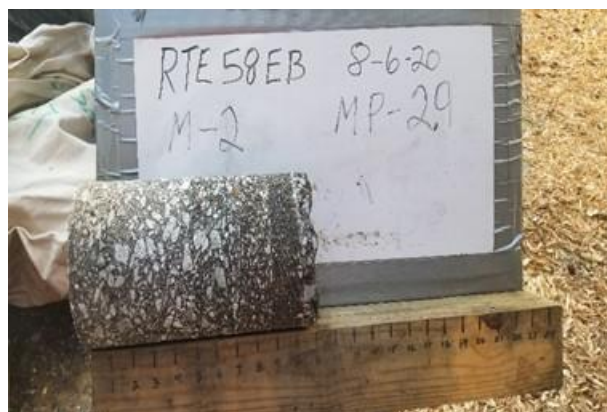
Figure 3. Intact Core on Rte. 58 EB, Richmond District

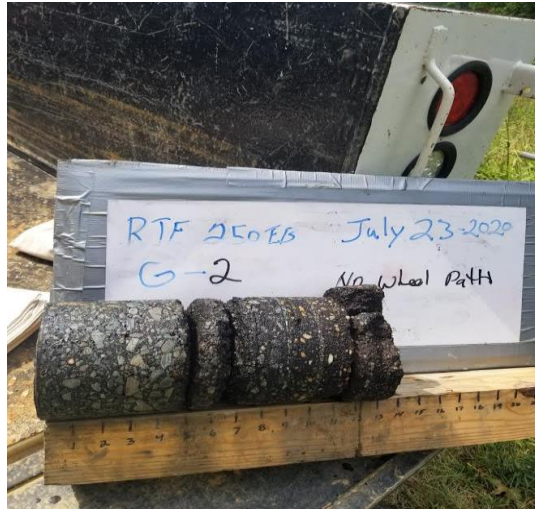
Figure 4. Core Showing Delamination in Multiple Layers and Moisture Damage at Bottom Layer (Rte. 250 EB, Richmond District)

Layer interface friction is an input parameter in Pavement ME Design, and cores and visual surveys can be used to determine if debonding exists along the project. Slippage cracks in the surface and separation of layers during the coring process may be an indication of low interface friction between AC layers (AASHTO, 2020). If debonding exists, the designer can assume no bond or a low interface friction during the rehabilitation design if those layers are to remain in place and not be milled or removed. It is recommended that debonded layers be removed in practice (AASHTO, 2020).

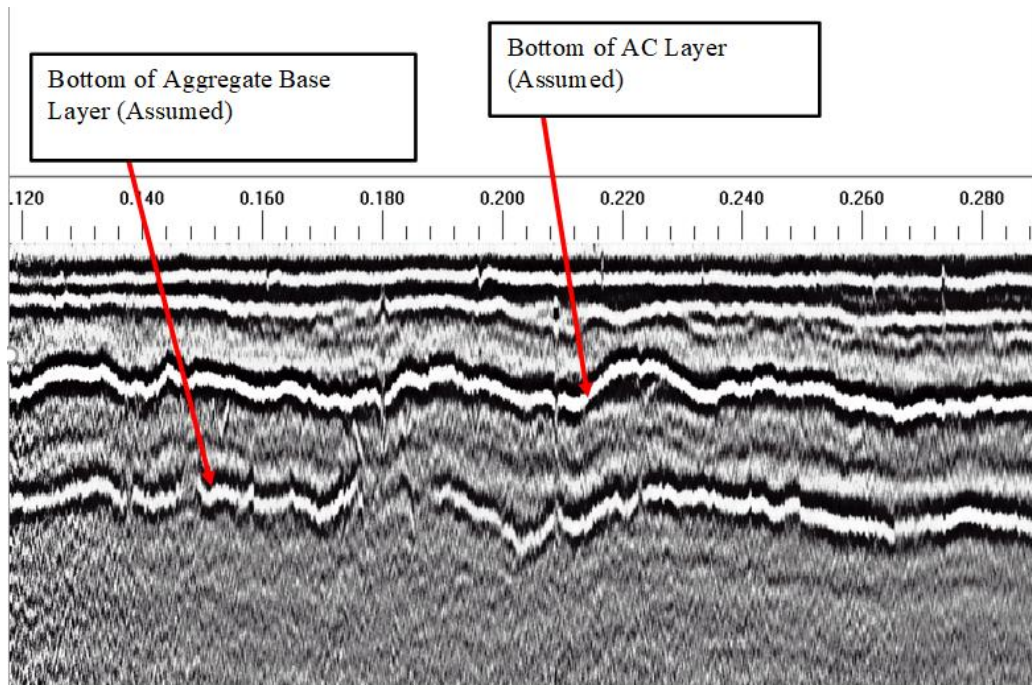
Figure 5. Example of GPR Scan. GPR = ground penetrating radar.

The thickness of AC and base pavement layers was captured in the analysis. Potential separation of layers or possible air voids were observed in the asphalt pavement for a few projects (around 15 projects), and these could be a possible concern for the future rehabilitation treatment type selection process. Analysis showed that the actual thickness of AC and base material varied along the project. To confirm the actual AC and base material thickness, pavement coring was performed at a few sites and GPR thickness was verified with core thickness. Pavement coring was not performed at all sites due to funding and other logistical and resource constraint reasons. The layer thickness was summarized by using the average of the data taken at 0.1-mi intervals. The data represented by each point were 0.05 mi on either side of the testing point. Each layer interface at the bottom of the scan image was marked, and AC bottom and aggregate base were marked separately. Deeper layers that could be the bottom of an aggregate base layer were not visible in the approximately 20 in within the GPR scan. An example of the marks in RADAN indicating the bottom of the layers is shown in Figure 5.

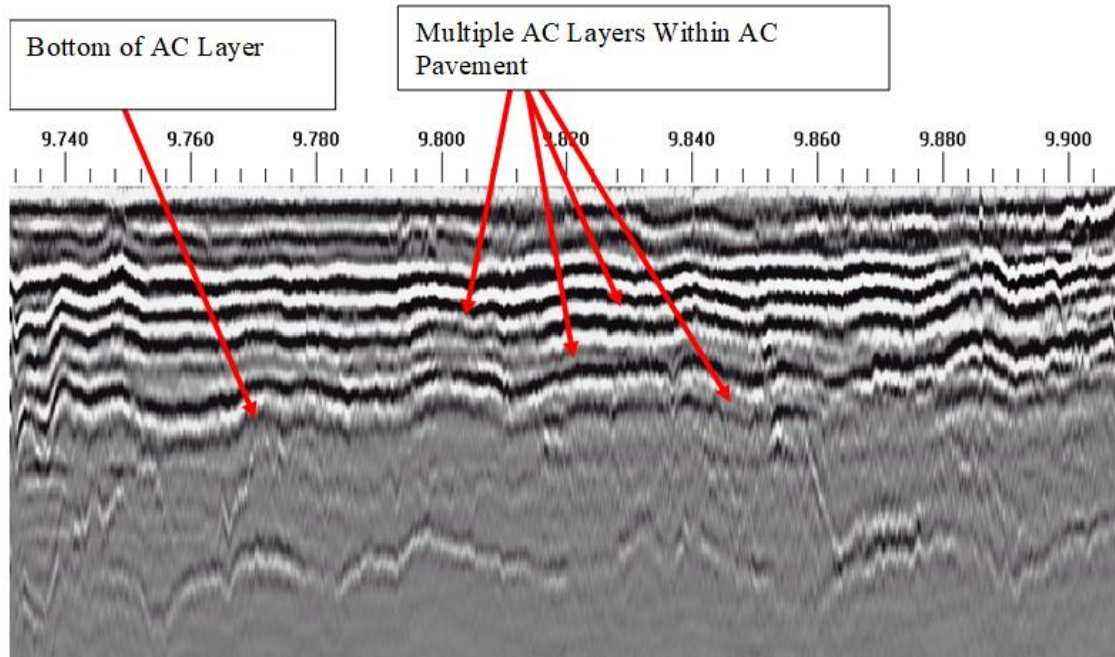
Figure 7. GPR Image of Rte. 250. GPR = ground penetrating radar.

Figure 7 shows a GPR-processed image. Processed images were evaluated carefully, and AC bottom and aggregate base bottom layers were marked. However, multiple faint AC layers were observed within the total AC layer. The presence of multiple layers may come from thin AC rehabilitation or also may be a potential indication of delamination within the AC layers. The GPR images were evaluated all along the project length, and the images show similar layers. Pavement coring was recommended to confirm the delamination within the AC layers.

Pavement coring was performed on Rte. 250 EB on July 23, 2020. Eight cores were taken from the wheel path and centerline locations. Most of the cores showed delamination and stripping, as shown from the GPR analysis. Core logs and images are shown in Appendix C for Rte. 250. Similar observations/results regarding delamination were also observed at two other pavement sites when GPR images were compared with coring. This shows that GPR can be used as an important tool in forensic investigation of asphalt pavements.

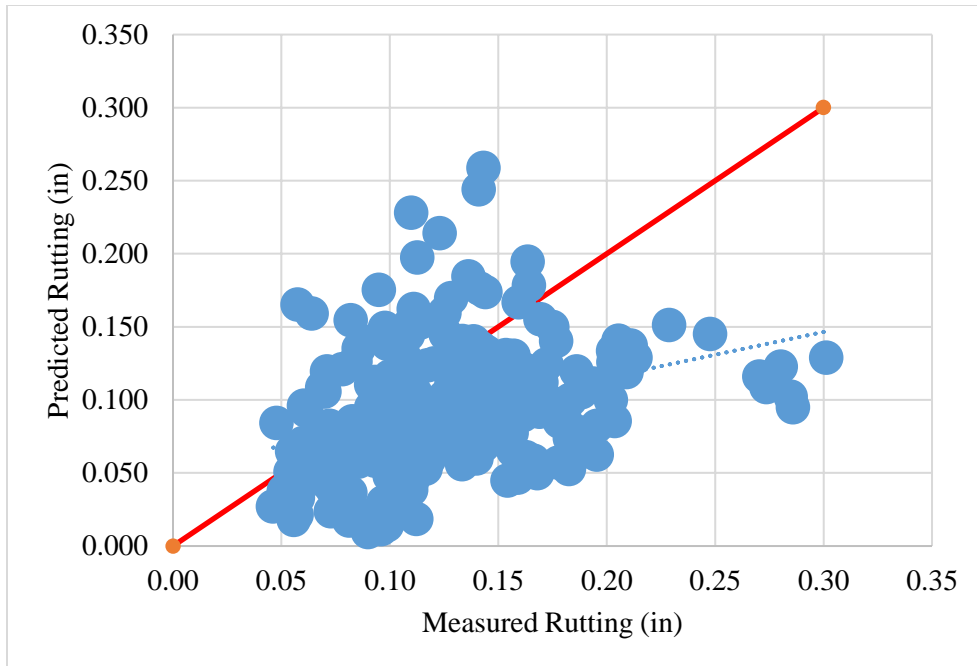
Figure 8. Asphalt Pavement Rutting Comparison With VDOT Calibration Coefficients

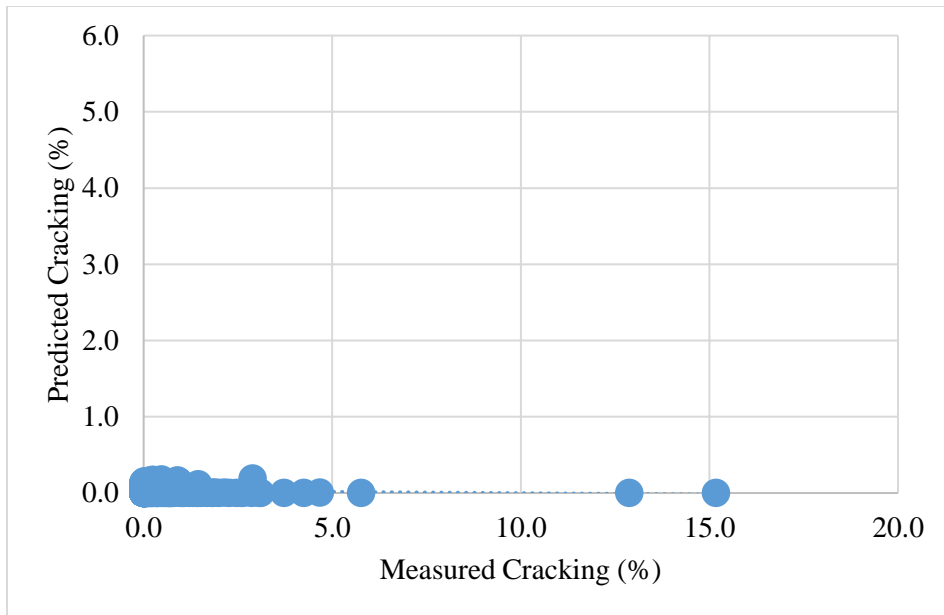
Figure 10. Predicted vs. Measured Bottom-Up Cracking With Current Coefficients

Figure 10 shows measured and predicted bottom-up fatigue cracking (from 8 to 9 years of performance data). Higher cracking (>10%) was observed in only one project. For most of the projects, measured cracking was less than 2%. Table 14 shows the calibration statistics, which showed bias. As mentioned earlier, debonding and pavement distress such as moisture damage are not accounted for in the calibration process and will increase the cracking prediction if considered. In general, projects with such features should not be included in the calibration study. Because of this, national experts suggest that rutting and cracking calibration should first be conducted using performance data from new pavement construction and then that the same coefficients be applied to rehabilitation design.

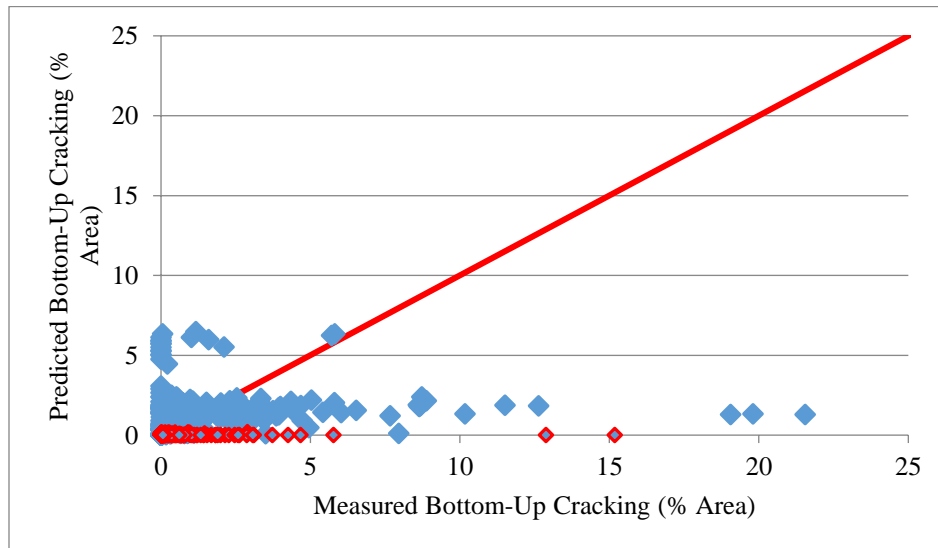
Figure 11. Comparison of Measured vs. Predicted Data. Data in blue are for new construction and are from a previous study (Smith and Nair, 2015); data in red are from the current study.

Figure 11 shows the bottom-up fatigue cracking results in comparison with results of new construction calibration from a previous study (Smith and Nair, 2015). Figure 11 shows, in general, that there is some improvement needed for bottom-up fatigue calibration. As mentioned previously, Level 2 and Level 3 severity level data from the PMS were used for bottom-up fatigue calibration. Bias in the data may also be due to this assumption. With a greater AC thickness (>10 in), some of the cracks may be top-down cracking. In rehabilitation projects, some of the cracks may also be reflective cracking. Should VDOT move to Pavement ME Design V2.6, it might be a good idea to repeat the calibration exercise for new construction using the data from the previous project and adding additional sites from the past 10 years. Such a study should also include some forensic investigation to identify top-down vs. bottom-up fatigue cracking. Further, AASHTO provides a calibration assistance tool (which is compatible with V2.6) to help agencies conduct local calibrations of the pavement ME performance models. The tool is being developed in accordance with the 11-step procedure given in AASHTO’s *Local Calibration Guide* (AASHTO, 2010) and offers the advantage of quick calibration using the latest versions of Pavement ME Design (V2.5 and V2.6).

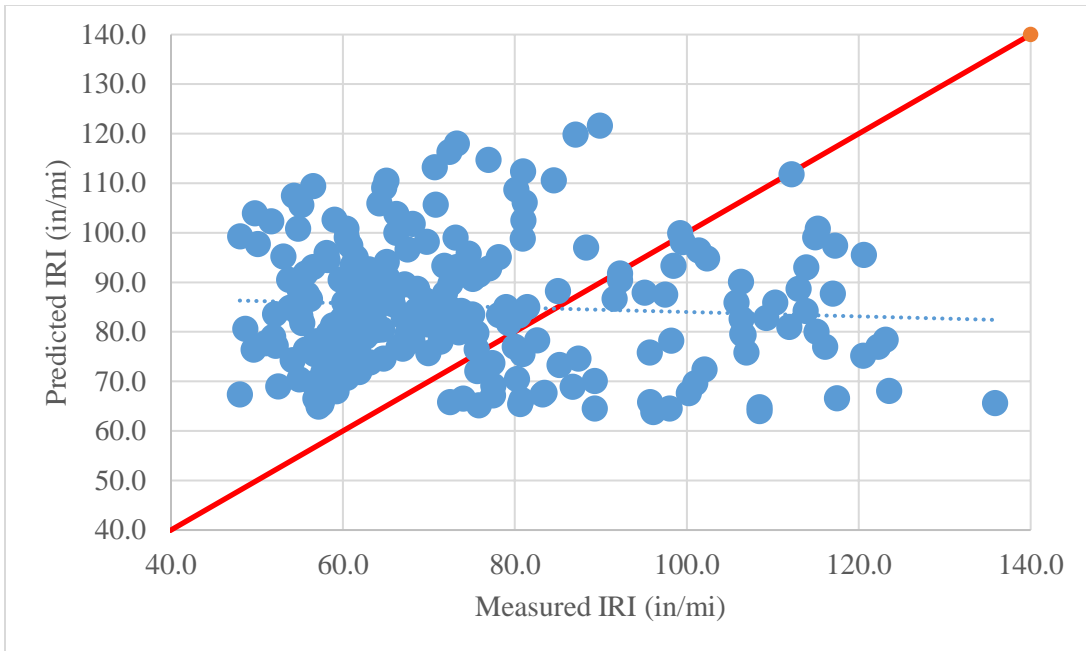
Figure 12. Measured and Predicted IRI Comparison. IRI = International Roughness Index.

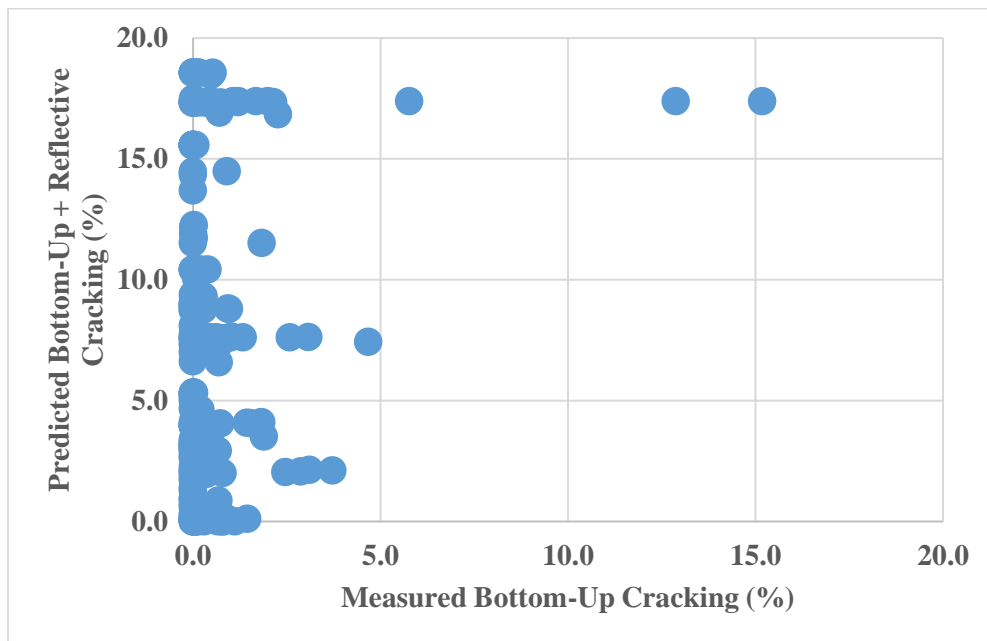
Figure 13. Comparison of Bottom-Up + Reflective Prediction vs. Measured Bottom-Up Cracking

Figure 13 shows a comparison of predicted bottom-up cracking + reflective cracking and measured bottom-up cracking (Level 2 and 3 severity), which shows that this model (bottom-up + reflective) needs further assessment and calibration. Tables 16 and 17 give comparisons of bottom-up + reflective prediction and bottom-up cracking and total cracking from the PMS for mill and fill and straight overlay application, respectively. It can be seen from the tables that the software predicts very high early reflective cracking compared to measured values. Further calibration of this model will be required if V2.6 is adopted.

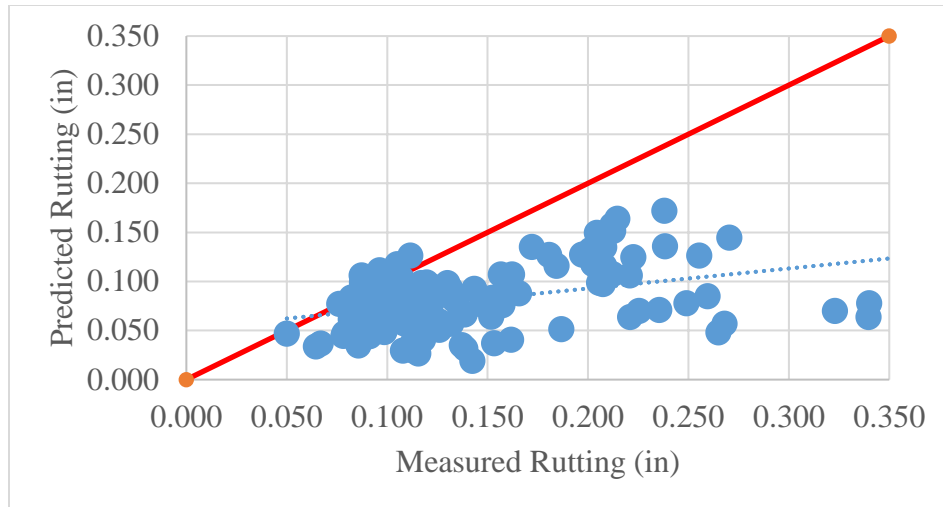
Figure 14. Measured vs. Predicted Rutting Comparison for AC Over CRCP Projects. AC = asphalt concrete; CRCP = continuously reinforced concrete pavement.

Figure 14 shows a comparison of measured and predicted rutting values for AC over CRCP. Considerable bias was observed when 8 to 9 years of measured and predicted values were compared. Most of the SMs used were SMA. Figures 15 and 16 show that one-half of the SMA mixtures showed good performance (<0.15 in) in terms of rutting and one-half showed higher rutting (>0.2 in). As mentioned previously, rutting calibration requires adjusting both β_1 and β_3 values to match the measured and predicted values.

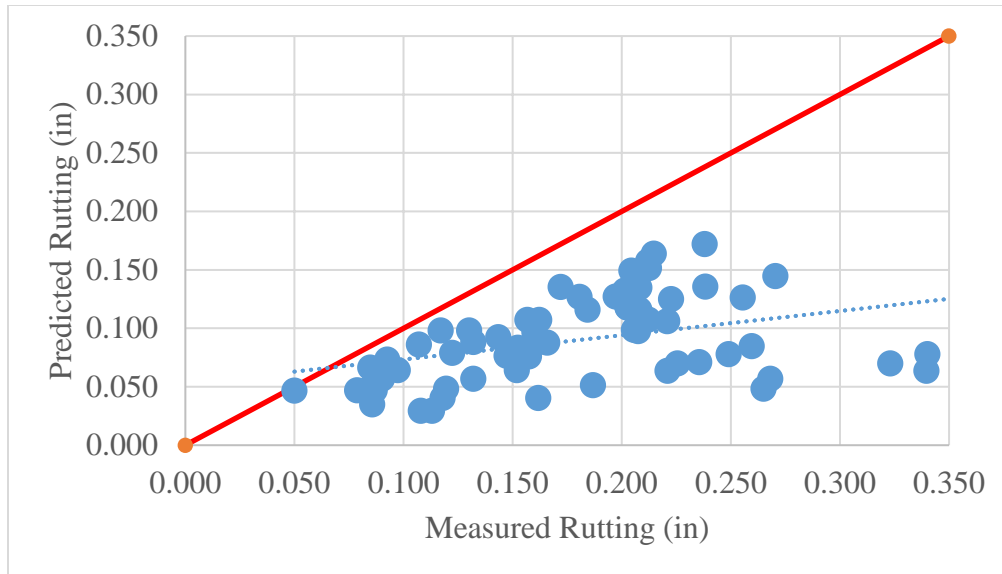
Figure 16. Measured vs. Predicted Rutting Comparison for SMA Over CRCP Projects. Measured rutting > 0.2 in. SMA = stone matrix asphalt; CRCP = continuously reinforced concrete pavement.

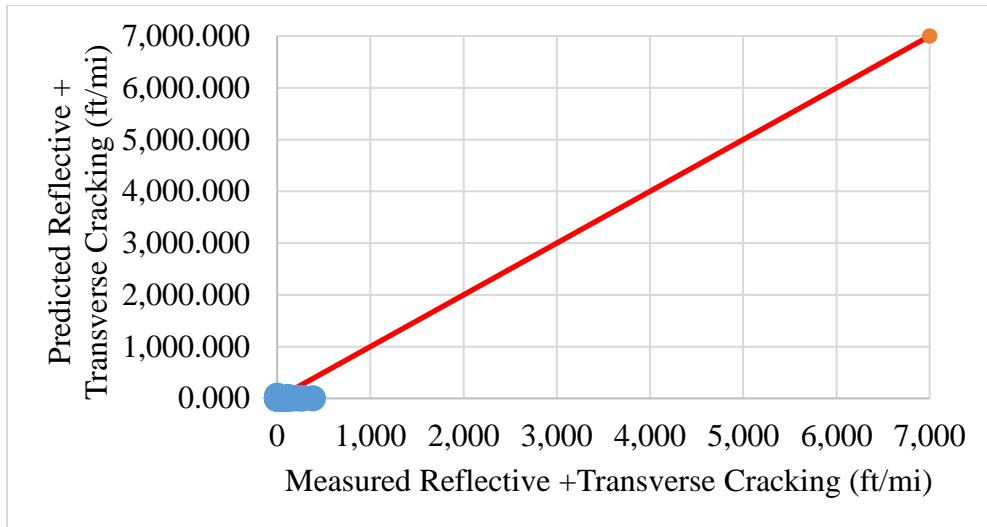
Figure 18. Comparison of Measured and Predicted Reflective + Transverse Bottom-Up Cracking

Figures 17 through 19 show comparisons of measured and predicted distress for bottom-up cracking, reflective + transverse cracking, and IRI. Except for IRI, all the other distresses showed good correlation with minimum bias. Other than for rutting, Pavement ME Design V2.2.6 with current coefficients can be used to predict bottom-up cracking and reflective + transverse cracking.

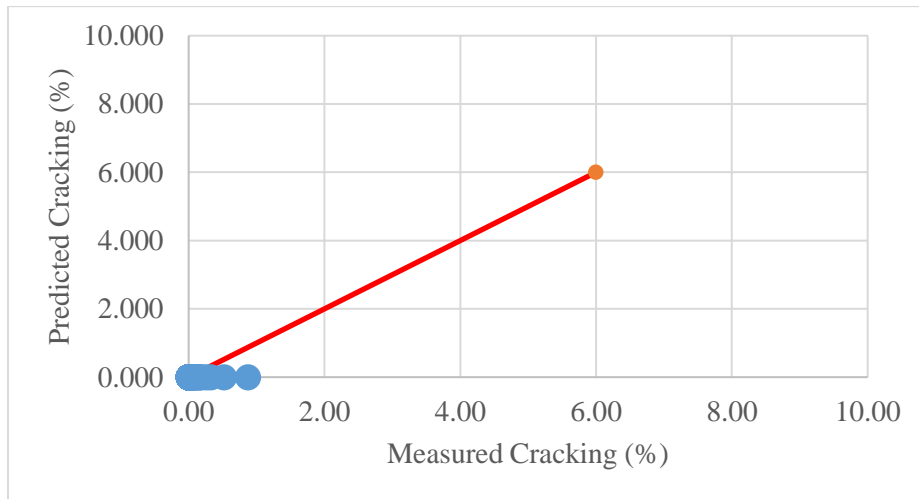
Figure 23. Comparison of Measured and Predicted Bottom-Up Cracking

Some of the outlier data that showed very higher cracking compared to others were removed from the analysis. However, most measured values were less than the AASHTO pavement ME default recommended criterion of 2,500 ft/mi. It is recommended that this model be calibrated with only V2.6. Further, it is recommended that reflection cracking mitigation for asphalt overlay over JCP be considered outside Pavement ME Design by means such as binder modification (high polymer binder, ground tire rubber, etc.) and asphalt mixture modification (use of fibers), use of paving fabrics, saw and sealing of the HMA overlay, or use of in-place recycling techniques. Researchers at VTRC have completed several studies in this area and are working further to document comparisons of different methods. Other than rutting, V2.2.6 with current coefficients can be used to predict bottom-up cracking and reflective + transverse cracking.

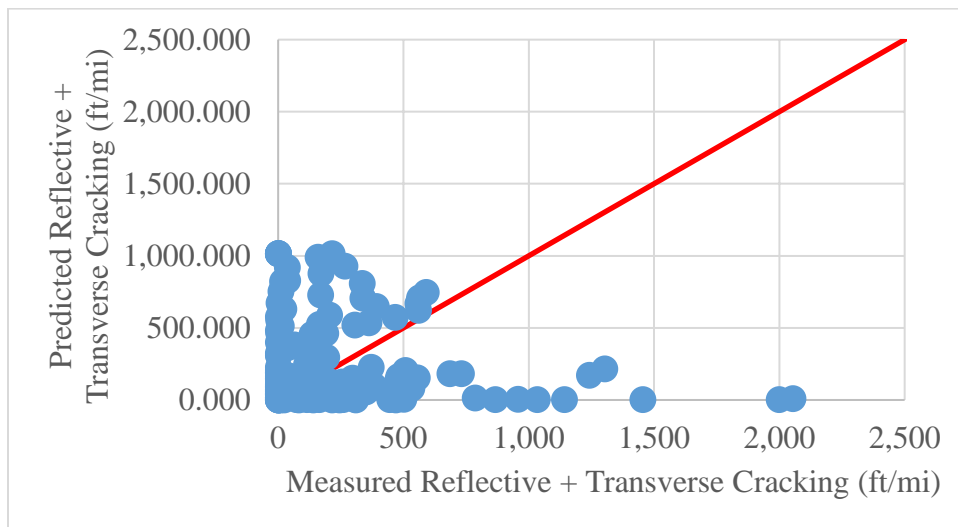
Figure 24. Comparison of Measured and Predicted Reflective + Transverse Bottom-Up Cracking

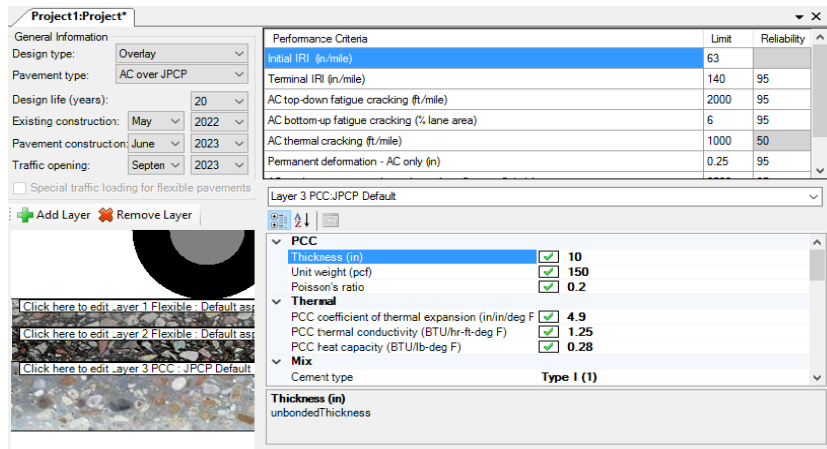
Figure 26. Pavement ME Design Simulation Showing 2 AC Layers Over JCP. AC = asphalt concrete; JCP = jointed concrete pavements/

Several existing composite pavements in this study were modeled as AC over CRCP and AC over JPCP. Some guidelines are provided in the AASHTO ME Design FY21 Webinar Series (AASHTO, 2021). Figure 26 shows an example of two AC layers over JPCP. The bottom AC layer can be considered an existing layer and field-measured properties (in-place air voids and binder content) can be entered for that layer.

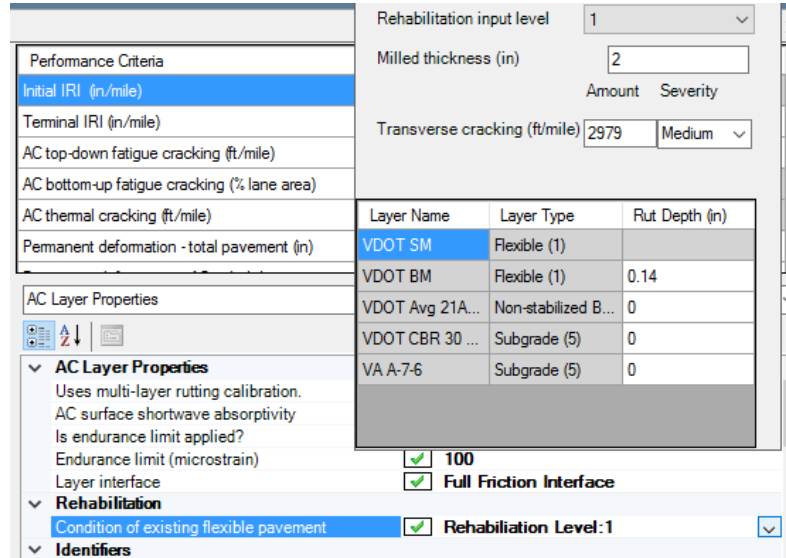
Rehabilitation input level: 1

Milled thickness (in): 2

Figure A1. Level 1 Rehabilitation Input in Pavement ME Design

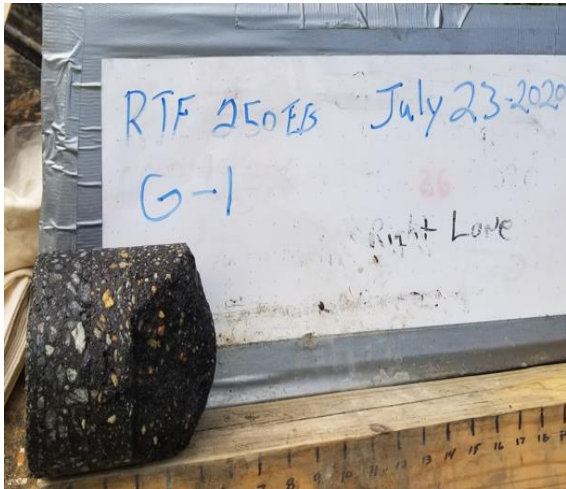
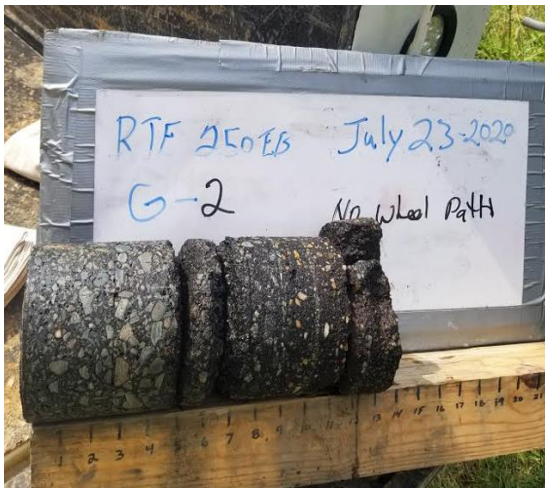
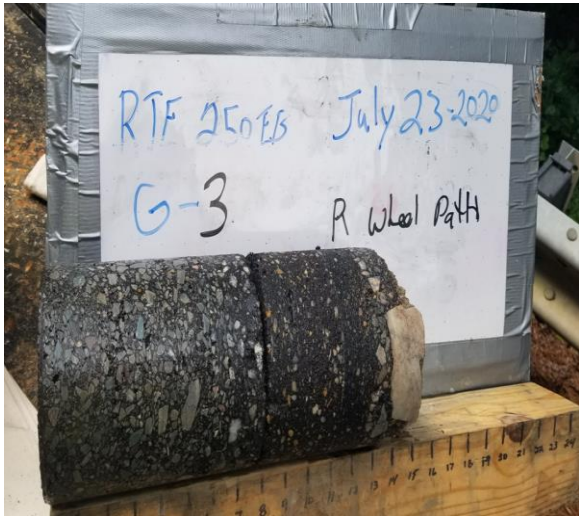
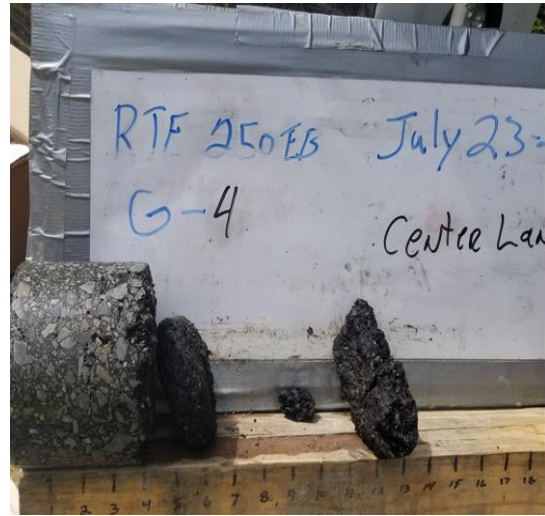
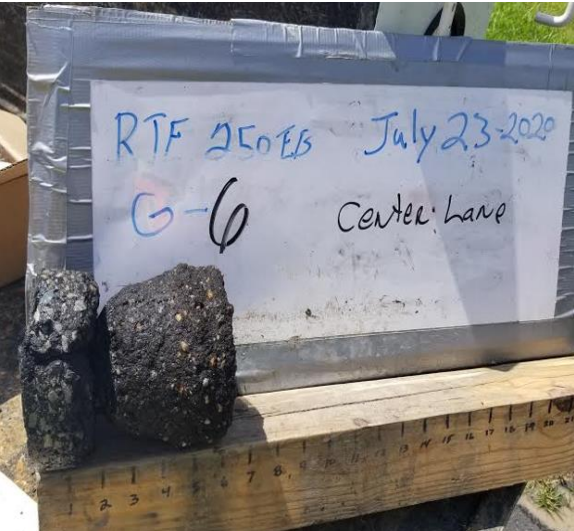
Core#	Depth	Condition	Location
	Hole Depth		
G-1	10" Hdr	Hole measured 10" core only 6"	CL
G-2	13"	stripping below 5"	CL
G-3	13"	good to 8" - stripping	wheel path
G-4	13	stripping below 5"	CL
G-5	9"	some cobble / Big stone subbase	WP
G-6	13	2" good then stripped	CL
G-7	13	All one piece - Good	WP
G-8	13	stripping below 3-4"	CL

Figure C2. Core Photographs From Rte. 250
