DOT/FAA/TC-21/27

Bonded Repairs to Composite Wing Panel Structure: Phase 3— Bonded Repair Size Limits Study for Solid Laminates with Full- Depth and Partial-Depth Scarf Configurations

July 2021

Final report

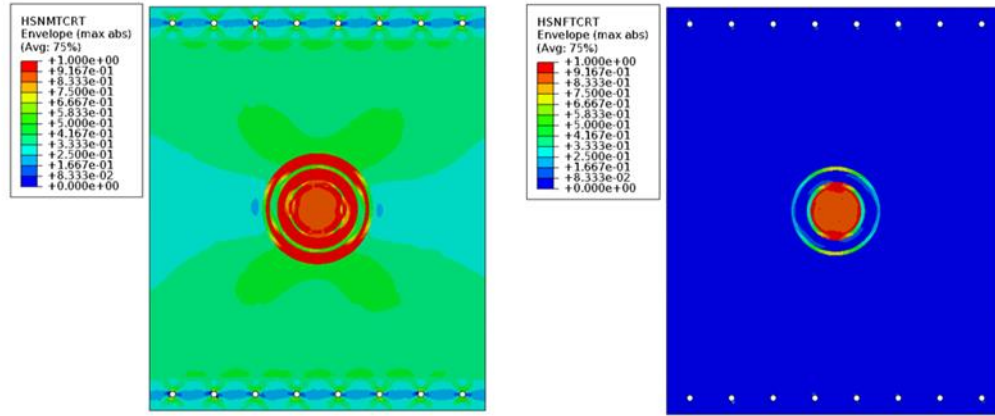
(b) Partial-depth scarf panel at failure

An advanced progressive failure analysis (PFA) approach was used to predict the ultimate load levels for various damaged panels in this test program. The current approach implements the Hashin in-plane failure criteria and the PFA input properties were derived from analysis and tests for the specific materials, processes and design practices. Figure 8 shows the matrix and fiber tensile failure index contours at ultimate load for a 30:1 scarf panel (only the damaged regions were shown).

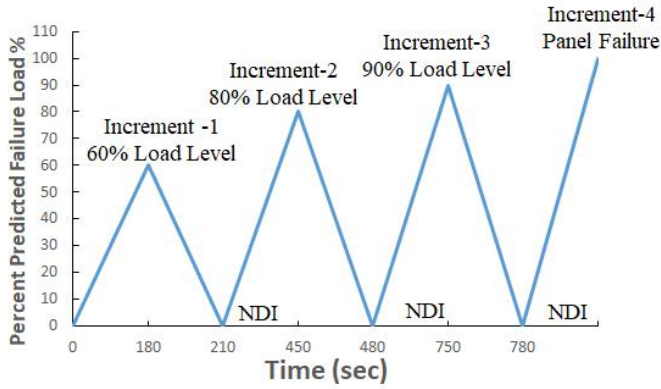
a. Residual strength load profile

After the initial strain survey, panel 3 was subjected to a residual strength test. Results are shown in Figure 12. The panel was loaded quasi-statically in a saw-tooth profile (sinusoidal loading), increasing the load level up to failure based on percentages of the predicted critical strength of 169,318 ft-lb_f calculated by PFA. During loading, damage formation was monitored visually using high-magnification cameras and DIC. After each load increment, the panel was inspected using a thermography system. Damage was first detected visually at 60% load level in the form of edge delamination (ply #9, middle 0° ply) along the scarf inner-edge at the 3 o'clock position. The edge delamination continued to grow circumferentially while loading to 80% load level. In addition, a delamination initiated in the fifth ply (first 0° ply from the panel external surface). At 90% load level, extensive damage occurred where the entire scarf region in the 3 o'clock position delaminated. Final failure through the net section of the panel occurred at an applied moment of 168,611 ft-lb_f, which was within 1% of the predicted value. As soon as the 0° plies delaminated, the load was transferred to the 12 o'clock and 6 o'clock positions and the panel failed catastrophically along the net section. Both DIC and thermography successfully captured the damage progression. The strain gage data collected during residual strength test is provided in appendix C.

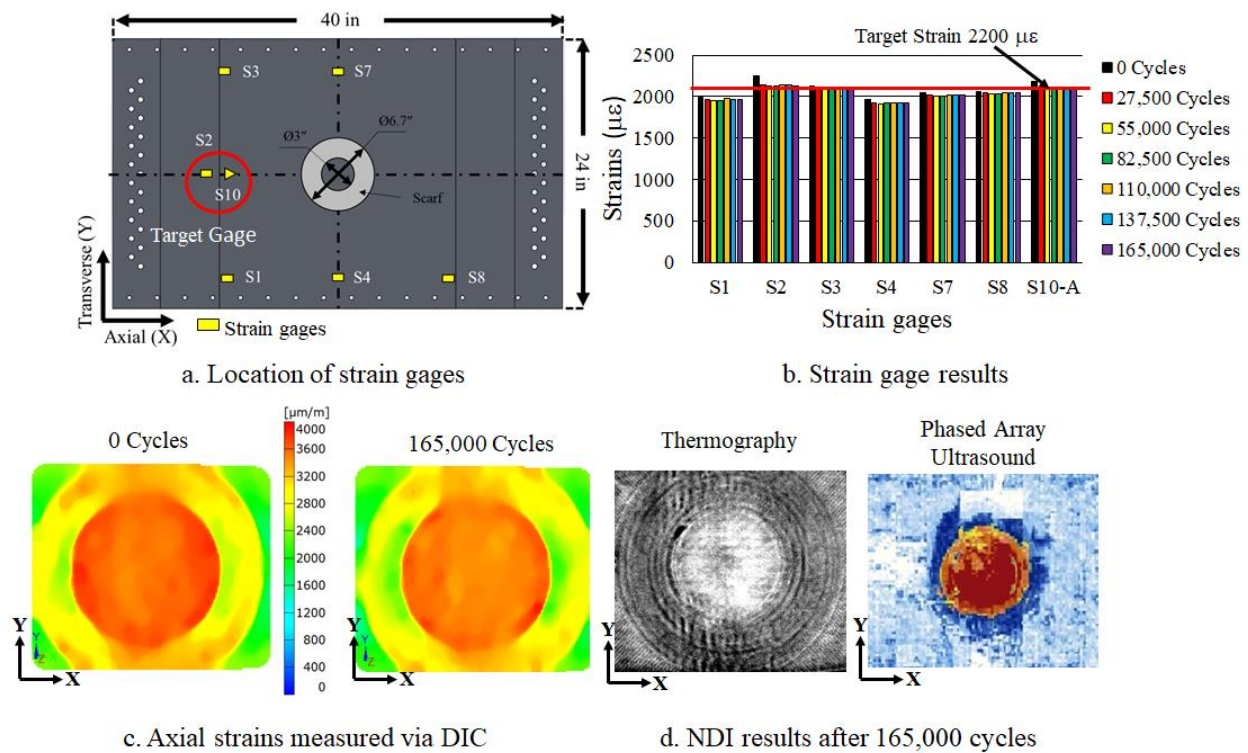
Figure 13. Panel 5 results during fatigue at SL strain level

Next, panel 5 was subjected to 165,000 fatigue cycles (3 DSGs) at SL conditions and $R=0.1$. No strain redistribution was observed during the fatigue cycles as shown by strain gage and DIC results in Figure 13b and Figure 13c. During the tests, the panel was also inspected using several NDI techniques. Although there were few spots of possible local delamination, the sizes of these possible indications were too small to provide any conclusive results, as shown in Figure 13d. Overall, the scarf was able to sustain 3 DSGs without any damage formation or growth.

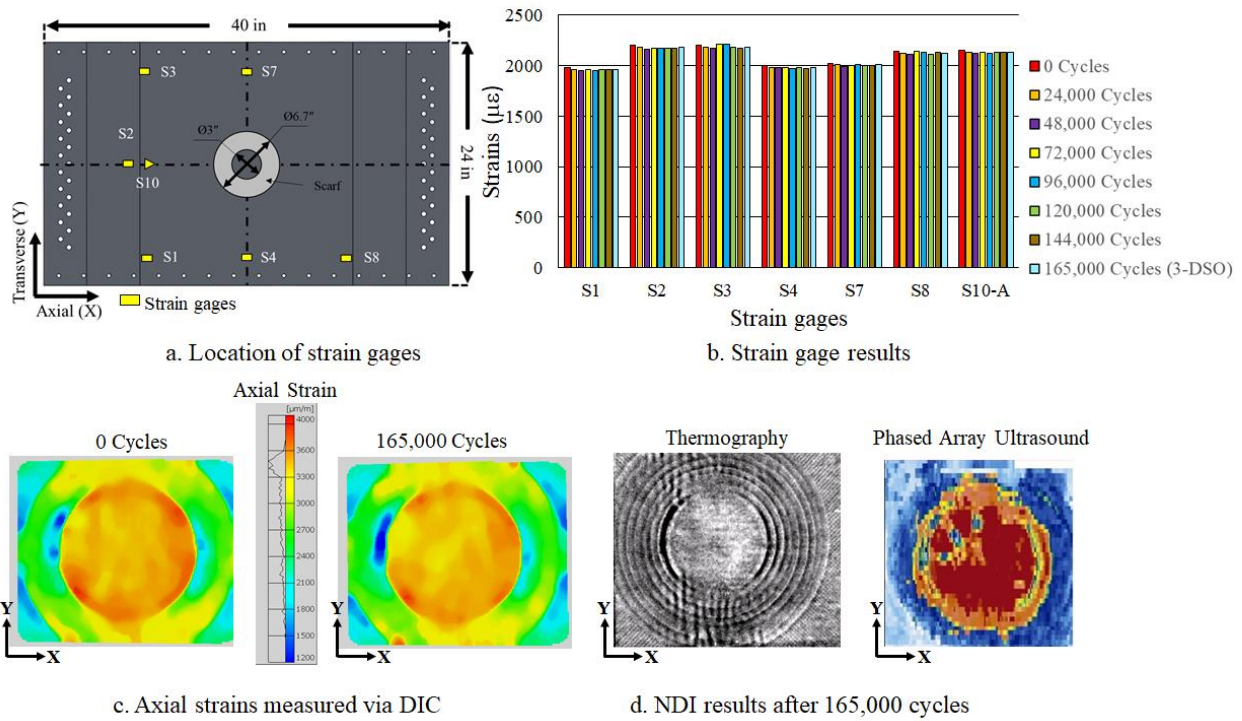
Figure 15. Panel 5 results during additional fatigue at SL strain level

After fatigue at the elevated load strain level, panel 5 was subjected to an additional 165,000 fatigue cycles (3 DSGs) at lower-level SL conditions and $R=0.1$. The goal of this test was to monitor the growth of the delamination (developed during fatigue at elevated load strain level), when the panel is subjected to the SL strain levels. All the strain gages and DICs showed no strain redistribution, and NDI techniques showed no growth in delaminations, as shown in Figure 15.

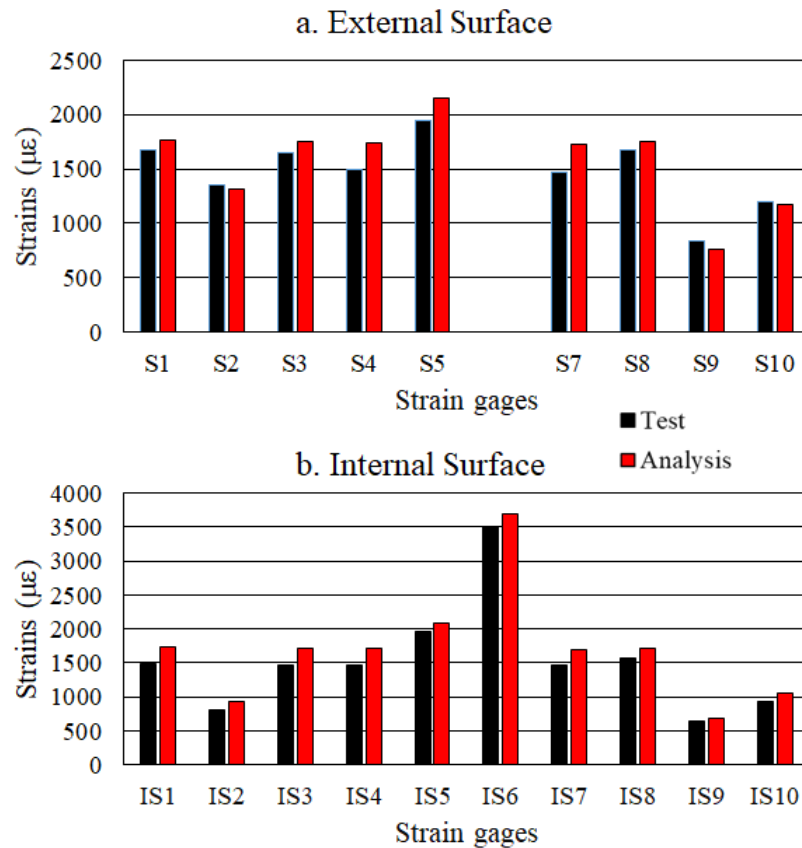
Figure 17. Baseline strain survey results for panel 4

Figure 17 shows the baseline strain survey results for panel 4, where loads were applied to yield far-field target strain of $1767 \mu\epsilon$. As shown in the figure, the strain gage S-10 was significantly lower than the target strain due the bending caused by the presence of a large scarf. Thus, the average of strain gages S-1 and S-3 was considered for target strains. It is clear that for both external and internal gages, there was good agreement between the test results and the analysis predictions.

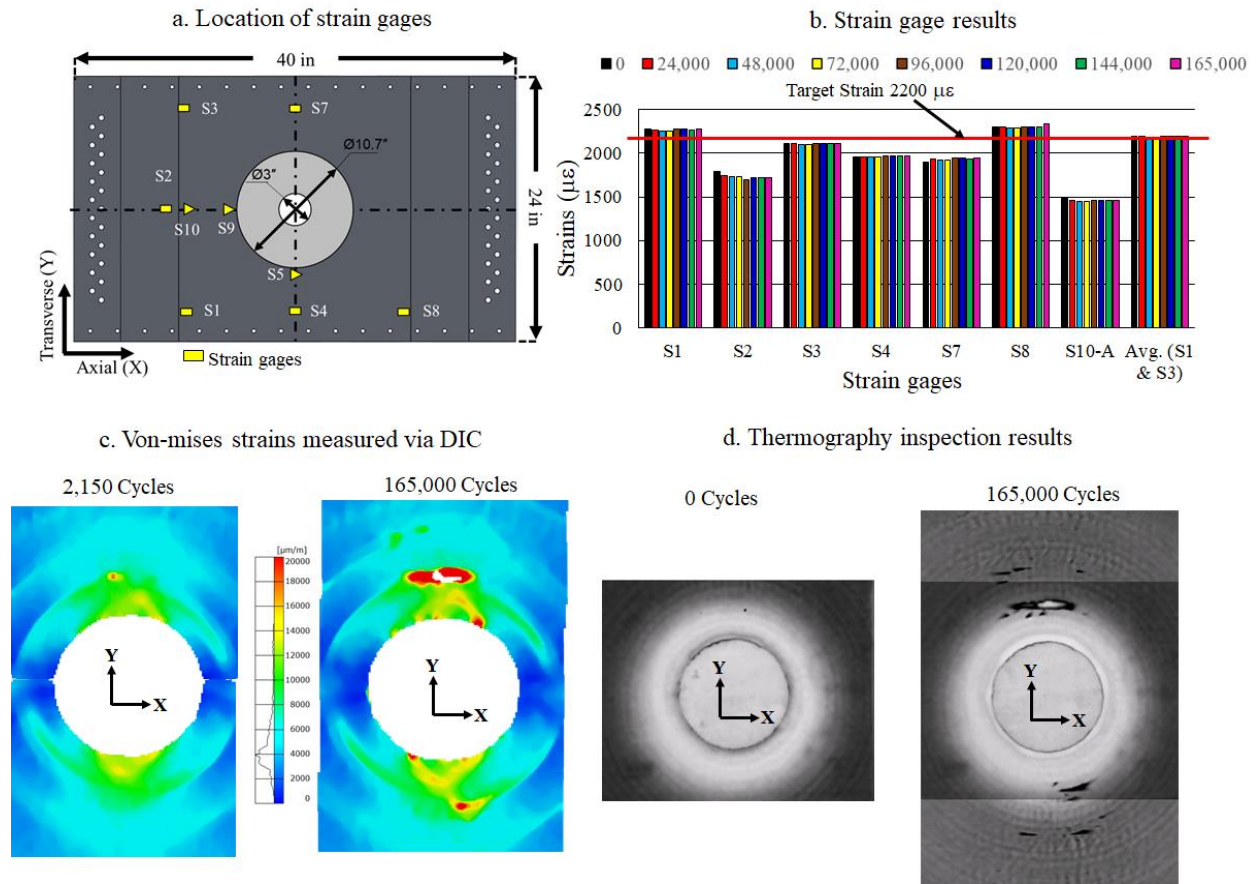
Figure 19. Panel 6 results during fatigue at service load strain level

Next, panel 6 was subjected to 165,000 fatigue cycles (3 DSGs) at SL conditions with $R=0.1$. The first local delamination in the scarf appeared at 2,000 fatigue cycles in ply #14 (first 0° ply from the internal surface of the panel) at the 12 o'clock position. Both flash thermography and DIC were able to detect the delamination, as shown in Figure 19c and Figure 19d. With the progress in fatigue cycles, another delamination appeared in the scarf at 6 o'clock position in the same ply #14 (0° ply). In addition, there were few small delamination indications in plies #9 and #10 (middle 0° plies), both at 6 o'clock and 12 o'clock positions. By the end of the third DSG, the delamination in ply #14 (0° ply) grew to 1.866 in. and 1 in. long at the 12 o'clock and 6 o'clock positions, respectively, as shown in Figure 20. The growth in the other delamination was significantly smaller. All the delamination occurrences were localized and did not cause any strain redistribution in the panel, as shown by constant far-field strains measured by the strain gages (see Figure 19b).

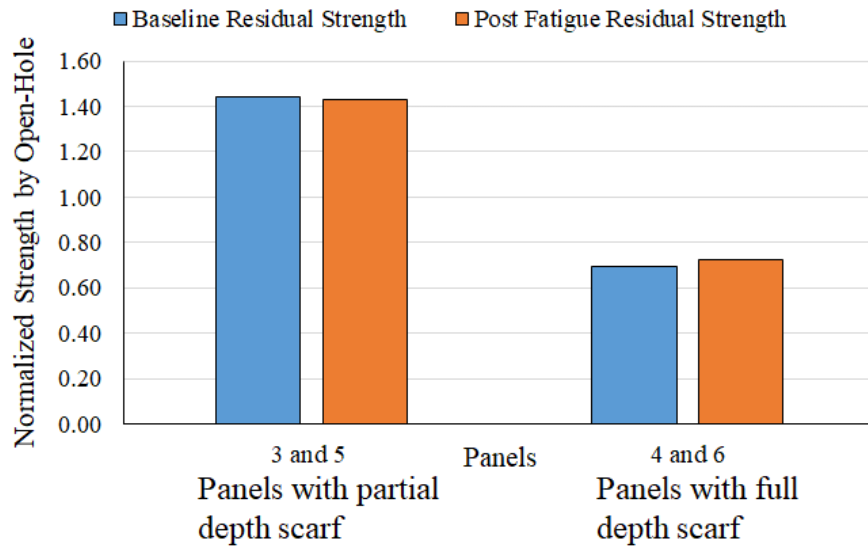
Figure 22. Comparison of strength for all four panels

The residual strength of all four panels is summarized in Figure 22.

Their strength is normalized by the strength of the open-hole panel (panel 2) tested during phase 2 (Neel et al., 2020). A comparison of panels 3 and 5 showed that subjecting the panel with the partial-depth scarf to 6 DSGs did not cause any reduction in the residual strength. Similar results were shown in panels 4 and 6, where there was no debit in strength of the panel with the full-depth scarf due to 3 DSGs. In addition, the strength of panels with partial-depth scarfs was almost twice the strength of the panels with full-depth scarfs, indicating the benefit of removing partial plies as compared to all the plies.

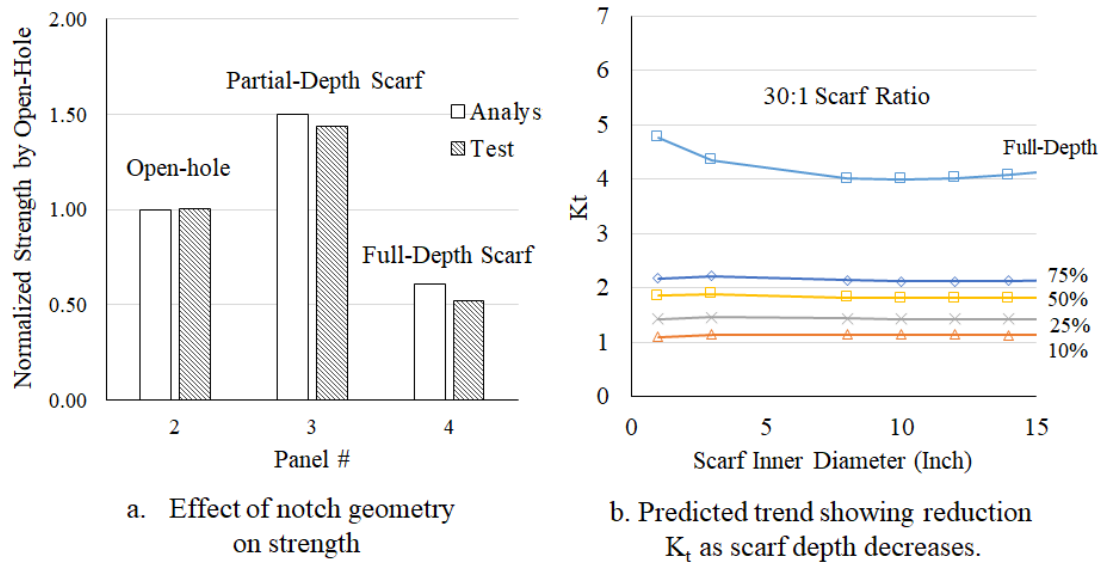
Figure 23. Benefits of partial-depth scarf

The effect of notched geometry on the ultimate strength of the solid laminates tested in this program is summarized in Figure 23.

As shown, good agreement was obtained between the test and stress concentration factor (K_t)-based analysis. The ultimate strains measured in panel 3 containing a partial-depth scarf were the highest, as expected, followed by panel 2 with the center hole (Neel et al., 2020), and then panel 4 containing the full-depth scarf. The benefit gained in the residual-strength limit-load capability of the failed partial-depth scarf is evident because it was much higher than the open-hole panel. In addition, analytical models currently under development to accurately predict the strain levels associated with failed repair depth are demonstrated. Model predictions show reduction of the K_t , as the scarf depth decreases.

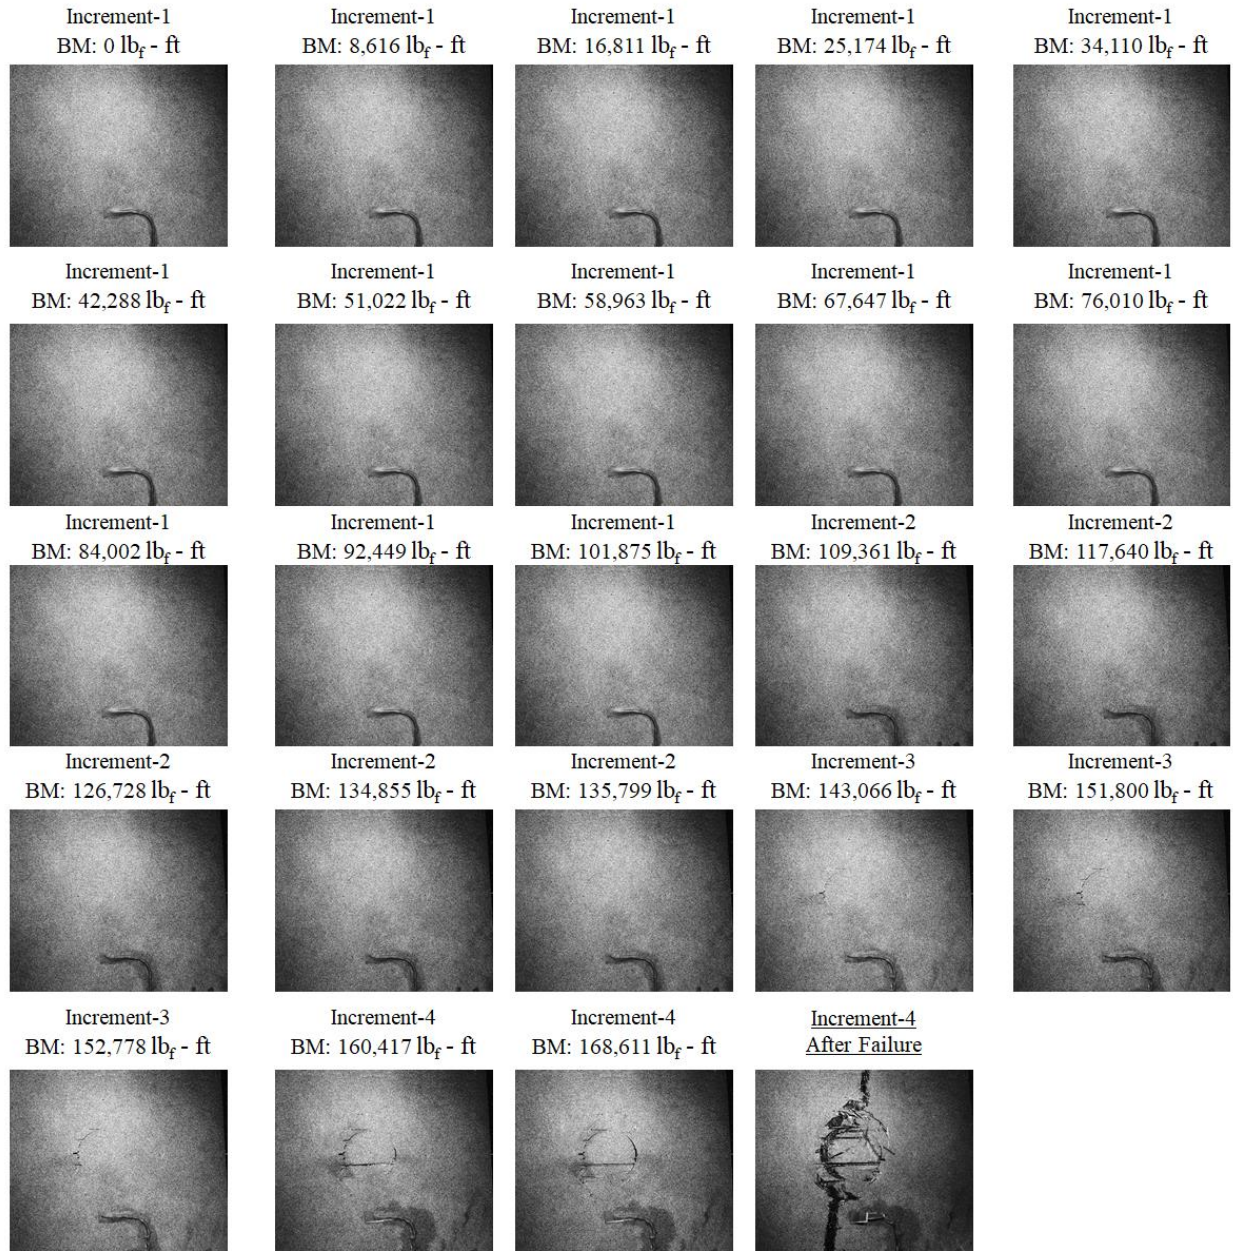
Figure E 1. Panel 3 visual results using WFOV camera during residual strength test

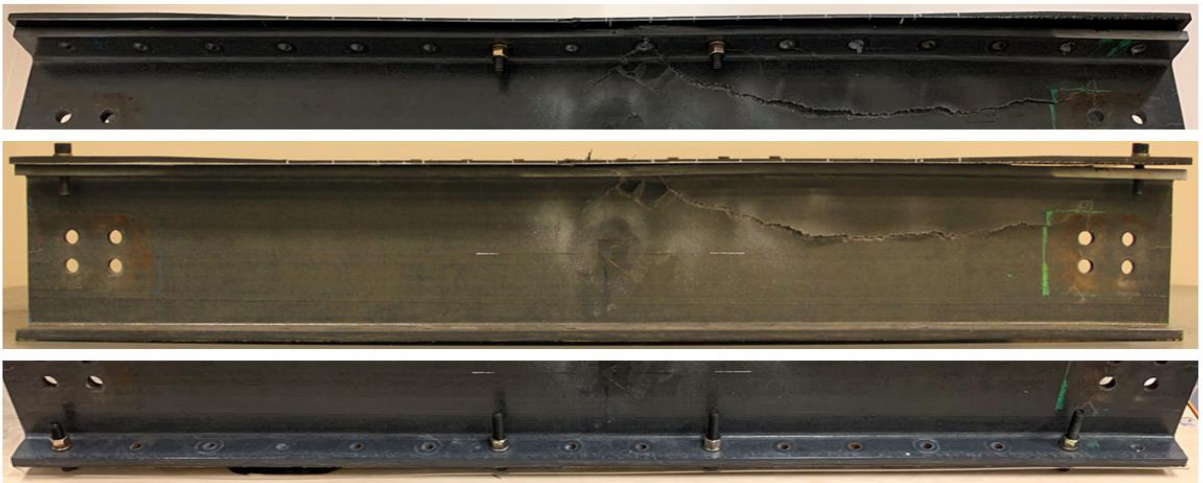
Figure E 3. Post-failure images of panel 3 and side-channels

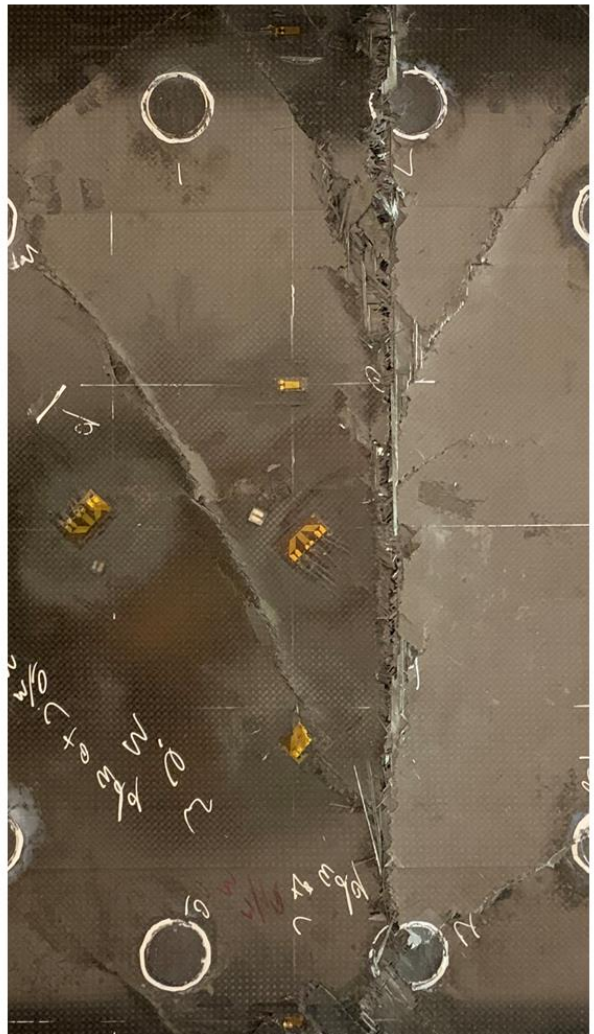
Figure E 4. Post-failure images of panel 3

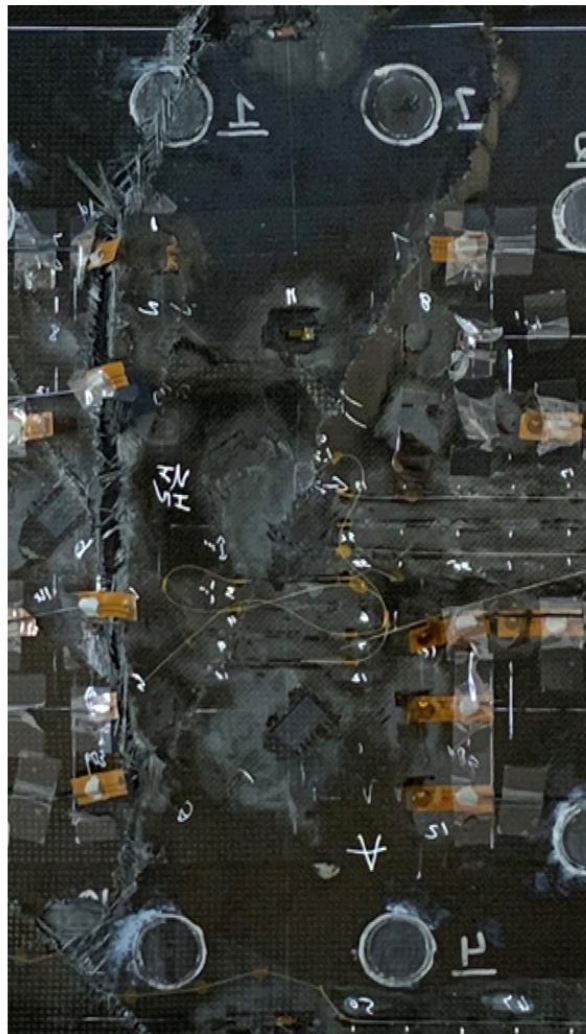
Figure E 11. Post-failure images of panel 5

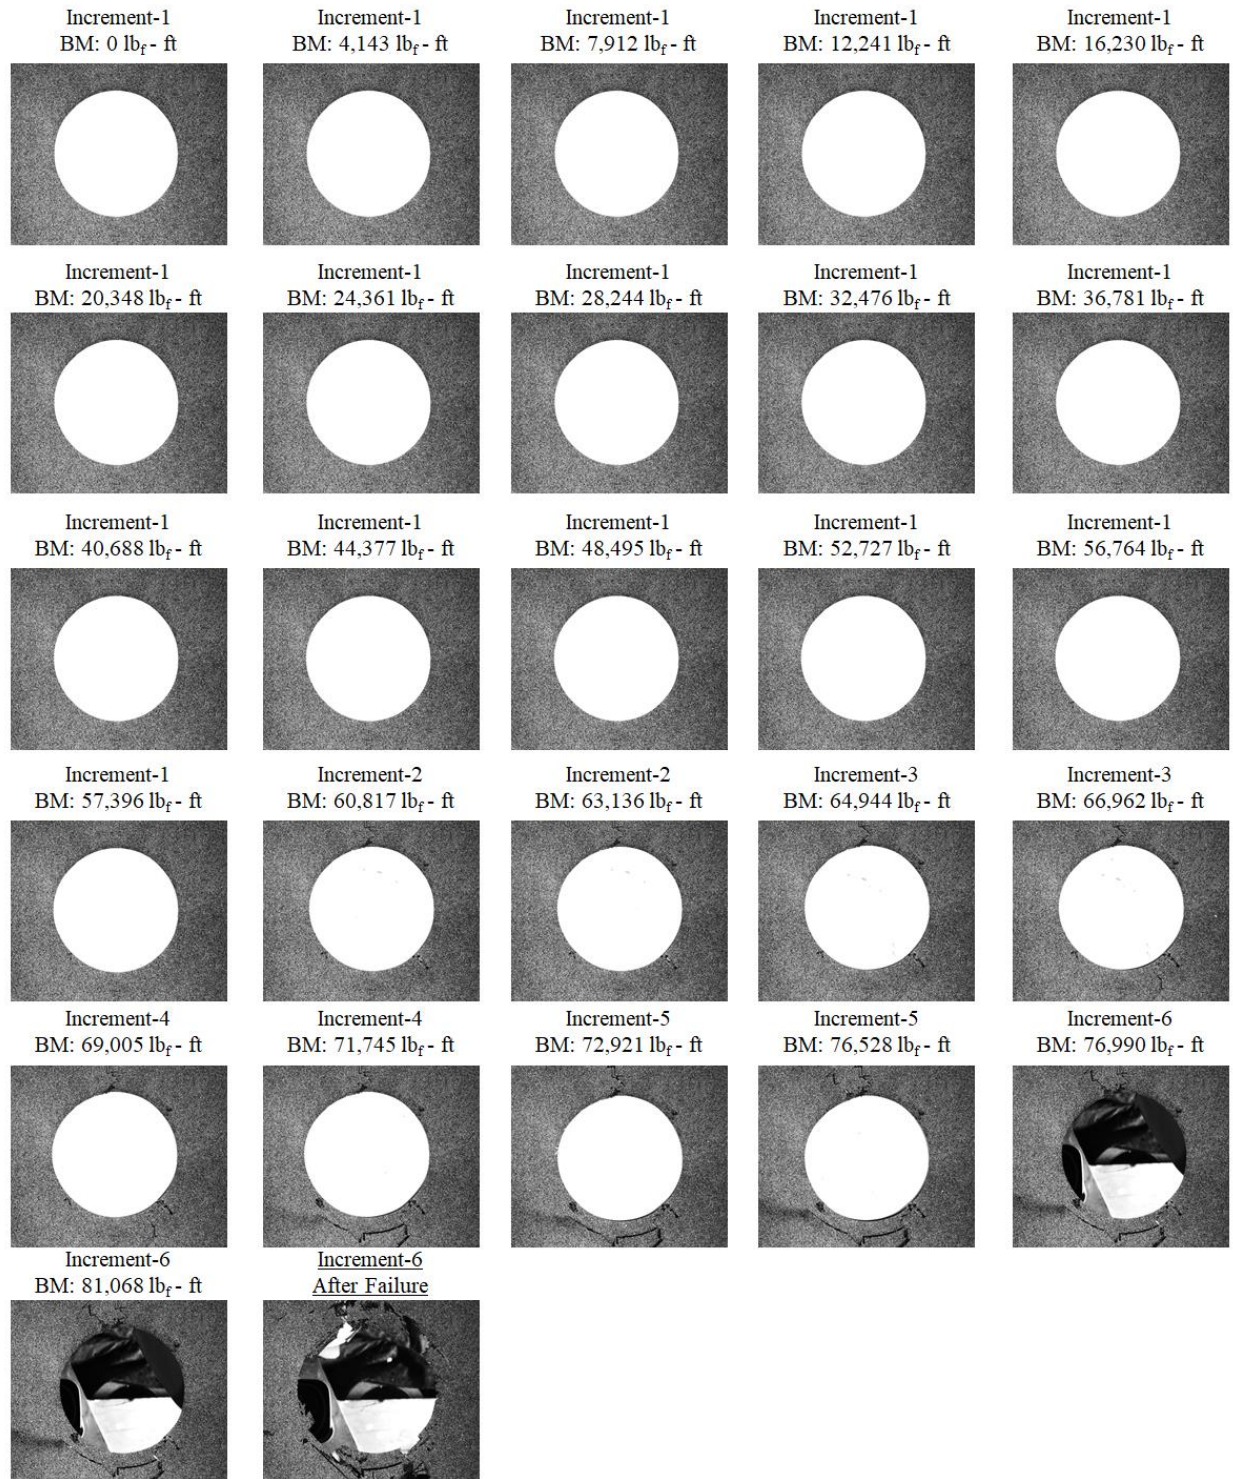
Figure E 13. Panel 4 visual results using NFOV camera during residual strength test

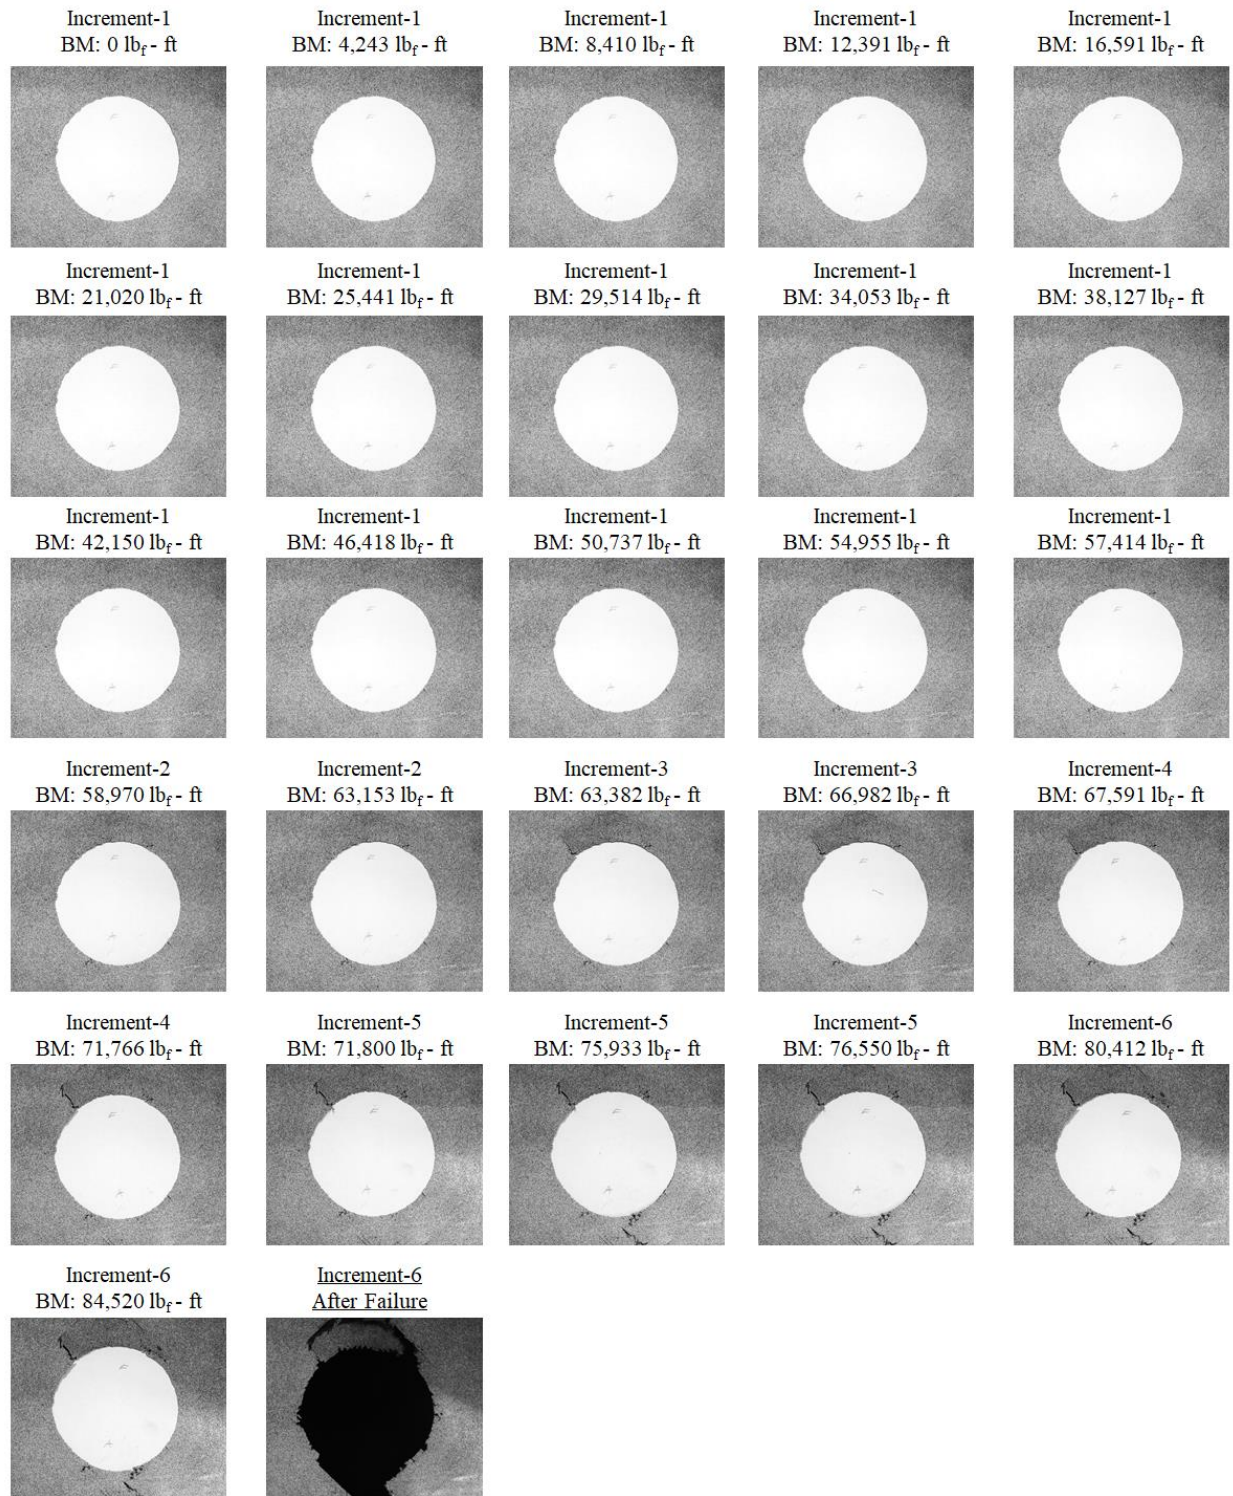
Figure E 18. Panel 6 visual results using NFOV camera during post-fatigue residual strength test

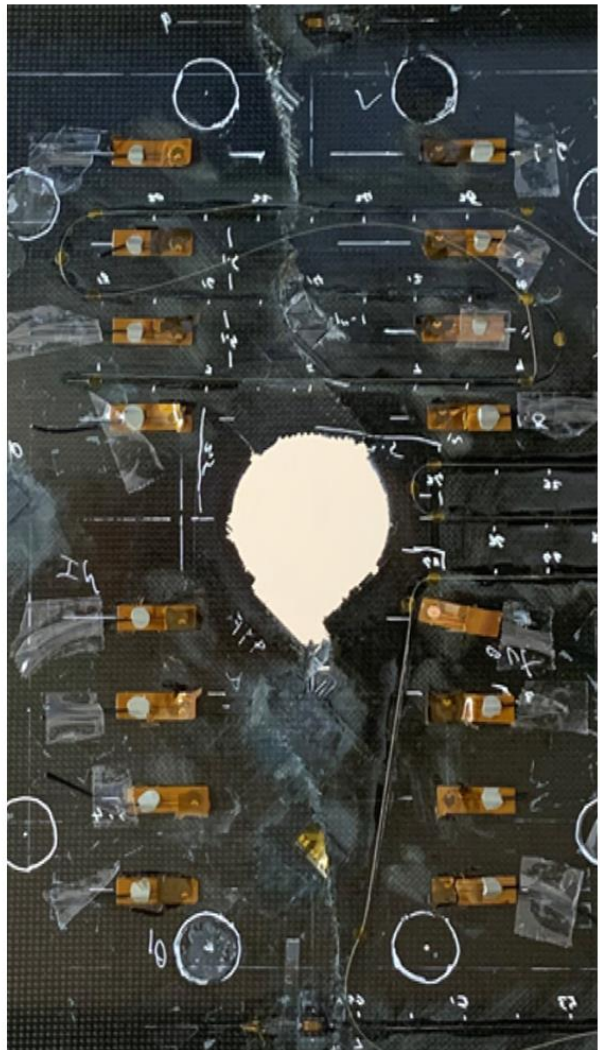
Figure E 20. Post-failure images of panel 6
