MASH TEST 3-10 ON WYOMING BOX BEAM SHOULDER BARRIER

Test Report No. 610031-01-1
Report No. WY-1903F, Final Report
Report Date: May 2019

Test No. 610031-01-1

TEXAS A&M TRANSPORTATION INSTITUTE PROVING GROUND

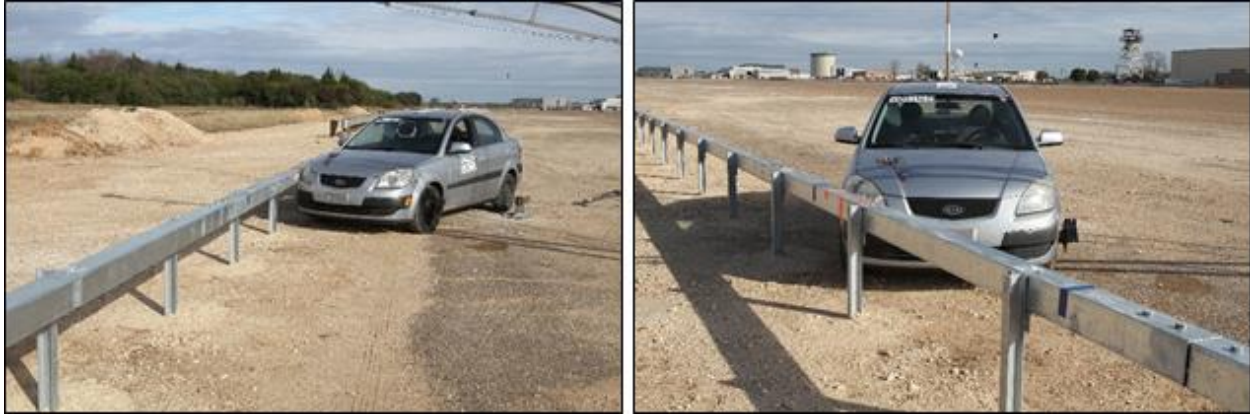
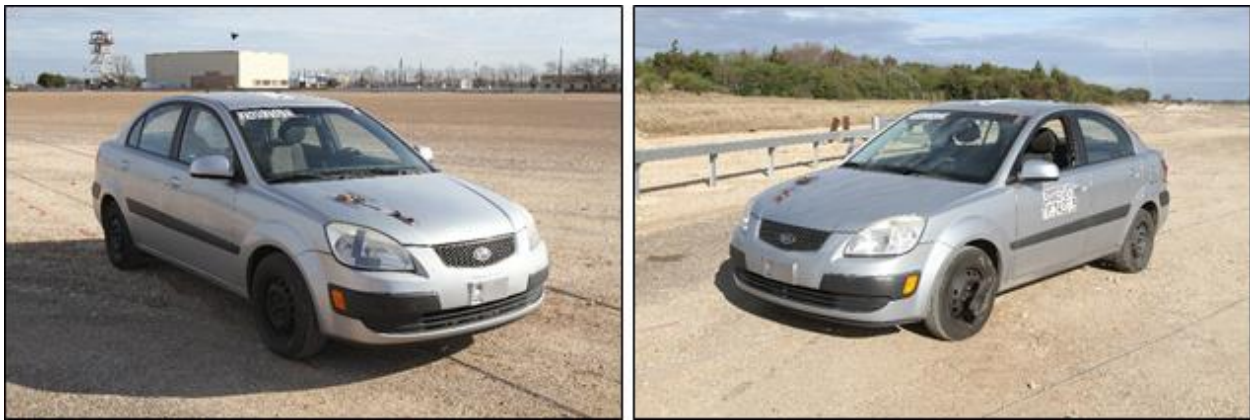
Figure 5.1. Barrier/Test Vehicle Geometrics for Test No. 610031-01-1.

Figure 5.1 and Figure 5.2 show the 2009 Kia Rio used for the crash test. The vehicle's test inertia weight was 2441 lb, and its gross static weight was 2606 lb. The height to the lower edge of the vehicle bumper was 7.75 inches, and the height to the upper edge of the bumper was 21.5 inches. Figure D.1 in Appendix D1 gives additional dimensions and information on the vehicle. The vehicle was directed into the installation using a cable reverse tow and guidance system, and was released to be freewheeling and unrestrained just prior to impact.

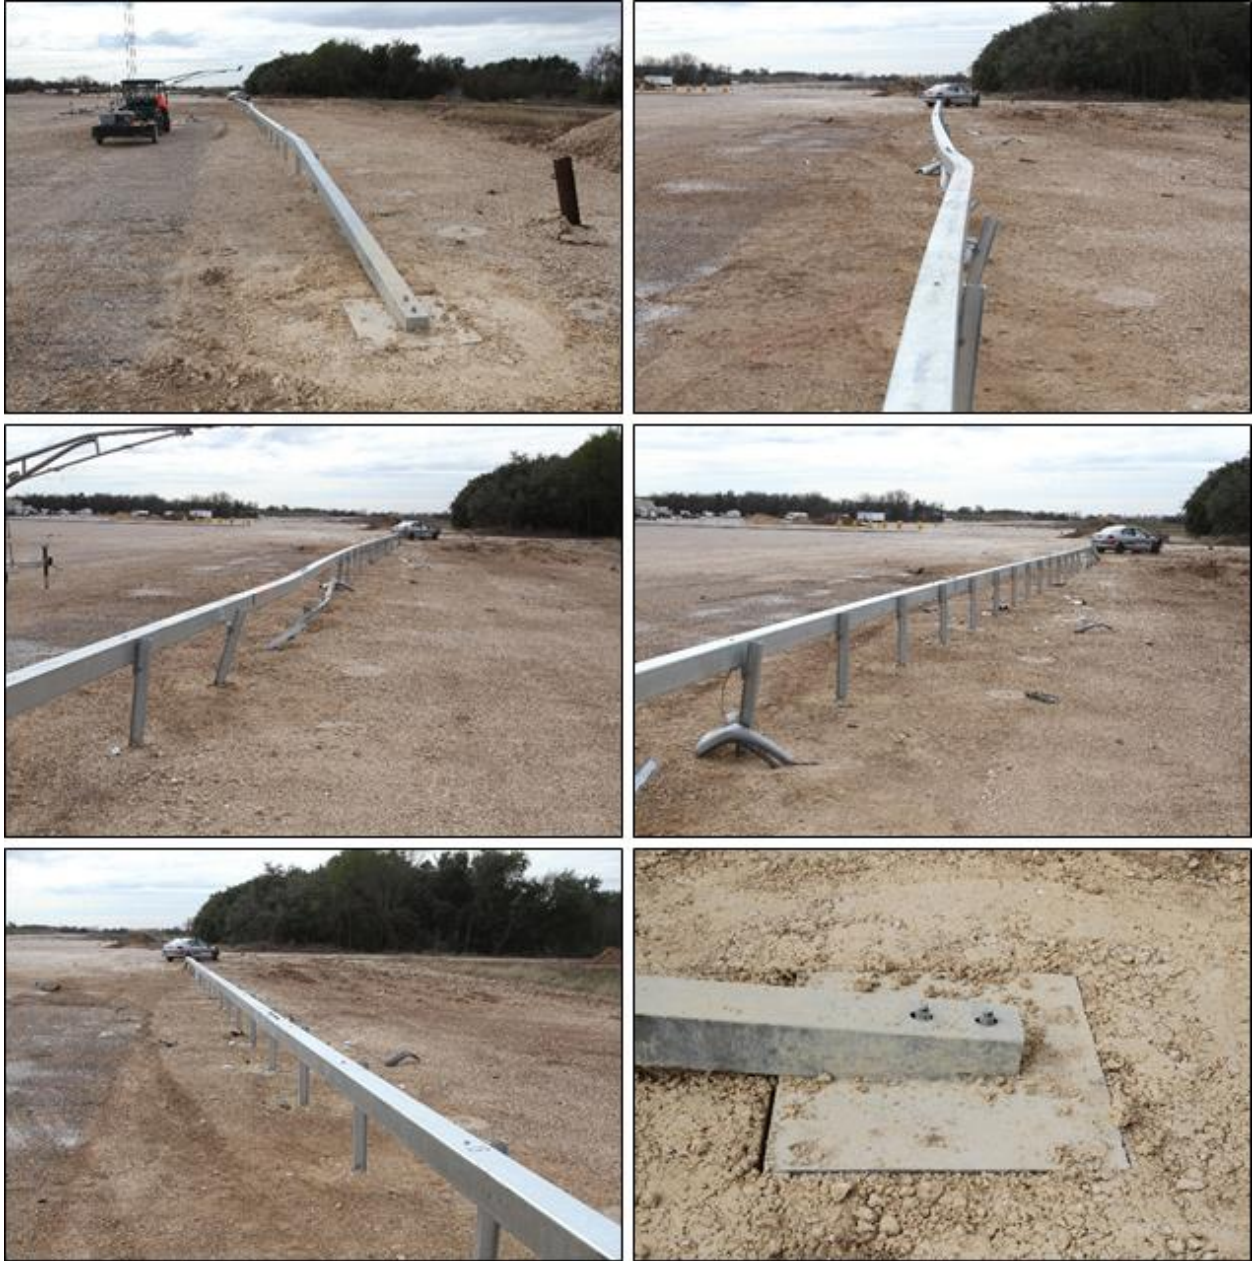
Figure 5.3. Barrier after Test No. 610031-01-1.

Figure 5.3 and Figure 5.4 show the damage to the Wyoming box beam shoulder barrier. There was a 0.75-inch gap between the soil and the upstream side of the upstream anchor block, and a 0.5 inch gap between the soil and the downstream side of the downstream anchor block. No movement was observed at posts 1–8, 20–30, and 32–34. The rail was detached from posts 12–16. Posts 9–19 and 31 were leaning toward the field side (see Table 5-2). The damage near post 31 resulted from a secondary impact of the vehicle with the downstream end of the guardrail installation. The working width was 34.8 inches, and the height of the working width was 28.8 inches. Maximum dynamic deflection during the test was 28.8 inches, and maximum permanent deformation was 11.5 inches.

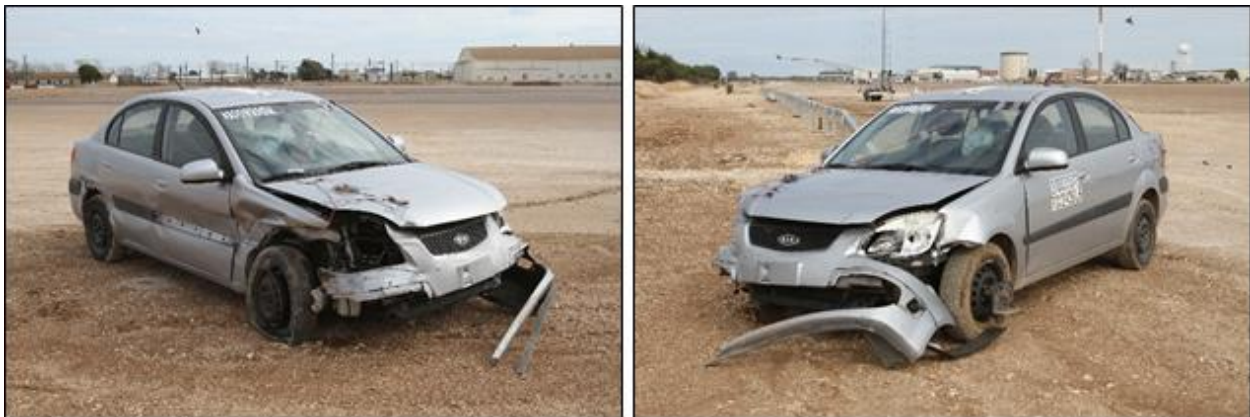
Figure 5.5. Test Vehicle after Test No. 610031-01-1.

Figure 5.5 shows the damage sustained by the vehicle. The front bumper, hood, right front fender, right front strut and tower, right front tire and rim, right front and rear doors, right rear quarter panel, rear bumper, and left front fender were damaged. Maximum exterior crush to the vehicle was 7.0 inches in the front plane at the right front corner at bumper height. No occupant compartment deformation or intrusion was observed. Figure 5.6 shows the interior of the vehicle. Figure D.2 and Figure D.3 in Appendix D1 provide exterior crush and occupant compartment measurements, respectively.

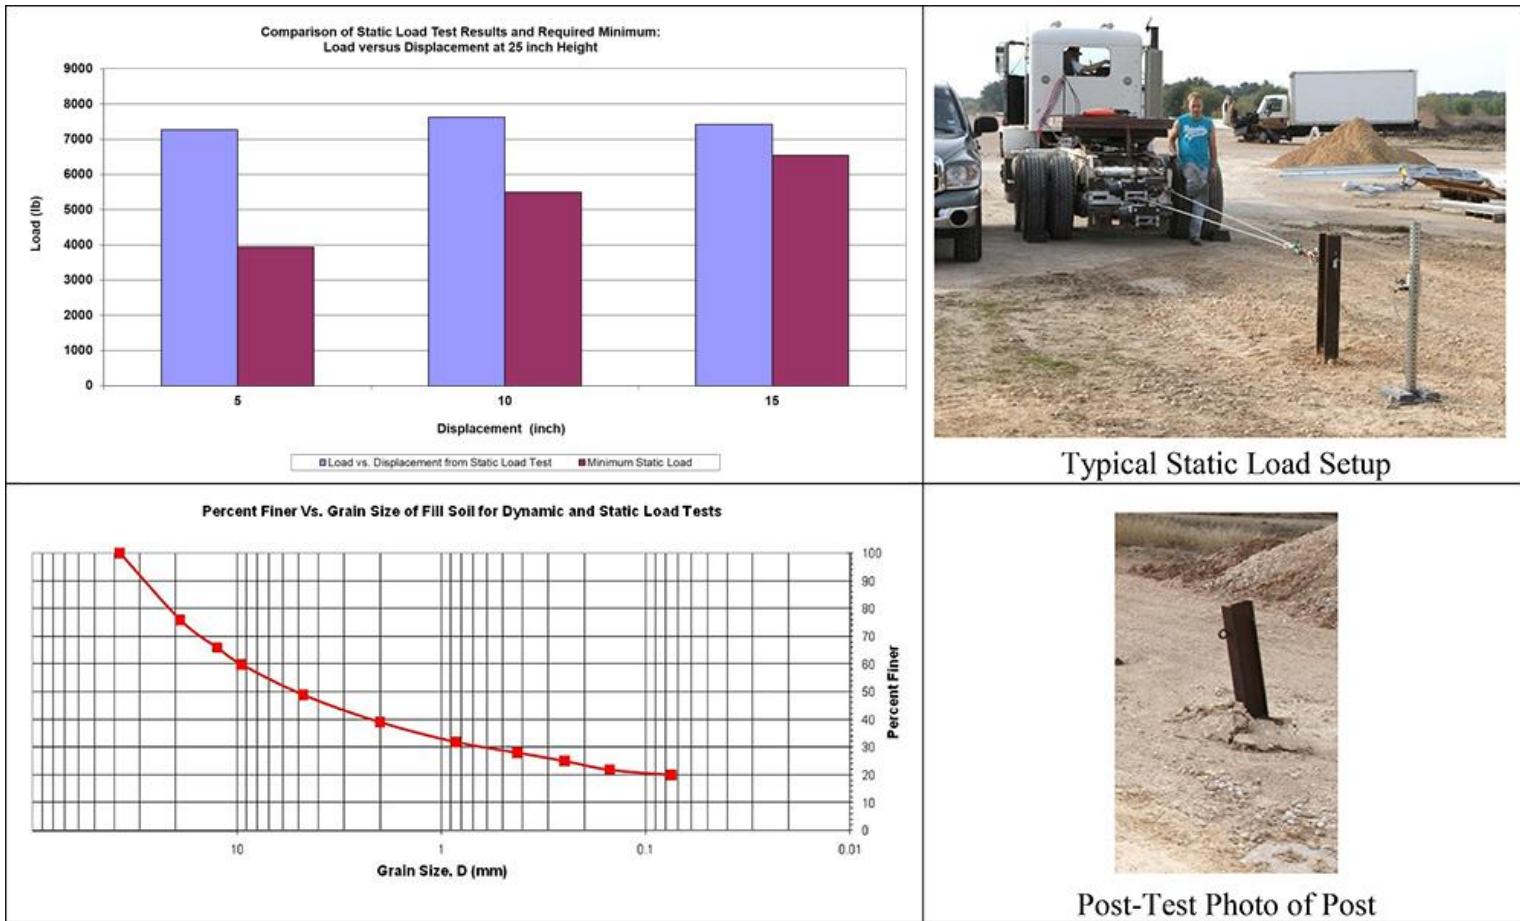
Figure C.2. Test Day Static Soil Strength Documentation for Test No. 610031-01-1.

Date 2019-01-11
 Test facility and site location..... TTI Proving Ground, 3100 SH 47, Bryan, TX 77807
 In-situ soil description (ASTM D2487) Sandy gravel with silty fines
 Fill material description (ASTM D2487) and sieve analysis AASHTO Grade B soil-aggregate (see sieve analysis)
 Description of fill placement procedure..... 6-inch lifts tamped with a pneumatic compactor

In accordance with Appendix B of *MASH*, soil strength was measured the day of the crash test. During installation of the barrier for full-scale crash testing, two W6×16 posts were installed in the immediate vicinity of the barrier utilizing the same fill materials and installation procedures used in the test installation and a previous standard dynamic test. Figure C.1 in Appendix C presents minimum soil strength properties established through the dynamic testing performed in accordance with *MASH* Appendix B.
