Evaluation of Tie-Bar Anchoring Methods: Non-Shrink Grout vs. Epoxy

Background

Purpose of the Investigation

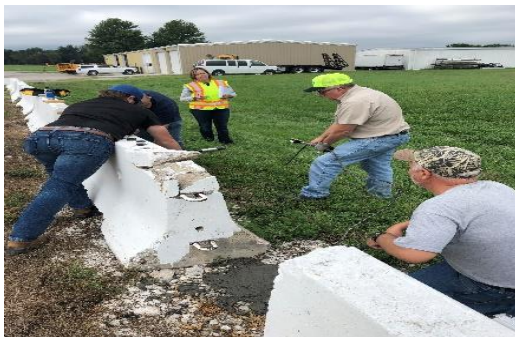
Figure 2 - Physical Tests technicians perform the pull-out test. Tie-bars were inserted into concrete barriers to determine the strength of non-shrink grout.

During this phase of the testing, researchers discovered that regardless of drilled-hole preparation, required strength of 12,000 lbs. was not achieved. Figure 2 shows the tie bar pulling from the barrier before achieving required strength. All the pull-out testing will be evaluated in accordance of the strength of anchors in concrete Elements ASTM E 488

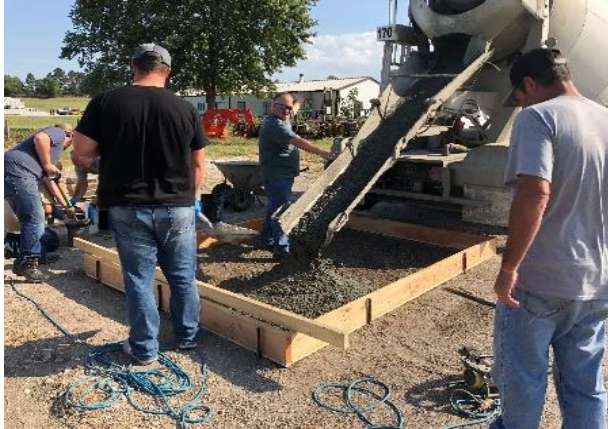
Figure 3 - Casting the 6' x 6' slab with 47BD concrete Salt Valley's maintenance yard

Following the barrier drilled-hole test, researchers started another field test to assess the epoxy and non-shrink grout strength on an in-house designed pavement repair test slab. First, a 6 x 6 foot concrete slab was cast using State of Nebraska 47BD mix design, shown in Figure 3. The concrete was finished by NDOT technicians and cured with white-pigment. The slab was cured in the field for 28 days, then was prepared for tie-bar placement by drilling six 8.5-inch deep holes on all four sides of the slab with a total of 24 drilled holes.

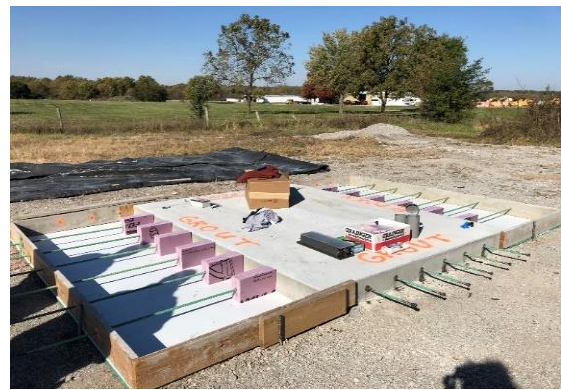
Figure 4 - The research slab awaiting placement of PR concrete. 18-inch bars were left exposed, while the 6-foot bars were embedded in the PR concrete. The pink foam inserts serve as a buffer to prevent sawing into the 47BD slab.

All bars were left exposed on the ends. The 6-foot bars were secured in a form with a smooth plastic liner on the bottom. Engineers designed foam blocks to serve as a buffer between the saw blade and the 47BD slab. Then PR concrete was cast around the bars and cured with white pigment. Figure 4. shows the 47BD slab with tie-bars anchored and secured forms before placing PR concrete.

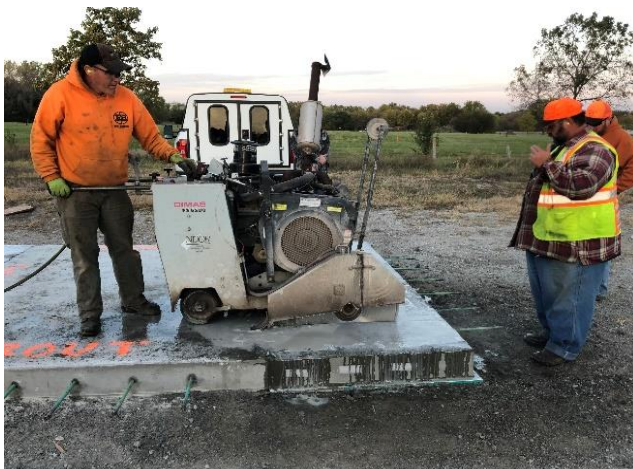
Figure 4 - The Salt Valley maintenance crew sawed through the thickness of the PR slab. Foam inserts prevented cutting into the 47BD slab.

Approximately 18 hours after placement, NDOT Salt Valley Maintenance crew sawed through the thickness of the PR pavement, shown in Figure 5. The foam blocks served as a buffer between the saw blade and the 47BD slab because cutting into the 47BD slab would weaken the concrete around the tie-bar.

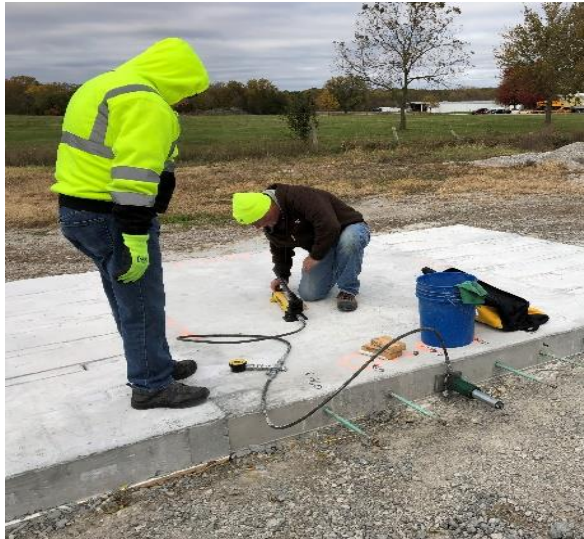
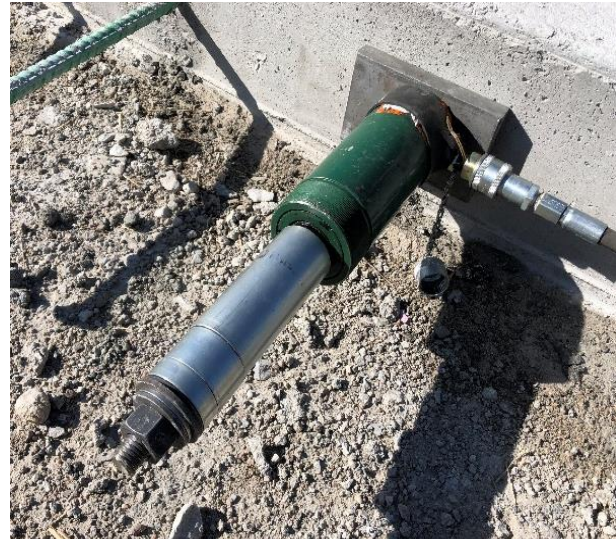
Figure 5 - Physical tests technicians operate the 12-ton hole-ram (left). The tie-bars are threaded so the ram can be fastened to the rebar. The ram is ready for testing (right).

After sawing, the NDOT Physical Tests Lab conducted pull-out testing on the 18-in. bars anchored in the 47BD concrete. Physical Tests pulled three 18-in. bars fixed with epoxy at 24-hrs and three 18-in. bars fixed with non-shrink grout at both 24-hrs and 96-hrs, as shown in Figure 6.

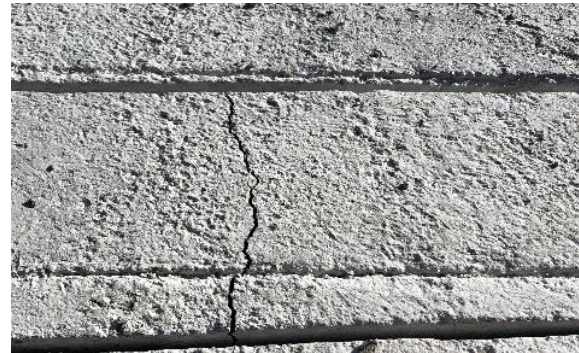
Figure 6 - PR concrete with embedded cracked during the pull testing.

The pull-out tests on the 18-in. bars fixed with epoxy showed that epoxy adequately achieved the required strength at 24-hours. The pulls on the PR-embedded bars also achieved the required strength by 24-hours. In these specimens, the concrete failed before the epoxy bond shown in Figure 7. The epoxy was not tested at 96-hours as the epoxy specimens maxed out the testing equipment. Strengths are shown in Table 2.
