## Review of Tank Car Side Impact Test Research and Analyses of 2007–2019

<b>1. REPORT DATE (DD-MM-YYYY)</b> March 2022		<b>2. REPORT TYPE</b> Technical Report		<b>3. DATES COVERED (From - To)</b> 2007 to 2019	
<b>4. TITLE AND SUBTITLE</b> Review of Tank Car Side Impact Test Research and Analyses of 2007–2019				<b>5a. CONTRACT NUMBER</b> DTFR53-11-D-00008	
				<b>5b. GRANT NUMBER</b>	
				<b>5c. PROGRAM ELEMENT NUMBER</b>	
<b>6. AUTHOR(S)</b> <sup>2</sup> Aswani Krishnamurthy – <a href="#">0000-0003-3116-7797</a> ; <sup>1</sup> Shawn Trevithick – <a href="#">0000-0001-6155-5526</a> ; <sup>2</sup> Michael Carolan – <a href="#">0000-0002-8758-5739</a> ; <sup>1</sup> Ulrich Spangenberg – <a href="#">0000-0003-2760-1394</a> ; <sup>1</sup> Nicholas Wilson – <a href="#">0000-0003-1140-7108</a> ; <sup>2</sup> Shaun Eshraghi – <a href="#">0000-0002-8152-0838</a> ; <sup>3</sup> Steve Kirkpatrick – <a href="#">0000-0001-9590-7980</a>				<b>5d. PROJECT NUMBER</b>	
				<b>5e. TASK NUMBER</b> 693JJ620F000040

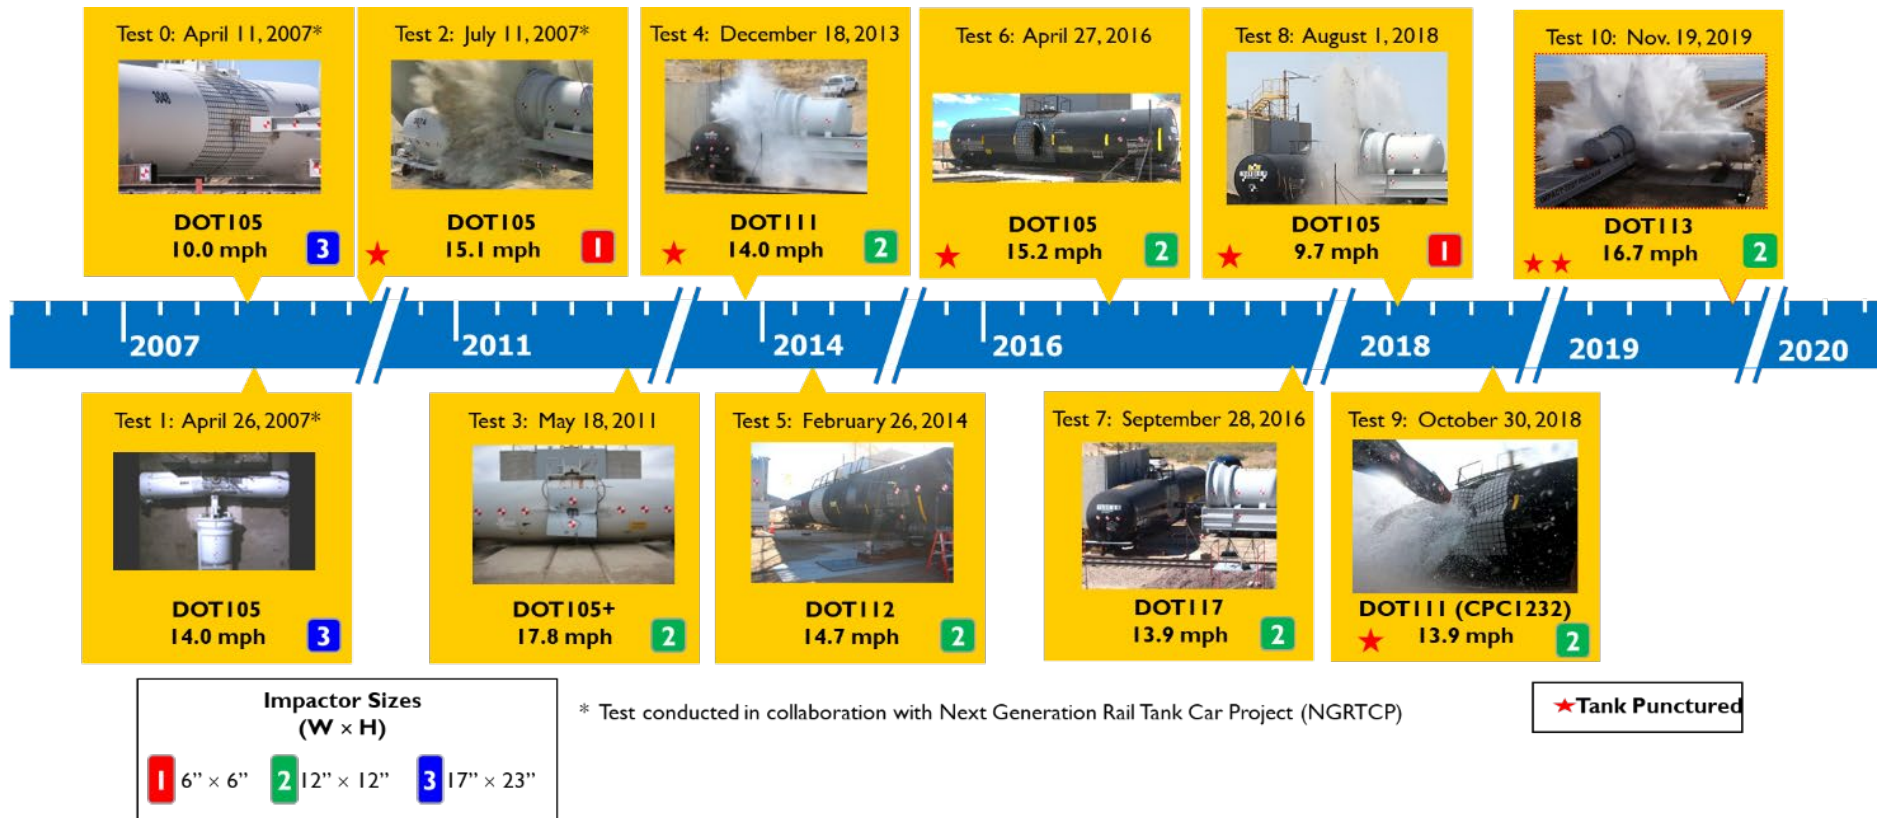
Figure 1. Timeline of Shell Impact Tests (2007–2019)

Figure 1 contains a timeline showing the 11 impact tests conducted between 2007 and 2019, including the tests conducted under the NGRTC program. As seen in this figure, three different sizes of impactors have been used in this research program. In Figure 1, one red star indicates tests where puncture occurred, and two red stars indicate puncture of the outer and inner shells (i.e., for the DOT113 tank car). The influence of impactor size on puncture response will be discussed.

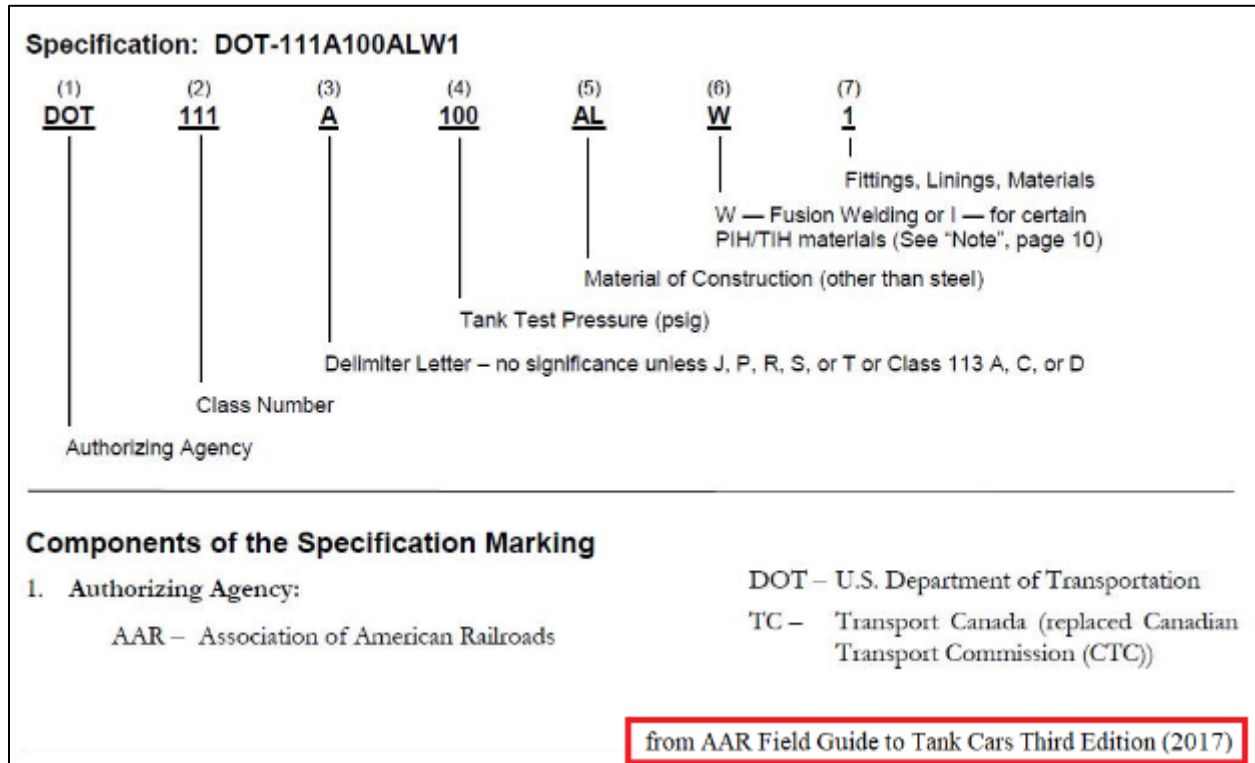
**Figure 2. Railroad Tank Car Marking System**

Figure 2 contains a description of the tank car specification marking system for tank cars used in the U.S. This figure provides a breakdown of the information contained in the stencil. Note that throughout this report, an abbreviated version of the tank car specification will typically be used to describe a particular car that was tested. For example, while the tank car used in Test 10 was a DOT113C120W tank car, it will generally be referred to as a DOT113 during discussion in this report.

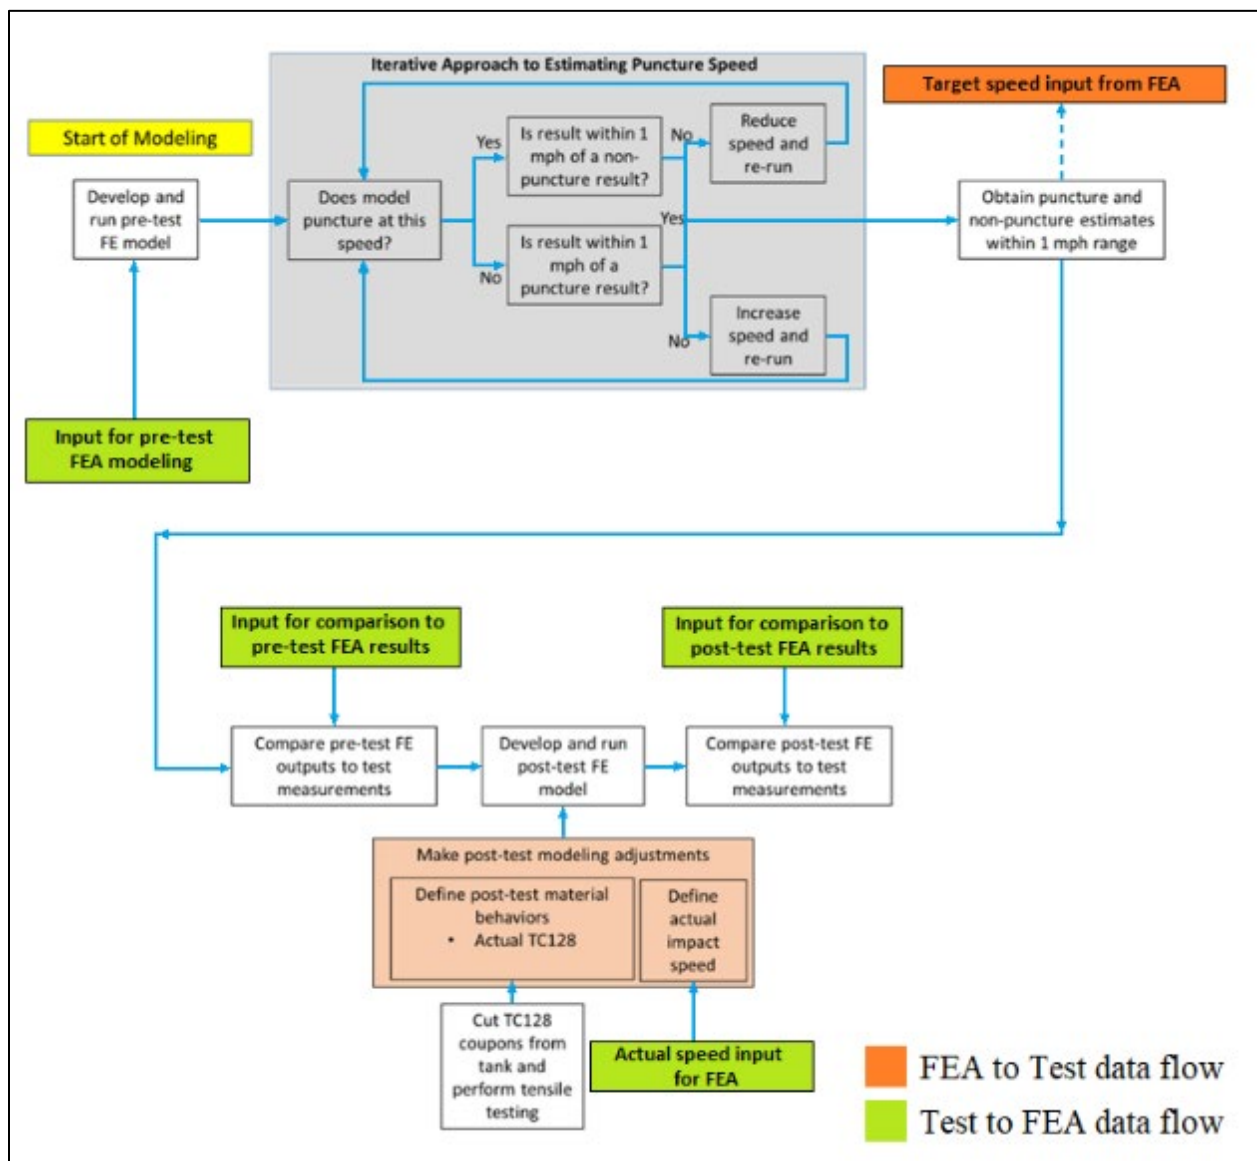
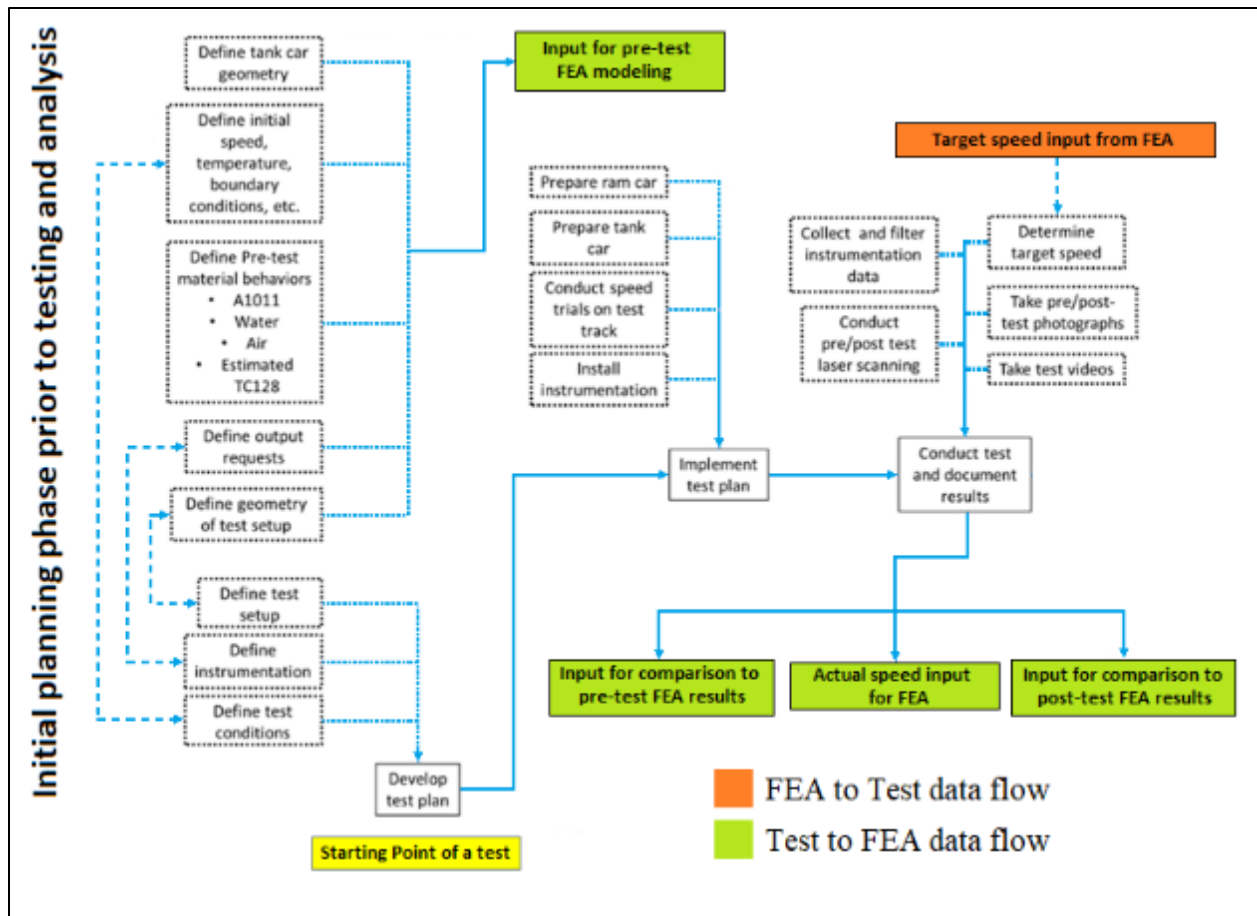
Various tests described in this report approached impact tests similarly. Figure 3 and Figure 4 contain flowcharts that summarize the typical finite element analysis (FEA) shell impact modeling approach and the typical testing approach. While these figures are specific to the process for one test, they represent the process with some minor differences (e.g., TC128 and A1011 materials were not always used in tank cars).

Figure 3. Flowchart Showing Typical FEA Modeling Approach

**Figure 4. Flowchart Showing Typical Testing Approach**

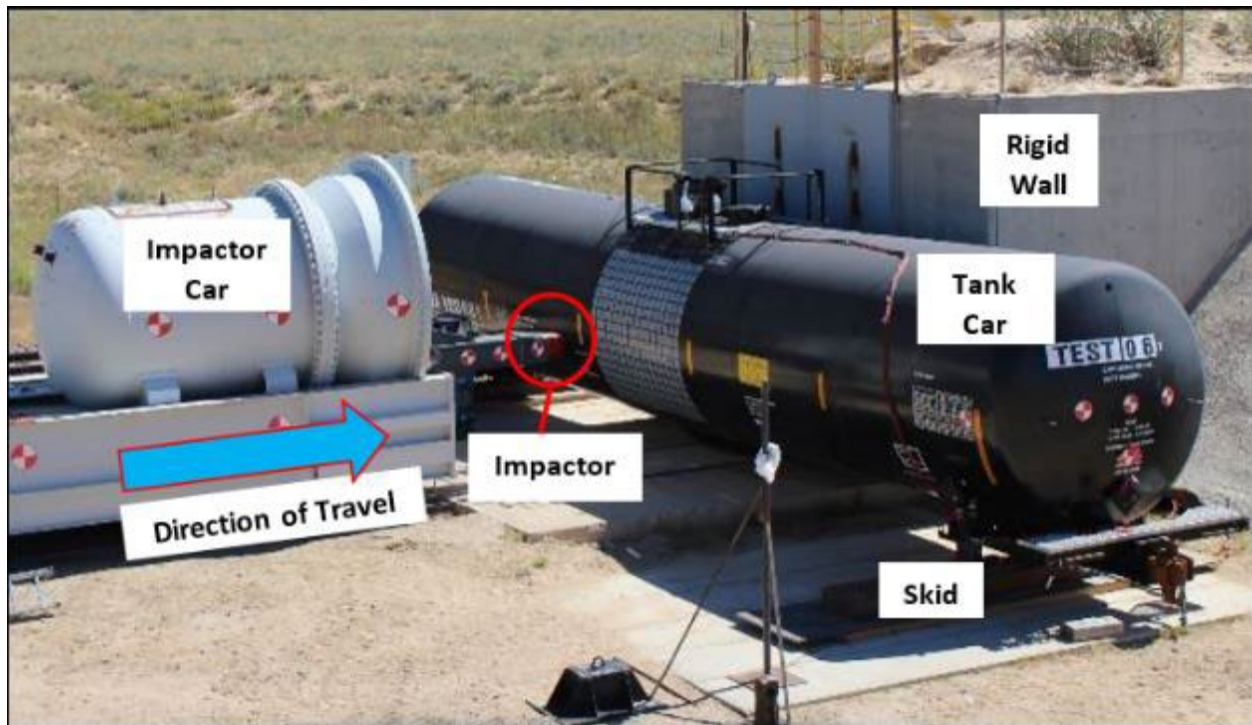
**Figure 5. Typical Test Setup**

Figure 5 shows the typical test setup used in the shell impact testing program. This test configuration was refined over the initial three tests (i.e., Tests 0, 1, 2). The tank car is removed from its trucks, placed on skids, and positioned against a rigid backing wall, perpendicular to the tracks leading up to the wall. The impactor car, equipped with the desired impactor head on its leading end, is initially positioned some distance from the standing tank car. The tracks leading to the wall are on a downgrade toward the wall. TTCI typically performs multiple speed trials on an adjacent track to the impact wall and has developed a procedure for estimating the distance for the initial release position of the impactor car based on the desired impact speed and ambient conditions (e.g., wind speed, temperature on test day).

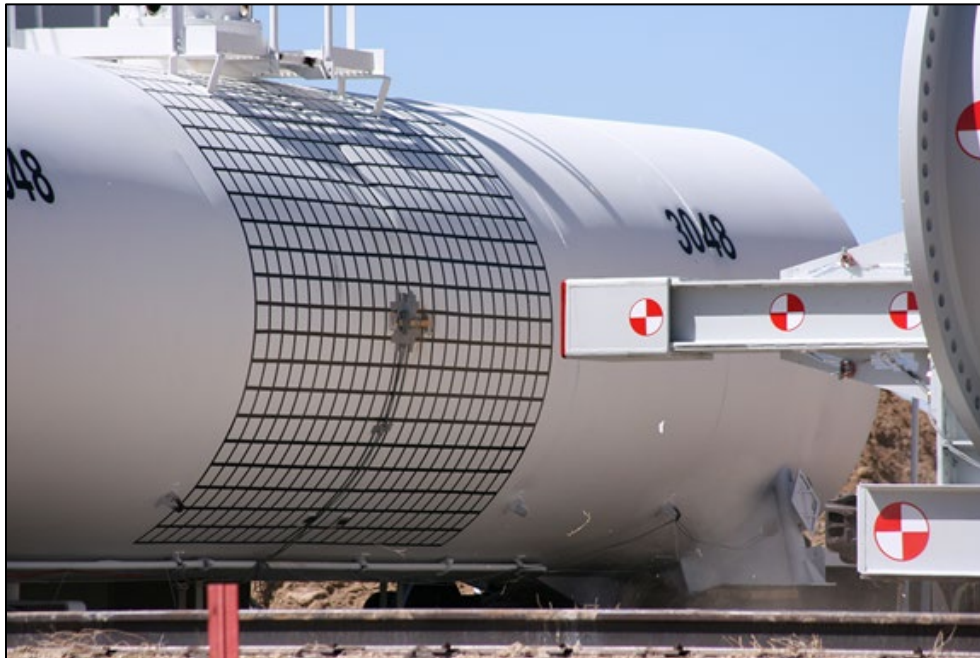
**Figure 8. Test 0 – Test Setup Showing DOT105 Tank Car and Impactor**

Test 0 was performed as part of the NGRTC project on April 11, 2007, at the TTC in Pueblo. Test 0 featured a 17,391-gallon DOT105 tank car struck by a 17-inch by 23-inch impactor centered on the tank. [Table 8](#) summarizes the specification for the tested DOT105J500W tank car. [Figure 8](#) shows the test setup with the position of the tank car and impactor. The tank car was sitting on stub rails transverse to the impactor car's track and backed by an impact wall to resist post-impact motion. The test was designated as Test 0 since it was performed as a limited instrumentation assurance test before the first official planned test in the NGRTC program.

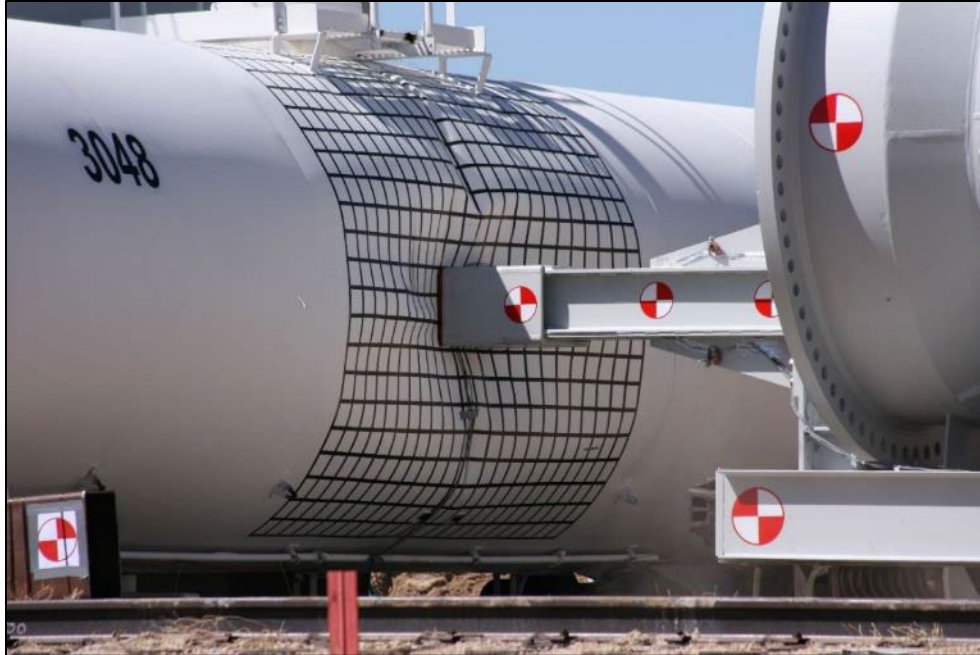
**Figure 9. Test 0 – Impact Response  
(Near maximum impactor displacement)**

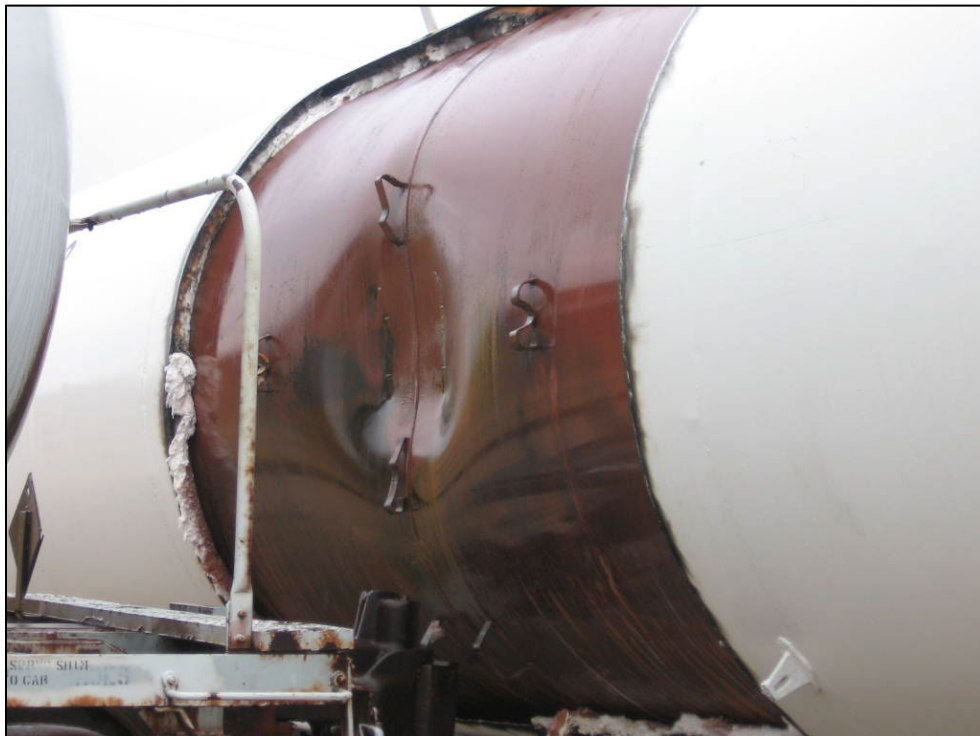
**Figure 10. Test 0 – Impact Damage to the Inner Tank Shell**

The test article was an unmodified DOT105 tank car in a loading condition considered typical for chlorine service. The tank car was filled with clay-slurry to the planned outage level. Witt et al. (2007) summarizes the test conditions and results. The actual impact speed was 9.6 mph. During the impact (Figure 9), the outer jacket and the inner tank of the chlorine car were dented as planned. The inner tank did not puncture, as Figure 10 shows. The dent in the outer jacket was approximately 7 5/8 inches deep. The dent in the inner tank was approximately 4 1/2 inches deep. These depths were measured relative to an 8-foot straight edge placed lengthwise over the dent. The dent in the outer jacket was slightly wider than the 8-foot straight edge.

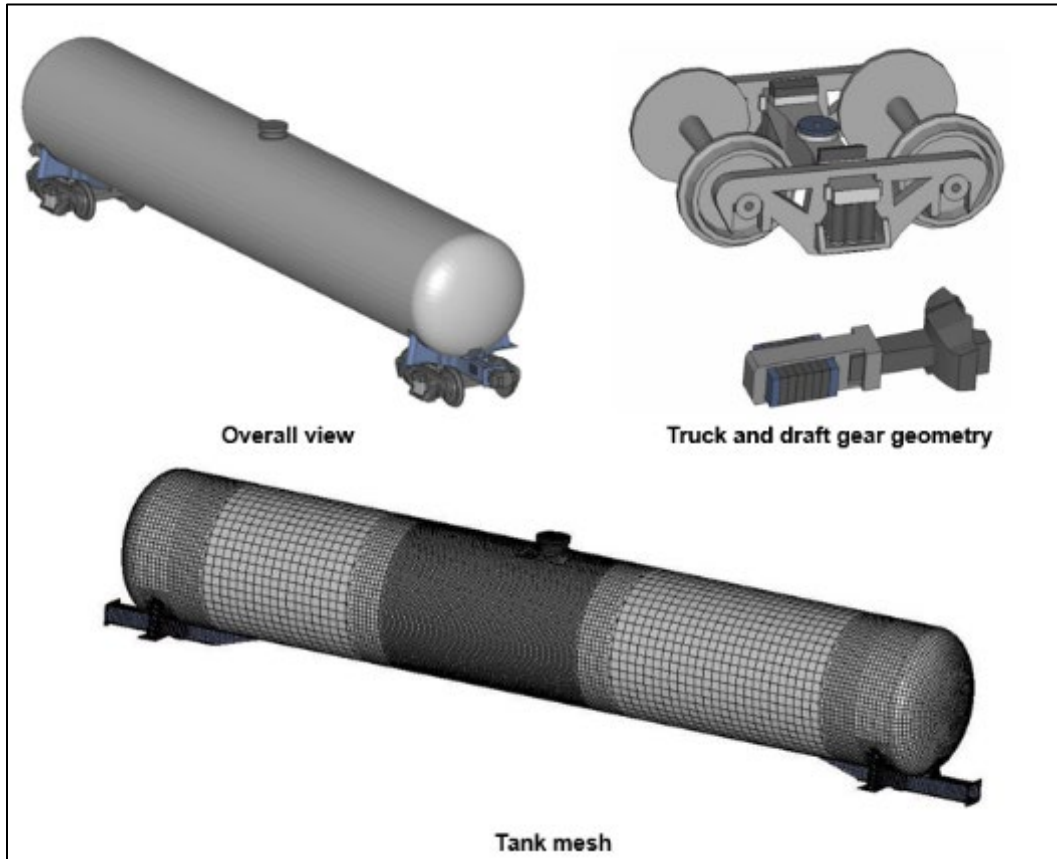
The ARA model for the Test 0 analyses was developed using the TrueGrid preprocessor code, and the LS-DYNA FE code was used for the analyses. LS-DYNA is an explicit nonlinear three-dimensional FE code for analyzing the large deformation dynamic response of solids and structures. The tank car model used in these analyses was based on a previous FE model of a DOT112A340W pressure tank car generated to analyze the loads and stresses in the tank car because of service and salvage operating conditions. This model was modified by changing the tank wall thickness, the stub sill was modeled in more detail, and the mesh resolution in the vicinity of the impactor was increased. [Figure 11](#) shows the resulting model for the DOT105 tank car, and [Figure 12](#) shows the analysis configuration for Test 0.

Figure 11. Test 0 – Updated Model Generated for a DOT105J500W Pressure Tank Car

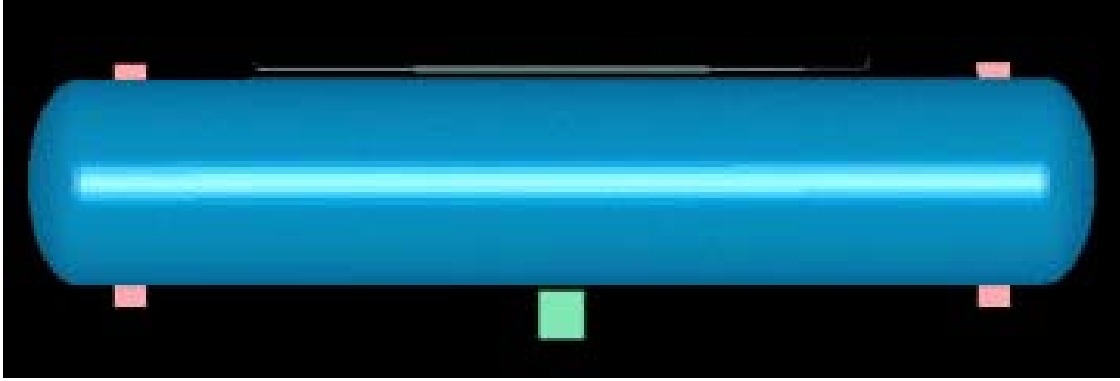
The Volpe used Abaqus and LS-DYNA to create and solve the models with a top-down view, as [Figure 13](#) shows. The models used a surrogate rigid block (indicated in green) impacting a tank (i.e., manway, body bolster, draft sill, jacket, and thermal insulation were not modeled). However, the Volpe analyses considered a wider range of modeling approaches for the lading including Eulerian modeling (i.e., comparable to traditional computational fluid dynamics modeling).

**Figure 13. Test 0 – Volpe Test 0 Impact Model**

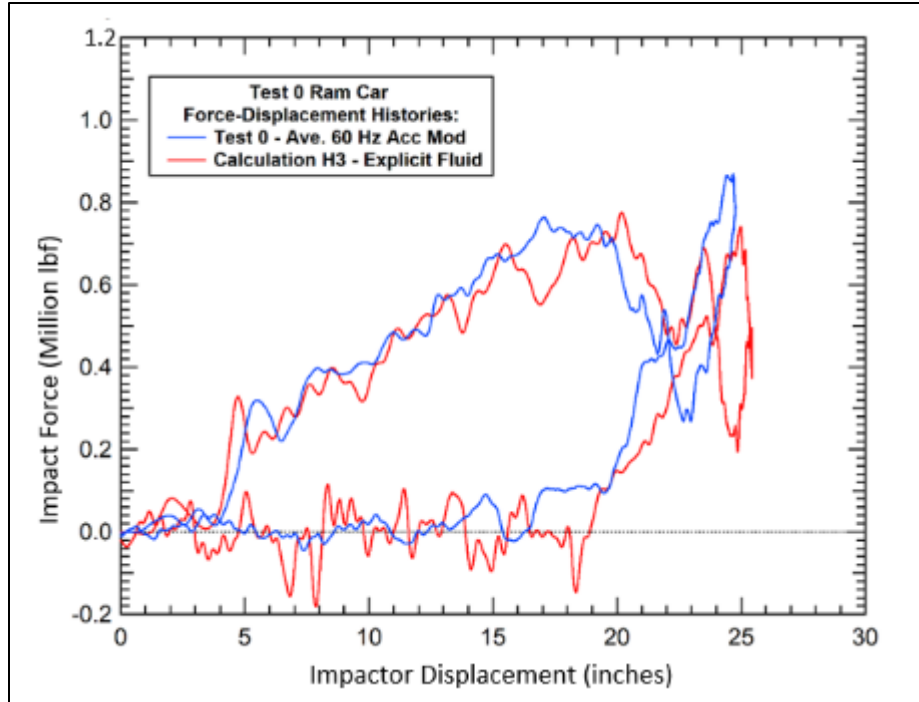
Figure 14 shows a comparison of the measured and calculated force-displacement behavior for Test 0. The analysis shown is a post-test analysis with the preliminary explicit fluid model. The analysis shown was performed post-test, so it includes the measured impact speed. The overall agreement was good for the level of modeling fidelity and uncertainty at the time.

**Figure 14. Test 0 – Comparison of Test 0 and ARA Post-Test Analyses**

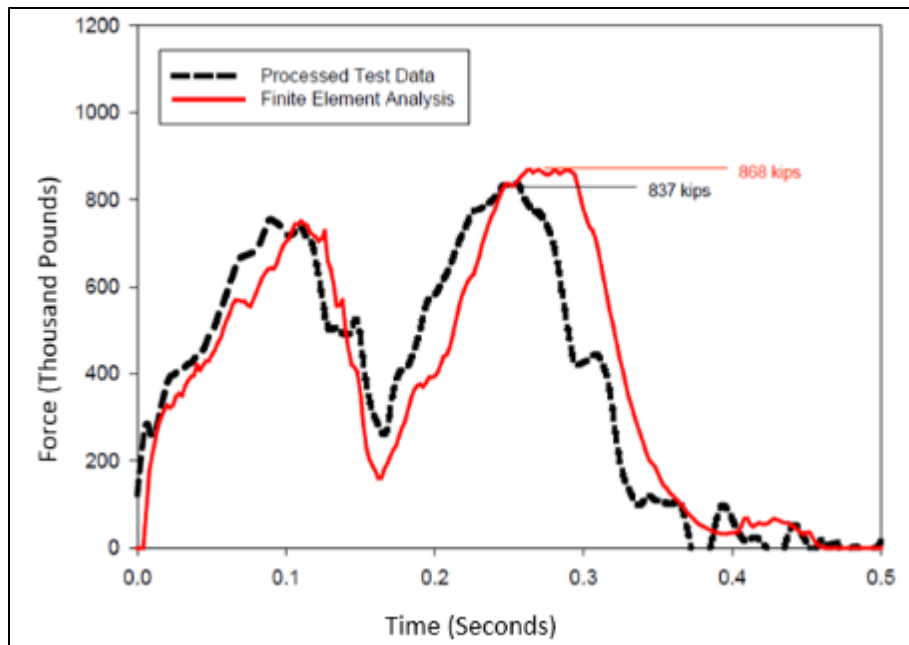
Figure 15 shows a corresponding comparison of the measured force-time history compared to the Volpe analysis. The comparison clearly shows the double peak force history caused by the collision dynamics of the tank impacting against the impactor and the collision wall. Again, the overall agreement was good for the level of modeling fidelity and uncertainty at the time.

**Figure 15. Test 0 – Comparison of Test 0 and Volpe Post-Test Analyses**

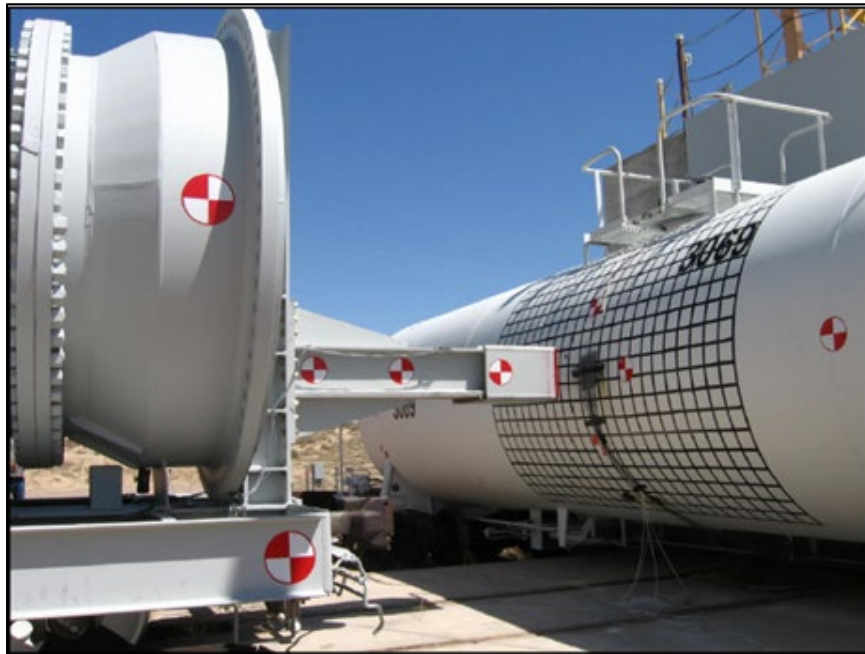
**Figure 16. Test 1 – Test Setup Showing Tank Car**

Test 1 was performed as part of the NGRTC project on April 26, 2007, at the TTC. Test 1 was essentially a repeat of the Test 0 conditions but at a higher impact speed and with additional instrumentation in the test. Test 1 featured a 17,391-gallon DOT105 tank car struck by a 17-inch by 23-inch impactor centered on the tank. [Table 10](#) summarizes the specifications for the tested DOT105A500W tested tank car. The objective of the test was to quantify the deformation mode, impact load-time history and puncture resistance of a DOT105 tank car in a side impact. The test was performed by impacting an impactor car into the side of a ballasted chlorine tank car that was backed by a rigid impact barrier. The tank car was filled with clay-slurry to appropriate pressure and outage. The tank car was sitting on stub rails transverse to the test track and backed by an impact wall to resist the motion. Full instrumentation was installed to measure accelerations, strains, and displacements on the impactor and on the tank cars. [Figure 16](#) shows the tank car positioned against the impact wall with the impactor car's intended point of impact. Like Test 0, the tank car remained on its trucks and wheels for this test. [Table 11](#) lists the test conditions and outcomes for Test 1.

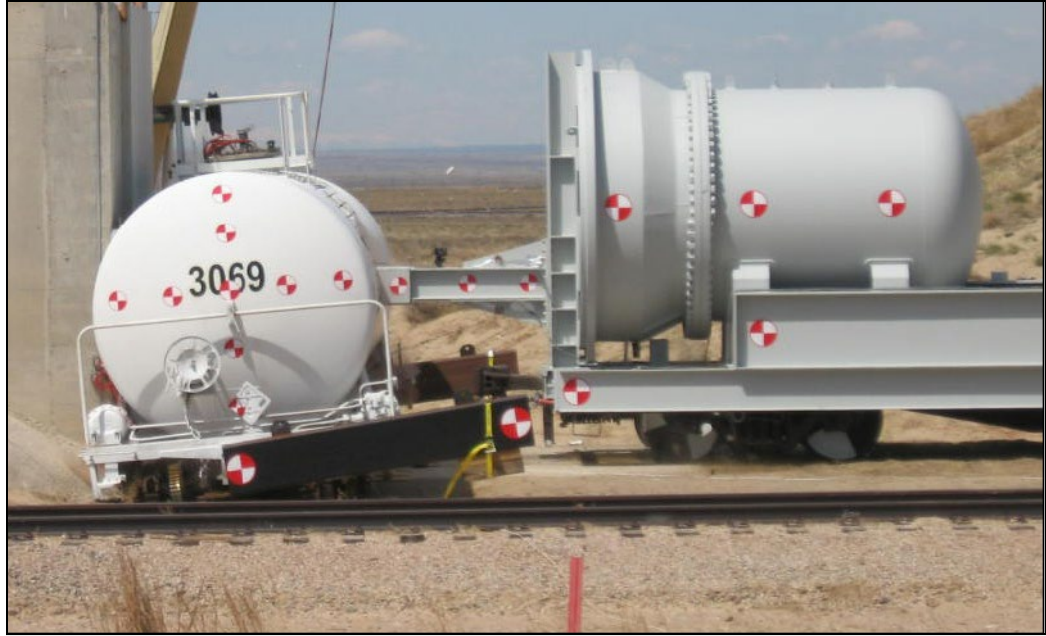
The desired impact speed of Test 1 was 14 mph, and the impactor car speed was measured optically at 13.9 mph using speed trap reflectors placed within 6 feet of the impact point. [Figure 17](#) shows the impact response in Test 1. The impact resulted in significant rotation of the target tank car during the test, which produced lifting forces on the front of the impactor car. Following the primary impact, there was a significant rebound of the impactor car from the tank car with a rebound speed of 7.6 mph. The tank car stayed upright throughout the test, but it did derail. The stub rail sections rolled over on the A-end, and the truck derailed on the B-end. The rebound of the impactor car was reacted by outriggers installed in the draft pockets of the car. Structural inspection after the impact showed no visible damage to the stub sills or their weld joints to the inner tank.

**Figure 17. Test 1 – Shell Side Impact Behavior in Test 1 for Tank Car 3069**

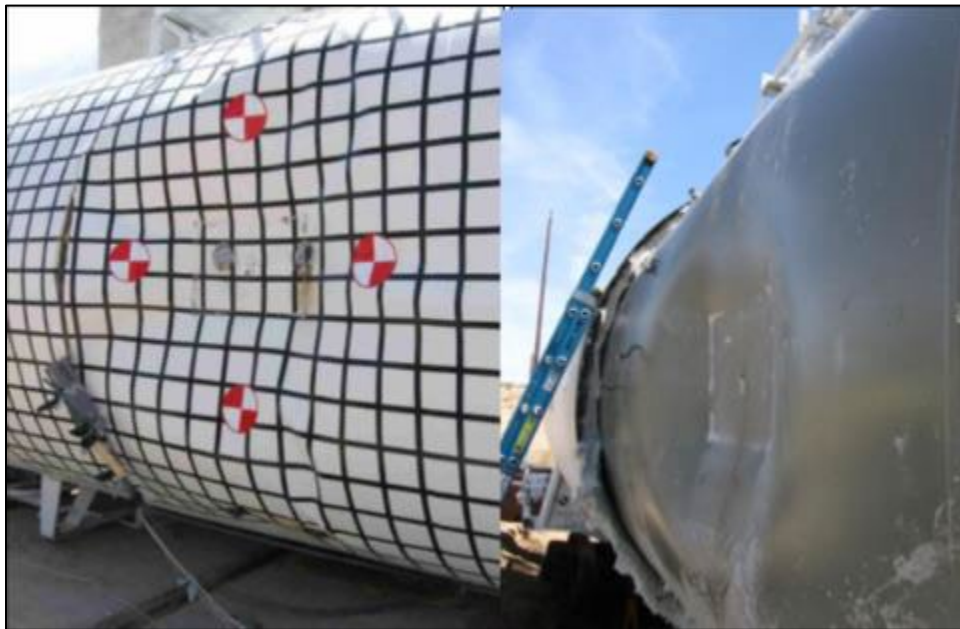
As predicted, the rigid impactor caused large dents in the outer jacket and the inner shell of the chlorine tank car without puncturing the inner tank. [Figure 18](#) shows the post-test dents in the jacket and in the commodity tank. The impact did result in the failure of one of the weld joints of the outer jacket near the impact area. The back of the tank car was also deformed by the reaction against the rigid impact barrier. The residual dent in the outer jacket was approximately 14 inches deep. The residual dent in the inner shell was approximately 10 inches deep.

**Figure 18. Test 1 – Post-Test Dents in the Jacket and Shell of Tank Car 3069**

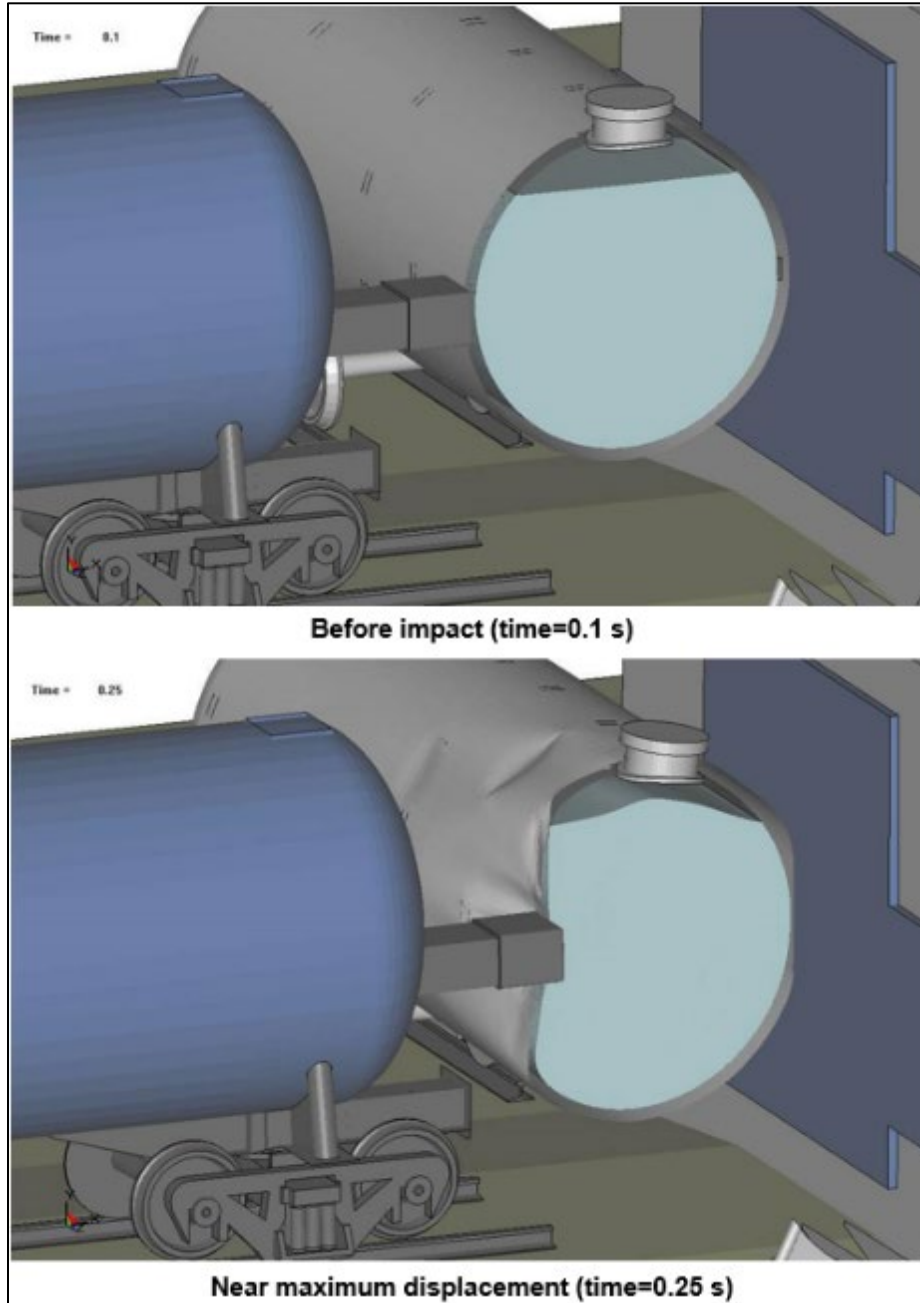
Figure 20 shows the pre-test predicted impact response with the ARA model, including the sloshing of the lading model as seen in the cutaway view. This lading modeling approach was established to capture the momentum transfer of the coupled fluid-structure response but minimize effects such as breaking wave or splashing at the fluid free surface that can cause numerical stability problems.

Figure 20. Test 1 – Calculated Test 1 Impact Response with Cutaway Showing Lading

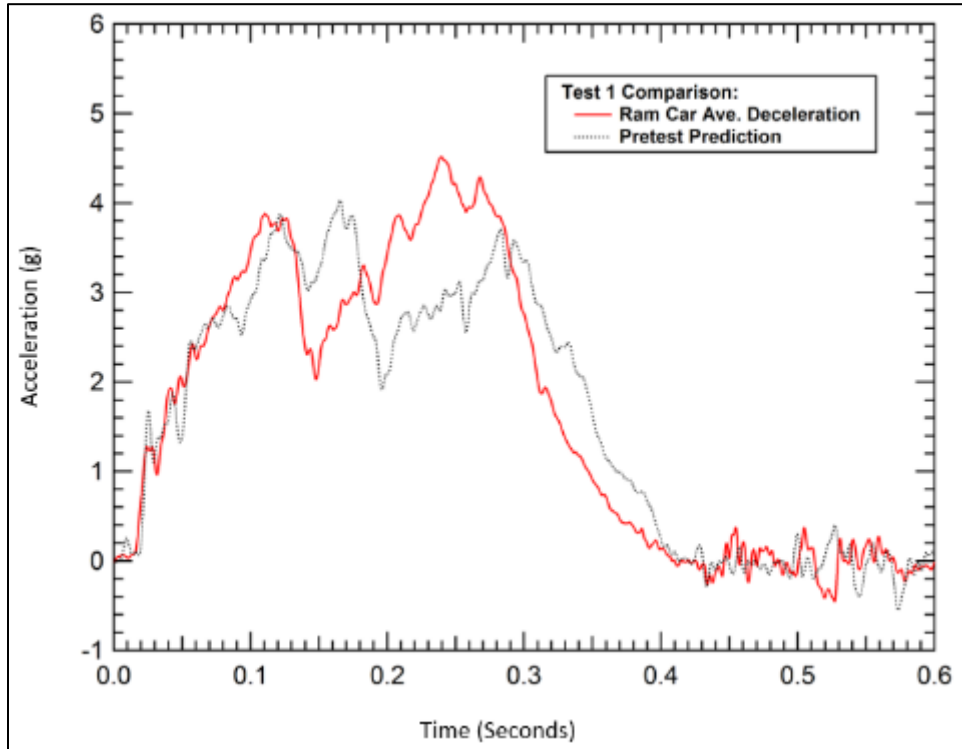
Figure 21 shows a comparison of the pre-test predicted and measured impactor car acceleration history. The comparison shows that the characteristics of the double peak acceleration response and the quantitative comparisons of maximum accelerations agree reasonably well between the calculation and the test

**Figure 21. Test 1 – Comparison of the Measured and ARA’s Predicted Impactor Car Accelerations**

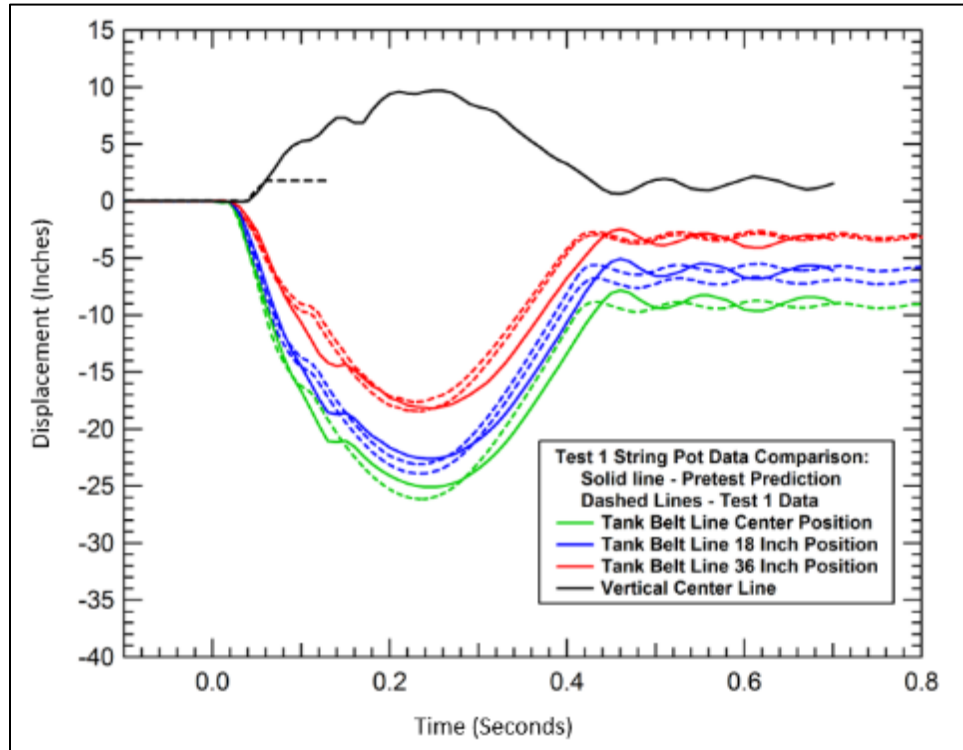
The above comparison of the pre-test prediction and impact test serves as a validation of the model for the tank collision dynamics and impact deformation behavior. The responses include the initial impact, the reaction of the impact loads against the wall, and the post-impact rebound from the wall. Additional details of the impact behavior captured in the model included the target tank roll motion and lifting forces on the impactor car caused by the lateral support of the target tank truck on the stub rail sections and the action of the outriggers resisting a post-test rollover behavior.

**Figure 22. Test 1 – Comparison of the Measured and ARA’s Predicted Test 1 Tank Displacements**

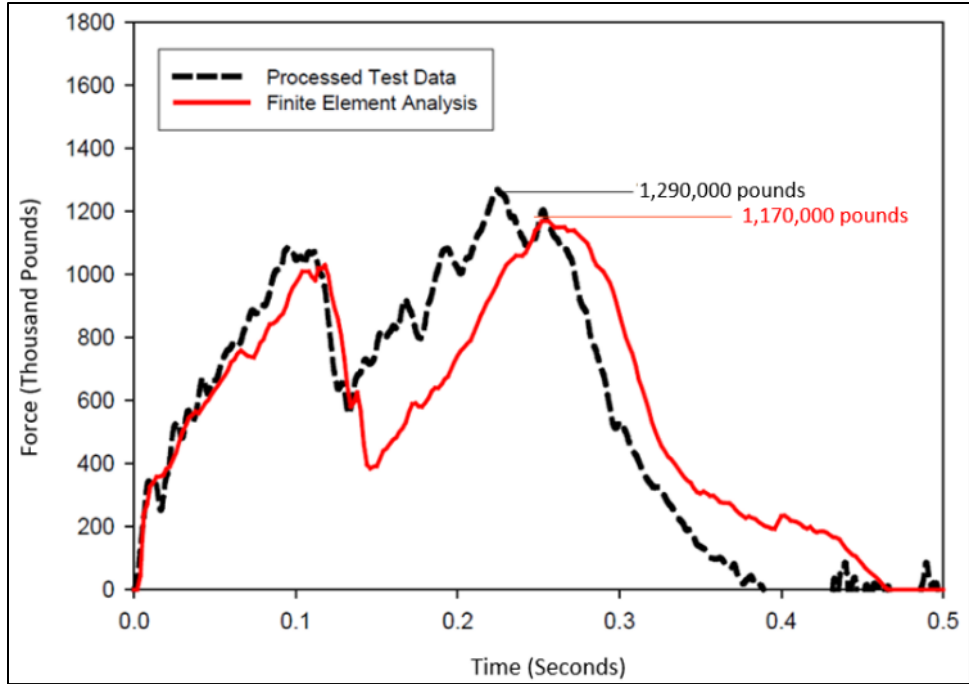
Figure 23 shows a corresponding comparison of the measured force-time history compared to the Volpe post-test analyses. The comparison clearly shows the double peak force history caused by the collision dynamics of the tank impacting against the impactor and against the collision wall. Figure 24 shows force-displacement results of the impactor. Again, the overall agreement was good for the level of modeling fidelity and uncertainty at the time.

Figure 23. Test 1 – Comparison of Test 1 and Volpe Post-test Analyses

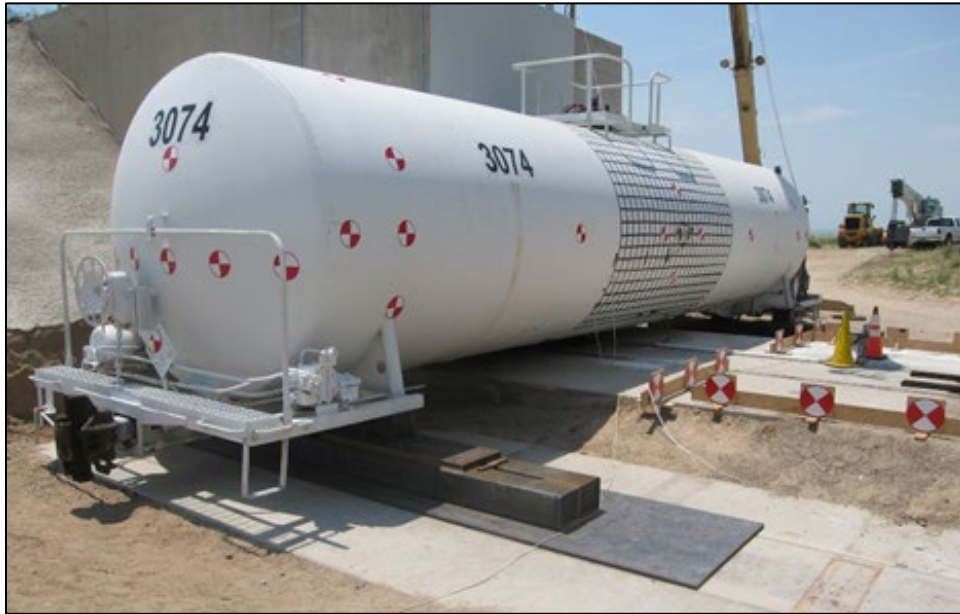
**Figure 25. Test 2 – Tank Car 3074 Mounted on Support Skids**

The side impact Test 2 was performed on July 11, 2007, at the TTC. Test 2 featured a 17,401-gallon DOT105 tank car struck by a tapered 6-inch by 6-inch impactor centered on the tank (Witte, M., & Anankitpaiboon, S., 2007). [Table 12](#) contains the specifications for the tested DOT105A500W tank car. The test was performed by running an impactor car into the side of a ballasted chlorine tank car that was backed by a rigid impact barrier. The tank car was filled with a clay-slurry to the appropriate pressure and outage. The test procedure was modified for Test 2 by lowering the tank position and mounting rigid support skids to the body bolster as [Figure 25](#) shows. The primary objective of these modifications to the target tank car and impactor car was to create a test procedure that was controlled, repeatable, and eliminated the post-impact roll of the tank.

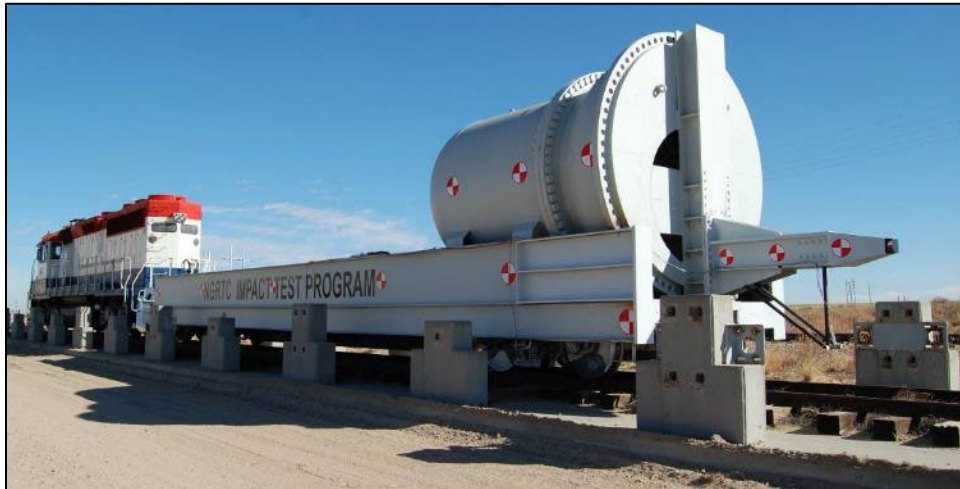
The impactor car was also modified before Test 2 by lowering the position of the impactor arm and adding the modified impactor head with a much smaller contact area, as [Figure 26](#) shows. The impactor arm was lowered (as was the target tank car) to more closely align the height of the centers of gravity (CG) of the target tank, impactor car and the line of impact. The modified impactor face was 6-inch by 6-inch square and had 1/2-inch radius on all edges and corners compared with the 1-inch radius of the 17-inch by 23-inch impactor used in Tests 0 and 1. The modified impactor significantly lowers the required impact speed to puncture the target tank and helps to establish an upper bound on the puncture conditions within safe limits for the test facility.

**Figure 26. Test 2 – Modified Impactor Car and Impactor Head Used in Test 2**

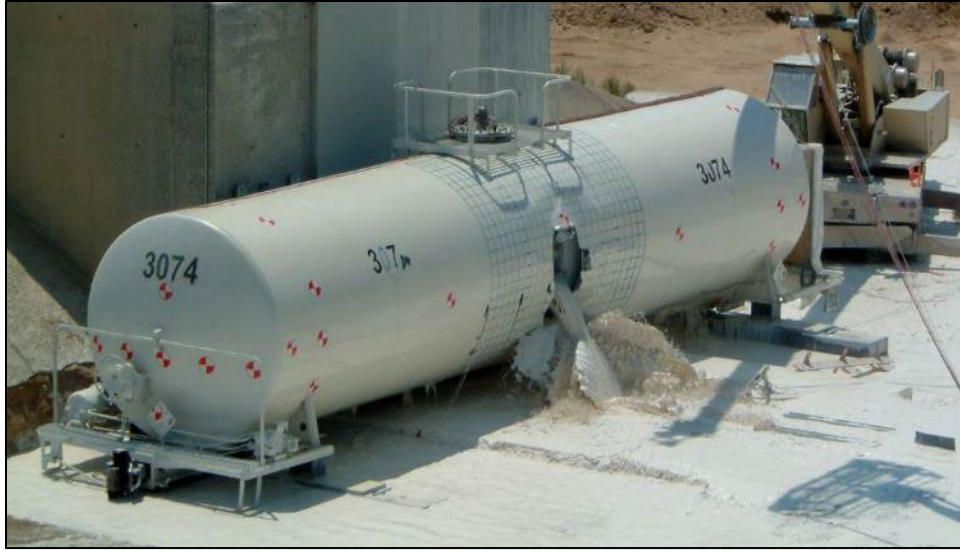
**Figure 27. Test 2 – Puncture Response Observed in the Full-Scale Impact Test 2**

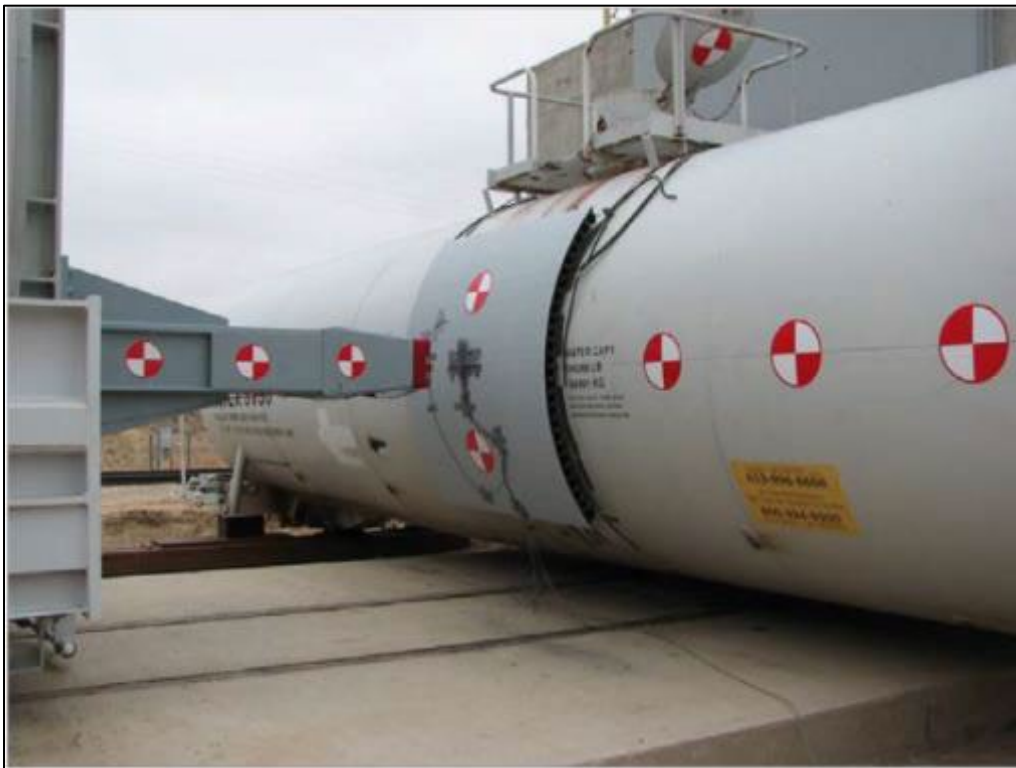
**Figure 32. Test 3 – Test Setup Showing Tank Car and Impactor**

This test was intended to evaluate the potential improvement in puncture resistance that could be offered by an engineered metal structure installed on a DOT105 tank car's shell. The 6-foot by 6-foot sandwich panel was hung using cables from the manway in the center of the tank car, as [Figure 32](#) shows. The sandwich panel was attached in this manner to allow it to “flex” in response to the impact.

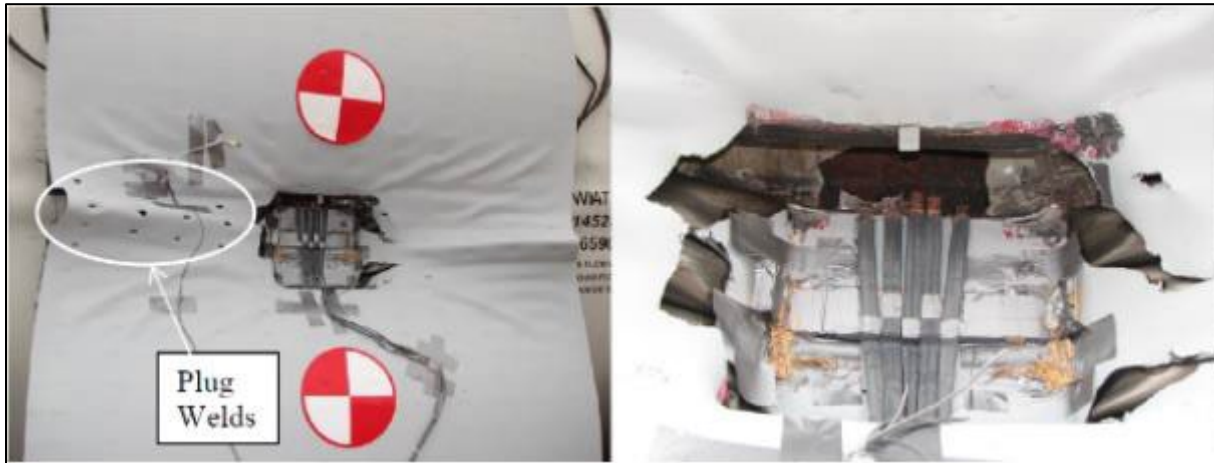
The impact dented and tore the protective panel, dented the tank car jacket, and dented the commodity tank as shown in [Figure 33](#) and [Figure 34](#). The tank was not expected to puncture, and the tank did not puncture, although a crack initiated in a weld seam near the contact area. The contents of the tank were not released due to this impact.

**Figure 33. Test 3 – Damage to Protective Panel**
