## Review of Tank Car Side Impact Test Research and Analyses of 2007–2019

<b>1. REPORT DATE (DD-MM-YYYY)</b> March 2022		<b>2. REPORT TYPE</b> Technical Report		<b>3. DATES COVERED (From - To)</b> 2007 to 2019	
<b>4. TITLE AND SUBTITLE</b> Review of Tank Car Side Impact Test Research and Analyses of 2007–2019				<b>5a. CONTRACT NUMBER</b> DTFR53-11-D-00008	
				<b>5b. GRANT NUMBER</b>	
				<b>5c. PROGRAM ELEMENT NUMBER</b>	
<b>6. AUTHOR(S)</b> <sup>2</sup> Aswani Krishnamurthy – <a href="#">0000-0003-3116-7797</a> ; <sup>1</sup> Shawn Trevithick – <a href="#">0000-0001-6155-5526</a> ; <sup>2</sup> Michael Carolan – <a href="#">0000-0002-8758-5739</a> ; <sup>1</sup> Ulrich Spangenberg – <a href="#">0000-0003-2760-1394</a> ; <sup>1</sup> Nicholas Wilson – <a href="#">0000-0003-1140-7108</a> ; <sup>2</sup> Shaun Eshraghi – <a href="#">0000-0002-8152-0838</a> ; <sup>3</sup> Steve Kirkpatrick – <a href="#">0000-0001-9590-7980</a>				<b>5d. PROJECT NUMBER</b>	
				<b>5e. TASK NUMBER</b> 693JJ620F000040

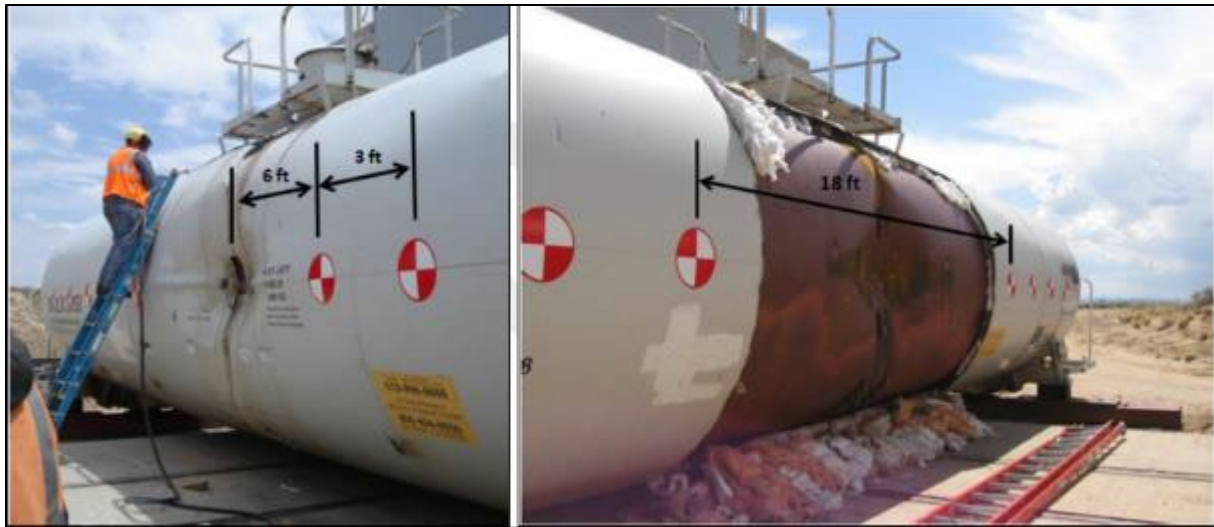
The impact dented and tore the protective panel, dented the tank car jacket, and dented the commodity tank as shown in [Figure 33](#) and [Figure 34](#). The tank was not expected to puncture, and the tank did not puncture, although a crack initiated in a weld seam near the contact area. The contents of the tank were not released due to this impact.

**Figure 34. Test 3 – Deformation to Jacket and Tank**

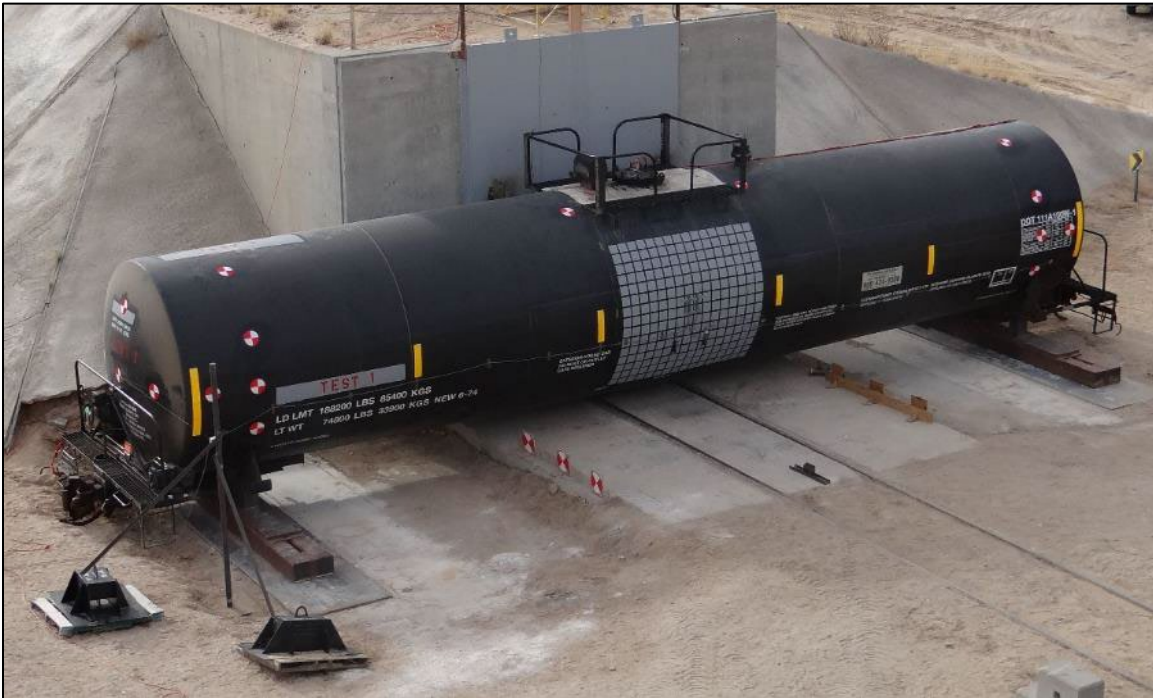
**Figure 36. Test 4 – Target Tank Car Mounted on Support Skids**

On December 18, 2013, the research team performed Test 4 at the TTC. Test 4 featured a DOT111A100W tank car that was equipped with an insulating jacket, insulation materials between the tank and jacket, and external heating coils. The 24,081-gallon DOT111 tank car was struck by a 12-inch by 12-inch impactor centered on the tank side. The test was performed by running the impactor car into the side of a ballasted chlorine tank car filled with water that was backed by a rigid impact barrier. [Figure 36](#) shows the tank car configuration before the test. [Table 16](#) contains the tank car specification.

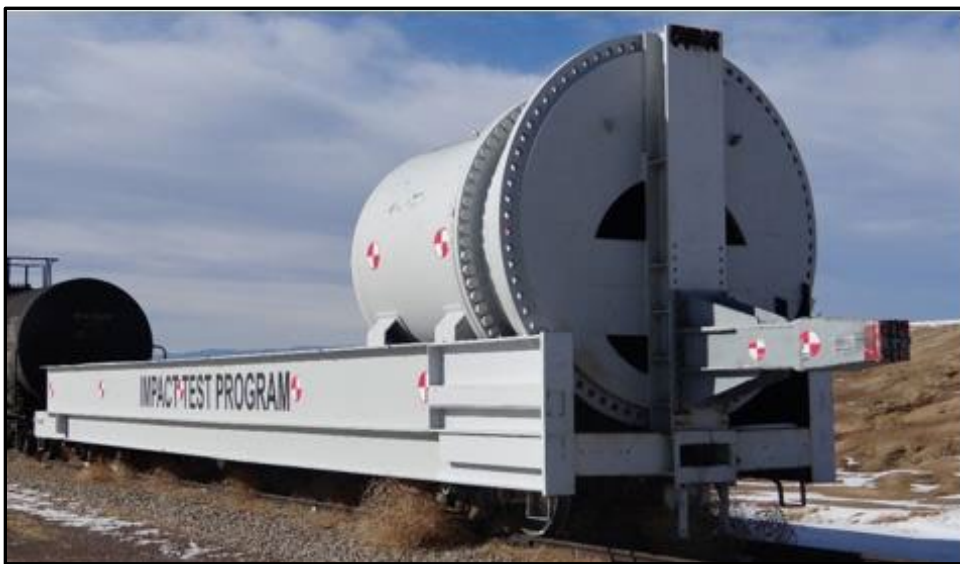
**Figure 38. Test 4 – Impactor Car Configuration Before Test**

Figure 38 shows the impactor car and impactor head. This photograph was taken before the test. Additional reinforcement was added to the impactor car end underframe before Test 3, increasing the weight by approximately 10,000 pounds.

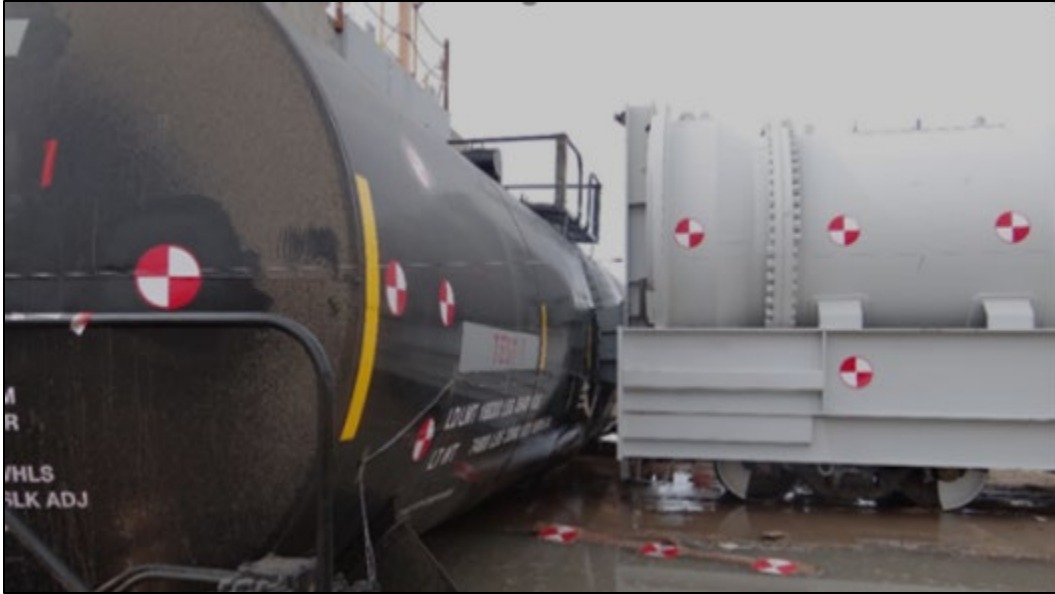
**Figure 39. Test 4 – Post-test Puncture Response of the Tank Car**

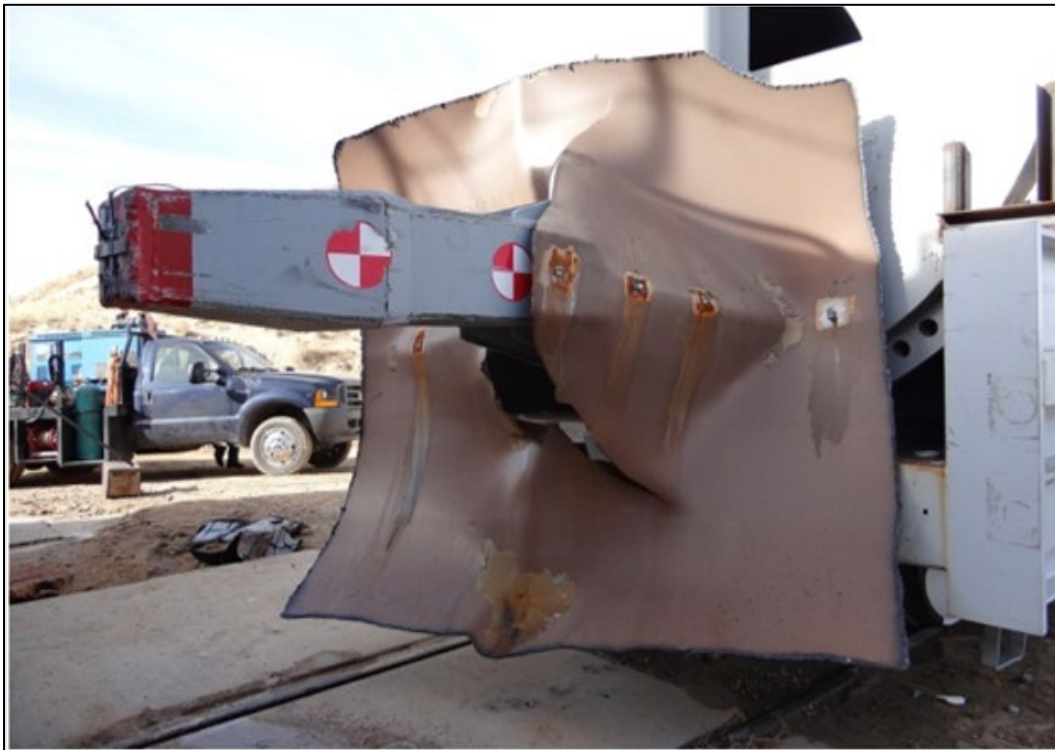
**Figure 40. Test 4 – Post-test Puncture Damage of the Tank Car**

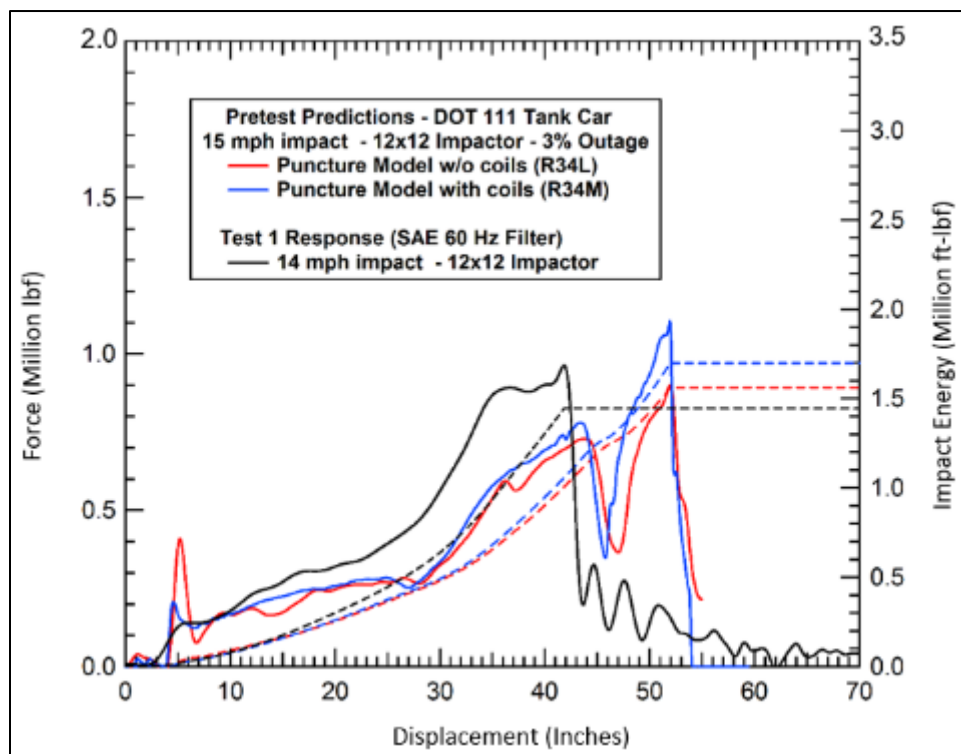
**Figure 47. Test 4 – Comparison of ARA’s Predicted and Measured Force-Displacement and Impact Energy**

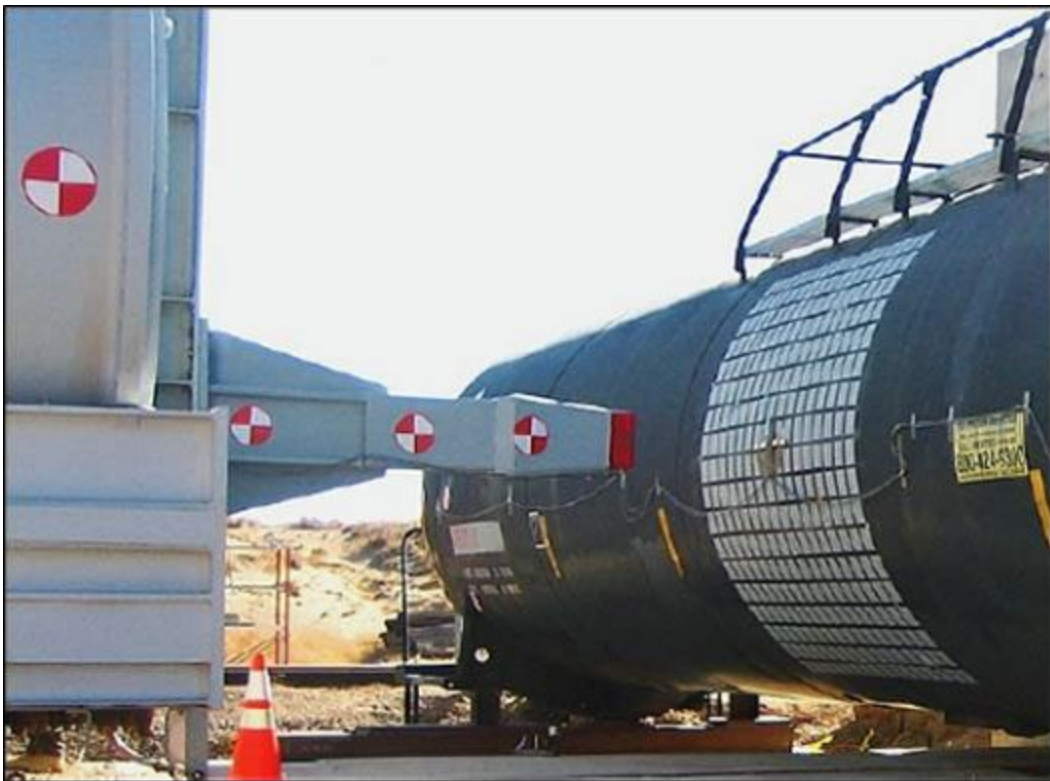
**Figure 52. Test 5 – Test Setup Showing DOT112 Tank Car and Impactor**

This test was a follow-up to Test 4, examining the potential improvement in shell puncture resistance that could be realized for unpressurized tank cars if a thicker tank shell was used. As a stand-in for an unpressurized tank car with a thicker shell, a DOT112 tank car was used in Test 5. DOT112 tank cars are usually pressurized in operating conditions, but it was loaded as if it were an unpressurized tank car. [Figure 52](#) shows the test setup.

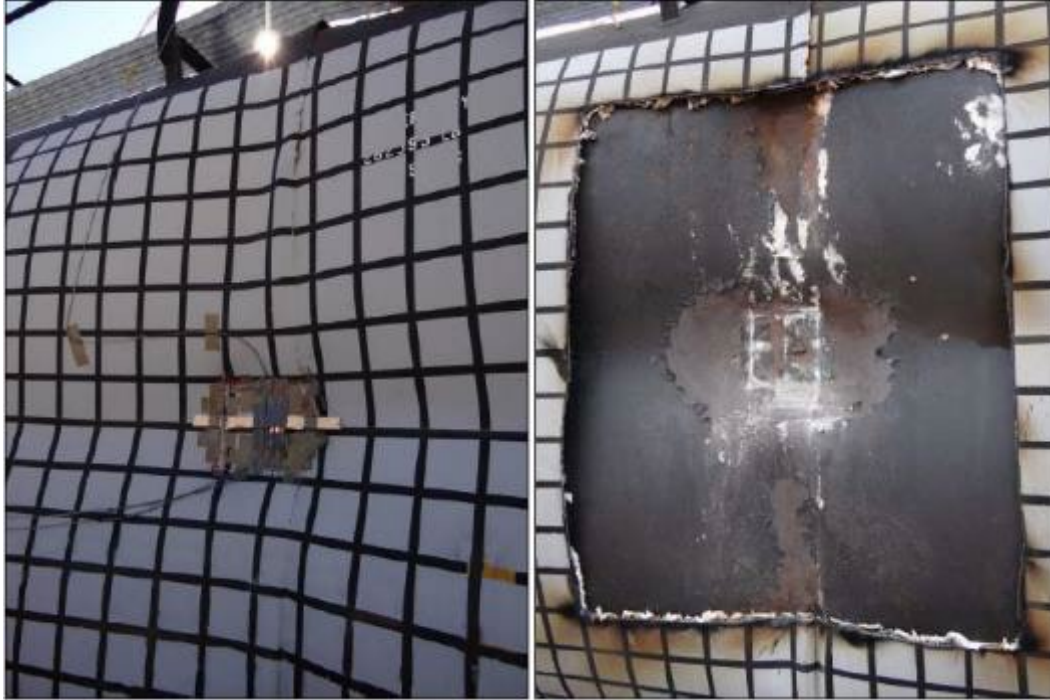
**Figure 53. Test 5 – Deformation of the (left) Jacket and (right) Tank Shell Due to Impact**

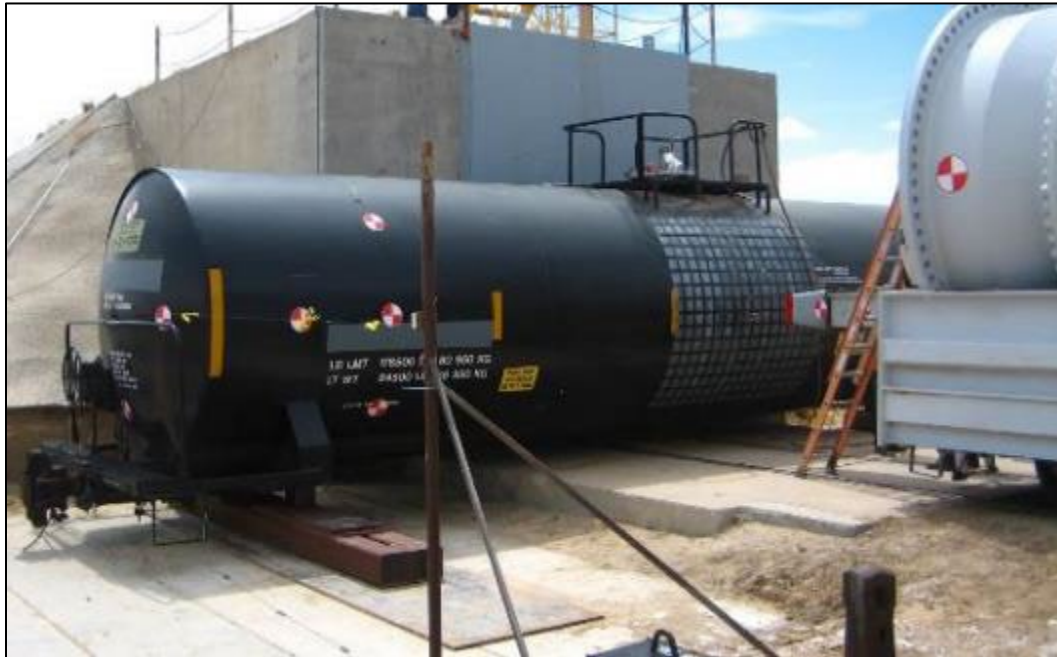
**Figure 55. Test 6 – Test Setup Showing DOT105 Tank Car and Impactor**

Before this test, Tests 0, 1, and 2 featured a DOT105 tank car struck by either a 17-inch by 23-inch impactor or a 6-inch by 6-inch impactor. Test 3 featured a DOT105 tank car struck by a 12-inch by 12-inch impactor, but the tank car in Test 3 also included a protective panel that is not a typical feature of any tank car. Thus, Test 6 was the first test to evaluate the performance of an unmodified DOT105 tank car when struck by a 12-inch by 12-inch impactor. [Figure 55](#) shows the test setup.

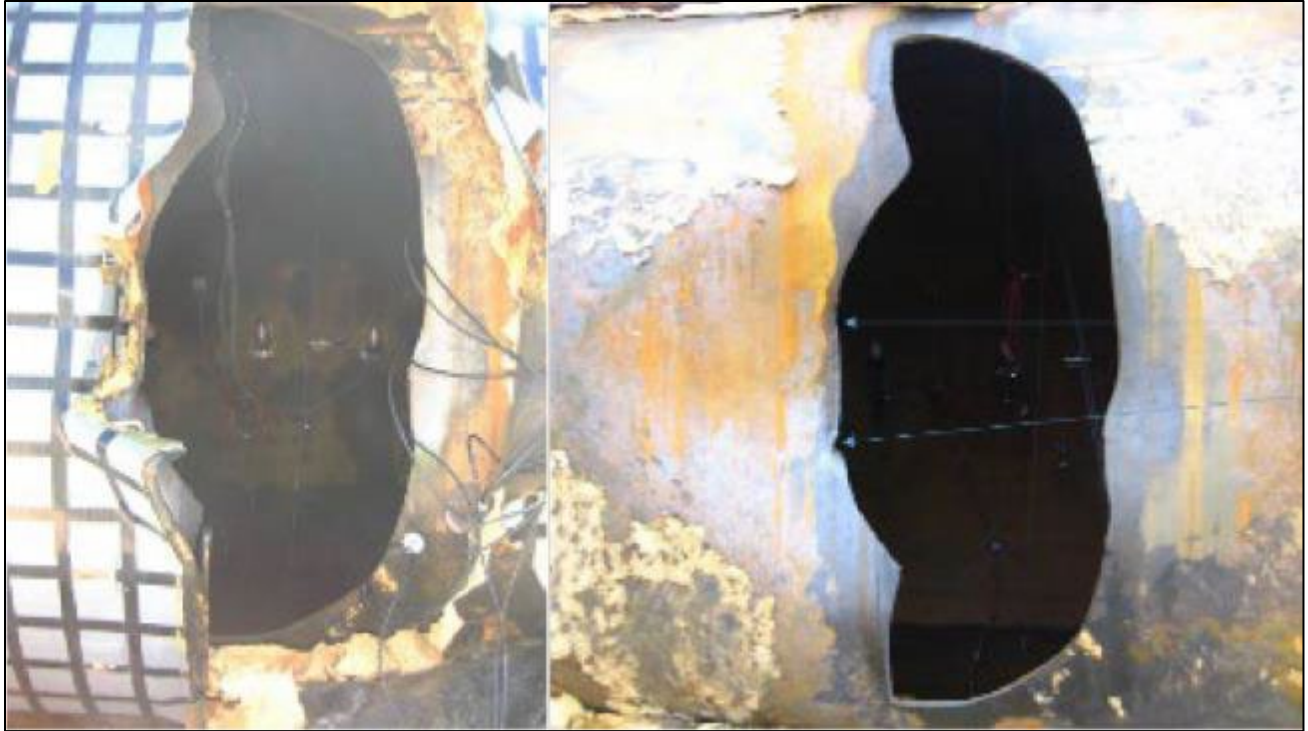
**Figure 56. Test 6 – Impact Zone Post-testing (left) With and (right) Without Jacket**

The test was intended to dent the tank car, but not puncture the tank’s shell. The impact deformed the tank car and punctured the external jacket and the tank’s shell. The impactor was brought to a stop because of energy absorbed by the tank car and rebounded from the tank car though it punctured. This outcome implied the impact speed only slightly exceeded the threshold puncture speed. The impactor car did not continue to penetrate the tank car after puncture. The internal pressure ejected a segment of the shell from the impacted area and created a large hole in the tank. This was the first test that featured a puncture and a rebound of the impactor car. This has also been, to-date, the only test where tank car material was separated and ejected from the tank. [Figure 56](#) shows the deformed tank car, with the left side figure showing the jacket in place and the right side showing the tank shell with the jacket removed.

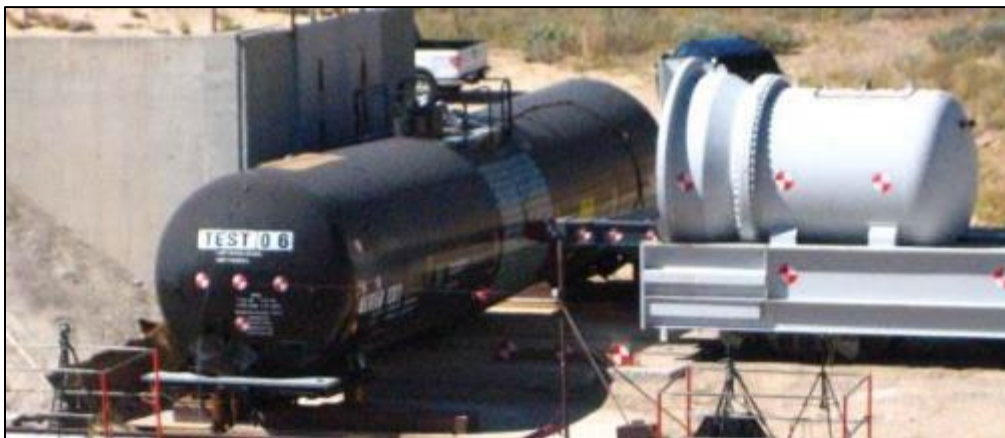
**Figure 58. Test 7 – Test Setup Showing DOT117 Tank Car and Impactor<sup>11</sup>**

While it is designed to withstand internal pressure, the DOT117 tank car is classified as an unpressurized tank car, like the DOT111. The DOT117 tank car tested was 1 year old and had never been used in revenue service. [Figure 58](#) shows the test setup.

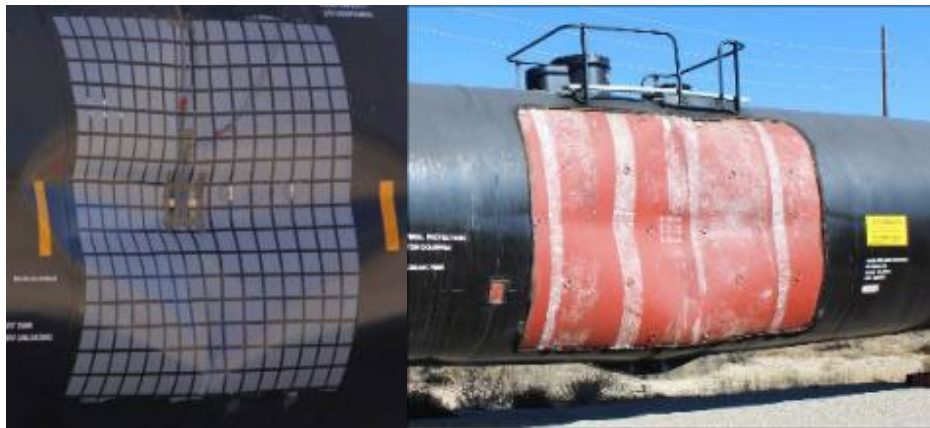
**Figure 59. Test 7 – Post-test Images of (left) the Tank Car with Jacket and (right) Tank Inner Shell**

The impact zone was centered on a circumferential weld seam on the tank. The post-test inspection showed no cracking of the weld seam. The impact zone on the jacket occurred near an area with a weld seam and two overlapping steel sheets. [Figure 59](#) shows the post-test impact zone, with the left side figure showing the jacket and the right side showing the tank inner shell.

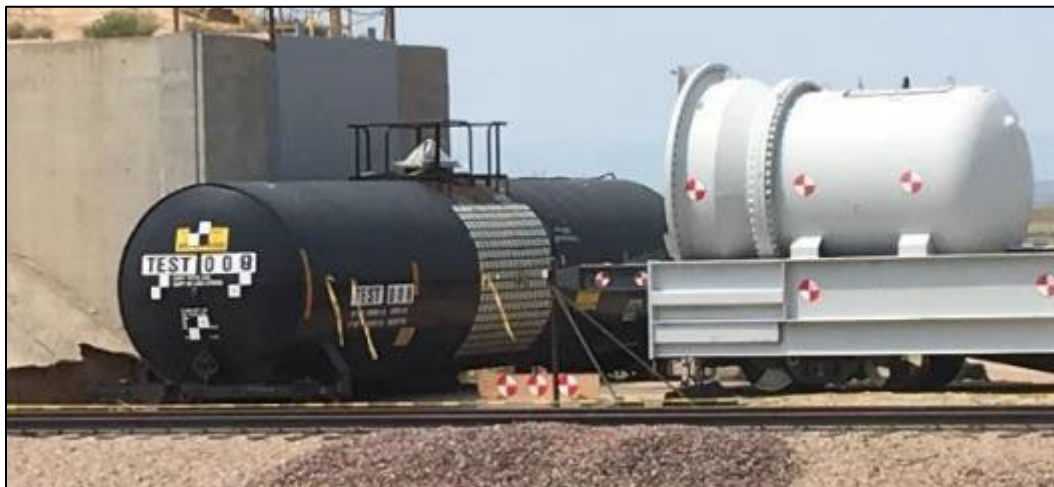
**Figure 61. Test 8 – Test Setup Showing DOT105 Tank Car and Impactor**

Before this test, Test 6 featured a DOT105 tank car struck by a 12-inch by 12-inch impactor at 15.2 mph. Test 6 resulted in puncture of the tank with a very small residual energy. [Figure 61](#) shows the test setup for Test 8.

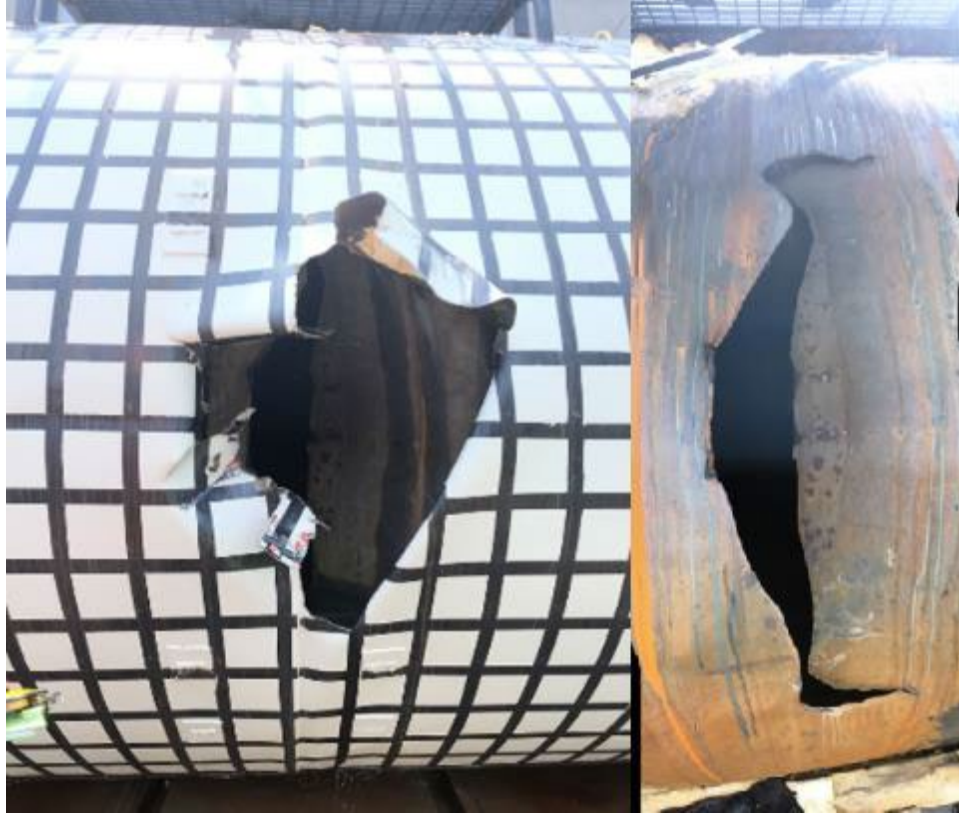
**Figure 62. Test 8 – Post-test Images (left) Tank and Jacket and (right) Tank Shell**

Test 8 used similar instrumentation to that of Test 7. The test was intended to puncture the tank's shell without excessive kinetic energy left in the impactor car. The impact deformed the tank car and punctured the external jacket and the tank's shell. The impactor was brought to a stop because of energy transfer to the tank car and rebounded from the tank car although the tank car punctured. This outcome implied the impact speed only slightly exceeded the threshold puncture speed. [Figure 62](#) shows the deformed tank car, with the left side figure showing the jacket and the right side showing the tank shell with the jacket removed.

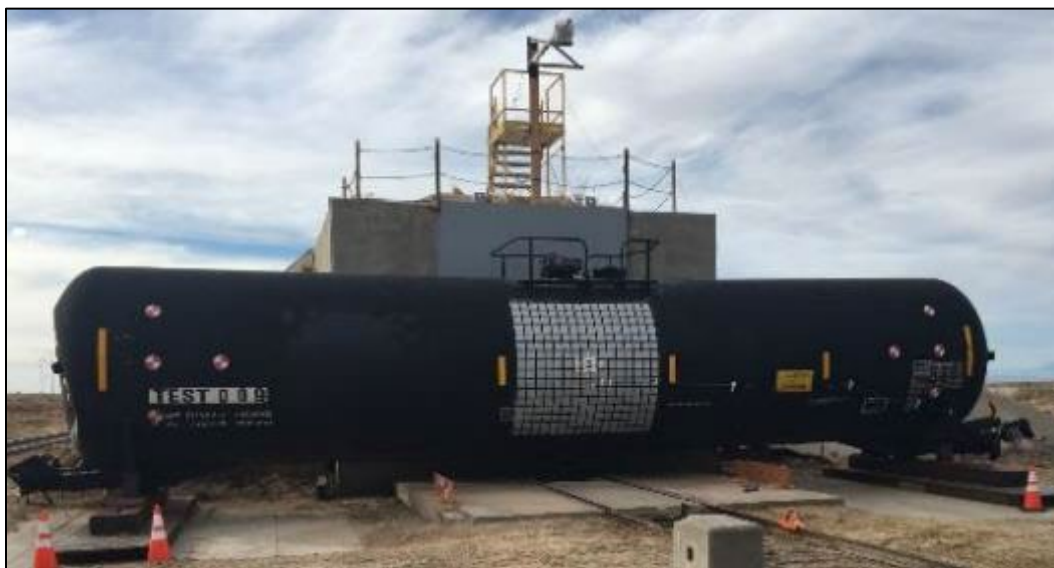
**Figure 64. Test 9 – Test Setup Showing DOT111 Tank Car**

The tank car used in Test 9 had been involved in a derailment which caused a dent to the tank head at the A-end of the tank car. This dent at the head of the tank car was not expected to affect the outcome of the shell impact test, because the point of impact was far away from the accident affected zone. However, to ensure integrity of the test, visual and magnetic particle inspections of the A-end tank head were performed on this tank car. The inspections found no indication of cracks in the metal. [Figure 64](#) shows the test setup used in Test 9.

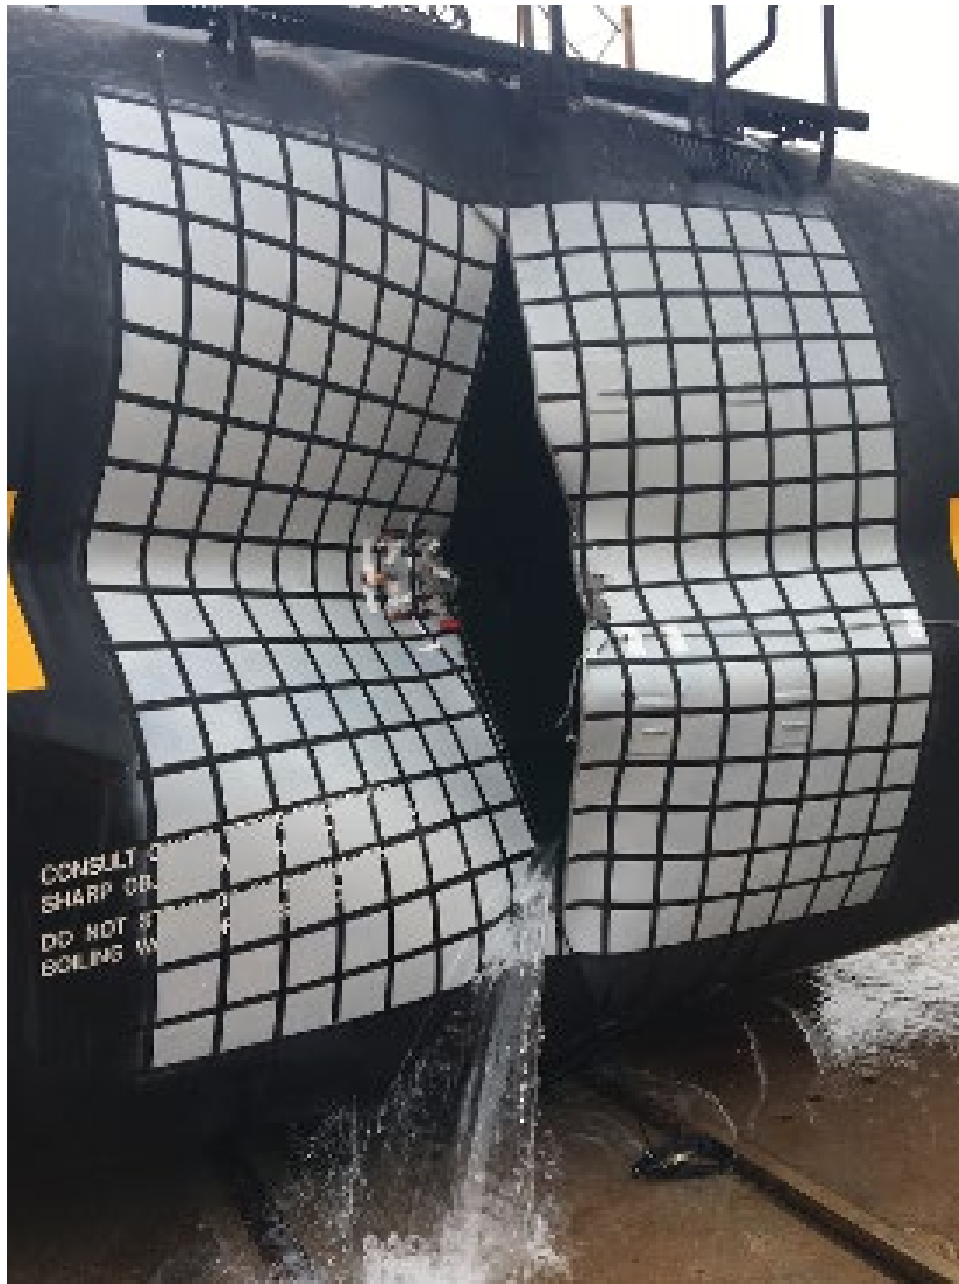
**Figure 65. Test 9 – Post-test Image of the Tank**

The instrumentation used in Test 9 was like that of Test 8. The test was intended to puncture the tank's shell without excessive kinetic energy left in the impactor car. The impact deformed the tank car and punctured the tank's shell. The impactor was brought to a stop because of energy transfer to the tank car and rebounded from the tank car although the tank car punctured. Leakage through the top fittings and PRV was observed during this test. This outcome implied

the impact speed only slightly exceeded the threshold puncture speed. [Figure 65](#) shows the punctured tank car.

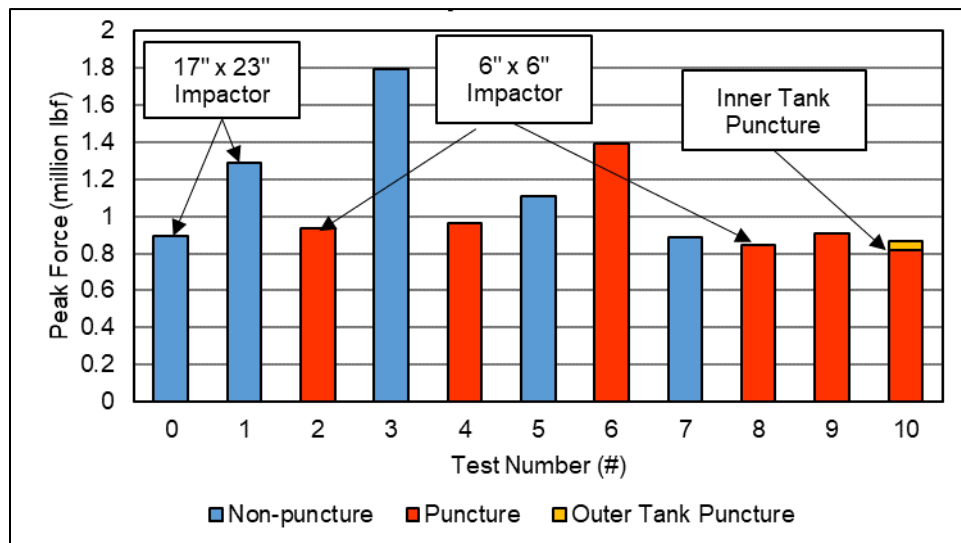
**Figure 90. Summary of Peak Forces Across Tests  
(12-inch by 12-inch impactor was used unless noted otherwise)**
