FHWA-WY-10/07F

State of Wyoming
Department of Transportation

BRIDGE DECK EVALUATION USING NONDESTRUCTIVE TEST METHODS

March 2012

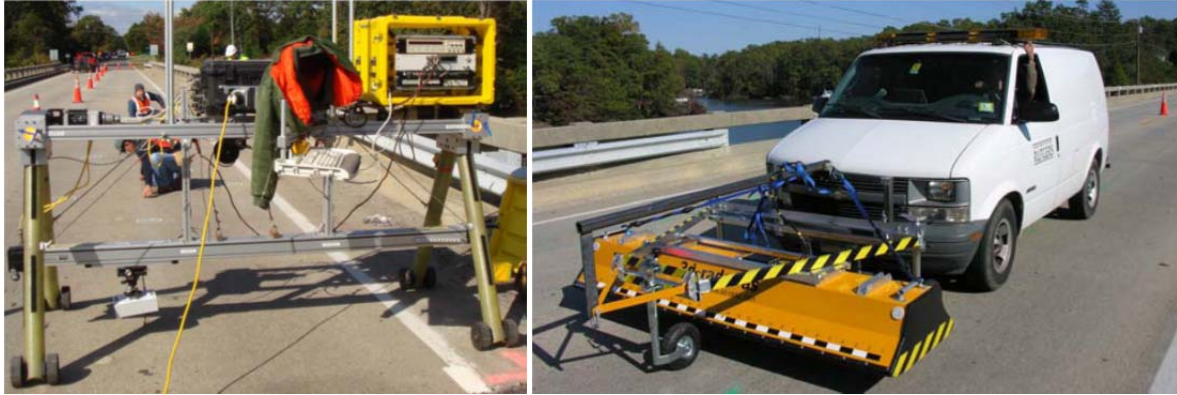
Air-coupled systems were used in vehicle mounted systems as early as 1992 (Alongi et al. 1993). Two air-coupled systems were developed by the Lawrence Livermore National Laboratory for the Federal Highway Administration (FHWA) (Warhus et al. 1994). High-speed Electromagnetic Roadway Mapping and Evaluation System (HERMES) was designed to survey deck condition during normal traffic flow. Precision Electromagnetic Roadway Evaluation System (PERES) is slower and provides a more accurate survey (Davidson and Chase 1998; Scott et al. 2000). FHWA funded the PERES system, a second generation of the HERMES (Huston et al. 2007a, b). It is much simpler and uses one antenna, whereas the HERMES system uses 64 antennae to get a wider scan in a single pass (Scott et al. 2000). The PERES system consists of an air horn antenna mounted onto two A-frames moved manually along the road (Huston et al. 2007a, b). Images of the van-mounted system and the PERES system are shown in Figure 9. The air horn systems must be calibrated for the distance from the bridge deck to the antenna.

Figure 9: PERES II system and vehicle mounted systems (Huston et al. 2007b).

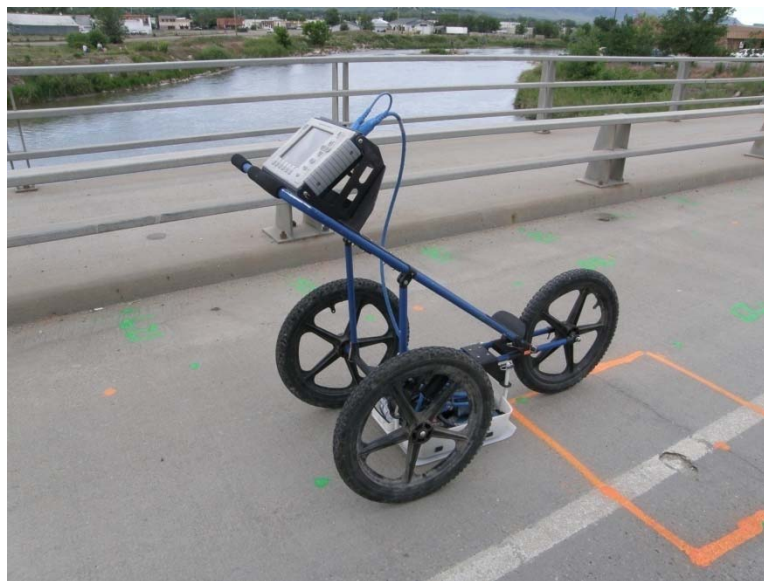
Ground-coupled systems rest directly on the roadway surface and transmit the impulses and return data in a form similar to that of the air-coupled system. Geophysical Survey Systems, Inc., (GSSI) developed and sells a self-contained, cart-based GPR system, which claims to accurately estimate repair costs (Figure 10). An optional GPS system can be integrated into the GPR in to ease data interpretation.

Figure 10: Typical GPR ground-coupled cart.

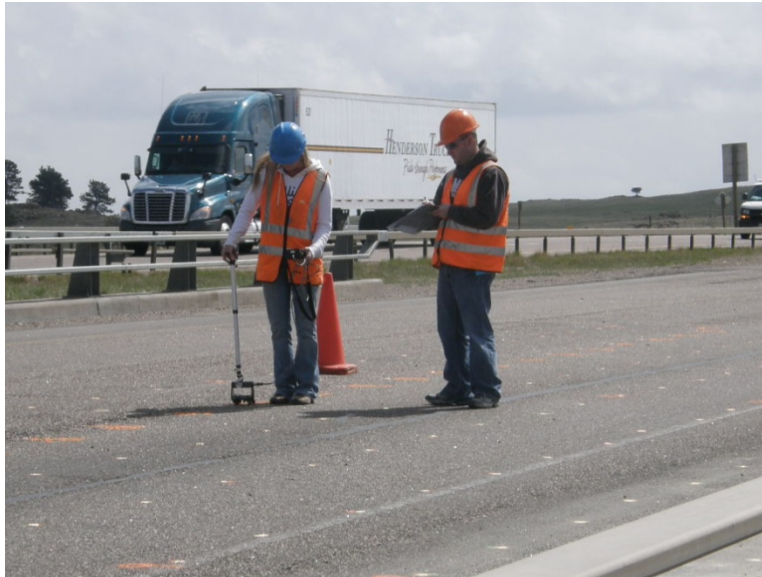
To gather data for the impact echo test, a digital sounding device was used to measure the depth of concrete decks (Olson Instruments Concrete Thickness Gauge CTG™). This device uses a solenoid that strikes the surface and a receiver that converts the reading to concrete depth via a Fast Fourier Transform. Figure 18 shows impact echo tests being carried out by the University of Wyoming researchers.

Figure 18: University of Wyoming researchers performing impact echo test.

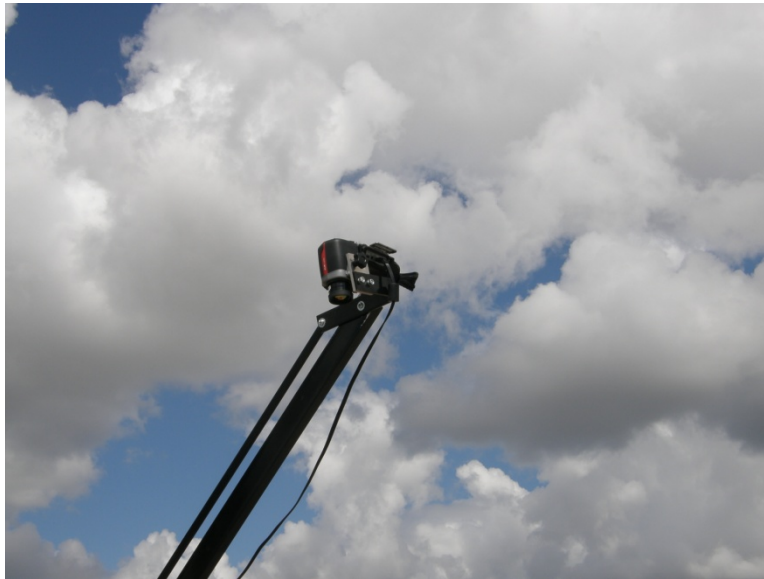
accuracy of ± 3.6 °F. It should be noted that this level of accuracy was reduced due to lens that was used to increase the area the camera could cover in one photograph. The camera used for the Remount Bridge, with and without the overlay, and the Douglas Bridge, without the overlay, was a FLIR B200, which has the same resolution and accuracy as the T250, but with a narrower range of readable temperatures. A boom and cart were used to raise the camera and orient it perpendicular to the bridge deck surfaces. Figure 19 and Figure 20 show the camera and the setup that was used.

Figure 19: Thermal camera.

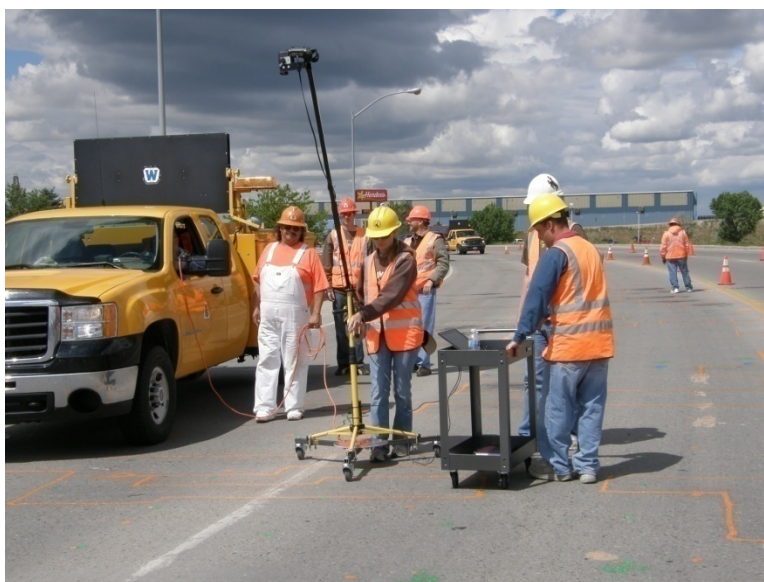
Figure 20: Thermal camera setup.

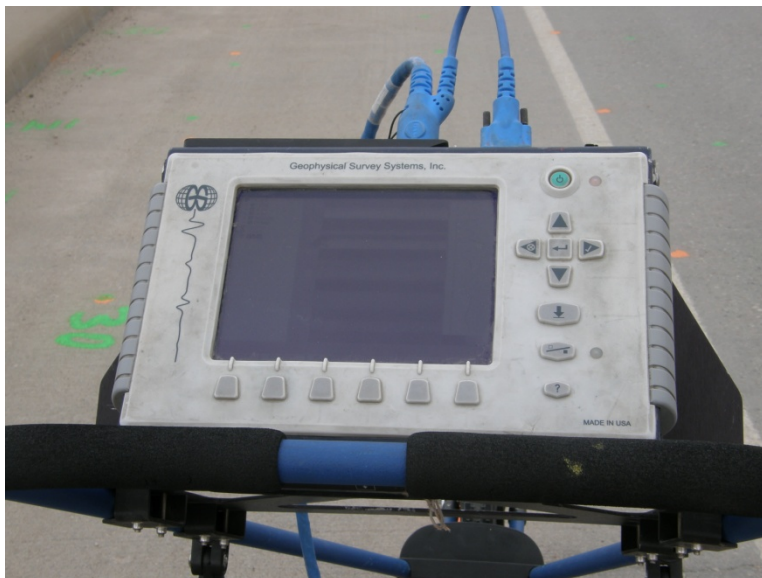
Figure 25: GSSI interface that Olson Engineering uses.

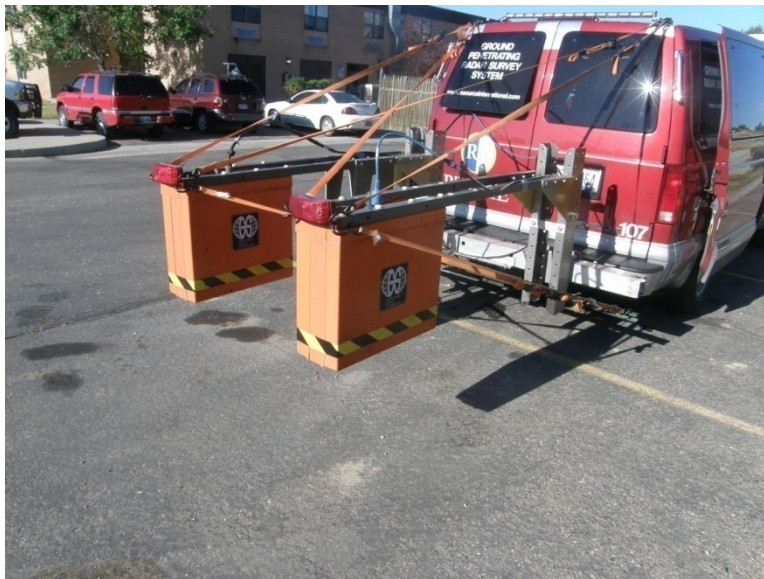
Another GPR air-coupled test was performed by Resource International, Inc. (Rii) from Ohio for comparison purposes. This system was able to travel at 30 mi/h without impeding traffic. Figure 26 shows the vehicle mounted GPR setup on the Rii van. Douglas Bridge with the overlay was evaluated in this subcontract.

Figure 26: Radar apparatus on Rii's van.

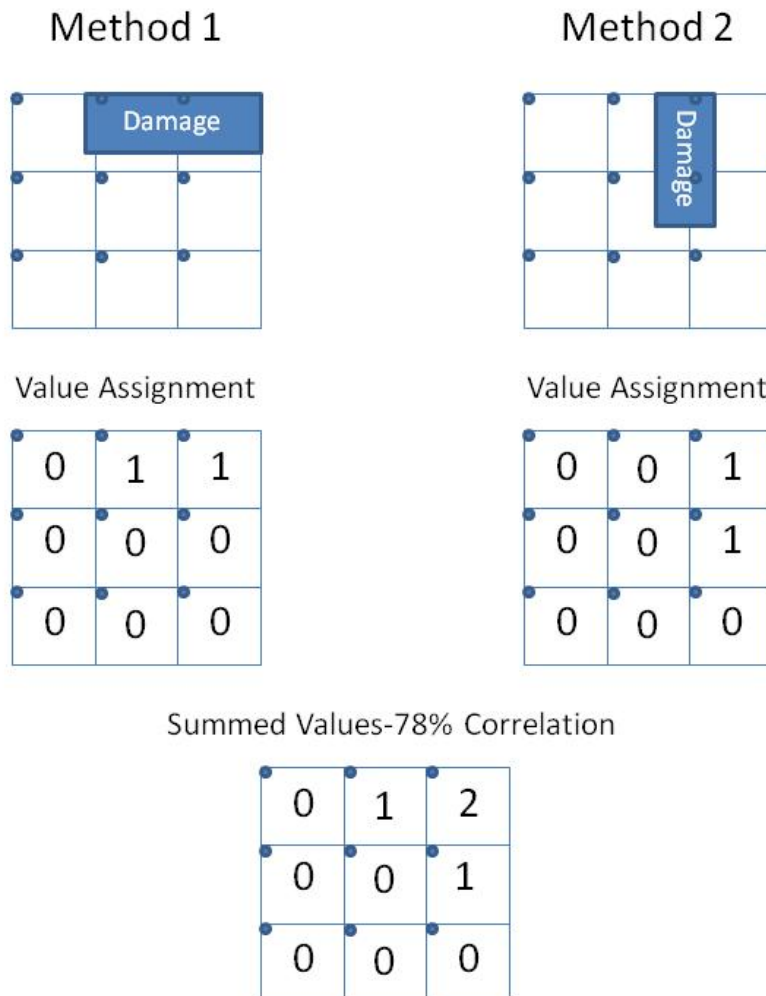
8): a value of zero indicates no damage was predicted and a value of one indicates damage was predicted by this method. The process was repeated for the other method under consideration. The numerical ratings for both methods were then added together at each grid intersection. If both methods predicted no damage a value of zero was assigned to this grid point. If one method predicted damage and the other method did not, a value of one was assigned, and a value of two was assigned if both methods predicted damage (Table 9). In the combined summed values figure, squares rated 0 and 2 were equally weighted and squares rated 1 carried no weight. A percent correlation was calculated and this value is an indication of how many times the two methods aligned. For the example shown in Figure 27, there were seven matching values (0 or 2 in the summed values section) and two values that did not match (1 in the summed values section). The resulting correlation is 7/9 or 78%. Perfect agreement between two methods would result in a score of 100 percent.

Figure 27: Pair-wise Correlation Example.

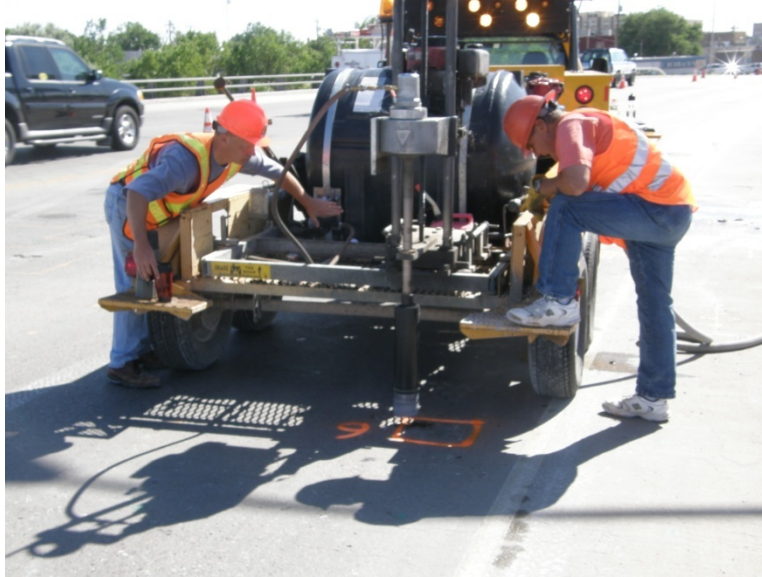
Cores were removed from each bridge to give a visual confirmation of the damage to the bridge deck in locations that had a range of methods indicating areas of concern. Areas that did not indicate damage were also taken to give a control core to compare with the others when possible. The overlay was present when the cores from the Douglas Bridge were removed whereas the coring on Casper and Remount bridges occurred on the bare concrete decks. The individual tests conducted on the cores are discussed in Appendix A for each of the bridges. Figure 28 shows the coring rig removing a core on the Casper Bridge. Although different crews were utilized to remove cores on each bridge, Tyler Robison was present for all coring.

Figure 28: Coring rig on Casper Bridge.

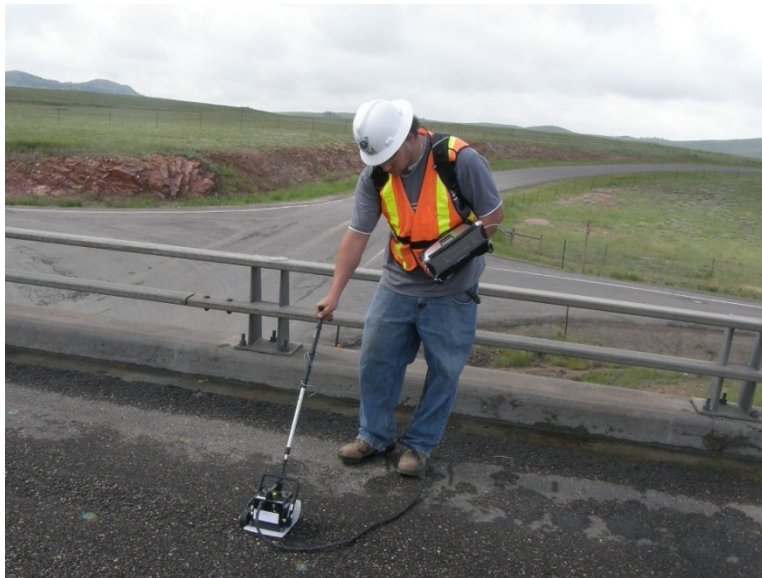
The new GPR system from IDS was also used on the Remount Bridge (Figure 30). This system was moved across the transverse direction at 10 cm intervals. Carts were not utilized due to the short distances and the possibility of the cart sticking out into traffic.

Figure 30: IDS Aladdin ground-coupled radar system.

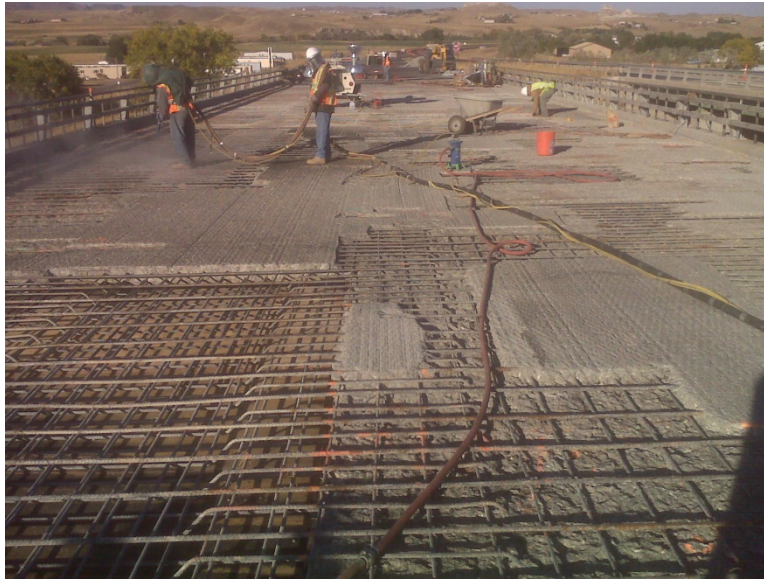
This section presents the actual repairs that were made to the Douglas Bridge. Every portion of this deck required milling and chipping. Figure 44 and Figure 45 show the extent of the necessary repairs.

Figure 44: Douglas Bridge chipping looking east.

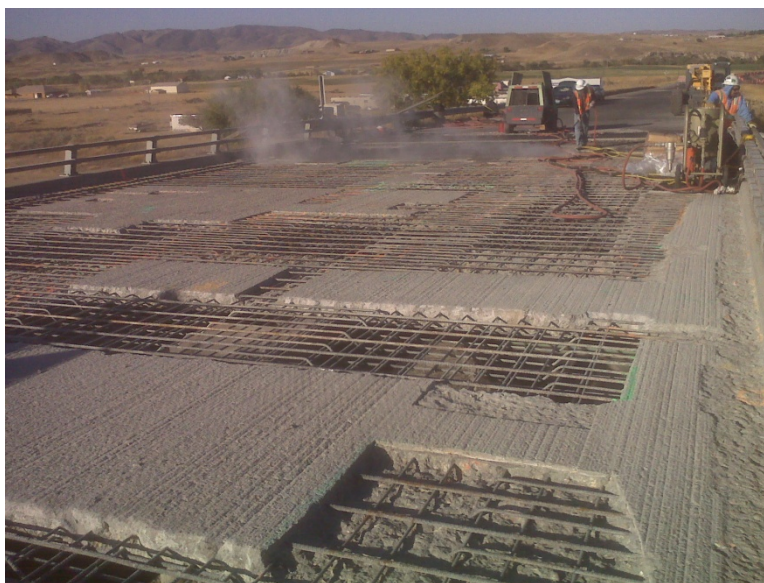
Figure 45: Douglas Bridge chipping looking east.

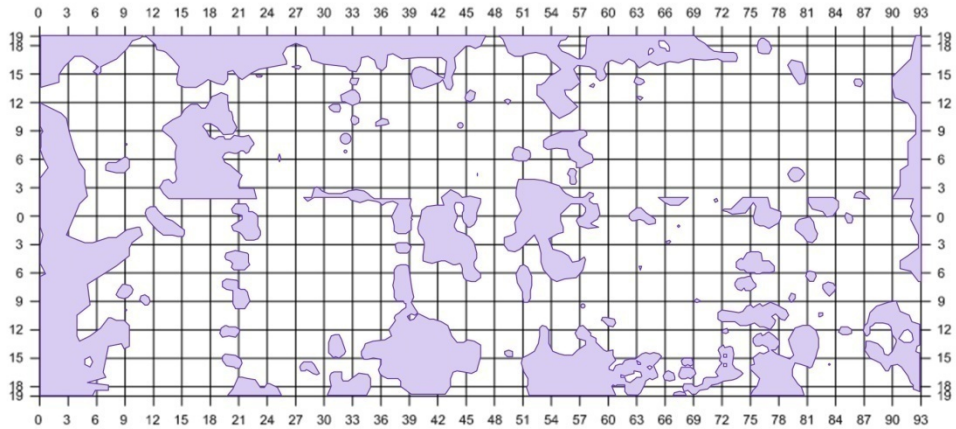
The ground penetrating radar corrosion results from the GSSI ground-coupled cart are presented in Figure 50. No half-cell potential data was valid due to the reinforcement being epoxy-coated, which interferes with the voltage readings. It was found that 24% of the deck had corrosion.

Figure 50: Ground Penetrating Radar Corrosion Evaluation.

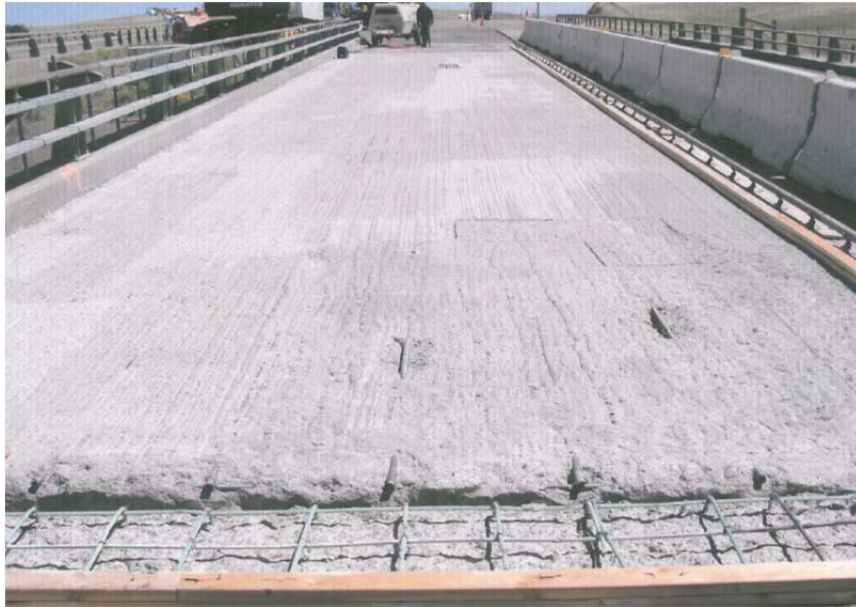
- Reinforcing steel was coated which caused problems with the corrosion data collection and analysis using the half-cell potential method.
- Longitudinal reinforcing steel was placed above the transverse steel. This resulted in running the GPR system in the transverse direction rather than along the length of the bridge.

Figure 54: Remount Bridge reconstruction.

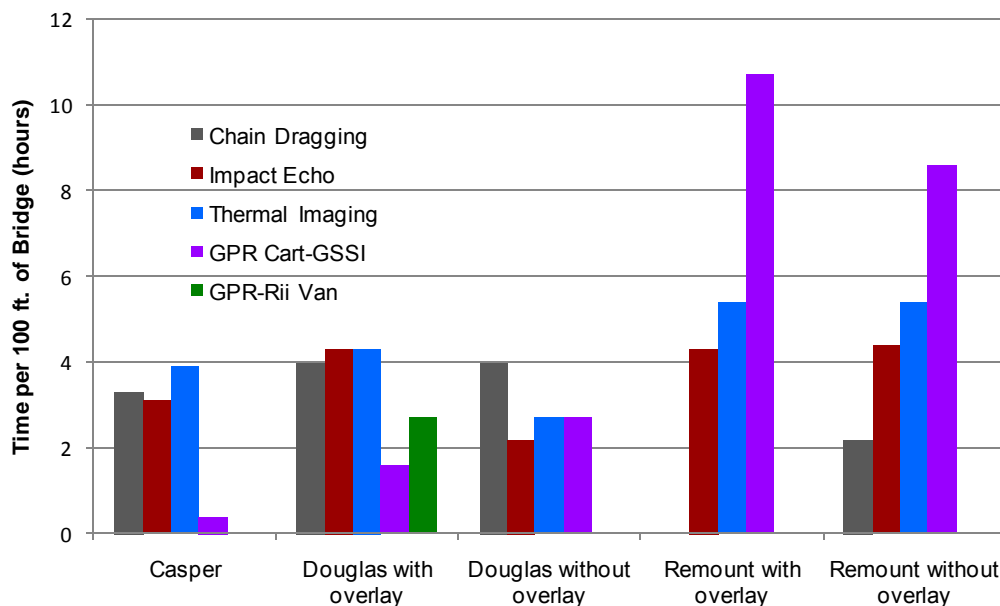
The following figures and tables compare methods over the three bridges. Figure 55 through Figure 57 provide a visual comparison of field time and analysis time for the successful evaluations. The times were normalized to person hours per 100 ft of bridge deck from each of the tests. Table 23 and Table 24 compare the percentages of damage and corrosion, while tables in Appendix A identify the field time and analysis time back in an office. Even though the GPR systems took longer to complete, the analyses were more comprehensive and could detect both delamination and corrosion in the deck. GPR might eliminate the need for half-cell potential evaluations.

Figure 55: Comparison of testing time.

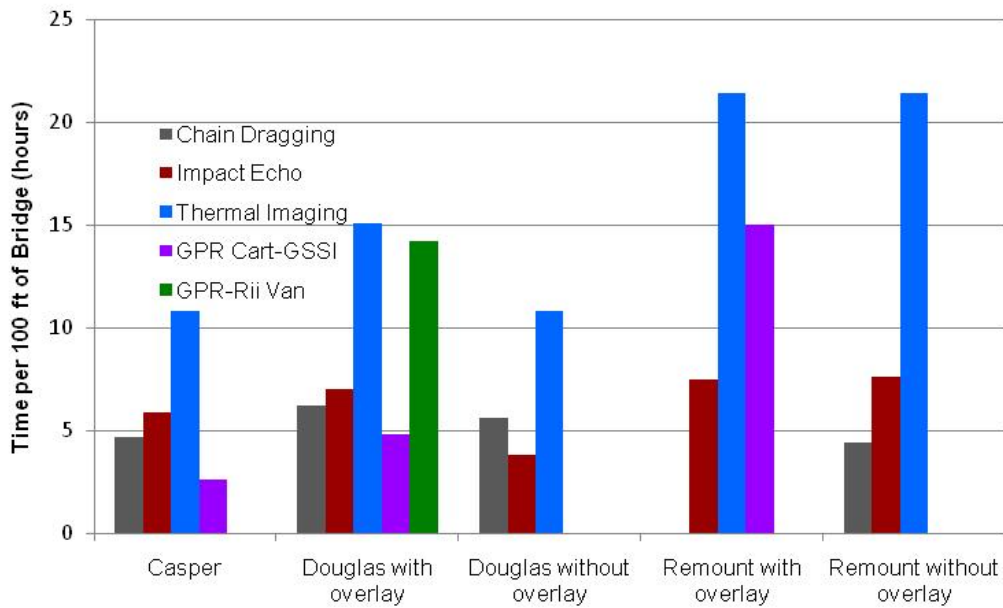
Figure 57: Comparison of the total time for evaluation and analysis.

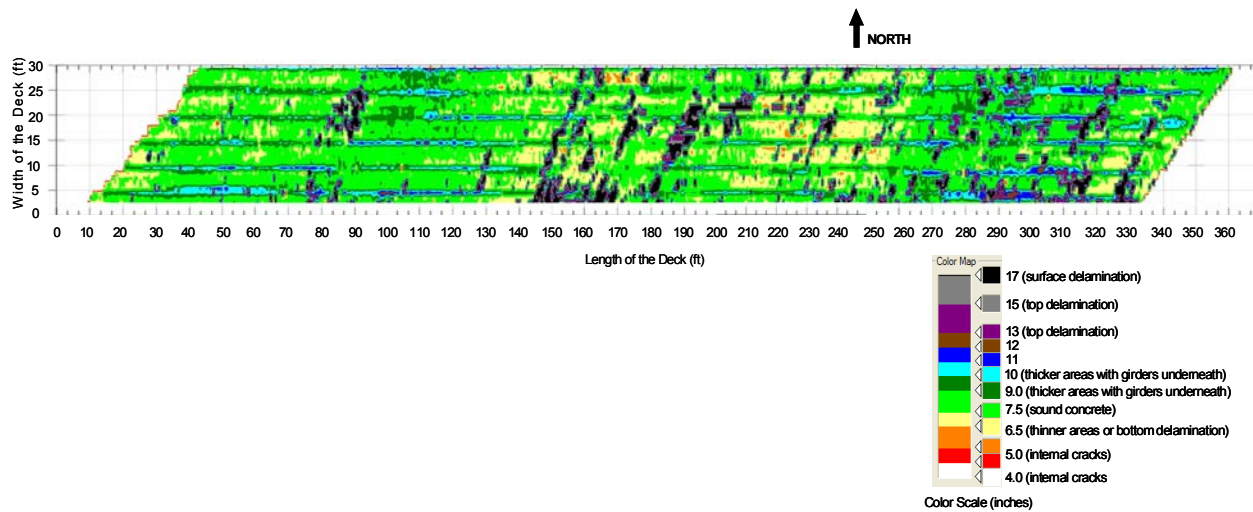
Engineering's system has 18 times more data points than the University of Wyoming's scan. Olson's rolling bridge deck impact echo scanner, still in the developmental stage, may be a quicker and more accurate solution for this method. For bridges located far away from WYDOT headquarters this would require developing software that rapidly provides a plan view of damaged area in the field or hotel room.

Figure 58: Olson Engineering truck mount Bridge Deck Scanner results from the Casper Bridge (Tinkey and Olson 2010).

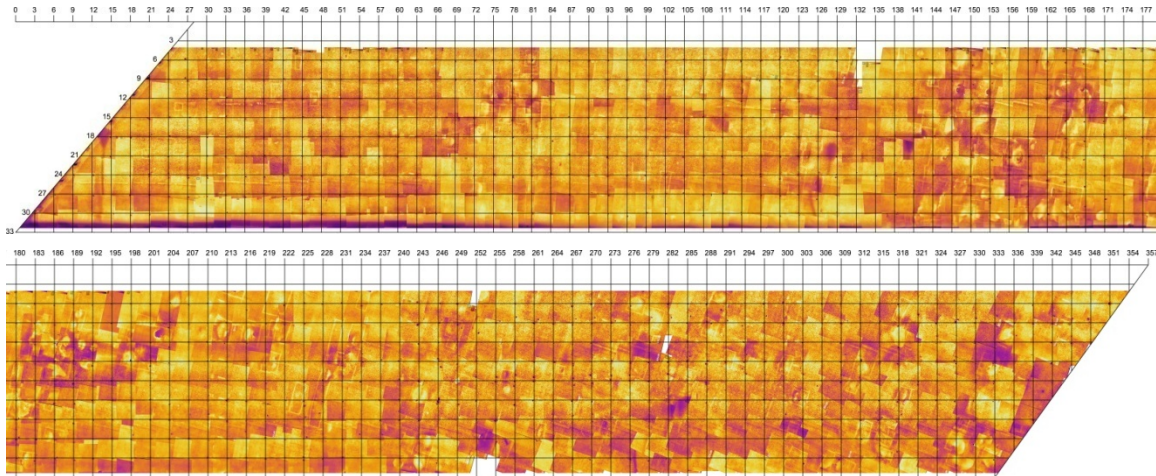
Figure A.5: Thermal images of the bridge deck

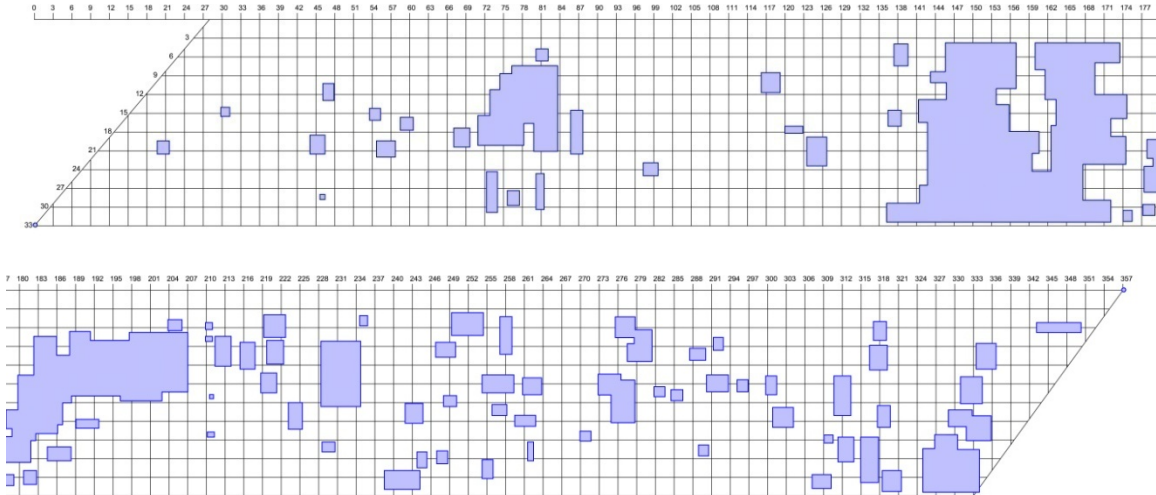
Figure A.6: Outlines of delamination/damage from thermal imaging test

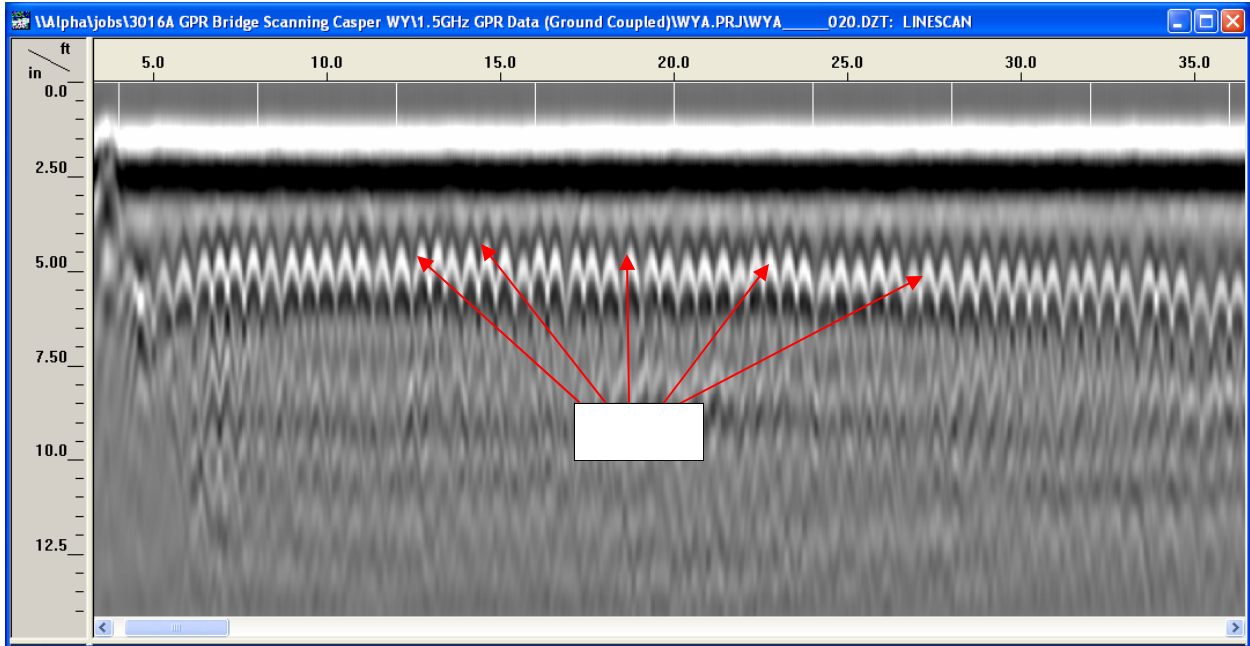
Figure 5 – 1500MHz ground coupled antenna GPR Scan 4.5 feet offset from South curb. The West joint is located at the far left of the plot.

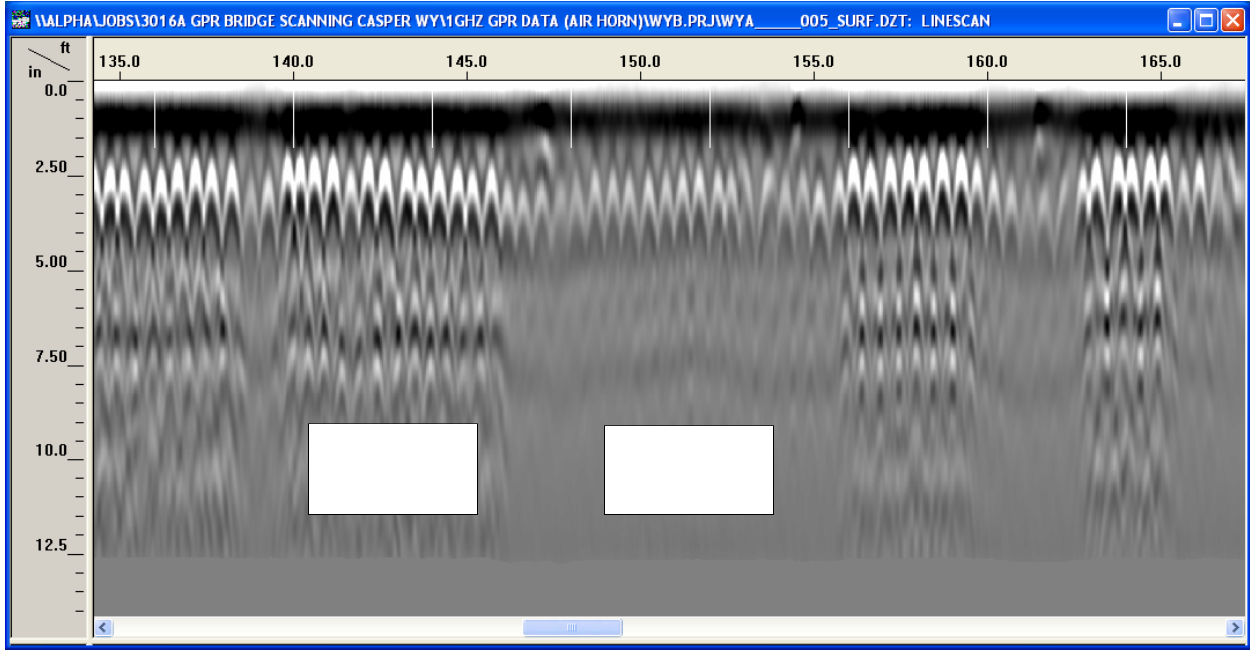
Figure 4 - GPR Scan 6 feet offset from the Bridge centerline. Note the variance of the signal strength as the radar passed areas of suspected corrosion.

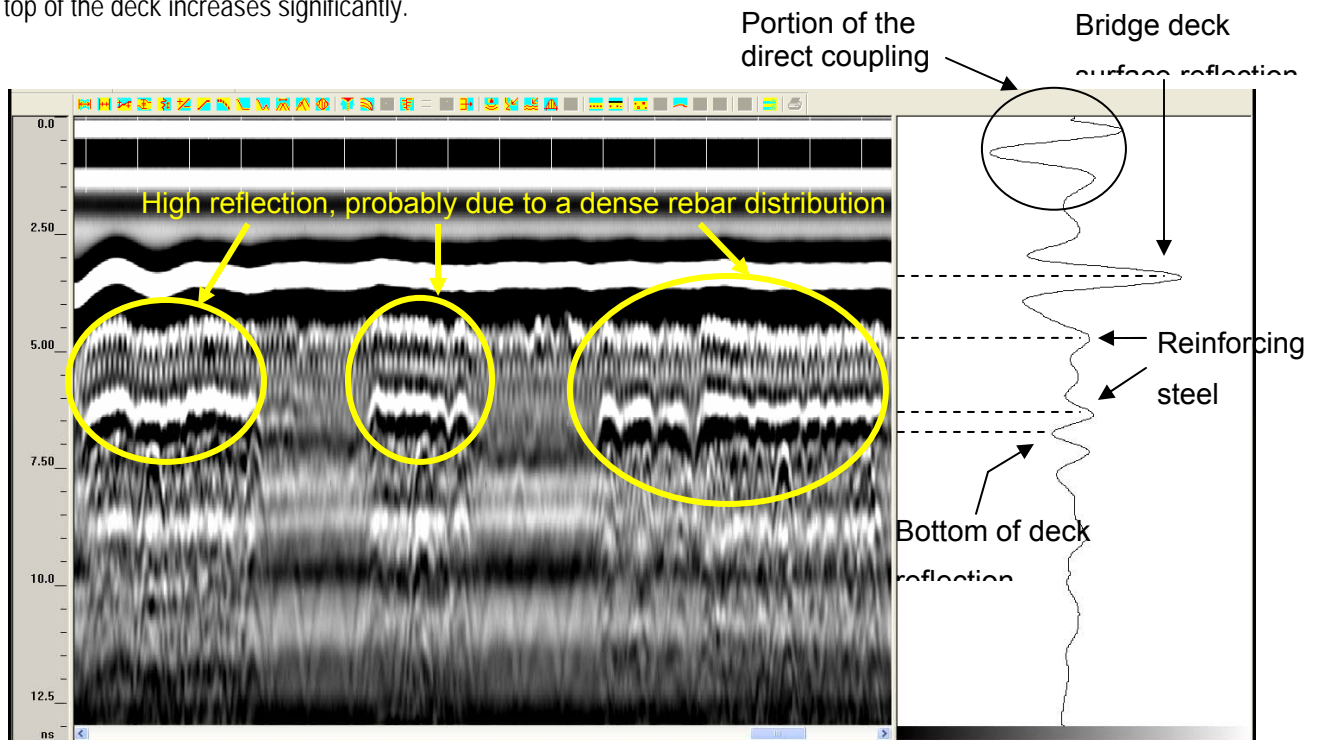
Figure 1. Raw data showing a GPR scan and a radar return waveform from Wyo. Proj.I-25-3(23) 144

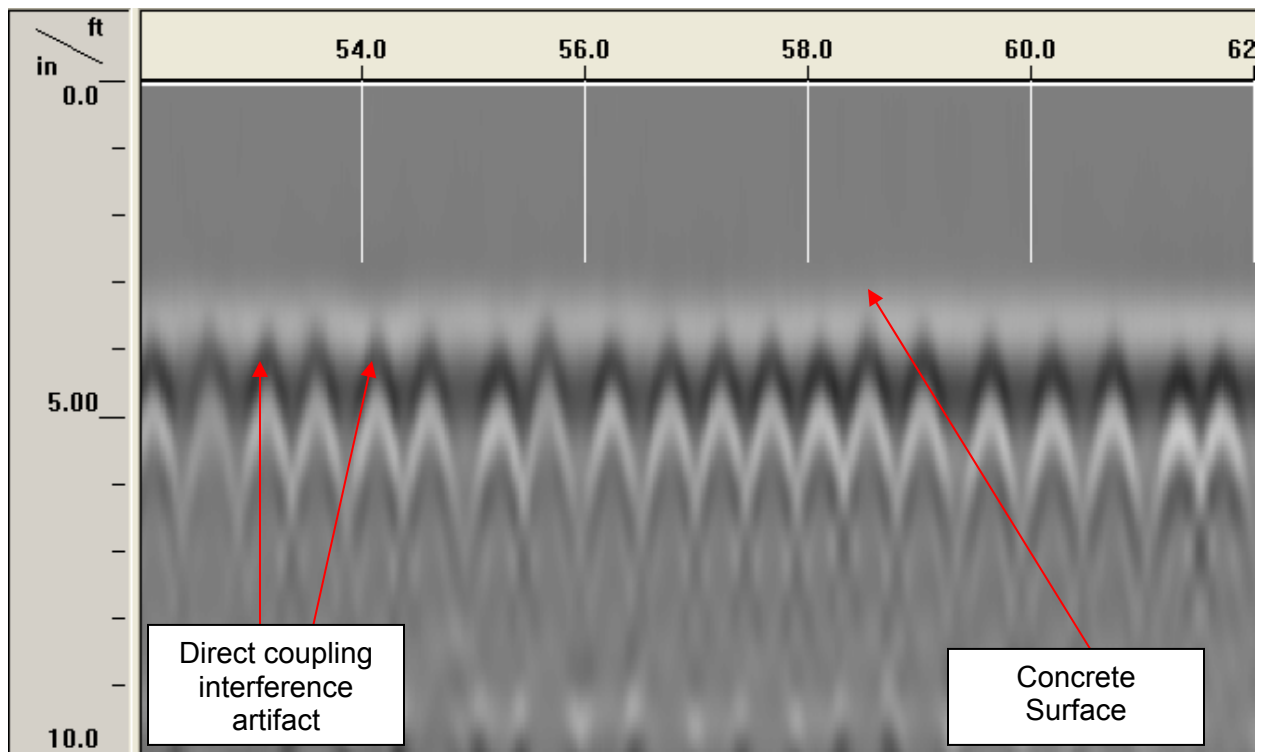
Figure 4 - GPR scan heading north 30 feet from the west end of the Douglas bridge deck. The displayed scan is indicating near surface rebar and direct coupling interference artifacts. The concrete surface is shown as nominally 3 inches down due to the chosen dielectric constant. Allowing for the surface to be visible in the data provides easier data interpretation in the field (rather than having all data start from zero in the given z-direction).

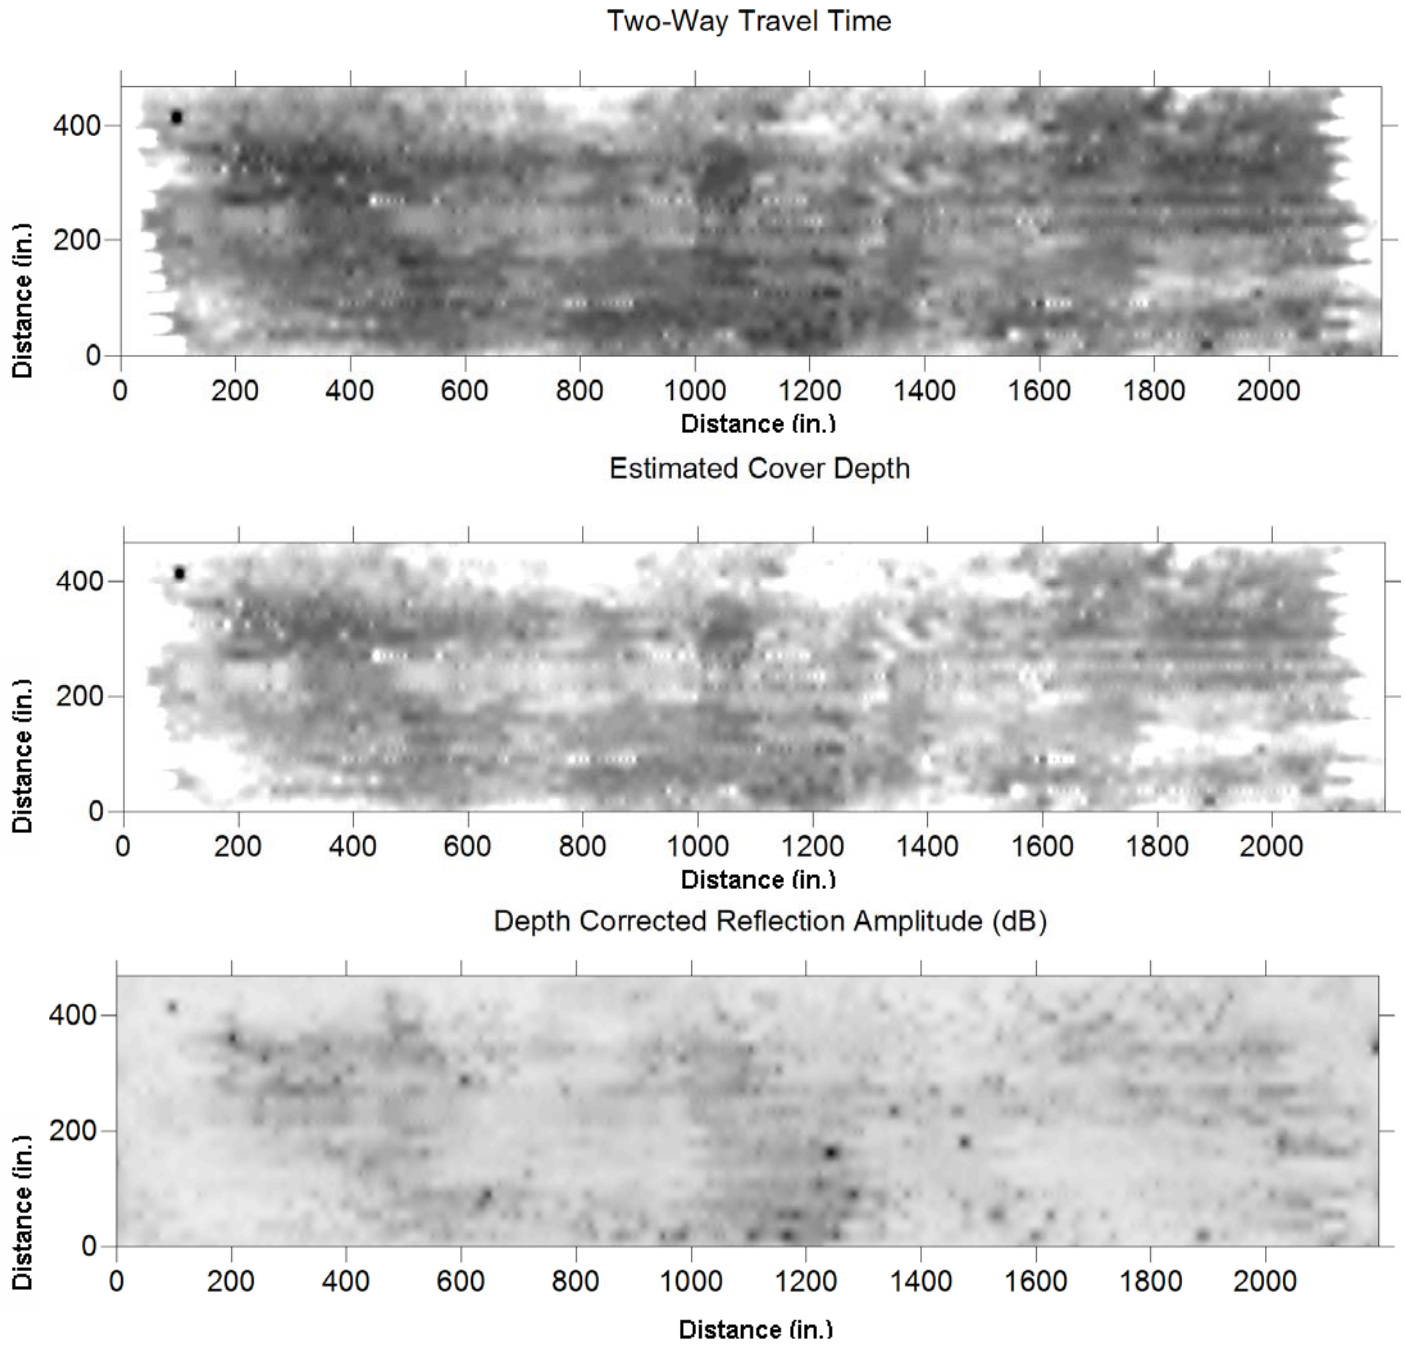
Figure 5 – Final results shown in Two-Way Travel Time, Estimated Cover Depth, and Depth Corrected Reflection Amplitude (dB). The correlation between all data is a direct effect of the direct coupling interference.

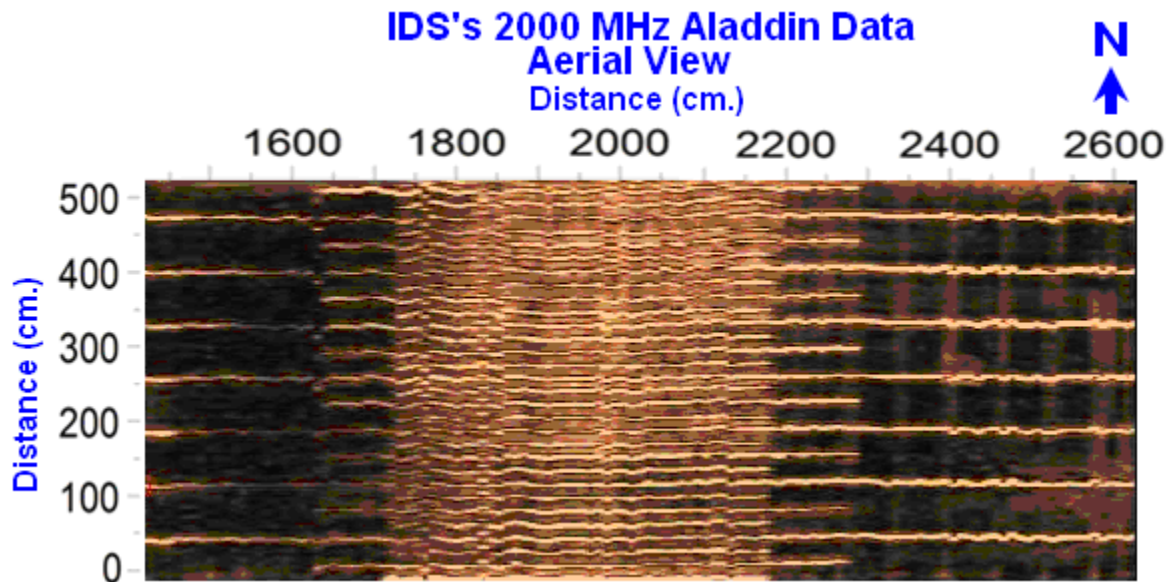
Figure 10 – Aerial view of Aladdin Data processed through IDS’s Georadar group. The light linear reflectors are the steel reinforcement within the slab. Some rebar appear squiggly due to the slight variations in scanned distances throughout the survey. There is also no clear attenuation existing within the middle of the survey where the bars appear to thin or disappear entirely within the tight rebar grid. Also notice the linear transversal bars on the east side of the survey. The ability to even detect this information with data collected in only one direction is a strong advantage for IDS’s full-polar 200MHz Aladdin antenna.

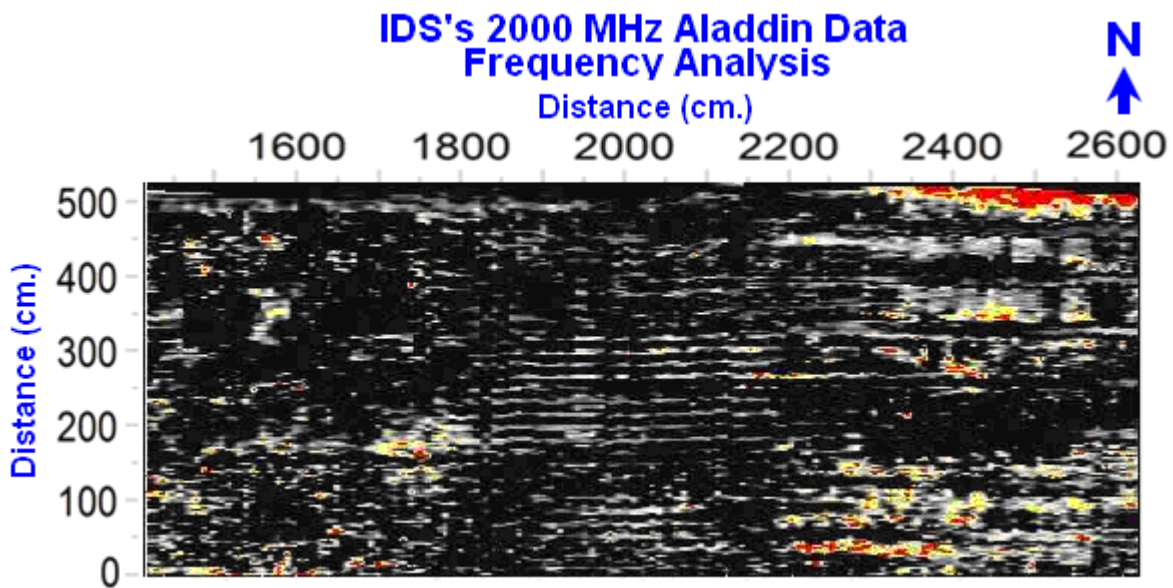
Figure 12 – IDS’s Georadar Group Frequency Analysis. The red areas are indications of high frequency reflections within the survey.

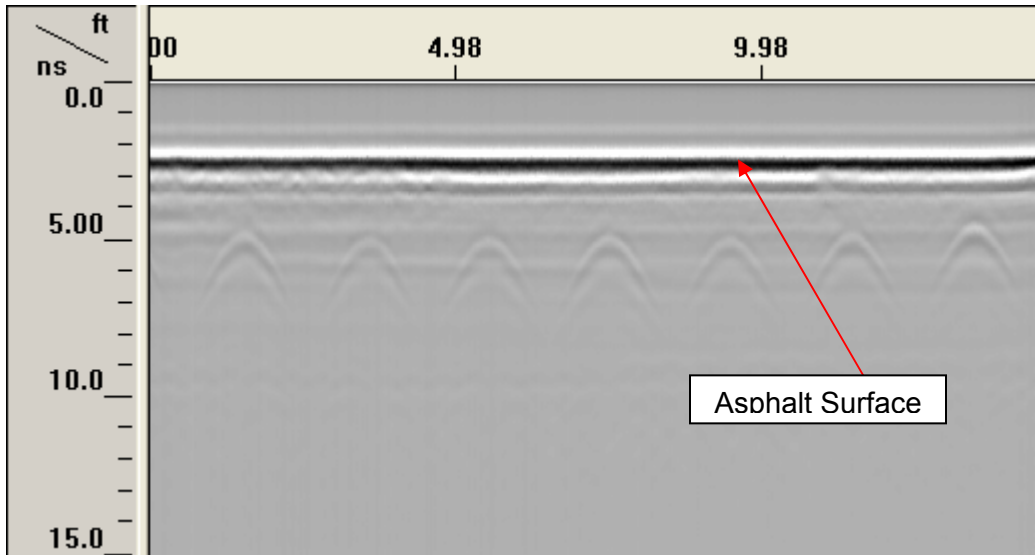
Figure 1 – IDS’s Aladdin GPR Data from initial testing before surface stripping. Notice the round hyperbolic signals for each steel reinforcement bar radar reflection.

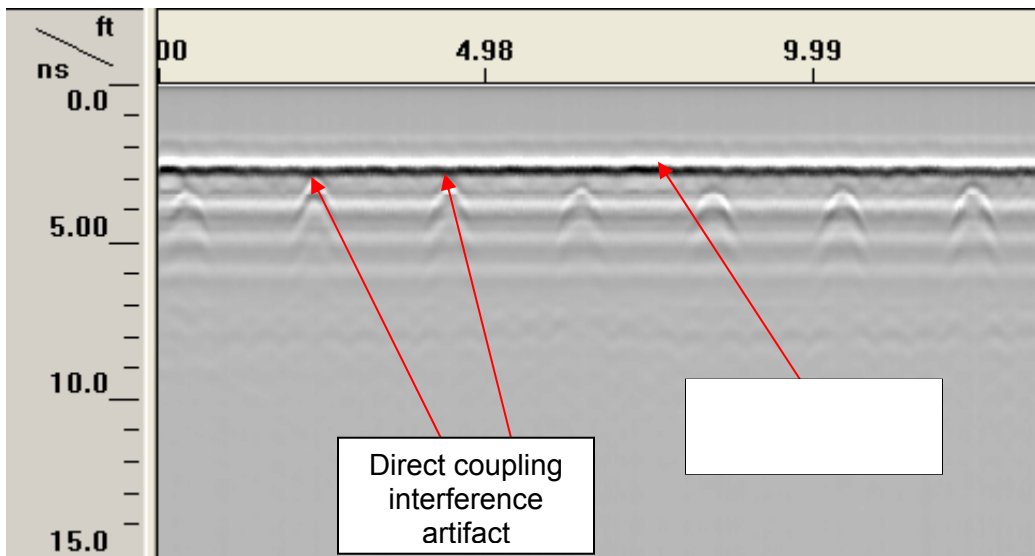
Figure 2 – IDS’s Aladdin GPR Data from final testing after surface stripping. Notice the direct coupling causes the steel reinforcement bar radar reflection signal to appear much sharper compared to Figure 1 and at a much shallower depth.

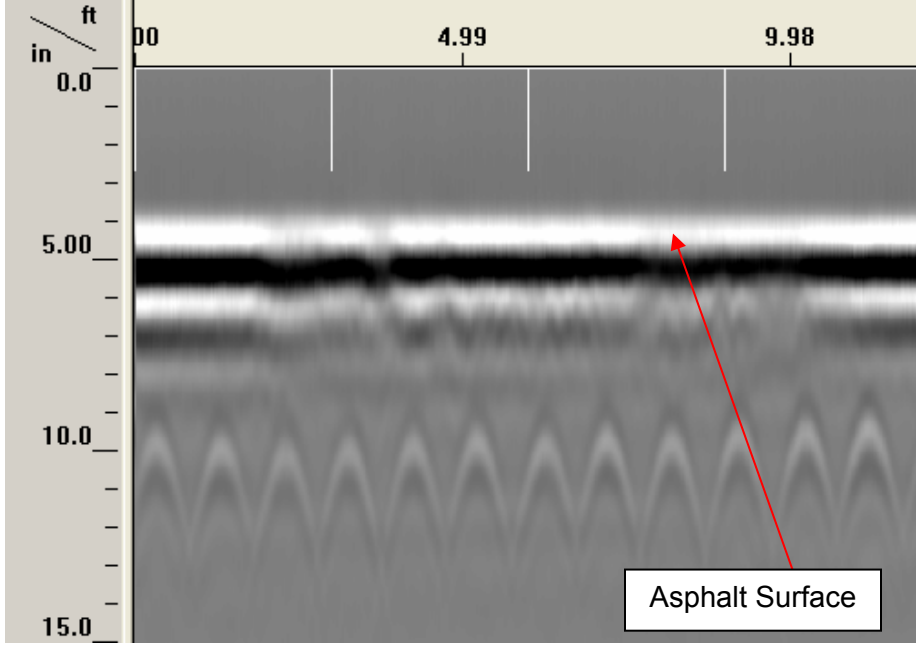
Figure 3 – 1600 MHz GPR Data from initial investigation of the asphalt overlaid deck before surface stripping. Notice the fading within the signal. This is most likely due to potential corrosion or delamination. This information in the data is most likely visible due to the lower frequency of the antenna in comparison to the 2000 MHz antenna.

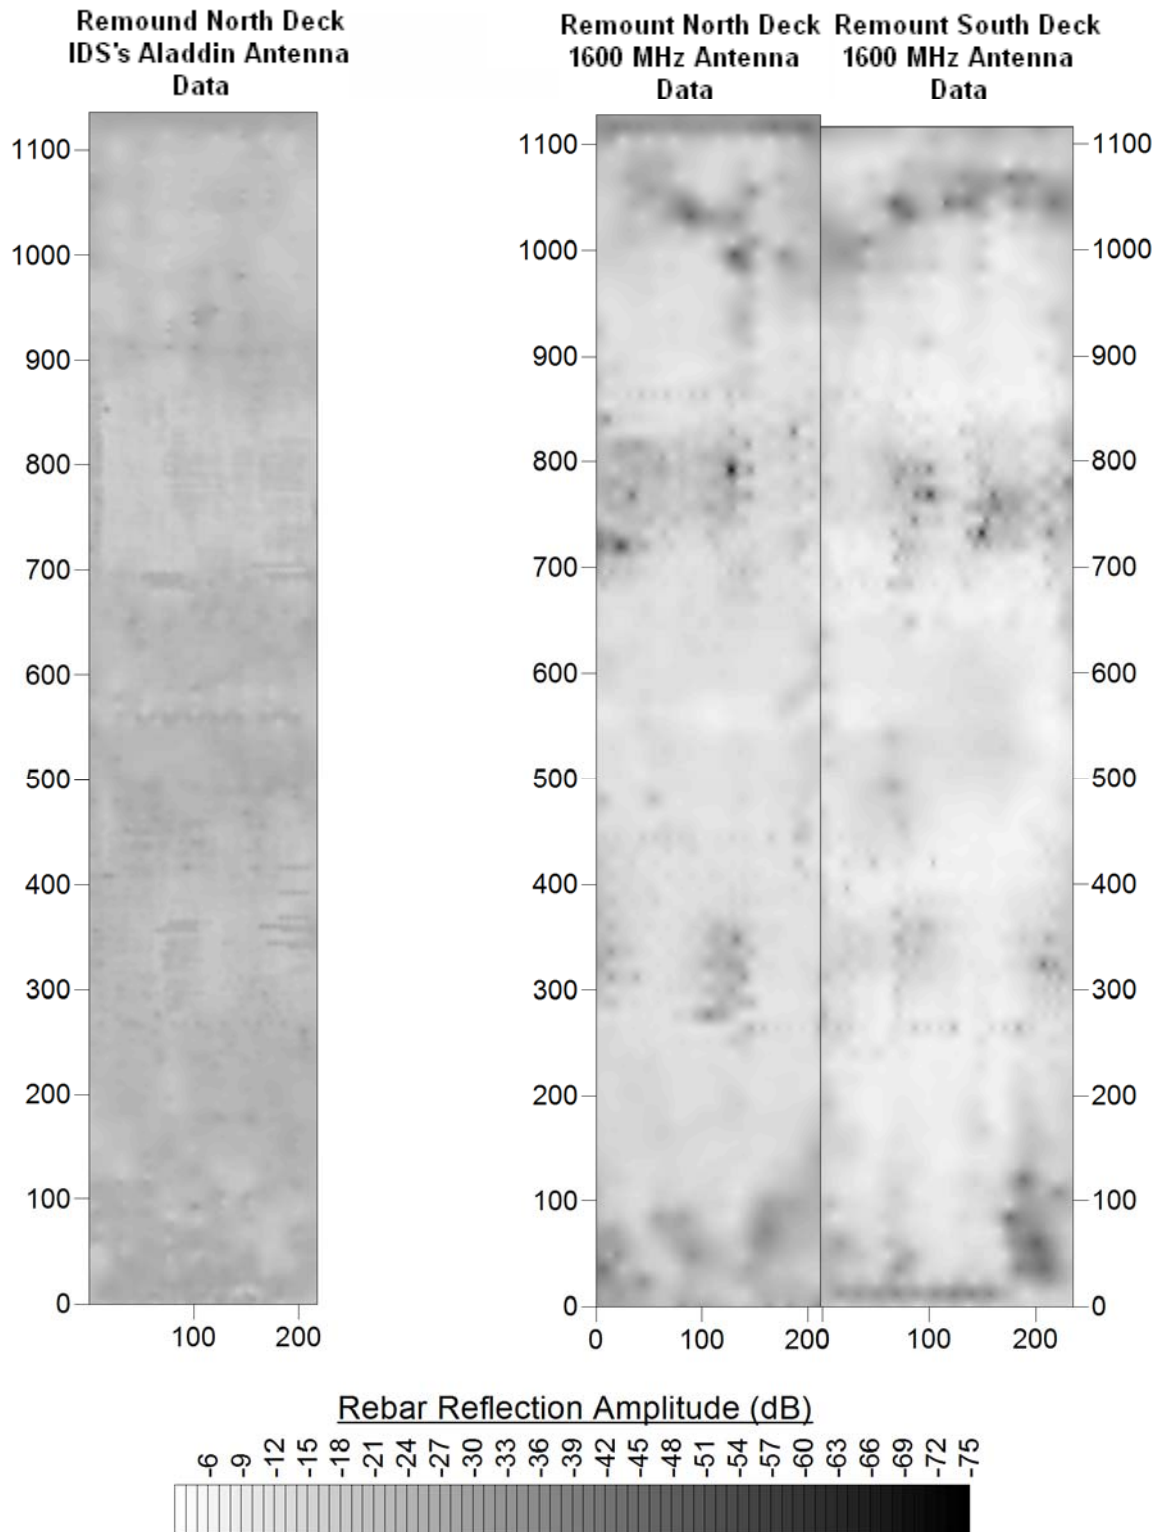
Figure 9 – Final rebar reflection amplitude results for the return survey with the top asphalt overlay and 1 inch of the bridge deck removed using the full range of the 1600 MHz results (4-75 dB). Note the IDS North Deck data is used only for potential comparison with the originally collected data set (due to the direct coupling interference however, comparisons are difficult if not impossible to determine). All results are shown in Rebar Reflection Amplitude due to the inability (from direct coupling interference) to determine corrosion/delamination.
