DOT HS 813 223

April 2022

# Testing of Unattended Child Reminder Systems

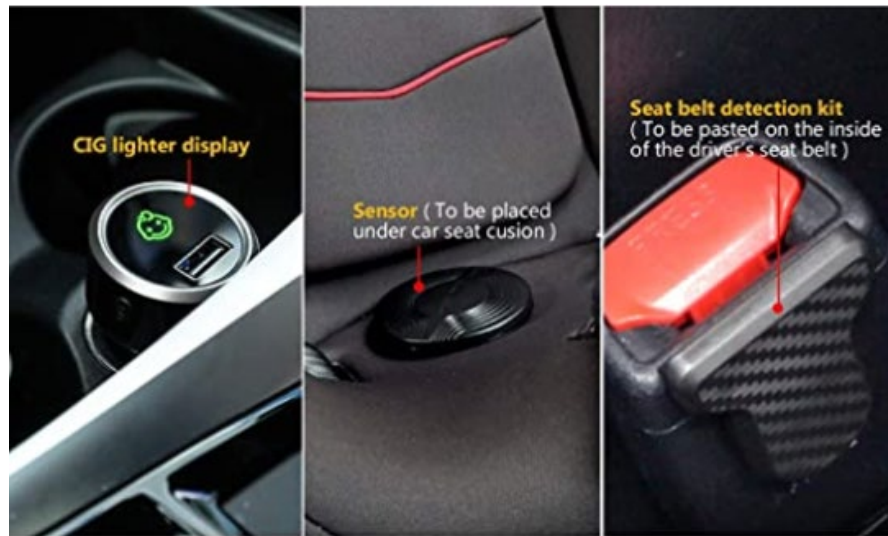
The system is installed by placing the pressure sensor pad under the CRS cushion or child and the seat belt detection clip on the driver seat belt buckle. Figure 8 shows the three sensors in the device along with the displayed LED light.

*Figure 8. Pressure Pad UCRS*

The pressure sensor system consists of a CRS pressure sensor pad, driver seat belt clip, and a cigarette (CIG) lighter display plugged into a cigarette lighter or 12-volt power socket. The pressure sensor pad and the seat belt clip communicate wirelessly via radio frequency with the CIG lighter display. All three devices include user-replaceable batteries.

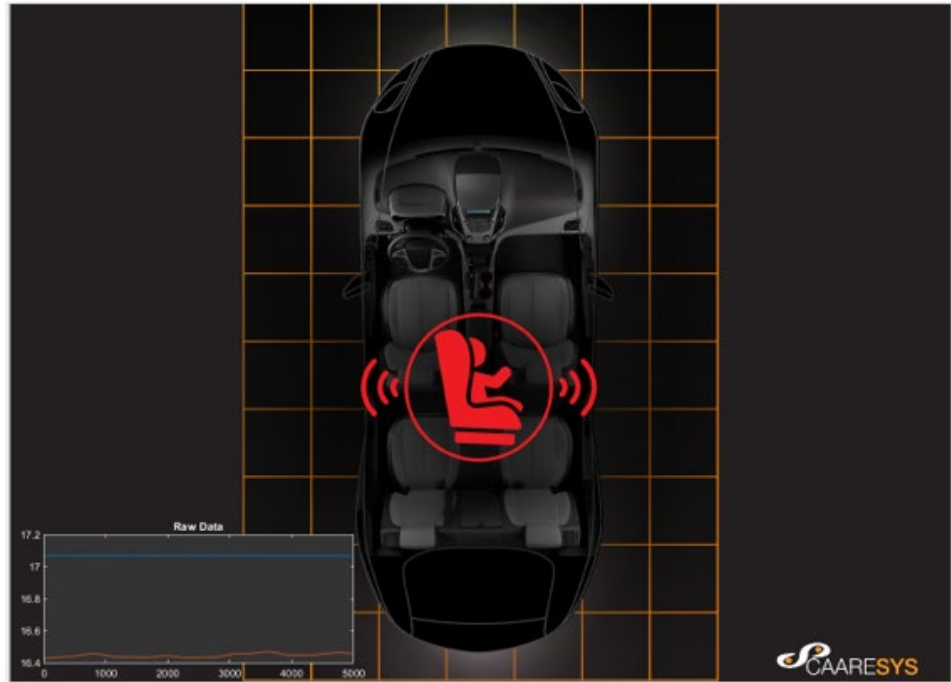
The radar-based system was developed and installed by the sensor manufacturer specifically for a 2011 Ford Explorer supplied by NHTSA. This system used a radar sensor to detect small movements throughout the vehicle, as small as breathing of a sleeping infant. The system alerts when 3 movements are detected within 5 minutes. To avoid false positives, after three consecutive detections of movement are observed, an alert goes off via a method chosen by the OEM (horn, lights, smartphone, laptop, or any other system to which it is connected). In the Ford Explorer used for testing the system, after three detections, an alert was displayed on a laptop connected to the system (Figure 12).

*Figure 12. Radar-Based System Alert on Laptop Display*

The radar sensor unit consisted of a Doppler-based motion radar sensor using a 24 gigahertz (GHz) transceiver together with transmit and receive antennae arrays. These are all integrated in a final package that is about 65 by 40 by 12 mm<sup>3</sup>, including the connector. The most suitable and recommended position to install the radar to get detection into the entire cabin was the center of the vehicle interior roof, although it could be tuned and installed at other locations and configurations. The system was installed in the 2011 Ford Explorer above the second-row seat in the middle of the bench (Figure 13). The radio frequency signal of the radar could penetrate through different vehicle materials, so no direct view between the radar and the moving subject was required.

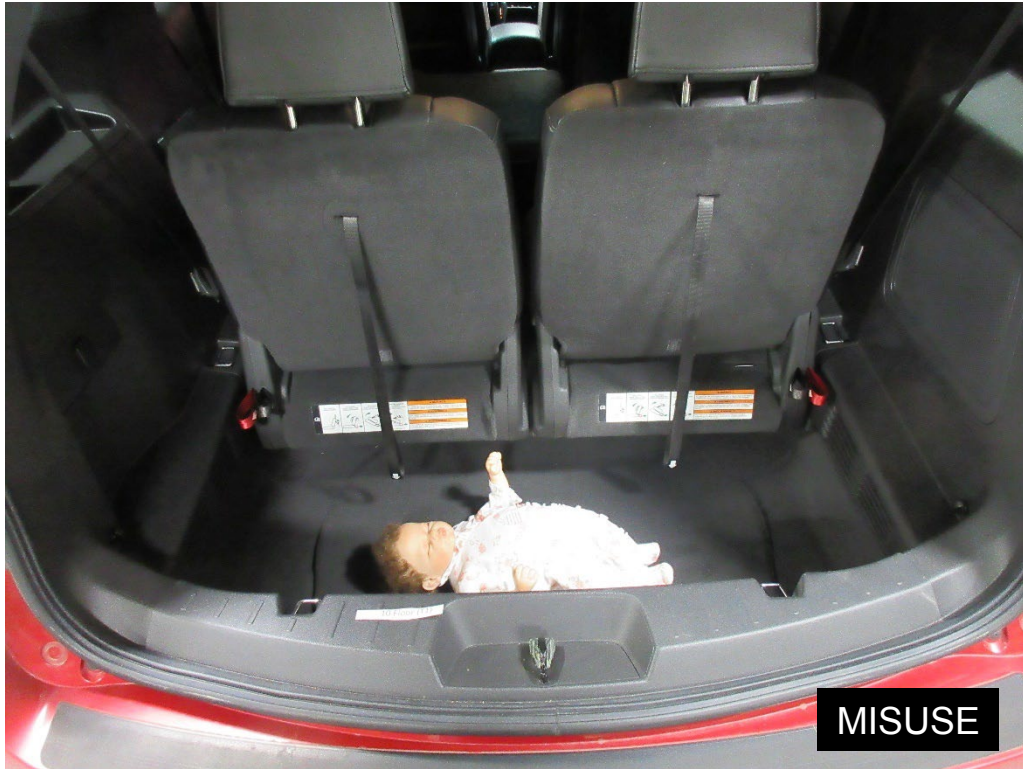
**Note:** The tests marked as “Misuse” are for testing the capabilities of the radar-based system to detect infants and small children under misuse conditions. Certain tested conditions can happen if a child gains unmonitored access to the vehicle.

*Figure C-9. Cargo Floor Test (See note on Page C7)*

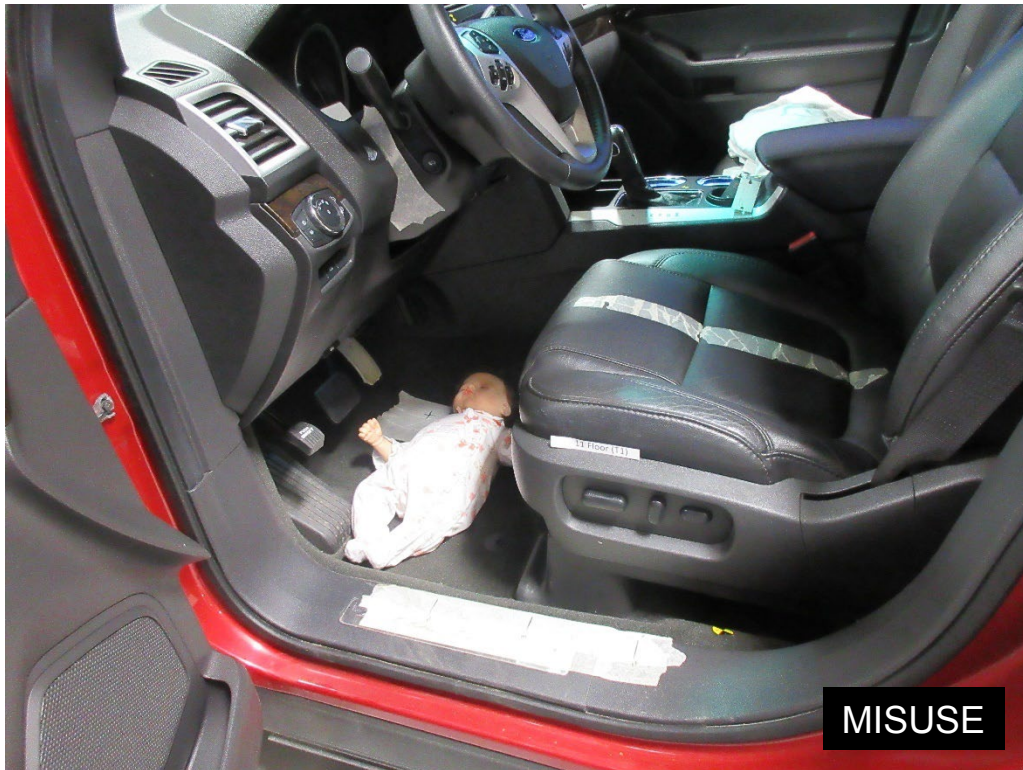
*Figure C-11. Driver Floor (See note on Page C7)*

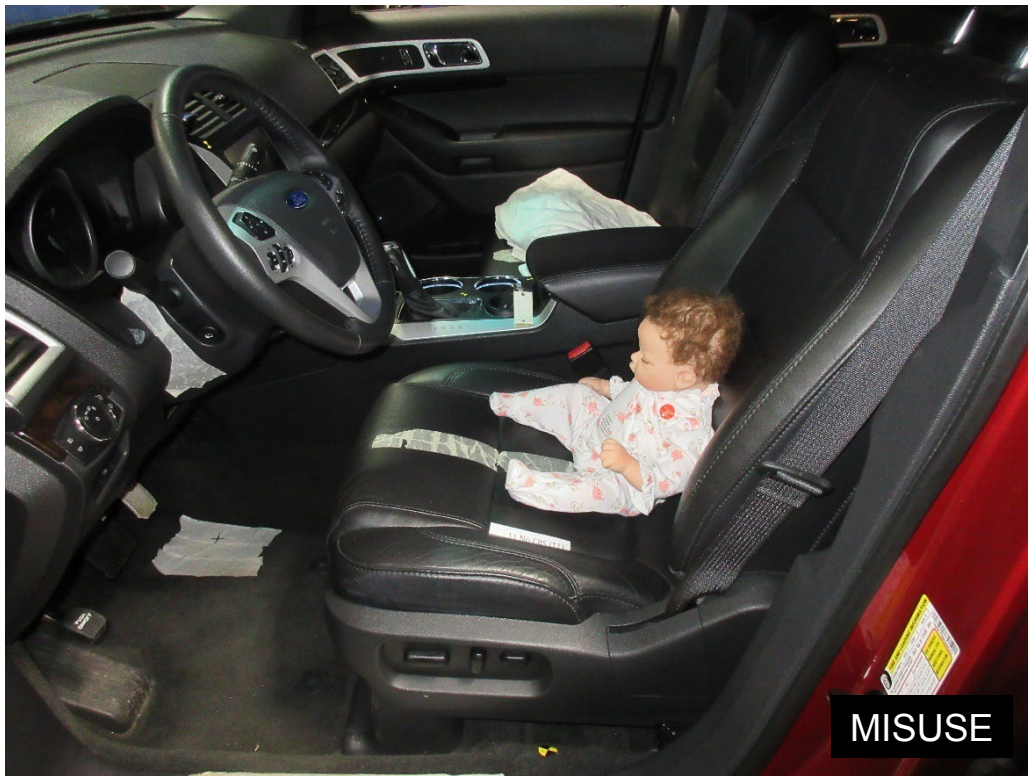
*Figure C-13. Driver Seat, No CRS (See note on Page C7)*

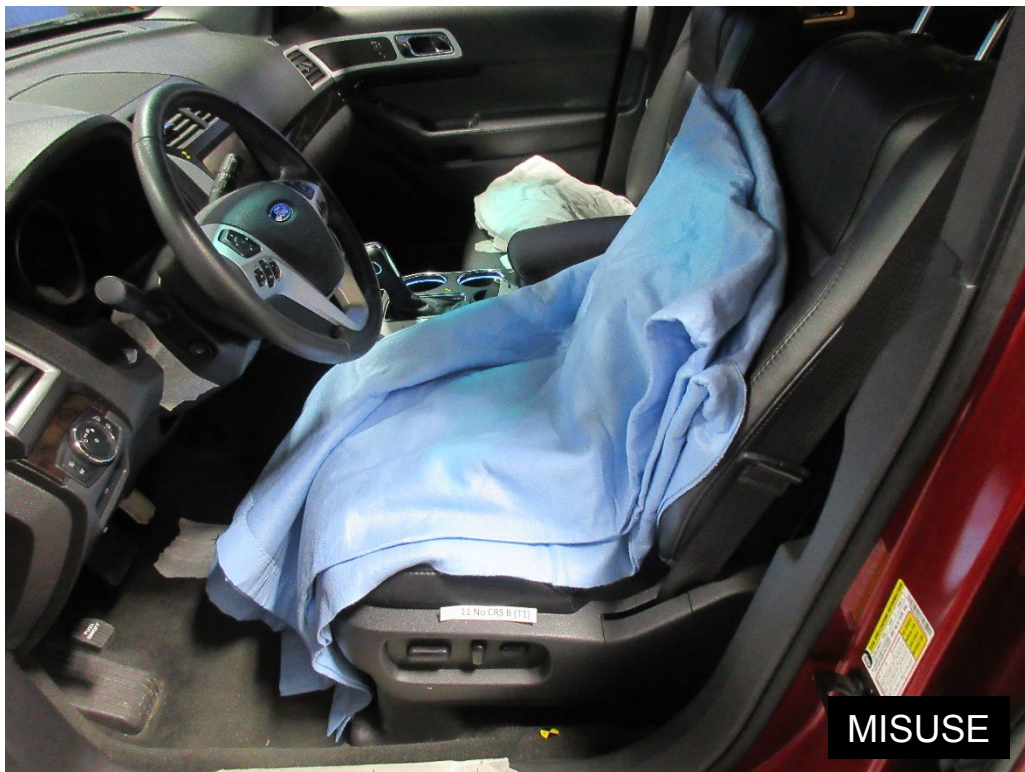
*Figure C-14. Driver Seat With Blanket but No CRS (See note on Page C7)*

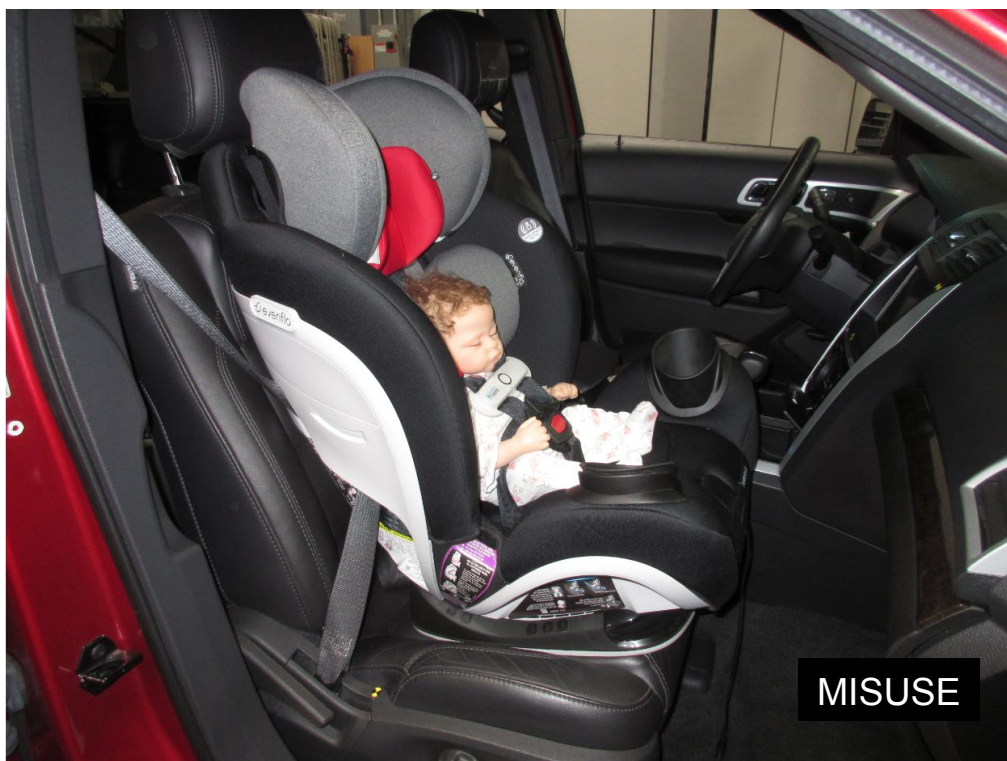
*Figure C-15. Front Passenger Forward-Facing CRS (See note on Page C7)*

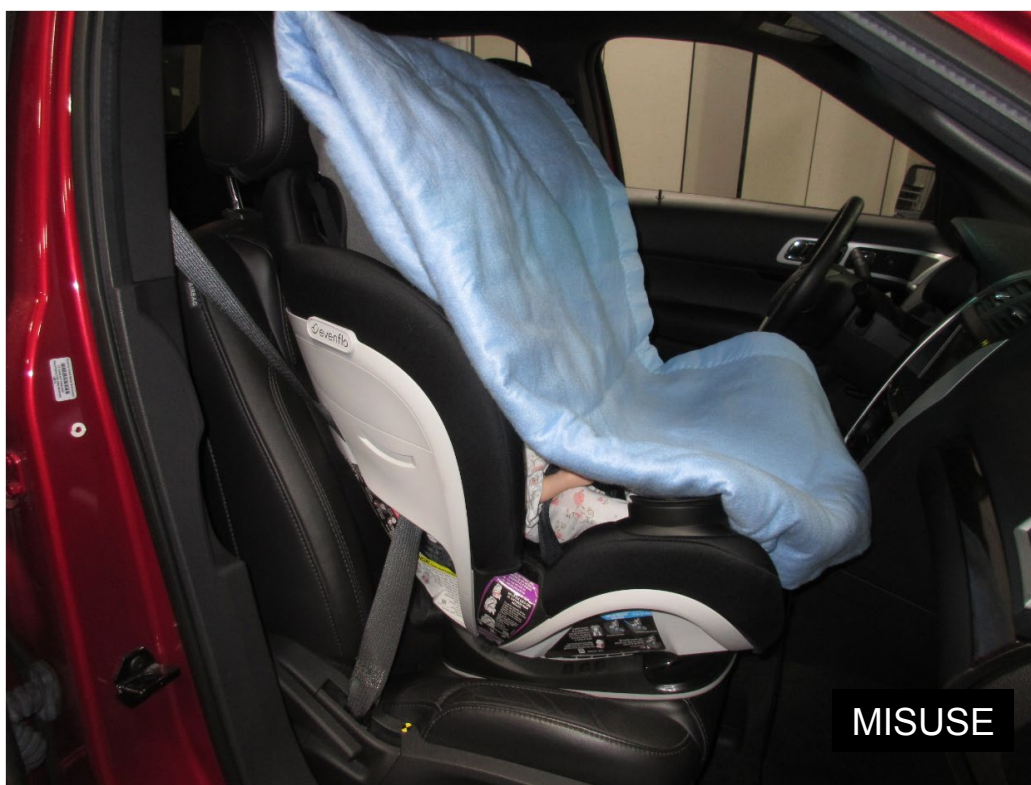
*Figure C-16 Front Passenger Forward-Facing CRS With Blanket (See note on Page C7)*

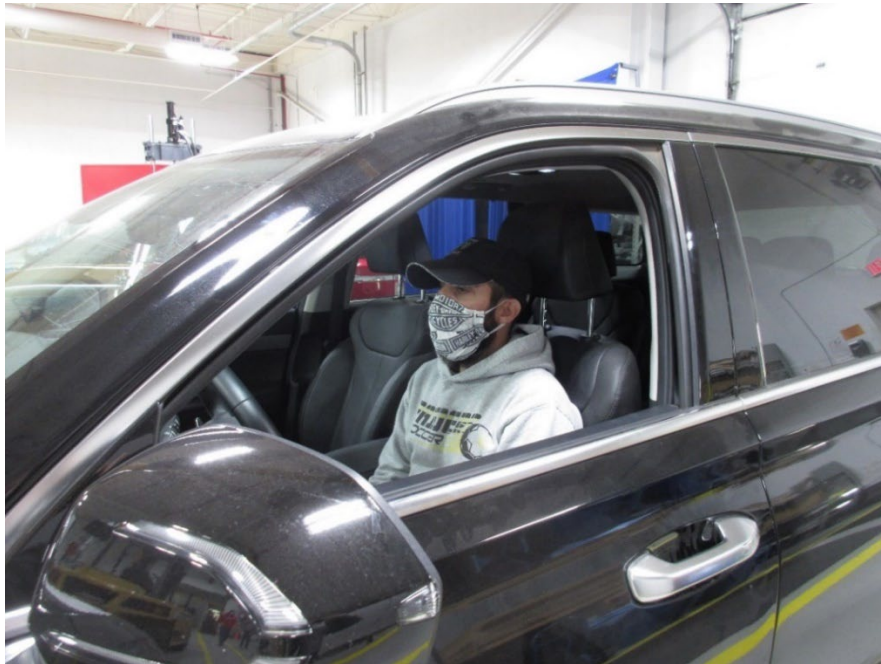
Conditions shown here represent a small adult seated in a vehicle seat and floor/cargo area, with arm movement, to test the door logic and occupant sensors. **All occupants should be properly seated and use seat belts.**

*Figure C-63. Driver Seat*
