NDOR Research Project Number SPR-PL-1 (038) P530

Long Term Monitoring of a Steel Bridge Constructed Using Phase Construction

Aaron J. Yakel
Paulo Marchon
Atorod Azizinamini

July, 2005

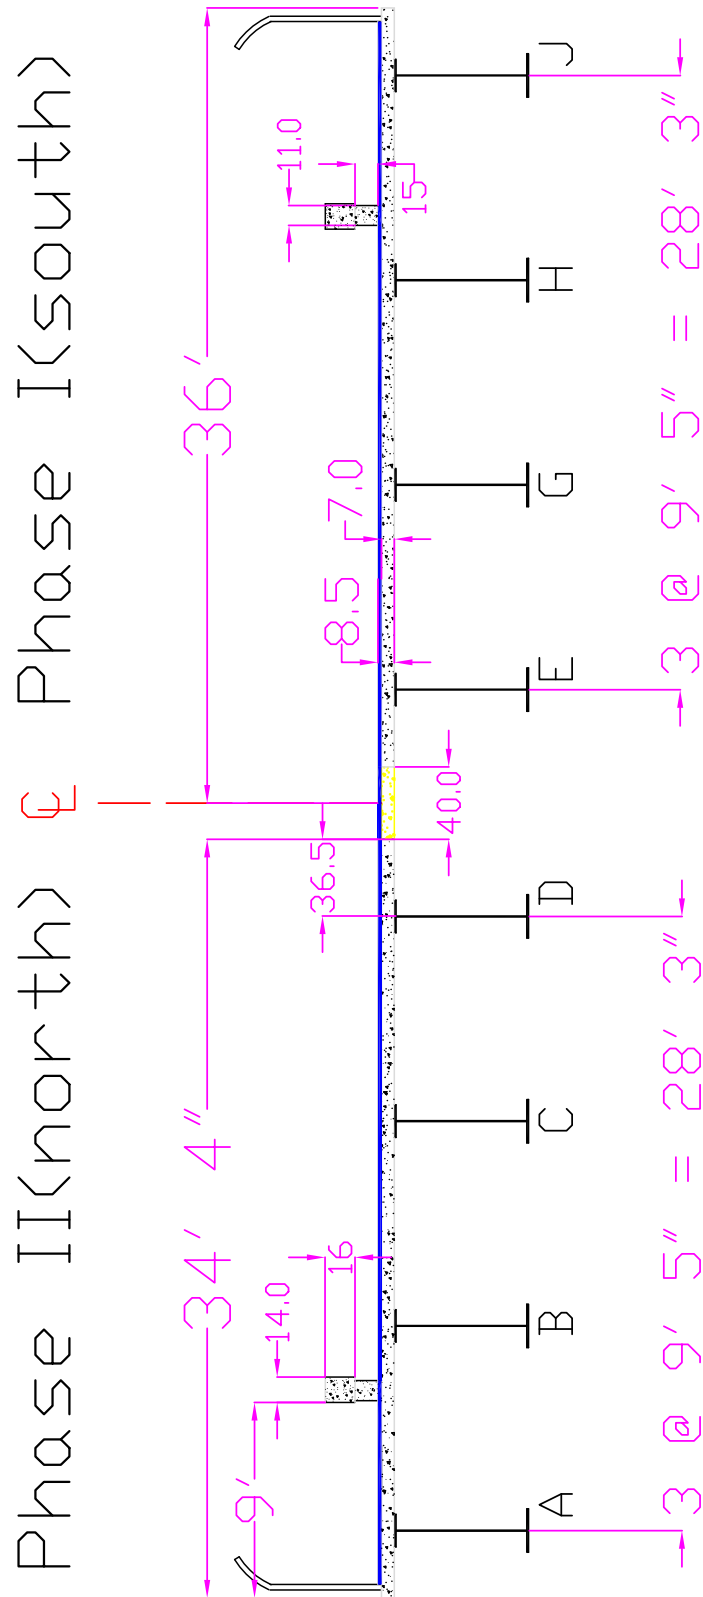
Figure 2-8: Completed bridge cross section. Note the phases are symmetric about the centerline. All dimensions are inches unless noted otherwise.

Once the overlay is complete, NDOR standard closed concrete rails are slip-formed on each side separating two 9 ft. sidewalks from 54 ft. of clear roadway. Figure 2-8 is a cross section of the completed bridge.

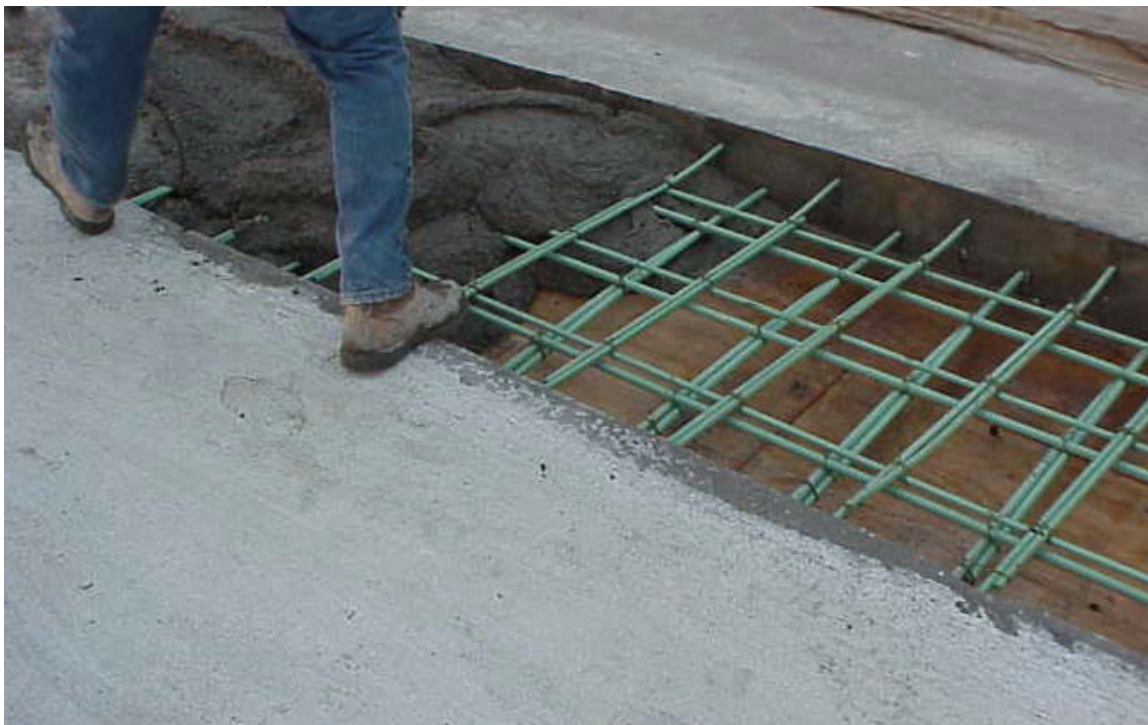
Figure 2-24: Closure pour

Concrete placement began 5:15am on May 6, 2000. Concrete trucks were not allowed on the bridge so concrete was either pumped or carted where it was needed with wheelbarrows. The closure pour was 40" wide and ran the entire bridge length. Pouring started at the East abutment and ended at the West abutment. The depth depended on the amount of differential elevation and was approximately the same as the Phase I and II decks, 7". Figure 2-24 shows the pour as it was being performed. The two decks from Phase I and II are clearly seen in the figure. Note transverse rebar tied together. This rebar consists of extensions of the rebar from the Phase I and II slabs to provide continuity. Longitudinal rebar was placed before the pour commenced. Figure 2-25 indicates the pouring direction.

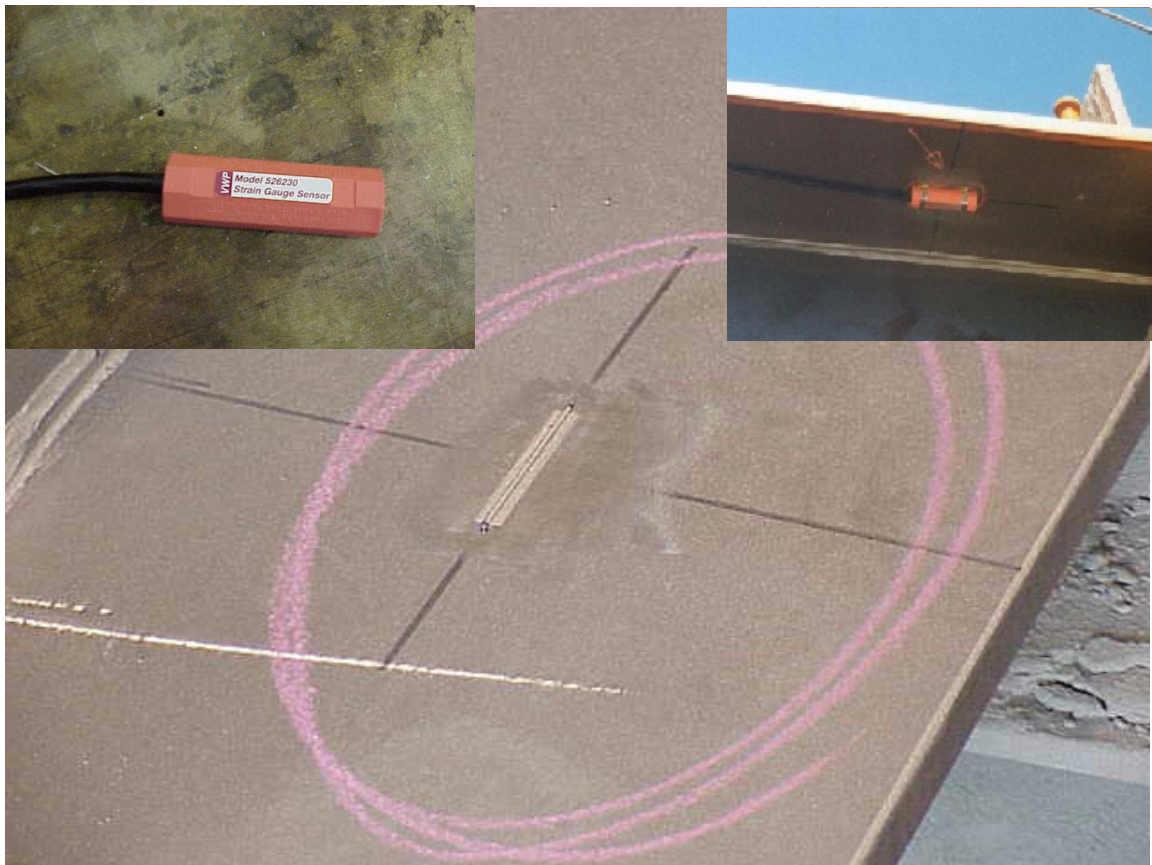
Figure 2-33: Steel strain gage and reader. Clockwise from upper left: reader, gage and reader in place, gage after being placed on reader.

Spot-Weldable Vibrating Wire(VW) sensors produced by Slope Indicator CO. of Bothell, WA were used to obtain data involving steel girder strain. The gauge consists of a steel wire held in tension inside a tube. The tube is mounted on a stainless steel flange, which is welded to a structural mem-

ber's surface using specialized equipment. Sensors placed over each gauge read the frequency at which the wire vibrates after the sensor plucks the wire. This frequency varies with the tension in the wire and can therefore be converted to a strain measurement. The reader also contains a thermistor that measures local temperature. An example of this gage can be seen in Figure 2-33. Vibrating wire gages were chosen for this project instead of typical electrical strain gages because of the monitoring duration. An electrical gage could not withstand constant excitation for over two years and reliable readings would be lost. Vibrating wire gages on the other hand have excellent long-term performance and can be expected to perform for many years.

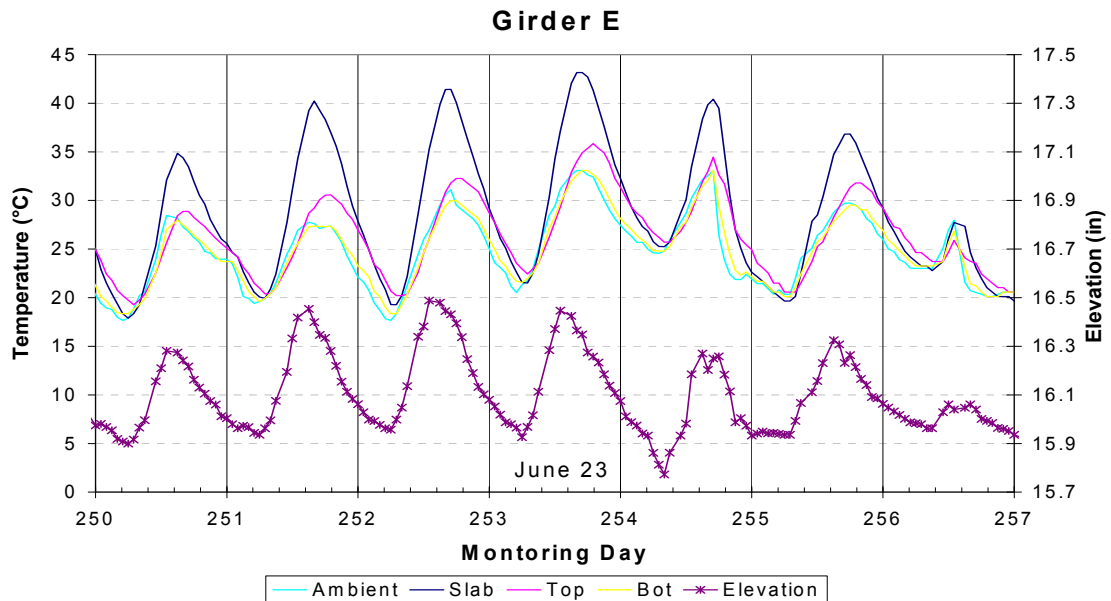
Figure 3-4: Vertical Movement due to daily temperature fluctuation

The temperature during a sunny summer day can be seen in Figure 3-4. The data in Figure 3-4 is from an interior girder taken around June 23, 2000. The numbers along the x-axis are the number of days since the beginning of the project with midnight falling on the whole numbers. It can be seen from the figure that the temperature in the slab can be a great deal higher than the temperature of the steel. This is due to solar heating. The temperature of the bottom flange follows very closely the ambient temperature. Further, due to conductive heating of the steel by the slab, the top flange temperature remains higher than the bottom flange. Finally, note that the temperature of the slab remains well above the temperature of the steel even into the morning hours. The entire system generally reaches a uniform temperature around 4:00 am.

It is of particular interest to observe the elevation of the girder at the time when the temperature is uniform over the depth of the girder. During the week presented in Figure 3-4 the early morning uniform temperature on most days was around 68° Fahrenheit. At that same time the elevation of the girder was around 15.95 inches. However, on the morning of the 24th the uniform temperature was found to be 9° higher at 77° F. On this day the elevation was at 15.75 inches. This demonstrates that as the uniform temperature increases the bridge deflects downwards.

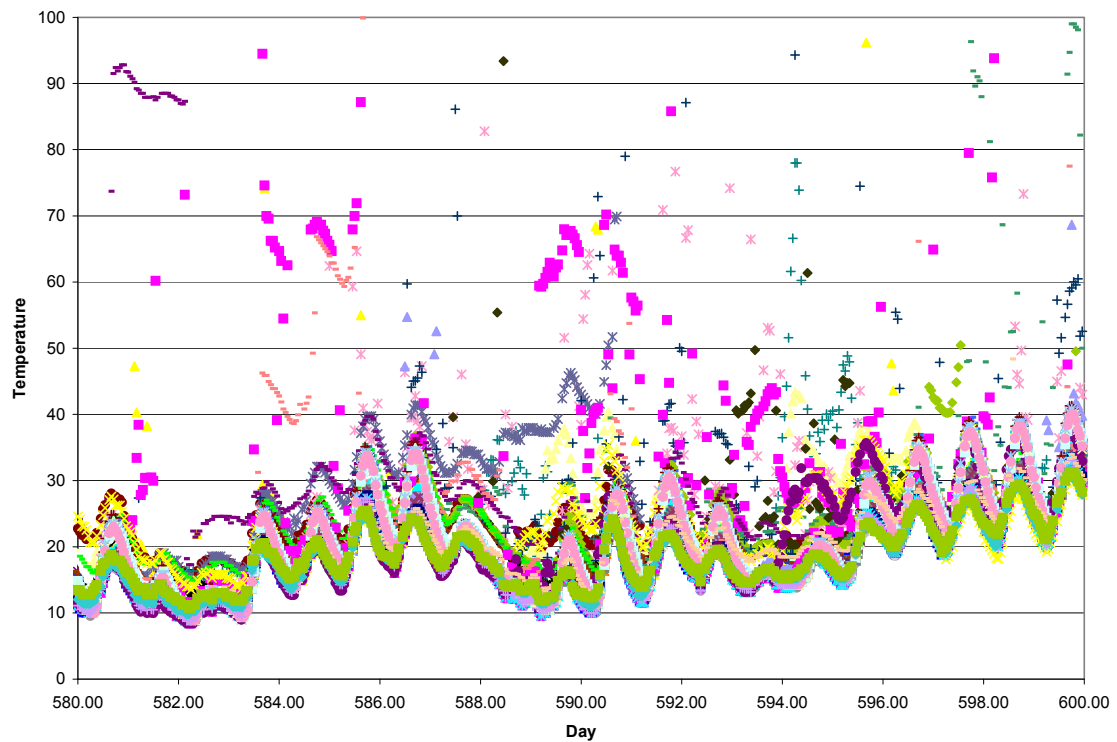
Figure 3-6: Raw Temperature Data

After completion of the second phase there were 75 sensors capable of indicating temperature however the results from each and every gage are not necessarily accurate. Looking at a two week period of time in Figure 3-6 one can see that the temperature data can be quite noisy. This noise can come from a number of sources including but not limited to communication problems, interference, faulty gages, loads and vibration, and moisture in the wiring.

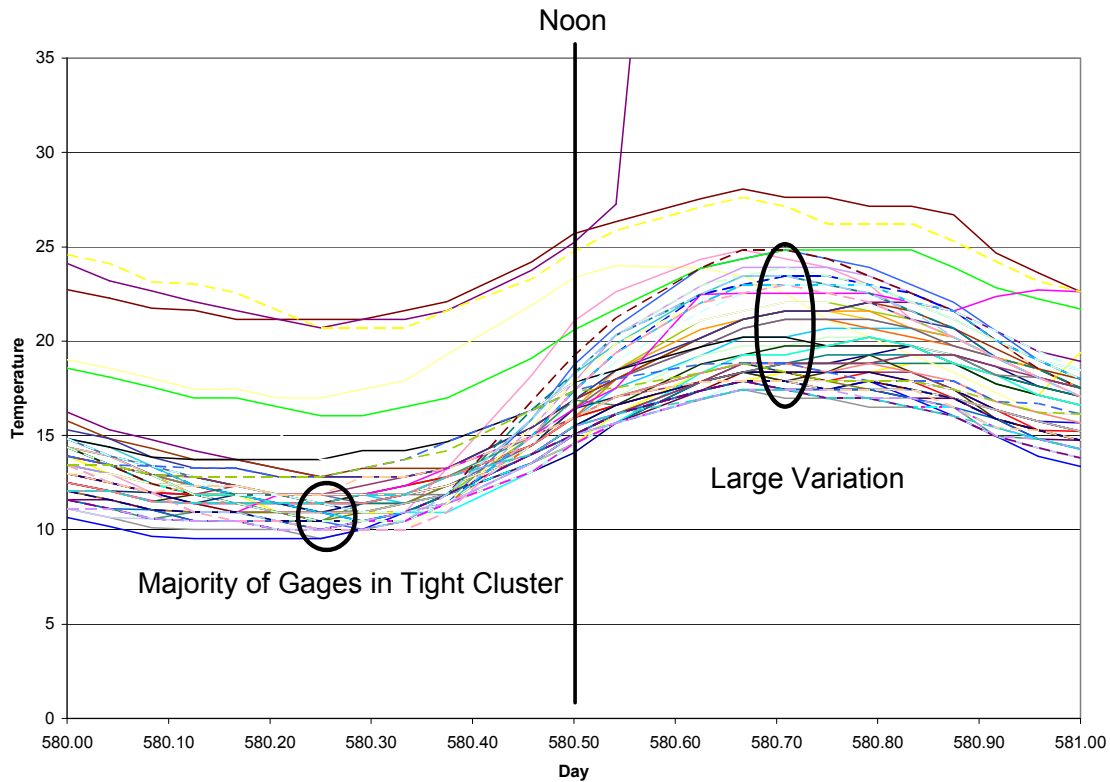
Figure 3-7: Variation in Temperature During Day

The first step in filtering the temperature data is to limit the time period used in the analysis. The time period chosen is from 4:00 am to 10:00 am resulting in seven readings for each day. The plots such as Figure 3-7 which shows all gages over a one day period indicate that the temperature is most stable during this period of time with the gages showing a small spread in values.
