# ***Louisiana Transportation Research Center***

Final Report 657

## **Cost-Effective Detection and Repair of Moisture Damage in Pavements**

5. Report No.  
**FHWA/LA.17/657**
6. Report Date  
December 2021
7. Performing Organization Code  
LTRC Project Number: 18-4P  
SIO Number: DOTLT1000241
8. Type of Report and Period Covered  
Final Report  
05/2018 – 05/2021

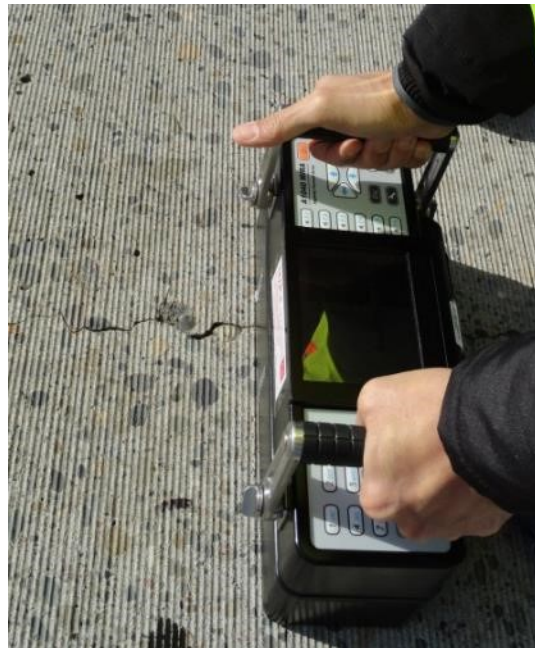
**Figure 15. MIRA tomographer**

**MIRA Tomography.** The MIRA tomographer, as shown in Figure 15, is a state-of-the-art instrument, which is capable of producing three dimensional (3-D) representations (tomogram) of flaws that are present inside a concrete structure [54, 55]. It does not require surface preparation as the subsurface condition of concrete elements can be investigated using an array of dry point contact (DPC) “touch and go” transducers. The antenna is composed of an array of DPC transducers and it sends low-frequency shear waves into the structure. Unlike traditional ultrasonic techniques, which generally produce one pair of waves per measurement, MIRA allows for 45 transmitting and receiving pair measurements in each approximately 1-second scan, which can achieve high productivity [56]. The received data are then used to create a 2-D image of the reflecting interfaces inside the concrete element. A proprietary software is used to assemble the stacks of 2-D images into a 3-D model of the test specimen. The test results can be interpreted by manipulating the generated 3-D image [55].

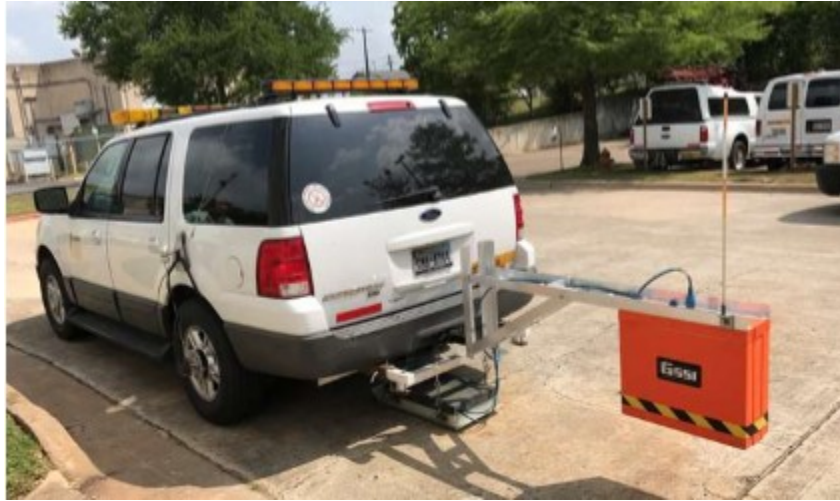
**Figure 16. Layout of a GPR system**

The equipment typically consists of a control unit, monitor, and two dipole bowtie (ground coupled) antennae operating at center frequencies of 900 MHz and 1.6 GHz. The setup can perform up to 16 scans per ft. at 10 mph, which results in a scan about every 1 in. The data are collected at the posted speed limit with a maximum of 55 mph, although the speed varies based on traffic and stops. A typical GPR acquisition setup is presented in Table 2.

GPR systems are generally available in two main types. In a ground-coupled GPR system, the antennas are in contact with the ground and when the antennas are not in contact with the ground, it is referred to as an air-coupled GPR system. Ground-coupled GPR systems are capable of producing clearer data as it can get more energy in to the ground and more energy out of it. However, ground-coupled GPR system is limited by the interference between the direct-coupling and ground reflection, which affects the usefulness of the data at shallow depth. Air-coupled GPR provides a faster mean of data collection without damaging the antennas since these are usually mounted on a vehicle. In addition, the direct-coupling between the antennas is separated from the ground reflection, which provides better quality of the data at shallow depth. The SIR-30 is an advanced high-performance multi-channel radar control unit that offers advanced filters and display capabilities for real-time processing, including migration, surface positioning, signal floor tracking, and adaptive background removal, see Figure 16 [61].

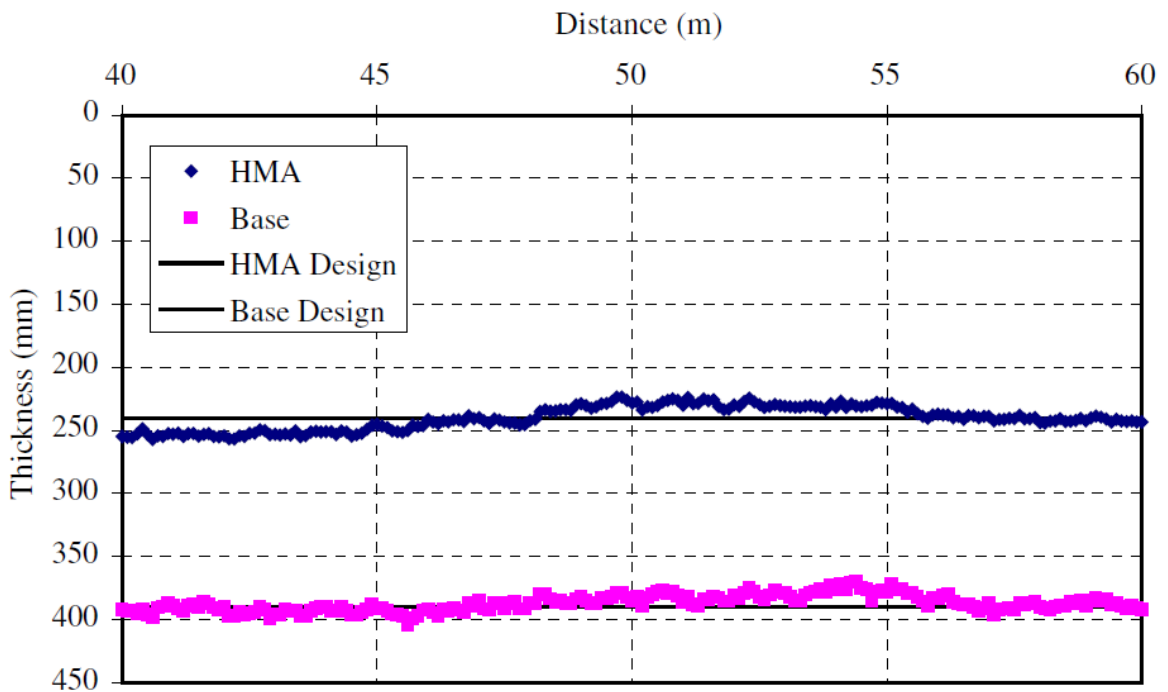
**Figure 19. Comparison between GPR estimated thicknesses and design thicknesses for the HMA and base layers of Route 288 [57]**

Al-Qadi and Lahouar used a GPR system to estimate pavement layer thicknesses and presented the limitations of the system using field tests. The results indicated GPR to be a reliable tool to estimate pavement thickness (see Figure 20). However, the accuracy of GPR was observed to decrease where at least one thin layer existed in the pavement structure. The authors recommended using signal processing techniques to minimize errors in pavements with thin layers [57].

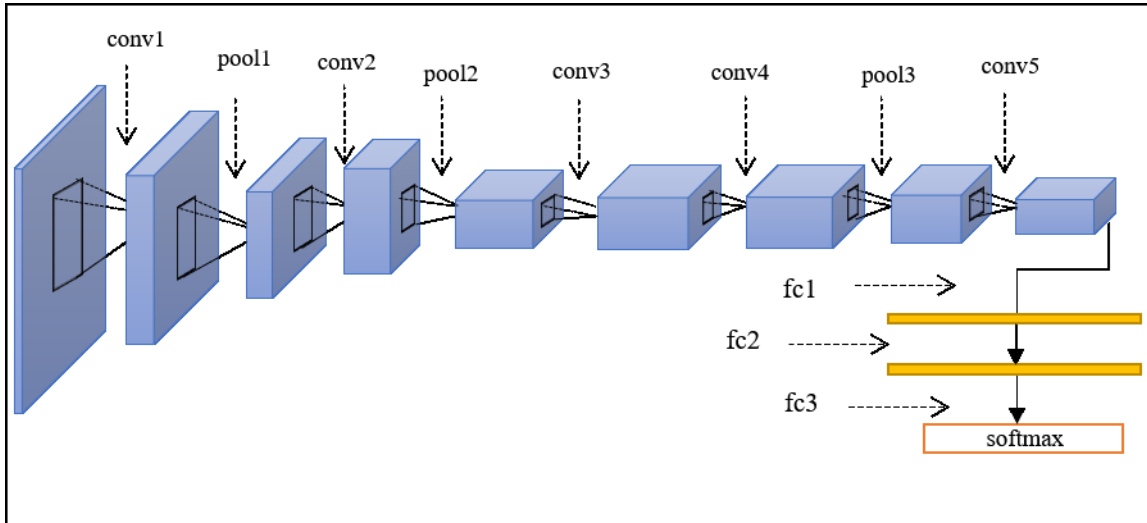
Figure 32. CNN's overall architecture [43]

*conv# = convolution, pool# = pooling, fc# = full connection*

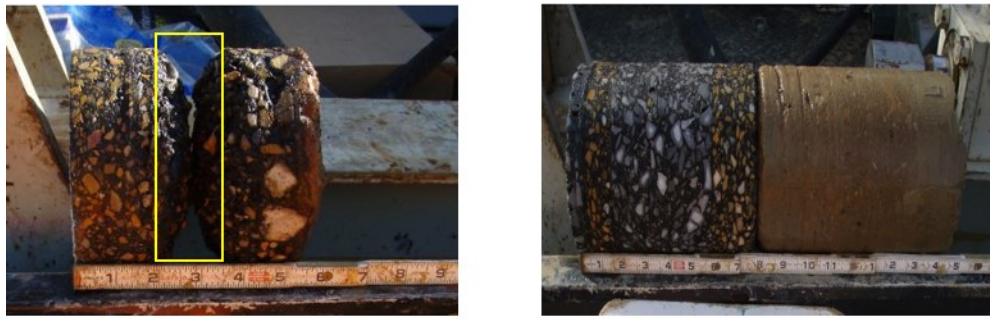
**Figure 36. Cores inspection to identify AC stripping in the underlying layers**

**(a) Stripped cores**

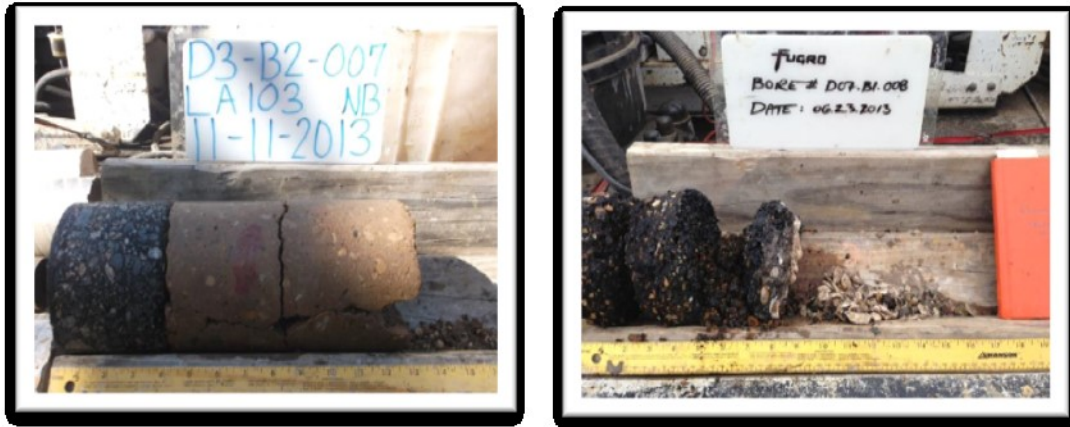
Figure 49. Examples of core data extracted by DOTD

(a) Non-stripped pavement

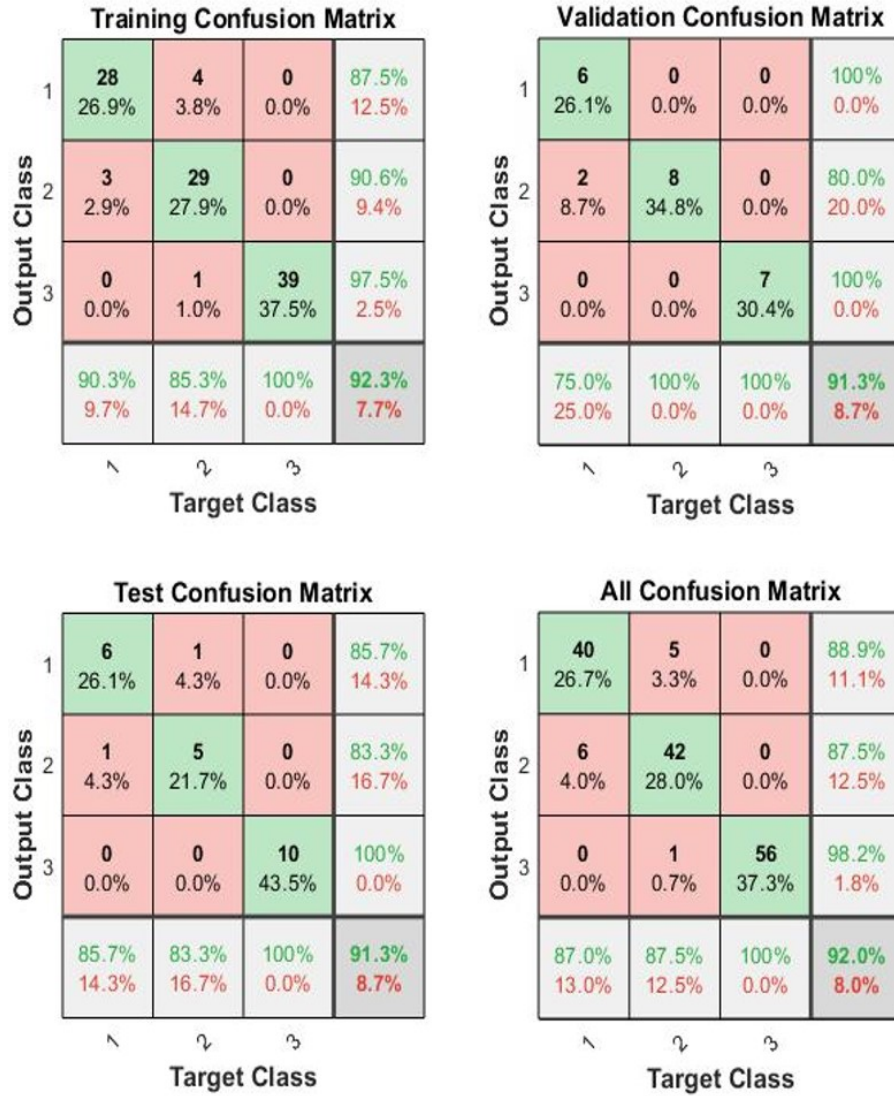
Figure 58. Confusion matrices for the pattern recognition system for training, validation, and testing for ANN model

Where, 1 = bottom up cracking, 2 = cement treated reflective cracking, and 3 = top down cracking

A computational tool available in MATLAB 2019a was used to process all the data and to develop the ANN decision-making tool. The input data corresponding to 150 pavement images used in the ANN model were collected from the Louisiana PMS. The data were then divided into 70%, 15%, and 15% for training, validation, and testing, respectively. Data overfitting was avoided by halting the training process when the validation set error stopped decreasing. The testing data were used to provide independent measure of the network performance as it had no effect on the training. Figure 58 presents the confusion matrices for training, validation, testing, and overall step for the pattern recognition system. As shown in the figure, the ANN tool achieved an accuracy of 91.3% in the testing and validation sets. The confusion matrices showed an overall prediction accuracy of 92% indicating the effectiveness of the ANN model to predict the correct crack types in the evaluation process.

The generalization ability of the overall network was enhanced and overfitting was avoided by halting the training as there was no observed decrease in the validation set error as shown in Figure 59. The matrices present  $N_{ij}$  with corresponding percentage, precision of every decision, and overall accuracy. The testing data set was used to provide an independent measure of the network performance. The network training time was found to be 4.2 seconds.
