Truck Routing Issues

Report Number: KTC-17-20/SPR17-534-1F

Research Report
KTC-17-20/SPR17-534-1F

September 2017

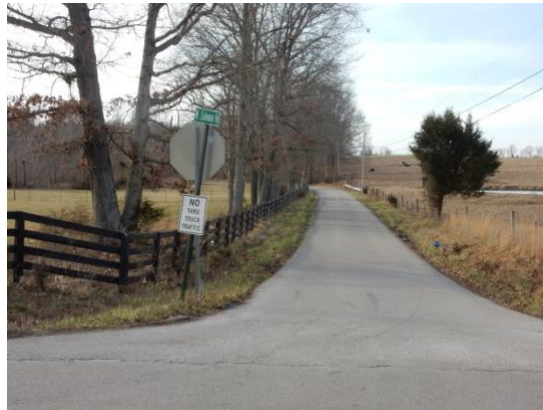
- **Intersection of KY 39 and Coleman Road in Pulaski County:** A fatal crash occurred at this intersection when a car traveled under the side of a trailer stopped across its lane of travel. The truck was stopped after the rear tandem wheels of the combination truck became stuck in a ditch when the driver attempted to turn left from Coleman Road onto KY 39. The crash occurred when it was dark. The truck driver said he was following GPS directions which led him onto the county road. An inspection of the accident site found that the county had placed “No Thru Truck Traffic” signs at both ends of the county road.

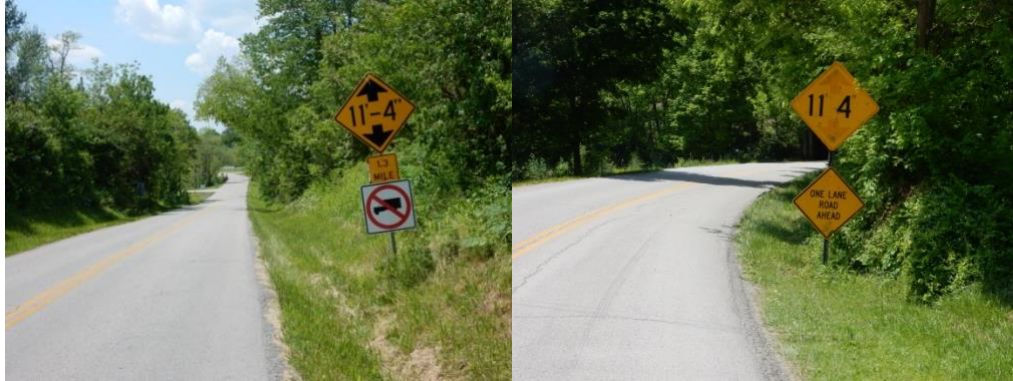
- **KY 1983 in Madison County:** A truck impacted a railroad underpass resulting in major damage to the structure. The driver stated he obtained his route from a “store bought” GPS. The driver stated that he realized the route was inappropriate for his truck but could not locate a place to turn around and did not notice the low clearance signs in advance of the underpass. The road also had a “No Trucks” sign at the intersection with US 25. This road has a Class A weight rating.

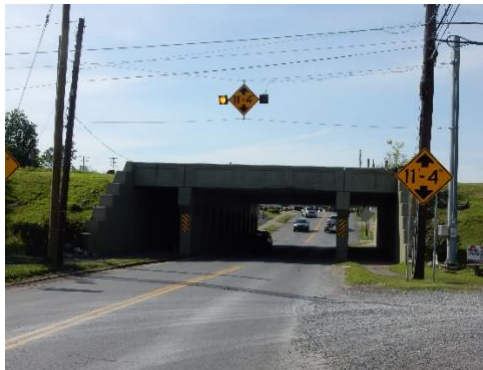
- **KY 1031 in Central City:** A truck driver stated he was following his GPS directions and did not observe the low clearance warning signs prior to his truck impacting a railroad underpass. This structure has been impacted several times. There are several low clearance warning signs both in advance and at the underpass (with flashing beacons at the structure).

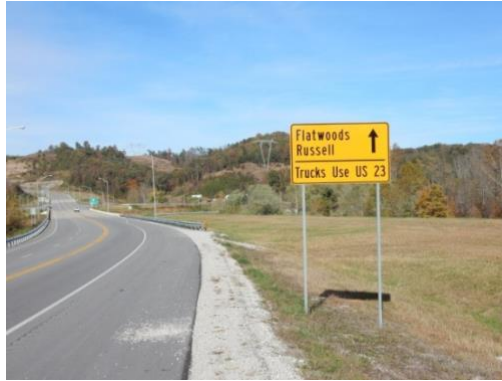
- **Third Street in Louisville:** A truck driver stated he was following his GPS directions and misjudged the clearance on the railroad underpass. There are several warning signs in advance of the underpass (including a variable message sign that warns drivers when an over-height truck is detected).
- **KY 207 in Greenup County:** A combination truck traveled into a ditch in a sharp curve. The driver stated he was following his GPS directions to an industry. Signs are located on US 23 prior to the location where truck drivers would turn onto KY 207 that direct truck drivers to use US 23 to their destination. Although KY 207 has an AAA weight rating, the roadway geometrics are not appropriate for large trucks.

- **Third Street in Louisville:** After a series of crashes in which truck drivers following GPS directions impacted a low clearance overpass, an active warning sign was installed to provide additional warning of the bridge clearance. Other warning signs are also installed.

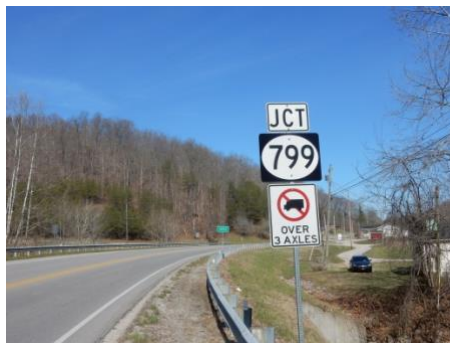
- KY 799 in Rowan County:** In two crashes at the same series of curves, a truck driver was unable to negotiate the curves and veered off the travel lanes. In both instances the driver said he was following his GPS directions. One police report narrative stated that the truck was on a road not permissible for its vehicle type. The other report noted that the driver did not observe the regulatory sign prohibiting trucks with more than three axles. One of the drivers stated that his GPS began to reroute him just prior to his crash. This road has a Class A weight rating, so in both instances the loaded tractor trailer would have been overweight.

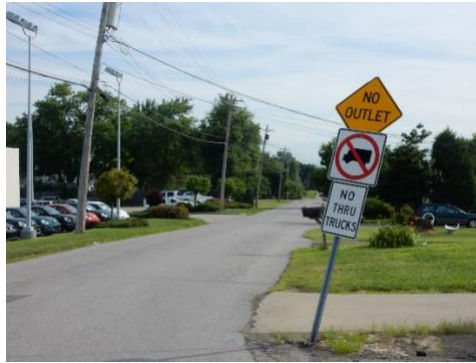
- **Greenview Road in Boone County:** A GPS routed a driver on a road where the driver observed a “No Truck” sign. The truck damaged property when the driver attempted to turn around.

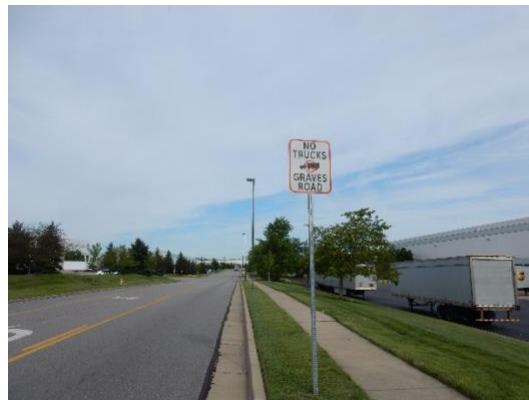
- **Gum Springs Road in McCracken County:** A truck driver followed his GPS directions down a narrow and curvy county road. The truck could not negotiate a sharp curve.
- **Graves Road in Boone County:** A truck driver was following GPS directions, leading him onto a road that had signs prohibiting combination trucks. The trailer off-tracked into a culvert.

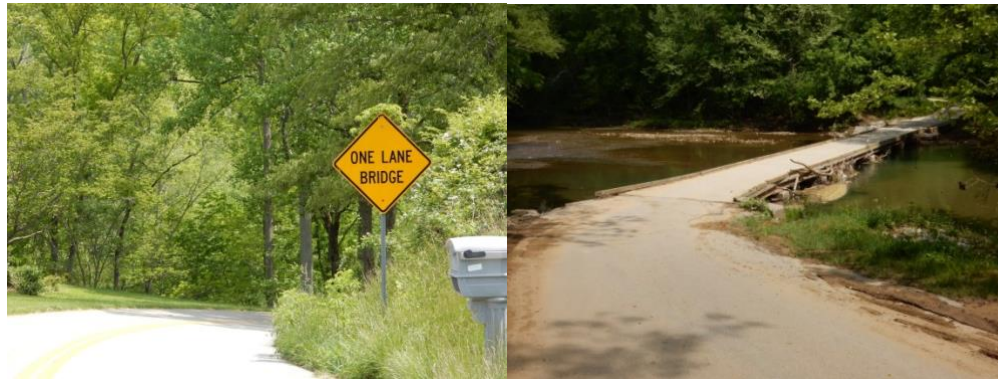
- **Frankfort:** A truck driver stated he was on the wrong street after following GPS directions. The truck impacted a passenger car when it attempted to turn around.
- **Cynthiana:** A truck driver stated his GPS unit directed him to make an incorrect turn onto a street, causing him to run over a fire hydrant.
- **Danville:** A truck driver followed his GPS directions into an unfamiliar area and collided with a pole and wires when attempting to make a turn.
- **KY 149 in Clay County:** A truck driver stated his GPS unit directed him onto a road where he failed to negotiate a curve leading to a narrow bridge. The tractor overturned with the trailer

overturning into the river. The road has a Class A weight rating and the loaded tractor trailer would have exceeded the 44,000-pound weight limit.

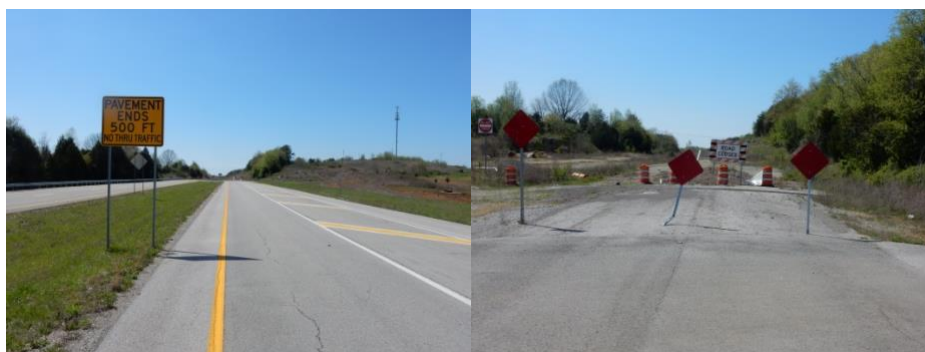
- **KY 6014 in Pulaski County:** The driver of a pickup stated he was following his GPS directions when he drove past the end of a road and struck a warning sign. The police narrative noted that several similar crashes had occurred at this location. The crash occurred at the end of a rerouted road where the GPS mapping had not been updated in the involved vehicles.

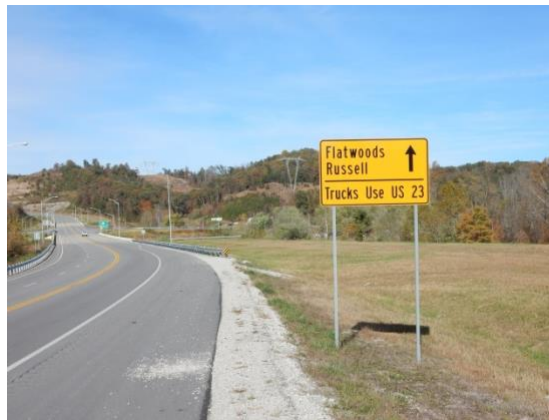
- **KY 207 in Greenup County:** Truck drivers were being directed by their GPS to use KY 207 (which has several sharp curves) to a specific industry. GPS units indicated this route because using KY 207 is shorter than US 23. A sign was placed on US 23 prior to the KY 207 turnoff informing truck drivers to use US 23 to travel to their destination.

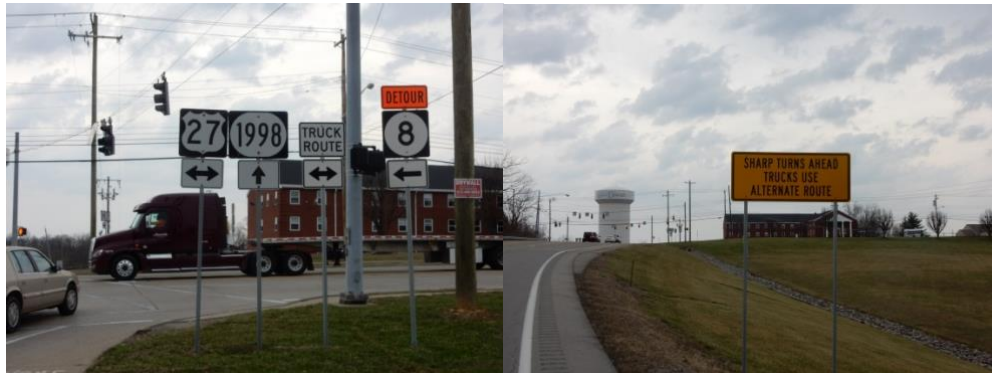
- **KY 1998 in Campbell County:** A state route with adverse geometrics was being used as a truck route over a preferable route (US 27) for trucks. A warning sign was installed on KY 1998 in advance of the intersection with US 27 along with a truck route sign at the intersection.

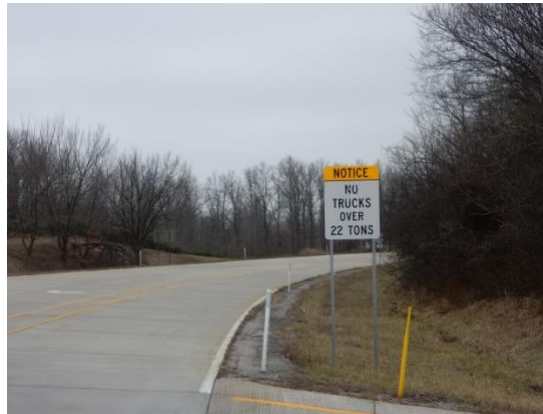
- **KY 416 in Henderson County:** Truck drivers were using a state route as a shortcut between two parkways. The route has a Class A weight rating. A regulatory sign was installed at a parkway

interchange exit stating, “Notice: No Trucks over 22 Tons,” which is the weight limit for a Class A road.

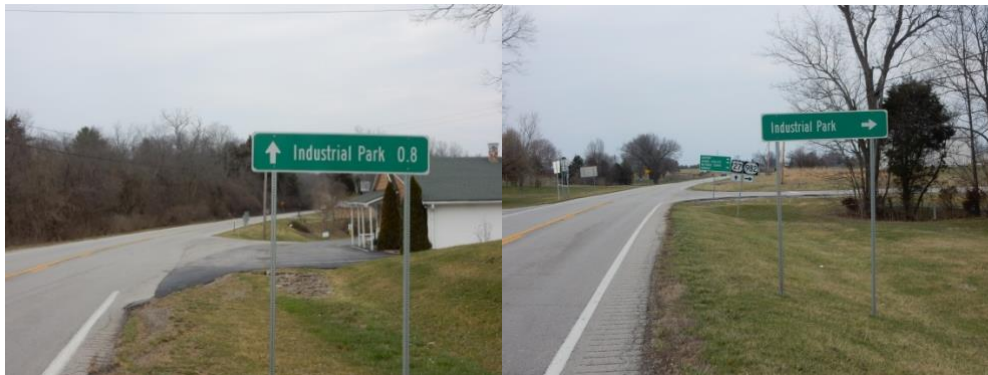
- **New Lair Road in Harrison County:** The GPS directions to several companies (in an industrial park) instructed truck drivers to take a road inappropriate for large trucks. Drivers were backing onto US 27 when they entered the county road and observed its cross section. Signs were placed on US 27 in advance of the county road directing drivers to the industrial park.

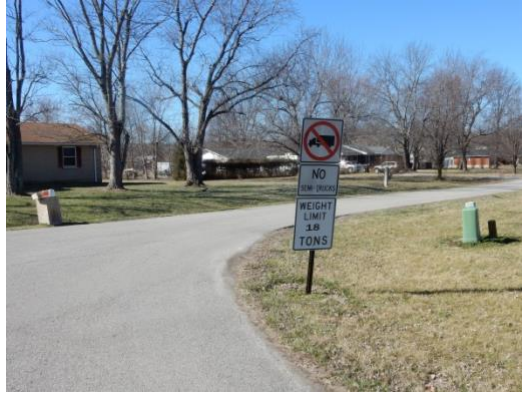
- **Near Exit 121 on I-65 in Bullitt County:** A county road was being used by truck drivers to travel to and from a truck stop at an interstate interchange. The local government placed signs on several streets in the area stipulating that no trucks (specifically, no semi-trucks) were permitted on local streets. The sign also noted the weight limit.

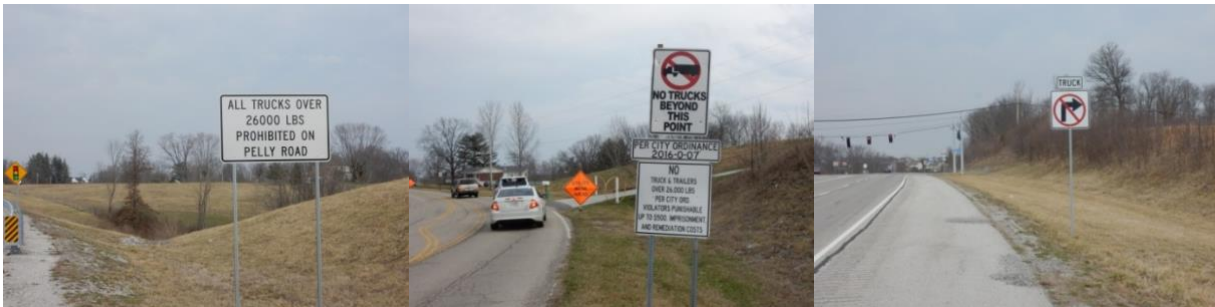
- Pelly Road in Kenton County:** A city-maintained road was being used by truck drivers to travel between two state routes. Signs were placed on both the state and city roads to prohibit trucks on Pelly Road. One sign noted a city ordinance that prohibited trucks on Pelly Road.

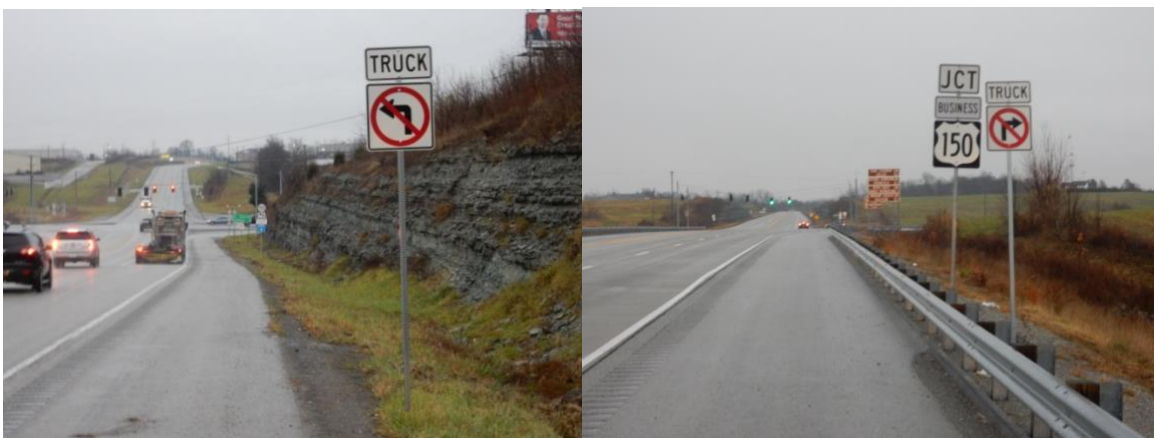
- Business Route at Springfield in Washington County:** Truck drivers were being routed by their GPS units onto a business route that included a local road and a roundabout instead of the preferable bypass route. Guide and truck prohibition signs were installed.

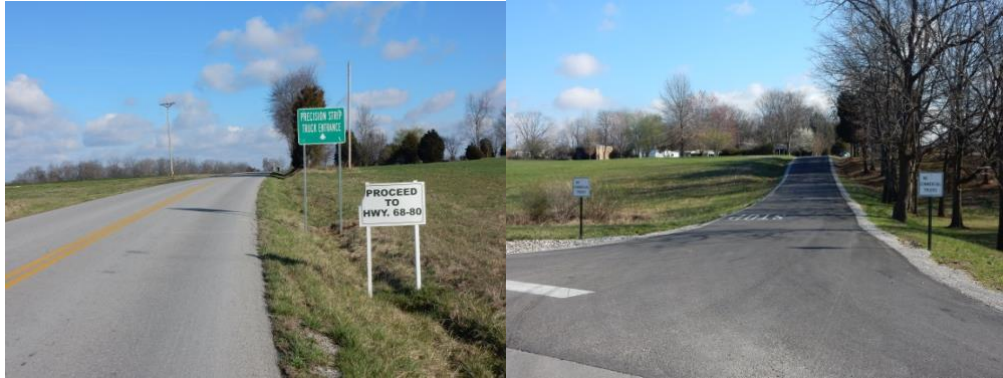
- **Between KY 73 and US 68 in Logan County:** Truck drivers were routed by their GPS units onto a county road to an industry. A guide sign was placed on KY 73 directing truck drivers to the specific industry and the county placed truck prohibition signs on its road.

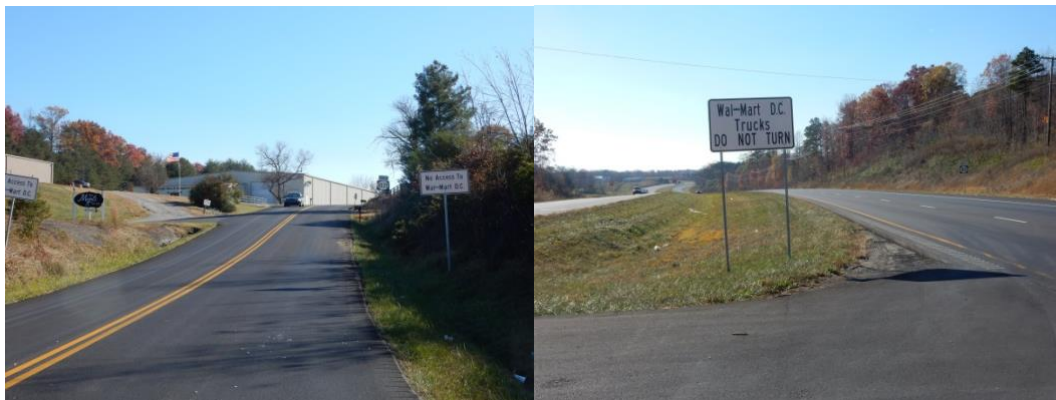
- **KY 80 near London:** Truck drivers were being directed onto inappropriate routes to a distribution center. Signs were installed on both KY 80 and the adjacent KY route directing drivers to remain on KY 80.

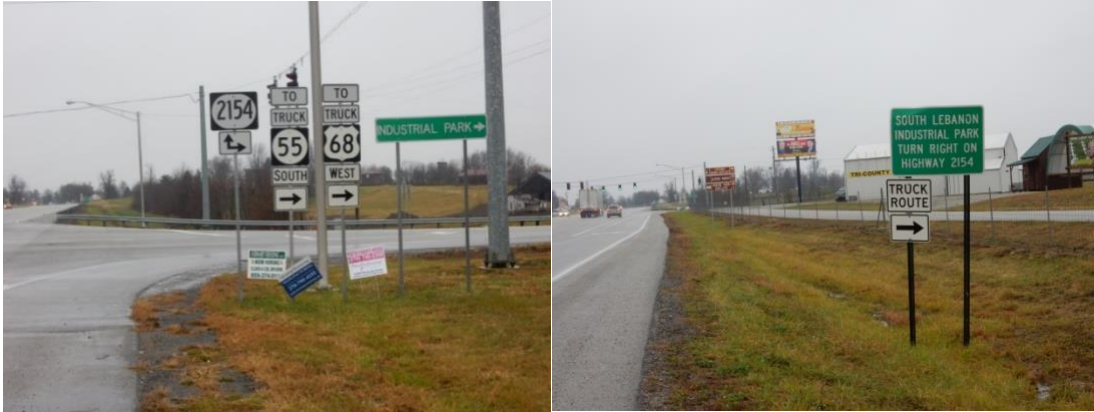
- **Lebanon in Marion County:** Truck drivers were driving on city streets rather than using the bypass route to the industrial park. Additional guide signs were installed on state routes to direct truck drivers to the industrial park. There was also communication between the local Office of Economic Development and the local industries to direct truck drivers to use the bypass. This communication also asked the logistics managers from each industry to coordinate with truck drivers to ensure that they had the most recent and accurate data available on their GPS units.

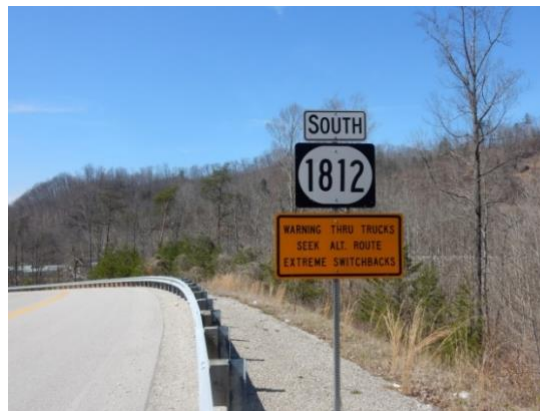
- KY 1812 in Breathitt County:** Truck drivers were being routed by their GPS units onto a state road with very severe curves. A non-typical warning sign was placed at the start of the road warning drivers of switchback curves and directing them to use an alternative route.

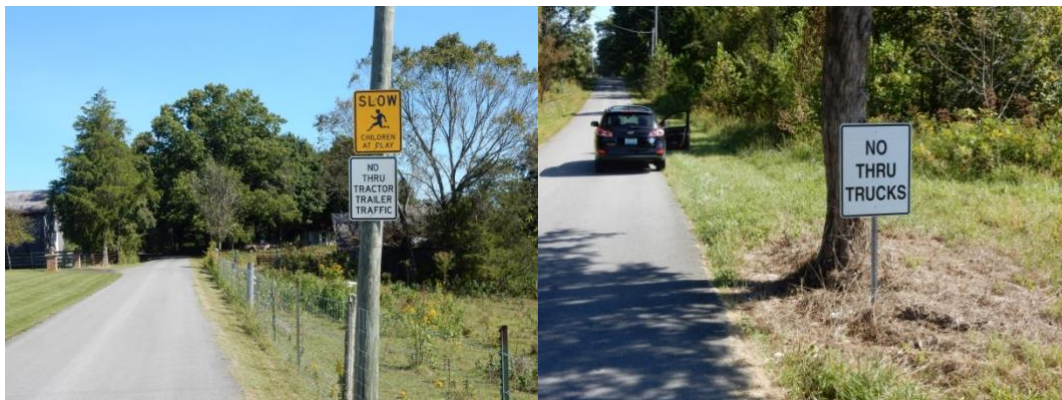
- West Wilson Road in Russell County:** Truck drivers were directed by their GPS units onto a county road to an industry. The county road narrows significantly and is impassable for large trucks. The county placed truck prohibition signs.

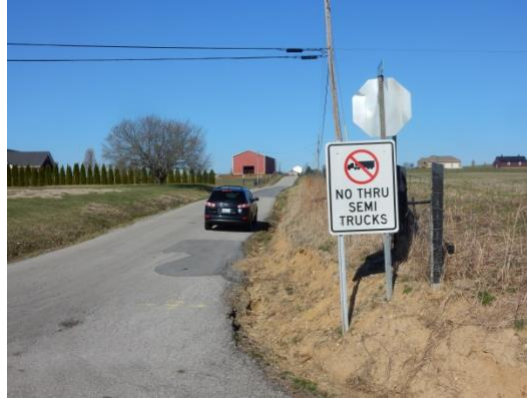
- **Burkes Springs Road in Marion County:** Truck drivers were using a county road to access an industry (from GPS directions) rather than alternative state routes. The county placed a sign at the intersection with the state route noting “No Thru Semi Trucks.” County officials also communicated with the industry about the proper routes for truck drivers accessing their facility.

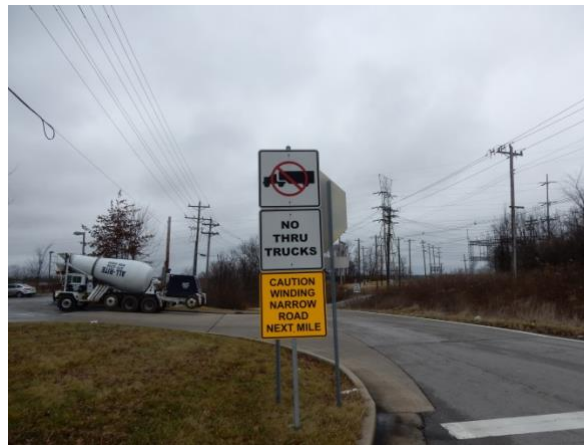
- **KY 3076 in Boone County:** Truck drivers traveling from I-275 to KY 8 were routed by their GPS units onto a narrow road. The road has numerous severe curves. A sign warning of the curves and truck prohibition signs were installed.

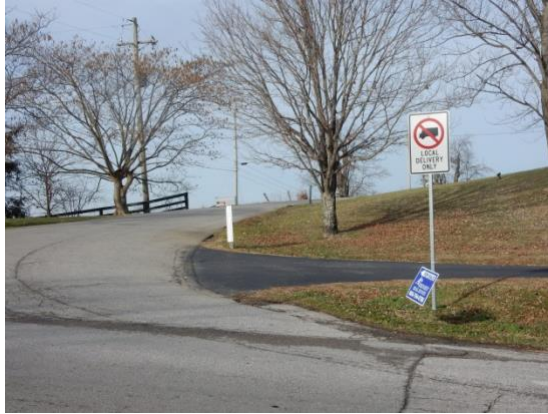
- **KY 1198 in Bath County:** A version of a truck prohibition sign was installed to limit commercial truck traffic on a road where the geometrics were inappropriate for large trucks.

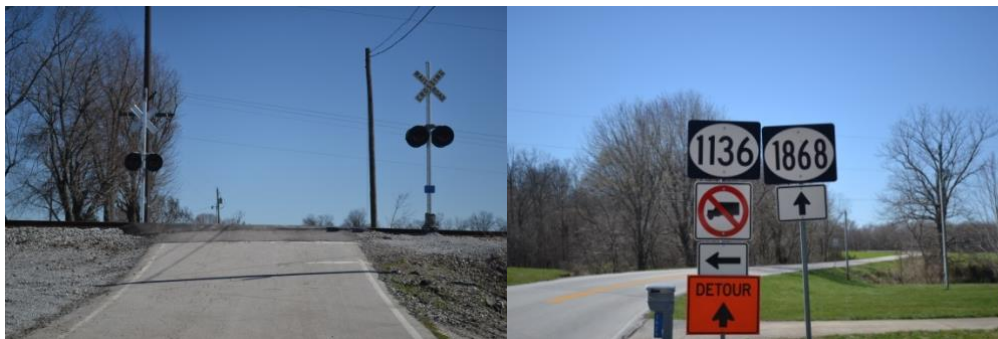
- **KY 1136 in Hardin County between KY 1868 and US 31W:** Truck prohibition signs were placed along a section of this roadway. The prohibition is a result of low ground clearance railroad crossing in this section of KY 1136.

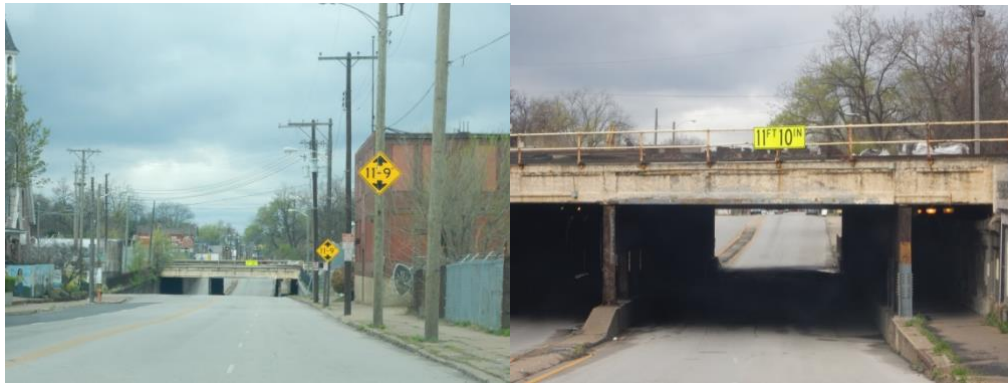
- **Oak Street in Louisville:** After a series of crashes in which truck drivers following their GPS units impacted a low clearance bridge, the railroad company worked with the transportation agency to improve advance warning signs. The railroad company also painted the overpass to increase its visibility.

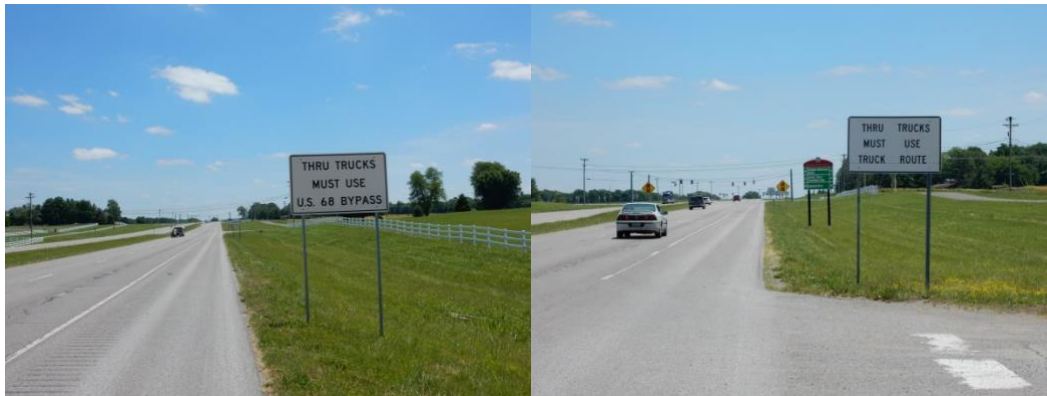
- US 68 in Hopkinsville:** The most direct route through Hopkinsville is the US 68 business route. However, this route takes drivers through the central business district, which is not appropriate for large trucks. Regulatory signs have been installed informing trucks they must use the US 68 bypass.

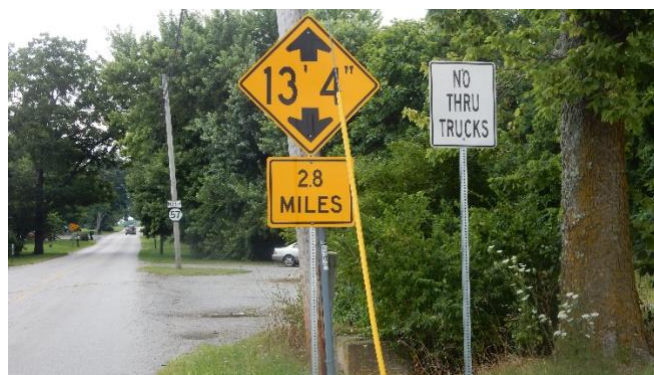
- KY 57 in Bourbon County:** Truck drivers had been provided incorrect information for the proper route to make a delivery. This resulted in large trucks traveling on a route with a height limitation and drivers being forced to turn around in a parking lot, resulting in damage to the property. Warning and regulatory signs were installed to stop the drivers before they reached the low overpass. However, drivers continued to have problems due to the routing directions.

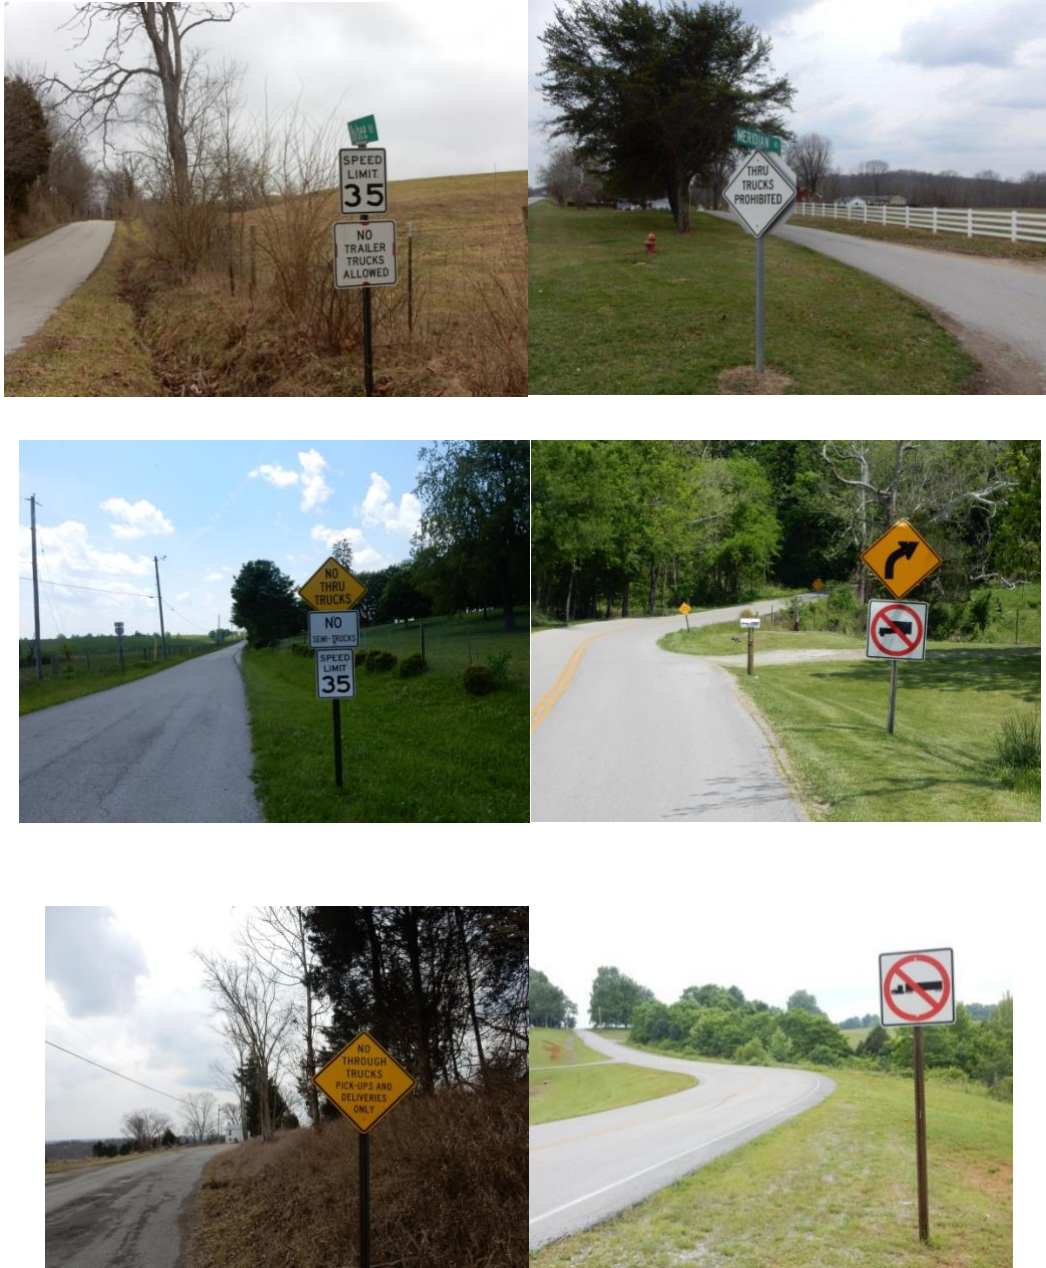
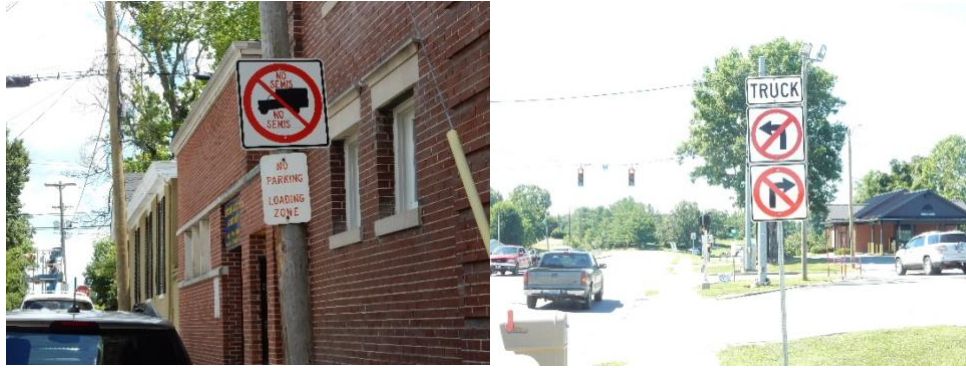
- The following images are examples of truck prohibition signs used (primarily by counties and cities) on roads where truck drivers were led by GPS units onto inappropriate routes. Inspections have found a range of signs used, with many signs being either non-standard or installed improperly.

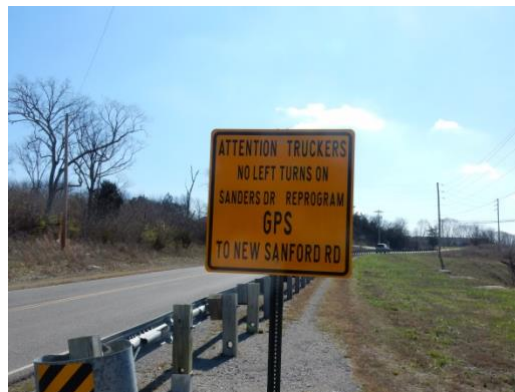
- A warning sign was installed to advise truck drivers of a change in the road configuration and specifically told drivers to reprogram their GPS units.

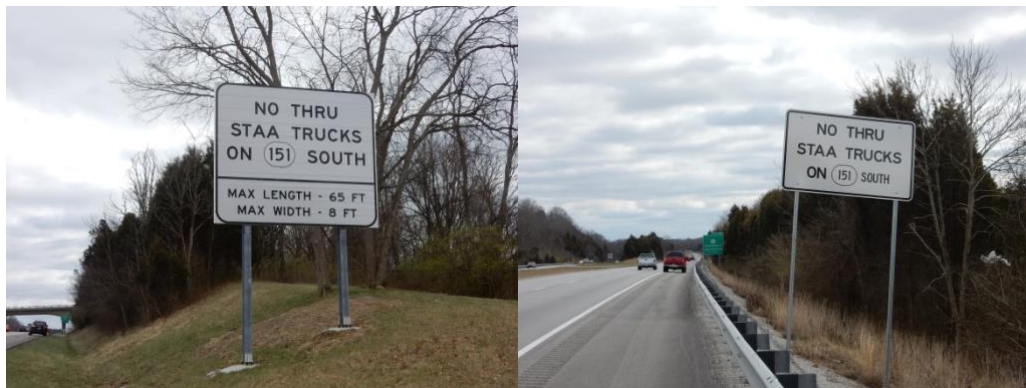
- Residents requested that large trucks be prohibited from traveling on a section of KY 151 in Franklin and Anderson Counties. Specifically, truck drivers traveling eastbound on I-64 used KY 151 (a two-lane road with narrow shoulders) to travel from the interstate to Lawrenceburg. There is an alternative four-lane road with wide shoulders (US 127) available to travel from the interstate to Lawrenceburg. An eastbound truck driver would have to remain on I-64 about five miles past the KY 151 interchange to use the US 127 route. A review of crash data did not show a problem related to commercial vehicles on KY 151. The roadway geometry and roadway cross section on KY 151 are adequate to accommodate large trucks. An alternative method to route truck drivers onto the four-lane road and away from the two-lane road is to coordinate with mapping companies to direct truck drivers traveling eastbound on I-64 to continue to the US 127 interchange. While this route (for eastbound drivers on I-64) is slightly longer (about five miles), the time difference is minimal due to the roadway characteristics of US 127 compared to KY 151. Both routes have a AAA truck weight classification.

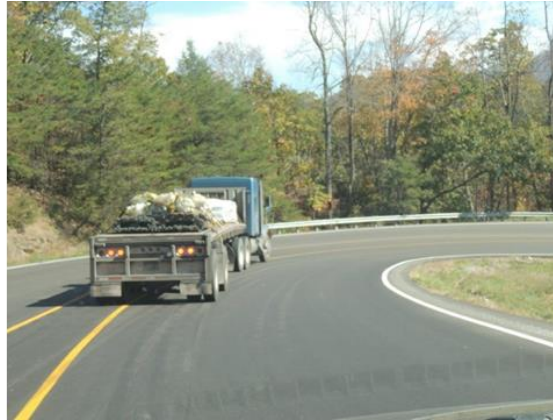
- After several crashes involving large trucks and residents voicing their concerns, truck travel was banned along a 7.1-mile section of US 119 in Letcher County (over Pine Mountain from Whitesburg toward Harlan). A section of the road was reconstructed to widen curves and provide pavement markings to allow a buffer zone between the lanes and permit tractor trailers to off-track and not intrude into the opposing lane. After the construction project was completed, the road was opened to truck traffic. This case study shows unique alternatives (initially a truck ban and then road reconstruction) to alleviate issues with large trucks.

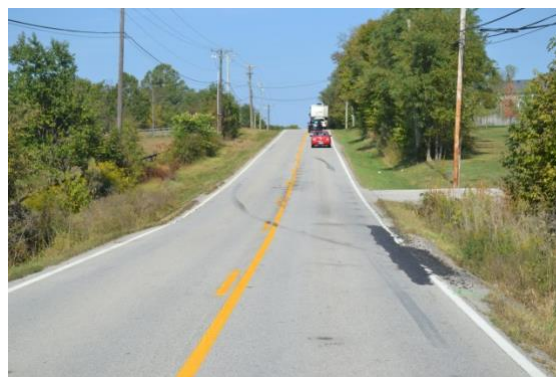
- A route used by truck drivers to travel to a landfill in Scott County has caused concern among residents (due to travel by large trucks on a two-lane section of US 25). The landfill is located less than two miles from Exit 136 on I-75. Garbage trucks traveling northbound on I-75 use Exit 129 and travel on KY 620 and then US 25 to the landfill (it is approximately 6.8 miles from exiting the interstate to the landfill). The alternative route would let drivers traveling northbound on I-75 continue north to Exit 136 and then use KY 32 (approximately 9.1 miles from driving past Exit 129 to the landfill). The issue with using Exit 129 (rather than Exit 136) is that this route requires traveling on a two-lane road (US 25) for a longer distance, and this section of US 25 has much higher average daily traffic compared to the alternative route. There should be no reason for a driver southbound on I-75 to not use Exit 136. Truck drivers on I-75 northbound would be directed by their GPS to use Exit 129 rather than Exit 136 to travel to the landfill since the distance is about 2.3 miles less. However, the time difference would be minimal given that most of the travel would be on an interstate (rather than a two-lane road) when using Exit 136. A method to ameliorate this situation would be for the companies and the landfill operators to direct drivers to use the Exit 136 route. The landfill is located a short distance north of Georgetown, which has directed its drivers to use the Exit 136 route.

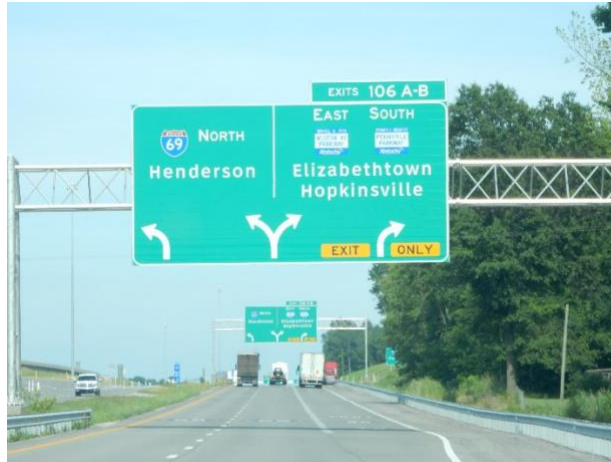
- The interchange of the Western Kentucky Parkway and Pennyryle Parkway was reconstructed when a portion of the Western Kentucky Parkway was designated as part of I-69. A routing problem occurred after the redesign when truck drivers intending to continue south toward Hopkinsville followed I-69 in a westerly direction since it is generally a north/south road. When the truck drivers

realized they were traveling west rather than south, they either continued to the next interchange or improperly used a crossover. At least one crash resulted from a truck driver's improper use of a crossover. Although the existing signs conformed to standard practice, additional signs and pavement markings were installed to provide drivers with the information necessary to travel in the desired direction at the interchange.

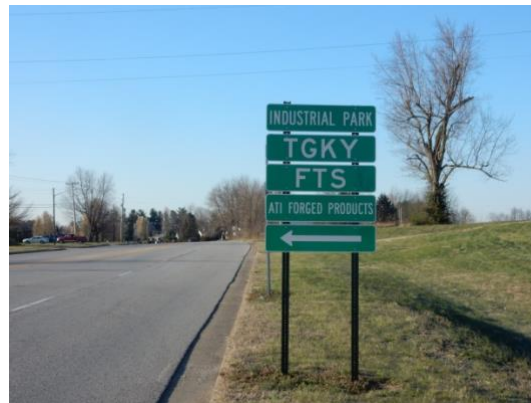
- Establish consistent signing related to truck routing, using signs that conform to the *Manual on Uniform Traffic Control Devices* (MUTCD).
- Install additional route signing to direct truck drivers to specific destinations (industries).

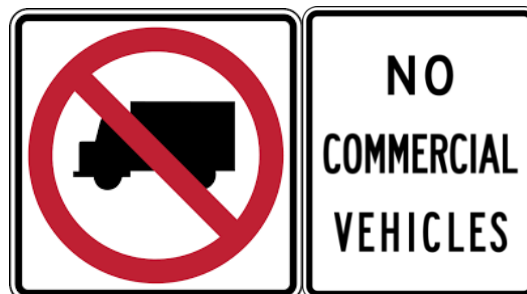
- Install regulatory signs prohibiting trucks from routes with inadequate roadway cross-section and geometrics. The MUTCD (signs R5-2 and R-4) allows selective exclusion signs to prohibit designated types of traffic (such as trucks) from particular roadways.

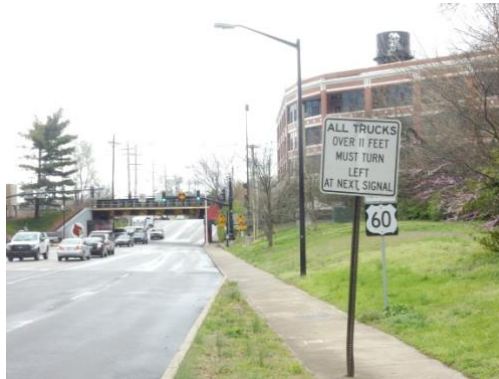
- Install advance warning signs and delineation for low clearance height bridges.

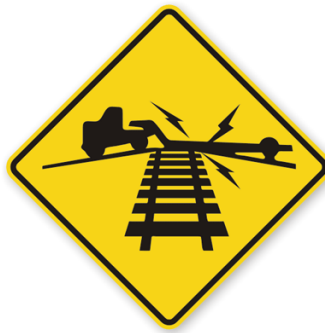
- Install warning signs in advance of low ground clearance railroad crossings.

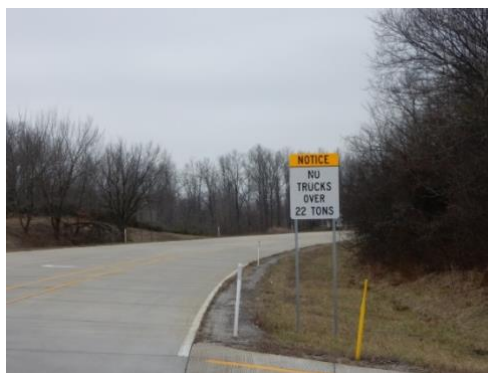
- Install regulatory signs restricting tractor trailer travel on state-maintained roads with a Class A weight rating (maximum weight of 44,000 pounds or 22 tons).
