1. Report No. FHWA/LA.18/588		2. Government Accession No.	3. Recipient's Catalog No.
4. Title and Subtitle Minimizing Shrinkage Cracking in Cement-Stabilized Bases through Micro-Cracking		5. Report Date October 2018

6. Performing Organization Code LTRC Project Number: 12-3P SIO Number: 30000729	
7. Author(s) Zhong Wu, Yilong Liu and Ferdous Intaj		8. Performing Organization Report No.

11. Contract or Grant No.	
12. Sponsoring Agency Name and Address Louisiana Department of Transportation and Development P.O. Box 94245 Baton Rouge, LA 70804-9245		13. Type of Report and Period Covered Final Report 11/2012 to 10/2017

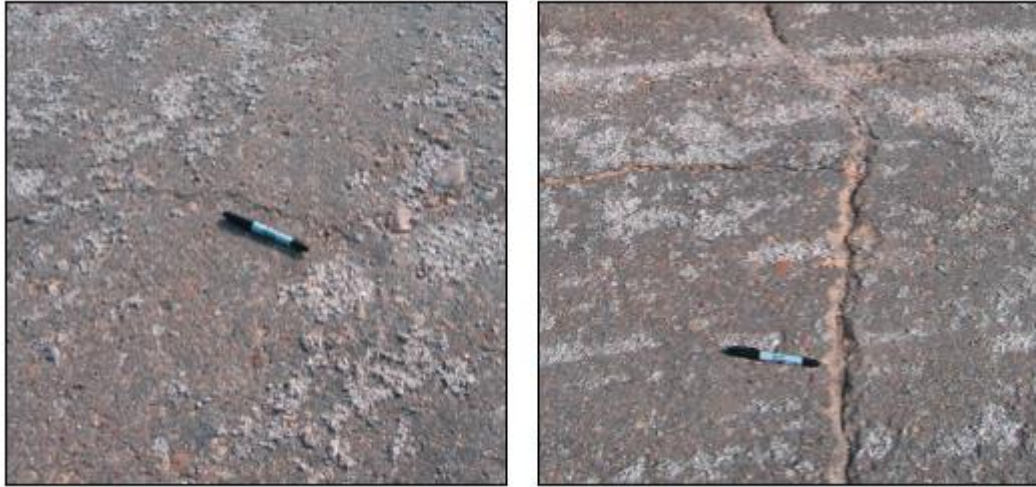
concrete surface of micro-cracked pavements was also monitored and compared with the control sections in several field projects in Texas. Overall, the long-term field performance of the micro-cracked sections was satisfying based on the observation [8]. For the test sections constructed in another project, the total length of the surface cracking appeared on the micro-cracked section was only 1/5 to 1/10 of that on the control section in a 6-month period [6].

Figure 4
Shrinkage cracks in a micro-cracked section and an untreated section [8]

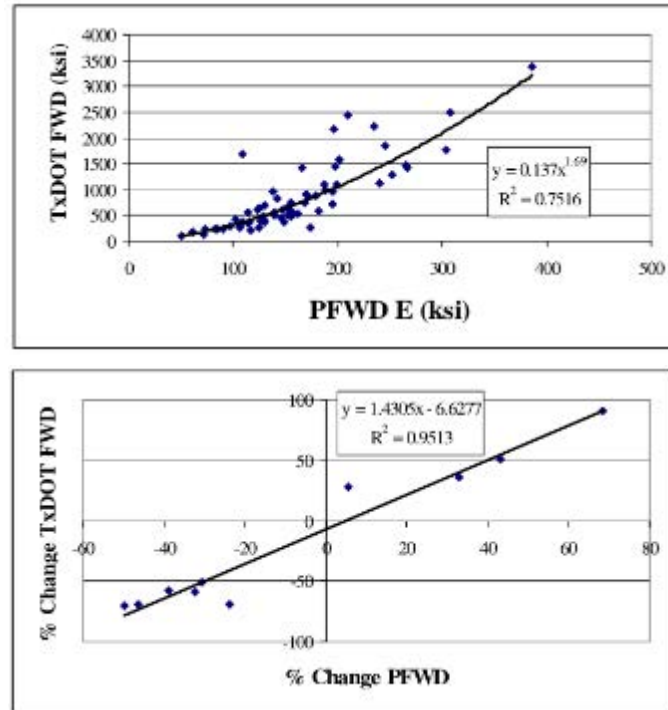
where, ΔE_{FWD} and ΔE_{LFWD} are the changes (in percentage) of back-calculated moduli from the FWD and LFWD, respectively, compared to the initial modulus of the cement stabilized base before micro-cracking. Based on equation (2), a 60% modulus reduction indicated by the FWD is equivalent to a 40% obtained from the LFWD [7].

Figure 5
Correlation between FWD and LFW measurements [7]

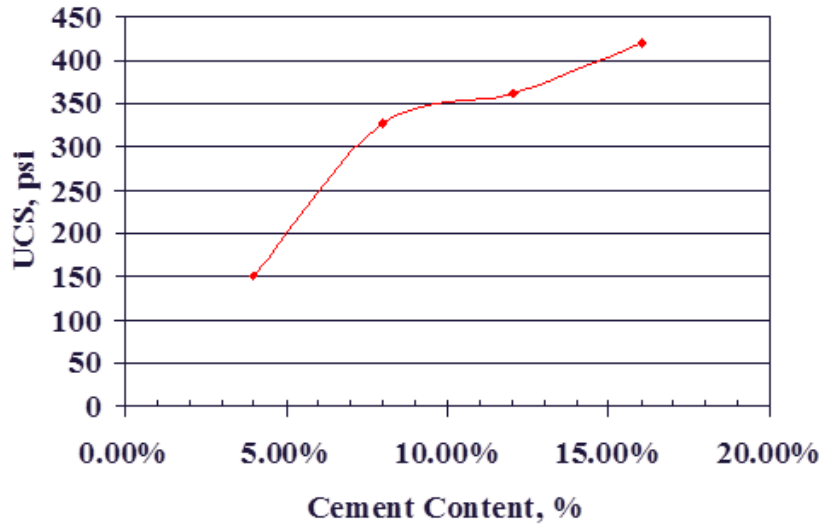
strength test results of the soil cement mixtures with varying cement contents. Based on the AASHTO soil classification, it was classified as an A-6 soil. According to the DOTD's roadway design specification, the minimum 7-day UCSs for a cement treated soil base and a soil cement base should be 150 and 300 psi, respectively. To meet the specification, the cement treated soil bases in Sections V and VI had a 6% cement content by volume, while those in Sections I-IV had a cement content of 8%.

Figure 7
7-day UCS of soil-cement mixtures with varying cement contents

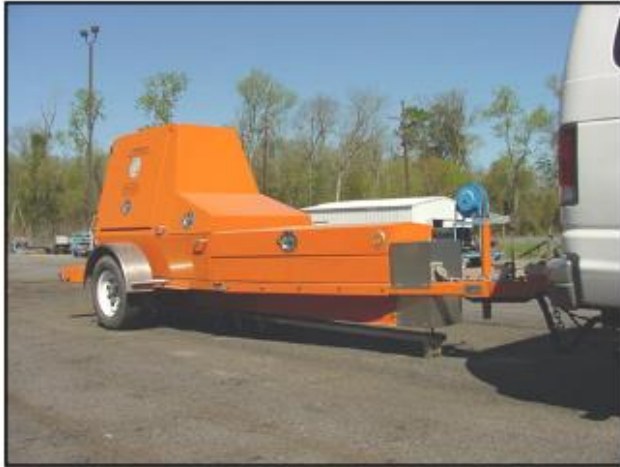
Figure 8

The research team used an FWD to monitor the reduction in base modulus due to micro-cracking [Figure 8 (a)]. In addition, two other portable devices, LFWD [Figure 8(b) and 8(c)] and Humboldt Geogauge [Figure 8(d)], were also employed during the application of micro-cracking to investigate the feasibility of using a portable device for controlling the quality of the micro-cracking process.

(a) Falling weight deflectometer (FWD)

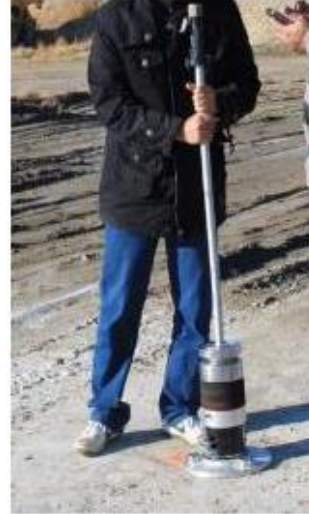
(b) Light falling weight deflectometer (LFWD), DYNATEST

LFWD is a portable NDT device as an alternative to the FWD, as shown in Figure 8(b) and 8(c). As the falling weight drops onto the loading plate, the impact force and the deflection of the loading plate are measured by built-in sensors. Compared with the FWD, LFWD has a much lower load capacity and is much less expensive. The mass of the dropping weight and the size of the loading plate vary in terms of product models. There are two types of commonly-used LFWD devices, Dynatest 3031 and ZFG 2000 (Zorn LFWD), which have different working procedures. Dynatest 3031 gives stiffness values for each drop, while ZFG 2000 requires three preloading drops and then three more drops are required to provide three deflection values and an average modulus [Average modulus = $1.5 \times 150 \times 0.1 / (\text{Average deflection})$].

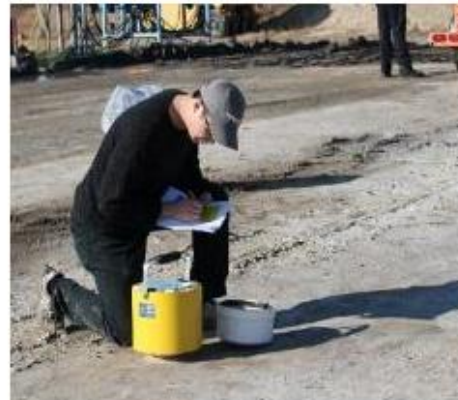
(d) Geogauge

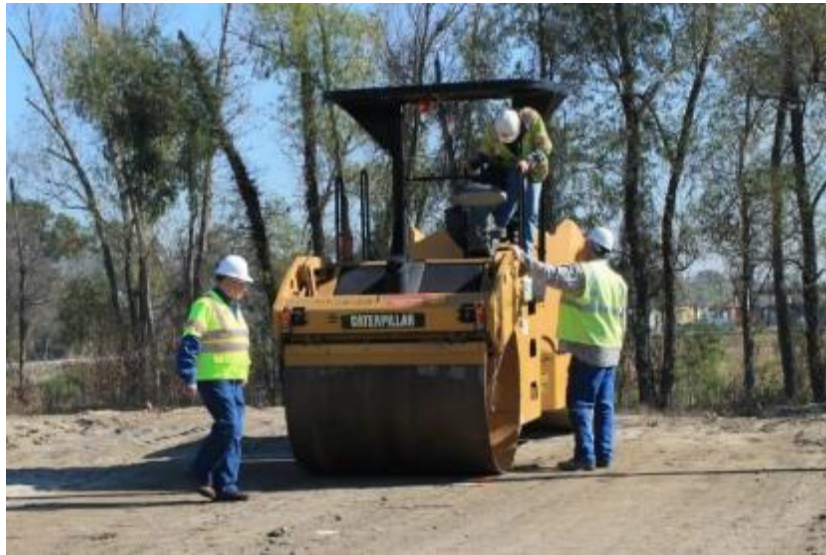
applied to each micro-cracking section was determined by the modulus (or stiffness) reduction back-calculated according to the FWD results after each roller pass.

Figure 9
Roller compactor used for the micro-cracking process at PRF

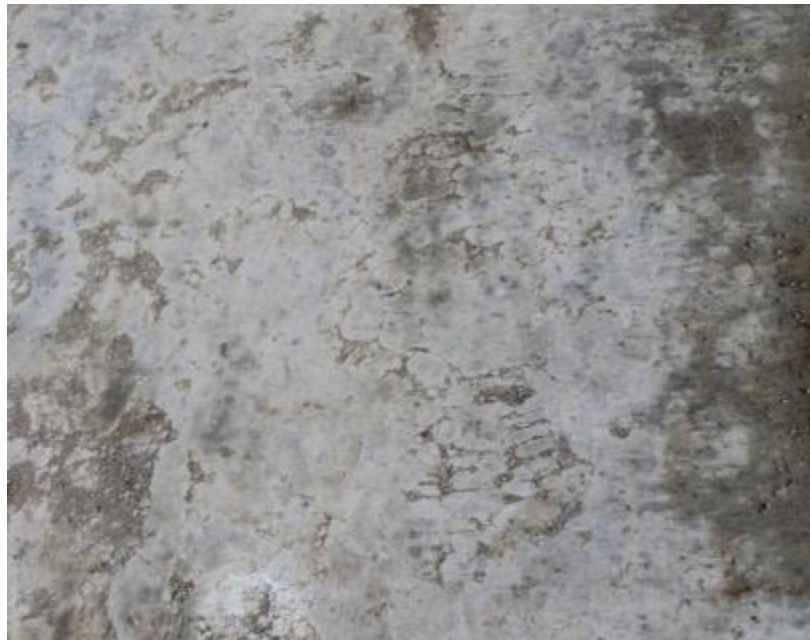
Figure 10
Surface of Section IV after 10 passes of micro-cracking

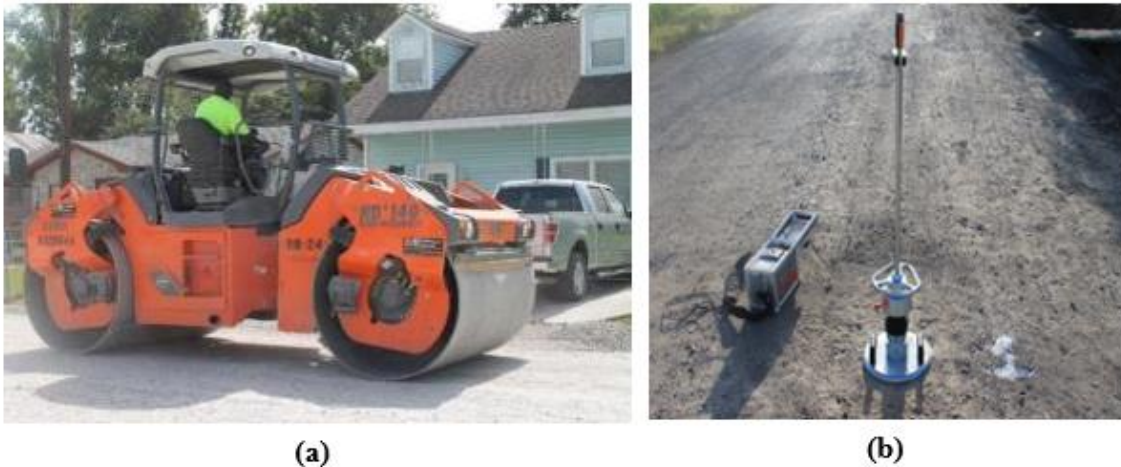
To monitor the application of the micro-cracking process, the research team visited the LA1003 project site on September 26, 2014, which was three days after the completion of the base construction. No curing membrane was used to cover the bases prior to the micro-cracking. Instead, the contractor was instructed to water the constructed bases at least once a day. In this project, a 14.5-ton RR-24 Hamm HD-140 vibratory roller as shown in Figure 13(a) was used for micro-cracking of the two base layers. Both the bases in the sections II and V underwent the micro-cracking process. For each of the micro-cracking test section, a preliminary testing was conducted on a 200-ft. portion to determine the number of roller passes required to reduce the base modulus by approximately 40% to 60%. After the number of passes was determined, the contractor performed the determined number of roller passes on the rest portion of each test section. Since the FWD devices were not available at the time of the micro-cracking application, an LFWD (ZORN -ZFG 2000) was used to monitor the base modulus reduction, as shown in Figure 13(b).

Figure 13
(a) Roller for micro-cracking (b) LFWD used on LA1003

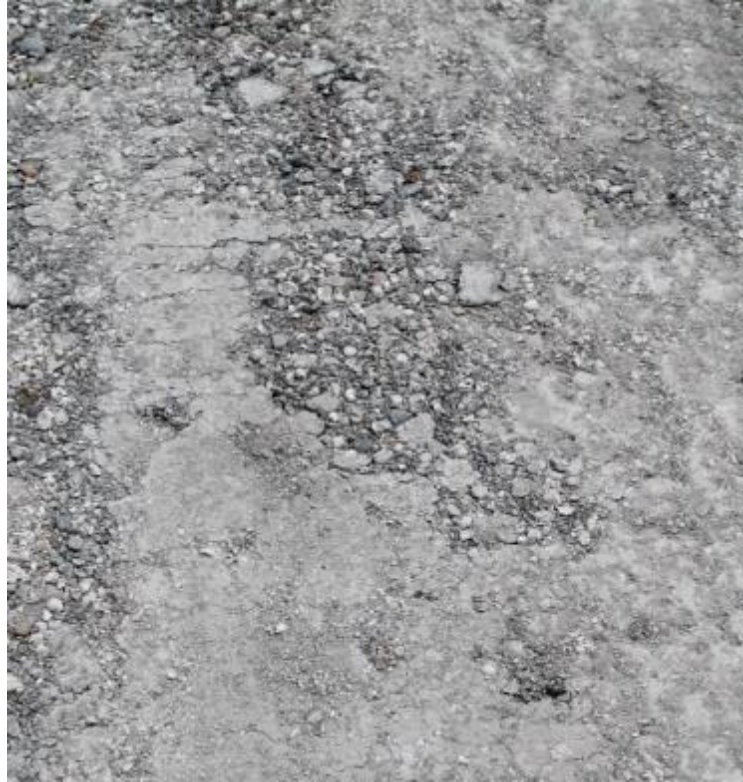
found after the micro-cracking. This may indicate that the micro-cracking technique did not result in pavement damage during the construction.

Figure 14
Typical base surface after the micro-cracking
LA 599 Test Sections

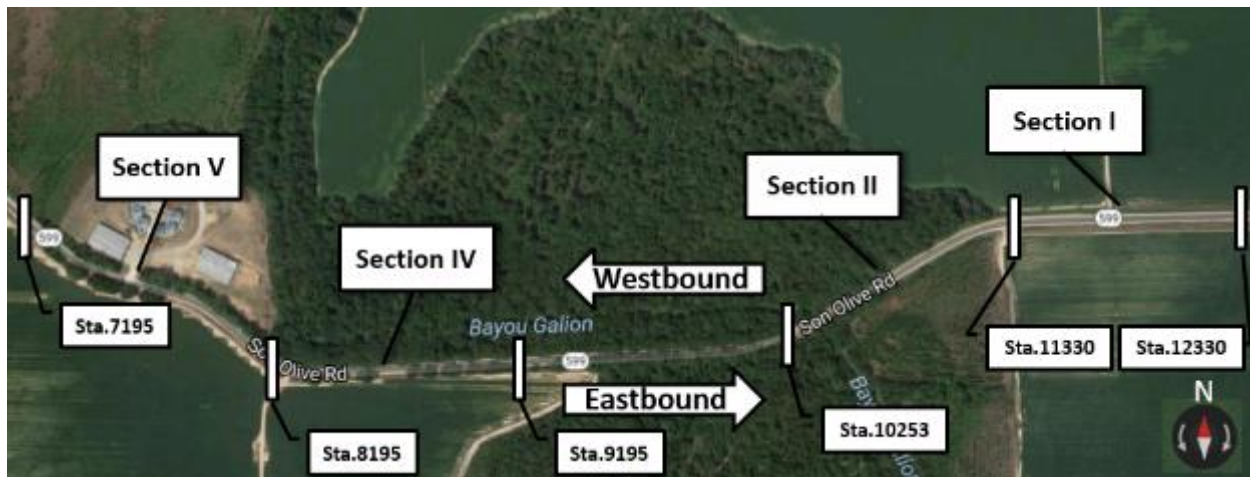
cement content of 9% for the construction of the 8.5-in. soil cement bases (in sections IV and V), as shown in Figure 15.

Figure 15
Section arrangement of project LA 599

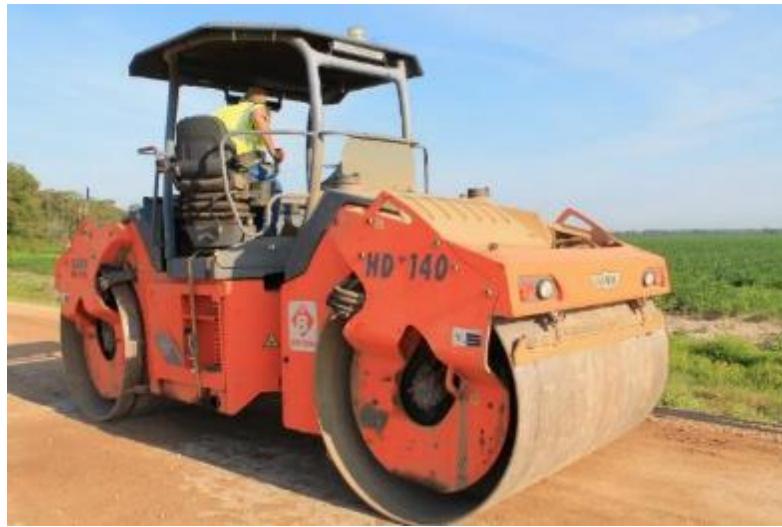
Figure 16
Micro-cracking with vibratory roller (HD 140)

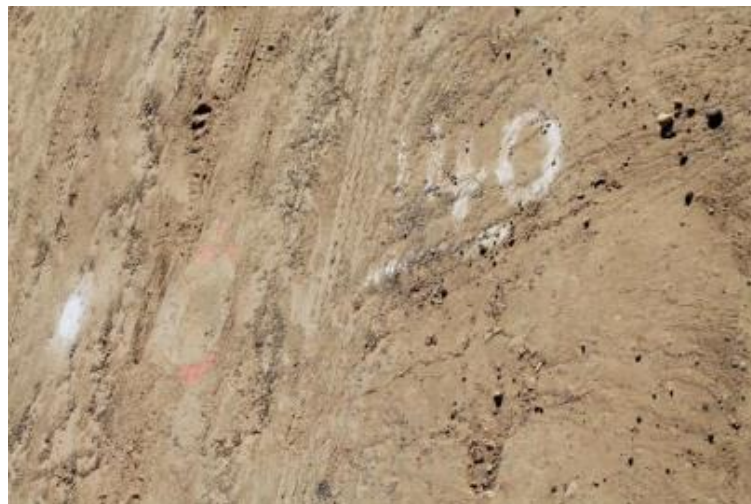
the FWD was found to be 33.6%. Figure 17 shows the surface of Section II after the application of micro-cracking. The research team did not observe any base damage or surface break-ups but a few fine cracks as shown in Figure 17. Based on the results, micro-cracking was performed on the rest of Section II by using 17 full roller passes. A similar micro-cracking procedure was adopted in Section IV. However, the back-calculated modulus of Section IV (i.e., the 8.5-in soil cement base) showed a more consistent trend of decreasing as compared with that of Section II. It was found that the base modulus was reduced by 35.2% after 18 passes in the preliminary test and additional passes became relatively ineffective in the modulus reduction. Thus, 18 passes were recommended for the remaining part of Section IV.

Figure 17**Section II after 17 passes**

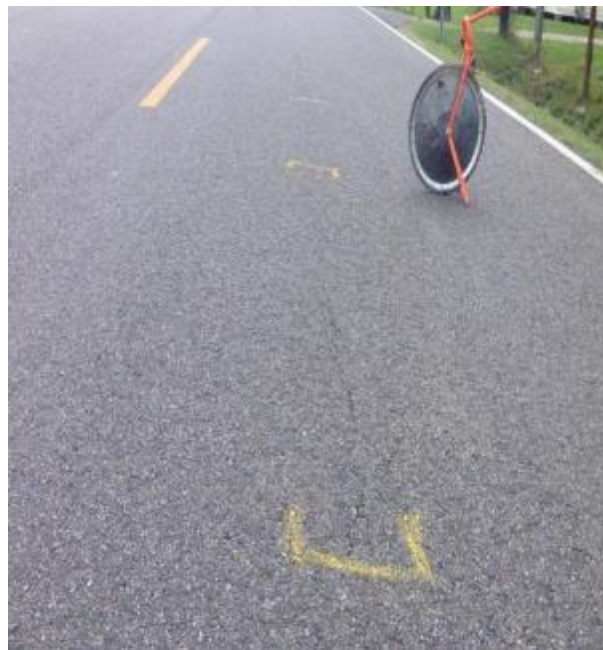
The visual crack survey was conducted on both the PRF sections and field test sections (LA 1003 and LA 599) to record the types, lengths, widths, and locations of the cracks appeared on the surface of the bases or asphalt layers. The crack survey was performed at several time intervals to observe the initiation and propagation of cracking. Figure 19 shows one longitudinal crack observed on the pavement surface of LA 1003.

Figure 19
Crack survey on LA 1003

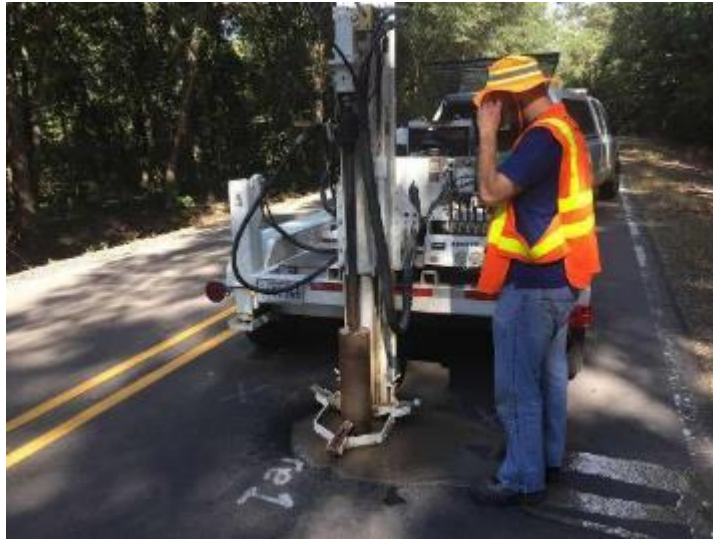
Coring was conducted on the selected cracking locations to collect samples for the investigation of the cracking behavior of the micro-cracked sections and control sections. The SIMCO 255 PTC drilling rig, as shown in Figure 20, was utilized and cores with a 6-in. diameter for both the asphalt and base layers were drilled and collected.

Figure 20
Pavement sampling on LA 599

The locations of coring were marked on both the longitudinal cracks and transverse cracks during the crack survey. The coring barrel was located accurately on the marked locations to intersect with the cracks so that the mechanism of the cracks can be investigated based on the cores. In addition, effort was made to assure that the drilling depth would be at least 10 in. so that the entire asphalt concrete and the base layer will be drilled through. The cores were retrieved from the coring barrel with extra caution to obtain integrated samples. After the coring, the drilling holes were backfilled with hot asphalt mixes and then compacted manually.

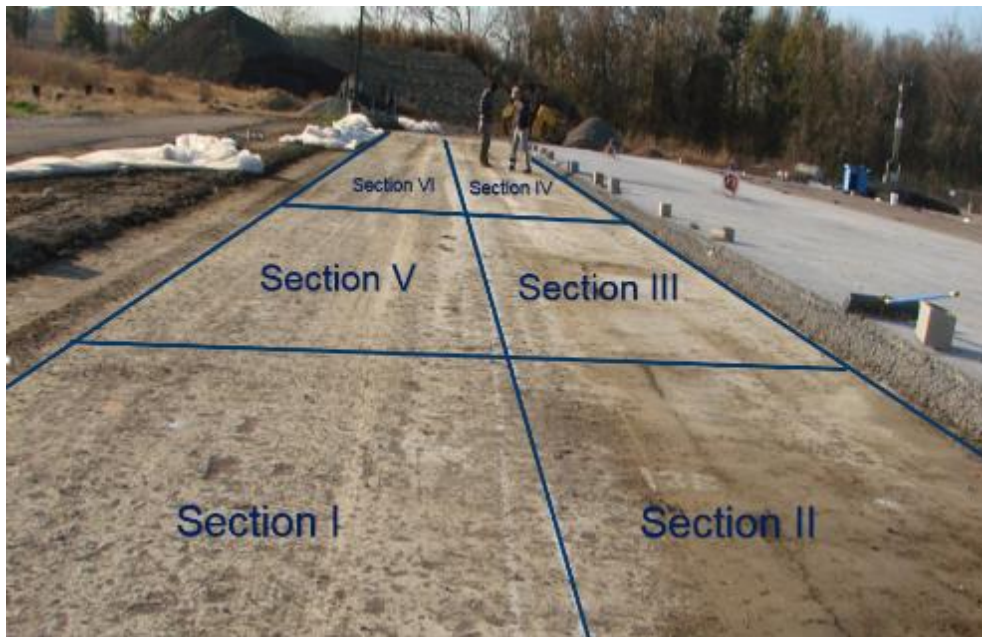
Figure 21 shows the overview of the constructed sections at PRF. After the micro-cracking, in-situ cracking survey including FWD and LFWD tests were performed periodically on these sections.

Figure 21
Overview of PRF test sections

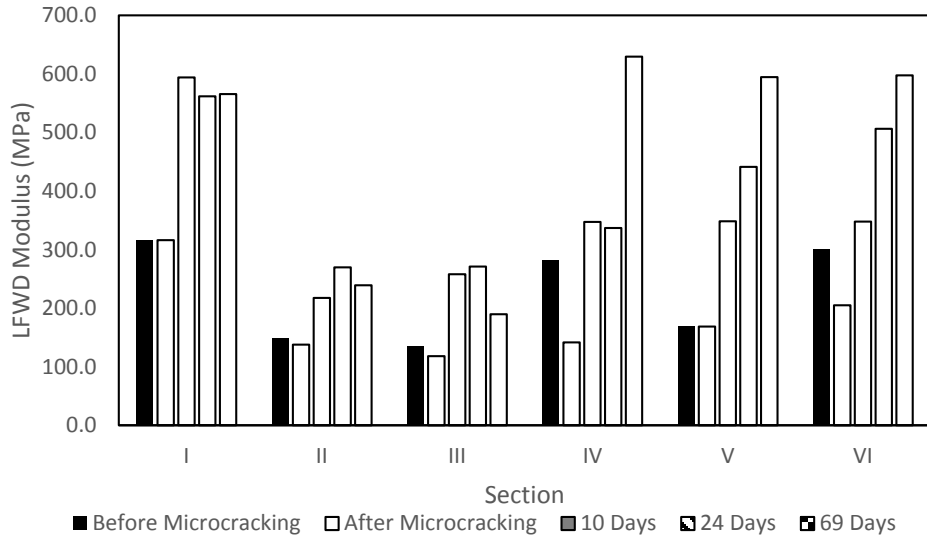
Section I, as shown in Figure 21. On the other hand, Sections V and VI, constructed on the same lane, demonstrated similar stiffness values after 69 days, indicating that, as other studies have reported, the micro-cracking process would not damage the base in the long run [4, 6].

Figure 22
Average LFWD moduli of PRF test sections

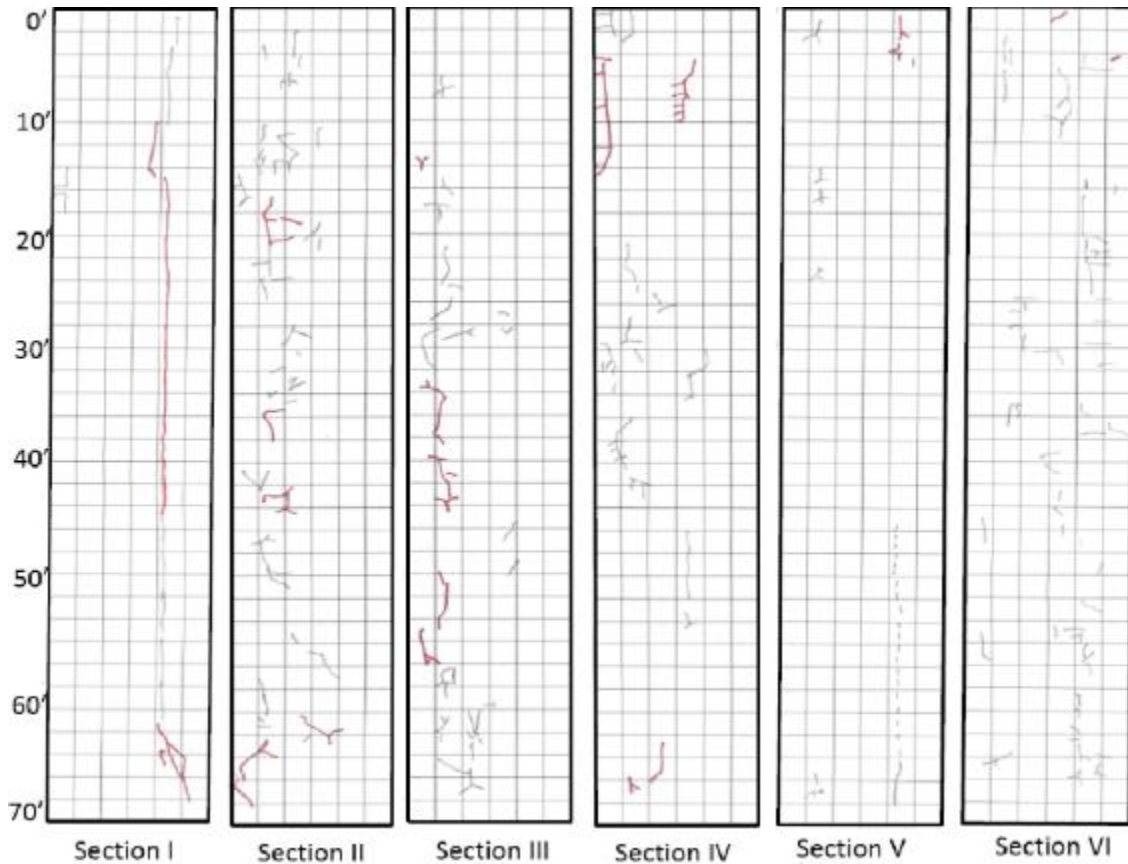
The test sections were monitored continuously for shrinkage cracks after the construction. Figure 23 shows the crack-mapping results of the six sections surveyed on April 25, 2014. As seen in Figure 23, many closely spaced short hairline cracks appeared on the surfaces of all micro-cracked sections (i.e., Sections II, III, IV and VI). Those cracks are likely to be the shrinkage cracks due to cement hydration. For the control sections, Sections I and V, the number of fine network cracks was relatively low. Instead, a couple of longitudinal cracks were observed. These cracking performance results indicate that the micro-cracking method seems to be able to reduce or eliminate long shrinkage cracks on both the CSD and CTD bases.

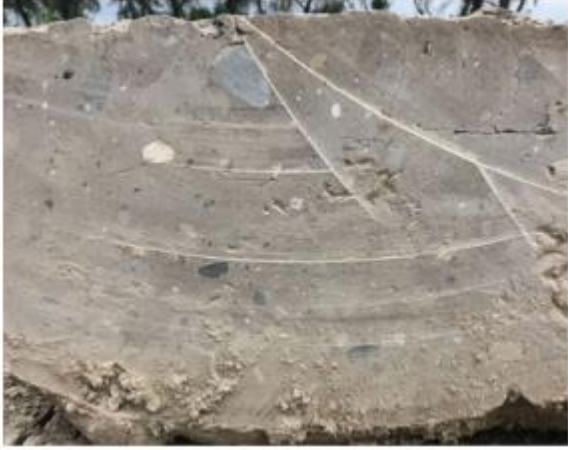
To determine if any shrinkage cracks might hide from the surface or propagate downward, saw-cut beams were collected on several selected locations on the soil cement sections (section I, II, and III). Figures 25 and 26 show the saw-cut beams on Sections I and III, respectively.

Figure 25
Saw-cut beam in Section I

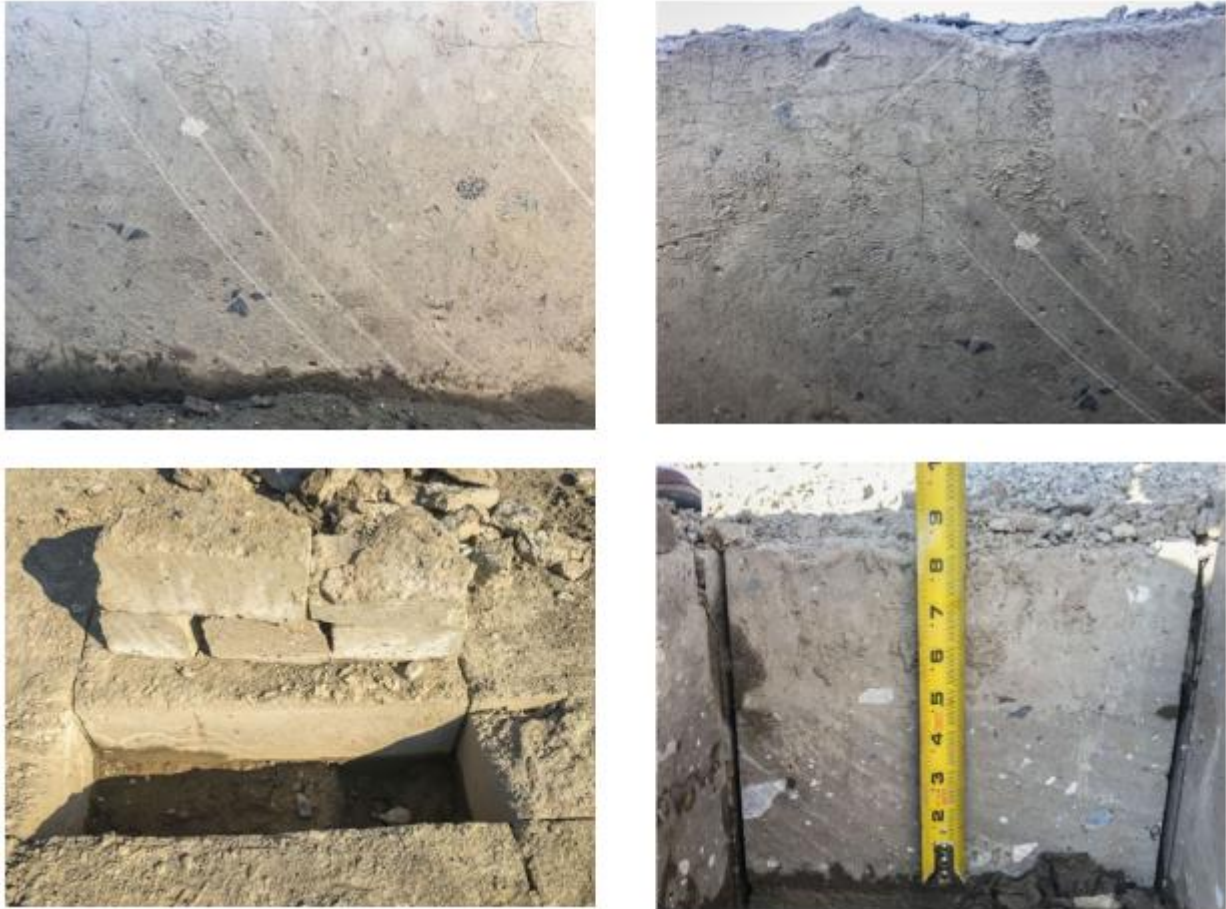
Figure 26
Saw-cut beam in Section III (micro-cracked section)

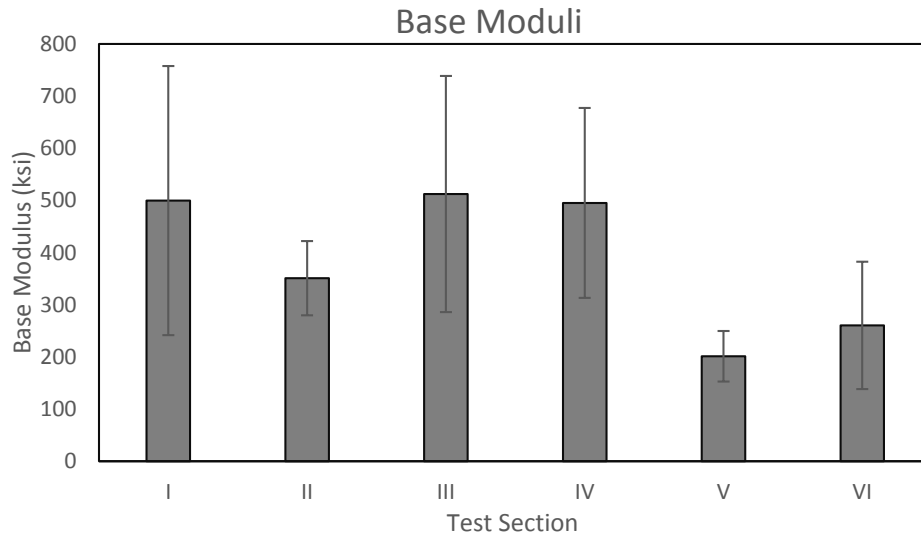
To evaluate the long-term base stiffness after micro-cracking, additional FWD tests were performed in May 2015, approximately eighteen months after construction. The back-calculated moduli of all the PRF sections are presented in Figure 27. As expected, the base moduli were found similar to each other for the same type of base courses. In general, the average base moduli were 464 ksi for the soil cement bases and 231 ksi for the cement treated soil bases.

Figure 27
Back-calculated moduli of PRF bases as of May 2015.

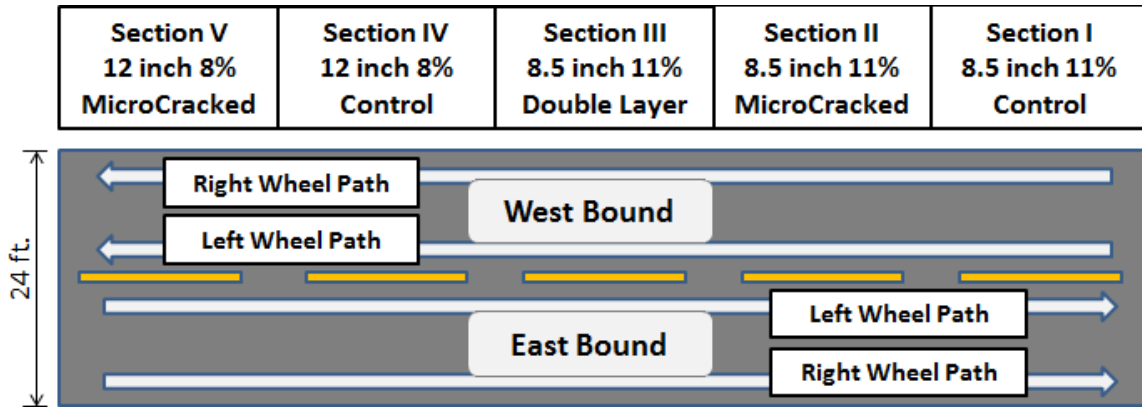
Figure 28 shows the plan view of the five test sections constructed in LA 1003. Each test section is approximately 1000-ft. long and 24-ft. wide, including one westbound (WB) lane and one eastbound (EB) lane. All the sections have a surface layer of 3.5 in. HMA. Especially, Section I (control) and Section II (micro-cracked) include an 8.5-in. soil cement base; whereas Sections IV (control) and V (micro-cracked) consist of a 12-in. cement treated base. Section III is a special section with a double chip seal layer over an 8.5-in. soil cement base. Micro-cracking was accomplished with a 14.5-ton roller on September 26, 2014. More details can be found in the Methodology section of this report.

Figure 28
Plan view of LA1003 test sections

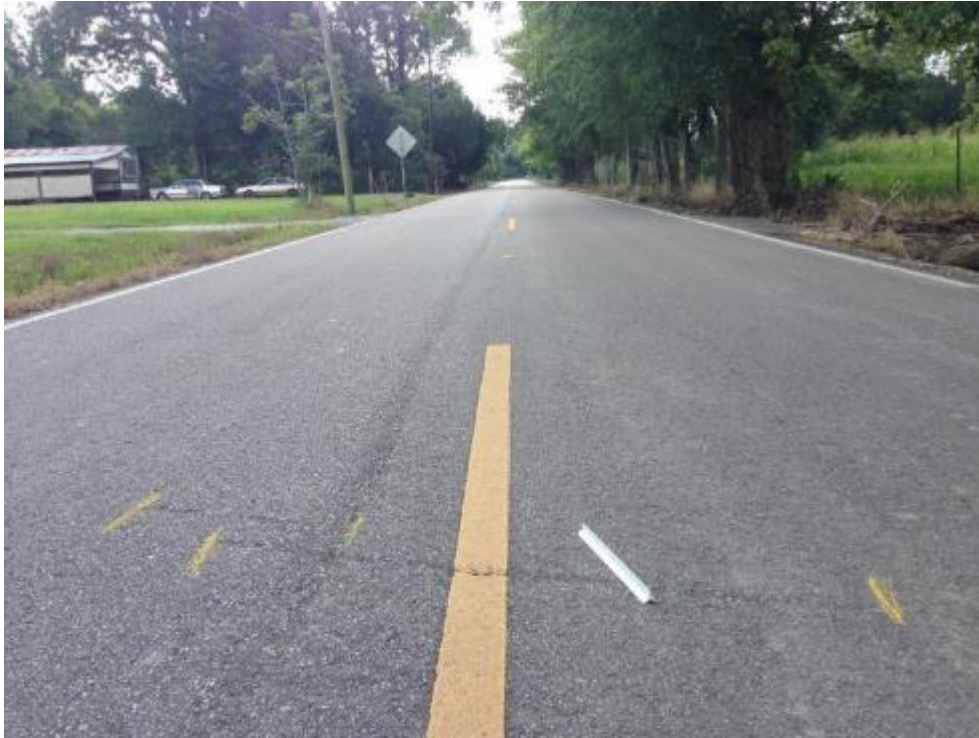
followed the same format. Only two transverse cracks were noticed on Section I as shown in Figure 29 and they are possibly reflective cracks due to the shrinkage of the soil cement base. Figures 32-33 show the pavement views of Section II and no surface cracks were found on Section II.

Transverse cracks near S1+715 on Section I of LA1003

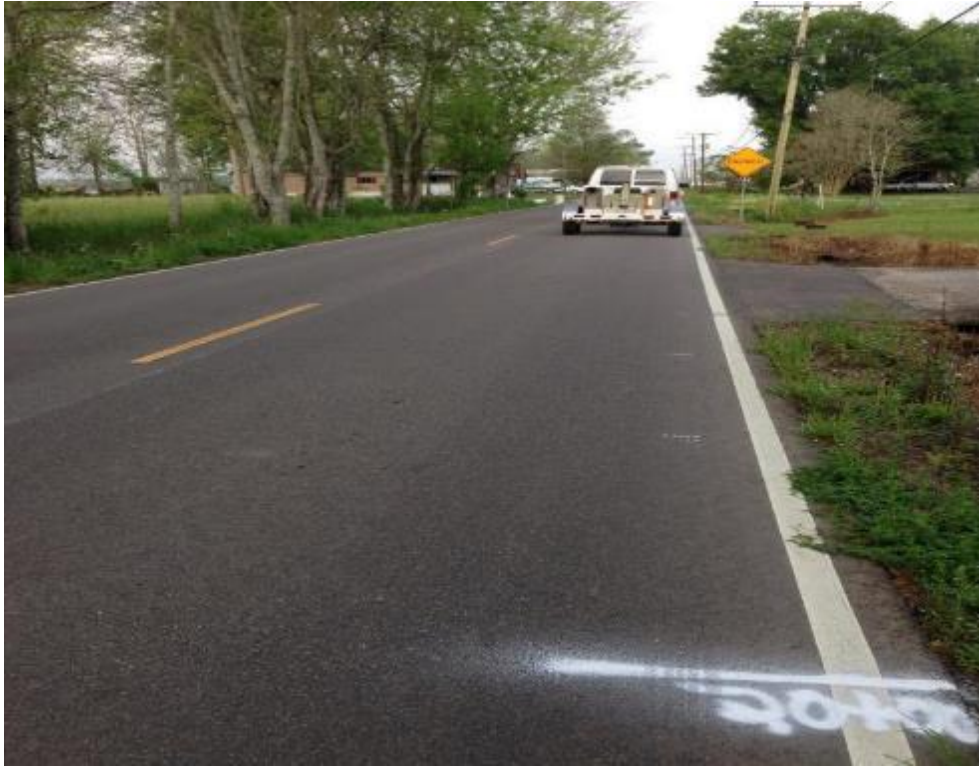
Figure 32
Westbound lane of Section II (first part) on LA1003

The cracking performances above may indicate that the micro-cracked soil cement section (Section II) performed slightly better than the non-micro-cracked section (Section I) in term of the reflective cracking. However, due to the relatively low crack density of the two test sections and the short duration (only three years) of low-volume roadway service, it may be too early to draw a conclusion.

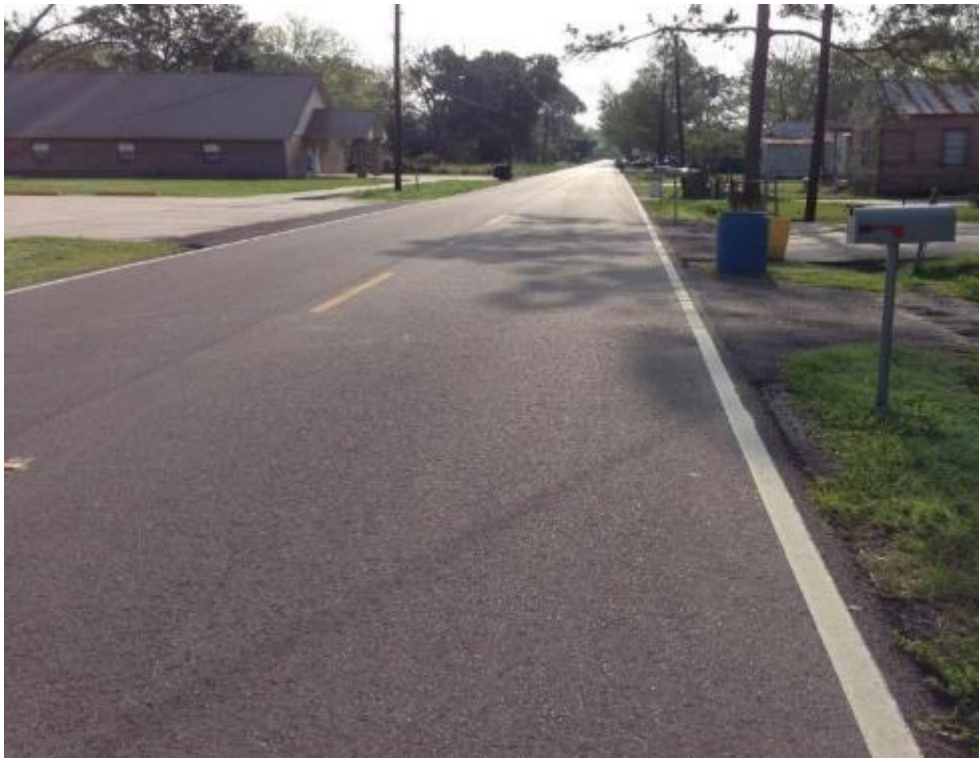
Figure 33
Westbound lane of Section II (second part) on LA1003

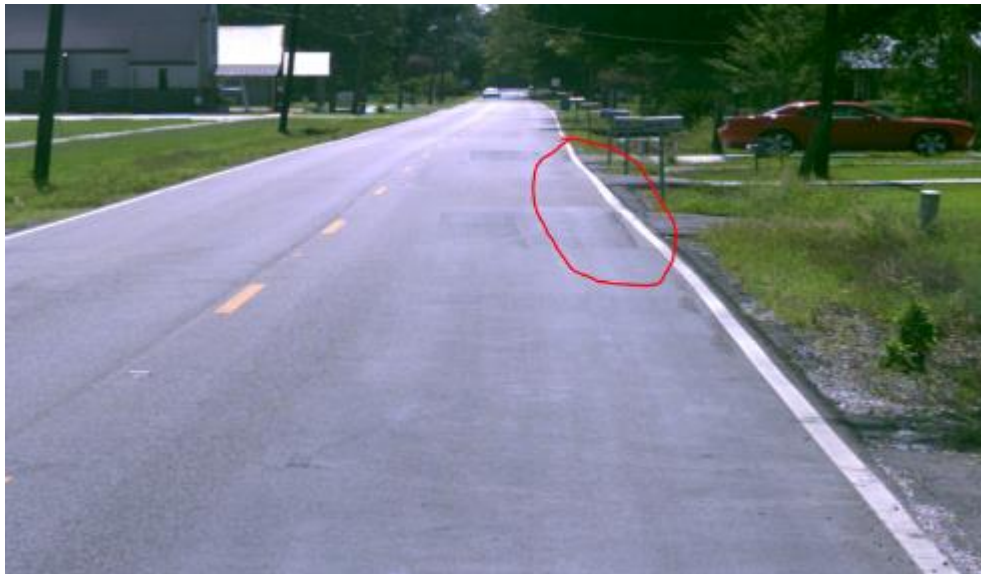
Figure 37
View of section I WB in front of residential entrances

The IRI test results on the right wheel paths of Sections IV and V are shown in Figure 49. For the right wheel paths of these two lanes, the average IRI values of micro-cracked sections are larger than those of their corresponding control sections. Table 14 summarizes the average IRI values and the results of the statistical analysis. It is found out that the difference is statistically significant in the westbound lane. The possible reason is that a residential area close to the westbound lane may have a higher influence on the westbound pavement surface, similar to the situation of Sections I and II (Figure 37).

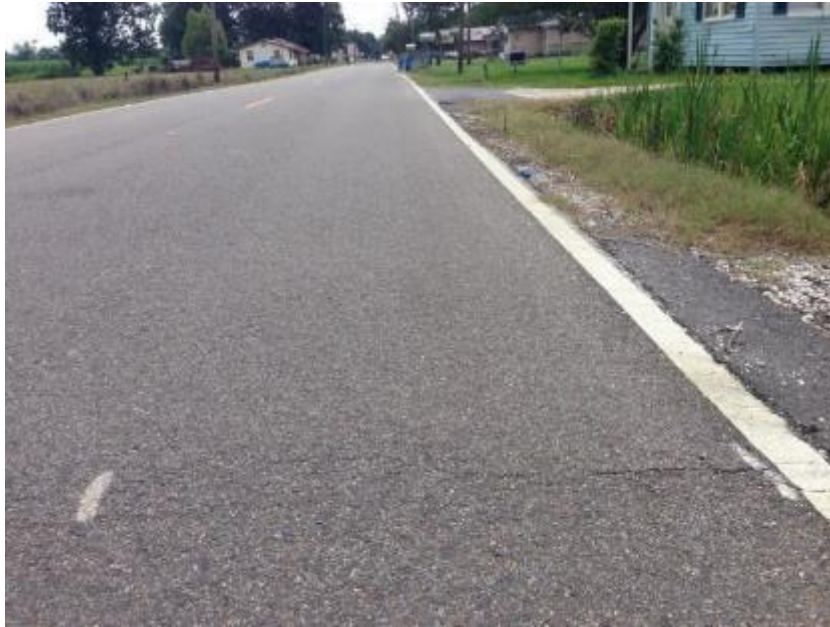
Figure 39

Crack performance. In total, two transverse cracks and 16 longitudinal cracks were observed on Section IV (the control section). Figures 38 and 39 show the transverse crack locations on Section IV, which are approximately 4 ft. long and 1-2 mm wide.

Transverse cracking, westbound lane, 4 ft. long, 2 mm wide (S4+500)

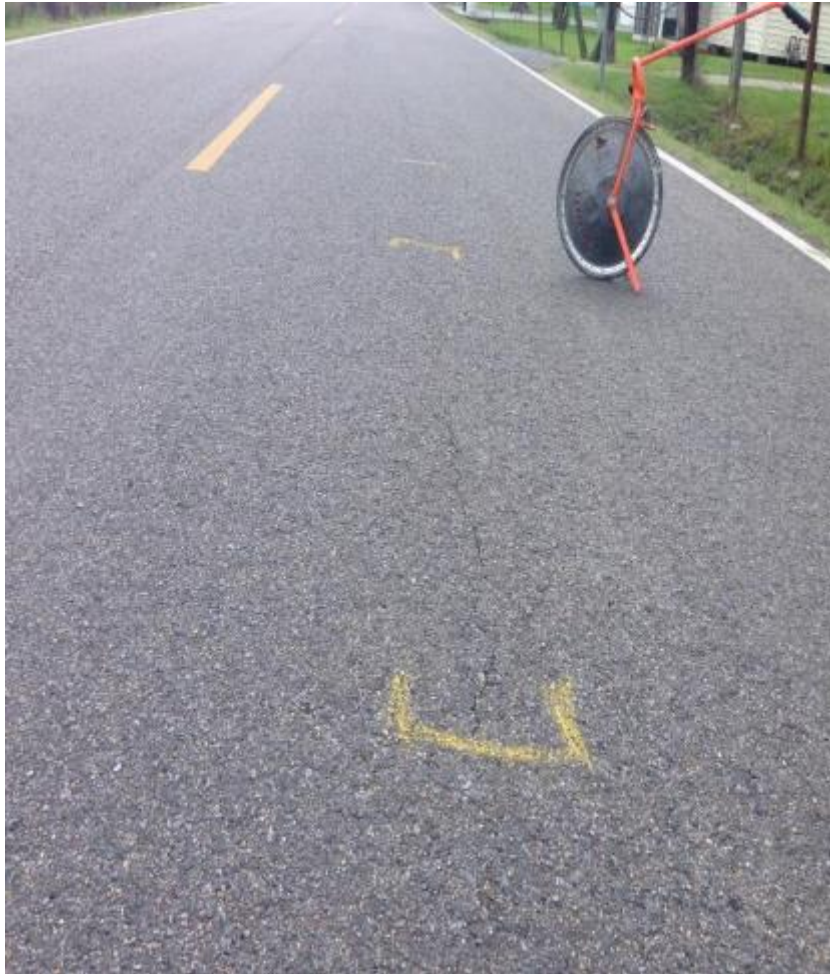
Figure 40

Figures 40 through 42 present typical longitudinal cracks on Section IV. Most of the longitudinal cracks (less than 10 ft. long and about 2 mm wide) occurred in the middle of a lane between wheel paths.

Longitudinal cracking, westbound lane, 8 ft. long, 2 mm wide (S4+380 approx)

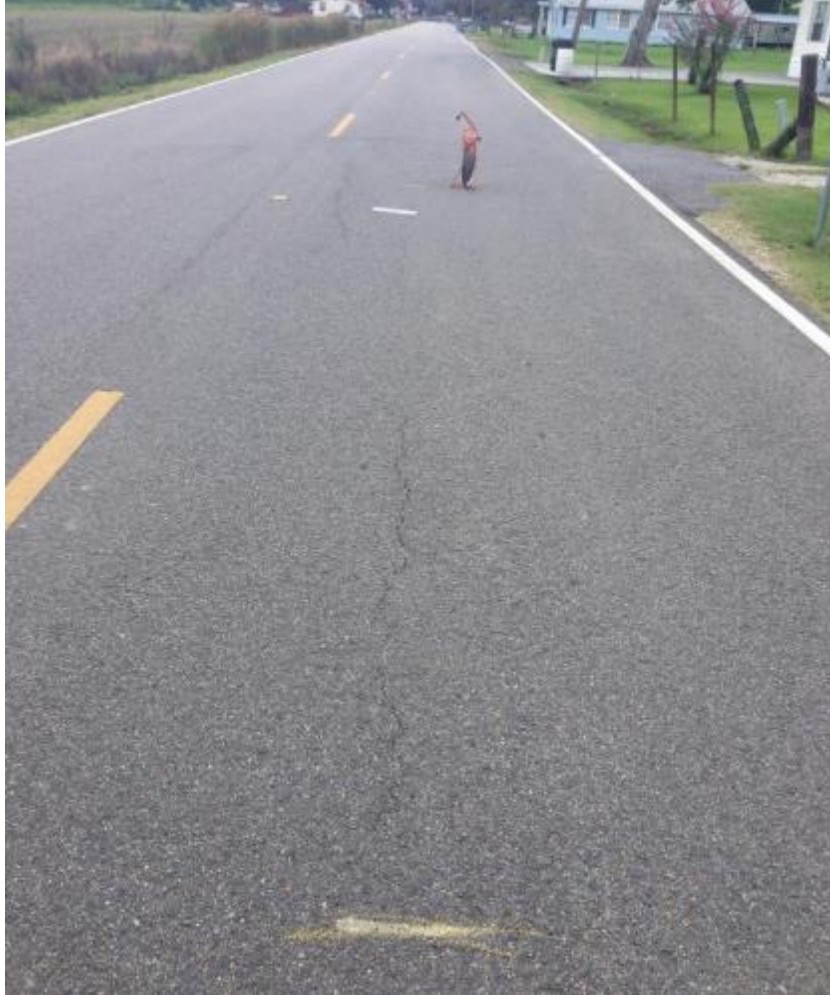
Figure 41

Longitudinal cracking, westbound lane, 26 ft. long, 2 mm wide (S4+639 approx)

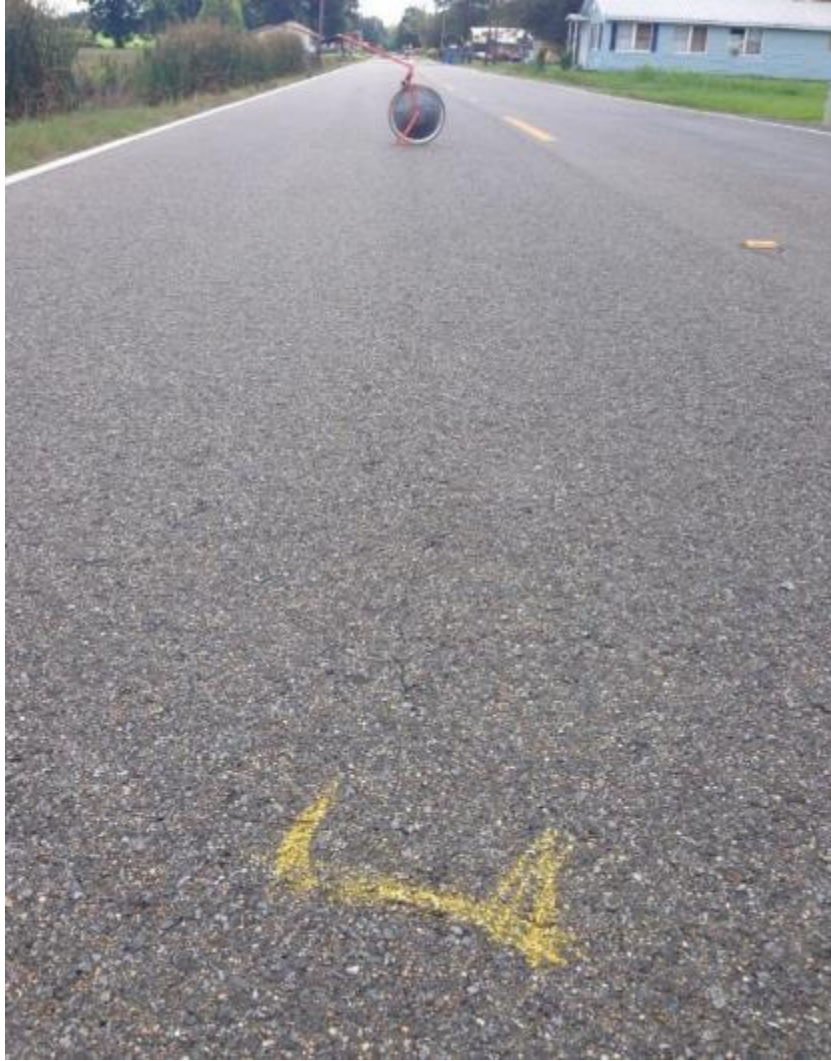
Figure 42

Longitudinal cracking, eastbound lane, 24 ft. long, 1 mm wide (S4+640 approx.)

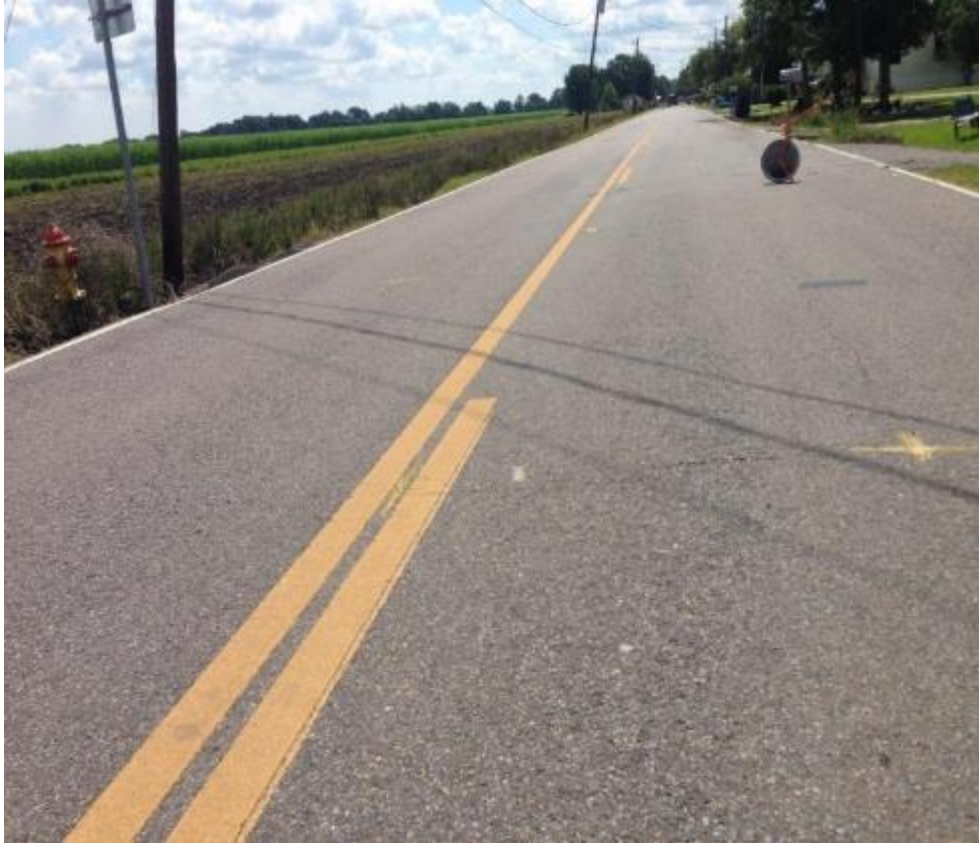
Figure 43

Figures 43-45 show three major transverse cracks on Section V. Although this section has been micro-cracked during its base construction, it did show slightly more transverse cracks than the control section IV in terms of both the cracking occurrence frequency and the total length, as listed in Table 8.

Transverse cracking, westbound lane, 4 ft. long, 2 mm wide (S5+448)

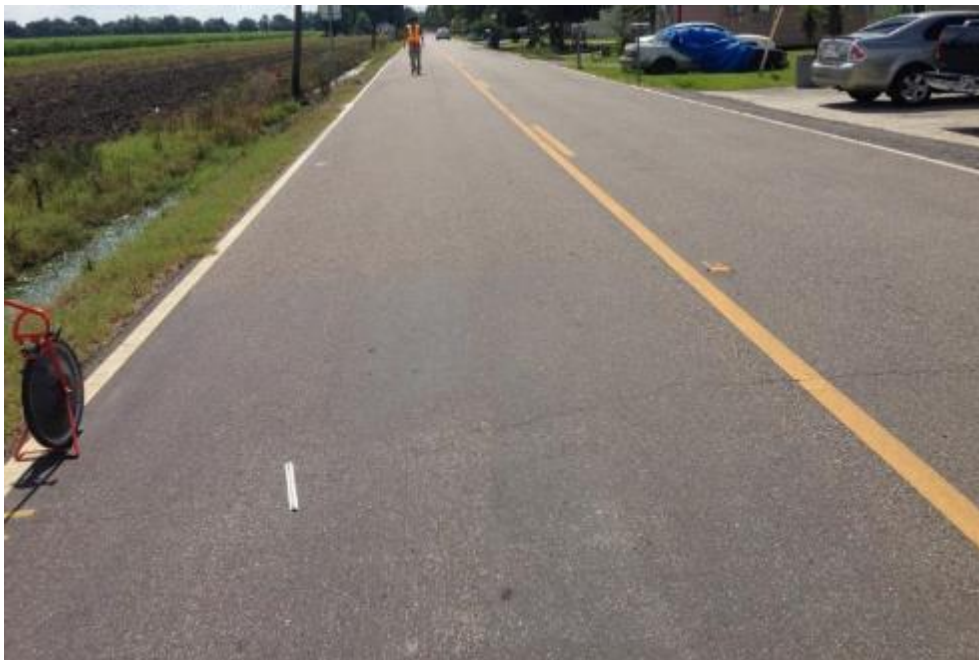
Figure 44

Transverse cracking, eastbound lane, 12 ft. long, 1 mm wide (S5+500 approx)

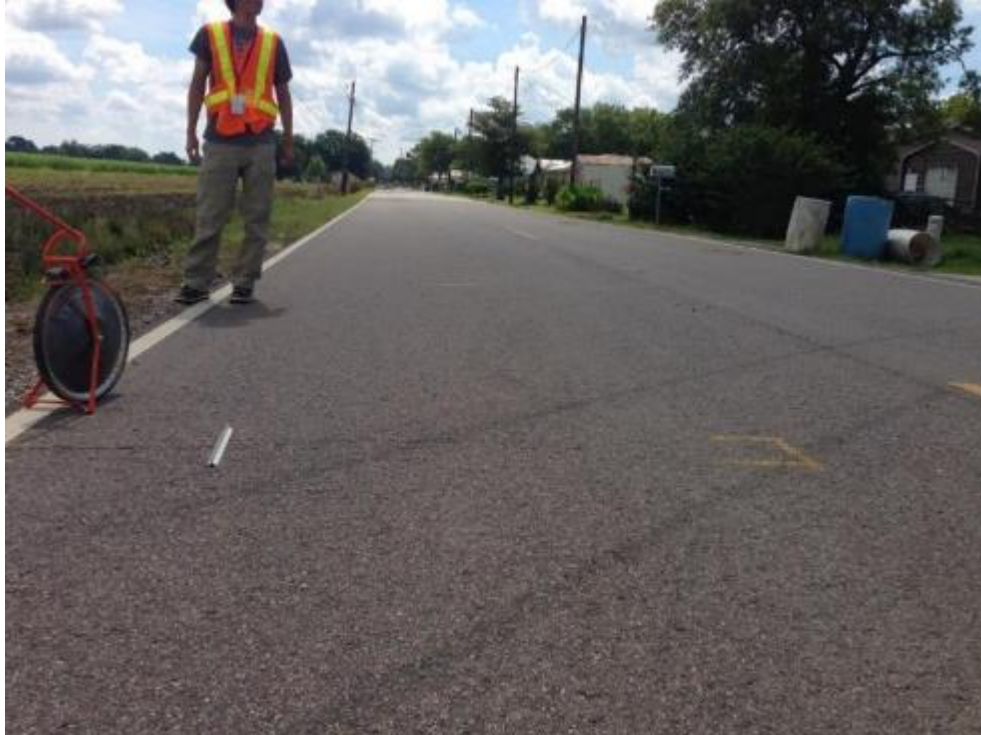
Figure 45

Transverse cracking, eastbound lane, 7 ft. long, 2 mm wide (S5+350 approx)
