1. Report No. FHWA/LA.18/588		2. Government Accession No.	3. Recipient's Catalog No.
4. Title and Subtitle Minimizing Shrinkage Cracking in Cement-Stabilized Bases through Micro-Cracking		5. Report Date October 2018

6. Performing Organization Code LTRC Project Number: 12-3P SIO Number: 30000729	
7. Author(s) Zhong Wu, Yilong Liu and Ferdous Intaj		8. Performing Organization Report No.

11. Contract or Grant No.	
12. Sponsoring Agency Name and Address Louisiana Department of Transportation and Development P.O. Box 94245 Baton Rouge, LA 70804-9245		13. Type of Report and Period Covered Final Report 11/2012 to 10/2017

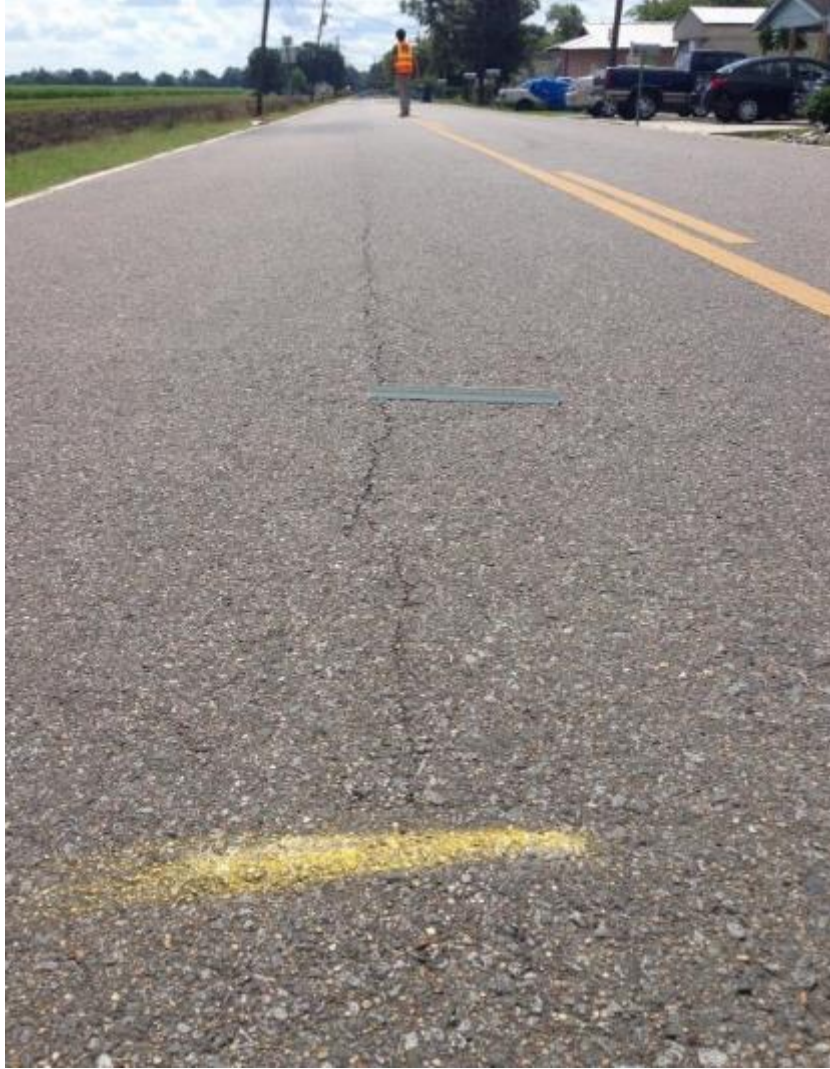
Figure 46

Figures 46 and 47 present typical longitudinal cracks on Section V. The longitudinal cracks observed on Section V are also located in the middle of a lane between the two wheel paths. Most of the cracks are less than 3-mm wide. It is worth mentioning that a 46-ft. long longitudinal crack was found on the eastbound lane at S5+541 (as shown in Figure 46). The longitudinal crack seems like a top-down cracking, resulted from the bending of the top asphalt concrete layer under heavy truck loading. The bending stress in the asphalt layer might also be exaggerated due to the weakened support caused either by the differential subgrade settlement or by a base failure, which was potentially caused by an over-compaction during the micro-cracking.

Longitudinal cracking, eastbound lane, 46 ft. long, 1 mm wide (S5+541)

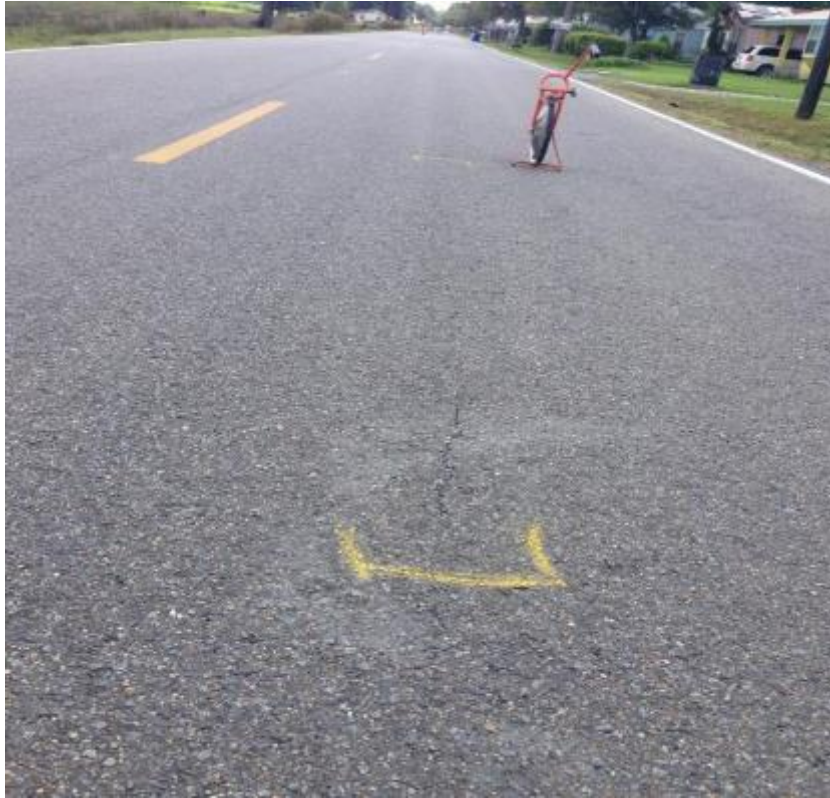
Figure 47

Longitudinal cracking, westbound lane, 12 ft. long, 2 mm wide (S5+122)

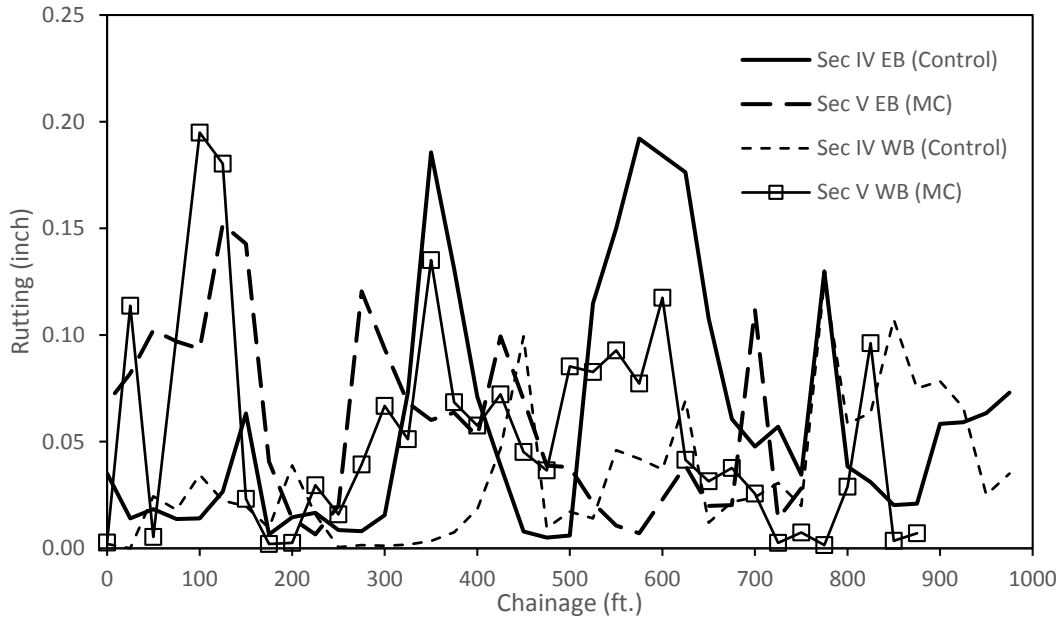
Figure 48

Rutting and IRI performance. Rut depth values were also measured and the results of Section IV and Section V are compared in Figure 48.

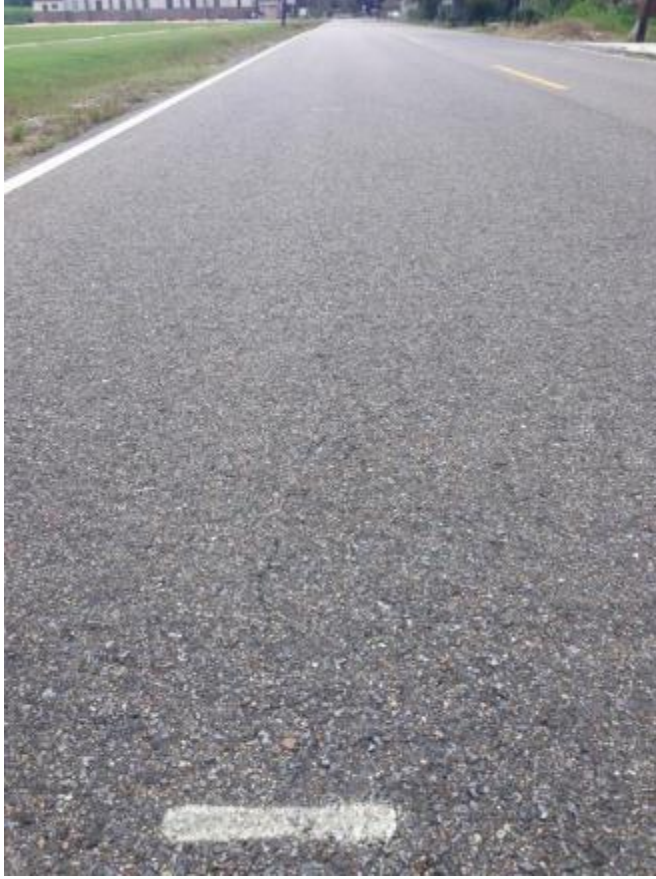
Figure 52

Crack Performance. The typical cracks observed on Section III are shown in Figures 52-55.

Longitudinal cracking, eastbound lane, 18 ft. long, 1 mm wide. (S3+307)

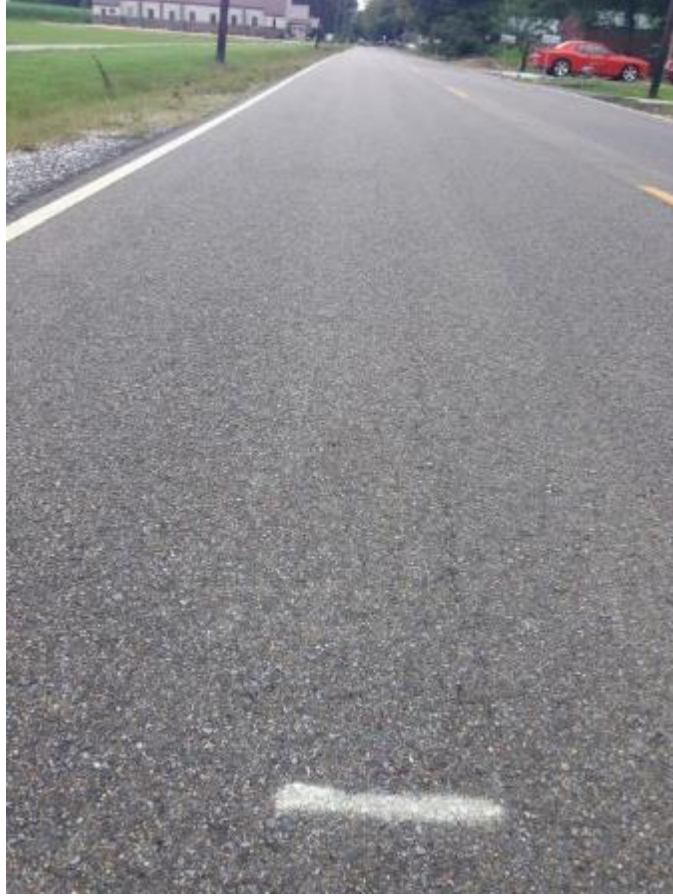
Figure 53

Longitudinal cracking, eastbound lane, 30 ft. long, 2 mm wide. (S3+358)

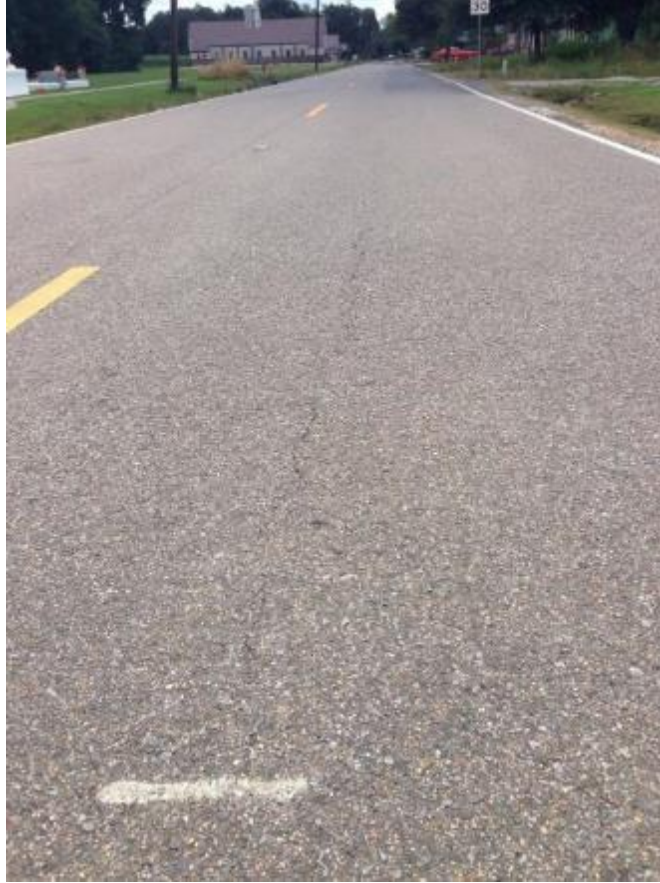
Figure 54

Longitudinal cracking, westbound lane, 26 ft. long, 2 mm wide. (S3+555)

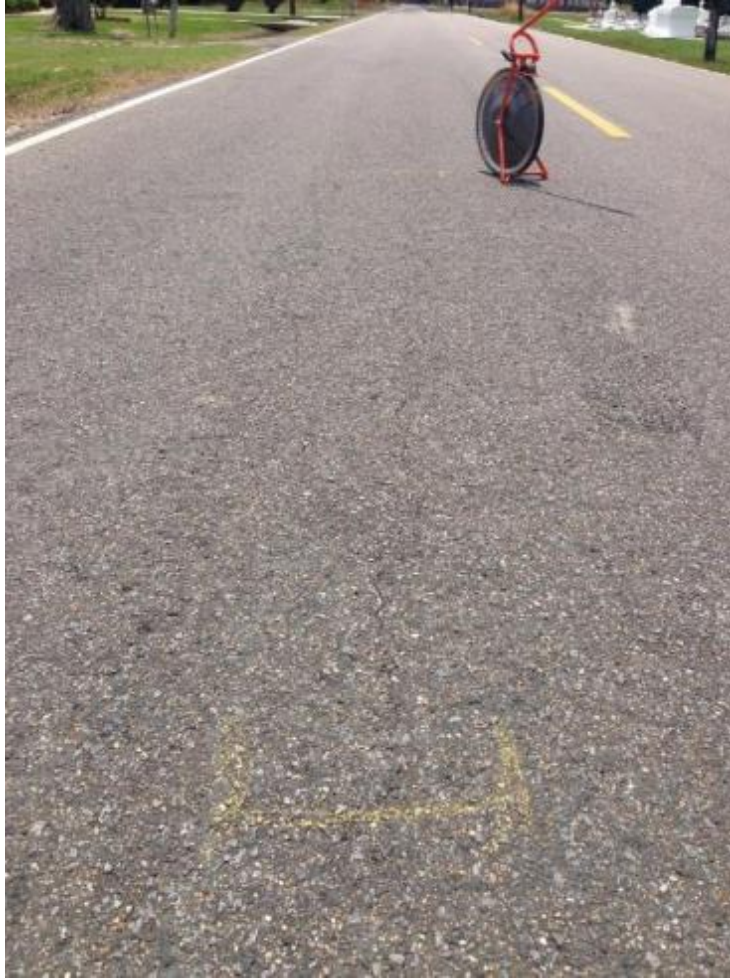
Figure 55

Longitudinal cracking, westbound lane, 11 ft. long, 1 mm wide. (S3+741)

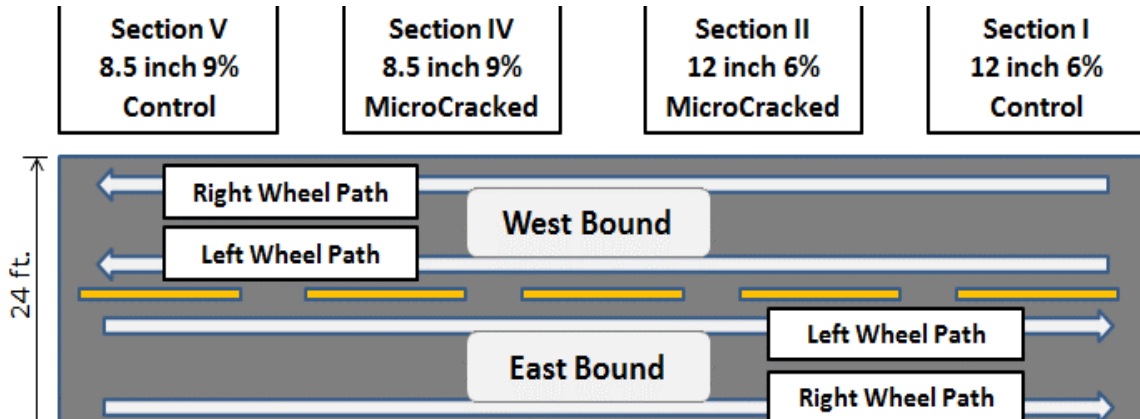
Figure 59 shows the plan view of five test sections constructed on LA 599. Each test section is approximately 1000-ft. long and 24-ft. wide, including one westbound (WB) lane and one eastbound (EB) lane. The sections have a 3.5-in. HMA layer. As shown in Figure 59, Section I (control) and Section II (micro-cracked) consist of a 12-in. cement treated base, whereas Section IV (micro-cracked) and Section V (control) include an 8.5-in. soil cement base. Section III is a 12-in. thick soil cement section. Due to a construction mistake of Section III, the section was not discussed in this report. Micro-cracking was performed by a 14.5-ton roller on August 3, 2015. More details may be found in the Methodology section of this report.

Figure 59
Section plan view of LA599

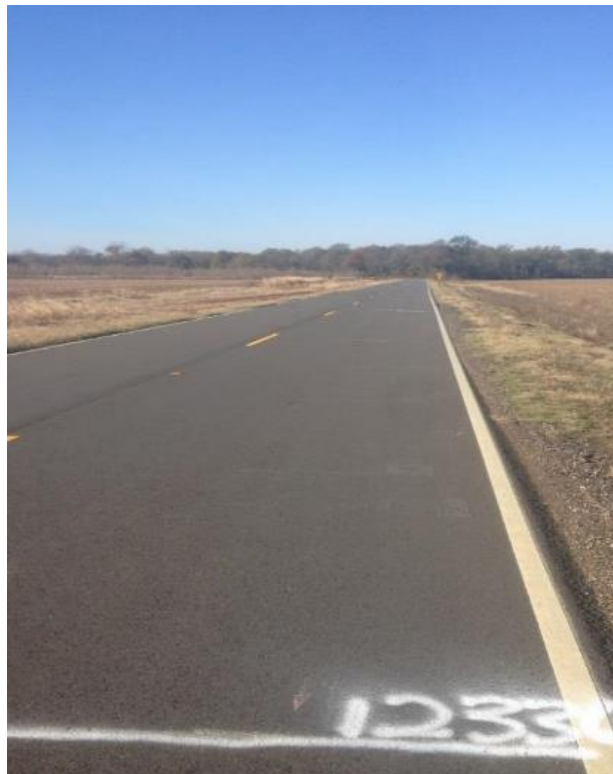
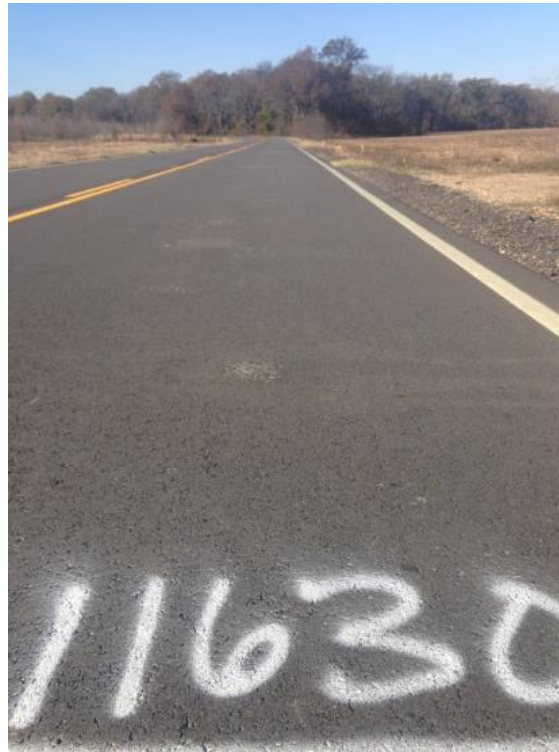
Figure 60

Crack Performance. Only two hair-line type longitudinal cracks were found on Section I, as shown in Figure 60. These cracks, developed along the centerline of the westbound lane of Section I, were too fine to be observed in a photo. No transverse cracks were found in this section.

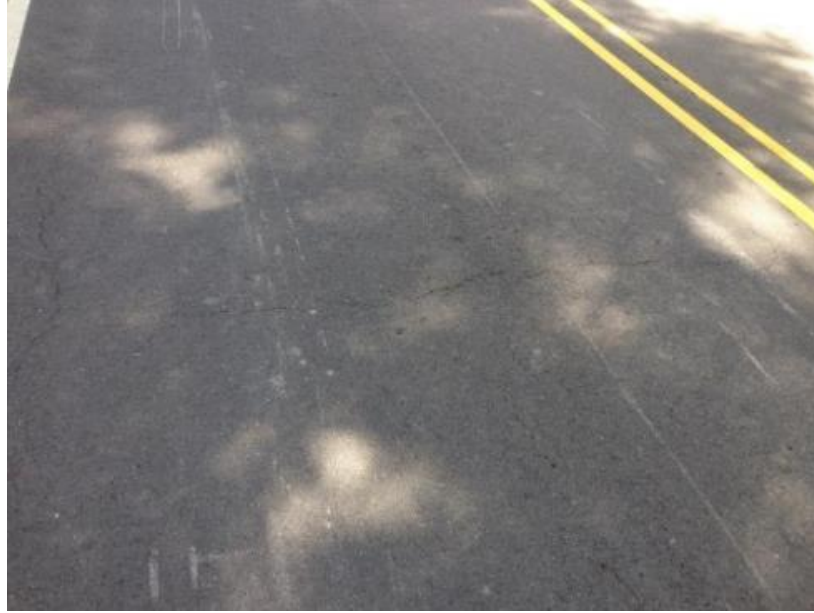
On the other hand, one transverse crack and nine longitudinal cracks were found on Section II on LA 599. Figure 61 shows the transverse crack observed and Figures 62-65 present typical longitudinal cracks found.

Transverse cracking with 9 ft. long and 2 mm wide on eastbound lane (S2+261)

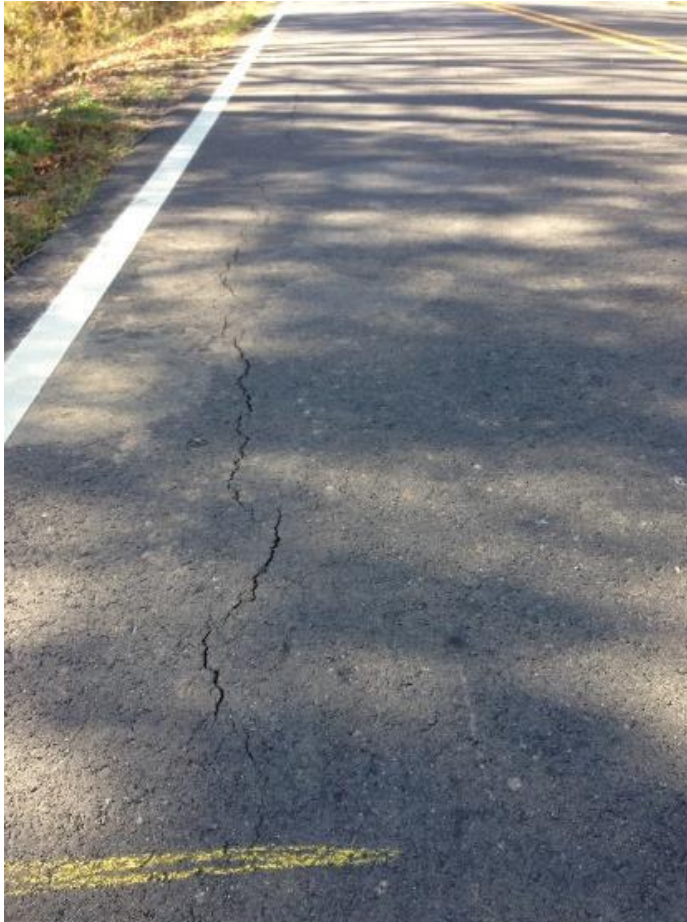
Figure 62

Longitudinal crack with 23 ft. long and 6 mm wide on eastbound lane (S2+327)

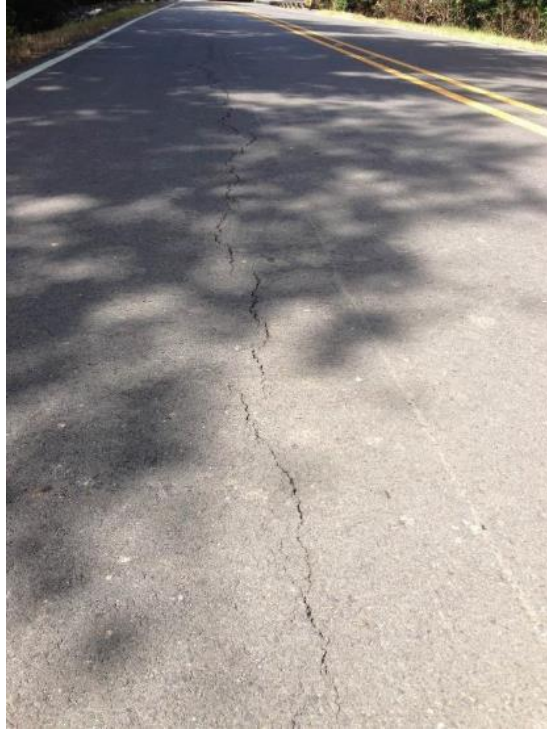
Figure 63

Longitudinal crack with 64 ft. long and 8 mm wide on eastbound lane (S2+267)

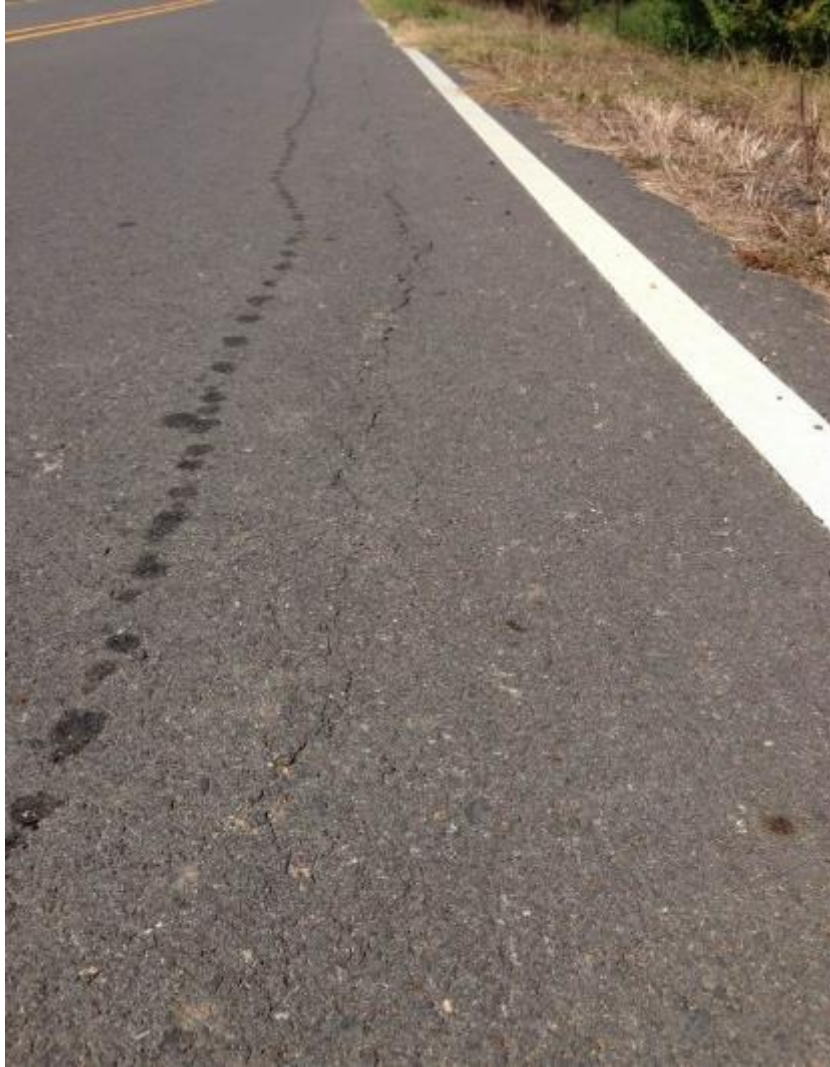
Figure 64

Longitudinal cracking with 20 ft. long and 5 mm wide on westbound lane (S2+486)

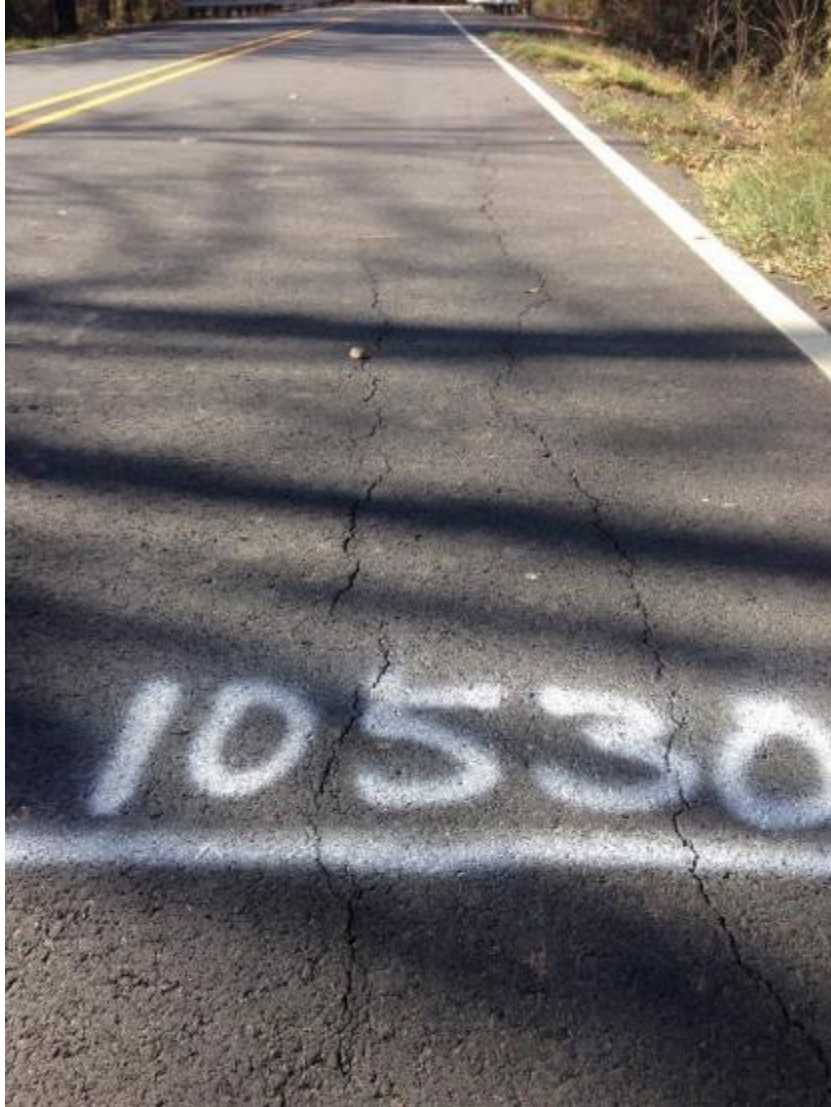
Figure 65

**Two longitudinal cracks with 22 & 43 ft. long and 10 mm wide on westbound lane
(S2+269 & S2+243)**

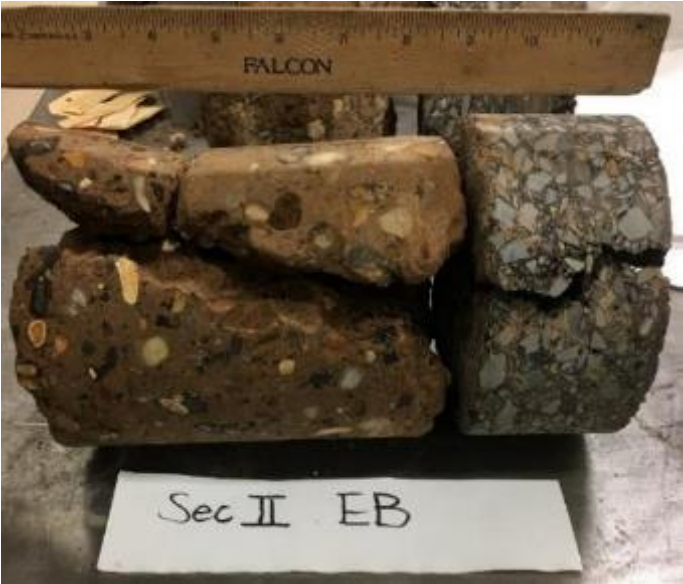
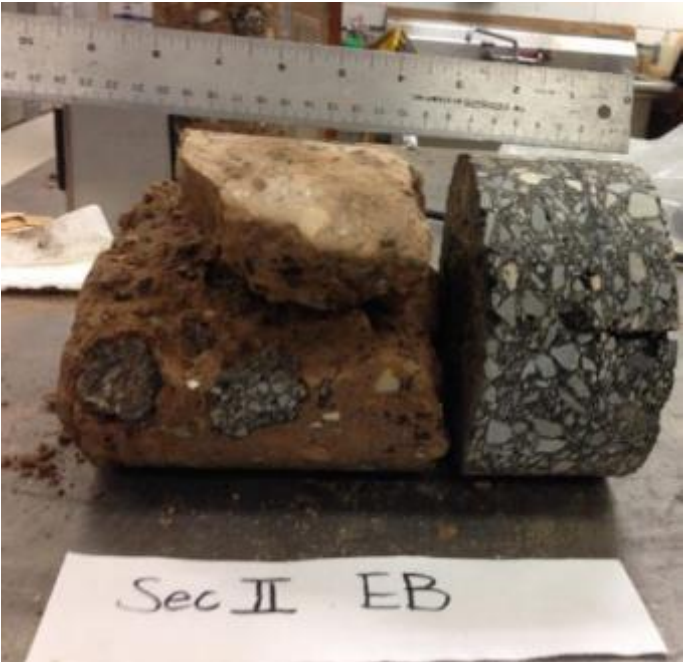
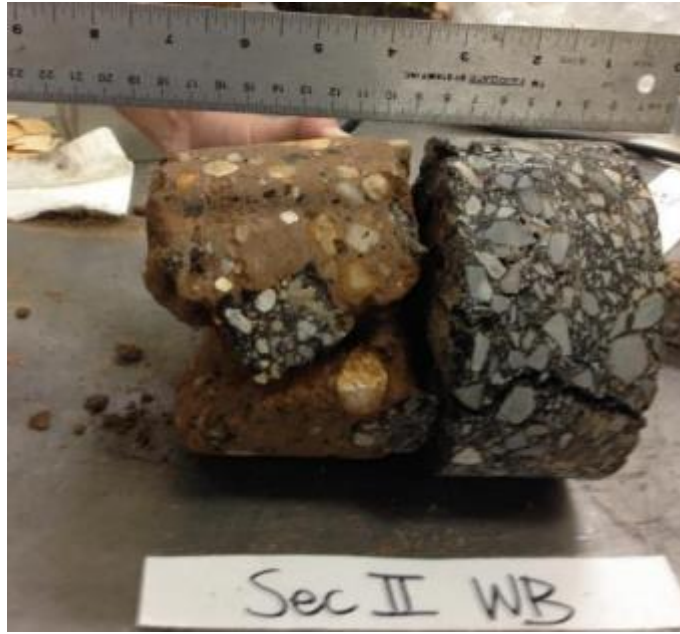
Three cores were taken on the selected cracked locations on Section II. Figure 66 shows the retrieved cores. As expected, all cores showed that there was no bonding between the asphalt and the base layer. Core #1, taken at a transverse crack location on Section II, clearly shows

that the crack is a reflective one. On the other hand, Cores #2 and #3 were taken from two longitudinal crack locations, and both of them seemed to be top-down cracks. In addition, only the top 3-in. portion of the 12-in. cement treated soil base was able to core out for Cores #2 and #3, indicating a weak cement bonding at the bottom portion of the base layer, at least at the locations of the two cores. No cores were taken from Section I, as no cracks were found in the visual crack survey. It should be noted that longitudinal cracks on Section I were detected by the road surface profiler during the subsequent survey.

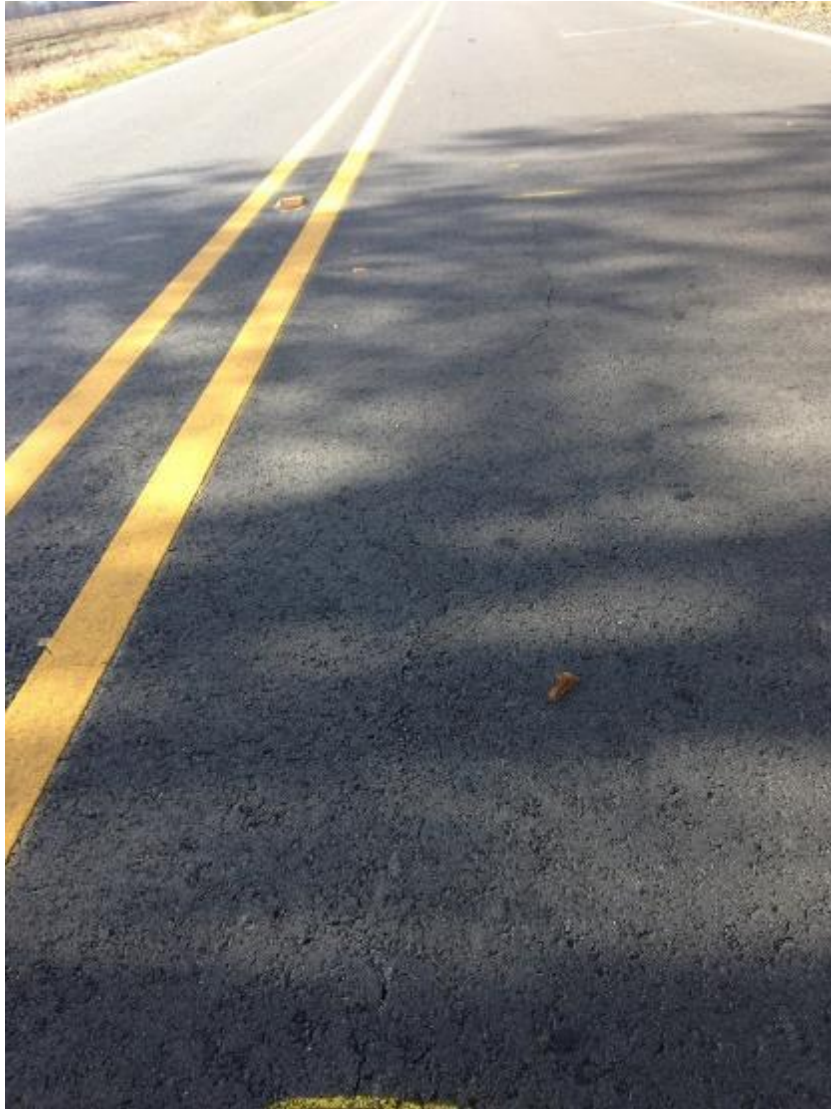
Figure 72

Longitudinal cracking, westbound lane, 11 ft. long, 5 mm wide (S4+374).

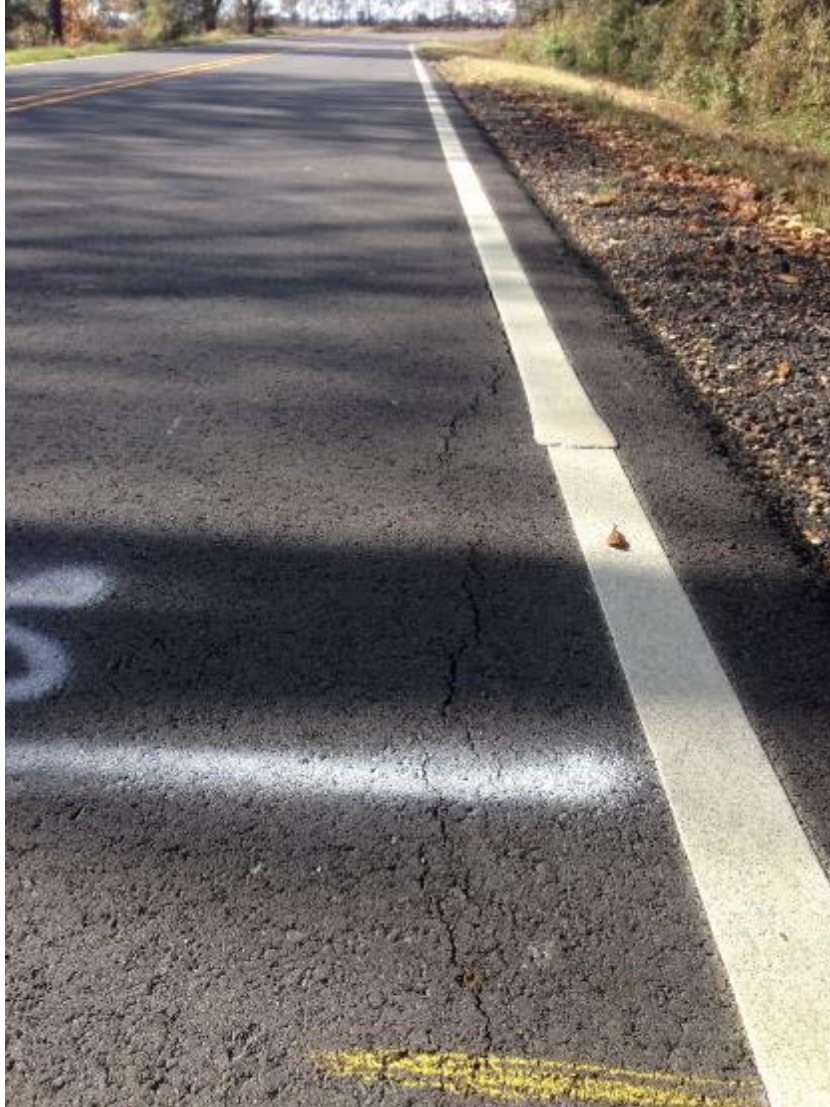
Figure 73

Longitudinal cracking with 35 ft. long and 5 mm wide on the westbound lane (S4+163).

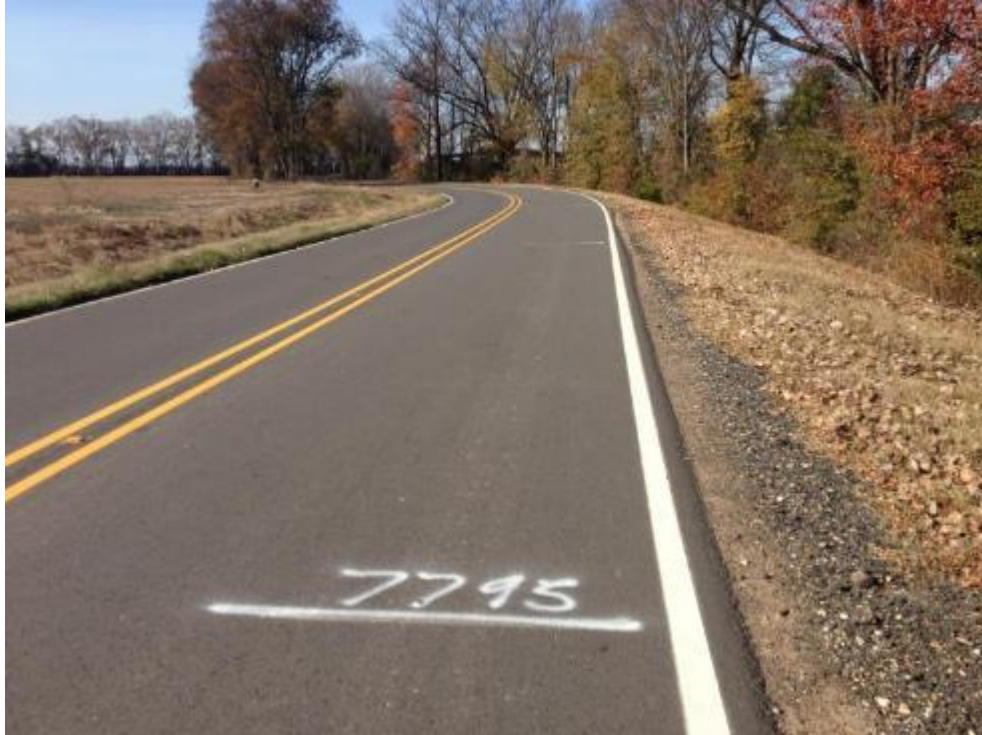
There was no cracking observed on Section V (control section). Figures 74 and 75 show two pavement views from Section V.

Westbound lane of Section V (first part) on LA599

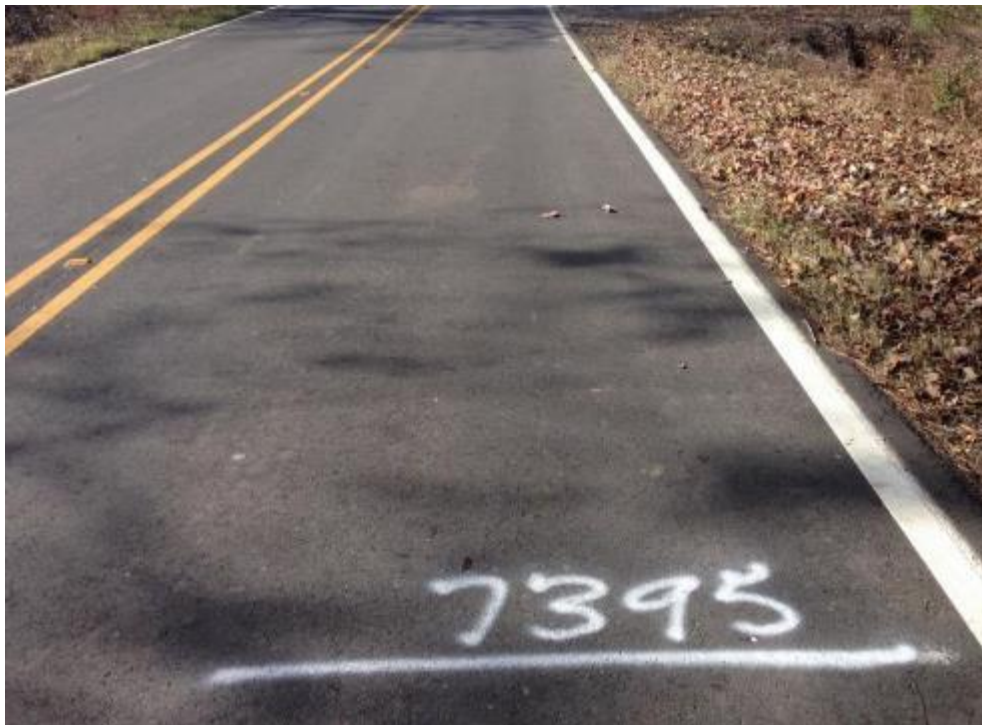
Eastbound lane of Section V (second part) on LA599

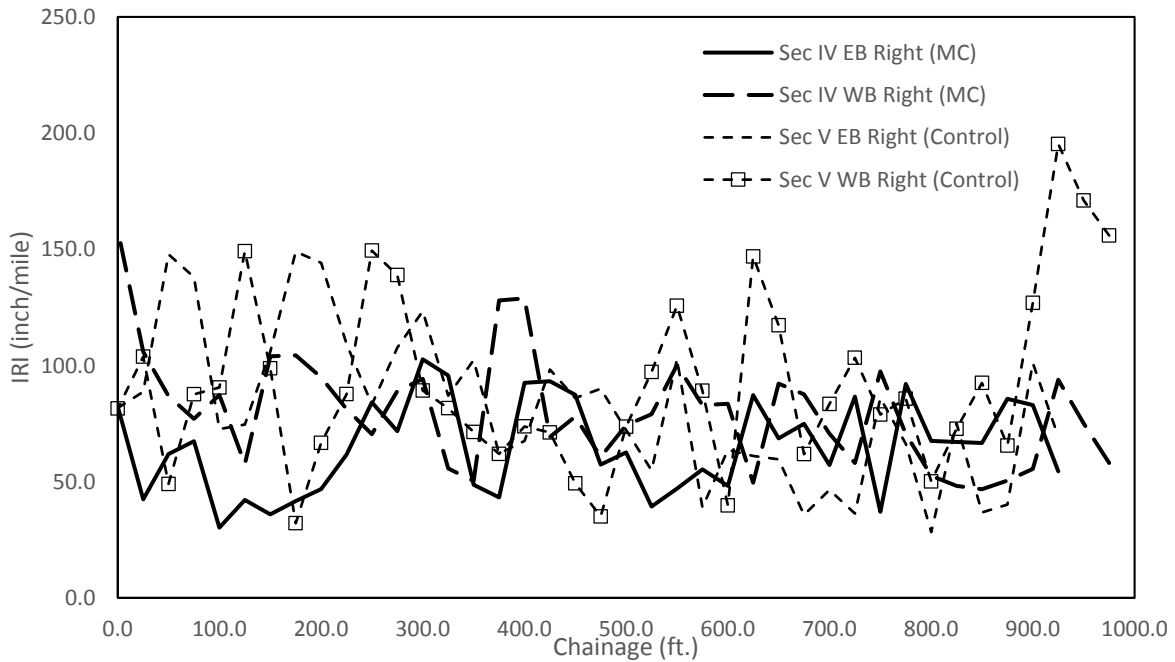
Figure 77
IRI values in the right wheel paths of Sections IV & V on LA 599

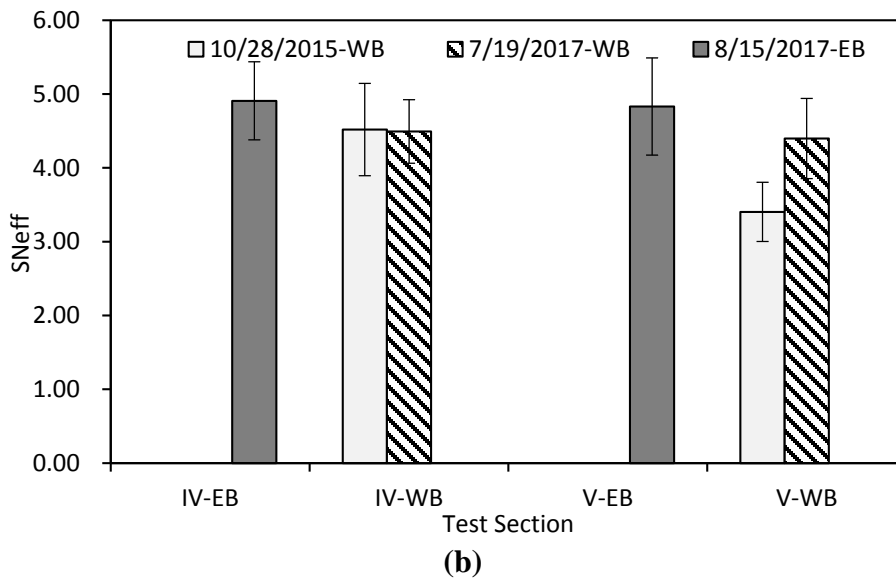
Figure 83
Effective structural numbers on LA 599 (a) Section I vs. Section II (b) Section IV vs. Section V
