# Motorcycle Crash Data Analysis to Support Development of a Retrofit Concrete Barrier System for Freeway Ramps

JULY 2019 | Final Report

1. Report No. TTI-Student-04	2. Government Accession No.	3. Recipient's Catalog No.	
4. Title and Subtitle Motorcycle Crash Data Analysis to Support Development of a Retrofit Concrete Barrier System for Freeway Ramps		5. Report Date July 2019

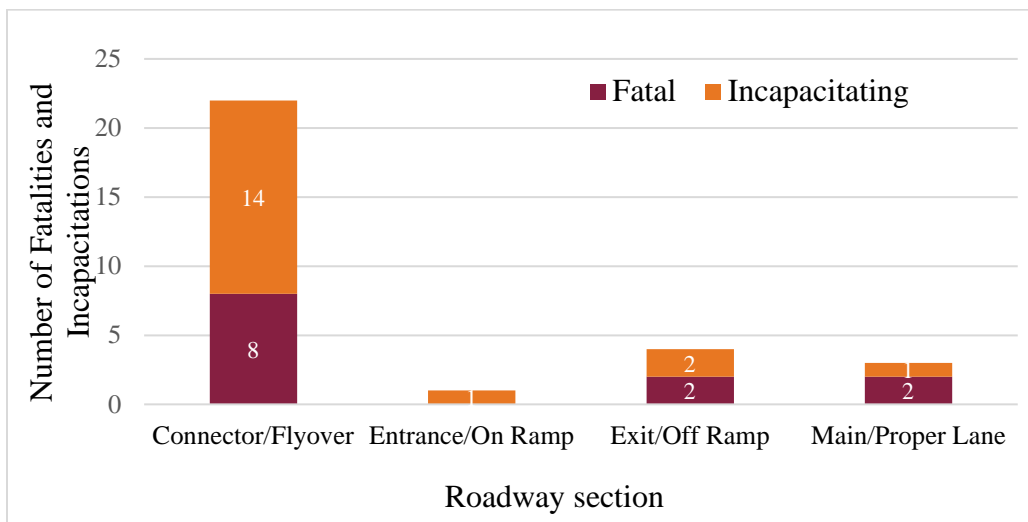
**Figure 3. Chart. All KA on flyovers/connectors for various roadway sections.**

Similarly, different sections of roadway were recorded. Even though all 30 of the fatal and incapacitating cases occurred on flyovers/connectors, only 22 were reported to be flyovers/connectors by the officer. Various other roadway sections where these accidents occurred were on exits/off-ramps and in the main/proper lane, with four and three total KA, respectively. All fatal and incapacitating injuries on flyovers/connectors for various roadway sections can be seen in Figure 3 below.

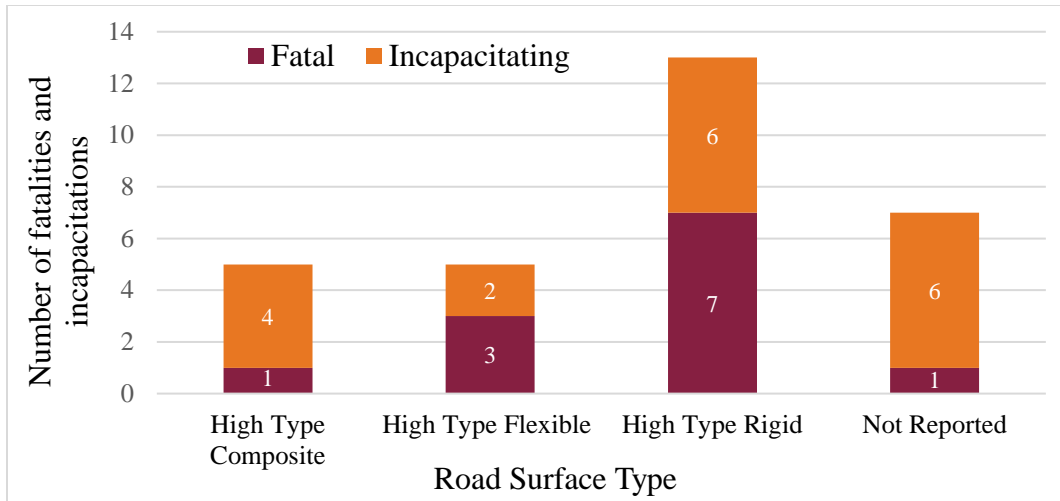
Figure 5. Chart. All KA on flyovers/connectors for various road surfaces.

The road surface type analysis is shown in Figure 5 below. The maximum number of fatalities and incapacitating injuries happened on High Type Rigid road surfaces. The road surface type that was recorded to have the second highest number of fatalities was High Type Flexible, with three fatalities.

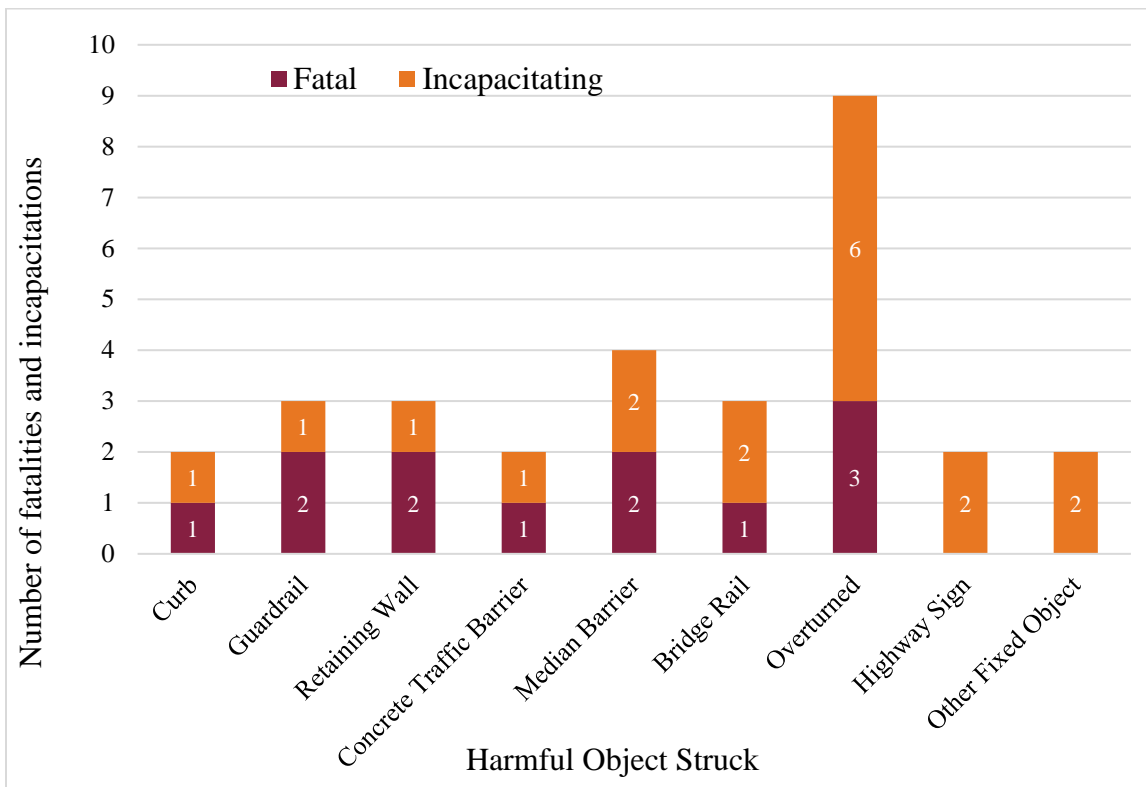
Figure 6. Chart. Distribution of all harmful objects struck resulting in KA on flyovers/connectors.

Figure 6 breaks down the different objects that were struck by motorcyclists in the 30 fatal and incapacitating cases. For cases where no object was struck, many times the bike was overturned, so Figure 6 also shows the number of fatal and incapacitating injuries received by motorcyclists overturning their motorcycle.

Figure 6 demonstrates that many riders involved in a crash on a flyover/connector either struck some type of roadside safety barrier or overturned their bike. On many of these flyovers and connectors, the “median width,” or the distance between where the lane ends and the barrier starts, was found to play some role in the distribution of injuries. Figure 7 shows the number of fatal and incapacitating injuries for different median widths. The highest number of incidences was nine when the median width was between 0 and 10 feet. The next most frequent range of median widths that resulted in either fatal or incapacitating injuries was much larger at 30 to 40 feet. Six KA

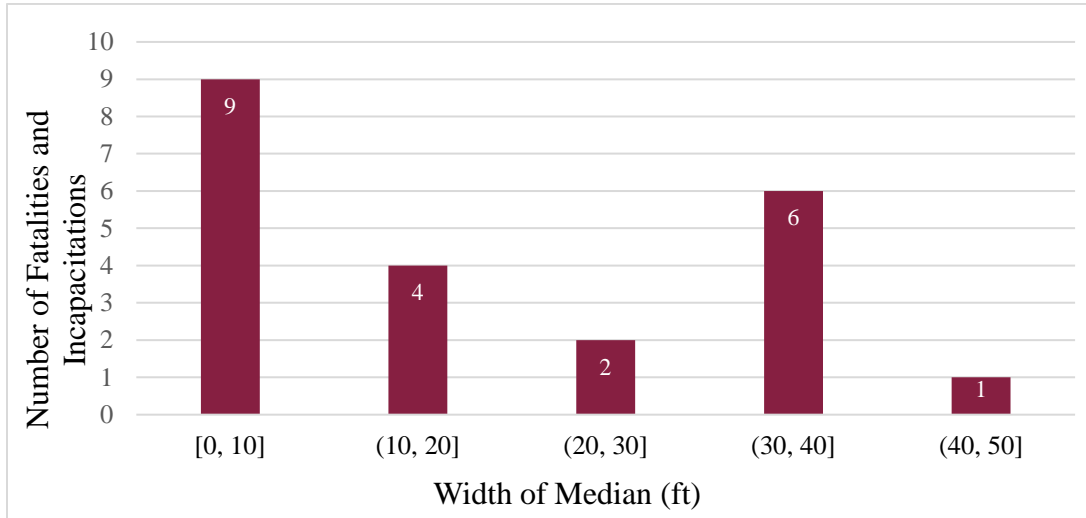
**Figure 7. Chart. All KA for flyovers/connectors with various median widths.**

incidences occurred in the 30- to 40-foot range. Both of these instances could possibly point to a higher risk to riders when the median width is not at an optimal distance away from the rider. Due to the small sample size of KA on flyovers/connectors (only 30 cases), it is difficult to draw this assumption.

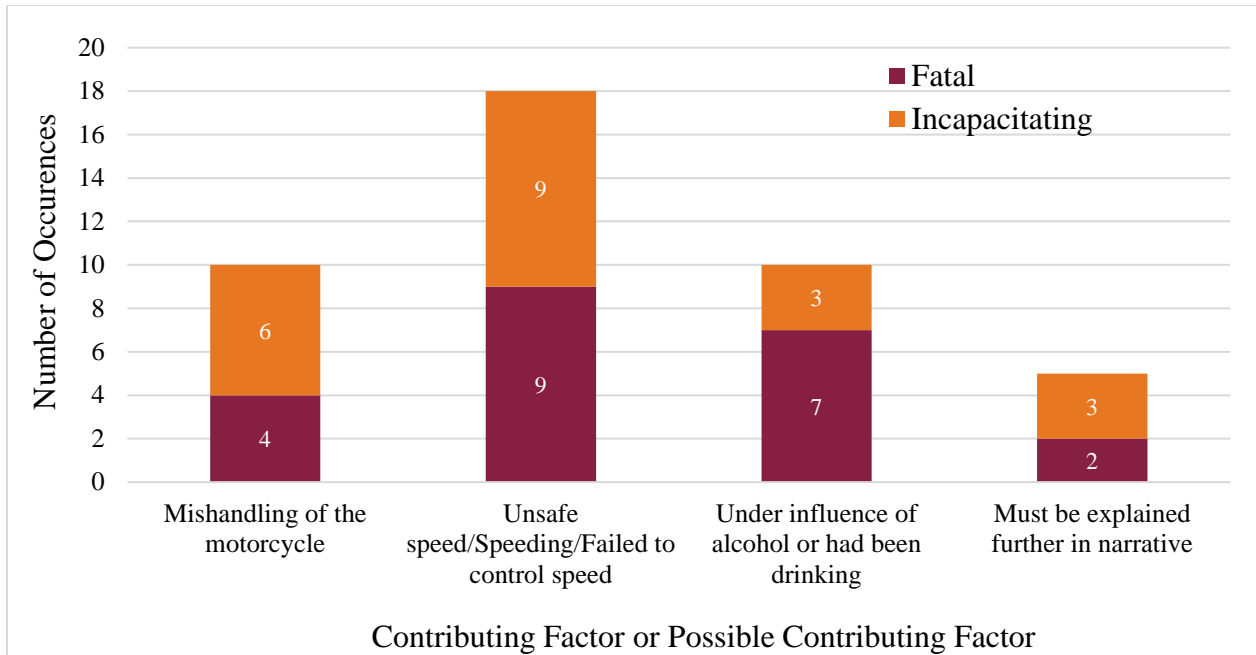
**Figure 8. Chart. Variation of contributing factors resulting in KA on flyovers/connectors.**

Figure 8 shows the breakdown of fatal and incapacitating injuries for the different categories of contributing or possible contributing factors. Different categories could have been created to analyze the data, but the ones that were felt to be the most effective were “Mishandling of the motorcycle,” “Unsafe speed/Speeding/Failed to control speed,” “Under influence of alcohol or drugs,” and “Needs to be explained further in narrative.”

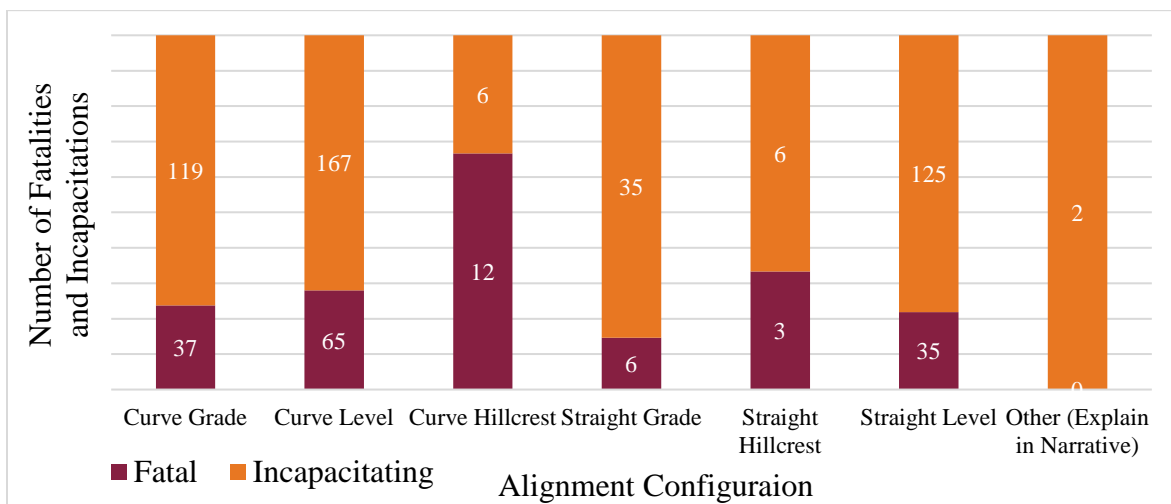
**Figure 9. Chart. All KA on curves for various road alignment configurations.**

Road alignment configuration, which is defined by TxDOT as “the geometric characteristics of the roadway at the crash site,” was recorded for each fatal and incapacitating case. The distribution of injuries for different configurations can be seen below in Figure 9.

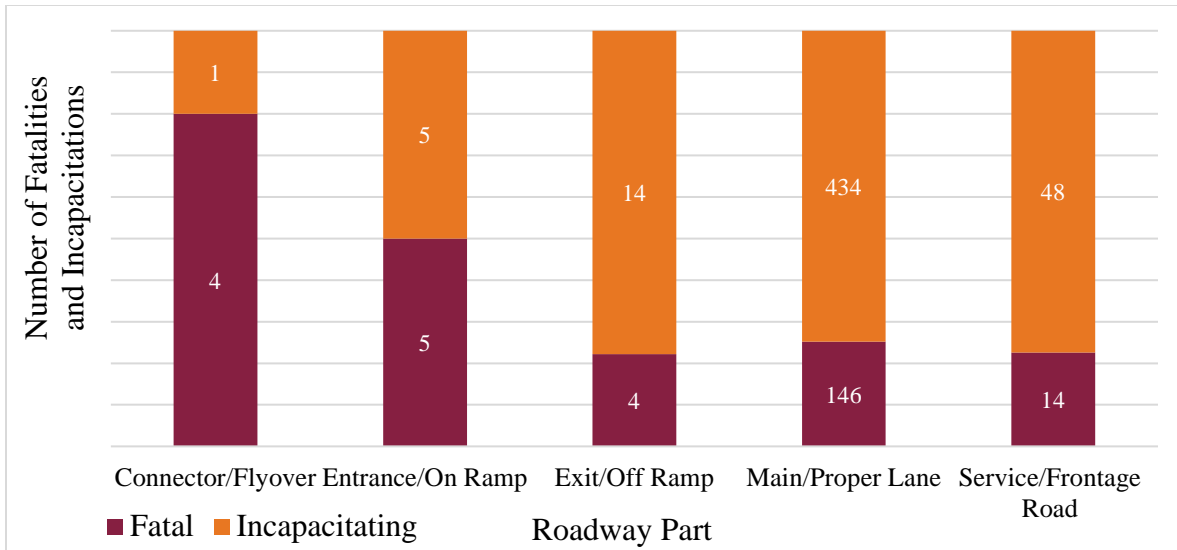
**Figure 10. Chart. All KA on curves for various roadway functional classifications.**

The fatal and incapacitating injury cases happening on curves can be further categorized based on roadway functional classifications. As seen in Figure 10, the majority of fatal and incapacitating injuries occurred in the main/proper lane. The category with the next highest number of fatal and incapacitating injuries was Service/Frontage Road. Very small numbers were recorded on roadways classified as both curves and flyovers/connectors.

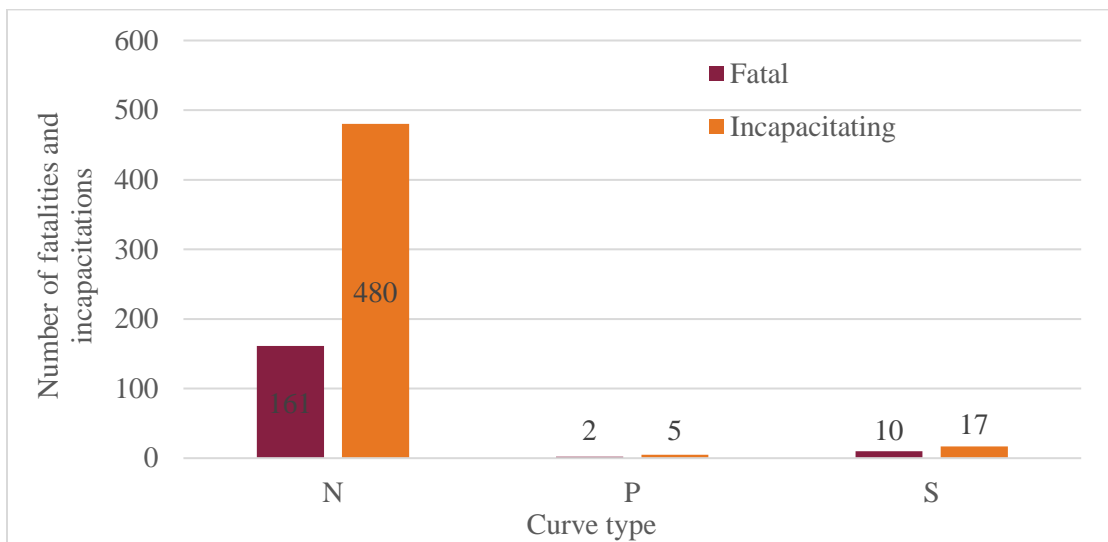
**Figure 11. Chart. All fatal and incapacitating injuries for various curve types.**

Each curve that was involved in these fatal and incapacitating cases can have different configurations, attributes, alignments, and properties. There are currently three types of curves that are used in Texas and recorded by officers when they conduct crash reports at the scene of the incident. These curve types as defined by TxDot are either type N, P, or S. The vast majority of injuries that happened on curves occurred on curves that were type N; small numbers were recorded for type S curves. The distribution of fatal and incapacitating injuries for different curve types can be seen in Figure 11.

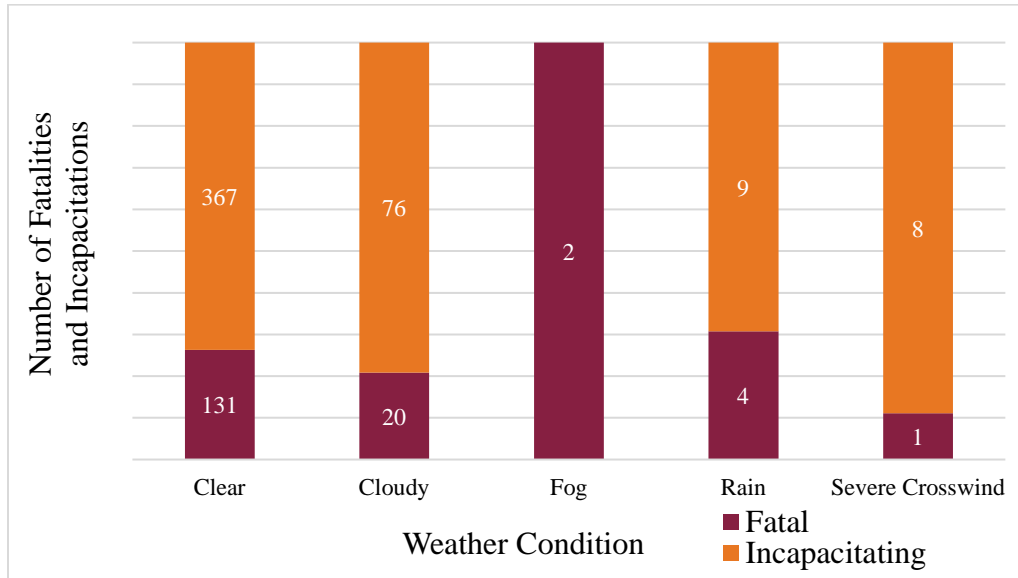
Figure 12. Chart. All KA on curves for various weather conditions.

All of the figures up to this point have focused on various aspects of the roadways, such as road type, alignment configuration, and roadway section type. Figure 12 and Figure 13, on the other hand, illustrate various environmental and lighting conditions. Figure 12 shows the distribution of fatal and incapacitating injuries in different weather conditions such as clear, cloudy, foggy, rainy,

and severe crosswinds. The most frequently recorded weather condition at the time of the accident for fatal cases (131) and incapacitating cases (367) was “clear.” The next most significantly recorded weather condition was “cloudy,” with 76 incapacitating cases and 20 fatal cases.

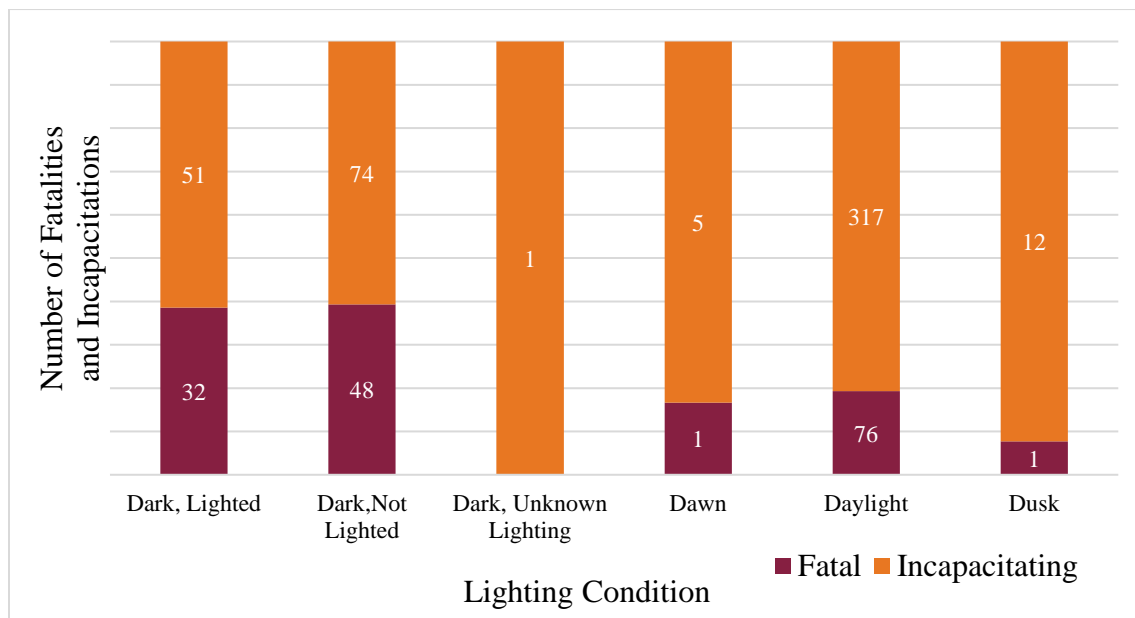
Figure 13. Chart. All KA on curves for various lighting conditions.

Figure 13 represents different lighting conditions that were present at the time of the crash. The most frequently recorded lighting condition that resulted in an incapacitating injury was daylight. The Daylight condition also had the highest number of fatal injuries. A large number of motorcyclists suffered injuries during times that were considered to be Dark, Not Lighted.

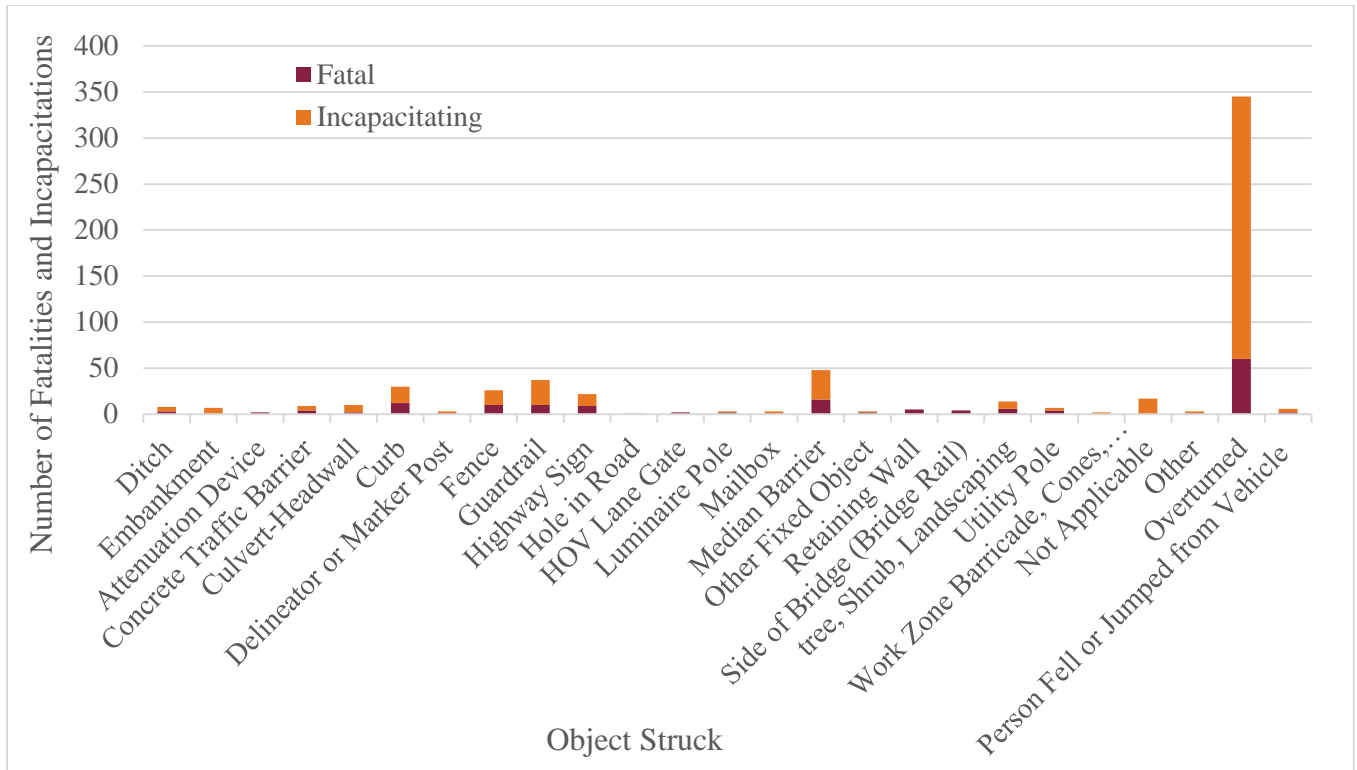
Figure 17. Chart. All KA on curves for objects struck.

Figure 17 provides details on exactly what the motorcycle struck, whether it was some type of roadside barrier system, a natural embankment, or a sign, etc. As previously stated, a large number of motorcyclists overturned and a large number of them hit fixed objects. Median barriers were the most hit object, with 32 incapacitations and 16 fatalities. There were also small numbers recorded for fences, guardrails, signs, and curbs. Figure 18 and Figure 19 show the distribution of crashes that occurred in areas of different posted speed limits. Figure 18 shows the distribution of fatalities, and Figure 19 shows the incapacitations. Note that the speed ranges represent the posted speed limits, not necessarily the speed of the motorcycle at the time of the crash.

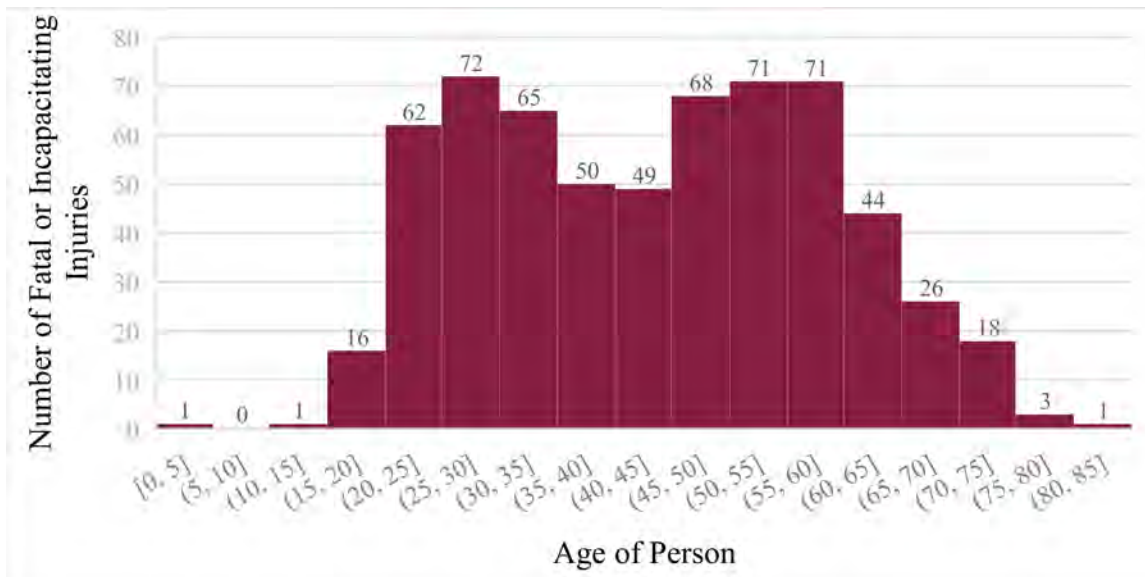
Figure 25. Chart. Number of KA victims of different age groups on curves.

Lastly, the age of each driver was plotted in a histogram to examine the crash distribution by age (Figure 25). The maximums were found to occur from age 25 to 30 and from age 50 to 60.

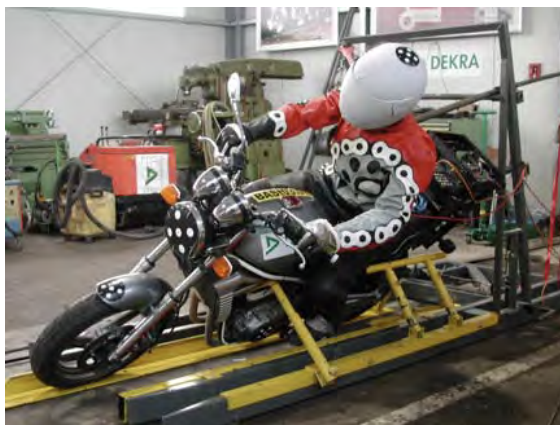
The data were separated into primary and secondary data to distinguish the difference between contact with the safety system and loads that are caused by the fall on the ground. This separation was necessary due to impact of the head on the ground, which caused a high peak in the acceleration data.

Figure 29. Test sled in inclined position with motorcycle and dummy (Peldschus et al., 2007).

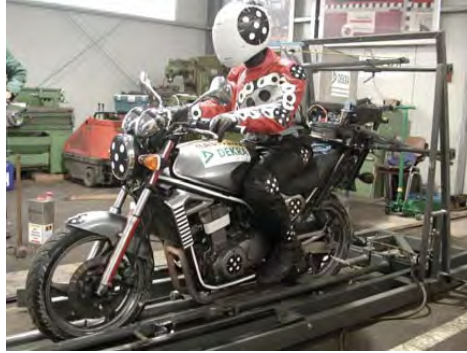
**Figure 30. Test sled in upright position with motorcycle and dummy (Peldschus et al., 2007).**

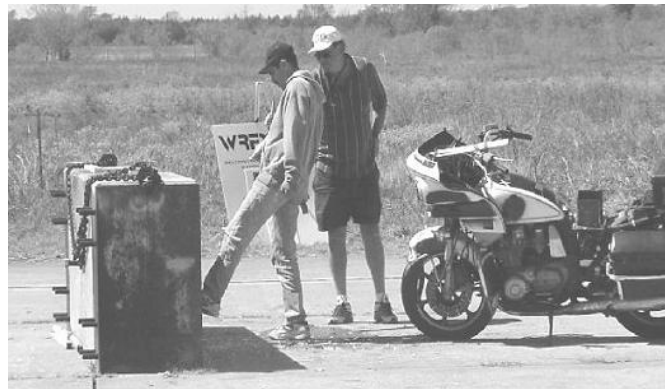
**Figure 31. Concrete barrier and motorcycle type used in full-scale motorcycle crash testing (Adamson et al., 2002).**

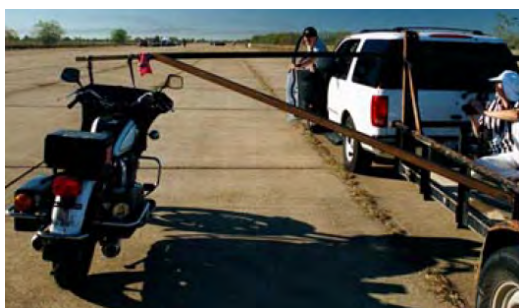
Figure 32. Motorcycle tow system (Adamson et al., 2002).

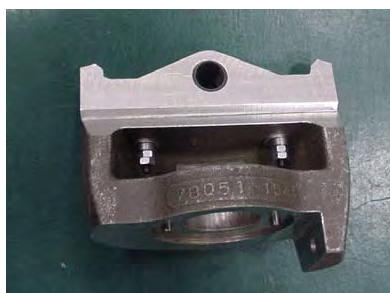
Figure 35. Frangible shoulder for Hybrid III dummy (Peldschus et al., 2007).
