Final Report
August 2019

Data Collection and Analysis of Crossing Structures along West I-80 and USA Parkway in Nevada

SOLARIS Consortium, Tier 1 University Transportation Center
Center for Advanced Transportation Education and Research
Department of Civil and Environmental Engineering
University of Nevada, Reno
Reno, NV 89557

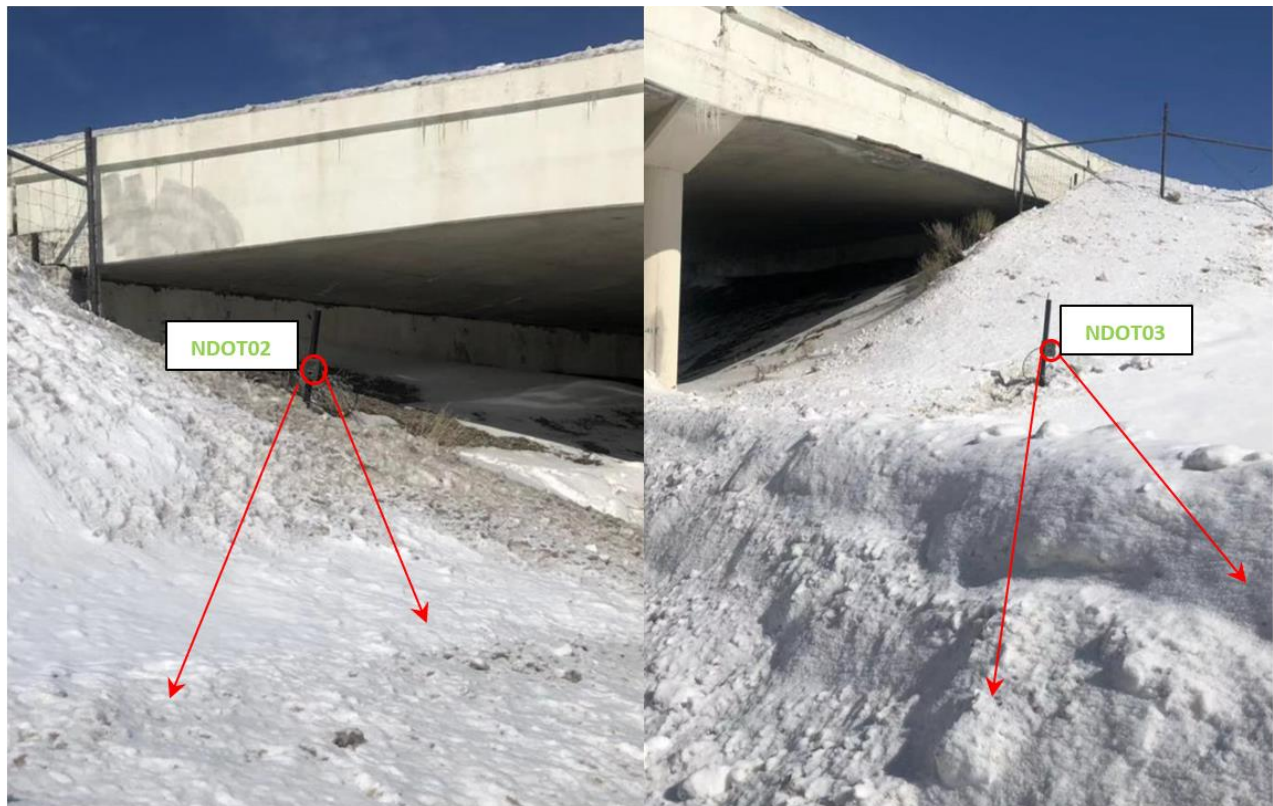
Figure 2-8 Locations and directions of two cameras at the west vehicle underpass in the Pequop Mountain (2019 spring)

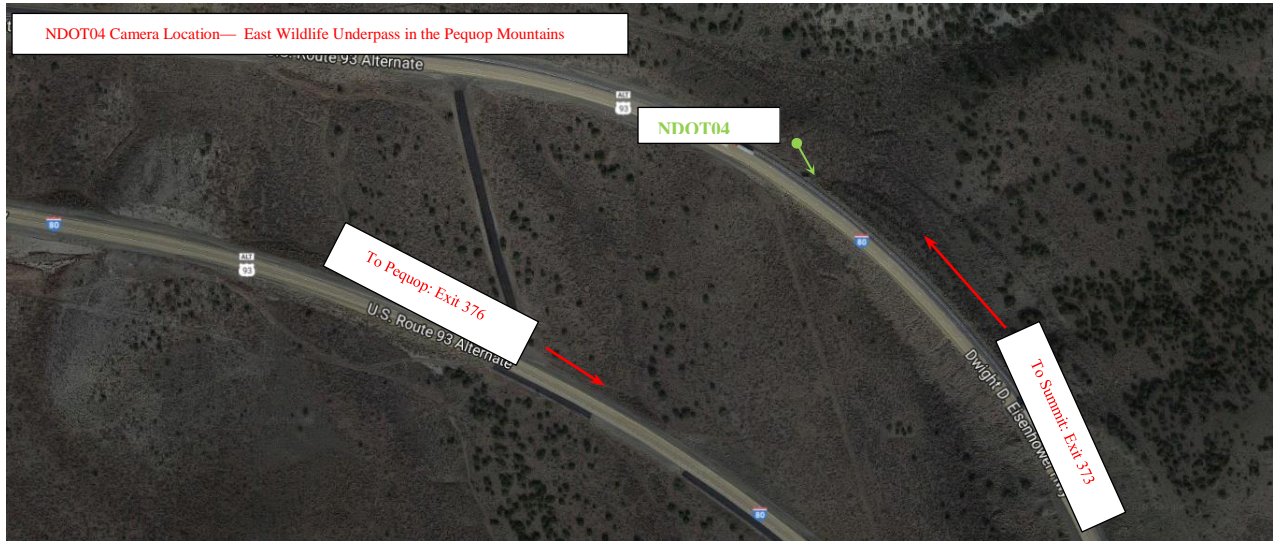
Figure 2-9 Camera layout at the east wildlife underpass in the Pequop Mountains (2018 fall)

installed on a fence pole at the north entrance in 2018 fall, Figure 2-9 and Figure 2-10, and moved to the south entrance in 2019 spring, Figure 2-11 and Figure 2-12.

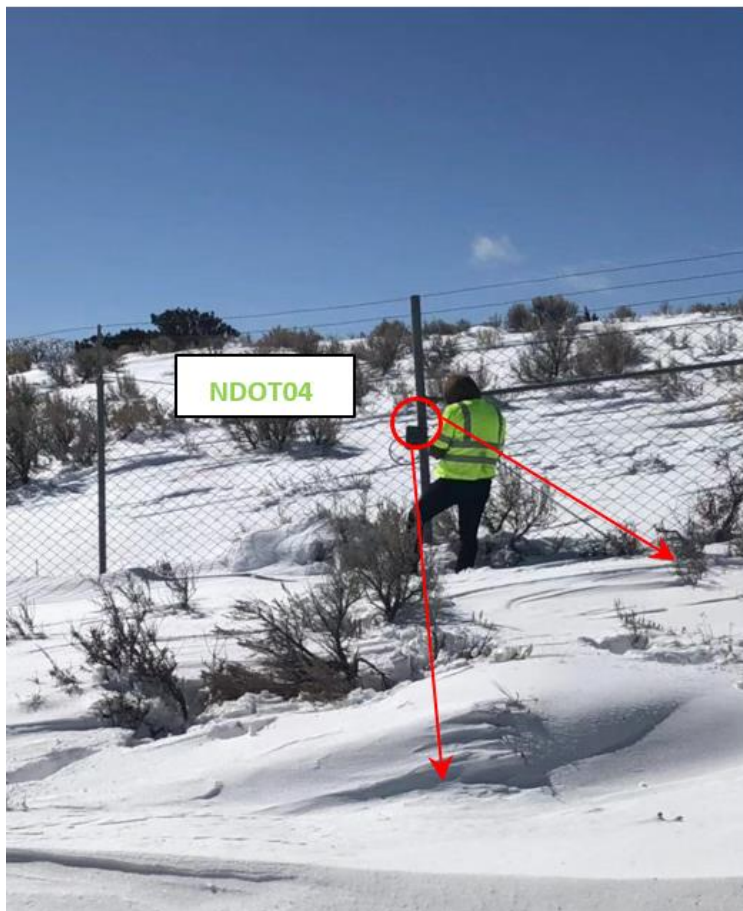
Figure 2-12 Locations and angles of the camera at the east wildlife underpass in the Pequop Mountains (2019 spring)

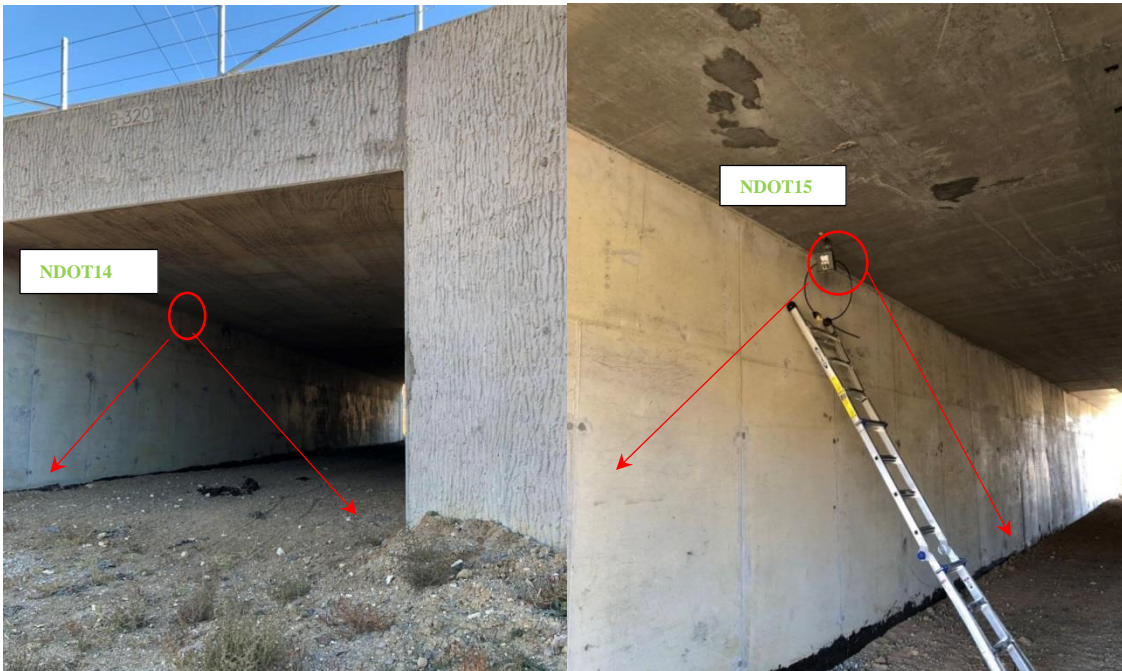
Figure 2-6 Locations and directions of the cameras at the north Wildlife Underpass on USA Parkway

Camera brackets were installed by NDOT District II before 10/12/2018. Locations of NDOT14 & NDOT15 were demonstrated in Figure 2-6.

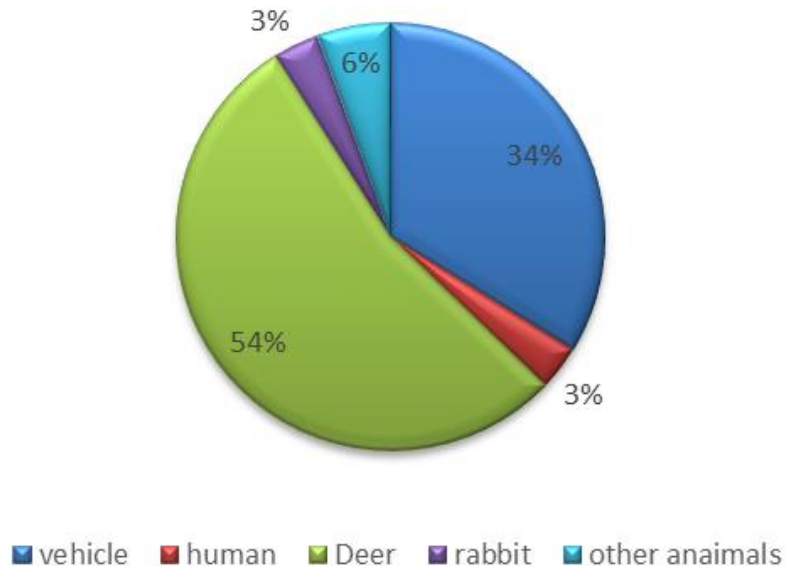
Figure 4-1 Observed frequency percentages of different species at the structures

There are total 3,249 groups of pictures recorded at the six crossing structures along I-80. Approaching frequency of different species is shown in the pie chart of Figure 4-1. The 1,553 deer records (groups) counted the major part of all records (groups). Other wildlife species included rabbits, bobcats, coyotes, grey fox, elk, and birds. There were also 904 records related to vehicles and pedestrians at the two vehicle-underpasses in the Pequop Mountain, these records were excluded due to they have nothing to do with wildlife migration. Figure 4-2 shows the number of captured pictures related to each species. Figure 4-3 compares the approaching records in the 2018 spring (3/21/2018 - 5/1/2018, 41 days), 2018 fall (9/15/2018 - 12/31/2018, 108 days), and 2019 spring (1/01/2019 - 5/12/2019, 133 days). It shows that more wildlife using these passing structures during 2018 fall than other periods.
